**SOUTHWIRE COMPANY
METALLURGICAL LABORATORY**

***ENCYCLOPEDIA
TEARS OF COPPER WIRE***

**by
dr. E. Henry Chia
and
Gautam R. Patel**

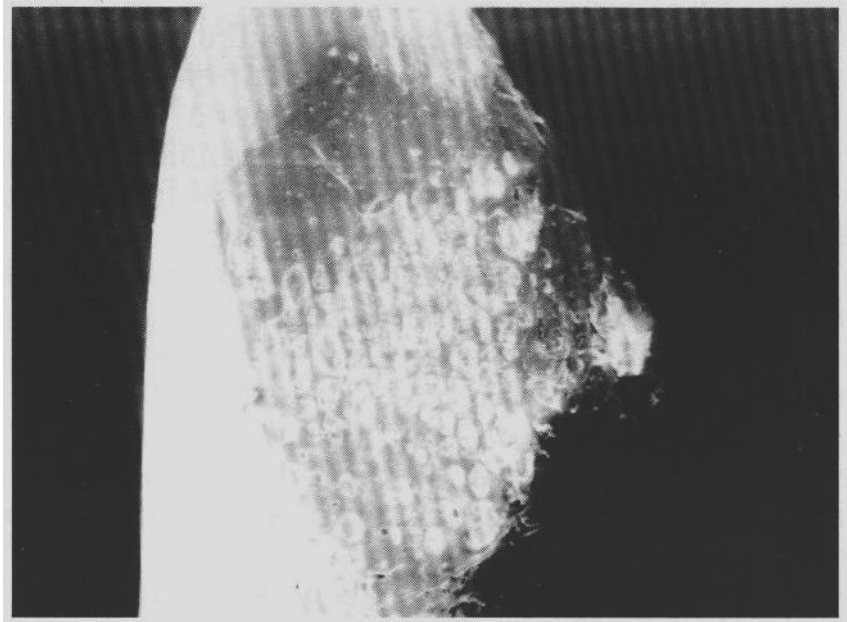
yarn breakage characterized by the formation of an electric arc (electrical scintillation) during the continuous annealing in the resistance to electric oven resulting in partial or complete melting of the copper wire

Fusione localizzata che si è verificata durante la ricottura del filo, in continuo.

- 1- contaminated ring surface of the furnace of the pulley contact.**
- 2- inadequate tensioning of the wire by the compensator or "dancer"**
- 3- pulley or the oven contact strip off-center or not fitted properly**

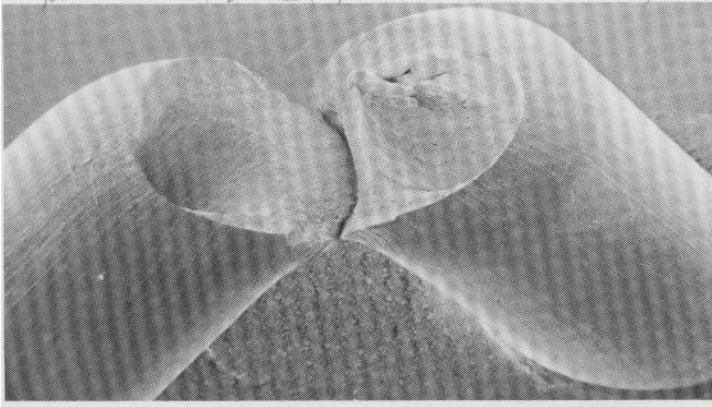
Two adjacent surfaces of a typical cup-cone failure (Central tear)

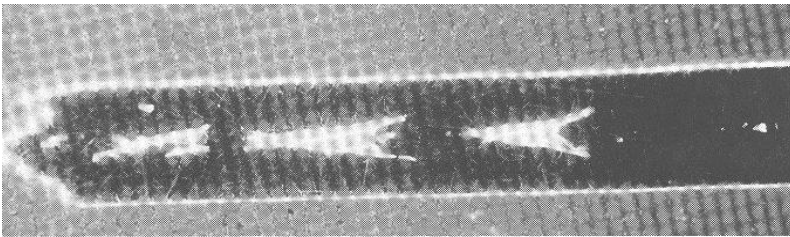
Longitudinal section of a wire showing the formation of defects: central tear (cup-cone)

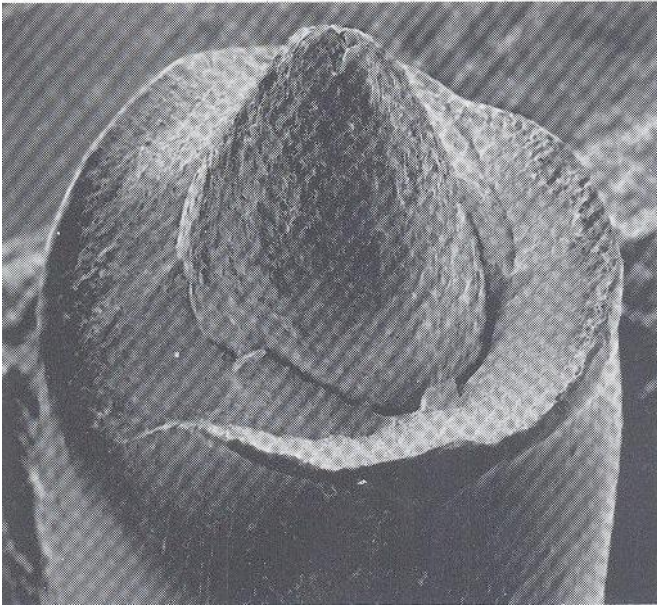
A portion of the central cone cup-cone failure

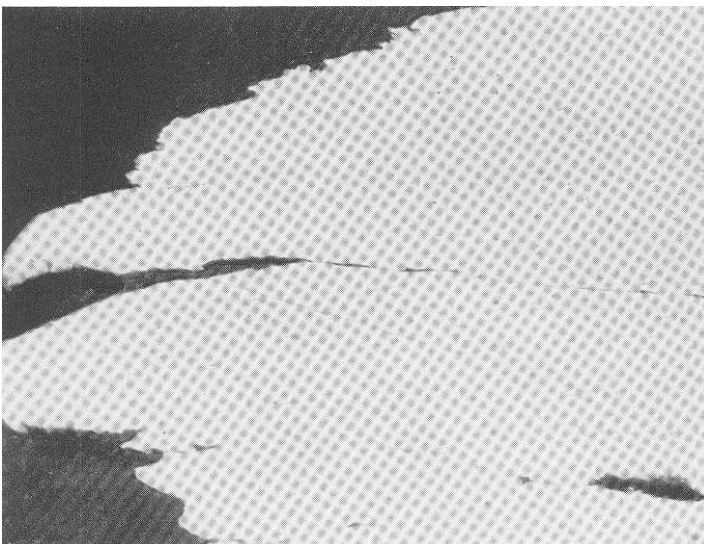
High concentration of particles of copper oxide present in the cup-cone fracture zone

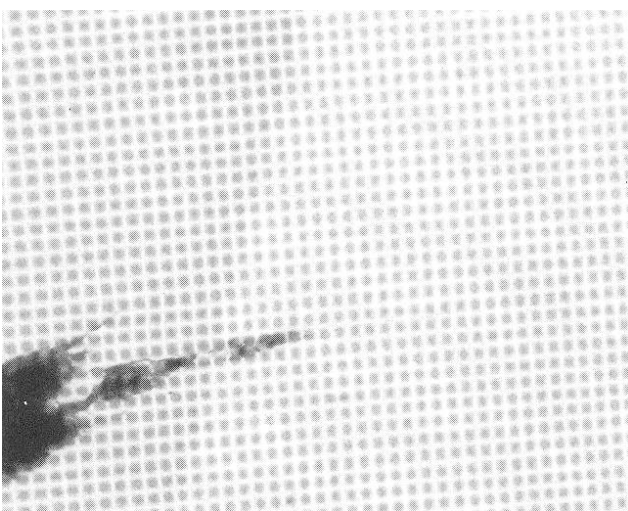
High concentration of strings of copper oxide particles present in the area of the cup-cone fracture

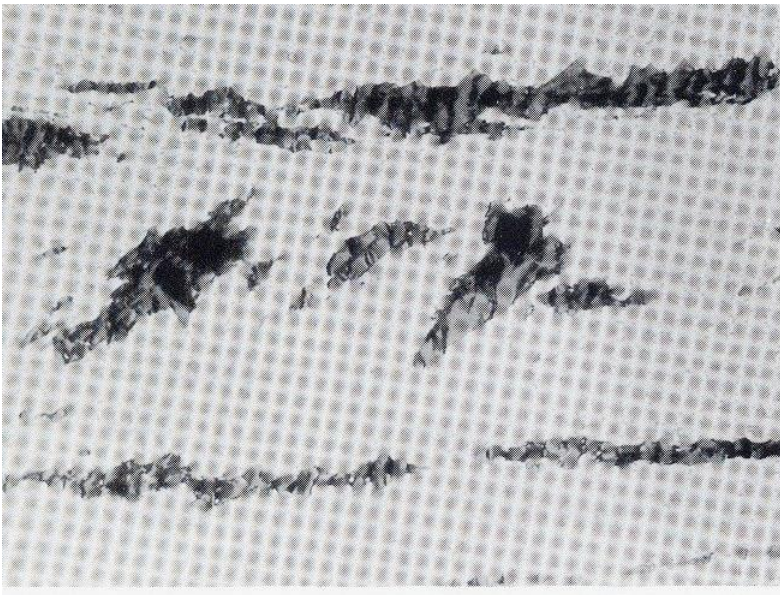
Segregations of large and small copper oxide particles in the cup-cone fracture zone

1- High concentration of particles or copper oxide strings in the central portion of the thread. These particles act as a point of origin where the focus is to initiate a micro-crack which will propagate during the drawing up to occur in the yarn breakage.

- 3- oxides circumferential of the pouring spout that have fallen into the liquid copper bar.
- 4- Bunch of copper oxide particles from the burner hole, have fallen in the liquid of the copper bar.
- 5- Incostante and uneven distribution of copper ossiduli in the matrix, caused by cooling inappropriate wheel / bar

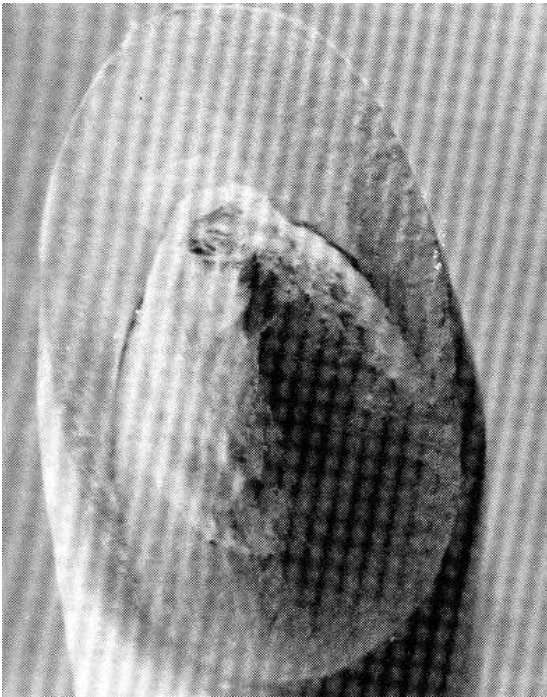
**the cone portion of a cup-cone failure
produced by a non-magnetic micro-
inclusion**

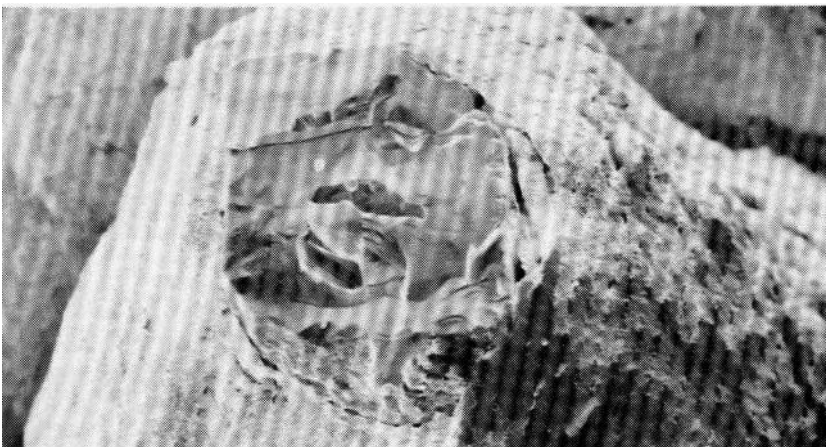
**high magnification
photograph of silicon-
based particle (likely
SiO₂)**

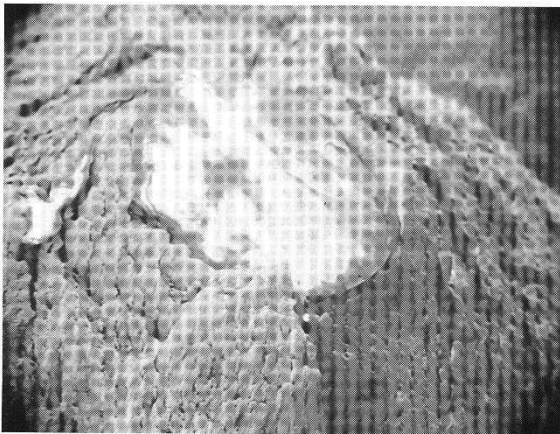
Photograph of a fracture caused by particle
containing **Ai-Si-Ti**

1- presence of micro particle of inclusion (composed of aluminum, silicon and titanium, in this case) that caused the crack during the drawing

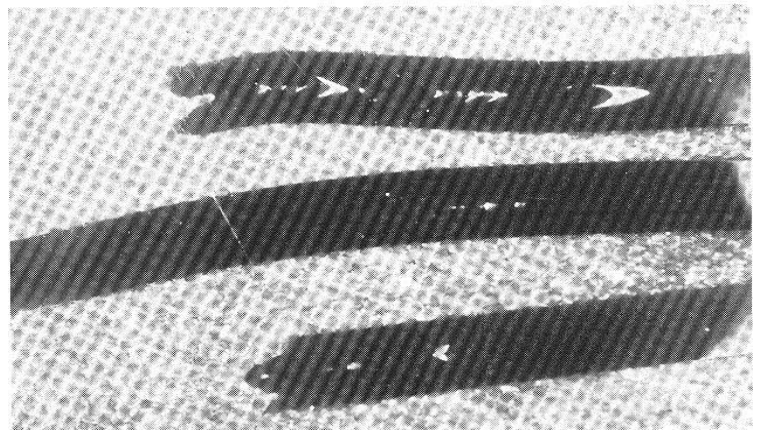
Macrograph of the longitudinal section of a cup-cone failure, where the "tear - central" lying on the longitudinal axis of the wire, caused by the angle of the incorrect chain reduction cone (20°) are visible

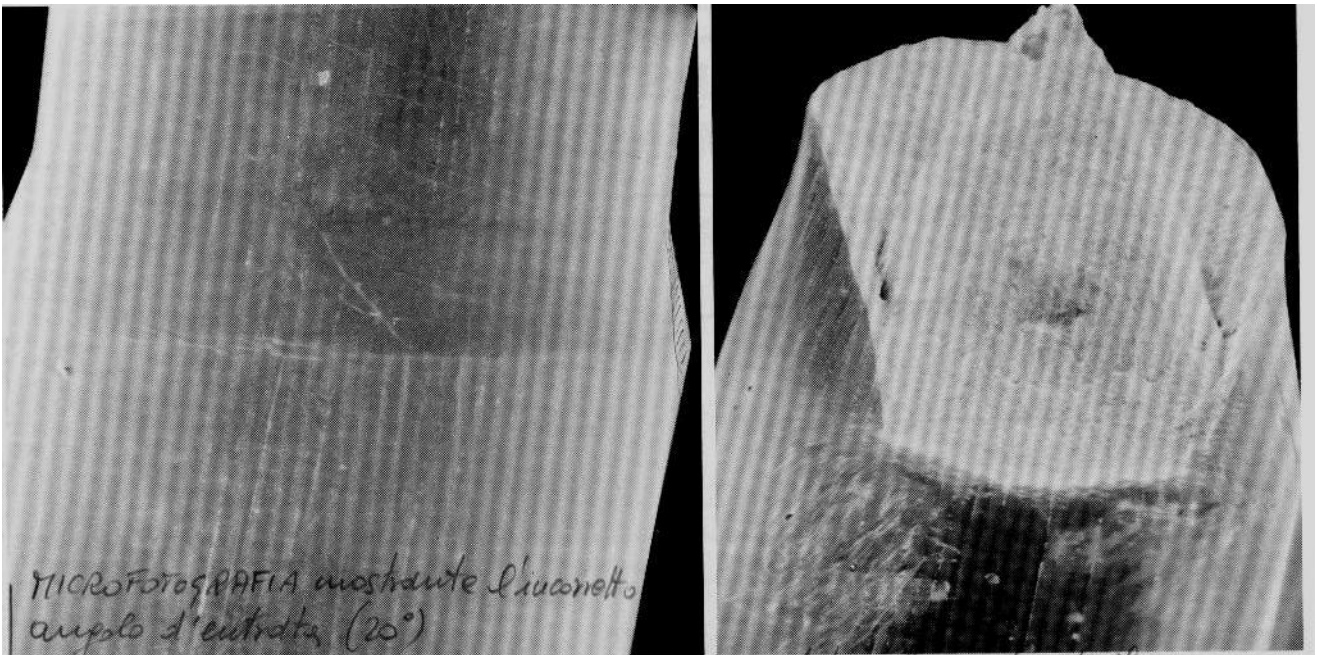
**Macro showing cup-cone break a cone semi-angle caused by angle
Incorrect chain reduction ($\alpha = 20^\circ$) chain reduction too open.**

- 1- excessive hydrostatic stress in the central portion of the thread during the drawing.
- 2- Force counterinsurgency increased traction
- 3- Reduction of insufficient section
- 4- Inadequate angle geometry of the chain reduction cone.
- 5- excessive angle of the incoming wire chain
- 6- Friction increased by insufficient lubrication and / or reduction rate or corner is not properly entered.
- 7- excessive length of the cylindrical part of the chain surface
- 8- very worn Capstans

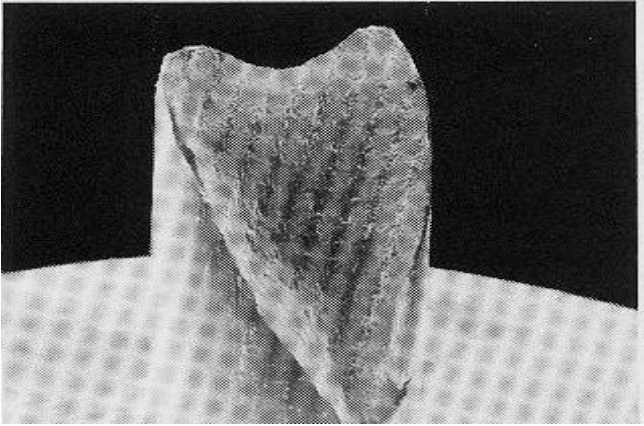
Fracture type cut, started by a defect in the shape of an arrow

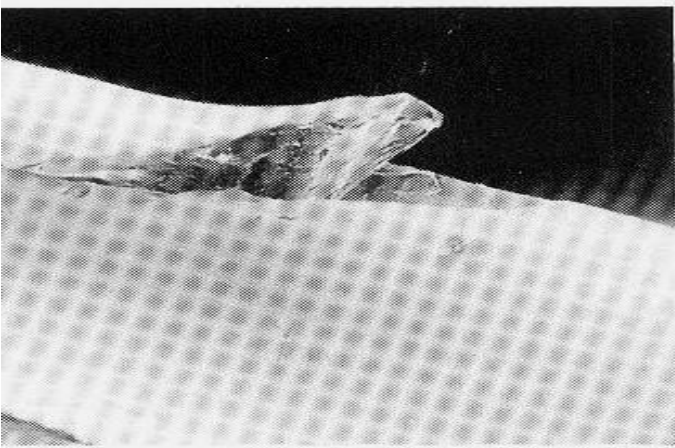
Eruption on the surface of a pointed defect of arrow, appeared after many drawing steps.

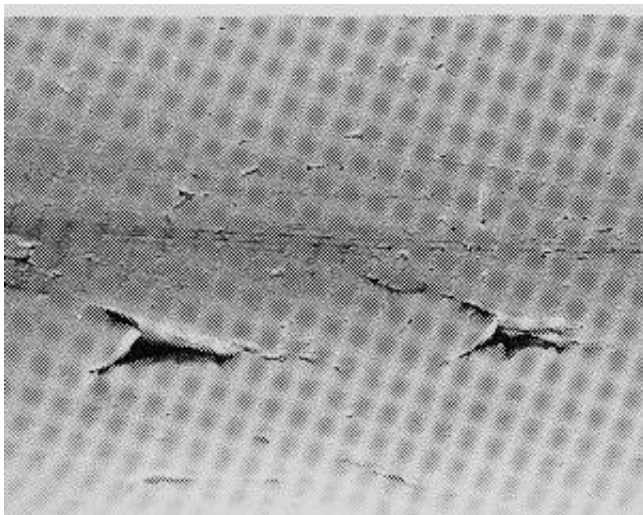
Defect in the shape of "V", On the wire surface

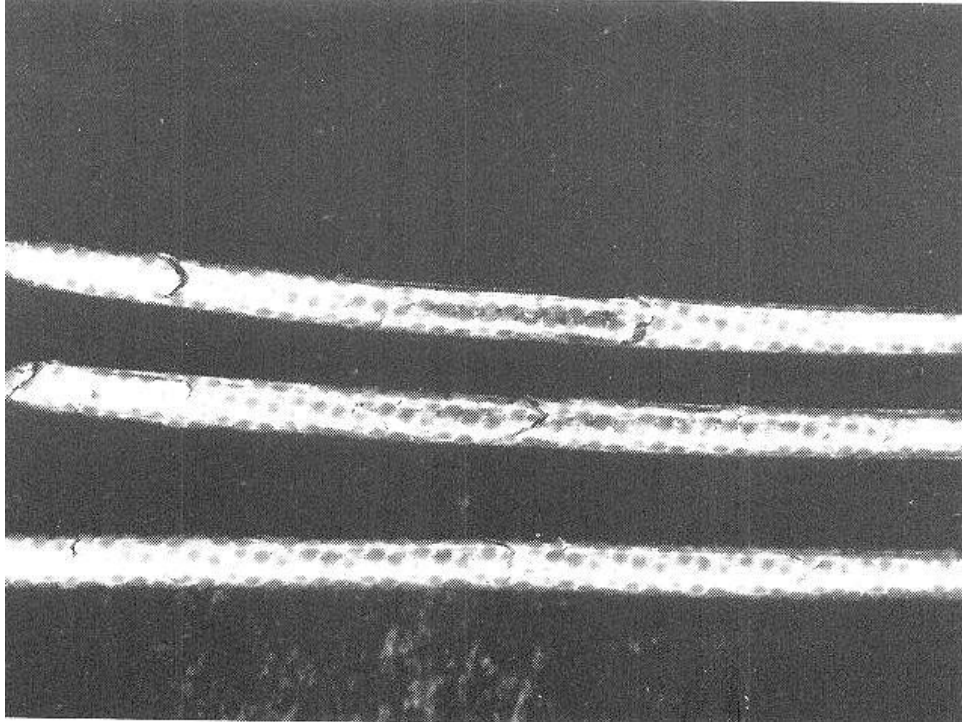
A flush with the inclined surface shows cracks in a "V-shaped" that will cause thread breakage.

- 1- Defectiveness of burning on the surface that represent the points di'inizio of thread breakage.
- 2- 1- strands of wire having hardened surface
- 3- 2- profile Inappropriate chain
- 4- 3- approach angle and reduction in the chain not perfectly coupled
- 5- 4- length of the cylindrical die too short.
- 6- 5- incorrect wire-chain alignment
- 7- 6- Rubbing and grooves of the wire on the outside and / or inside the machine.

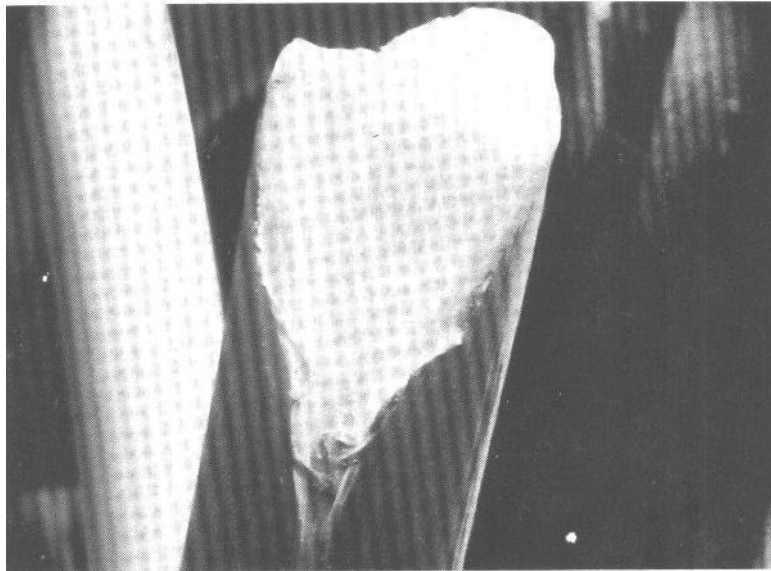
**Cutting
resulting
defects in
"crow's**

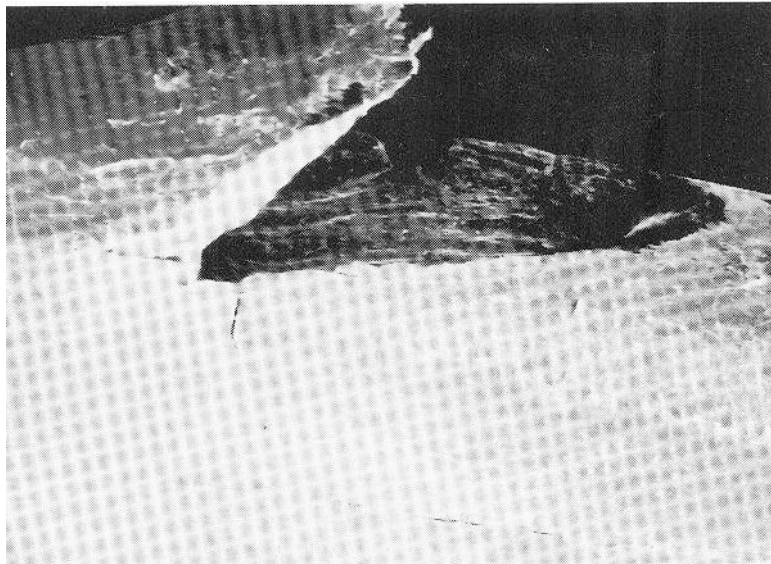
eruption on the surface caused by a defect in "crow's feet"

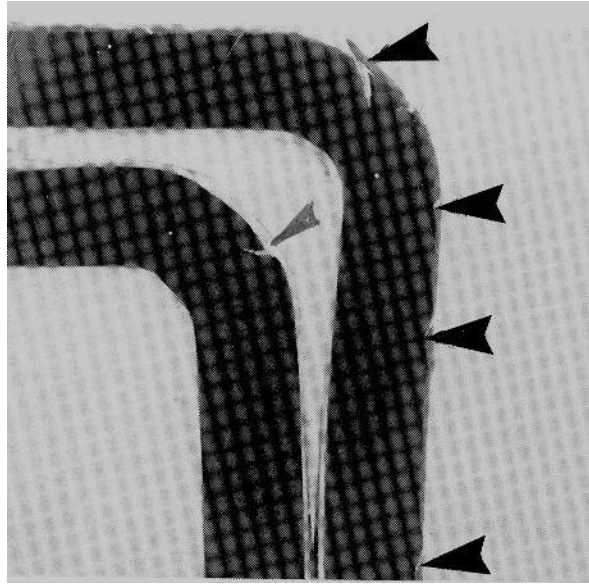
longitudinal section, of wires which have been bent specifically, where the surface cracks are clearly visible caused by a set of oxides hidden skin".

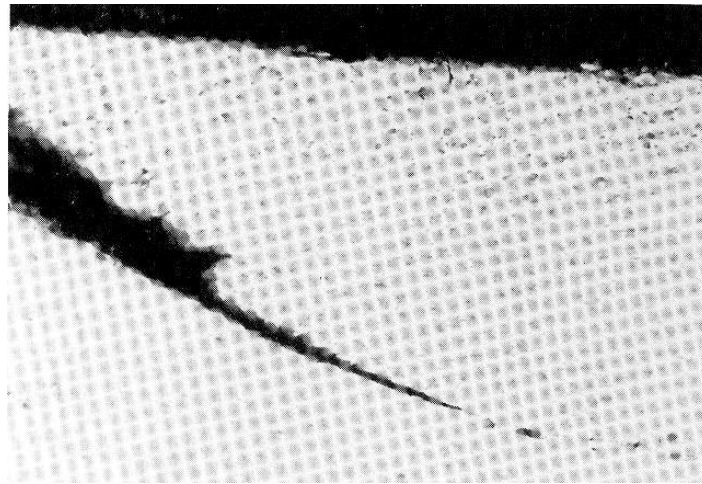
A set of surface oxides is clearly visible in the "crow's feet" in the form of cracking section.

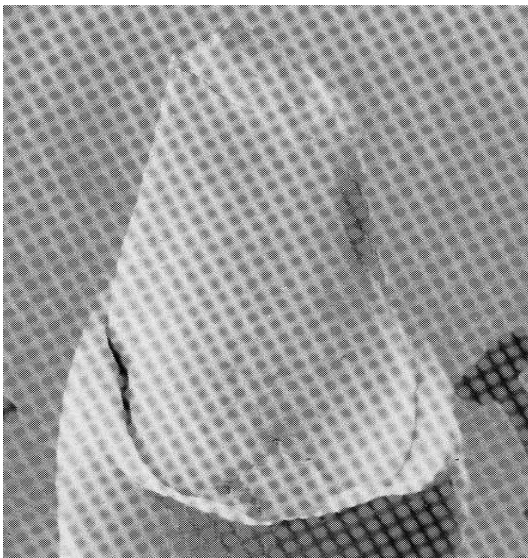
Micrograph of the wire breaking showing a large piece of inclusion of Fe.

- 1-reggette steel or fragments of seals introduced with the load cathodes
- 2- rod erosion of copper flow adjustment
- 3- Wireless usta iron to gush the hole of the pouring spout
- 4- flakes and specks of steel wire from dirt on the floors
- 5- deterioration of the orifice of exit of the flame of the gas burner in the melting furnace.
- 6- steel falls drops in the oven during electric arc welding for the repair
- 7- small chips, flakes and particles fall out of the cylinders that are worn out.

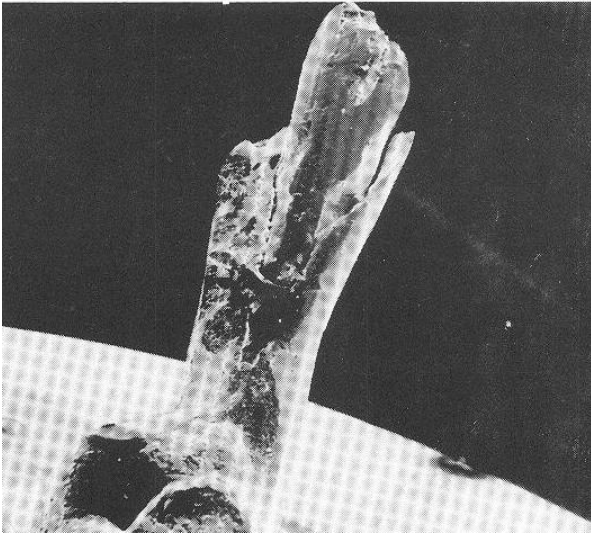
The U. S. M. micrograph of a break for inclusion

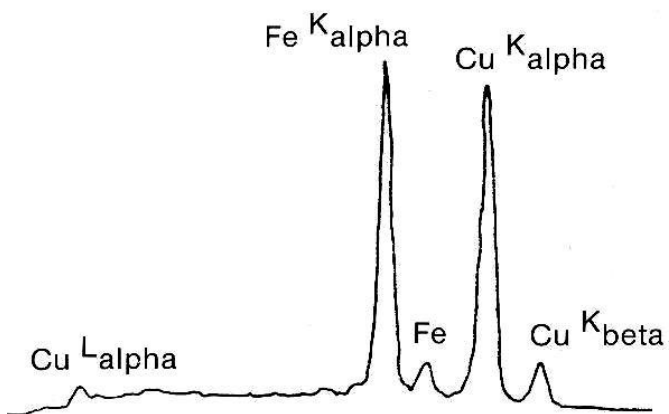
Microanalysis to S. E. M. area of inclusion Which one shows the presence of iron and copper.

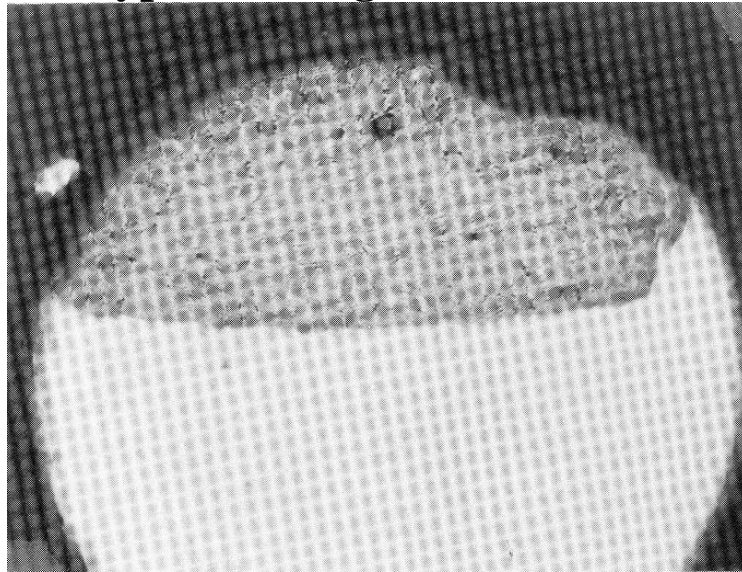
Ferrous inclusion in a copper wire having 0.254mm diameter (Nikon attack)

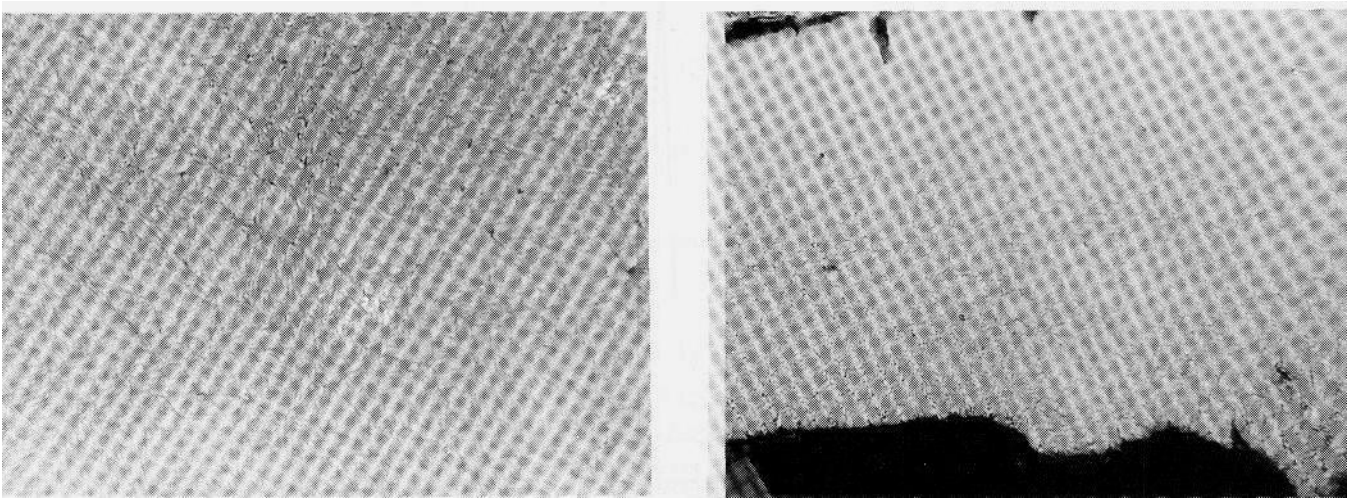
Inclusion in a ferrous wire having 0,559mm diameter, identified as Fe-Cr (4-6%); Mo (1-2%); V (0.8-1.5%); corresponding to: H13 stainless steel cylinder; . (Nikon attack)

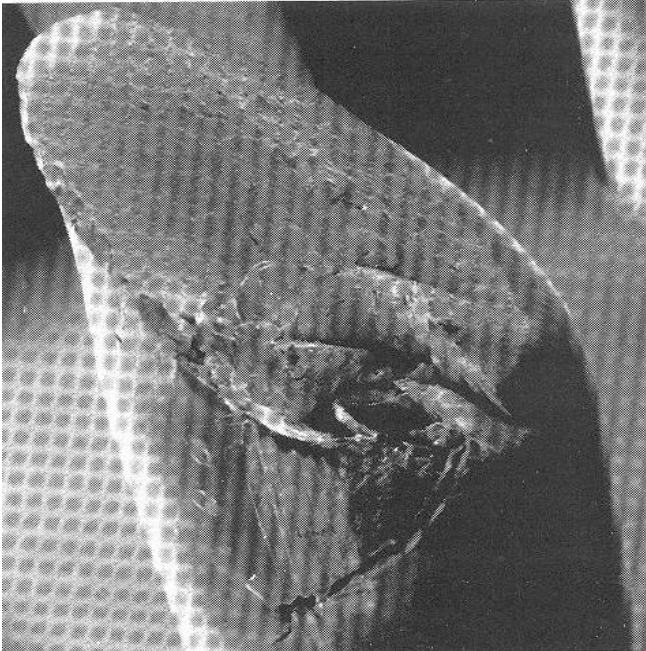
of copper oxide inclusion on the fractured surface of the wire breaking

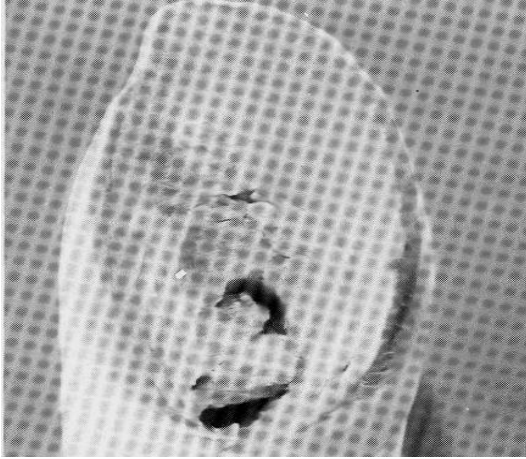
la presenza di inclusioni magnetica (Fe) e non-magnetica (Si)

1- breakage caused by the presence of inclusion non-magnetic (Cu₂O; It; You C; SiO₂, Al₂O₃, Mg O, and slag particles)

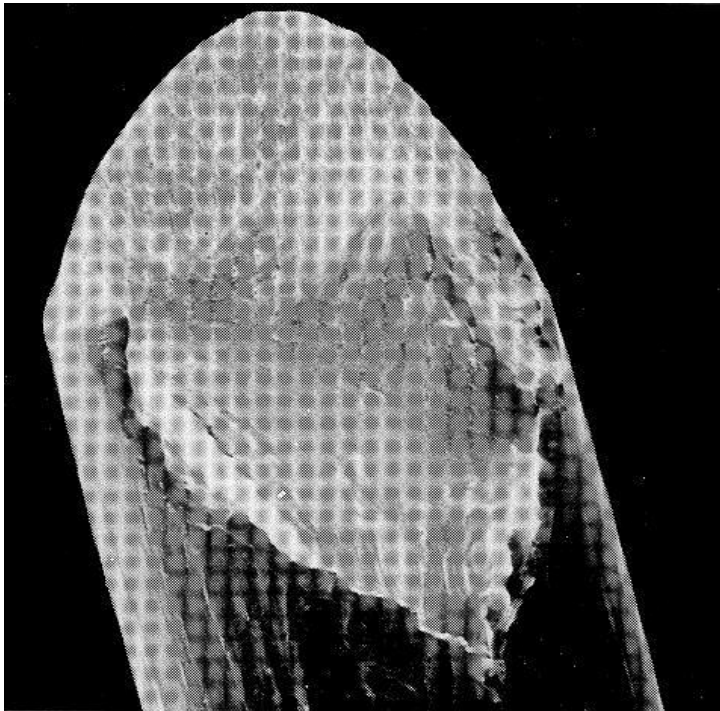
Fracture absent inclusion.

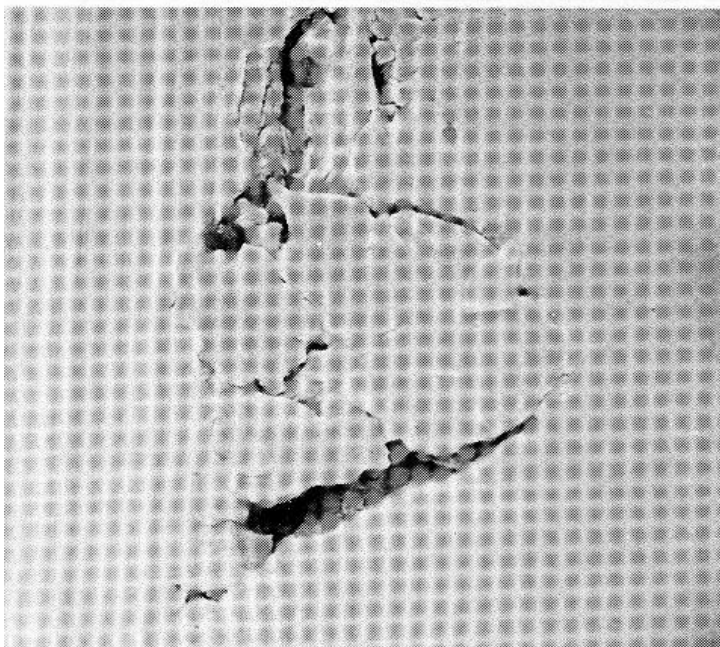
**Inclusion on the wire surface,
away from the main fracture,
was found to contain Iron**

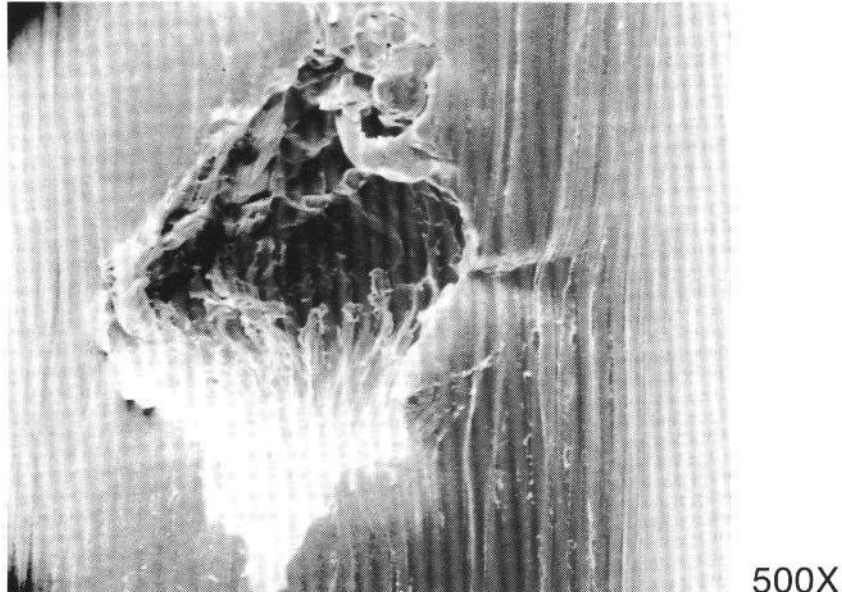
Cavity left by an inclusion that was present on the wire surface. The shape of the cavity on the surface recalls the shape of the fracture.

1-magmatic and non-magnetic inclusions that are present in the wire matrix, damage to the beginning of cracking of the wire drawing process to proceed. The inclusion comes to the surface and breaking comes out and falls in the emulsion, leaving on the surface of the wire its cavity.

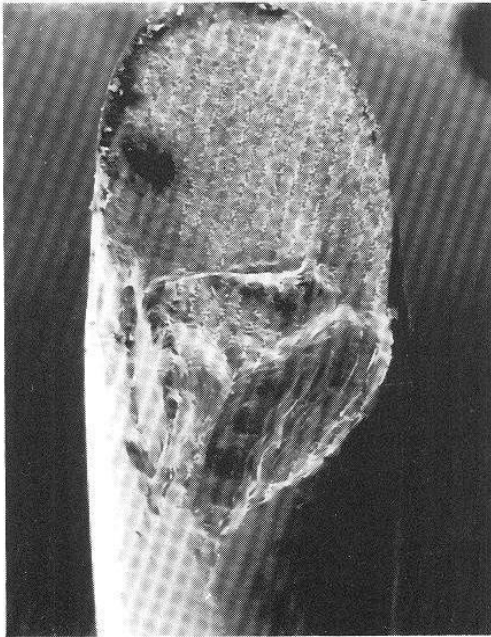
25X

incision left by a inclusion (in this case one of Fe particle) present on the wire surface.

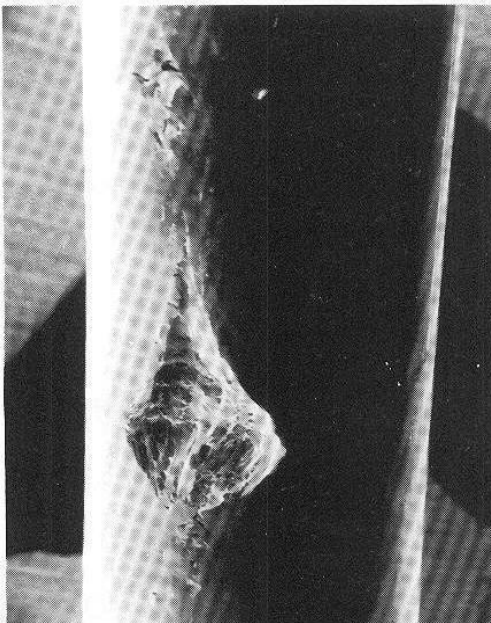
25X

Engraving left by a inclusion (in this case a particle of Fe) on the wire surface, away from the area where it is fractured.

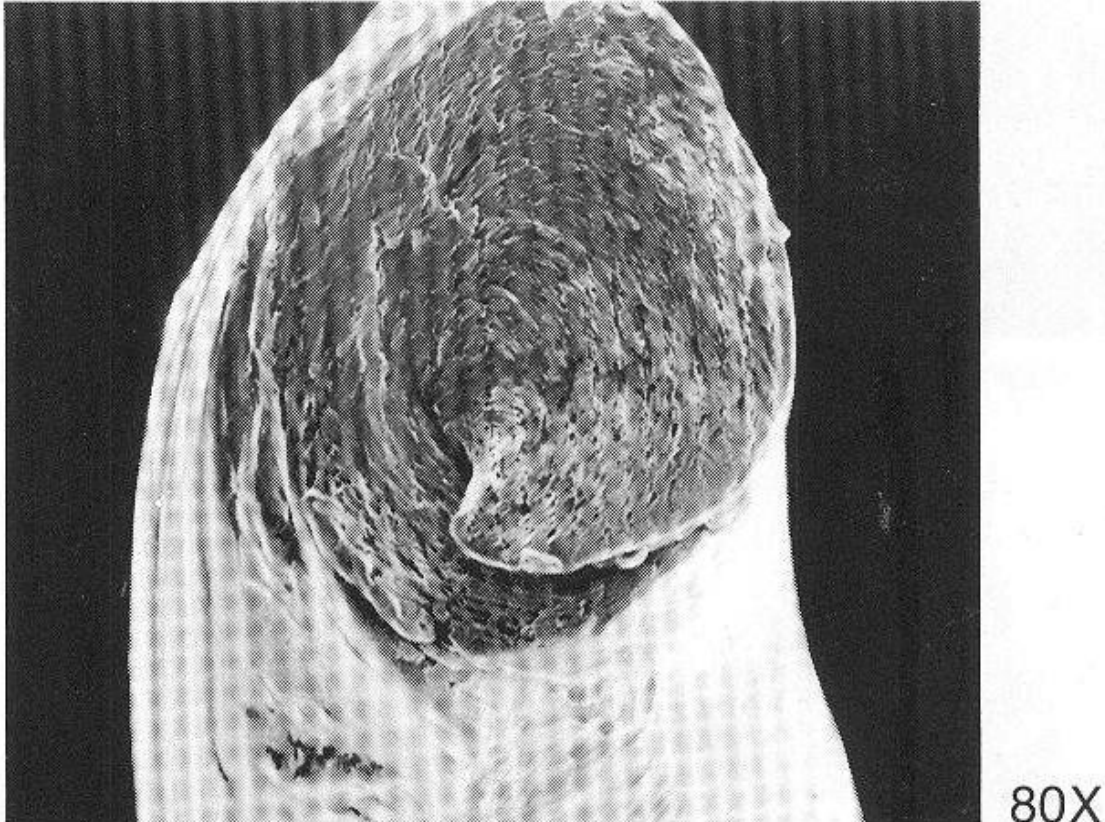
Rupture associated torsion and bending the wire on the area of fracture

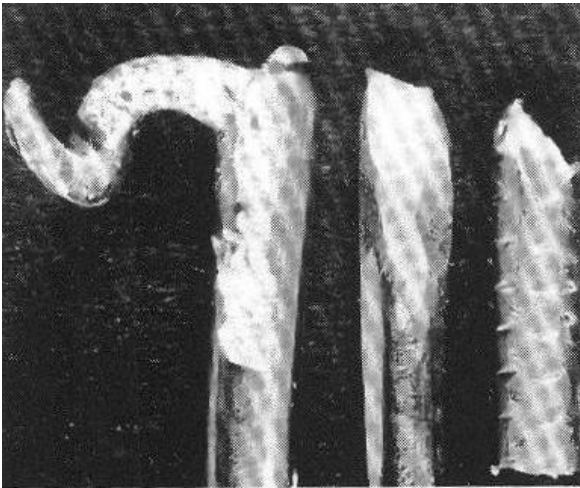
1X

abrasion damage observed in the vicinity of the wire breaking

CAUSE / E:Rupture caused by the capstan of the drawing machine which has abraded the wire in the

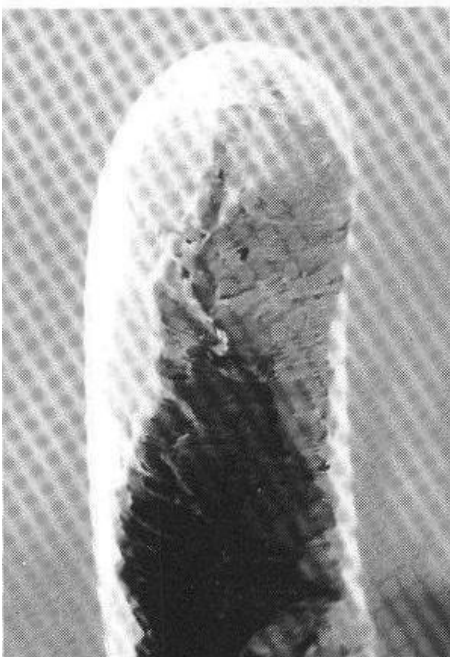
69X

from abrasion damage observed in the vicinity of the wire breaking

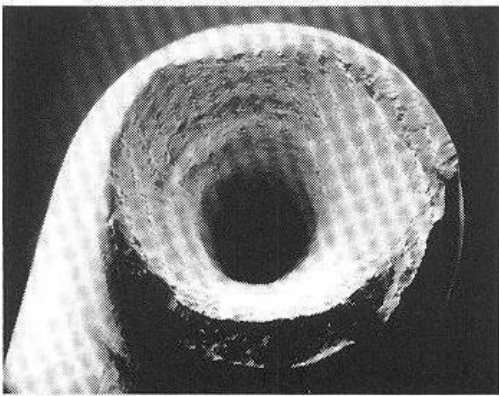
SEM micrograph of a thread break for macro porosity that exhibits the characteristic funnel-shaped cavity.

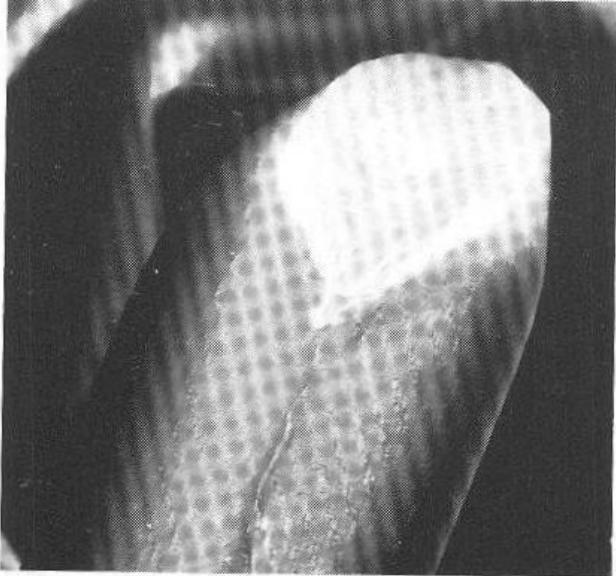
31X

Breakage associated with a defect of hot-rolling of the wire rod.

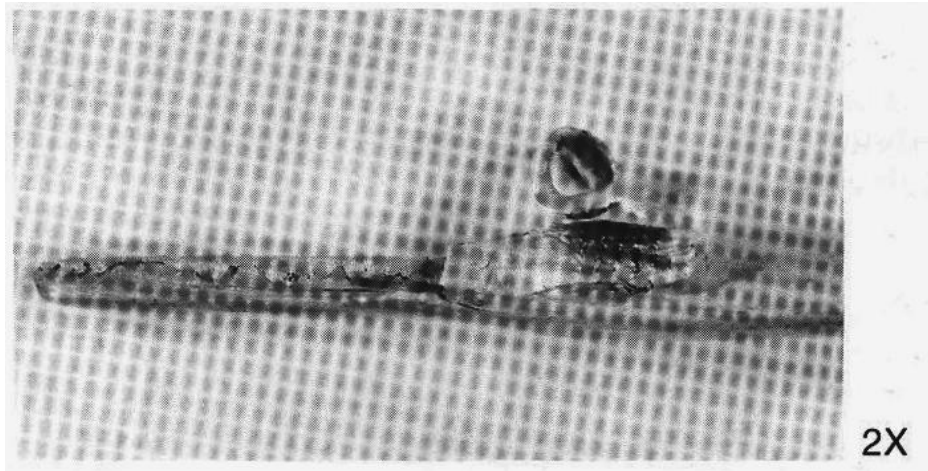
The chip performs the "characteristics of a folded piece of metal"; this is the result of a longitudinal row (or "swaging") of rolling (overfills).

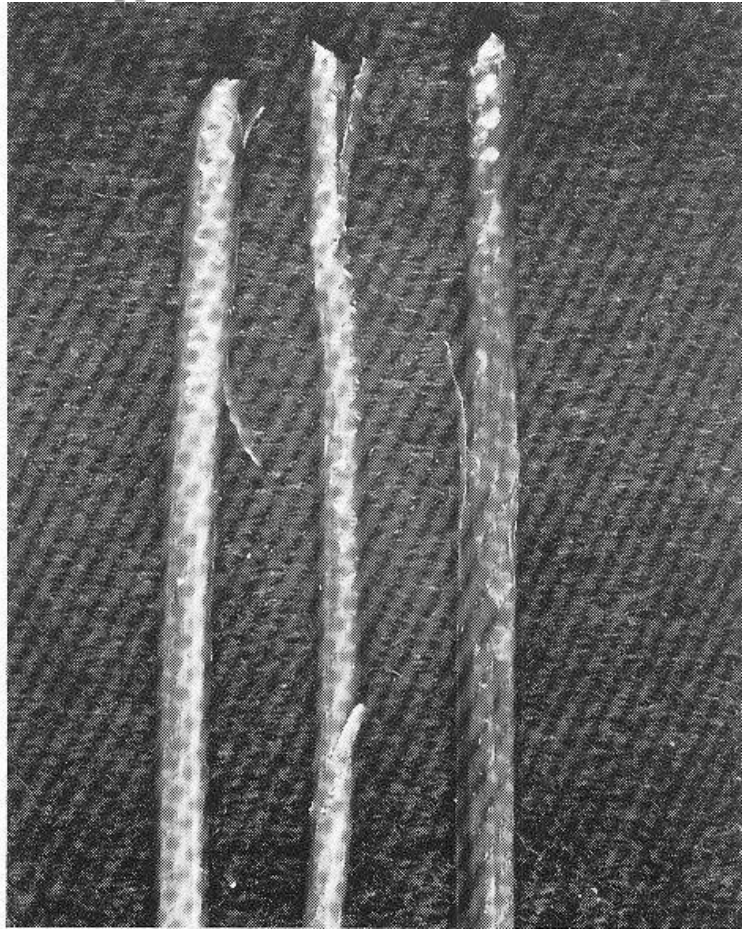
2X

Broken wire showing splinters (caricatures) on the wire surface, where the breakage occurred.

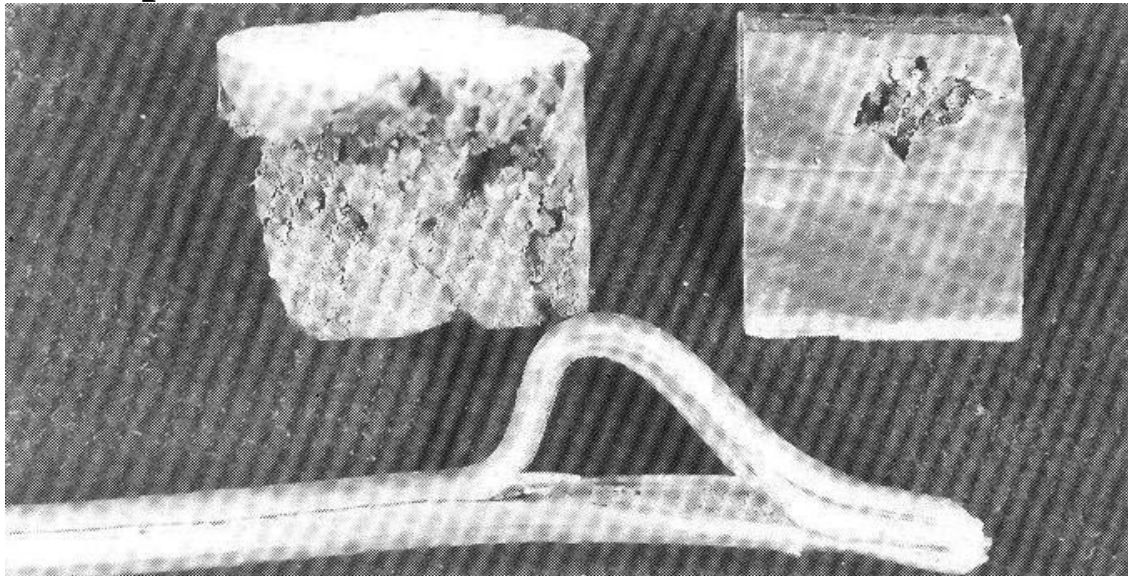
Presence of a slag of coarse copper oxide in the fracture area.

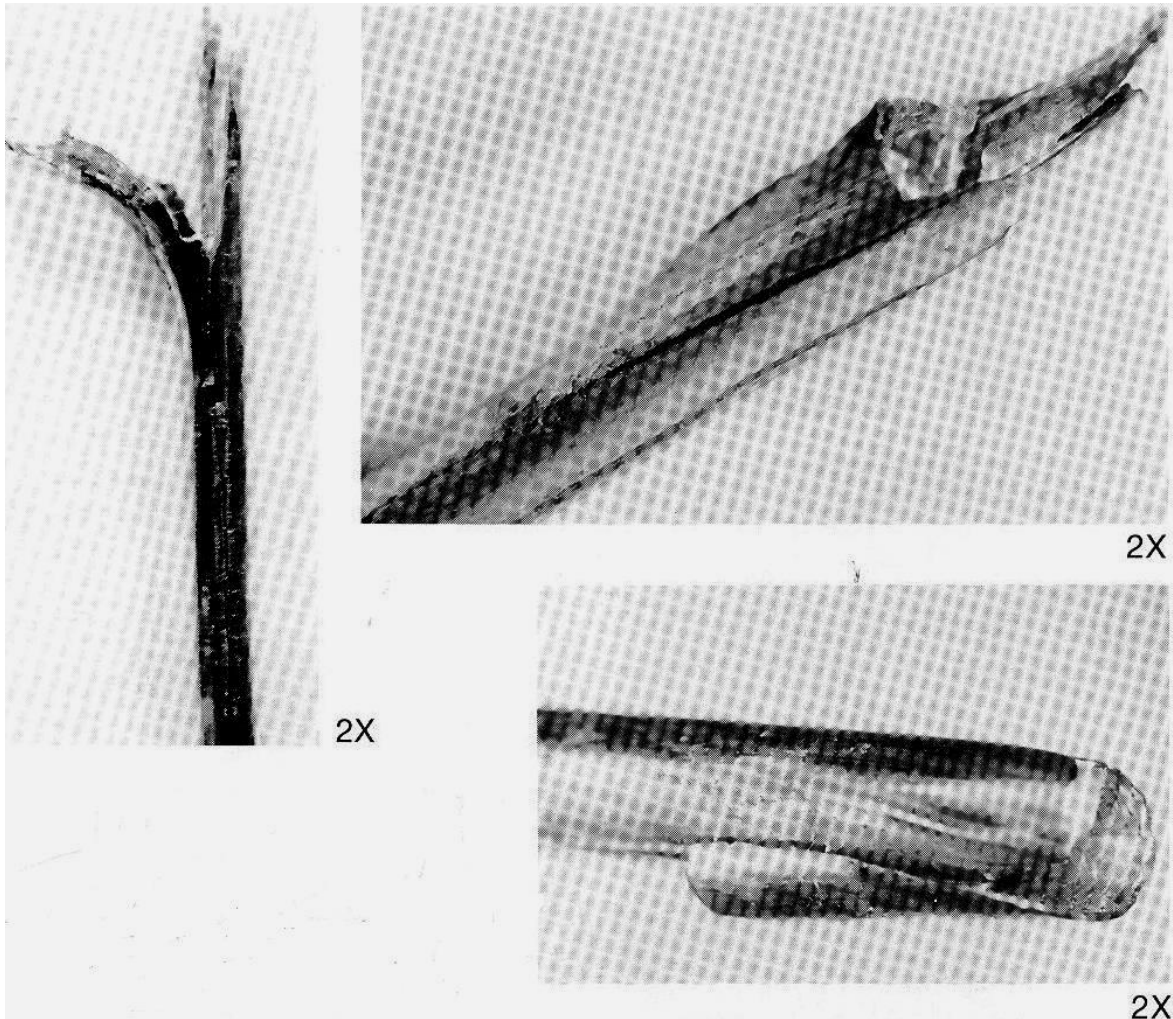
Macro showing
different ways to present
fracture due to flakes
incorporated by laminating
hot wire rod

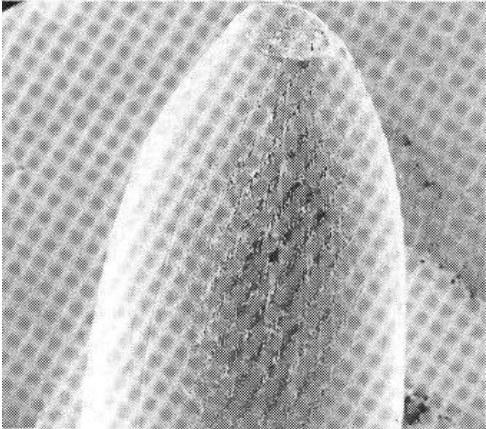
20X

Micrograph electronic scanning of a type of failure by necking showing the characteristics of "the two cups" and the symmetry of the break in the necking area.

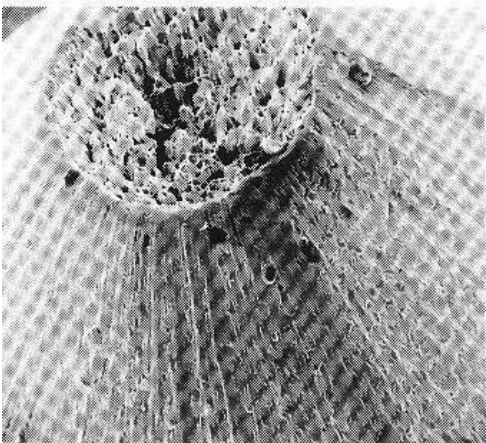
60X

SEM micrograph of a tensile failure showing the formation of "craters" on the fracture surface.

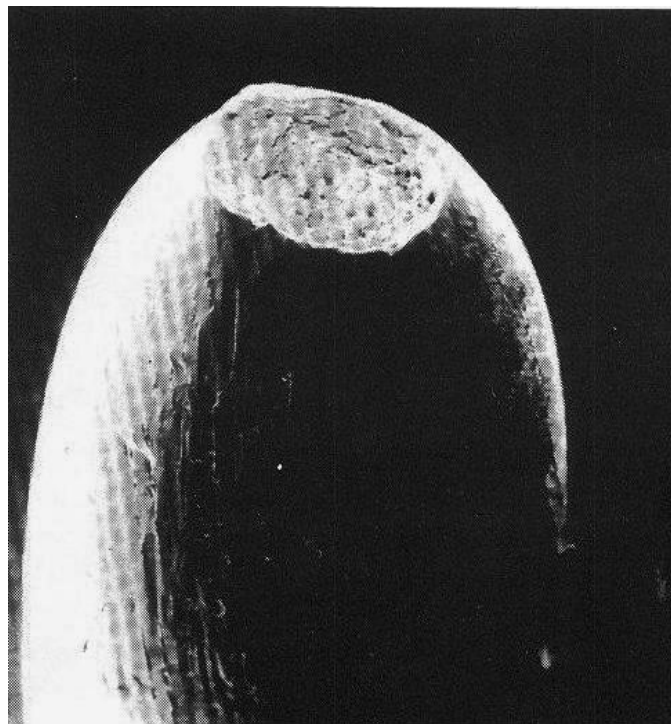
tensile failure caused by overlapping cross (crossover) of the wire ring of the capstan

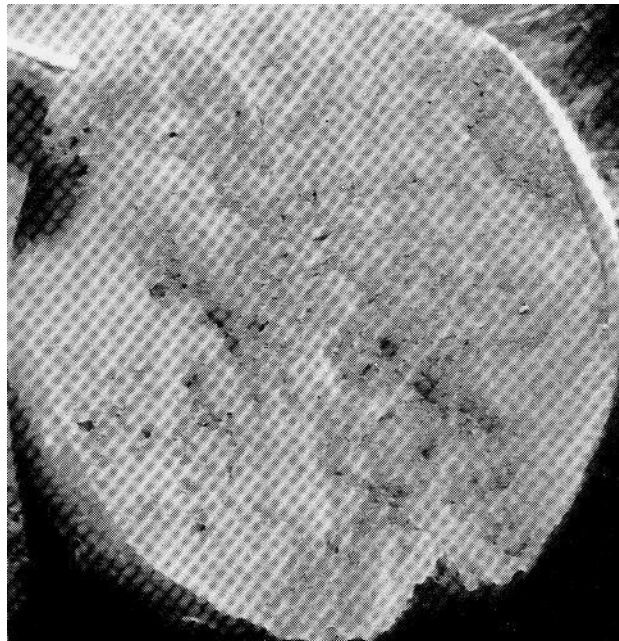
Flat" rupture of a weld ("Power")
