به نام خدا

مرکز دانلود رایگان
مهندسی متالورژی و مواد

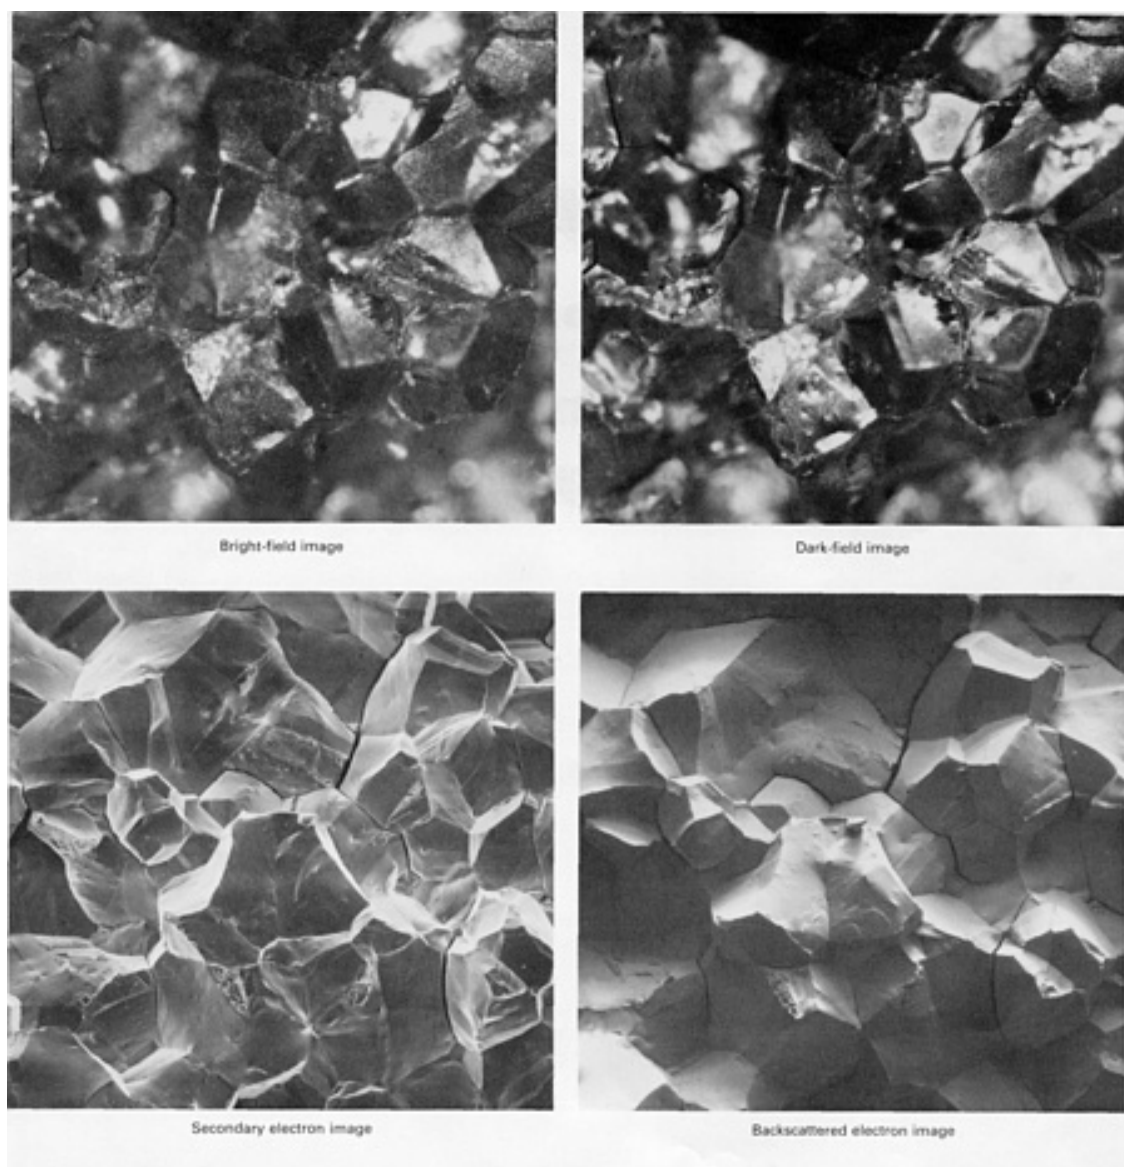
Fig. 1 Comparison of light microscope (top row) and scanning electron microscope (bottom row) fractographs showing the intergranular fracture appearance of an experimental nickel-base precipitation-hardenable alloy

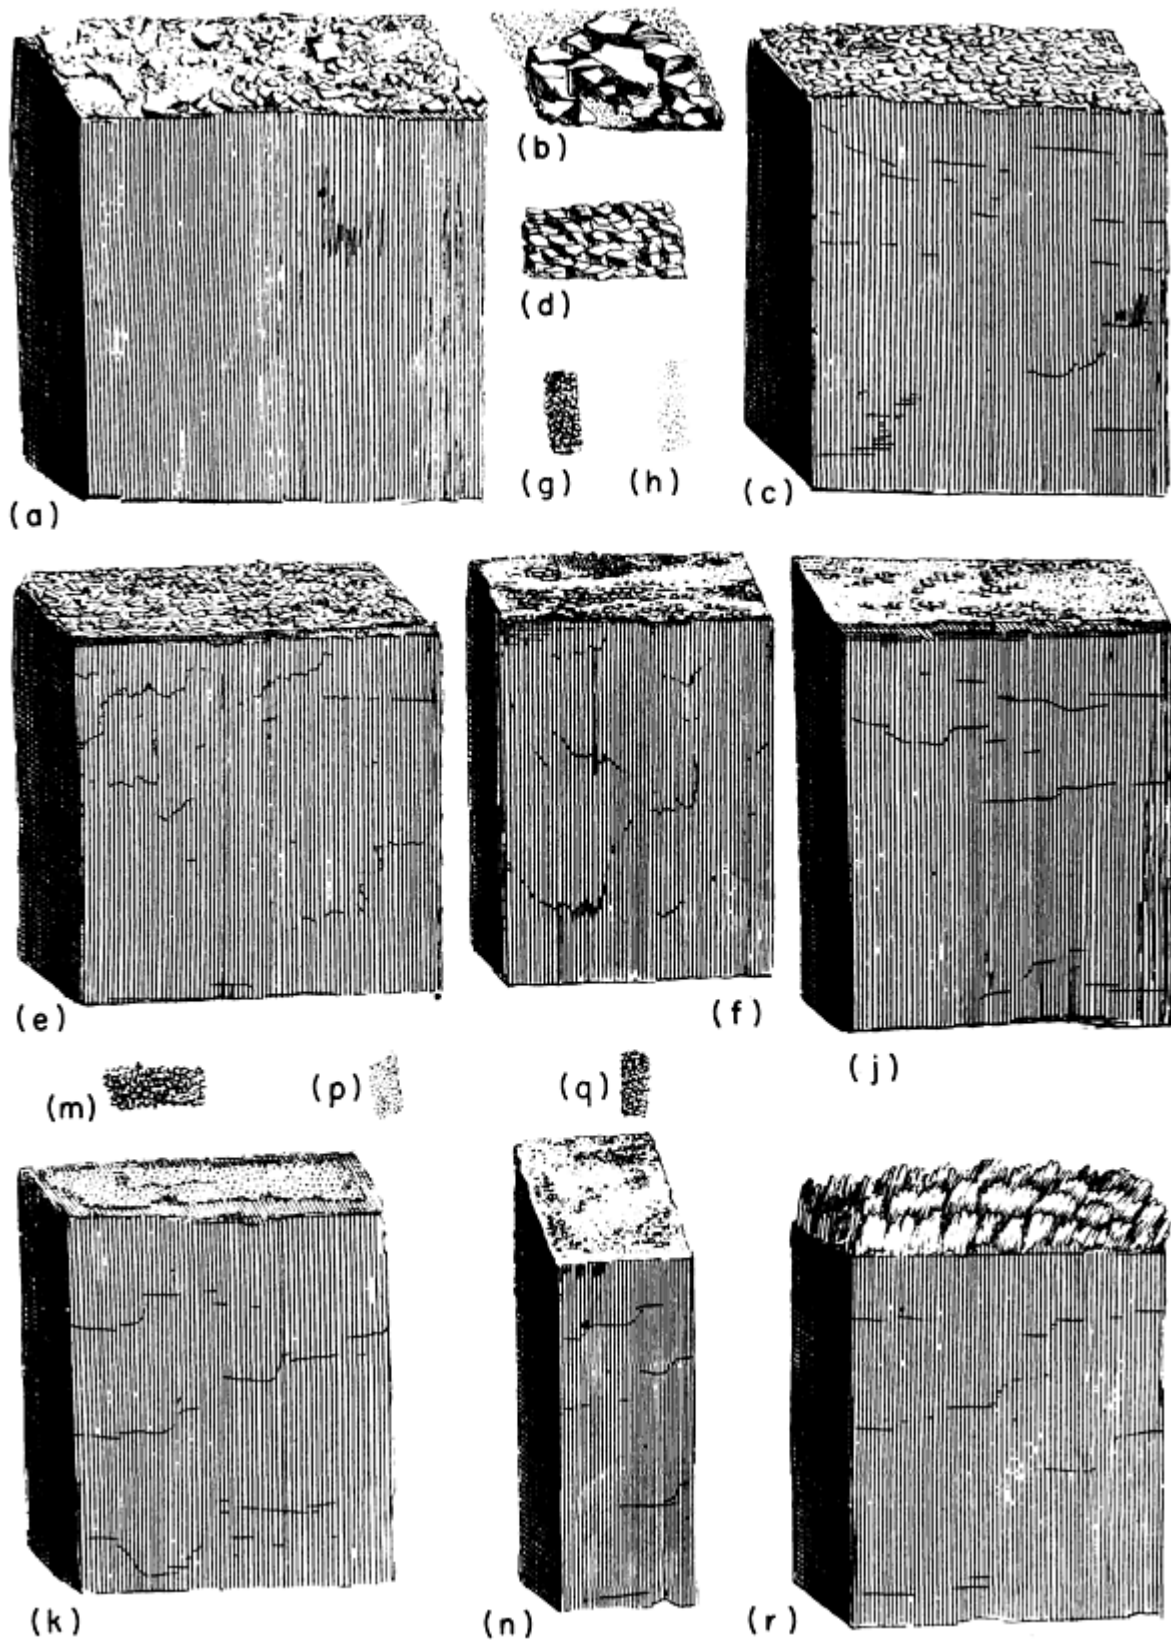
Fig. 1 Sketches from R.A.F. de Réaumur (Ref 10) depicting seven categories of fracture appearance in iron and steel. (a) Type I fracture; large mirrorlike facets. (b) Same as (a), but as viewed with a hand lens. (c) Type II fracture; smaller facets and more regular distribution. (d) Same as (c), but as viewed with a hand lens. (e) Another type II fracture, but improved in regularity of distribution and reduced facet size compared with (c). (f) type III fracture; advantageous occurrence of interposed areas of fibrous metal between facets. (g) Detail of

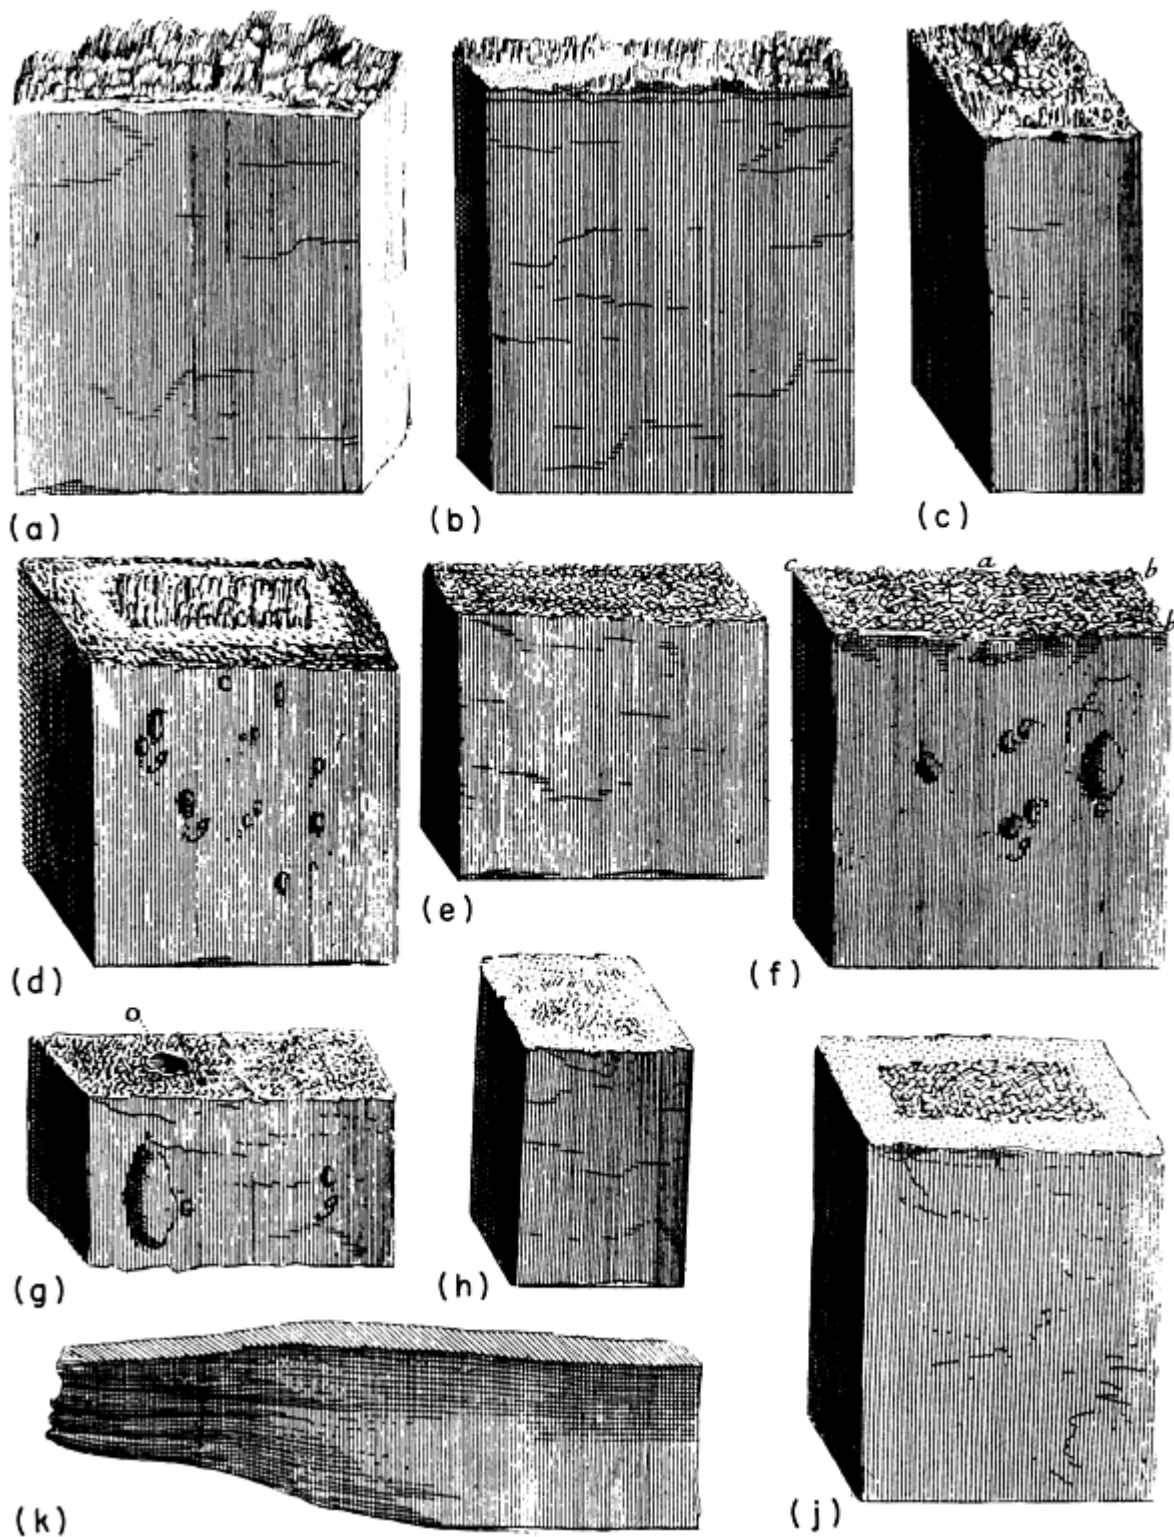
Figure 2(h) shows a fracture that is typical of an iron that will convert easily to steel Fig. 2(j), a fracture typical of an iron that will not convert to steel.

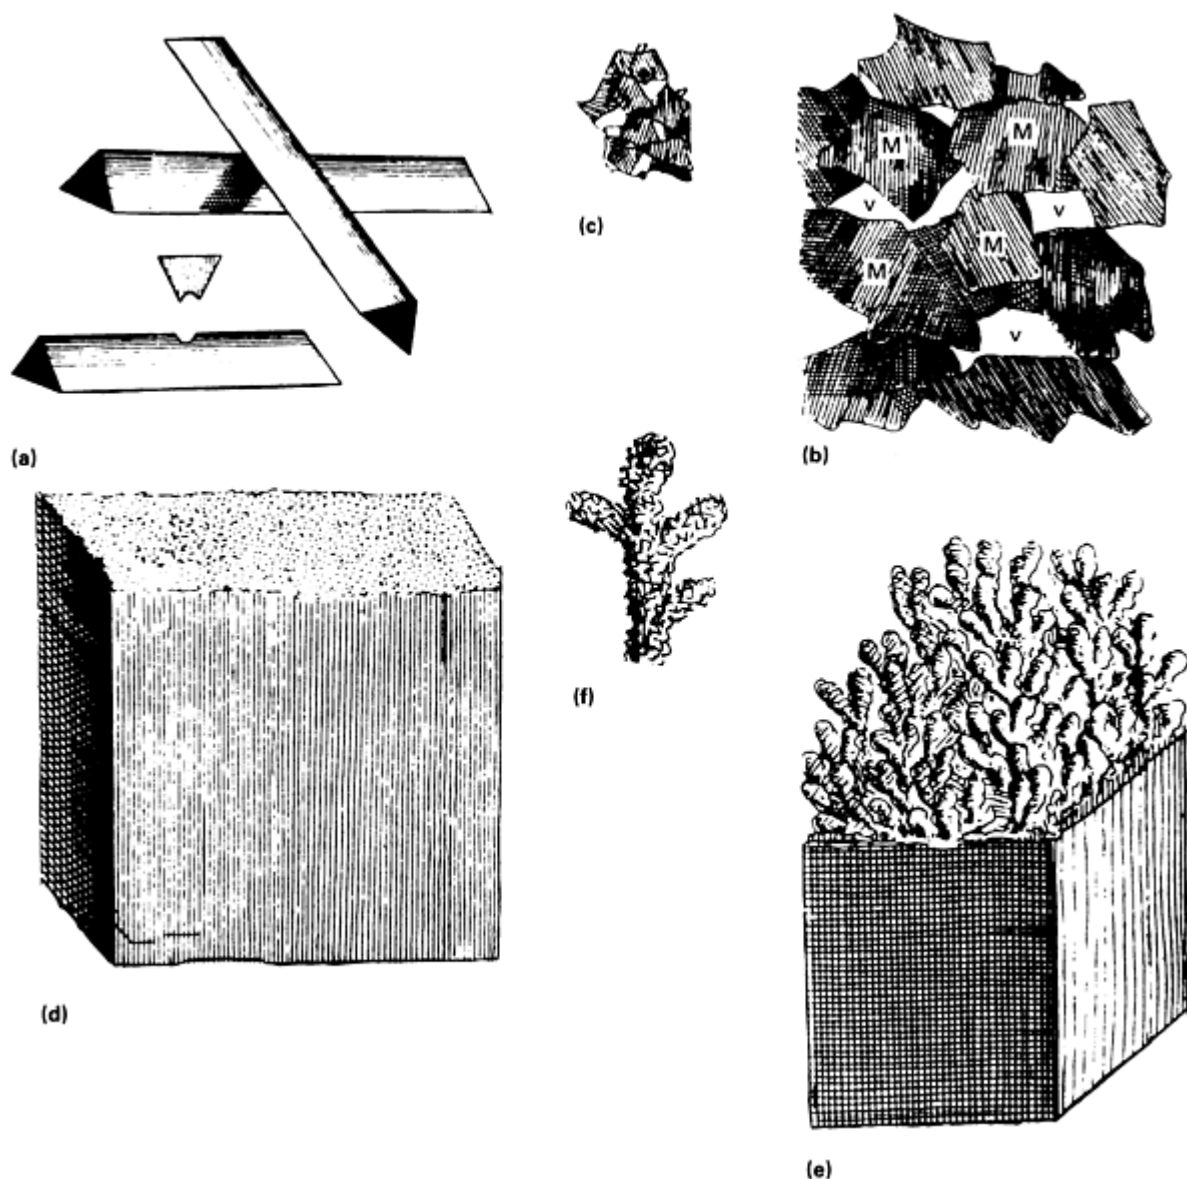
A third plate from de Réaumur (Fig. 3) displays his fracture studies at high magnifications and his fracture test. The minute platelets shown in Fig. 3(f), which may have been pearlite or cementite in some form, were recorded a full century and a half before the founding of metallography.

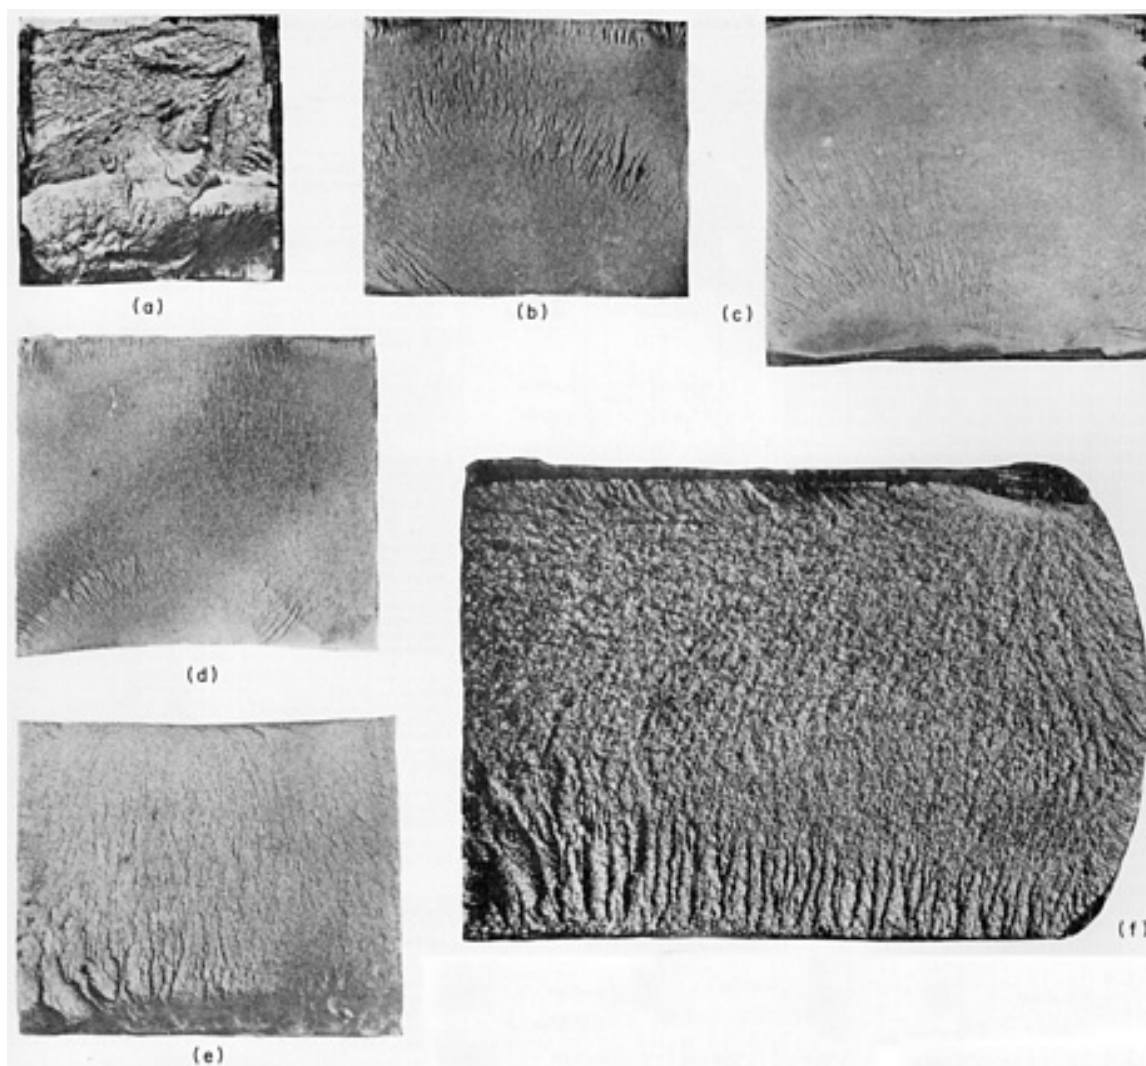
Fig. 4 Steel fractures recorded by A. Martens (Ref 25, p 237, Plate X). Martens called attention to the radial fracture marks in these fractographs, terming them Bruchlinien (fracture lines). (a) Ingot steel; tensile strength, 765 MPa (111 ksi). (b) through (e) Tool steels from Böhler Bros. of Vienna and others: (b) extra hard; (c) very hard, special; (d) moderately hard; (e) ductile. (f) Chisel steel with fracture lines. (a) through (e) Actual size. (f) 6×

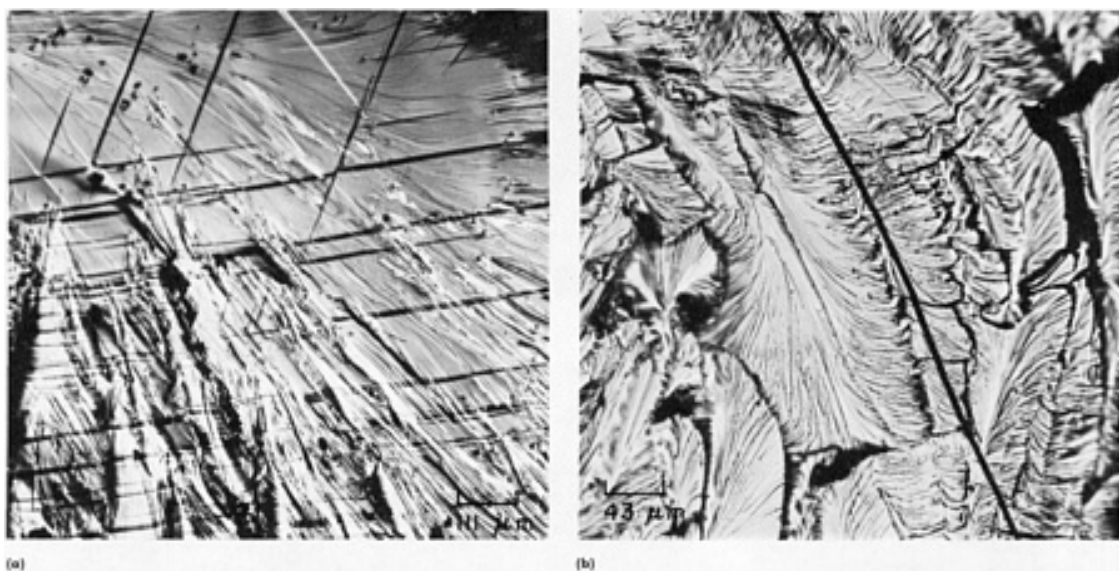
Fig. 5 Cleavage fractures in room-temperature impact specimens examined by C.A. Zapffe. (a) Cast polycrystalline antimony (99.83Sb-0.04S-0.035As-0.035Pb-0.015Fe-0.01Cu) (b) Vacuum-arc-cast high oxygen

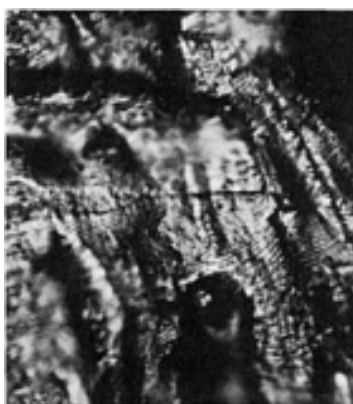
Fig. 6 Fatigue striations observed by Zapffe (Ref 50) in an aluminum alloy specimen tested in completely reversed bending, at a maximum stress of 172 MPa (25 ksi) at room temperature, to failure at 336×10^3 cycles

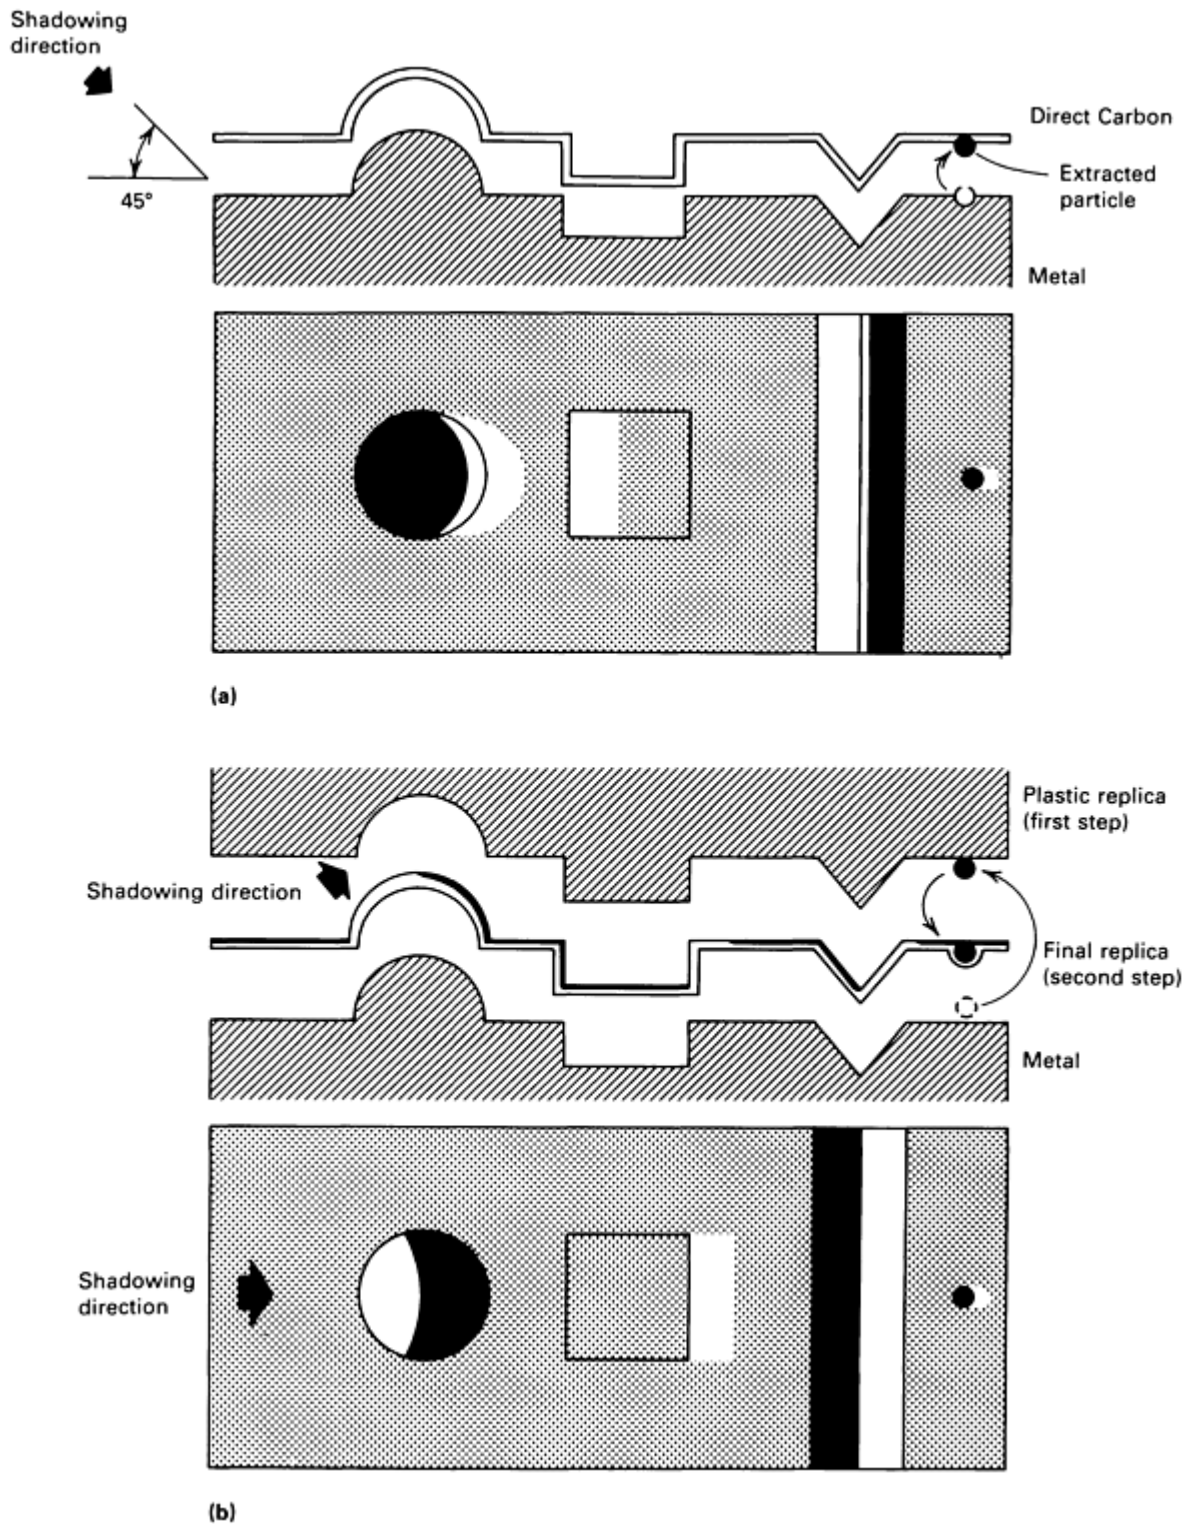
Fig. 7 Schematic of the two types of replicas. (a) One-step replica. (b) Two-step replica

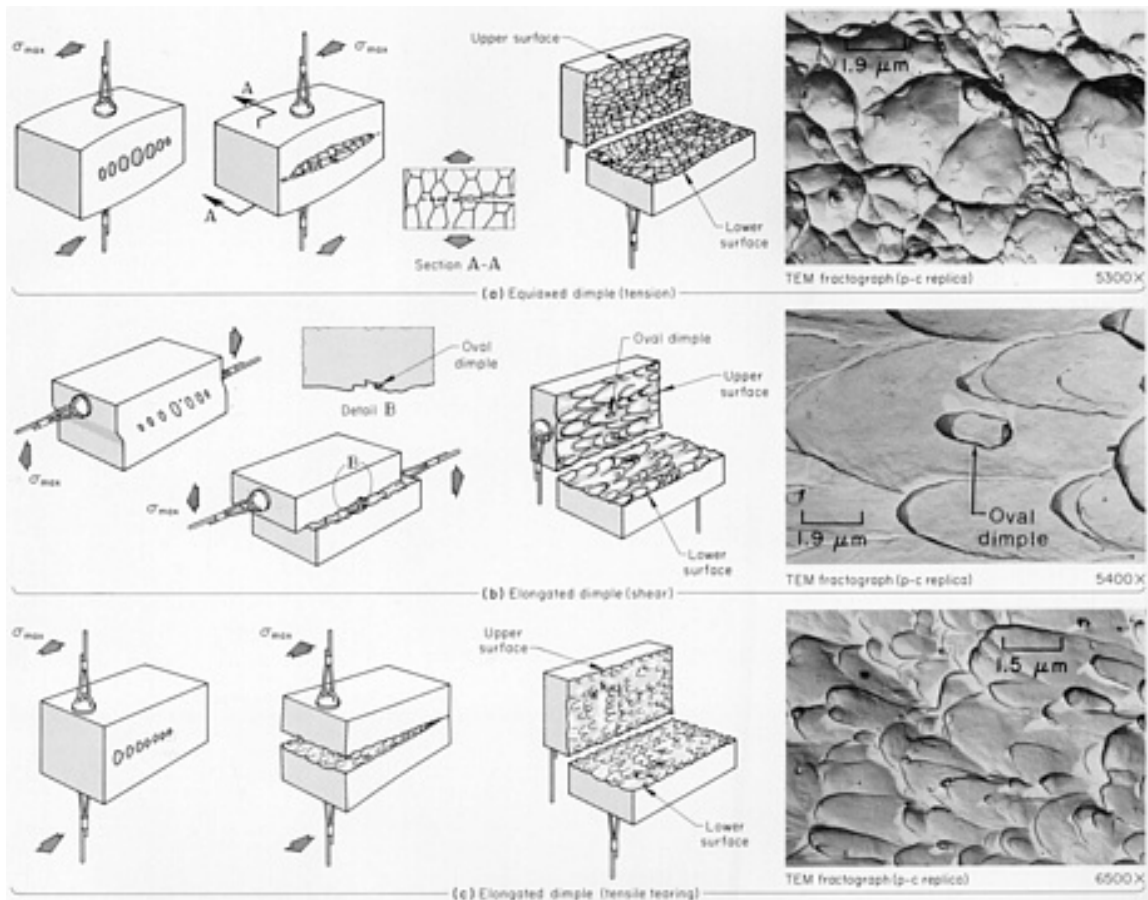
Fig. 1 Influence of direction of maximum stress (σ_{max}) on the shapes of dimples formed by microvoid coalescence. (a) In tension, equiaxed dimples are formed on both fracture surfaces. (b) In shear, elongated dimples point in opposite directions on matching fracture surfaces. (c) In tensile tearing, elongated dimples point toward fracture origin on matching fracture surfaces

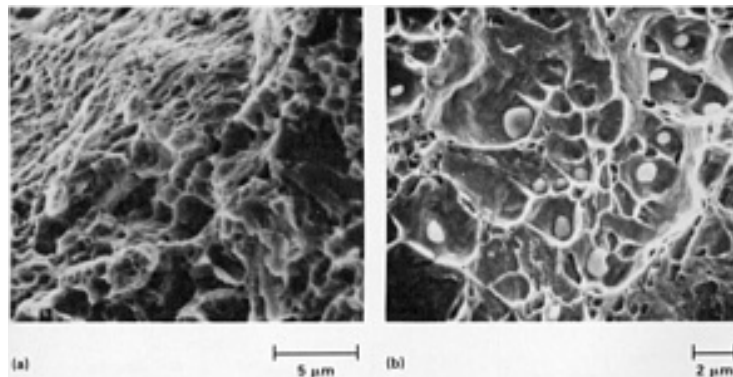
Fig. 2 Examples of the dimple rupture mode of fracture. (a) Large and small dimples on the fracture surface of a martempered type 234 tool steel saw disk. The extremely small dimples at top left are nucleated by numerous, closely spaced particles. (D.-W. Huang, Fuxin Mining Institute, and C.R. Brooks, University of Tennessee). (b) Large and small sulfide inclusions in steel that serve as void-nucleating sites. (R.D. Buchheit, Battelle Columbus Laboratories)

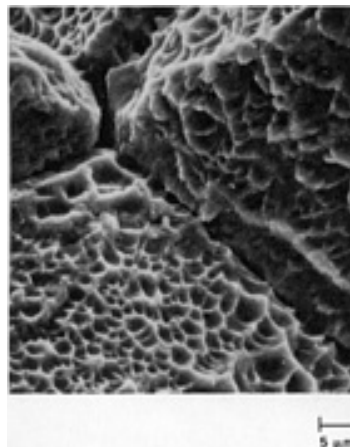
Fig. 3 Intergranular dimple rupture in a steel specimen resulting from microvoid coalescence at grain boundaries.

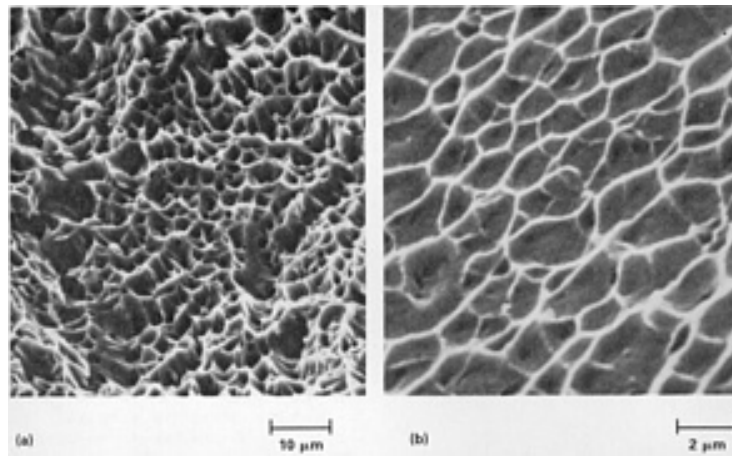
Fig. 4 Different types of dimples formed during microvoid coalescence. (a) Conical equiaxed dimples in a spring steel specimen. (b) Shallow dimples in a maraging steel specimen

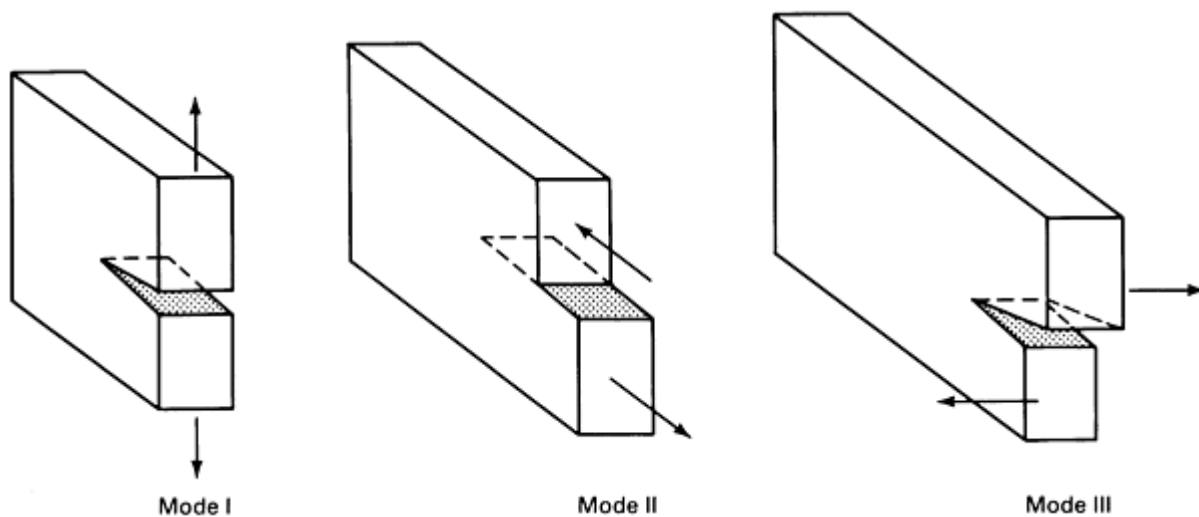
Fig. 5 Fracture loading modes. Arrows show loading direction and relative motion of mating fracture surfaces.

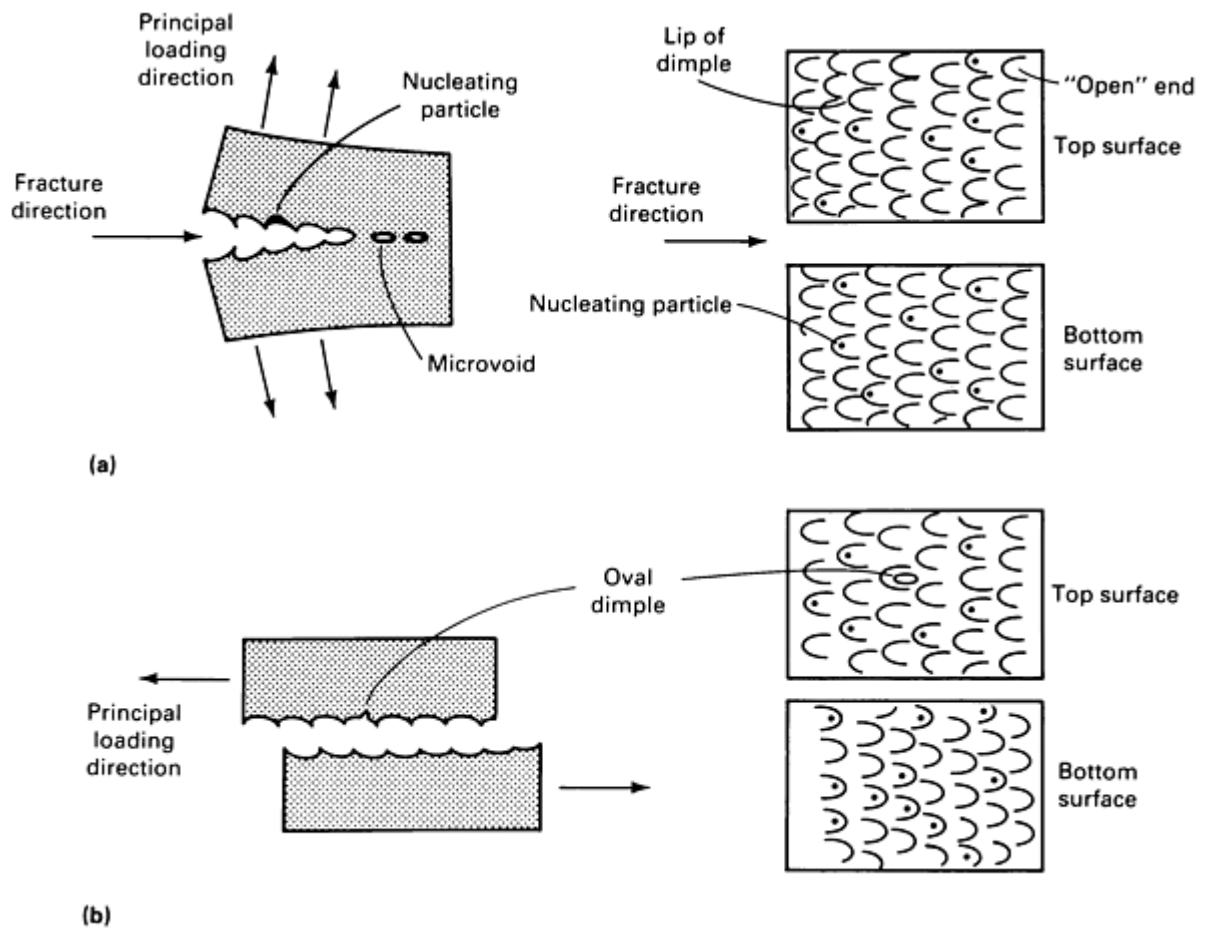
Fig. 6 Formation of elongated dimples under tear and shear loading conditions. (a) Tear fracture. (b) Shear fracture

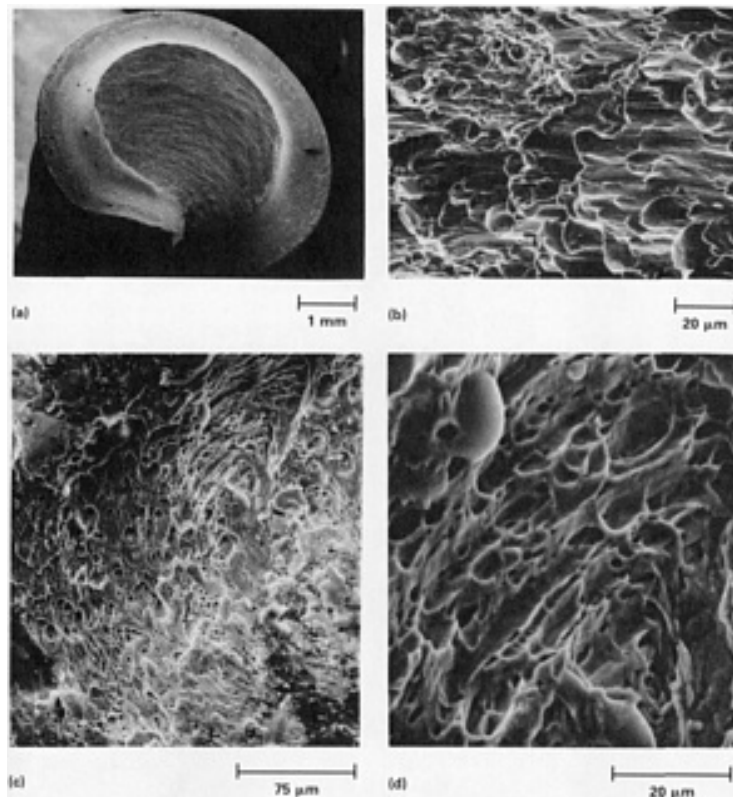
Fig. 7 Elongated dimples formed on shear and torsion specimen fracture surfaces. (a) Shear fracture of a commercially pure titanium screw. Macrofractograph shows spiral-textured surface of shear-of screw. Typical deformation lines are fanning out on the thread. (b) Higher-magnification view of (a) shows uniformly distributed elongated shear dimples. (O.E.M. Pohler, Institut Straumann AG). (c) Elongated dimples on the surface of a fractured single-strand copper wire that failed in torsion. (d) Higher-magnification view of the elongated dimples shown in (c). (R.D. Lujan, Sandia National Laboratories)

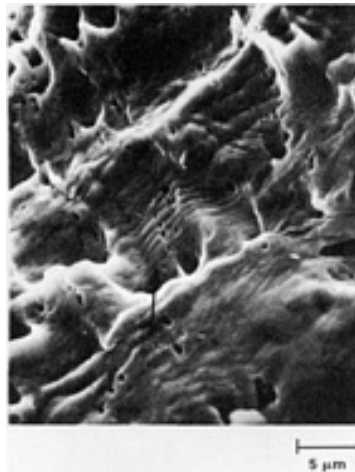
Fig. 10 Serpentine glide formation (arrow) in oxygen-free high-conductivity copper specimen

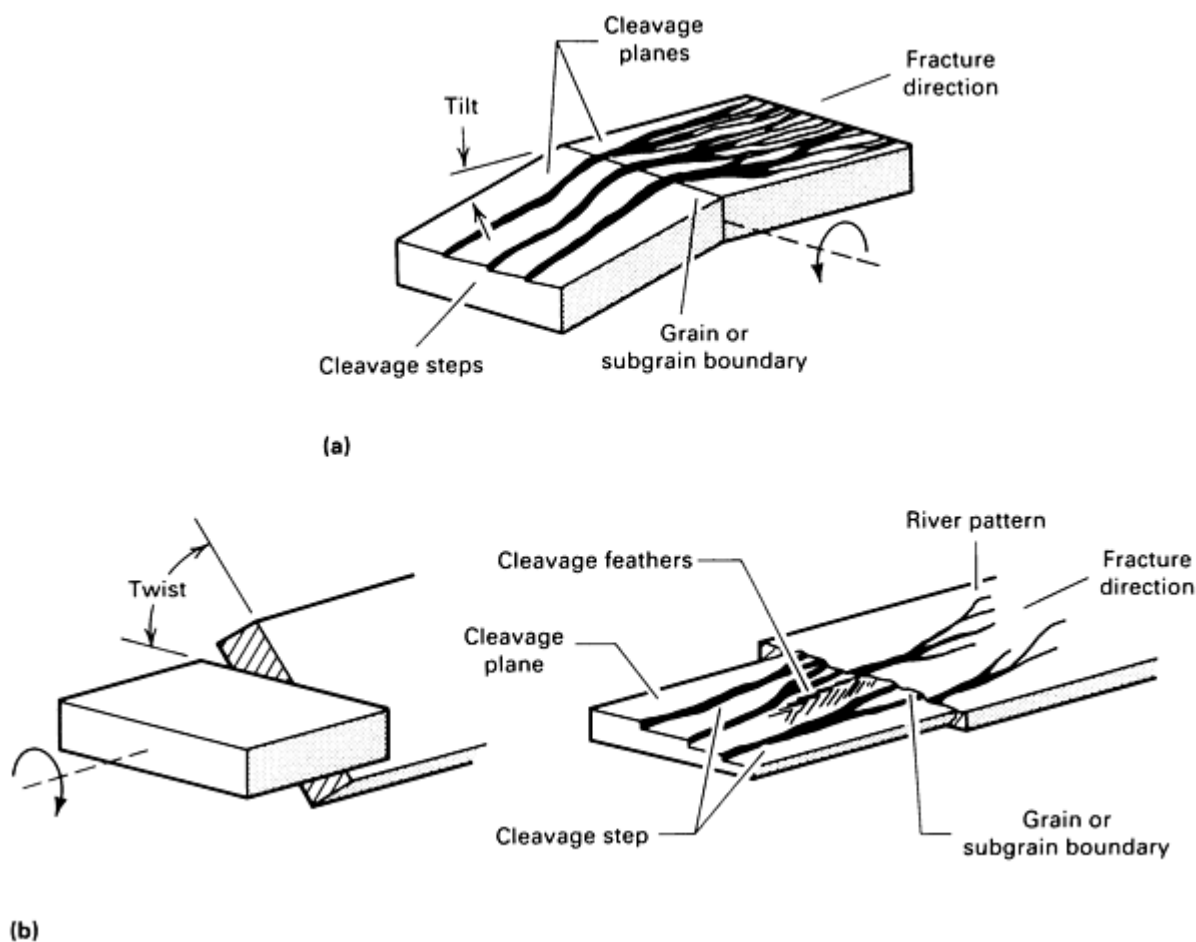
Fig. 11 Schematic of cleavage fracture formation showing the effect of subgrain boundaries. (a) Tilt boundary. (b) Twist boundary

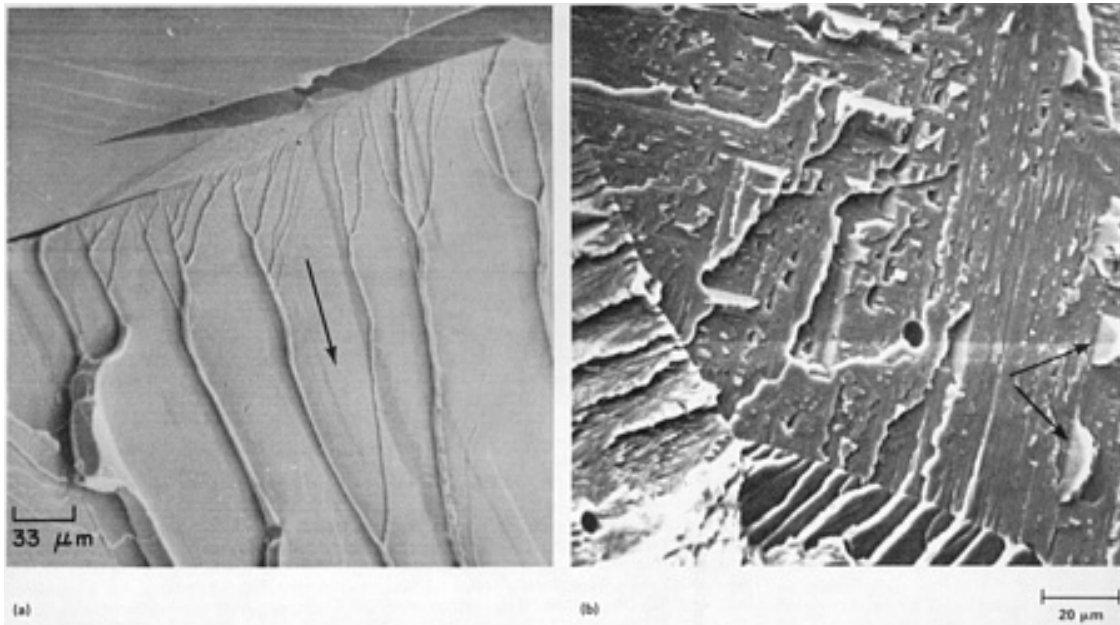
Fig. 12 Examples of cleavage fractures. (a) Twist boundary, cleavage steps, and river patterns in an Fe-0.01C-0.24Mn-0.02Si alloy that was fractured by impact. (b) Tongues (arrows) on the surface of a 30% Cr steel weld metal that fractured by cleavage

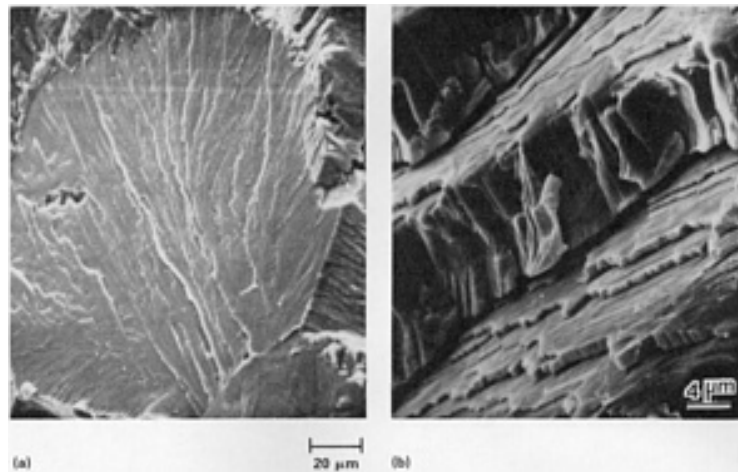
Fig. 14 Examples of cleavage fractures. (a) Feather pattern on a single grain of a chromium steel weld metal that failed by cleavage. (b) Cleavage steps in a Cu-25 at.% Au alloy that failed by transgranular stress-corrosion cracking. (B.D. Lichter, Vanderbilt University)

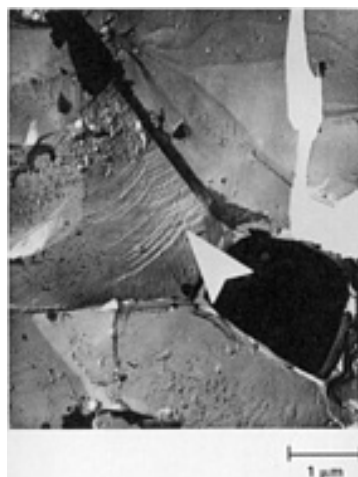
Fig. 15 Wallner lines (arrow) on the surface of a fractured WC-Co specimen. TEM formvar replica. Etched with 5% HCl. (S.B. Luyckx, University of the Witwatersrand)

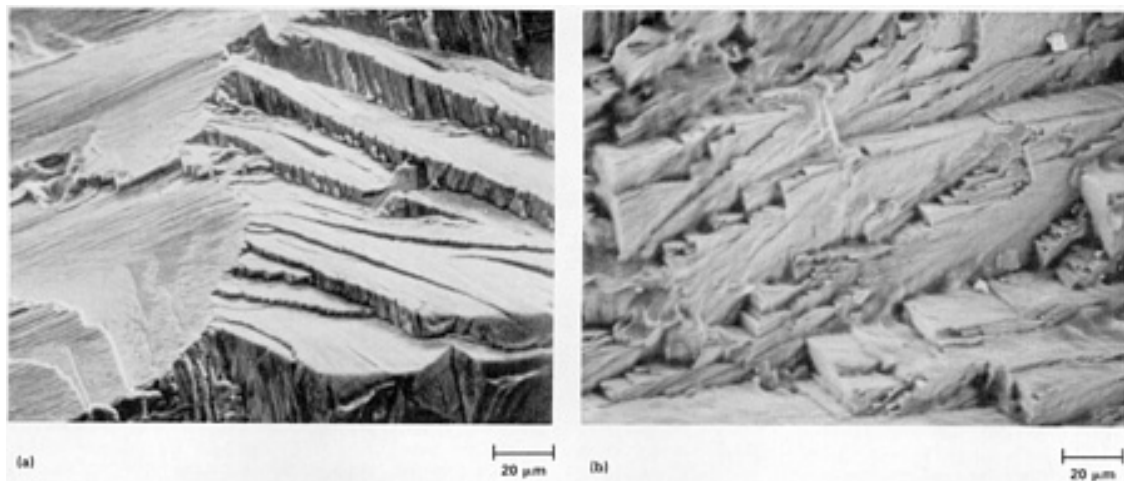
Fig. 16 Stage I fatigue appearance. (a) Cleavagelike, crystallographically oriented Stage I fatigue fracture in a cast Ni-14Cr-4.5Mo-1Ti-6Al-1.5Fe-2.0(Nb + Ta) alloy. (b) Stair-step fracture surface indicative of Stage I fatigue fracture in a cast ASTM F75 cobalt-base alloy. SEM. (R. Abrams, Howmedica, Div. Pfizer Hospital Products Group Inc.)

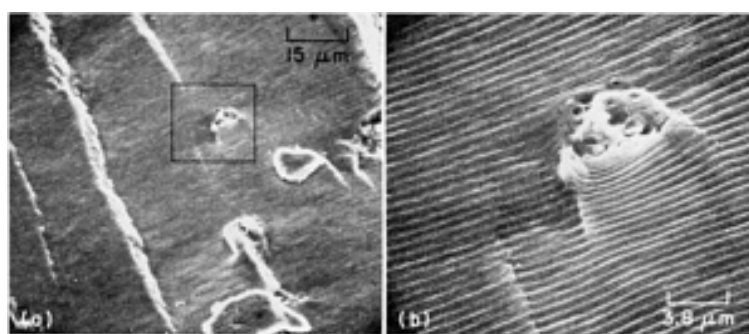
Fig. 17 Uniformly distributed fatigue striations in an aluminum 2024-T3 alloy. (a) Tear ridge and inclusion (outlined by rectangle). (b) Higher-magnification view of the region outlined by the rectangle in (a) showing the continuity of the fracture path through and around the inclusion. Compare with Fig. 18.

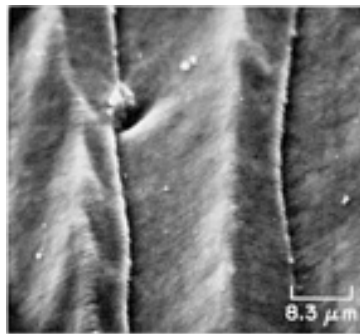
Fig. 19 Fatigue striations in a 2024-T3 aluminum alloy joined by tear ridges

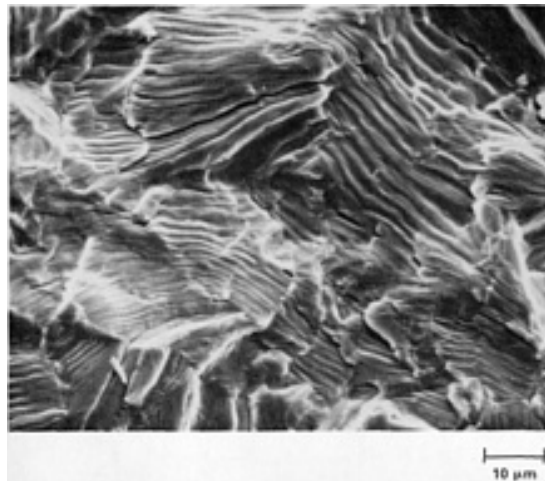
Fig. 20 Fatigue striations on adjoining walls on the fracture surface of a commercially pure titanium specimen. (O.E.M. Pohler, Institut Straumann AG)

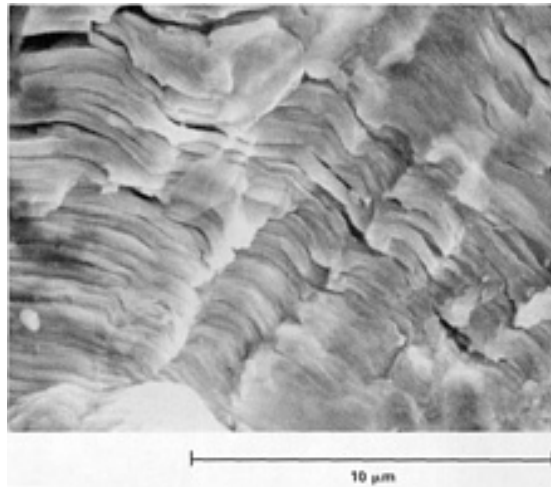
Fig. 21 Fatigue striations on the fracture surface of a tantalum heat-exchanger tube. The rough surface appearance is due to secondary cracking caused by high-cycle low-amplitude fatigue. (M.E. Blum, FMC Corporation)

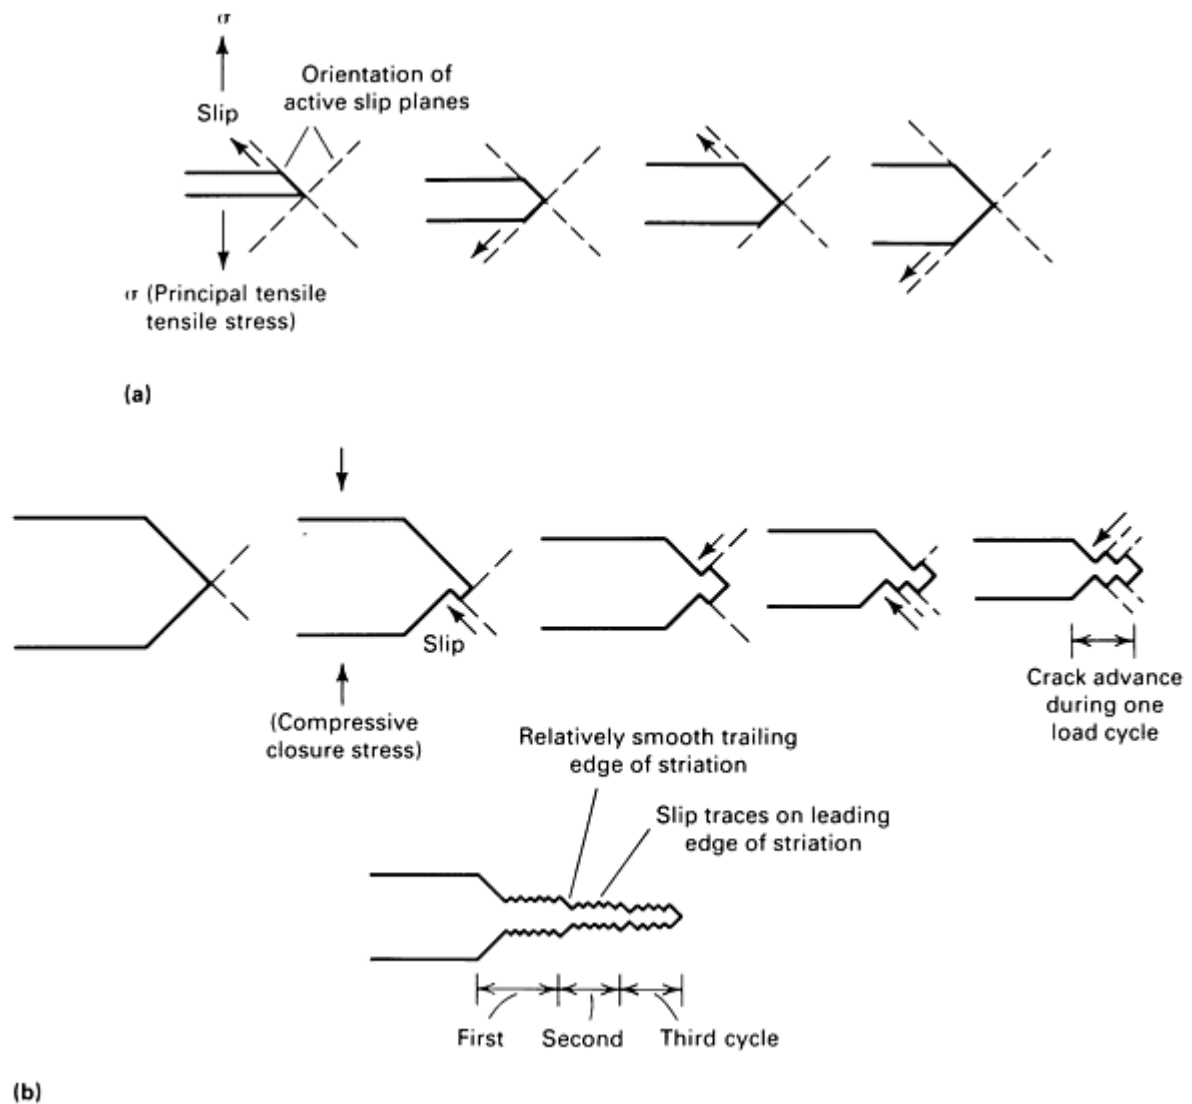
Fig. 23 Mechanism of fatigue crack propagation by alternate slip at the crack tip. Sketches are simplified to clarify the basic concepts. (a) Crack opening and crack tip blunting by slip on alternate slip planes with increasing tensile stress. (b) Crack closure and crack tip resharpening by partial slip reversal on alternate slip planes with increasing compressive stress

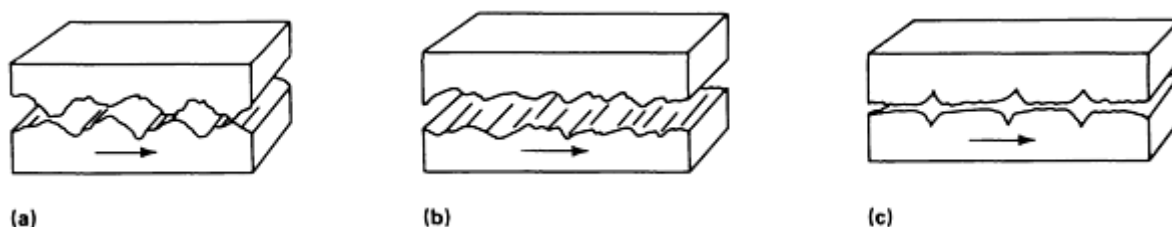
Fig. 24 Sawtooth and groove-type fatigue fracture profiles. Arrows show crack propagation direction. (a) Distinct sawtooth profile (aluminum alloy). (b) Poorly formed sawtooth profile (steel). (c) Groove-type profile (aluminum alloy). Source: Ref 23

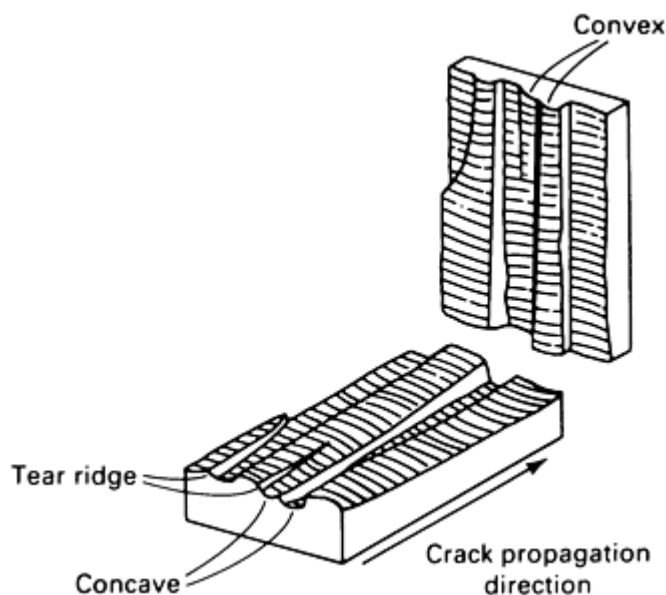
Fig. 26 Schematic illustrating fatigue striations on plateaus

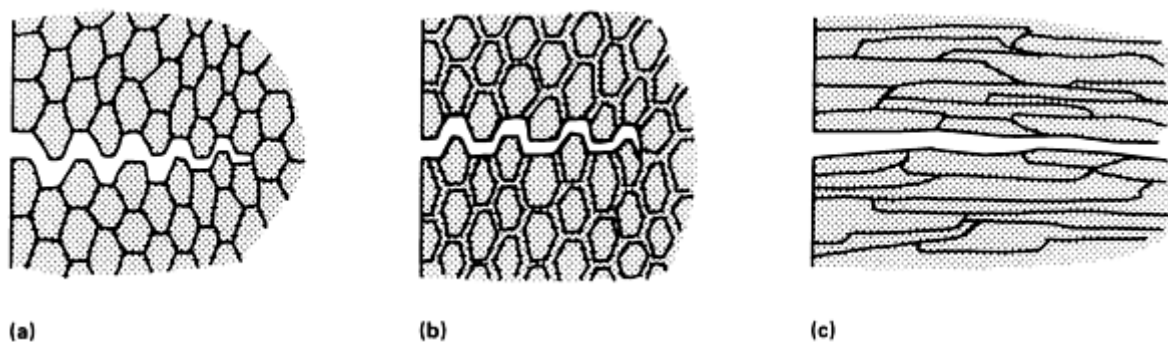
Fig. 29 Schematic illustrating decohesive rupture along grain boundaries. (a) Decohesion along grain boundaries of equiaxed grains. (b) Decohesion through a weak grain-boundary phase. (c) Decohesion along grain boundaries of elongated grains

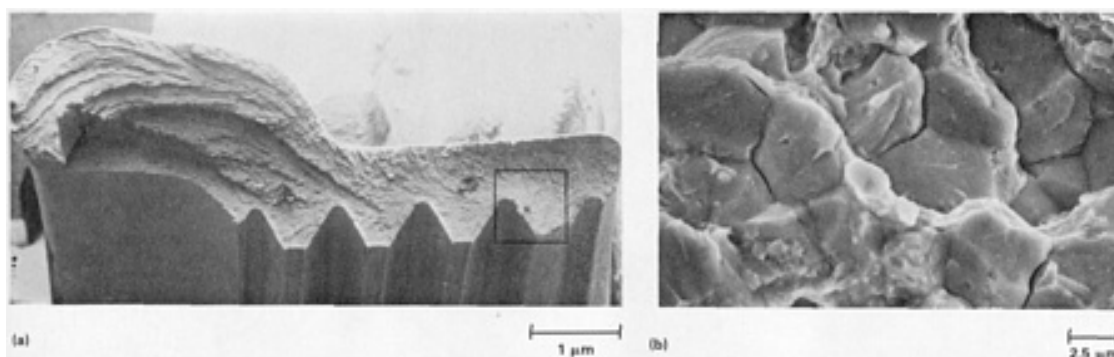
Fig. 30 Decohesive rupture in an AISI 8740 steel nut due to hydrogen embrittlement. Failure was due to inadequate baking following cadmium plating; thus, hydrogen, which was picked up during the plating process, was not released. (a) Macrograph of fracture surface. (b) Higher-magnification view of the boxed area in (a) showing typical intergranular fracture. (W.L. Jensen, Lockheed Georgia Company)
