به نام خدا

مرکز دانلود رایگان
مهندسی متالورژی و مواد

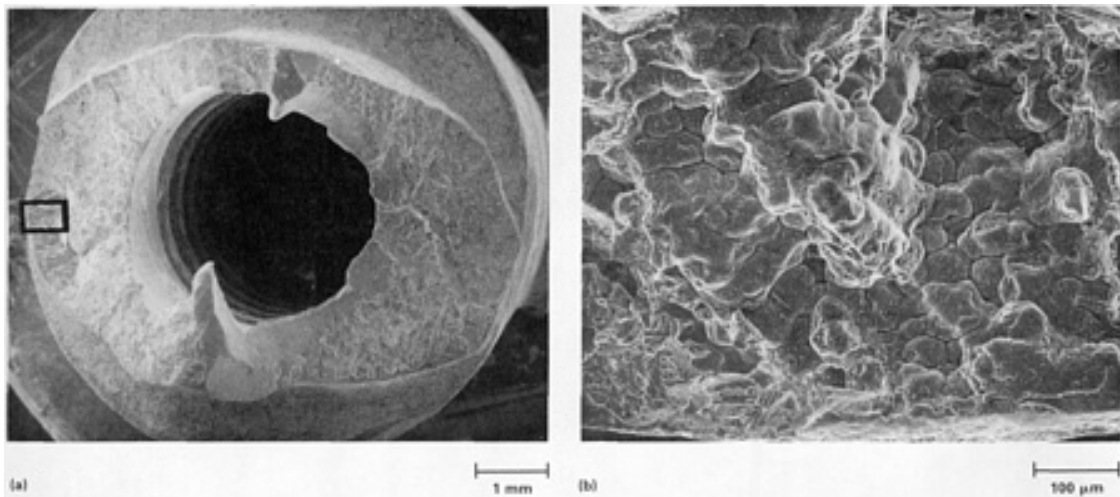
Fig. 31 17-4 PH stainless steel main landing-gear deflection yoke that failed because of intergranular SCC. (a) Macrograph of fracture surface. (b) Higher-magnification view of the boxed area in (a) showing area of intergranular attack. (W.L. Jensen, Lockheed Georgia Company)

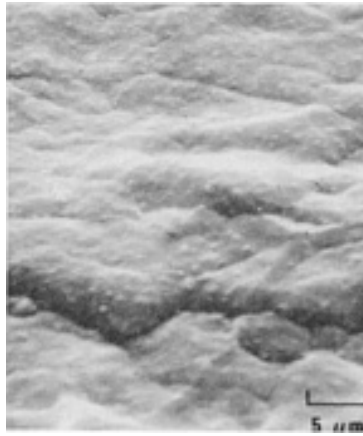
Fig. 33 Stress-corrosion fracture that occurred by decohesion along the parting plane of an aluminum alloy forging

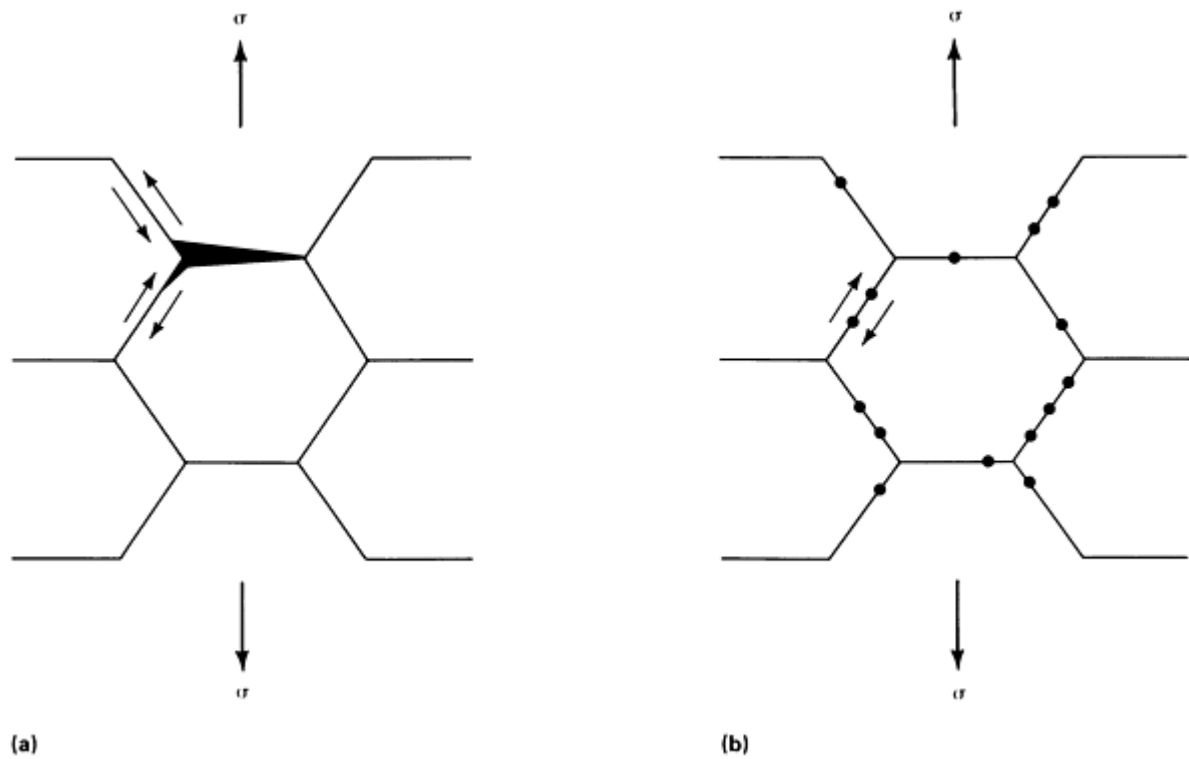
Fig. 34 Triple-point cracking (a) and cavitation (b) in intergranular creep rupture. Small arrows indicate grain-boundary sliding.

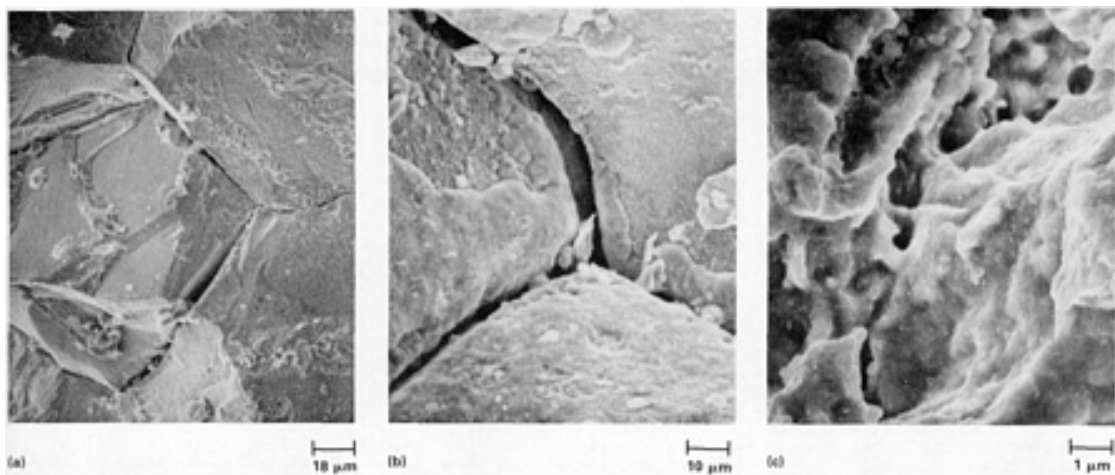
Fig. 35 Examples of intergranular creep fractures. (a) Wedge cracking in Inconel 625. (b) Wedge cracking in Incolay 800. (c) Intergranular creep fracture resulting from grain-boundary cavitation in PE-16. Source: Ref 59

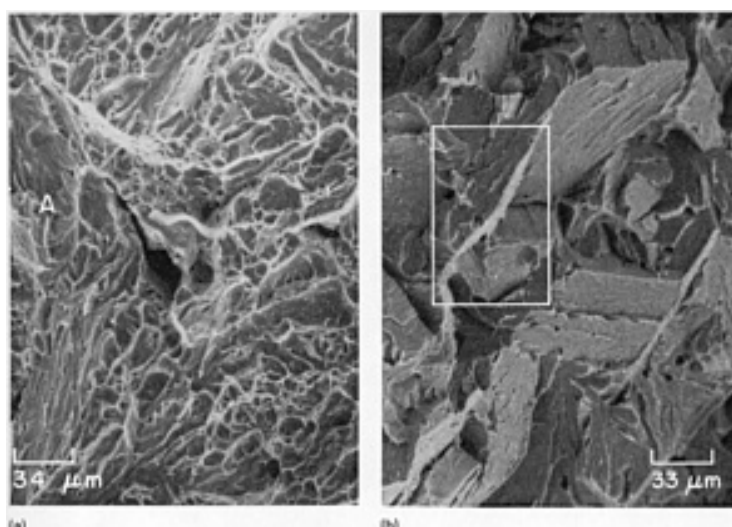
Fig. 36 Examples of quasi-cleavage. (a) Fracture surface of an austenitized Fe-0.3C-0.6Mn-5.0Mo specimen exhibiting large quasi-cleavage facets, such as at A; elsewhere, the surface contains rather large dimples. (b) Charpy impact fracture in on Fe-0.18C-3.85Mo steel. Many quasi-cleavage facets are visible. The rectangle outlines a tear ridge.

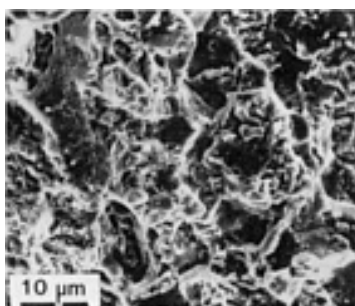
Fig. 37 Small and poorly defined quasi-cleavage facets connected by shallow dimples on the surface of a type

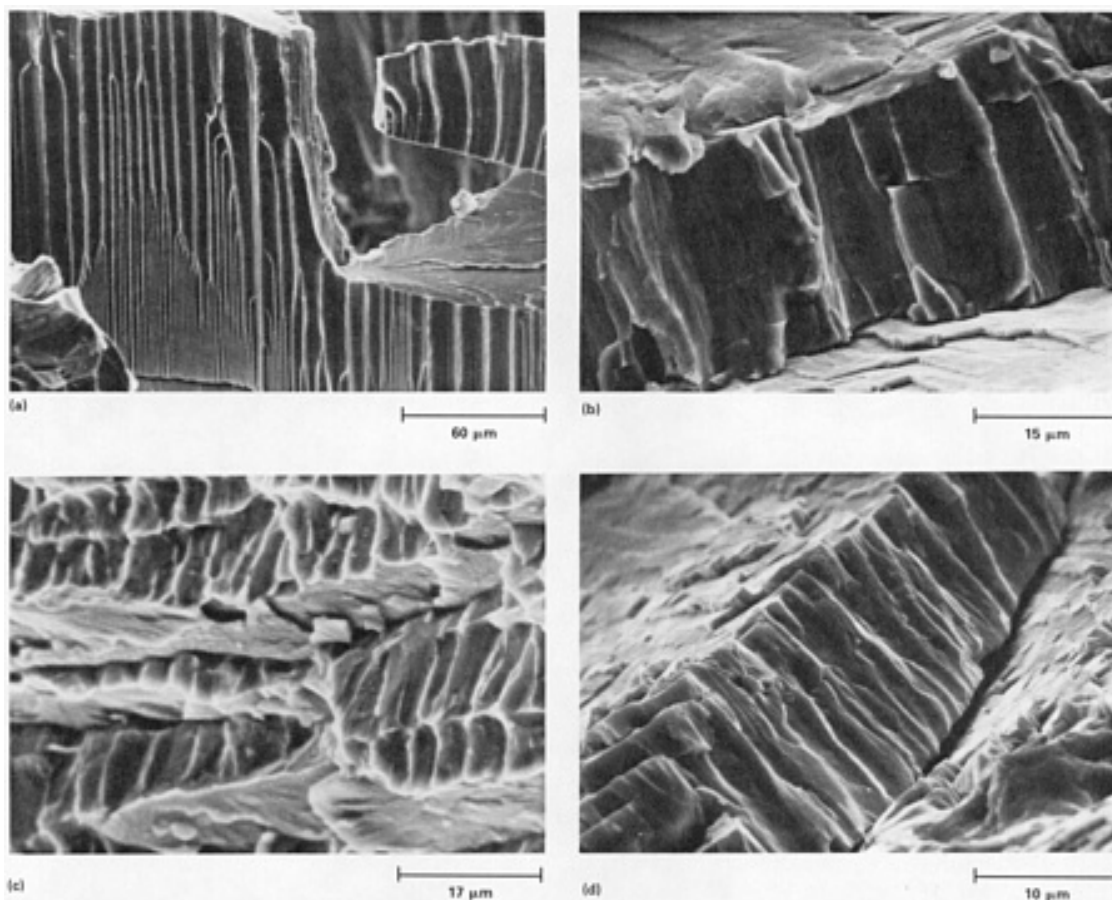
Fig. 38 Example of fluting. (a) Flutes and cleavage resulting from a mechanical overload of a Ti-0.35O alloy. (b) Flutes and cleavage resulting from SCC at β -annealed Ti-8Al-1Mo-1V alloy in methanol. (c) Flutes cleavage Ti-8Al-1Mo-1V resulting from sustained-load cracking in vacuum. (d) Flutes occurring near the notch on the fracture surface of mill-annealed Ti-8Al-1Mo-1V resulting from fatigue in saltwater. Source: Ref 89

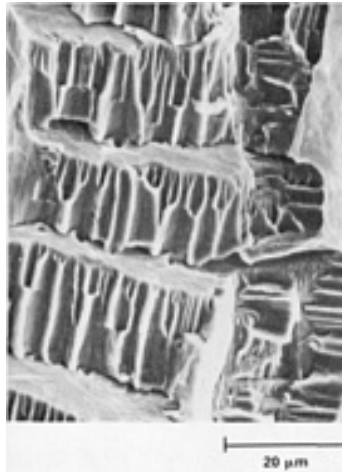
Fig. 39 Flutes and cleavage from SCC of β -annealed Ti-8Al-1Mo-1V in methanol. Source: Ref 89

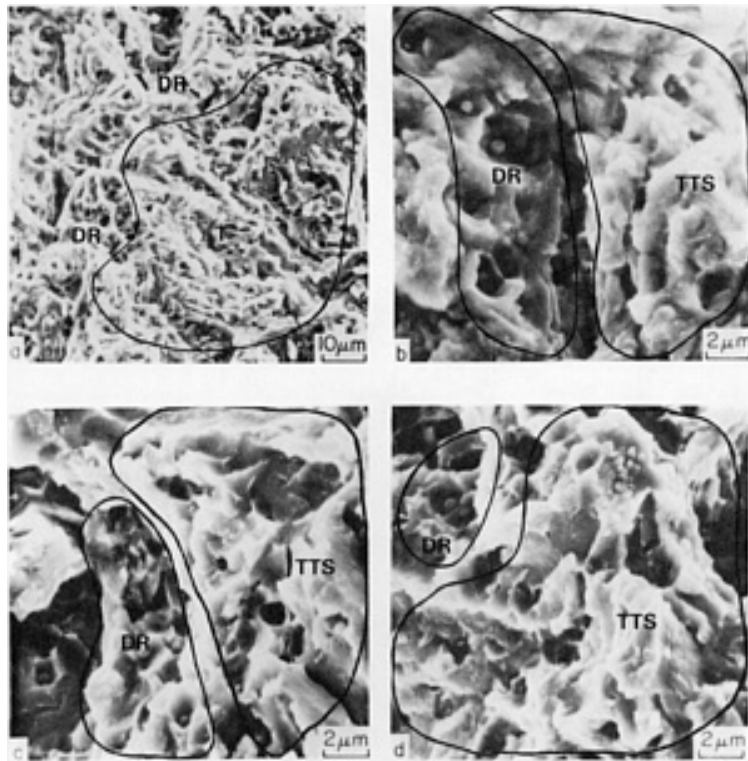
Fig. 40 Appearance of TTS fracture in bainitic HY-130 steel. (a) Areas of complex tearing (T) and dimple rupture (DR). (b) Detail from upper left corner of (a) showing particle-nucleated dimples (DR) and regions of TTS. SEM fractographs in (c) and (d) show additional examples of TTS fractures. Source: Ref 91, 93

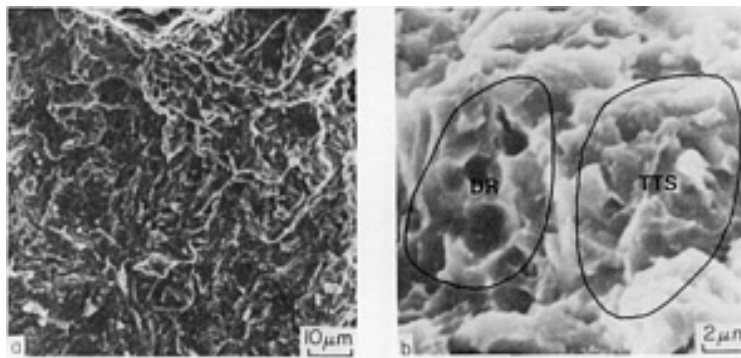
Fig. 41 Appearance of TTS fracture. (a) An essentially 100% pearlitic eutectoid steel (similar to AISI 1080) where fractures propagate across pearlite colonies. (b) Fractographs showing dimple rupture (DR) and TTS fracture in a quenched-and-tempered (martensitic) HY-130 steel. Source: Ref 91, 93

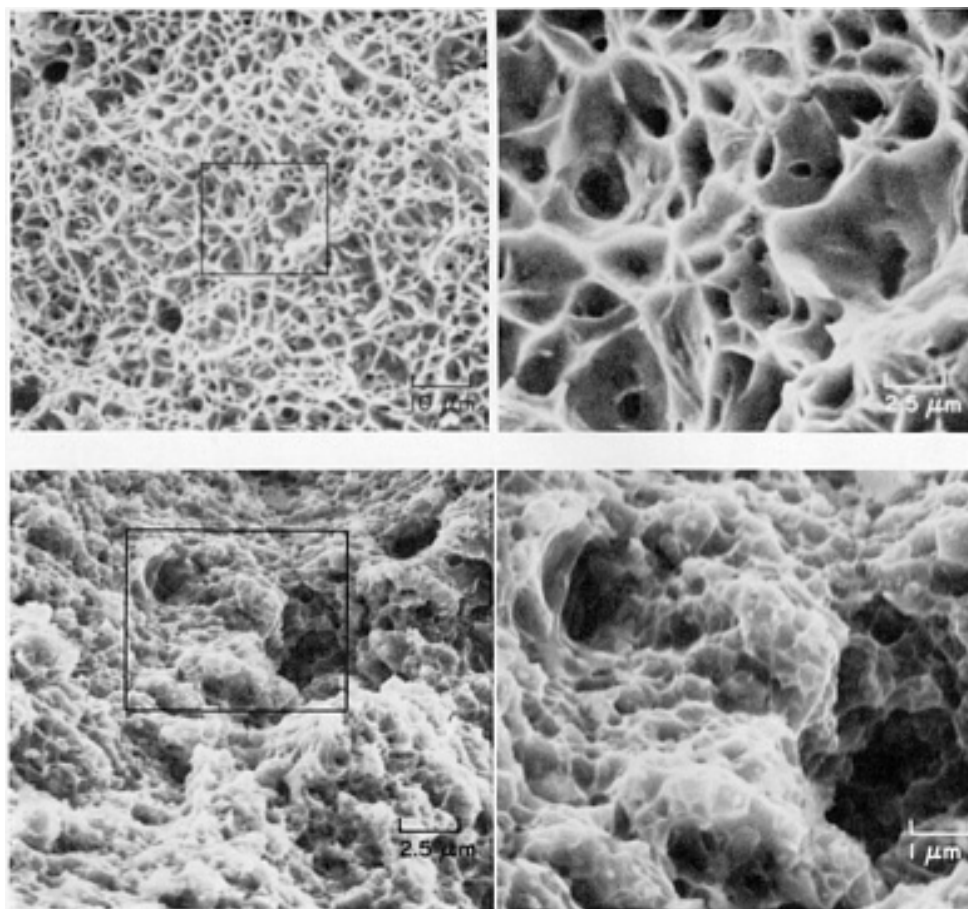
Fig. 43 Effect of hydrogen on fracture appearance in 13-8 PH stainless steel with a tensile strength of MPa (237 ksi). Top row: SEM fractographs of a specimen not embrittled by hydrogen. Bottom row: SEM fractographs of a specimen charged with hydrogen by plating without subsequent baking.

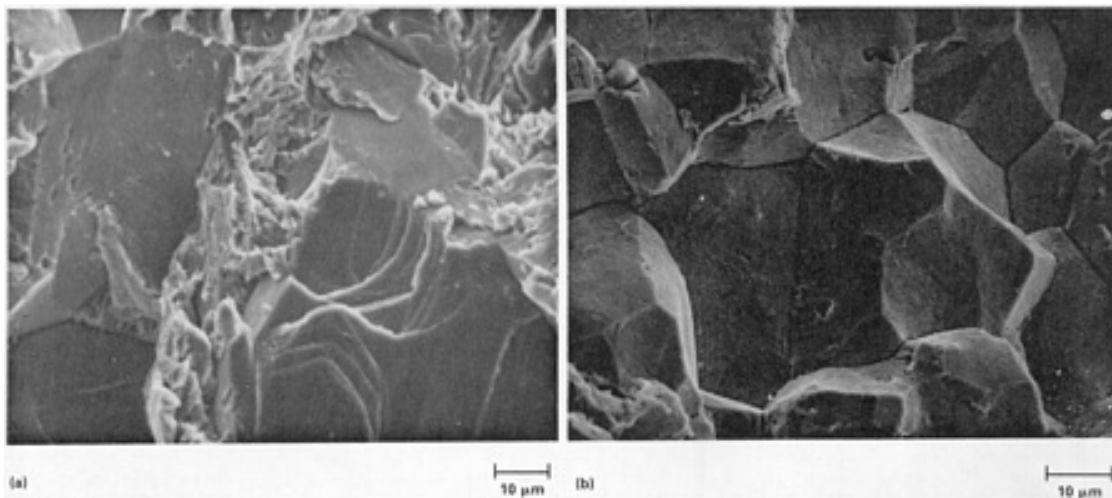
Fig. 45 Examples of hydrogen-embrittled steels. (a) Cleavage fracture in a hydrogen-embrittled annealed type 301 austenitic stainless steel. Source: Ref 98. (b) intergranular decohesive fracture in an AISI 4130 steel heat treated to an ultimate tensile strength of 1281 MPa (186 ksi) and stressed at 980 MPa (142 ksi) while being charged with hydrogen. Source: Ref 111

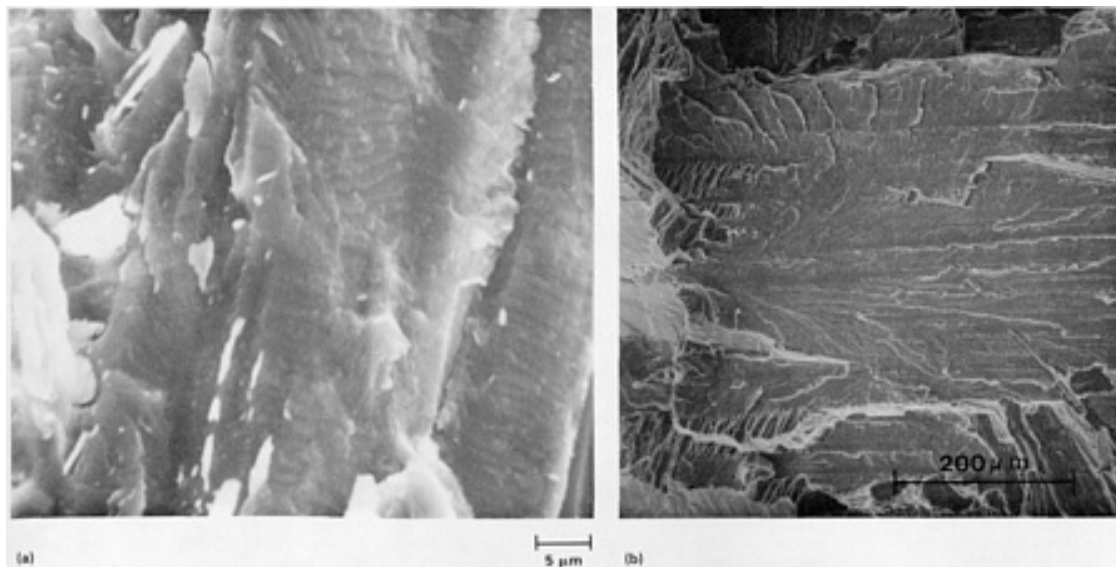
Fig. 46 Examples of hydrogen-embrittled titanium alloys. (a) Hydrogen embrittlement fracture in a Ti-8Al-1Mo-1V alloy in gaseous hydrogen. Note crack-arrest marks. Source: Ref 137. (b) Cleavage fracture in hydrogen-embrittled Ti-5Al-2.5Sn alloy containing 90 ppm H. Source: Ref 141

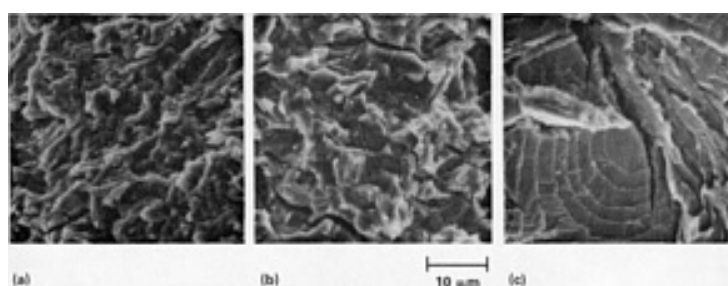
Fig. 47 Influence of heat treatment and resulting microstructure on the fracture appearance of a hydrogen-embrittled Ti-6Al-4V alloy. Specimens tested in gaseous hydrogen at a pressure of 1 atm. (a) Transgranular fracture in a specimen heat treated at 705 °C (1300 °F) for 2 h, then air cooled. (b) Intergranular decohesion along α - β boundaries in a specimen heat treated at 955 °C (1750 °F) for 40 min, then stabilized. (c) Coarse acicular structure resulting from heating specimen at 1040 °C (1900 °F) for 40 min, followed by stabilizing. The relatively flat areas of the terraced structure are the prior- β grain boundaries. See text for a discussion of the microstructures of these specimens. Source: Ref 142.

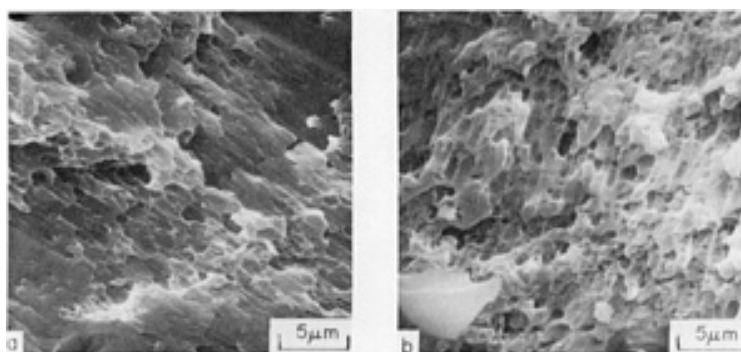
Fig. 48 Hydrogen-embrittled 2124-UT aluminum alloy that shows no significant change in the fracture appearance. (a) Not embrittled. (b) Hydrogen embrittled. Source: Ref 99

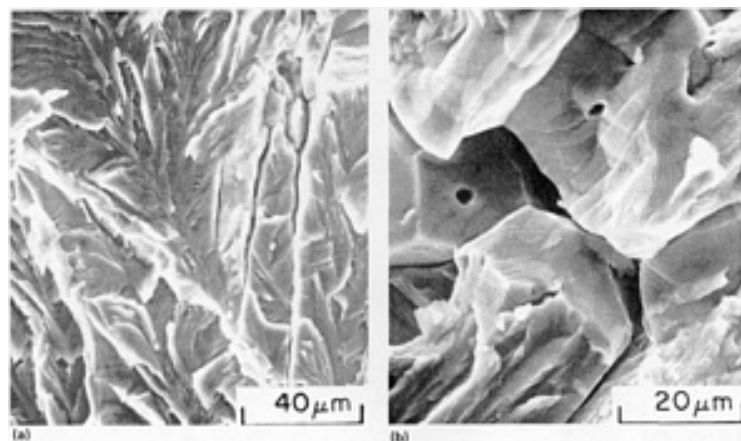
Fig. 49 Effect of heat treatment on the fracture appearance of a hydrogen-embrittled low-copper 7050 aluminum alloy. (a) Transgranular cleavagelike fracture in a peak-aged specimen. (b) Combined intergranular decohesion and transgranular cleavagelike fracture in an underaged specimen. Source: Ref 106

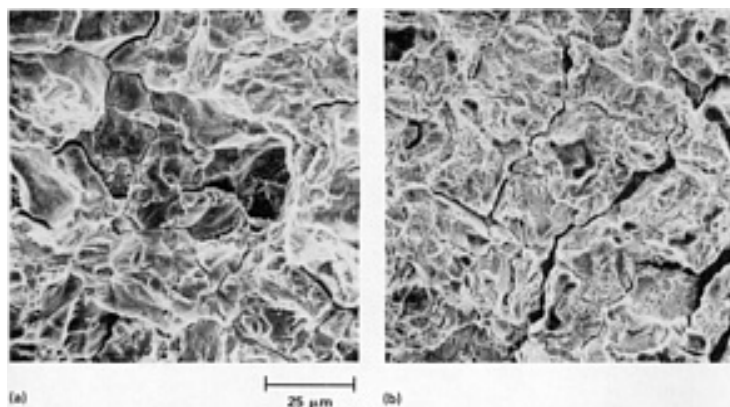
Fig. 50 Stress-corrosion fractures in HY-180 steel with an ultimate strength of 1450 MPa (210 ksi). The steel was tested in aqueous 3.5% sodium chloride at an electrochemical potential of $E = -0.36$ to $-0.82 V_{SHE}$ (SHE, standard hydrogen electrode). Intergranular decohesion is more pronounced at lower values of stress intensity, $K_I = 57 \text{ MPa} \sqrt{m}$ (52 ksi $\sqrt{in.}$) (a), than at higher values, $K_I = 66 \text{ MPa} \sqrt{m}$ (60 ksi $\sqrt{in.}$) (b). Source: Ref 154

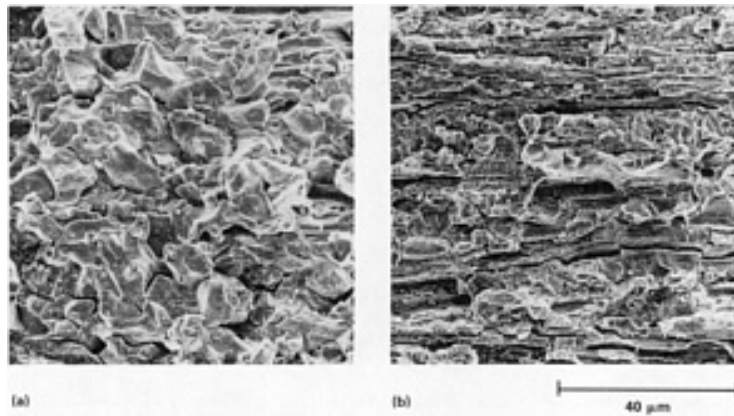
Fig. 52 Effect of electrochemical potential on the stress-corrosion fracture path in a cold-worked AISI C-1018 low-carbon steel with a 0.2% offset yield strength of 63 MPa (9 ksi). The steel was tested in a 92- °C (198- °F) aqueous 33% sodium hydroxide solution. At a potential of $E = -0.76 V_{SHE}$, the fracture propagates along grain boundaries (a) by a metal dissolution process; however, at a freely corroding potential of $E = -1.00 V_{SHE}$, the fracture path is transgranular and occurs by a combination of hydrogen embrittlement and metal dissolution (b). Source: Ref 182

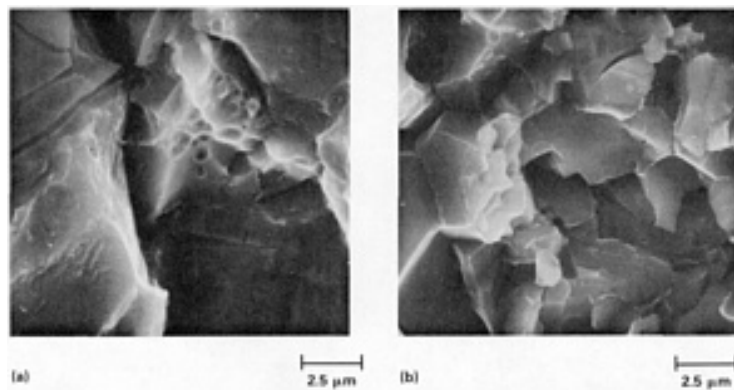
Fig. 53 Stress-corrosion fractures from two different areas in a 7075-T6 aluminum alloy specimen exposed to water at ambient temperature. The fracture exhibits intergranular decohesion, although same dimple rupture is present near center of fracture in (a).

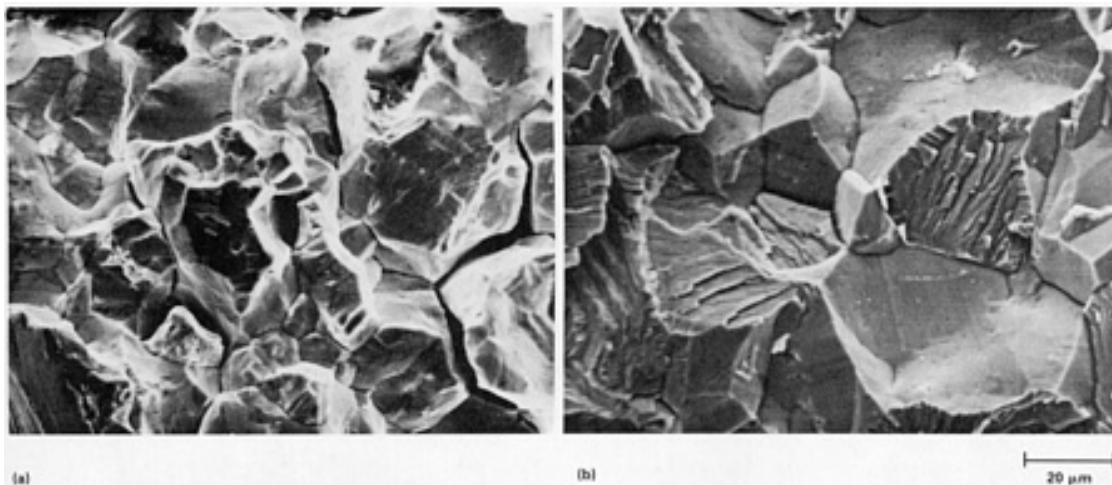
Fig. 54 Stress-corrosion fractures in a Cu-30Zn brass tested in distilled water at a potential of $E = 0 V_{SCE}$ (SCE,

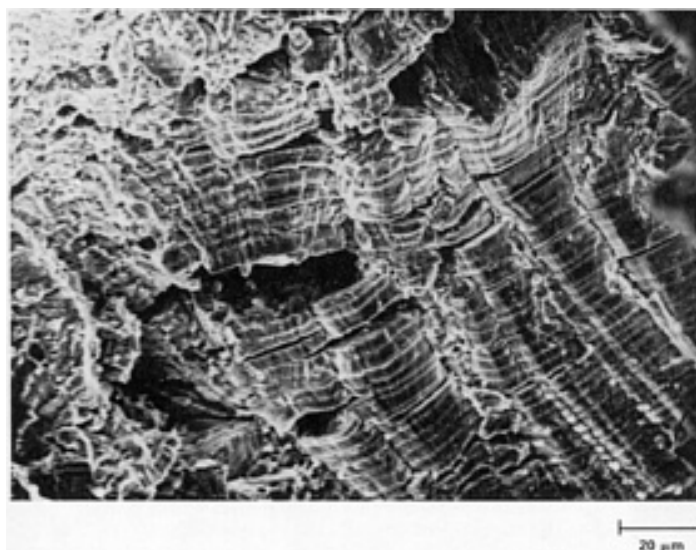
Fig. 55 Stress-corrosion fracture in a Cu-30Zn brass with 0.032% As tested in water containing $5 \times 10^{-3}\%$ sulfur dioxide at a potential of $E = 0.05 V_{SCE}$. The periodic marks are believed to be the result of a stepwise mode of crack propagation. Source: Ref 176

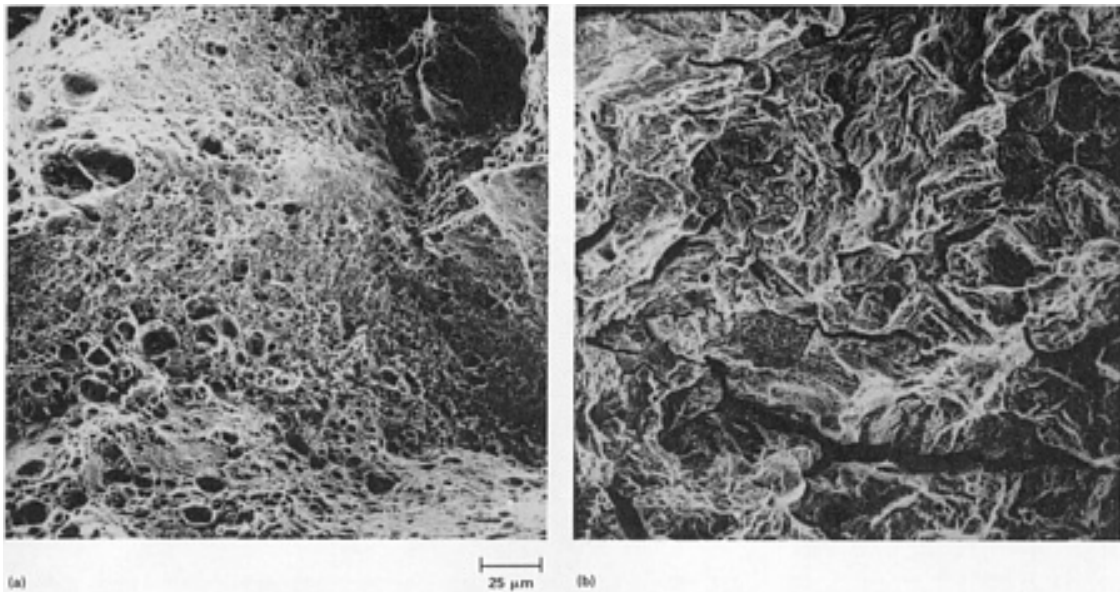
Fig. 59 Influence of lead on the fracture morphology of an AISI 4340 steel. (a) Ductile failure after testing in argon at 370 °C (700 °F). (b) Same steel tested in liquid lead at 370 °C (700 °F) showing brittle intergranular fracture

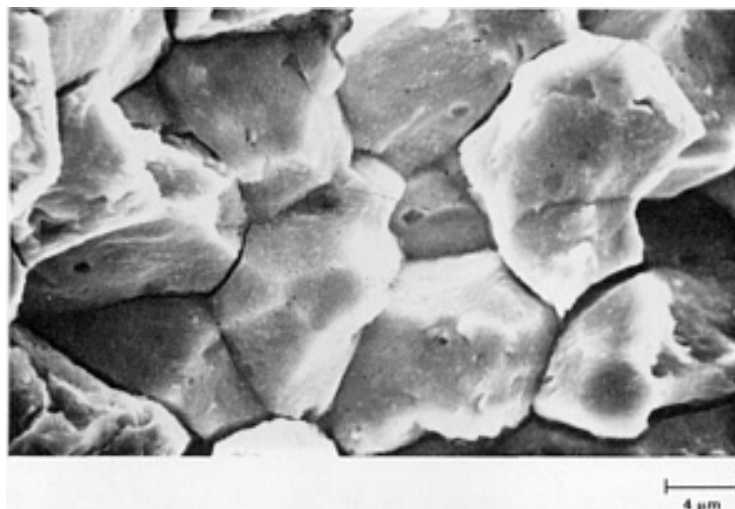
Fig. 61 Intergranular fracture surface of an AISI 4140 low-alloy steel nut that failed because of embrittlement by liquid cadmium

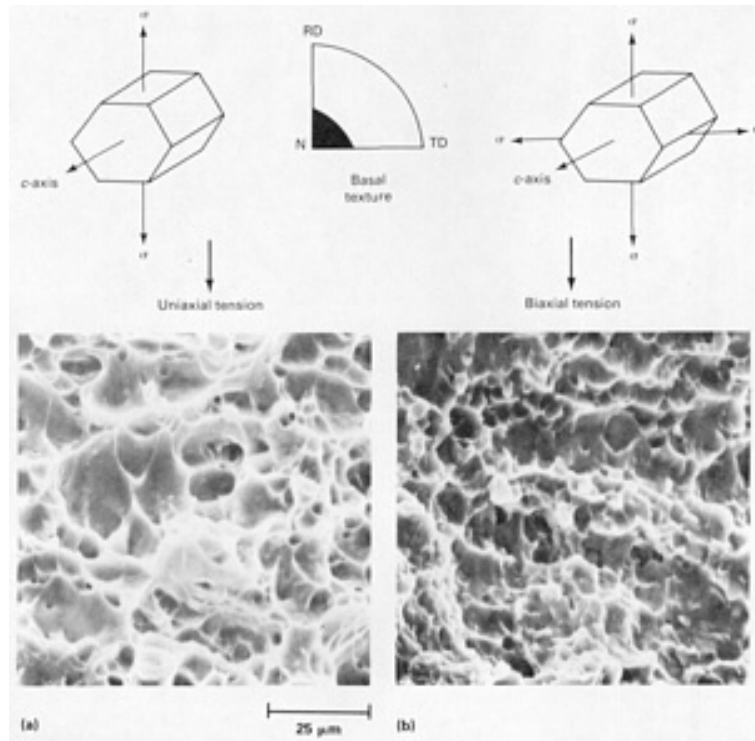
Fig. 62 Effect of balanced biaxial tension on dimple rupture in a hot-rolled basal-textured Ti-6Al-4V alloy. The dimples on the biaxially fractured specimen (b) are smaller and more shallow when compared to the uniaxially fractured specimen (a). Source: Ref 196

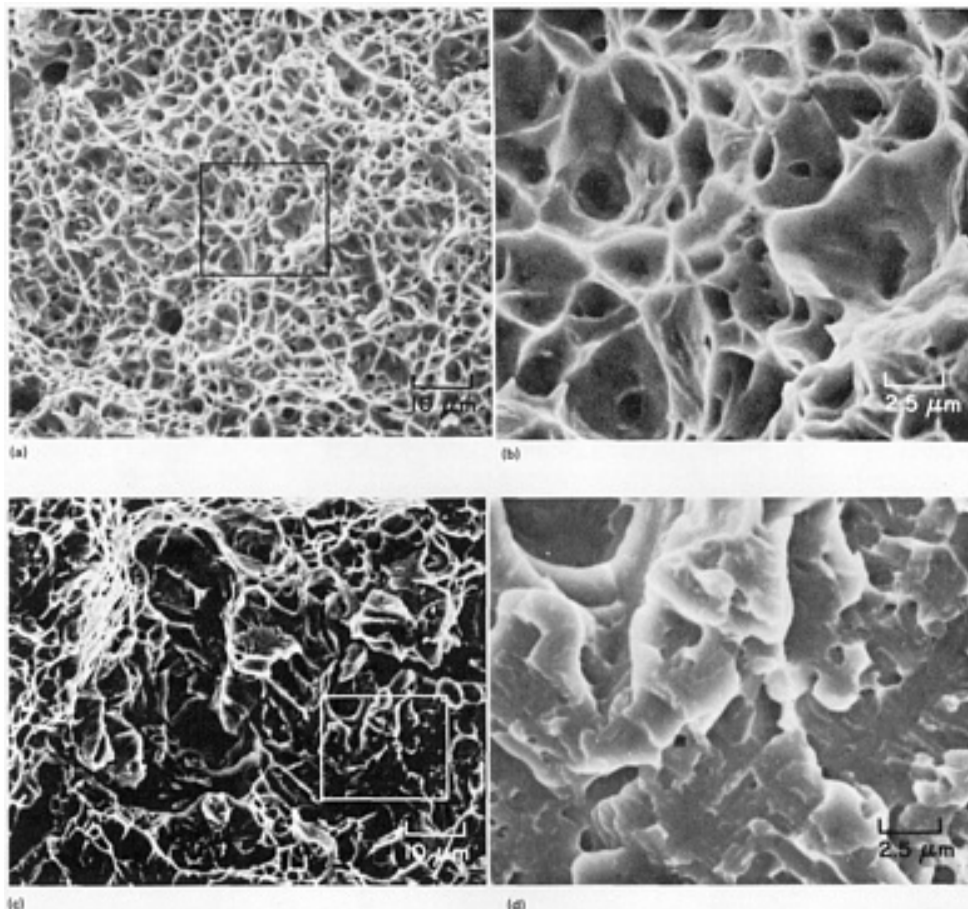
Fig. 63 Effect of a triaxial state of stress on the fracture mode in 13-8 pH stainless steel heat treated to an ultimate tensile strength of 1634 MPa (237 ksi). (a) and (b) Equiaxed dimples on the fracture surface of an unnotched specimen. (c) and (d) The quasi-cleavage fracture appearance if a notched specimen

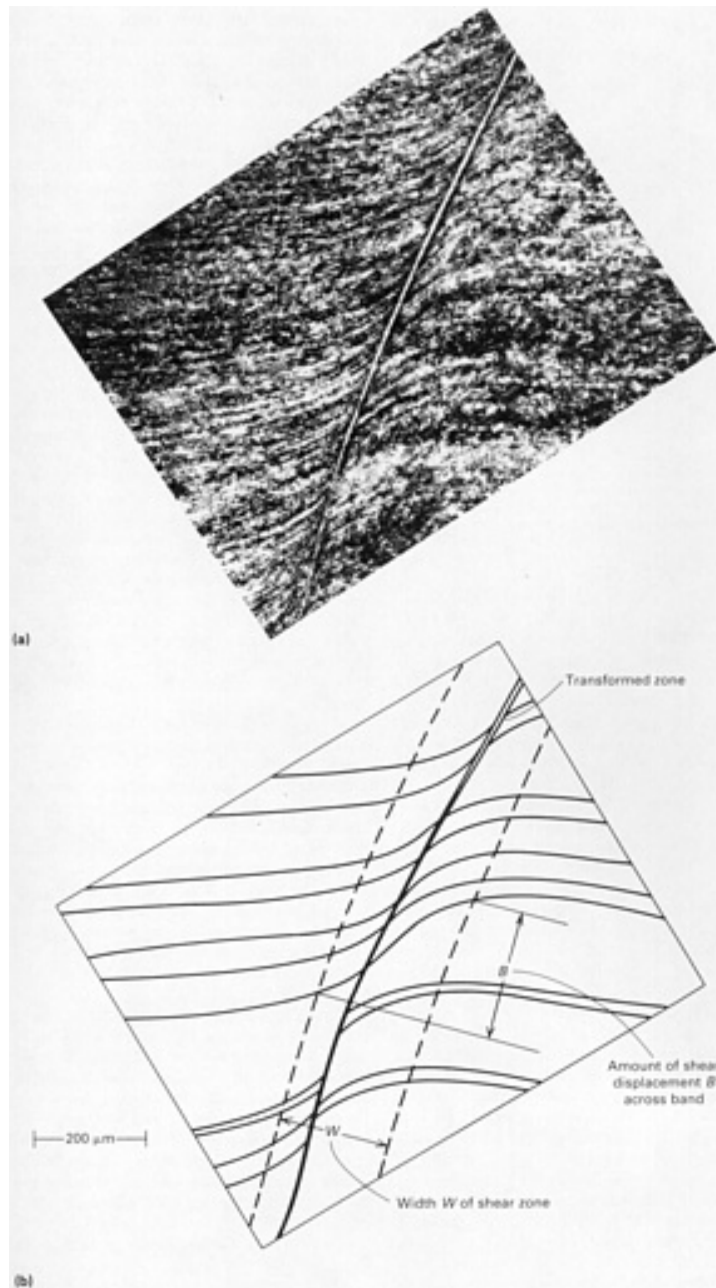
Fig. 65 Micrograph (a) and schematic (b) of a shear band in a plate of rolled medium carbon steel produced by ballistic impact showing the transformed zone and the zone of strain localization. (D.A. Shockey, SRI International)

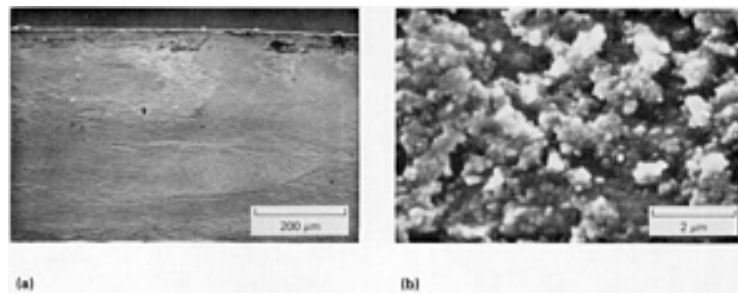
Fig. 67 Low-magnification (a) and higher-magnification (b) views of a failure surface produced in vacuum-arc remelted AISI 4340 steel (40 HRC) by dynamically shearing in a split Hopkinson torsion bar at a nominal shear strain rate of 6000 s^{-1} . The knobby fracture surface suggests that local melting occurred. (J.H. Giovanola, SRI International)

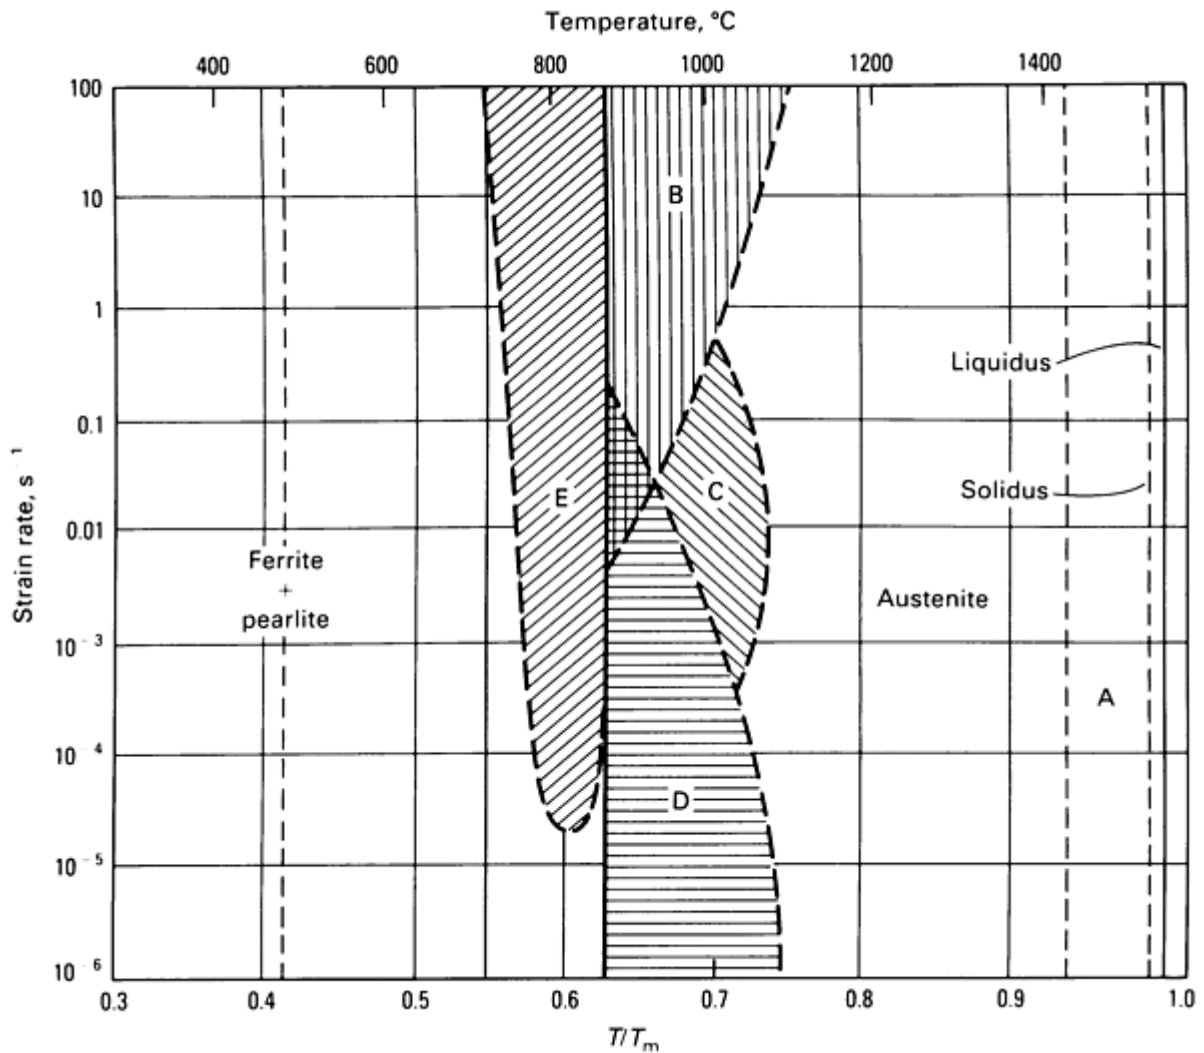
Fig. 68 Possible fracture zones mapped for a 0.2% C plain carbon steel in strain rate temperature space. T , testing temperature; T_m , melting temperature. The zones, which are shaded in the diagram, are as follows: A, subsolidus intergranular fracture due to segregation of sulfur and phosphorus; B, high strain rate intergranular fracture associated with MnS; C, ductile intergranular fracture--may or may not be preceded by B or D; D, low strain rate intergranular fracture; E, two-phase mixture with fracture at second-phase particles in the weaker preferentially strained ferrite. Source: Ref 209

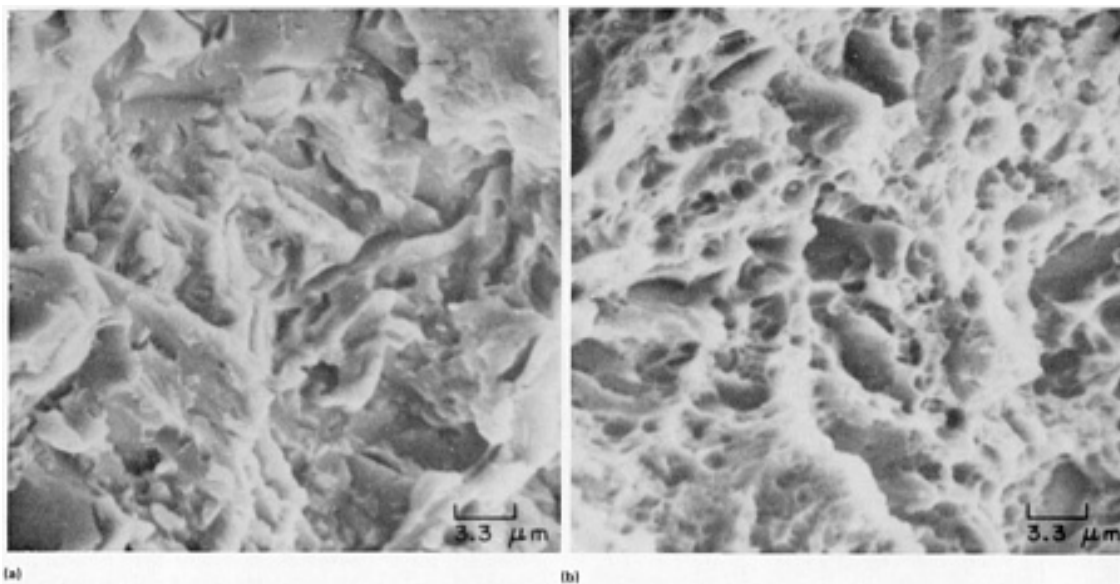
Fig. 70 Effect of test temperature on an AISI 1042 carbon steel with a slightly tempered martensitic (660 HV) microstructure that was Charpy impact tested at -196 and 100 °C (-320 and 212 °F). The fracture at -196 °C (-320 °F) consists entirely of cleavage (a), and at 100 °C (212 °F), it is dimple rupture (b).

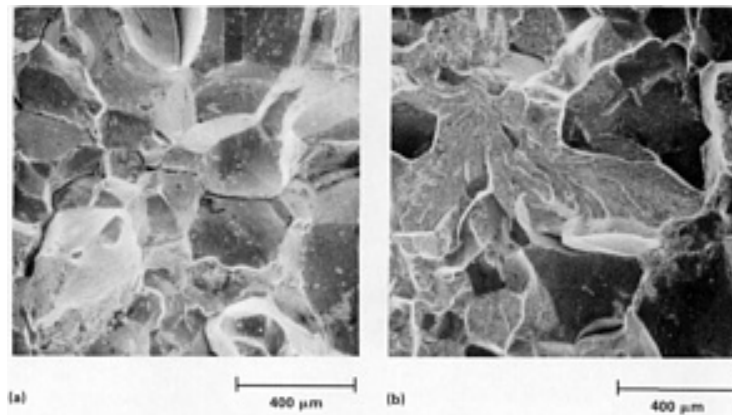
Fig. 71 Effect of test temperature on a 0.39C-2.05Si-0.005P-0.005S steel that was heat treated to a hardness of 30 HRC and Charpy impact tested at room temperature at -85 °C (-120 °F). The fracture at room temperature occurs by intergranular fracture (a) and by a combination of intergranular fracture and cleavage (b) at -85 °C (-120 °F). Source: Ref 211

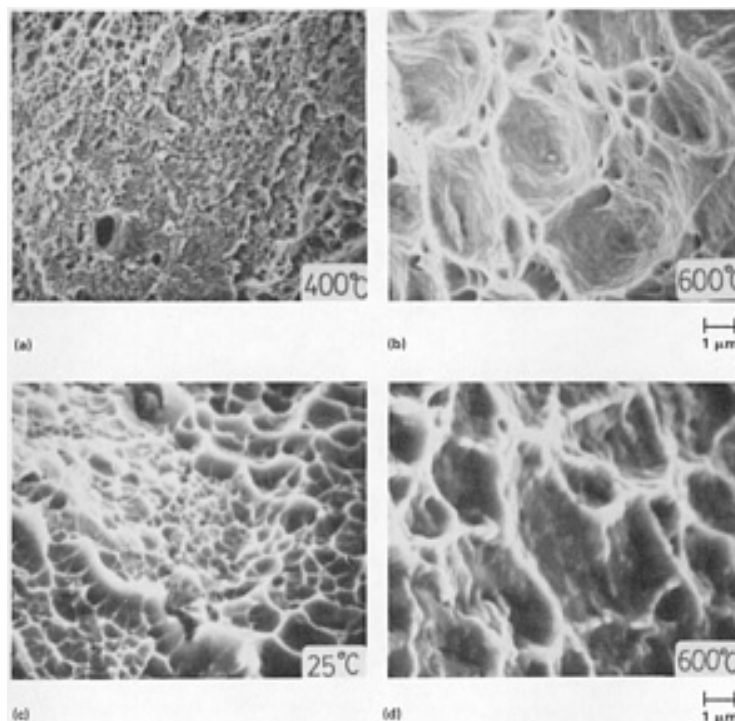
Fig. 72 Effect of temperature on dimple size in a 0.3C-1Cr-1.25Mo-0.25V-0.7Mn-0.04P steel that was heat treated to an ultimate strength level of 880 MPa (128 ksi). (a) and (b) Dimples on transgranular facets. (c) and (d) Dimples on intergranular facets. Note that dimple size increased with temperature. Source: Ref 213

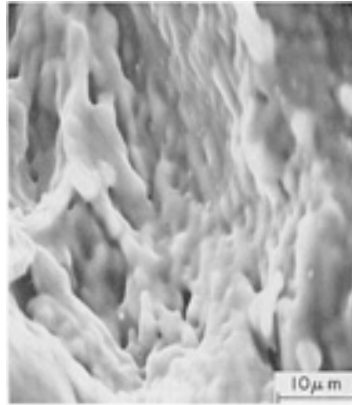
Fig. 73 Effect of temperature on the fracture of an ultralow-carbon steel. The 0.05C-0.82Mn-0.28Si steel containing 180 ppm S was annealed for 5 min at 1425 °C (2620 °F), cooled to 950 °C (1740 °F), and held for 3 min before tensile testing at a strain rate of $2.3 \times 10^{-4} \text{ s}^{-1}$. The fracture, which occurs by dimple rupture when tested at room temperature, exhibits intergranular decohesion at 950 °C (1740 °F). Source: Ref 209

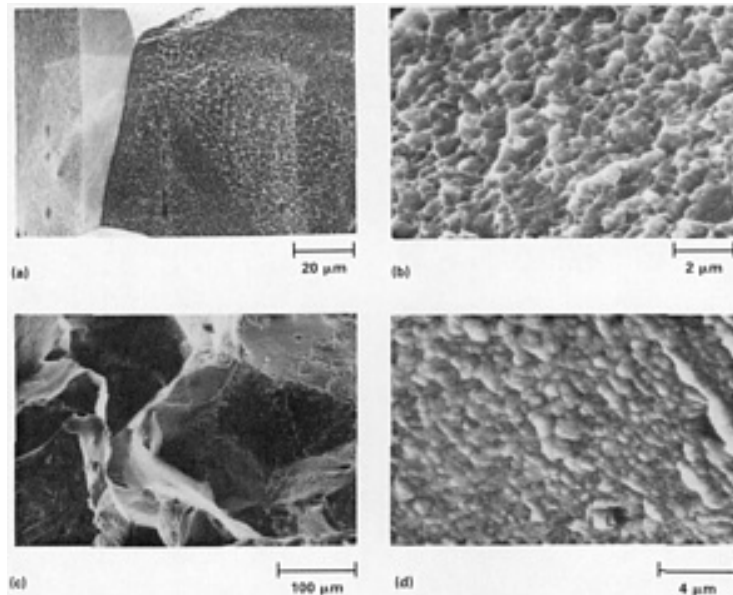
Fig. 74 Effect of temperature on double-aged Inconel X-750 that was tested at a nominal strain rate of $3 \times 10^{-5} \text{ s}^{-1}$. (a) and (b) The fracture at room temperature occurs by intergranular dimple rupture. Note the evidence of dimple rupture network on the intergranular walls. (c) and (d) At 816 °C (1500 °F), the fracture shows intergranular decohesion with no dimple rupture. However, the intergranular facets are roughened by the presence of $M_{23}C_6$ carbides. Source: Ref 214.

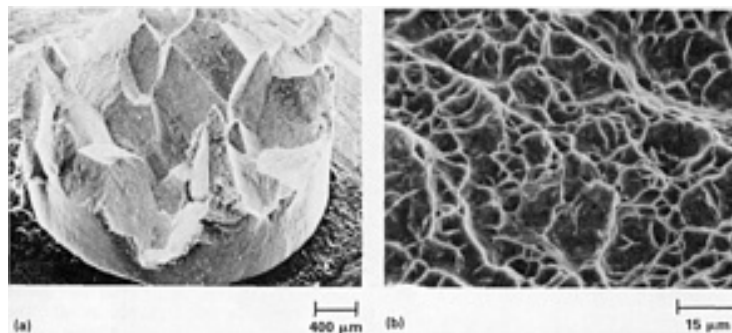
Fig. 76 Intergranular dimple rupture in a Ti-6Al-2Nb-1Ta-0.8Ta alloy tested at $800 \text{ }^{\circ}\text{F}$ ($1470 \text{ }^{\circ}\text{F}$). The fracture path in this alloy, tensile tested at a strain rate of about $3.3 \times 10^{-4} \text{ s}^{-1}$, changes at $800 \text{ }^{\circ}\text{C}$ ($1470 \text{ }^{\circ}\text{F}$) from a predominantly transgranular dimple at room temperature (not shown) to intergranular dimple rupture. Source: Ref 215

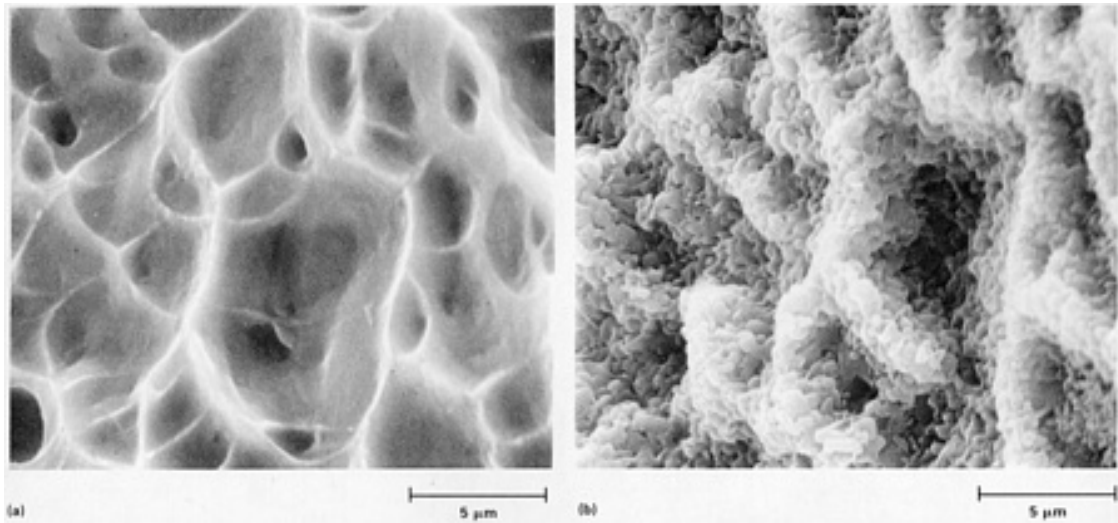
Fig. 78 Effect of a 15-min 800- °C (1470- °F) air exposure on a dimple rupture fracture surface of an annealed Ti-6Al-6V-2Sn alloy. (a) Fracture appearance before exposure. (b) The identical fracture surface after exposure. The oxide buildup is so great that it is impossible to identify the fracture mode. (V. Kerlins, McDonnell Douglas Astronautics Company)

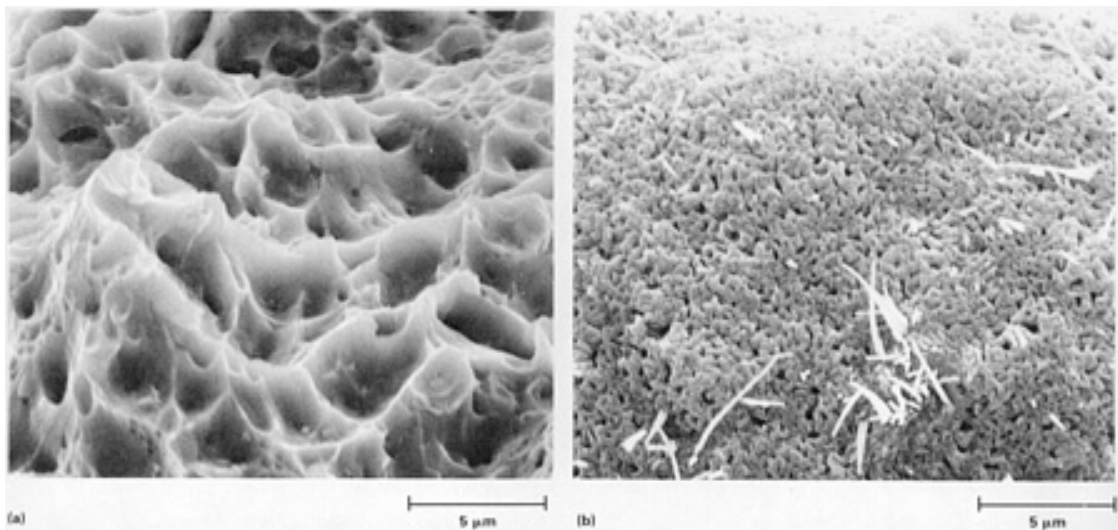
Fig. 79 Effect of a 5-min 700- °C (1290- °F) air exposure on a 300M (2028 MPa, or 294 ksi) high-strength steel overload fracture. (a) Fracture appearance before exposure. (b) The same area after exposure. The entire fracture, which exhibited dimple rupture, was covered by an oxide that obscured all fracture detail. Some areas on the oxidized surface contained needlelike whiskers, which are probably an iron oxide. (V. Kerlins, McDonnell Douglas Astronautics Company)

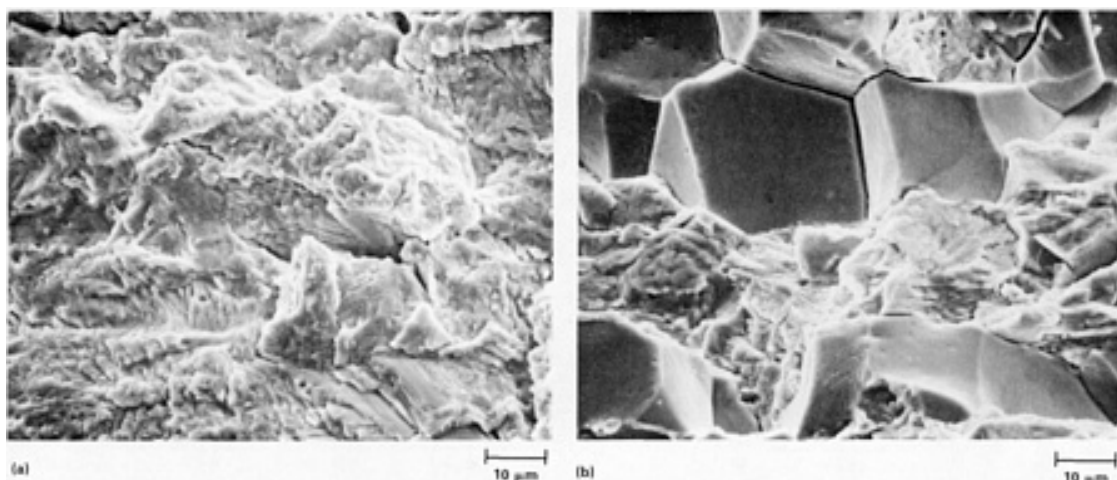
Fig. 80 Effect of hydrogen on the fatigue fracture appearance of a grade X42 pipeline steel. (a) Tested in dry nitrogen gas at a stress intensity range of $\Delta K = 20 \text{ MPa} \sqrt{m}$ ($18 \text{ ksi} \sqrt{in}$), a load ratio of $R = 0.1$, and a cyclic frequency of 5 Hz. (b) Tested in dry hydrogen gas at a stress intensity range of $\Delta K = 10 \text{ MPa} \sqrt{m}$ ($9 \text{ ksi} \sqrt{in}$), a load ratio of $R = 0.1$, and a cyclic frequency of 1 Hz. Both room-temperature fatigue tests resulted in a fatigue crack growth rate of approximately $2 \times 10^{-4} \text{ mm/cycle}$. The fatigue fracture in nitrogen exhibited principally a serrated transgranular fracture, along with occasional bands of intergranular decohesion (not shown); however the fracture in hydrogen exhibited fewer regions of serrated fracture and more bands of intergranular decohesion. Source: Ref 218

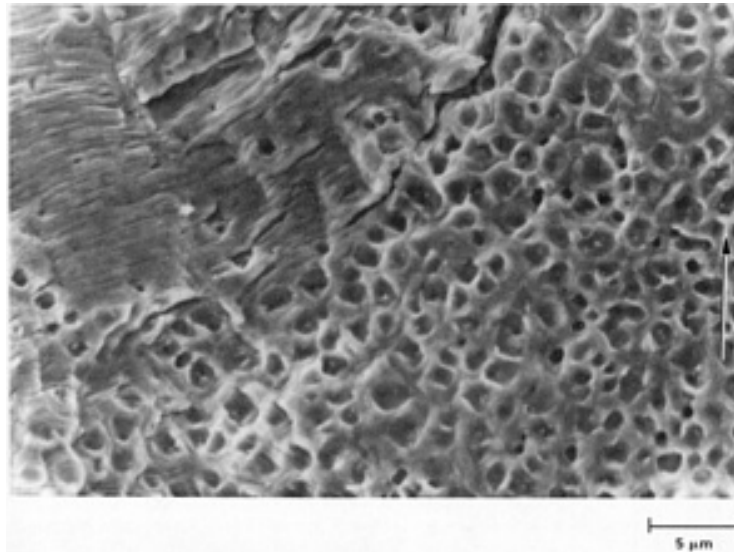
Fig. 81 Effect of severe hydrogen attack on the fatigue fracture appearance of an ASTM 533B pressure vessel steel. The severely charged material was tested at room temperature at a stress intensity range of $\Delta K = 20 \text{ MPa}\sqrt{m}$ ($18 \text{ ksi}\sqrt{in}$), a load ratio of $R = 0.1$, and a cyclic frequency of 50 Hz. The fracture exhibited fatigue striations (upper left) as well as cavitated intergranular facets resulting from methane gas bubble formulation at grain boundaries. Arrow indicates crack growth direction. Source: Ref 223

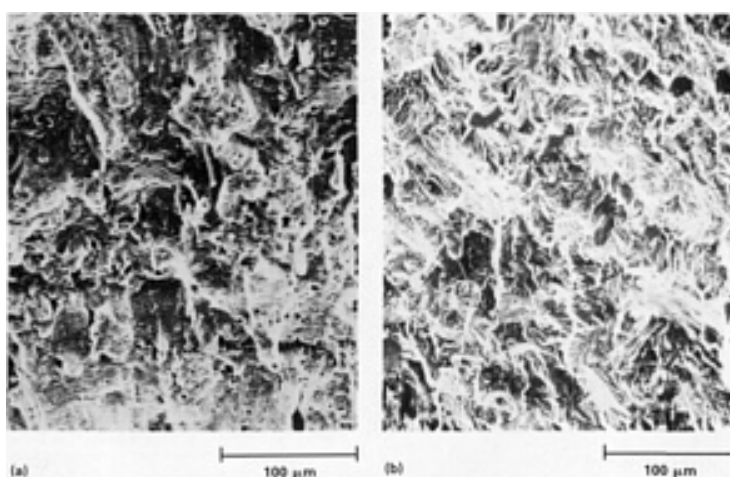
Fig. 82 Fatigue fracture surfaces of annealed type 301 and type 302 stainless steels tested at 25 °C (75 °F) in 1 atm hydrogen gas. The type 302 stainless steel (a) showed well-developed fatigue striations. The type 301 stainless steel (b) showed a more brittle-appearing fracture surface with few striations but containing flat, cleavagelike facets and small, parallel facets at different elevations joined by tear ridges. Source: Ref 217
