به نام خدا

مرکز دانلود رایگان
مهندسی متالورژی و مواد

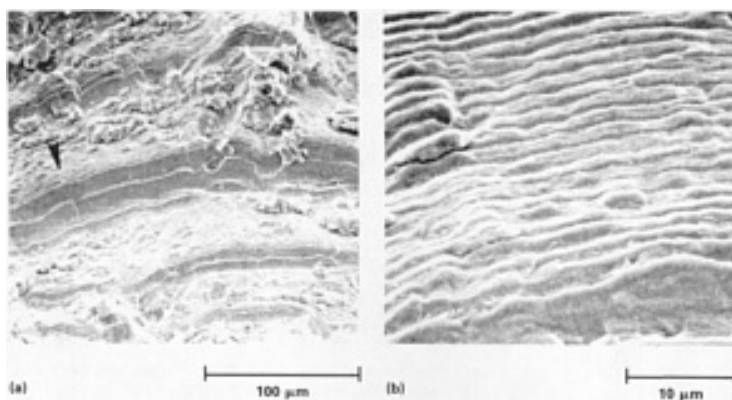
Fig. 84 Typical ridges and fatigue striations on the fracture surface of an annealed Incoloy 800 specimen tested in a sulfidizing atmosphere in the 316 - to 427 - °C (600 - to 800 - °F) temperature range. (b) Higher-magnification fractograph of the area indicated by arrow in (a). Note the width of the smooth stretched areas at the ridges. Source: Ref 228

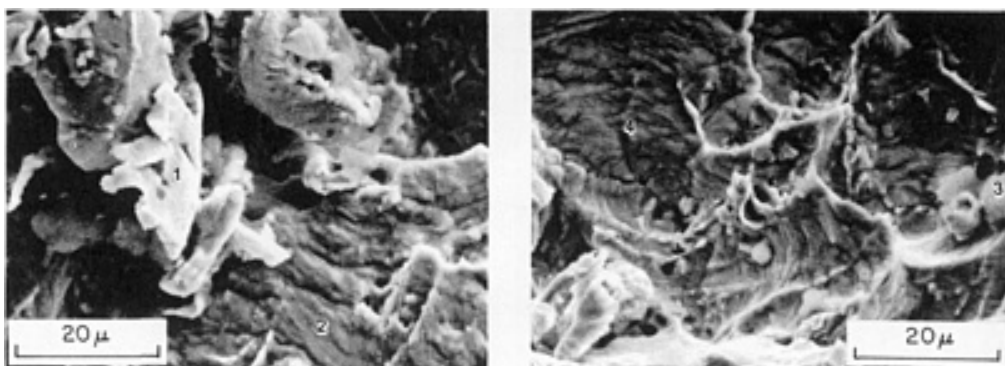
Fig. 85 Discrete sulfide particles on fracture surfaces of an Incoloy 800 tested in a sulfidizing atmosphere. Energy-dispersive x-ray analysis indicated that sulfur was present at particles 1 and 3 and that no sulfur was

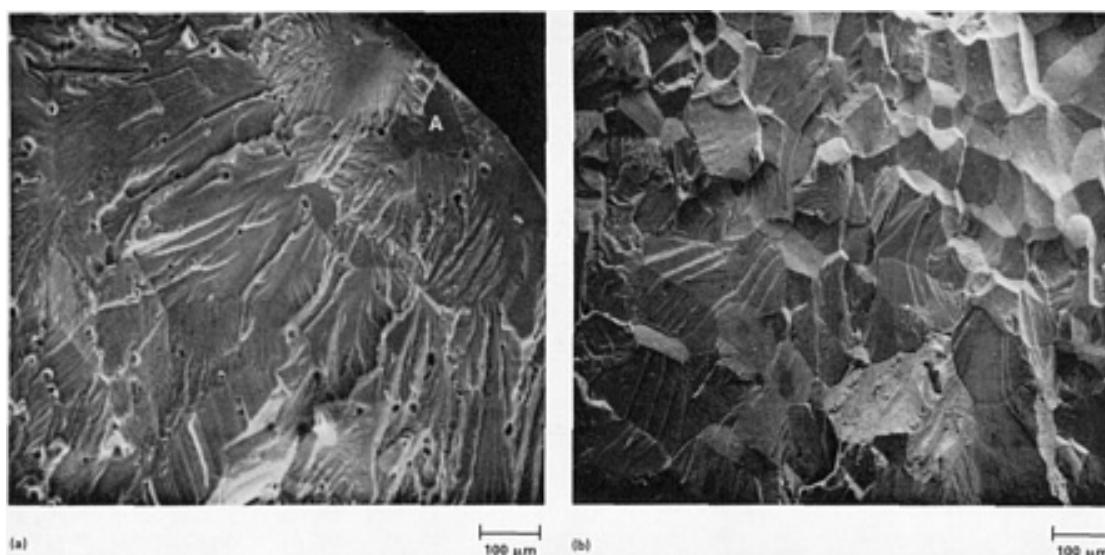
Fig. 86 Effect of environment on the fatigue fracture appearance in a 7075-T6 aluminum alloy tested at room

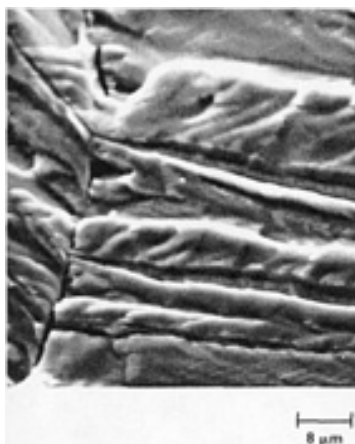
Fig. 87 Furrow-type fatigue fracture in a commercially pure titanium alloy IMI 155 tested at room temperature in laboratory air. $\Delta K = 16 \text{ MPa}\sqrt{m}$ ($14.5 \text{ ksi}\sqrt{in}$), $da/dN = 10^{-8} \text{ m/cycle}$. Source: Ref 236

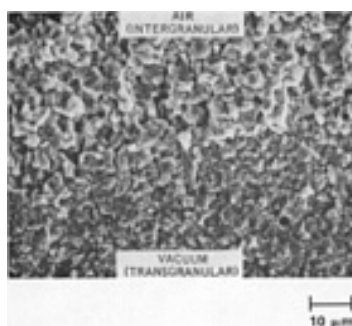
Fig. 88 Typical fatigue fracture appearance of Astroloy tested in air and vacuum at 650 °C (1200 °F). In air (upper portion of fractograph) the fracture exhibits a predominantly intergranular character; in vacuum (lower half of fractograph) the fracture is transgranular. Source: Ref 244

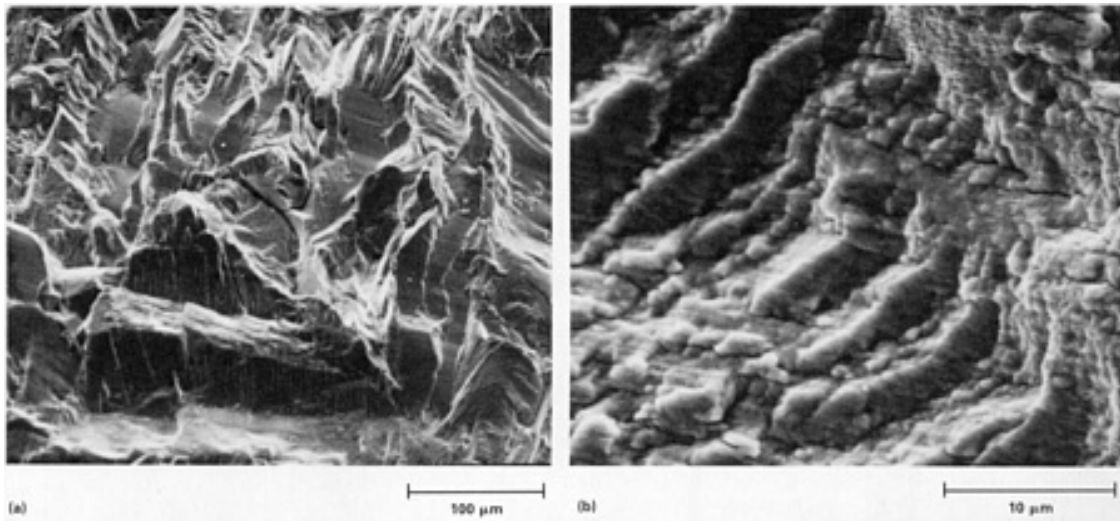
Fig. 90 Fatigue fractures in Inconel X-750 tested at a stress intensity of $\Delta K = 20 \text{ MPa}\sqrt{m}$ ($18 \text{ ksi}\sqrt{in}$) in air and vacuum at 650°C (1200°F). The crack propagation direction is from bottom to top. The fracture in air (a) exhibited a faceted, crystallographic appearance; the vacuum fracture (b) was less faceted and contained distinct, periodic crack front markings. Source: Ref 245

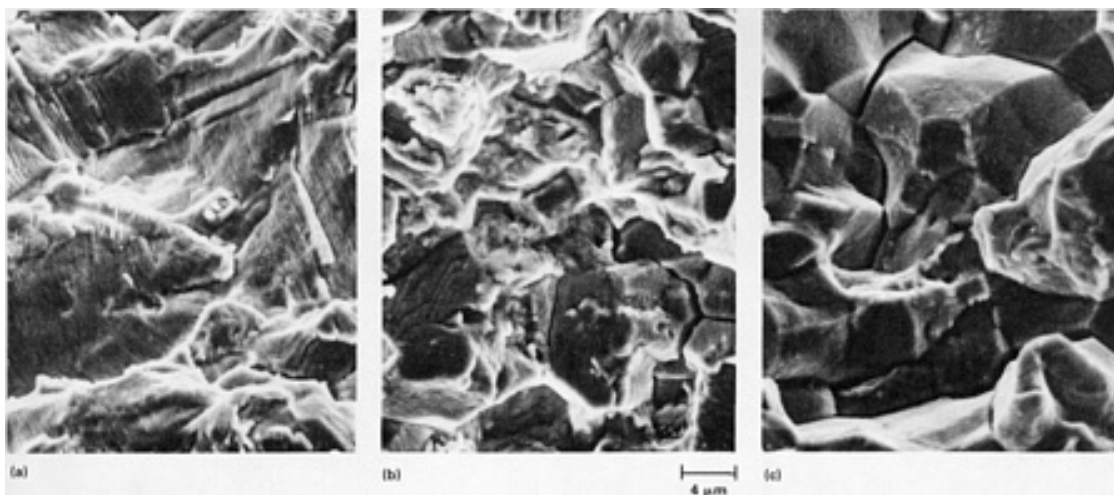
Fig. 93 Effect of frequency on the fracture appearance of an IN-718 nickel-base superalloy that was creep fatigue tested at 650 °C (1200 °F): $R = 0.1$, $K_{\max} = 40 \text{ MPa} \sqrt{m}$ ($36.5 \text{ ksi} \sqrt{in}$). (a) Striation formation at 10 Hz. (b) Mixture of intergranular and transgranular cracking at 0.5 Hz. (c) Fully intergranular cracking at 0.001 Hz

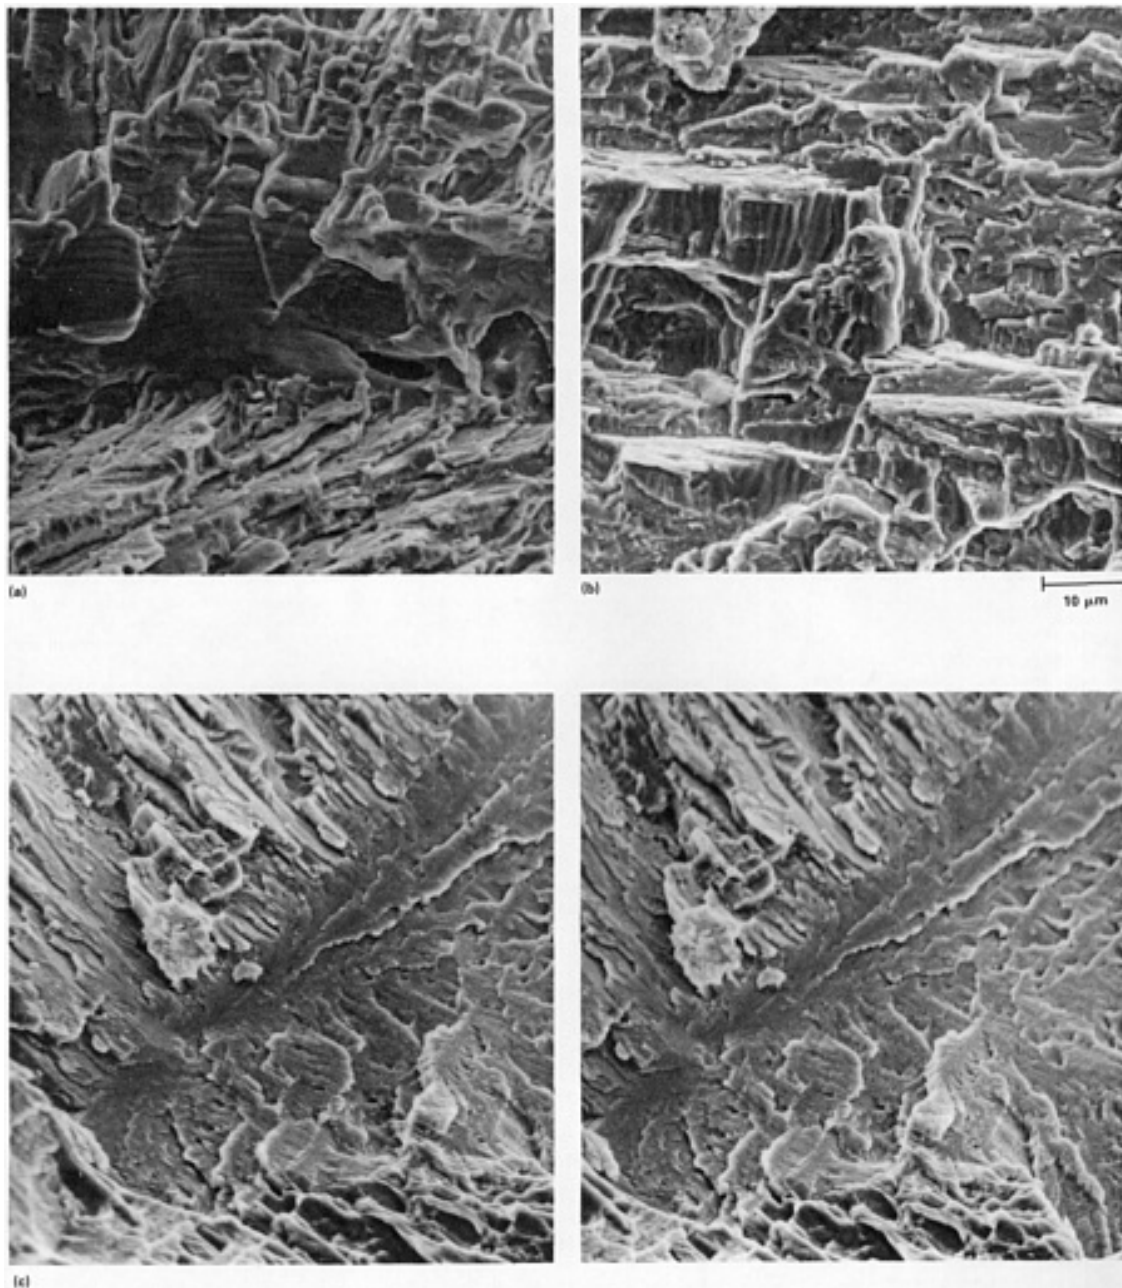
Fig. 95 Changes in the principally fatigue-striated fracture appearance of a Ti-6Al-5Zr-0.5Mo-0.25Si alloy as a result of a 5-min dwell at maximum tensile stress. The changes included a local increase in the striation spacing after the dwell period (a); a change in the local fracture direction, as indicated by the orientation of the fatigue striations (central portion of photograph), which are normal to the macroscopic fracture propagation direction (b); and the introduction of cleavage fracture shown in the stereo pair in (c). The macroscopic crack growth direction is vertical. Source: Ref 257

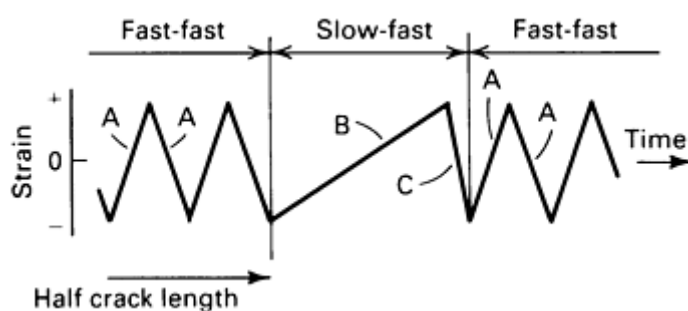
Fig. 96 Fatigue test strain wave form. A, strain, rate = $50 \times 10^{-5} \text{ s}^{-1}$ (fast-fast cycles); B, strain rate = $1.4 \times 10^{-5} \text{ s}^{-1}$ (the slow-rising strain ramp of the slow-fast cycle); C, strain rate = $28 \times 10^{-5} \text{ s}^{-1}$ (the fast-declining strain ramp of the slow-fast cycle). Source: Ref 255

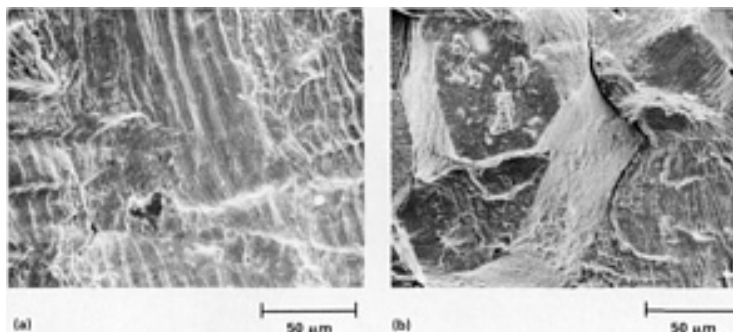
Fig. 97 Effect of one slow-fast cycle on the fracture appearance of an SUS 304 stainless steel that was fatigue tested in air at 600 °C (1110 °F). (a) Increase in fatigue striation spacing after the introduction of the slow-fast cycle at a half crack length = 0.97 mm (0.038 in.) (b) Intergranular fracture after the application of one slow-fast cycle at a half crack length of 1.0 mm (0.039 in.). Crack growth direction in both figures is right to left. Source: Ref 255

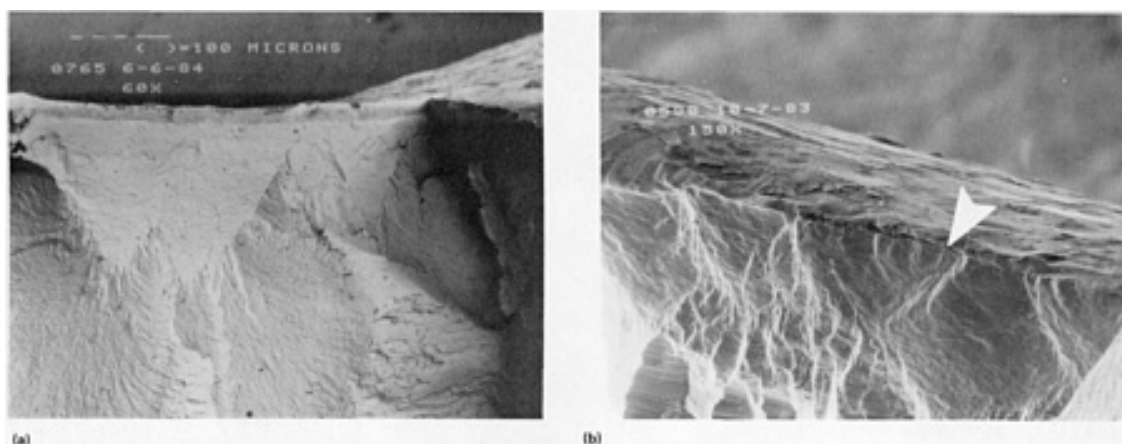
Fig. 99 Fractures in AISI 5160 wire springs that originated at seams. (a) Longitudinal fracture originating at a seam. (b) Fracture origin at a very shallow seam, the arrow indicates the base of the seam. (J.H. Maker, Associated Spring)

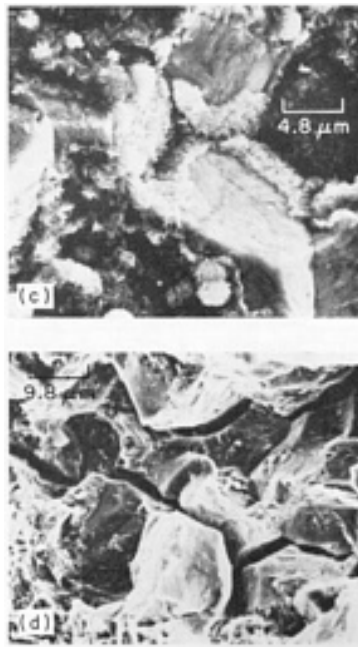
Fig. 101 SEM views of the corrosion products (a) and the intergranular fracture and secondary grain-boundary cracks (b) that were the result of the laps shown in Fig. 100

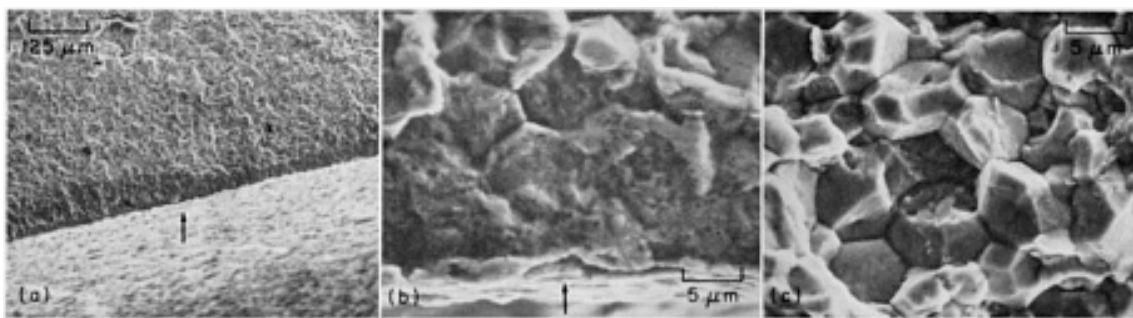
Fig. 102 Fracture caused by a portion of a pre-existing intergranular stress-corrosion crack that was not removed in reworking. The part was made of AISI 4340 steel that was heat treated to a tensile strength of 1790 to 1930 MPa (260 to 280 ksi). (a) and (b) Remains of an old crack along the edge of the surface of the part (arrows); note dark zone in (a) and extensively corroded separated grain facets in (b). (c) Clean intergranular portion of crack surface that formed at the time of final fracture

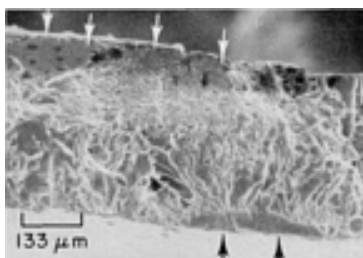
Fig. 103 Fracture in a weld in commercially pure titanium showing incomplete fusion. Unfused regions, on both surfaces (arrows), served as nuclei of fatigue cracks that developed later under cyclic loading.

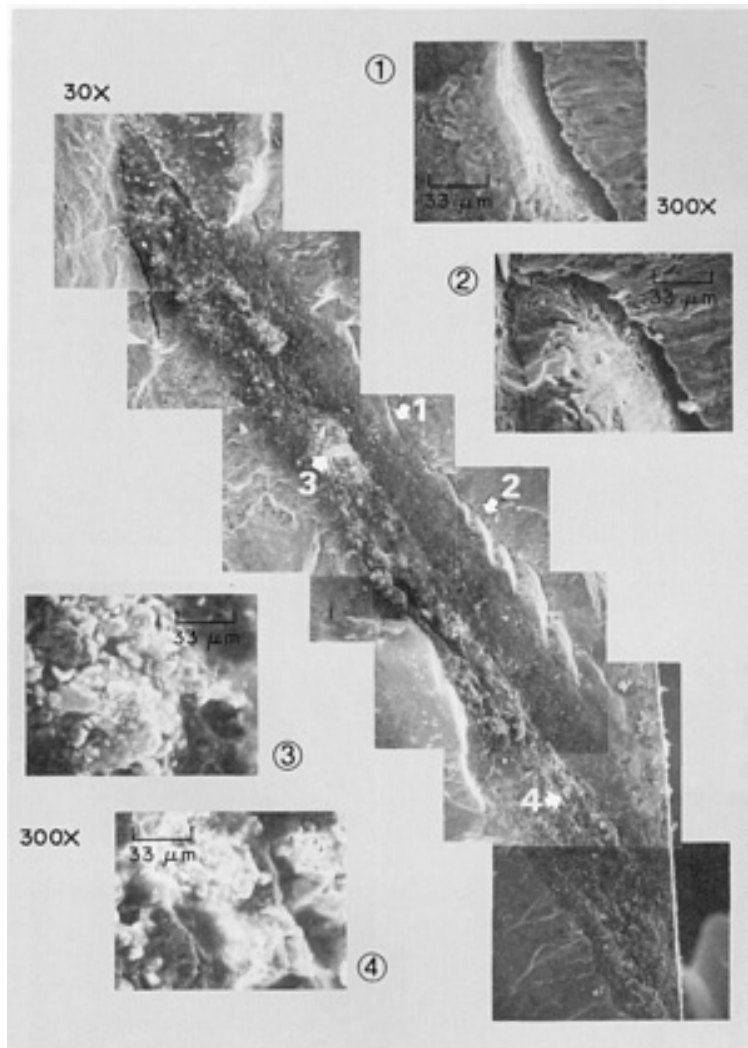
Fig. 104 Inclusion in a surface of a service fracture in a case-hardened AISI 9310 steel forging. The diagonal view is a composite of several fractographs showing a very large inclusion, which was a fragment of the pouring-ladle firebrick lining. Fractographs 1 to 4 are higher-magnification views of areas indicated by arrows 1 to 4, respectively, in the diagonal view.

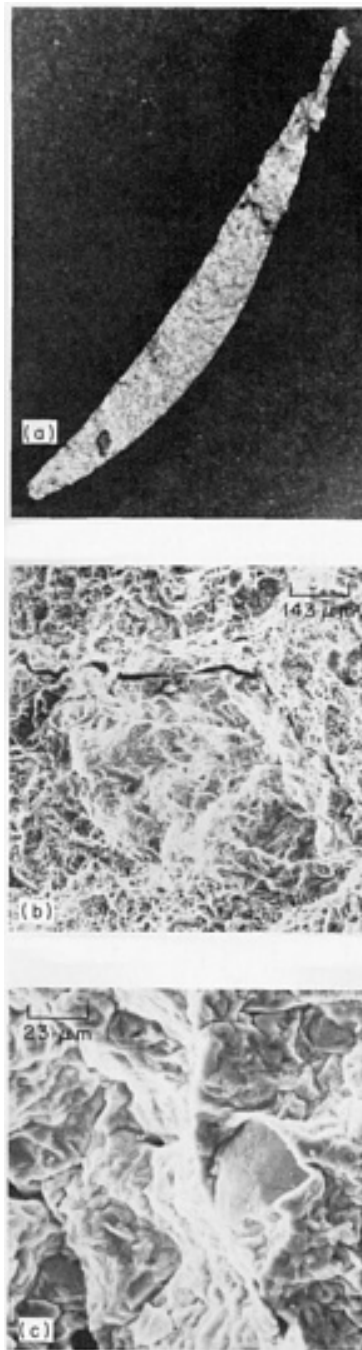
Fig. 105 Fracture surface of a cast aluminum alloy A357-T6 air-turbine blade. (a) Overall view of the fracture surface showing a large inclusion (dark) near the tip of the blade. Approximately 0.4×. (b) and (c) Decohesion at the interfaces between the inclusion and the aluminum matrix

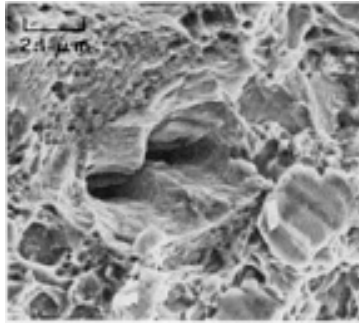
Fig. 106 Fracture surface of an AISI 4340 steel that was heat treated to a tensile strength of 1790 to 1930 MPa (260 to 280 ksi) showing deep dimples containing the inclusions that initiated them. (J. Kilpatrick, Delta Air Lines)

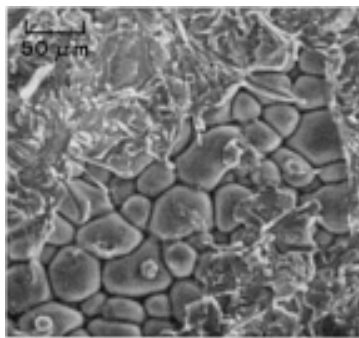
Fig. 107 Halide-flux inclusion (rounded granules) in the joint between an actuator and an attachment bracket of aluminum alloy 6061 that were joined by dip brazing using an Al-12Si brazing alloy

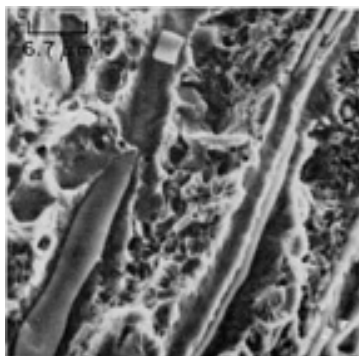
Fig. 108 Stringers on the surface of a fracture that occurred during straightening of an AISI 4340 steel forging that had been heat treated to a tensile strength of 1380 to 1520 MPa (200 to 220 ksi). Stringers are visible as parallel features inclined about 30° to right of vertical. They were not identified as to composition, but may be accidentally entrapped slag that was elongated in the major direction of flow during forging.

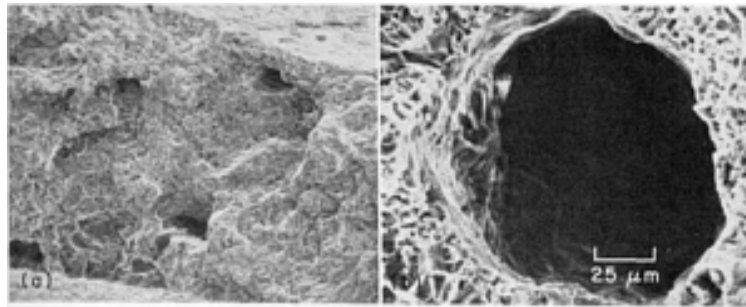
Fig. 109 Porosity in a fracture of a cast aluminum alloy A357 blade from a small air turbine. The blade fractured by overload from an impact to its outer edge.

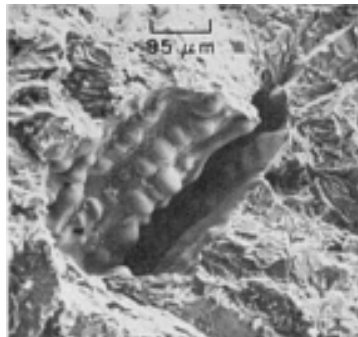
Fig. 110 Shrinkage void with dendrite nodules on a fracture surface of a cast aluminum alloy A357-T6 gear housing that broke by overload

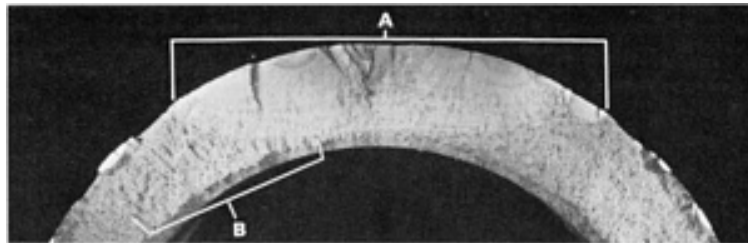
Fig. 112 Fatigue fracture through a region of unfavorable grain flow and large inclusions in an aircraft landing-gear axle forged from AISI 4340 steel. Several fatigue crack origins were found in region A. Numerous small discontinuous marks nearly perpendicular to the direction of crack propagation were determined by metallographic examination to be related to forging flow lines and large, elongated sulfide inclusions. Woody appearance outside fatigue zones, region B, also suggests unfavorable grain flow. Light fractograph. 1.8×

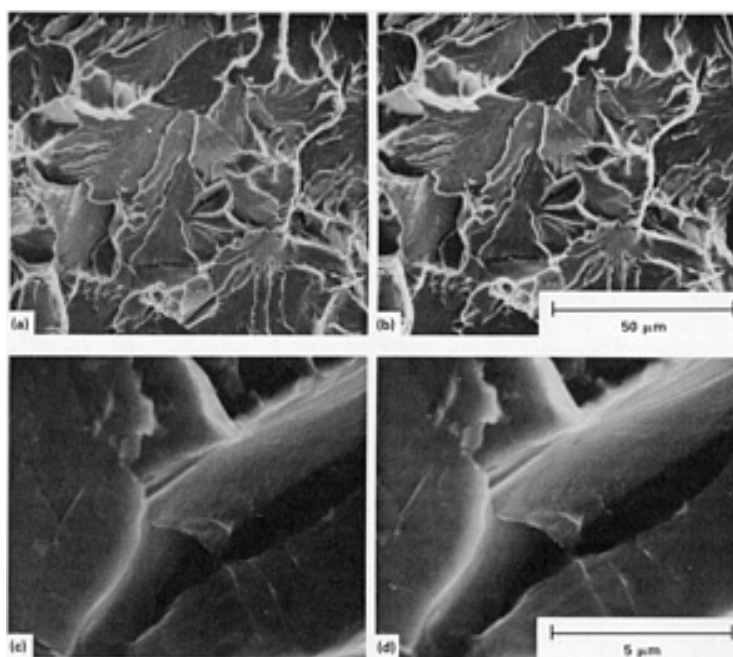
Fig. 1 Comparison of identical fracture areas of steel Charpy specimens at increasing magnifications. (a) and (c) show the as-fractured surface; (b) and (d) show the same fracture surface after coating with Tectyl 506, exposing

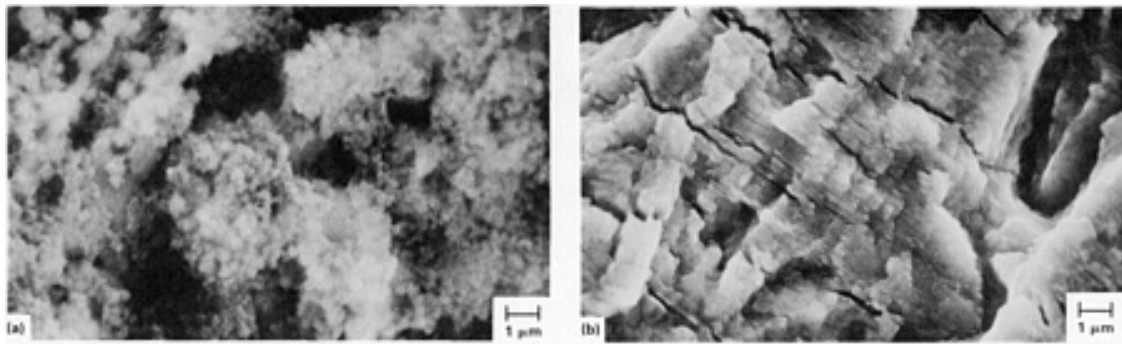
Fig. 4 Fatigue precrack region shown in Fig. 3. (a) Before ultrasonic cleaning in a heated Alconox solution for 30 min. (b) After ultrasonic cleaning

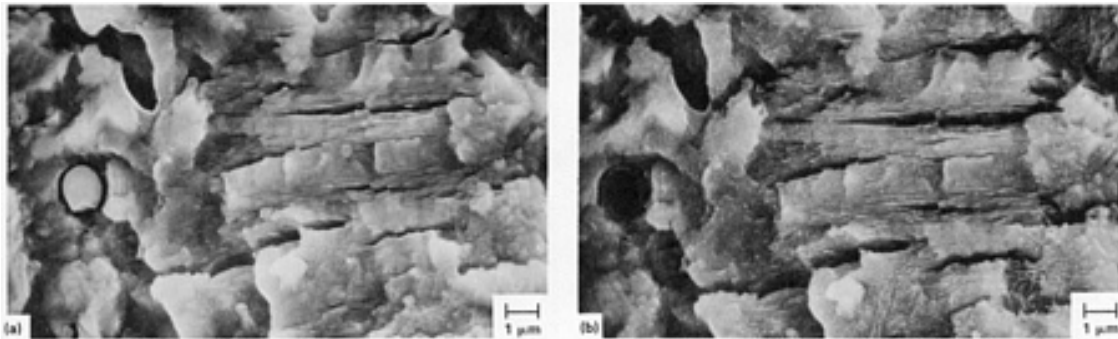
Fig. 5 Effect of increasing the ultrasonic cleaning time in a heated Alconox solution. (a) 30 min. (b) 3.5 h. Note the dislodging of the inclusion (left side of fractograph) and chemical etching of the fracture surface.

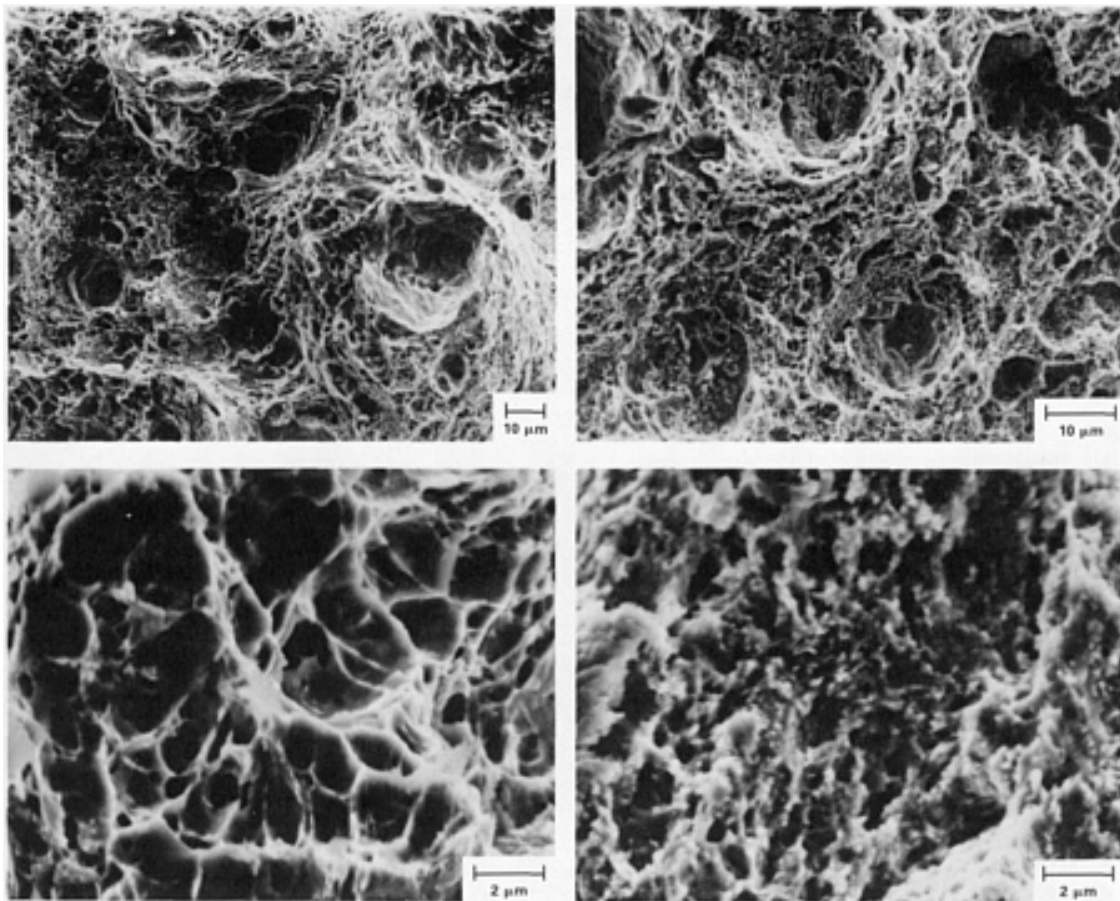
Fig. 6 Comparison of stable ductile crack growth areas from quenched-and-tempered 1085 carbon steel at increasing magnifications. The fractographs on the left show the as-fractured surface; those on the right show the fracture surface after corrosion exposure and cathodic cleaning.

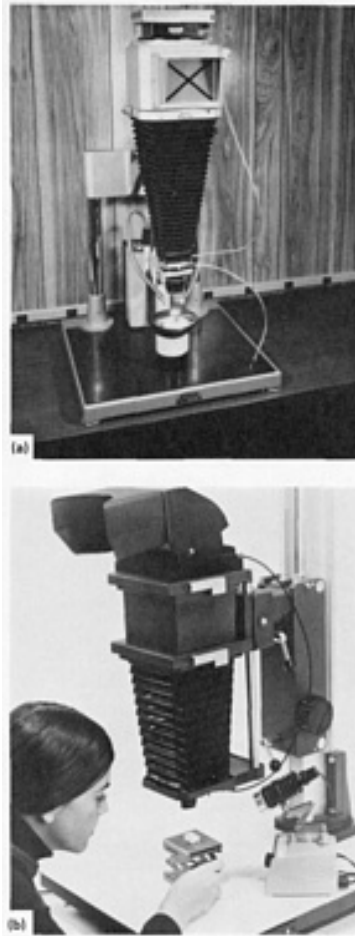
Fig. 1 Specialized view camera systems for photomacrography. (a) System with a bifurcated fiber optic source. Courtesy of Nikon, Inc. (b) View camera system. Courtesy of Polaroid Corporation

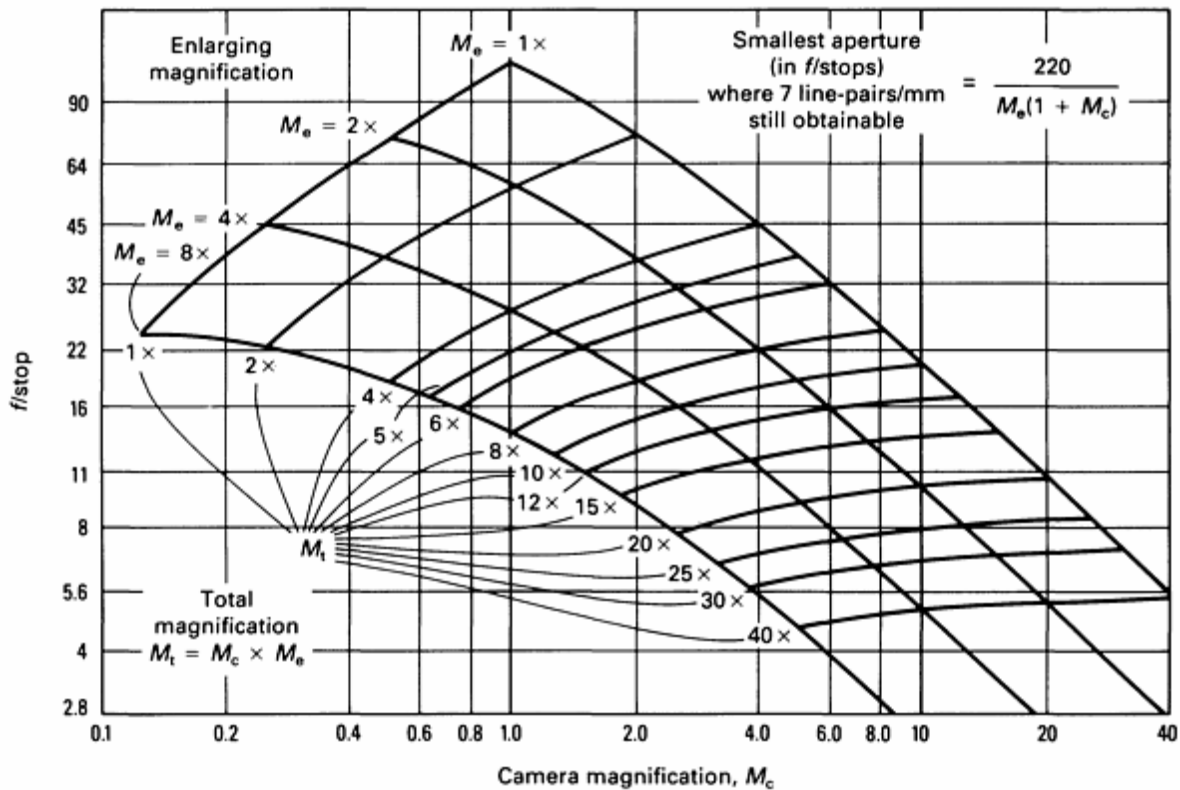
Fig. 3 Recommended f /numbers for optimum depth of field with high resolution. See Table 1. Source: Ref 4

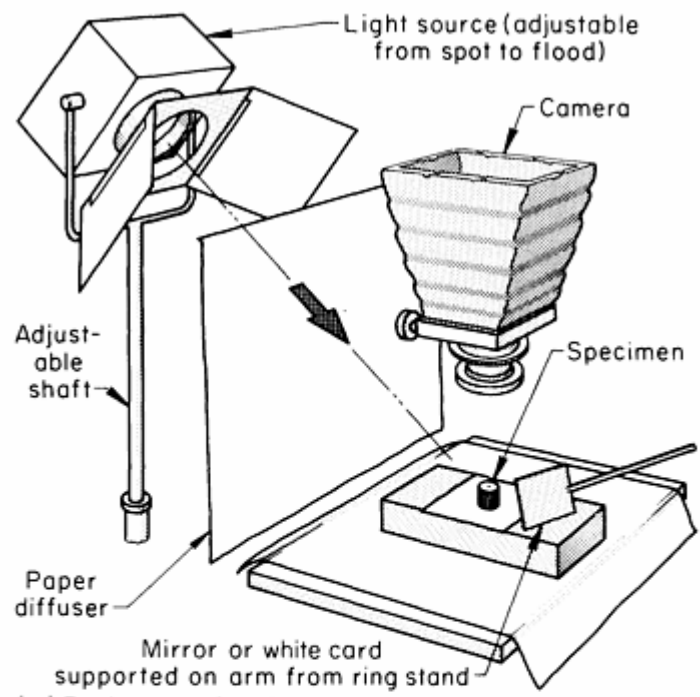
(a) Basic setup for photography of fracture specimens

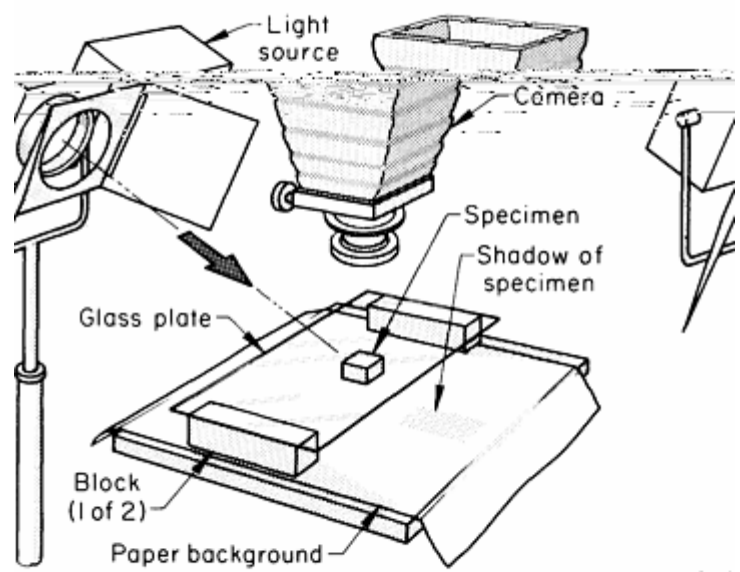
Shadowless background for photography of fracture specimens

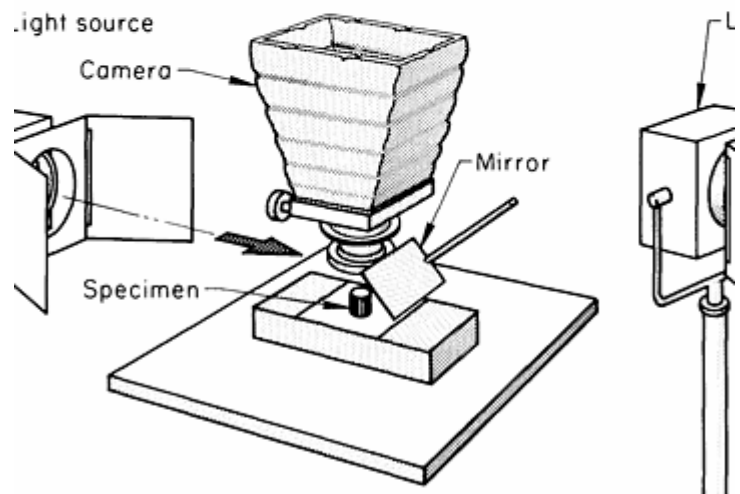
Horizontal illumination for close-up photography of fracture specimens

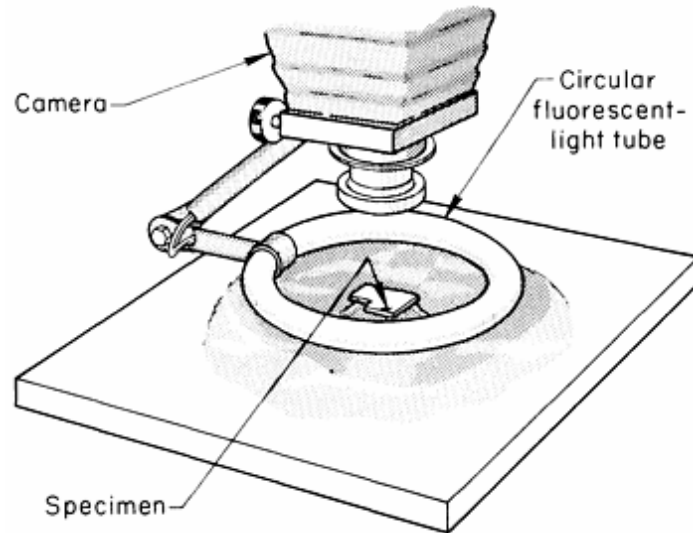
Fig. 7 Ring illumination by a circular fluorescent-light tube. This setup provides a soft, low-contrast, uniform illumination for 360 ° and generates a minimum of heat.

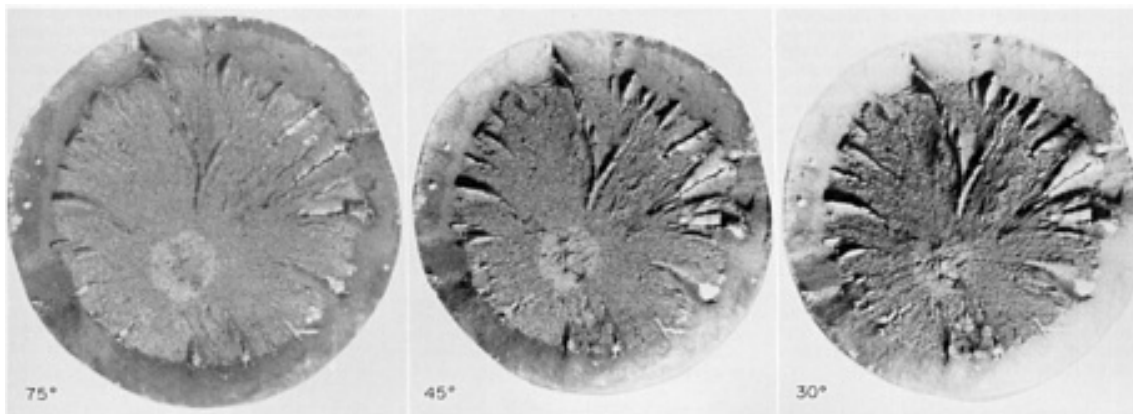
Fig. 10 Light fractographs showing effect of angle of incident light in delineating texture of a fracture surface of an unnotched laboratory tensile-test specimen of 4340 steel. The microstructure was tempered martensite. As the angle of illumination approaches 90°, the surface becomes featureless. The precise optimum angle of obliquity depends on the nature of the markings. 7×

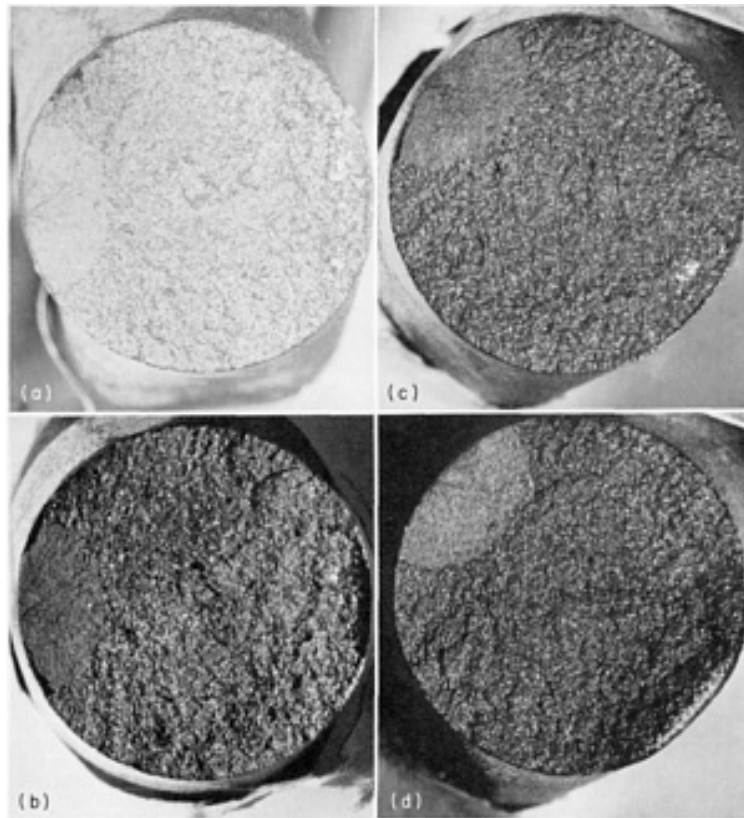
Fig. 11 Effect of illumination technique on appearance of a fracture surface of a laboratory fatigue test specimen of 1039 steel quenched and tempered to a hardness of 42 HRC. (a) Photographed with fluorescent-tube ring illumination; note low contrast and overexposure. (b) Photographed with oblique light from a point source lamp. General fracture area exhibits more contrast than (a), but fatigue zone is not well defined. (c) Photographed with illumination from a mirror at camera lens. Quality is about the same as in (b). (d) Photographed with vertical illumination. For this particular fracture surface, vertical illumination gave the best contrast and detail of all features. Light fractographs. All 2 \times .

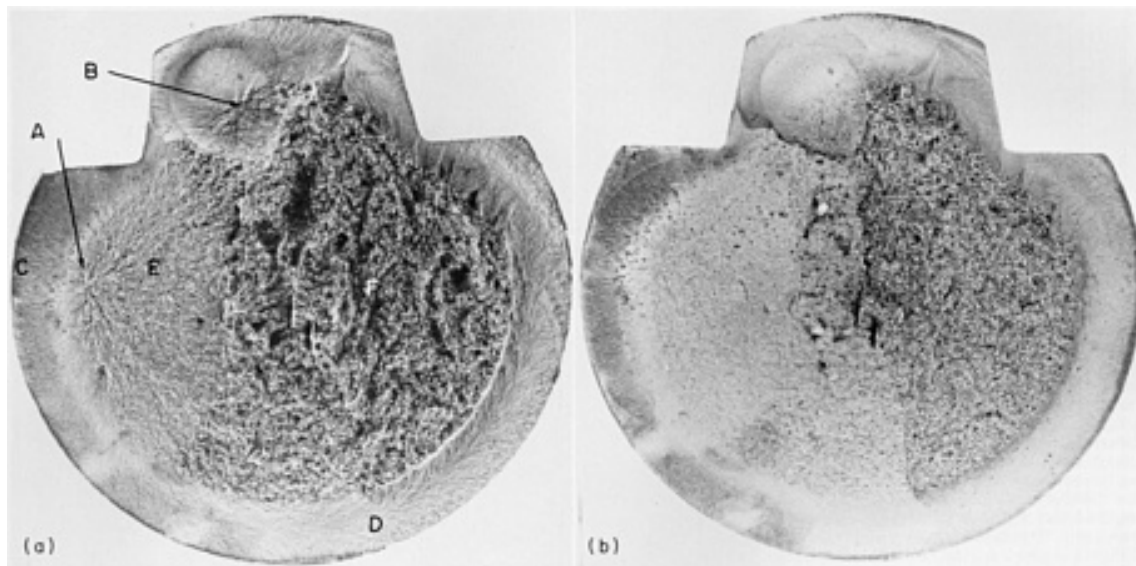
fracture surface. For Fig. 14(b), the light was moved up 25 mm (1 in.), which changed the degree of obliquity, with consequent loss of detail.

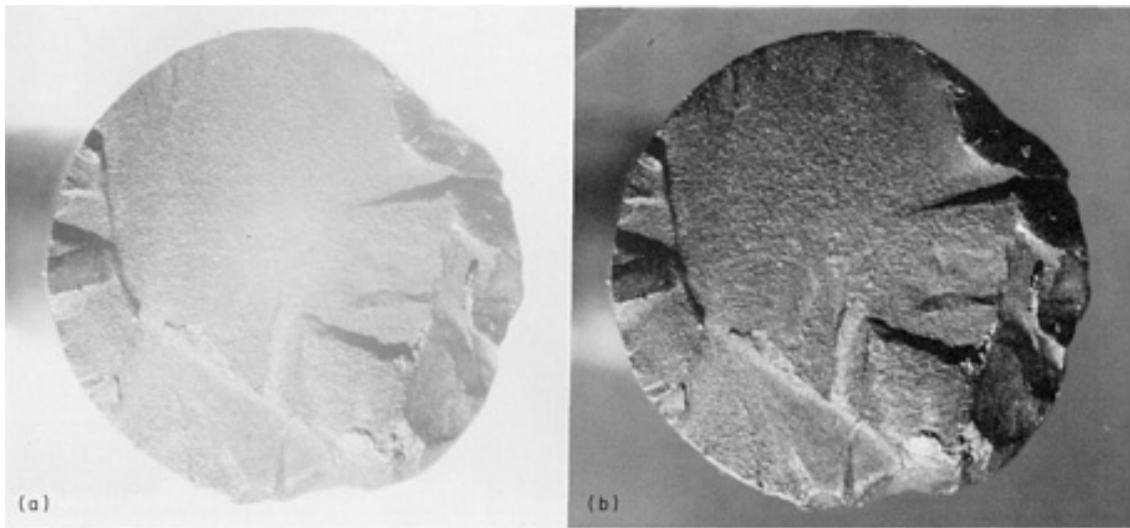
Fig. 15 Surface of a fracture in an exhaust-valve stem of 21-4N (SAE EV 8) steel photographed with a 40-mm lens and with the specimen resting on (a) white paper and (b) black paper. In (a), lens flare and overexposure from the white background obscured some of the detail. A clear picture resulted when the specimen was placed on black paper (b), which eliminated the lens flare. Light fractographs. Both 10 \times

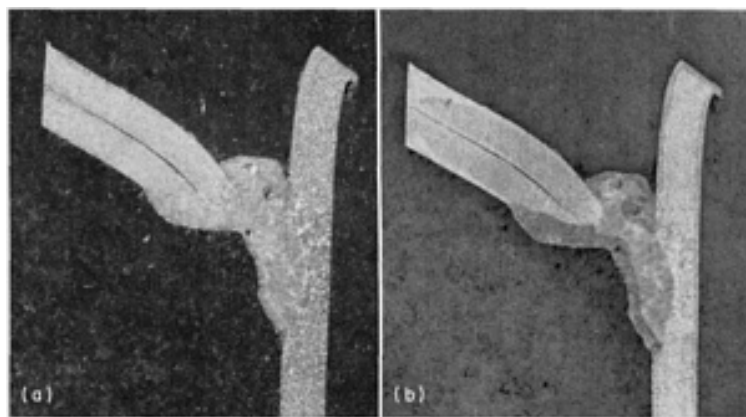
Fig. 16 Effect of oblique and vertical lighting on structures revealed in a macroetched section through a multiple-pass weld in 1008 steel strip. (a) Oblique lighting reveals the grain structure of the steel base metal but no detail of the weld beads. (b) Vertical lighting shows the weld beads and the rim of the steel, but the grain structure is less distinct. Photomicrographs. Etched in ammonium persulfate. Both 4 \times

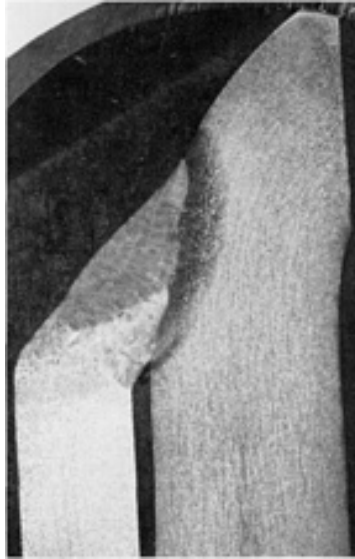
Fig. 17 A properly illuminated section through a weld. Vertical lighting was used to reveal flow lines in the base metal, the heat-affected zone, and the successive weld beads. Base metal was 1018 steel, component, an axle housing. Photomicrograph. Etched in ammonium persulfate. 4×

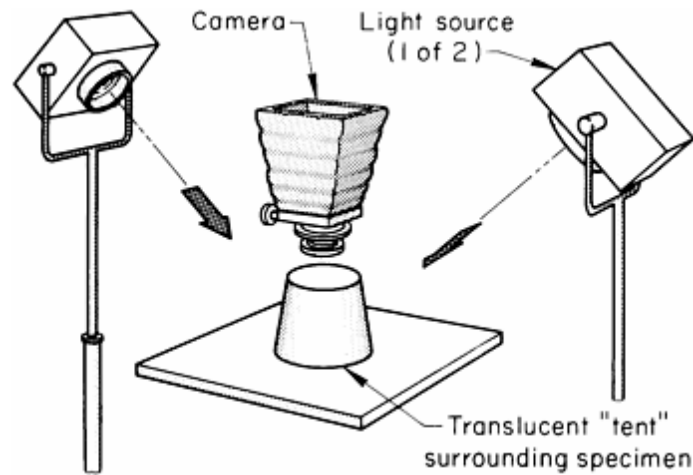
Fig. 18 Tent lighting used in photographing highly reflective parts

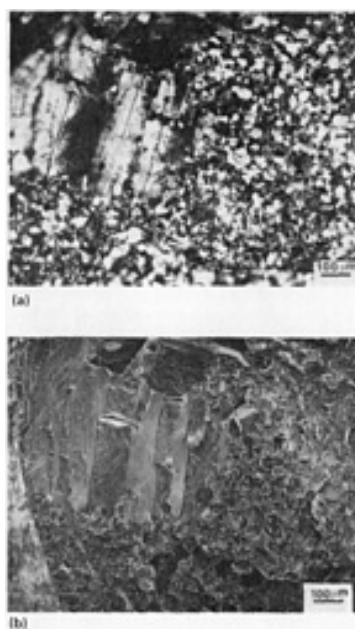
Fig. 1 Comparison of dark-field light microscope fractograph (a) and an SEM secondary electron image (b) of the same area in an iron-chromium-aluminum alloy. Both 50×

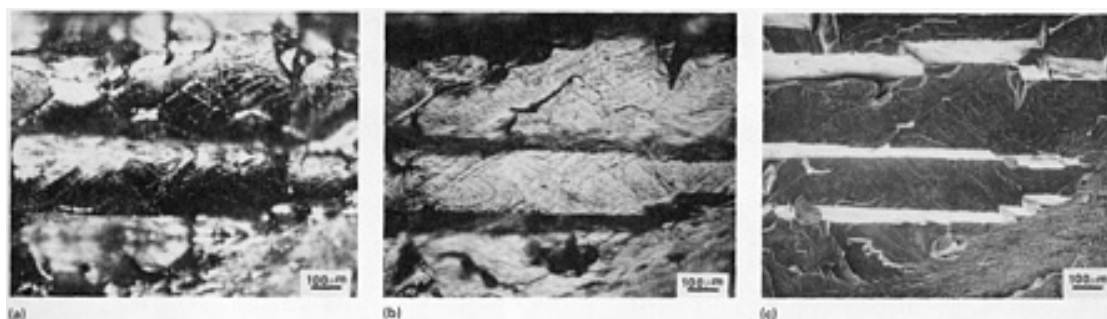
Fig. 2 Comparison of light microscope and SEM fractographs of the same area of an iron-chromium-aluminum alloy. (a) Bright-field light fractograph. (b) Dark-field light fractograph. (c) SEM secondary electron image. All 50×

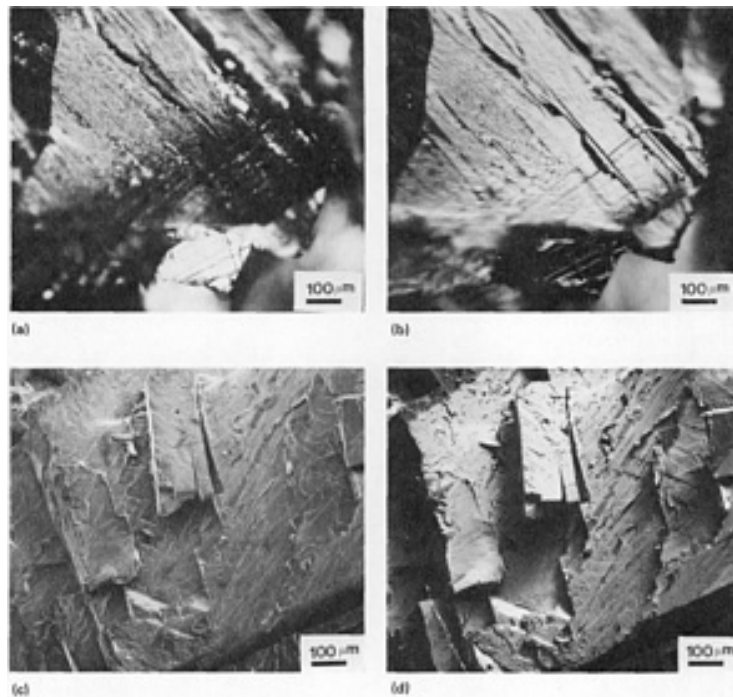
Fig. 3 Comparison of light microscope (a and b) and SEM (c and d) fractographs of cleavage of faces in a coarse-grain Fe-2.5Si alloy broken at $-195\text{ }^{\circ}\text{C}$ ($-320\text{ }^{\circ}\text{F}$). (a) Bright-field illumination. (b) Dark-field illumination. (c) Secondary electron image. (d) Everhart-Thornley backscattered electron image. All $60\times$

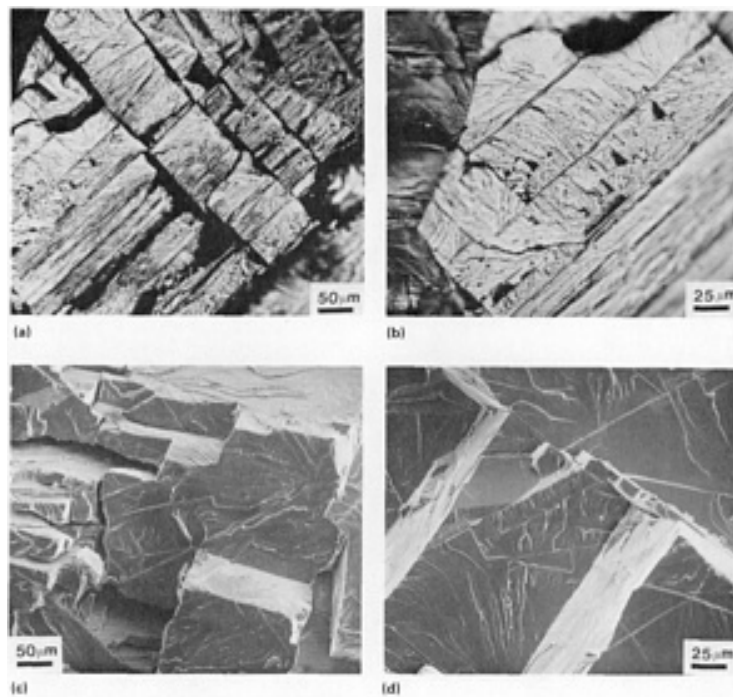
Fig. 5 Comparison of light microscope (a and b) and SEM (c and d) fractographs of cleavage facets in a coarse-grain Fe-2.5Si alloy impact specimen broken at $-195\text{ }^{\circ}\text{C}$ ($-320\text{ }^{\circ}\text{F}$). (a) Bright-field illumination. (b) Dark-filled illumination. (c) Secondary electron image. (d) Secondary electron image. (a) and (c) $120\times$. (b) and (d) $240\times$

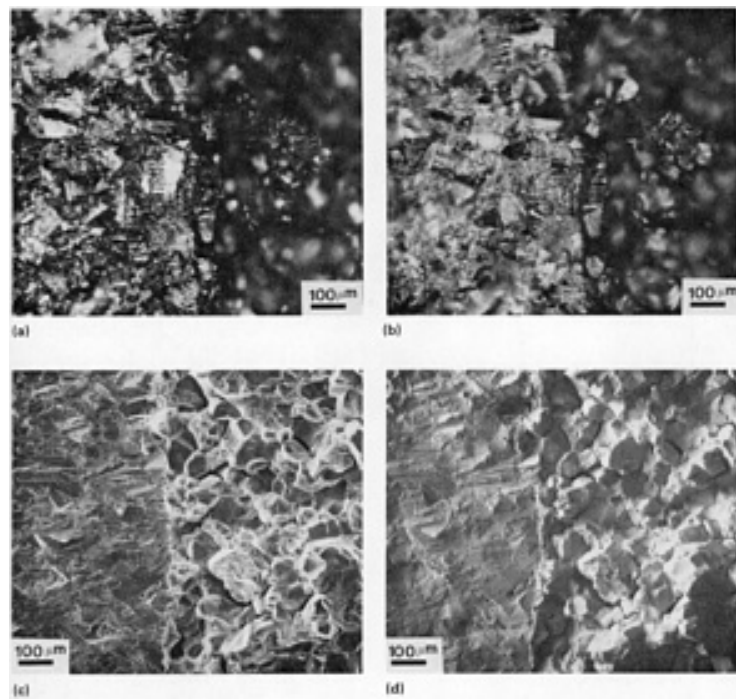
Fig. 6 Comparison of light microscope (a and b) and SEM (c and d) fractographs of the interface between the fatigue-precracked region and the test fracture in an X-750 nickel-base superalloy rising-load test specimen. The test was performed in pure water at 95 °C (200 °F). Note the intergranular nature of the fracture. (a) Bright-field illumination. (b) Dark-field illumination. (c) Secondary electron image. (d) Everhart-Thornley backscattered electron image. All 60×

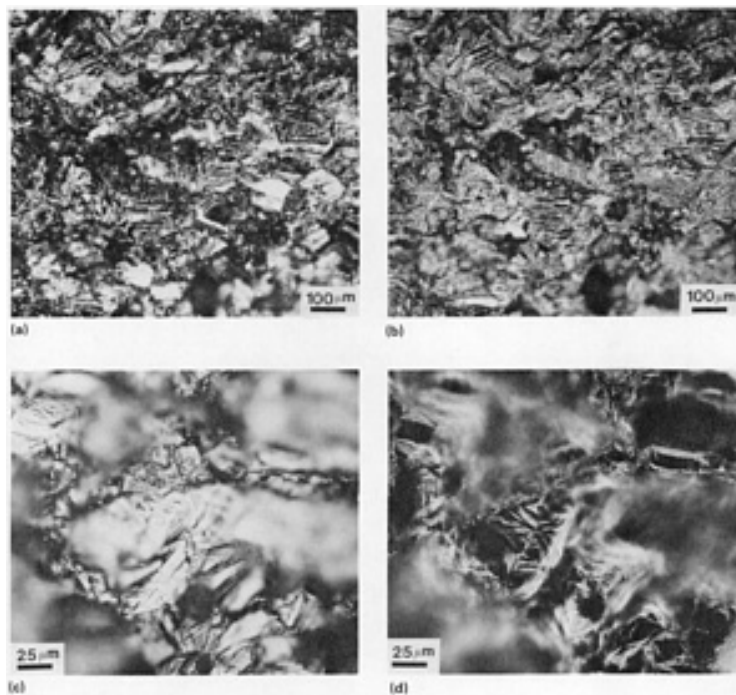
Fig. 7 Light microscope fractographs of the fatigue-precracked region of an alloy X-750 rising load test specimen. (a) Bright-field image. (b) Dark-field image. (c) Bright-field image. (d) Dark-field image. (a) and (b) 60×. (c) and (d) 240×.
