به نام خدا

مرکز دانلود رایگان
مهندسی متالورژی و مواد

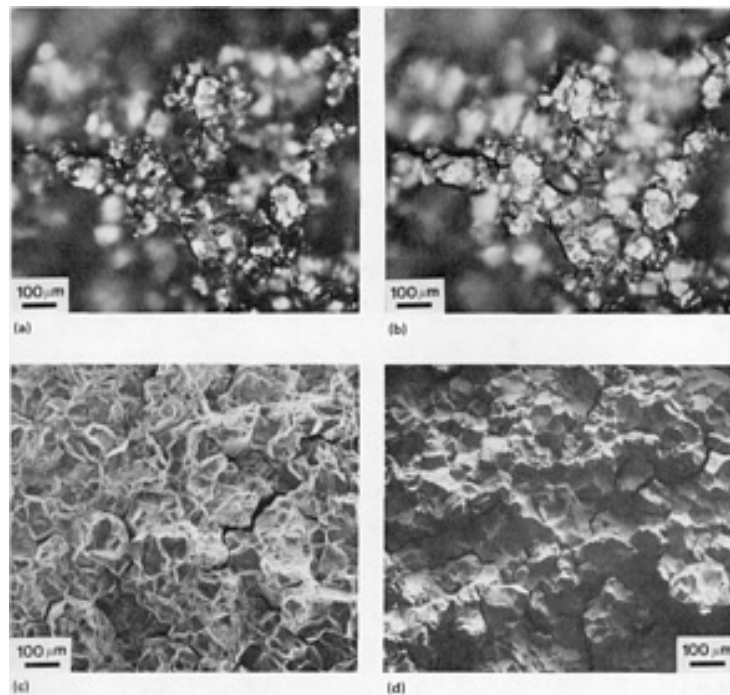
Fig. 9 Comparison of light microscope (a and b) and SEM (c and d) fractographs of the test fracture in an alloy X-750 rising-load test specimen. Test was performed in pure water at 95 °C (200 °F). Note the intergranular appearance of the fracture. (a) Bright-field image. (b) Dark-field image. (c) Secondary electron image. (d) Everhart-Thornley backscattered electron image. All 60 \times

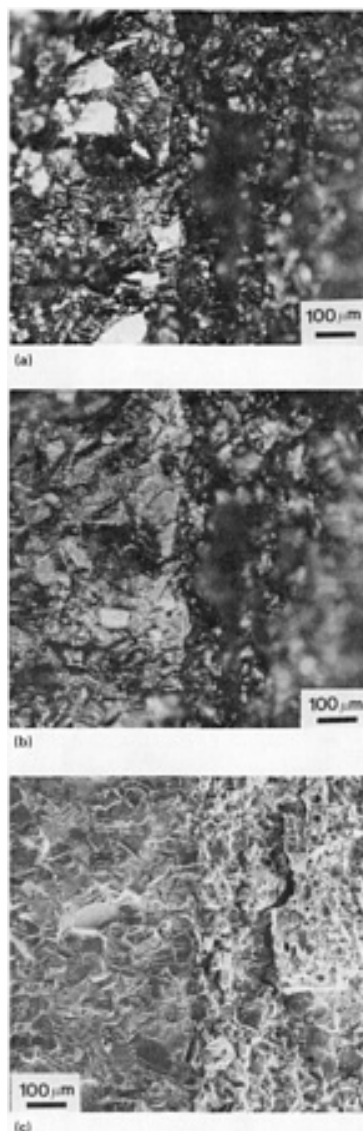
Fig. 10 Comparison of light microscope (a and b) and SEM (c) images of the interface between the fatigue-precrack area (left) and the test fracture region (right) of an alloy X-750 rising-load test specimen broken in air. The test fracture is ductile. (a) Bright-field image. (b) Dark-field image. (c) Secondary electron image. All 68 \times

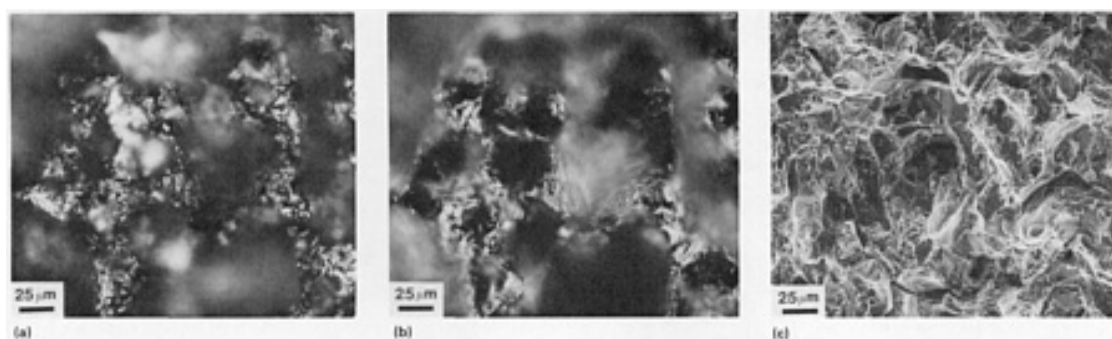
Fig. 11 Comparison of light microscope (a and b) and SEM (c) images of a ductile fracture in an alloy X-750

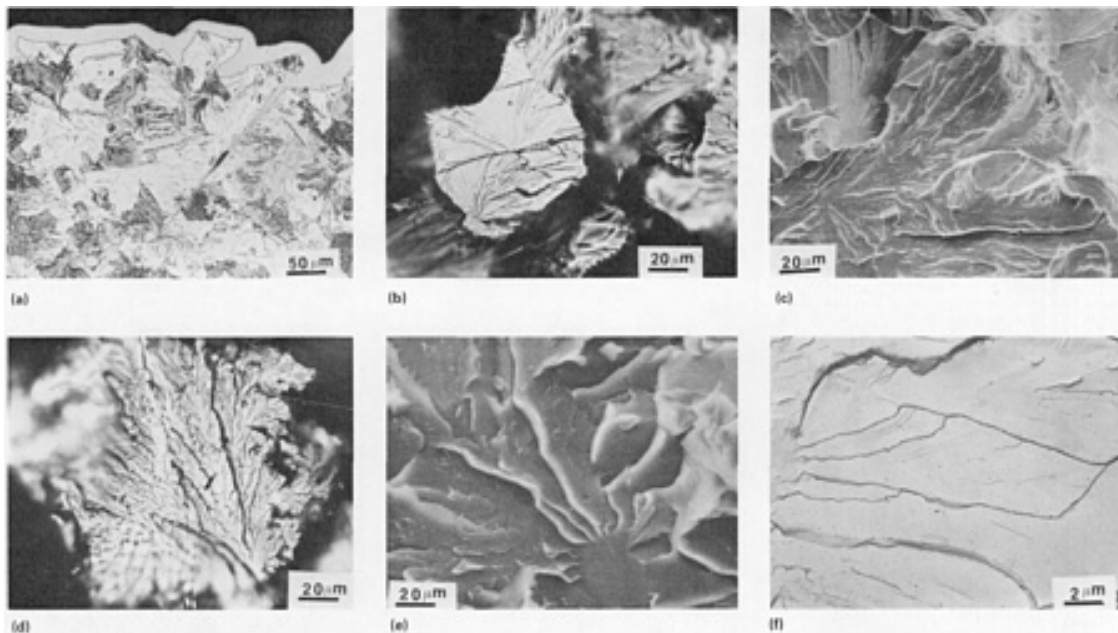
Fig. 12 Examples of three direct (a to c) and three replication procedures (d to f) for examination of a cleavage fracture in a low-carbon martensitic steel. (a) Light microscope cross section with nickel plating at top. (b) Direct light fractograph. (c) Direct SEM fractograph. (d) Light fractograph of replica. (e) SEM fractograph of replica. (f) TEM fractograph of replica

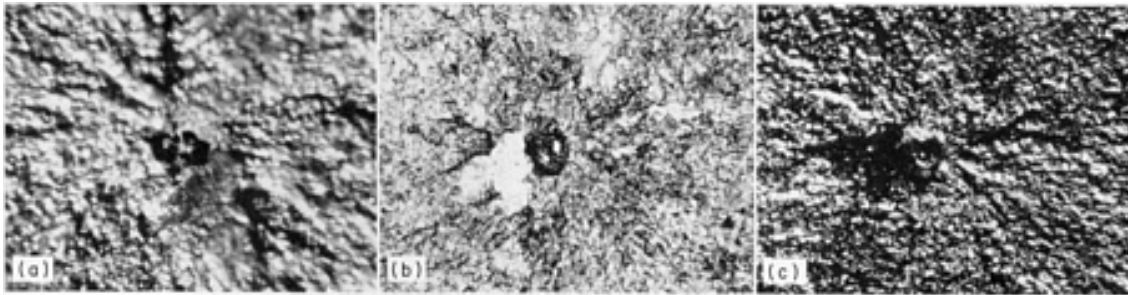
Fig. 14 Comparison of replica fractographs of a fatigue fracture in an induction-hardened 15B28 steel shaft. Fracture was initiated at the large inclusion in the center of the views during rotating bending. (a) Oblique illumination from a point source lamp. (b) Same area as (a), photographed using transmitted light. (c) Replica shadowed with a vapor-deposited coating and photographed using oblique illumination from a point source lamp. All 30×

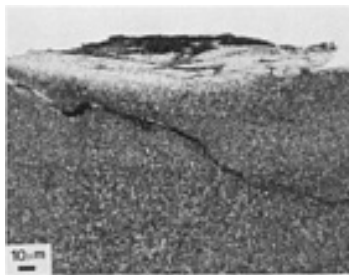
Fig. 15 Example of the use of electroless nickel plating to provide edge retention. The micrograph shows wear damage at the surface of a forged alloy steel Medart roll. Etched with 2% nital. 285×

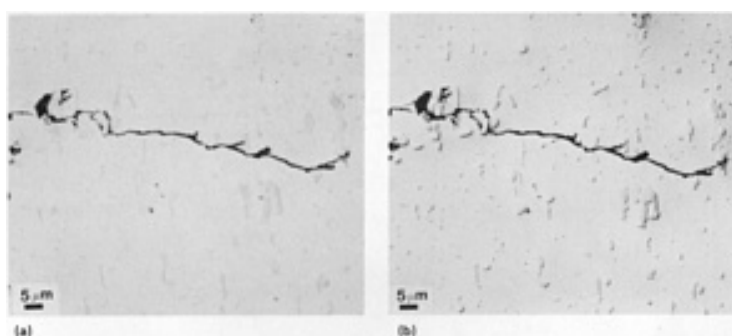
Fig. 16 Comparison of bright-field (a) and Nomarski DIC (b) illumination for examination of a fatigue crack in an as-polished aluminum alloy. See also Fig. 71. Both 600×

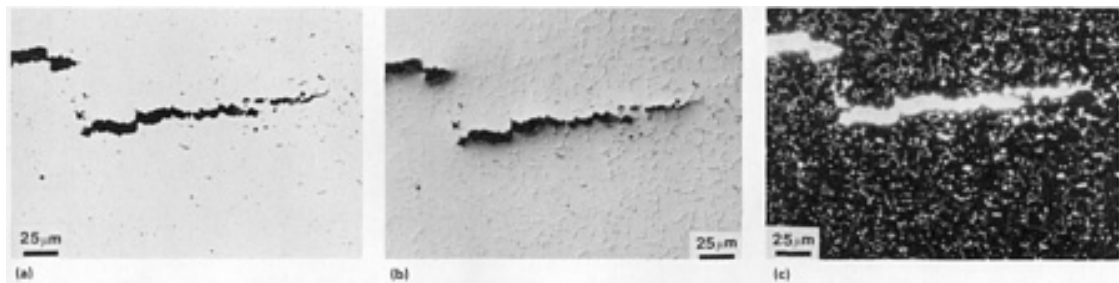
Fig. 17 Comparison of bright-field (a), DIC (b), and dark-field (c), illumination for viewing a partially fractured (by impact) specimen of AISI type 312 weld metal containing substantial σ phase. All 240 \times

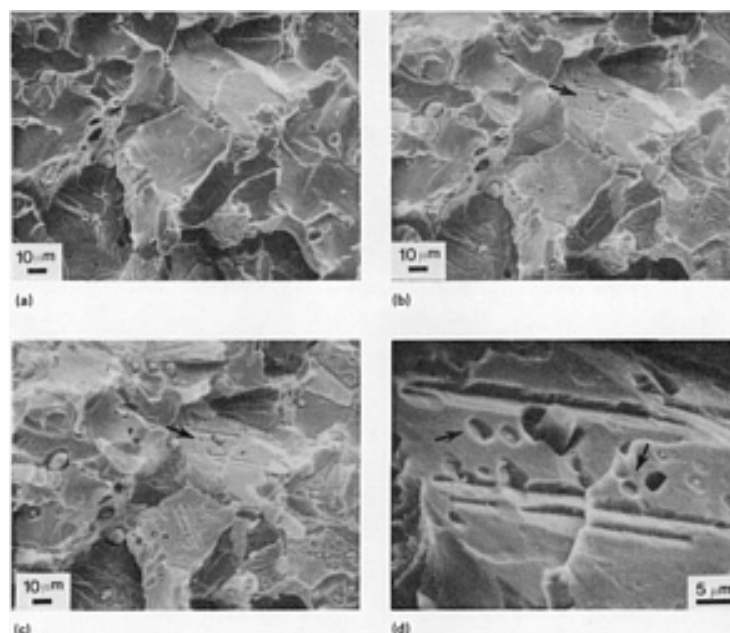
Fig. 18 Example of the use of etching to produce etch pits (arrows) on a cleavage fracture. (a) As-fractured. 320 \times . (b) Etched 60 s with nital. 320 \times . (c) Etched 360 s with nital. 320 \times . (d) Etched 360 s with nital. 1280 \times

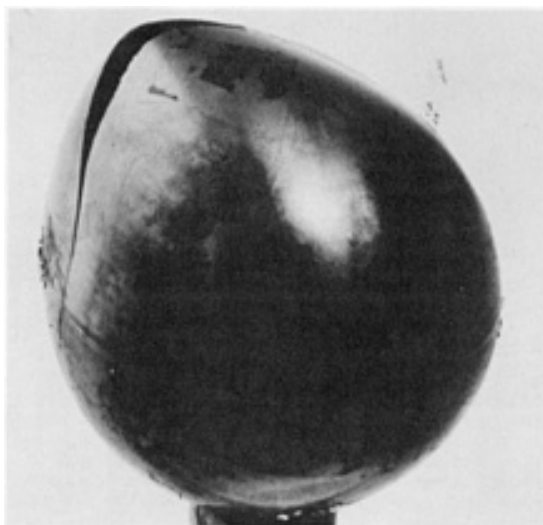
Fig. 19 Macrograph showing ductile overload fracture of a high-pressure steel vessel tested at room temperature. See also Fig. 20.

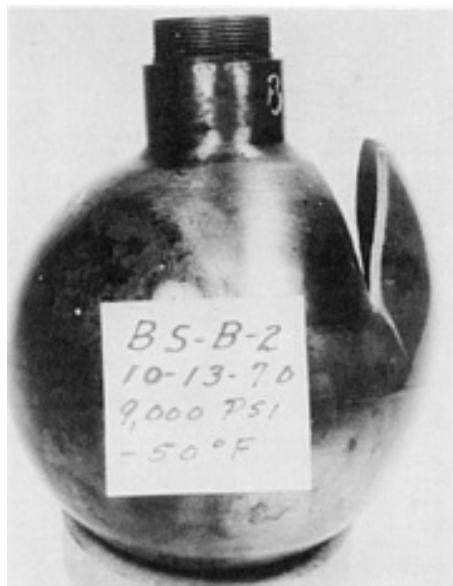
Fig. 20 Macrograph showing ductile overload fracture of a high-pressure steel vessel tested at $-45\text{ }^{\circ}\text{C}$ ($-50\text{ }^{\circ}\text{F}$). See also Fig. 19.

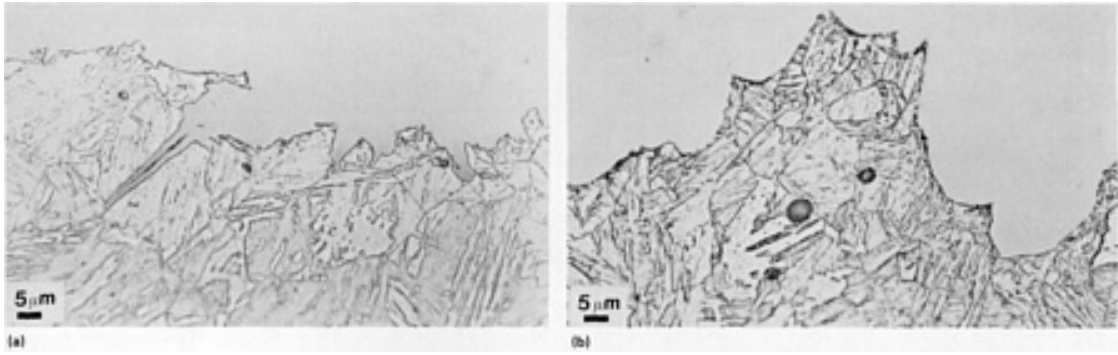
Fig. 21 Brittle (a) and ductile (b) crack paths in a fractured quenched-and-tempered low-alloy steel. Both etched with 2% nital. 800×

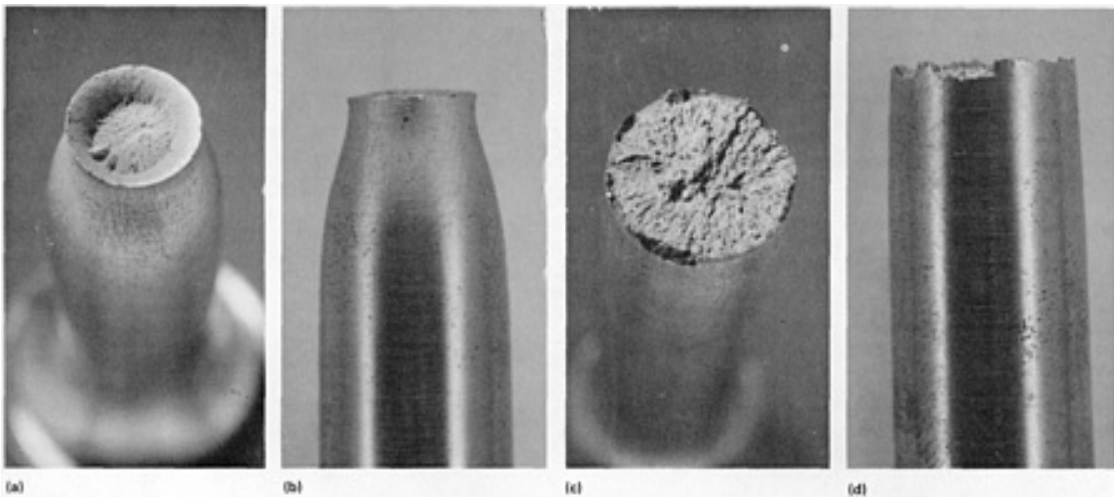
Fig. 22 Macroscopic appearance of ductile (a) and brittle (b) tensile fractures

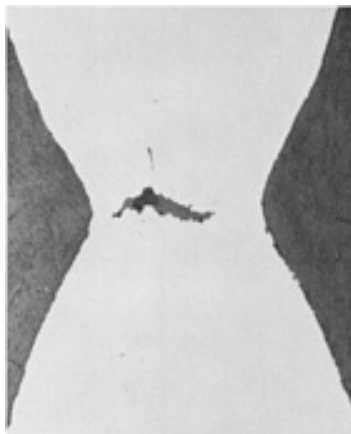
Fig. 23 Initiation of fracture in a tensile-test specimen. Note that the fracture initiated at the center of the specimen 4.75 ×

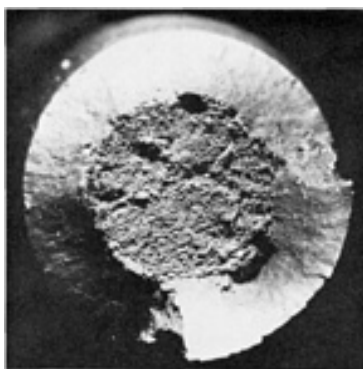
Fig. 24 Tensile fracture of a 4340 steel specimen tested at 120 °C (250 °F). The fracture contains a fibrous zone and a shear-lip zone. The steel microstructure consisted of tempered martensite; hardness was 46 HRC. The fracture started at the center of the fibrous zone, which shows circumferential ridges. The outer ring is the shear-lip zone. About 11 ×

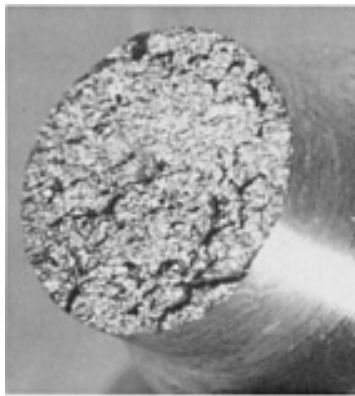
Fig. 25 Macrograph showing a granular brittle fracture in a cast iron tensile bar. Note the large cleavage facets. 2x

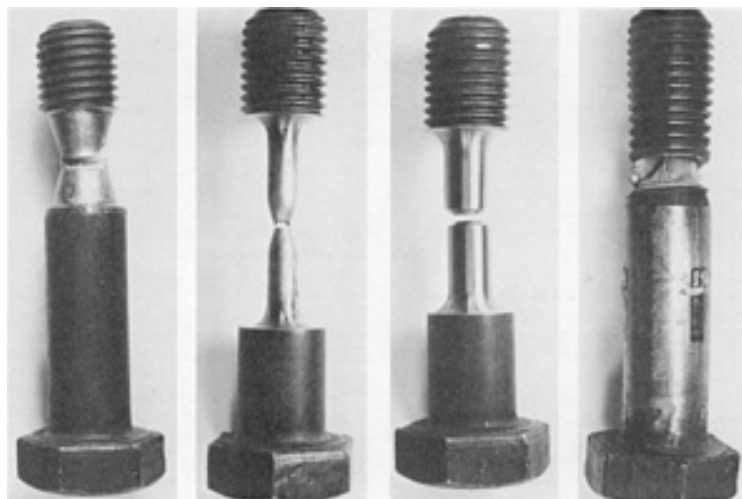
Fig. 26 Side views of four types of ASTM A490 high-strength steel bolt tensile specimens. See also Fig. 27. Left to right: bolts 1, 4, 6, and 7

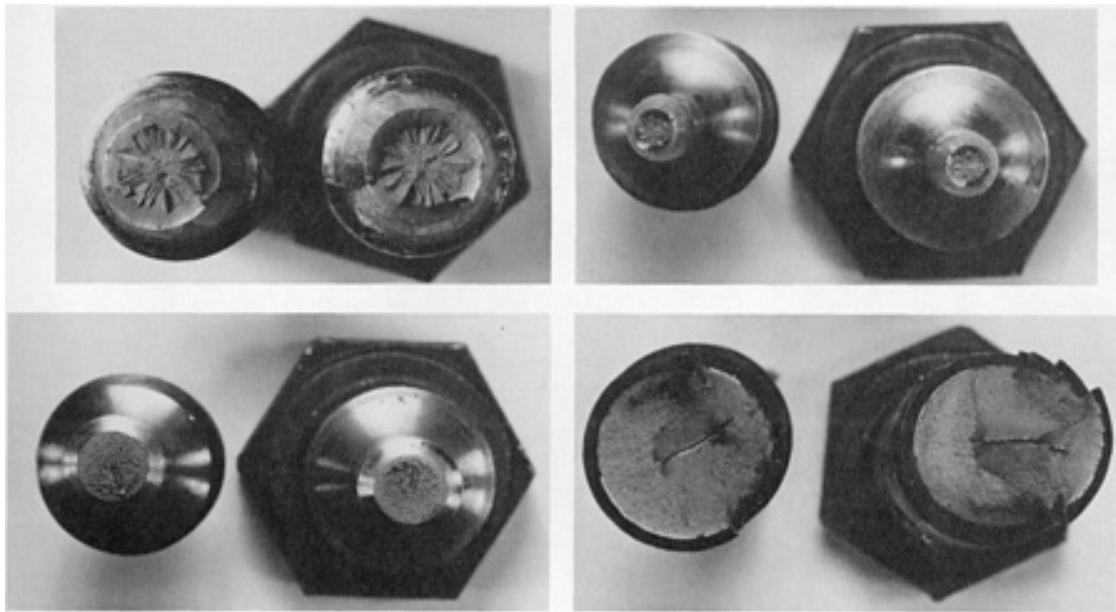
Fig. 27 Macrographs of fracture surfaces of ASTM A490 high-strength bolt tensile specimens shown in Fig. 26. Top left to right: bolts 1 and 4; bottom left to right: bolts 6 and 7

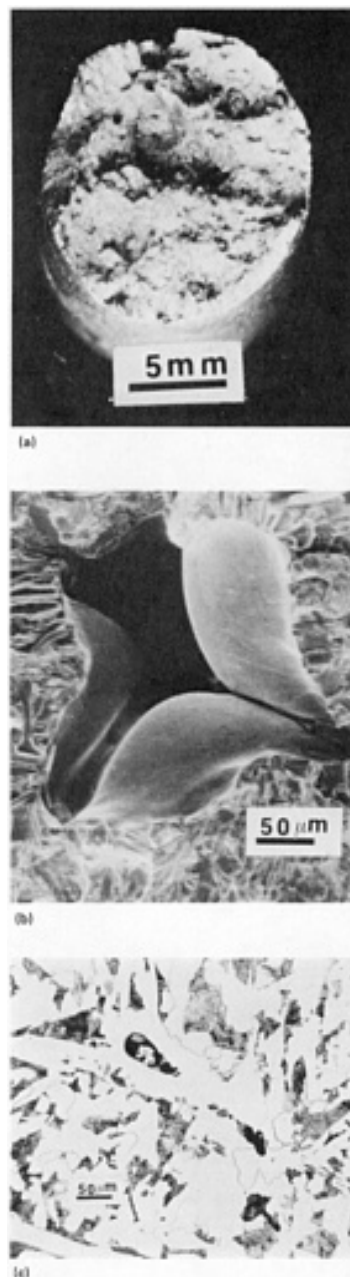
Fig. 28 Three views of an unusual tensile fracture from a carbon steel casting. (a) Macrograph of the fracture surface. (b) SEM view of voids on the fracture surface. (c) Light micrograph showing shrinkage cavities. (c) Etched with 2% nital

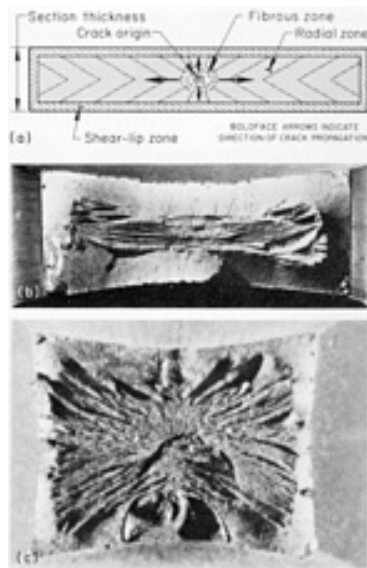
Fig. 29 Appearance of fracture surfaces in rectangular steel tensile specimens. (a) Schematic of tensile fracture features in a rectangular specimen. (b) Light fractograph with fracture features conforming to those of the schematic. (c) Light fractograph of a fracture similar to (b) but having a much narrower shear-lip zone. Source: Ref 63

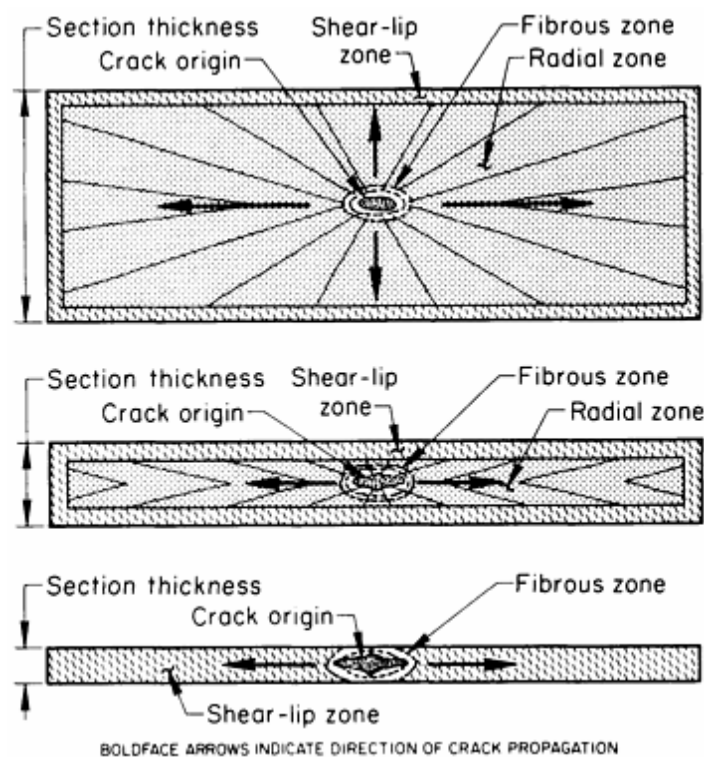
Fig. 30 Effect of section thickness on the fracture surface markings of rectangular tensile specimens. Schematics show the change in size of the radial zone of specimens of progressively decreasing section thickness. The thinnest of the three examples has a small fibrous zone surrounding the origin and a shear-lip zone, but no radial zone. Source: Ref 63

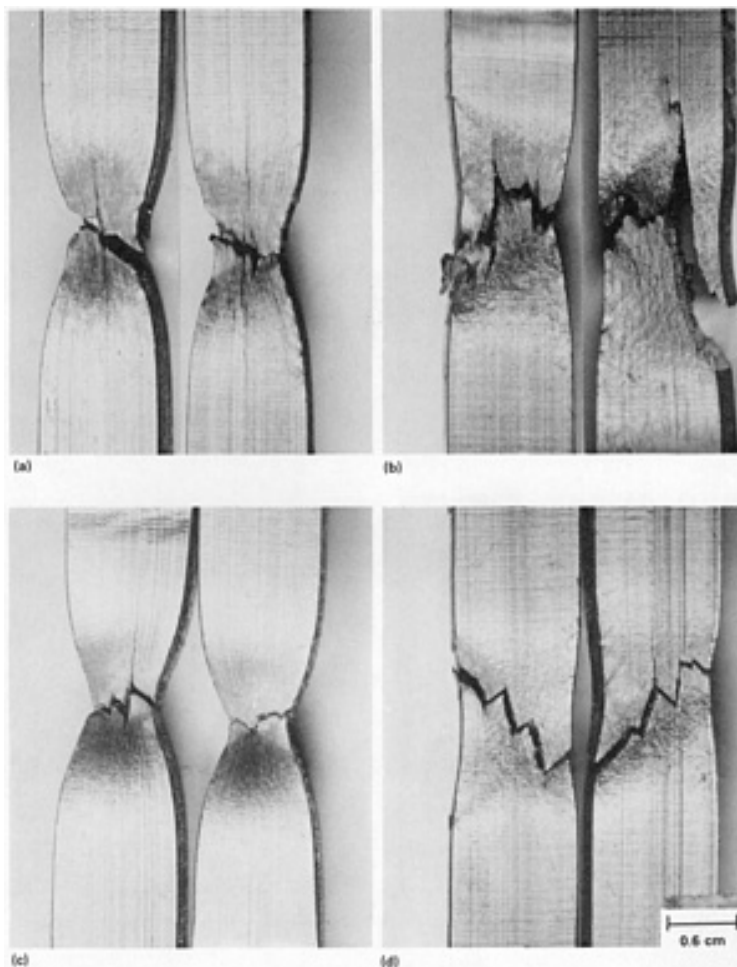
Fig. 32 Macrographs of fractured longitudinal and transverse tensile specimens from plates finish-rolled at two temperatures. (a) Longitudinal specimen finished at 315 °C (600 °F). (b) Transverse specimen finished at the same temperature. (c) Longitudinal specimen finished at 150 °C (300 °F). (d) Transverse specimen finished at the same temperature. Source: Ref 83

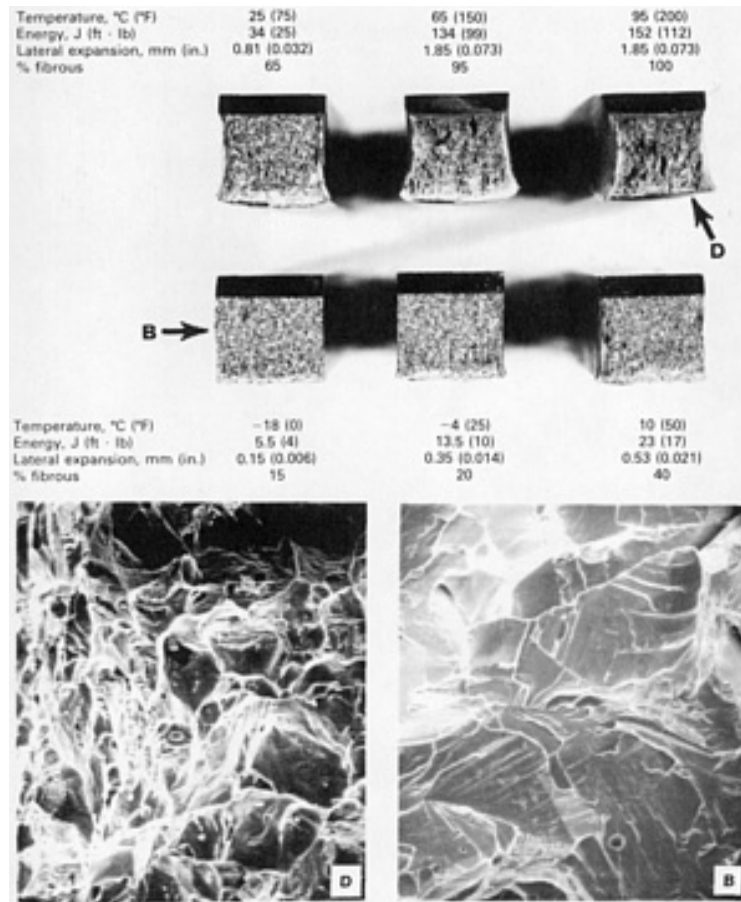
Fig. 33 SEM fractographs of ductile (D) and brittle (B) fractures in Charpy V-notch impact specimens shown at top. Both 400×

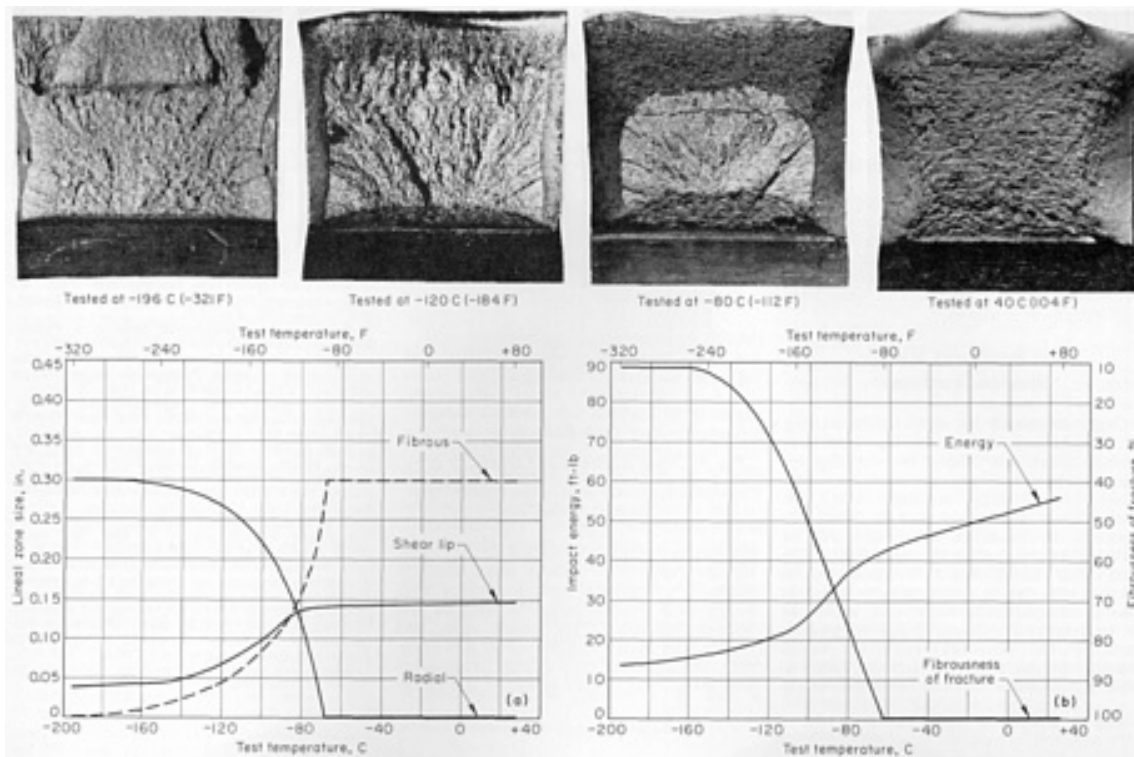
Fig. 34 Transition curves for fracture appearance and impact energy versus test temperature for specimens of 4340 steel. Light fractographs at top show impact specimens tested at various temperatures. Linear measurements were made parallel to the notch for the shear-lip zones, perpendicular to the notch for the fibrous zone, and perpendicular to the notch for the radial zone. The measurements yielded the three curves shown in (a). The curve of percentage of fibrousness of fracture (b) was constructed from visual estimates of the fibrous-plus-shear-lip zones. This curve, together with the impact energy curve shown in (b), shows that the transition temperature for fracture appearance is essentially the same as for impact energy. Source: Ref 63

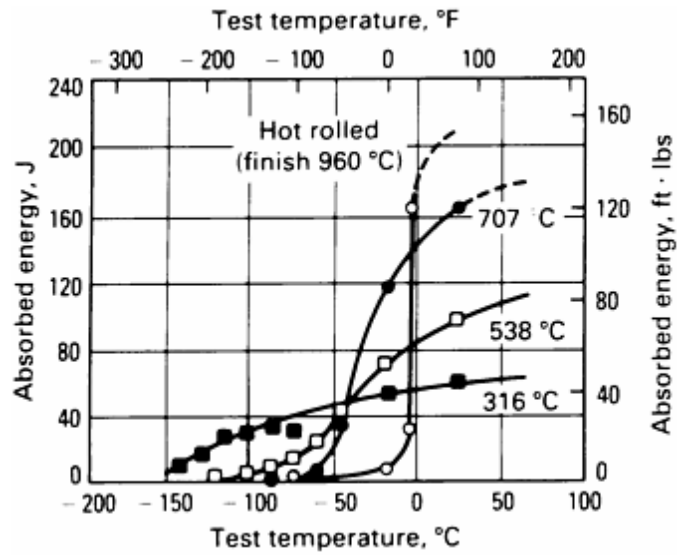
Fig. 36 Plot of absorbed-energy Charpy V-notch test data for Fe-1Mn steels finished at different temperatures (indicated on graph). Source: Ref 83

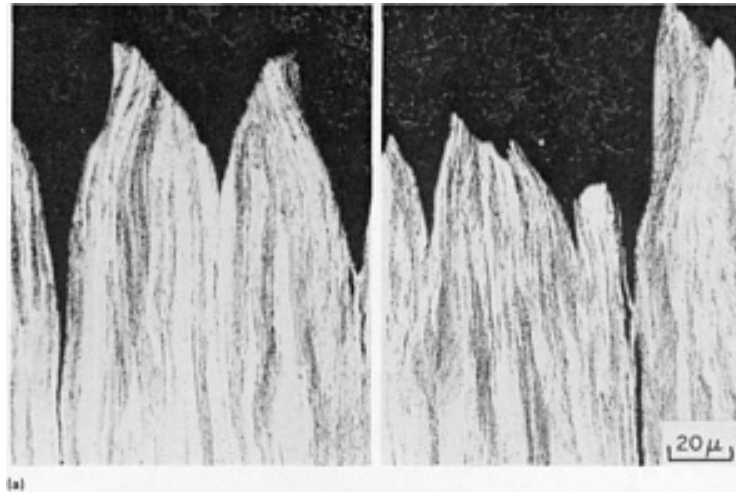
Fig. 38 The microstructure of Fe-1Mn steel finish rolled at 315 °C (600 °F) and impact tested at two temperatures. A, tested at -18 °C (0 °F); B, tested at -135 °C (-210 °F). Source: Ref 83

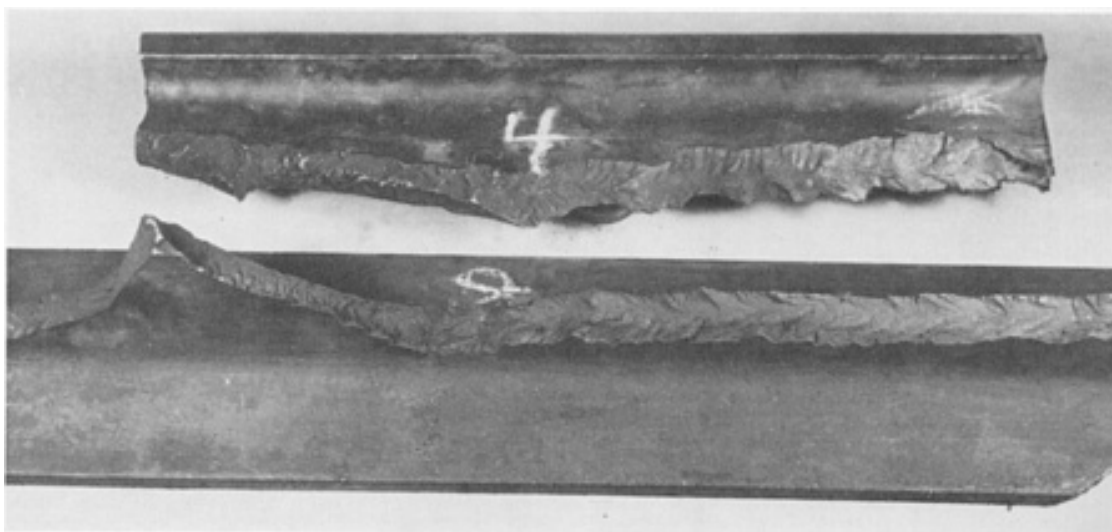
Fig. 39 Classic appearance of chevrons on a brittle fracture of a steel railroad rail. The fracture origin is not on the section shown.

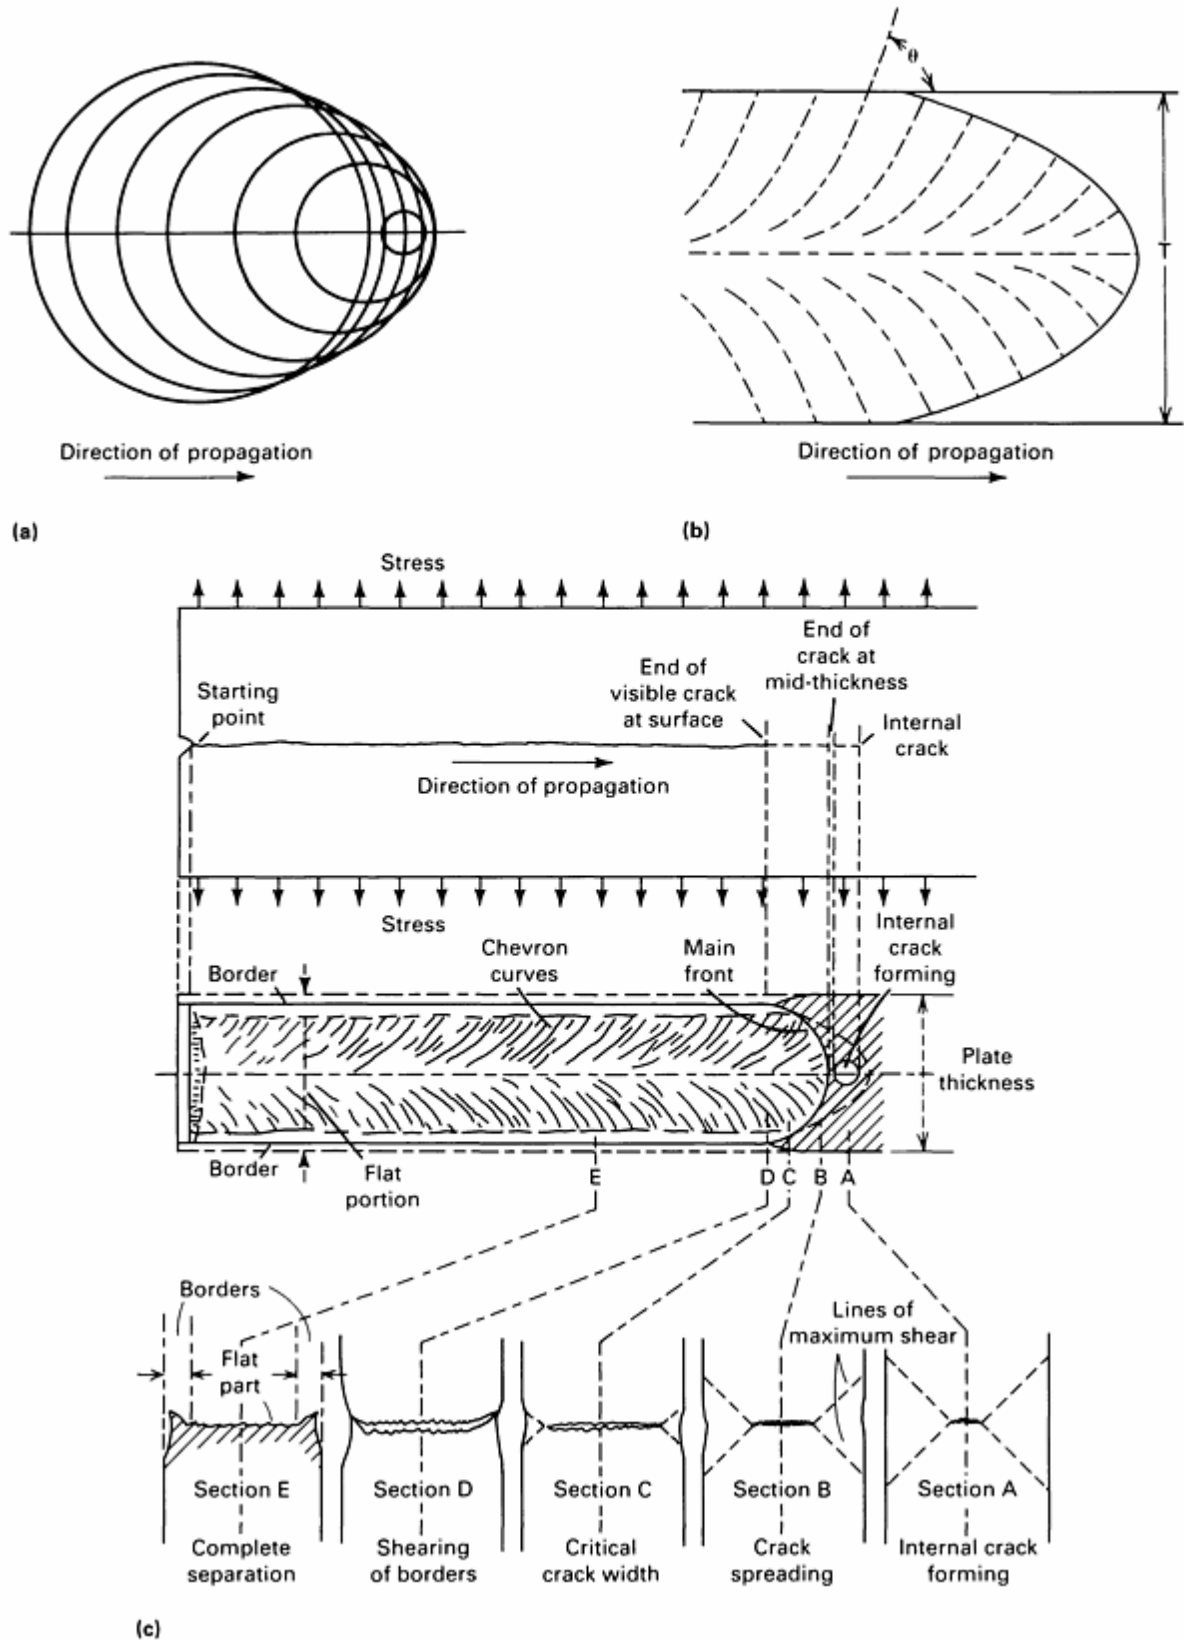
Fig. 40 Schematics showing a model for chevron crack formation. (a) Crack front propagation model. (b) Crack front at any given time. (c) Analogy between chevron formation in plate and cup-and-cone fracture. Source: Ref 108

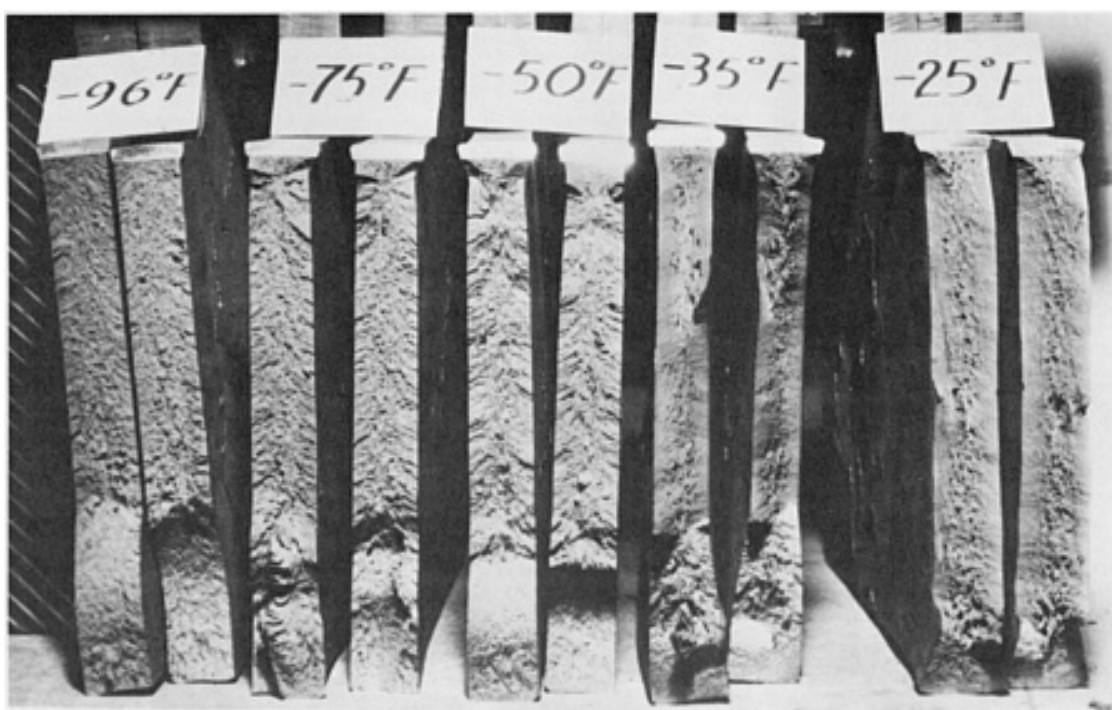
Fig. 41 Mating drop-weight tear test fractures in ship steel showing the influence of test temperature of fracture appearance. Note that chevrons are most clearly developed at -45°C (-50°F). The fractures were located by the notch at the top of each specimen.

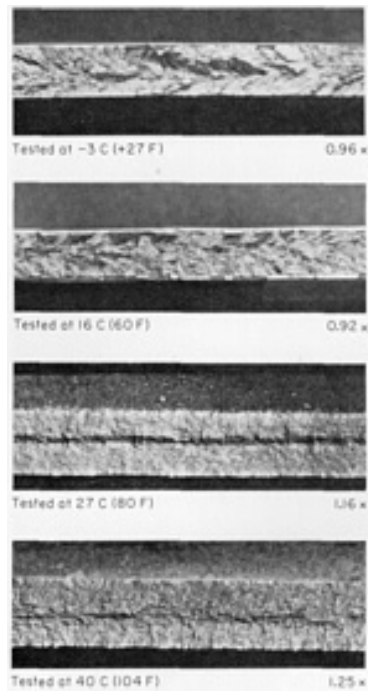
Fig. 42 Transition of fracture appearance with change in test temperature. Light fractographs show four specimens cut from a single length of low-carbon steel pipe that were burst by hydraulic pressure at the temperatures indicated. Note the increasing size of the shear-lip zone as test temperature increases.

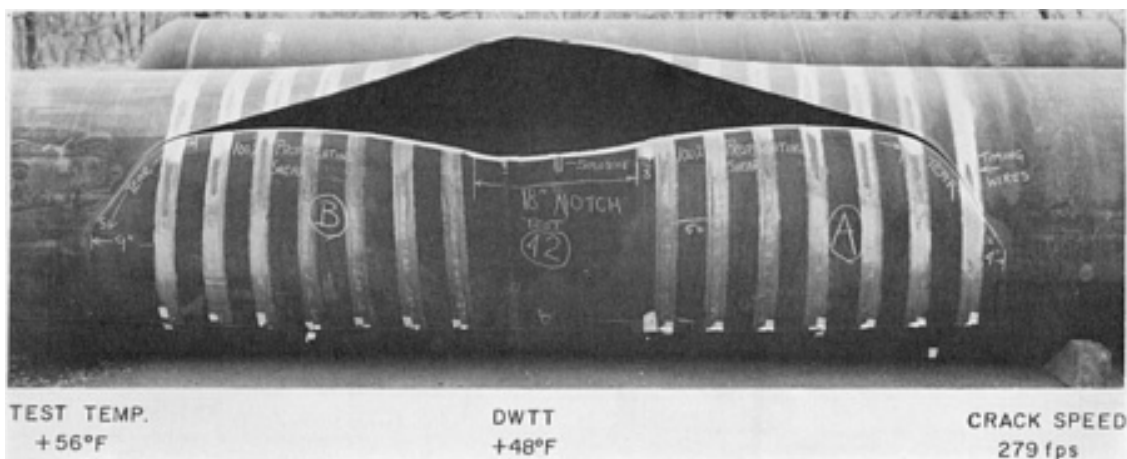
Fig. 43 Fracture of API grade X-60 line pipe tested 5 °C (8 °F) above the 50% shear area drop-weight tear test transition temperature. See also Fig. 44, 45, 46 and text for details.

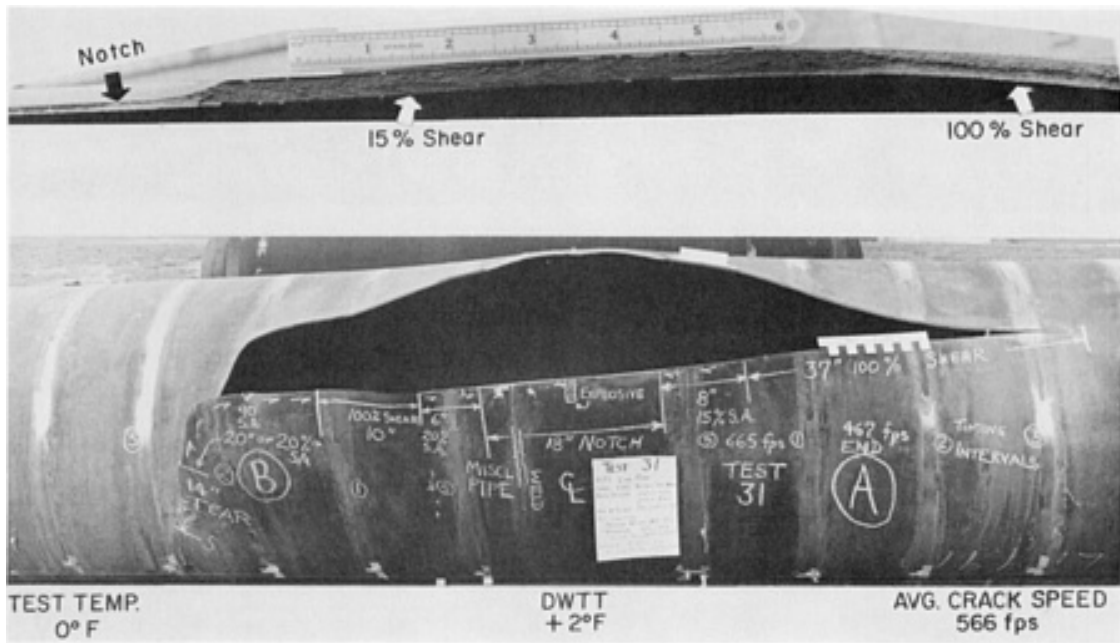
Fig. 44 Fracture of API grade X-60 line pipe tested 1 °C (2 °F) below the 50% shear area drop-weight tear test transition temperature. See also Fig. 43, 45, and 46.

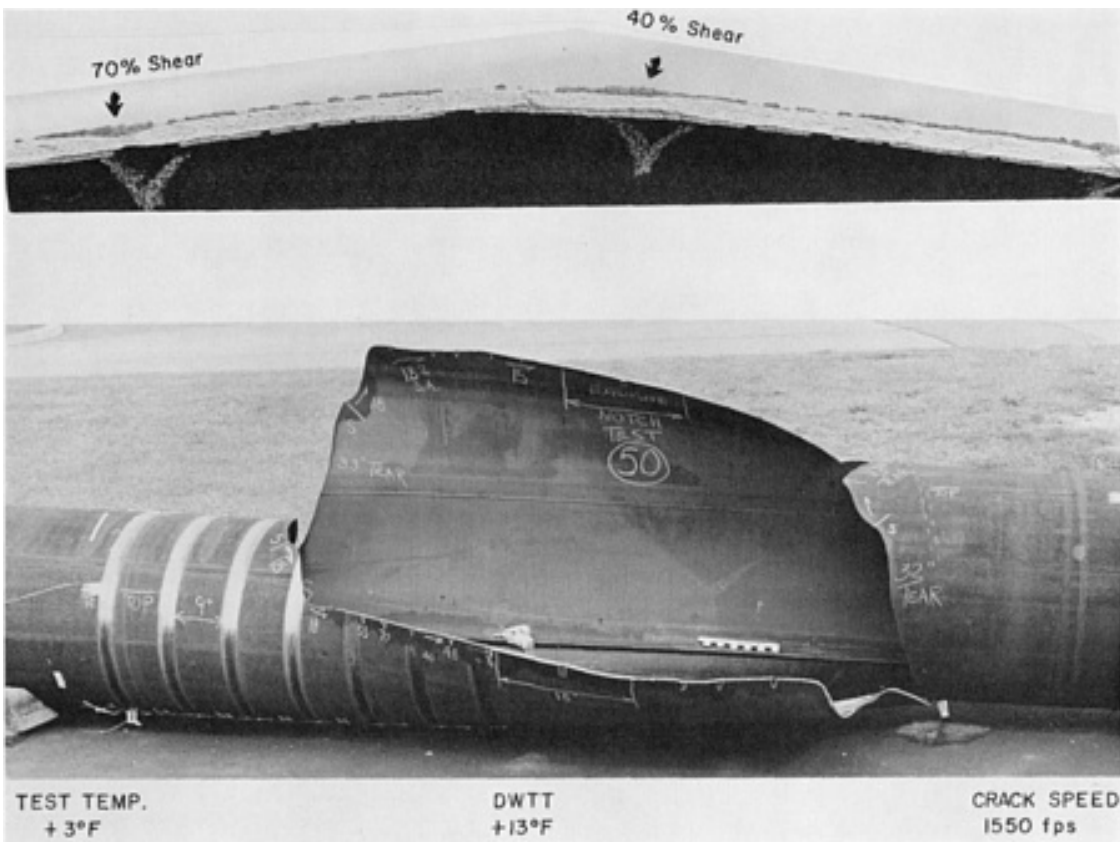
Fig. 45 Fracture of API grade X-60 line pipe tested 6 °C (10 °F) below the 50% shear area drop-weight tear test transition temperature. See also Fig. 43, 44, and 46.

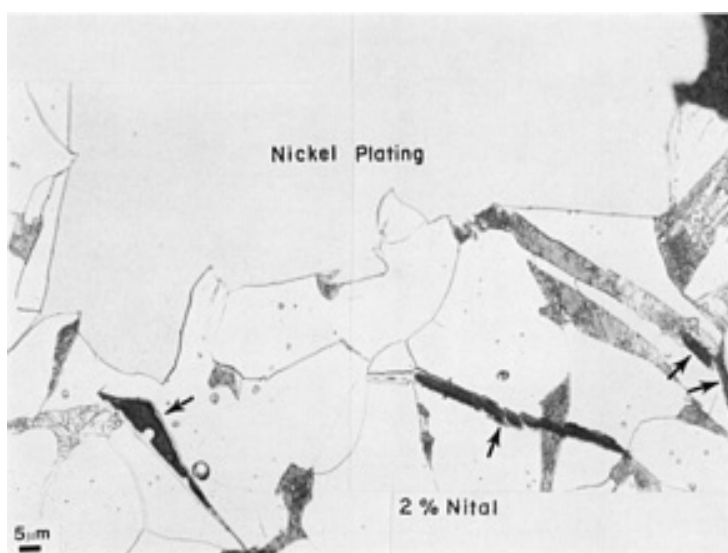
Fig. 47 Cleavage crack path in a ferritic-pearlitic low-carbon steel. Note the subsurface cracks (arrows). One crack has been partially filled by nickel plating. Etched with 2% nital. 1000×

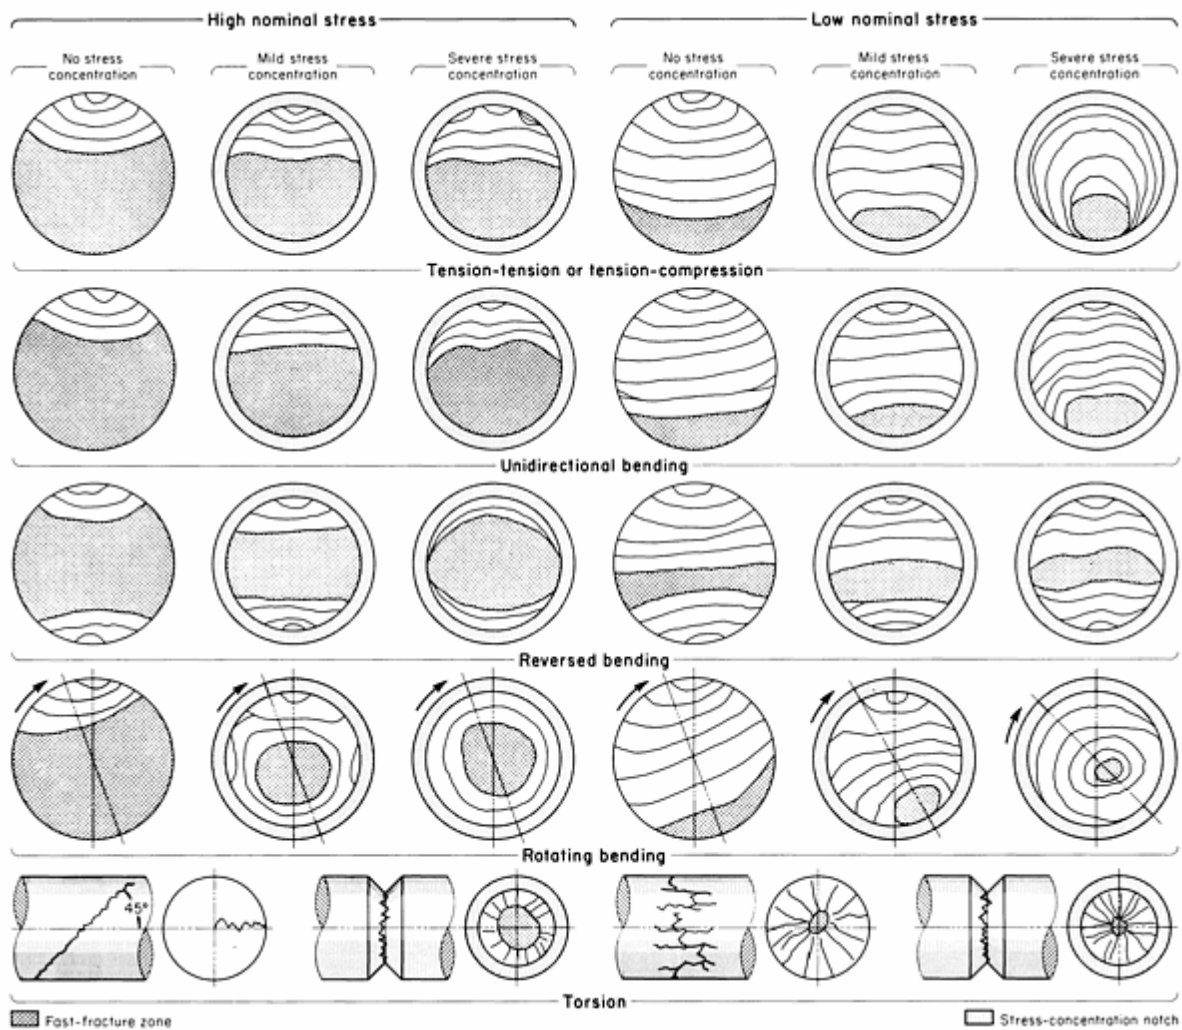
Fig. 48 Schematic representation of fatigue fracture surface marks produced on smooth and notched components with circular cross sections under various loading conditions

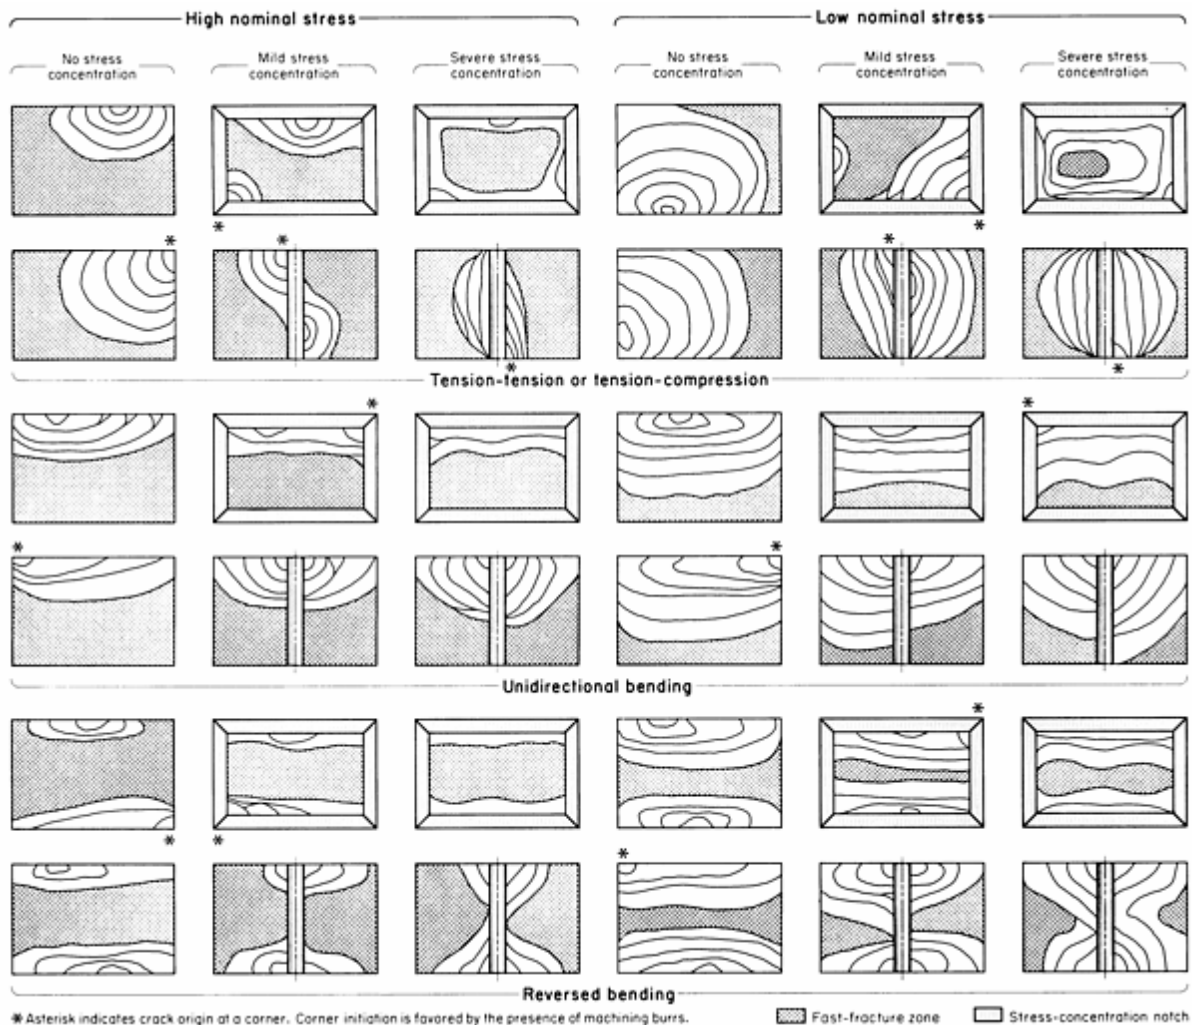
Fig. 49 Schematic representation of fatigue fracture surface marks produced in square and rectangular components and in thick plates under various loading conditions

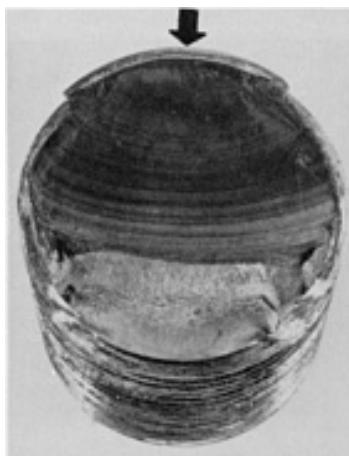
Fig. 50 Fatigue failure of a bolt due to unidirectional cycling bending loads. The failure started at the thread root (arrow) and progressed across most of the cross section before final fast fracture. Actual size.

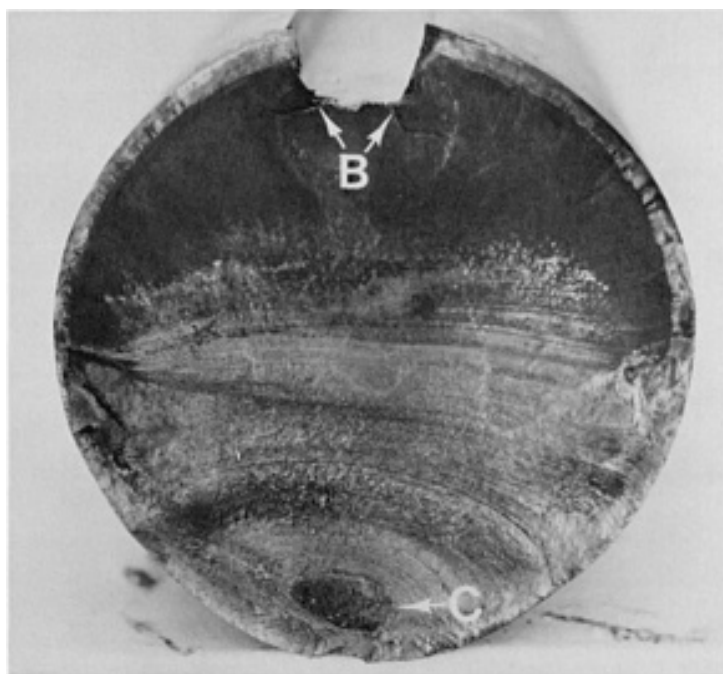
Fig. 51 Macrograph of the fracture face of an AISI 4320 drive shaft that failed by fatigue. The failure began at the end of a keyway that was machined without fillets (B) and progressed to final rupture at (C). The final rupture zone is small, indicating that loads were low.

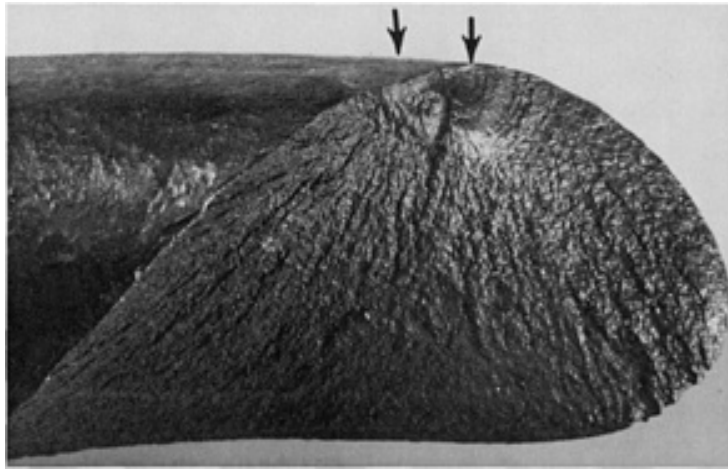
Fig. 53 Torsion failure of an AISI 51B60 railroad spring. The failure began by fatigue at the abraded area at the top (arrows).
