به نام خدا

مرکز دانلود رایگان
مهندسی متالورژی و مواد

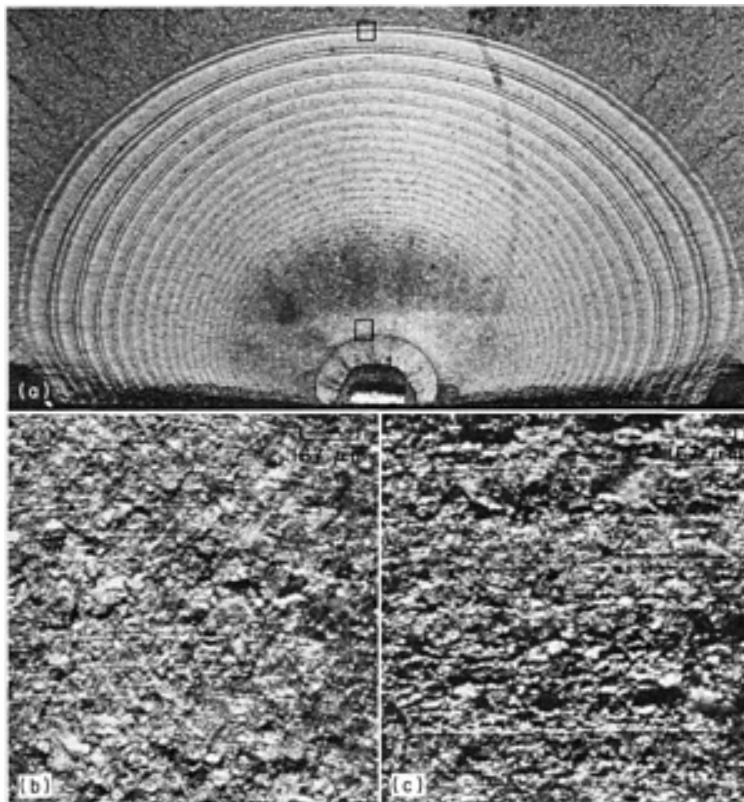
Fig. 54 Three views of a fatigue fracture in D6AC steel plate, showing beach marks. (a) Plate subjected to a series of varied loading cycles in the laboratory. The crack origin, at the bottom center, was at a starter notch formed by electrical discharge machining. (b) Area in lower square in (a), just above beach mark registering the first change in loading. (c) Area in upper square in (a), just ahead of the zone of final fast fracture. Both (b) and (c) contain faintly resolved, fine beach marks. (a) About 5 \times . (b) and (c) 60 \times . Source: Ref 124

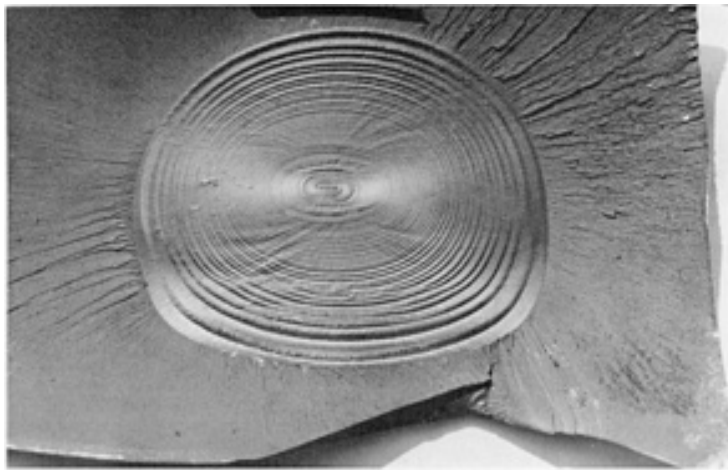
Fig. 55 Circular spall that began at a large subsurface inclusion in a hardened steel roll

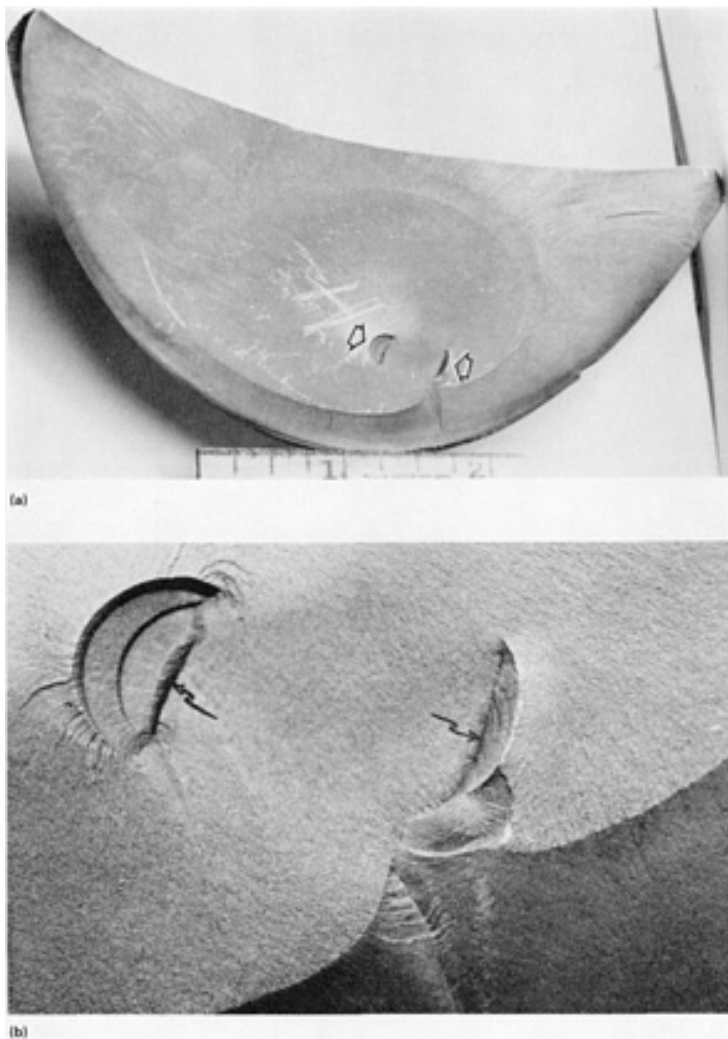
Fig. 56 Circular spall from the shoulder of a forged, hardened alloy steel mill roll with two small fatigue origins. A subsurface crack connected the two fatigue zones. Note that the spall surface is relatively featureless. (a) About

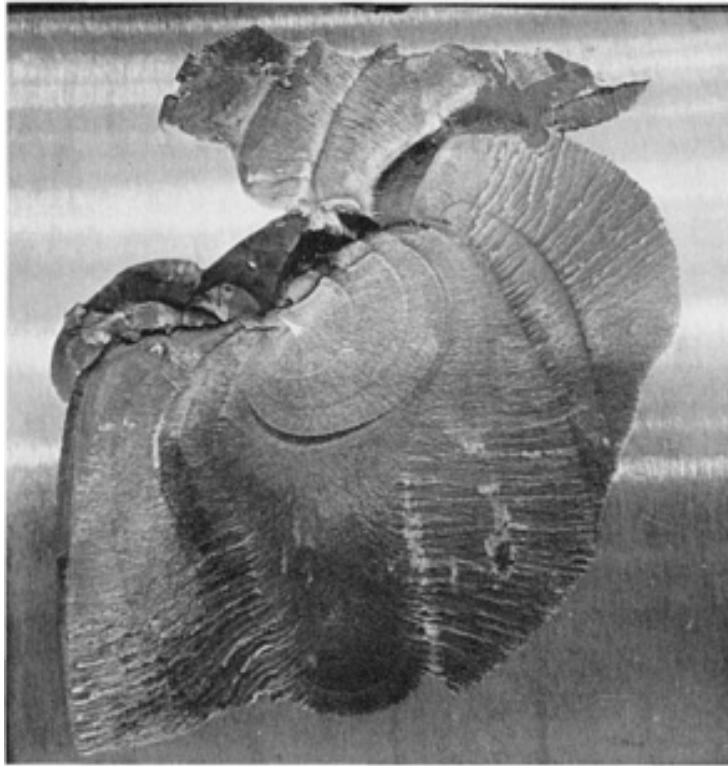
Fig. 57 Circular spall on the surface of a forged, hardened alloy steel mill roll. The arrow indicates the fracture origin. Note the fatigue marks showing the growth away from the origin, followed by brittle fracture. 0.68×

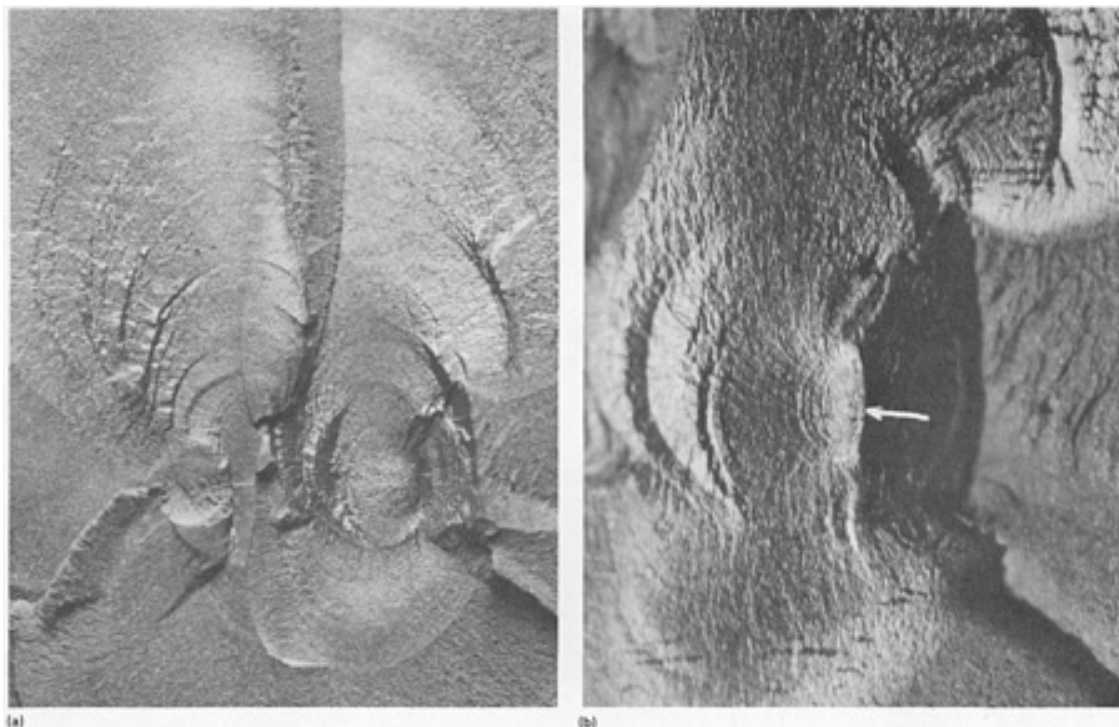
Fig. 59 Close-ups of the primary initiation site of the spall shown in Fig. 58. (a) Area A. 4x. (b) Area B. 8x. See also Fig. 60.

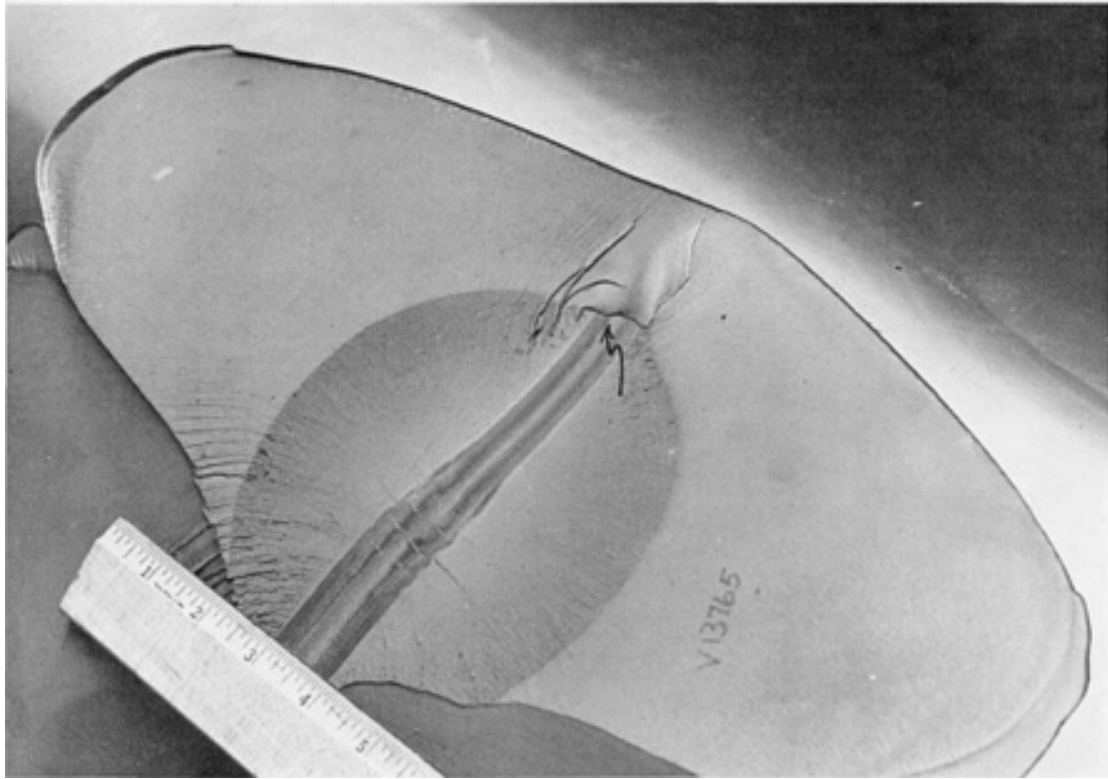
Fig. 62 Another view of the line spall shown in Fig. 61. The arrow indicates the location of the line spall under the unfractured surface. See also Fig. 61 and 63. 0.6x

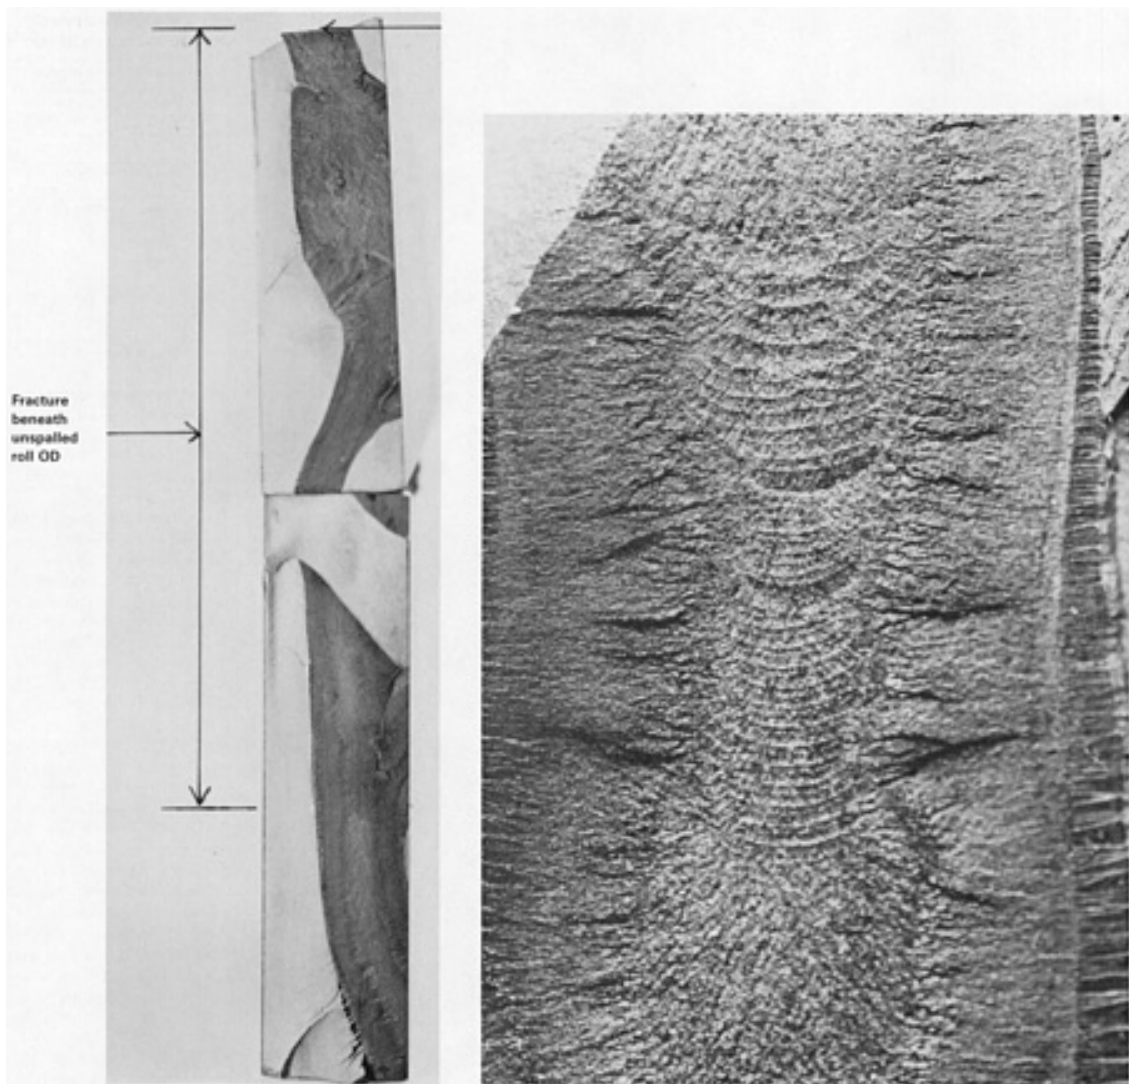
Fig. 63 The line spall fracture surface beneath the unspalled roll surface (see Fig. 61 and 62), revealed by sectioning and fracturing. The smooth, white fracture region formed when the spall was opened. The arrow at the top indicates the origin, shown at the right at higher magnification, which revealed beach marks.

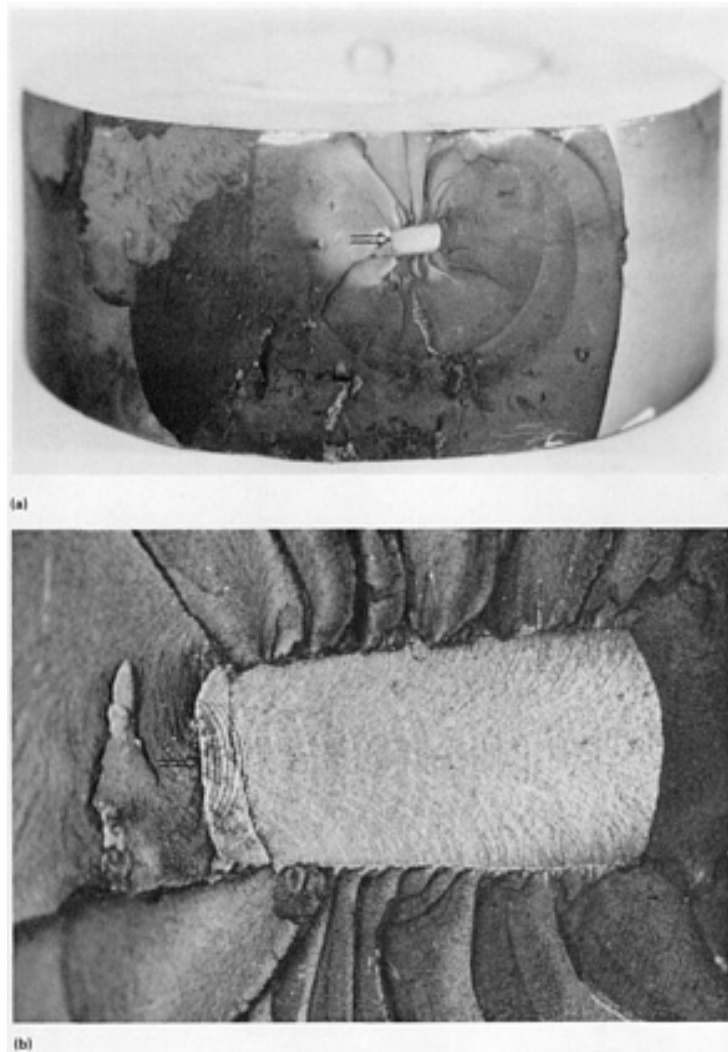
Fig. 64 Example of a line spall in a forged, hardened steel roll. (a) Section containing the spall cut from the roll. The arrow indicates the origin of the fracture, about 6 mm (0.25 in.) below the roll surface. (b) The fracture origin at $6.5\times$. Fatigue beach marks originate at the arrow; gross fracture marks can be seen radiating from the fatigue zone.

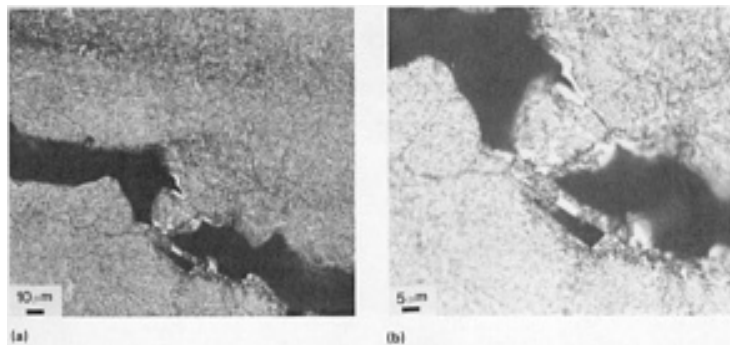
Fig. 67 Two views of white-etching deformation bands, termed butterflies, that formed at a growing fatigue crack in a forged, hardened alloy steel mill roll. The crack would have led to spalling in later service. These white-etching zones form from the original tempered martensite due to cyclic service stresses and are often observed at the initiation sites of spalls.

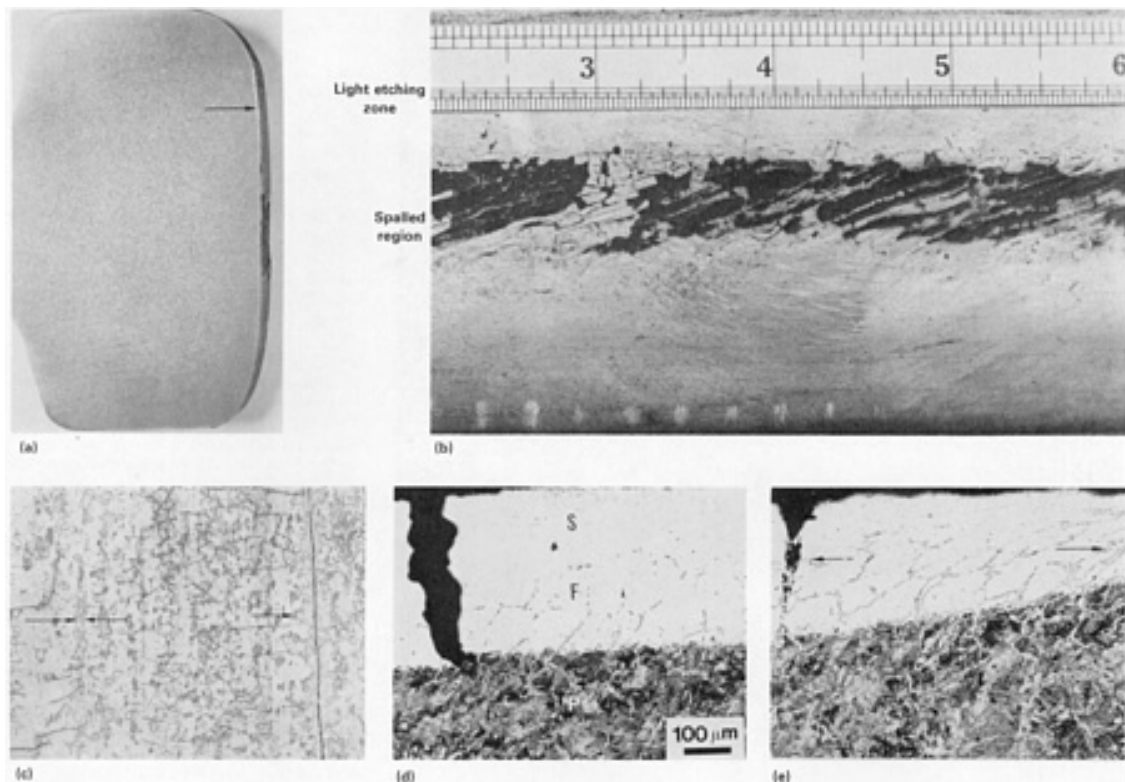
Fig. 68 Spalling of the hard surface region of a rail head was caused by rolling-contact fatigue in service. The hard area was formed by localized overheating, probably by spinning locomotive wheels. (a) Section through rail head, with field side at top and gage side at bottom. (b) Rail surface. 1.2×. (c) Rail surface. 9×. (d) Area adjacent to spall showing featureless surface zone (S), featureless zone with ferrite (F), and pearlite matrix (P). 7×. (e) Section from near field side. Etched with 4% picral. 80×

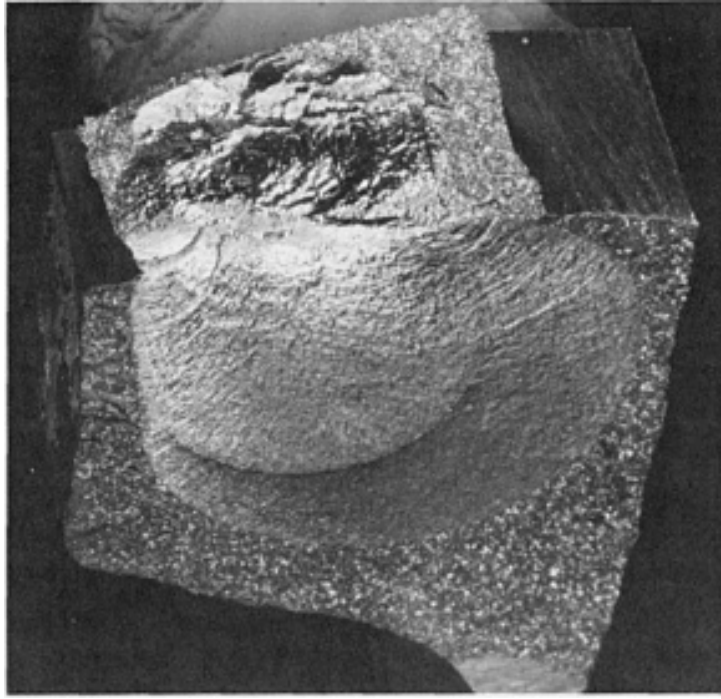
Fig. 69 Macrograph of broken rail showing the interconnection between the shell fracture (across the top) and the detail fracture (on the transverse plane). 3.5 \times . (R. Rungta, Battelle Columbus Laboratories)

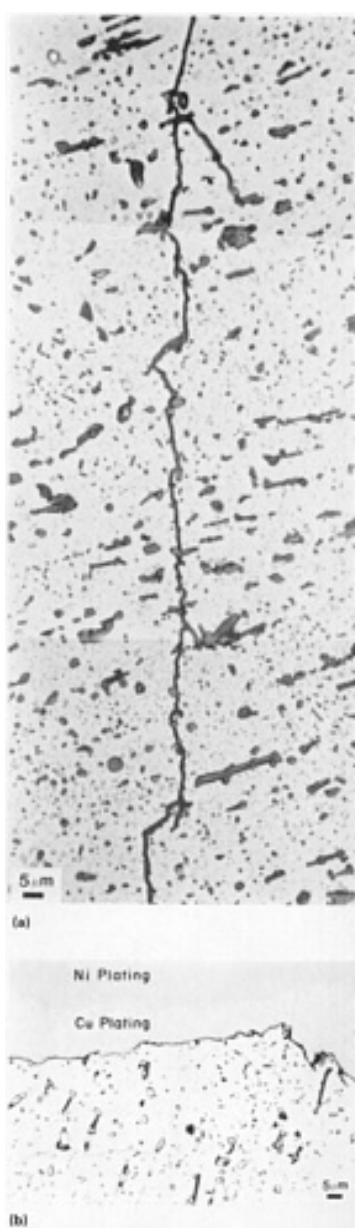
Fig. 71 Fatigue cracks in an unbroken (a) and completely broken (b) aluminum alloy. (a) Etched with Kroll's reagent. 680× (b) Etched with Keller's reagent. 510×

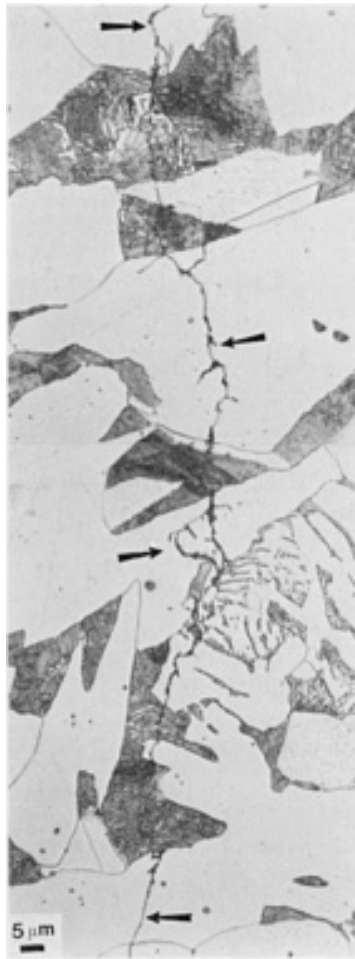
Fig. 72 Fatigue crack (arrows) in a ferrite-pearlite microstructure in a carbon steel. Etched with 2% nital. 800×

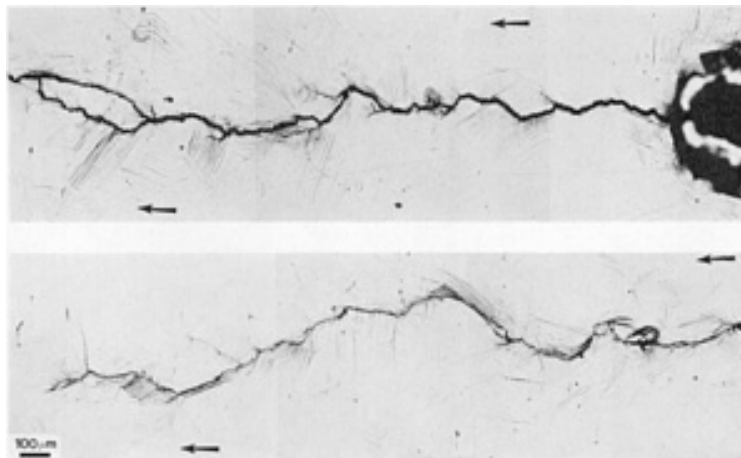
Fig. 73 Fatigue crack appearance in an austenitic stainless steel specimen polished before fatigue loading, revealing slip lines on surfaces associated with crack formation and growth. Arrows indicate the direction of crack

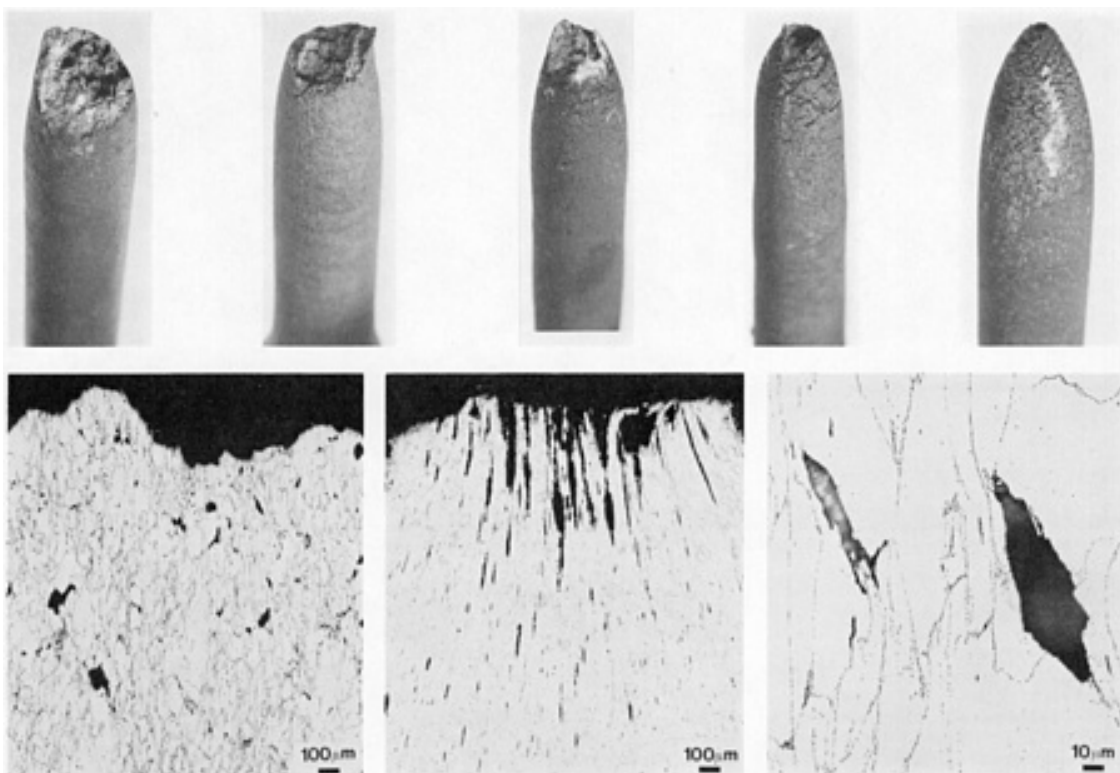
Fig. 74 Macrographs (top) and microstructures (bottom) of short-time type 316 stainless steel tensile specimens tested at various temperatures. Top, from left: specimens tested at 760 °C (1400 °F), 815 °C (1500 °F), 870 °C (1600 °F), 925 °C (1700 °F), and 980 °C (1800 °F). Bottom, from left: Specimen tested at 760 °C (1400 °F). 35 ×. Specimen tested at 980 °C (1800 °F) 35 ×. Specimen tested at 815 °C (1500 °F). 350 ×. Specimens at bottom etched with mixture of HCl, HNO₃, and H₂O.

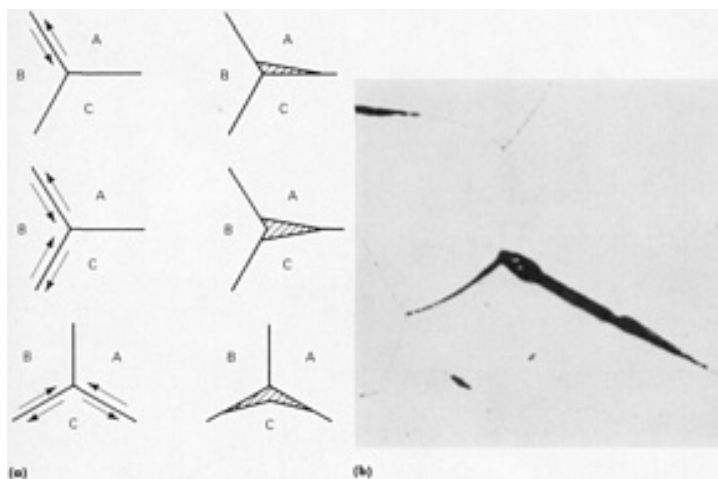
Fig. 75 One mechanism of intergranular cracking. (a) Schematic showing cracking due to grain-boundary sliding. Arrows along a grain boundary indicate that this boundary underwent sliding. (b) Cracks and voids in Al-5.1 Mg that was stress rupture tested at 260 °C (500 °F). Electrolytically polished. 60 ×. Source: Ref 194

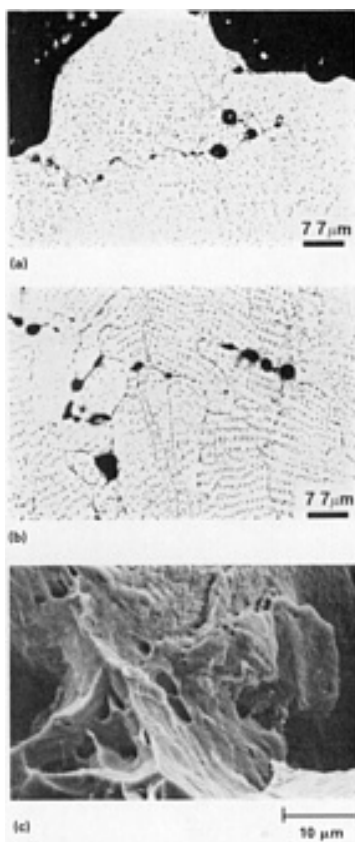
Fig. 76 Microstructure and fracture appearance of type 316 stainless steel tested in creep to fracture in air at 800 °C (1470 °F) at a load of 103 MPa (15 ksi). Time to rupture: 808 h. Light micrographs (a and b) illustrate r-type cavities caused by vacancy condensation on boundaries perpendicular to the stress axis. Both 90 × and electrolytically etched with oxalic acid. The SEM fractograph (c) illustrates the formation of the r-type cavities at the grain boundaries. 1260 ×. (W.E. White, Petro-Canada Ltd.)

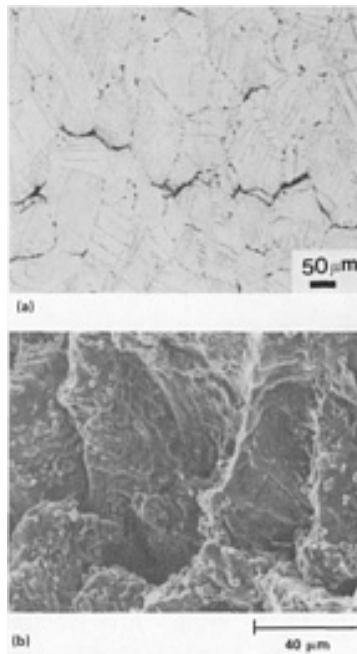
Fig. 77 Microstructure and fracture appearance of type 316L stainless steel tested in creep to fracture in air at 800 °C (1470 °F), using a 53-MPa (7.7-ksi) load. Time to rupture: 839 h. The light micrograph (a) illustrates w-crack coalescence by slow shearing along grain boundaries. The SEM fractograph (b) shows the fracture appearance characterized by poorly formed shear dimples and particle dragging. (a) Electrolytically etched with oxalic acid. 84 ×. (b) 420 ×. (W.E. White, Petro-Canada Ltd.)

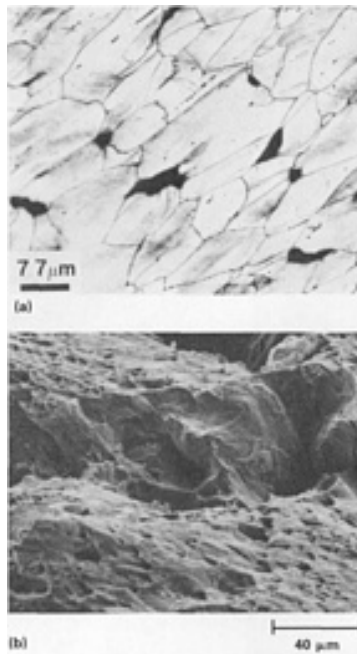
Fig. 78 Microstructure and fracture appearance of type 316 stainless steel tested in creep to fracture in air at 685 °C (1265 °F) at a load of 123 MPa (17.9-ksi). Time to rupture: 710 h. The light micrograph (a) shows triple boundary cracking with extensive bulk deformation and grain elongation. The SEM fractograph (b) illustrates classic shear dimple topography. (a) Electrolytically etched with oxalic acid. 110 ×. (b) 380 ×. (W.E. White, Petro-Canada Ltd.)

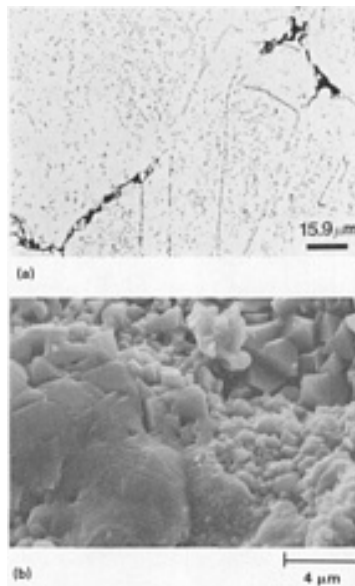
Fig. 79 Microstructure and fracture appearance of type 316 stainless steel tested in creep to fracture at 770 °C (1420 °F) using a 62-MPa (8.95-ksi) load. Time to rupture: 808 h. (a) Optical micrograph showing crack nucleation and growth by decohesion along the carbide/matrix interfaces. Etched with dilute aqua regia. 440 ×. (b) SEM fractograph illustrating carbide morphology at the fracture surface. 3150 ×. (W.E. White, Petro-Canada Ltd.)

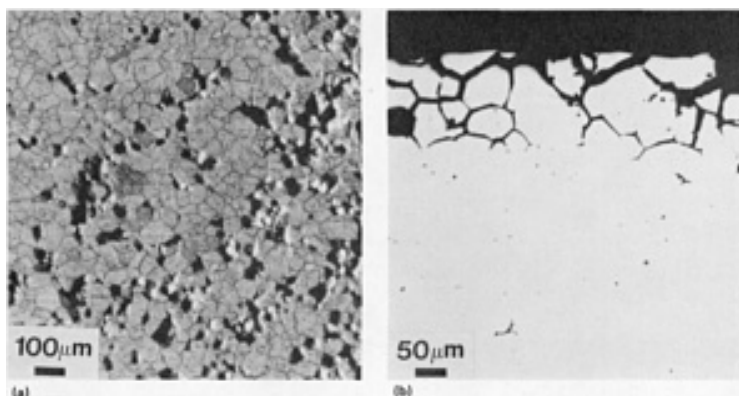
Fig. 82 Planar (a) and cross sectional (b) views of intergranular corrosion (grain dropping) in a sensitized austenitic stainless steel. As-polished. (a) 50×. (b) 100×

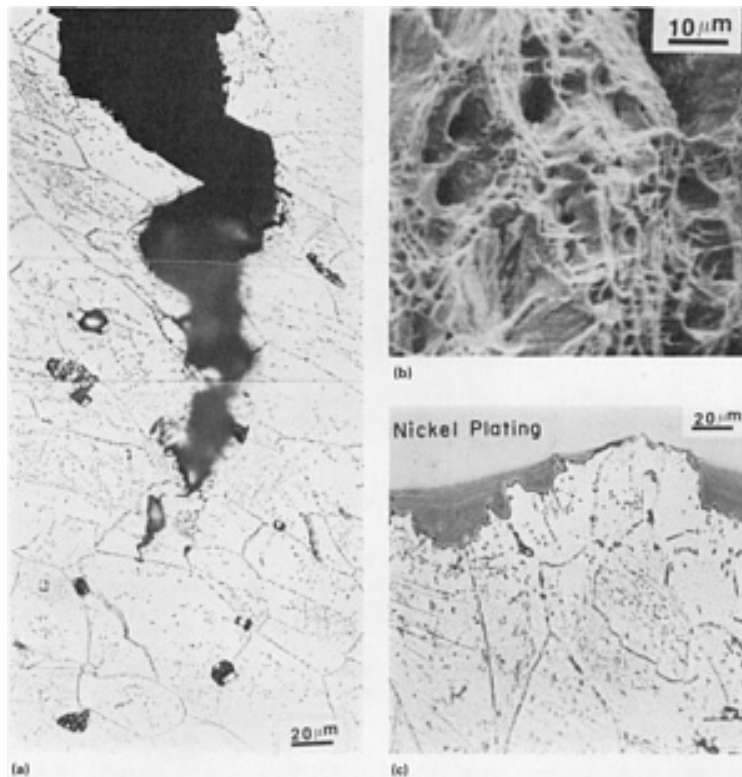
Fig. 83 Three views of a fractured sensitized specimen of type 304 stainless steel. (a) Partially broken specimen. Etched with mixed acids. (b) SEM view of fracture; specimen broken at $-195\text{ }^{\circ}\text{C}$ ($-320\text{ }^{\circ}\text{F}$). (c) Cross section of fracture. Etched with acetic glyceric acid

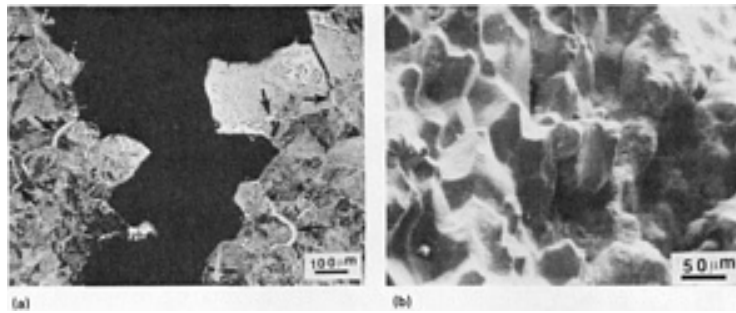
Fig. 84 Eutectoid carbon steel specimen embrittled by liquid copper at 1100 °C (2010 °F). (a) Micrograph of partially broken specimen; arrows point to grain-boundary copper penetration. Etched with 4% picral. (b) SEM fractograph of completely broken specimen

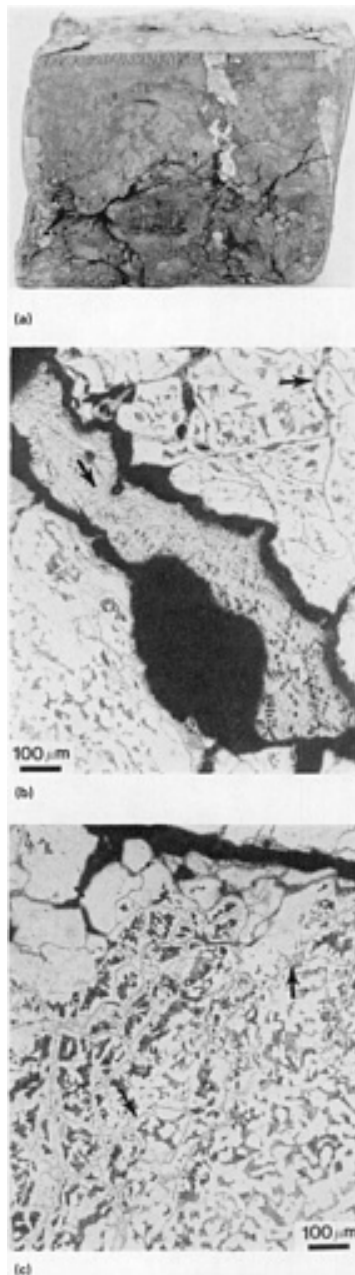
Fig. 85 Hot shortness in a structural steel caused during rolling by internal LME due to copper segregation. (a) Macrograph of section from toe of flange. 0.4 ×. (b) and (c) Micrographs showing grain-boundary copper films that were molten during rolling. (b) and (c) Etched with 2% nital. Both 70×

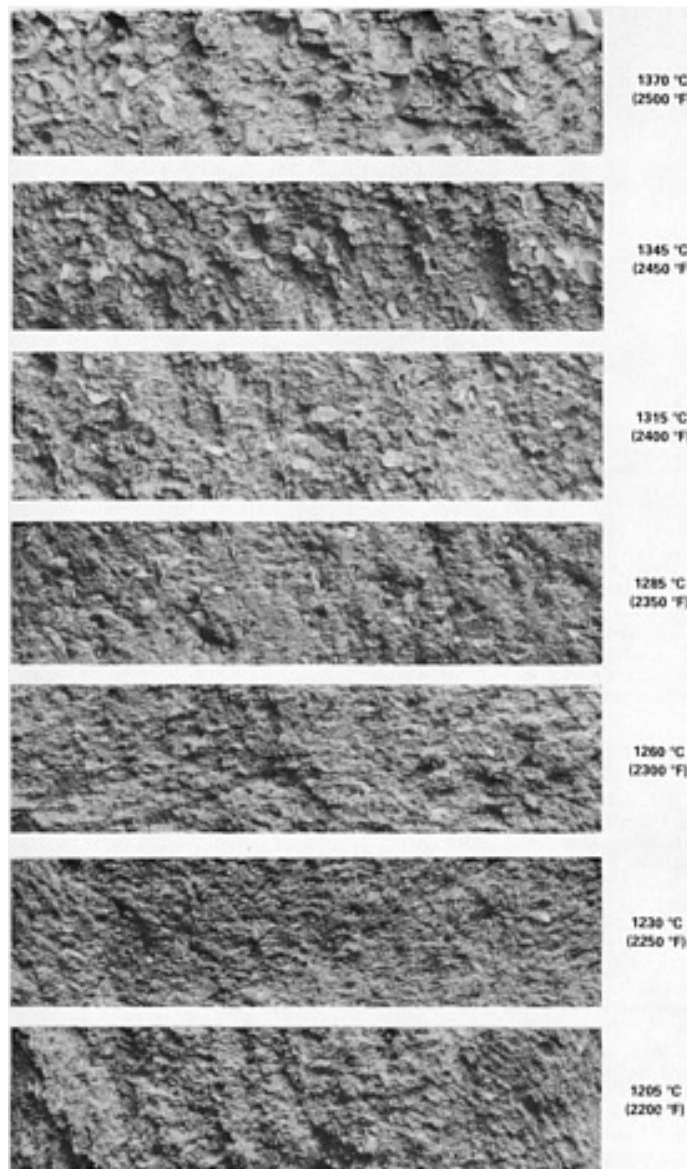
Fig. 88 Macrographs of specimens of ASTM A508 class II steel heated to the indicated temperatures, normalized, quenched, tempered to about 37 to 39 HRC, and fractured. Overheating facets are observed in all samples, but are not excessively large until the steel is heated to 1260 ° (2300 °F) or above. Source Ref 390

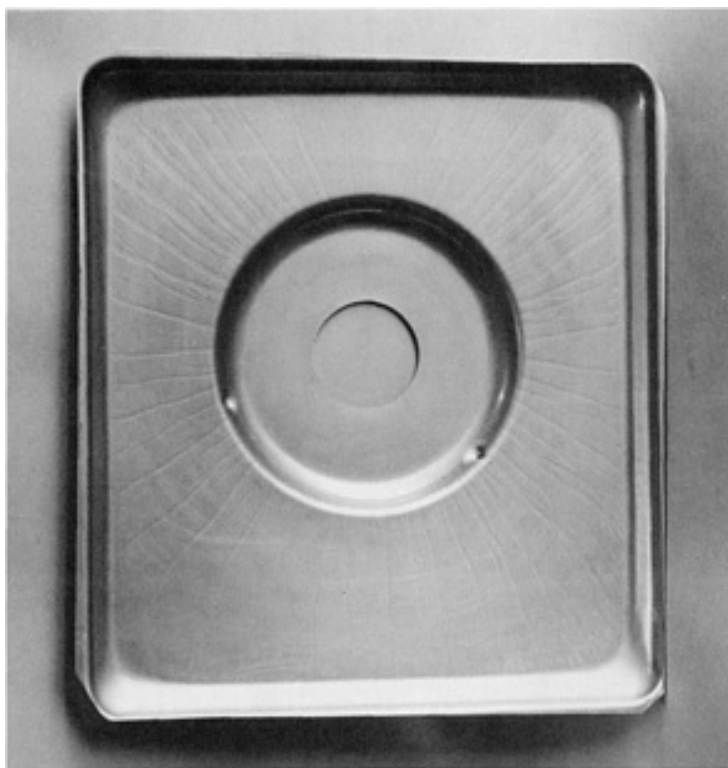
Fig. 90 Stretcher-strain marks (Lüders bands) on the surface of a range component after forming 0.25 ×.

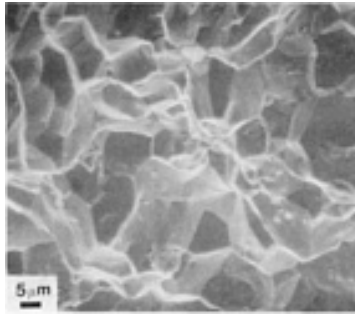
Fig. 91 SEM fractograph of a quench crack surface in AISI 5160 alloy steel showing a nearly complete intergranular fracture path. 680×

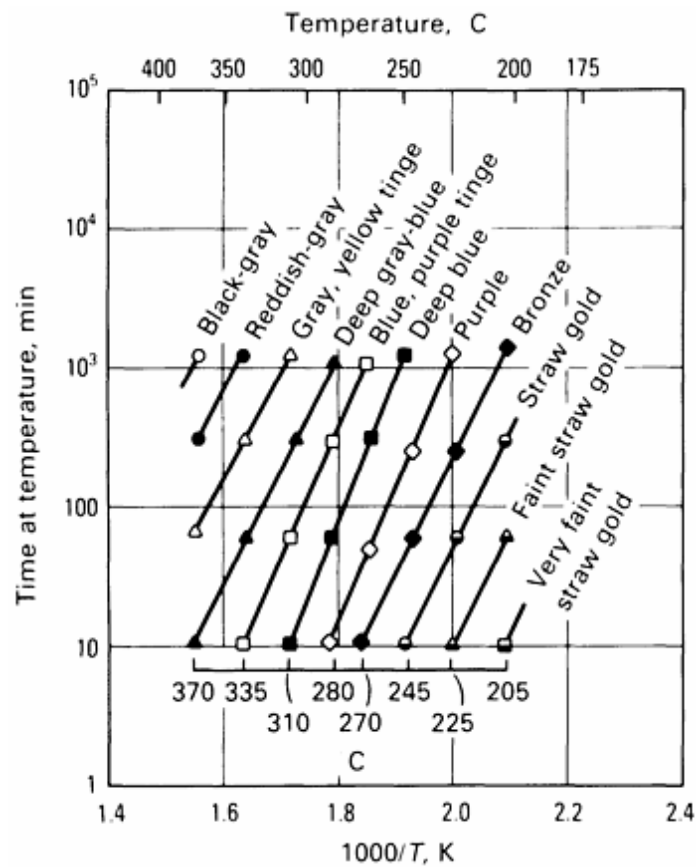
Fig. 92 Temper colors as a function of time at heat for AISI 1035 steel. Source: Ref 414

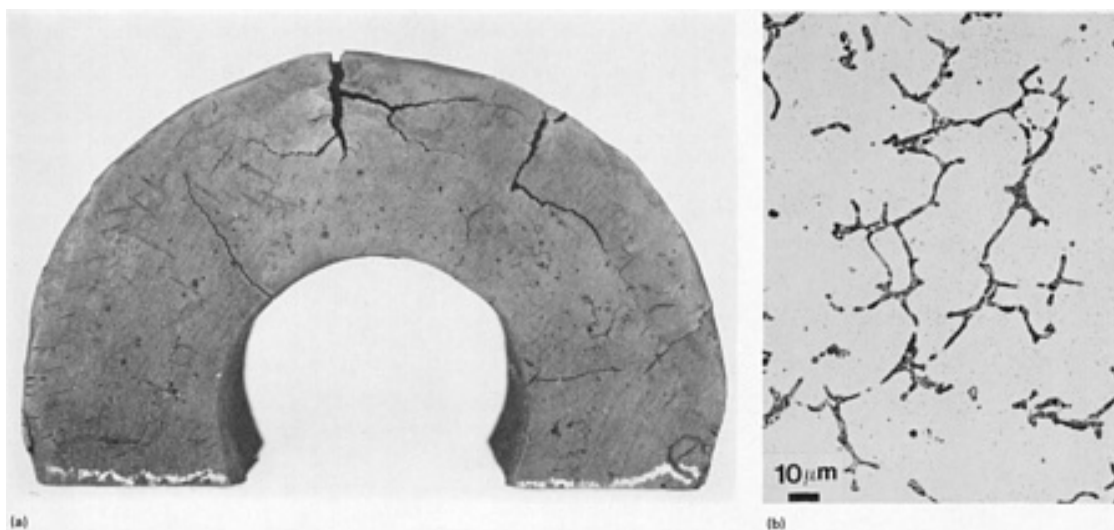
Fig. 94 Cracked 25Cr-12Ni cast stainless quenching fixture. (a) Macrograph of part of the fixture. (b) Microstructure showing substantial σ phase. Electrolytically etched with 10 N KOH. 500 \times

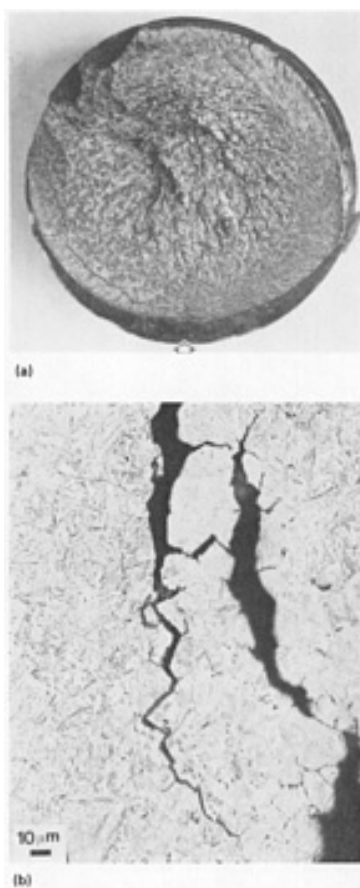
Fig. 96 Broken 25-mm (1-in.) diam AISI 1040 steel bolt. (a) Macrograph of fracture surface; corrosion products obscure most of the surface. 2 \times . Intergranular secondary cracks (b) were observed in the region near the surface of the bolt shown by the arrow in (a). The bolt was not tempered (surface hardness was 53 to 57 HRC) and probably failed by SCC. (b) Etched with 2% nital. 340 \times

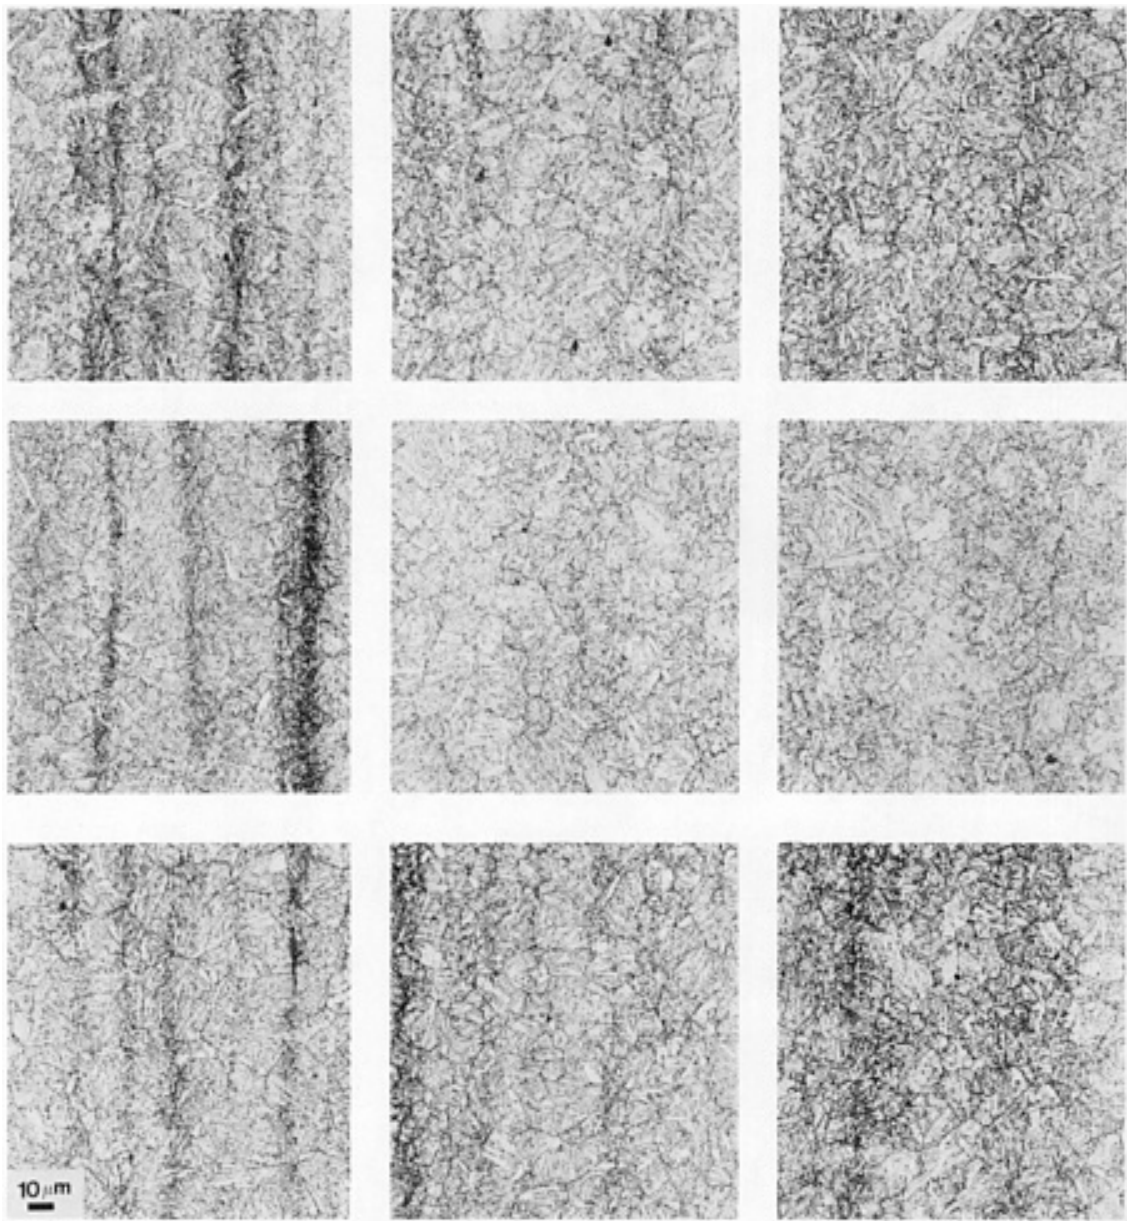
Fig. 99 Microstructures of AISI 4140 steel with 0.004% P (left column), 0.013% P (center column), and 0.022% P (right column). Specimens were etched with the etheral-picral etchant described in Ref 442 (top row) and Ref 444 (middle row) and with saturated aqueous picric acid plus a wetting agent (bottom row). All 425 \times

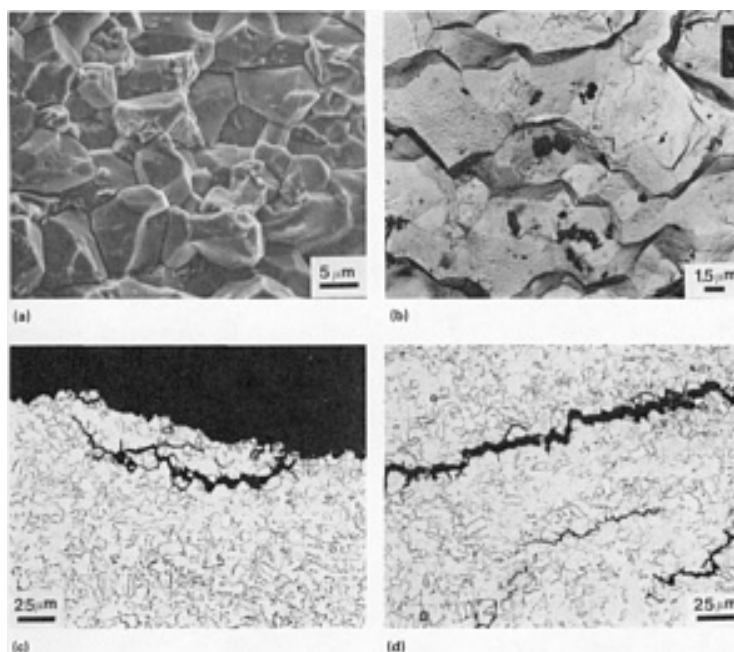
Fig. 100 Fracture in a thermally embrittled cobalt-free high-titanium maraging steel. (a) Secondary electron image of fracture surface, 1300 ×. (b) TEM extraction fractograph, 2150 ×. (c) Light micrograph of fracture edge, 260 ×. (d) Light micrograph of internal cracks, 260 ×. Light micrograph specimens etched with modified Fry's reagent

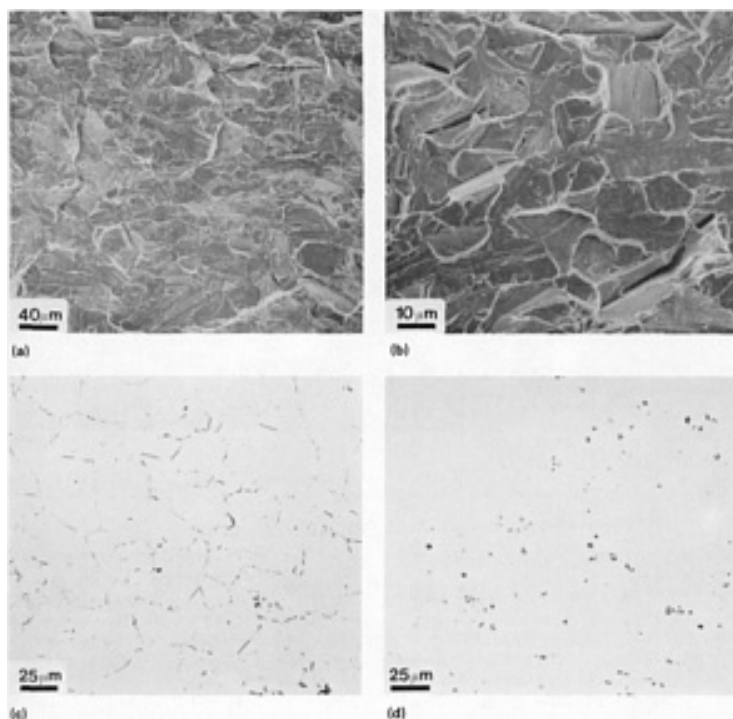
Fig. 101 Example of the fracture appearance and microstructure of a duplex stainless steel (similar to type 329) in the embrittled condition after heating at 370 °C (700 °F) for 1000 h. (a) and (b) SEM fractographs at 165 and 650 ×, respectively, showing cleavage fracture with some splitting. (c) Light micrograph showing dark-etching ferrite-ferrite grain boundaries in a specimen subjected to the embrittling treatment. (d) Light micrograph of a hot-rolled and annealed nonembrittled specimen, which shows only carbides. (c) and (d) Etched with Vilella's reagent. Both at 260 ×

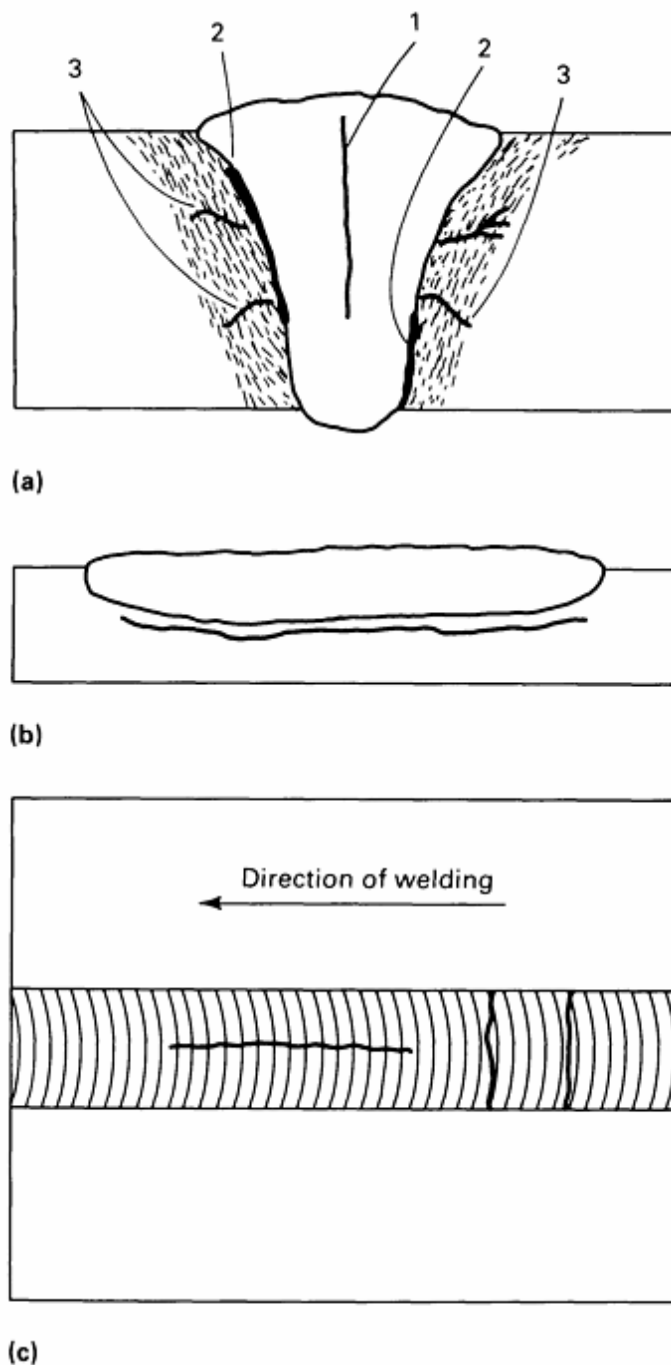
Fig. 102 Schematics illustrating the nomenclature used to describe weldment cracks. (a) Weld metal (1), fusion line (2), and HAZ (3) cracks. (b) Underbead crack. (c) Longitudinal and transverse weld metal cracks. Source: Ref 480

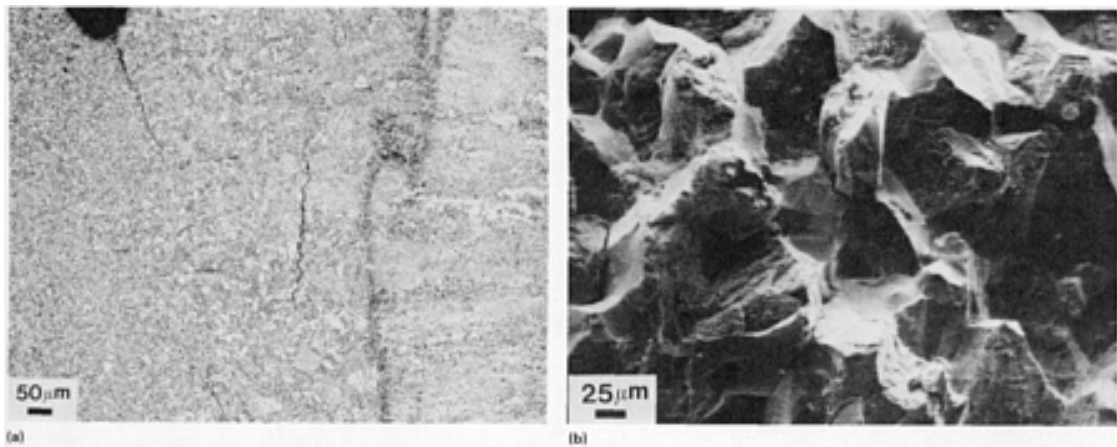
Fig. 103 Cold cracks in an RQC-90 steel plate welded with a high-hydrogen electrode. The sample was an implant specimen loaded to 193 MPa (28 ksi) during solidification. (a) Light micrograph showing cracking. Etched with nital. 80 \times . (b) SEM fractograph showing the intergranular nature of the cracks. 200 \times . (J.P. Snyder, Bethlehem Steel Corporation)
