به نام خدا

مرکز دانلود رایگان
مهندسی متالورژی و مواد

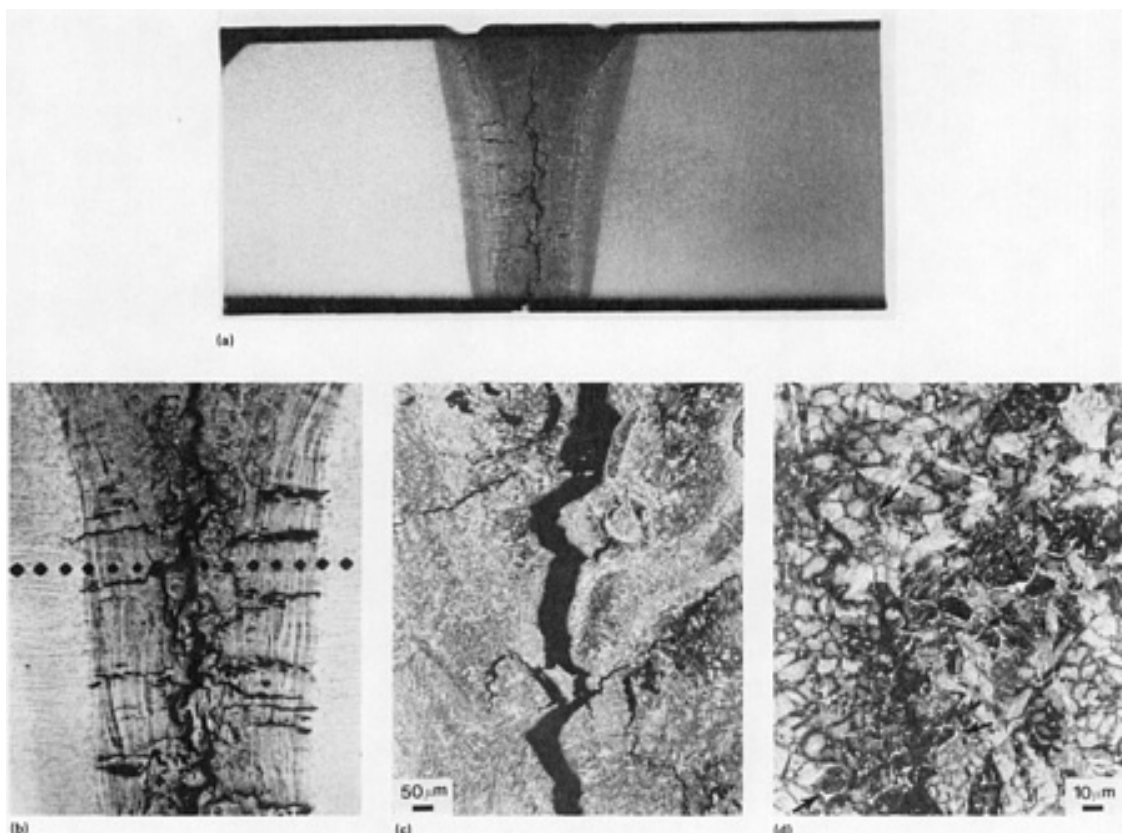
Fig. 104 Hot cracking of an electron beam weld due to accidental melting of the copper backing plate. Note the extensive intergranular cracking and the grain-boundary copper film. (a) 4 ×. (b) 13 ×. (c) 68 ×. (d) 340 ×

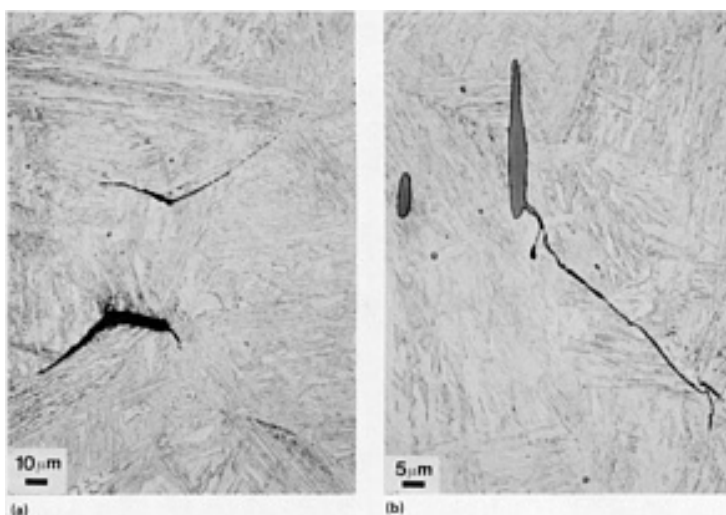
Fig. 105 Two examples of hot tears in the HAZ of gas-metal arc welded HY-80 steel. Note the crack associated with the manganese sulfide inclusion (b). Both etched with 1% nital. (a) 370×. (b) 740×. Courtesy of C.F. Meitzner, Bethlehem Steel Corporation

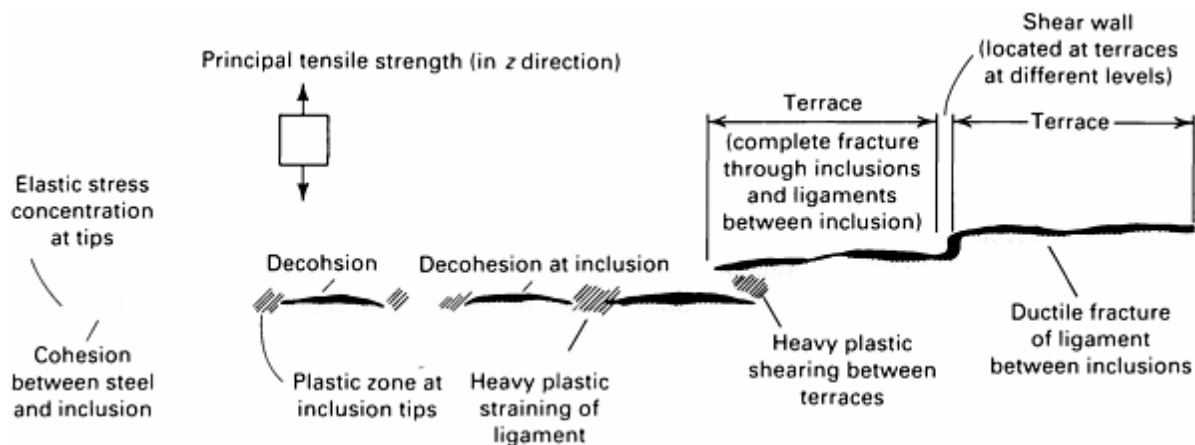
Fig. 106 Schematic illustrating the formation of lamellar tears. Source: Ref 499

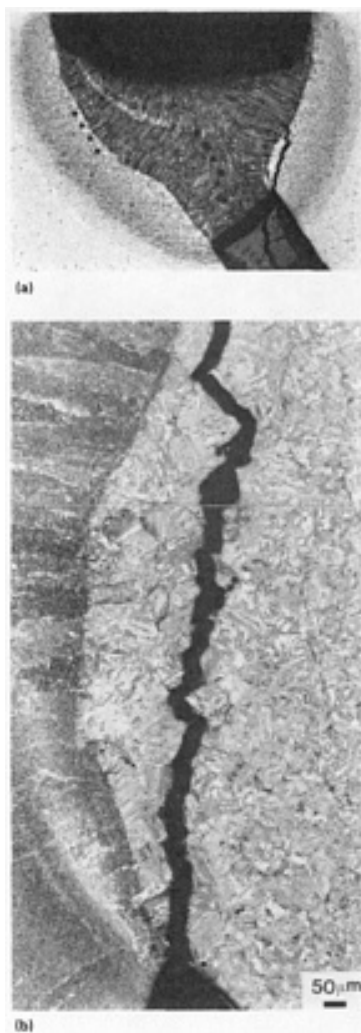
Fig. 108 Stress-relief crack in plate steel Lehigh restraint sample. The crack is intergranular, but the high restraint suppresses crack branching. The square marks in the weld HAZ in (a) are hardness impressions. (a) 9×. (b) Etched with 2% nital. 74×

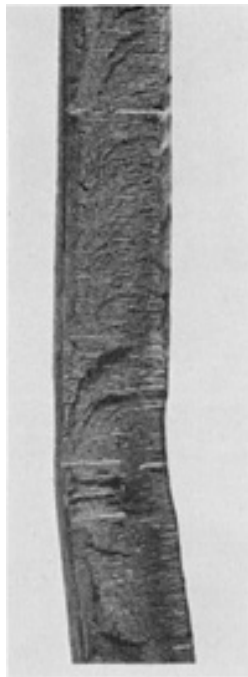
Fig. 111 Example of inclusion stringers (white streaks against the dark background) on a longitudinal test fracture. The specimen was blued to reveal the stringers.

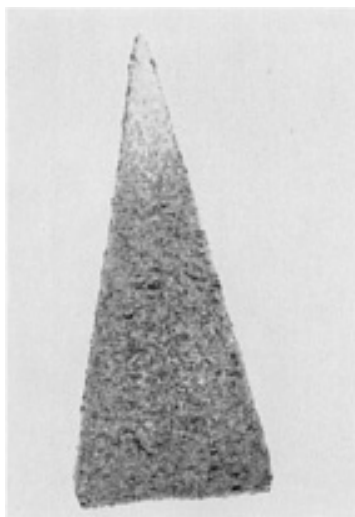
Fig. 112 Example of a fractured wedge test specimen used to assess the carbide stability in a cast iron melt. Note the change in fracture appearance in the tip (white fracture due to the presence of carbide) compared to the base of the wedge (dark due to the presence of graphite). Actual size

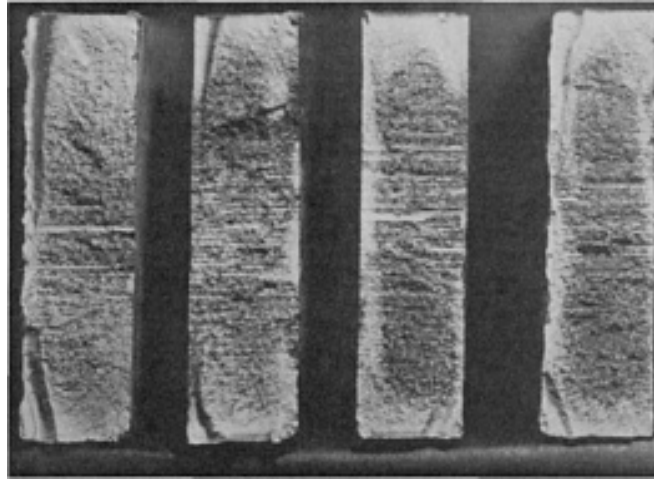
Fig. 113 Four fractured, hardened etch disks of a high-carbon (1.3% C) tool steel that contained excessive graphite (dark regions) due to an accidental aluminum addition. About 0.5×

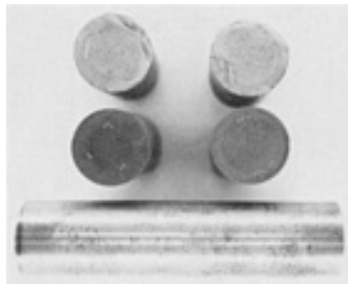
Fig. 114 Example of specimens used in the Shepherd P-F test. The 19-mm ($\frac{3}{4}$ -in.) diam, 100-mm (4-in.) long specimen is shown at the bottom. The test consists of fracturing an austenitized and brine-quenched specimen. Case depth can be observed on the fracture. After fracture grain size is rated, the fracture surface is carefully ground off. Macroetching then reveals the depth of hardening. Superficial hardness tests are used to determine the case depth to a particular hardness.

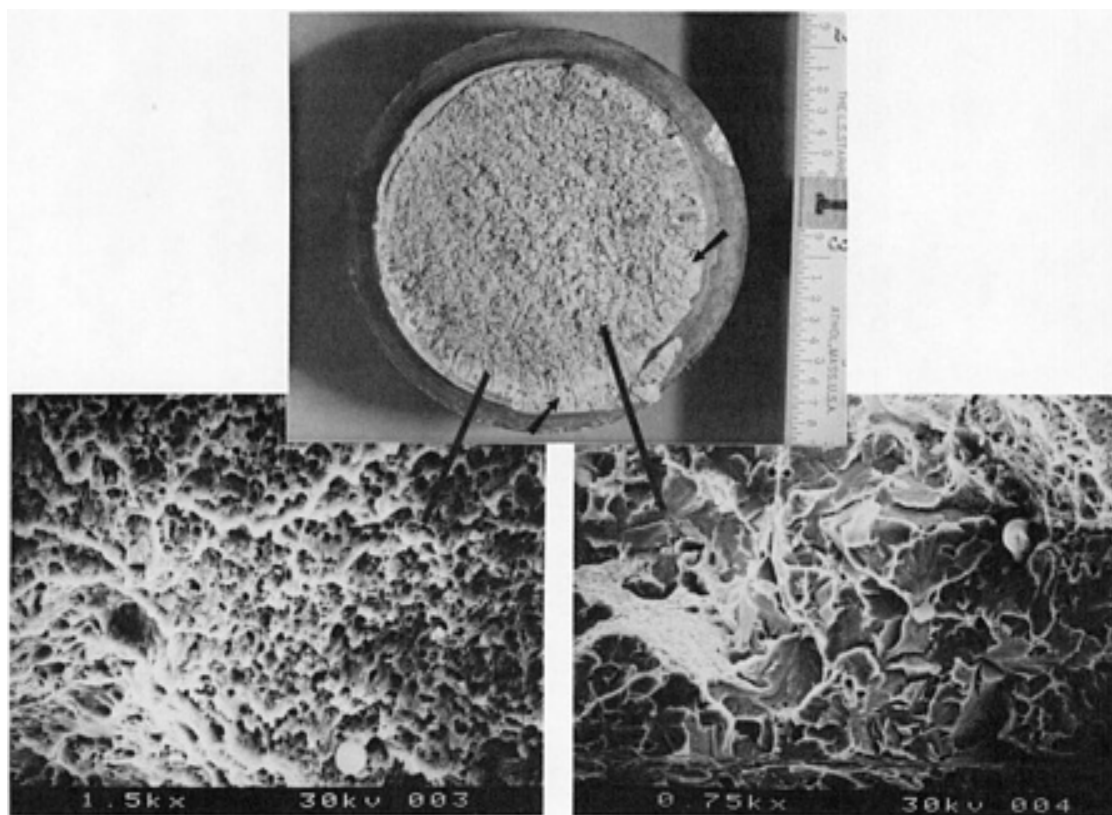
Fig. 5 Radial marks (arrows) in the fibrous zone of a bolt fractured under conditions of tensile overload. The morphologies of the different texture zones are shown in the SEM fractographs: ductile fracture (left) and transgranular fracture (right).

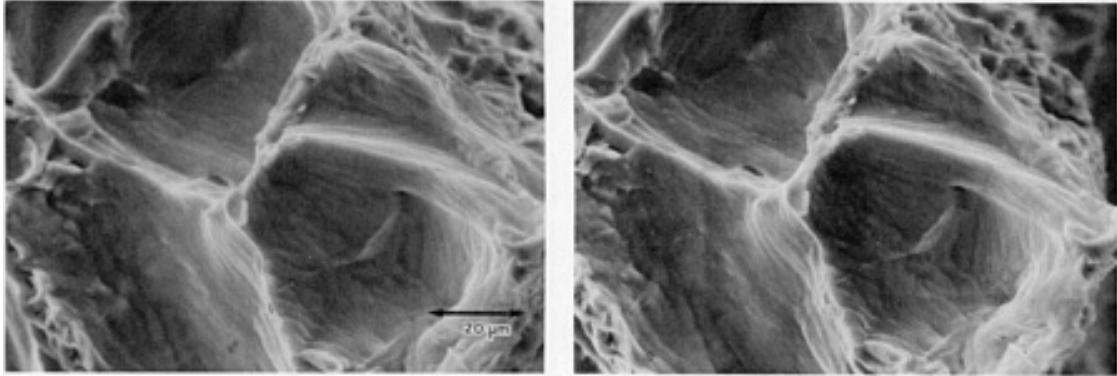
Fig. 7 Stereo pair showing deep dimples in the fracture surface of commercially pure titanium. Average grain size is 46 μm . Large dimples originated at grain-boundary triple points. Note small dimples at rim that nucleated at dislocation cell walls. (M. Erickson-Natishan, University of Virginia)

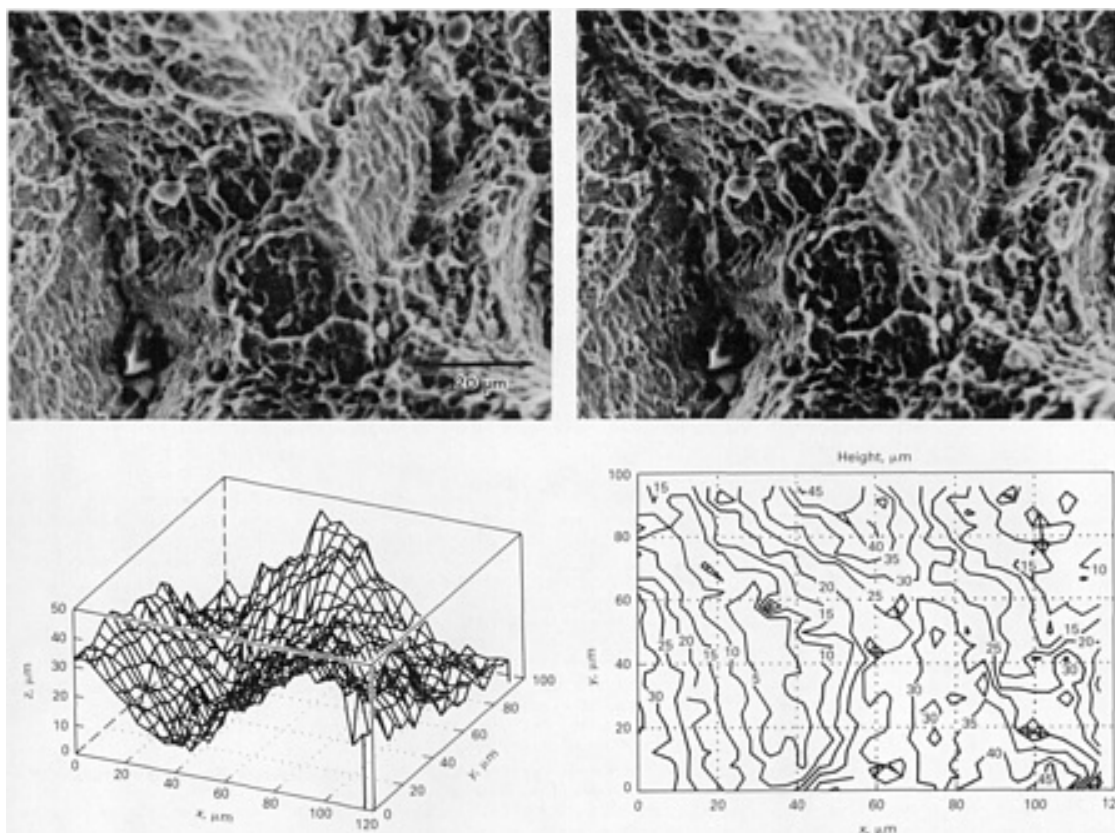
Fig. 8 Stereo pair (top left and right) of a fractured Ti-10V-2Fe-3Al alloy that was heat treated at 780 °C (1435 °F) for 3 h, water quenched, and aged for 1 h at 500 °C (930 °F). The corresponding carpet plot (bottom left) and contour plot (bottom right) of the fracture surface are also shown. (J.D. Bryant, University of Virginia)

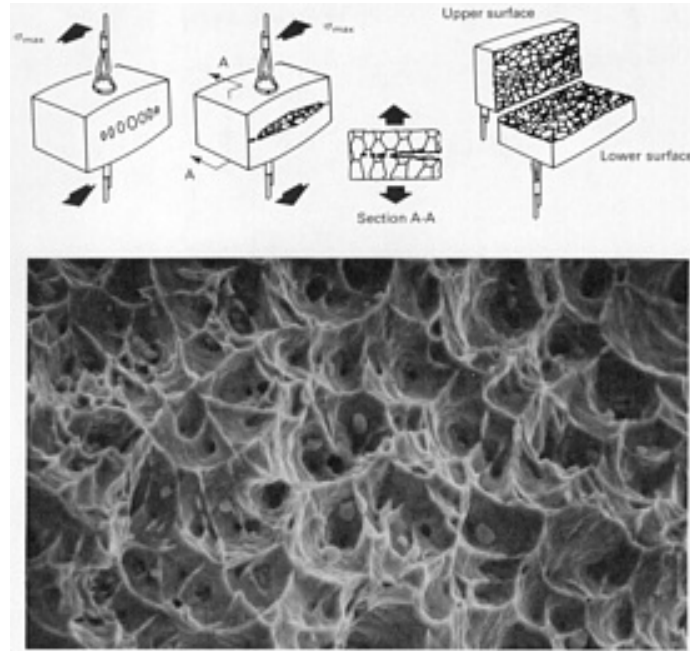
Fig. 9 Formation of dimples under conditions of tension using a copper test specimen. Note that the dimples are equiaxed. 750 \times

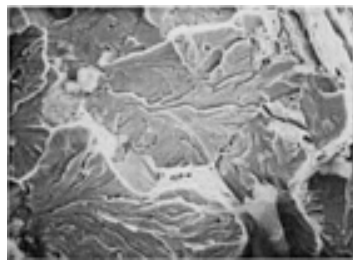
Fig. 12 Cleavage in a low-carbon steel specimen that was impact fractured at liquid-nitrogen temperatures. 385×

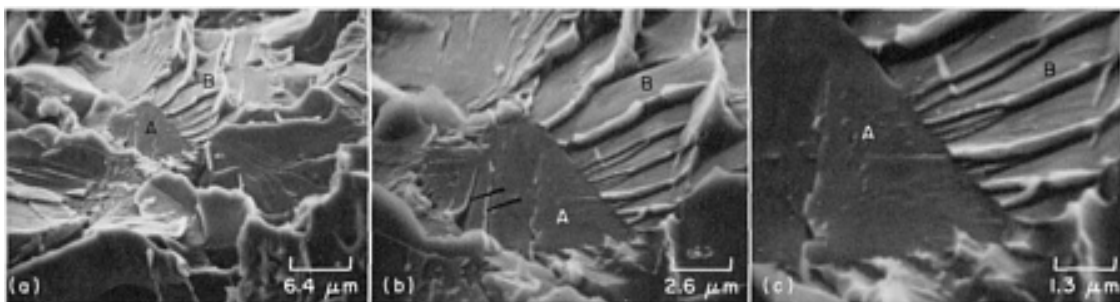
Fig. 13 Cleavage fracture in a notched impact specimen of hot-rolled 1040 steel broken at $-196\text{ }^{\circ}\text{C}$ ($-320\text{ }^{\circ}\text{F}$), shown at three magnifications. The specimen was tilted at an angle of 40° to the electron beam. The cleavage planes followed by the crack show various alignments, as influenced by the orientations of the individual grains. Grain A, at center in fractograph (a), shows two sets of tongues (see arrowheads in fractograph b) as a result of local cleavage along the $\{112\}$ planes of microtwins created by plastic deformation at the tip of the main crack on $\{100\}$ planes. Grain B and many other facets show the cleavage steps of river patterns. The junctions of the steps point in the direction of crack propagation from grain A through grain B, at about 22° to the horizontal plane. The details of these forks are clear in fractograph (c).

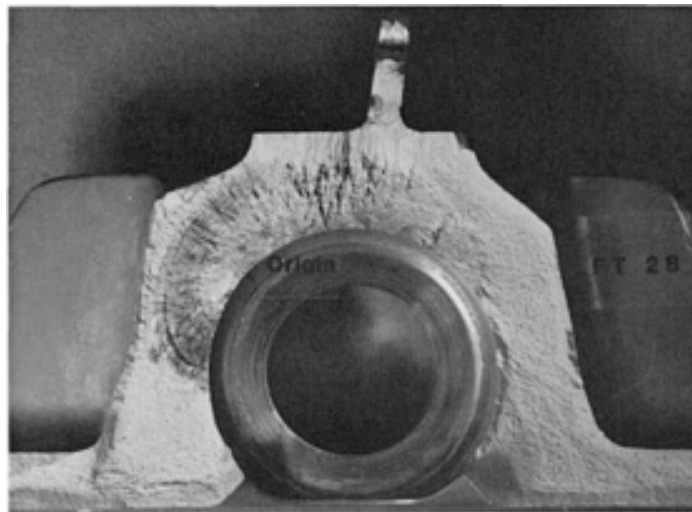
Fig. 14 Forged aluminum alloy 2014-T6 aircraft component that failed by fatigue. Characteristic beach marks are evident. See also Fig. 15.

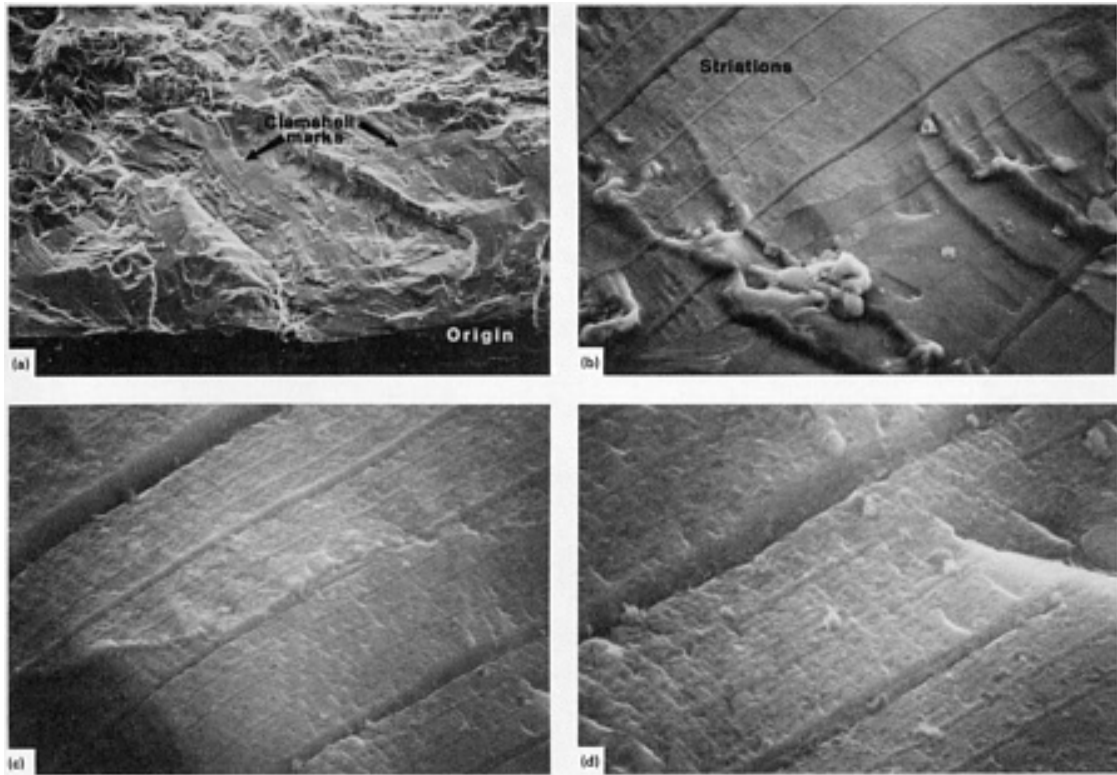
Fig. 15 A series of low- to high-magnification micrographs of the specimen shown in Fig. 14. Note that as magnification is increased, progressively finer striations are resolved. (a) 80 \times . (b) 800 \times . (c) 4000 \times . (d) 8000 \times .

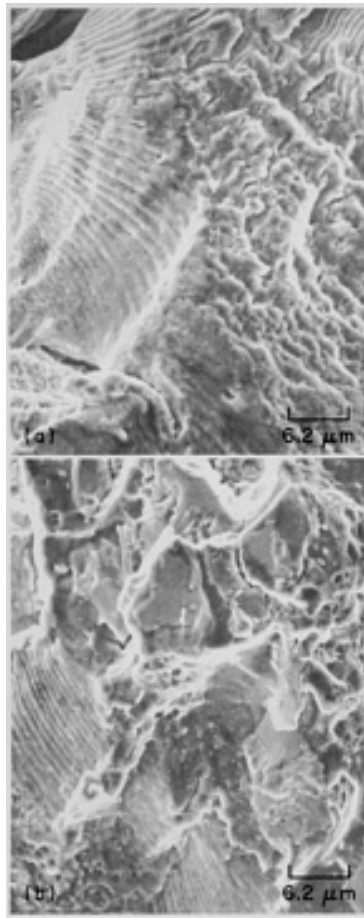
Fig. 16 Intermingled dimples and fatigue striations in low-cycle fatigue test fractures in aluminum alloy 2024-T851 at a high range of stress intensity (ΔK) at the crack tip. Orientation of fatigue striations differs from patch to patch, particularly in fractograph (a). Dimples in fractograph (b) are associated with inclusions. Both 1600 \times

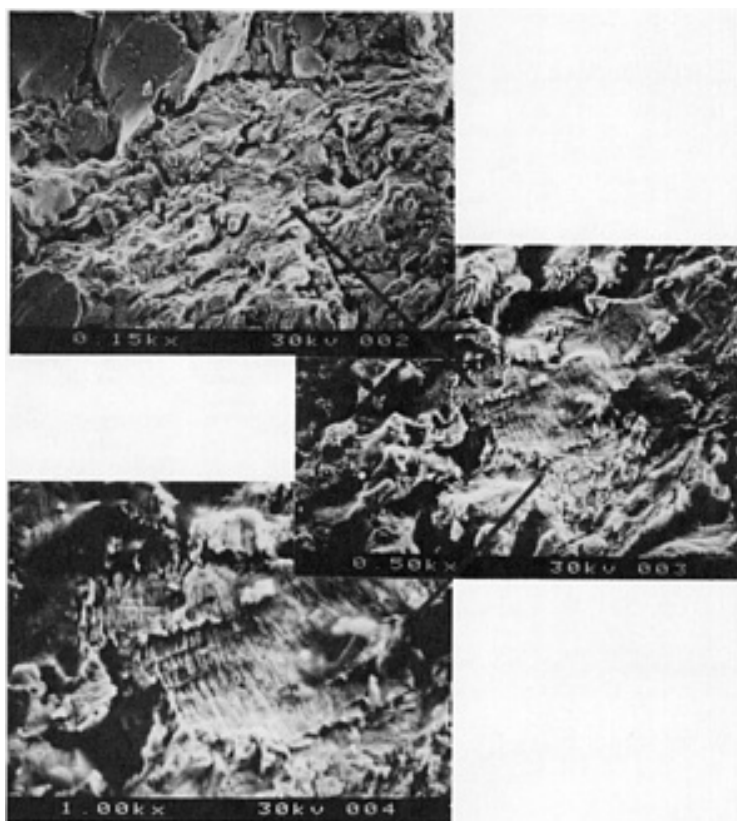
Fig. 17 Poorly defined fatigue striations in a low-carbon steel specimen

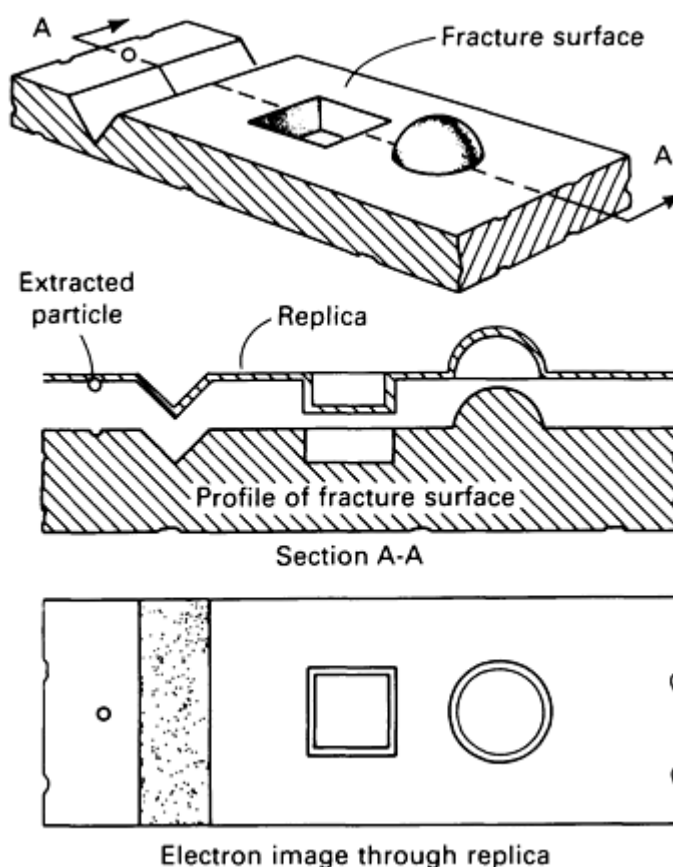
Fig. 1 Schematic views illustrating the single-stage replication technique

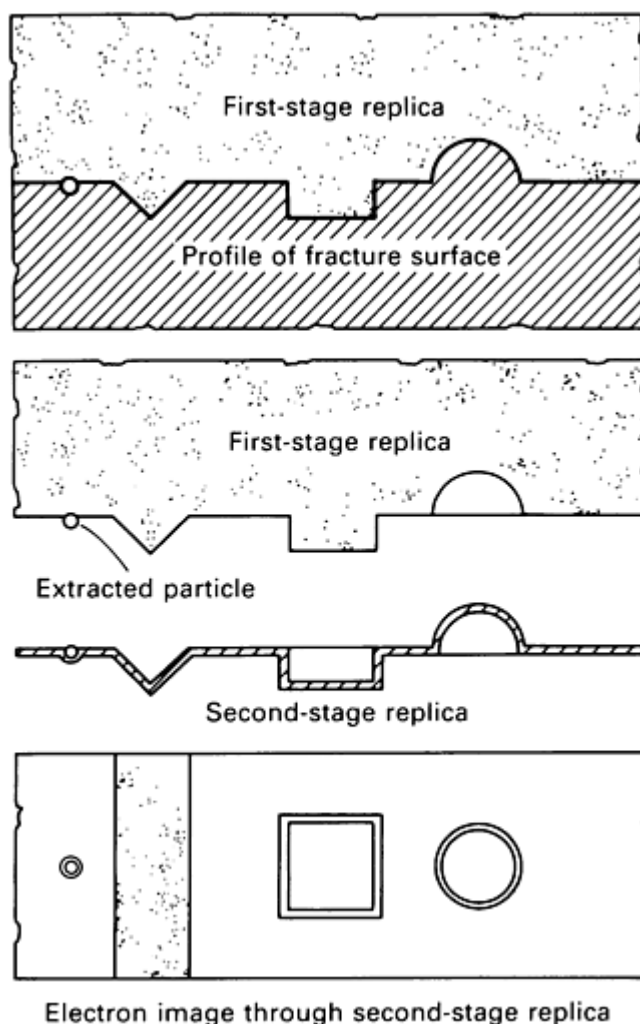
Fig. 2 Schematic views illustrating the two-stage replication technique

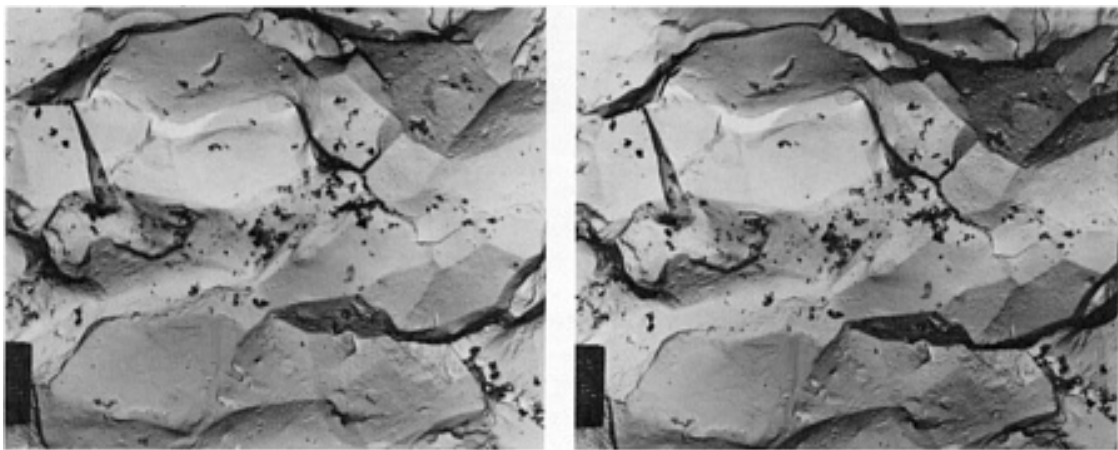
Fig. 4 Transmission electron stereo pair at 3300 × showing grain-boundary precipitates in an extraction replica taken from the fracture surface of a cobalt-free maraging steel that was solution annealed at 815 °C (1500 °F) for 1 h and air cooled, followed by aging at 480 °C (900 °F) for 3 h and air cooling. The specimen fractured several hours after aging. The particles shown ranged from 0.1 to 4 μm. The smallest were titanium-rich and also contained a small amount of molybdenum. These are probably TiC carbides. A few small (0.2 to 0.3 μm) iron-titanium-molybdenum-rich particles were also observed. The larger particles were either titanium- or zirconium-rich, and these may also be an MC-type precipitate. Such grain-boundary precipitates lower the notch toughness of steels. (G.F. Vander Voort, Carpenter Technology Corporation)

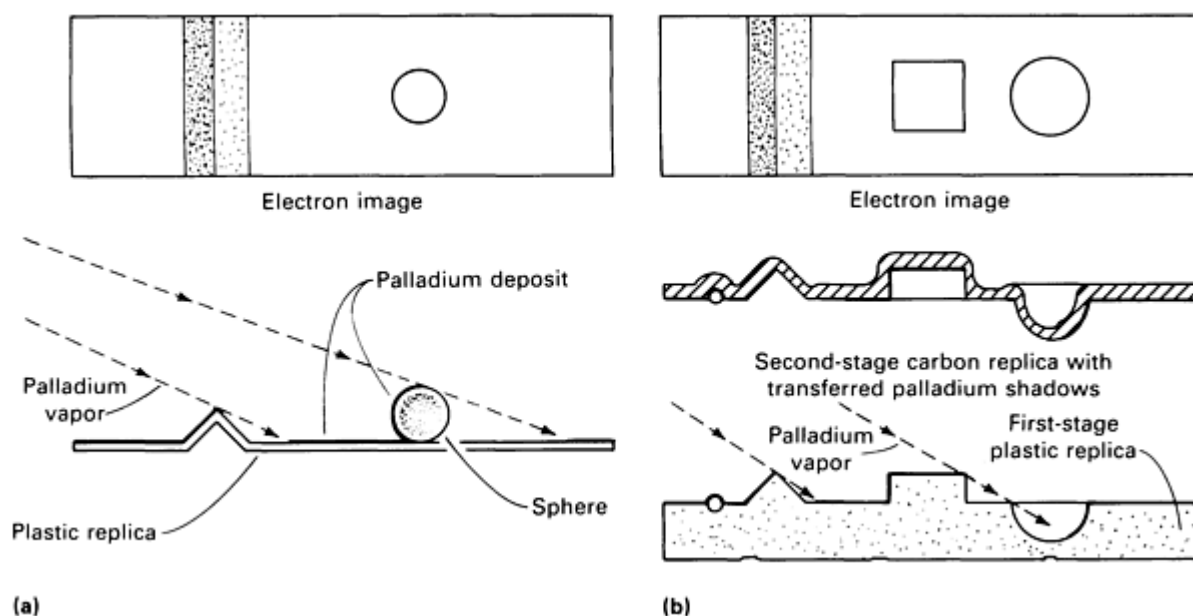
Fig. 5 Shadowing processes for single-stage plastic replicas (a) and two-stage plastic-carbon replicas (b). A sphere of known size can be placed on a replica, as in (a), to calibrate shadow length.

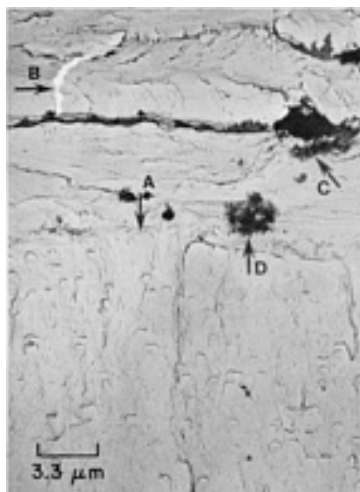
Fig. 6 Four types of artifacts found on two-stage plastic-carbon replicas. The appearance of the bottom half of

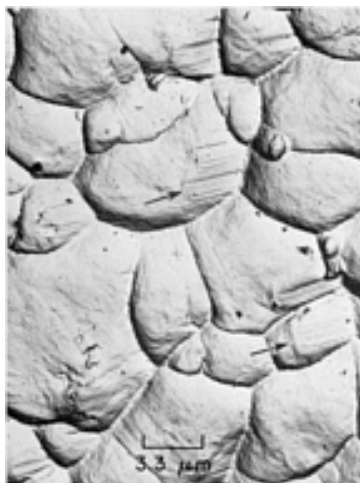
Fig. 7 Scraping artifacts (as at arrows) which resemble linear striations, on the sides of dimples. TEM plastic-carbon replica. 3000×

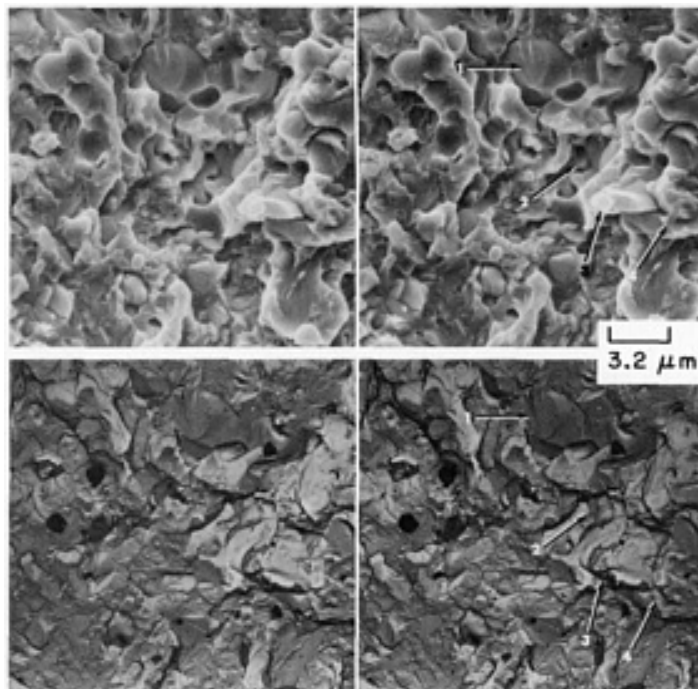
Transmission-Electron-Microscope Fractographs" in Volume 9 of the 8th Edition of *Metals Handbook*. The two stereofractographs of each fracture surface presented in these figures are mounted with the SEM view at the top and the TEM view at the bottom of each set. When viewing in three dimensions, the eyes may be shifted from the SEM fractographs to the TEMs and back at will without losing the three-dimensional appearance. It will be observed that the conformity of contour between the SEM and the TEM pairs is surprisingly close, considering the disparity in appearance between the two types of fractographs. Artifacts in the TEM fractographs will be indicated when present.

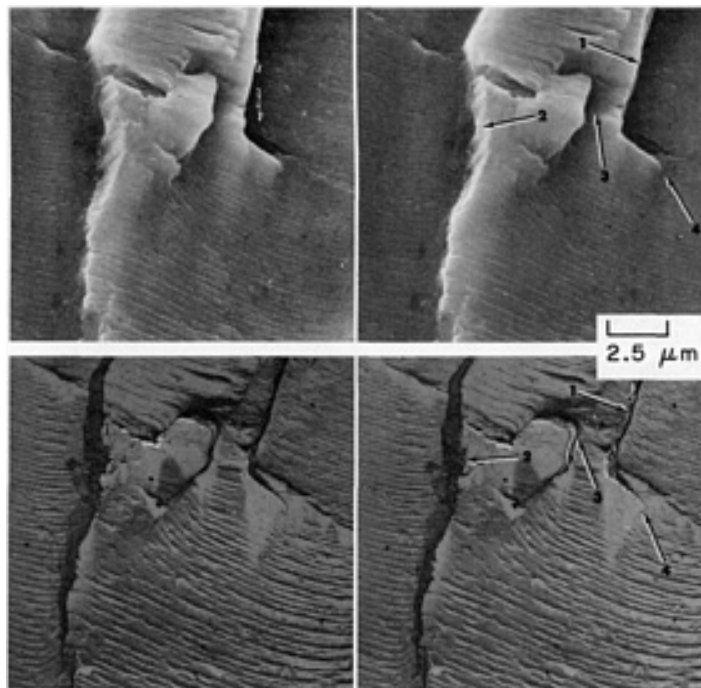
Fig. 11 The first of two sets of views at increasing magnification showing four areas of the surface of a low-cycle fatigue test fractured in aluminum alloy 7075-T6 obtained with a maximum loading of 117 MPa (17 ksi) at 1900 cpm. Fracture occurred at 600,000 cycles. The tensile strength of the material was 586 MPa (85 ksi). In

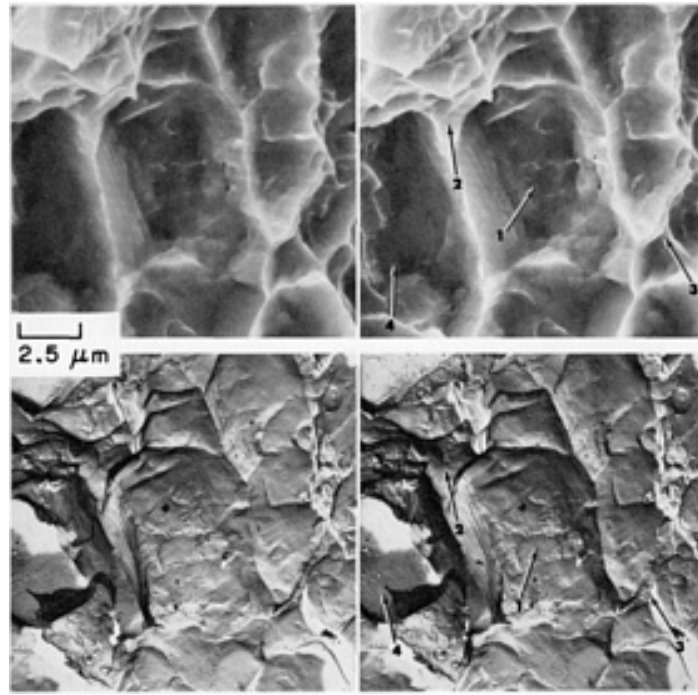
Fig. 16 A more highly magnified set of views of a different area of the surface of the tension overload fracture in annealed Ti-8Al-1Mo-1V alloy shown in Fig. 15. This area shows rather large dimples. For the most part, the topographic agreement between the SEM and TEM pairs is very close, as can be seen by comparing the contours at arrows 1 to 3. Note that the stretch marks on the left side of the cavity at arrow 2 are clearly visible in both pairs. Elsewhere, however, similar marks are largely unresolved in the SEM fractograph. The feature at arrow 4 in the TEM is not a fracture contour but an artifact caused by a bubble entrapped in the plastic replica. The dark regions above and below this artifact are the result of folds in the carbon replica. The SEM fractograph shows the true surface at arrow 4. Fig. 16 (top): SEM stereo pair. Fig. 16 (bottom): TEM stereo pair. Both 4000 \times

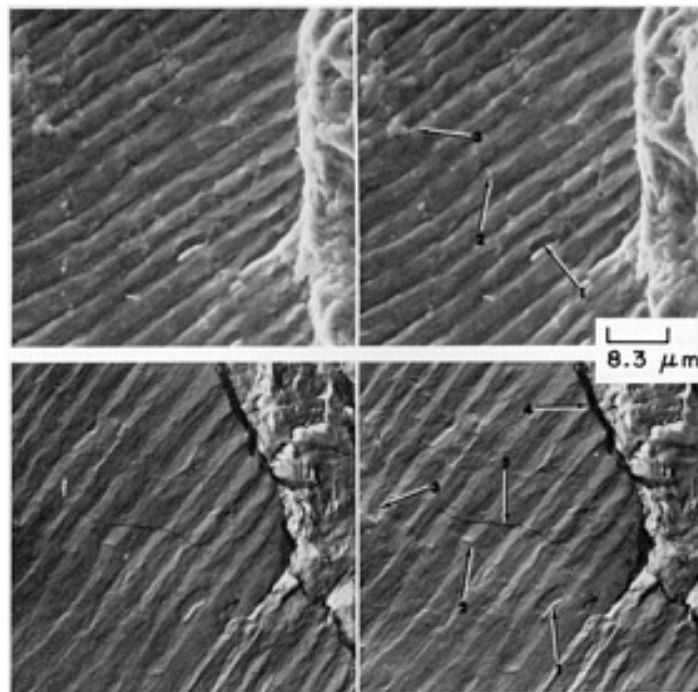
Fig. 17 Surface of high-cycle fatigue fracture produced at room temperature in a specimen of the same annealed Ti-8Al-1Mo-1V alloy shown in Fig. 15 and 16. Shown here is a portion of a fatigue patch with widely spaced well-defined fatigue striations bounded on the right by a high step to the next patch. There is good

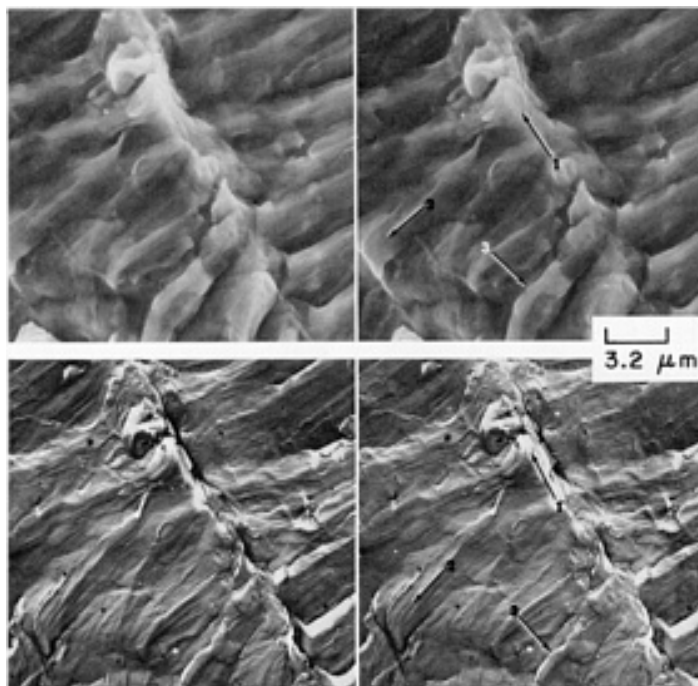
Fig. 18 A more highly magnified set of views of another area of the surface of the high-cycle fatigue fracture in annealed Ti-8Al-1Mo-1V alloy in Fig. 17. These stereo-fractographs show the junction of two adjacent fatigue striation patches that exhibit considerable irregularity in striation orientation in the neighborhood of the step separating the patches. Comparison of the SEM and TEM pairs shows good agreement in registry of contours, as can be seen at arrows 1 to 3. The fine marks along the ridges of the striations are sufficiently pronounced for many to be shown in the SEM fractograph, but others are not resolved there and are shown much more distinctly in the TEM pair. Fig. 18 (top): SEM stereo pair. Fig. 18 (bottom): TEM stereo pair. Both 3100 ×

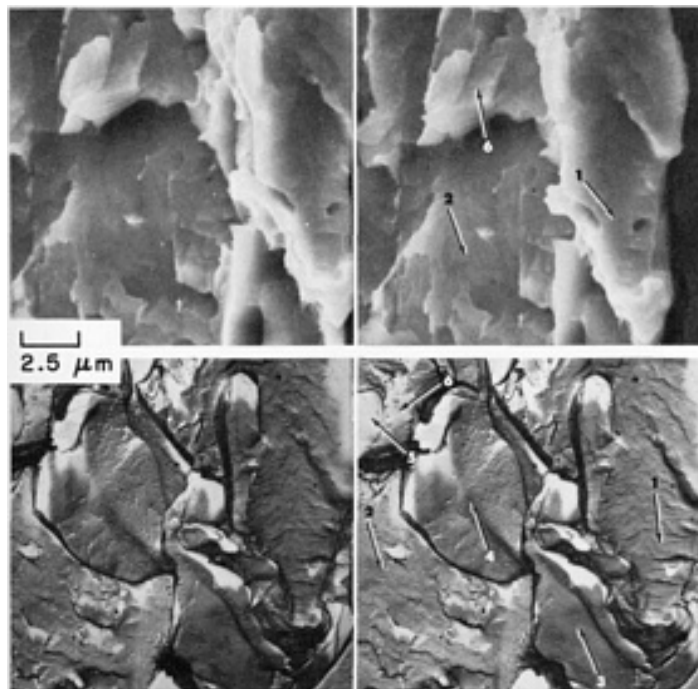
Fig. 20 A higher-magnification set of views in another area of the stress-corrosion fracture of the annealed Ti-

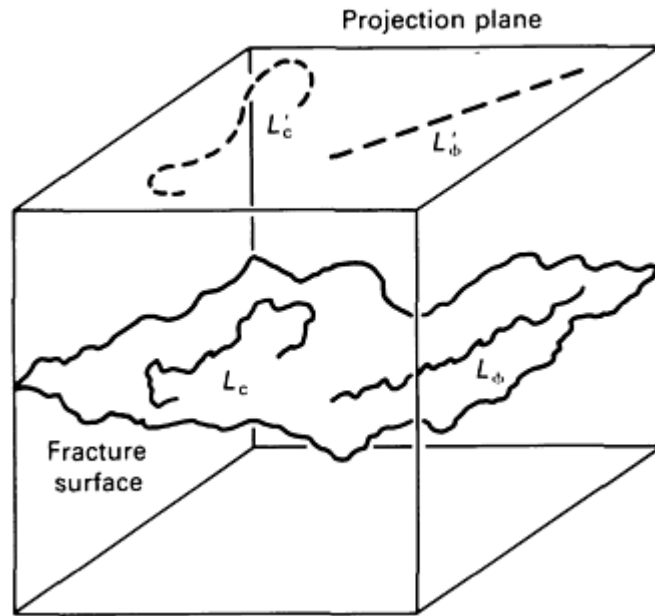
Fig. 3 Relation of curved and straight lines in the projection plane to lines in the fracture surface. $L_c = (4/\pi) \bar{L}$ and $L'_c = (\pi/2) \bar{L} \cdot f$.

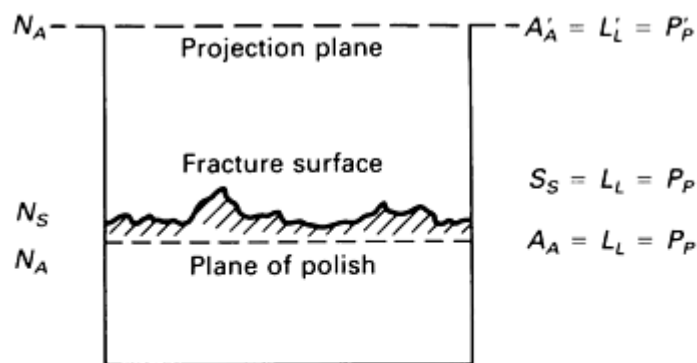
$$N_S = \frac{N'_A}{R_S} \text{ (generally valid)}$$

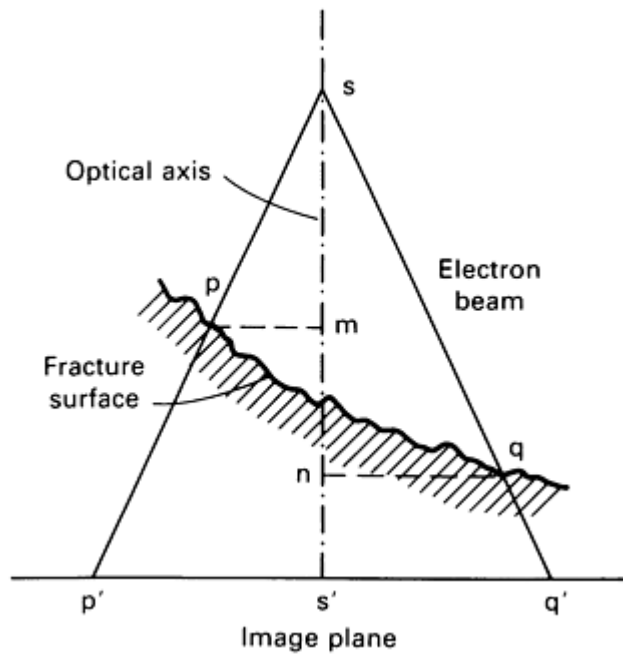
Fig. 5 Geometry of image formation in the scanning electron microscope

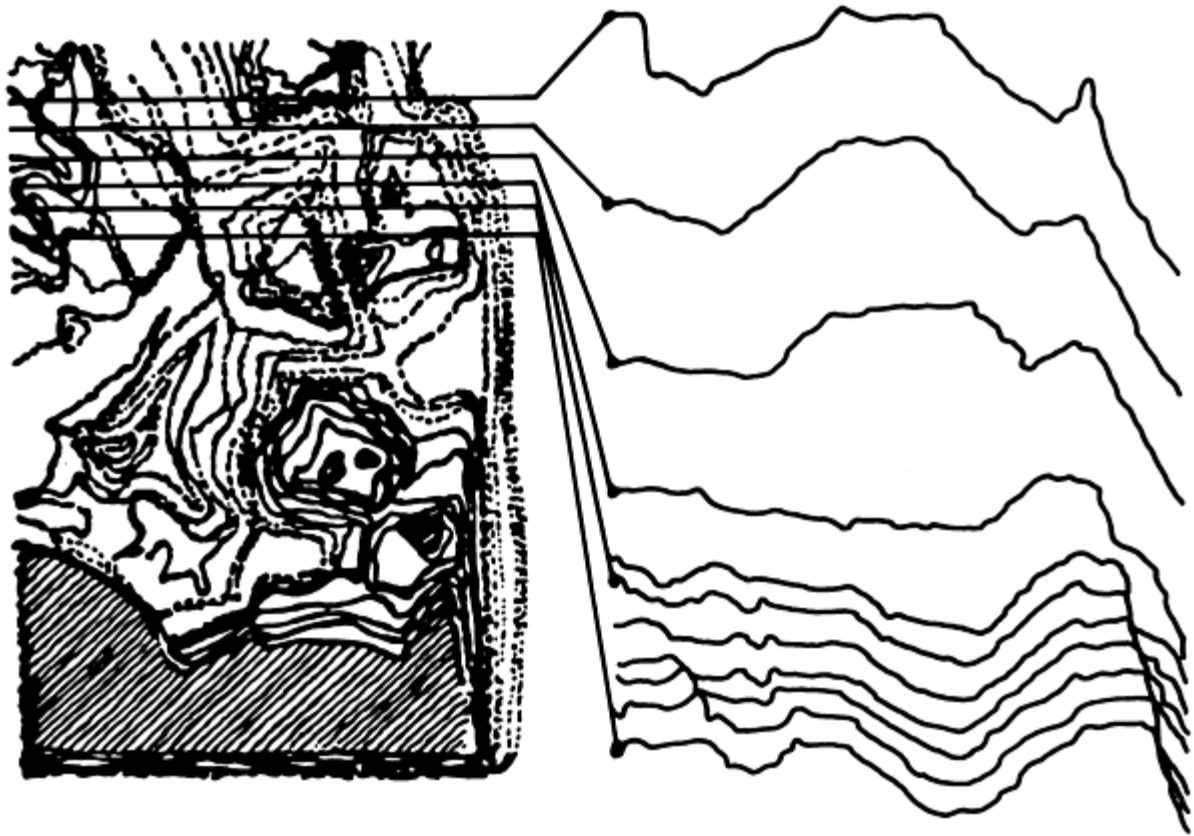
Fig. 7 Contour map and profiles obtained by stereophotogrammetry. Source: Ref 58

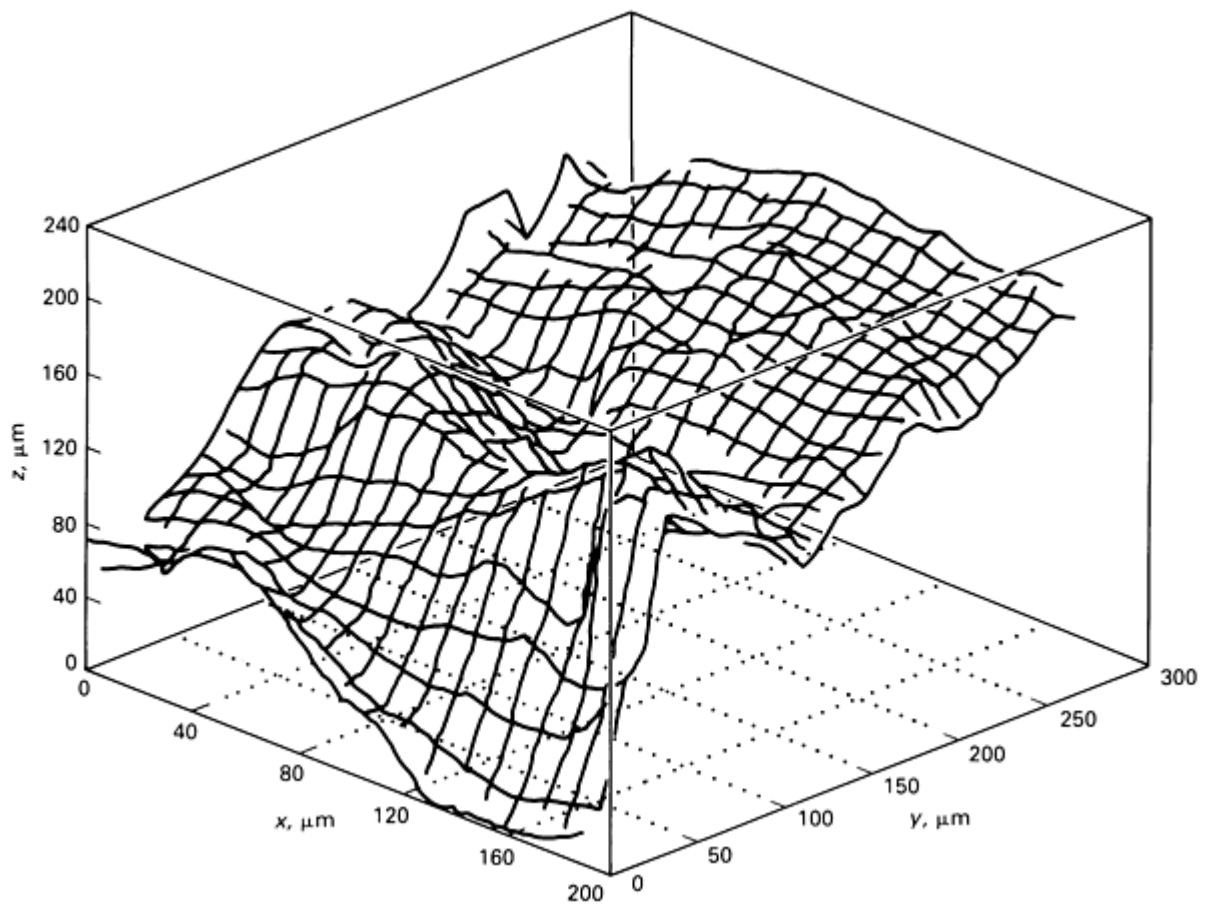
Fig. 8 Fracture surface map (carpet plot) of a Ti-10V-2Fe-3Al specimen by stereophotogrammetry. Source: Ref 57

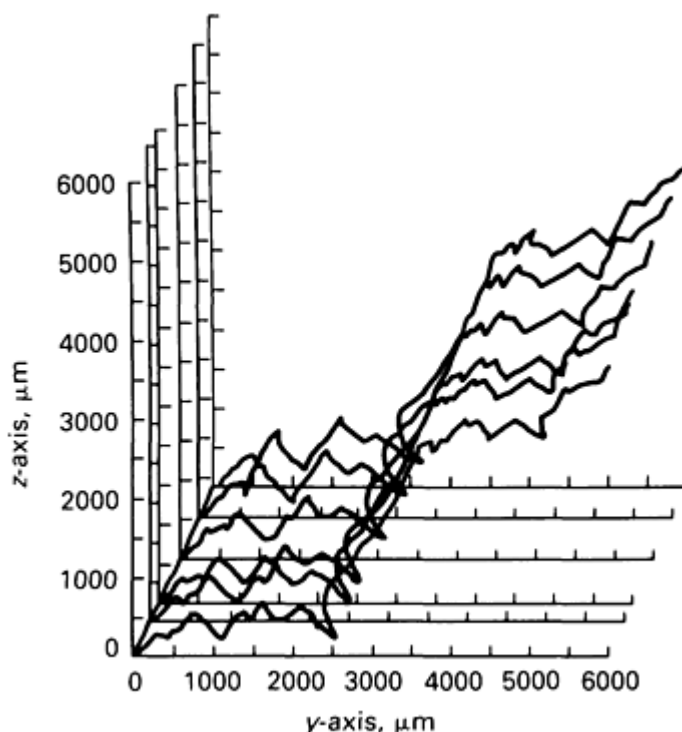
Fig. 9 Profiles obtained by serial sectioning of a fractured Al-4Cu alloy

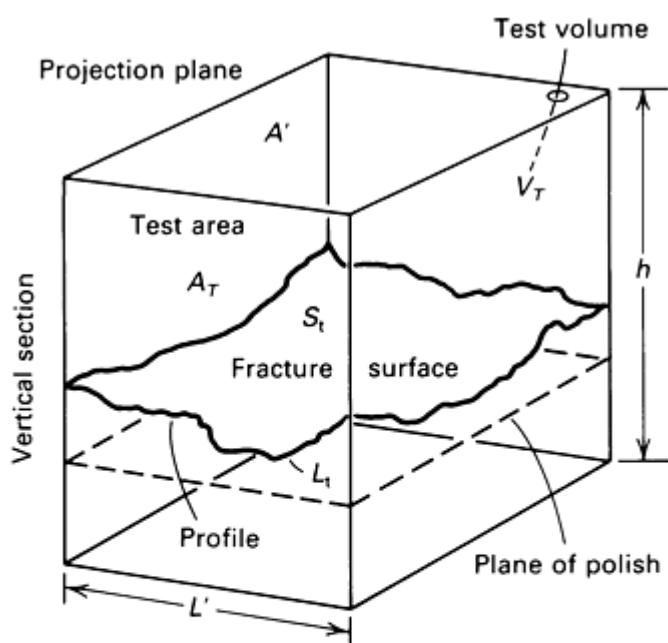
$$\text{Profile roughness parameter, } R_L = \frac{L_t}{L}$$

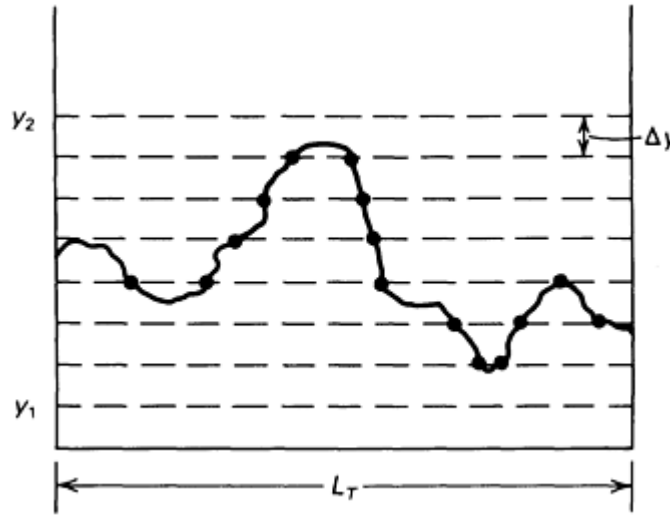
Fig. 11 Profile configuration parameter, R_p , which is the ratio of average peak height to average peak spacing

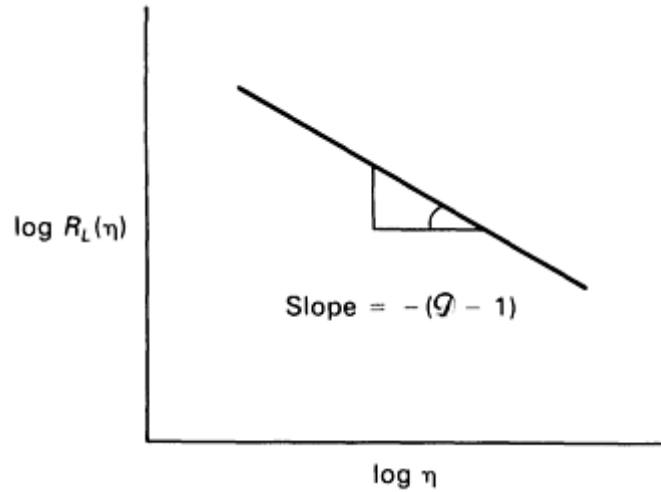
Fig. 12 Fractal dimension D and its relationship to slope of log-log plot of $R_L(\eta)$ versus η

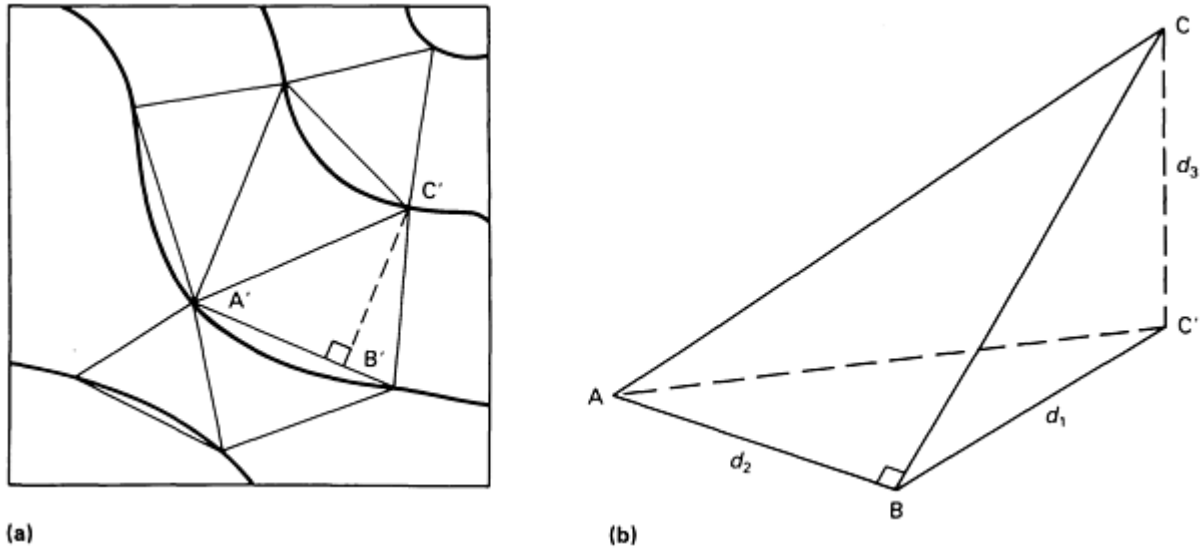
Fig. 13 Representation of a fracture surface with triangular elements between contour lines. (a) Projection of contours and triangles. (b) Three-dimensional view of triangle ABC
