به نام خدا

مرکز دانلود رایگان
مهندسی متالورژی و مواد

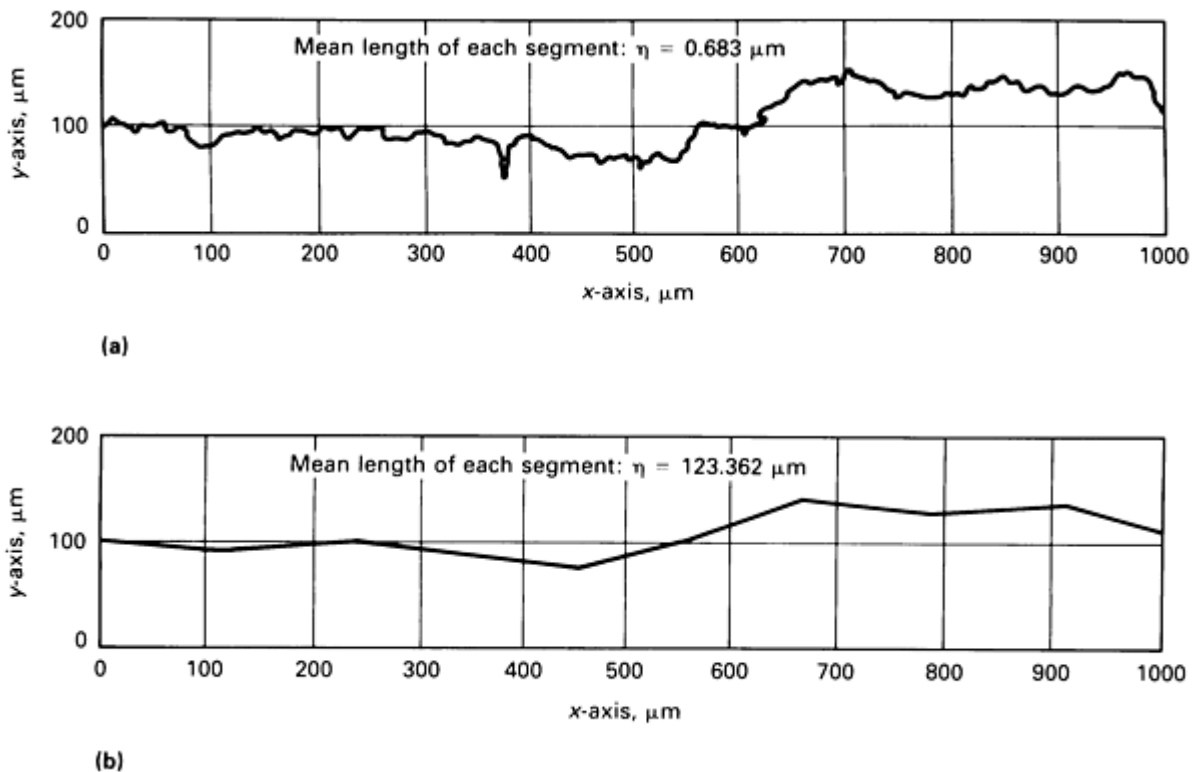
Fig. 14 Profiles for 4340 steel. (a) Dimpled fracture surface. (b) Prototype faceted fracture surface. Compare with Fig. 15

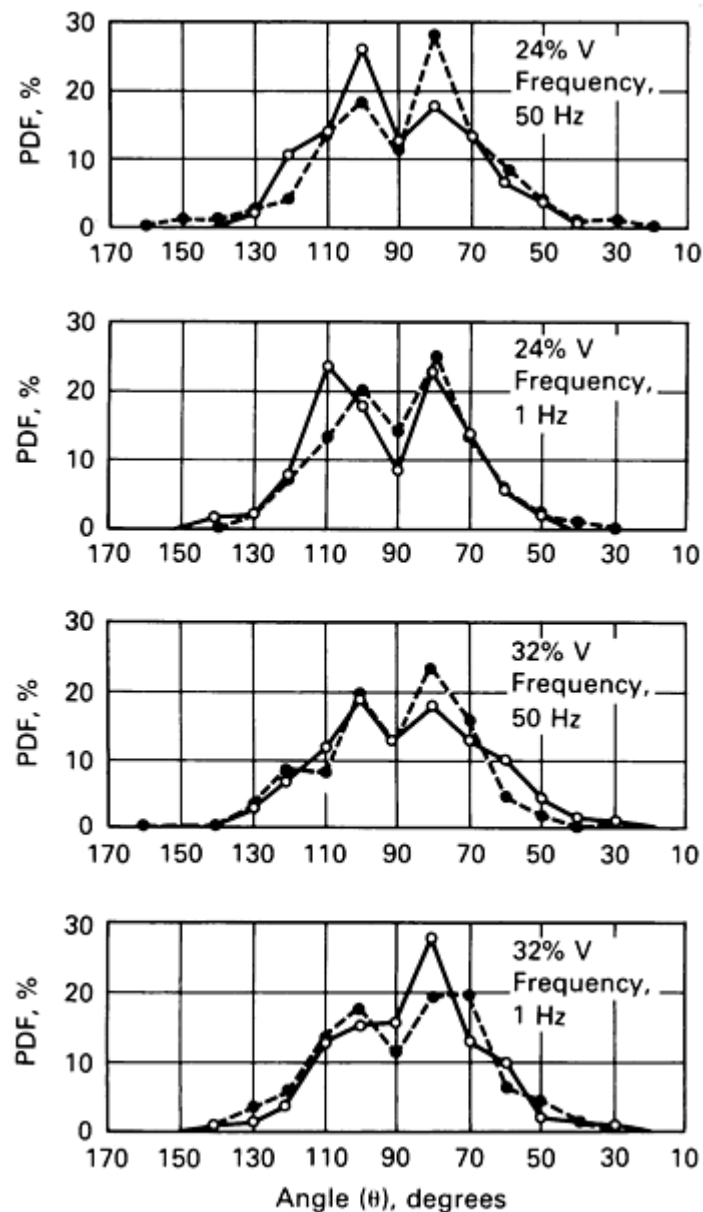
Fig. 16 Experimental angular distribution curves for profiles of Ti-24V and Ti-32V alloys fractured in fatigue. Longitudinal sections made along edge (solid lines) or through center (dashed lines) of compact tensile specimens. Angles measured counterclockwise from horizontal to segment normals

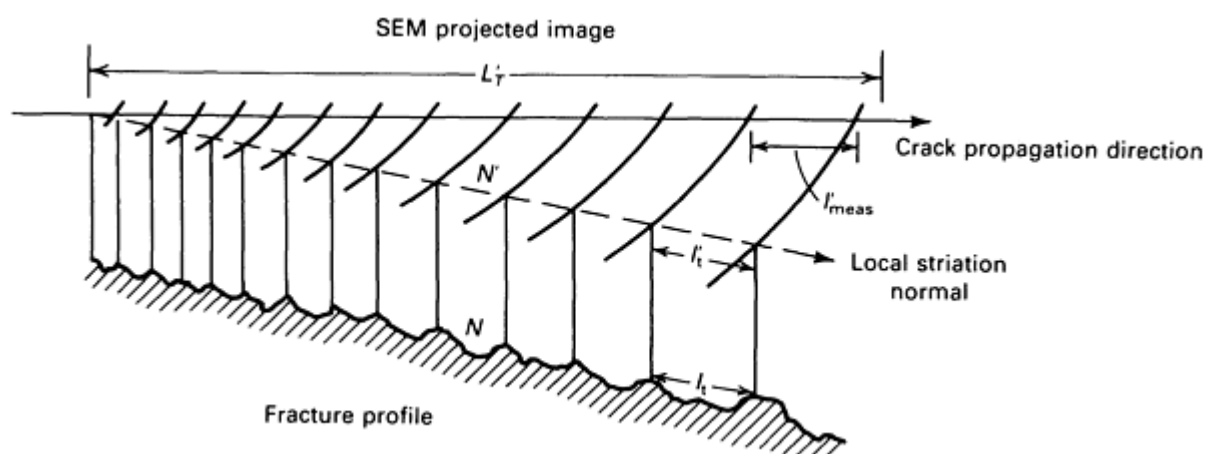
Fig. 18 Relationship of fatigue striation spacings to their projected images. L'_T : test line length; N' : number of striations; l'_t : true striation spacing; l'_{meas} : measured striation spacing in crack propagation direction. Primes indicate quantities in projection planes.

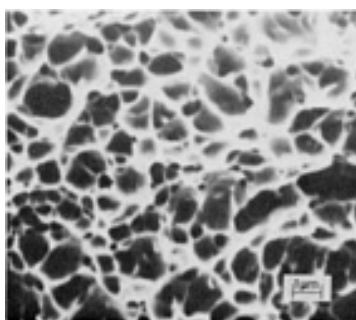
Fig. 20 SEM fractograph of dimples in fractured 4340 steel

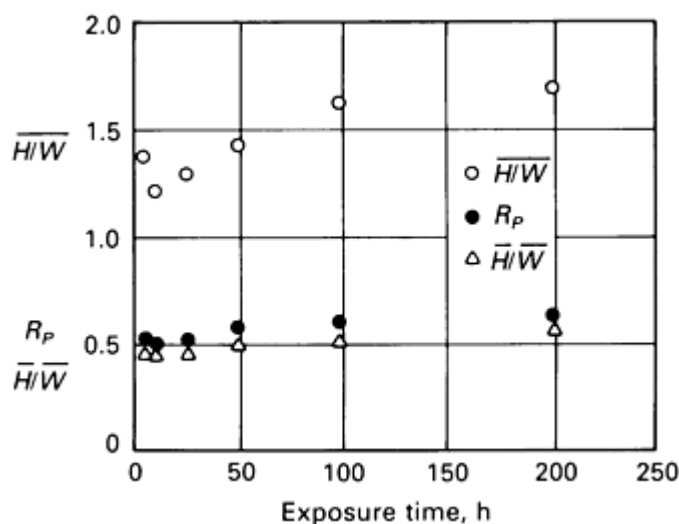
Fig. 21 Height and width measurements of dimples in fractured 4340 steel

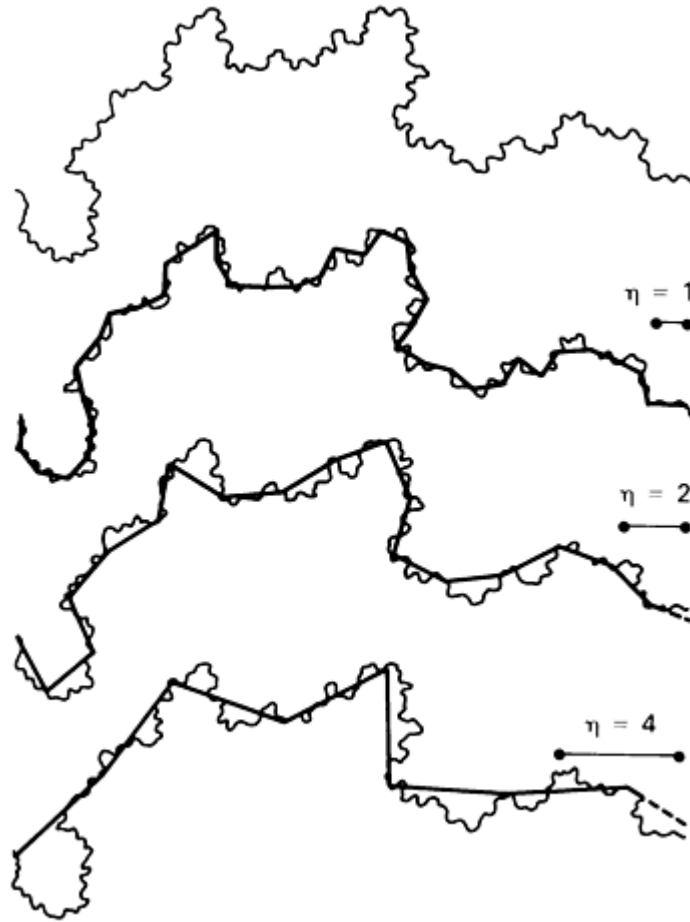
Fig. 1 Interaction of an irregular curve and the measuring unit η . (Ref 12)

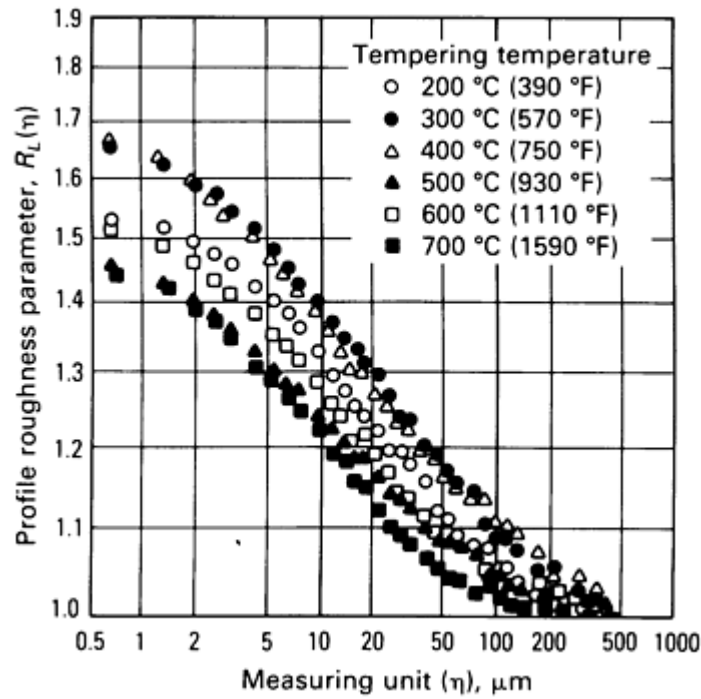
Fig. 3 Fractal plots for AISI 4340 steel specimens tempered at temperatures between 200 and 700 °C (390 and 1290 °F) for 1.5 h and fractured at room temperature showing RSC behavior

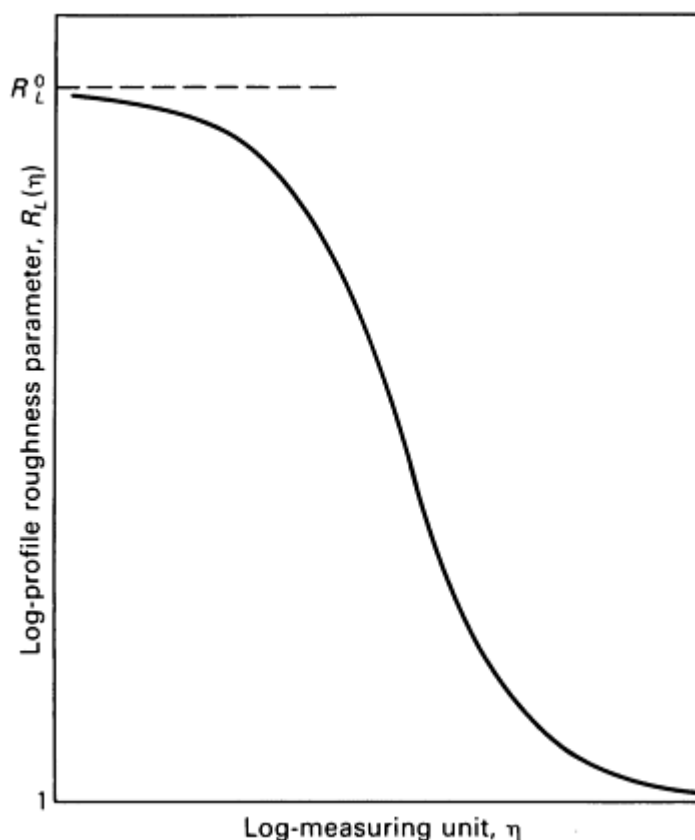
Fig. 4 Upper and lower asymptotic limits to fractal plot showing RSC behavior

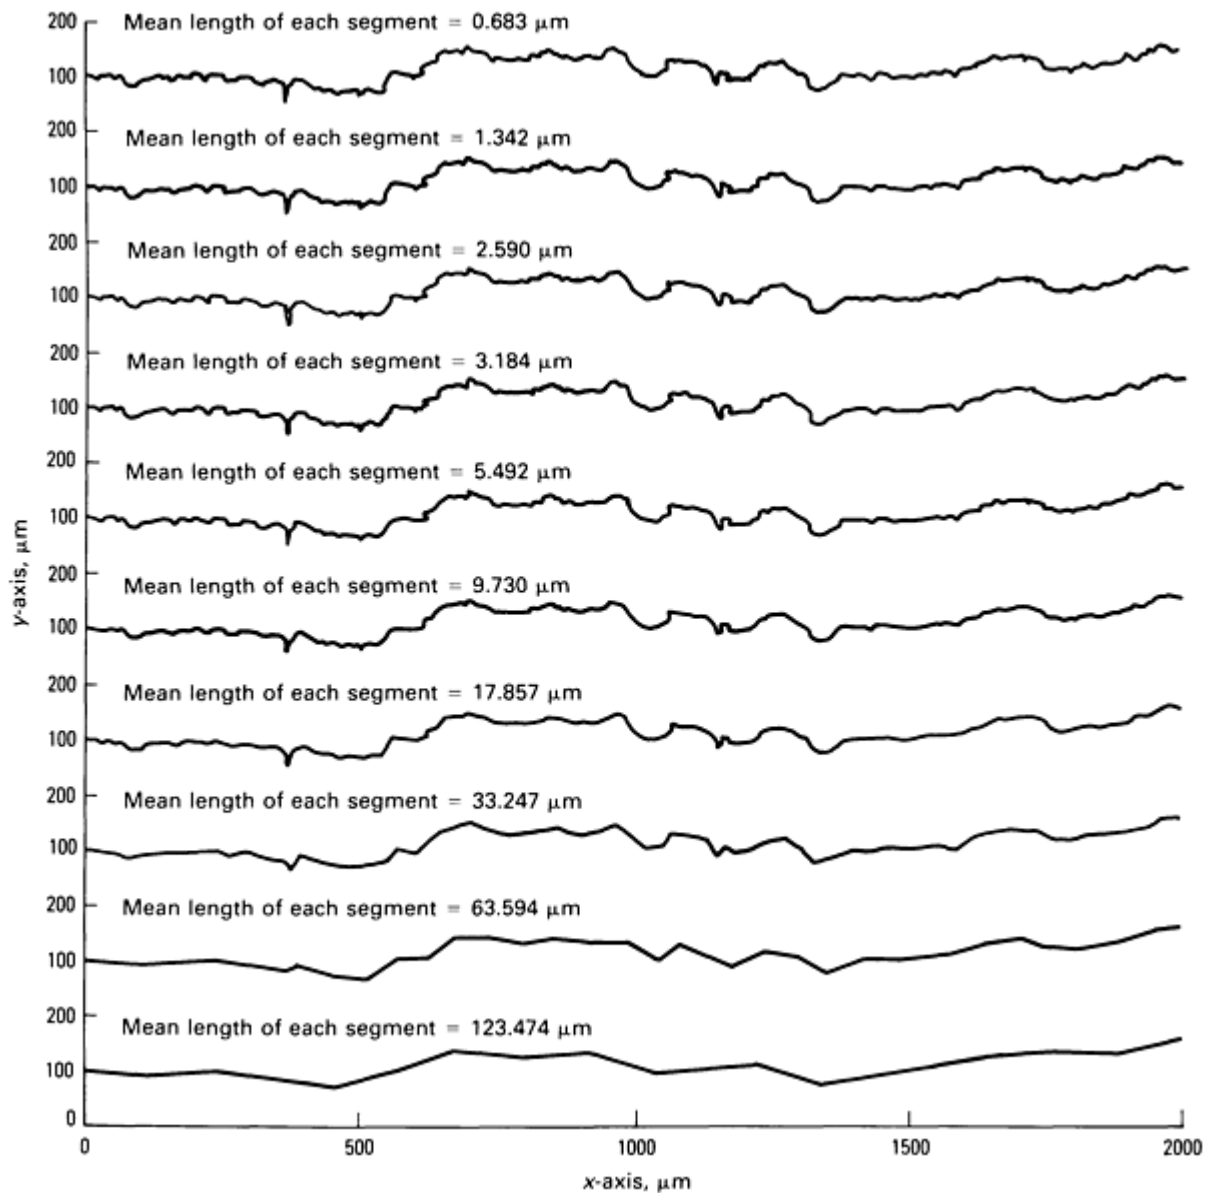
Fig. 5 Fracture profile of AISI 4340 steel specimen plotted with increasing lengths of measuring unit η . The numbers on the curves indicate the value of η .

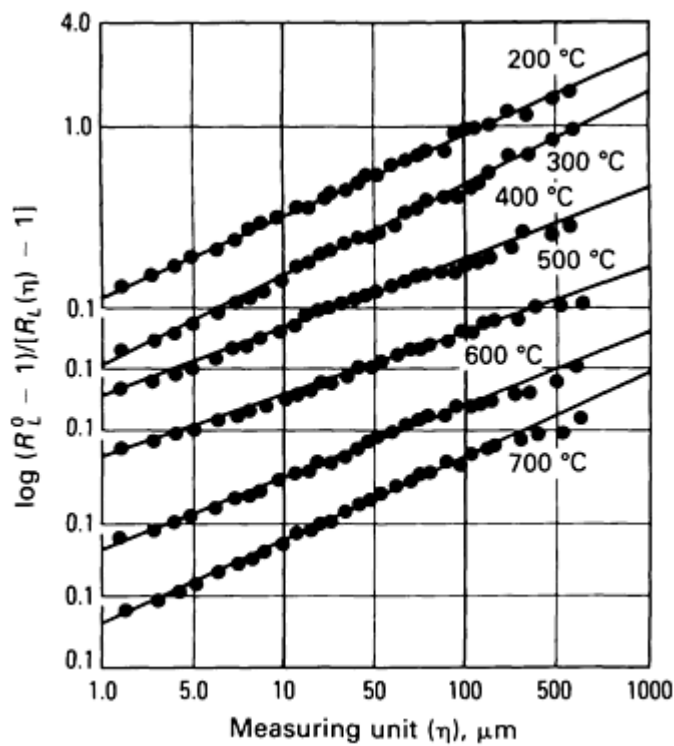
Fig. 6 Linearized RSCs as a function of $R_L(\eta)$ for AISI 4340 steel specimens fractured at room temperature

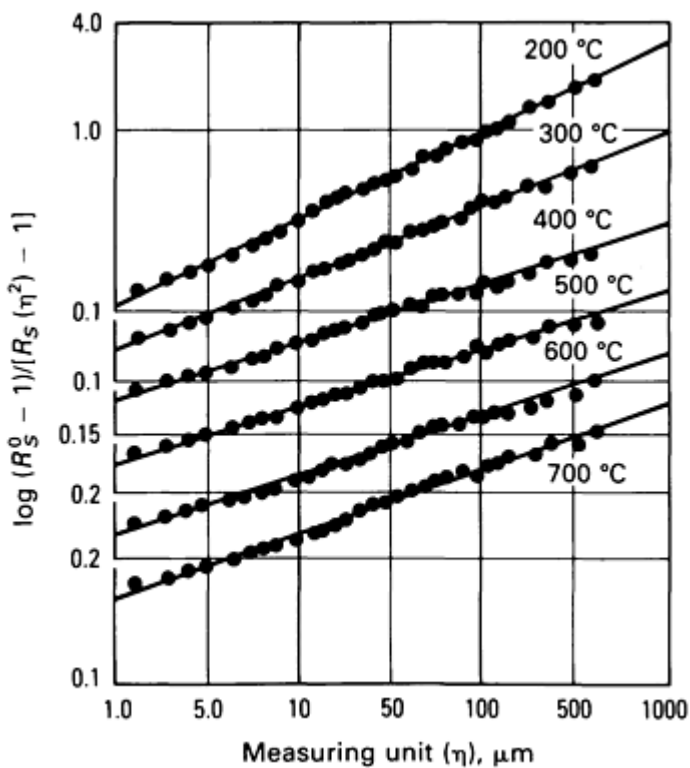
Fig. 7 Linearized RSCs as a function of $R_S(\eta^2)$ for AISI 4340 steel specimens fractured at room temperature

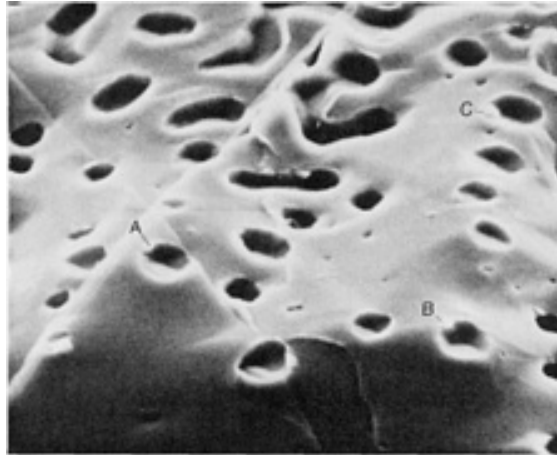
Fig. 1 Grain-boundary cavitation in iron. This is the mechanism by which metals typically fail when subjected to elevated temperatures and low strain rates. Composition, in parts per million: 70 C, 60 S, 54 O, 11 N, 40 P. Rod, 13 mm (0.5 in.) in diameter, was made by vacuum induction melting, chill casting, and swaging. Heat treatment: recrystallize for 30 min at 850 °C (1560 °F), austenitize for 1 h at 1100 °C (2010 °F), air cool. Sample was tensile tested at 700 °C (1290 °F) and an initial strain rate of 1.1×10^{-6} /s. Test was interrupted other 12 h, and the sample was then broken by impact at -100 °C (-150 °F). Fracture surface reveals cavitated grain boundaries. The intergranular cavities nucleated on second-phase (iron sulfide) particles, examples of which are shown at A, B, and C. SEM, 4500 \times (E.P. George and D.P. Pope, University of Pennsylvania)

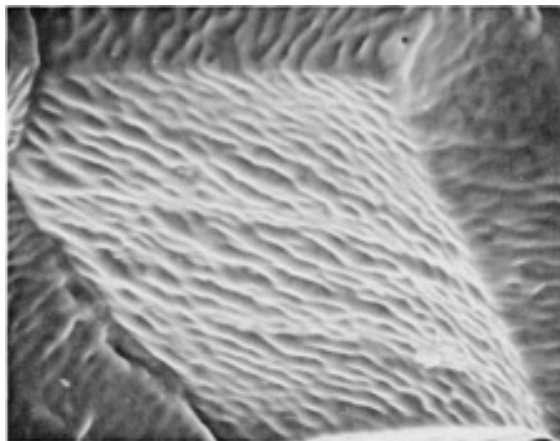
Fig. 2 Slip lines in iron. Composition, in parts per million: 160 C, 40 S, 13 O, 6 N, 30 P. Rod, 13 mm (0.5 in.) in diameter, was made by vacuum induction melting, chill casting, and swaging. Heat treatment: recrystallize for 30 min at 850 °C (1560 °F), austenitize for 1 h at 1100 °C (2010 °F), air cool. Sample was tensile tested to failure at 700 °C (1290 °F) and an initial strain rate of 4.4×10^{-5} /s. Slip lines, smoothed by diffusional flow, are visible on grain boundaries of the elevated-temperature fracture surface. Failure was intergranular and resulted from the nucleation, growth, and eventual coalescence of grain-boundary cavities (see Fig. 1). In this case, however, cavity outlines were masked by the slip steps created on grain boundaries due to severe plastic deformation within the grains. The wavy nature of the slip lines is a characteristic of body-centered cubic iron.

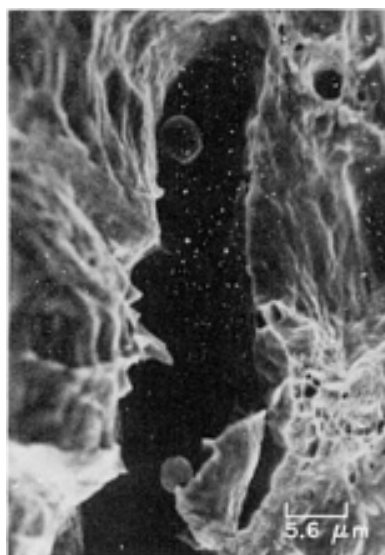
Fig. 4 Surface of a room-temperature tensile-test fracture in a specimen taken from an ingot prepared by adding Fe_2O_3 to pure iron in a vacuum melt equilibrated at $1550\text{ }^{\circ}\text{C}$ ($2820\text{ }^{\circ}\text{F}$) in a silica crucible. The ingot contained 0.07% O in the form of FeO. The fracture surface contains dimples that initiated at globular FeO inclusions averaging $5.2\text{ }\mu\text{m}$ in diameter. SEM, 1800×

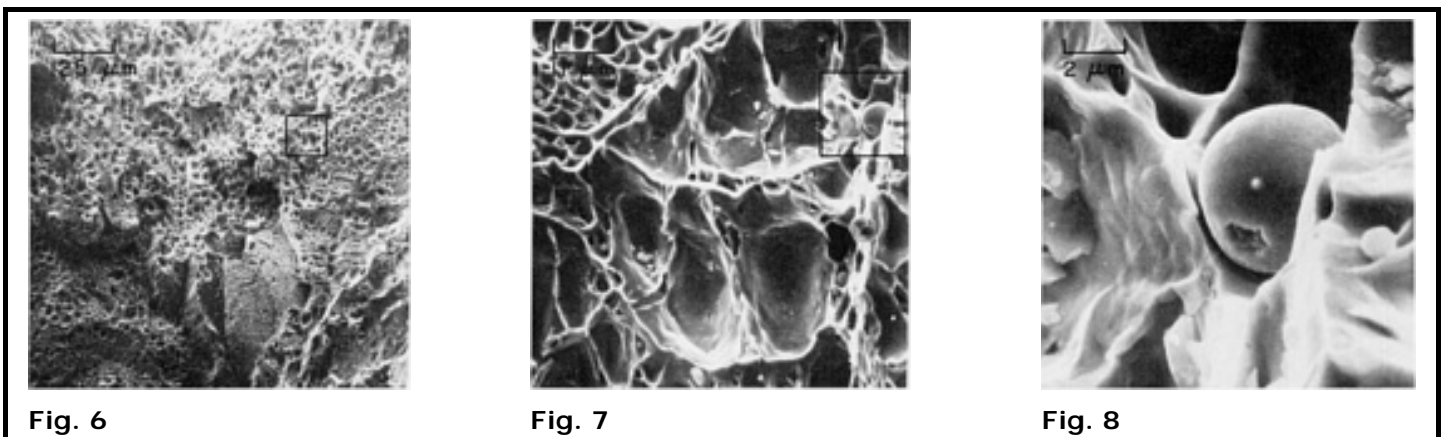
Fig. 6 **Fig. 7** **Fig. 8**

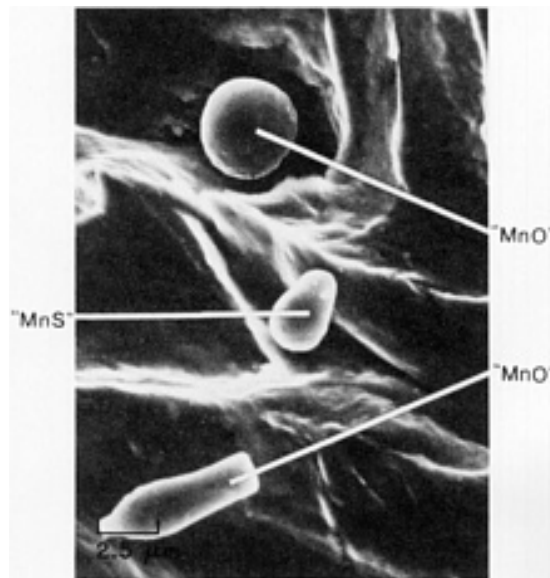
Fig. 12 Higher-magnification view of the same fractured specimen shown in Fig. 11. X-ray fluorescent analysis of the inclusions indicates that some of them are Mn(Fe)O and that others are Mn(Fe)S, but the exact amount of contained iron was not determined. SEM, 4000×

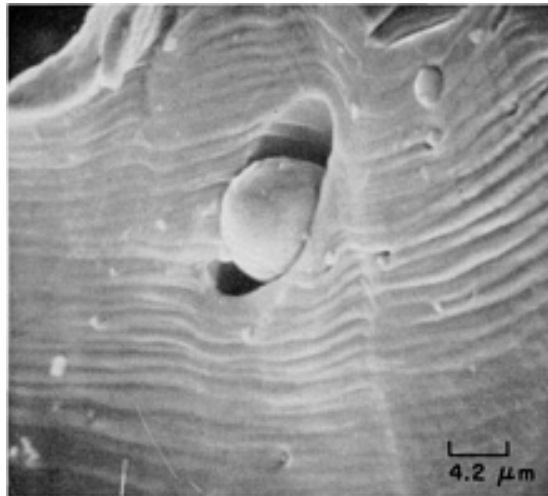
Fig. 13 Low-carbon iron containing a high percentage of oxygen, fractured in fatigue at room temperature. A large oxide inclusion has been nearly completely disengaged from its original pocket. Fatigue striations detour around, or extend into, the pocket. Crack propagation was from bottom to top. SEM, 2400×

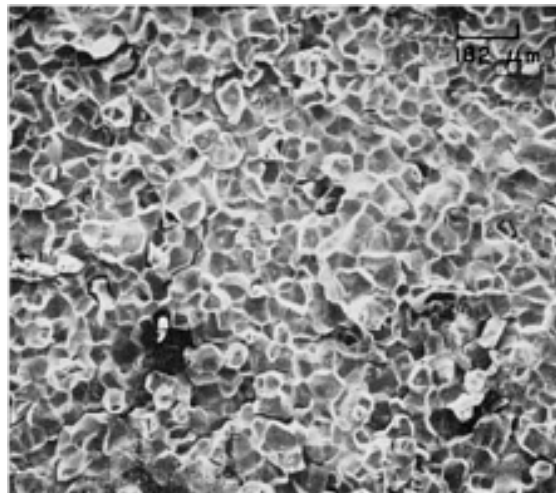
Fig. 14 Intergranular fracture that was generated in a specimen of oxygen-embrittled Armco iron by a Charpy impact test at room temperature. The grain facets appear sharp and clean. Note the secondary cracks, which follow grain boundaries. See also Fig. 15 and 16 for views of other regions of this fracture. SEM, 55×

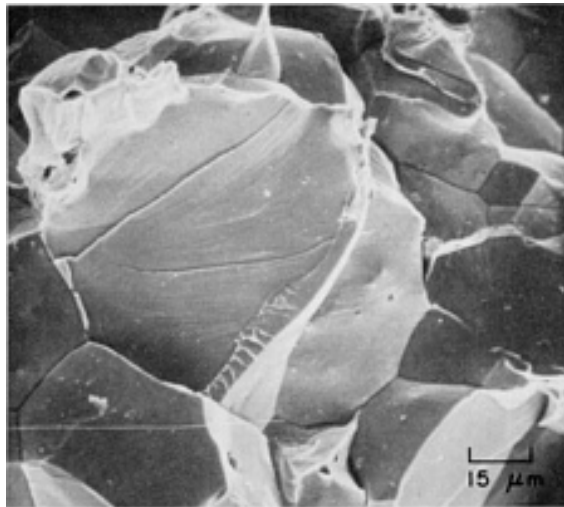
Fig. 15 View of another region of the surface of the impact fracture shown in Fig. 14, showing facets that resulted from a combination of intergranular rupture and transcrystalline cleavage. Note the array of small river patterns at the bottom edge of the large facet at center. See also Fig. 16. SEM, 655 \times

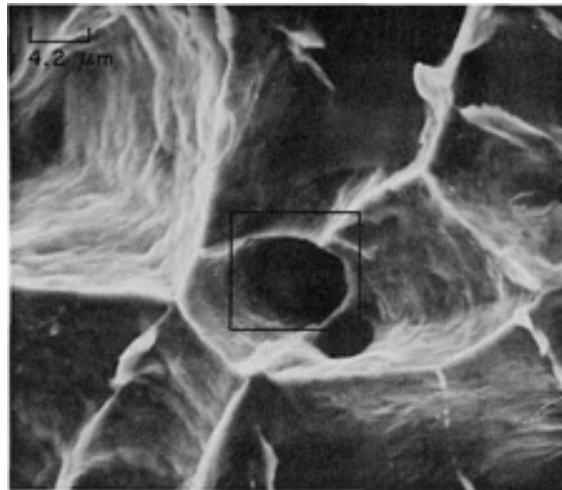
Fig. 18 Enlargement of the area within the rectangle in Fig. 17, showing the surface contours of the dimple cavities of the very ductile fracture. Dimly visible in the central dimple is a globular particle of FeO; the particle is shown more clearly in Fig. 19. SEM, 2400 \times

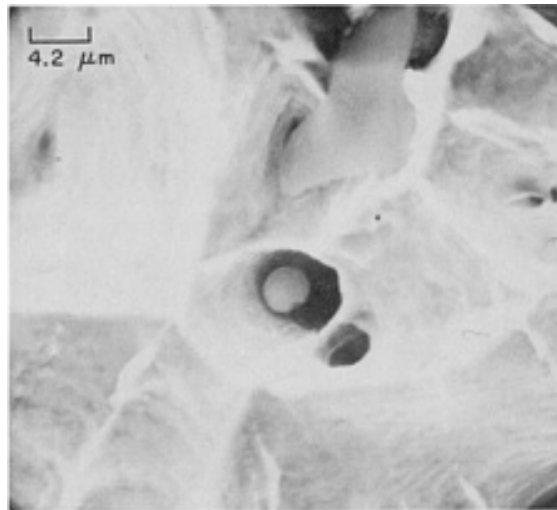
Fig. 19 Same fracture-surface area as that shown in Fig. 18, but processed with a different exposure to bring out the shape and size of the globular particles of FeO in the central dimple. The small dark spot at the lower right on the FeO particle is a shrinkage area. SEM, 2400×

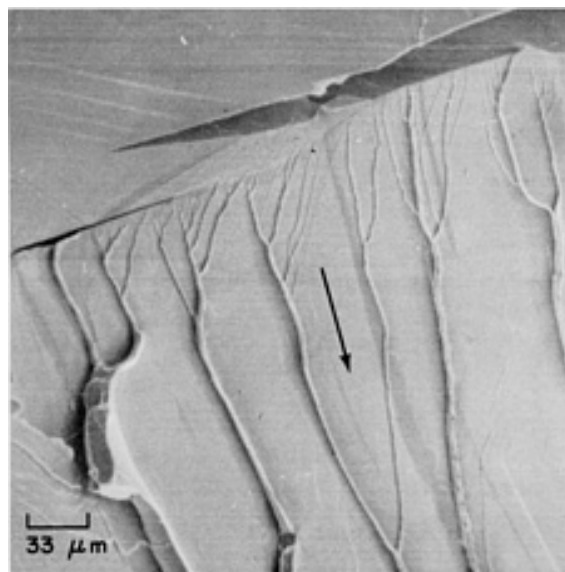
Fig. 20 Fe, 0.01% C, 0.24% Mn, and 0.02% Si, heat treated at 950 °C (1740 °F) $\frac{1}{2}$ h, air cooled. The structure is ferrite. Hardness, 62 HV. The fracture was generated by impact at -196 °C (-321 °F). Cleavage steps beginning at the twin at top form a sharply defined river pattern. Crack propagation was in direction of arrow. SEM, 300×

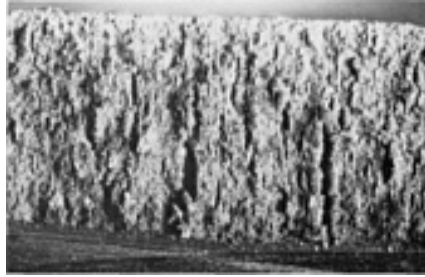
Fig. 22 A companion notch-impact fracture to the one shown in Fig. 21, but here the longitudinal stringers of slag are normal to the fracture surface. Individual particles of slag are not readily visible at this magnification, but they cause the speckled appearance. 6×

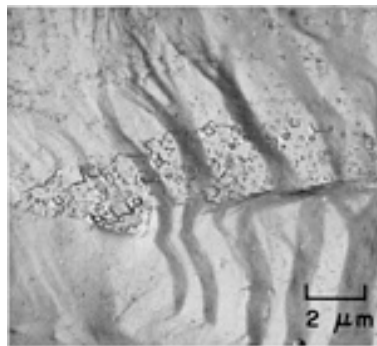
Fig. 23 External surface of a specimen of Armco iron that had been etch-pitted and then subjected to tension during one cycle of a 2.5° bend test. Note the slip steps. See also Fig. 24. TEM p-c replica, 5000×

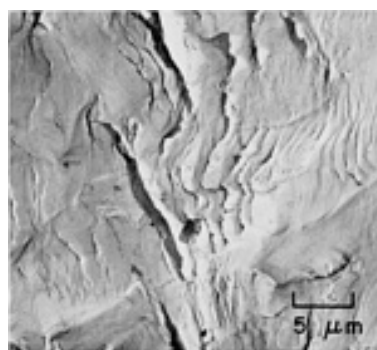
Fig. 24 Same specimen as in Fig. 23 after 5.5 cycles of 2.5° bending. At center is the same area as in Fig. 23 (reversed left to right) showing slip-band cracks that have grown at slip steps. TEM p-c replica, 2000×

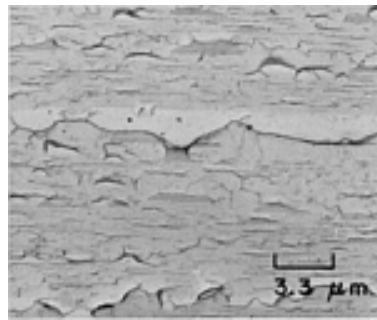
Fig. 26 Cleavage fracture in Armco iron broken at dry-ice temperature (-78.5 °C, or -109.3 °F), showing facets of which most have the same orientation. Facets that depart from the general orientation appear lighter or darker than the majority. TEM direct carbon replica, 3000×

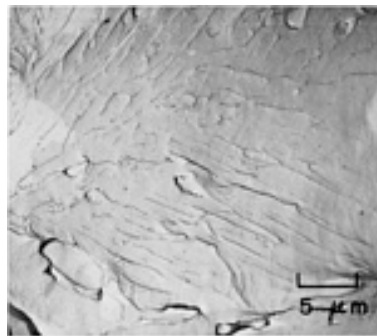
Fig. 27 Cleavage fracture in Armco iron broken at -45 °C (-49 °F). Instead of cleavage steps, tear ridges (occasionally forming river patterns) were produced here by microscopic plastic flow. TEM p-c replica, 2000×

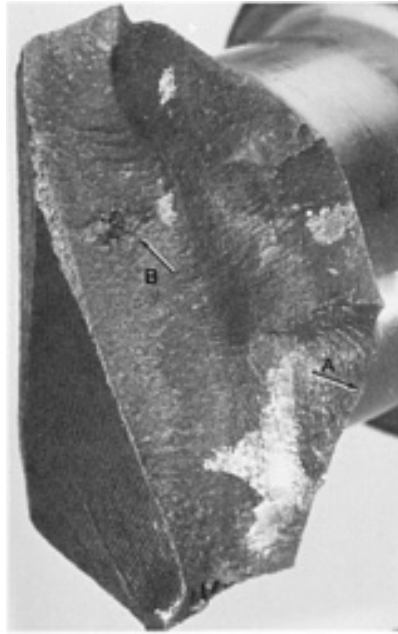
Fig. 41 Surface of a fatigue-test fracture in an experimental crankshaft of induction-hardened 80-60-03 ductile iron with a hardness of 197 to 225 HB. Fatigue-crack origin is at arrow A. Porosity at arrow B was unrelated to fracture initiation. 2.5×

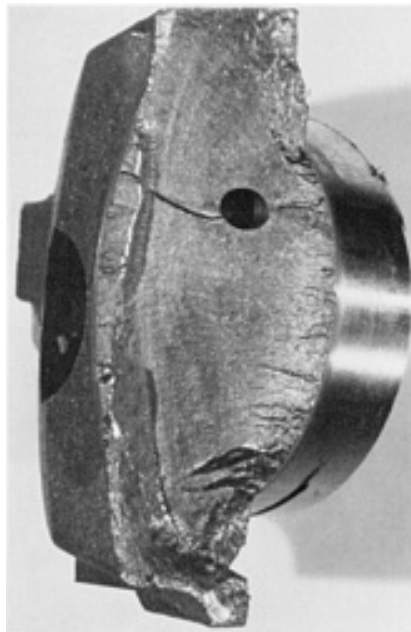
Fig. 42 Surface of a fatigue-test fracture in an experimental crankshaft of ductile-iron with a hardness of 241 to 255 HB. Note the multiple fatigue-crack origins at the journal edge (at right). Fatigue beach marks are evident, which is unusual in cast iron. Actual size

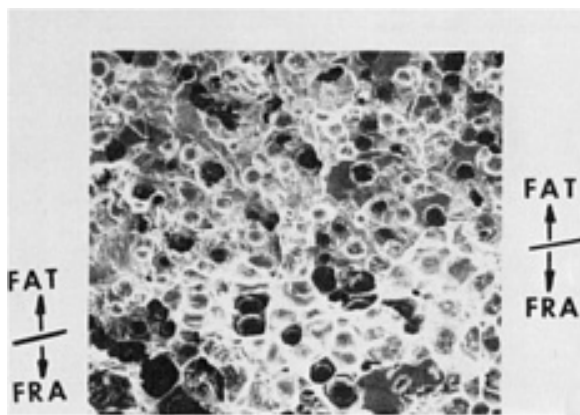
Fatigue fracture surfaces of pearlitic and ferritic ductile irons. Compositions of pearlitic irons: 3.63 to 3.80% C, 0.34% Mn, 2.02 to 2.66% Si. Compositions of ferritic iron: 3.75 to 2.82% C, 0.34% Mn, 2.30 to 2.66% Si. Striations noted in all cases. Fig. 47 and 48: Mixture of striations and fractured pearlite lamellae on fracture surfaces of commercial pearlitic ductile irons. Striations are the fine steplike features, not the macroscopic waviness or undulations. SEM, 207 \times and 198 \times . Fig. 49: A high load fatigue fracture surface of a ferritic ductile iron. SEM, 375 \times (F.J. Worzala, University of Wisconsin)

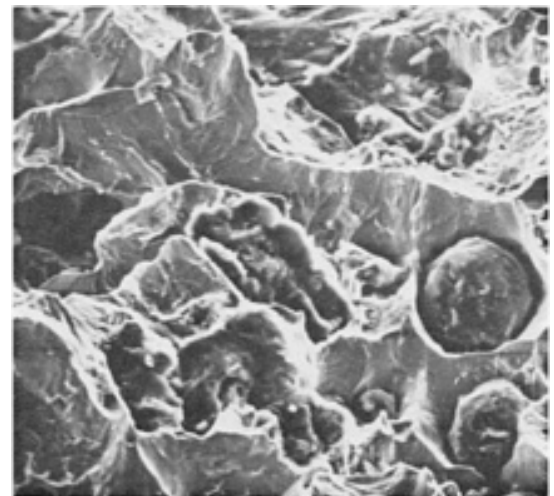
Fracture modes in slow monotonic loading (tension or bending) of ferritic ductile irons. The only

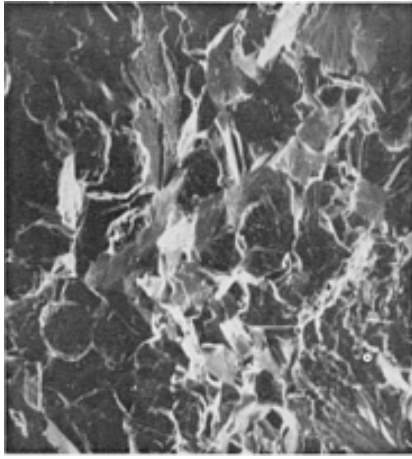
modes operative at ambient temperature are ductile tearing and microvoid coalescence. The propagating crack will cut through any "lumps" of nonspheroidal graphite that may be present. Fig. 60: Fracture surface of ferritic ductile iron subjected to slow monotonic loading is characterized by ductile tearing and microvoid coalescence. Internodular ferrite undergoes a substantial amount of deformation. SEM, 300×. Fig. 61: Fracture surface of ferritic ductile iron with nonspheroidal graphite shows how crack cuts through the irregularly shaped graphite lumps while leaving graphite nodules intact. SEM, 534× (F.J. Worzala, University of Wisconsin)

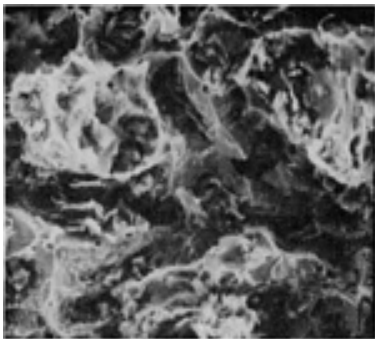
Fracture modes in impact (fast monotonic) loading of a ferritic ductile iron tested at $-45\text{ }^{\circ}\text{C}$ ($-50\text{ }^{\circ}\text{F}$). Fig. 68: Fracture surface reveals little deformation with no stretching around graphite nodules. Several nodules appear to have been broken. Also, the matrix failed in an entirely brittle mode, as evidenced by the numerous river patterns and cleavage and quasi-cleavage steps. Compare with the slow monotonic (tension or bending) fracture in Fig. 62. Although they generally resemble each other, the fast fracture exhibits no graphite cavity stretching or microvoids, and nodules remain intact in the slow fracture. SEM, $220\times$. Fig. 69: Internodular area of impact-loaded specimen in Fig. 68. Fracture in this region was entirely brittle. Microtongues lie on the iron $\{112\}$ plane and intersect the cleavage

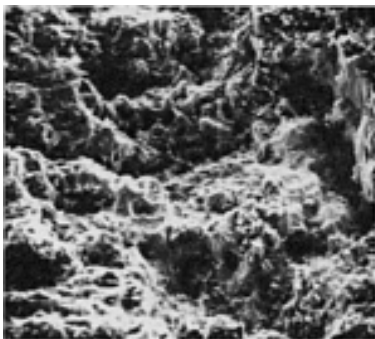
Presence of nonspheroidal graphite affects impact fracture of ductile irons by producing a rough fracture surface with continuous change in crack path direction even at low test temperatures. Fig. 70: Fracture surface of ferritic ductile iron tested at $-18\text{ }^{\circ}\text{C}$ ($0\text{ }^{\circ}\text{F}$). SEM, $240\times$. Fig. 71: Fracture surface of pearlitic ductile iron impact tested at $-75\text{ }^{\circ}\text{C}$ ($-100\text{ }^{\circ}\text{F}$). SEM, $100\times$ (F.J. Worzala, University of Wisconsin)

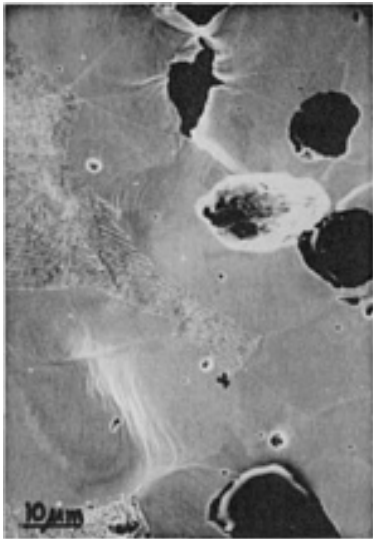
at low temperature. SEM, 1600× (R.C. Voigt and L.M. Eldoky, University of Kansas)

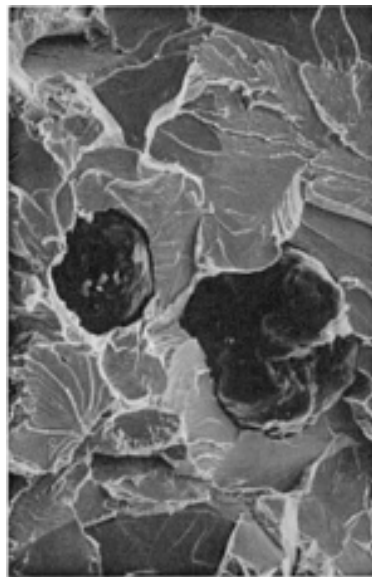
Fig. 87 Fracture surface of ferritic-pearlite ductile iron in Fig. 85 and 86. The low-temperature fracture occurred via a brittle, quasi-cleavage mode. SEM, 715× (R.C. Voigt and L.M. Eldoky, University of Kansas)

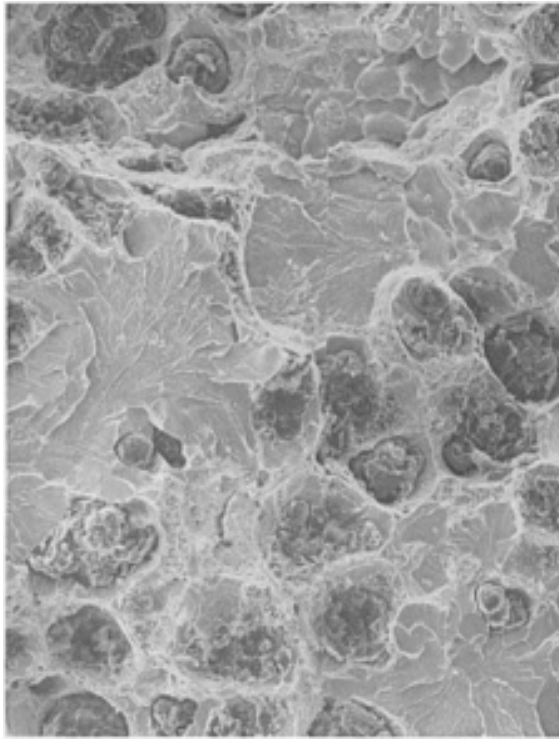
Fig. 92 Fracture surface of a ferritic-pearlitic ductile iron. Note ductile fracture of ferrite in matrix around nodules and cleavage (brittle) fracture of pearlite in matrix. SEM, 50 \times (W.L. Bradley, Texas A&M University)

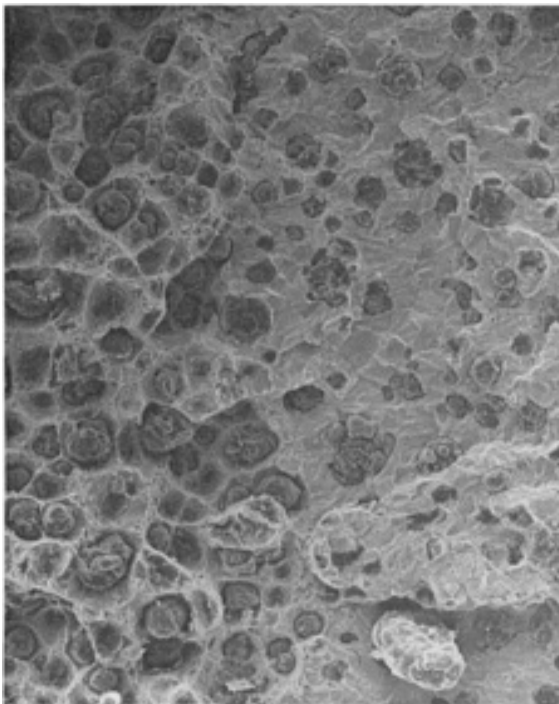
Fig. 93 Regions of fatigue precracking (at right) and crack extension or fracture (at left) in the fracture surface of a ferritic ductile iron compact tension specimen. Note how crack ignores nodules in fatigue and grows almost exclusively through nodule-nucleated voids during ductile fracture. $\sim 80\times$ (W.L. Bradley, Texas A&M University)

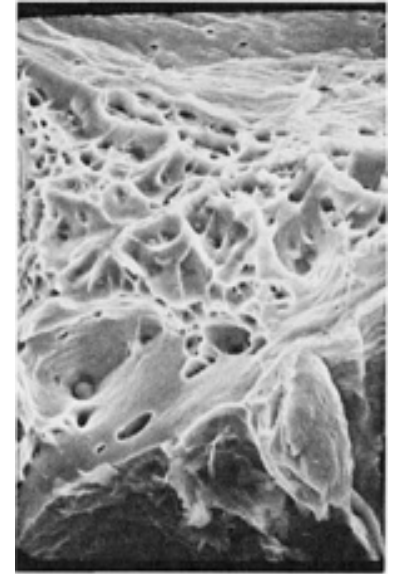
Ductile fracture in ferritic ductile iron. Fig. 94: SEM, 160 \times . Fig. 95: Example of the finely dimpled ductile fracture that occurs between the much larger voids nucleated at graphite nodules. SEM, 2000 \times

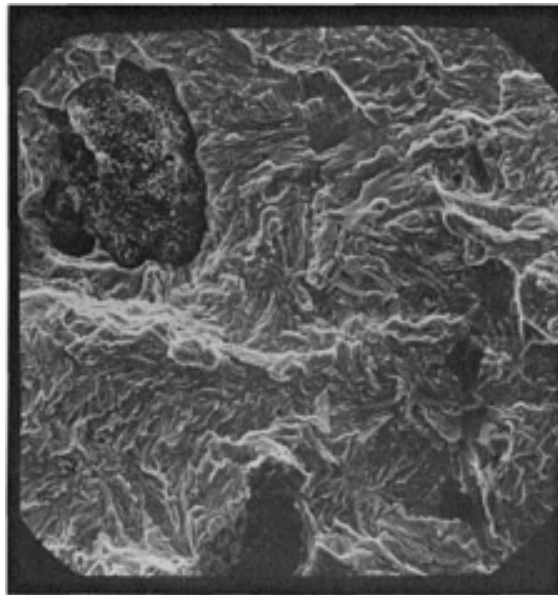
Fig. 96 Fatigue precracked region on the fracture surface of a ferritic ductile iron compact tension specimen. Morphology is typical of fatigue fractures in this material. SEM, 500 \times (W.L. Bradley, Texas A&M University)

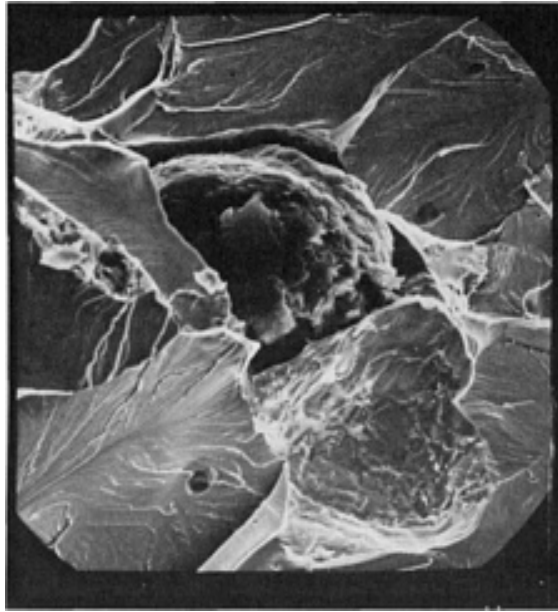
Fig. 97 Brittle cleavage fracture in ferritic ductile iron. SEM, 1000× (W.L. Bradley, Texas A&M University)

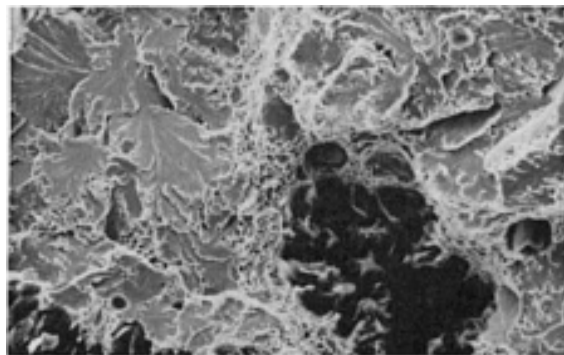
Fig. 103 Fracture surface of ferritic malleable iron after impact loading at -196 °C (-320 °F). Same material as in Fig. 98, 99, 100, 101, and 102. Regions of dimpled rupture can still be observed even at this low temperature. Primary fracture mode is brittle quasi-cleavage. SEM, 830× (R.C. Voigt and B. Poursaidian, University of Kansas)

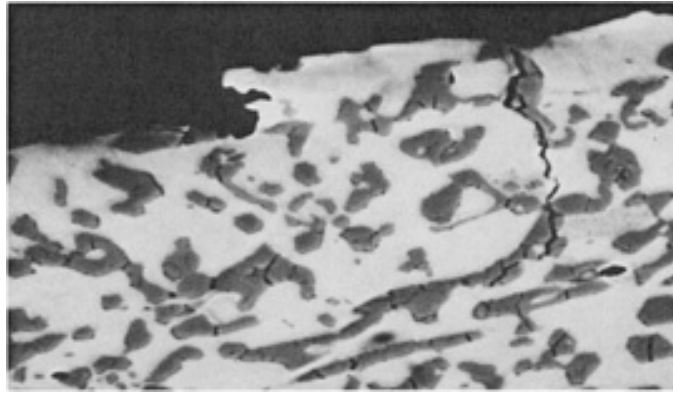
plastic deformation and microcracking ahead of the primary crack front. SEM, 150×. Fig. 105: Microcracking occurring between adjacent temper carbon sites. Also note small microcracks through sulfide inclusions. SEM, 1,150×. (R.C. Voigt and B. Poursaidian, University of Kansas)

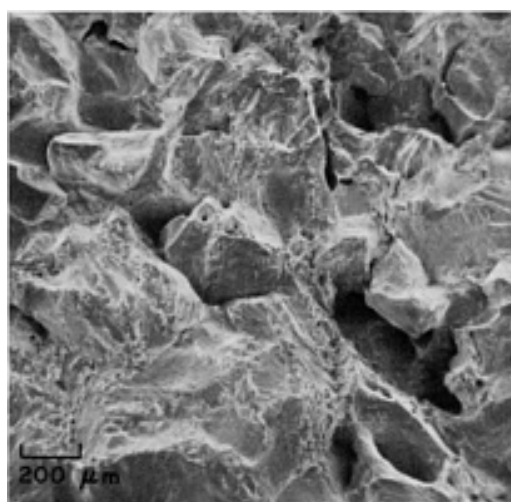
Fig. 111 Fracture in low-carbon steel containing 0.065% C, 0.52% Mn, 0.01% P, 0.022% S, and 0.076% Si (Mn:S ratio, 23.6:1). The specimen was "sensitized," and broken in tension, as described for Fig. 110. Under these conditions, a low Mn:S ratio would result in a completely intergranular fracture. However, because of the intermediate ratio here (23.6:1), the grain-boundary facets show dimples in many areas, indicating ductility.

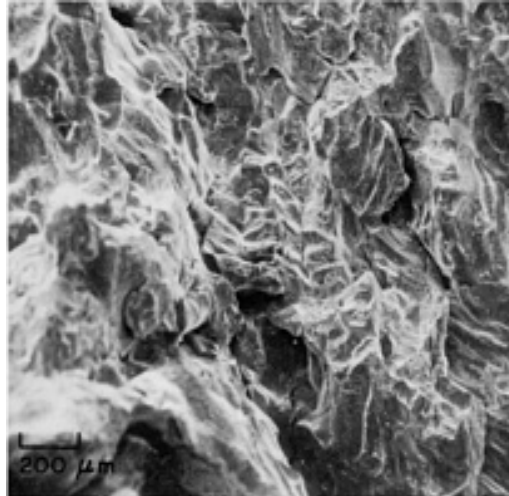
Fig. 112 Surface of fracture obtained in test bar of low-carbon steel containing 0.041% C, 0.62% Mn, 0.008% P, 0.028% S, and 0.032% Si (Mn:S ratio, 22.1:1). The test bar was remelted in its central zone in a Gleeble test unit, solidifying *in situ* in its quartz sleeve. Following controlled cooling from the freezing point, the test bar was pulled in tension at 925 °C (1700 °F). Although the path of this fracture was largely intergranular, there is also transgranular cleavage, and some facets show very fine dimples. SEM, 50×

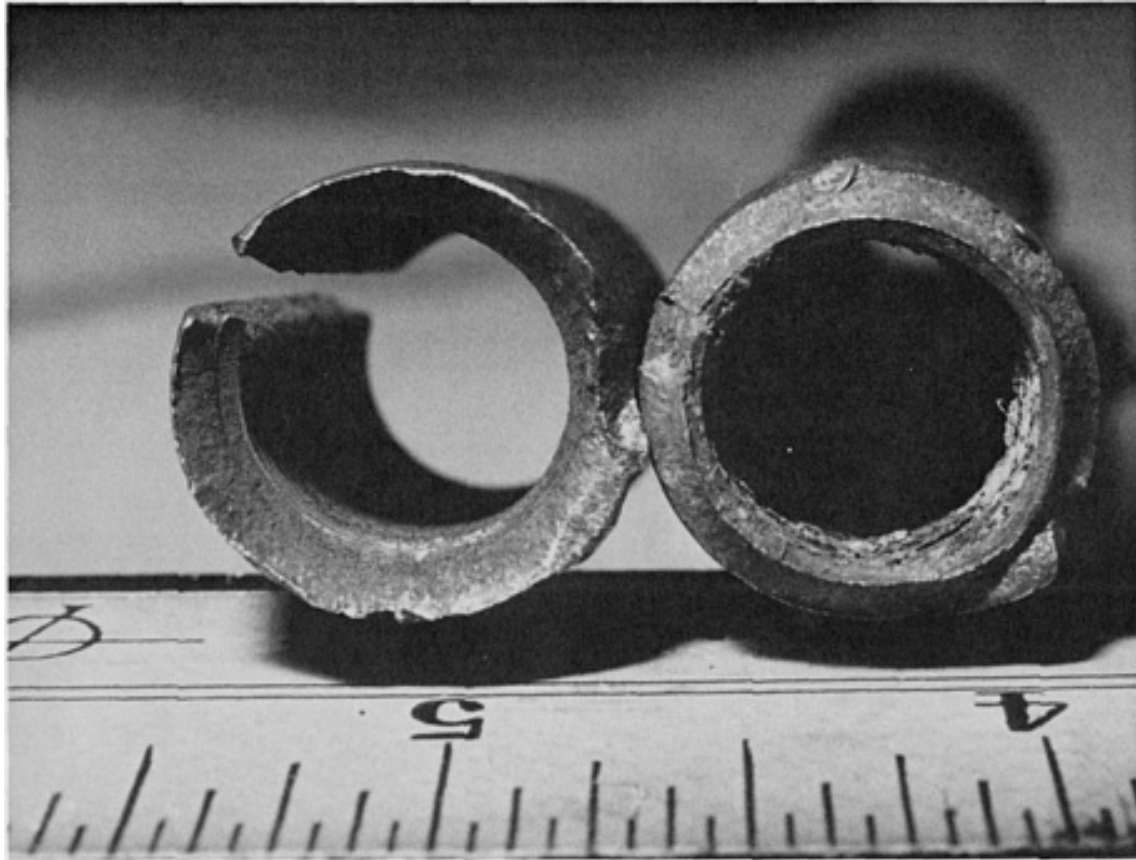
In-service fatigue fracture of SAE 1010 tie rod adjusting sleeve for automobile steering system. Fig. 113: Tubular part was made by cold forming cold-rolled sheet. 1.8×. Fig. 114: Macrograph reveals fracture progressed at 90° to surface. (General Motors Research Laboratories)

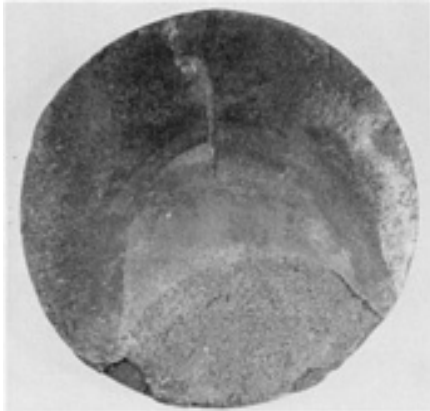
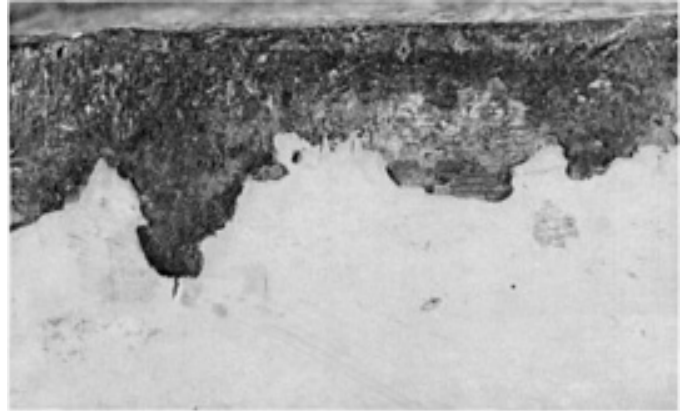
Bending impact fracture of SAE 1010 tie rod adjusting sleeve for automobile steering system. This part, unlike that in Fig. 113 and 114, was made of cold-drawn seamless tubing. Compressive forces produced when wheel was struck during an accident caused sleeve failure. Fig. 115: Macrograph of mating fracture surfaces shows impact fracture progressed at 45° to surface. 2×. Fig. 116: Photomicrograph near point of origin reveals dimpled structure characteristic of a ductile, single load

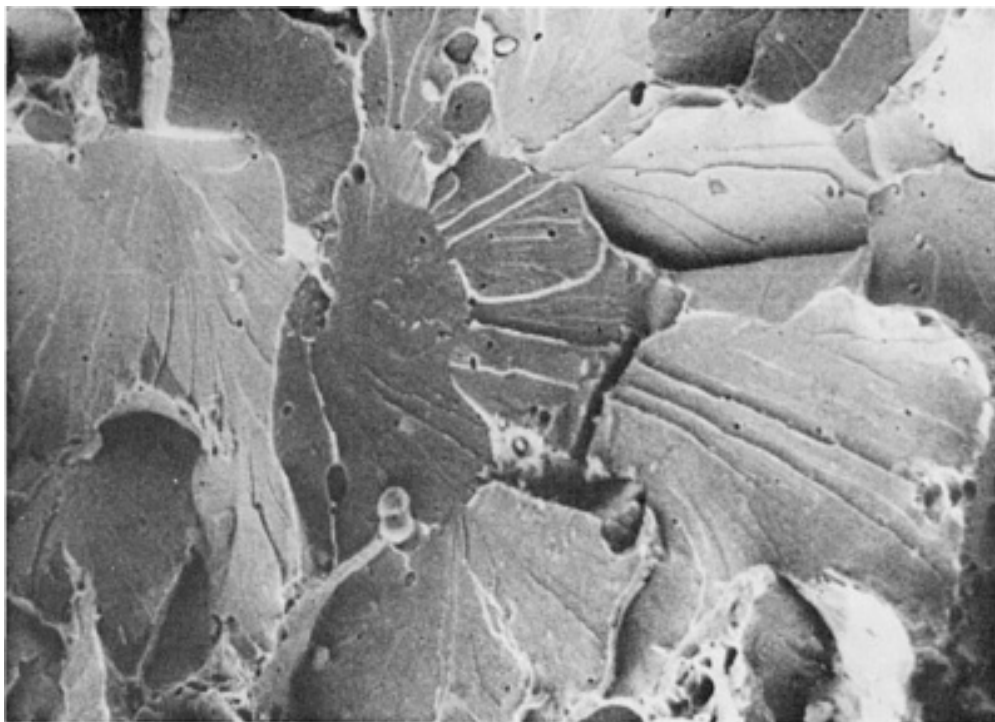
Fig. 119 Brittle fracture of AISI 1020 hydraulic jack shaft. Failure originated at root of machined thread. Corrosion (evident on part) and fatigue (due to repeated loading of shaft) may also have played roles in the failure. Photomicrograph of fracture surface shows transgranular cleavage with individual grains identified by changes in fracture plane orientation. The apparent grain size of 100 to 125 μm corresponds to a ductile-to-brittle transition temperature of approximately 100 °C (212 °F). SEM, 450× (J.M. Rigsbee, University of Illinois)

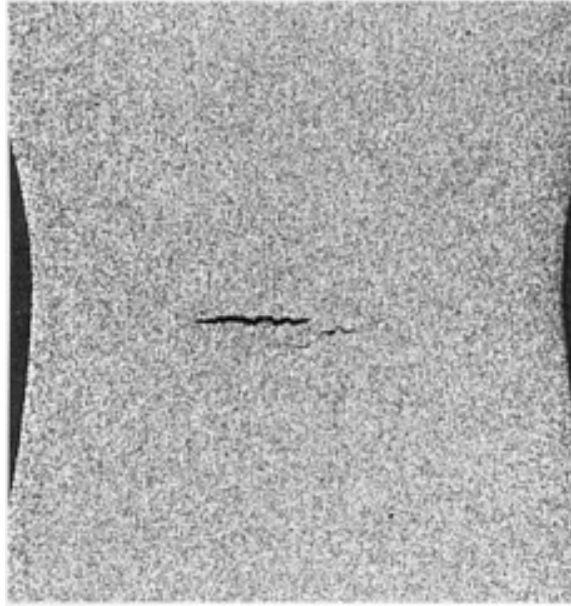
Fig. 120 Polished and etched section taken longitudinally through a 13-mm (0.505-in.) diam tensile-test specimen of AISI 1020 steel. The tensile test was halted after the centerline cracks shown here were formed, but before complete fracture occurred. See also Fig. 121 and 122. Nital etch, 10 \times

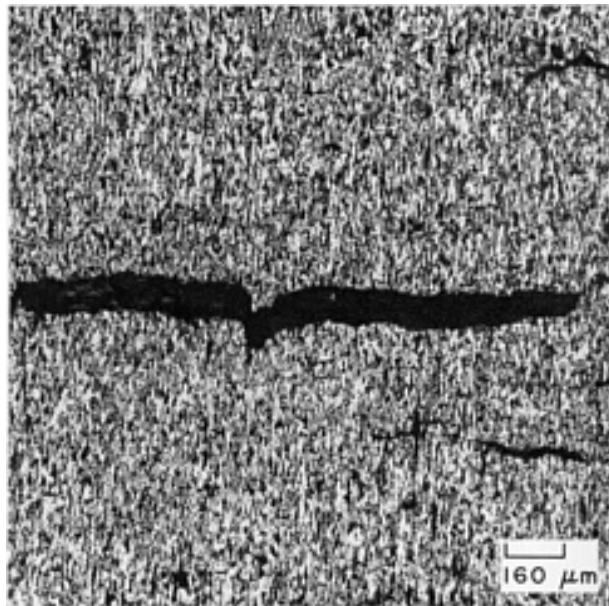
Fig. 121 Higher-magnification view of one of the centerline cracks in the specimen shown in Fig. 120, demonstrating that the cracks are transgranular. Secondary cracks also are visible at right, above and below the main crack. See Fig. 122. Nital etch, 62.5 \times
