به نام خدا

مرکز دانلود رایگان
مهندسی متالورژی و مواد

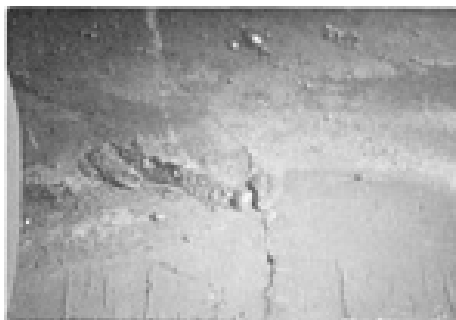
Other views of crank handle collar failure shown in Fig. 124, 125, and 126. Fig. 127: Craters and cavities on fractured collar. Note dark, roughly circular markings in large cavity. SEM, 8 \times . Fig. 128: Close-up of dark patches. SEM, 80 \times . Fig. 129: High-magnification view of dark patch revealing thiobacilli carcasses (nodules) and sulfur-bearing compounds (smooth area). SEM, 800 \times (H.J. Snyder, Snyder Technical Laboratory)

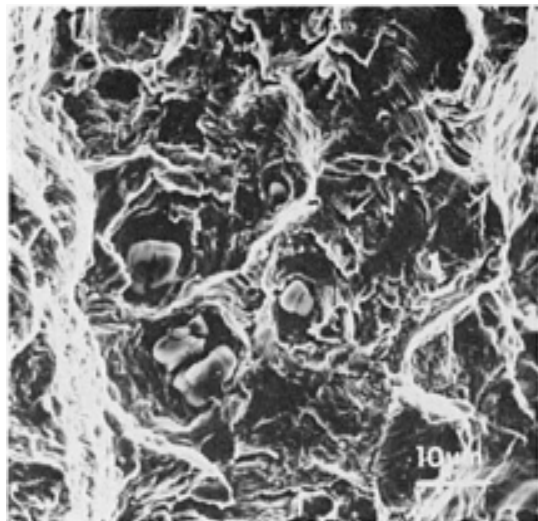
layer of metallic copper on the tube inner diameter. 2% nital. 300× (F.W. Tatar, Factory Mutual Research Corporation)

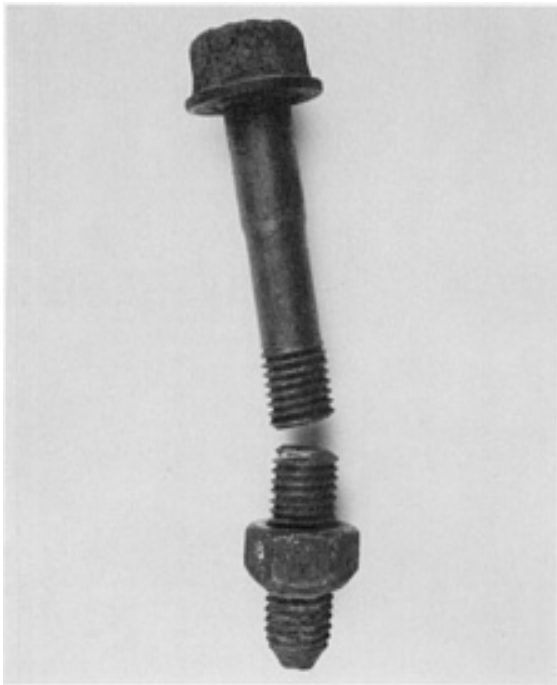
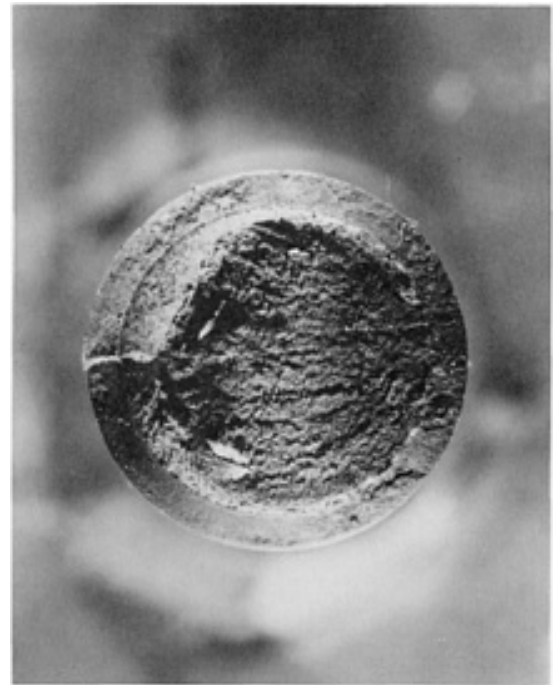
Fracture surfaces of conventionally melted ASTM A517-70 fatigue crack propagation (FCP) test specimens, S-L orientation, at two levels of ΔK . Fig. 139: $22 \text{ MPa}\sqrt{m}$ ($20 \text{ ksi}\sqrt{in}$). Fig. 140: $55 \text{ MPa}\sqrt{m}$ ($50 \text{ ksi}\sqrt{in}$). Steel normalized at $900 \text{ }^\circ\text{C}$ ($1650 \text{ }^\circ\text{F}$) and air cooled. Fracture occurred in regions containing inclusion formations (compare with Fig. 137 and 138). Failure in both cases was by fatigue striation formation in the interinclusion material. In higher strength steels at the higher ΔK level, interinclusion material undergoes ductile fracture (microvoid coalescence). Direction of macroscopic FCP is from bottom to top in both figures. SEM, $1200\times$ (A.D. Wilson, Lukens Steel Company)

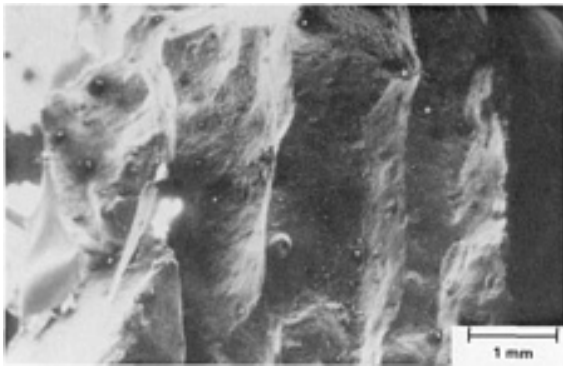
Delayed fracture of martensitic low-carbon boron steel (similar to AISI 15B22) automotive bolts due to corrosion-induced, hydrogen-assisted cracking. Application: secure forward ends of rear suspension lower control arms to vehicle frame. Class 12.8 bolts (SAW J1199, Appendix) were selected because the cold formability of the steel permitted a bolt head design with integral washer. Bolts were quenched and tempered to 39 to 44 HRC. Failed bolts had a hardness near or above the 44-HRC maximum and a soft, decarburized surface layer (permitted by the specification) typically 0.2 mm (8 mils) thick. Fig. 141: Actual size. Fig. 142: $4\times$ (T.J. Hughel, General Motors Research Laboratories)

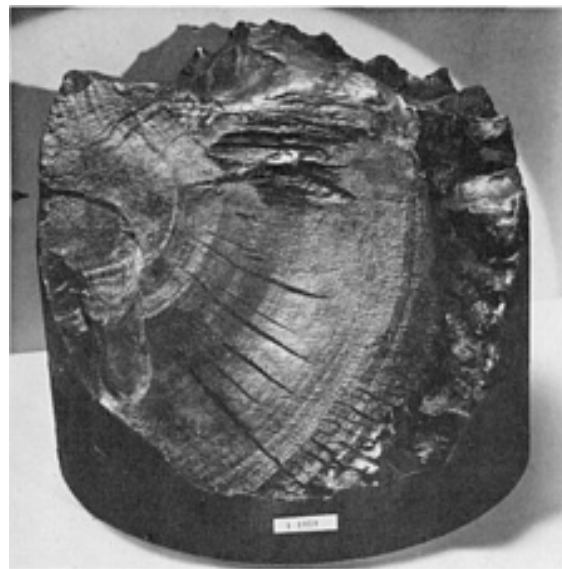
Fig. 152 Fracture surface of a carbon steel drive shaft of a 180-Mg (200-gross-ton) marine tug. The shaft failed by corrosion fatigue after seawater displaced the lubricant between the shaft and the stern tube. Beach marks indicate that the fracture origin was at left (arrow). See also Fig. 153, 154, 155, and 156. 0.8 \times

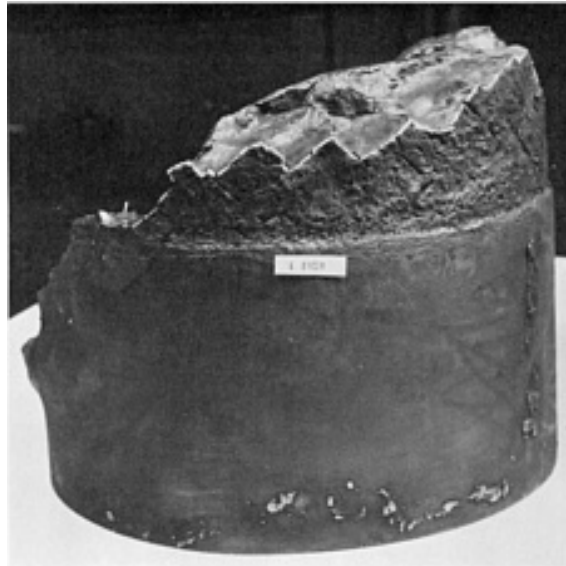
Fig. 153 Side view of the fractured drive shaft in Fig. 152. Note the serrated profile (retouched for clarity) of this edge of the fracture surface and the diagonal cracks on the shaft surface. The cracks were caused by corrosion fatigue from the combination of reversed shaft torsion, perhaps some bending, and seawater attack. 0.8x

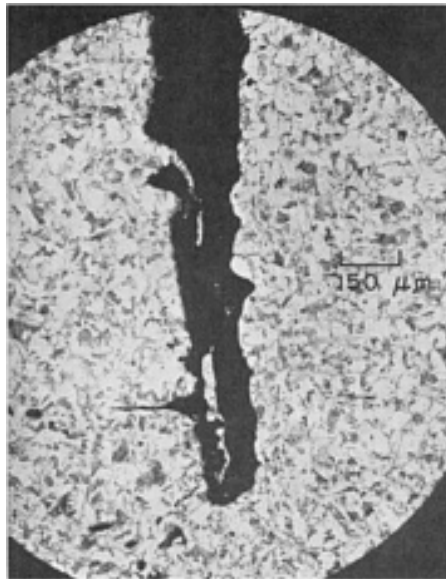
Fig. 156 Section of the fractured shaft shown in Fig. 151, revealing the bottom of one of the corrosion-fatigue cracks. Note that corrosion blunted the tip of the main crack but not the tip of the sharp secondary crack at left, which formed later. Picral etch, 67×

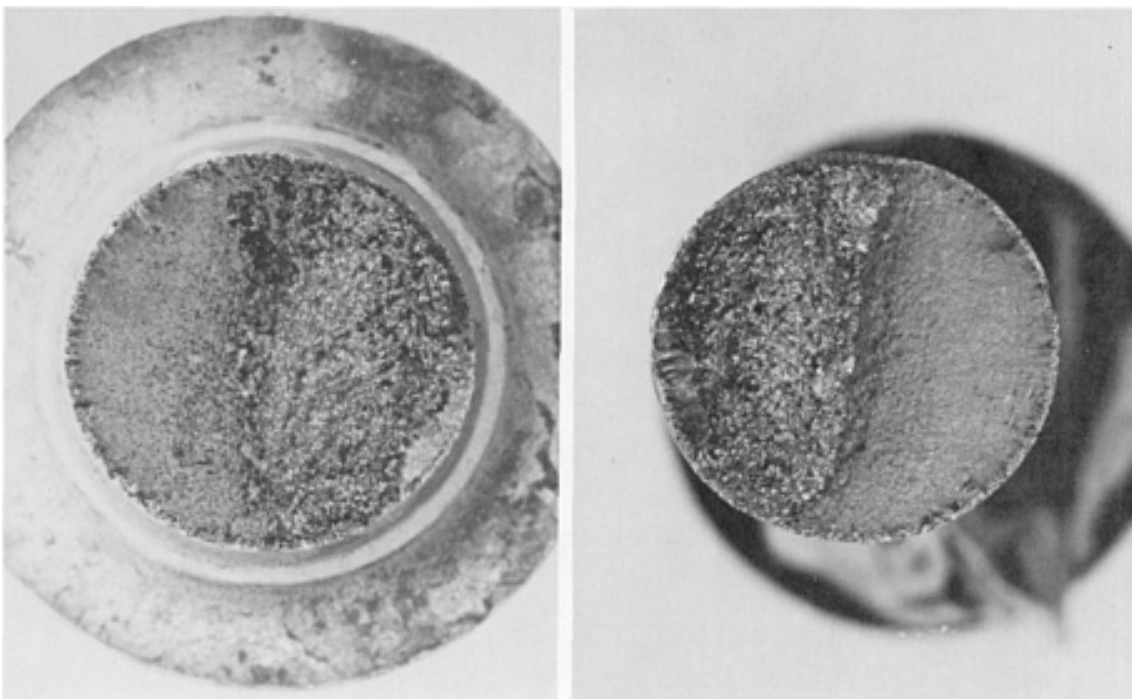
Fig. 157 Mating fracture surfaces of carburized and hardened low-carbon (0.08% C) steel bicycle pedal axle. The in-service fatigue failure initiated at quench cracks in the thin carburized case. 5× (R. Goco, California Polytechnic State University)

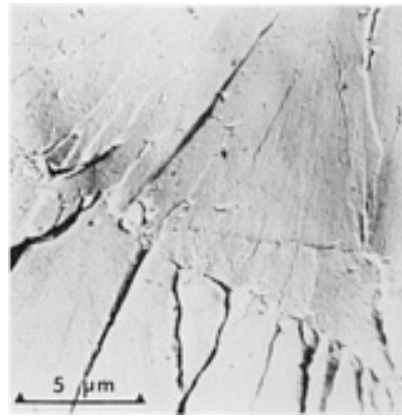
Fig. 164 River pattern on cleavage fracture surface of low-carbon steel bolt. When a crack crosses a twist boundary, many small parallel cracks may form with cleavage steps between them. These steps run together, forming larger ones and leading to the river patterns characteristic of cleavage fracture in polycrystalline metals. TEM replica, 4000× (I. Le May, Metallurgical Consulting Services Ltd.)

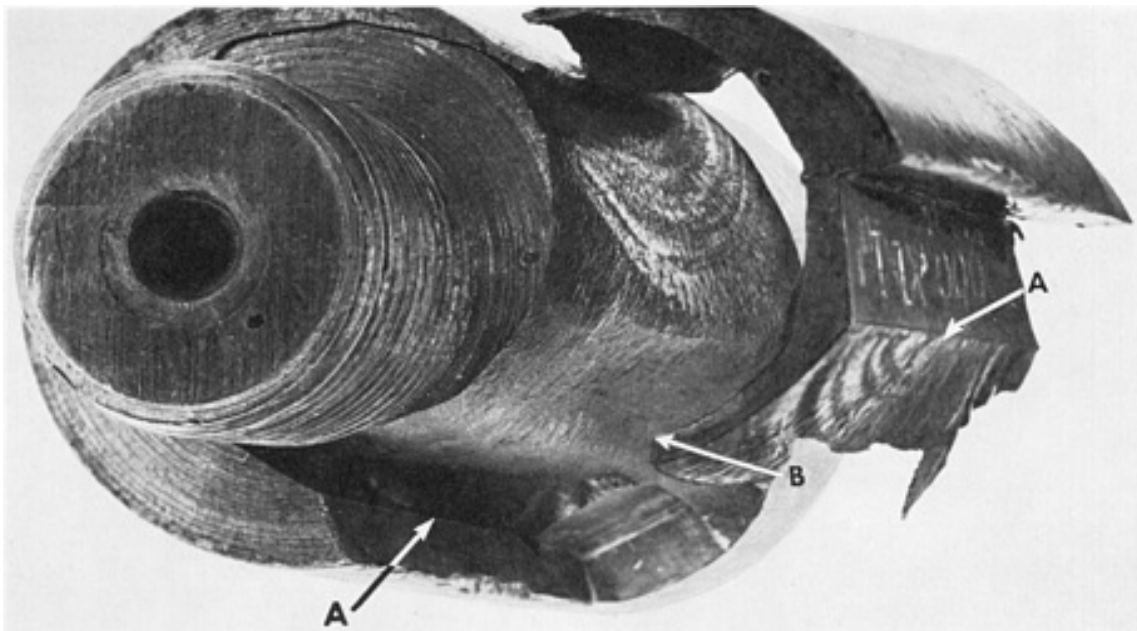
Fig. 165 Torsional fatigue fracture in an 86-mm ($3\frac{3}{8}$ -in.) diam keyed tapered shaft of 1030 steel, commonly termed a "peeling" type of fracture. A loose nut had reduced the frictional force on the tapered portion of the shaft, transferring the torsional load to the key. The fatigue crack originated at a corner in the keyway (arrows A) and progressed completely around the shaft in a clockwise circular path, returning beneath the keyway to the location marked by arrow B, where final fracture occurred. 1.2×

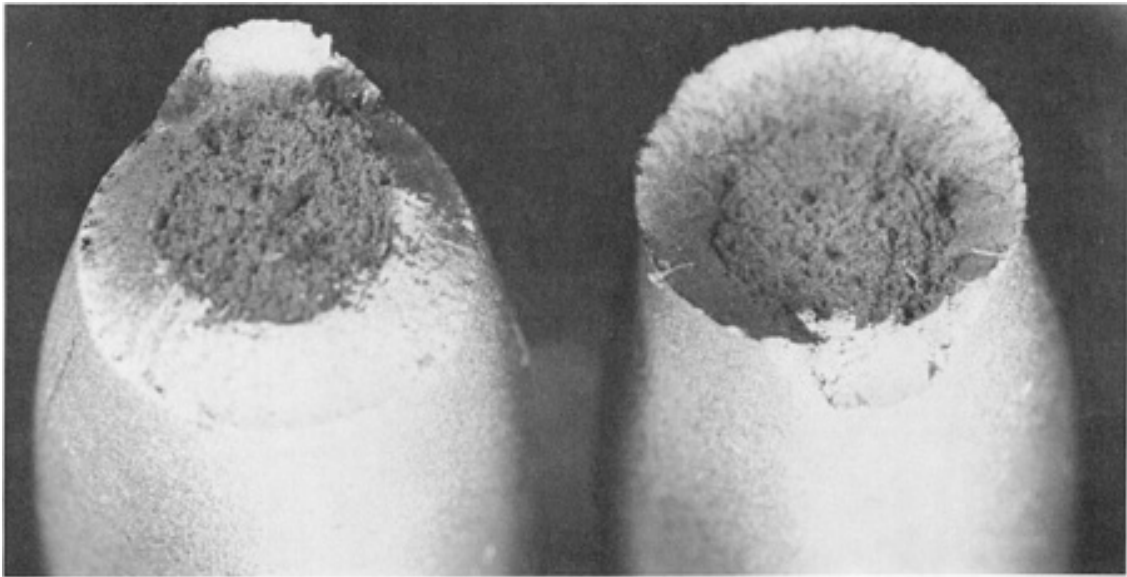
Fig. 166 "Cup and cone" tensile fracture of cylindrical test specimen is typical for ductile metals; in this case, annealed AISI 1035. Fracture originates near the center of the section with multiple cracks that join and spread outward. When cracks reach a region near the surface, the stress state changes from tension to macroshear, forming a fracture at approximately 45° to the plane of the major fracture--the familiar "shear lip." (D.J. Wulpi, Consultant)

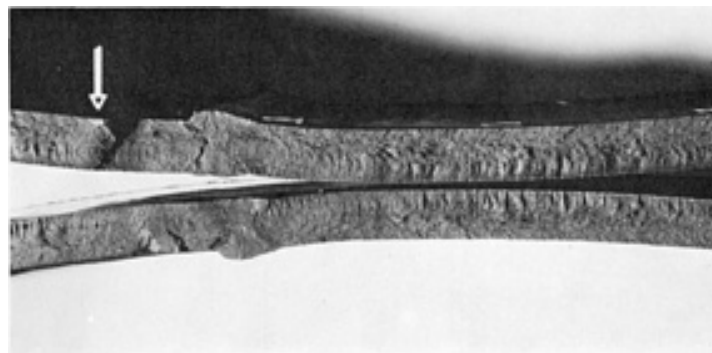
Fig. 171 Mating surface of a crack in a shell plate of an ASTM A515, grade 70, steel pressure vessel used in dehydration of natural gas. Normally, operating pressure was 1.5 MPa (220 psi) and operating temperature was -12 to +4 °C (10 to 40 °F). The crack was exposed by sectioning after a leak was discovered. See Fig. 172, 173, 174, 175, and 176 for views of the portion near arrow at left. 0.4×

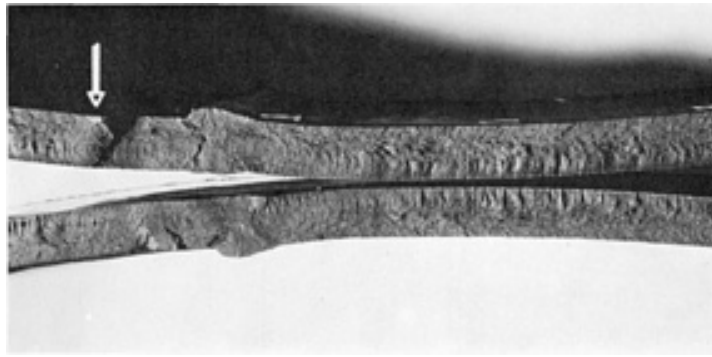
Fig. 171 Mating surface of a crack in a shell plate of an ASTM A515, grade 70, steel pressure vessel used in dehydration of natural gas. Normally, operating pressure was 1.5 MPa (220 psi) and operating temperature was -12 to +4 °C (10 to 40 °F). The crack was exposed by sectioning after a leak was discovered. See Fig. 172, 173, 174, 175, and 176 for views of the portion near arrow at left. 0.4×

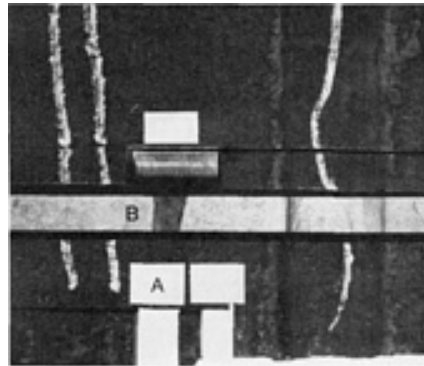
Fig. 172 Portion of the fracture shell plate in Fig. 171 near arrow. A and B indicate where sections were cut for further study. Fracture surface is shown in profile at bottom. 0.57×

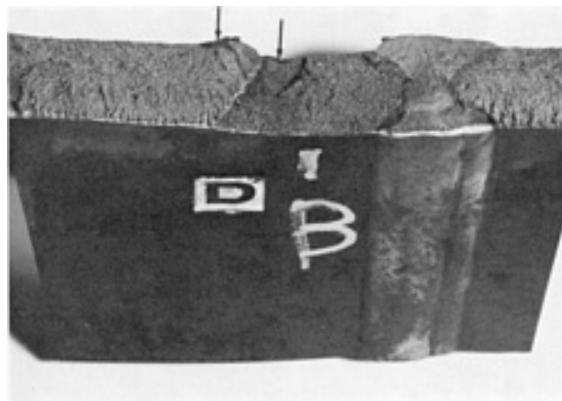
Fig. 173 Same portion of the shell plate as in Fig. 172, but before sectioning and at a different orientation. The two dark crescents partly visible at top edge of the fracture surface (at arrows) were caused by arc strikes and served as crack nuclei. 0.7×

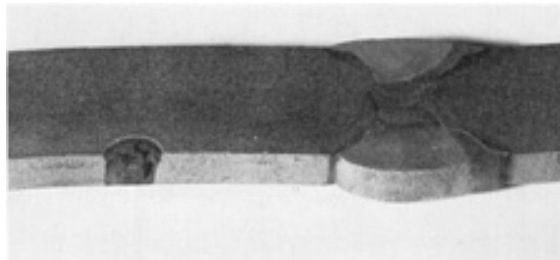
Fig. 176 Polished and etched shell-plate section marked B in Fig. 172. Note that the smaller arc strike, visible at the arrow at right in Fig. 173 and 175, does not extend this far from the fracture. Note also the surface damage caused by the arc strike, in contrast to the excellent condition of the weld deposit. 0.95×

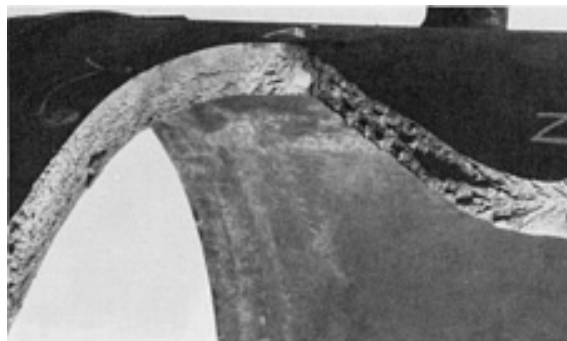
Fig. 181 View of the far left end of the top segment of the fractured pressure-vessel shell in Fig. 177, showing chevron marks. The chevron marks were smeared subsequent to fracture, but can be clearly identified as

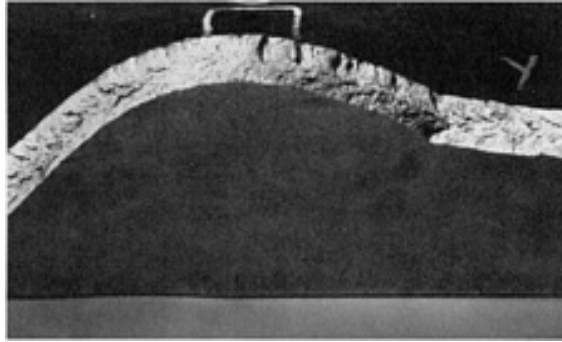
Fig. 182 View of the top segment of the fractured pressure-vessel shell in Fig. 177, showing an area just to the right of the area in Fig. 181. Again, chevron marks are visible and consistently point to the right. 0.25×

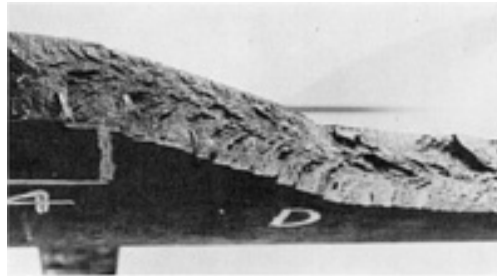
Fig. 183 View of the bottom segment of the fractured shell in Fig. 177, showing an area opposite the one in Fig. 182. This view also reveals sharply defined chevron marks that point to the right. 0.45×

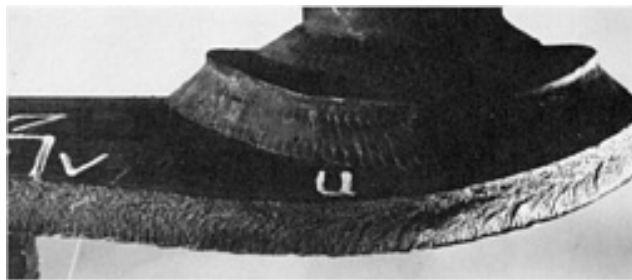
Fig. 184 View of the top segment of the fractured shell in Fig. 177, showing an area just to the left of the fracture origin. The continuity of the chevron marks that point toward location S (at right end) is much more perceptible here than in Fig. 179 because of a difference in illumination. 0.28×

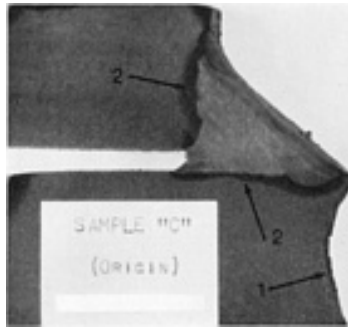
Fig. 185 Section through the flange weld in Fig. 179 and 184, taken at the fracture origin and normal to the fracture surface, shown in profile at bottom right (arrow 1). Heat-affected zones (arrows 2) appear as shadows here. $\sim 0.9\times$

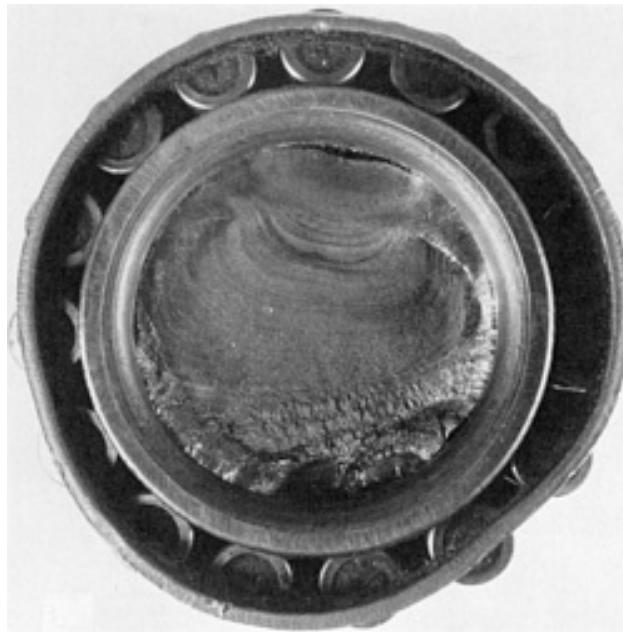
Figure 189 is a view of a drive shaft (actual size shown) of AISI 1035 steel, with a hardness of 34 HRC, that fractured under torsional overload, twisting off in a fashion that produced a surface almost as flat as if it had been machined. The threaded portion, at right, contains a fracture surface. A thin slice containing the mating fracture surface was cut from the portion at left; this slice is shown at center, with the fracture surface up. Shaft portion at left, including cut fracture surface, was hot etched in equal parts of hydrochloric acid and water to reveal deformation flow and forging flash lines. The plastic deformation is characteristic of torsional overload in ductile metals and is not typical of rotating fatigue. Figure 190 is a higher-magnification view (2×) of the threaded portion of the fractured drive shaft in Fig. 189 and the mating surface of the fracture.

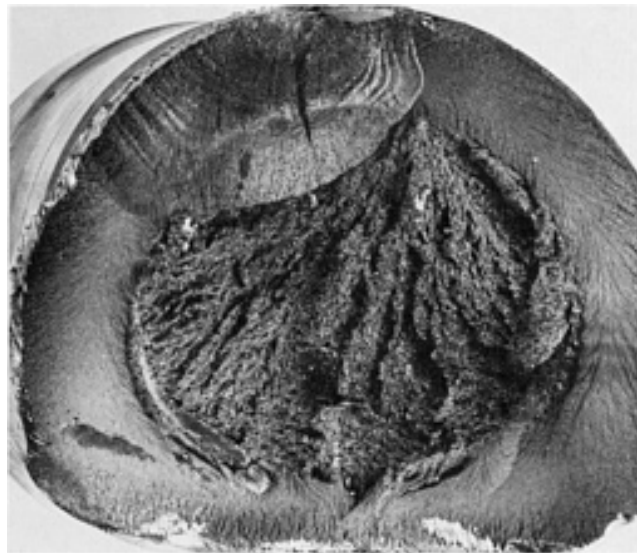
Fig. 196 Surface of a bending-plus-torsional-fatigue fracture in an experimental 89-mm ($3\frac{1}{2}$ -in.) diam tractor axle of AISI 1041 steel that had been induction hardened. Fracture occurred after 1212 h on an endurance-test track. Note beach marks fanning out from the fatigue-crack origin (slightly to left of center, at top). Beyond the beach marks, cracking progressed by fast fracture along the hardened perimeter, producing two sets of chevron marks pointing toward the crack origin (like the chevron marks in Fig. 195). See also Fig. 197. 1.25 \times

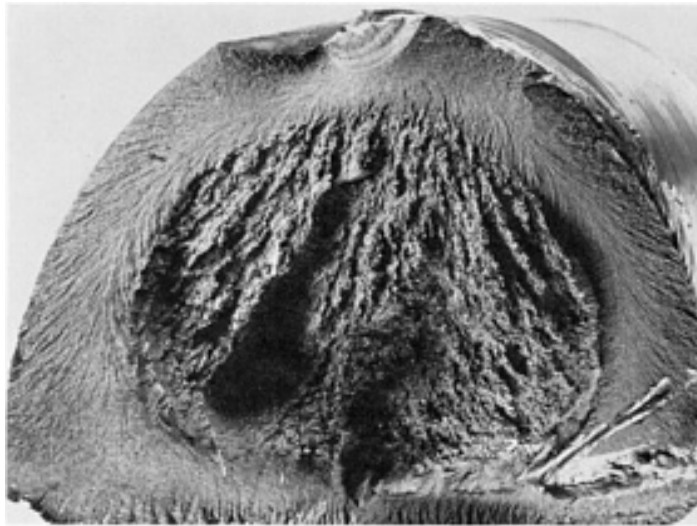
Fig. 197 Surface of a torsional-fatigue fracture in an induction-hardened AISI 1041 steel experimental tractor axle same as in Fig. 196. Hardness in the hardened zone was 50 HRC at 11 to 12 mm ($\frac{7}{16}$ to $\frac{15}{32}$ in.) beneath the axle surface at the crack origin. This axle fractured after 450 h of endurance testing. In this axle, as in the axle in Fig. 196, crack origin is near top, at a sharp corner of a keyway runout. 1.25×

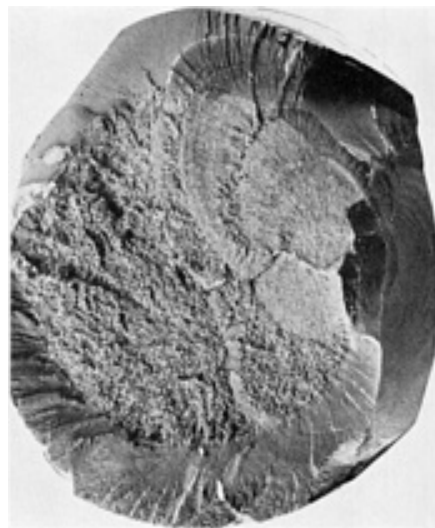
Fig. 198 Surface of a fatigue fracture in a truck axle of AISI 1041 steel induction hardened to 55 HRC. The axle broke after 490 h of service. Crack origin was subsurface, near a keyway. Note that fatigue crack progressed in steps. Actual size.

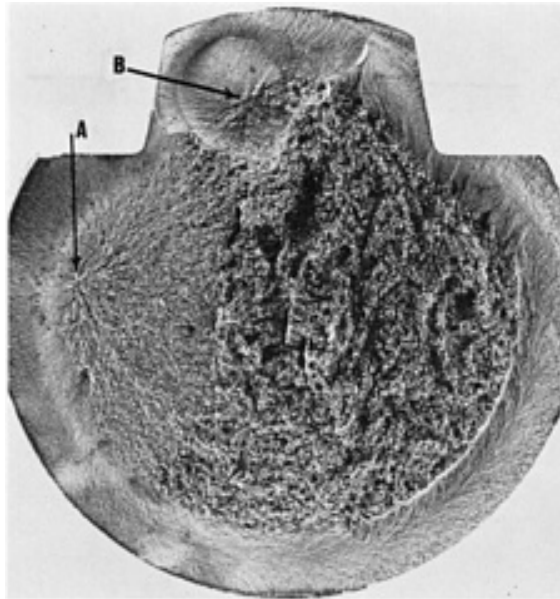
Fig. 199 Fatigue fracture in an AISI 1041 steel axle induction hardened to 50 HRC and tested in rotating bending. Two cracks are evident; one began at A and progressed around most of the perimeter by fatigue, then by fast fracture, before meeting a smaller crack, which began by fatigue at B. Chevron marks in hardened zone point to both origins. 1.2×

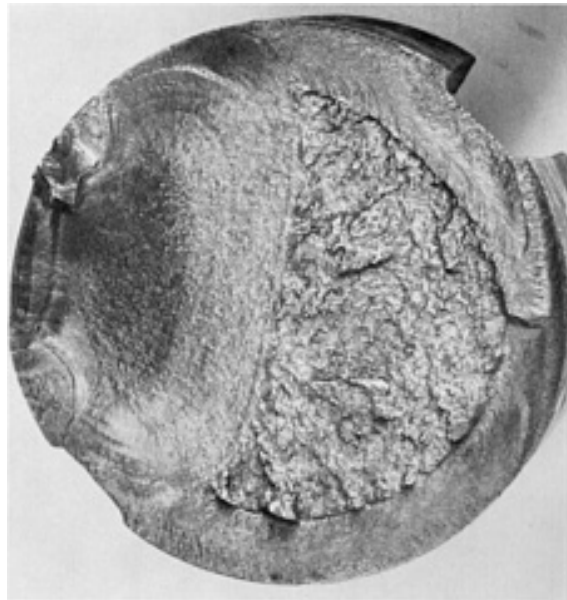
Fig. 200 Surface of a fatigue fracture in a keyed axle of AISI 1041 steel induction hardened to 50 HRC. An accidental arc strike on the axle surface, at left, initiated a fatigue crack, which grew about halfway through the cross section before fast fracture occurred in the hardened zone; fast fracture progressed from both sides of the fatigue crack, as shown by chevron marks. 1.3×

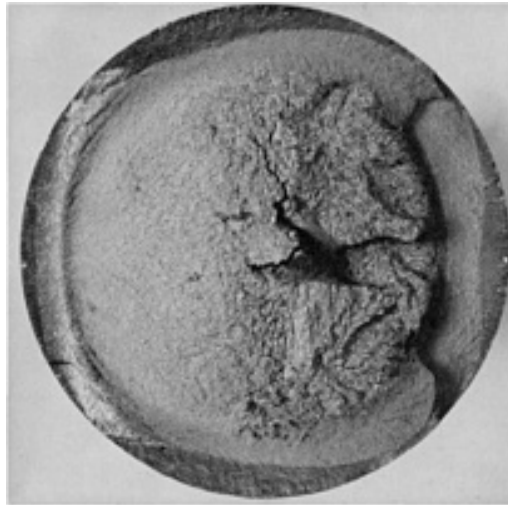
Fig. 201 Fatigue-fracture surface of a case-hardened AISI 1039 steel shaft. Case hardness, 50 HRC; core, 19 HRC. Note that fracture of the case was nearly complete before the fatigue cracks penetrated into the core. 2×

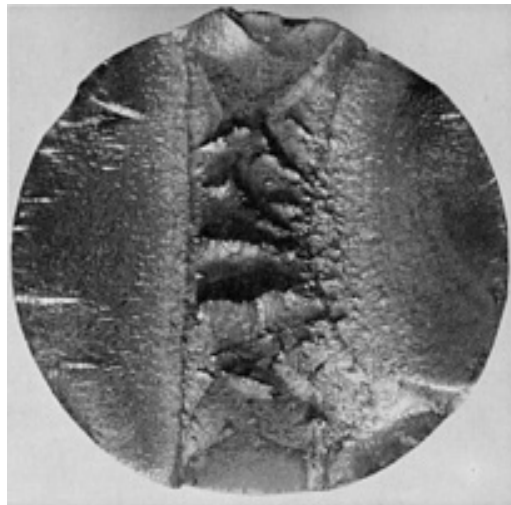
Fig. 202 Surface of a fatigue fracture in a shaft of AISI 1041 steel with a hardness of 302 HB. The shaft was broken by reversed stressing. Note the two fatigue-crack origins at right edge and the third origin at left. 2×

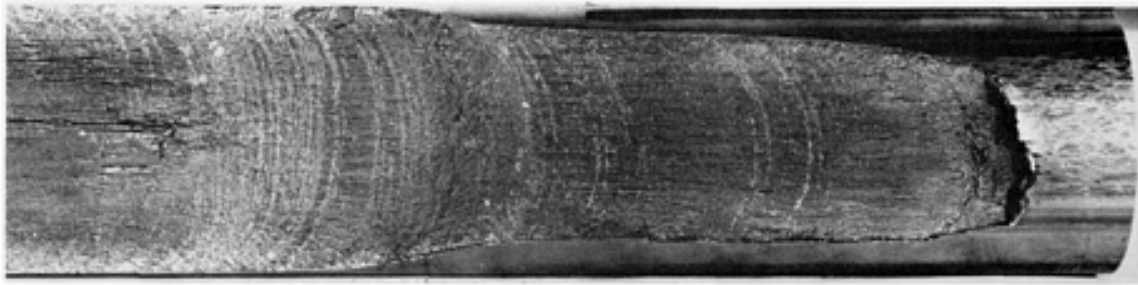
Fig. 205 Fatigue-fracture surface of the shaft of a forging hammer of AISI 1144 steel containing 0.45% C, 1.60% Mn, and 0.28% S. The fatigue crack began at a heavily abraded surface area (out of view to the left), penetrated to the center of the shaft, then turned 90° and propagated longitudinally to the point of termination at right (about 635 mm, or 25 in.). See also Fig. 206. ~0.5x

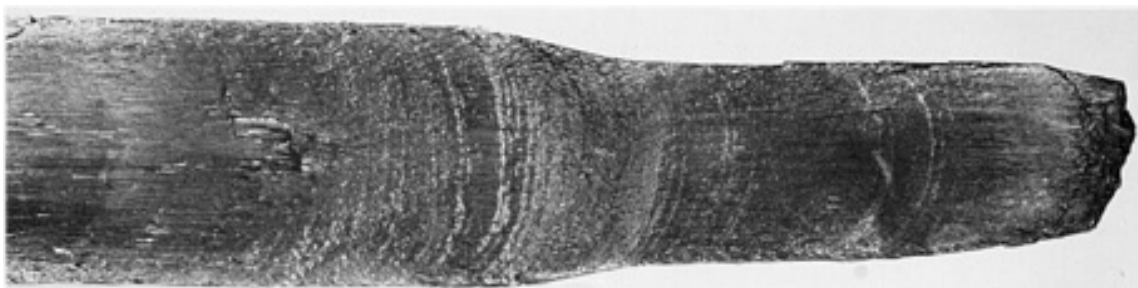
Fig. 206 Mating fracture surface to the one shown in Fig. 205. This piece of the shaft broke away during service. It is believed that the crack propagated a long distance in the longitudinal direction because of weaknesses associated with the presence of longitudinal bands of elongated manganese sulfide inclusions. ~0.5x

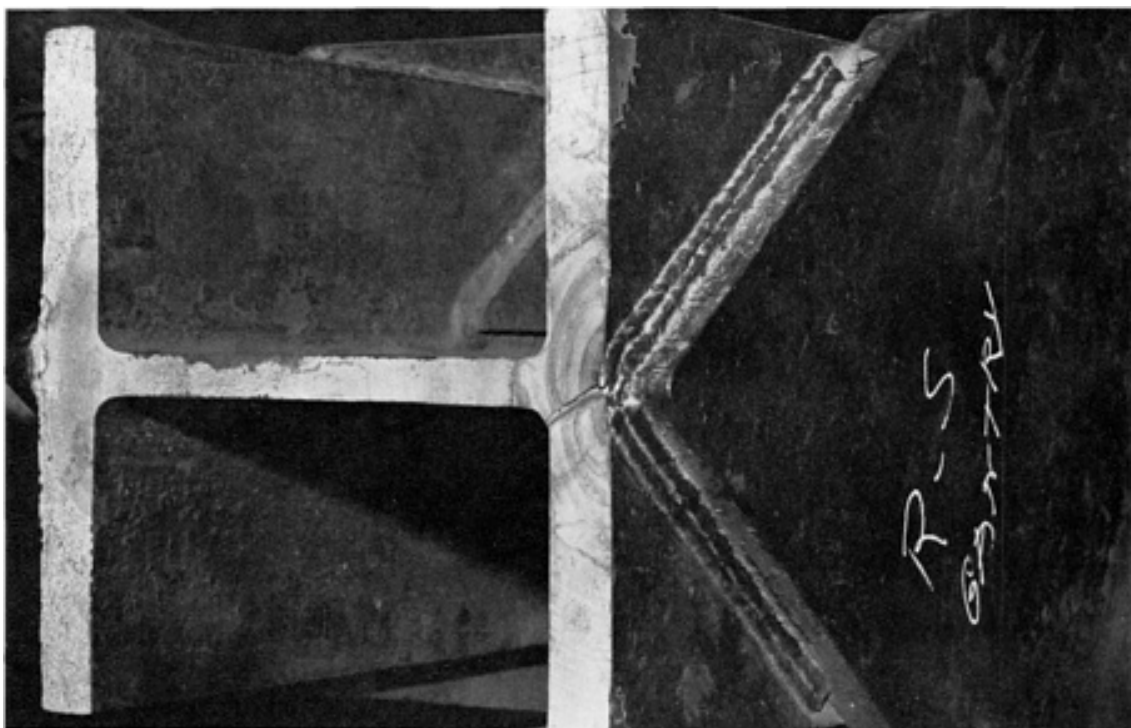
Fig. 207 Surface of a fatigue fracture in a medium-carbon steel I-beam, with a flange 400 by 400 by 40 mm

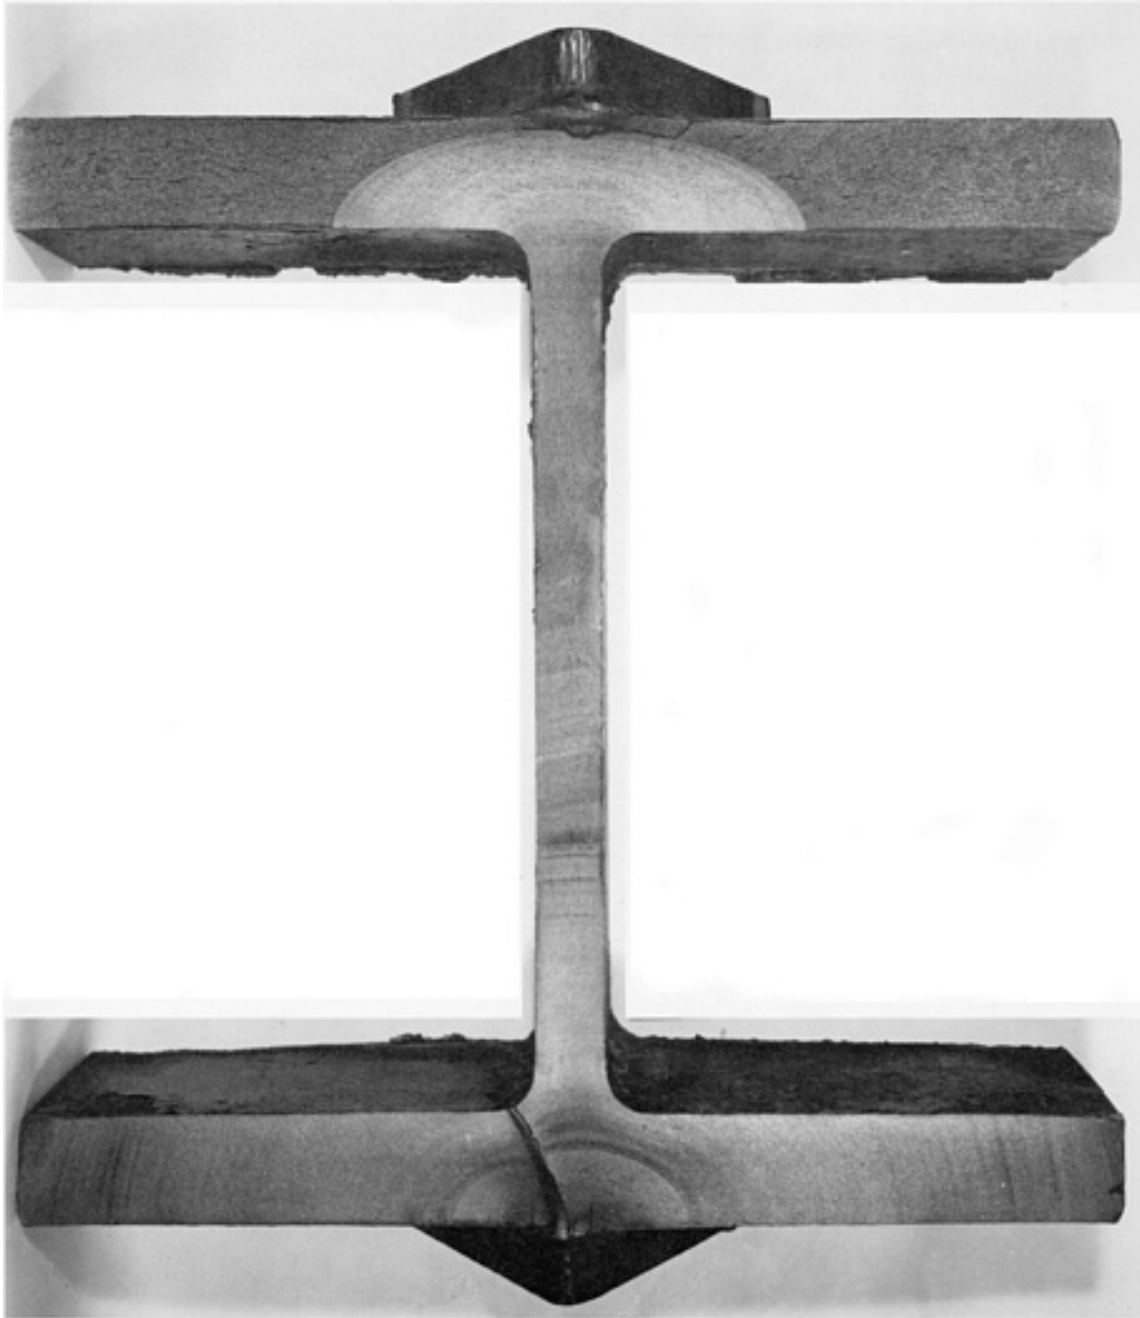
Fig. 208 Another view of the fatigue-fracture surface of the medium-carbon steel I-beam in Fig. 207. The fracture origins are clearly evident in the flange at bottom, where two nuclei are situated at the toe of the weld joining a reinforcement plate to the flange. It is remarkable that the fatigue crack penetrated the entire flange at bottom, the entire web, and part of the flange at top before final fast fracture occurred. See also Fig. 209 and 210. 0.5×

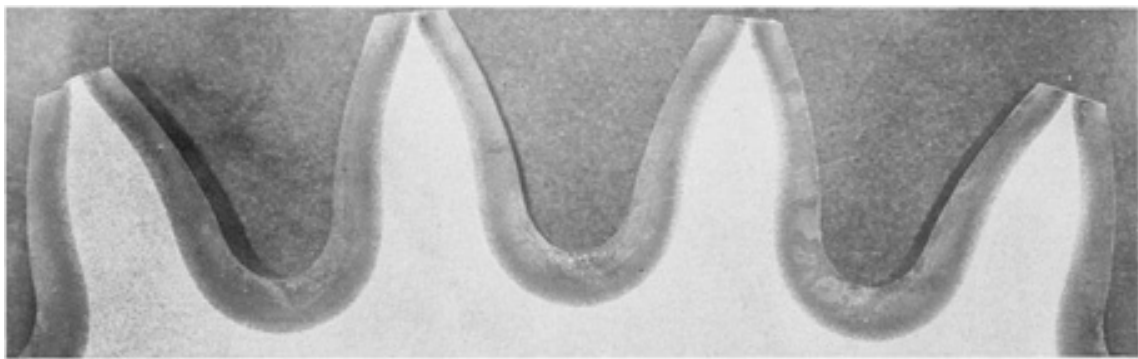
Figure 211 is a polished and etched cross section of a partially flame-hardened crane gear of AISI 1045 steel in which fatigue cracks formed at the roots of many teeth after one year of service. The cracks have been sharply delineated by etching. Note that hardening did not extend even to the root fillet of any tooth. Figure 212 is a polished and etched cross section of a portion of a gear that was subjected to full-contour flame hardening; note the better tooth form, with fully radiused tooth roots. Both etched

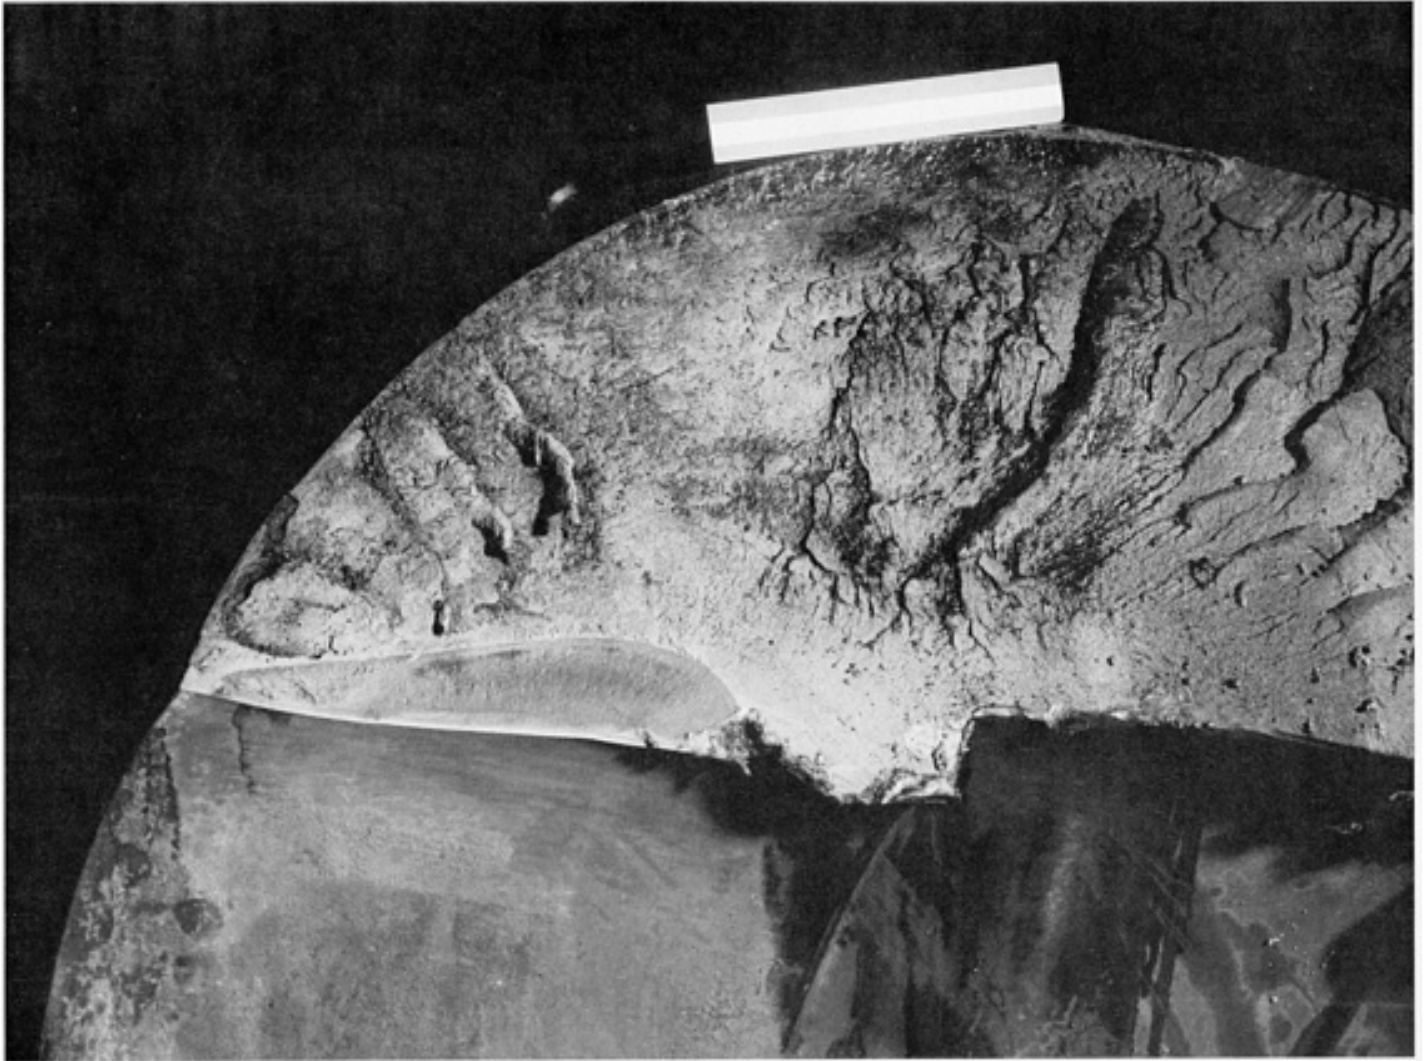
Fig. 213 Fracture surface in the jaw end of a blooming-mill spindle of forged AISI 1045 steel. This spindle was 8.2 m (27 ft) long, 890 mm (35 in.) in diameter at the jaw end, and 1065 mm (42 in.) in diameter at the drive end. The white 6-in. rule at top indicates the massive size of the spindle. After the spindle had been normalized, the inner surface of the jaw was flame hardened. The fracture originated at the jaw surface, at the lower edge of the fatigue zone (left of center). See also Fig. 214. 0.4×

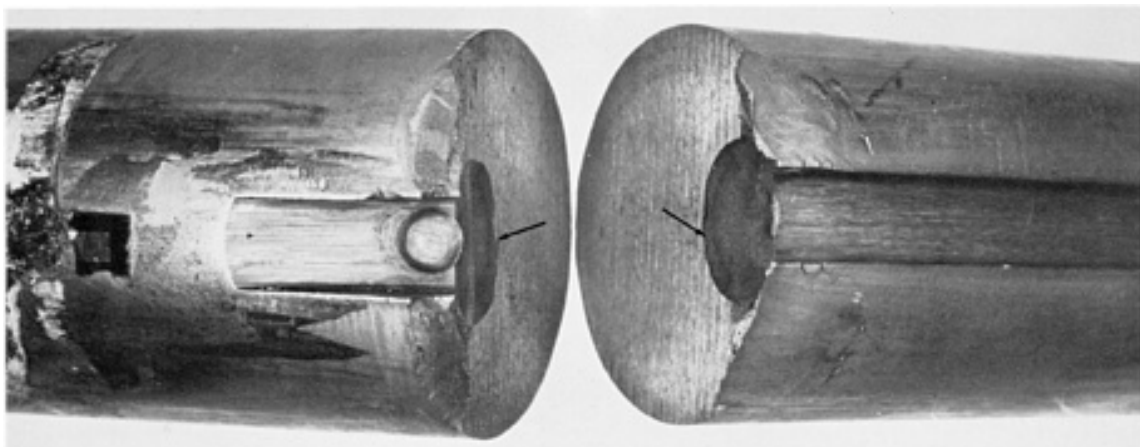
Fig. 215 View of the mating surfaces of a fatigue crack (dark areas) exposed by sectioning an AISI 1045 steel shaft quenched and tempered to a hardness of approximately 40 HRC. The crack, which was discovered before it could penetrate the entire cross section of the shaft, originated at a weld deposit that served as a stop in a

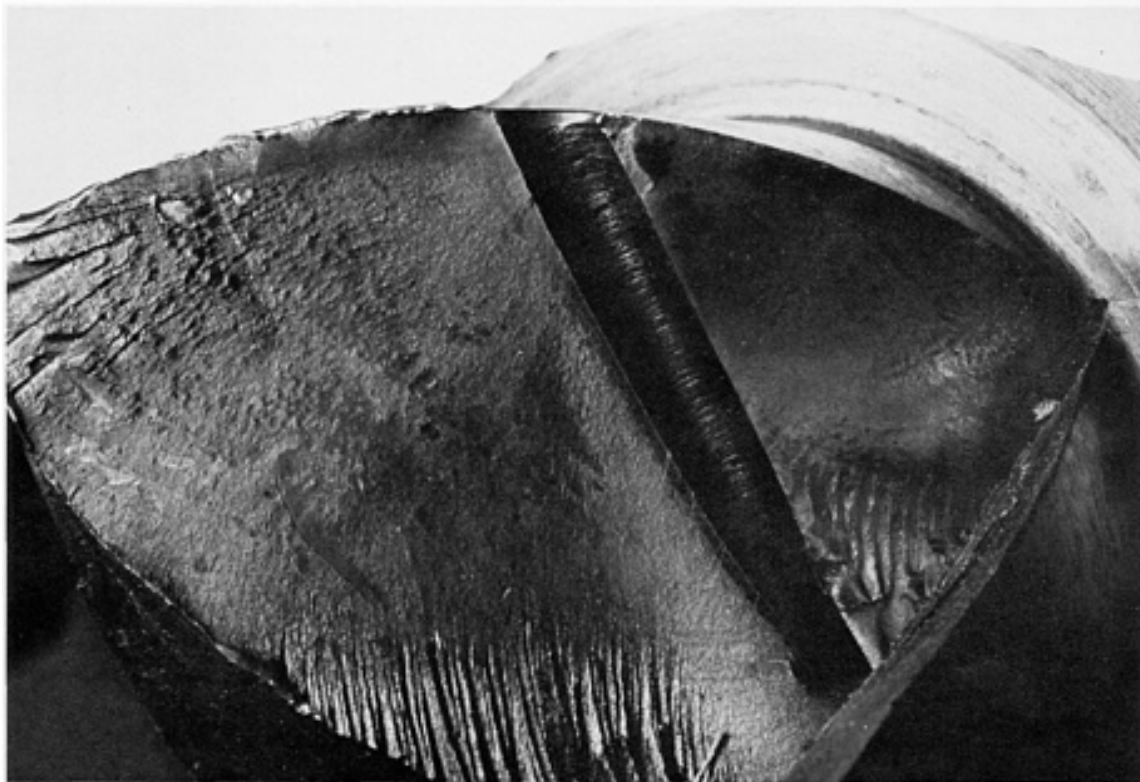
Fig. 216 Surface of a torsional-fatigue fracture in an AISI 1045 steel crankshaft induction hardened to 55 HRC. The crack originated at the edge of an oil hole. Although it is not clearly evident in this view, the crack grew at a 45° angle to the axis of the crankshaft because of tensile-stress components caused by the torsional loading. 2.5×

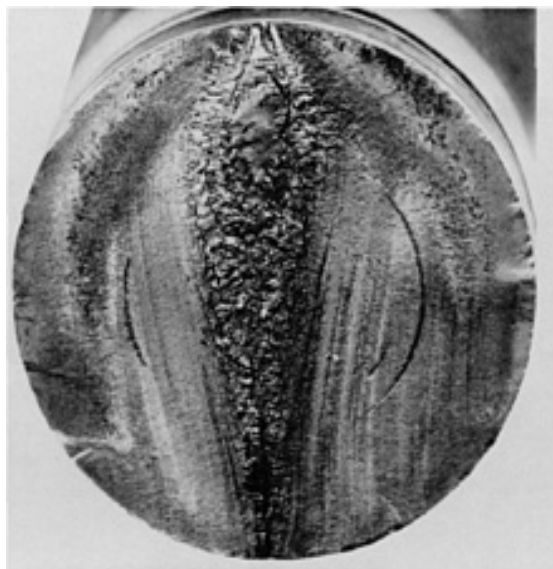
Fig. 217 Reversed bending fatigue of a 40-mm (1.6-in.) diam AISI 1046 steel shaft (30 HRC). Note the symmetrical fatigue pattern of beachmarks on each side, with the final rupture on the diameter. This indicates that each side of the shaft was subjected to the same maximum stress and to the same number of load applications. (D.J. Wulpi, Consultant)

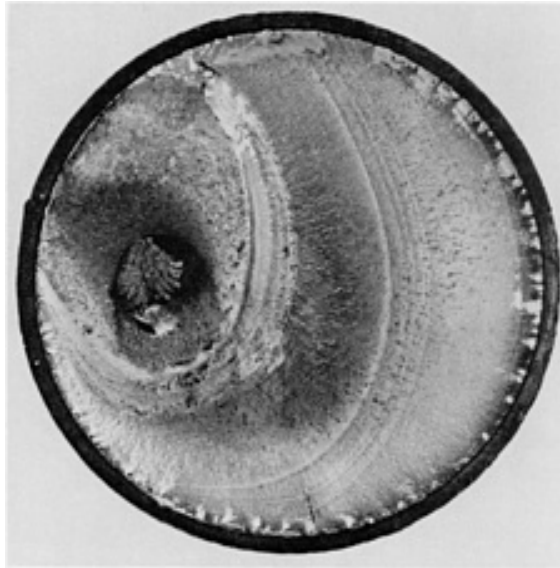
Fig. 218 Fatigue-fracture surface of an AISI 1050 shaft (35 HRC) subjected to rotating bending. Numerous ratchet marks (small shiny areas at surface) indicate that fatigue cracks were initiated at many locations along a sharp snap-ring groove. The eccentric pattern of oval beachmarks indicates that the load on the shaft was not balanced. The final rupture area is near the left (low stress) side, where there may have been no fatigue action. (D.J. Wulpi, Consultant)

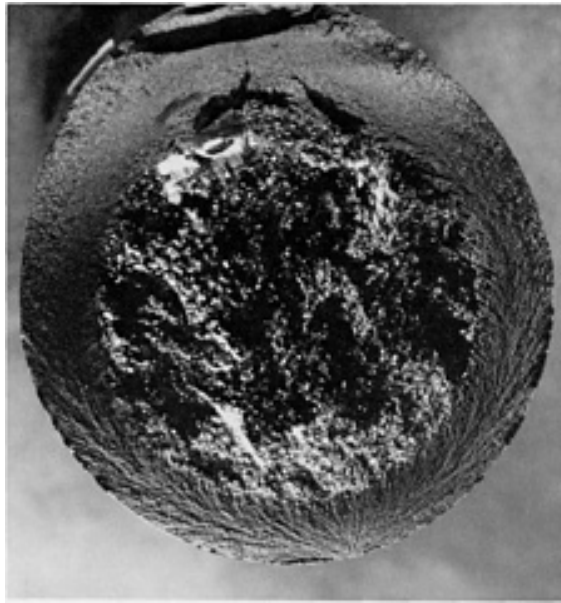
Fig. 220 Fracture surface of the modified SAE 1050 axle shaft shown in Fig. 221. Note chevrons pointing to fracture origin in the fine structured case. See also Fig. 222, 223, 224, 225, 226, and 227. 2.75×

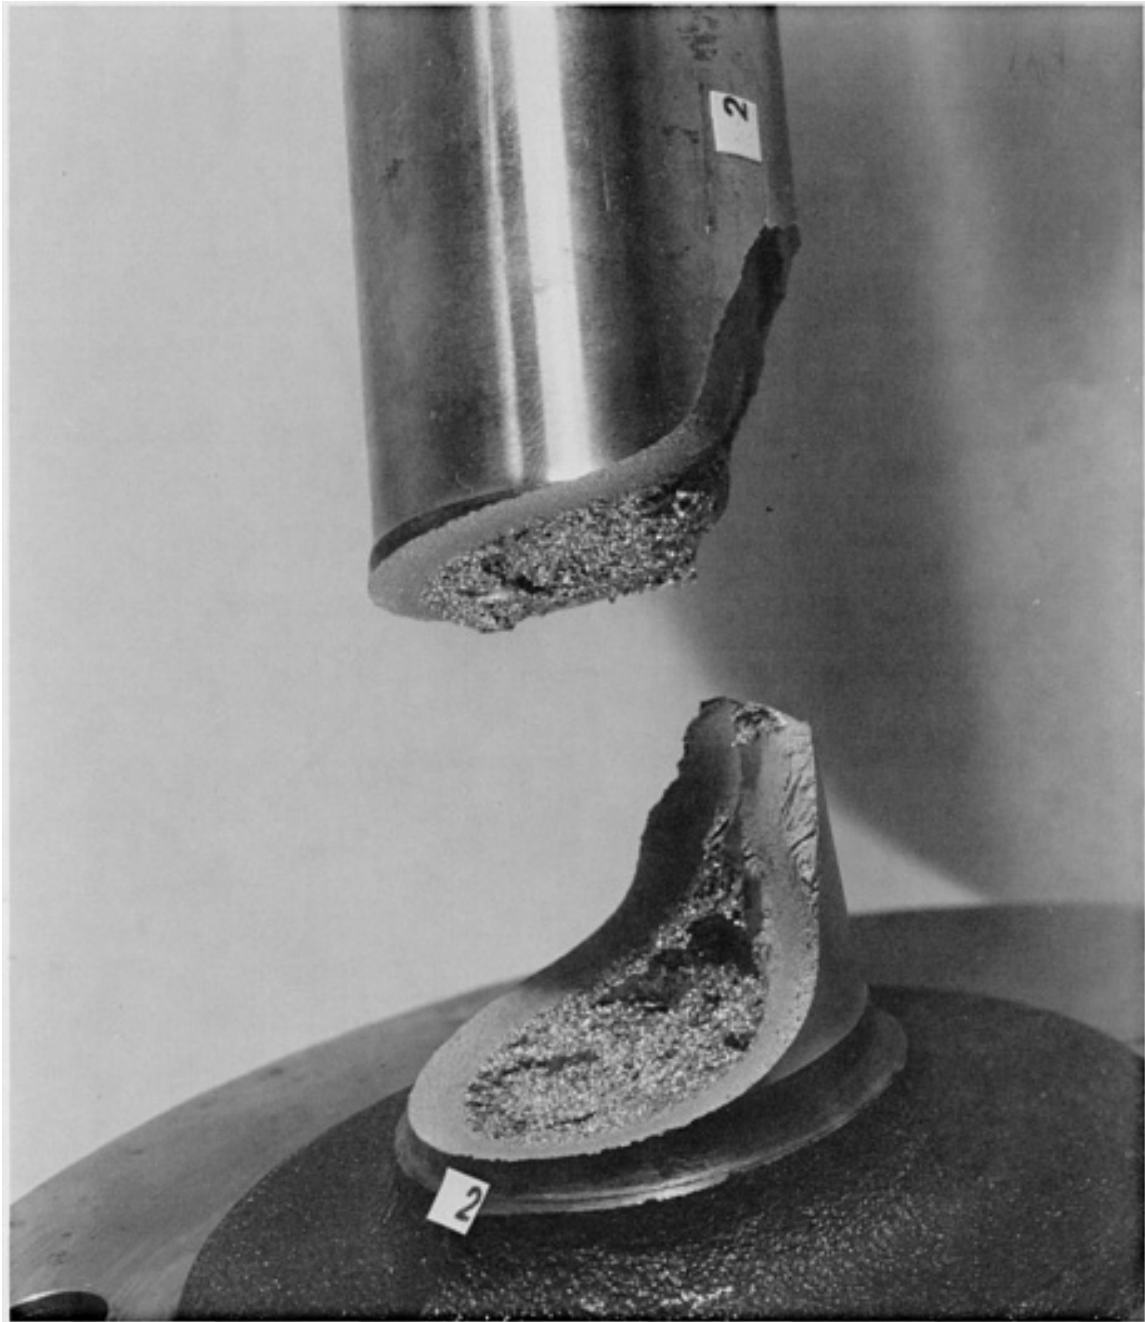
Fig. 221 Brittle fracture of a modified SAE 1050 axle shaft due to single bending impact load. Steel nominal composition: 0.50% C, 0.95% Mn, 0.25% Si, 0.01% S, and 0.01% P. The hot-rolled and upset shaft had an induction-hardened martensitic case (60 HRC) and a pearlite-ferrite core (20 HRC). Failure occurred at the flange end. Part was broken in the laboratory. Shown in this fractograph are the fracture surfaces, including a compression chip. See also Fig. 220, 222, 223, 224, 225, 226, and 227. Actual size (General Motors Research Laboratories)

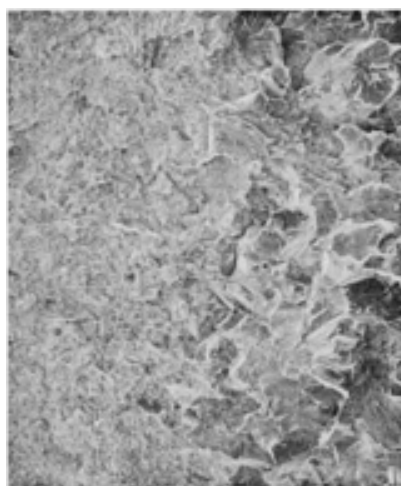
Fractographs of case structure on shaft side of axle failure in Fig. 220 and 221. Fig. 222: Structure at fracture origin. SEM, 20×. Fig. 223 (Same as Fig. 222, but at higher magnification. Note primarily intergranular fracture. SEM, 1000×. Fig. 224: Same as Fig. 223, but at higher magnification. SEM,

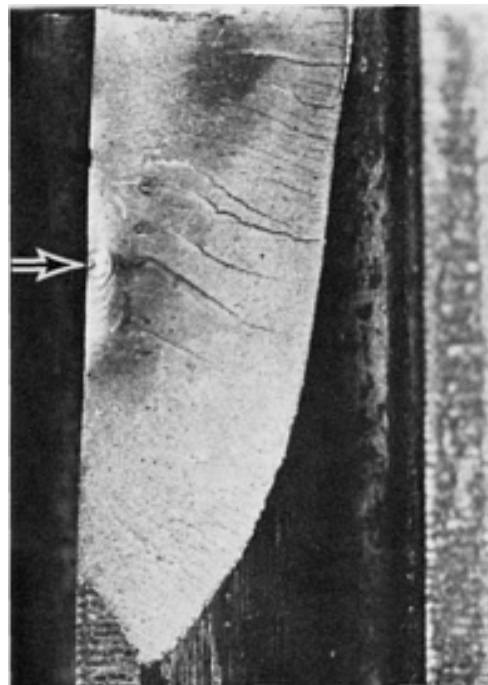
Fig. 232 Surface of a fatigue fracture in a tooth of an AISI 1050 steel gear with a hardness of 55 HRC. The fatigue crack originated at a forging defect (at arrow). Fatigue beach marks are visible near the fatigue-crack origin. Beyond these marks are the steps of a river pattern, caused by cleavage. $\sim 2.5\times$
