به نام خدا

مرکز دانلود رایگان
مهندسی متالورژی و مواد

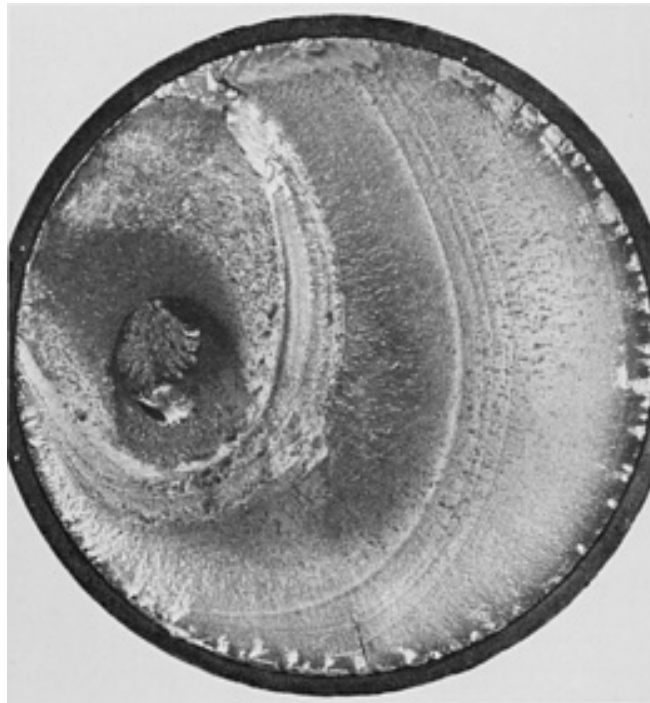
Fig. 233 Surface of a fatigue fracture in an AISI 1050 steel shaft, with a hardness of about 35 HRC, that was subjected to rotating bending, showing ratchet marks indicating that fatigue cracks were initiated at many locations along a sharp snap-ring groove. An eccentric pattern of oval beach marks is visible, the presence of which suggests an imbalance in loading. $\sim 2.4\times$

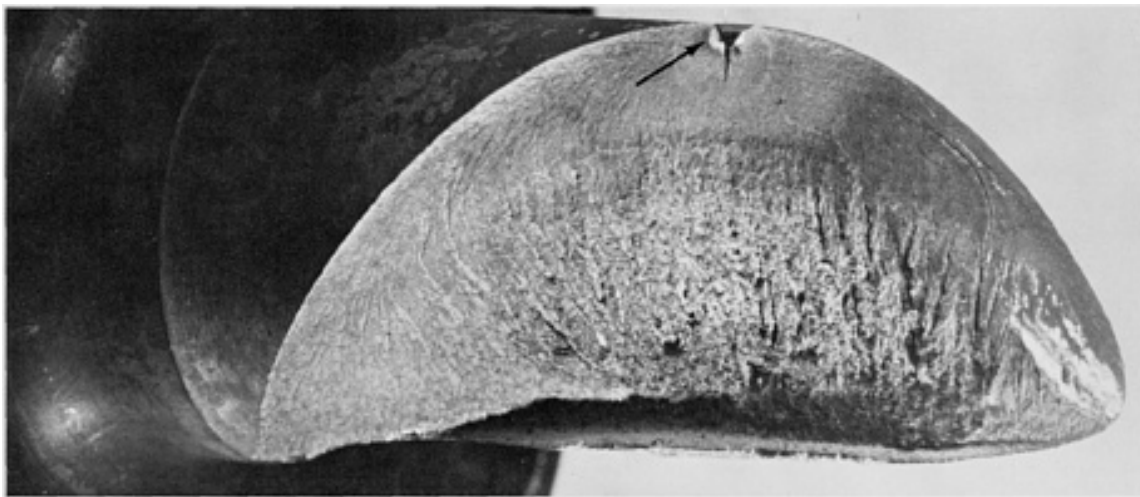
Fig. 234 Surface of a fatigue fracture in a full-floating axle of an AISI 1050 steel induction hardened to about 50 HRC. The axle was tested in reversed torsion. The arrow indicates the origin of the fatigue crack, which grew by shear fatigue to the small, circular beach mark. Subsequent crack growth was by tension fatigue until final fracture (brittle tensile) occurred under a single torsional load. $\sim 2\times$

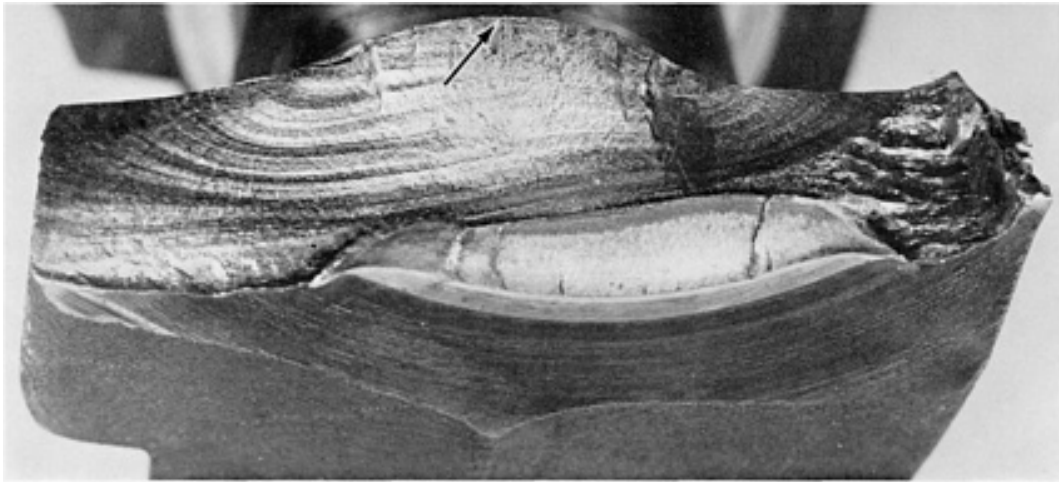
Fig. 238 Surface of a fatigue fracture in a crankshaft of AISI 1046 steel with a hardness of 25 HRC in the region of fracture. Two cracks were generated under a bending stress; one crack started in the journal fillet at the arrow and progressed through the cheek until it met the second crack, which began in the fillet on the opposite side of the cheek. Note the sharply defined beach marks in the upper portion of the fracture surface. $\sim 0.75\times$

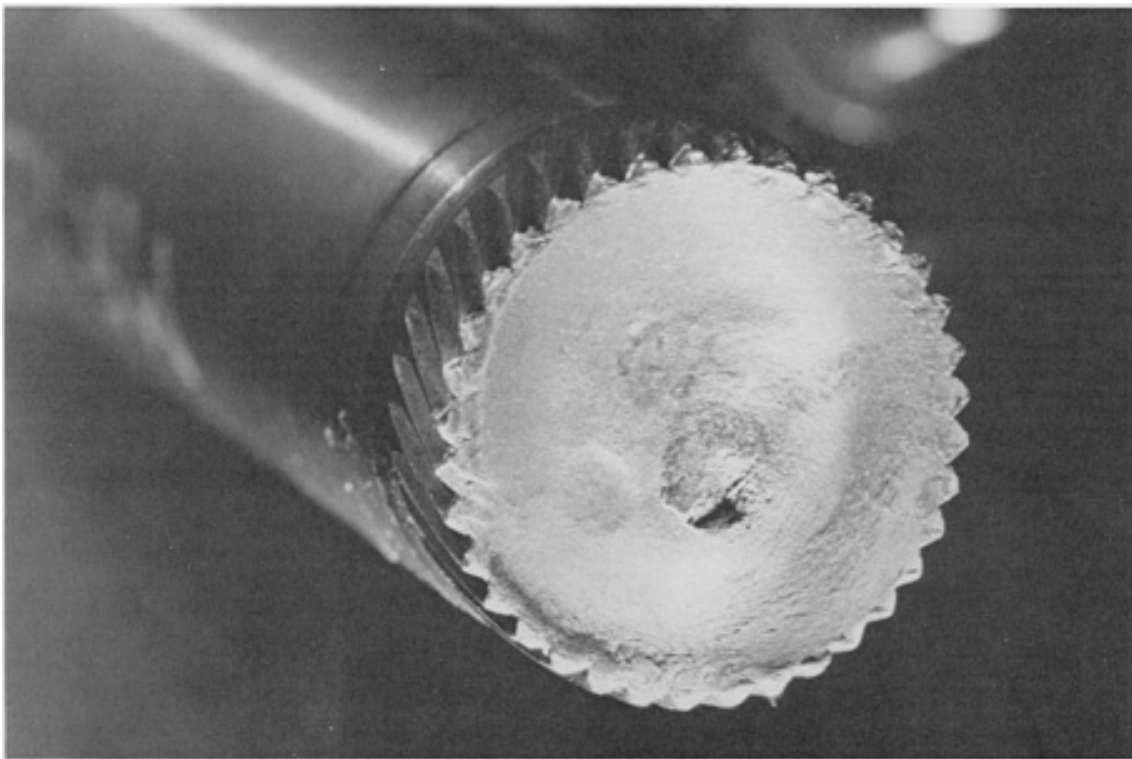
Fig. 242 Single-overload torsional fracture on transverse shear plane of a medium-carbon steel shaft of moderate hardness. Degree of torsional deformation preceding fracture is indicated by counterclockwise twisting of originally straight splines. Final rupture was slightly off-center because of the presence of a relatively low bending force in addition to the torsional force. Fracture face has been severely rubbed and distorted in a circular direction due to contact with the mating fracture surface at the moment of separation. (D.J. Wulpi, Consultant)

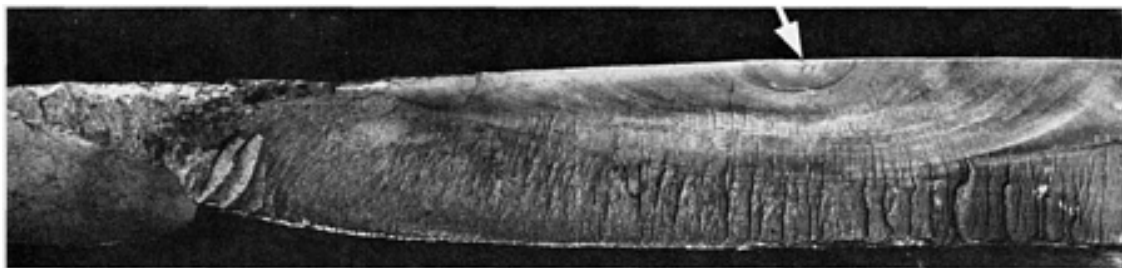
Fig. 245 Surface of a fatigue fracture that occurred, after 732 h of service, in a tooth of the induction-hardened AISI 1053 steel left-side bull gear of a tractor. Hardness of the tooth was 57 HRC at the tip and 50 HRC at a depth of 13.3 mm (0.52 in.). Hardness in the root fillet was approximately 56 HRC near the surface and 50 HRC at a depth of 11.5 mm (0.45 in.). The arrow indicates the origin of the fatigue crack. See also Fig. 246, 247, and 248. $\sim 2.5\times$

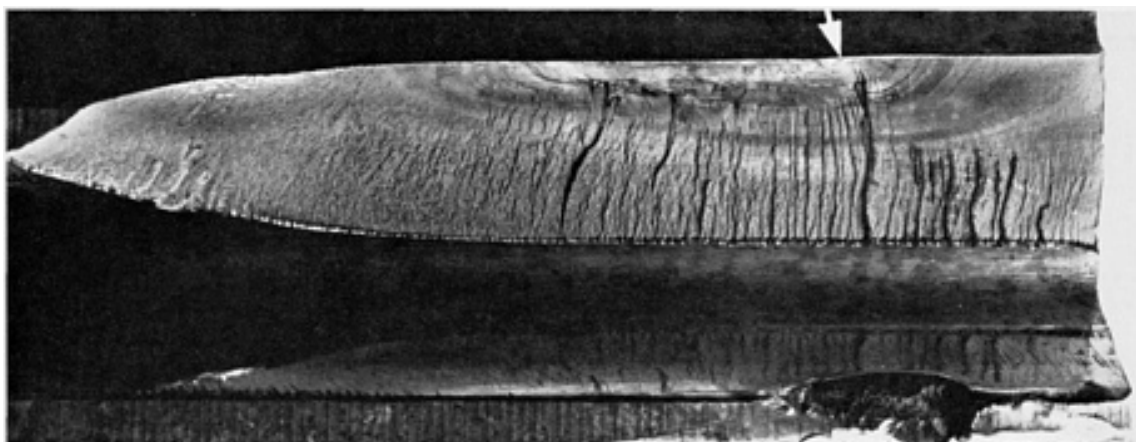
Fig. 246 Surface of a fatigue fracture (similar to that in Fig. 245) that occurred, after 841 h of service, in a tooth of the right-side bull gear of the same tractor. This gear also was made of AISI 1053 steel and induction hardened. Hardness of this gear was similar to that of the gear in Fig. 245 except that the depths at which hardness was 50 HRC were 12.2 mm (0.48 in.) below the tip of the tooth and 9.5 mm (0.37 in.) below the surface of the root fillet. The arrow indicates the fatigue-crack origin. The damage to the tooth just below the one that fractured probably resulted from jamming by a fragment from the fracture. $\sim 2.5\times$

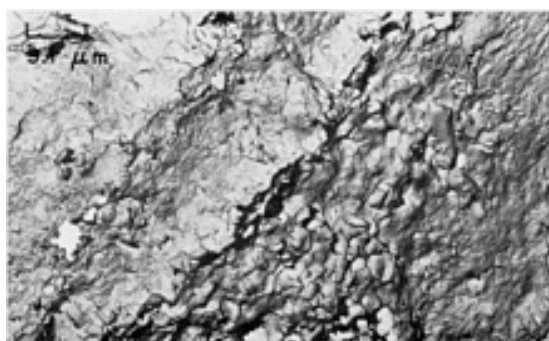
Fig. 247 Area of the fracture surface of the left-side bull gear in Fig. 245, taken near the fatigue-crack origin. Visible are several inclusions believed to have contributed to the formation of the fatigue crack. See also Fig.

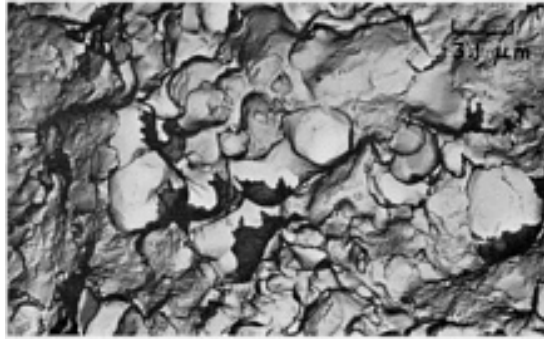
Fig. 248 Portion of the area in Fig. 247, but at higher magnification, showing the inclusions more clearly. Similar inclusions were found near the crack origin in the fracture surface of the right-side bull gear in Fig. 246. TEM p-c replica, 3200×

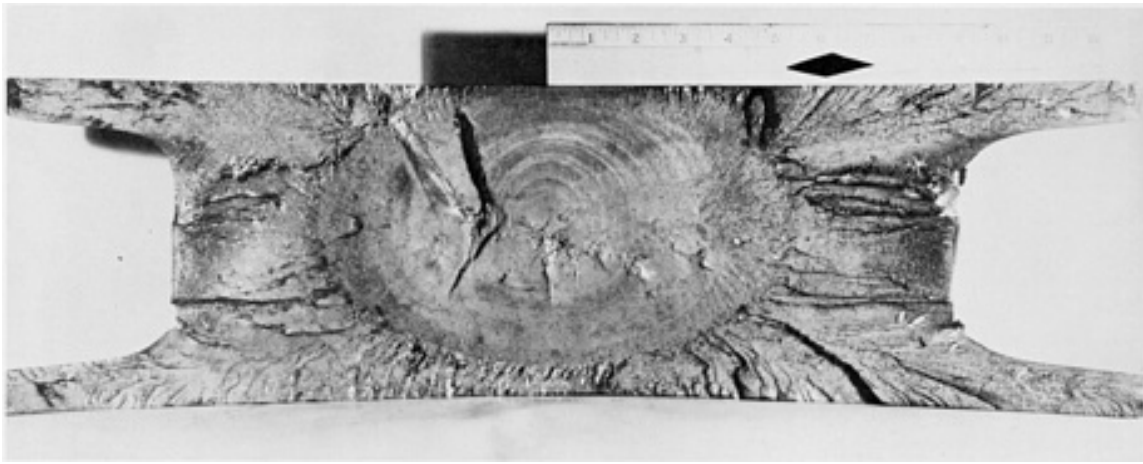
Fig. 257 Surface of a fatigue fracture that occurred, after approximately 1 year of service, in an AISI 1055 steel wheel of a 545-Mg (600-ton) stripper crane. Visible in the center of the fracture is a fatigue zone showing beach marks that are concentric around the fatigue-crack origin, which evidently was an internal flaw approximately 38 mm ($1\frac{1}{2}$ in.) beneath the wheel-tread surface. The chemical analysis of the steel was 0.60% C, 0.82% Mn, 0.009% P, 0.024% S, and 0.24% Si, which was acceptably close to specification. Note the chevron patterns in the area of final fast fracture that surrounds the fatigue zone. 0.3×

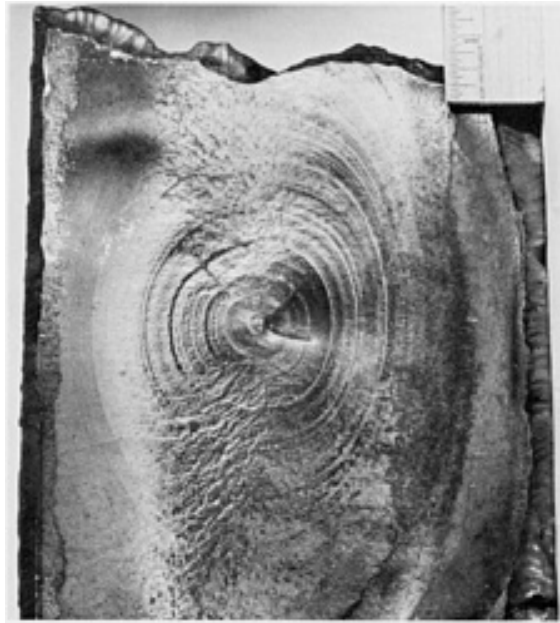
Fig. 258 Surface of a fatigue fracture that developed in the flange of an AISI 1055 steel wheel of an open-hearth crane after nearly 20 years of service. The fracture surface was exposed by arc cutting the adjacent metal. This fatigue fracture, like the one shown in Fig. 257, was initiated by an internal flaw and propagated outward radially; no external defect was found to be involved in either this fracture in Fig. 257. 0.44×

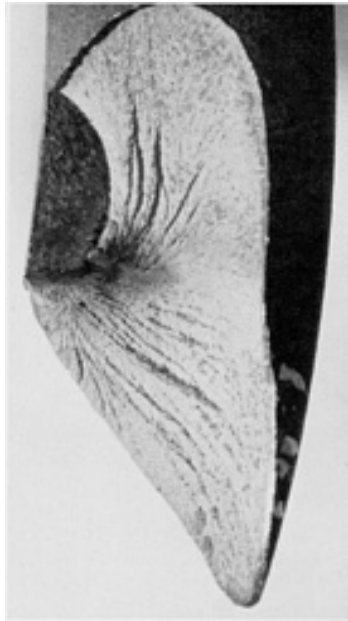
Fig. 260 Surface of a fatigue fracture in 16-mm ($\frac{5}{8}$ -in) diam spring wire of AISI 1060 steel. The crack origin, which undoubtedly was a surface flaw, generated a fatigue zone (dark area at upper left). The fatigue crack grew slowly, and beach marks became obscured by oxide. $\sim 3\times$

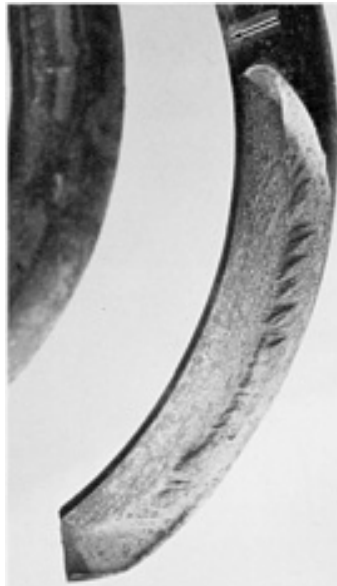
Fig. 261 Fatigue-fracture surface of a suspension spring of AISI 10B62 steel wire with a hardness of 460 HB. Note the fine seam (at arrow), which is the fatigue-crack origin. $2\times$

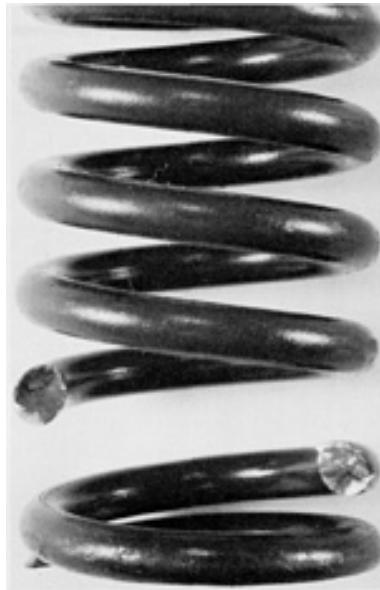
Fig. 262 Fatigue-fractured valve spring of 4.8-mm ($\frac{3}{16}$ -in.) diam AISI 1060 steel wire. The wire appears to be free of surface defects, a conclusion that is supported by the evidence in Fig. 263. 2×

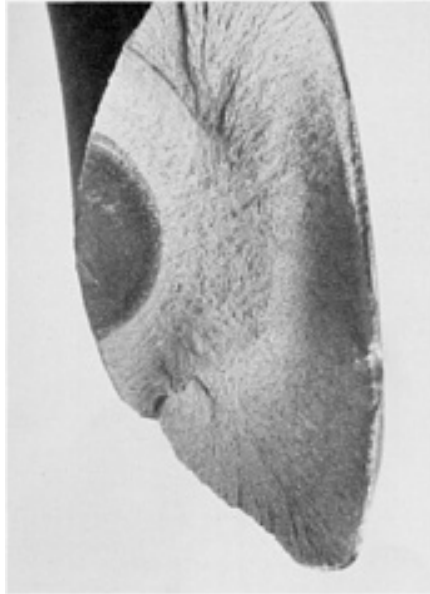
Fig. 264 Fatigue fracture in a 16-mm ($\frac{5}{8}$ -in.) diam suspension spring of AISI 10B62 steel wire. The fatigue crack probably originated at a surface defect and grew so slowly that oxidation occurred (note darkness of fatigue zone at left). 3×

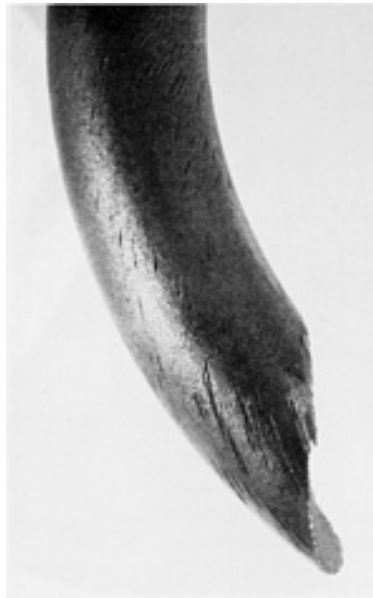
Fig. 265 Fractured 13-mm ($\frac{1}{2}$ -in.) diam spring of AISI 10B62 steel wire with a hardness of 477 HB. Note the spiral gouges, which are screw marks that were generated during coiling. See also Fig. 266. 2×

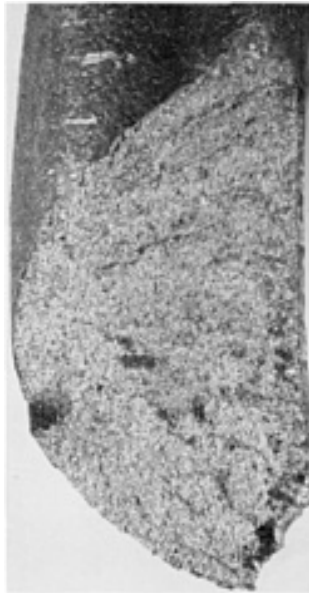
Fig. 268 Fracture surface of the spring in Fig. 267. The fatigue-crack origin is at the seam at left edge. The surface of the wire was gouged after fracture. 3×

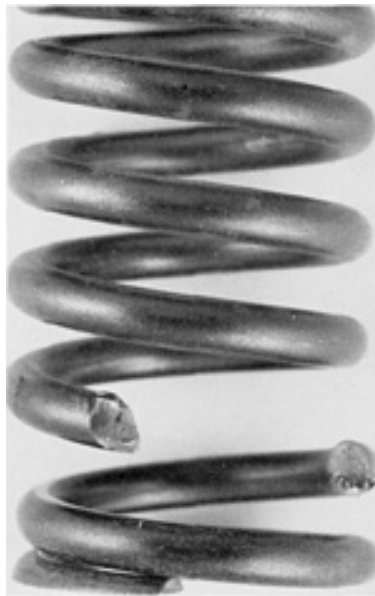
Fig. 269 Fatigue-fractured spring of 5-mm (0.200-in.) diam AISI 1060 steel wire (hardness, 43 to 48 HRC). This fracture, unlike that of the similar spring in Fig. 261, originated at the surface (see Fig. 270). 1.7×

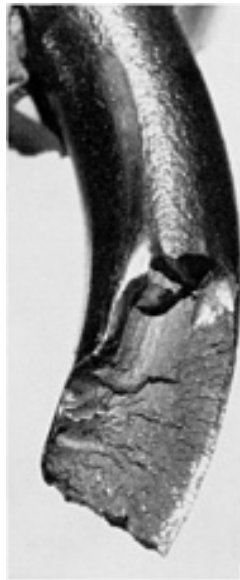
Fig. 271 Surface of a complex fatigue fracture in a valve spring formed from AISI 1070 steel wire, showing two facets at right angles. 8×

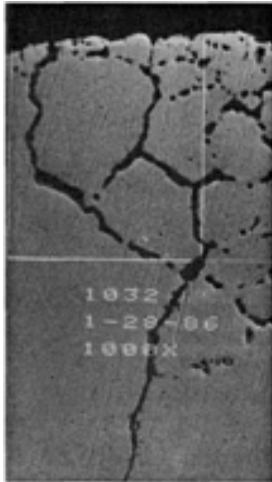
Fatigue fracture in a spring of AISI 1070 steel wire with a hardness of 54 HRC. Fig. 272: Side view of one fracture surface, deep etched to show a long seam (at arrow). 10×. Fig. 273: Frontal view of the mating fracture surface, showing the fatigue-crack origin (at right), which is at a second seam. 10×

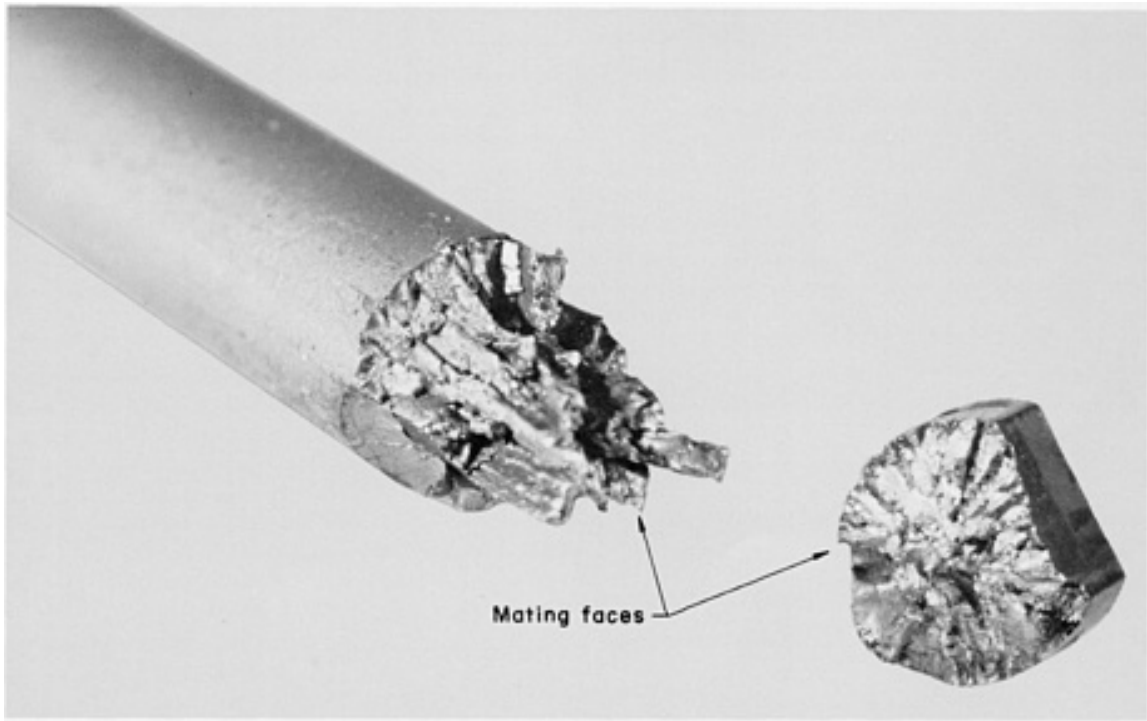
Fig. 278 Torsional fatigue fracture in an 8-mm ($\frac{5}{16}$ -in.) diam torsion bar of AISI 1070 steel that was quenched and tempered to a hardness of 45 HRC. Cracking occurred along both longitudinal and transverse shear planes. 5.6x

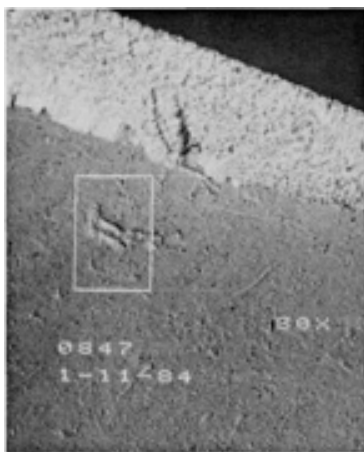
Fracture of power spring made of tempered AISI 1074. Initially, a "scab" or some other type of mechanical damage was suspected as the cause of failure because of the surface appearance of the steel. However, SEM examination revealed that fracture was due to a large nonmetallic inclusion (probably alumina, type B) located within 6 to 13 μm (0.25 to 0.50 mils) of the surface. Fig. 283: Surface of fractured power spring and portion of fracture area showing origin. Note surface damage near "C" and prominent feature, "D," at edge near fracture origin. SEM, 50×. Fig. 284: Close-up of feature at fracture edge in Fig. 283 reveals the subsurface inclusion at "D" and its effects on surface appearance ("C"). SEM, 400×. Fig. 285: Longitudinal microsection near origin. SEM, 200× (J.H. Maker, Associated Spring, Barnes Group Inc.)

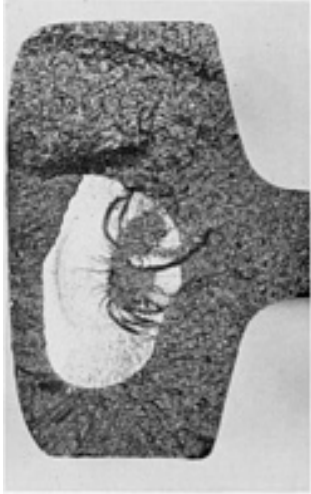
Fig. 291 Fatigue failure of flat, cantilever-type AISI 1070 spring due to inadequate removal of blanking fracture. Failure initiated at a point on the edge of the spring. SEM, 100× (J.H. Maker, Associated Spring, Barnes Group Inc.)

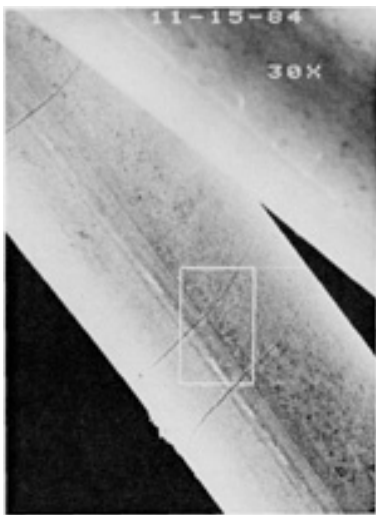
Figure 292, 293, and 294 show surfaces of "transverse fissures" that occurred in the heads of AREA 59-kg (131-lb) railroad rails made of AISI 1075 steel. All three fissures were caused by the presence of hydrogen-induced flakes (or "fisheyes"), which appear as dark gray areas within the bright zones. These bright zones are fatigue cracks that were initiated by the flakes. Beach marks are visible in the fatigue zones, particularly near the initiations of final fast fracture. Figure 295 shows the surface of a longitudinal fracture in an AREA 59-kg (131-lb) rail of AISI 1075 steel that had been hydrogen embrittled. That white arrowhead points to an unusually large nonmetallic stringer that acted as a site for hydrogen segregation. All shown at actual size

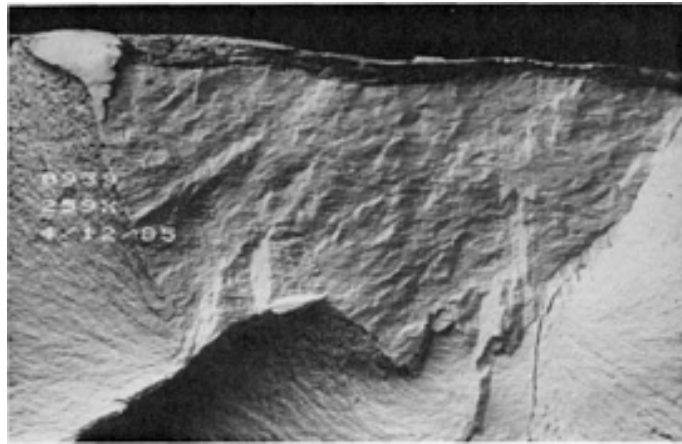
Fig. 305 Fatigue failure of an automotive engine valve spring made of a steel similar to ASTM A230. The spring was shot peened; service stresses were very high. Cause of fracture was a seam 15 μm (0.5 mils) deep. The surface defect initiated a longitudinal shear crack that propagated to a depth of 75 to 100 μm (3 to 4 mils), where the crack root then induced stage I fatigue. SEM, 250 \times (J.H. Maker, Associated Spring, Barnes Group Inc.)

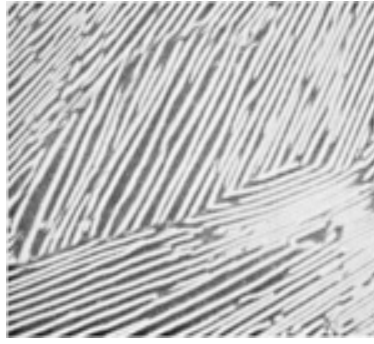
Fig. 316 Photomicrograph shows typical lamellar pearlite structure in railroad rail steel (0.69 to 0.82% C). The interlamellar spacing is approximately 300 nm. This structure is sometimes mistaken for fatigue crack growth striations in SEM and TEM fractographs (see Fig. 311, 312, 313, 314, and 315). 5000× (J.M. Morris, U.S. Department of Transportation)

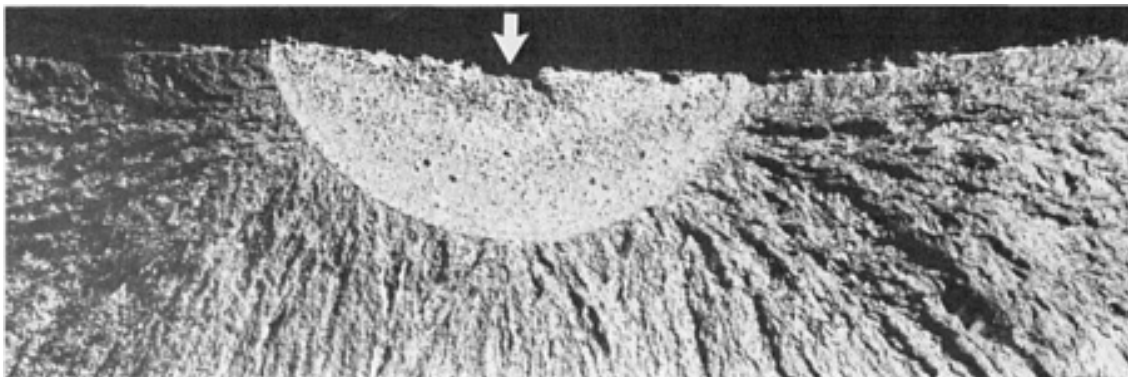
Fig. 319 Fracture due to corrosion fatigue of a 115-mm (4.5-in.) diam API 5A, grade E, seamless drill pipe. The fine-grained 0.4C-Mn alloy steel (~AISI 1340) was used in the normalized condition in an oil-field application where chlorides and sulfides were present in the strata being drilled. Fracture initiated at a corrosion pit (arrow) on the inside diameter of the pipe. 5.5× (E.V. Bravenec, Anderson & Associates, Inc.)

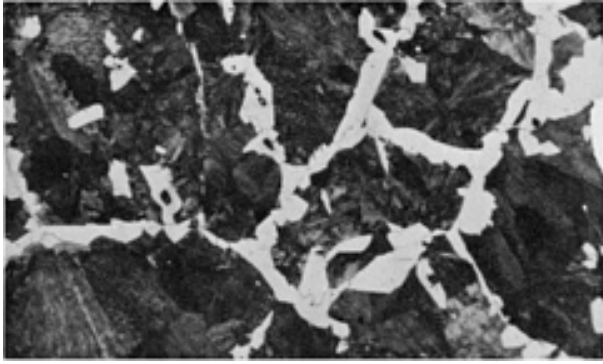
of shaft. Failure mode is brittle fracture. Note river patterns. SEM, 100×. Fig. 322: Fractograph of near-surface region of shaft. Failure mode: dimple rupture. SEM, 100× (R.W. Bohl, University of Illinois)

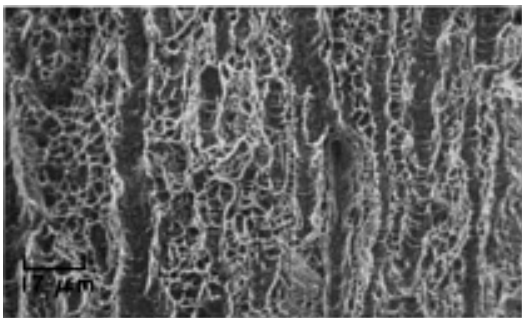
Metallographic study of hitch post shaft failure in Fig. 320, 321, and 322. All etched in 2% nital. Fig. 323: Coarse, as-forged structure of AISI 4130 shaft. 100×. Fig. 324, 325, 326, and 327: Microstructures at increasing depths beneath surface of fractured shaft. Gradual coarsening is evidence of superficial austenitization. Fig. 324: 4 mm (0.15 in.). 150×. Fig. 325: 11 mm (0.45 in.). 150×. Fig. 326: 30 mm (1.2 in.). 150×. Fig. 327: 75 mm (3 in.). 225× (R.W. Bohl, University of Illinois)

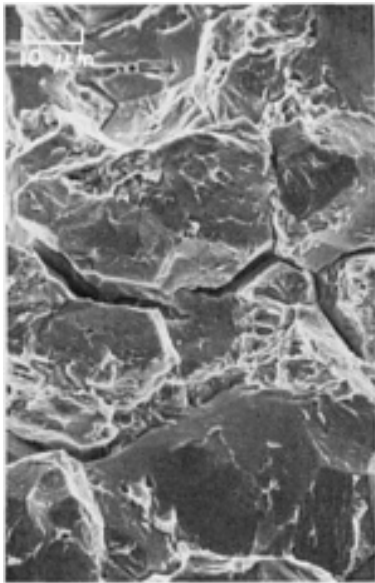
Two SEM views, at different magnifications, of the surface of a fracture in a specimen of AISI 4130 steel that was austenitized at 845 °C (1550 °F), oil quenched, and tempered for 2 h at 250 °C (480 °F). The fracture was produced in a toughness test in air; the rate of crack growth was in the range of rapid, unstable fracture. Dimples in an extremely wide variety of sizes and channels formed by linear coalescence of voids are evident. See Fig. 330, 331, 332, 333, 334, and 335 for the fracture behavior of this material when tested in a hydrogen atmosphere. Fig. 328: 600×. Fig. 329: 2400×

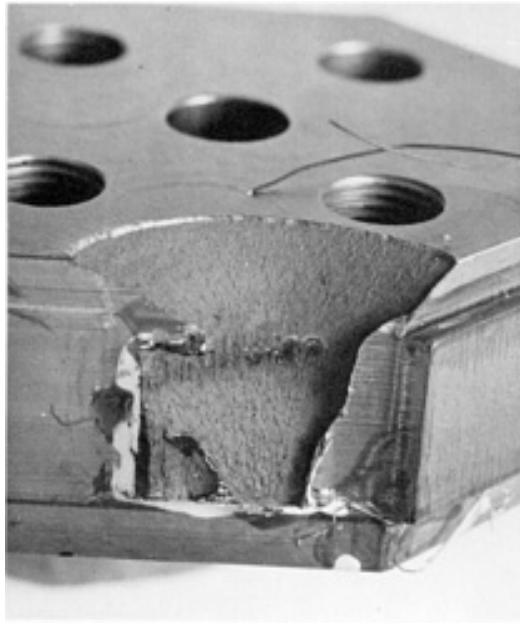
Fig. 336 Fracture surface of a broken AISI 4140 steel load cell. The radial marks indicate that two crack origins formed at the bottom surface of the cell, apparently near the toe of a weld. Note the continuous shear lip around the top edge. See also Fig. 337 and 338. Actual size

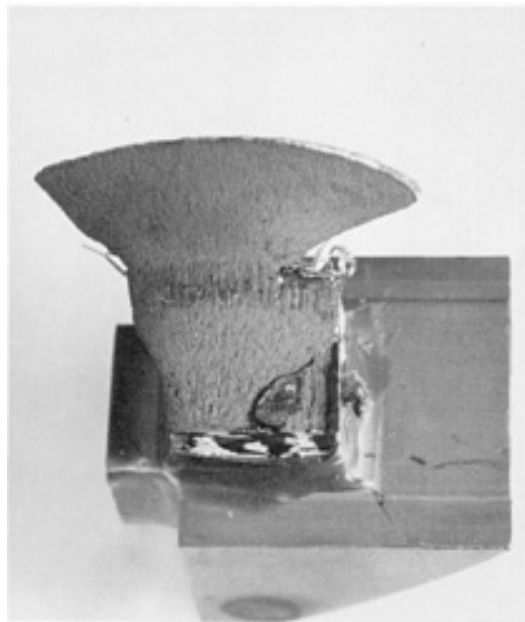
Fig. 337 Mating fracture surface to that shown in Fig. 336. There appears to be no evidence of fatigue marks; however, fatigue cracking may have taken place within a very small area at the crack origins. Fracture was evidently caused by a sudden overload. See also Fig. 338. Actual size

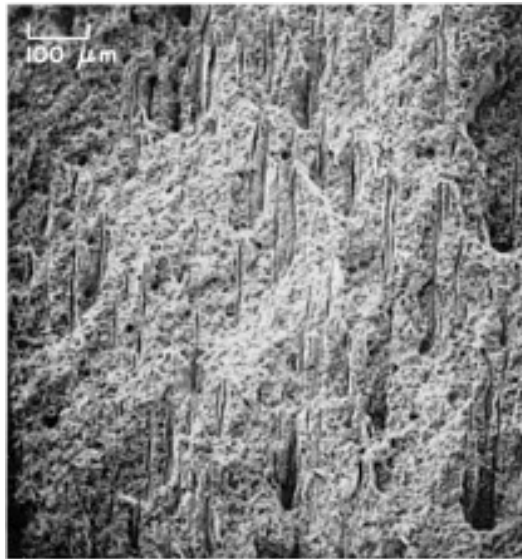
Fig. 338 Magnified view of the fracture surface in Fig. 336, taken at an area away from the edge, and showing the dimples that are typical of transgranular fast fracture. Vertical marks are sulfide stringers. SEM, 100 \times

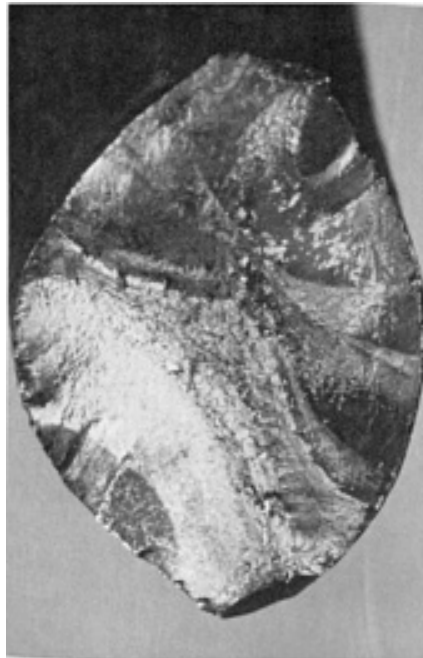
Fig. 341 Surface of a fatigue fracture in a suspension component of AISI 4140 steel heat treated to a hardness of 273 HB. Two fatigue zones are evident, at lower left and at upper right; the remainder of the fracture surface is the zone of final fast fracture. 5×

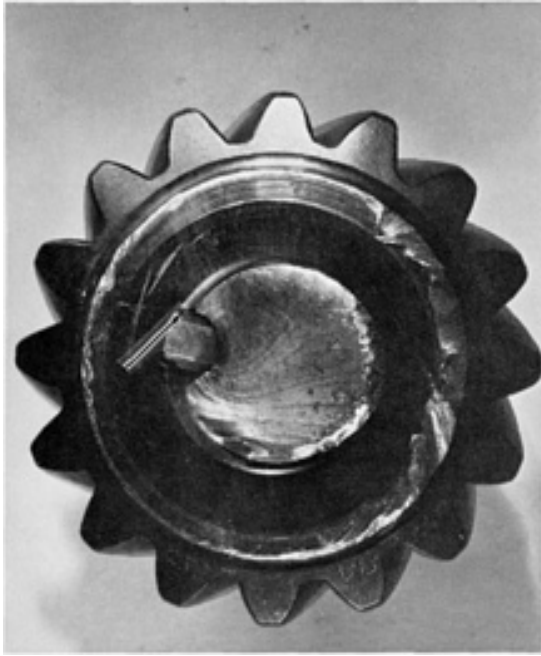
Figure 343 is a view of the threaded end of the fractured shaft in Fig. 342, after removal of the pinion gear. Figure 344 is a view of the bore of the pinion gear. Both photographs display severe galling damage of the contacting surfaces, which resulted in the gear being frozen on the shaft; the gear was removed by cutting through it from both sides. The appearance of the gouge marks indicates that most of the galling damage was done in forcing the gear onto the shaft. Figure 343 also shows a keyway and an oblique view of a fracture surface; the fracture originated at a location on the keyway edge that is not visible here. Both at 5×

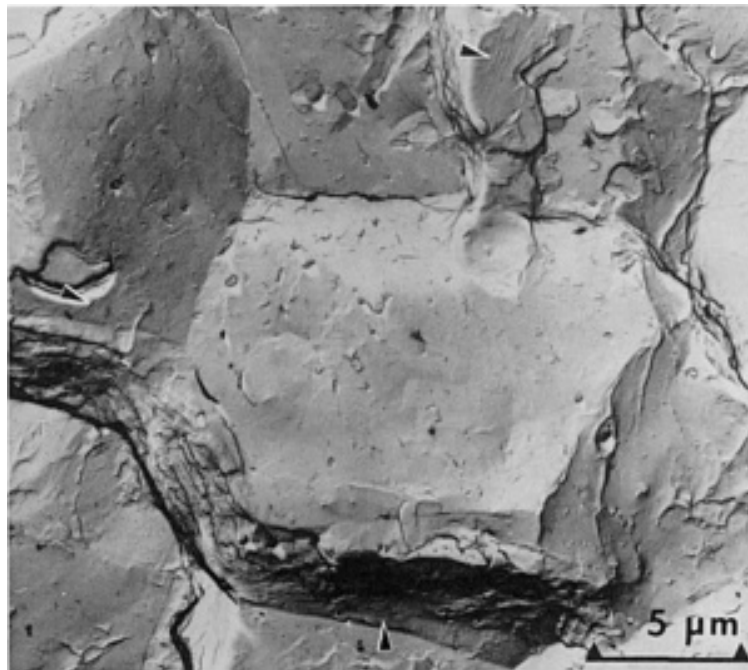
Fig. 347 Fatigue fracture along prior-austenite grain boundaries in as-quenched AISI 4140. Note striations (arrows) at places where the crack met grain-boundary carbides. TEM replica, 5000 \times (I. Le May, Metallurgical Consulting Services Ltd.)

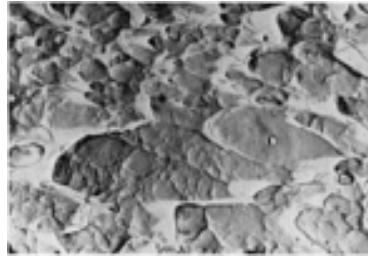
Fig. 354 Ductile fracture of quenched and tempered AISI 4140 showing elongated dimples on fracture surface. Dimple shape is related to mode of fracture--in this case, either shearing or tearing. Matching replicas from adjacent surfaces are needed to distinguish between the two. TEM replica, $8000\times$ (I. Le May, Metallurgical Consulting Services Ltd.)

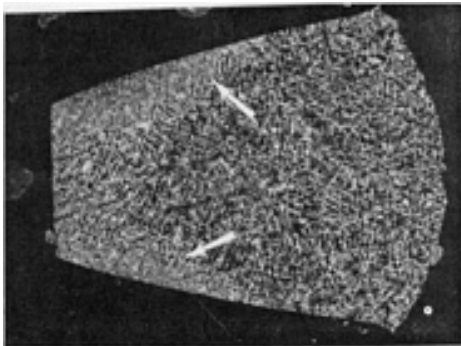
Fatigue fracture of AISI 4140 bull gear due to improper heat treatment. The one-of-a-kind replacement gear had a service life of just 2 weeks. Heat treatment did not produce full hardness in gear teeth. Hardness at tooth face, 15 HRC; at tooth core, 82 HRB. Fig. 357: Outside diameter of gear showing where teeth broke off. Fatigue pattern on fracture surfaces is typical of reversed bending even though the gear was driven in only one direction. 0.6×. Fig. 358: Fracture surfaces of four teeth. Fatigue cracks propagated from both roots of each tooth. Arrows point to area of final overload on one tooth. 0.84× (Z. Flanders, Packer Engineering Associates, Inc.)

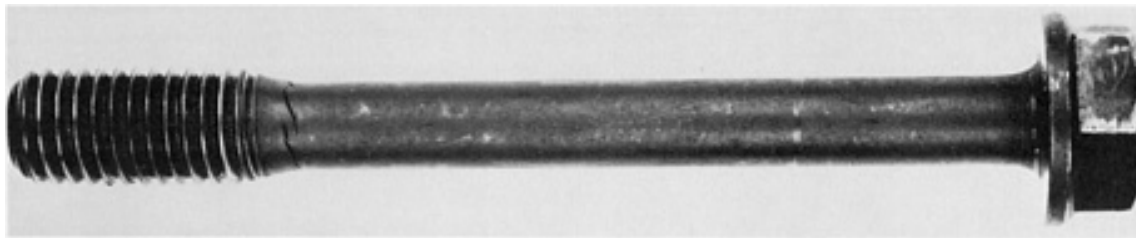
Structure of fractured tooth from AISI 4140 bull gear in Fig. 357 and 358. Fig. 359: Tooth cross section. Arrows show depth to which temperature exceeded A_{c1} during heat treatment. Fig. 360: Near-surface hardened region of tooth. Large ferrite indicates that complete austenitization was not obtained during heat treating. 2% nital, 200× (Z. Flanders, Packer Engineering Associates, Inc.)

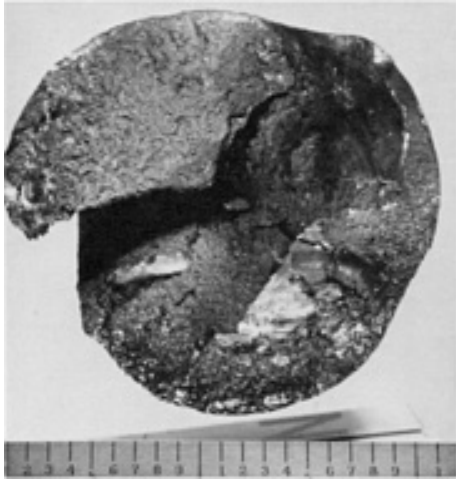
Fractographic analysis of sulfide stress-corrosion failures of bearing cap bolts in Fig. 361, 362, and 363. Although this analysis is of a failure induced in the laboratory, the mode is very similar to that of bolts that failed in engines. Fig. 364: Failure origin area with intergranular fracture continuous to the surface. SEM, 620 \times . Fig. 365: Approximately 0.4 mm (0.015 in.) from origin. Mode of crack propagation is intergranular. Note corrosion products and secondary cracking. TEM replica, 1560 \times . Fig. 366. Nonembrittled area in overload region exhibits primarily a dimpled-rupture mode of fracture. TEM replica, 3240 \times (R.D. Zipp, J.I. Case, a Tenneco Company)

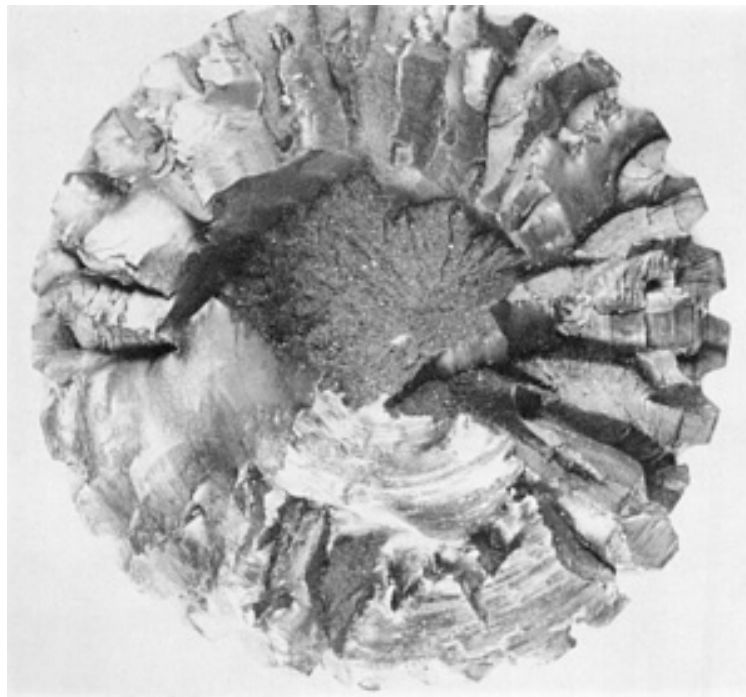
Fig. 375 Reversed torsional fatigue fracture of splined shaft due to overtempering. The SAE 4150 part was oil quenched and tempered to 34 HRC throughout--a hardness too soft for the application. Note the "starry" pattern characteristic of multiple fatigue cracks. 3.5 \times (D. Roche and H.H. Honegger, California Polytechnic State University)

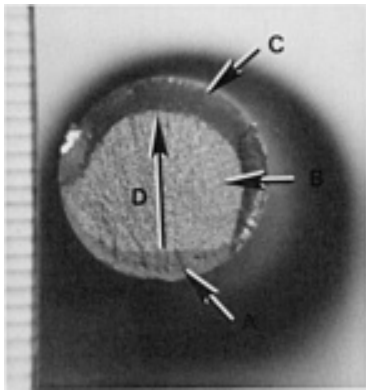
How hydrogen damage affects fracture in AISI 4340. Shown are side views (Fig. 378) and fracture surfaces (Fig. 379) of 13-mm (0.505-in.) diam tensile specimens. Specimen A was tempered at 400 °C (750 °F) for 114 min in argon. Note specimen B's more ductile behavior in the tensile test. See also Fig. 380, 381, 382, 383, and 384. Both at actual size (S. Harding and S.W. Stafford, University of Texas)

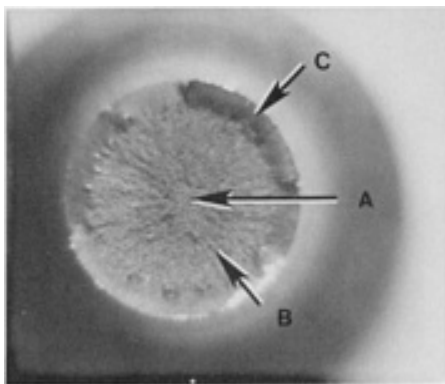
Fractographic analysis of AISI 4340 specimen tempered in hydrogen (specimen A) in Fig. 378 and 379. Fig. 380: Fracture surface showing region of ductile crack growth and crack initiation site (A), region of rapid crack growth indicated by presence of radial lines (B), a shear lip (C), and the direction of crack propagation in the region of rapid crack growth (arrow D). 2.5 \times . Fig. 381: Fractograph of region of subsurface crack initiation (B in Fig. 380). Note large transgranular crack and very small dimples. SEM, 550 \times . Fig. 382: Fractograph reveals predominantly cleavage (transgranular) rupture (facet indicated by arrow) in hydrogen-embrittled specimen of AISI 4340. SEM, 220 \times (S. Harding and S.W. Stafford, University of Texas)

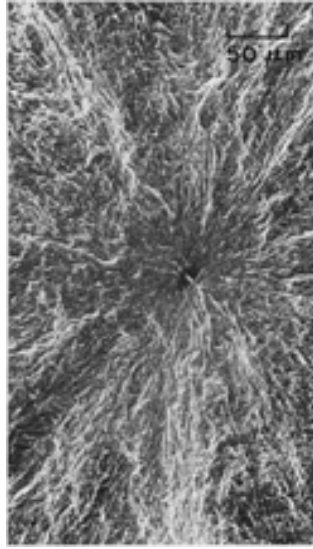
Fig. 386 A higher-magnification view of the center of the "star" in Fig. 385, showing the inclusion (dark, at center) that initiated the crack. Fine radial marks are evident. See also Fig. 387. SEM, 200 \times

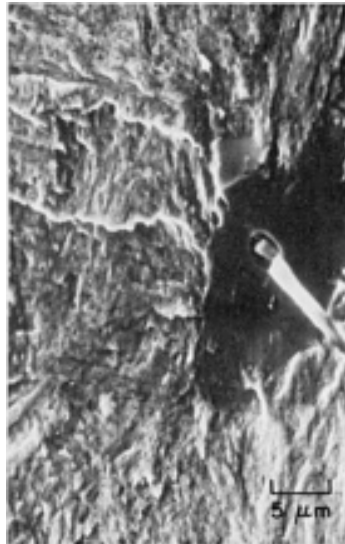
Fig. 387 Higher-magnification view of the inclusion (fracture origin) shown at center in Fig. 386. Little evidence of fatigue striations is found this close to the origin. See also Fig. 388. SEM, 2000 \times

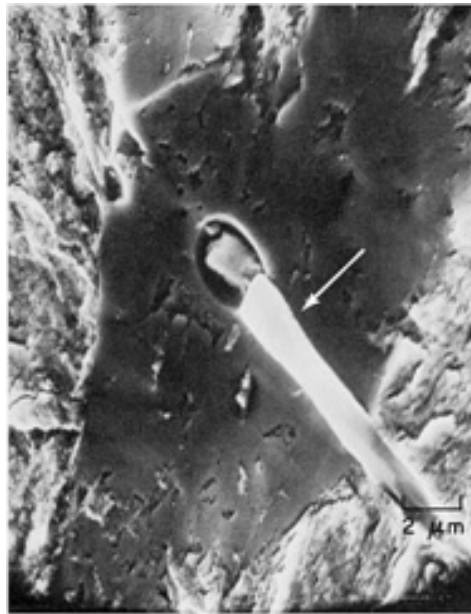
Fig. 388 View, at still higher magnification, of the inclusion in Fig. 386 and 387, showing that the inclusion was fractured by cleavage. The cleavage surface bears a bright metal silver (at arrow). SEM, 5000×

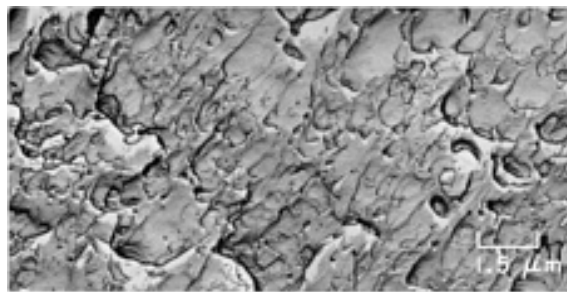
Fig. 391 Surface of a fracture in an unnotched specimen of AISI 4340 steel that was broken in tension overload, displaying elongated and quite flat shear dimples. Note that some crude steps have formed, which suggests that there may have been some degree of pulsation in the applied stress during testing. TEM p-c replica, 6500×

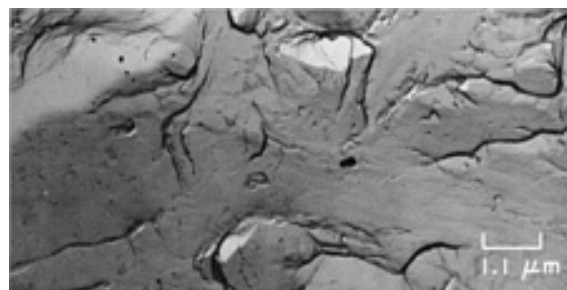
Fig. 392 Surface of a fracture in a notched specimen of AISI 4340 steel that was broken in tension overload, showing scattered dimples. It is not certain whether the remainder of the surface in this area consists of quasi-cleavage facets or of large dimples that have undergone appreciable stretching. TEM p-c replica, 9300×

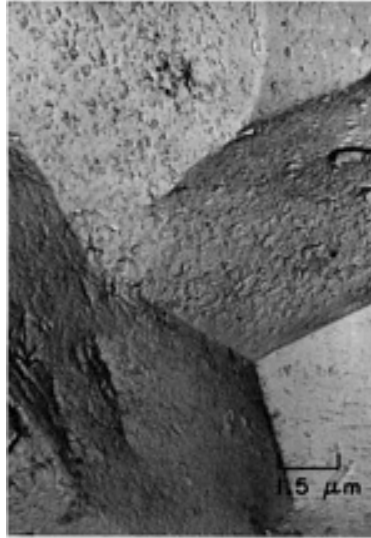
Fig. 398 TEM p-c replica taken from area A (the quench-crack crescent) in the impact fracture surface shown in Fig. 397. Here, the crack is completely intergranular in nature, having faithfully followed the grain interfaces. Traces of oxidation are evident. See also Fig. 399 and 400. 6500 \times

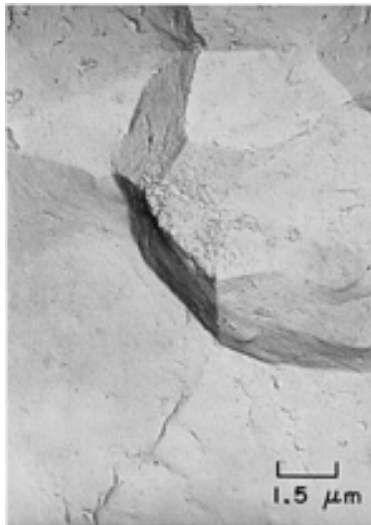
Fig. 399 TEM p-c replica from a different region in area A (the quench-crack crescent) in the fracture surface shown in Fig. 397. Here, as well as in Fig. 398, the crack path has been along the grain interfaces. Scattered marks here resemble the hairline indications associated with either hydrogen embrittlement or stress-corrosion cracking. 6500 \times

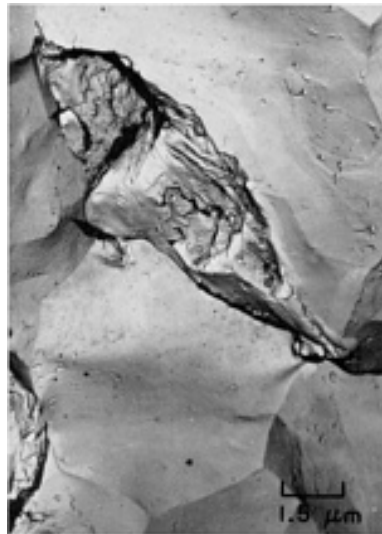
Fig. 400 TEM p-c replica taken near the root of the quench crack, marked A, in Fig. 397. In addition to separated-grain facets, localized regions of transgranular tearing are visible. The grain facets are clean of oxidation, although they display a few hairline indications. 6500×

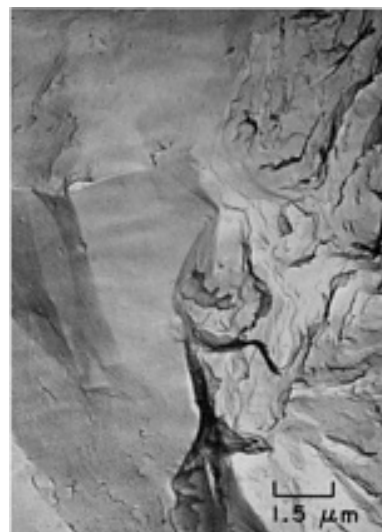
Fig. 401 TEM p-c replica taken at the root of the quench crack, marked A, in Fig. 397, and the beginning of the impact fracture, marked B there. At left are the last vestiges of intergranular cracking, and at right is the beginning of quasi-cleavage cracking in this very brittle specimen. 6500×

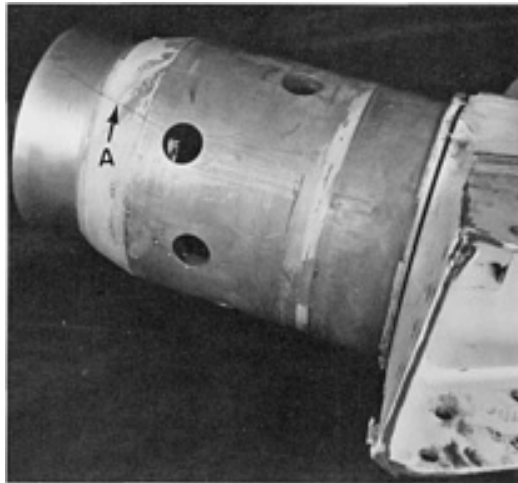
Fig. 403 View of an aircraft horizontal tail-actuator shaft that was found during a preflight inspection to contain several cracks (one is shown at A). The shaft was forged from AISI 4340 steel, was heat treated to a minimum tensile strength of 1793 MPa (260 ksi) and a hardness of 50 to 53 HRC, and then was vacuum cadmium plated. Cracks were attributed to hydrogen embrittlement. See also Fig. 404, 405, 406, 407, 408, 409, 410, 411, and 412. 0.5×

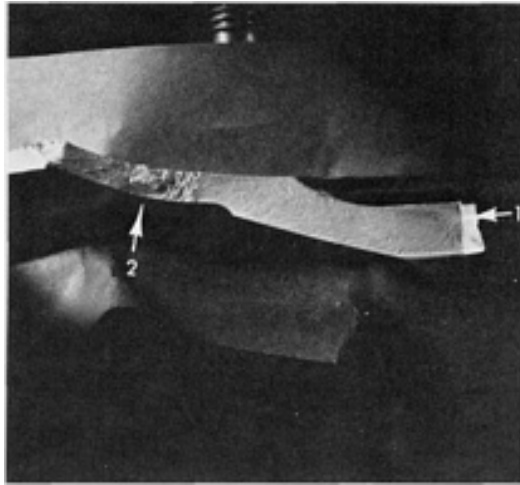
Fig. 404 Surface of the crack visible at A in Fig. 403, opened for examination, showing two internal points of crack nucleation, which are marked 1 and 2 and are shown at higher magnification in Fig. 405 and 406. Neither this crack nor any other crack found in this shaft or in companion shafts showed evidence of the corrosion products (red rust) that would be expected if stress corrosion had been involved. Actual size

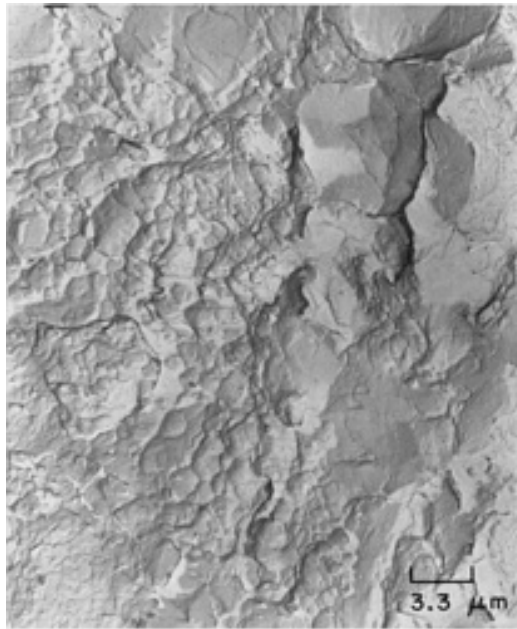
Fig. 407 TEM p-c replica of a region near the right edge of the fracture surface in Fig. 405, showing a transition from intergranular facets (at right) to dimples (at left). This transition is typical of all cracks in the actuator shaft that originated near holes, in each instance, transition occurred at 0.5 to 1.8 mm (0.02 to 0.07 in.) from the edge of the hole. 3000×

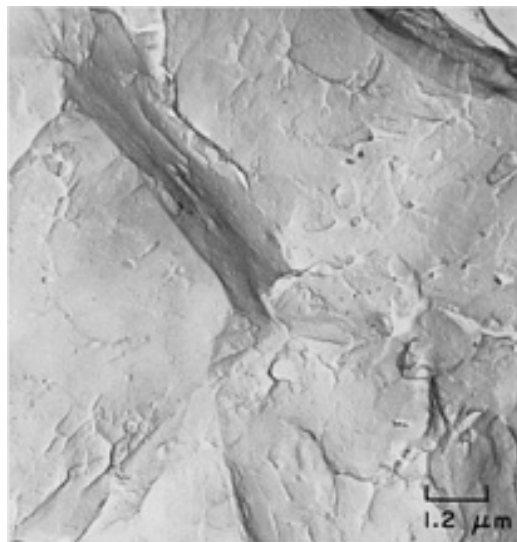
Fig. 408 TEM p-c replica of a region centered on the crack-nucleation point visible near the right edge of the fracture surface shown in Fig. 405. The surface is intergranular and free of corrosion products, which is consistent with fracture caused by hydrogen embrittlement. 8000×

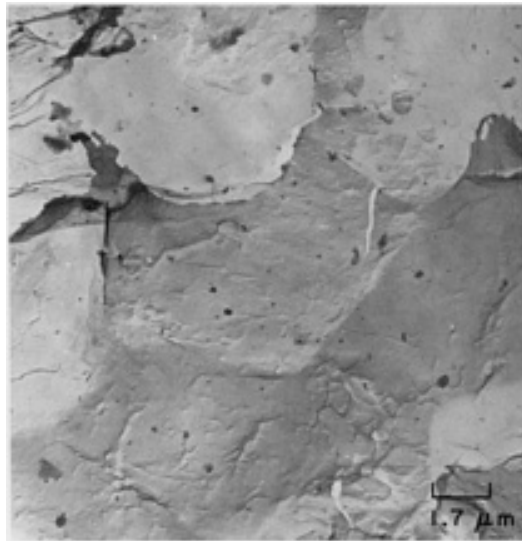
Fig. 409 TEM p-c replica of a region containing the crack-nucleation site near point 2 in Fig. 404. The features that are visible in this region are the same as those in the region shown in Fig. 408, which further indicates that hydrogen embrittlement caused the cracks. 6000×

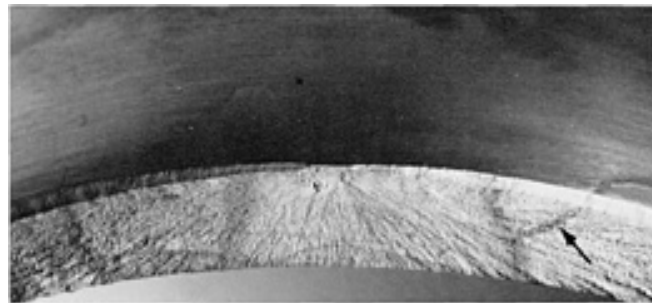
Fig. 413 Surface of a low-cycle fatigue fracture in an aircraft landing-gear cylinder made of AISI 4340 steel that was hardened and tempered to a tensile strength of 1793 to 1931 MPa (260 to 280 ksi). The cylinder was stressed in the laboratory to its tensile strength four times and broke at a stress of 1103 MPa (160 ksi) during the final loading. Note the secondary crack (arrow) to the right of the crack origin (at center), representative of many that extended completely through the wall of the cylinder. See also Fig. 414, 415, 416, and 417. 2×

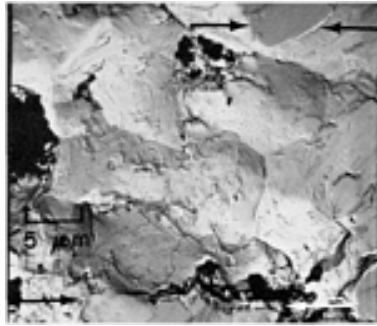
Fig. 415 TEM p-c replica of a portion of the surface crack in Fig. 414, where fracture originated. Note rubbed areas between arrows. The facets are intergranular; the opaque particles lie 0.05 to 0.075 mm (0.002 to 0.003 in.) below the outer surface of the cylinder. 2000×

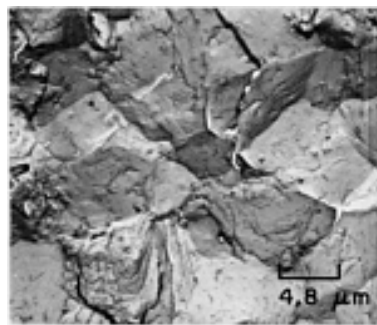
Fig. 416 TEM p-c replica of the fracture surface in Fig. 414, showing a region 0.25 mm (0.01 in.) below the outer surface. The mixture of intergranular facets and dimples shown here is typical of some plane-strain fracture surfaces in AISI 4340 steel. 2100×

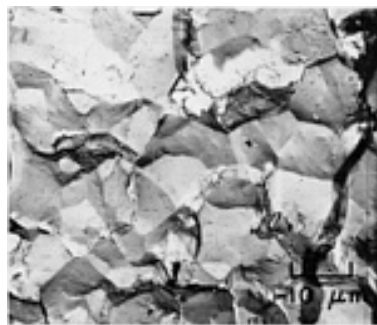
Fig. 417 TEM p-c replica of the fracture surface in Fig. 414, showing a region at the bottom of a depression directly below the surface crack. In this entire area of projections and depressions (see Fig. 414), fracture was completely intergranular. 1000×
