به نام خدا

مرکز دانلود رایگان
مهندسی متالورژی و مواد

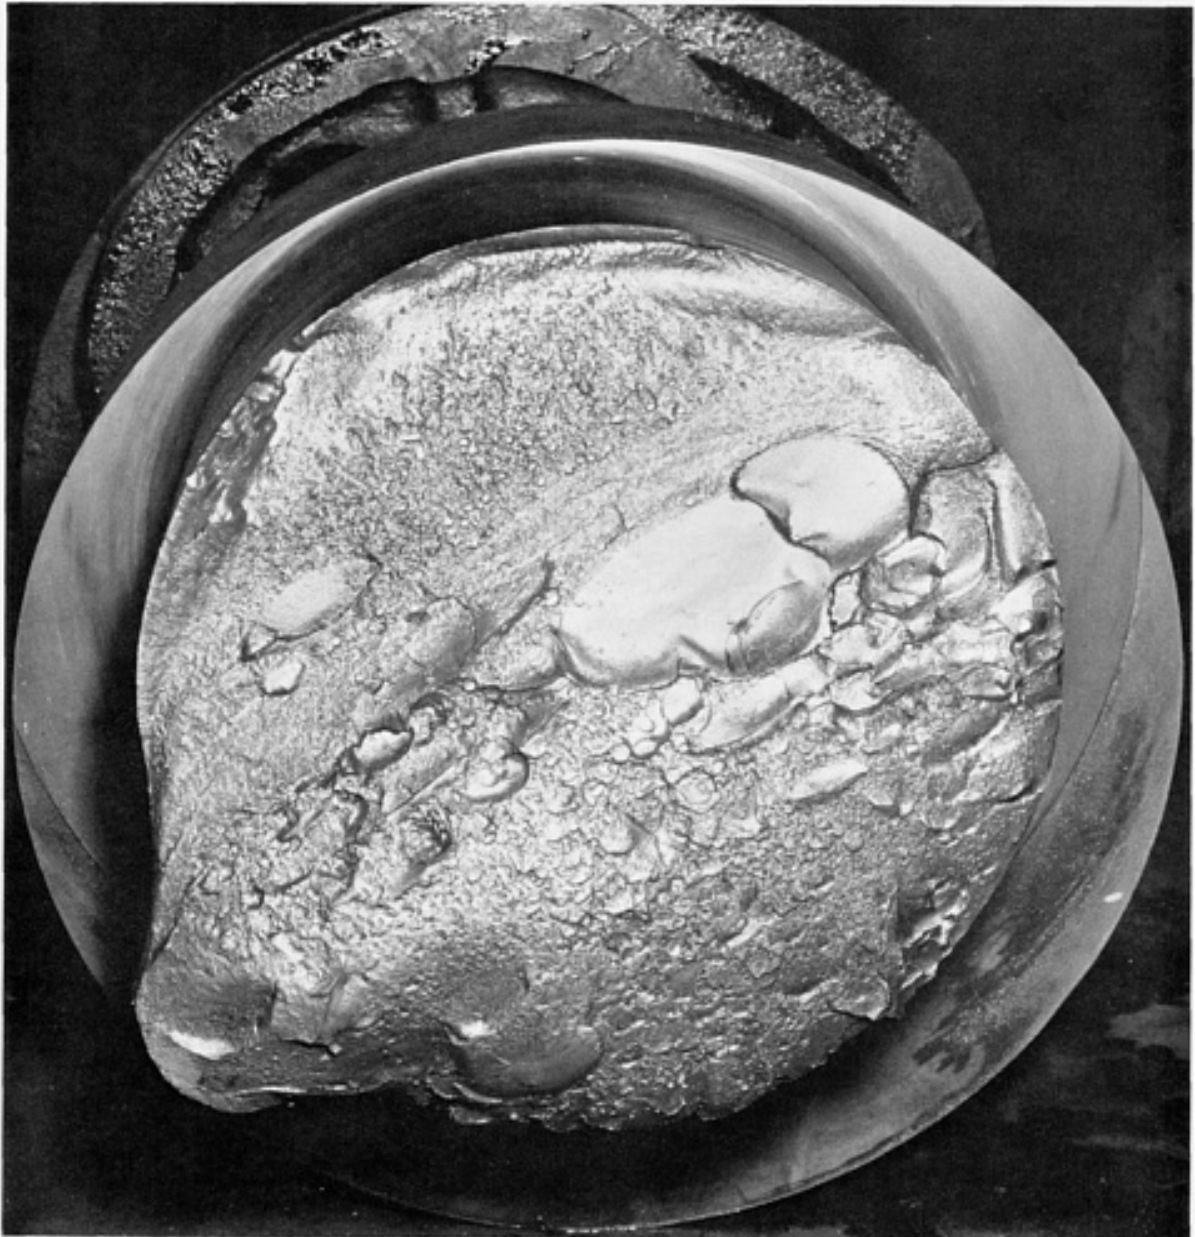
Fig. 421 Surface of a fatigue fracture through a journal of a crankshaft for a 150-mm (6-in.) upsetting machine. The crankshaft was forged of AISI 4340 steel and was normalized to a yield strength of 593 MPa (86 ksi), a tensile strength of 807 MPa (117 ksi), 20.5% elongation, and a hardness of 232 HB. Specimens cut from the crankshaft and reheat treated in exact accordance with prescribed practice had a tensile strength of 945 MPa (137 ksi), 18% elongation, and a hardness of 277 HB. The increased tensile strength and hardness indicate that the original heat treatment of the crankshaft was improper and led to a short fatigue life. See Fig. 422 for a view of the mating fracture surface. Actual size

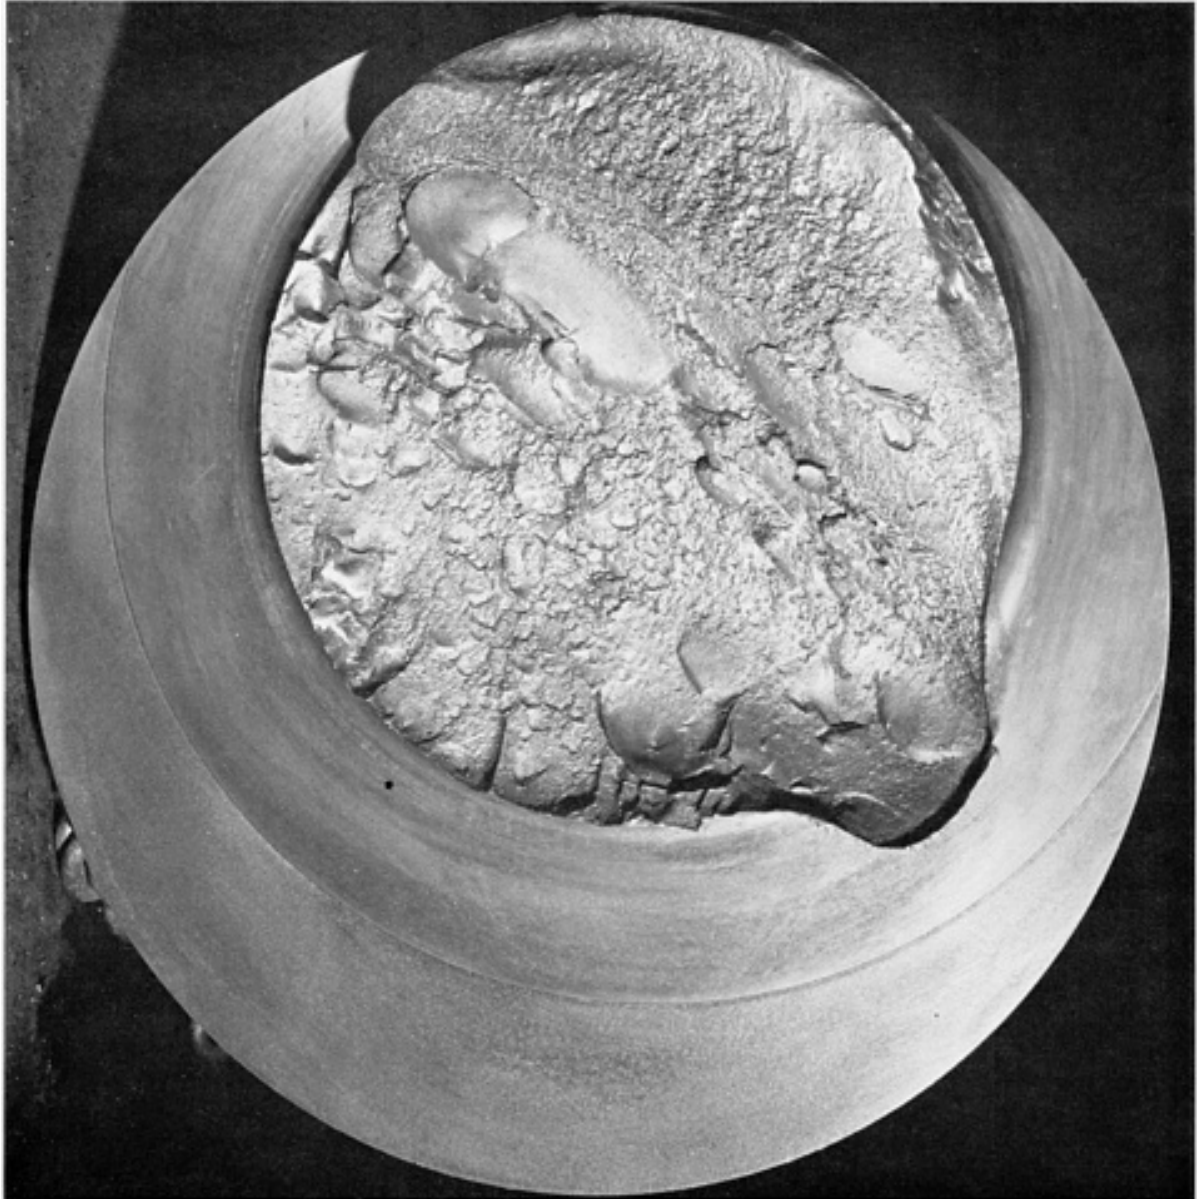
Fig. 422 View of the mating fracture surface to that shown in Fig. 421. The illumination here is at a different angle from that in Fig. 421, with the result that in some locations it is difficult to determine which of the features are projections and which are depressions. It appears likely that there were several fatigue-crack nuclei around the journal perimeter; the principal nucleus probably was in the rubbed area at upper right here (upper left in Fig. 421). There is a possibility that the crankshaft contained forging flakes and that some of these flakes were exposed during machining of the journal and initiated the fatigue cracks. 0.88×

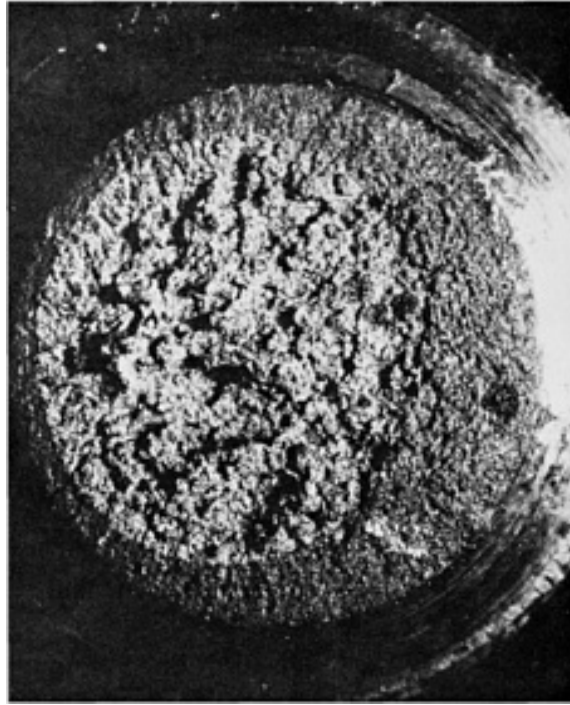
Fig. 427 Surface of a tension-overload fracture in another notched specimen of AISI 4340 steel, the same as in Fig. 426, but tested at $-120\text{ }^{\circ}\text{C}$ ($-185\text{ }^{\circ}\text{F}$). Two distinctly different fracture-surface zones are visible; a fibrous zone, which originated at the notch, surrounds a radial region of final fast fracture. $17\times$

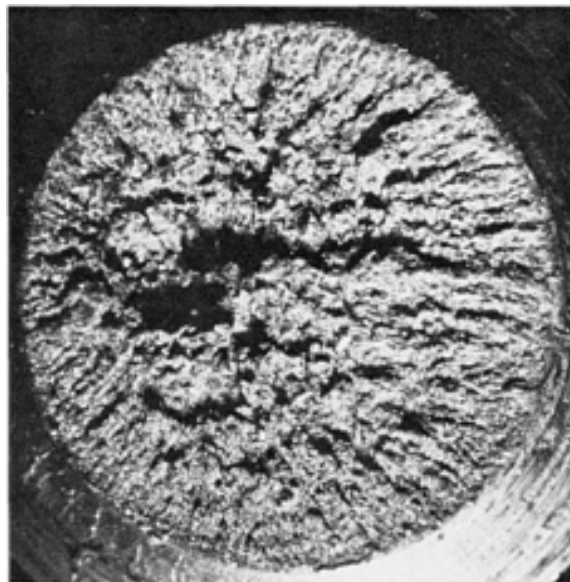
Fig. 428 Surface of tension-overload fracture in a third notched specimen of AISI 4340 steel, the same as those in Fig. 426 and 427, but tested at $155\text{ }^{\circ}\text{C}$ ($-245\text{ }^{\circ}\text{F}$). At this low test temperature, a completely radial fracture was produced. The surface shows no fibrous zone, only radial marks. $17\times$

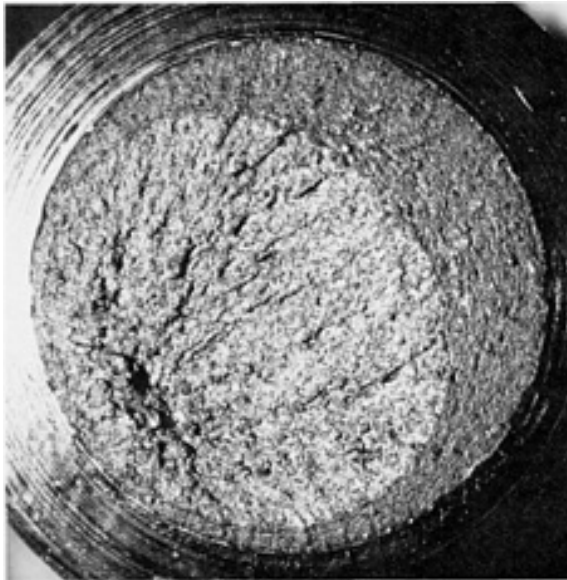
Fig. 430 Surface of a tension-overload fracture in a notched specimen of AISI 4340 steel the same as the specimen shown in Fig. 429, but tested at $80\text{ }^{\circ}\text{C}$ ($-110\text{ }^{\circ}\text{F}$). A fibrous zone, which originated at the notch, surrounds a radial zone, which is off-center because of nonsymmetrical crack propagation. $17\times$

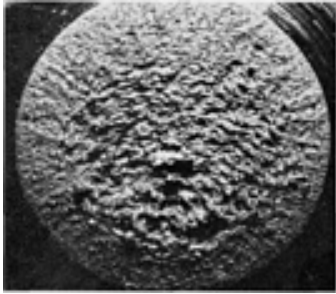
temperatures indicated beneath the fractographs. The specimen shown in Fig. 435 was broken at 0 °C (32 °F) but, in contrast to the specimen in Fig. 434, which was tempered at 315 °C (600 °F), yielded a completely fibrous fracture. The fracture shown in Fig. 436 which was produced at -80 °C (-112 °F), shows a fibrous rim surrounding a zone of radial marks. The fracture shown in Fig. 437, which was produced at -196 °C (-321 °F), shows only radial marks. All at 8×

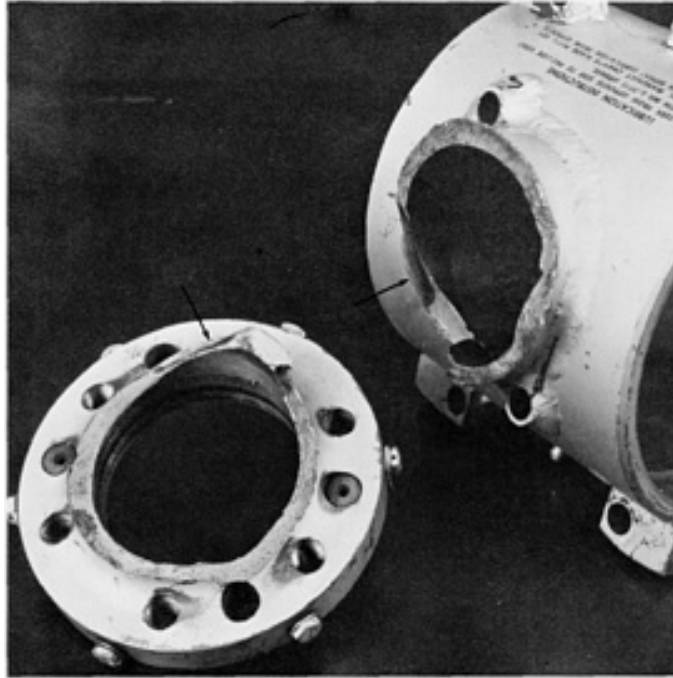
Fig. 449 Mating segments of an aircraft propeller hub of quenched and tempered AISI 4340 steel that broke by fatigue, showing both surfaces of the fracture, which occurred at the welded joint between the barrel of the hub and the fitting for attachment of the hub to the hydraulic cylinder. Arrows indicate on each fracture surface the location of the fatigue-crack origin--at the toe of the weld bead, where a slight weld overlap had formed. See also Fig. 450. 0.5×

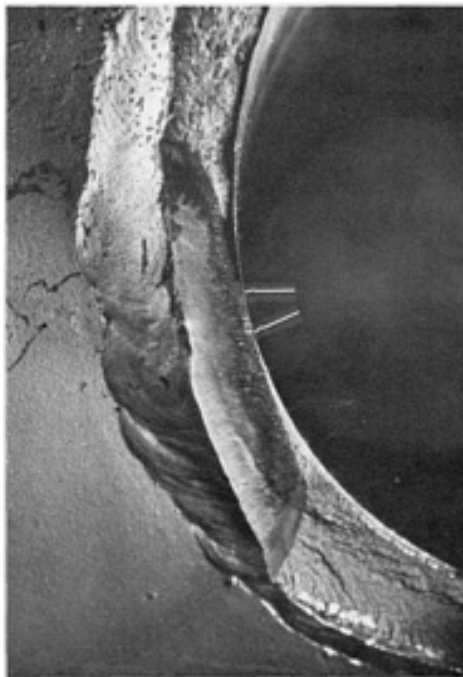
Fig. 450 Fracture surface of the barrel portion of the broken hub in Fig. 449, showing the fatigue-crack origin. The fatigue crack was about 44 mm ($1\frac{3}{4}$ in.) long, but had penetrated the hub wall completely for only about 3.2 mm ($\frac{1}{8}$ in.) (arrows). Note shear lip at inside of hub wall on either side of the fatigue crack. 2×

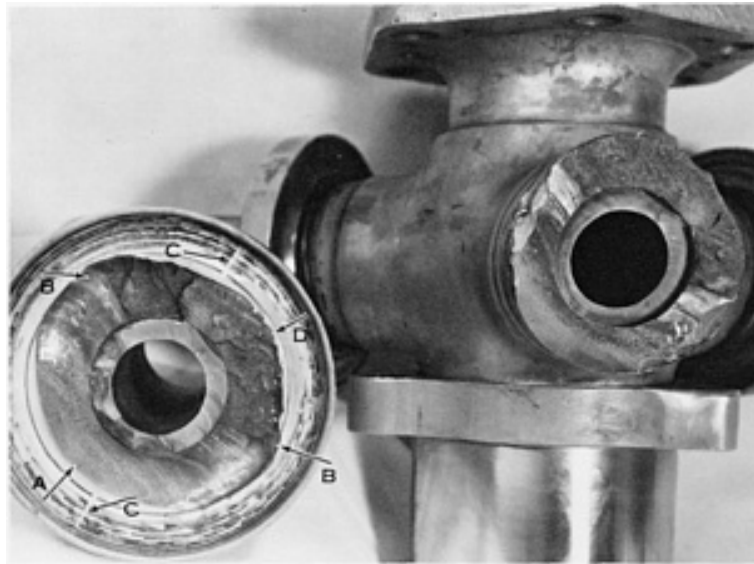
Fig. 451 Mating surfaces of a fatigue fracture in a blade arm of a forged aircraft propeller-hub spider of AISI 4340 steel and through the central pilot tube of the arm. The fatigue crack originated in the fillet between the bearing-retention flange and the blade arm. Hardness of the forging was 35 HRC. The origin is at arrow A (lower left), at an inclusion. The fatigue crack penetrated as far as the locations indicated by arrows B before final fast fracture occurred. Alignment of the bearing-race parting line (arrows C) was not as specified. Arrow D indicates the region of final fast fracture. See Fig. 452 for a higher magnification view of this region. 0.6x

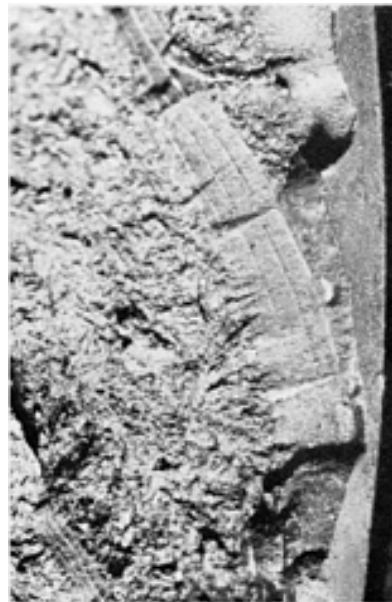
Fig. 452 View of an area at arrow D in Fig. 451, in the region of final fast fracture. Fatigue patches are interspersed among areas of rapid crack advance, indicating that final fracture occurred in stages. 10x

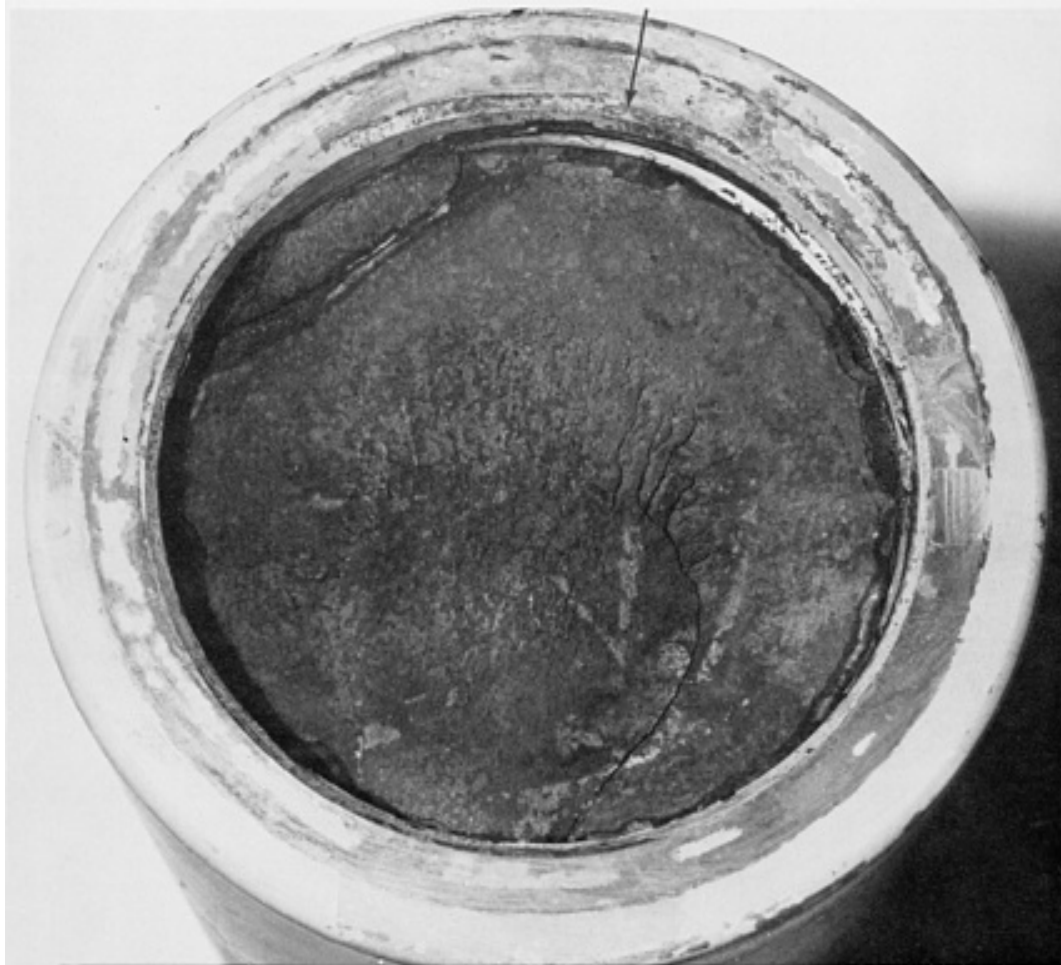
Two views of the surface of a fatigue fracture in a 145-mm ($5\frac{3}{4}$ -in.) diam threaded piston rod of AISI 4340 steel heat treated to 341 HB. The full-face view in Fig. 453 shows plainly the beach marks in the region of the primary fatigue crack, at top. Secondary fatigue cracks are visible on either side of it, as well as the bottom. The oblique view in Fig. 454 reveals that the fatigue cracks began at the roots of the threads, the origin of the primary crack being two threads to the right of the abutting secondary cracks. Although these reduced-size views do not permit detailed scrutiny, it seems evident that the thread roots were too sharp, causing stress concentrations locally. Beyond the fatigue-zone limits, failure was by radial fibrous fast fracture. Fig. 453: $\sim 0.5\times$. Fig. 454: $0.67\times$

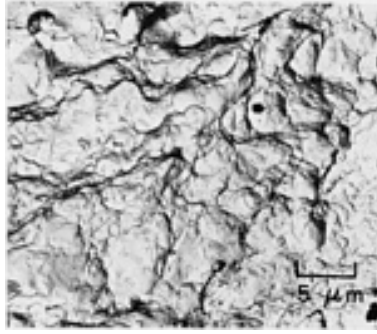
Fig. 460 Surface of a tension-overload fracture in a notched specimen of AMS 6434 steel sheet that was broken at 27 °C (81 °F), showing small equiaxed dimples. The heavy curved lines are intersections of dimple surfaces. See also Fig. 461 and 462. TEM p-c replica, 2000×

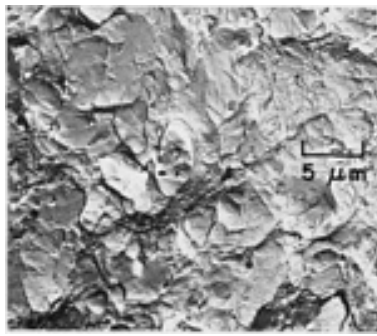
Fig. 461 Surface of a tension-overload fracture in a notched specimen of the same AMS 6434 steel sheet as in Fig. 460, but broken at -73 °C (-99 °F). The dimples here are of the same size and nature as those in Fig. 460. See also Fig. 462. TEM p-c replica, 2000×

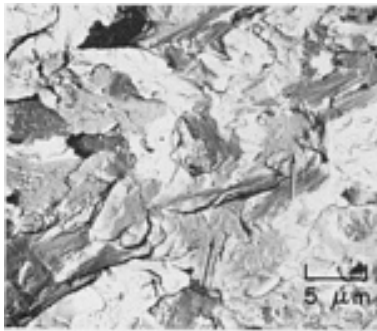
Fig. 462 Surface of a tension-overload fracture in a notched specimen of the same AMS 6434 steel sheet as in Fig. 460 and 461, but broken at -190 °C (-310 °F), showing a mixture of scattered dimples and (at arrows) cleavage facets. TEM p-c replica, 2000×

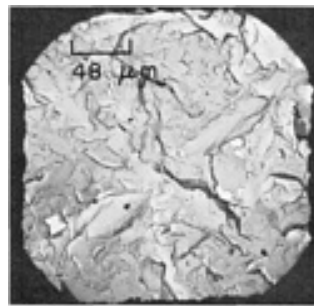
Fig. 466 Impact fracture in a specimen of AMS 6434 steel quenched and then tempered at 205 °C (400 °F) to a yield strength of about 1550 MPa (225 ksi) and broken at -196 °C (-321 °F), showing a woody type of cleavage-fracture surface. TEM p-c replica, 210×

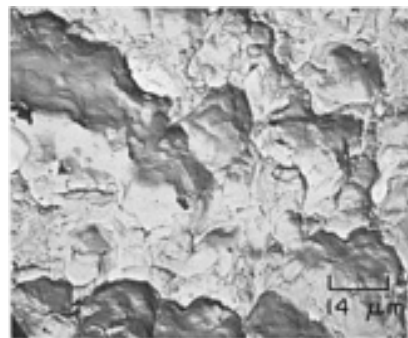
Fig. 467 Impact fracture in a specimen of AMS 6434 steel (same properties as Fig. 466) broken at room temperature, showing fairly large equiaxed dimples, which are characteristic of tension-overload fractures. TEM p-c replica, 700×

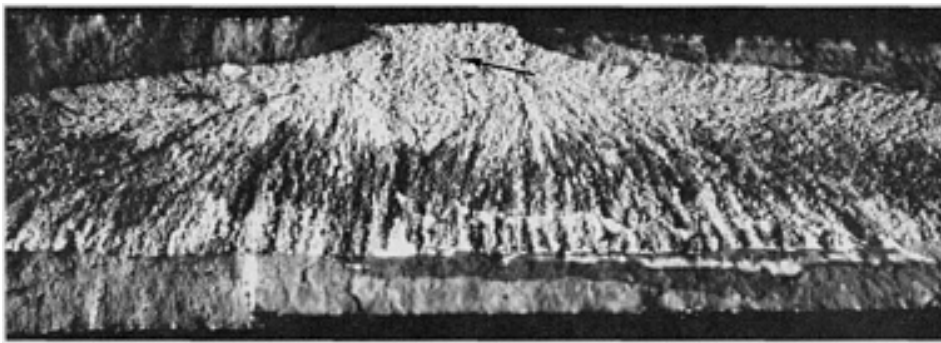
Fig. 469 Surface of a fracture in a wall of a flask made of AMS 6434 steel tempered at 205 °C (400 °F) that was stressed while exposed to tap water, producing stress-corrosion cracking. See Fig. 470 for a higher-magnification view of the region at arrow. 15 \times

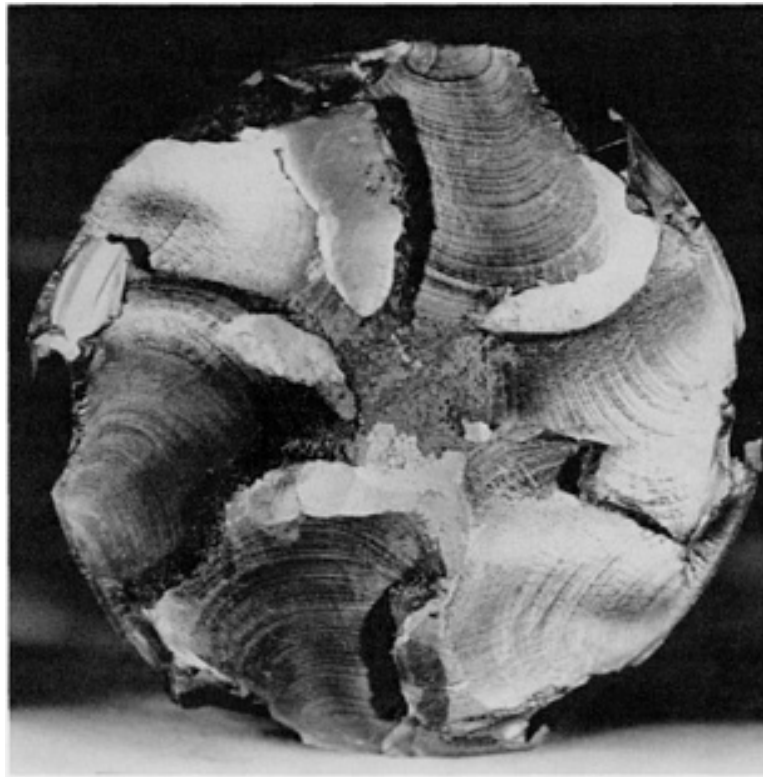
Fig. 473 Rotating bending fatigue fracture of an AISI 4817 shaft, carburized and hardened to 60 HRC on the surface. Fracture initiated in six fillet areas around the periphery, near the runouts of six grooves. Each fatigue area propagated separately, but uniformly, inward to final rupture at the center. Cause of fracture was traced to grinding damage in the fillet. The bright and shiny flat areas are regions of postfracture damage produced by the rubbing together of the broken portions of the shaft. (D.J. Wulpi, Consultant)

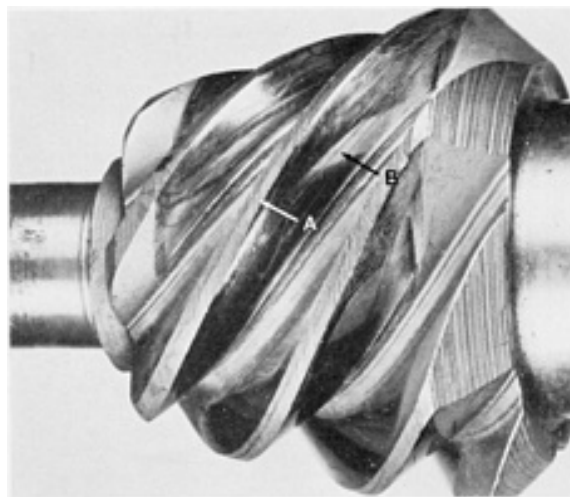
Fig. 474 View of a carburized spiral gear of AISI 4817 steel, showing fine subcase fatigue cracks in the gear-tooth tips (such as at arrow A) and flanks (such as at arrow B); these cracks are evidence of the first stages of spalling fatigue, which originated near the case-core interface because the load-carrying capacity of the gear was exceeded. Compare with Fig. 475. Actual size

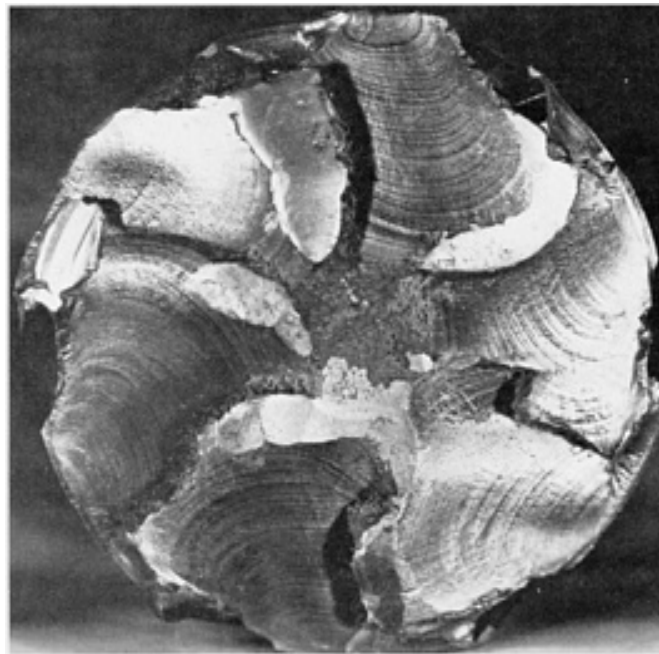
Fig. 476 Surface of a fatigue fracture that began at six fillet areas around the periphery of a shaft, near the runouts of spiral grooves. The material is AISI 4817 steel; the shaft was carburized and heat treated to a surface hardness of 60 HRC. The fatigue cracks penetrated equally, indicating that stress concentrations at the six fillet areas were essentially equal. $\sim 2.13\times$

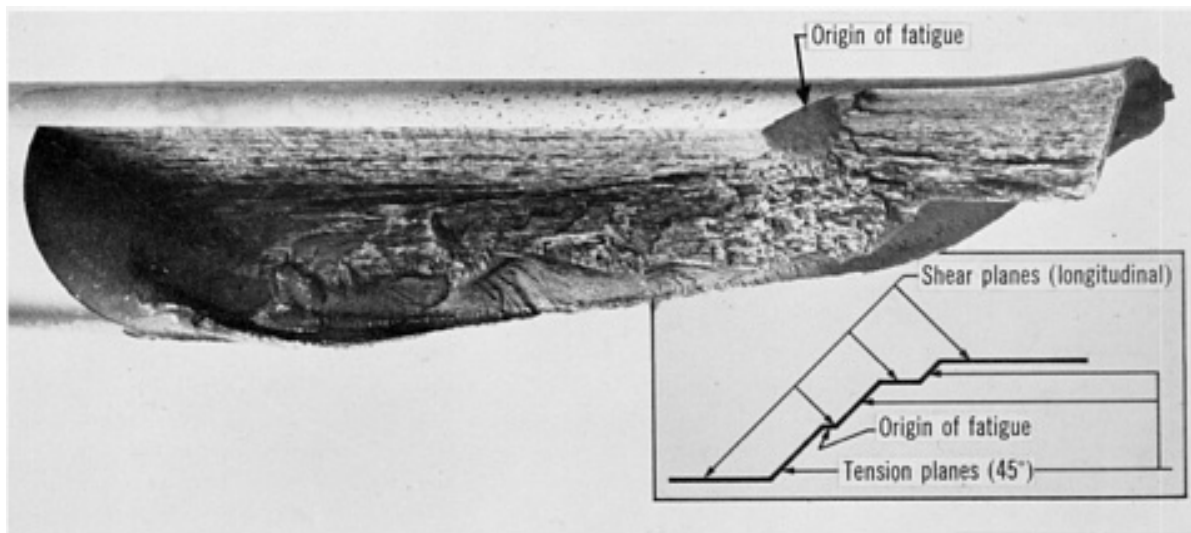
Fig. 481 Surface of a torsional-fatigue fracture in the cylindrical portion of a 35-mm ($1\frac{3}{8}$ -in) diam torsion-bar spring of AISI 50B60 steel heat treated to a hardness of 53 HRC. The fatigue crack originated in a very small (0.38 mm, or 0.015 in. long) facet (labeled "Origin of fatigue") on a longitudinal shear plane and progressed alternately on 45° tension planes and longitudinal shear planes, as indicated in the diagram. Note that the semicircular fatigue patch surrounding the origin lies in the 45° plane. 1.25×

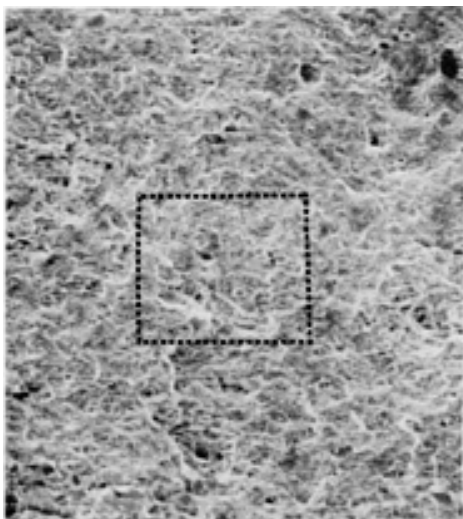
Impact fracture of leaf spring at front connecting eye. The SAE 5160 part was quenched and tempered to 450 HB. The spring was broken in the laboratory by a single impact load in bending. Fig. 482: Matching fracture faces. Origin is at top of upper face and at bottom of lower face. 1.8 \times . Fig. 483: Fractograph of origin side of fracture surface. Higher-magnification fractographs of zones I and II are shown in Fig. 482, 483, 484, 485, 486, 487, 488, 489, 490, 491, and 492. SEM, 35 \times (General Motors Research Laboratories)

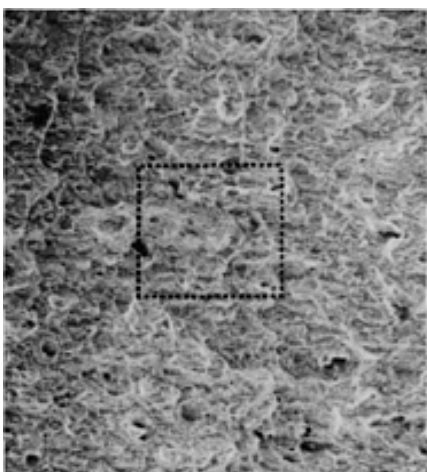
Fracture features in zone I of fractograph of SAE 5160 leaf spring (Fig. 482 and 483). Fig. 484: SEM, 300 \times . Fig. 485: Enclosed area in Fig. 484. SEM, 1000 \times . Fig. 486: Enclosed area in Fig. 485. Note numerous fine dimples. SEM, 10,000 \times (General Motors Research Laboratories)

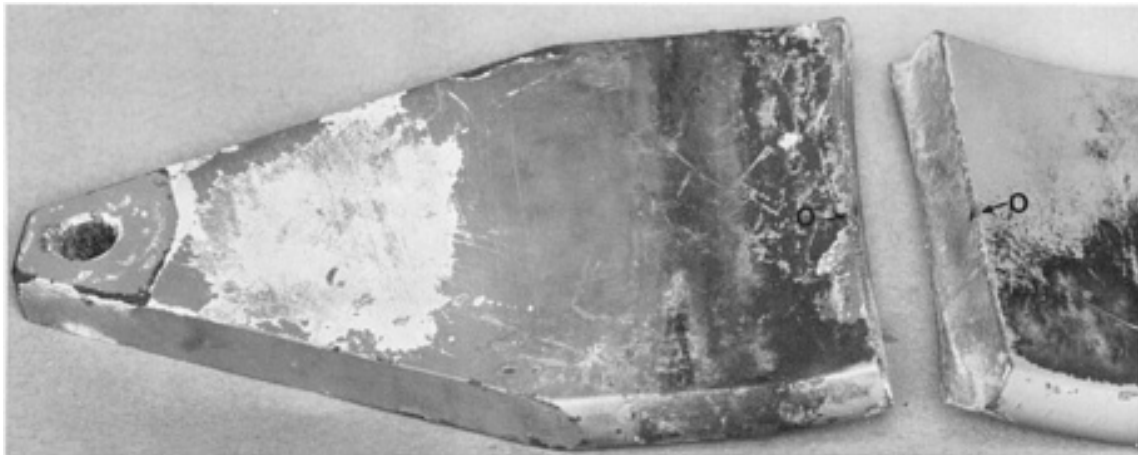
Fig. 499 Fatigue fracture in an AISI 6150 steel spring leg of an aircraft main landing gear, heat treated to a minimum tensile strength of 1550 MPa (225 ksi) and a hardness of 49 HRC. Visual inspection of the fracture surfaces showed that the fatigue crack originated at the location marked by arrows O. The appearance of the external surface of the spring leg indicated that the part had been shot peened, but that peening had been inadequate. The dimensions of the spring leg conformed to specifications. See also Fig. 500, 501, 502, 503, and 504. 0.6 \times

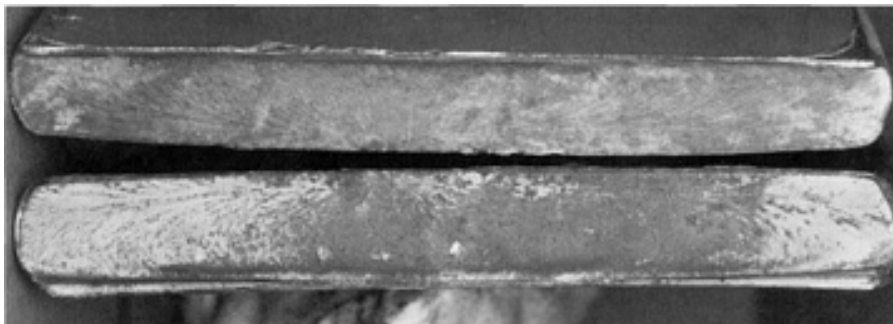
Fig. 500 Mating fracture surfaces of the broken main-landing-gear spring leg in Fig. 499. A small fatigue zone

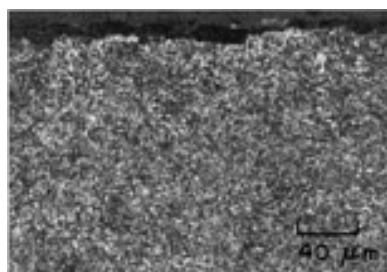
Fig. 504 Another section through the spring leg in Fig. 499, showing a profile of the fatigue-crack surface (at top). Compare the smoothness of this surface with the irregularity of the fast-fracture surface in Fig. 501. 1% nital etch. 250×

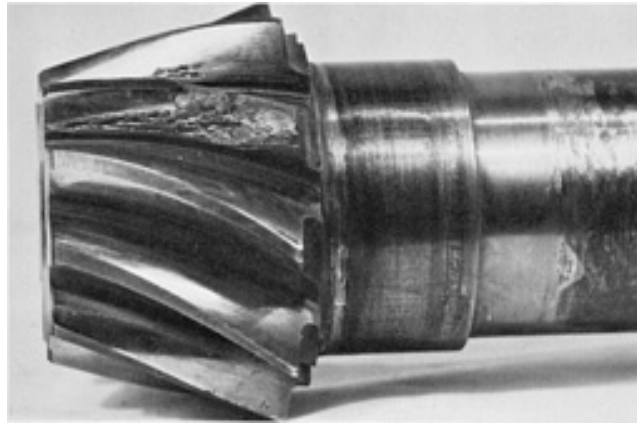
Fig. 510 Bending-fatigue fracture in the heel of one tooth of a spiral bevel pinion of AISI 8617 steel, carburized and hardened to 57 HRC in the case. Fracture resulted from severe pitting. Note that pitting had begun in an adjoining tooth (near top). 0.75x

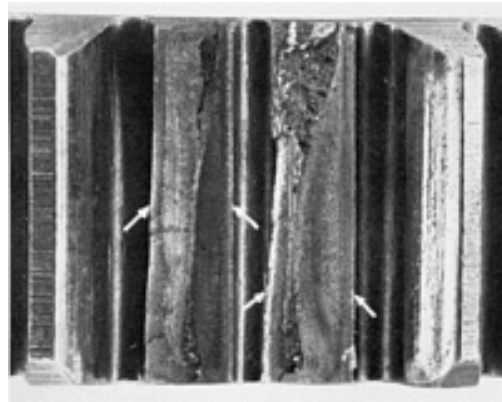
Fig. 511 Bending-fatigue fracture in two teeth of a reverse idler gear of AISI 8617 steel, carburized and hardened to 60 HRC in the case. Arrows point to the root fillets on both sides of each tooth, where fracture began due to excessive stress in these locations. ~2x

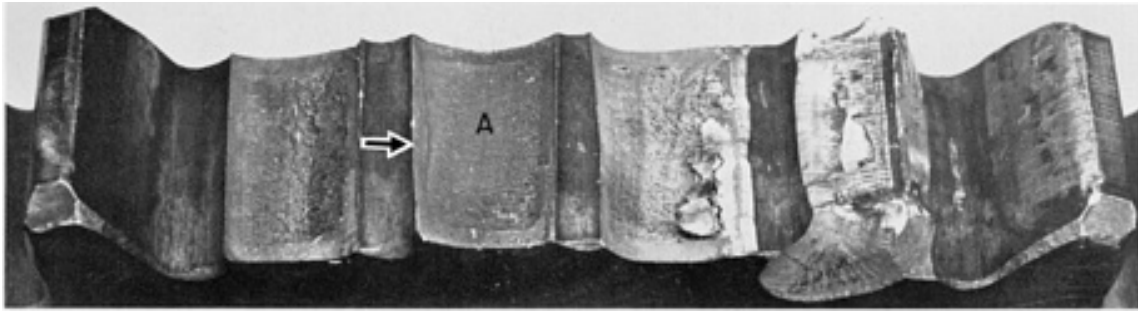
Fig. 513 Bending-fatigue fractures in several teeth of a spur gear of AISI 8620 steel, carburized and hardened to 60 HRC in the case. The tooth marked A apparently broke first, as the result of a fatigue crack that originated in the fillet to the left of the tooth (arrow). After this tooth broke off, fracturing of the teeth on each side of it was accelerated. 2×

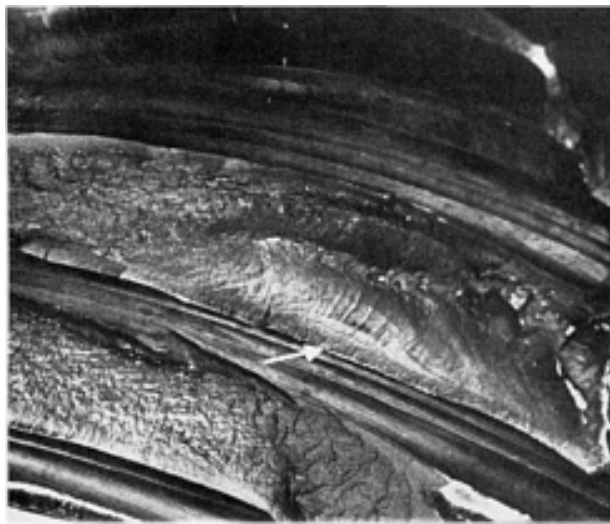
Fig. 514 Surface of a bending-fatigue fracture in a tooth (upper tooth in this view) of a large spiral bevel pinion of AISI 8620 steel carburized and hardened to 60 HRC at the surface. The arrow marks the fatigue-crack origin, in the root fillet. The absence of this tooth resulted in fracture of the tooth below by overload. 1.65×

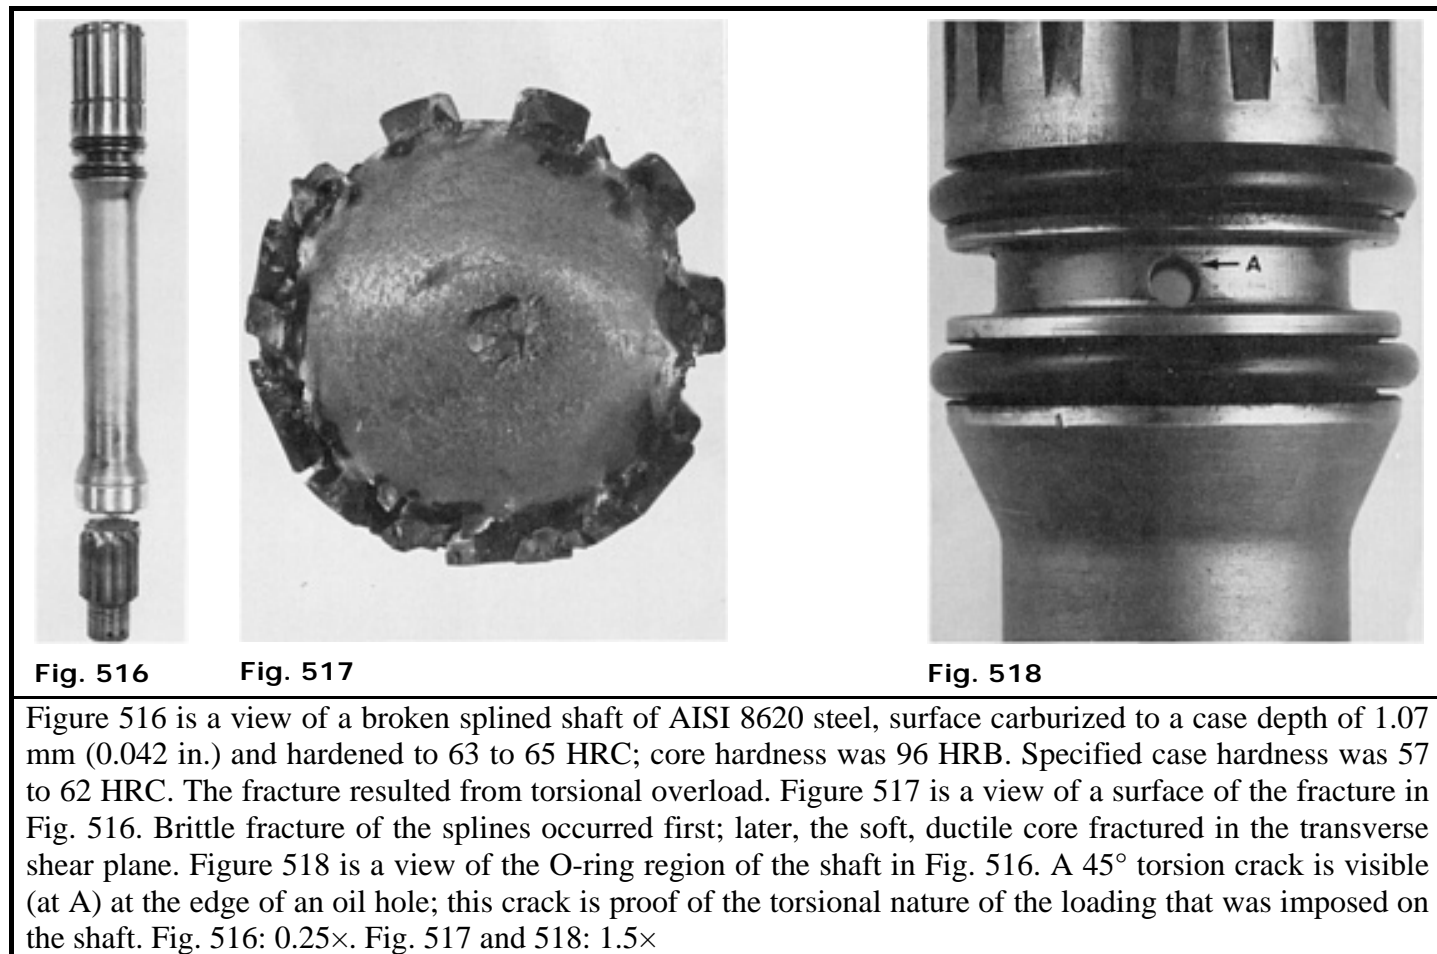
Fig. 519 Fatigue striations in AISI 8620. The roughly horizontal ridges reveal how the crack front advanced with each load application. The crack propagated in the direction of the arrow. SEM, 2100× (D.J. Wulpi, Consultant)

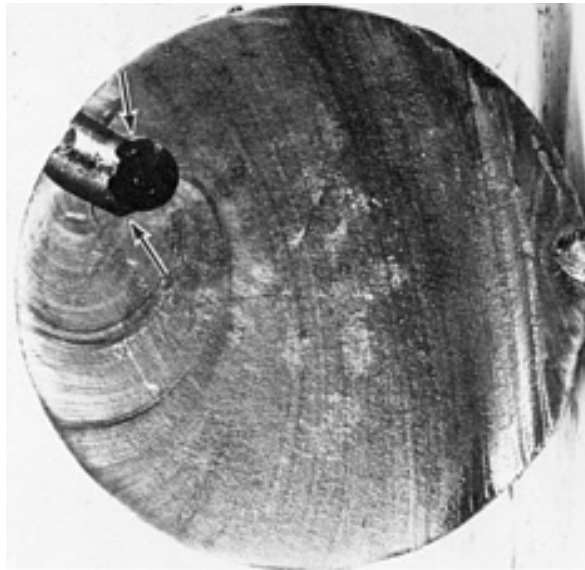
Fig. 520 Surface of a fracture in an AISI 8640 boom-point pin that broke during service. Steel was quenched and then tempered to a hardness of 269 HB. Sharp corners of mismatched transverse grease holes provided stress concentrations that generated two fatigue cracks (arrows). Actual size.

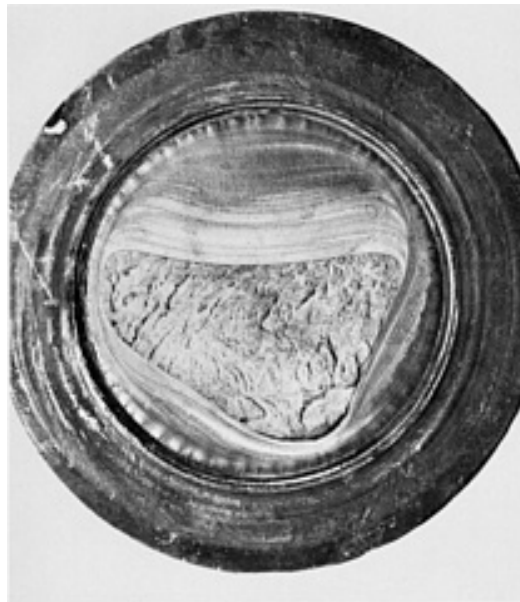
Fig. 521 Surface of a fatigue fracture in a 200-mm (4-in.) diam axle of AISI 8640 steel with a hardness of approximately 30 HRC. Contained within a shrink-fitted collar (visible here), the nonrotating axle was subjected to bending stresses in three directions, which produced this unusual pattern of beach marks. 0.65x

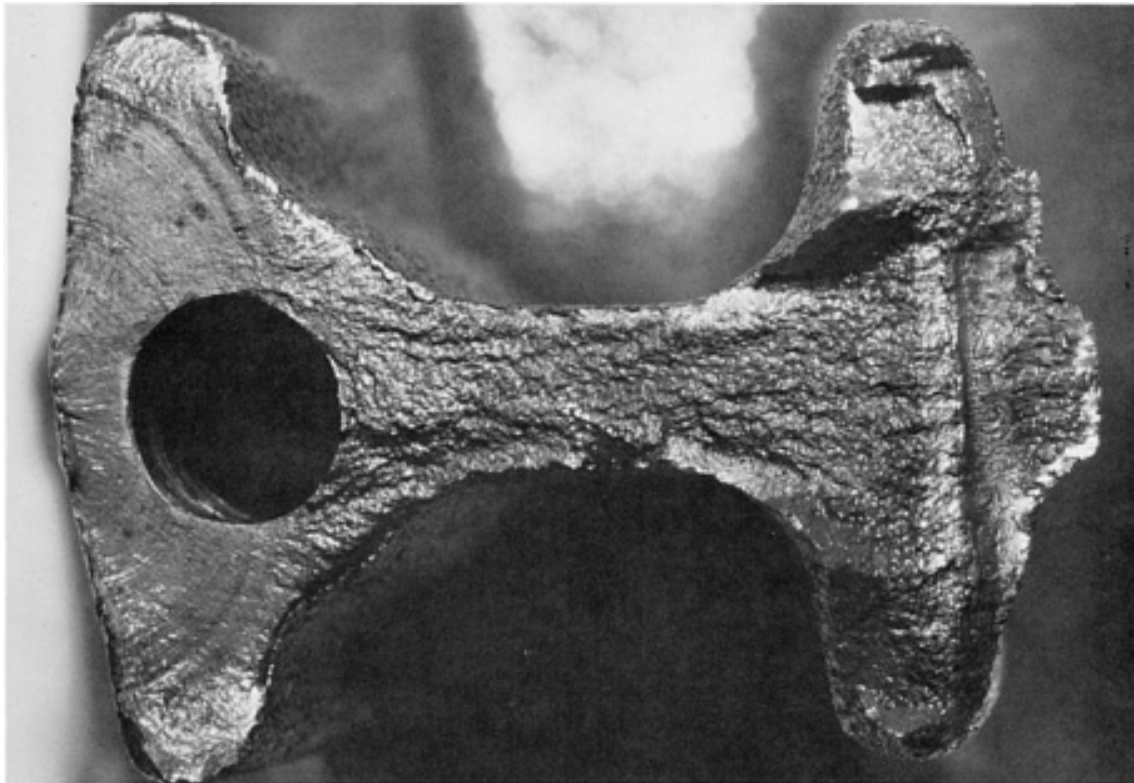
Fig. 523 Surface of a fatigue fracture in a forged connecting rod of AISI 8640 steel with a hardness of 26 to 27 HRC throughout. The rod broke after approximately 84,000 km (52,000 miles) of service. The fatigue-crack origin is at the left edge, at the flash line of the forging, but no unusual roughness of the flash trim there was discovered. No metallurgical cause of the fracture was detected. The fatigue crack progressed about halfway around the oil hole at left before final fast fracture occurred. Note the pronounced shear lip at the right edge. $\sim 7\times$

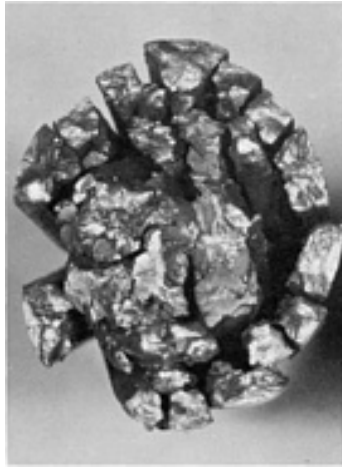
Fig. 527 Fracture surface of the left portion of the shaft in Fig. 525, showing the badly mangled splines separated by longitudinal cracks, which are evident also in Fig. 525. 1.25x

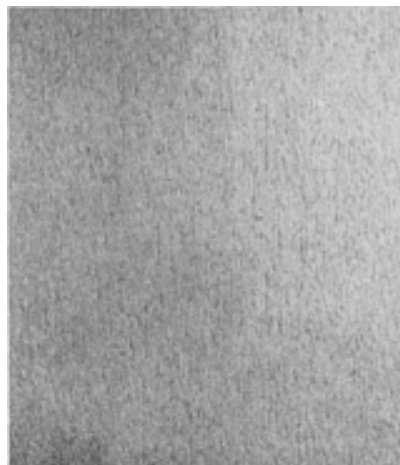
Fig. 529 Longitudinal section through the same spline as in Fig. 528, displaying the size and even distribution of the inclusions in the steel. Some of the inclusions were found to be as long as 8 mm ($\frac{5}{16}$ in.). Etched in 1 part HCl, 1 part H₂O. 2×

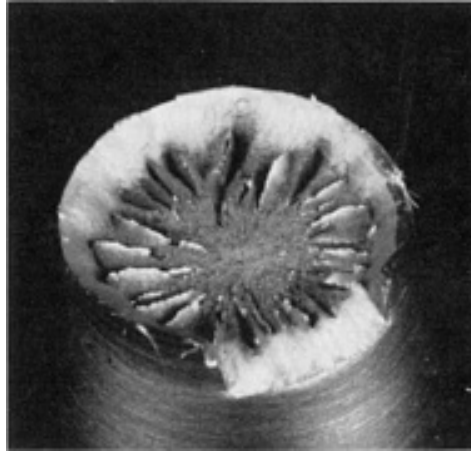
Fig. 530 Tensile-overload fracture in an unnotched specimen of AISI 8740 steel; tensile strength, 1351 MPa (196 ksi). A cup-and-cone fracture with a fibrous zone containing radial features between the central fibrous region and the shear lip. See also Fig. 531 and 532. 9×

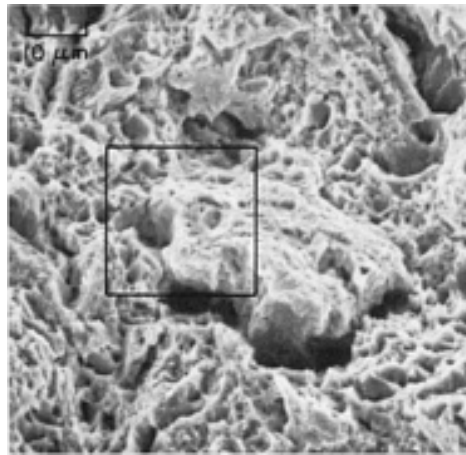
Fig. 531 Area adjacent to one of the radial features in Fig. 530, showing dimples, which are typical of tensile-overload fracture. Note the scattered secondary cracks, which appear to be unusually deep. See also Fig. 532, a higher-magnification view of area in the rectangle. SEM, 1000×

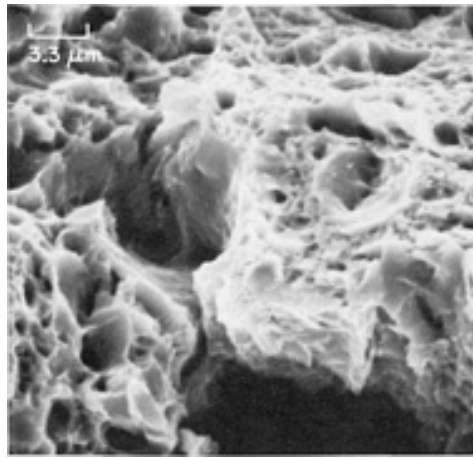
Fig. 532 Area outlined by the rectangle in Fig. 531, shown at higher magnification. A wide range of sizes of the dimples is clearly visible. Unlike many other dimpled fractures, the one here appears to contain no evidence of inclusions. SEM, 3000×

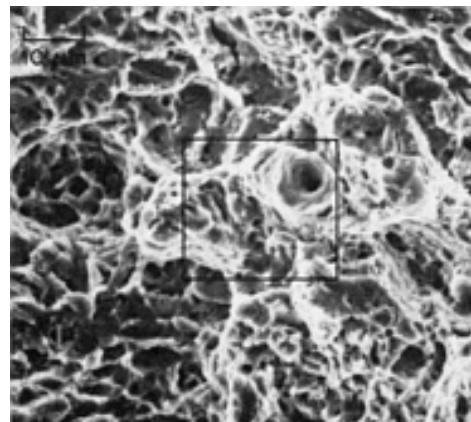
Fig. 534 Area in the central final-fracture region in Fig. 533. The range of dimple sizes is similar to that in the unnotched fracture in Fig. 531, but only one secondary crack is evident, and it is of modest size. See Fig. 535 for a higher-magnification view of the area outlined by the rectangle. SEM, 1000×

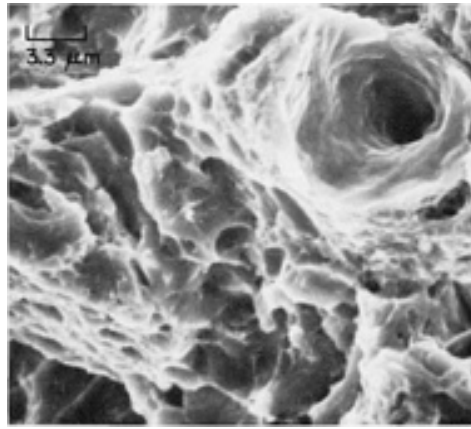
Fig. 535 Higher-magnification view of the area in the rectangle in Fig. 534. Range in dimple size is more clearly evident here. Large dimple at upper right was presumably initiated by a large inclusion (not shown). SEM, 3000 \times

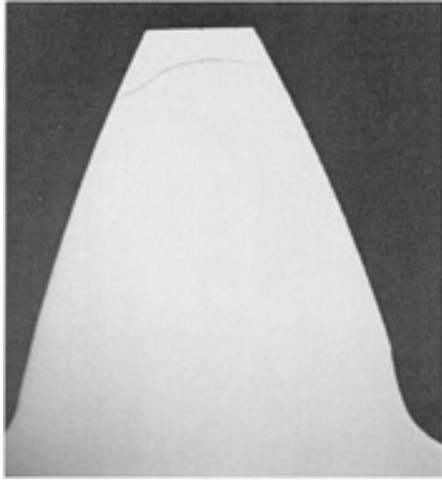
Grinding cracks in AISI 9310 helical pinion. Part was rough machined, carburized, hardened and tempered (56 to 58 HRC), and finish ground. Cracks, due to abusive final grinding, were discovered in a tooth root during nondestructive testing. Fig. 536: Helical pinion. Arrows point to cracks. 2 \times . Fig. 537: Fracture surface of opened crack (arrows) reveals a crack depth of 0.5 to 0.9 mm (0.020 to 0.035 in). 5 \times (P.J. Walling, Metcut Research Associates, Inc.)

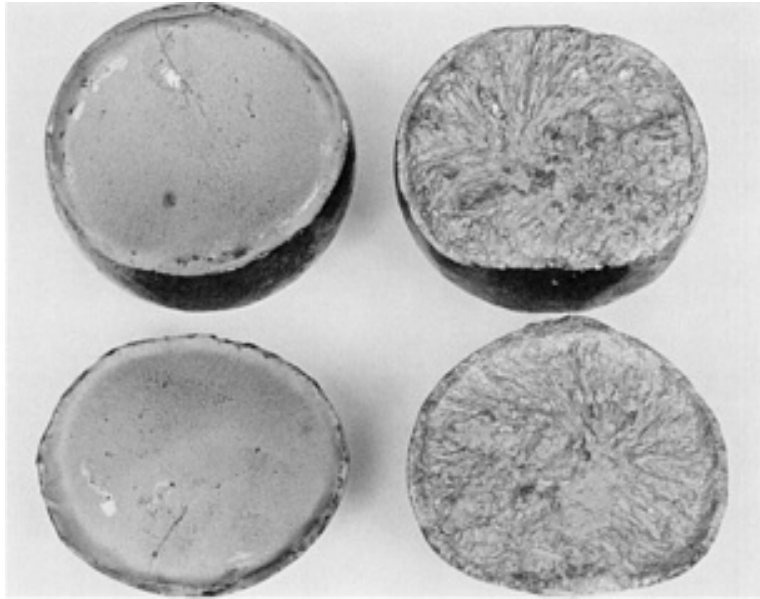
Fig. 541 Mating fracture surfaces of commercial 75-mm (3-in.) diam grinding balls. Fracture was caused by severe ball-on-ball impacts in laboratory tests. Left top and bottom: Commercial forged and heat-treated low-alloy steel ball. Composition: 0.63% C, 0.90% Mn, 0.76% Si, 0.66% Cr, 0.018% P, and 0.011% S. Right top and bottom: Experimental manganese steel ball, cast and heat treated. Composition: 0.97% C, 5.3% Mn, 1.9% Cr, 1.0% Mo, 0.48% Si, 0.03% P, and 0.018% S. Outer rim of ball was under compression due to heat treatment and plastic deformation from impacts. (H.W. Leavenworth, Jr., U.S. Bureau of Mines)

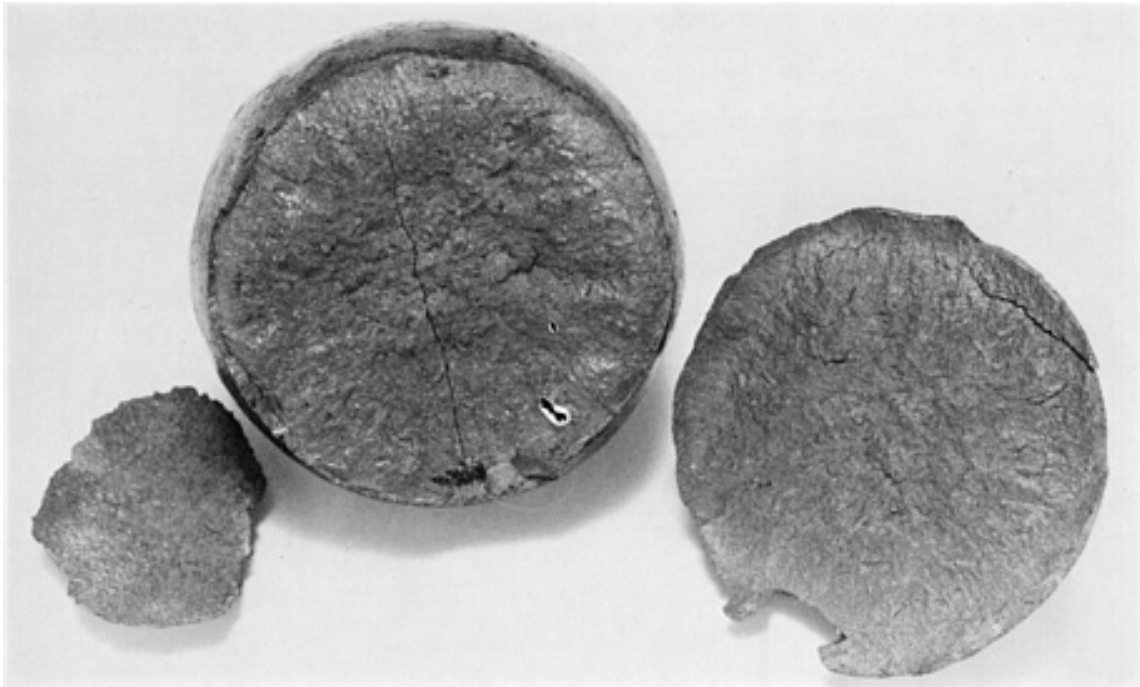
Fig. 542 Catastrophic failure of 75-mm (3-in.) diam manganese steel grinding ball after 51,440 severe ball-on-ball impacts in a laboratory test. Composition: 1.21% C, 5.3% Mn, 1.8% Cr, 1.1% Mo, 0.46% Si, 0.1% Ni, and 0.1% Cu. Fracture initiated at an interior crack. (Note another such crack on the fracture surface at center.) The interior of the ball was under tension. The outer rim was under compression due to heat treatment and plastic deformation from impacts. (H.W. Leavenworth, Jr., U.S. Bureau of Mines).

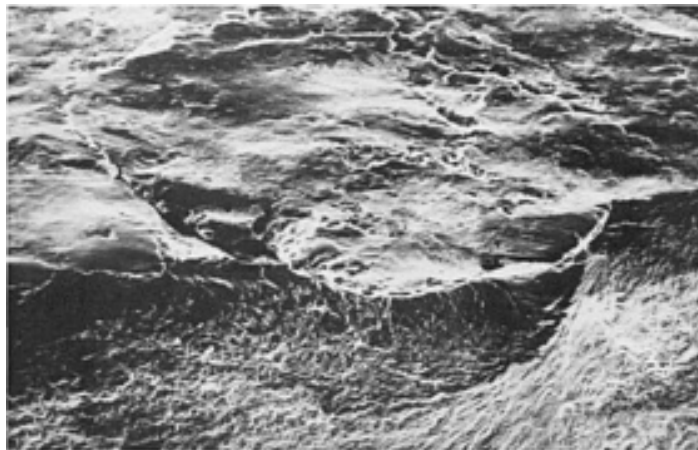
High-cycle fatigue fracture of valve spring for automobile engine. Material: Cr-V alloy steel (modified ASTM A232). Failure occurred during qualification testing at 17.56 million cycles. No material defect was found; stress-life combination was considered normal for this type of service. Fig. 543: Fracture surface near origin. Note "factory roof" features usually associated with high-cycle fatigue. SEM, 50 \times . Fig. 544: Same as Fig. 543, but at higher magnification. SEM, 200 \times (J.H. Maker, Associated Spring, Barnes Group Inc.)
