به نام خدا

مرکز دانلود رایگان
مهندسی متالورژی و مواد

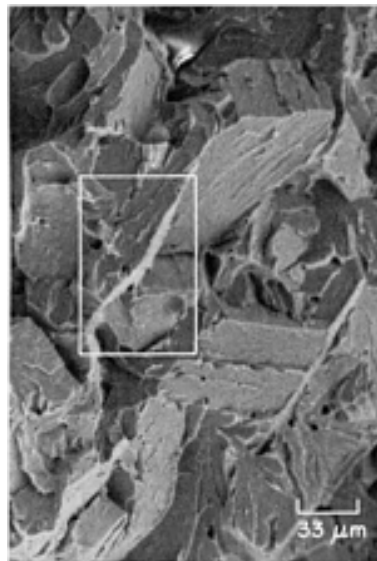
Fig. 548 Charpy impact fracture in 0.18C-3.85Mo steel after heat treatment in an inert atmosphere at $1200\ ^\circ\text{C}$ ($2190\ ^\circ\text{F}$) for 1 h, followed by an ice/10% brine quench. Many quasi-cleavage facets are visible. See Fig. 549 (an enlargement of the area in the rectangle). SEM, $300\times$

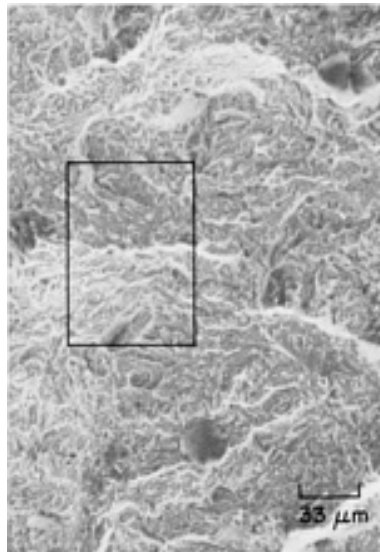
Fig. 551 Charpy impact fracture in 0.41C-4.2Mo steel after the same heat treatment as that for the specimen in Fig. 548. This fracture occurred by dimpled rupture, although the impact energy was only one-third that of Fig. 548. See also Fig. 552 and 553. SEM, 300×

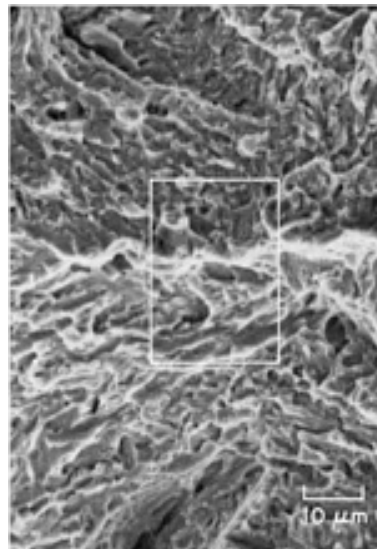
Fig. 552 This view at higher magnification of the area outlined by the rectangle in Fig. 551 reveals that many of the dimples are highly elongated, exhibiting locally some features suggestive of cleavage. Area in rectangle here is shown enlarged in Fig. 553. SEM, 1000×

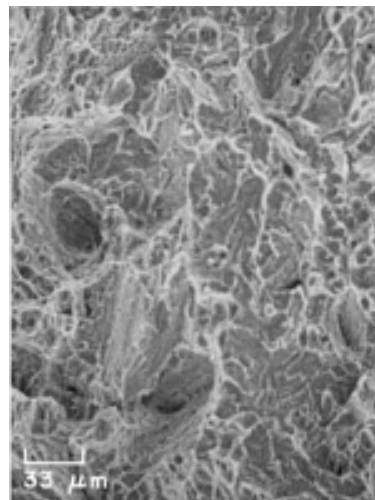
Fig. 555 This specimen was austenitized at 1095 °C (2000 °F). This fracture, like that in Fig. 554, displays quasi-cleavage facets; some of them are apparently rather deeply indented. There are also intervening regions

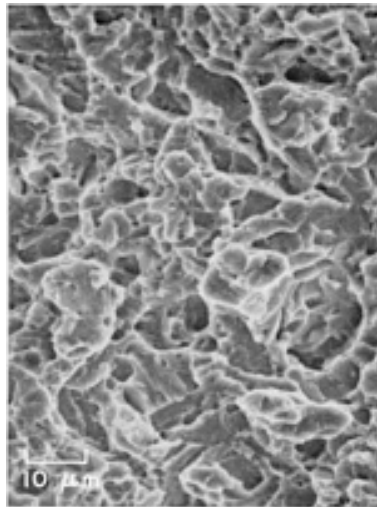
Fig. 556 This specimen, austenitized at 980 °C (1800 °F), shows none of the quasi-cleavage facets observed in Fig. 554 and 555. There appear to be many scattered dimples, but most of the surface consists of small facets, seemingly caused by cleavage. SEM, 1000×

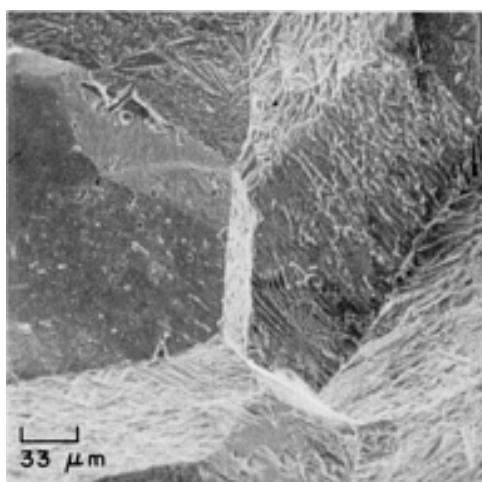
Fig. 558 The heat treatment of this specimen was altered as follows: austenitized at 1205 °C (2200 °F) for 1 h, quench to 870 °C (1600 °F) and hold for 30 min, ice-brine quench, then refrigerate in liquid nitrogen. Fracture appears to have occurred by a combination of transgranular and intergranular cleavage. The K_{Ic} value of this specimen was even lower than that for the specimen in Fig. 557; the lower value is believed to

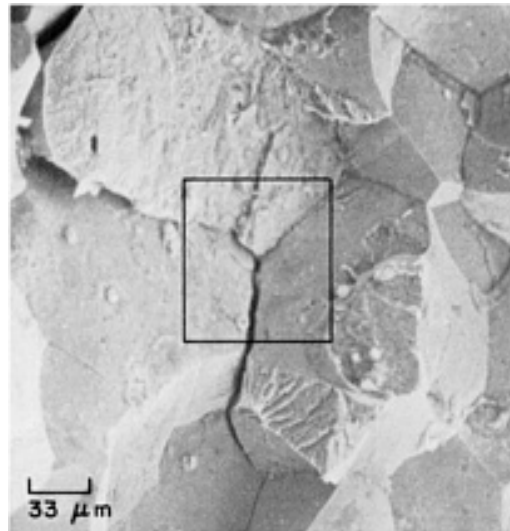
Fig. 562 A V-notch Charpy impact fracture in a specimen of 0.42C-2.1Mo-5.2Co alloy steel that was not as tough as had been expected. The fracture has been largely intergranular, although three facets appear to be transgranular cleavage facets. Note the secondary grain-boundary crack. Area in rectangle is shown enlarged in Fig. 563. SEM, 300×

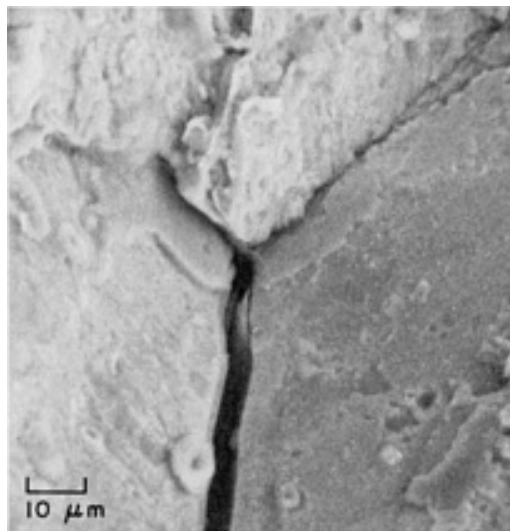
Fig. 563 Area outlined by the rectangle in Fig. 562, shown at a higher magnification. The two facets in the lower portion are believed to be grain surfaces; facet in upper portion is believed to be transgranular cleavage facet. The cause of the low toughness of this specimen was quench cracking. Small rings visible here may be artifacts. SEM, 1000×

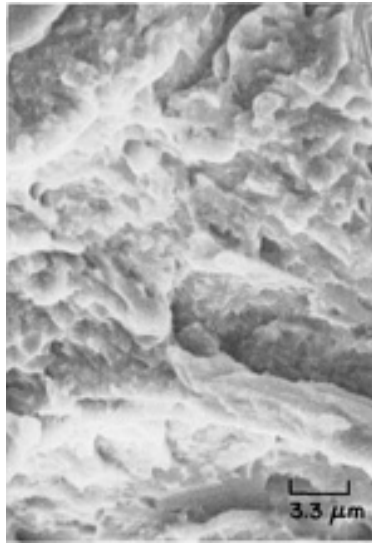
Fig. 566 Higher-magnification view of the area within the rectangle in Fig. 565, which reveals additional small dimples that are not readily apparent at the lower magnification. See Fig. 567, 568, and 569 for the effects of tempering on the fracture surface. SEM, 300 \times

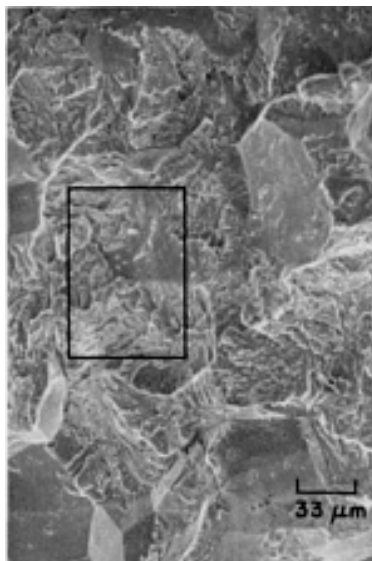
Fig. 567 Charpy impact fracture in a specimen of the same alloy steel and given the same austenizing treatment as in Fig. 564, but then tempered for 1 h at 600 °C (1110 °F), which maximized secondary hardening, and air cooled. See also Fig. 568. SEM, 300 \times

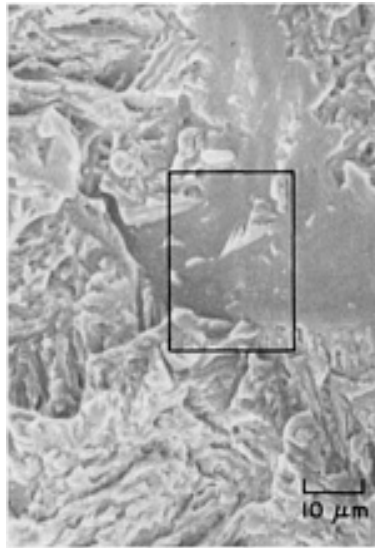
Fig. 568 An enlargement of the area in the rectangle in Fig. 567. This specimen, which had the same yield strength as that of the as-quenched specimen in Fig. 564, fractured mainly by intergranular separation. See Fig. 569 for a higher-magnification view of the area in the rectangle here. SEM, 1000 \times

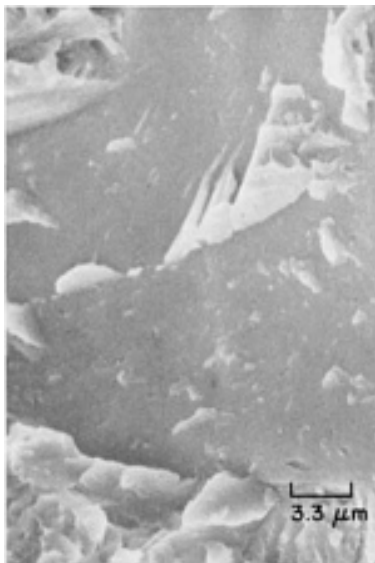
Fig. 569 Higher-magnification view of the area in the rectangle in Fig. 568. A tongue-like formation is visible (at left center) on the flat surface of a grain. Tempering has produced embrittling networks of carbide particles. SEM, 3000 \times

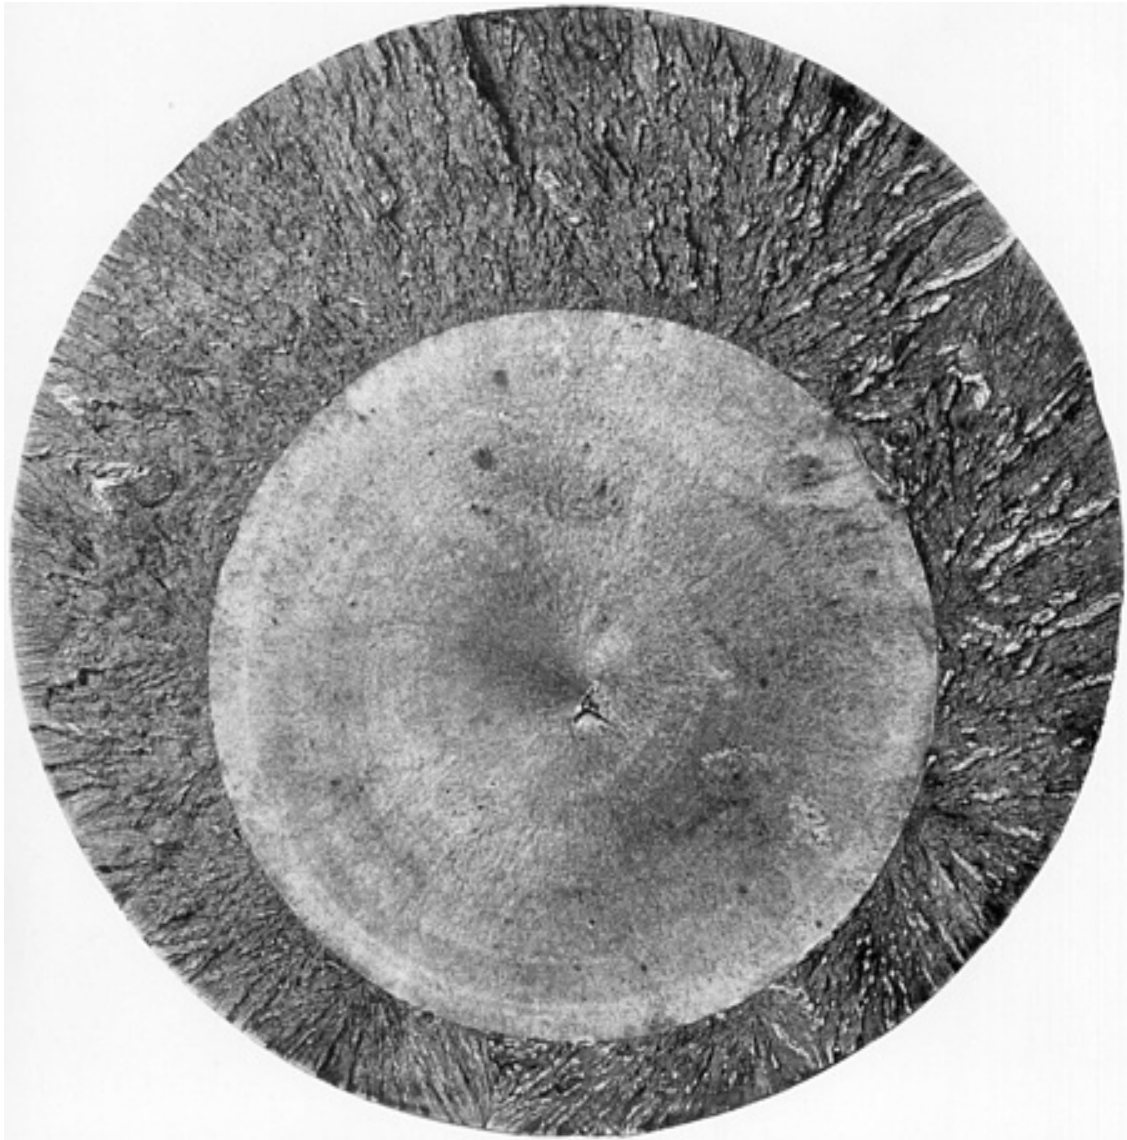
Fig. 570 Surface of a fatigue fracture in a 200-mm (8-in.) diam piston rod of a steam hammer for forging. The rod was fabricated from 0.26C-0.70Mn-0.87Ni-1Cr steel and heat treated to a hardness of 24 HRC at the surface and 17 HRC at the center of the section. This is an example of the fracture caused by pure tensile fatigue, in which surface stress concentrations are absent and a crack may start anywhere in the cross section. In this instance, the initial crack formed at a forging flake slightly below center, grew outward symmetrically, and ultimately produced a brittle fracture without warning. 0.93×

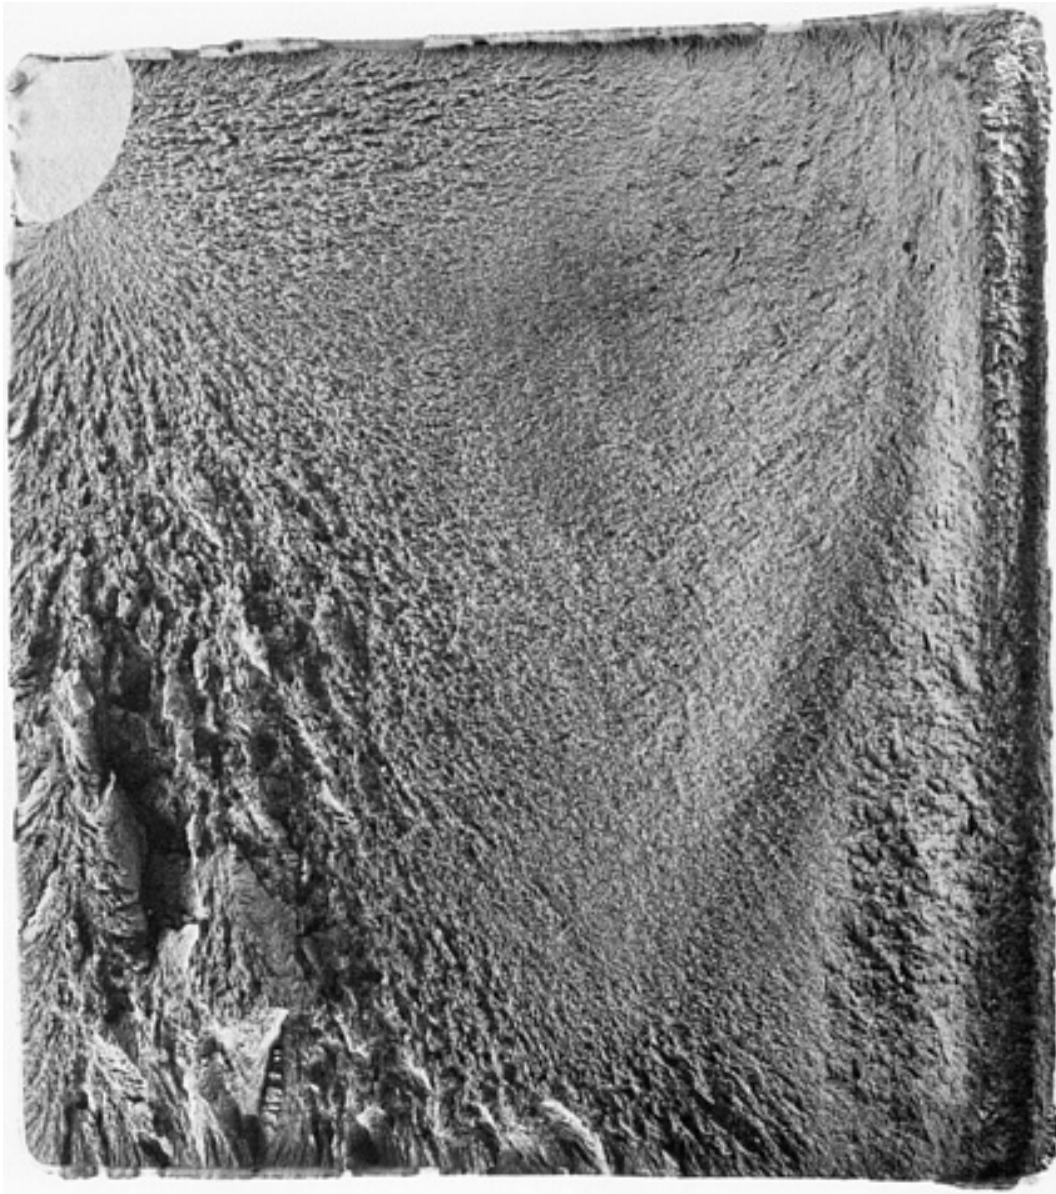
Fig. 571 Surface of a fracture in an equalizer bar, which supports the front end of a tractor, fabricated from D6B steel and heat treated to a hardness of 45 to 47 HRC. The bar was put into service for 200 h and then returned to the laboratory, where it was flexed in fatigue to fracture at 60×10^3 cycles. Note the very fine texture of the fatigue-crack zone at the upper left corner. It is concluded that because there are no beach marks beyond that small corner zone, the remainder of the fracture occurred in a catastrophic manner. Shear lips are evident along the top and right edges, and may also be present around the lower left corner. (D6B steel contains 0.45% C, 0.80% Mn, 1.00% Cr, 0.50% Ni, 1.00% Mo, and 0.10% V.) $\sim 1.13\times$

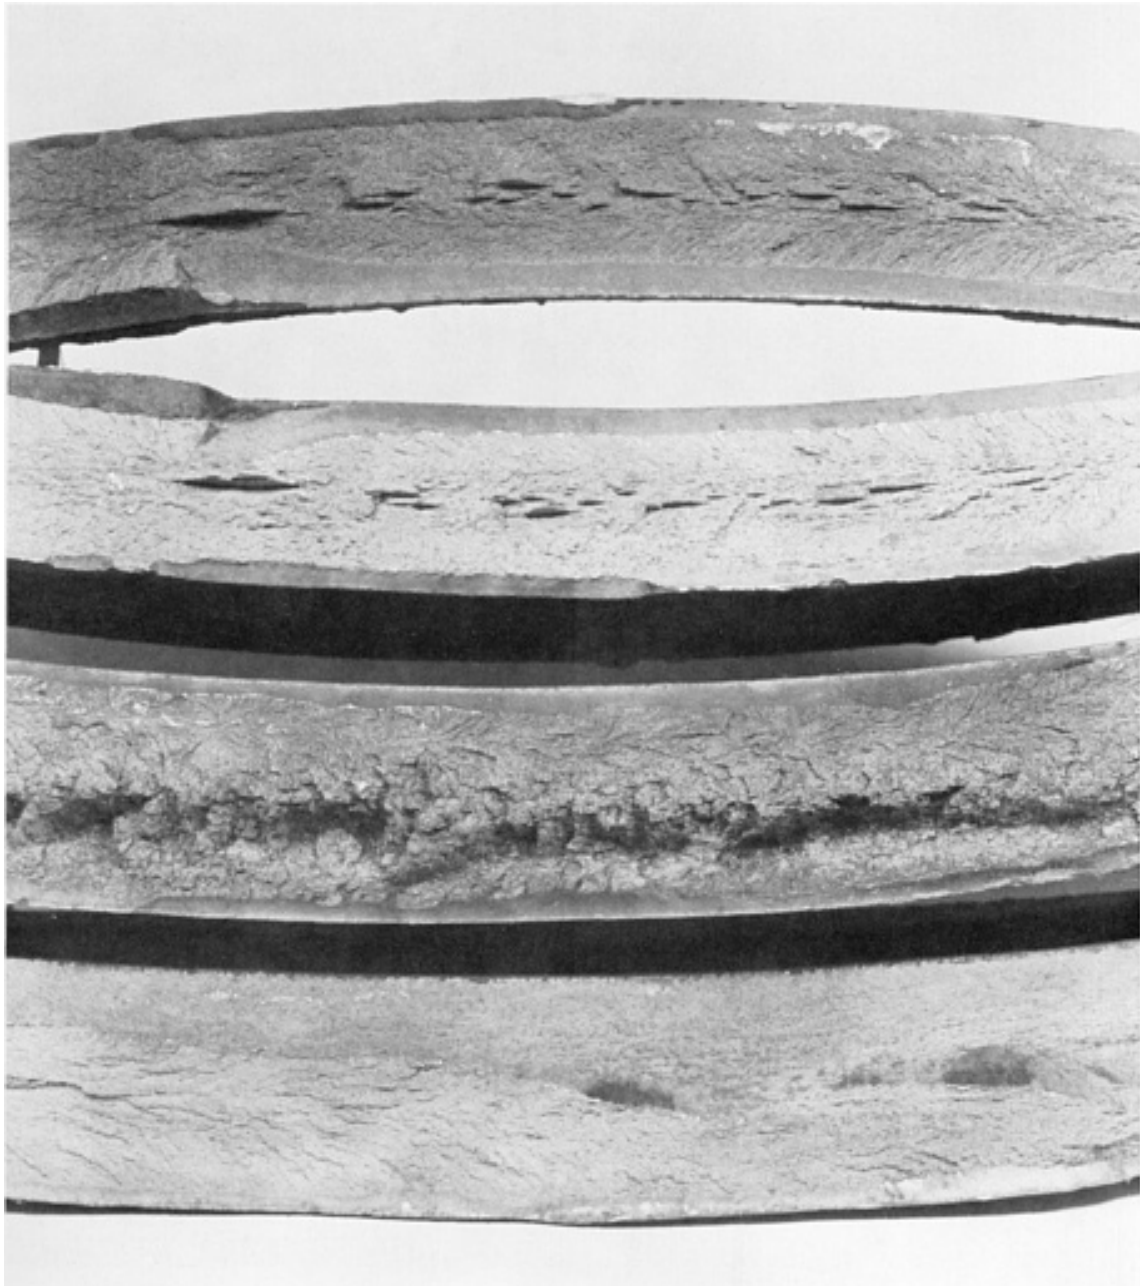
Fig. 572 Four fracture surfaces of a hemispherical accumulator head of high-strength low-alloy steel (0.15% C, 0.8% Mn, 0.6% Cr, and 0.85% Ni) that broke into several pieces during pressure testing at room temperature. Hardness ranged from 28 to 39 HRC. Fracture originated at a thin spot in the wall, where banding, was also present. At top are mating surfaces of a fracture near the origin, showing chevron marks and tongues, although tongues are more typical of low-temperature cleavage of iron-base alloys than of room-temperature cleavage. The fracture surface third from the top is very coarse-grained, whereas the surface at bottom is fine-grained and silky; the difference in appearance between these two surfaces may have resulted from a difference in rate of crack propagation. Actual size

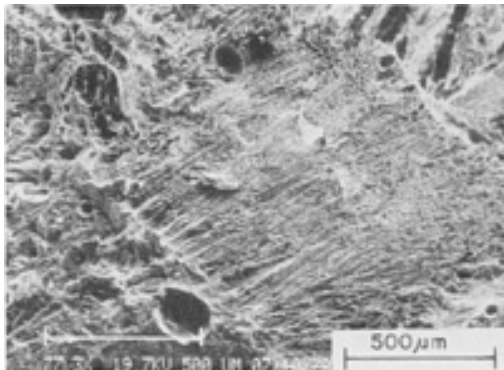
ASTM/ASME Alloy Steels

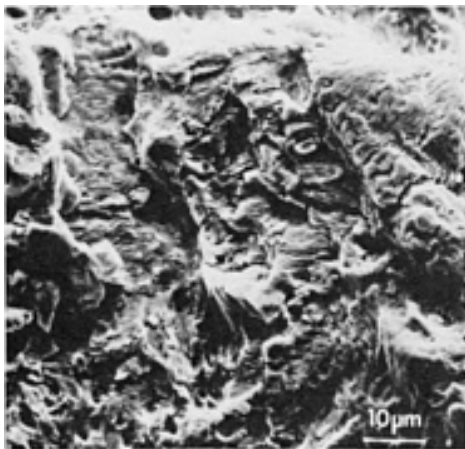
Effect of inclusions on fatigue crack propagation (FCP) in ASTM A514F. The conventionally melted electric furnace steel was water quenched from 900 °C (1650 °F), tempered at 620 °C (1150 °F), water quenched, stress relieved at 595 °C (1100 °F), and then air cooled. $\Delta K = 72 \text{ MPa } \sqrt{m}$ (65 ksi \sqrt{in}). Fig. 579: Elongated features on T-L (standard transverse) orientation FCP test specimen. Direction of FCP is toward the top. This "streaking" in the FCP direction (and the major hot-rolling direction) is associated with inclusion formations present on the vertical faces of long protrusions or depressions, which also extend in the FCP direction. SEM, 53 \times . Fig. 580: Same as Fig. 579 but at higher magnification. See also Fig. 281, 282, and 283. SEM, 1055 \times (A.D. Wilson, Lukens Steel Company)

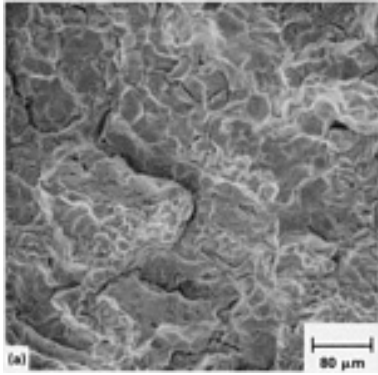
Effects of inclusions on fatigue crack propagation (FCP) in ASTM A533B. In conventional electric furnace steel, protrusions perpendicular to the direction of FCP were noted on T-S and L-S fracture surfaces. The protrusions result from inclusion formations (type II MnS and Al_2O_3) acting as crack deflectors. Figures show T-S orientation features. FCP direction is toward the top. Fig. 595: Protrusions on fracture surface. Fig. 596: Metallographic cross section reveals MnS inclusions on a protrusion. 170 \times . Fig. 597: Protrusion. SEM, 15 \times . Fig. 598: Protrusion with Al_2O_3 galaxy. SEM, 28 $^\circ$ tilt angle, 325 \times . Fig. 597 and 598 at ΔK of $40 \text{ MPa } \sqrt{m}$ ($36 \text{ ksi } \sqrt{in}$). See also Fig. 588, 589, 590, 591, 592, 593, and 594. (A.D. Wilson, Lukens Steel Company)

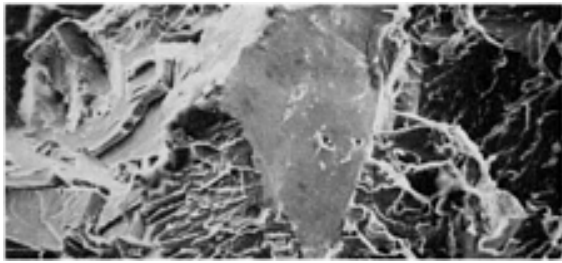
Fig. 601 Elevated-temperature fracture surface of Cr-Mo-V alloy steel specimen tensile tested at failure at 500 °C (930 °F) and an initial strain rate of 4.4×10^{-5} /s. Composition of the hot-rolled steel plate: 0.29% C, 1.01% Cr, 1.26% Mo, 0.25% V, 0.01% Mn, 0.59% Si, 0.037% P, 0.004% S, and 0.006% Sn. Heat treatment: two-step austenitize 1 h at 1300 °C (2370 °F), followed by 1 h at 950 °C (1740 °F), air cool; temper at 700 °C (1290 °F) to 28 HRC. Failure resulted from the nucleation, growth, and eventual coalescence of grain-boundary cavities. The cavities nucleated on complex sulfides. SEM, 2500× (D.P. Pope, University of Pennsylvania, and S.-H. Chen, Norton Christensen)

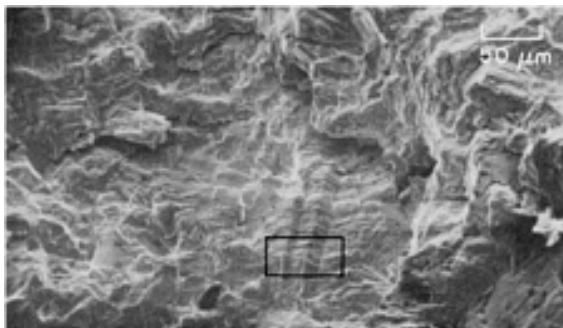
Fig. 611 Surface of fatigue-crack fracture in a specimen of AISI type 301 stainless steel that was highly stressed, breaking in 2000 cycles. Crack growth was very irregular, with many pronounced offsets. At center, twin boundaries have affected crack propagation. Area in rectangle is shown at higher magnification in Fig. 612. SEM, 200×

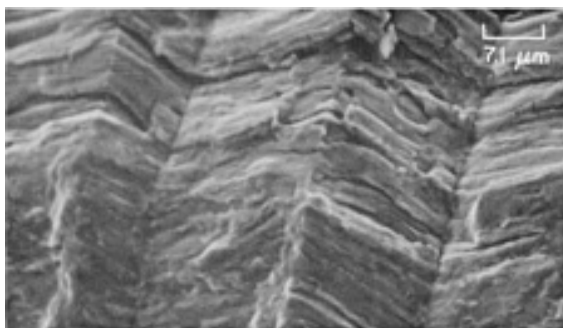
Fig. 612 A higher-magnification view of the area outlined by the rectangle in Fig. 611, which includes twin-boundary outlines. Several secondary cracks have formed at the roots of the fatigue striations. The striae, however, are not delineated well enough to permit a confident estimate of the spacing. SEM, 1400×

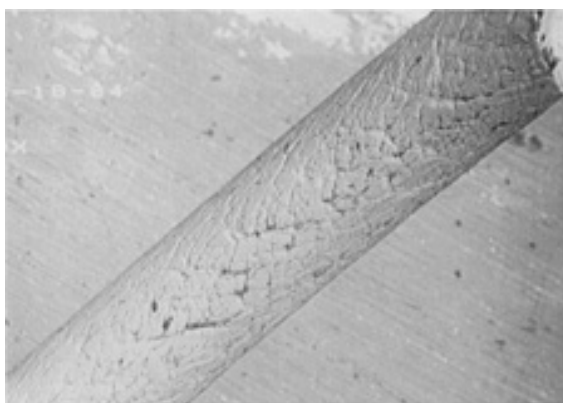
Fig. 613 Fatigue fracture of AISI type 302 spring wire. Failure initiated at grain-boundary damage called "alligatoring," a condition resulting from overetching during acid cleaning. Alligatoring is always detrimental to fatigue resistance and in extreme cases (such as this one) can lead to fracture of small index springs during coiling. SEM, 50× (J.H. Maker, Associated Spring, Barnes Group Inc.)

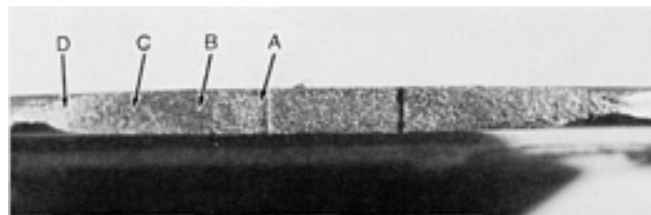
Fig. 618 Surface of a high-cycle fatigue fracture in a notched specimen of AISI type 302 stainless steel sheet subjected at 425 °C (800 °F) to tensile stress cycled from 24.8 to 124 MPa (3.6 to 18 ksi) at 1000 cycles/min. Fracture occurred after 1,625,450 cycles. The notch in the specimen was a center hole 0.25 mm (0.01 in.) in radius and 5 mm (0.20 in.) wide. Fatigue area became purple; fast-fracture area became straw colored, with shear and necking. See Fig. 616, 617, 619, 620, 621, 622, 623, 624, 625, and 626 for views at A, B, C, and D. 5×

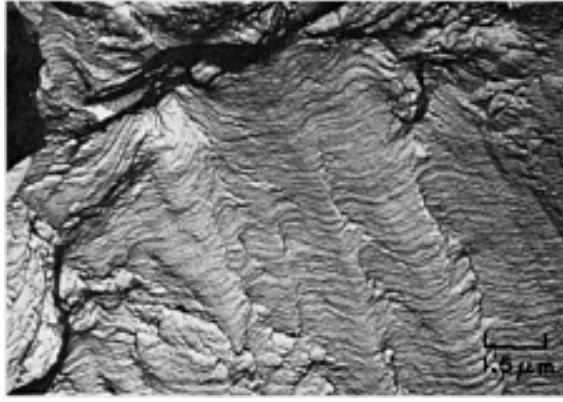
Fig. 619 TEM p-c replica of a third area near A in the fracture surface shown in Fig. 618. Here, fatigue striations are present in rather narrow and somewhat irregular patches. Some evidence of surface oxidation can be seen. 6500×

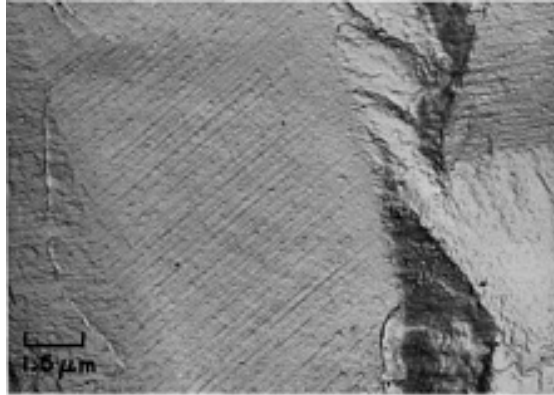
Fig. 620 TEM p-c replica of a fourth area near A in the fracture surface in Fig. 618, showing flat facets quite suggestive of intergranular cleavage. The parallel marks may not be fatigue striations, but rather features associated with the oxide film. 6500×

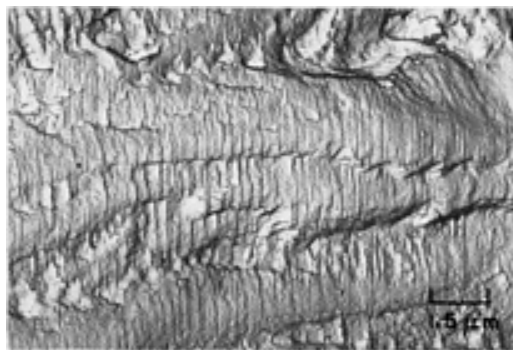
Fig. 621 TEM p-c replica of a fifth area near A in the fracture surface in Fig. 618. This area is characterized by narrow patches of extremely sharp and distinct fatigue striations. Again, the oxide film is apparent. 6500×

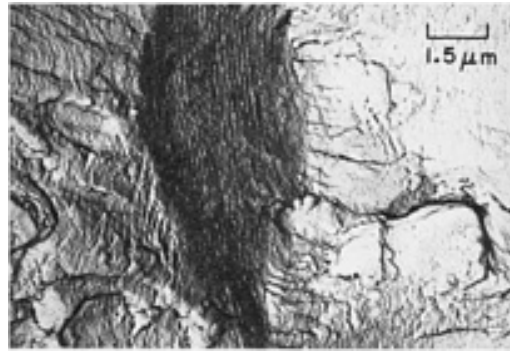
Fig. 622 TEM p-c replica of a sixth area near A in the fracture surface in Fig. 618, showing distinct fatigue striations. The markings to the right of the dark region are believed to be cleavage steps, not fatigue striations. 6500x

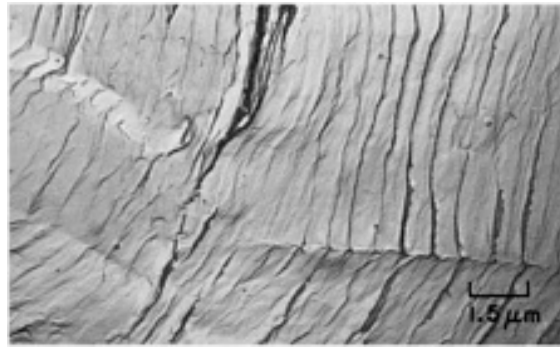
Fig. 625 TEM p-c replica of another area near C in Fig. 618, showing a further increase in fatigue-striation spacing. A junction of two crack fronts is visible at lower right. Secondary cracks appear to have formed at some striations. 6500×

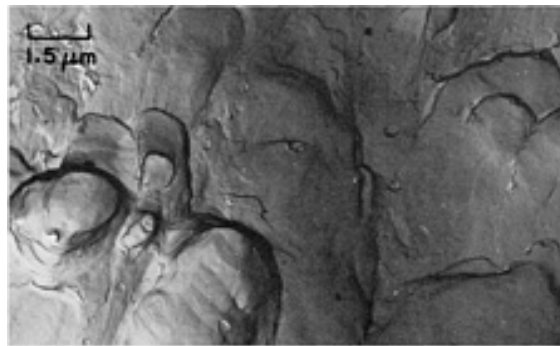
Fig. 626 TEM p-c replica of an area at D, in the region of final fast fracture and about 11.7 mm (0.46 in.) from the notch, in Fig. 618. The elongated dimples confirm that final fracture was by shear. Fatigue striations ceased to form when this final stage of fracture began. 6500×

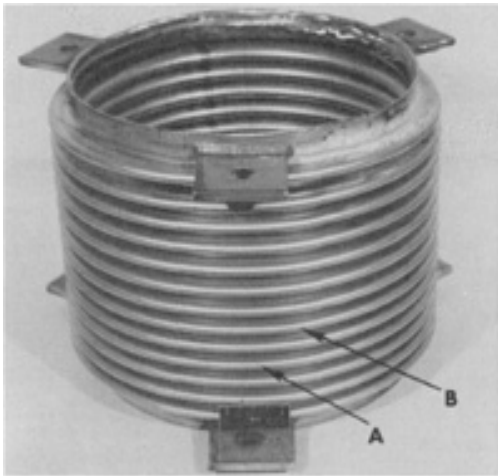
oxygen with the already existing sulfidic scale on the inner diameter of the pipe. The region near the dissimilar-metal weld provides both the required sensitized microstructure and either residual or differential thermal stresses. 10% oxalic acid electrolytic etch, 15× (D.R. Diercks, Argonne National Laboratory)

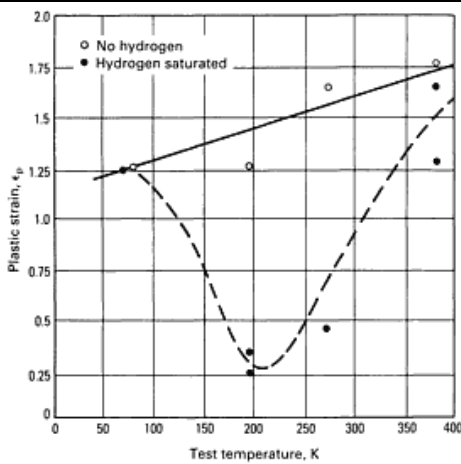
Hydrogen-embrittlement failure of AISI type 304 bellows. The component was made by rolling sheet into tube, seam welding, and then forming. Continuous pressurization with gaseous hydrogen at 172 kPa (25 psi) induced hydrogen embrittlement at roots of bellows convolutes, regions where residual stresses from forming were at a maximum. Fig. 634 and 635: Bellows assembly and hydrogen-induced circumferential cracks at A and B. Fig. 636, 637, and 638: Microstructure of fifth convolute cross section, showing twins, transgranular and intergranular fracture modes, and secondary cracking. Oxalic acid electrolytic etch, 10 \times , 50 \times , and 200 \times , respectively (R.J. Schwingamer, NASA Marshall Space Flight Center)

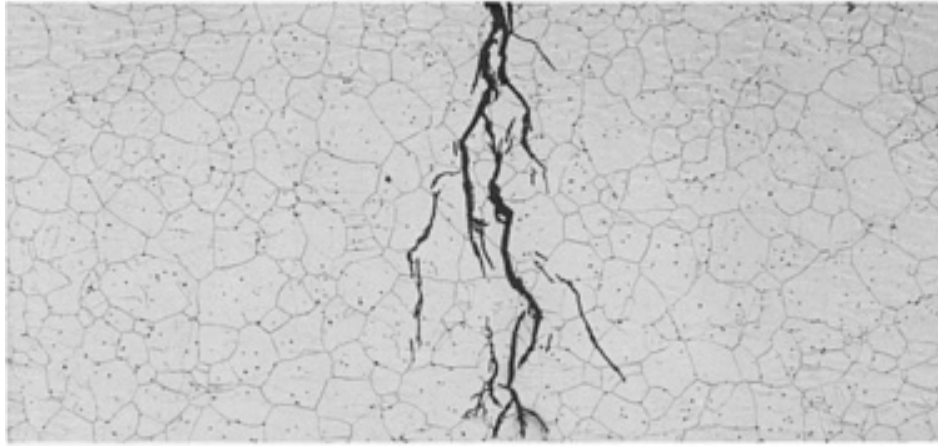
Fig. 650 Failure due to chloride stress-corrosion cracking (SCC) of an AISI type 316 pipe. The pipe served as a vent for the preheater-reactor slurry transfer line in a coal-liquefaction pilot plant. Although no material flowed through the vent line--a "dead leg"--the service temperature was low enough to permit formation of an aqueous condensate on its inside surface. Extensive cracking originated at the inside wall of the pipe. Examination of an etched transverse section of the crack tip (shown here) revealed transgranular cracking with a branching pattern characteristic of chloride SCC. 200× (J.R. Keiser and A.R. Olsen, Oak Ridge National Laboratory)

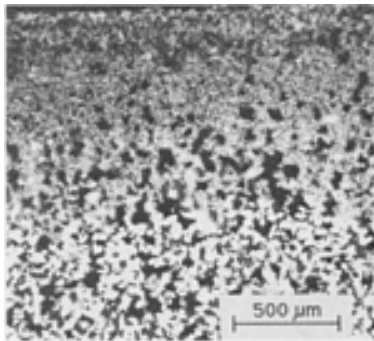
Fracture surface. Note beach marks. SEM, 20×. Fig. 652: Close-up of fracture origin (arrow) in Fig. 651. SEM, 50×. Fig. 653: High-magnification view of fracture origin and associated corrosion pit. Wire surface is at top, fracture surface at bottom. SEM, 620×. Fig. 654: Region on surface of wire near location of fracture, showing two corrosion pits. SEM, 1000× (C.R. Brooks, University of Tennessee)

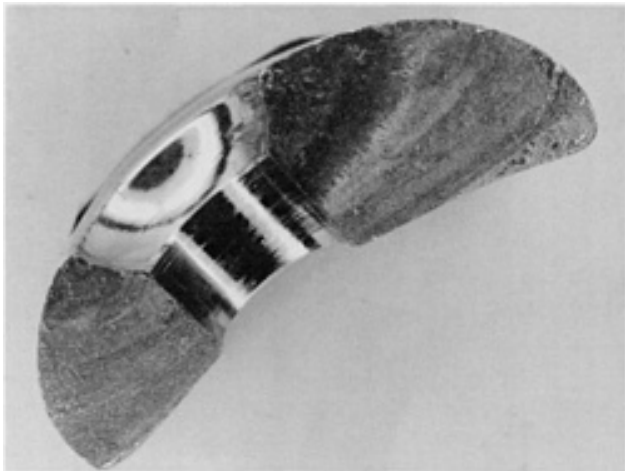
Torsional overload fracture of cortical screw. The bone screw was machined from cold-worked AISI type 316L rod and then stress relieved. Its surface was electropolished and passivated. Fig. 658: Fracture surface of screw. SEM, 28 \times . Fig. 659: Close-up of edge of fracture surface. Note torsional shear bands and dimpled region typical of a ductile fracture. SEM, 117 \times . Fig. 660: High-magnification view of dimpled-rupture portion of fracture surface reveals elongated dimples characteristic of a torsional (shear) failure mode. SEM, 1170 \times (H.R. Shetty, Zimmer Inc.)

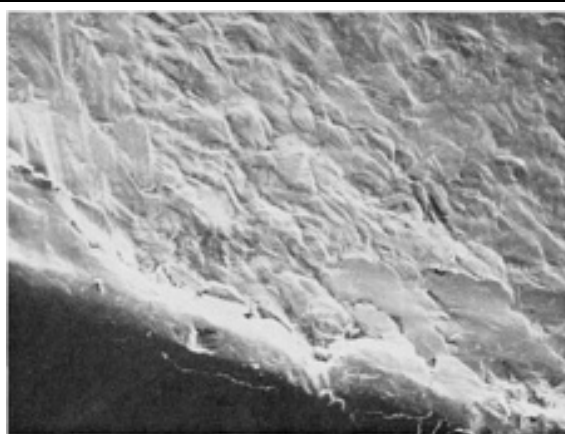
Fatigue crack nucleation at slip bands in the plate of a hip screw (compression tube and plate) surgical implant. Material and processing same as in Fig. 661, 662, and 663. Scanning electron photomicrographs are of the lateral (tension or screw-head-side) surface of plate subjected to fatigue loading. Fig. 664: Lateral surface of plate. Note slip-band activity and intrusions formed by slip bands. SEM, 187×. Fig. 665: Higher-magnification view of area on lateral surface of plate. Note microcracking at slip bands and the crack being formed at a grain-boundary triple point. SEM, 1160×. Fig. 666: Fatigue crack formed on lateral surface of plate. Growth is along slip planes. SEM, 983×. Fig. 667: Area on lateral plate surface near fracture origin. Features include slip-band cracking and crack growth along intersecting slip planes. SEM, 1400× (H.R. Shetty, Zimmer Inc.)

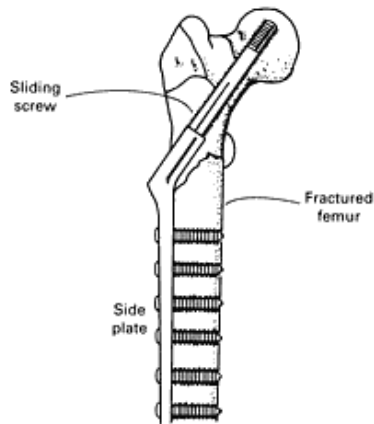
Fatigue crack nucleation in the plate of compression hip screw. Material and processing same as in Fig. 661, 662, and 663. This pair of scanning electron photomicrographs shows the medial (compression or bone-side) surface of the failed plate. Fig. 668: Medial surface near fracture origin. Ridges result from grain deformation. SEM, 86×. Fig. 669: Higher-magnification view of representative area in Fig. 668. Note slip-band activity and intersecting slip bands. See also Fig. 664, 665, 666, and 667. SEM, 859× (H.R. Shetty, Zimmer Inc.)

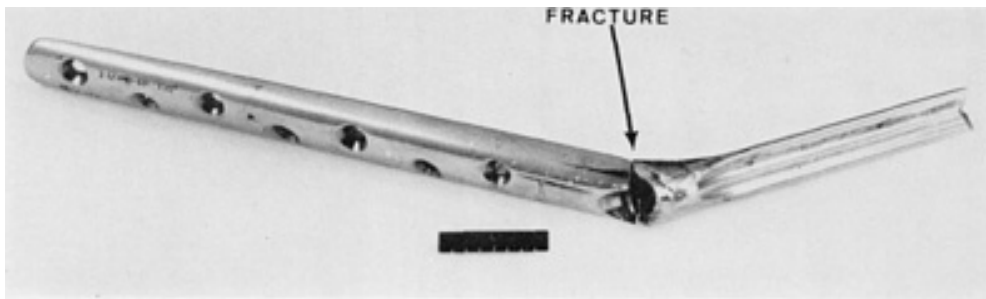
Fatigue fracture of AISI type 316L sliding lag screw in compression hip screw (see Fig. 670). Failure occurred in forward notch of last of six thread roots. First five threads were embedded in the femoral head. Last root was in line with or close to the femoral neck fracture, where it would have been subjected to cyclic bending forces during patient mobility. Fig. 676 and 677: Recovered portion of failed screw and on unused screw. Fig. 678 (bottom left): Scored surface of thread root near where fracture occurred. SEM, 78×. Fig. 679: Close-up of gouge on thread root surface in Fig. 678. Note fissure that developed due to low-cycle bending fatigue patient mobility. SEM, 235× (R.J. Gray, Consultant)

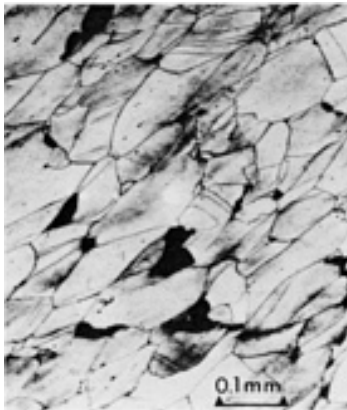
A secondary cause of the Jewett nail fracture in Fig. 680, 681, 682, and 683 may have been intergranular corrosion. Fig. 684: Close-up of chamfer-fracture surface interface (I in Fig. 682). SEM, 50×. Fig. 685: Higher-magnification view of region A on fracture face in Fig. 684. Note evidence of intergranular corrosion. In some cases, however, these "mud crack" patterns are believed to be dried body fluids that were not completely removed from the fracture surface during sample preparation (compare with Fig. 672). SEM, 500×. Fig. 686: Same as Fig. 685, but at higher magnification. SEM, 1000×. Fig. 687: Metallographic section transverse to fracture face lends support to contention that intergranular corrosion played a role in this fracture. Note how the "corrosion-etched grain size" in Fig. 686 is very similar to the etched grain size in this photomicrograph. 1000× (R.J. Gray, Consultant)

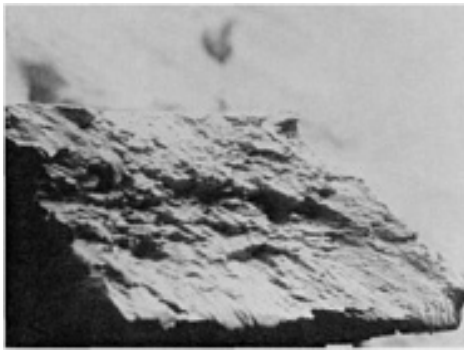
boundary precipitates and the matrix, as shown here in a type 316 sample. 600×. Fig. 690: Creep failure due to wedge cracking at triple points produces a rough fracture surface with identifiable grain-boundary precipitates. For example, carbides and σ -phase particles are found on the fracture surface of this type 316 stainless steel. TEM replica, 10,000×. Fig. 691: Rounded-type voids in type 316L weld metal. Sample failed in creep at high temperature. 100× (I. Le May, Metallurgical Consulting Services Ltd.)

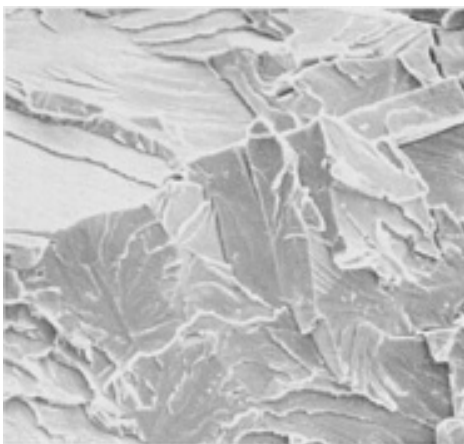
"Channel fracture" of irradiated AISI type 316. In this type of fracture, which is unique to highly irradiated materials, dislocation motion is confined to a few narrow zones or channels. The 20% cold-worked type 316 sample was irradiated at 385 °C (725 °F) to a neutron fluence of 1.28×10^{23} n/cm² ($E_n > 0.1$ MeV). Fig. 692: Fracture surface of sample after tensile testing at 205 °C (400 °F). Fracture mode is shear. SEM, 43×. Fig. 693: Higher-magnification view of fracture surface reveals the steplike topography of channel fracture. SEM, 1440×. Fig. 694: Extreme close-up of a single channel on the fracture surface in Fig. 693. Note the numerous voids and the narrow zone at center, where dislocations have produced elongated voids by shear. TEM thin foil specimen, 57,000× (J.E. Nolan, Westinghouse Hanford Company)

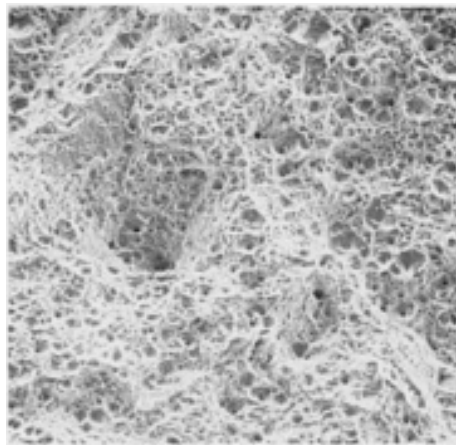
Fig. 697 Substitution of iron-aluminum alloys is one potential way to reduce dependence on conventional austenitic stainless steels with their high contents of the strategic element chromium (see Fig. 695 and 696). Another, perhaps more promising, alternative is to develop alloys that contain lesser amounts of chromium. An example is Fe-8Cr-12Ni-4.5Si-1Al-1Mn-0.05C. A ductile fracture characterized by dimple rupture is obtained in this material after annealing for 1 h at 1100 °C (2010 °F) and air cooling. Credit for the high ductility goes to a microstructure of low-carbon martensite. SEM, 250× (H.W. Leavenworth, Jr., U.S. Bureau of Mines)

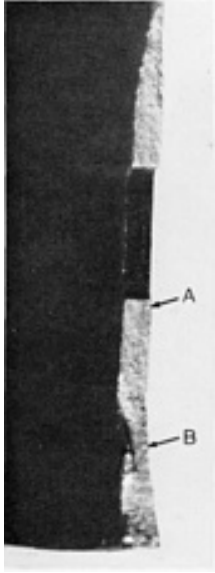
primary and secondary heat-treat cracks formed before the links were oil quenched from the annealing temperature. All etched in super picral. Fig. 701 and 703: 250×. Fig. 702: 100×

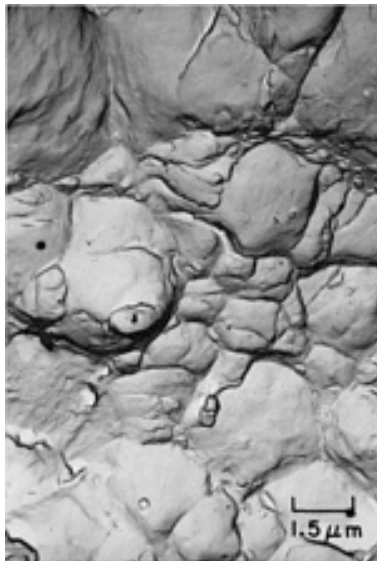
Fig. 709 TEM p-c replica of an area at B in Fig. 704. The equiaxed dimples visible here resulted from tension overload during final fracture, but before final shear rupture. 6500×

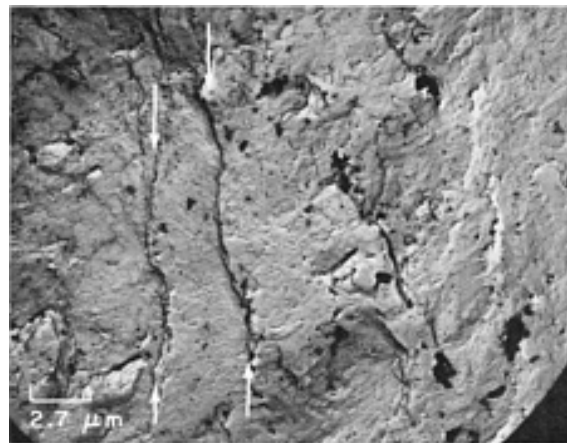
Fig. 713 TEM p-c replica of the fracture surface in Fig. 710, showing a region about 30 μm from a crack nucleus. Visible between the arrows are steps that separate fatigue patches. Fatigue striations are faintly visible within the patches. 3750 \times

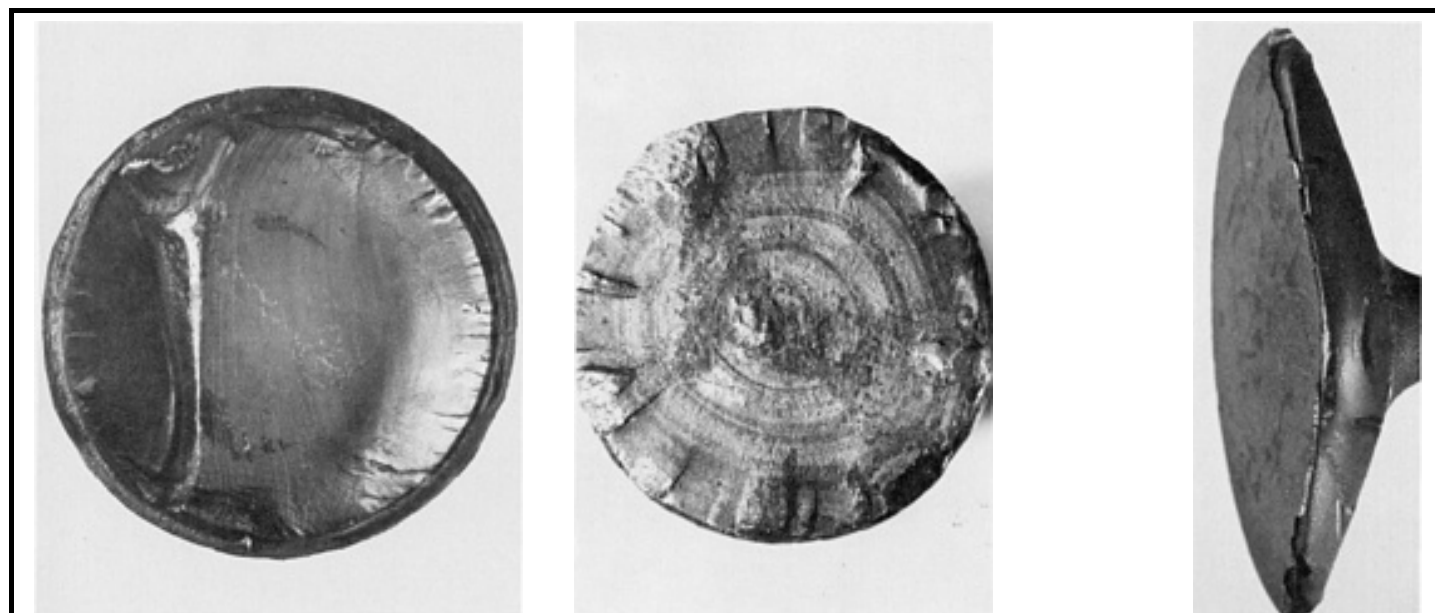
which resulted when microvoid coalescence occurred during final tensile-shear fracture. The dark areas are probably rust or "dirt." 18750×

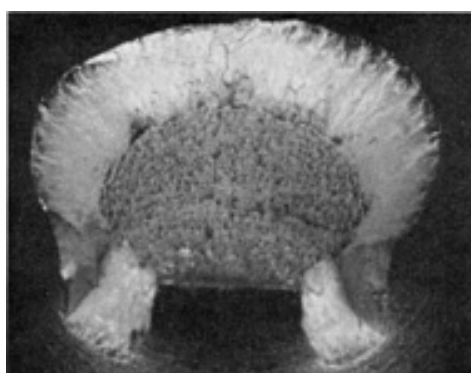
Fig. 720 A classic example of cup-and-cone tension-overload fracture in an unnotched specimen of 13-8 PH

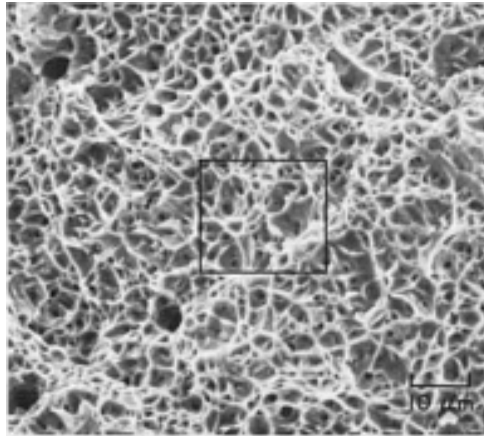
Fig. 721 SEM view of an area in the flat, central region of the fracture surface in Fig. 720, showing the equiaxed dimples of rather uniform size that are expected in this type of fracture. The scattered ridges produce the fibrous appearance seen at low magnification (Fig. 720). See also Fig. 722, a higher-magnification view of the area outlined by the rectangle. 1000×

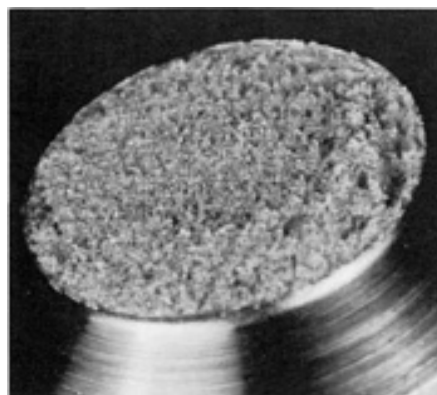
Fig. 723 A typical tension-overload fracture in a notched specimen of 13-8 PH stainless steel with the same properties as those of the specimen in Fig. 720. The fracture surface appears uniformly fibrous, with a hint of a shear lip. See also Fig. 724. 9×

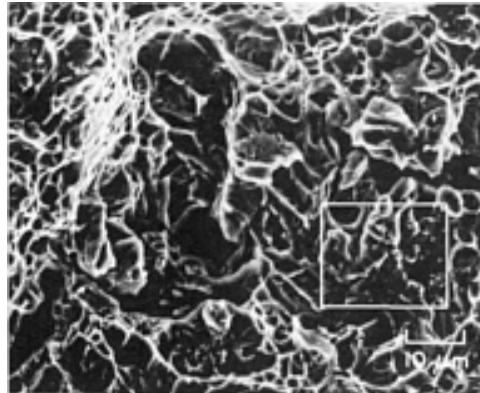
Fig. 724 SEM view of an area of the fracture surface in Fig. 723, showing dimpled rupture in some regions (at left, for example) and, elsewhere, facets that suggest local quasi-cleavage without evidence of any conventional river patterns. See also Fig. 725, a higher-magnification view of the area in the rectangle. 1000×

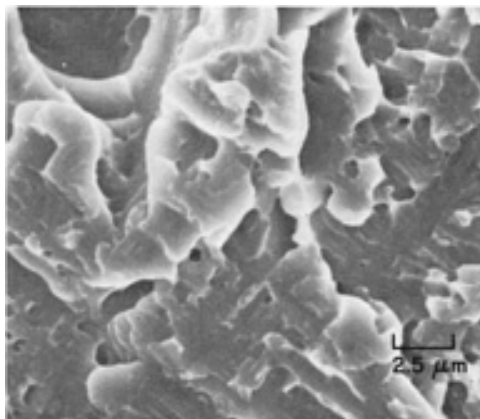
Fig. 725 Higher-magnification view of the area in the rectangle in Fig. 724. This SEM view shows that in the fine-scale structure there do appear to be some delicate cleavage steps, particularly at right. 4000×

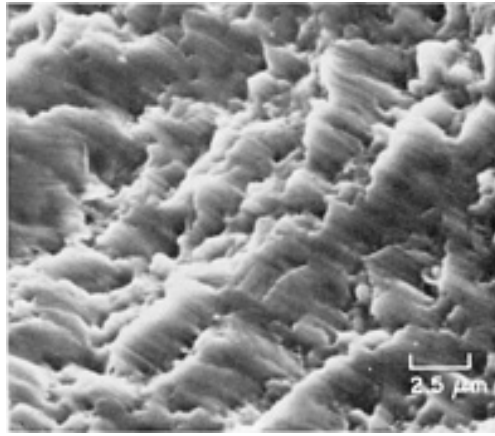
Fig. 727 SEM view of the fracture surface in Fig. 726, taken at the rounded lip at the bottom edge of the crescent-shaped area. Even this close to the crack origin, there are no fatigue striations. The irregular surface displays ridges formed by a shear process. 4000 \times

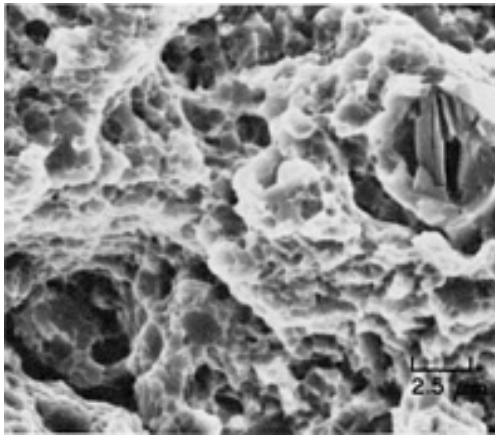
Fig. 728 Another SEM view of the fracture surface in Fig. 726, taken in the region of final fast fracture. Fatigue fracture has given way to dimpled rupture. Two pockets, one at the left and one at the right, contain features that resemble localized quasi-cleavage. 4000 \times

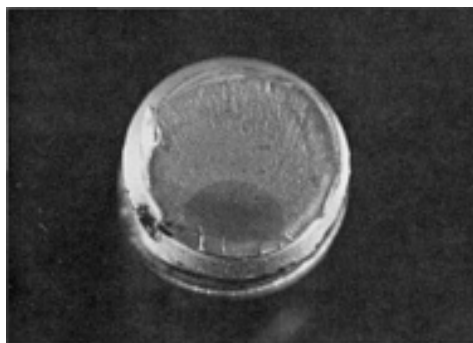
Fig. 729 High-cycle fatigue fracture in threaded specimen of 13-8 PH stainless steel (same properties as for specimen in Fig. 726) tested in tension-tension ($R = 0.1$) with maximum loading at 30% of tensile strength. Fracture occurred at 959,000 cycles. Note the crescent-shaped crack nucleus. See also Fig. 730 and 731. 6 \times

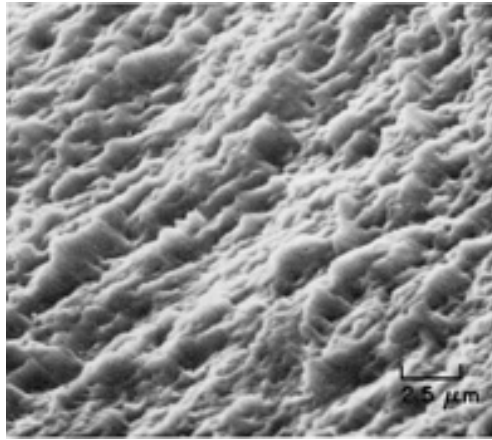
Fig. 730 SEM view of fracture in Fig. 729, taken as close as possible to the bottom edge of the origin region. This rough surface does not contain fatigue striations, but instead suggests a shear mechanism of fracture and bears considerable resemblance to Fig. 727. 4000 \times

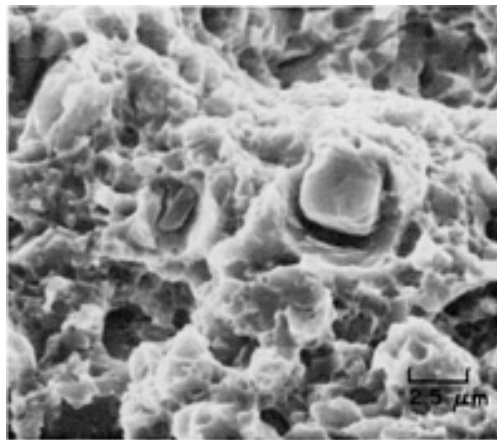
Fig. 731 View of the fracture surface in the fast-fracture region in Fig. 729, showing basically equiaxed dimpled rupture, but also containing scattered features of quasi-cleavage. Some of the regions display heavy concentrations of extremely small dimples. SEM, 4000 \times

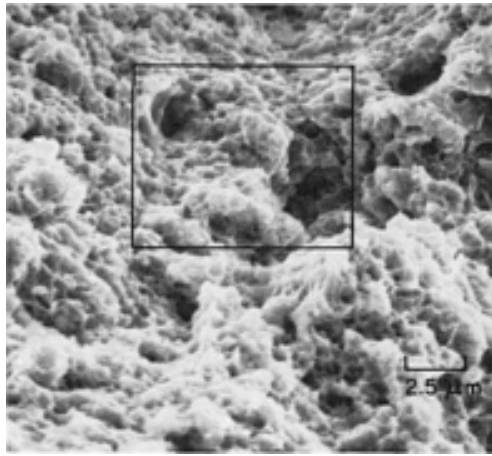
Fig. 733 SEM view of a region of the fracture surface shown in Fig. 732, revealing none of the intergranular rupture characteristic of hydrogen embrittlement, but showing the equiaxed dimples of tension overload. See Fig. 734 for enlarged view of outlined area. 4000×

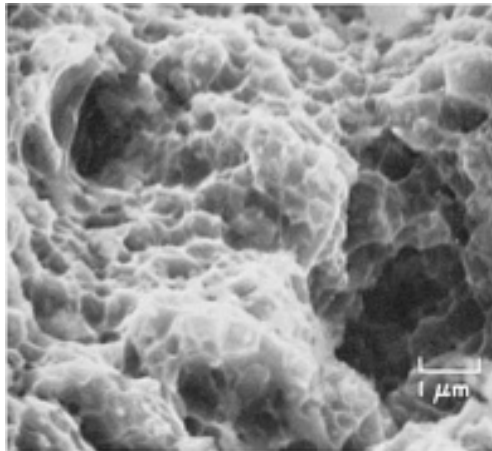
Fig. 734 Higher-magnification view of the area in the rectangle in Fig. 733, showing clearly the very dense grouping of very small dimples around larger dimples. There is no evidence here of either grain-boundary facets or inclusions. SEM, 10,000×

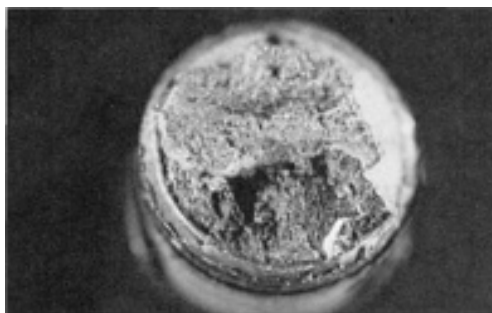
Fig. 735 Stress-corrosion cracking fracture in threaded specimen of 13-8 PH stainless steel (same properties as in Fig. 726) loaded to 75% of tensile strength in a 3.5% NaCl solution. See also Fig. 736. 6×

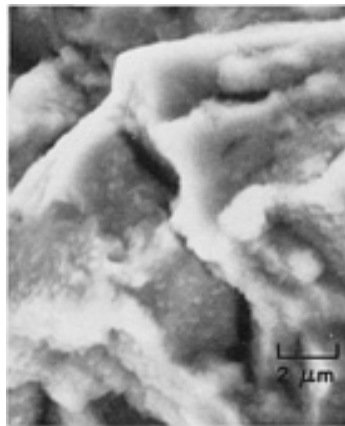
Fig. 737 Enlargement of the area in the rectangle in Fig. 736. The oxide coating appears to be quite continuous, except for the scattered secondary cracks. Compare with Fig. 738. SEM, 5000×
