به نام خدا

مرکز دانلود رایگان
مهندسی متالورژی و مواد

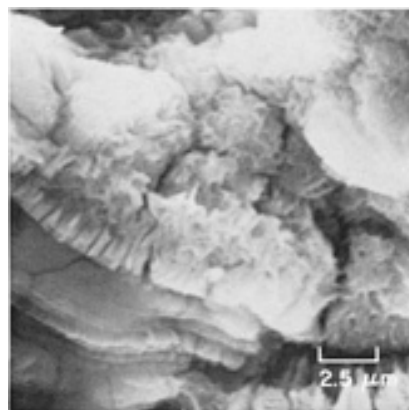
Fig. 738 Another higher-magnification view of the crack-origin area of the SCC fracture surface shown in Fig. 735, displaying a coating of a hydroxide corrosion product containing many fine secondary cracks. Compare with the area shown in Fig. 737. SEM, 4000×

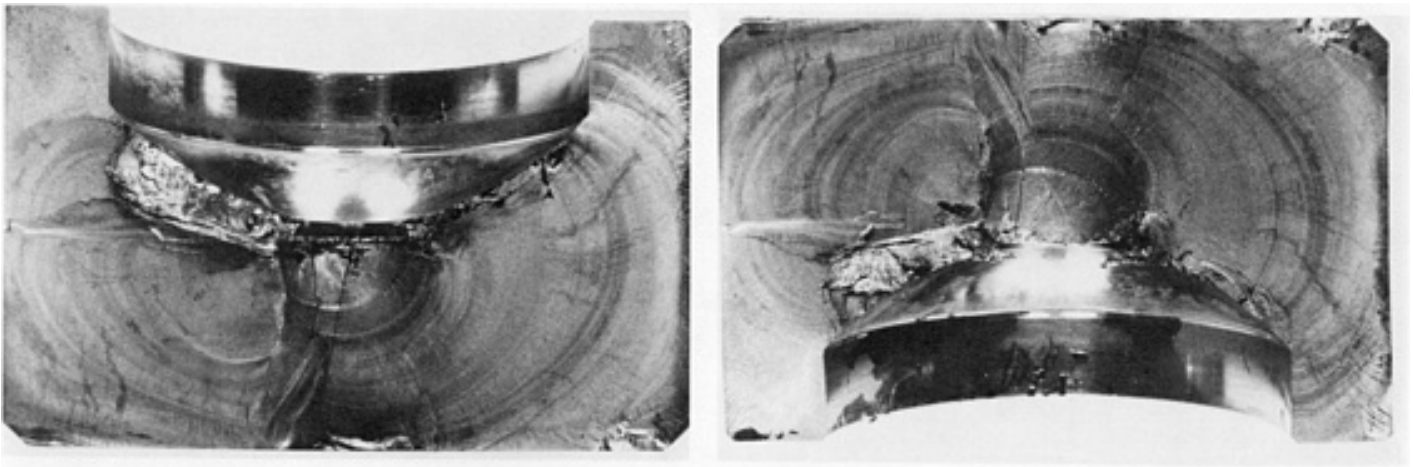
Fig. 739 High-cycle fatigue fracture of the end cap for a high-pressure compressor used in a polyethylene process. The forging was made of Armco 15-5PH (UNS S15500), quenched and tempered to the H1075 condition. The end cap was located between the crosshead and plunger of the compressor, where it was subjected to repeated impacts by the tungsten carbide plunger. Failure initiated in a sharply radiused machining recess (see mating fracture surfaces). 1.55× (E.V. Bravenec, Anderson & Associates, Inc.)

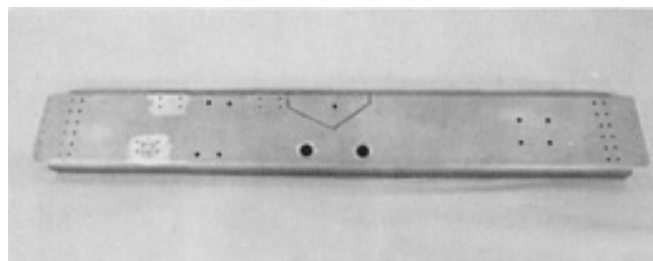
Fracture of deflector yoke for aircraft main landing gear due to intergranular stress-corrosion cracking. Material: Armco 17-4PH (UNS S17400), 36 to 44 HRC. Seals were missing from both fractured and unbroken yokes. The inside of the broken part was filled with particulate matter, sand, and corrosion products, indicating that water had been present. Fig. 740: Unbroken deflector yoke. Note pitting. 4×. Fig. 741: Fracture surface. Box outlines area where evidence of intergranular attack was found. SEM, 12×. Fig. 742: Boxed area in Fig. 741. Note intergranular nature of corrosion. SEM, 145× (W.L. Jensen, Lockheed-Georgia Company)

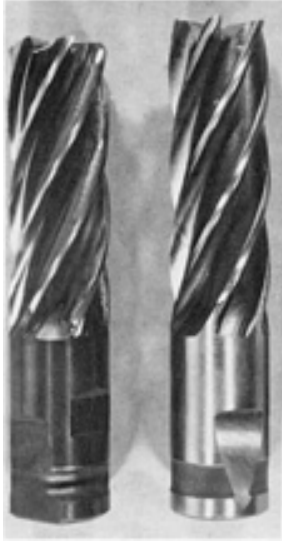
Fracture of Armco 17-7PH (UNS S17700) spring due to presence of "cross-check" defect. The wire broke during coiling. Cross-checks are probably caused by lubricant breakdown during wire drawing. Fig. 746: Fracture surface (top) and surface of stainless steel wire. Origin is boxed. Note cross-check defects on wire. SEM, 20 \times . Fig. 747: Higher-magnification view of fracture origin and associated cross-check. SEM, 100 \times (J.H. Maker, Associated Spring, Barnes Group Inc.)

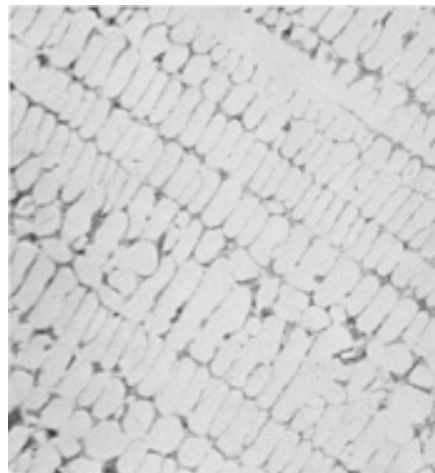
Fig. 751 Microstructure of as-deposited weld metal discussed in Fig. 748, 749, and 750, which consists of untempered martensite dendrites and a carbide eutectic in interdendritic regions. This a brittle structure that is prone to cracking during welding. See the brittle fracture regions labeled B in Fig. 750. 5% nital, 500 \times (W.L. Jensen, Lockheed-Georgia Company)

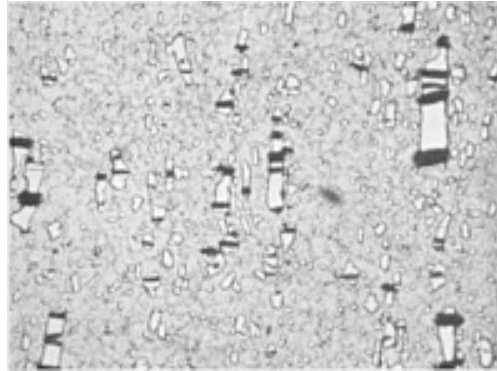
Fig. 756 Brittle in-service failure of diesel engine injector plunger. The part was made of AISI D2 bar. Heat treatment: air cool from 995 °C (1825 °F), cool to -75 °C (-100 °F), doubled temper at 175 °C (350 °F). Microstructure consists of carbides of various sizes dispersed in a martensitic matrix. The larger carbides are cracked, indicating that the material had been embrittled at some stage during its thermomechanical processing history. 3% nital, 280 \times (J.R. Kattus, Associated Metallurgical Consultants Inc.)

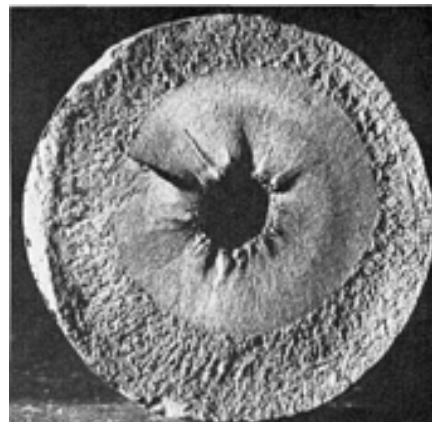
Fig. 758 A Surface of a fatigue fracture that originated at the inside of a hollow drill of AISI W1 tool steel. Fracture initiation was attributed to distortion of the bore of the drill during the production of a hot upset joint. 1.8×

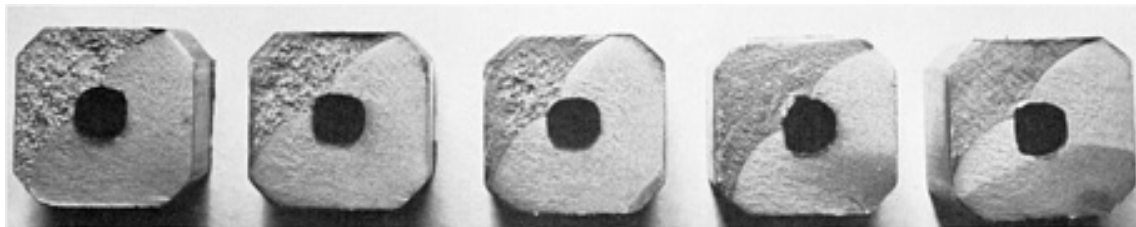
Fig. 759 Five fatigue-fracture surfaces that were produced in reversed bending in pneumatic testing machine. The material is AISI W1 tool steel. The lighter areas of the fracture surfaces are the fatigue zones--all of which were initiated at the lower right corners. Note the lack of beach marks, which indicates that during each test the load amplitude and environment were uniform. The dark regions at the upper left corners are the regions of final fast fracture. 1.5×

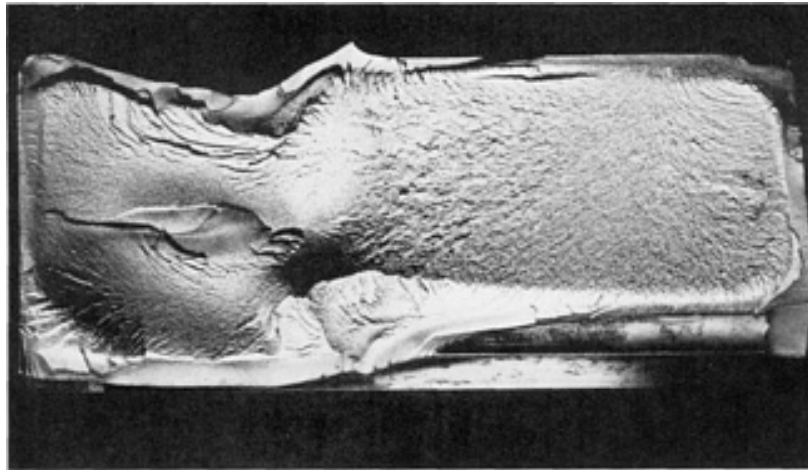
Fig. 764 Surface of a catastrophic fracture in an open-header die of AISI W2 tool steel that was case carburized to 0.95% C at the surface, heat treated in the range of 815 to 845 °C (1500 to 1555 °F), and water quenched. This die was used for cold forming and upsetting square heads. Upsetting stresses opened a small fatigue crack in the hardened case in the top edge near the upper right corner; it is to this area that the markings of radial fibrous fracture in the core of the die may be traced. The region of fast fracture encompasses nearly the entire fracture surface. Note the fine-grained, sharply defined case that frames the fibrous core. Actual size.

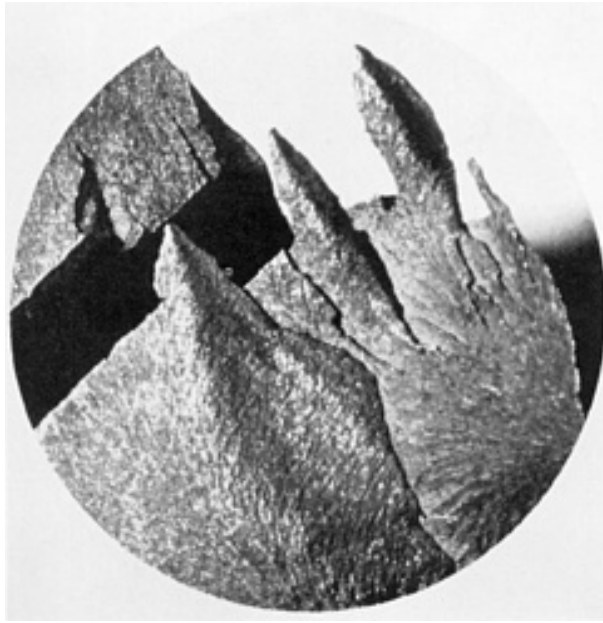
Fig. 768 Surface of an impact fracture in a shear blade of AISI L6 tool steel heat treated to a hardness of 55 HRC. The impact generated the two crack fronts whose junction may be seen at the secondary fissure that enters the field of view at lower right; the radial markings on either side clearly meet this at divergent angles. A third and separate crack front (at top left) met these two crack fronts at the wide secondary crack beneath the projecting shards. 3×

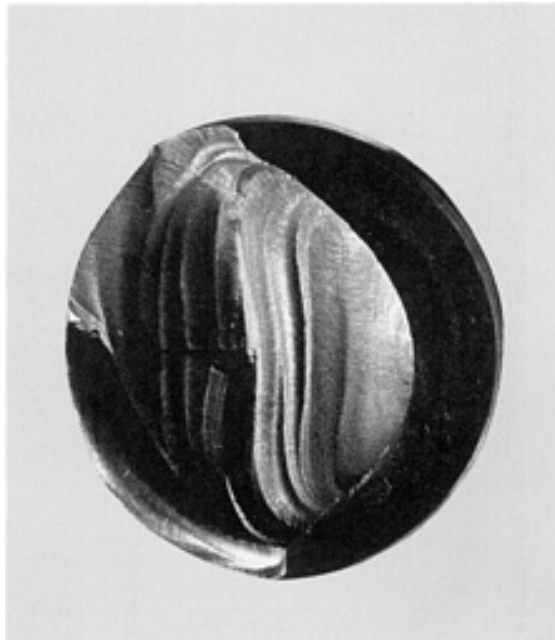
Fig. 769 Surface of a low-cycle fatigue fracture in the collar of a rivet-heading tool of AISI S1 tool steel heat treated to a hardness of 56 to 58 HRC. Following the development of the smooth fatigue zone at right, fracture occurred in a few hours of service, generating the unusual beach marks at center and left. 2×

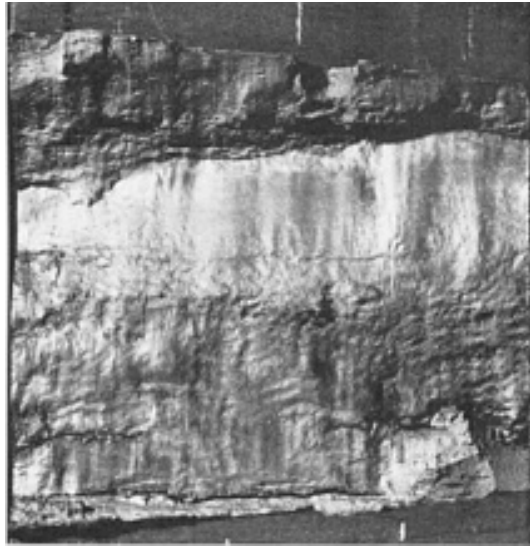
Fig. 770 A "hammer-burst" fracture at the center of a 130-mm ($5 \frac{1}{8}$ -in.) diam, 38-mm ($1 \frac{1}{2}$ -in.) thick forged disk of AISI T1 tool steel. This longitudinal fracture shows a surface of either a lap or a cold shut; the appearance of such a fracture is often called "platy" or "laminated." 2.3x

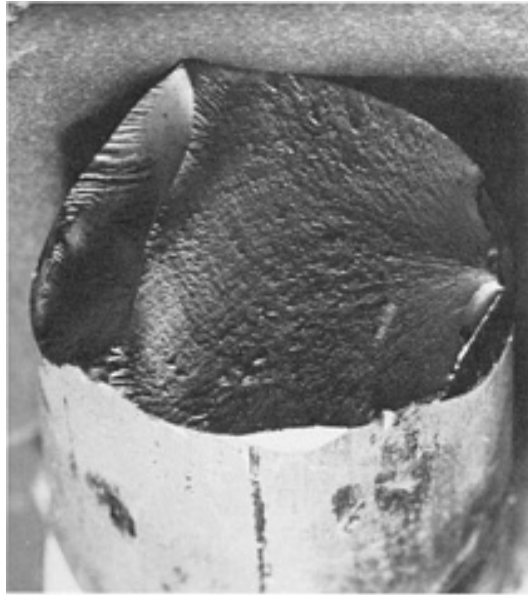
Fig. 772 An impact fracture in a 44-mm ($1 \frac{3}{4}$ in.) diam notched bar of AISI T1 tool steel that was broken for inspection same as the bar in Fig. 771. The crack resulting from the first hammer blow, which started at the notch at right, shows the network of intersecting fine markings called "Wallner lines." The crack that resulted from the second hammer blow is at left. 1.9×

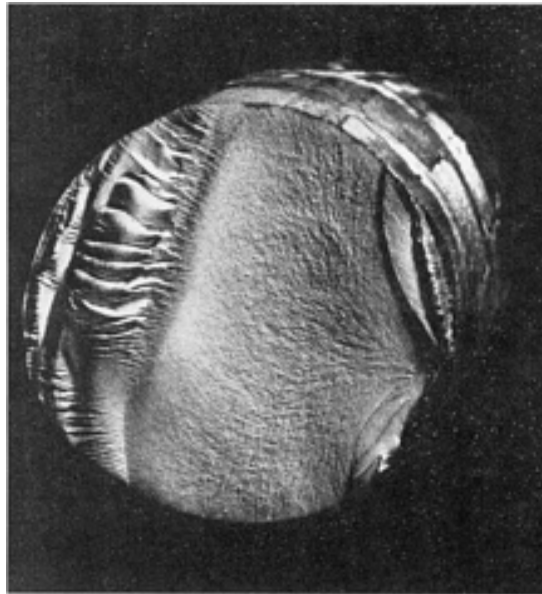
Fig. 773 An impact fracture in a notched bar of AISI M3 class 1 tool steel broken for inspection as in Fig. 771 and 772. The crack from the first hammer blow originated in the notch at right (origin is readily located by tracing back to the beginning of the fan-shaped pattern of radial marks); this crack penetrated the area at left with the second hammer blow. 1.7×

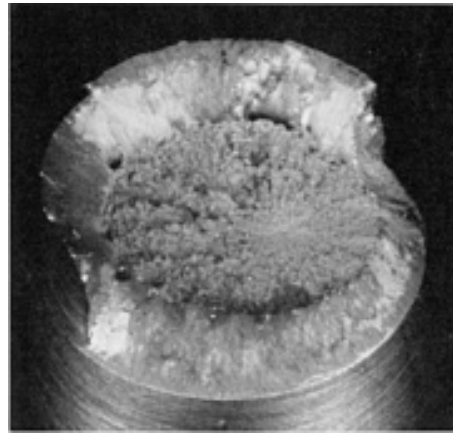
Fig. 774 Tension-overload fracture in an unnotched specimen of AISI H11 tool steel heat treated to a tensile strength of 2041 MPa (296 ksi) and 48% reduction of area. Note radial features between fibrous origin (just right of center) and shear lip. See also Fig. 775 and 776 for higher-magnification views of this fracture. 9×

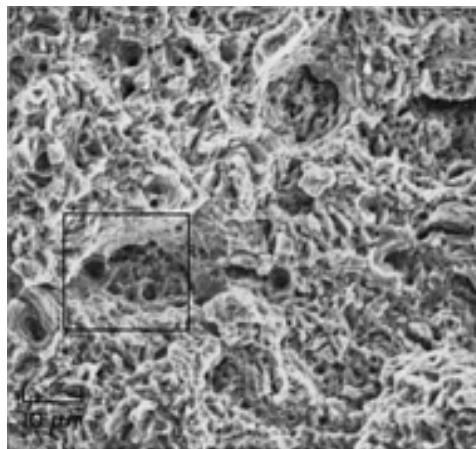
Fig. 775 Another view of the fracture surface in Fig. 774, taken in the vicinity of the fracture origin, showing an unusually uneven array of dimpled facets with a scattering of large voids. See Fig. 776 for a higher-magnification view of the area in the rectangle. SEM, 1000×

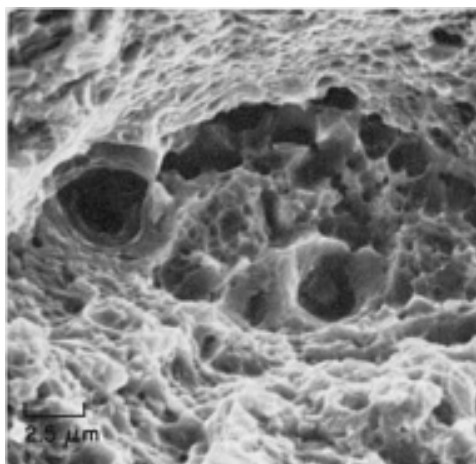
Fig. 776 Higher-magnification view of the area in the rectangle in Fig. 775, showing one of the large voids and

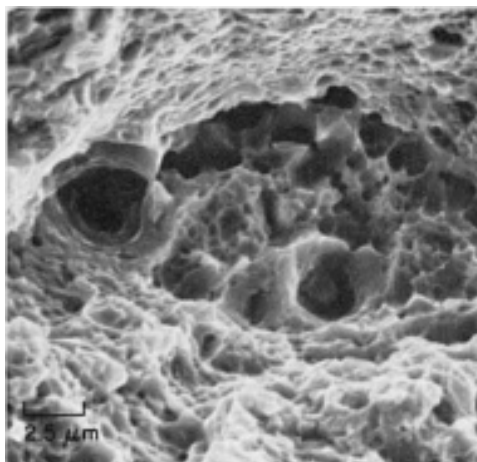
Fig. 777 Tension-overload fracture in notched specimen of AISI H11 tool steel (same heat treatment as in Fig. 774). Notched tensile strength ($K_c = 3.5$) is 2665 MPa (386.5 ksi). A flat surface, partly bounded by a hairline shear lip. See also Fig. 778 and 779. 9×

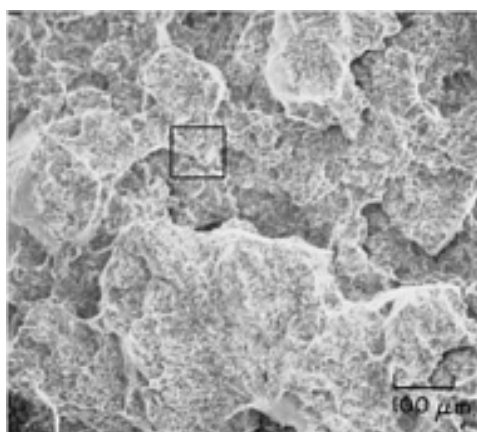
Fig. 778 SEM view of the fracture surface in Fig. 777. This surface seems to be generally dimpled, but at this relatively low magnification the features that appear to be dimples are not adequately resolved. See also Fig. 779, an enlarged view of area in rectangle. 100×

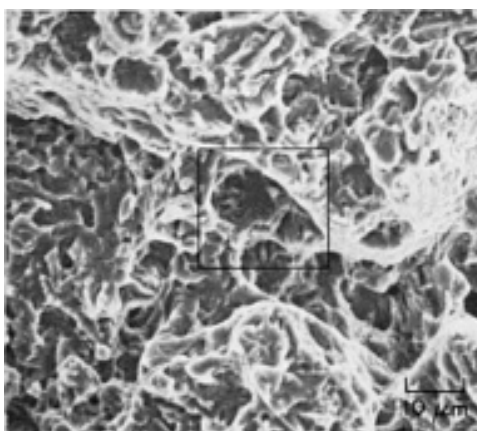
Fig. 779 Higher-magnification view of the area in the rectangle in Fig. 778, showing dimples that are associated with local quasi-cleavage. Very little evidence of secondary cracking is present. Area in rectangle is shown at higher magnification in Fig. 780. SEM, 1000×

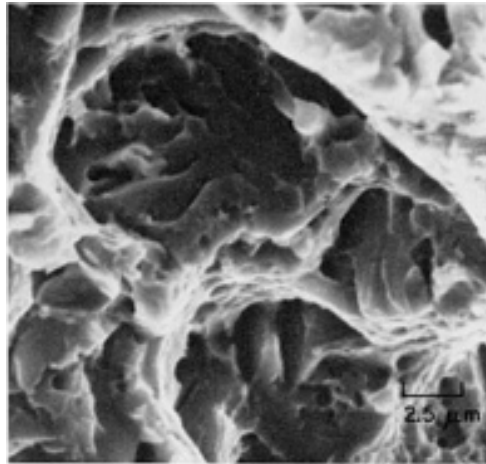
Fig. 780 Higher-magnification view of the area in the rectangle in Fig. 779. Small quasi-cleavage facets are visible, both within and adjacent to the larger dimples. SEM, 4000×

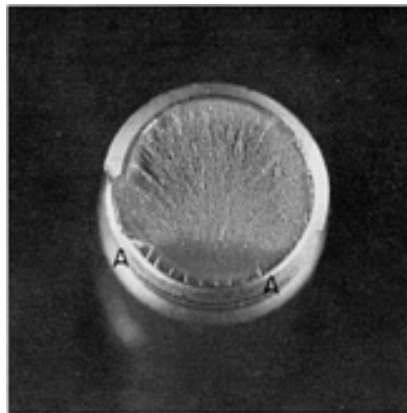
Fig. 781 Low-cycle fatigue fracture in threaded specimen of AISI H11 tool steel (same heat treatment and tensile strength as in Fig. 774) that broke after 21,000 cycles of tension-tension ($R = 0.1$); maximum load, 60% of tensile strength. Region A-A is fatigue portion of fracture. See also Fig. 782, 783, 784, and 785. 6×

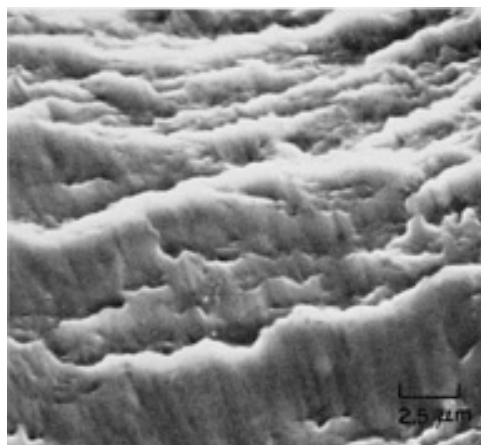
Fig. 782 SEM view taken near the outer edge of the crescent in Fig. 781. Evident are ridges that are attributed to mechanical damage during shear deformation. In this region, there appear to be no secondary cracks. 4000×

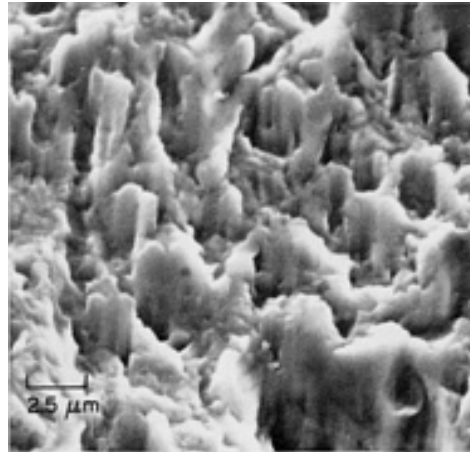
Fig. 783 View of the crescent in Fig. 781, showing a region farther from the outer edge than that in Fig. 782 and revealing ridges, formed during shear deformation, that have very irregular crests. SEM, 4000×

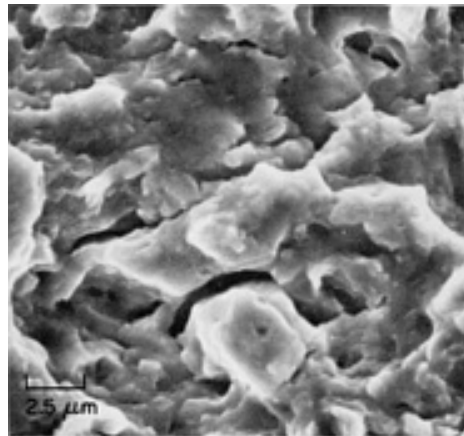
Fig. 784 Another view of the crescent in Fig. 781, showing a region still farther from the outer edge than that in Fig. 783. This region shows little evidence of conventional fatigue striations, but reveals small cleavage facets, many of which are separated by secondary cracks. SEM, 4000×

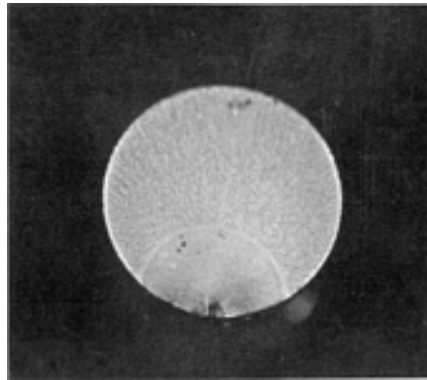
Fig. 786 High-cycle fatigue fracture in AISI H11 tool steel heat treated to a tensile strength of 2041 MPa (296 ksi) and 48% reduction of area, which broke after 775,000 cycles of tension-tension ($R = 0.1$) under a maximum load of 30% of tensile strength. The fatigue-crack origin is at the outer edge of the crescent-shaped region at bottom. See also Fig. 787 and 788 for higher-magnification views of this fracture. 6×

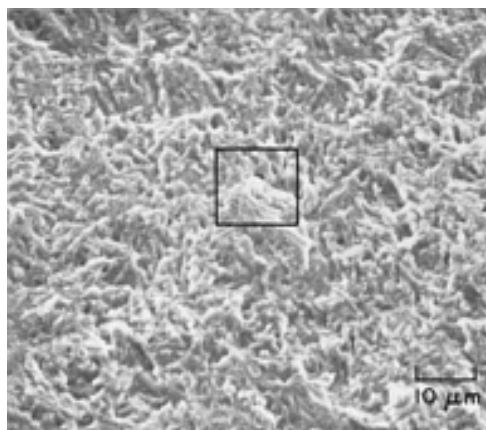
Fig. 787 An area within the crescent-shaped (fatigue) region of the fracture surface in Fig. 786. The surface contains many pockmarks, which resemble dimples. There are no suggestions of fatigue striations. See Fig. 788 for an enlargement of the area in the rectangle. SEM, 1000×

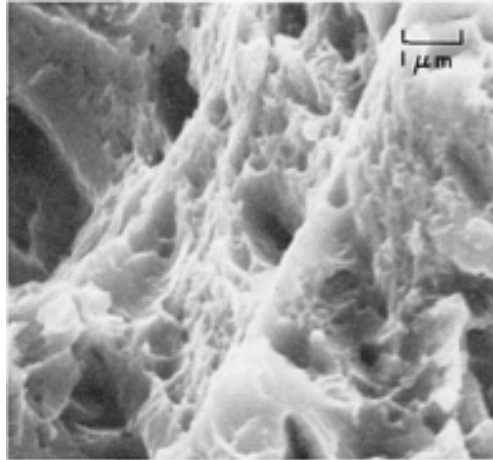
Fig. 791 Higher-magnification view of the area in the rectangle in Fig. 790. Very fine dimples and large dimples are both present. A few features resemble cleavage facets, but the grain-boundary parting expected in hydrogen-embrittlement fractures is absent. SEM, 10,000×

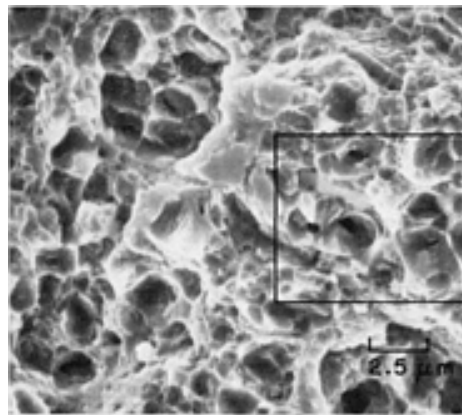
Fig. 792 Another view of the fracture surface in hydrogen-embrittled AISI H11 tool steel shown in Fig. 789. The surface consists almost entirely of dimpled rupture. A few facets are present and suggest possible local cleavage. See also Fig. 793. SEM, 4000×

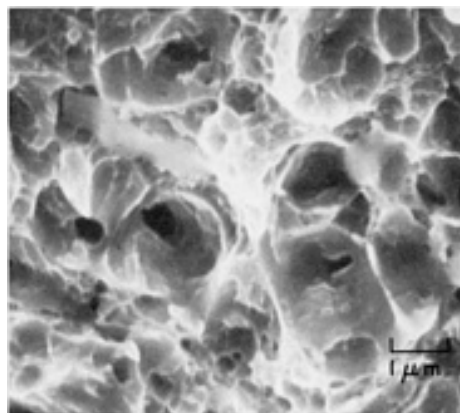
Fig. 793 Higher-magnification view of a region of which most is contained within the rectangle in Fig. 792. This region, like the one shown in Fig. 791, exhibits a considerable range in dimple size and no trace of grain-

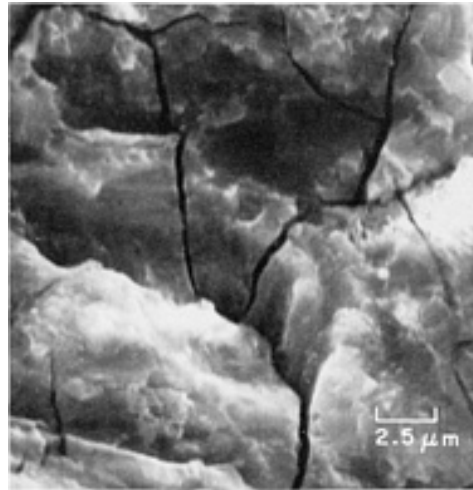
Fig. 797 High-magnification view of a region of the fracture in Fig. 794 not shown in Fig. 795, displaying grain-boundary facets and some corrosion. Some of the deep secondary cracks may be transgranular. SEM, 4000 \times

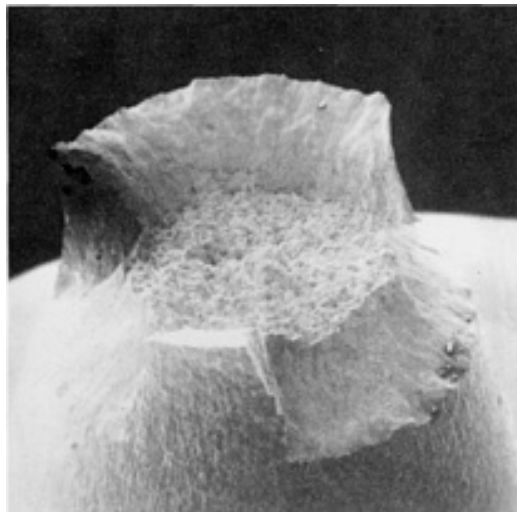
Fig. 798 Surface of a fracture in a tensile-test specimen of 18% Ni, grade 300, maraging steel aged 3 h at 480 °C (900 °F), broken at room temperature. The crack-initiation zone (at center) is an example of extremely uneven fibrous fracture; there appear to be no radial marks leading to the base of the surrounding shear lip. The shear lip is of the pronounced type that is observed when a large reduction in cross-sectional area accompanies fracture. See also Fig. 799, 800, 801, and 802. 26 \times

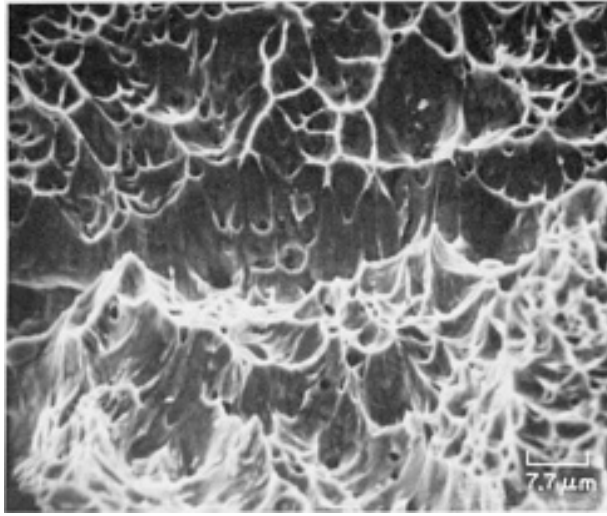
Fig. 799 SEM view of the fracture surface of the specimen of 18% Ni, grade 300, maraging steel in Fig. 798, showing a region in the area of transition from fibrous fracture in the central zone to fracture by shear in the surrounding lip. Visible in the lower portion of the fractograph are the equiaxed dimples (viewed obliquely) that are characteristic of fracture in pure tension; above are the elongated dimples of the shear lip. Note the horizontal boundary between these two types of fracture. See also Fig. 800 and 801. 1300 \times

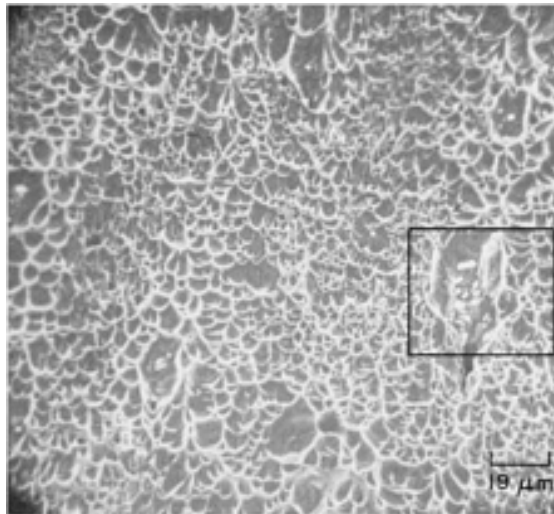
Fig. 800 View of the shear-lip region of the fracture surface in Fig. 798. Microvoid coalescence here has produced shear dimples with characteristic elongated shape. Note the large voids, which formed at inclusions of Ti(C,N). The matrix did not adhere to these inclusions, which allowed the voids to open early in the fracture process and to grow large. See Fig. 801 for a higher-magnification view of the area in the rectangle. SEM, 520 \times

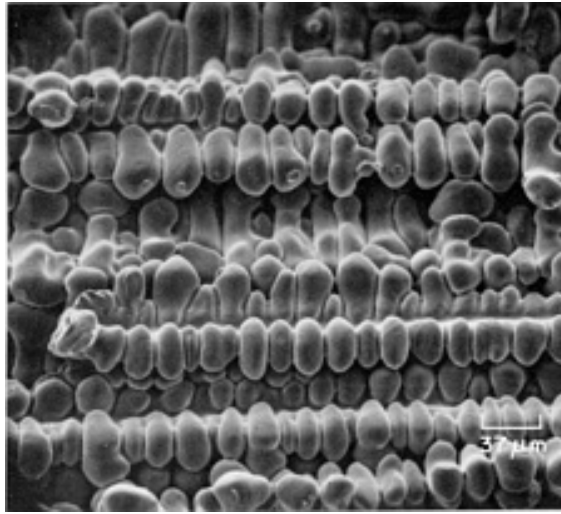
Fig. 803 Surface of tensile-test fracture in a cast specimen of 18% Ni, grade 300, maraging steel, showing a region where the fracture intersected a shrinkage cavity and exposed dendrites whose growth during solidification was arrested by a lack of molten metal within the cavity. In this view, the primary dendrite arms are oriented horizontally. See also Fig. 804 and 805. SEM, 270 \times

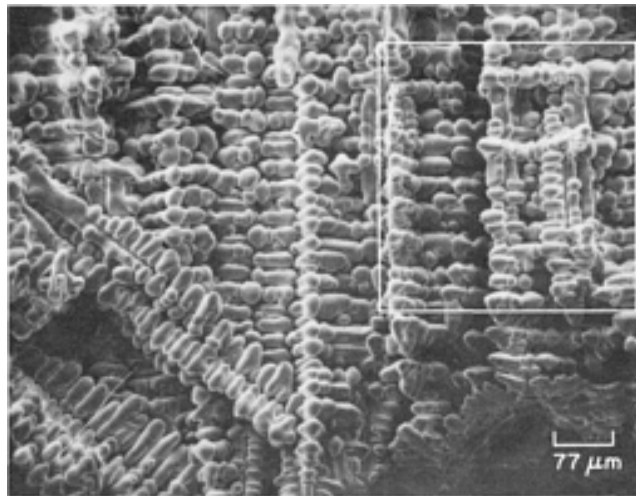
Fig. 804 Lower-magnification view of the exposed dendrites in the shrinkage cavity in the cast specimen of 18% Ni, grade 300, maraging steel in Fig. 803, showing dendrites that formed at different orientations. Had this casting been properly risered, the channels between the dendrite arms would have been filled, forming continuous metal. See also Fig. 805, which shows the area in the rectangle at higher magnification. SEM, 130 \times

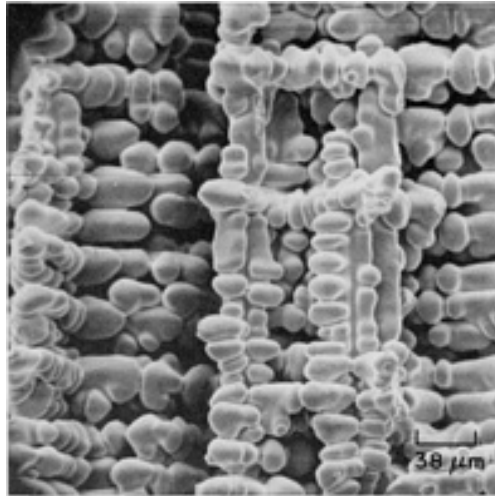
Fig. 805 Enlarged view of the area in the rectangle in Fig. 804. Primary dendrite arms are oriented vertically here; secondary arms are at various orientations normal to the primary arms. Appreciable secondary-arm growth is evident, but the higher-order branching often found in castings has not occurred. SEM, 260×

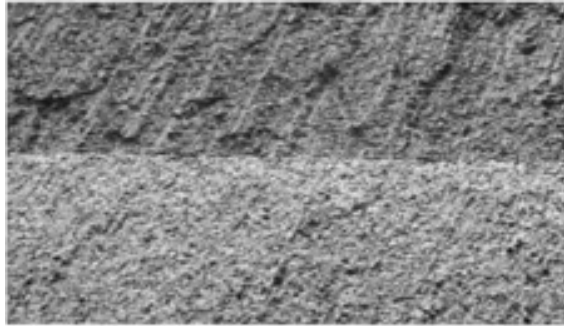
Fig. 806 Fracture surface of a fracture-toughness specimen of 18% Ni, grade 300, maraging steel; the heat treatment of this specimen was not reported. This view shows entry of the fatigue crack from bottom, and sharp onset of final fast fracture at center. See also Fig. 807 and 808; compare with Fig. 809. SEM, 26×

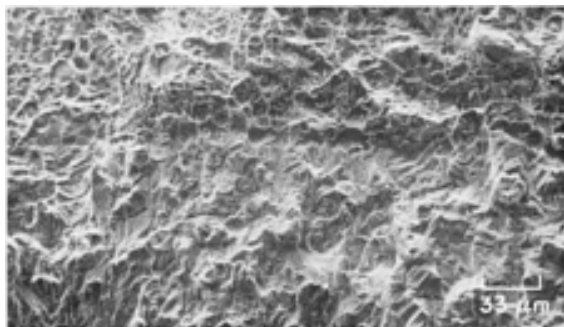
Fig. 807 SEM view, at higher magnification, of the fracture surface shown in Fig. 806, with the fatigue-crack surface at bottom and the fast-fracture surface at top. Note the secondary cracks and lack of clear fatigue striations in the fatigue area. See also Fig. 808. 300×

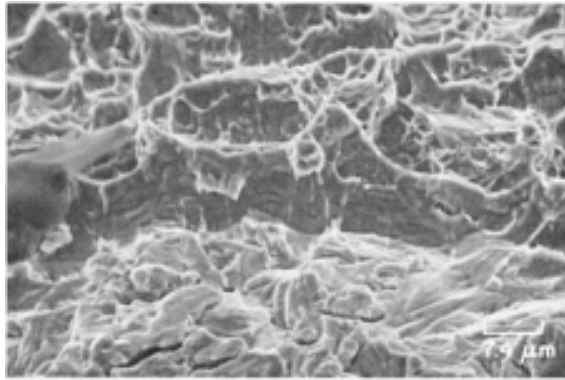
Fig. 808 Same fracture surface in 18% Ni, grade 300, maraging steel as in Fig. 806 and 807, shown here at still higher magnification. At bottom, fatigue has produced numerous secondary cracks. Note the stretched zone at center, at the transition from fatigue to final fast fracture. SEM, 1350×

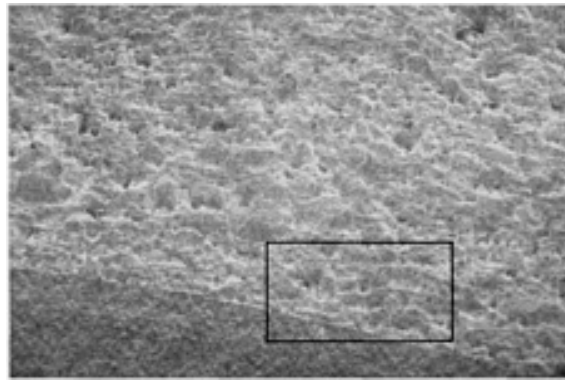
Fig. 809 Fracture surface of a fracture-toughness specimen of 18% Ni, grade 300 maraging steel aged 3 h at 540 °C (1000 °F) and air cooled. Fatigue crack at bottom; ductile, tension-overload fracture at top. Note ridges, spaced at about 60 μm, in ductile region parallel to crack front. See also Fig. 806, 810, and 811. SEM, 47×

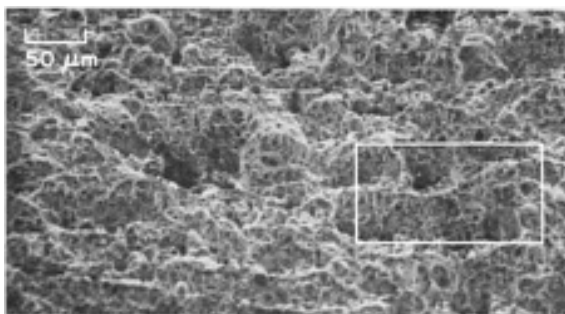
Fig. 810 Higher-magnification view of the area in the rectangle in Fig. 809. Tension-overload dimples are clearly shown, but no details of the fatigue zone (bottom) are visible. The discontinuous nature of the ridges in the tension-overload region is evident. See Fig. 811 for enlarged, composite view of area in rectangle here. SEM, 200×

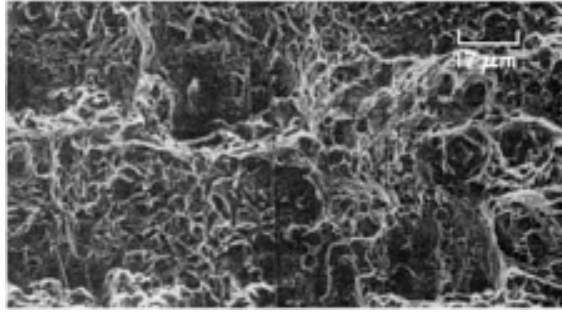
Fig. 811 Composite of four SEM fractographs of the plane-strain region of the area of tension-overload fracture in the specimen shown in Fig. 809 and 810, taken from the area in the rectangle in Fig. 810. This shows more clearly the changes in surface orientation between the ridges. 600×

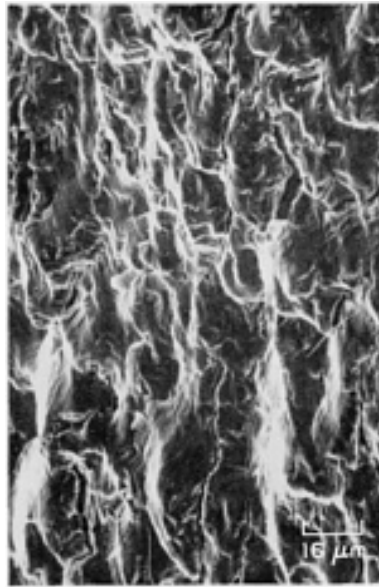
Fig. 812 A low-cycle fatigue fracture (at about 3000 cycles) of 18% Ni, grade 300, maraging steel that had been annealed 1 h at 815 °C (1500 °F) and air cooled. There is no evidence of clearly defined striations, but there is a system of more or less parallel secondary cracks. See also Fig. 813 and 814. SEM, 640×

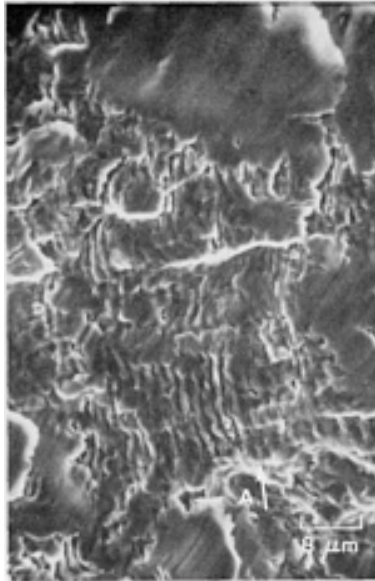
Fig. 813 A view of a different area of the low cycle fatigue fracture of Fig. 812. Note that in this area quite regular striations are in evidence, many of them with fissures at their roots (as at A). Note also the several rubbed areas, particularly those at the top. See also Fig. 814. SEM, 1250 \times

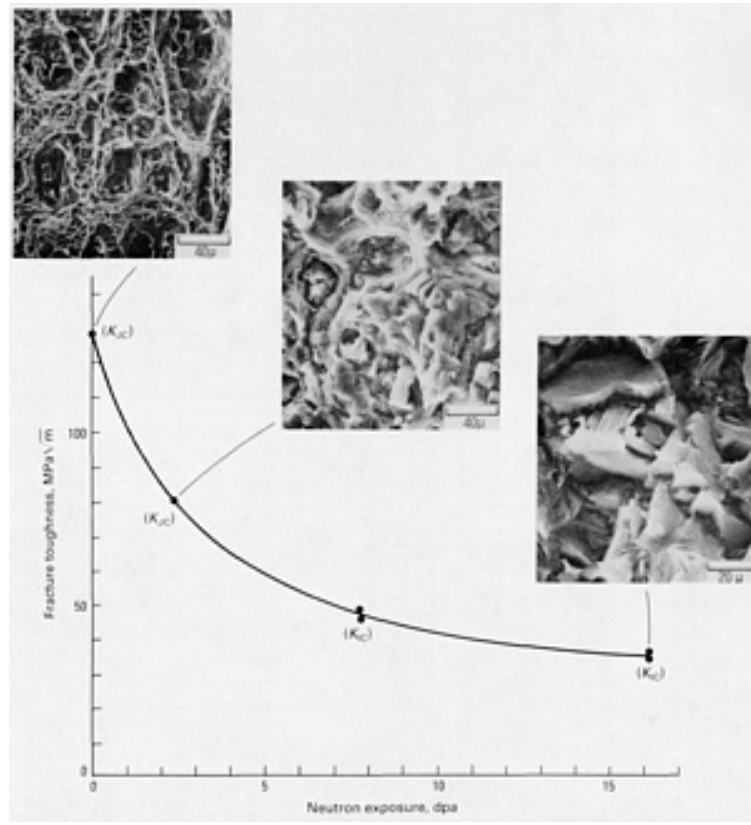
Fig. 823 Effect of neutron irradiation on fracture mode and fracture toughness of the iron-nickel-base superalloy A-286 (UNS S66286). The plot of fracture toughness versus neutron exposure charts the degradation of K_{Ic} with increased irradiation. Note the fracture-mode transition from microvoid coalescence at no exposure to channel fracture in the highly irradiated condition. At the high exposure level, all dislocation activity was localized in a planar slip band, and cracking eventually initiated and propagated along the resultant dislocation channels, causing fracture toughness to fall off. (J.E. Nolan, Westinghouse Hanford Company)

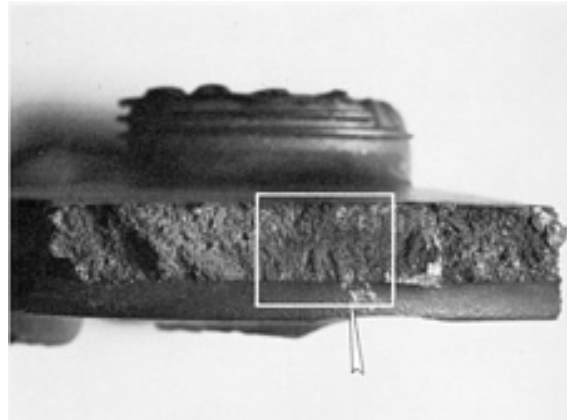
Fig. 835 Segment of a fractured second-stage gas-turbine wheel, cast from alloy 713C, that broke from fatigue in service. (About half of the disk portion of the wheel was never recovered.) The fracture origin (at arrow) was in a grinding-relief groove adjacent to the wheel-balancing pad. Additional circumferential cracks, not adjuncts of fracture, were found elsewhere in the grinding-relief groove. See Fig. 836 for a higher-magnification view of the rectangular area. 2×

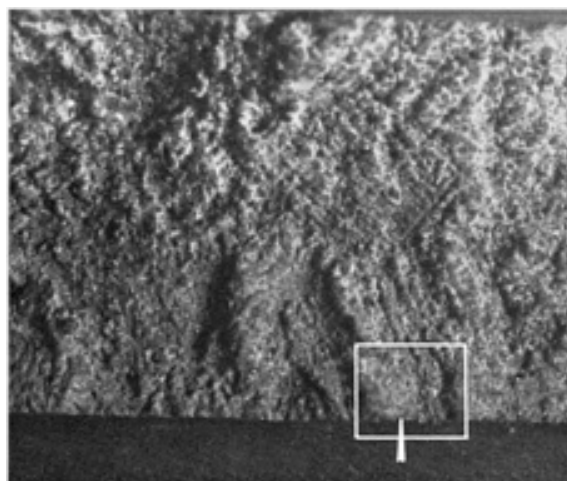
Fig. 836 Crack-origin region in the rectangle in Fig. 835, at higher magnification. Arrow marks the probable location of the crack nucleus. The surface of the grinding-relief groove is below the fracture surface. Measurements of the radius of the bottom of the groove gave values that were about 70% of the average desired and about 87% of the minimum. The excessive sharpness of the radius may have been conducive to cracking. See also Fig. 837. 10×

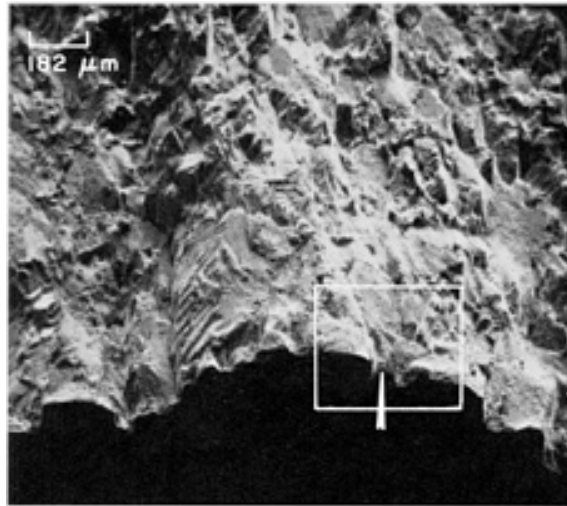
Fig. 837 SEM view taken of the outlined area in Fig. 836 after the fracture surface, which contained many white, gelatinous particles as received at the laboratory, was cleaned ultrasonically in 18% HCl solution for $1 \frac{1}{2}$ min and then washed in acetone and blown dry. The interface between the fracture and the grinding-relief groove was carefully examined in the origin area, and only one probable crack origin was discovered--that marked by the arrow. Area in rectangle is shown at higher magnification in Fig. 838. 55×

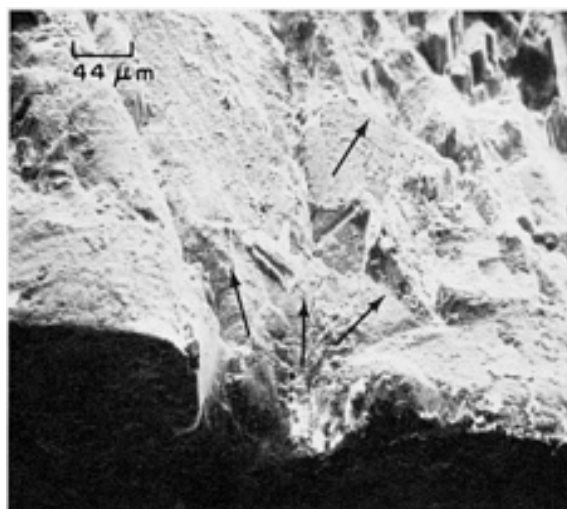
Fig. 838 A view at higher magnification of the outlined area (containing the probable origin of fracture) in Fig. 837. Numerous patches of fatigue striations are visible; the arrows indicate the directions of fatigue-crack propagation from what appears to be a surface defect within the grinding-relief groove. The fatigue facets were found to be transgranular, giving way, outside of the dark, crescent-shaped fatigue-crack area visible in Fig. 835, to ductile dimples. SEM, 225×

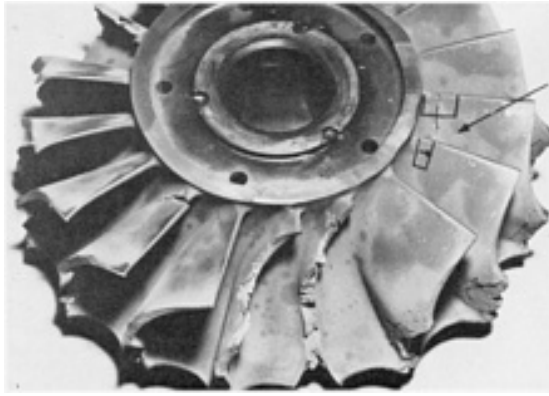
Fig. 839 A gas-producer turbine rotor cast of alloy 713LC that fractured after 440 h of service, as the result of hot corrosion fatigue. Fracture was abrupt, with three blades being thrown off. See Fig. 841 for a view of the area near the arrow. See also Fig. 840 and 842. 0.5×

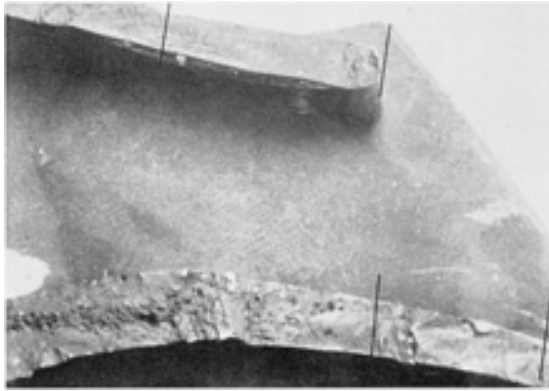
Fig. 840 Fracture surfaces of the two broken turbine-rotor blades at the bottom in Fig. 839. Fatigue beach marks are faintly visible at right on the fracture surface of the lower blade. The region between the parallel black lines on each blade was examined by electron microscopy. 6×

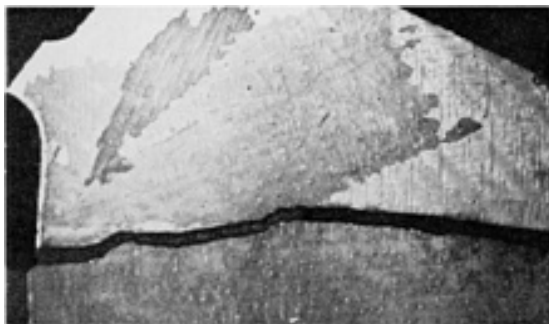
Fig. 841 A macroetched view of a cracked turbine-rotor blade near the arrow in Fig. 839, displaying large columnar grains and a crack that initiated at the trailing edge (at left in this view) of the blade. This crack appears to have followed an intergranular path. Etched in 95 parts conc HCl, 5 parts 35% H₂O₂. 5.5×

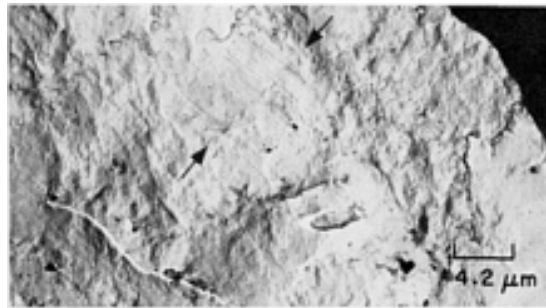
Fig. 842 TEM p-c replica of a fracture surface of one of the turbine-rotor blades in Fig. 840. This view is typical of all the areas examined. A patch of fatigue striations is faintly visible at center between arrows. The fatigue crack is believed to have been initiated by hot corrosion, which was shown, by sectioning of blades, to exist at concentrations of lead. 2400×

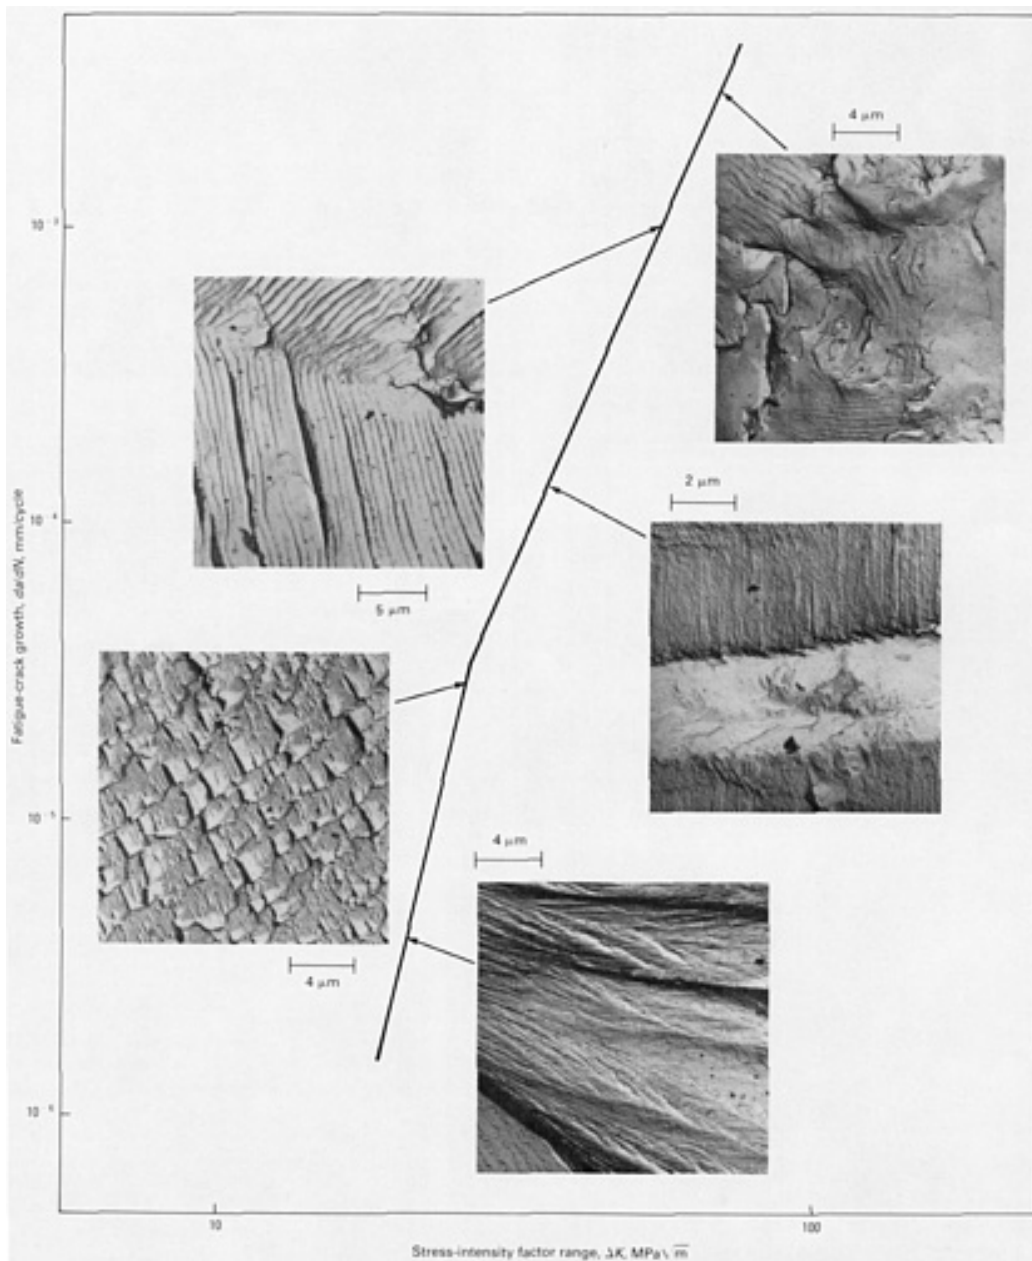
Fig. 846 Fatigue fracture mechanisms in Incoloy alloy X750 (UNS N07750) as a function of the stress-intensity factor range, ΔK . Test conditions: 24 °C (75 °F). 300 cycles/min. $R = 0.05$. The plot of fatigue crack growth rate, da/dN , versus ΔK shows that at high ΔK , the fatigue fracture surface exhibited well-defined striations and dimples. At progressively lower values of ΔK , a combination of fatigue fissures (associated with small secondary cracks) and striations was observed. At low ΔK , a highly faceted fracture surface resulted due to crystallographic fracture along intense slip bands. (J.E. Nolan, Westinghouse Hanford Company)

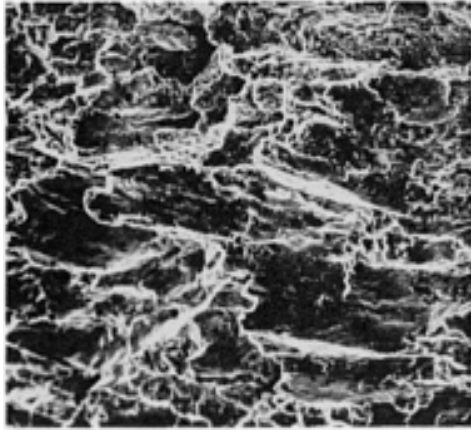
Simultaneous metallographic-fractographic evaluation of an Inconel alloy 718 (UNS N07718) fracture-toughness test sample via selective-area electropolishing technique. The nickel-base alloy was conventionally heat treated. Fig. 847: Schematic of selective-area electropolishing. Use of method enables simultaneous study of both the fracture surface topography and the underlying microstructure. Fig. 848: Metallographic-fractographic profile (fracture surface at bottom left). SEM, 460 \times . Fig. 849: Higher-magnification view of field in Fig. 848. These profiles reveal a duplex microvoid coalescence morphology. Growth of the large primary microvoids, which nucleated at ruptured (Ni,Ti)C inclusions, was preempted as many smaller microvoids nucleated at δ -phase precipitates. SEM, 950 \times (J.E. Nolan, Westinghouse Hanford Company)

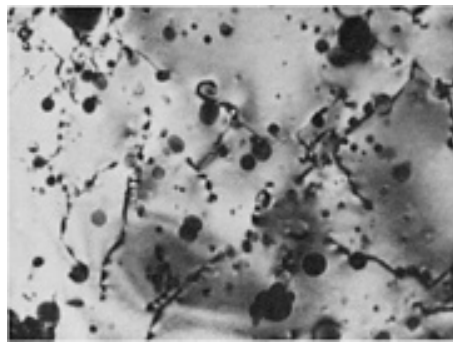
Fig. 852 "Departure side pinning" during creep of Inconel alloy MA754. The mechanically alloyed nickel-base superalloy is stabilized by yttria (0.8% Y_2O_3). Samples were tested in creep to 2% strain at 760 °C (1400 °F) and 221 MPa (32 ksi) and then cooled on load. TEM examination revealed that dislocations were still associated with Y_2O_3 particles--the departure side pinning phenomenon. Etched in 60% ethanol, 30% *n*-butanol, 10% perchloric acid (70%). TEM thin foil, 76,800× (J.K. Tien, V.C. Nardonne, and D. Matejczyk, Columbia University).

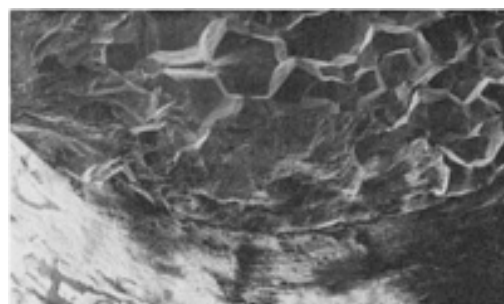
Fig. 861 Fatigue fracture of the nickel-base superalloy Udimet 720 tested in a salt environment at 705 °C (1300 °F). Fatigue conditions: 690 MPa (100 ksi) ± 207 MPa (30 ksi) 10,500 cycles to failure. Salt coating: 40% MgSO₄, 59% Na₂SO₄, 1% NaCl. Sample heat treatment: 4 h at 1170 °C (2140 °F), air cool; 4 h at 1080 °C (1975 °F), air cool; 12 h at 845 °C (1550 °F), air cool; 16 h at 760 °C (1400 °F), air cool. Fracture surface shows dual, transgranular fatigue origins. Initiation attributed to salt corrosion of grain boundaries located at surface and perpendicular to stress axis. Note salt coating on sample surface. SEM, 30× (E.A. Schwarzkopf, J. Stefani, and J.K. Tien, Columbia University)

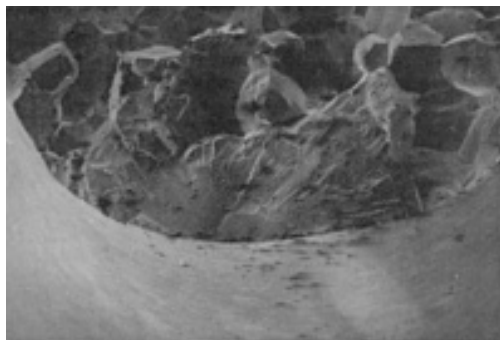
Fig. 862 Fatigue fracture of Udimet 720 tested in air at 705 °C (1300 °F). Heat treatment and other test conditions same as in Fig. 861. Cycles to failure: 338,000, compared with 10,500 for the sample tested in a salt environment (Fig. 861). Fracture surface shows a transgranular "thumbprint," with river patterns pinpointing initiation sites. The major origin is where a grain boundary intersects the sample surface. SEM, 25× (E.A. Schwarzkopf, J. Stefani, and J.K. Tien, Columbia University)

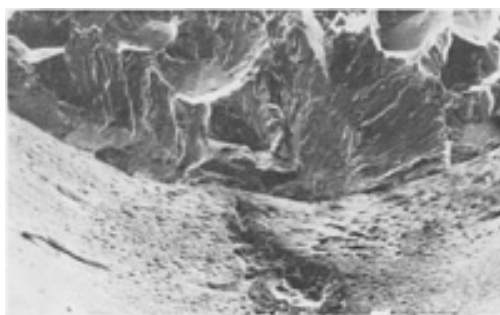
Fig. 865 Fatigue fracture of Udimet 720 tested in air at 705 °C (1300 °F). Heat treatment and other test

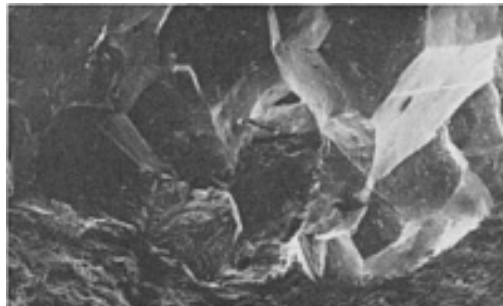
Fig. 866 Creep fracture of Udimet 720 tested in a salt environment at 705 °C (1300 °F). Sample heat treatment and salt composition same as in Fig. 861. Test stress: 896 MPa (130 ksi). Fractograph shows salt-coated sample surface and intergranular stress-rupture surface. Note salt corrosion of grain boundaries that intersect the sample surface. SEM, 40× (E.A. Schwarzkopf, J. Stefani, and J.K. Tien, Columbia University)

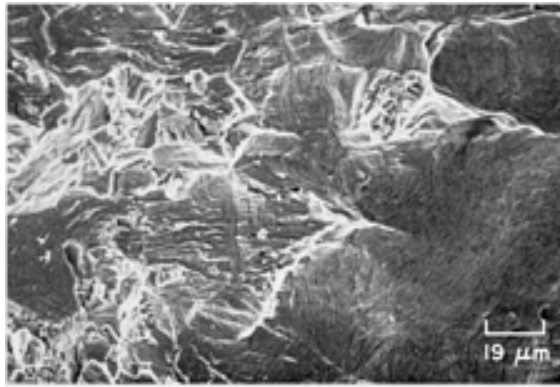
Fig. 868 View of an area of the fracture surface in Fig. 867 that shows the transition from fracture in hydrogen (left) to subsequent fracture in air (right). Much of the fracture in hydrogen shows transgranular cleavage. In the portion produced in air, flow occurred after the crack front has passed. SEM, 540×
