به نام خدا

مرکز دانلود رایگان
مهندسی متالورژی و مواد

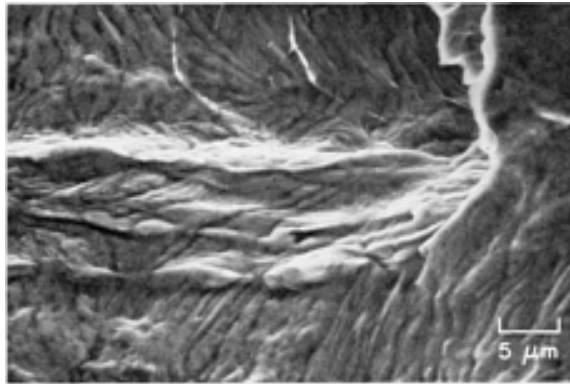
Fig. 869 View of the fracture surface in Fig. 867, showing a region from the portion of the fracture that was produced in air. Visible are suggestions of dimples, but these features have been largely obscured by the effects of the secondary flow that occurred in this very ductile metal following passage of the crack front. SEM, 2000×

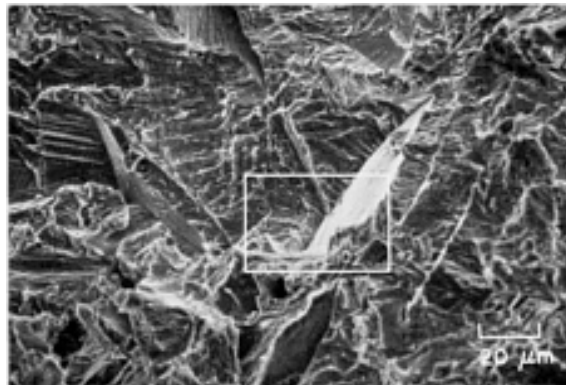
Fig. 870 View of the fracture surface in Fig. 867, showing a region from the portion of the fracture that was produced in hydrogen. As in the left portion of Fig. 868, the fracture here is mainly by transgranular cleavage. Scattered regions of intergranular were reported, but are not visible here. See also Fig. 871. SEM, 500×

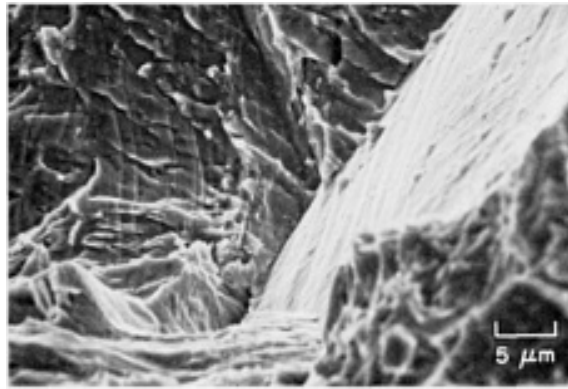
Fig. 871 Higher-magnification view of the area in the rectangle in Fig. 870, showing the ledgelike character of the cleavage facets. In contrast, a suggestion of dimpled rupture is visible a bottom right. Note the small tongues on the bright facet at right. SEM, 2000 \times

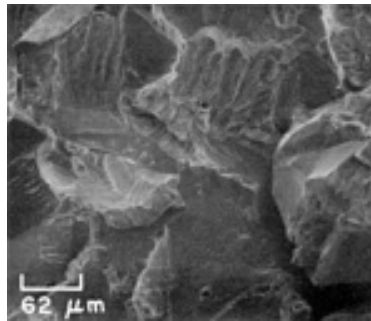
Fig. 872 Fracture surface of a specimen of Duranickel, vacuum solution treated and quenched, aged 1 h at 500 °C (930 °F) and cooled in air. The specimen, which was notched, precracked, and slow-bend fracture-toughness tested in hydrogen, broke by combined cleavage and intergranular fracture. See also Fig. 873. SEM, 160 \times

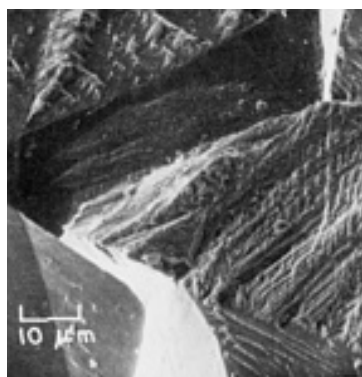
Fig. 873 A portion of the same fracture surface as that in Fig. 872, but at higher magnification, showing facets that contain cleavage river patterns (bottom right) and pyramid-shaped tongues (top left). SEM, 1000 \times

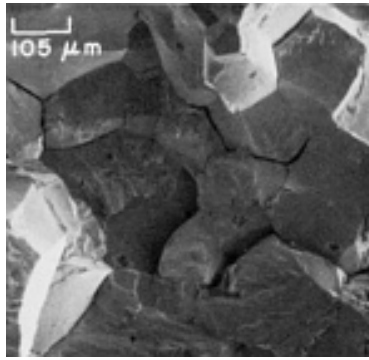
Fig. 874 Fracture in Duranickel that, except for being aged 4 h, was heat treated and tested same as Fig. 872. Fracture here is more completely intergranular, with less cleavage, than Fig. 872. Both fractures show secondary cracks. See also Fig. 875. SEM, 95 \times

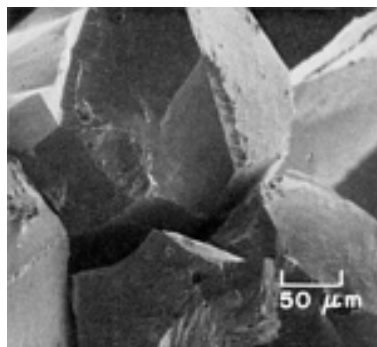
Fig. 875 A view at higher magnification of the fracture in Fig. 874, showing it to be also a nearly wholly intergranular fracture, with deep secondary cracks at the grain boundaries. SEM, 200 \times

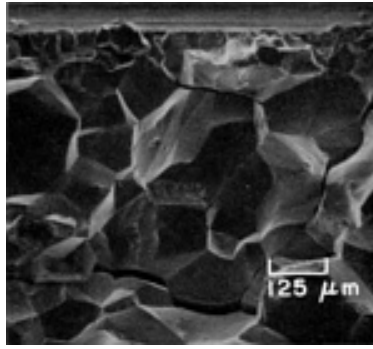
Fig. 877 A similar but larger view of the fracture in Fig. 876, showing notch at top but no fatigue crack. Fine grains at notch were presumably cold worked in machining and recrystallized in aging. SEM, 80×

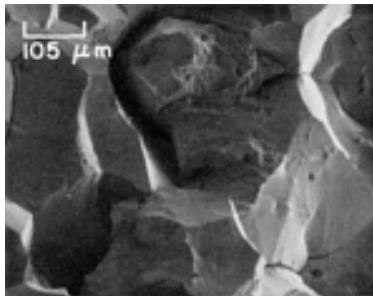
Fig. 878 Same fracture as that shown in Fig. 876 and 877, but an interior area. One or two cleavage facets are seen. Most of the fracture is intergranular, with large secondary cracks. SEM, 95×

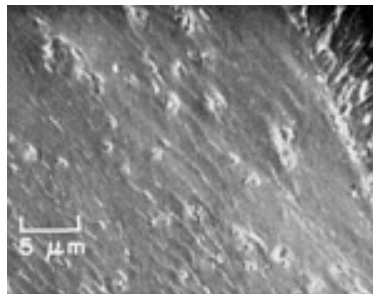
Fig. 879 A highly magnified view of the fracture in Fig. 876, 877, and 878. Striations visible here show crack advances under constant bending deflection in hydrogen; compare with the fatigue striations in Fig. 880. SEM, 2000×

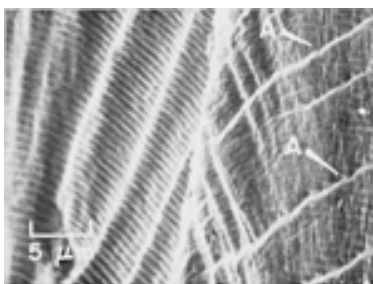
Fig. 880 High-magnification view of the fatigue precrack produced in air at base of notch in specimen in Fig.

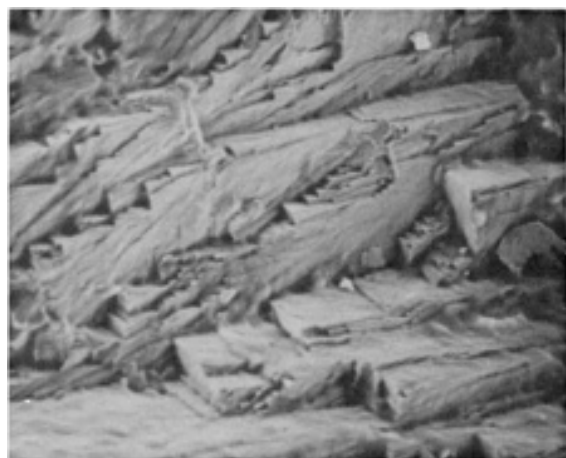
Fatigue fracture of a cast Vitallium (Co-30Cr-7Mo) surgical implant (side plate of Jewett nail) due to improper insertion. A tool used by the surgeon to contour the plate prior to its insertion into the patient also accidentally damaged the surface of the implant, introducing microcracks that led to fracture. Fig. 881: Tool damage on surface of implant near fracture surface. 3×. Fig. 882: The Jewett nail broke across a screw hole. Radial marks on the fracture surface (shown here) reveal the fatigue crack origin near the top of the hole. 10× (C.R. Brooks and A. Choudhury, University of Tennessee)

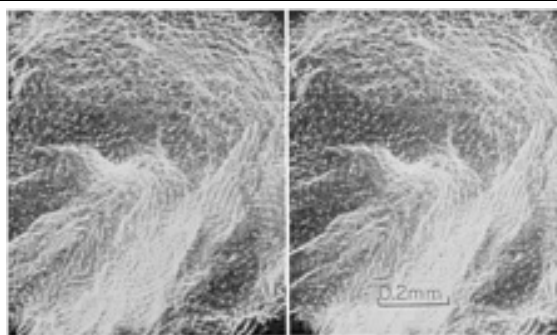
Fig. 887 Area at α in Fig. 886, at higher magnification. 60×

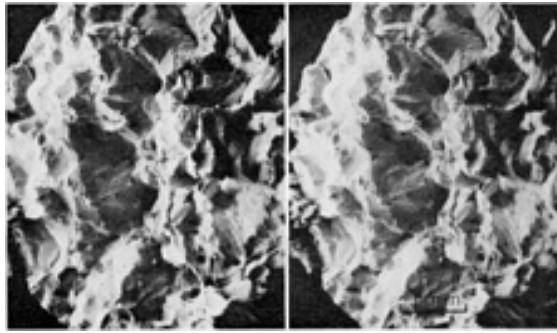
Fig. 889 Fracture at 440 °C (824 °F), 15.5 MPa (2.25 ksi). 11×

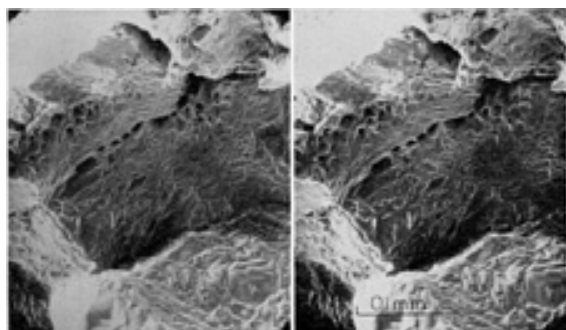
Fig. 890 A different area of the fracture in Fig. 889. 135×

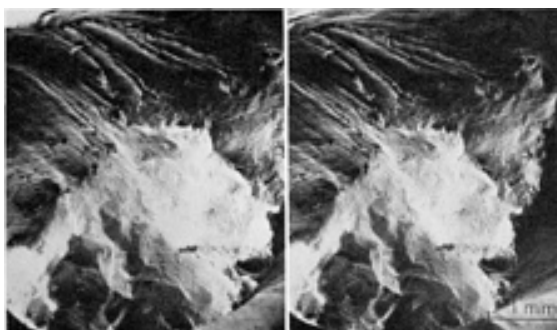
Fig. 891 Fracture at 525 °C (977 °F), 10.3 MPa (1.5 ksi). 12.5×

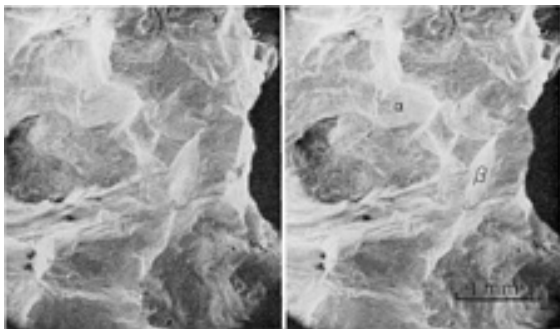
Fig. 892 Fracture at 540 °C (1004 °F), 10.3 MPa (1.5 ksi). 11.5×

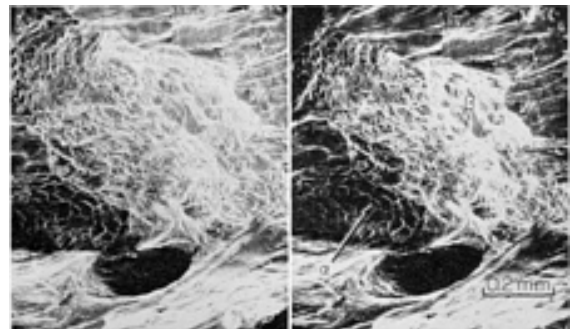
Fig. 893 Area at bottom of cavity at left center in Fig. 892. 60×

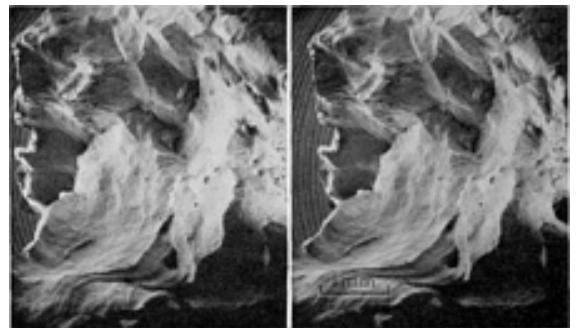
Fig. 895 Fracture at 602 °C (1116 °F), 10.3 MPa (1.5 ksi). 11.5×

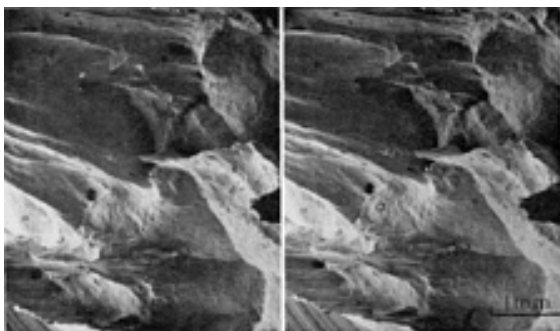
Fig. 896 Fracture at 642 °C (1188 °F), 7 MPa (1 ksi). 12×

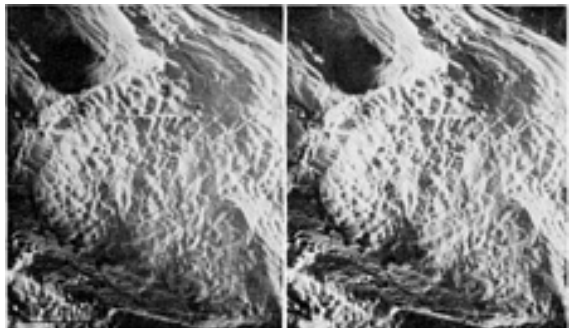
Fig. 897 Region at α in Fig. 896, at higher magnification. 60×

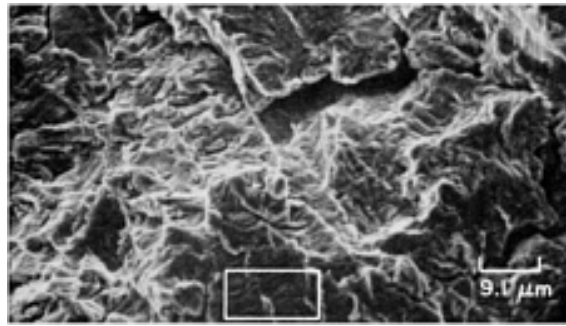
Fig. 900 A region of the surface of the fatigue-test fracture in OFHC copper shown in fig. 898, 5 mm from the notch, where the rate of crack growth was greater than in the region in Fig. 898. Intergranular secondary cracks are clearly evident. Fatigue striations are not well resolved at this magnification. See Fig. 901 for a higher-magnification view of the area in the rectangle. SEM, 1100 \times

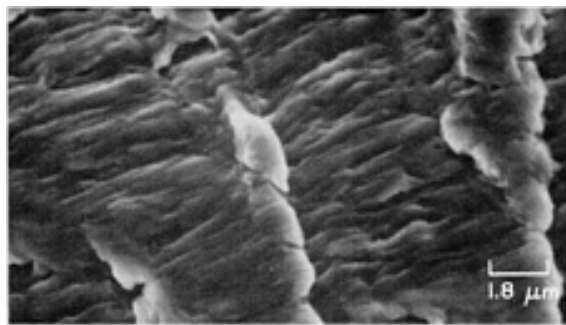
Fig. 901 Higher-magnification view of the area in the rectangle at the bottom of Fig. 900. Here, many of the fatigue striations have resulted in small fissures, but show the same irregularity displayed in Fig. 899; however, the steps visible here (at center and near right edge) appear to be much smaller than the one in Fig. 899. SEM, 5500 \times

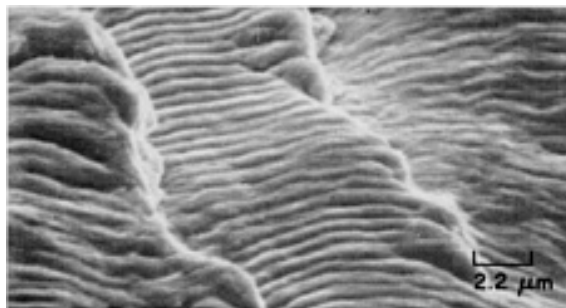
Fig. 902 Region of the fatigue-fracture surface in Fig. 898, 899, 900, and 901, 20 mm (0.8 in.) from the notch, where the rate of crack growth had increased considerably. The result of this high rate of crack growth is the array of very regular fatigue striations visible here, which are more typical of aluminum than of copper. SEM, 4600 \times

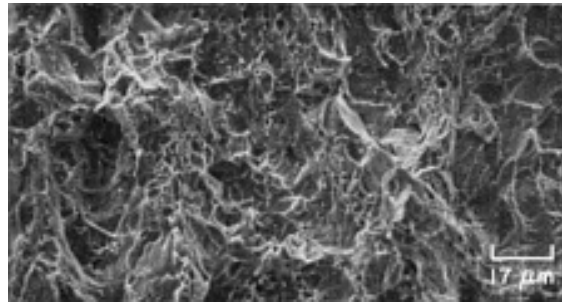
Fig. 904 Fracture surface of an underaged fracture-toughness test specimen of Cu-2.5Be alloy that had been aged for $1 \frac{1}{2}$ h at 260 °C (500 °F) prior to being tested in air. Tensile strength was 930 MPa (135 ksi). Fracture was transgranular and produced the wide variety of dimple sizes shown here. There are some large pores, but there is little evidence of secondary cracking. Compare with Fig. 905. SEM, 600×

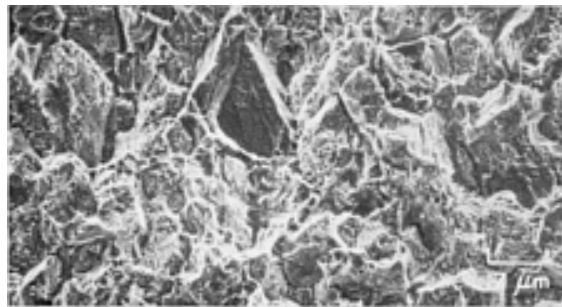
Fig. 905 Fracture surface of a fully aged fracture-toughness test specimen of Cu-2.5Be similar to that in Fig. 904, but aged 3 h at 315 °C (600 °F) before being tested in air. Tensile strength was 1240 MPa (180 ksi). The dimples on the transgranular facets are much finer than in Fig. 904, and there is a network of secondary cracks that appear to be intergranular. One facet (at top center) appears to have formed by quasi-cleavage. SEM, 600×

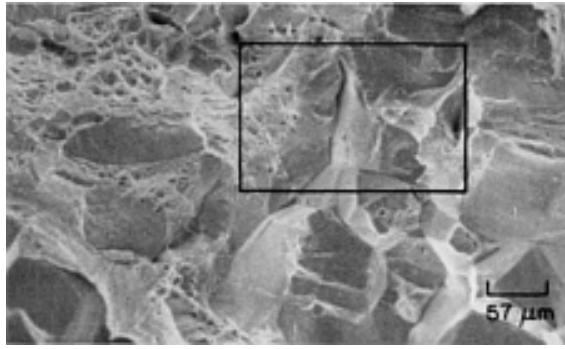
Fig. 906 Tensile-overload fracture in a fracture-toughness specimen of 64Cu-27Ni-9Fe alloy that underwent spinodal decomposition during heat treatment for 10 h at 775 °C (1425 °F). The surface contains many intergranular facets with intervening regions of dimpled transgranular facets. See Fig. 907 for a higher-magnification view of the area in the rectangle. SEM, 175×

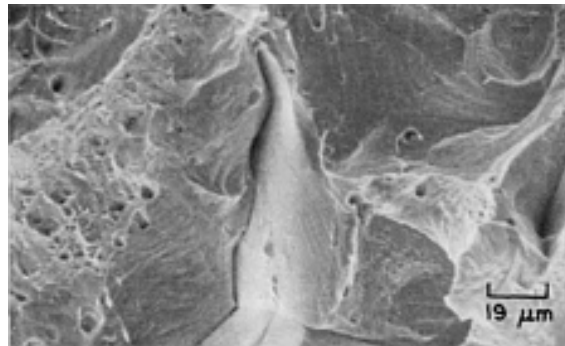
Fig. 907 Higher-magnification view of the area in the rectangle in Fig. 906, revealing a fine structure of dimples, which resulted from microvoid coalescence, on the separated-grain facets. The regions of intergranular fracture here may have been caused by increased coarsening of the spinodal microstructure at the grain boundaries. SEM, 525×

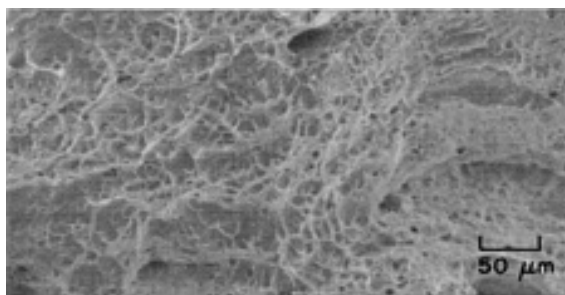
Fig. 908 Tensile-overload fracture in a fracture-toughness test specimen of the same 64Cu-27Ni-9Fe alloy as in Fig. 906, but here spinodal decomposition occurred during heat treatment at 775 °C (1425 °F) for 100 h. Only dimpled transgranular facets are visible (no intergranular facets); this may be due to a coarser spinodal structure resulting from the longer heat treatment. SEM, 200×

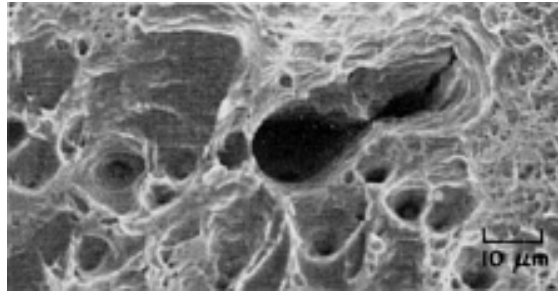
Fig. 909 Surface of the fracture in a fracture-toughness test specimen of the same 64Cu-27Ni-9Fe alloy as in Fig. 906, 907, and 908, but which was heat treated at 775 °C (1427 °F) for 200 h. Very fine dimples can be seen among the larger ones. The large cavity at the center of this view is believed to have resulted from a localized separation at a grain boundary. SEM, 1000×

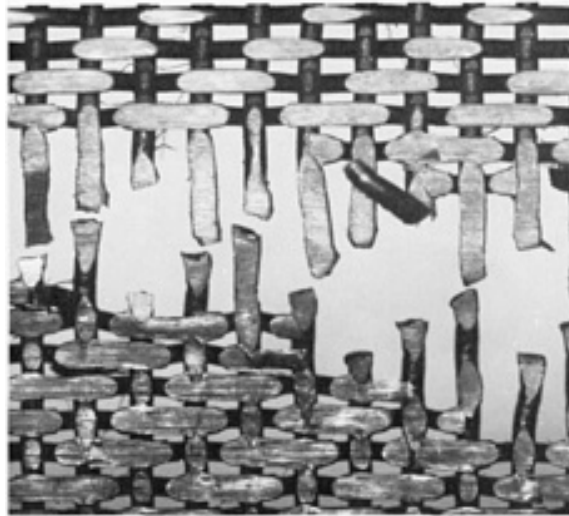
Fig. 917 View of bottom of a Fourdrinier wire cloth of phosphor bronze C (C52100) that was removed from service after 14 days of operation. Heavy wear had occurred on both warp and shute (weft) wires. The fractures in the wires apparently occurred when the wires had worn almost completely through. The warp wires are shown horizontal in this view. 10×

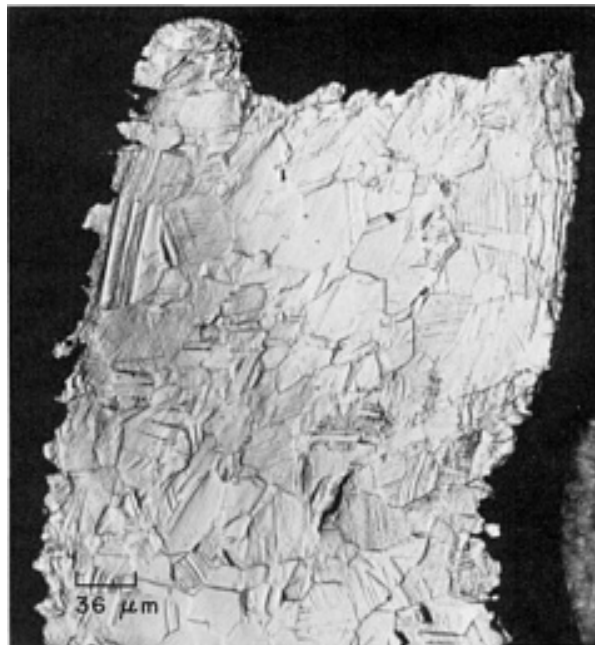
Fig. 920 Longitudinal section through a fatigue fracture in a shute (weft) wire of Fourdrinier wire cloth of 80Cu-20Zn brass with 0.5% Sn added. The profile of the fracture is shown at top. Note corrosion pitting visible on the wire surface at left and at right, FeCl_3 . $265\times$

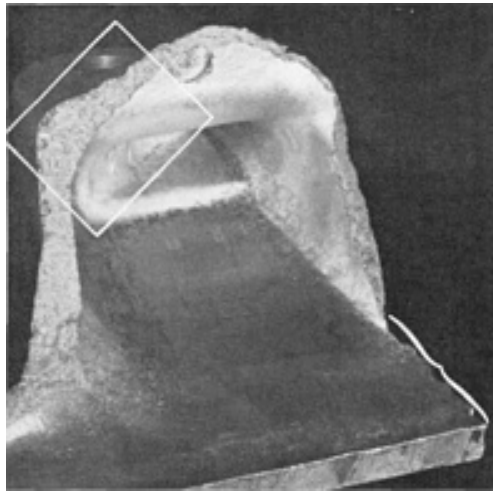
Fig. 921 A portion of a fractured carrier tray and sand cast of an aluminum alloy intended to be 356.0-T6. Chemical analysis revealed that the copper and zinc contents were of an order of magnitude above the specified limits. The silicon content was approximately as dictated by the specification. The hardness measured 82 HB--appreciably above the 70 HB expected. Tensile strength was 179 to 193 MPa (26 to 28 ksi)--slightly below the specified minimum of 207 MPa (30 ksi). See Fig. 922 for the area in the rectangle and Fig. 923 for bracketed area at a magnification of 3 \times . Actual size

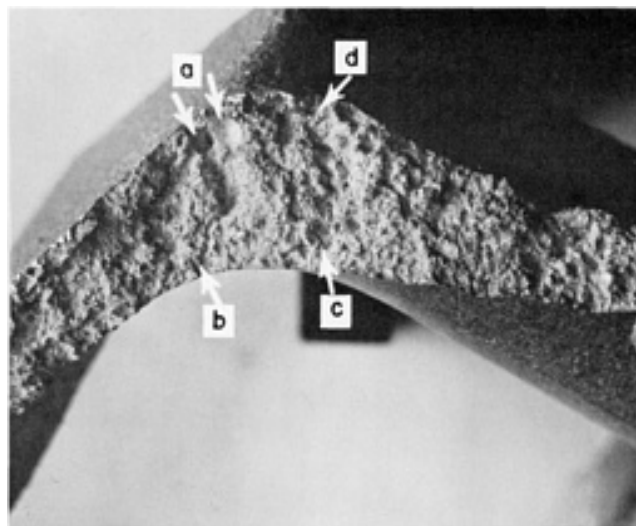
Fig. 922 Fracture surface of the shoulder of the sand-cast carrier tray shown in the rectangle in Fig. 921. The appearance of this surface suggests that fracture occurred in a brittle manner. The two arrows at "a" indicate two large gas cavities. The arrows at "b," "c," and "d" identify sites that were examined with a scanning electron microscope. (SEM fractographs of these sites are shown in Fig. 924 and Fig. 925.) Note the absence of shear lips on the edges of this fracture surface, indicating a general lack of ductility. 3 \times

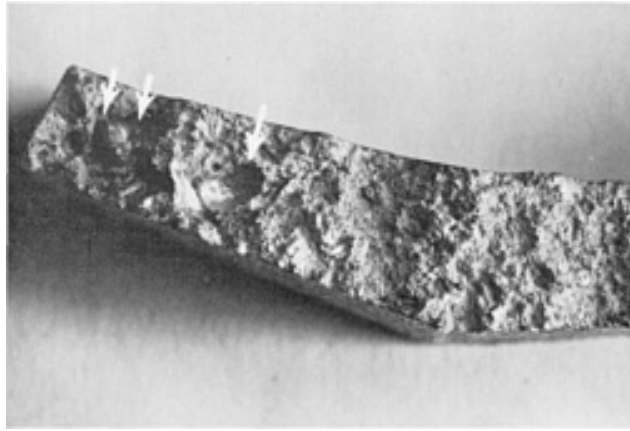
Fig. 923 This fracture surface is from the bracketed edge of the sand-cast carrier tray in Fig. 921. Like the surface shown in Fig. 922, the one here exhibits the characteristics of brittle fracture, there being no sign of a shear lip at any of these edges. Again, there is evidence of porosity; the arrows point to quite large gas cavities. The cavities could have been caused by a reaction between the liquid metal and organic binders in the sand mold, or could have resulted from entrapped air being carried into the mold by undue turbulence in pouring the casting. 3×

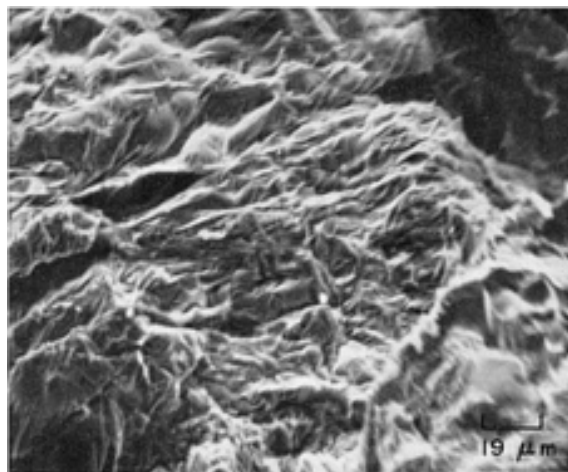
Fig. 928 Enlarged view of a part of the fracture surface area in Fig. 927. Some features vaguely resemble fatigue striations, but it is doubtful that they were caused by fatigue inasmuch as they do not seem to have been formed in an orderly sequence (and there are no beach marks in Fig. 922 and 923). Instead, the surface is very tumbled, with no suggestion of fatigue patches, and many regions bear whiskerlike features resembling some form of cleavage step. Lacking a significant amount of dimples, this surface can be rated as a brittle fracture. SEM, 520 \times

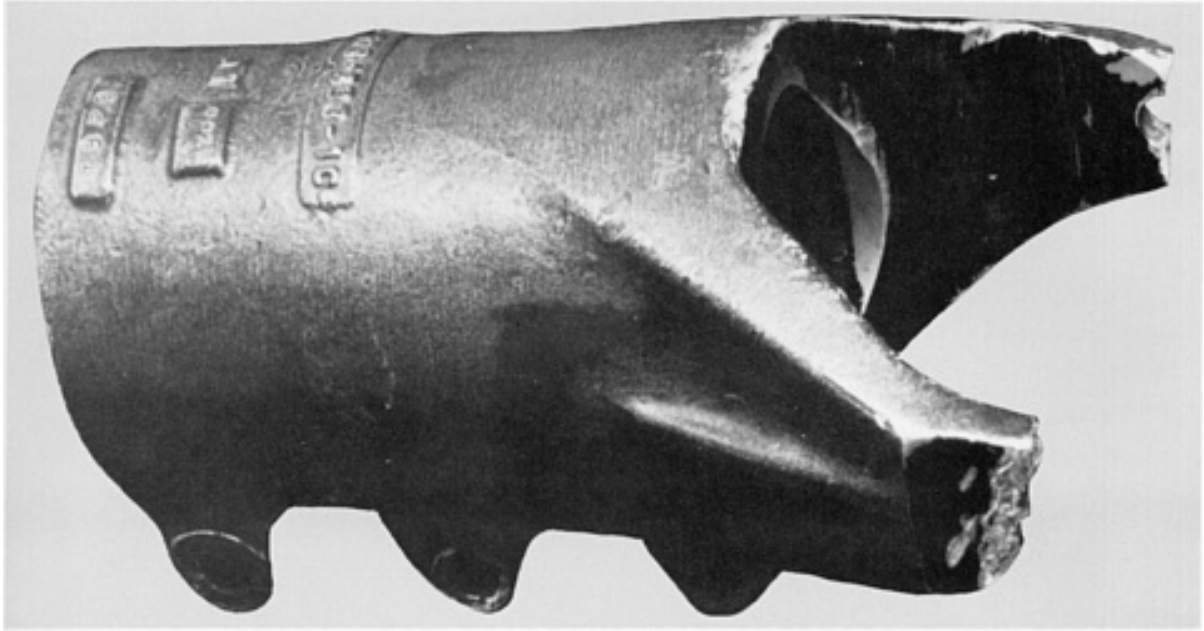
Fig. 929 A broken extension-housing yoke, part of a helicopter tail-rotor drive assembly, that fractured by fatigue in service. The fracture occurred through the left and right lugs at the points of attachment to the tail boom. The yoke was cast from aluminum alloy 356.0 and heat treated to the T6 temper. Chemical analysis showed that the composition of the yoke conformed to specifications, except for silicon, which was 0.05% below the required minimum. Hardness measurements ranged from 48 to 52 HRB (or about 81 to 85 HB), which was above the required minimum. Details of the fractures are shown in Fig. 930, 931, 932, 933, 934, 935, 936, 937, and 938. Actual size

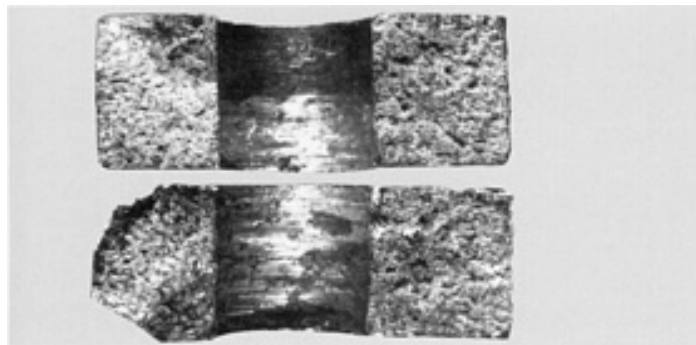
Fig. 933 Views of (at top) fracture surfaces of the lower lug in Fig. 930 and 931 and of (at bottom) the mating surfaces of the yoke. Note discolored quadrant at top left corner of the bore of the lug (see also Fig. 934) and corresponding area in yoke fracture adjacent to bottom left corner of the bore. Edge of the discoloration is the beach mark of the fatigue crack that was the origin of final fracture. 3×

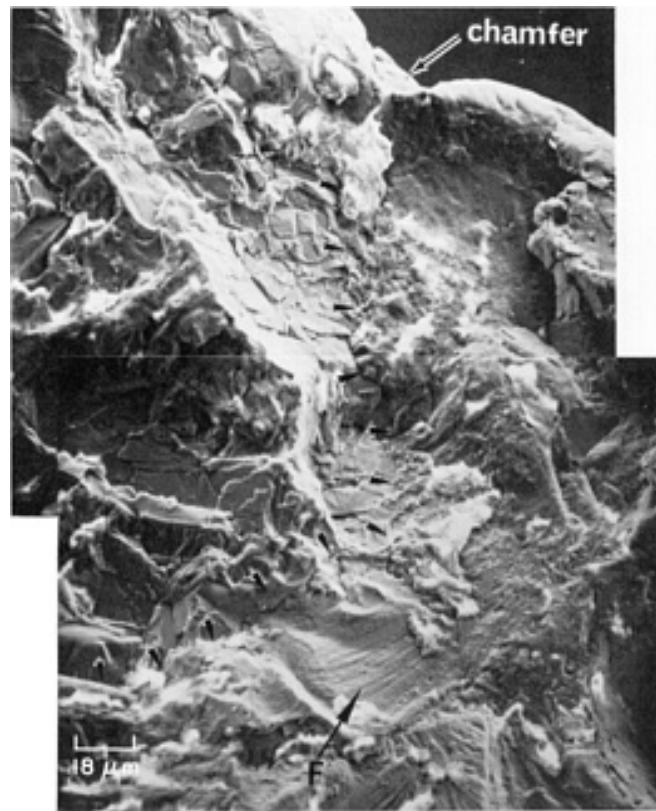
Fig. 937 This is the area within the dashed lines in Fig. 936, shown at higher magnification. The initial crack opened at the chamfer (upper right corner). The onset of fatigue fracture is indicated by the small arrows running from upper middle to lower left. The arrow at F points to an area of typical fatigue striations. The initial phase of fracture was brittle. SEM, 550×

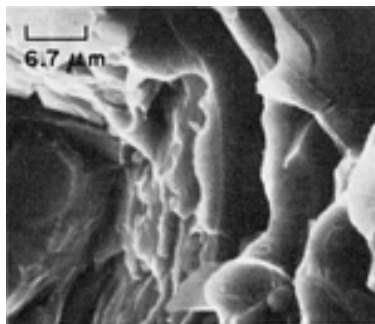
Fig. 942 Higher-magnification view of the area in the rectangle in Fig. 941. There are no suggestions of dimples visible here, instead, the surface exhibits platelets that have been bent and cracked. SEM, 1500×

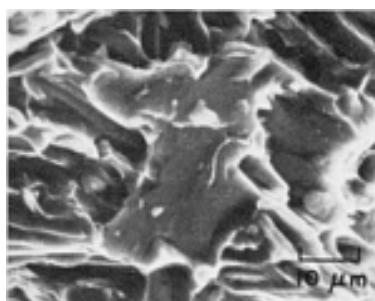
Fig. 944 Another view of the fracture surface shown in Fig. 938. Again, no evidence of true dimples, but cellular structure only. There are many small inclusions on the surface; most are not bonded to the matrix. SEM, 1000×

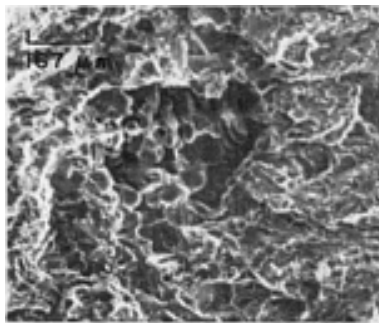
Fig. 949 Surface of a fracture in a miniature impact-test specimen cut from the broken aluminum alloy 356.0-T6 bell-crank fitting shown in Fig. 938. The appearance here is very similar to that of the service fracture in Fig. 939. SEM, 60 \times

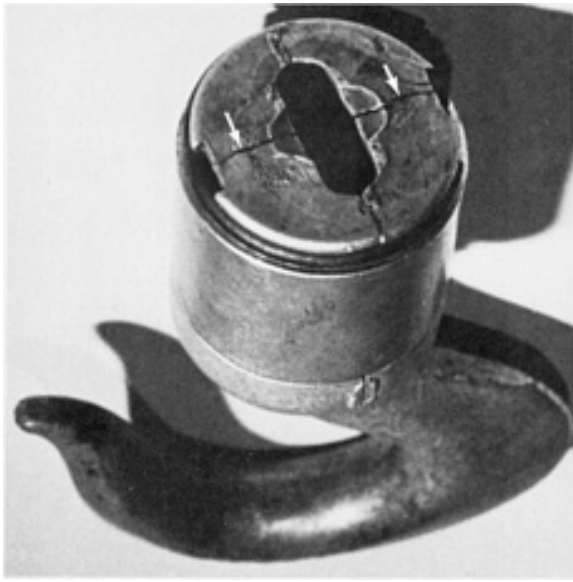
Brittle fracture of die cast aluminum alloy 380.0 wheel. Failure initiated during normal operation at a cold shut defect in the as-cast part. Fig. 953: Wheel after failure. Distance between fracture surfaces indicates that residual stresses were present. Fig. 954: Portion of fracture surface showing cold shut defect. Fig. 955: Presence of sharp-edged silicon (light gray) in the microstructure of the aluminum alloy is evidence that heat treating to increase toughness and relieve residual stresses was not performed. 0.5% HF etch, 400× (R.W. Bohl, University of Illinois)

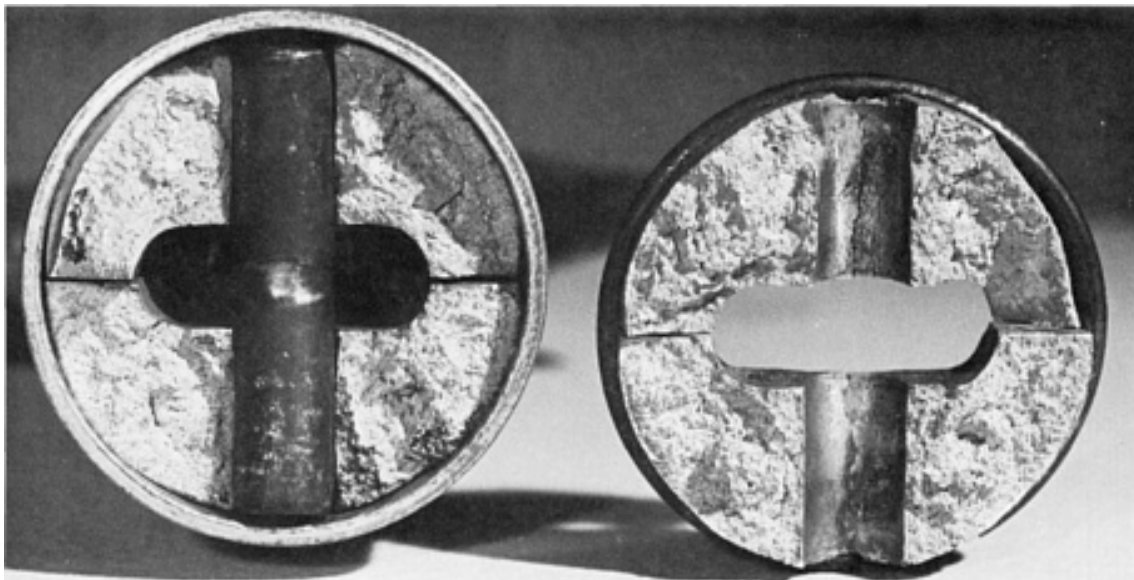
Fig. 959 Mating surfaces of the fracture in the side of the housing in Fig. 957. At right is the upper surface, with the retaining ring (shown at top in Fig. 957) still in place; visible in the bore of the retaining-pin hole is the fracture in the top surface of the housing (see Fig. 956). At left is the lower surface, with the retaining pin in place inside a collar. $\sim 2.25\times$

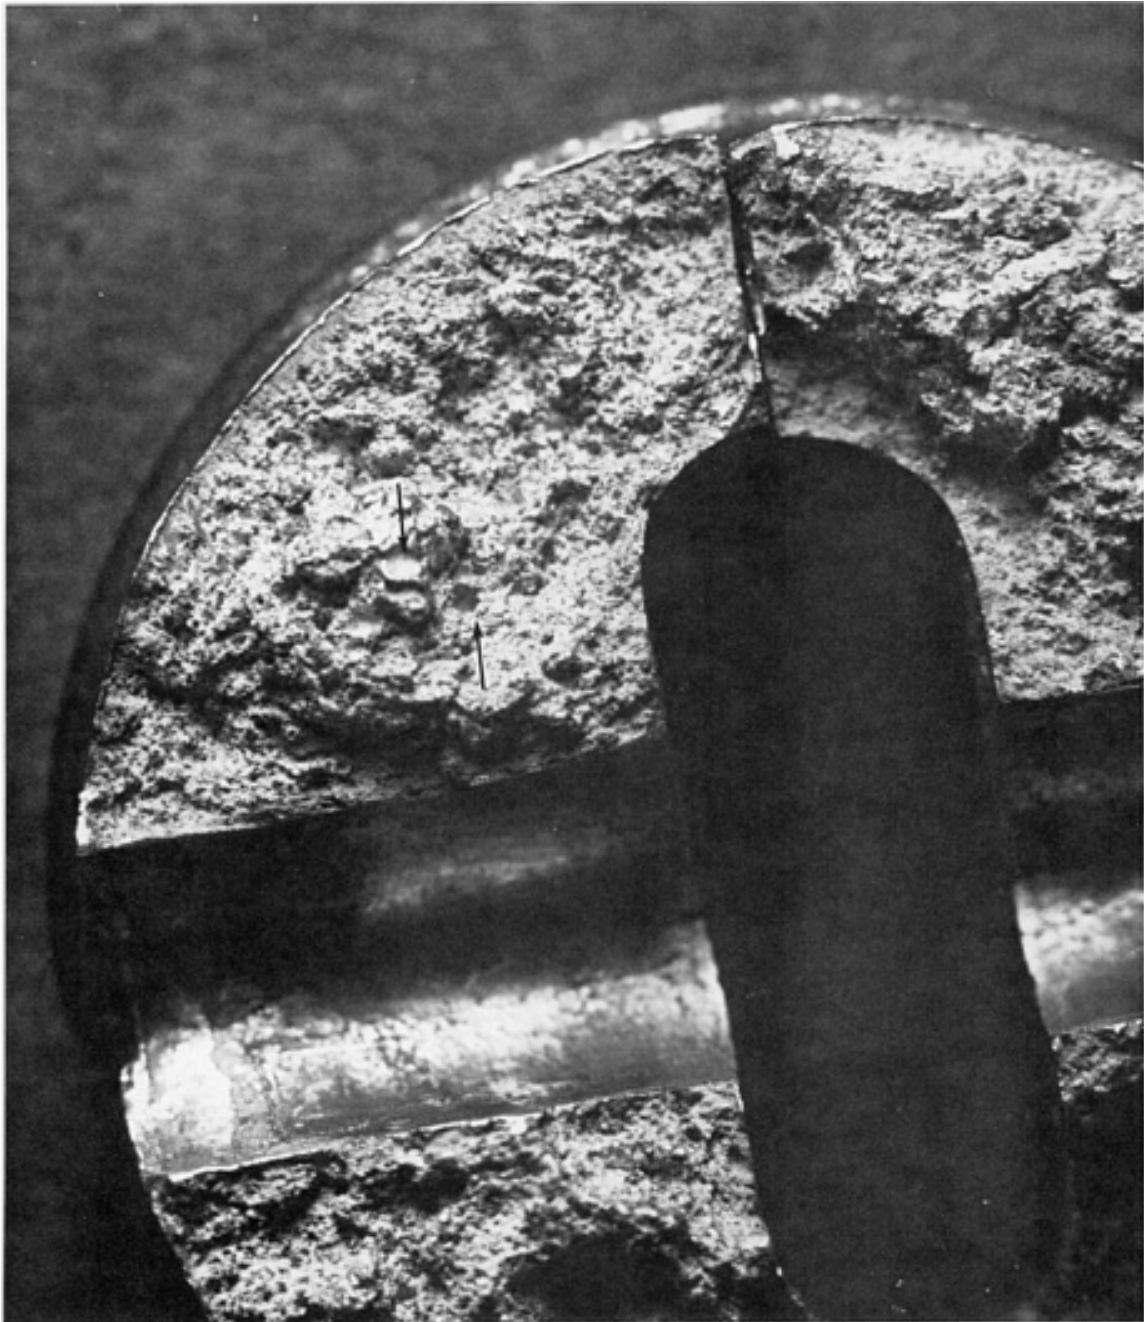
Fig. 960 Enlarged view of the lower left portion of the top fracture surface (shown at right in Fig. 959) of the broken die cast housing in Fig. 956. Note gas cavities (at arrows), which are common interior features of satisfactory die castings. Bending of the retaining pin (see Fig. 958) is believed to have occurred after the transverse fracture of the top surface of the housing caused relocation of the load-bearing points on the pin. Low-cycle fatigue would have a likely cause of fracture, but no fatigue beach marks could be found. 7.5×

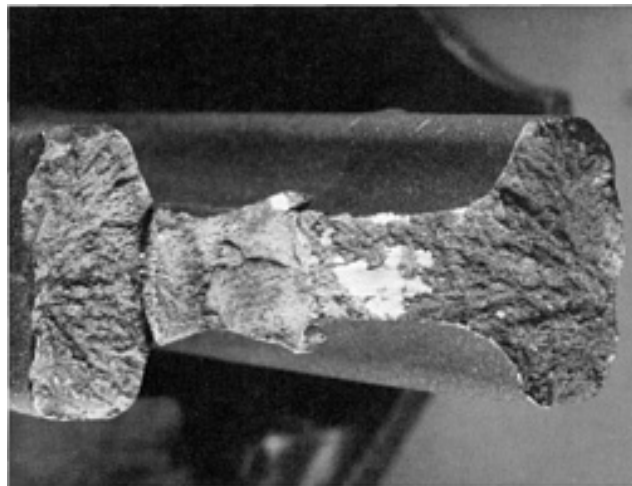
Fig. 962 Fracture surface of the portion of the aluminum alloy connecting rod in Fig. 961 that was still attached to the piston after the test. It appears that each flange contains a chevron pattern, which suggests that there were two crack origins. This supports the theory that two successive fractures occurred in the rod. The mechanical damage in the right fracture surface indicates that the right origin probably led to the initial rupture. There are no indications of the beach marks that are characteristic of fatigue fractures. See also Fig. 963. $2\times$

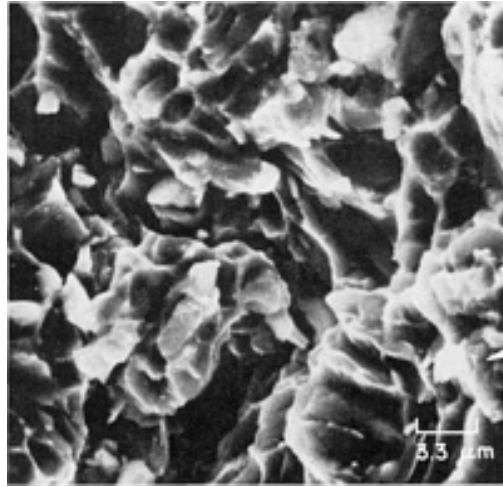
Fig. 963 High-magnification view of one of the fracture surfaces of the fractured connecting rod shown in Fig. 961. It is evident that fracture was by dimpled rupture, which indicates that the fracture was caused by sudden overload. As in the views of about 0.75 \times in Fig. 961 and at 2 \times in Fig. 962, no indications of fatigue are visible here. The fracture appears quite "clean," with very little evidence of nonmetallic inclusions. SEM, 3000 \times

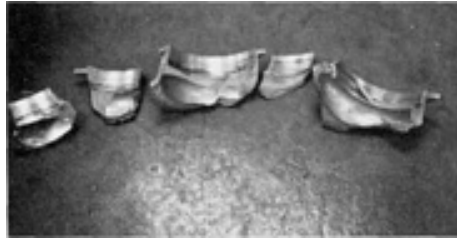
Fig. 968 Pieces of the hub of a forged aircraft main-landing-gear wheel half, which broke by fatigue. The material is aluminum alloy 2014-T6. Tensile specimens from elsewhere in the wheel had tensile strength of 493.7 MPa (71.6 ksi) and 8.9% elongation in the transverse direction, and tensile strength of 466.1 MPa (67.6 ksi) and 8.0% elongation in the longitudinal direction. See also Fig. 969. ~0.1×

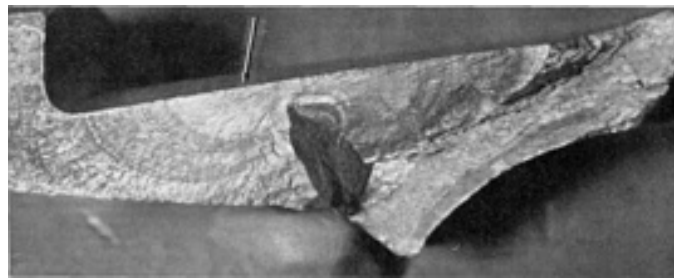
Fig. 969 View of an area of one fracture surface of the broken hub in Fig. 968, showing the fatigue-crack origin. Visible are beach marks, which suggest that the origin is at the location marked by the arrow, presumably at one of several corrosion pits that were found on the surface of the hub. After having penetrated a short distance, the fatigue crack developed a step (dark facet); a second fatigue crack originated at one end of the step. 1.8×

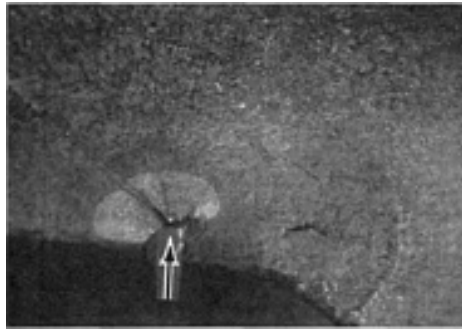
Fig. 972 Enlarged view of the fatigue-crack origin in Fig. 971, which plainly shows the region of initial penetration (light area). At arrow is a forging defect usually known as a bright flake. Note that grain flow is approximately parallel to the flake. $\sim 5\times$

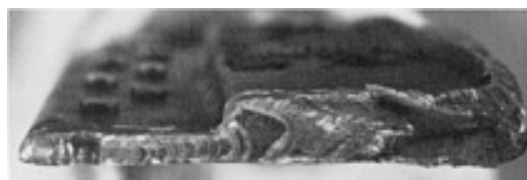
Fig. 975 View of the fracture surface in Fig. 974. The rivet hole intersected by the fracture is abnormal, consisting of two overlapping holes (see Fig. 976). Beach marks, which are clearly visible, indicate that the fatigue crack began at the double-drilled rivet hole. $1.13\times$

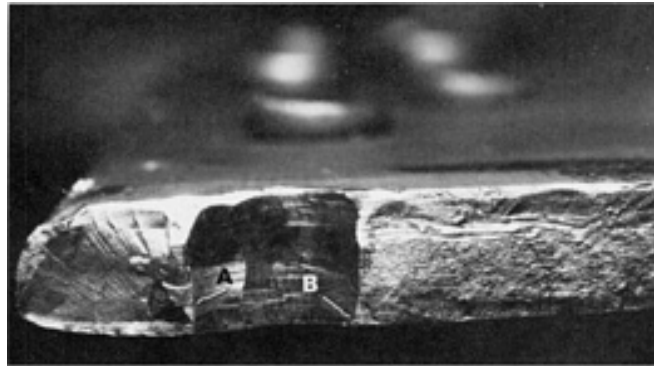
Fig. 976 Higher-magnification view of the rivet-hole area of the fracture surface shown in Fig. 975. The double-drilled nature of the rivet hole is shown quite clearly here. Two fatigue cracks originated at this hole--one beginning at arrow A and growing to the left, and the other beginning at arrow B and growing to the right. 5×

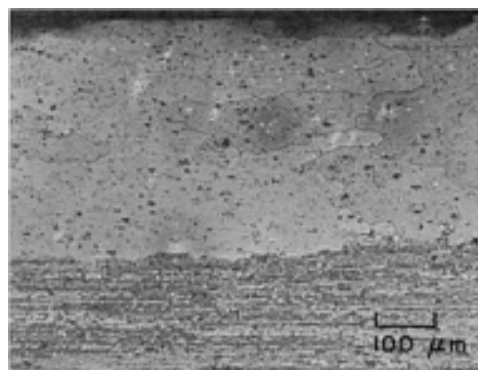
Fig. 977 Polished and etched section through the cap in Fig. 974. At bottom is a fibrous interior structure typical of aluminum alloy extrusions. At top is one of the coarse-grained, recrystallized layers, 0.46 to 0.94 mm (0.018 to 0.037 in.) thick, at the top and bottom surfaces of the cap. Keller's reagent, 100×

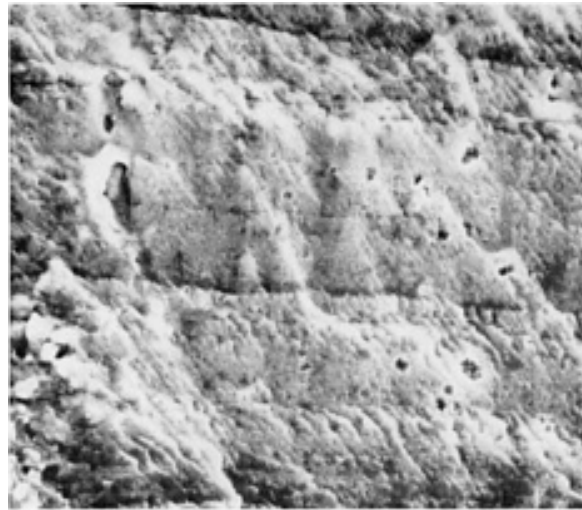
Fig. 980 Fatigue fracture of an aluminum alloy 2014-T6 heat-treated forging. Details of the heat-treatment procedure were not available. Some machining was carried out on the forging prior to heat treatment. The aircraft structural component cracked in service. The horizontal lines on the fracture surface are grain boundaries. Fatigue striations are also visible, traversing the fracture face at roughly 60°. Note the absence of discontinuities at their intersections with the grain boundaries. SEM, 1800× (E. Neub, University of Toronto)

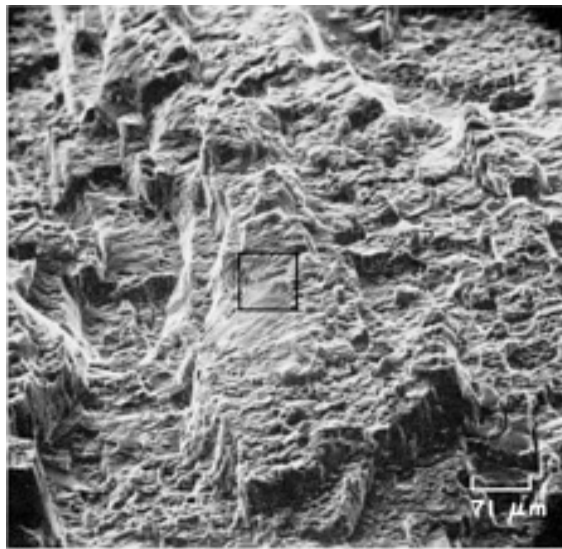
Fig. 982 A different area of the fracture surface shown in Fig. 981. This also exhibits vertical faces that are tear ridges. The surface is covered with voids, but at this low magnification it is not possible to decide whether or not they are dimples. The smooth central area outlined by the rectangle is shown enlarged in Fig. 983. SEM, 140 \times

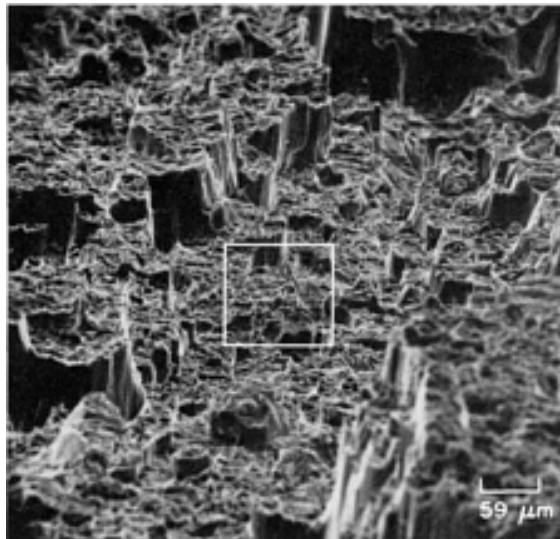
Fig. 984 Fracture surface of a fatigue-test specimen of aluminum alloy 2024-T3 tested at 23 °C (73 °F) in argon. The fatigue crack, similar in appearance to the one in Fig. 982, was produced by a stress-intensity range (ΔK) of 24.8 MPa \sqrt{m} (22.6 ksi \sqrt{in}) at a frequency of 10 cps. Much of the surface shows features resembling dimples, but the vertical "cliffs" are probably delaminations along grain boundaries. See Fig. 985 for a higher-magnification view of the area in the rectangle. SEM, 170 \times

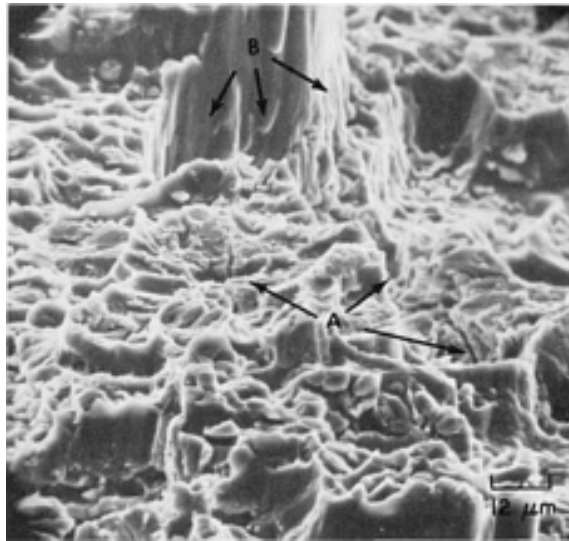
Fig. 985 Area outlined by the rectangle in Fig. 984, as seen at higher magnification. This view provides a much clearer delineation of the fine details of the fracture surface and shows a combination of dimpled rupture and grain-boundary separation. Intergranular secondary fissures such as those marked by the arrows at A led to the formation of the vertical "cliffs" shown here (arrows at B) and in Fig. 984. Cracked and broken inclusions are visible at many locations. SEM, 850×

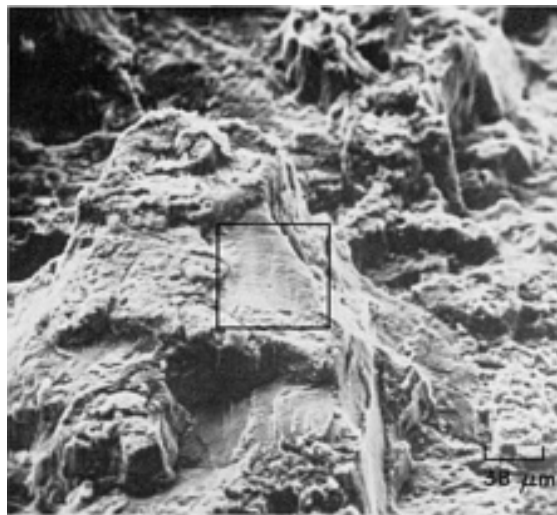
Fig. 986 Fracture surface of a fatigue-test specimen of aluminum alloy 2024-T3 that was tested in an environment of a 3.5% solution of NaCl in water. The stress-intensity range (ΔK) was $19.8 \text{ MPa}\sqrt{m}$ ($18 \text{ ksi}\sqrt{in}$) at 10 cps. The central region of this view contains patches of well-defined fatigue striations. In adjacent regions, there appear to be faintly defined striae that have been obscured by corrosion. In other regions, it is uncertain whether fatigue or cleavage was active. See Fig. 987 for area in rectangle. SEM, 260×

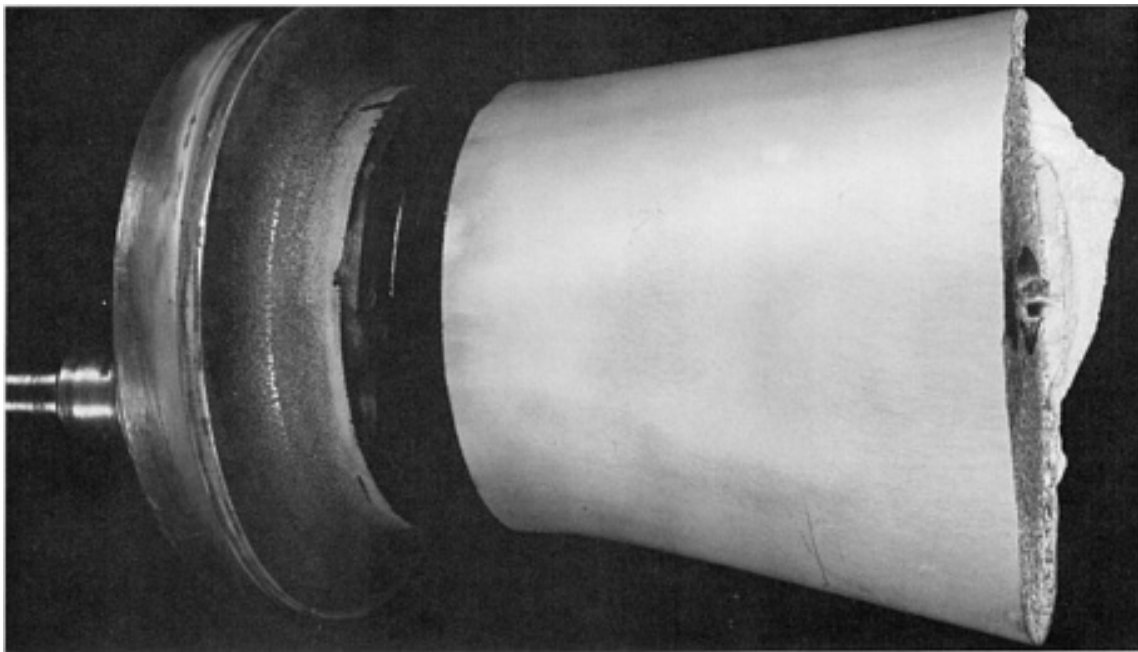
Fig. 988 View of the shank end of a fractured aircraft propeller blade fabricated of aluminum alloy 2025-T6. The blade broke by fatigue, which originated at an interior cavity that was provided to contain a balance weight comprised of compacted lead wool. Chemical analysis established that the blade was within specified composition limits. Hardness measurements (500-kg load) yielded an average value of 107 HB, which was above the required minimum of 100 HB. See also Fig. 989. Actual size.

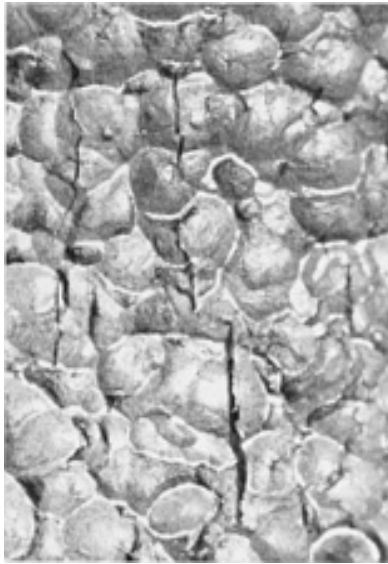
Fig. 993 Surface of the shot-peened fillet of another companion propeller blade to that in Fig. 990, showing the same type of fatigue cracks as those in the propeller blade shown in Fig. 992. These cracks were present in large numbers in the fillet area. 20×

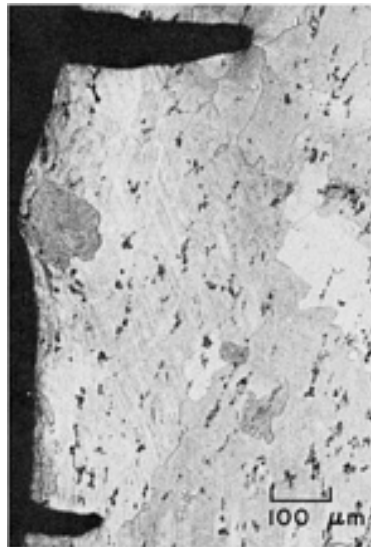
Fig. 994 A polished and etched section through the slot-peened fillet of the fractured blade in Fig. 990, showing two small fatigue cracks pulled open and blunted by plastic deformation. Note slip bands, which indicate that a slight amount of plastic flow occurred near cracks. Etched in Keller's reagent, 100×

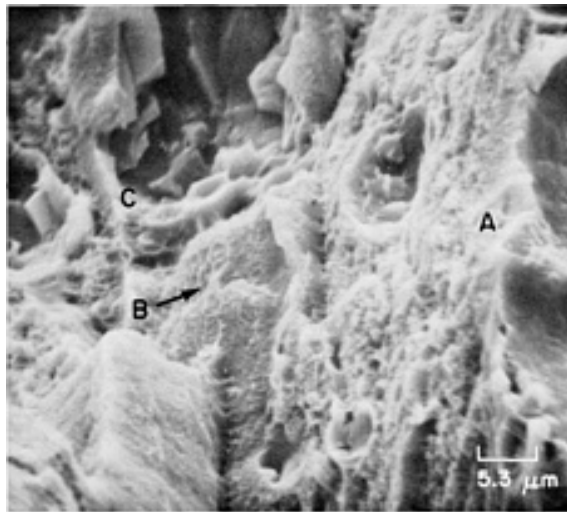
Fig. 1007 Higher-magnification view of the area in the rectangle in Fig. 1006. At A is a region of extremely fine dimples, which are slightly out of focus. At B, there appear to be grain-boundary facets bearing small, very shallow dimples. At C are fragments of a number of second-phase inclusions, many of which have separated from their original pockets in the matrix. SEM (gold shadowed), 1900×

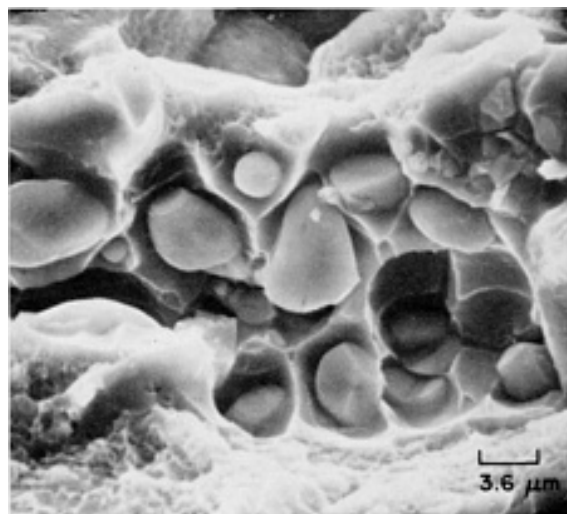
Fig. 1008 Tension-overload fracture in the short-transverse plane of a specimen of aluminum alloy 7075-T6. At top and bottom are regions of quite small dimples. In the central portion of this view are large pockets in which the cleaved facets of intermetallic inclusions are visible. These inclusions, which are rich in iron and silicon, are only slightly bonded to the walls of the pockets. SEM, 2800×

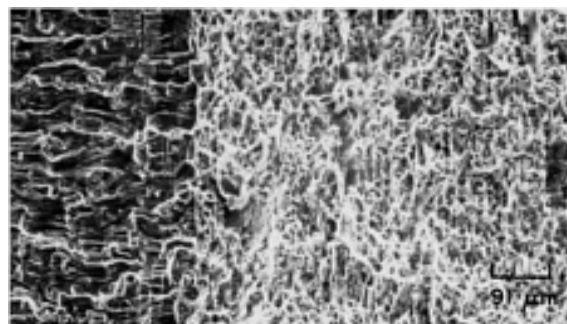
Fig. 1009 Specimen of aluminum alloy 7075-T6 broken in a slow-bend fracture-toughness test in air. Dark area, at left, is the fatigue-precrack surface, which shows no fatigue striae. At right is the tension-overload fracture surface; here, the surface appears dimpled, although this is uncertain at only 110 \times . See also Fig. 1010. SEM, 110 \times

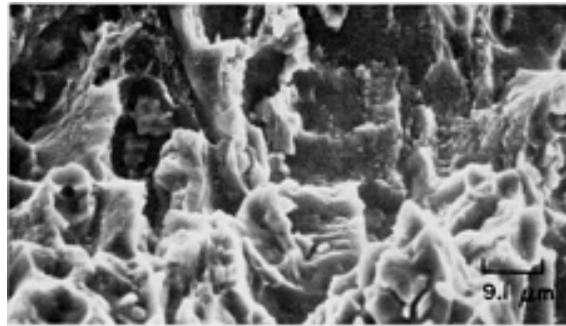
Fig. 1010 A portion of the tension-overload fracture surface in Fig. 1009, as seen at ten times the magnification there, which reveals fine details. A number of medium-size dimples contain inclusions, some of which are broken. In contrast are the minute dimples visible at left and right in the upper portion of this view. SEM, 1100 \times
