به نام خدا

مرکز دانلود رایگان
مهندسی متالورژی و مواد

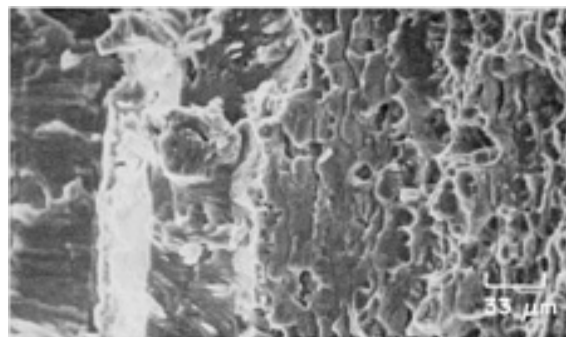
Fig. 1011 View of the transition between a slow-bend fracture induced in mercury vapor (left of center) and one occurring in air (right of center) in a specimen of aluminum alloy 7075-T6. The fracture induced in mercury vapor appears to have occurred by cleavage; the fracture in air exhibits dimples, which increase in frequency toward the right side of this fractograph. SEM, 300 \times

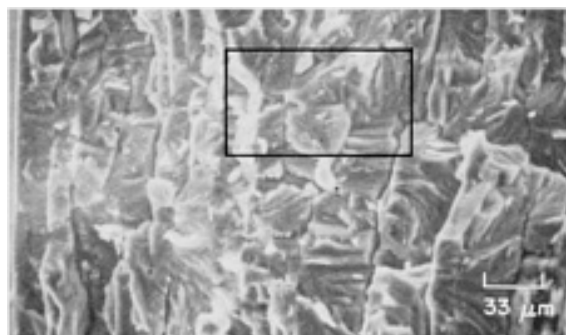
Fig. 1012 Fracture surface of an aluminum alloy 7075-T6 specimen broken in a slow-bend fracture-toughness test in mercury vapor. Obviously, this is completely brittle fracture. Many facets show faint characteristics of quasi-cleavage. Note the large number of secondary cracks, possibly at grain boundaries, all of which are more or less parallel. Area in rectangle is shown enlarged in Fig. 1013. SEM, 300 \times

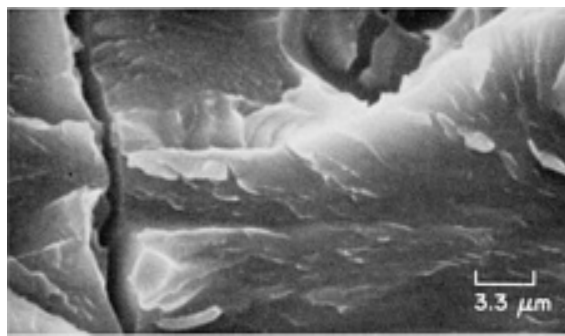
Fig. 1014 Another view, at still higher magnification, at the fracture surface in Fig. 1012 and 1013. At top is what appears to be a pocket holding a cracked inclusion. The remainder of the surface shows cleavage facets plus projections that are somewhat similar to the tongues seen in cold fractures of iron. SEM, 3000×

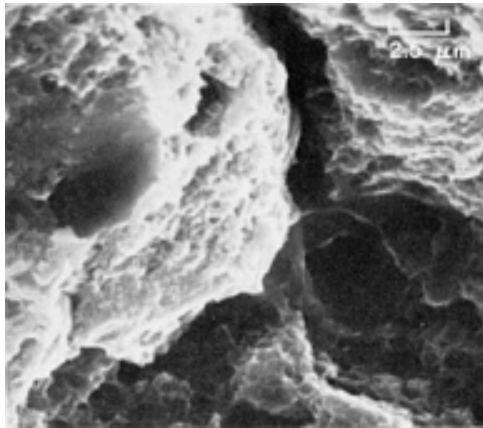
Fig. 1017 Enlarged view of the fracture-surface area in the rectangle in Fig. 1016. The higher magnification here makes it possible to observe the fine size of the dimples, which in general is less than half a micron. This is remarkable uniformity of size in a fracture surface as rough as this one. SEM, 4000×

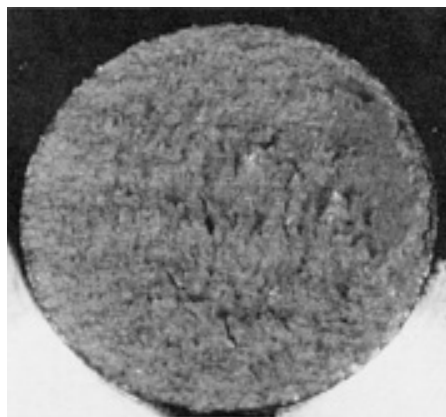
Fig. 1018 Tension-overload fracture in notched specimen of aluminum alloy 7075-T6. Notched tensile strength, 750 MPa (109 ksi); unnotched tensile strength, same as in Fig. 1015. Surface is flat and coarsely fibrous. Considerable secondary cracking is evident, even at this low magnification. See also Fig. 1019 and 1020. 9×

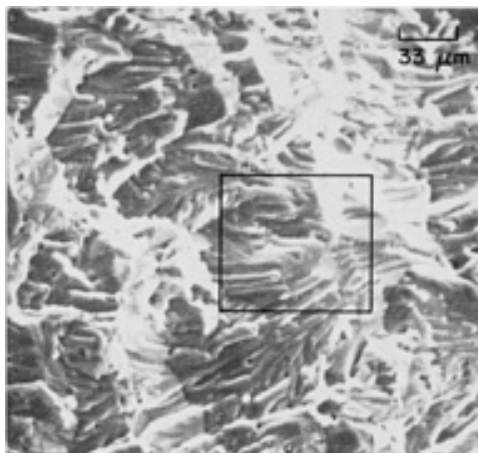
Fig. 1022 SEM view of a very complex surface found near the outer edge of the fracture in Fig. 1021, believed to have formed principally by severe deformation by slip. There appears to be a complete absence of secondary cracks. See also Fig. 1023. 300×

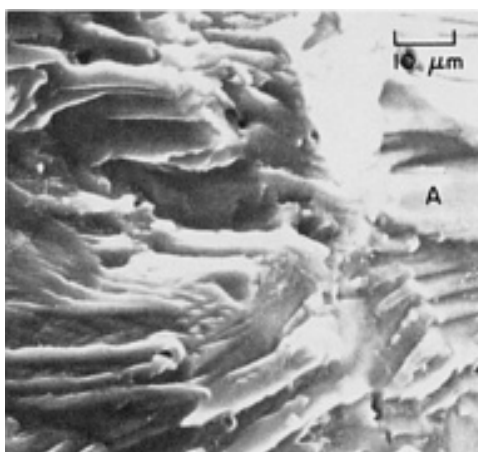
Fig. 1023 View at higher magnification of the area in the rectangle in Fig. 1022. Fatigue striations with a spacing of about 0.5 μm were discerned at region A when magnified at 4000×, oriented at a slight angle counterclockwise to the vertical edge of this print. SEM, 1000×

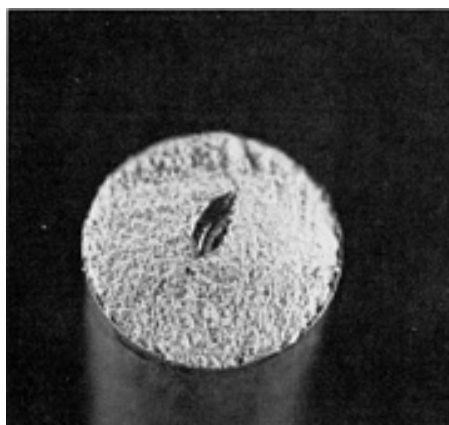
Fig. 1024 High-cycle fatigue fracture in aluminum alloy 7075-T6 (same mechanical properties as in Fig. 1015) loaded in tension-tension with $R = 0.1$ and a maximum loading of about 159 MPa (23 ksi). Fracture was at 548,000× cycles. Gouge near center is post-test mechanical damage. See also Fig. 1025. 6×

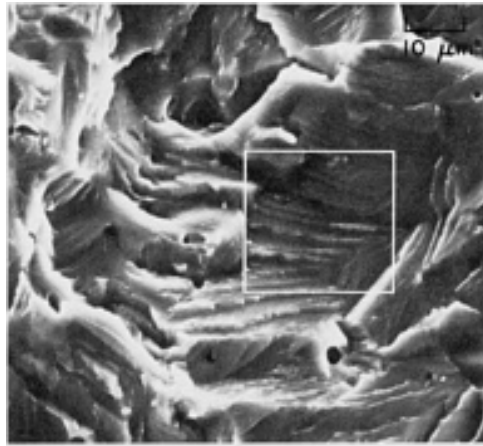
Fig. 1025 View of the fracture surface in Fig. 1024 that is very similar to the view of the low-cycle fracture surface in Fig. 1023. It is believed that the steplike formations resulted from a slip mechanism. Secondary cracks are not visible. See also Fig. 1026. SEM, 1000×

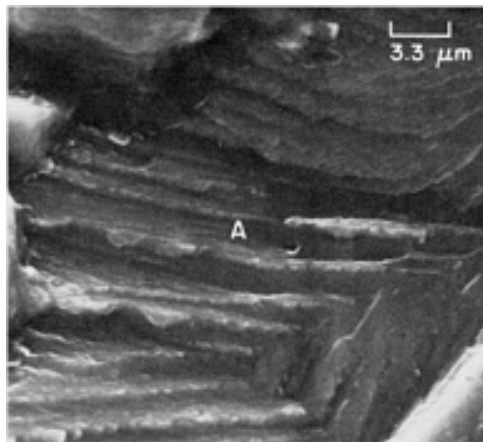
Fig. 1026 Area outlined by the rectangle in Fig. 1025, as seen at triple the magnification there. Fatigue striations, which are about an order of magnitude smaller than the steplike formations, are faintly visible parallel with the edges of the "steps" as at area A. SEM, 3000×

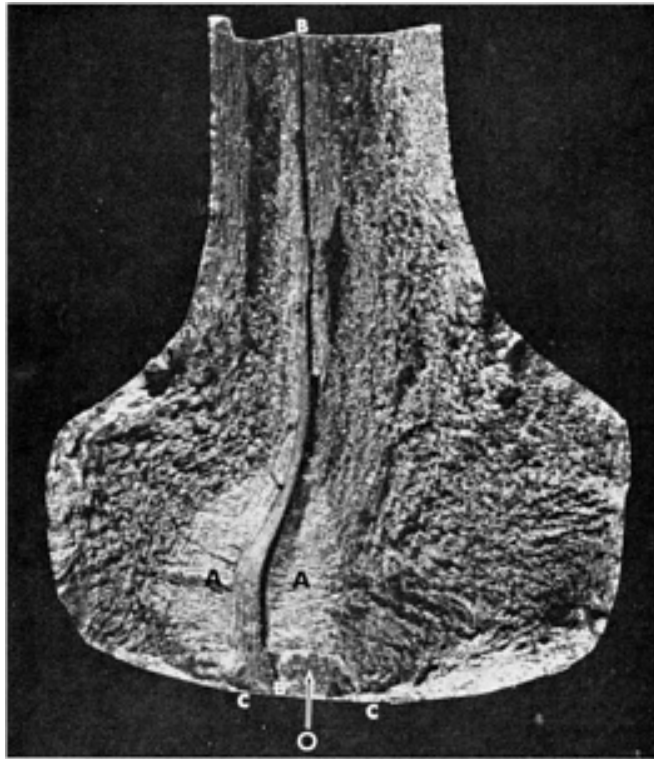
Fig. 1027 Surface of a crack in an aircraft wing-spar carry-through forging of aluminum alloy 7075-T6. The crack was discovered during inspection after 5269 h of service and was opened up. The external surface at edge C-C had been machined after forging. The regions marked A contain fatigue features that originated at a flaw (marked B-B) extending the full length of the segment. Area at O is shown enlarged in Fig. 1028. See also Fig. 1029, 1030, 1031, 1032, 1033, and 1034. ~3.5×

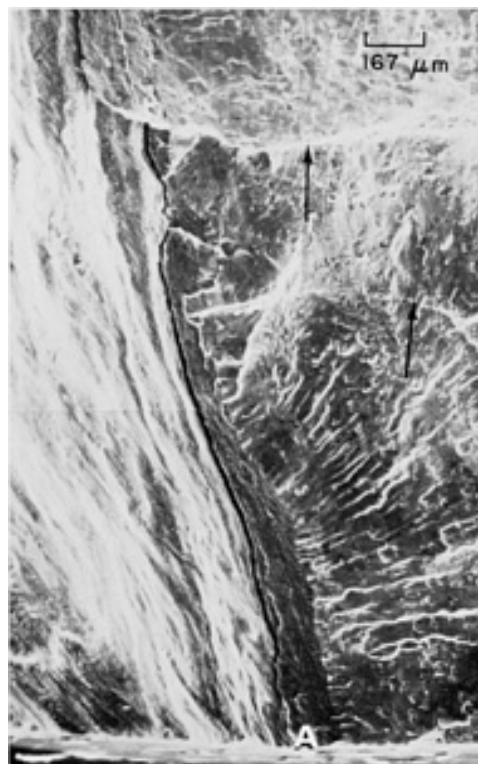
Fig. 1028 SEM view, at higher magnification, of the area at O in Fig. 1027. At left of the boundary (dark line running up from A) is the surface of the flaw (B-B in Fig. 1027); at right of it is a fatigue surface (A at right in

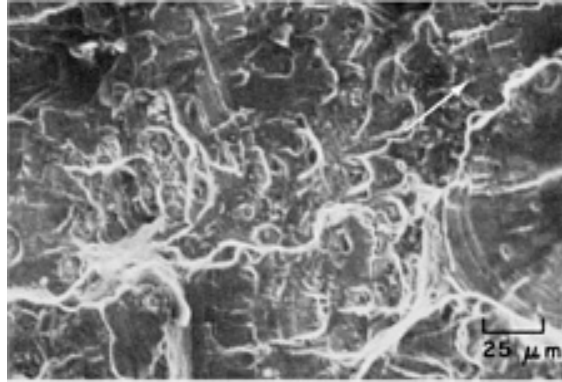
Fig. 1029 A typical region in an area A of Fig. 1027. Fatigue striations that are nearly vertical (arrow) are faintly visible. These were found to be parallel to the flaw (B-B in Fig. 1027) in both A areas in Fig. 1027. Scattered dimples are evident in locations adjacent to the fatigue striations. See also Fig. 1030. SEM, 400×

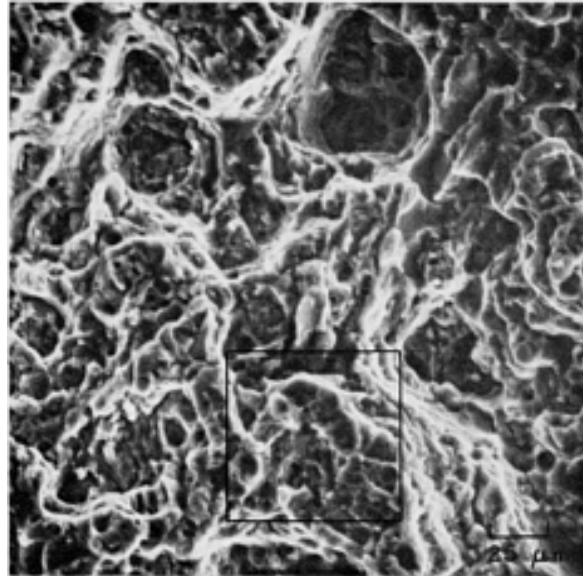
Fig. 1032 Area in the rectangle in Fig. 1031, as seen at five times the magnification there. Large dimples show the inclusions that initiated them; fine dimples that are too small to be resolved at this magnification exist among the large dimples. See also Fig. 1033. SEM, 400×

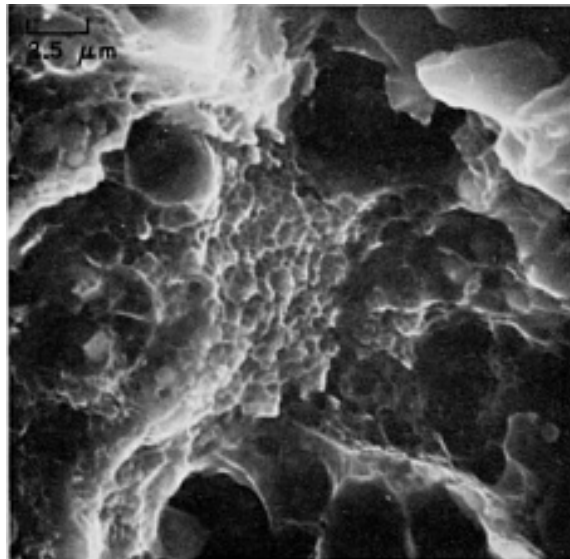
Fig. 1034 Greatly magnified view of the fracture region in Fig. 1031, showing the area in the rectangle in Fig. 1033. The region at center is made up of equiaxed dimples of quite uniform size. Note that several dimples are too deep for their bottoms to be lighted by an exposure proper for most of the dimples. SEM, 4000 \times

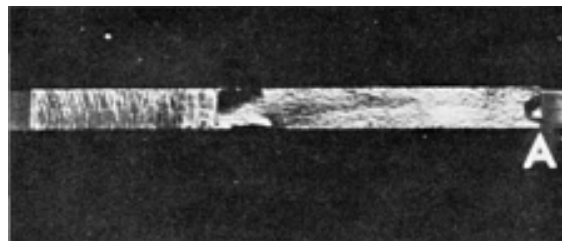
Fig. 1035 Fatigue-fracture surface of a bomb-rack side plate fabricated of aluminum alloy 7075-T6. Saw marks at left were made in opening up the fatigue crack for study. Crack origin was found to be at the edge of an attachment hole (marked A, at right). See Fig. 1036 for a view of the area near A at 5 \times . Actual size

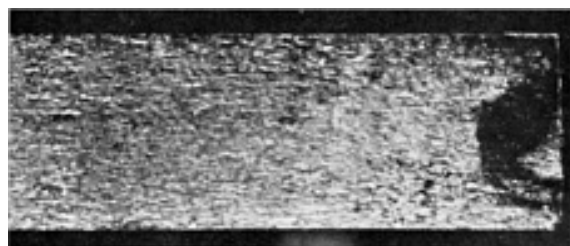
Fig. 1036 Enlarged view of the area near A in Fig. 1035, showing corrosion (in dark area at right end) at the site of crack initiation. The side plate had been used as a fuel-tank support element in a 25-h ground-level qualification test of the tank in a corrosive environment under spectrum loading. See also Fig. 1037. 5 \times

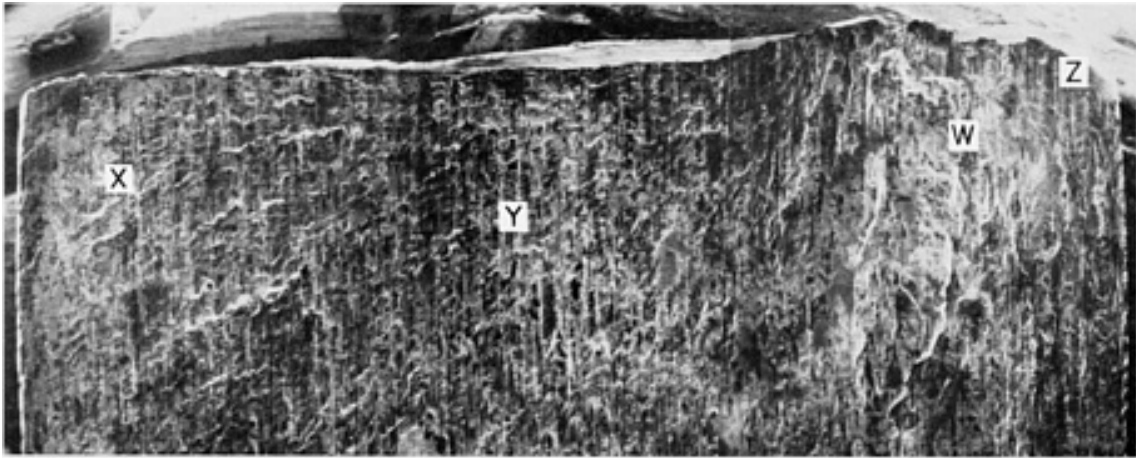
Fig. 1037 Composite of three low-magnification SEM fractographs of the surface of the fatigue fracture at A in Fig. 1035 after ultrasonic cleaning. A small portion of the attachment hole is visible along the top of this view. The lack of beach marks here is perhaps due to the brevity of the test (25 h). Attempts to locate the exact point of crack initiation were not successful, because of the presence of tool marks at the edge of the attachment hole. It is believed, from the orientation of the fatigue striations at W, X, Y, and Z (see Fig. 1038, 1039, 1040, and 1041 for enlarged views of these areas), that the crack began at top right, near the edge of the attachment hole. 26×

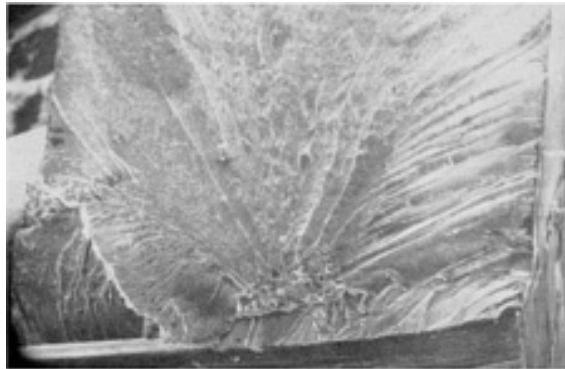
Fig. 1042 Fatigue fracture in a notched plate specimen of aluminum alloy 7075-T6 subjected to cyclic stresses in air. (Notch is at bottom; sides of plate, at far left and right). It is apparent that the fracture consists of at least three cracks that formed on various planes and temporarily grew independently. SEM, 26×

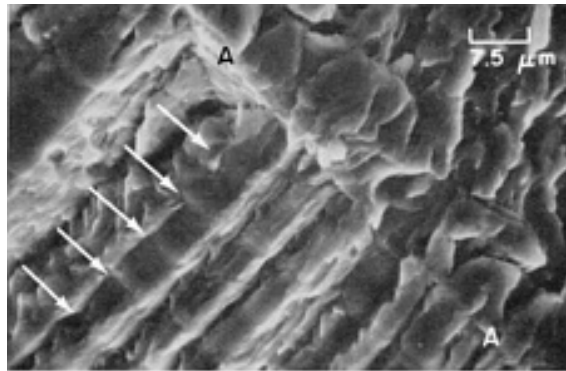
Fig. 1043 Fatigue fracture in a specimen of aluminum alloy 7075-T6 tested in air. The surface exhibits a pattern of brittle, widely spaced striations (at arrows) that are nearly parallel to a grain boundary (A-A). The tensile component (wide, flat region) of each striation was formed by a cleavage fracture. SEM, 1325 \times

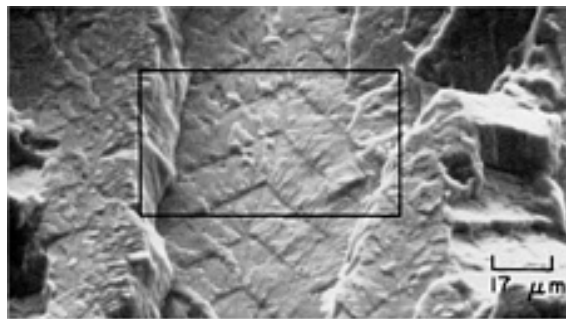
Fig. 1044 Corrosion-fatigue fracture in a specimen of aluminum alloy 7075-T6 tested in distilled water. Surface exhibits fatigue striations. The unusual sharp angle in the striations defines the location of a nearly vertical grain boundary in the central grain. Area in rectangle is shown at higher magnification in Fig. 1045. SEM, 600 \times

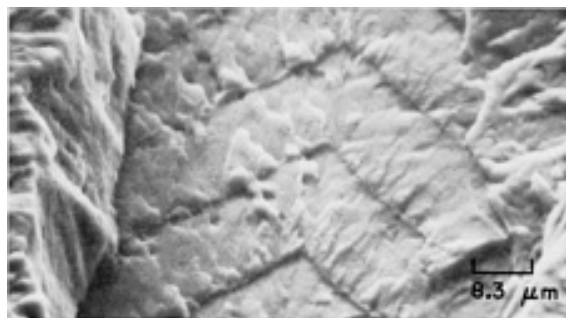
Fig. 1045 View of the area in the rectangle in Fig. 1044, at double the magnification there. Observe the wide, flat regions of the fatigue striations; these regions have progressed by cleavage. The unusual angled shape of the striations is the result of adherence of the crack fronts to crystallographic directions. SEM, 1200 \times

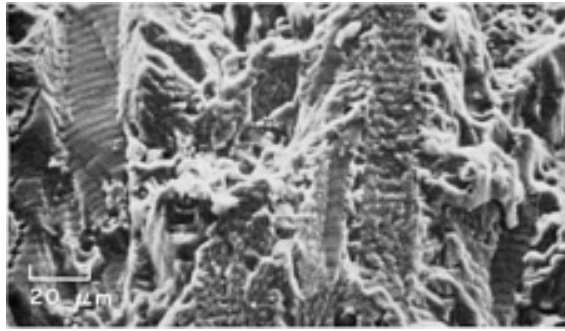
Fig. 1046 Corrosion-fatigue fracture in a specimen of aluminum alloy 7075-T6 that was tested in a 3.5% NaCl solution. Surface shows two types of striations: at left and at lower right are grains with ductile striations, and between them lies a grain with pronounced brittle striations. See also Fig. 1047. SEM, 500×

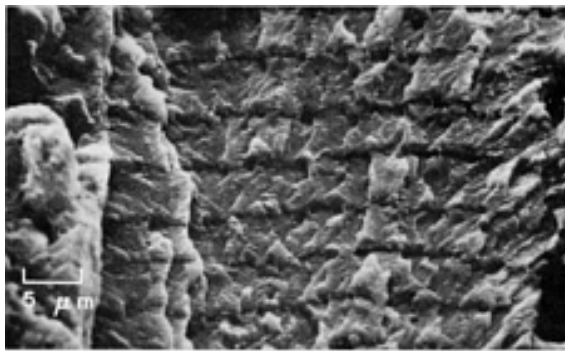
Fig. 1047 Brittle striations in a corrosion-fatigue fracture in a specimen of aluminum alloy 7075-T6 that, like the specimen in Fig. 1046, was tested in a 3.5% NaCl solution. Striations (horizontal here) have very uniform spacing. SEM, 2000×

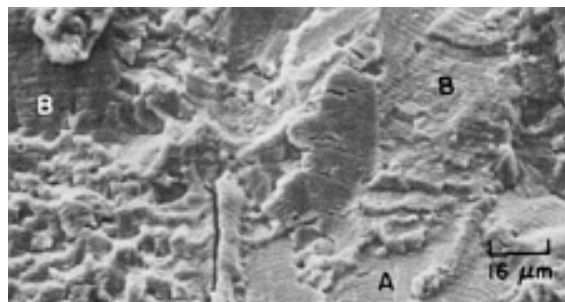
Fig. 1048 Corrosion-fatigue fracture in aluminum alloy 7075-T6 tested in a 3.5% NaCl solution. During testing, specimen was subjected to an applied electrical potential of -0.700 mV as measured against a standard calomel electrode. A mixture of ductile striations (at A) and brittle striations (at B) is evident, with some fissures. See also Fig. 1049. SEM, 625×

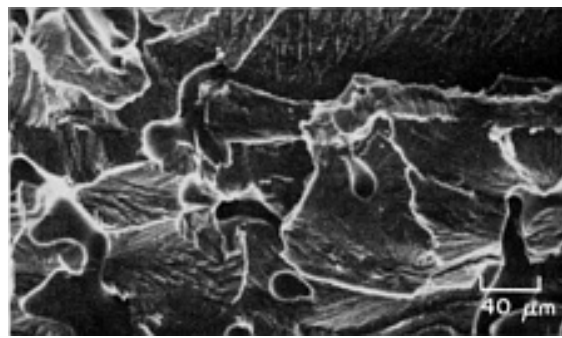
Fig. 1053 Fatigue-fracture in a cast single-crystal specimen of aluminum alloy 7075 that was aged to the T6 temper and then tested in a 3.5% NaCl solution. Most of the view is filled with an interdendritic network of solidification porosity, which did not halt or blunt the fatigue crack. SEM, 250 \times

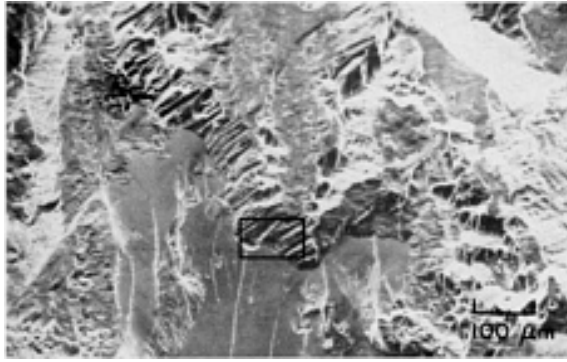
Fig. 1058 Corrosion-fatigue fracture in aluminum alloy 7475-T6 tested in a 3.5% NaCl solution under a cyclic stress-intensity range (ΔK) of $13 \text{ MPa}\sqrt{m}$ ($12 \text{ ksi}\sqrt{in}$) at 10 cps, showing contrasting features: ductile striations (unresolved) in smooth regions; brittle striations in adjacent grains. See also Fig. 1059. SEM, 100 \times

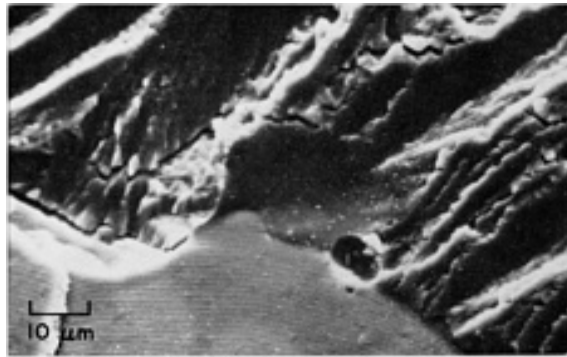
Fig. 1059 The area outlined by the rectangle in Fig. 1058, as seen at ten times the magnification there, which makes the fine fatigue striations in the smooth region clearly visible. Above are brittle striations forming, at a steep incline, what is in effect a cleavage step up to a second fracture level. SEM, 1000 \times

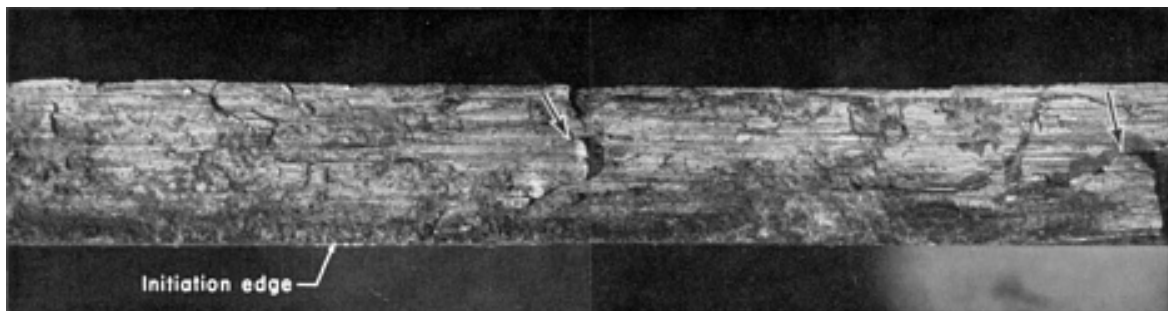
Fig. 1060 Surface of a fracture in an aircraft lower-bulkhead cap fabricated from an extrusion of aluminum alloy 7075-T6. The cap was cut open to expose the fracture for inspection, and evidence of corrosion was found along the edge at which fracture was initiated (bottom edge in this view). Secondary cracks had produced "leaves" (at arrows) in the fracture surface. See also Fig. 1061, 1062, 1063, 1064, 1065, 1066, 1067, 1068, and 1069. 8 \times

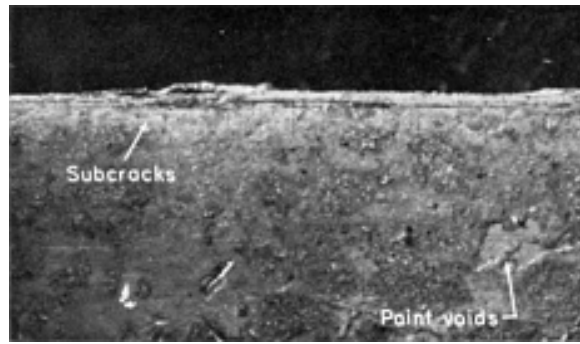
Fig. 1061 A portion of the painted external surface of the fractured aircraft lower-bulkhead cap in Fig. 1060, showing a profile of the fracture surface (at top) and voids in the paint film. Subcracks are evident immediately below and parallel with the fracture surface. Compare with Fig. 1062. 8 ×

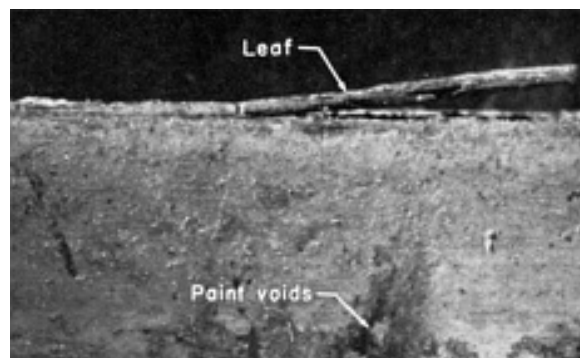
Fig. 1062 Another portion of the painted external surface of the cap in Fig. 1060. Fracture surface, shown in profile at top, contains a "leaf"; compare this view of the "leaf" with that in Fig. 1060, which is normal to the fracture surface. As in Fig. 1061, paint voids are evident. 8 ×

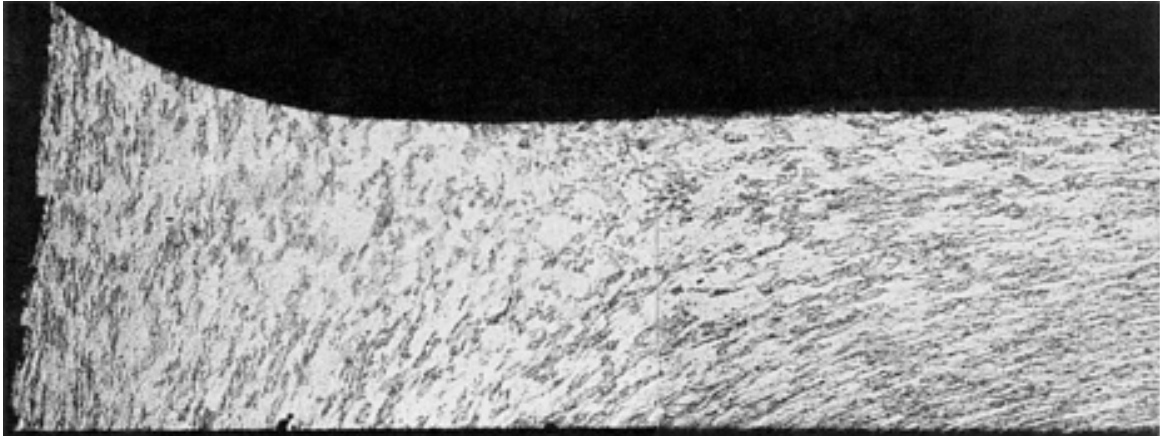
Fig. 1065 Polished and etched section through the fractured aluminum alloy 7075-T6 bulkhead cap in Fig. 1060, showing the fracture surface in profile at left. Note change in grain flow produced during extrusion, from a longitudinal orientation at right to transverse at left; transverse orientation results in grains being parallel to the fracture surface, a condition that aggravates stress-corrosion cracking. Etched in Keller's reagent, 20×

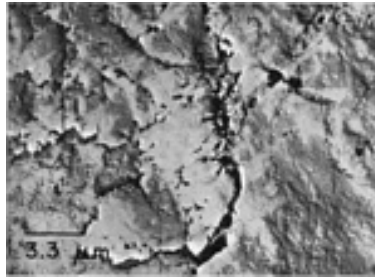
Fig. 1066 TEM p-c replica of an area of the fracture surface in Fig. 1060 near the edge at which fracture was initiated, showing corrosion debris on a very flat intergranular surface. The original separated-grain facets have been corroded away. 3000×

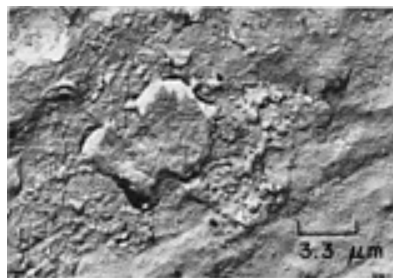
Fig. 1067 TEM p-c replica taken from another area of the fracture surface in Fig. 1060 near the edge at which fracture was initiated. This area, like the one in Fig. 1066, shows that cracking was intergranular and was accomplished by severe corrosion. 3000×

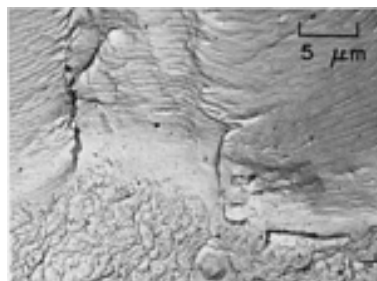
Fig. 1071 TEM p-c replica of the surface of a fracture in a specimen of aluminum alloy 7075-T6 that first was

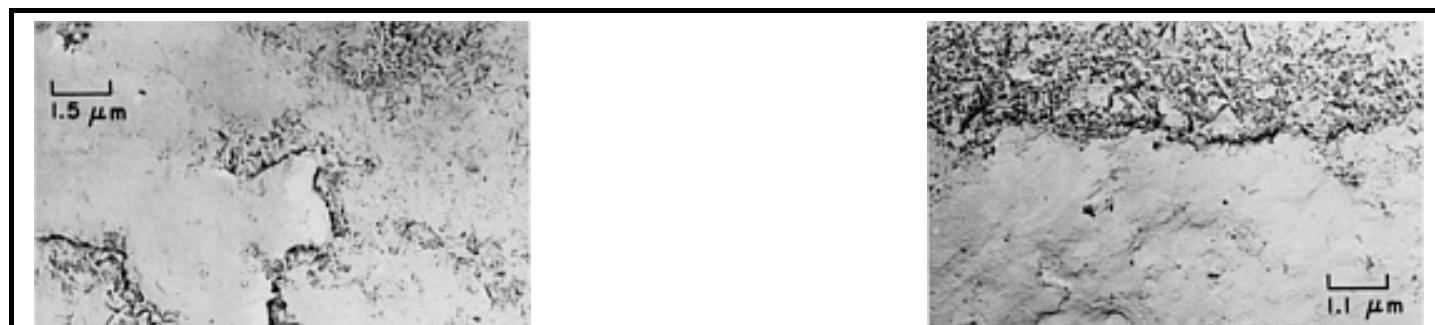
cracked by fatigue and then was broken by impact. Stretching and serpentine glide are evident at about mid-height, at the root of the fatigue crack; below are tear dimples formed on impact. 2000×

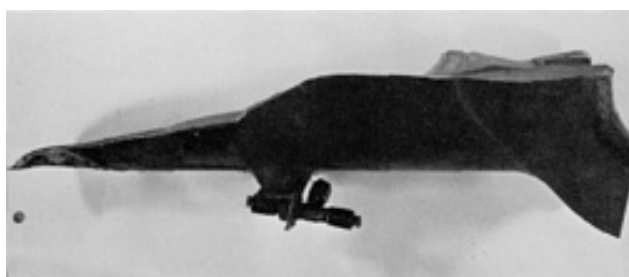
Fig. 1074 Side view of a piece of fractured aluminum alloy 7079-T6 bogie beam of an aircraft main landing gear. The fracture surface is at top, in profile. The very straight edge at lower right is a saw cut that was made to separate the fracture area from the remainder of the beam to facilitate inspection. Hardness of the beam was 84 HRB. See also Fig. 1075 and Fig. 1076. 0.25×

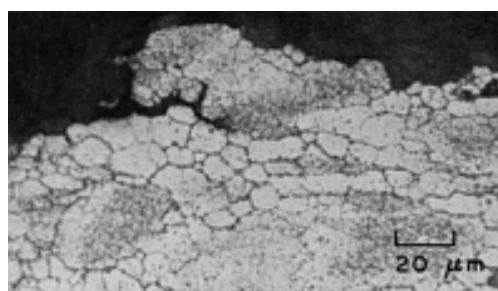
Fig. 1075 Polished and etched section through the light region at arrow "d" in Fig. 1076. At top in this view is the profile of the fracture surface. Note that the fracture usually followed grain boundaries. Cracks branching from the fracture surface are also evident. Etched in Keller's reagent, 500×

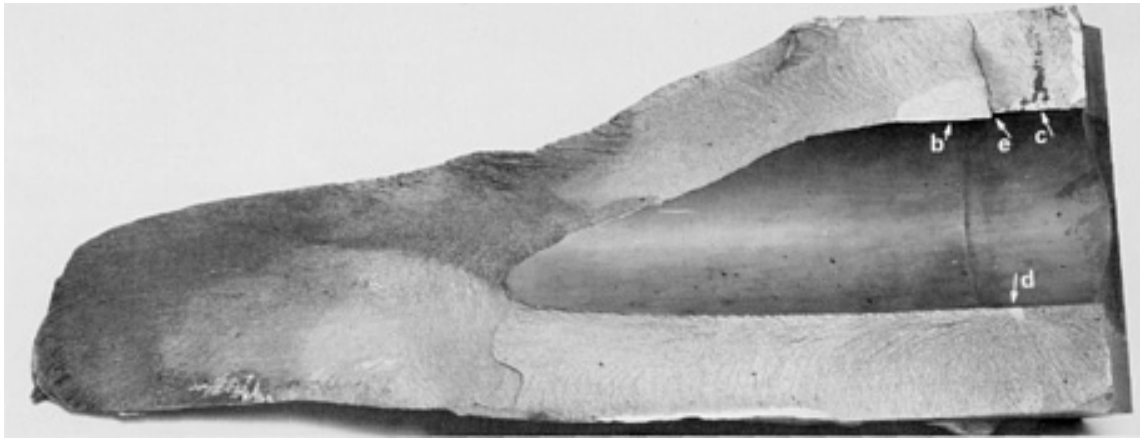
Fig. 1076 Surface of the fracture in the bogie beam shown in Fig. 1074. Three stress-corrosion cracks caused the final fast fracture, which was a tearing type of rupture. The intergranular attack characteristic of stress corrosion is shown in Fig. 1075. The three stress-corrosion cracks are the light areas marked by arrows "b," "c," and "d." The crack surfaces appear flat, but contain many small steps. Some of these steps were found to have been pulled away from the fracture surface in a leaf fashion, indicating overlapping or branching cracks. At arrow "e" is a pronounced step, which hides a portion of area "b." ~0.4x

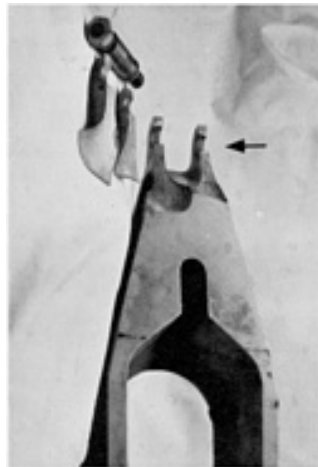
Fig. 1077 Portion of a broken aircraft landing-gear actuator beam of Al alloy 7079-T6, showing stress-corrosion fractures (at arrow). 0.17x

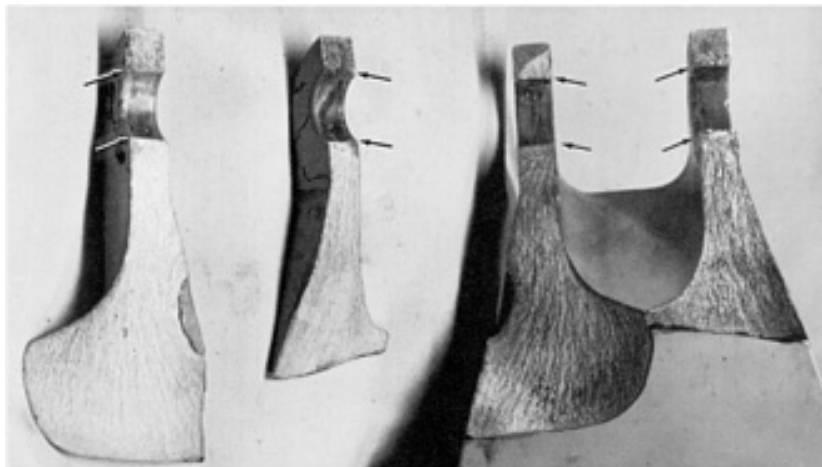
Fig. 1078 Higher-magnification view of the surfaces of the stress-corrosion fractures shown in Fig. 1077. These fractures originated at the interior edges of boltholes in clevis-attachment lugs, at the locations designated by the arrows. An appreciable amount of evidence of both corrosion and secondary cracking was found at these origins. Visible are chevron marks, which also confirm these locations as the origins of fracture. 0.63x

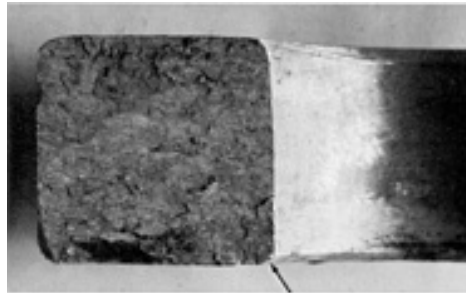
Fig. 1079 Fracture surface outboard of the bolthole in the clevis-attachment lug at right in Fig. 1078. Entire surface is typical of stress-corrosion cracking. Origin is at arrow (lower right corner of surface). 4x

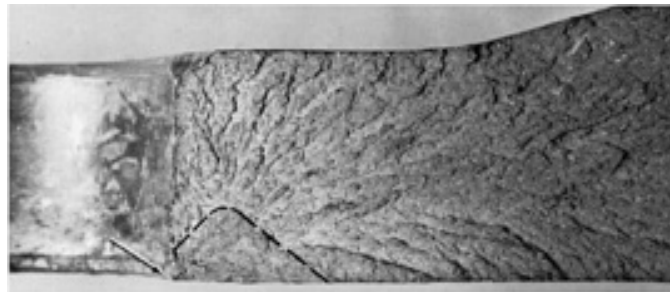
Fig. 1080 Fracture surface inboard of the bolthole in the clevis-attachment lug in Fig. 1079. The primary stress-corrosion crack, which originated at arrow, is within the area enclosed by the dashed line (lower left). The remainder of this surface shows chevron marks typical of final fast fracture. 4x

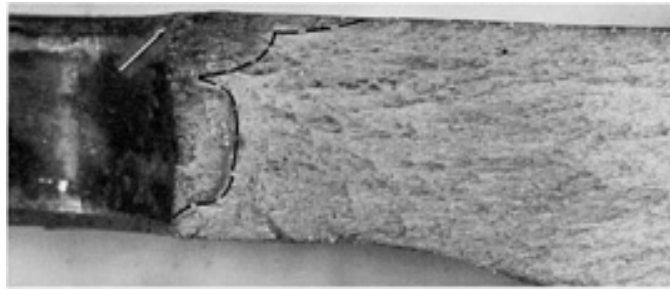
Fig. 1082 Fracture surface inboard of the bolthole in the clevis-attachment lug in Fig. 1081. The primary stress-corrosion crack, which originated at the arrow, and which is enclosed by the dashed line, is larger than that in Fig. 1080. This actuator beam had hardness normal for 7079-T6: 152-157 HV (10-kg load). 4×

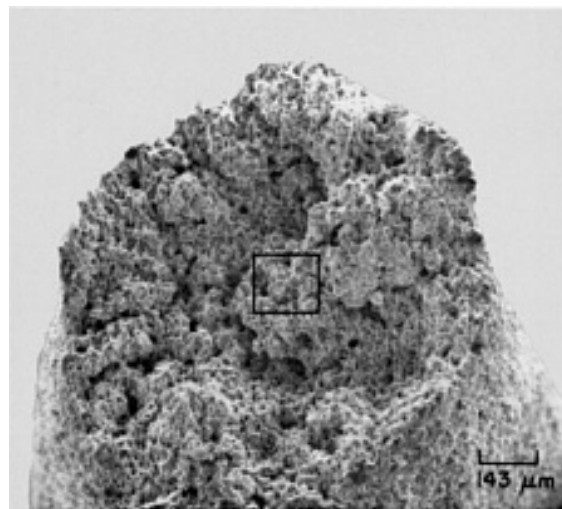
Fig. 1083 Tensile-overload fracture in a specimen of a superplastic eutectic alloy containing 67% Al and 33% Cu. The material was cast, and the as-cast ingot was extruded at 430 °C (805 °F). Testing was performed at 0.025 mm/s (0.001 in./s) and at a controlled temperature of 450 °C (840 °F). The surface shows course dimples and an irregular contour. There is some suggestion of a shear lip, but it is not sharply defined. See also Fig. 1084. SEM, 70×

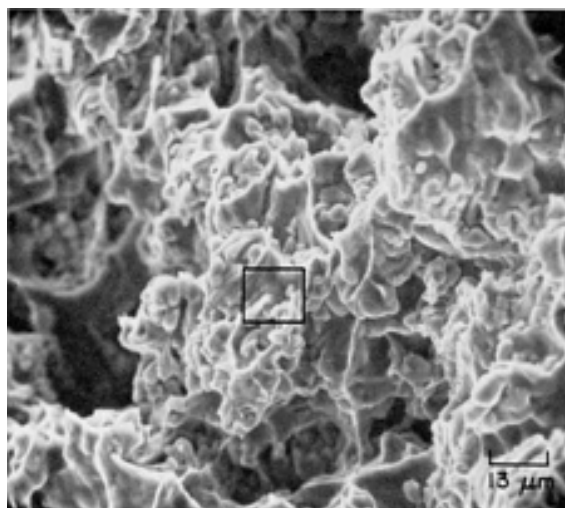
Fig. 1084 Higher magnification view of the area in the rectangle in Fig. 1083, showing more clearly the details

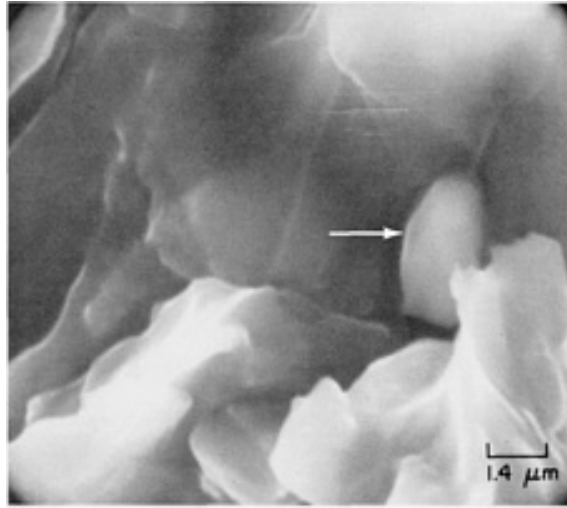
Fig. 1085 Higher-magnification view of the area outlined in Fig. 1084. The contours of the facets in the right foreground show that the Al solid-solution matrix phase of this eutectic alloy was highly ductile. Arrow points to a spheroidal particle that should be of the CuAl_2 phase; most of the surface of this particle appears to be detached from the matrix. SEM, $7000\times$

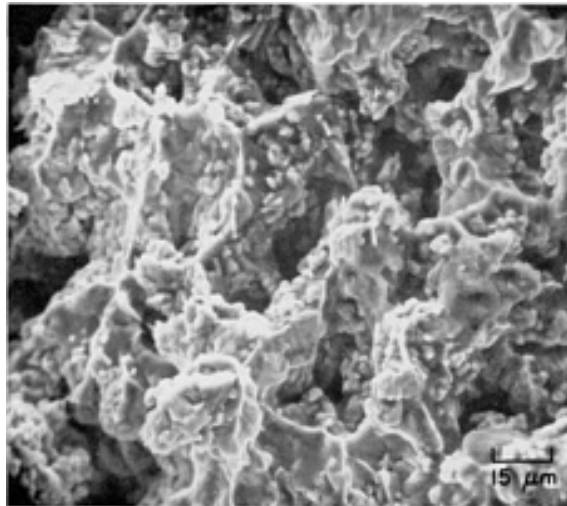
Fig. 1086 Tensile-overload fracture in a specimen of 67Al-33Cu alloy that was cast, extruded, and tested the same as the specimen in Fig. 1083. In this specimen, the grain size is only $2\ \mu\text{m}$. It appears that both the large dimples and the CuAl_2 particles here are smaller than those in Fig. 1084. SEM, $670\times$

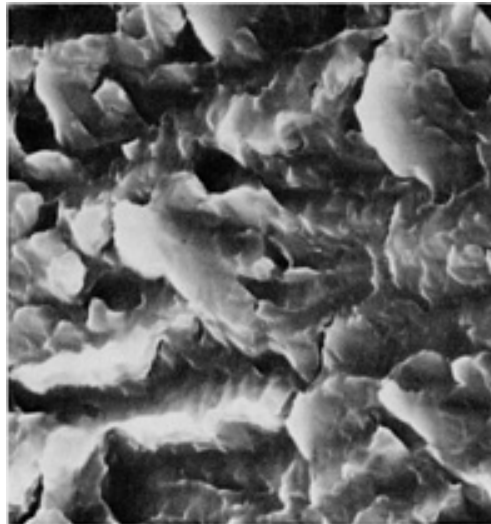
Fig. 1088 Transgranular corrosion-fatigue crack propagation in a solution-treated and peak-aged Al-5.6Zn-1.9Mg sample tested in humid nitrogen gas. Compare with Fig. 1091 and 1092. SEM, 5000× (R.E. Ricker, University of Notre Dame, and D.J. Duquette, Rensselaer Polytechnic Institute)

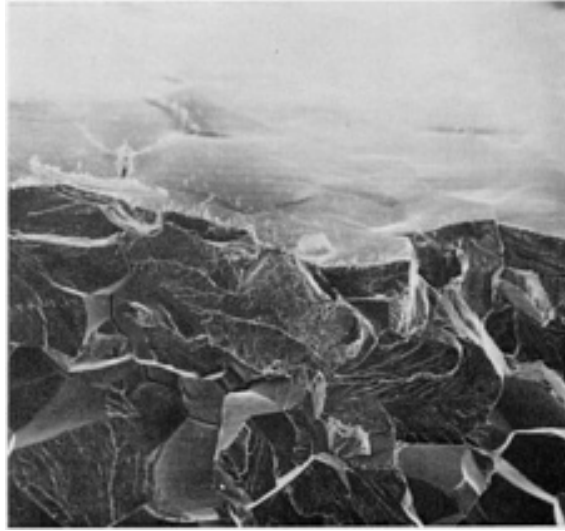
Fig. 1089 The external surface (top) and the corrosion-fatigue fracture surface (bottom) of a solution-treated and peak-aged Al-5.6Zn-1.9Mg sample tested in high-purity deaerated water. SEM, 100× (R.E. Ricker, University of Notre Dame, and D.J. Duquette, Rensselaer Polytechnic Institute)

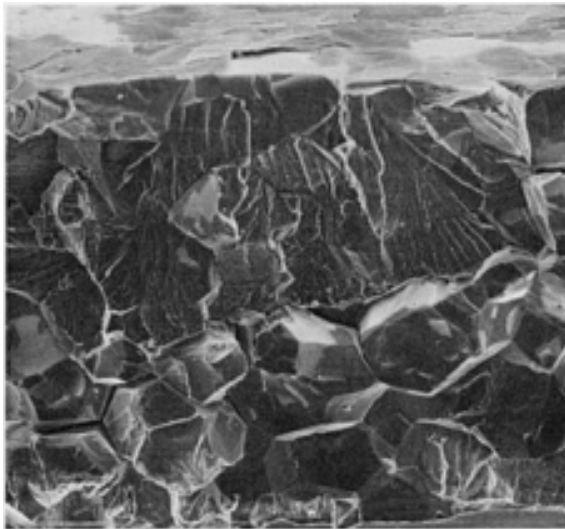
Fig. 1090 The external surface (top) and the corrosion-fatigue fracture surface (bottom) of a solution-treated and peak-aged Al-5.6Zn-1.9Mg sample tested in deaerated 0.5 mol NaCl at a cathodic potential of -1.6 V (SCE). Compare with Fig. 1089, 1093, and 1095. SEM, 100× (R.E. Ricker, University of Notre Dame, and D.J. Duquette, Rensselaer Polytechnic Institute)

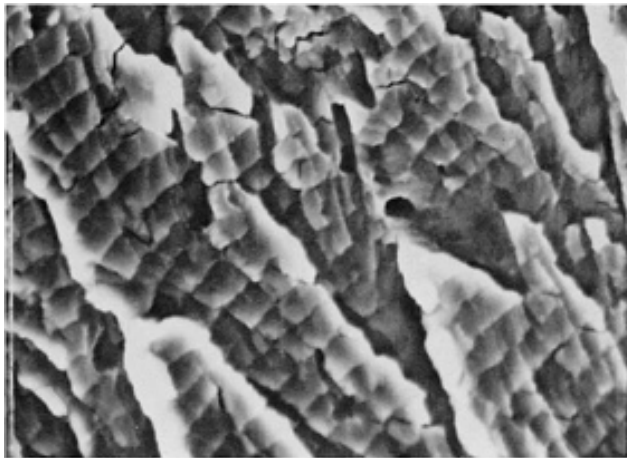
Fatigue crack propagation in a solution-treated and peak-aged Al-5.6Zn-1.9Mg sample tested in an inert environment (dry nitrogen gas). Compare with the examples in Fig. 1088, 1089, 1090, 1094, and 1095 of corrosion fatigue in this experimental alloy. Fig. 1091: Region of transgranular fatigue crack propagation. SEM, 500 \times . Fig. 1092: High-magnification view of fine fatigue striations on a transgranular portion of the fracture surface. SEM, 10,000 \times . Fig. 1093: Typical region of intergranular fracture in an Al-5.6Zn-1.9Mg alloy tested in an inert environment. SEM, 500 \times (R.E. Ricker, University of Notre Dame, and D.J. Duquette,

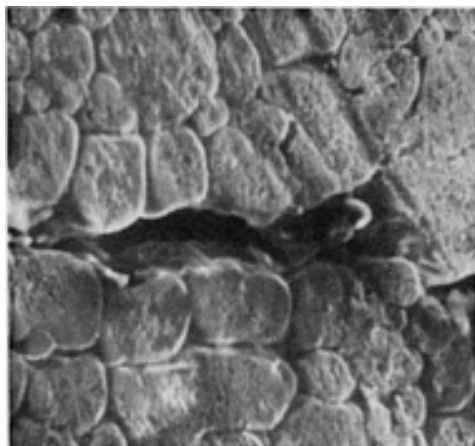
Fig. 1096 Fracture along prior powder particle boundaries in cold-rolled Al-4.2Mg-2.1Li. The experimental P/M alloy was solution treated for 1 h at 510 °C (950 °F), water quenched, naturally aged, and then cold rolled to a 4% thickness reduction in one pass. The cracks at particle boundaries reflect the low ductility typical of aluminum-lithium alloys. SEM, 375× (R.E. Ricker, University of Notre Dame, and D.J. Duquette, Rensselaer Polytechnic Institute)

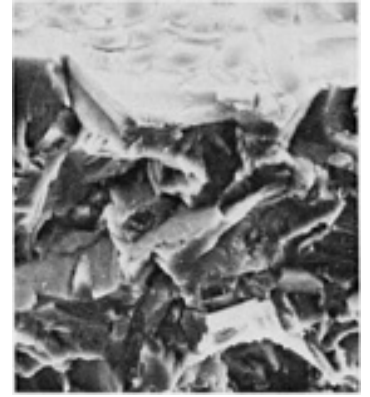
Corrosion-fatigue crack initiation and propagation in a solution-treated and peak-aged Al-4.2Mg-2.1Li P/M alloy tested in deaerated high-purity water. Fig. 1097: View of external surface (top) and fracture surface (bottom). SEM, 500×. Fig. 1098: Higher-magnification view of fracture surface. SEM, 1000× (R.E. Ricker, University of Notre Dame, and D.J. Duquette, Rensselaer Polytechnic Institute)

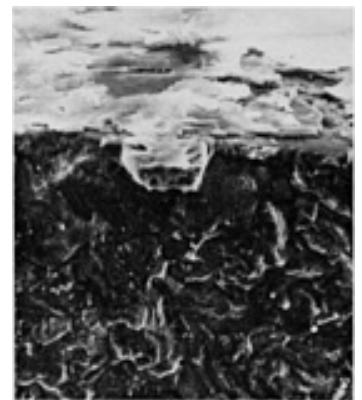
Corrosion-fatigue crack propagation in a solution-treated and peak-aged Al-4.2Mg-2.1Li P/M alloy tested in deaerated 0.5 mol Na₂SO₄. Fig. 1099: View of external surface (top) and fracture surface (bottom). SEM, 400×. Fig. 1100: Corrosion products on the fracture surface. SEM, 800× (R.E. Ricker, University of Notre

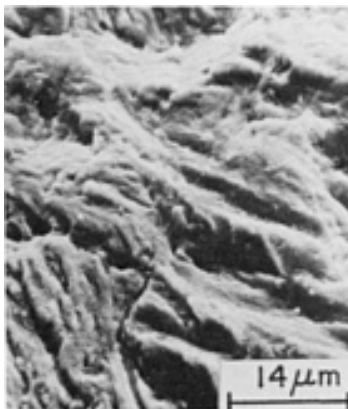
Same material as in Fig. 1103, 1104, 1105, 1106, 1107, 1108, 1109, and 1110, but tested in air at 540 °C (1000 °F). Crack growth direction is from right to left. Fig. 1111: At $da/dN = 0.018 \mu\text{m}/\text{cycle}$, the fracture surface was 100% faceted. The macroscopically smoother surface (compare with Fig. 1103) reflects the effect of oxidation. SEM, 150×. Fig. 1112: High-magnification view of a facet reveals parallel markings that indicate the underlying α -platelet microstructure and highlight the tendency for crack propagation to occur perpendicular to the α platelets. One of many small, parallel cracks is noted at A. SEM, 1500× (J.A. Ruppen and A.J. McEvily, University of Connecticut)

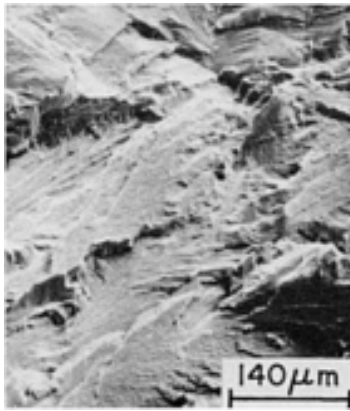
Same material as in Fig. 1103, 1104, 1105, 1106, 1107, 1108, 1109, 1110, 1111, and 1112, but tested in vacuum at room and elevated temperatures. Fracture surfaces were more ductile appearing, and striation formation was suppressed (compare with samples tested in air). Fig. 1113: At 25 °C (75 °F) and $da/dN = 0.0051 \mu\text{m}/\text{cycle}$, both the degree of faceting and the irregularity of the fracture surface were reduced (compare with Fig. 1104). Crack growth direction is from left to right. SEM, 1500×. Fig. 1114: At 540 °C (1000 °F) and $da/dN = 0.0051 \mu\text{m}/\text{cycle}$, the amount of faceting increased but not to the extent observed in samples tested in air (Fig. 1111). Crack growth direction is from right to left. SEM, 840× (J.A. Ruppen and A.J. McEvily, University of Connecticut)

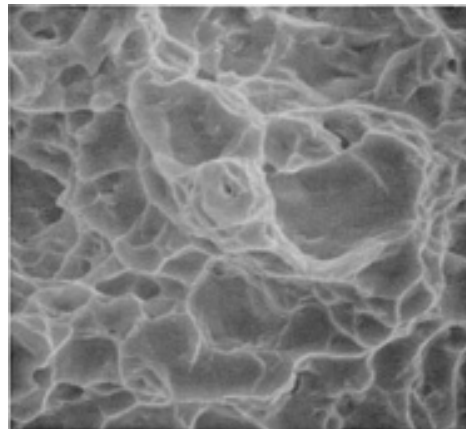
Fig. 1121 Ductile overload fracture of a tensile specimen of Ti-6Al-4V ELI (ASTM F136, UNS R56401). The wrought alloy was annealed for 1 h at $760 \text{ }^\circ\text{C}$ ($1400 \text{ }^\circ\text{F}$) and air cooled prior to testing. The fracture surface is characterized by essentially 100% dimpled rupture. SEM, $1000\times$ (R. Abrams, Howmedica, Pfizer Hospital Products Group Inc.)

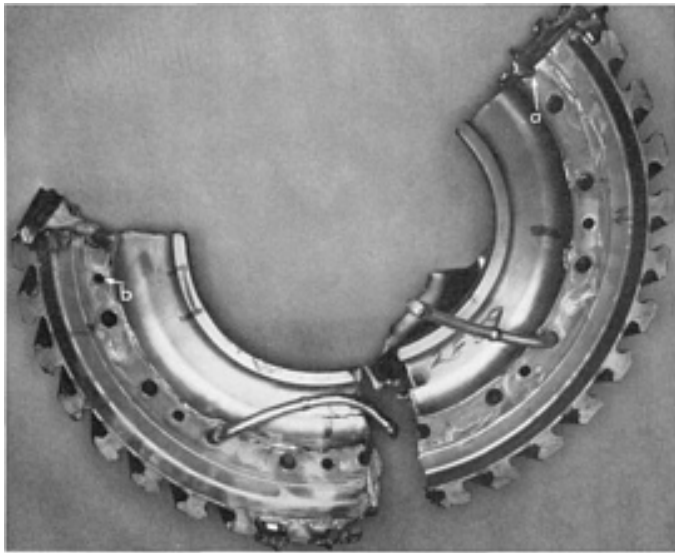
fracture. Rounded voids lend support to contention that tensile stress initiated fracture. Duplex etch, Kroll's solution and H₂O₂-KOH. Differential interference contrast microscopy, 500×. Fig. 1131 and 1132: Comparison of shear-band orientation in tensile-tested Ti-6Al-4V fasteners made by producer of failed pins (Fig. 1131) and a producer of pins that did not fail during installation (Fig. 1132). Shear-band angles are higher--40° to 50° versus 20° to 30°--in the former. SEM, 200× (G. Hopple, Lockheed Missiles & Space Company, Inc.)

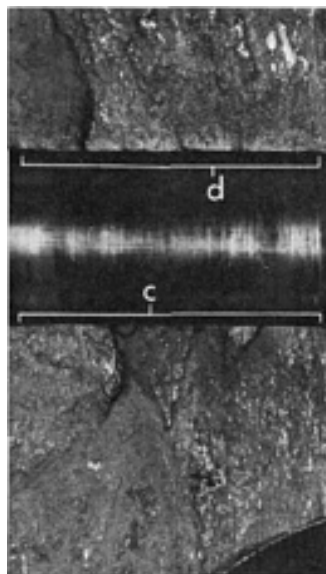
Fig. 1135 Enlarged view of the fatigue-crack regions (indicated by brackets) at the edges of the bolthole in Fig. 1134. The cracks grew in both directions from the hole. 3×

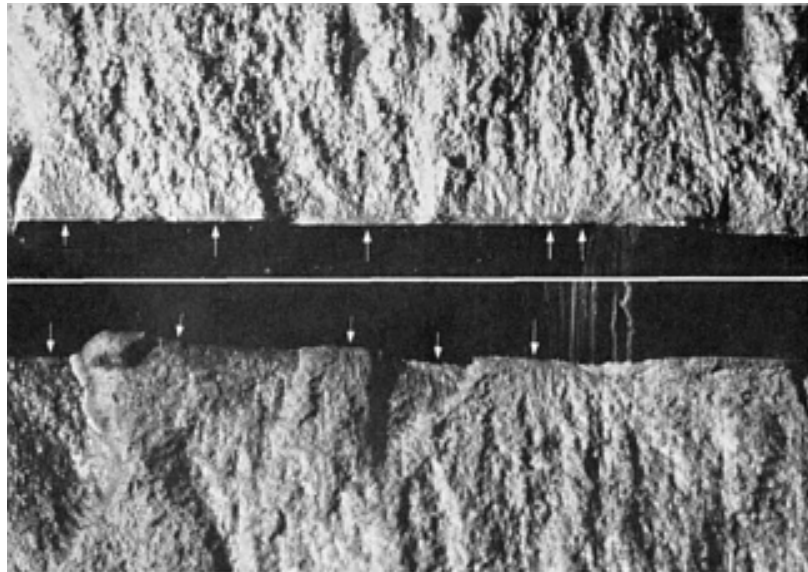
Fig. 1136 Separate, higher-magnification views of the bracketed regions of the edges of the compressor-disk bolthole in Fig. 1134 and 1135, shown correctly aligned opposite each other. Visible are beach marks in several fatigue-crack zones (at arrows). These separate cracks penetrated only a short distance before joining to form common fronts, which then advanced toward both the rim and the bore of the disk. 8×

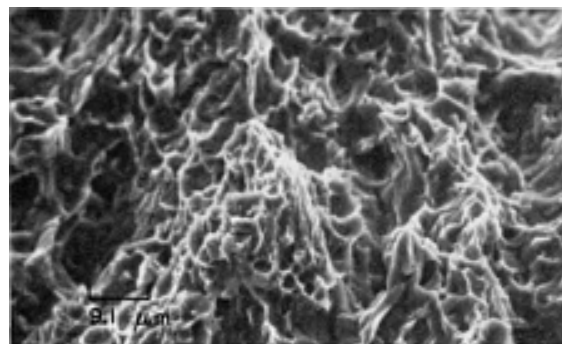
Fig. 1142 Higher-magnification view of the fracture surface in Fig. 1141, typical of fractures produced in this alloy in air after various solution treatments. Entire surface shows dimpled fracture of fine, equiaxed α phase that ruptured in ductile shear. SEM, 1100×

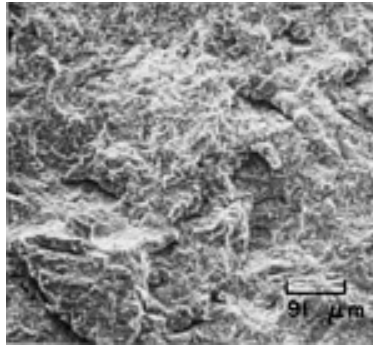
Fig. 1143 Fracture surface of a specimen of Ti-6Al-4V alloy similar to the specimen shown in Fig. 1141 and having the same history, but tested in a hydrogen atmosphere. The principal features here are numerous secondary cracks. See also Fig. 1144. SEM, 110×

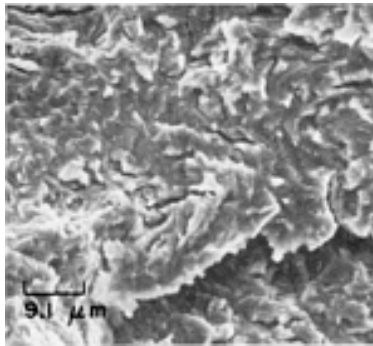
Fig. 1144 Higher-magnification view of the fracture surface shown in Fig. 1143. The embrittlement of this specimen by hydrogen was slight (about 12%). Fracture was by a mixture of shear rupture and transgranular cleavage. See also Fig. 1145. SEM, 1100×

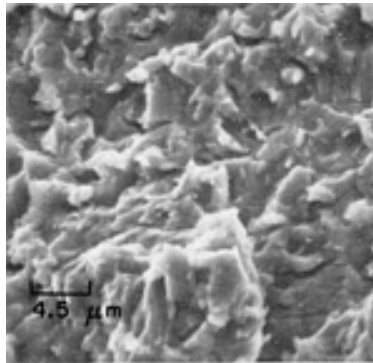
Fig. 1145 Same fracture surface as in Fig. 1143 and 1144, but shown at even greater magnification. Many small secondary cracks are present among moderate-sized dimples. SEM, 2200×

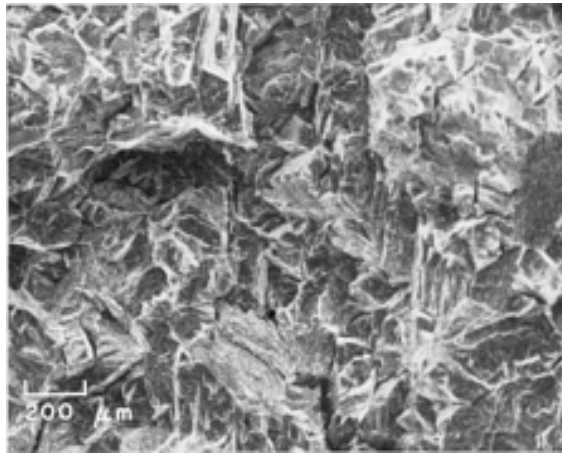
Fig. 1146 A Ti-6Al-4V fracture-toughness specimen identical to that in Fig. 1155, except broken in hydrogen at 25 °C (77 °F). This fracture surface appears to be very brittle, showing intergranular secondary cracks that follow exceedingly angular paths. Note the larger cleavage facets. See also Fig. 1147. SEM, 50×

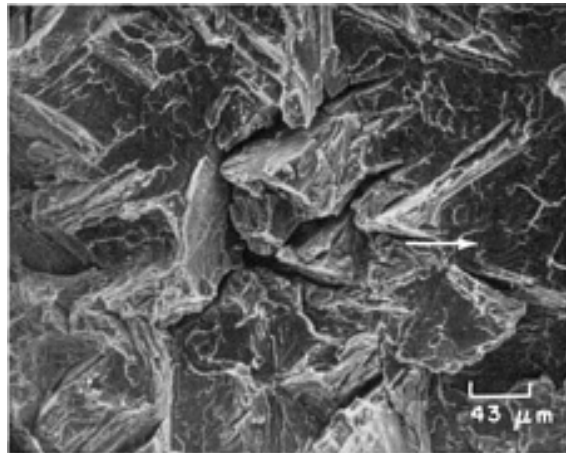
Fig. 1147 Higher-magnification view of the fracture surface in Fig. 1146, showing quasi-cleavage facets and detailed river patterns. Note particularly the unusual concentric pattern of steps at arrow and compare it with the similar pattern of steps that is shown at higher magnification in Fig. 1148. SEM, 230×

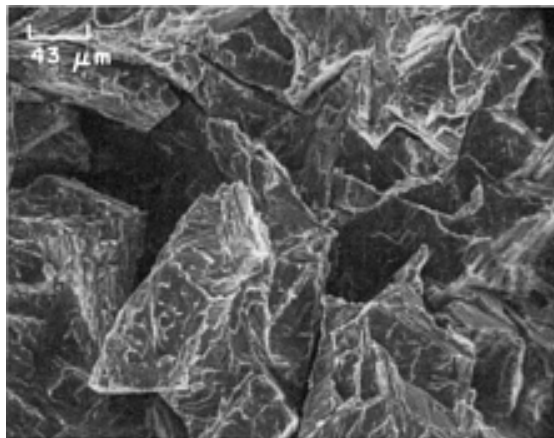
Fig. 1148 Higher-magnification view of the fracture surface in Fig. 1146, showing an area different from that in Fig. 1147. As in Fig. 1146, the very angular secondary cracking is noteworthy and is believed to have been
