به نام خدا

مرکز دانلود رایگان
مهندسی متالورژی و مواد

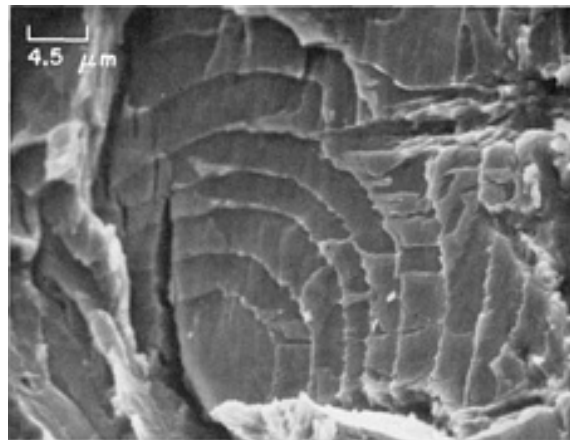
Fig. 1149 Another view of the fracture surface in Fig. 1146, 1147, and 1148, at even higher magnification, showing a region containing a very unusual "terraced" facet that is similar to the area shown and discussed in Fig. 1147. It is possible that this relatively flat area was a prior- β grain. Also note that the "terraces" have cleavage steps of their own. SEM, 2200 \times

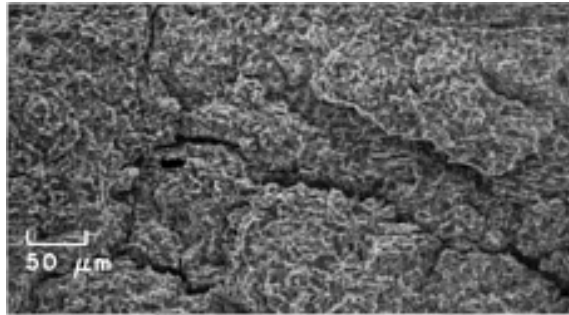
Fig. 1152 Fracture surface of a fracture-toughness specimen same as in Fig. 1150, except this specimen received a 24-h soak at 955 °C (1750 °F) before undergoing the stabilizing treatment. (Stabilizing consisted of furnace cooling to 704 °C (1300 °F) from the heat-treating temperature, holding 1 h, furnace cooling to 593 °C (1100 °F), holding 1 h and air cooling. This treatment was used to secure a large grain size to increase the susceptibility of the alloy to slow-strain-rate embrittlement in hydrogen.) (Structure is continuous β phase with dispersed α phase.) A gross network of secondary intergranular cracks is evident, providing steps that separate different levels of the main crack advance. See also Fig. 1153. SEM, 200×

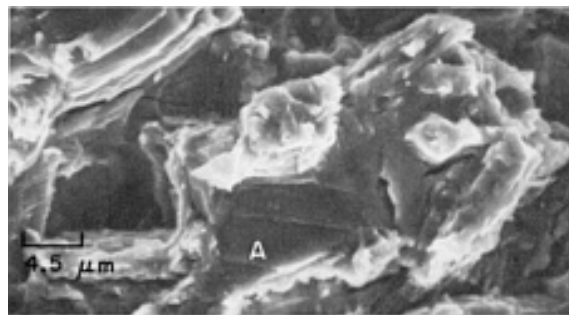
Fig. 1153 View of the fracture surface in Fig. 1152, at 11 times the magnification there. (Structure is continuous β phase with dispersed α phase.) Note the intricate rupture patterns. Some of the main cracks are believed to follow the interfaces between the continuous β -phase matrix and the dispersed acicular α phase. Observe the "terraced" area at A; similar areas are visible in Fig. 1149. SEM, 2200×

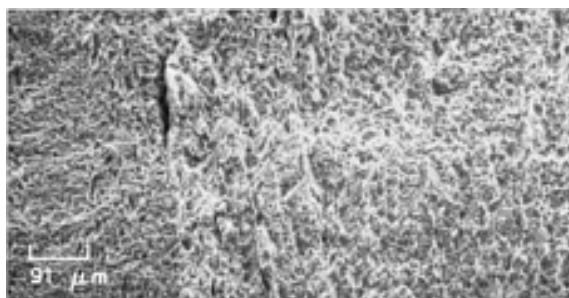
Fig. 1154 Fracture surface of a fracture-toughness specimen of titanium alloy Ti-6Al-4V heat treated 40 min at 955 °C (1750 °F) and water quenched, aged at 510 °C (950 °F), and tested in hydrogen. (Structure is continuous β phase with dispersed α phase.) The fatigue-precrack region is at left. The tensile-overload region, at right, closely resembles that of the specimen in Fig. 1158. SEM, 110×

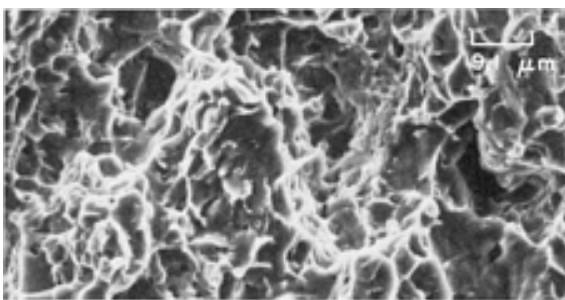
Fig. 1157 Portion of the tensile-overload fracture region of the fracture surface in Fig. 1156, as seen at ten times the magnification there. (Structure is continuous α phase with dispersed β phase.) This displays a rather uniform size of equiaxed dimples, shows essentially no inclusions, and contains no indication of secondary cracking; in summary, this is a thoroughly ductile fracture. SEM, 1100 \times

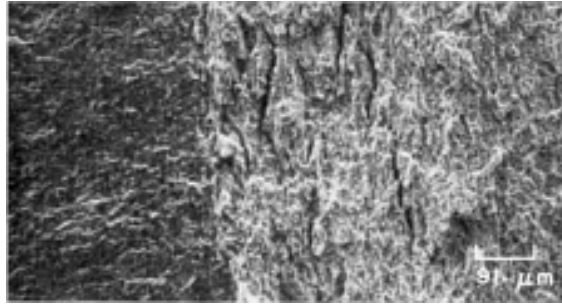
Fig. 1158 Fracture surface of a specimen of the same material and condition as in Fig. 1156 (mill-annealed Ti-6Al-4V sheet), but fracture-toughness tested in hydrogen at 1 atm. (Structure is continuous α phase with dispersed β phase.) The fatigue-precrack region (dark area at left), produced in air, is identical with that in Fig. 1156, but note the deep cracks among the dimples in the tensile-overload region at right. See also Fig. 1159. SEM, 110 \times

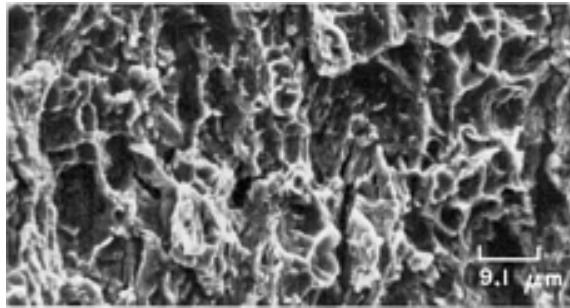
Fig. 1159 View of the region of tensile-overload fracture in Fig. 1158, at ten times the magnification there. (Structure is continuous α phase with dispersed β phase.) In spite of the effects of hydrogen, this region is quite similar in appearance to the tensile-overload region of the air-tested specimen in Fig. 1157. However, note that here there are many fine, parallel secondary cracks scattered throughout the dimpled surface. SEM, 1100 \times

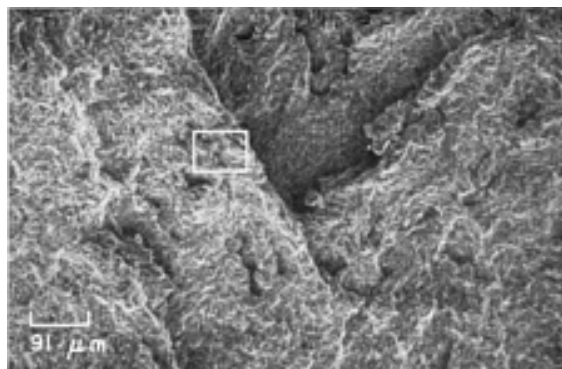
Fig. 1160 Same as Fig. 1158, except that before being fracture-toughness tested in hydrogen, this specimen was heat treated at 705 °C (1300 °F) for 2 h and air cooled. (Structure is continuous α phase with dispersed β phase.) In contrast to the fracture surface shown in Fig. 1158, no dimples are evident here. This surface exhibits giant steps. See also Fig. 1161. SEM, 110 \times

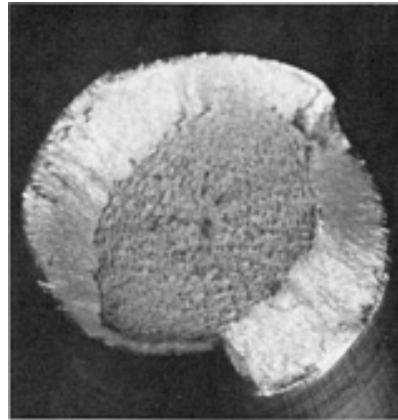
Fig. 1162 Tensile-overload fracture surface of an unnotched specimen of titanium alloy Ti-6Al-4V heat treated to tensile strength of 1158.8 MPa (168.5 ksi) and 47% reduction of area. A classic example of cup-and-cone fracture having a flat, fibrous central zone. See also Fig. 1163. 9 \times

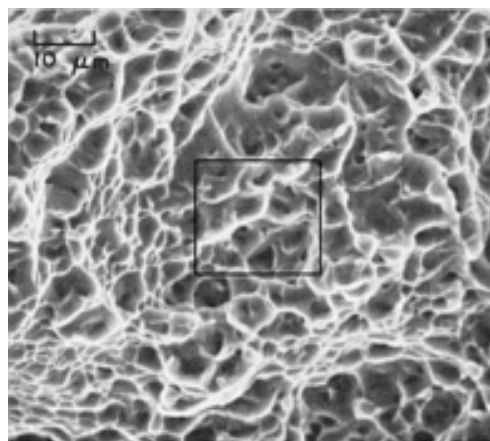
Fig. 1163 View of the fibrous central zone of the fracture surface in Fig. 1162, showing the equiaxed dimples expected in this region. The dimples are relatively uniform in size, with none being extremely large. A few inclusions are evident. See Fig. 1164 for an enlarged view of the area in the rectangle. SEM, 1000 \times

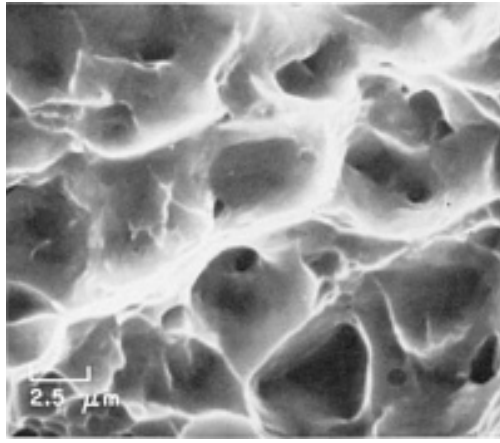
Fig. 1164 Area outlined by the rectangle in Fig. 1163, as seen at four times the magnification there. Note the numerous small dimples that are situated within the larger dimples. This ductile fracture exhibits no sign of secondary cracking. SEM, 4000 \times

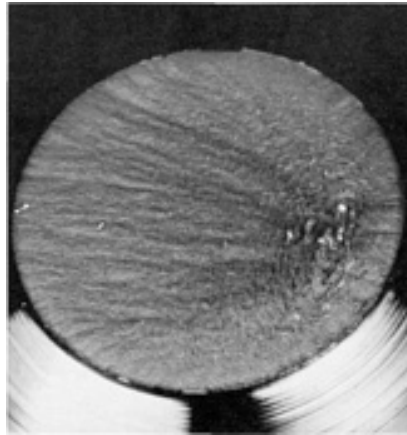
Fig. 1165 Tensile-overload fracture surface of a notched specimen of titanium alloy Ti-6Al-4V heat treated to the same mechanical properties as specimen in Fig. 1162 and with a notched tensile strength of 1696 MPa (246 ksi). Crack nucleus is below center, at right. See also Fig. 1166. 9 \times

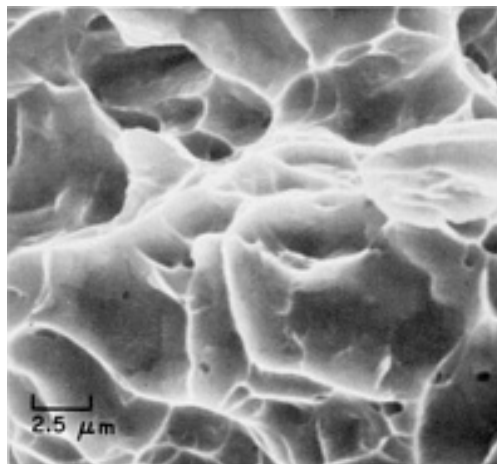
Fig. 1167 View a higher magnification of area in the rectangle in Fig. 1168. Note the small dimples that are present both at the edges of and within the larger dimples. SEM, 4000×

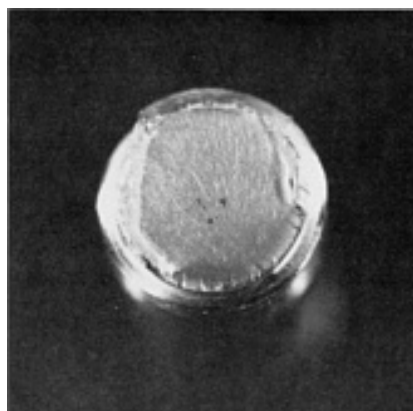
Fig. 1168 Fracture surface of a specimen of titanium alloy Ti-6Al-4V (same mechanical properties as in Fig. 1162) broken in low-cycle fatigue (26,000 cycles) in tension-tension ($R = 0.1$) at maximum loading of 689 MPa (100 ksi). Several crack origins are visible at bottom. See also Fig. 1169. 6×

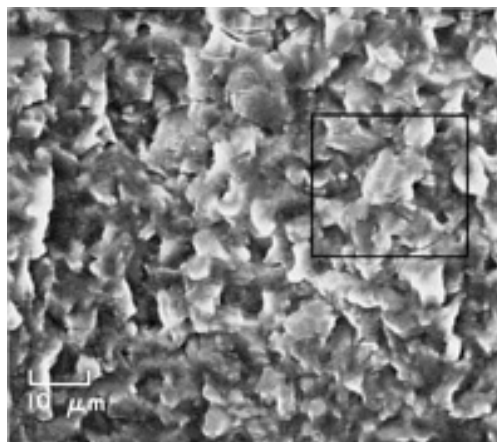
Fig. 1169 View of the fracture surface in Fig. 1168, showing an area close to the edge of the crack origins. Many small voids, which bear little resemblance to conventional dimples, are visible among the small facets.

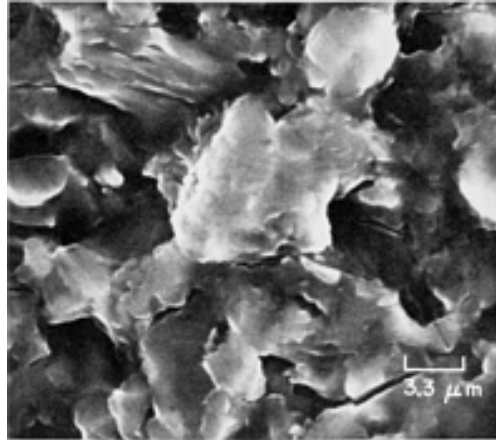
Fig. 1170 Area in the rectangle in Fig. 1169, as seen at triple the magnification there. Note the several small secondary transgranular cracks. The features at upper left are not considered fatigue striations, being too widely spaced. SEM, 3000×

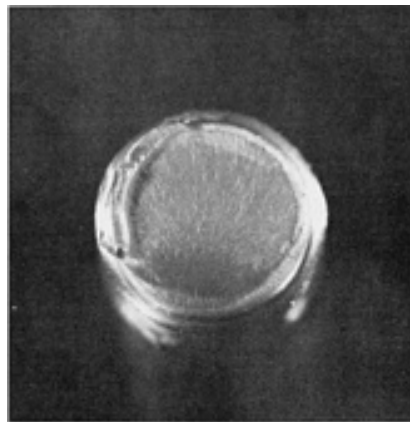
Fig. 1171 Highly-cycle fatigue fracture in a specimen of titanium alloy Ti-6Al-4V (same mechanical properties as in Fig. 1162) that was tested in tension-tension ($R = 0.1$) at maximum loading of 345 MPa (50 ksi), breaking in 937,000 cycles. The curved fatigue beach mark can be seen near bottom. See also Fig. 1172 and 1173. 6×

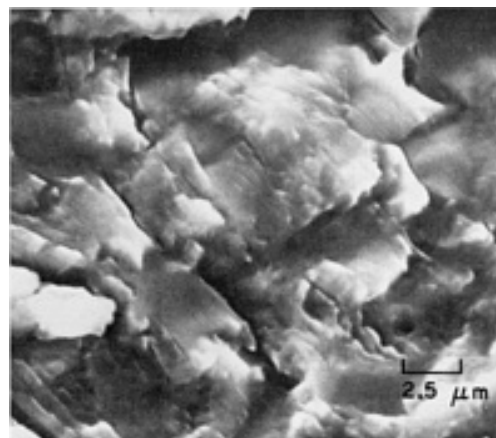
Fig. 1172 View of fracture surface in Fig. 1171, showing an area at the curved beach mark. As in Fig. 1170,

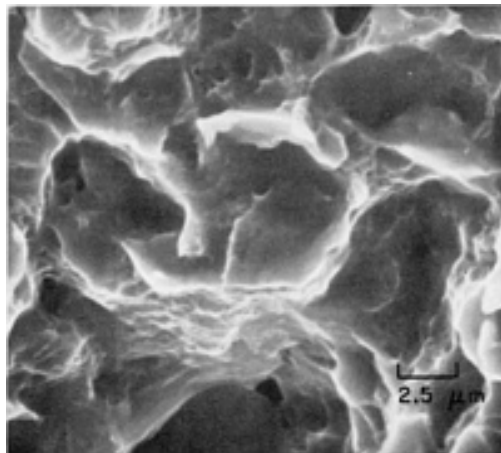
Fig. 1173 Another view of the fracture surface in Fig. 1171, this one showing an area in the rapid-fracture region beyond the fatigue beach mark. Fine tear dimples are distinctly evident on the walls of the larger dimples. No fissures or secondary cracks are visible here. SEM, 4000 \times

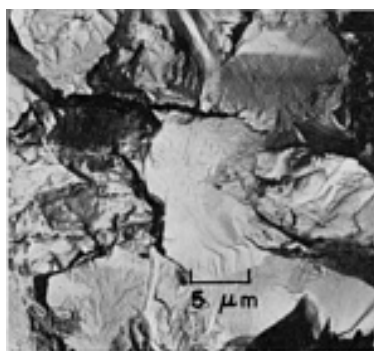
Fig. 1174 Fracture resulting from stress-corrosion cracking in a specimen of titanium alloy Ti-6Al-4V that was stressed in methanol. The crack path is transgranular (by cleavage). See also Fig. 1175. TEM p-c replica, 2000 \times

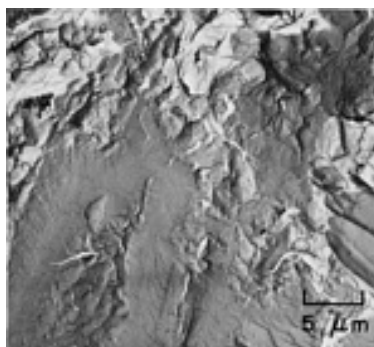
Fig. 1175 A companion fractograph to that in Fig. 1174, from the same specimen of titanium alloy Ti-6Al-4V, but showing an area farther from the fracture origin. Visible are what appear to be a few small dimples. TEM p-c replica, 2000 \times

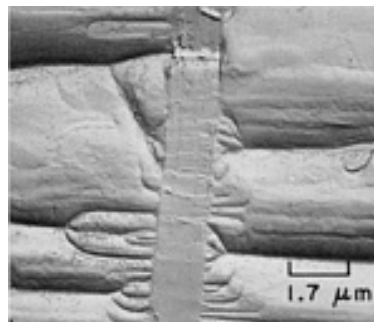
Fig. 1178 Fracture produced by tension over-load in a specimen of titanium alloy Ti-7Al-2Nb-1Ta, showing staining and very large dimples. Vertical band at center is where crack initiated at a second-phase region and propagated to left and right. TEM p-c replica, 6000 \times

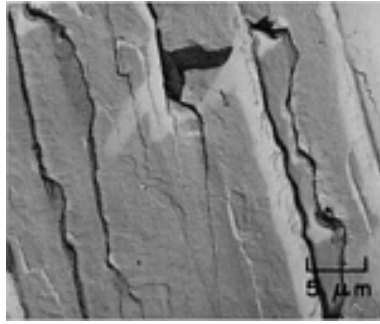
Fig. 1179 Fracture resulting from stress-corrosion cracking in a chill cast specimen of titanium alloy Ti-7Al-2Nb-1Ta that was stressed in distilled water, exhibiting facets that were produced by essentially pure cleavage. TEM p-c replica, 2000×

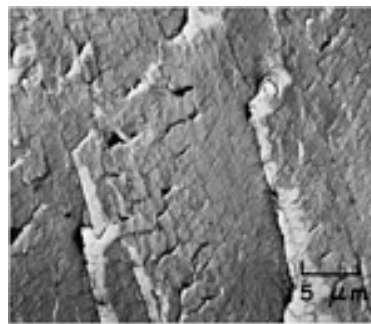
Fig. 1180 Cleavage fracture in a specimen of titanium alloy Ti-7Al-2Nb-1Ta, produced by stress-corrosion cracking in methanol. Note the regular array of fissures, which are parallel to the crack front. See also Fig. 1181. TEM p-c replica, 2000×

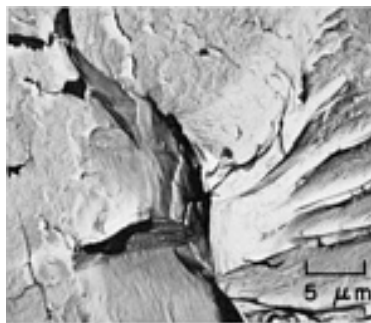
Fig. 1181 Companion fractograph to that in Fig. 1180, from the same specimen, but taken at the stress-corrosion crack front. In general, the facets here show features of cleavage; in contrast, the facets at top center show what apparently are ripples. TEM p-c replica, 2000×

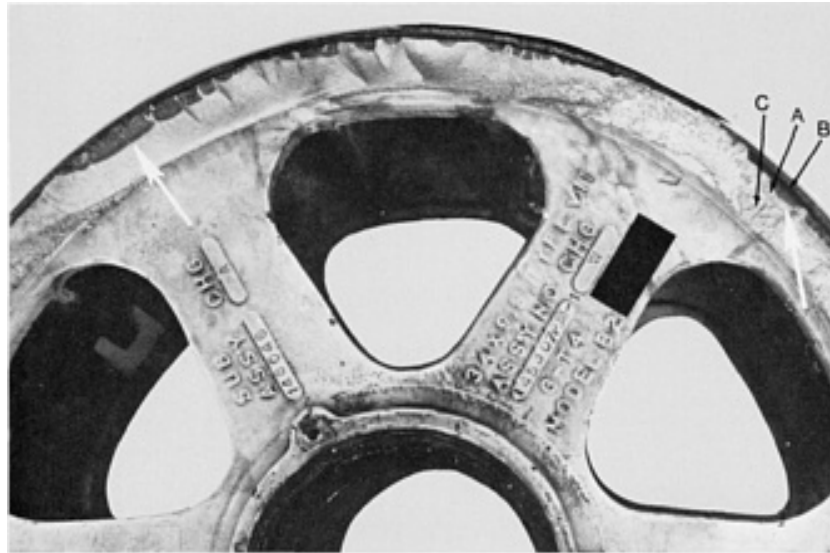
Fig. 1196 Portion of an aircraft landing wheel of sand-cast magnesium alloy AZ81A-T4, showing a corrosion-fatigue fracture that occurred in service at the locking-ring channel. Nominal tensile strength was 276 MPa (40 ksi). The fracture extended halfway around the perimeter of the wheel. Many discolored, crescent-shaped fatigue-crack nuclei were found; two are indicated by white arrows. See Fig. 1197, 1198, 1199, and 1200 for TEM views of areas at A, B, and C. 0.3x

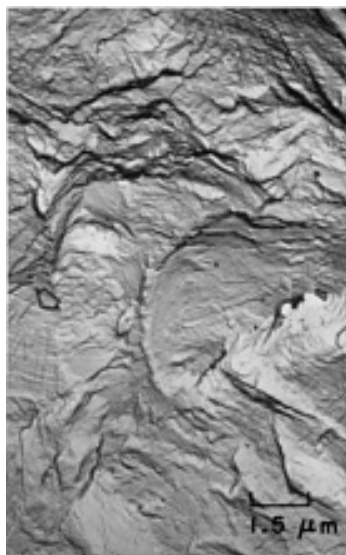
Fig. 1197 TEM p-c replica of an area at the fatigue-crack nucleus at A in the fracture surface in Fig. 1196, showing "brittle" fatigue striations (such as at the arrow at left center). 6500x

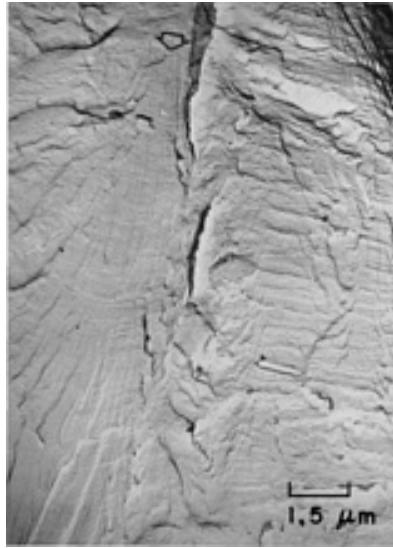
Fig. 1198 TEM p-c replica of another area at A in Fig. 1196. Fine, roughly horizontal striations are visible in a fatigue patch at the arrow at top center; the marks at the right include widely spaced horizontal fissures. 6500×

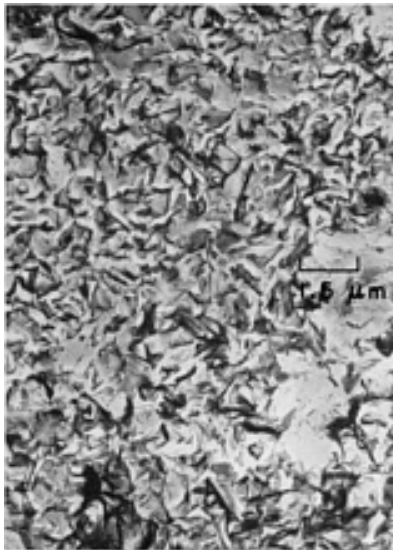
Fig. 1199 TEM p-c replica of an area at B in Fig. 1196. In this area, the fracture surface is largely obscured by corrosion products. The few facets that are visible have essentially no distinguishable features. 6500×

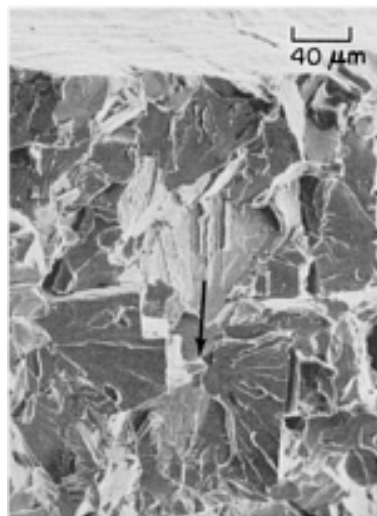
Fig. 1201 Surface of a slow-bending fracture produced at $-160\text{ }^{\circ}\text{C}$ ($-256\text{ }^{\circ}\text{F}$) in Fe-3.9Ni alloy deoxidized with aluminum and titanium, which was forged at $1260\text{ }^{\circ}\text{C}$ ($2300\text{ }^{\circ}\text{F}$), hot rolled at $1040\text{ }^{\circ}\text{C}$ ($1905\text{ }^{\circ}\text{F}$), annealed at about $1000\text{ }^{\circ}\text{C}$ ($1830\text{ }^{\circ}\text{F}$), and air cooled. Root of specimen notch is at top. Fracture was by cleavage that began at cracked Ti(C,N) particles (as at arrow). See also Fig. 1202. SEM, 250 \times

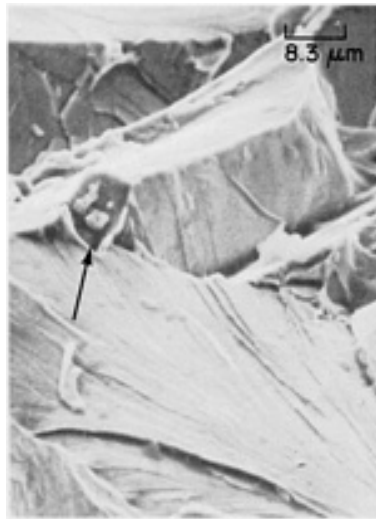
Fig. 1202 Higher-magnification view of the slow-bending fracture in Fig. 1201. During testing, specimen temperature was controlled by an isopentane bath cooled with liquid nitrogen. Ferrite grain size, $30\ \mu\text{m}$. The angle of the notch was 45° , and the nominal radius of the root of the notch was $0.25\ \text{mm}$ ($0.01\ \text{in.}$). The fracture originated at cracked $\text{Ti}(\text{C}, \text{N})$ particles (as at arrow). SEM, $1200\times$

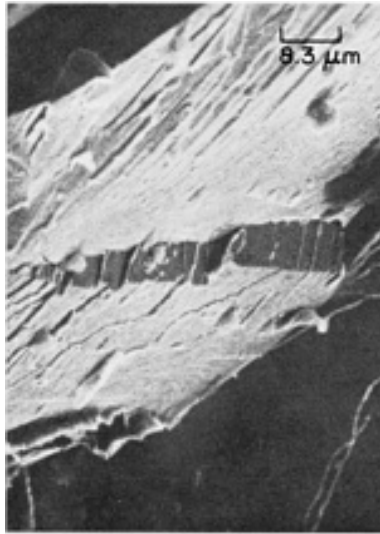
Fig. 1204 Another view of the slow-bending fracture in Fig. 1201, showing a different region of the fracture surface at higher magnification. Here, as in the specimen shown in Fig. 1201 and 1202, fracture was by quasi-cleavage. Also shown is the intersection of a twin boundary with the cleavage plane. See also Fig. 1205. SEM, 1200 \times

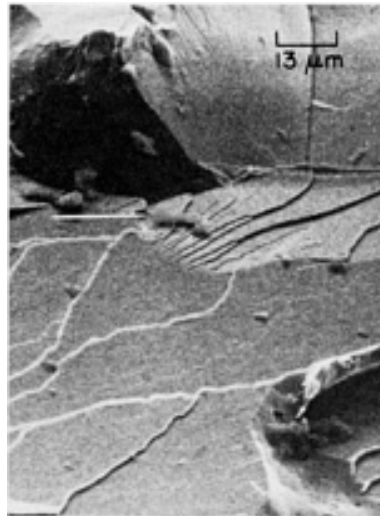
Fig. 1205 Surface of a bending fracture in a specimen of the same alloy and the same history as that in Fig. 1203, showing assorted river patterns. Note twist boundary at center, which has generated several cleavage steps. Although the higher nickel content of the alloy in Fig. 1201 gave greater strength, the aspects of subzero impact rupture are about the same for both alloys. See also Fig. 1206. SEM, 750 \times

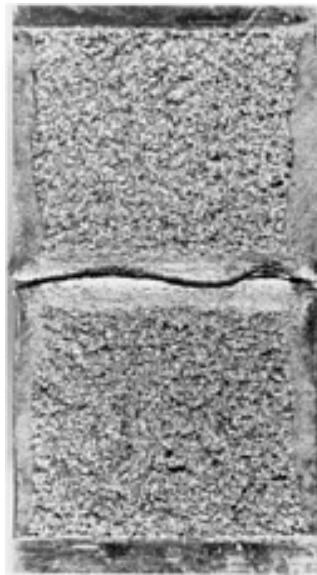
Fig. 1207 Both fracture surfaces of a specimen that was not aged after austenitizing. See also Fig. 1208. 4.8× (Figures 1207, 1208, 1209, 1210, 1211, 1212, 1213, 1214, 1215, 1216, 1217, and 1218 present six related pairs of light and SEM fractographs of specimens of an Fe-12Ni-0.5Ti alloy intended for use at cryogenic temperatures. The series shows the effect on Charpy impact energy at -196 °C (-321 °F), and on fracture-surface characteristics, of the temperature of aging after austenitizing at 900 °C (1650 °F) for 2 h and air cooling.)

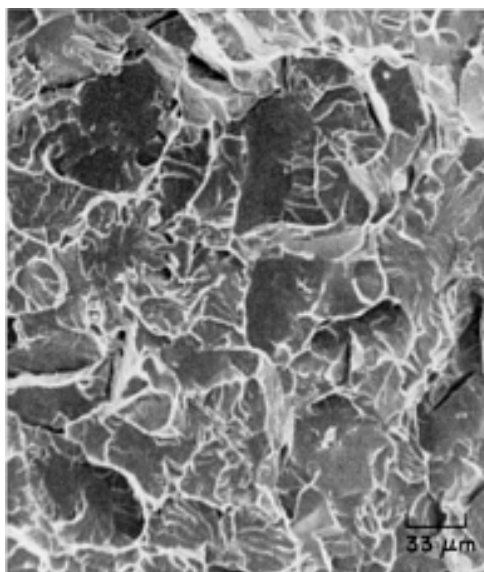
Fig. 1208 This SEM fractograph of the unaged specimen in Fig. 1207 shows quasi-cleavage facets. The impact energy was less than 27 J (20 ft · lb). 300× (Figures 1207, 1208, 1209, 1210, 1211, 1212, 1213, 1214, 1215, 1216, 1217, and 1218 present six related pairs of light and SEM fractographs of specimens of an Fe-12Ni-0.5Ti alloy intended for use at cryogenic temperatures. The series shows the effect on Charpy impact energy at -196 °C (-321 °F), and on fracture-surface characteristics, of the temperature of aging after austenitizing at 900 °C (1650 °F) for 2 h and air cooling.)

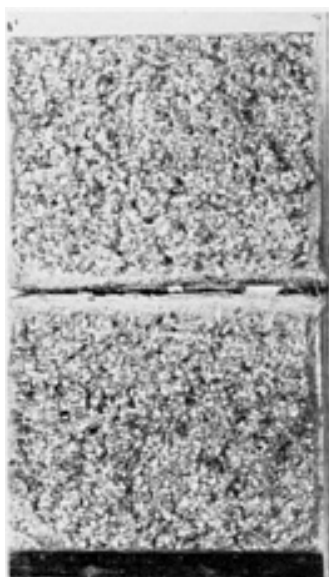
Fig. 1209 Both fracture surfaces of a specimen aged at 650 °C (1200 °F) 2 h and air cooled. See also Fig. 1210. 4.8× (Figures 1207, 1208, 1209, 1210, 1211, 1212, 1213, 1214, 1215, 1216, 1217, and 1218 present six related pairs of light and SEM fractograph of specimens of an Fe-12Ni-0.5Ti alloy intended for use at cryogenic temperatures. The series shows the effect on Charpy impact energy at -196 °C (-321 °F), and on fracture-surface characteristics, of the temperature of aging after austenitizing at 900 °C (1650 °F) for 2 h and air cooling.)

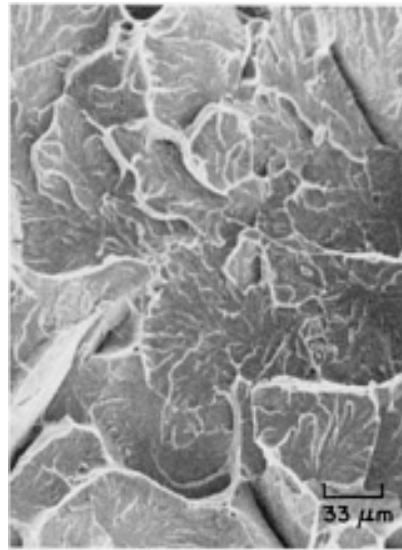
Fig. 1210 This SEM view of the specimen in Fig. 1209 shows that aging at 650 °C (1200 °F) produced almost no change in fracture-surface characteristics from those of unaged specimen in Fig. 1207. Impact energy was less than 27 J (20 ft · lb). 300× (Figures 1207, 1208, 1209, 1210, 1211, 1212, 1213, 1214, 1215, 1216, 1217, and 1218 present six related pairs of light and SEM fractograph of specimens of an Fe-12Ni-0.5Ti alloy intended for use at cryogenic temperatures. The series shows the effect on Charpy impact energy at -196 °C (-321 °F), and on fracture-surface characteristics, of the temperature of aging after austenitizing at 900 °C (1650 °F) for 2 h and air cooling.)

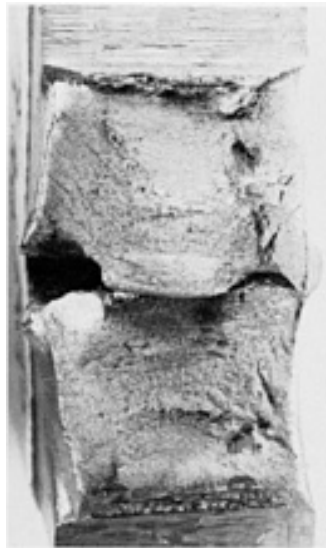
Fig. 1211 Both fracture surfaces of a specimen aged at 700 °C (1290 °F) 2 h and air cooled. Impact energy was about 203 J (150 ft · lb). Much deformation accompanied fracture. See also Fig. 1212. 4.8× (Figures 1207, 1208, 1209, 1210, 1211, 1212, 1213, 1214, 1215, 1216, 1217, and 1218 present six related pairs of light and SEM fractograph of specimens of an Fe-12Ni-0.5Ti alloy intended for use at cryogenic temperatures. The series shows the effect on Charpy impact energy at -196 °C (-321 °F), and on fracture-surface characteristics, of the temperature of aging after austenitizing at 900 °C (1650 °F) for 2 h and air cooling.)

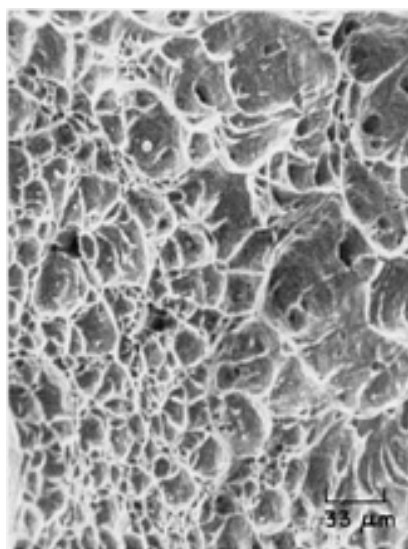
Fig. 1212 This SEM fractograph of the specimen in Fig. 1211, which was aged at 700 °C (1290 °F), shows dimpled rupture instead of the quasi-cleavage facets observed in the specimens in Fig. 1208 and 1210. 300× (Figures 1207, 1208, 1209, 1210, 1211, 1212, 1213, 1214, 1215, 1216, 1217, and 1218 present six related pairs of light and SEM fractograph of specimens of an Fe-12Ni-0.5Ti alloy intended for use at cryogenic temperatures. The series shows the effect on Charpy impact energy at -196 °C (-321 °F), and on fracture-surface characteristics, of the temperature of aging after austenitizing at 900 °C (1650 °F) for 2 h and air cooling.)

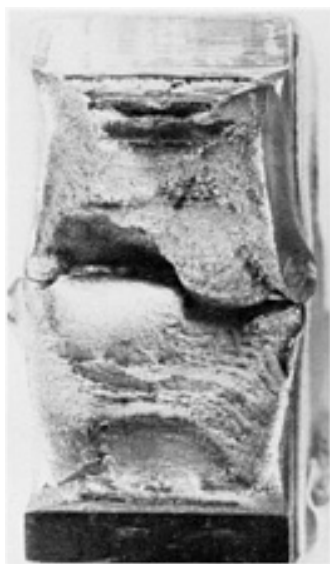
Fig. 1213 Both fracture surfaces of a specimen aged at 750 °C (1380 °F) 2 h and air cooled. Impact energy was about 203 J (150 ft · lb); deformation is similar to that in Fig. 1211. See also Fig. 1214. 4.8× (Figures 1207, 1208, 1209, 1210, 1211, 1212, 1213, 1214, 1215, 1216, 1217, and 1218 present six related pairs of light and SEM fractograph of specimens of an Fe-12Ni-0.5Ti alloy intended for use at cryogenic temperatures. The series shows the effect on Charpy impact energy at -196 °C (-321 °F), and on fracture-surface characteristics, of the temperature of aging after austenitizing at 900 °C (1650 °F) for 2 h and air cooling.)

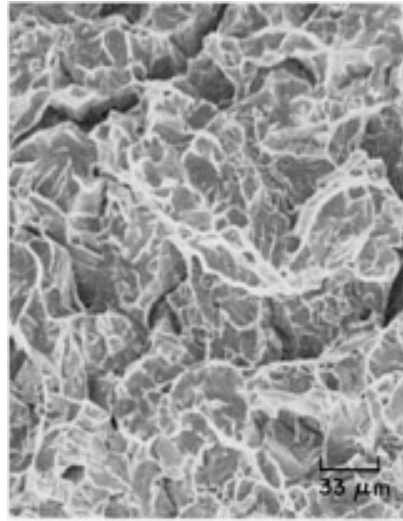
Fig. 1216 SEM view of specimen in Fig. 1215. Fracture appears to have propagated by a mixture of intergranular separation and cleavage, yet shows indications of some dimples. Note the deep secondary intergranular cracks. 300× (Figures 1207, 1208, 1209, 1210, 1211, 1212, 1213, 1214, 1215, 1216, 1217, and 1218 present six related pairs of light and SEM fractograph of specimens of an Fe-12Ni-0.5Ti alloy intended for use at cryogenic temperatures. The series shows the effect on Charpy impact energy at $-196\text{ }^{\circ}\text{C}$ ($-321\text{ }^{\circ}\text{F}$), and on fracture-surface characteristics, of the temperature of aging after austenitizing at $900\text{ }^{\circ}\text{C}$ ($1650\text{ }^{\circ}\text{F}$) for 2 h and air cooling.)

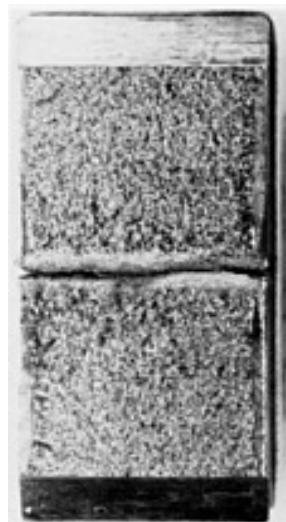
Fig. 1217 Specimen aged at $850\text{ }^{\circ}\text{C}$ ($1560\text{ }^{\circ}\text{F}$) 2 h and air cooled. The fracture is much coarser than that of the specimen in Fig. 1215, but is similar to it in other respects. See also Fig. 1218. 4.8× (Figures 1207, 1208, 1209, 1210, 1211, 1212, 1213, 1214, 1215, 1216, 1217, and 1218 present six related pairs of light and SEM fractograph of specimens of an Fe-12Ni-0.5Ti alloy intended for use at cryogenic temperatures. The series shows the effect on Charpy impact energy at $-196\text{ }^{\circ}\text{C}$ ($-321\text{ }^{\circ}\text{F}$), and on fracture-surface characteristics, of the temperature of aging after austenitizing at $900\text{ }^{\circ}\text{C}$ ($1650\text{ }^{\circ}\text{F}$) for 2 h and air cooling.)

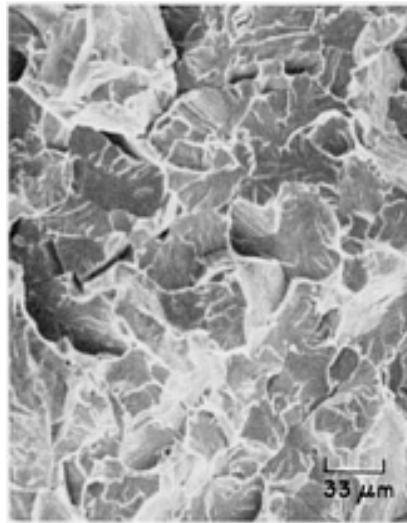
Fig. 1218 This SEM fractograph of the specimen in Fig. 1217 shows that the fracture, like that in Fig. 1216, exhibits cleavage facets and short, deep intergranular cracks. This specimen also had impact energy of less than 27 J (20 ft · lb). (Figures 1207, 1208, 1209, 1210, 1211, 1212, 1213, 1214, 1215, 1216, 1217, and 1218 present six related pairs of light and SEM fractograph of specimens of an Fe-12Ni-0.5Ti alloy intended for use at cryogenic temperatures. The series shows the effect on Charpy impact energy at -196 °C (-321 °F), and on fracture-surface characteristics, of the temperature of aging after austenitizing at 900 °C (1650 °F) for 2 h and air cooling.)

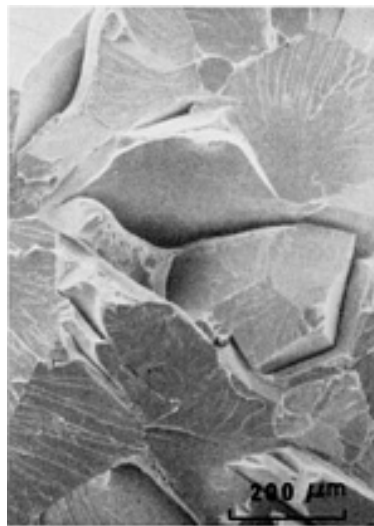
Fig. 1219 Fracture surface in an iron-base alloy containing 7 at.% (6.4 wt%) Cr and 1 at.% (3.2 wt%) Ta, pulled in tension at room temperature after solution treatment for 1 h at 1320 °C (2410 °F) and water quenching, then aging at 700 °C (1290 °F) for 40 min and air cooling. Fracture was by transgranular cleavage believed to have originated at a grain-boundary network of Laves-phase Fe_2Ta precipitate. See also Fig. 1220, 1221, and 1222. SEM, 100×

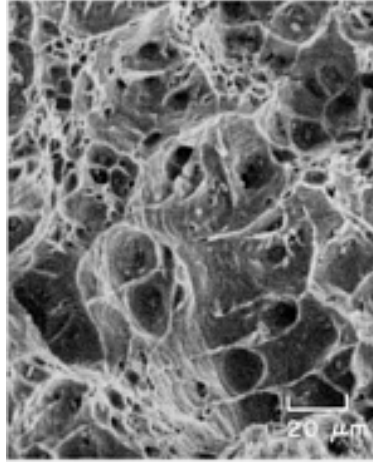
Fig. 1222 Fracture surface in a specimen of the same Fe-Cr-Ta alloy, and with the same heat treatment, as in Fig. 1219, 1220, and 1221, but which was broken in tension at 600 °C (1112 °F). At this test temperature, the ductility was sufficient to eliminate completely both cleavage and intergranular mechanisms of failure, and fracture occurred entirely by microvoid coalescence. SEM, 500×

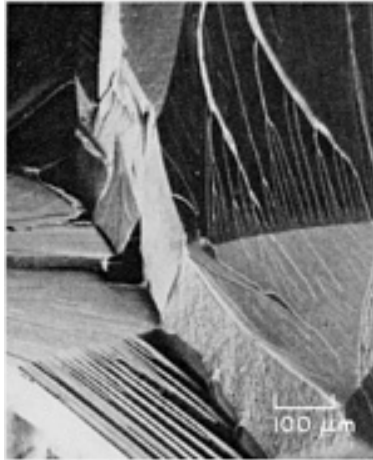
Fig. 1223 Room-temperature tensile fracture by cleavage of an Fe-6.2Ta alloy solution treated 1 h at 1400 °C (2550 °F), water quenched, aged 1 h at 700 °C (1290 °F) and air cooled. Laves-phase Fe₂Ta precipitate, uniformly distributed in the matrix and believed present at grain boundaries, caused brittleness (<1% tensile elongation). See also Fig. 1224. SEM, 100×

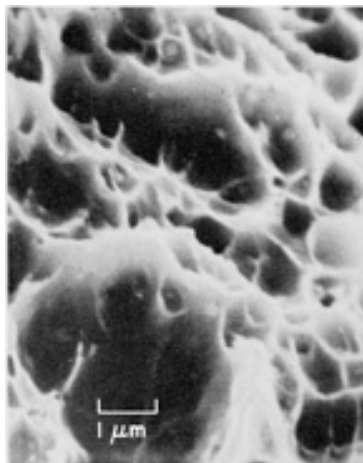
Fig. 1224 Room-temperature tensile fracture in a specimen of the same alloy as in Fig. 1223, given the same heat treatment plus a spheroidizing treatment of 10 min at 1100 °C (2010 °F) and air cooling. Spheroidization of precipitates at grain boundaries and within grains, plus a finer grain size than in Fig. 1223, resulted in dimpled fracture and 22% tensile elongations. SEM, 10,000×

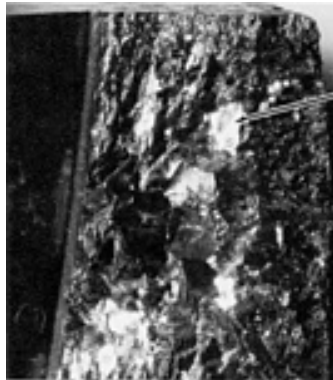
Fig. 1225 Surface of a "rock candy" fracture in a notched as-cast specimen of Alnico alloy broken by impact at room temperature, showing large, shiny facets. The brittle nature of this specimen is reflected in its unnotched tensile strength of only 34 MPa (5 ksi). See also Fig. 1226, 1227, 1228, 1229, 1230, and 1231. 5.5×

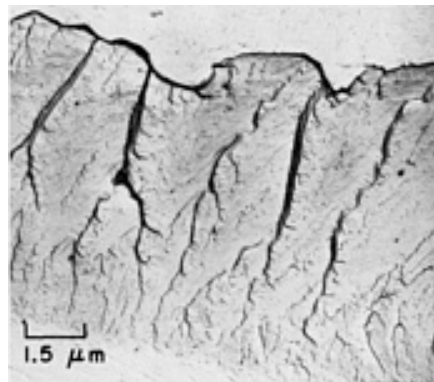
Fig. 1226 TEM p-c replica of an area of the facet at the arrow in Fig. 1225, showing features resulting from transgranular cleavage. Pronounced cleavage steps in central region indicate that fracture progressed from bottom to top. The margins of this central region are believed to have formed at grain boundaries; the cause of the marked irregularity of the margin at top is not known. 6500×

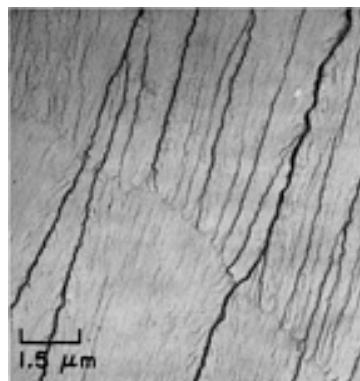
Fig. 1227 TEM p-c replica at a second area of the facet at the arrow in Fig. 1225, showing features resulting

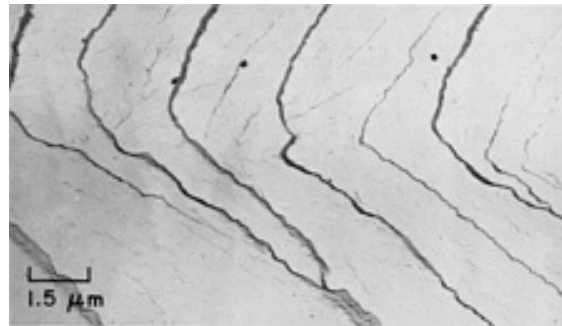
Fig. 1228 TEM p-c replica of a third area of the facet at the arrow in the fracture surface shown in Fig. 1225. Although no sharp boundary is visible, it appears certain that the cleavage steps, which entered from the top in this view, cross a tilt boundary at mid-height, where they change direction. 6500×

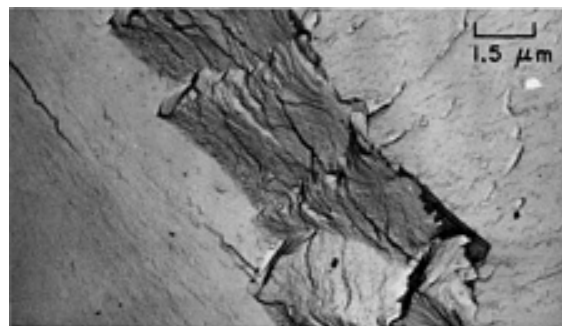
Fig. 1229 TEM p-c replica of a fourth area of the facet at the arrow in Fig. 1225, showing evidence that here fracture occurred in two different directions and on two different levels. The appearance of the fracture region that connects these two levels (diagonal dark band) has been markedly affected by local microstructure. 6500×

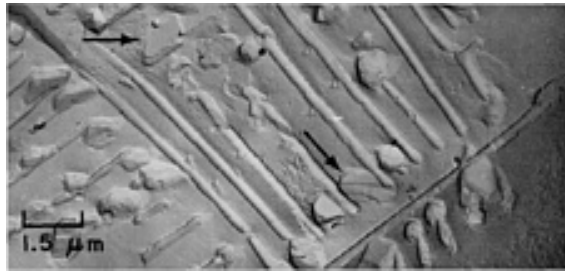
Fig. 1231 TEM p-c replica of a sixth area of the facet at the arrow in Fig. 1225. This area contains features that could be cleaved second-phase particles or imprints of pulled-out particles. Also visible is a geometric array of rodlike second-phase particles. 6500×

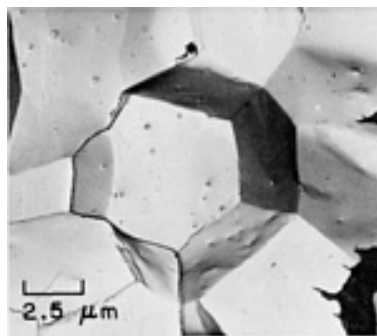
Fig. 1234 A very clean intergranular fracture in sintered tungsten that was broken by impact. Note the several very flat separated-grain facets; small sintering pores can be seen in several of the facets. TEM p-c replica, 4000×

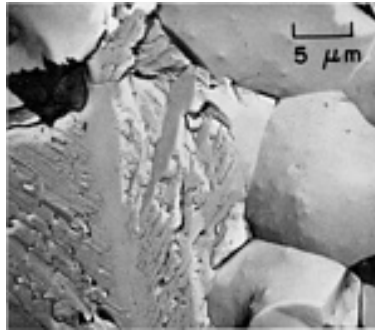
Fig. 1235 Impact fracture in sintered tungsten that had been recrystallized, showing separated-grain facets (at right) and cleavage facets (at left); the cleavage facets exhibit twins in the {112} plane. TEM p-c replica, 2000×

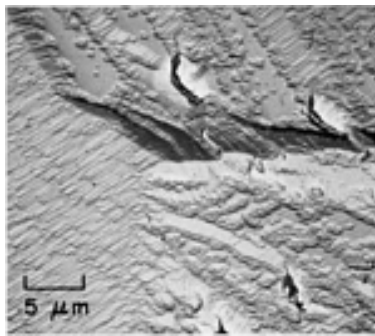
Fig. 1236 Surface of an impact fracture in a single crystal of tungsten that was etched with H₂O₂ after fracture. Cleavage along both the {100} and {113} planes is evident. TEM p-c replica, 2000×

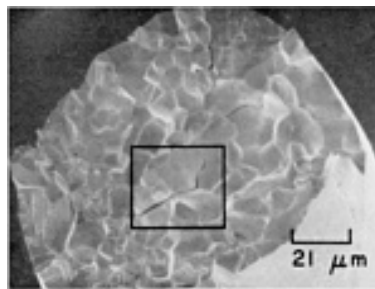
Fig. 1237 Surface of a brittle, intergranular fracture, produced by bending, in a polycrystalline iridium wire (0.127-mm, or 0.005-in., diam) that had been annealed in vacuum for 2 h at 1200 °C (2190 °F). See Fig. 1238 for an enlarged view of the area in the rectangle. SEM, 470×

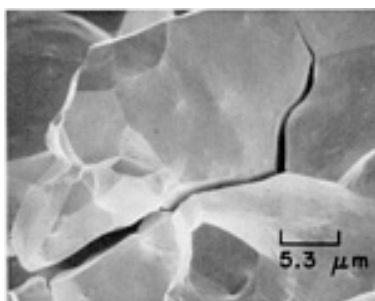
Fig. 1238 Higher-magnification view of the area in the rectangle in Fig. 1237. This entire area exhibits separated-grain facets and shows no evidence of plastic flow. SEM, 1900 \times

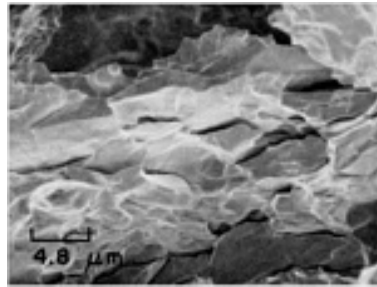
Fig. 1239 Surface of a brittle, intergranular fracture, produced by bending, in an iridium sheet (rolled to a thickness of 0.076 mm, or 0.0003 in.) that had been annealed for 2 h at 1200 $^{\circ}\text{C}$ (2190 $^{\circ}\text{F}$) in vacuum. Note the deep secondary cracks between the elongated grains. 2100 \times

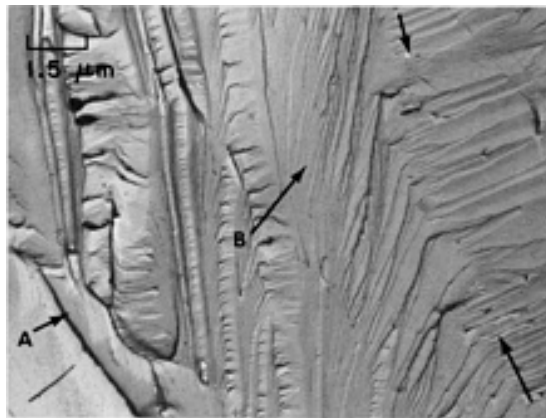
Fig. 1245 TEM p-c replica of an area at the arrow in Fig. 1244. Here, the fracture surface shows transgranular cleavage. Tilt boundary at A; elsewhere, twist boundaries (between arrows) and suggestions of cleavage feather marks (at B). 6500×

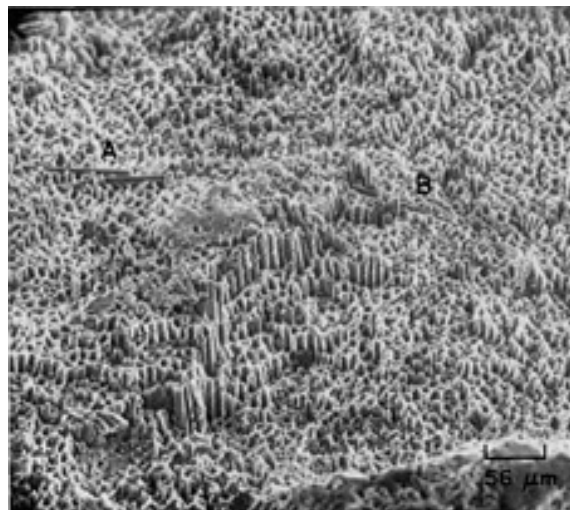
Fig. 1251 Higher-magnification view of the area in the larger rectangle in Fig. 1250. At A are two transversely oriented features that appear to be graphite fibers that either are lying loose on the surface or were inadvertently misaligned during manufacture. The feature at B is probably a ridge. Much of the surface exhibits broken fibers, the ends of which are roughly in the same plane as the fracture in the surrounding matrix, but at center are exposed fibers with the appearance of "palisades." SEM, 180×

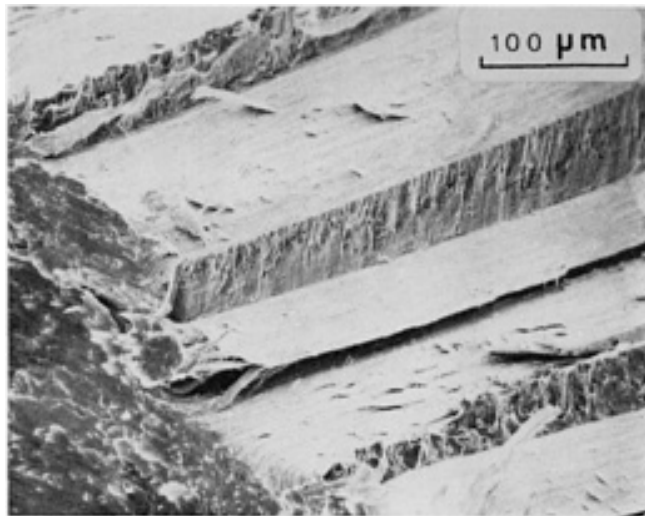
Fig. 1260 Fracture due to fiber splitting in tungsten fiber reinforced metal-matrix composites. When the tungsten/aluminum and tungsten/steel composites in Fig. 1255, 1256, 1257, 1258, and 1259 fractured under transverse tension loading, the predominant failure mode was fiber splitting, as shown here for the 45 vol% tungsten/1010 steel composite. More than 80% of the fibers split. In the 45 vol% 6061 aluminum alloy matrix material, 70% of the fibers split. SEM, 250× (C. Kim, Naval Research Laboratory)

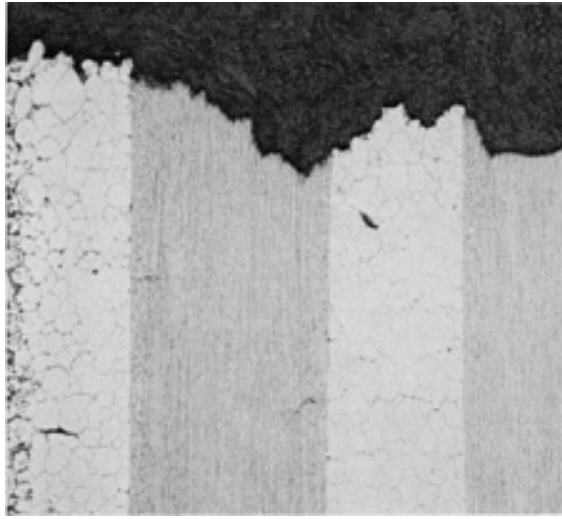
Fig. 1268 Fracture of metal-matrix composite stress-rupture specimen. Material and processing same as in Fig. 1265 and 1266. The composite failed after 3 h at 1205 °C (2200 °F) and 103 MPa (15 ksi). Fibers failed in a brittle mode. Compare with Fig. 1267. Murakami's reagent, 100× (D.W. Petrasek, NASA Lewis Research Center)

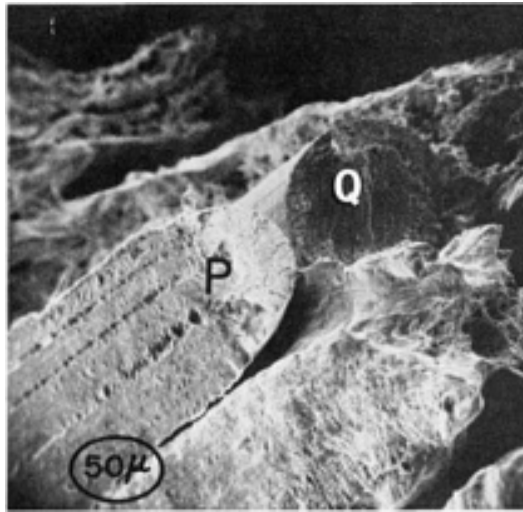
Fig. 1271 Surface of a tension-overload fracture in a composite consisting of tungsten fibers in a silver matrix. The tungsten fiber marked P has undergone a ductile fracture with necking, whereas fiber Q has suffered a sharp, flat, transverse cleavage fracture. See also Fig. 1272. SEM, 320×

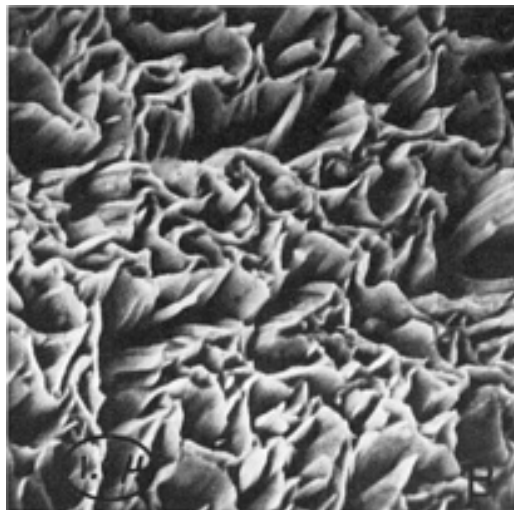
Fig. 1272 Higher-magnification view of an area of tungsten fiber P in Fig. 1271. Deformation during fracture has thinned the walls of the dimples to sharp edges, which shows the highly ductile nature of the fracture. Note the uniformity in height of the walls. Compare with Fig. 1262. SEM, 10,000×

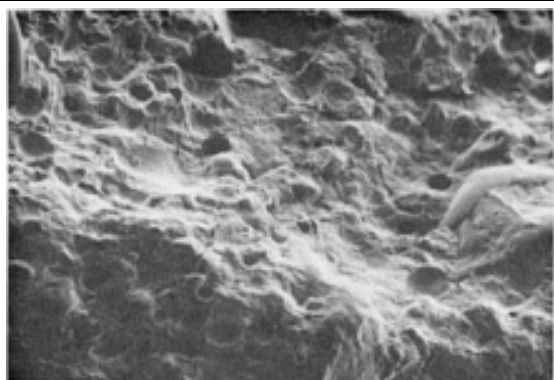
Concrete and Asphalt

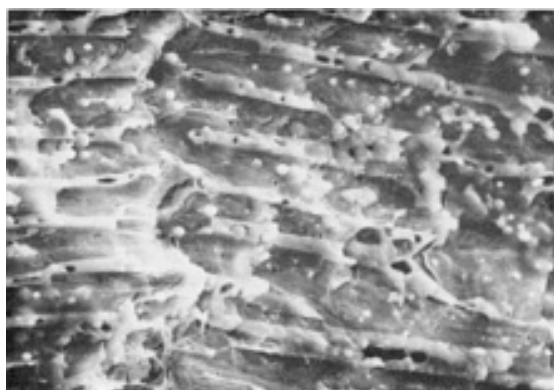
Fracture surface of a sulfur concrete featuring noninterconnecting voids. Its sulfur cement bonds well to the aggregate to form a dense concrete. (Compare with Fig. 1287, 1288, 1289.) Fig. 1281: Backscattered electron (BE) display of sulfur concrete with noninterconnecting voids, 17 \times . Fig. 1282: Higher-magnification view of portion of field in Fig. 1281 has a noninterconnecting void at its center. BE image, 170 \times Fig. 1283: The structure within a void region. BE image, 165 \times . Fig. 1284: Fractograph shows aggregate embedded in the sulfur cement matrix. BE image, 17 \times (H.W. Leavenworth, Jr., U.S. Bureau of Mines)

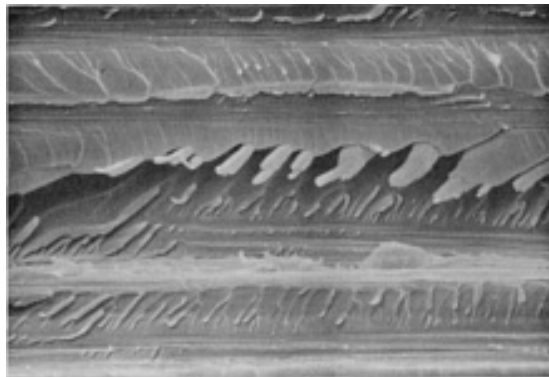
temperatures noted.) (L. Clements, San Jose State University, and J.C. Liu, Cornell University)

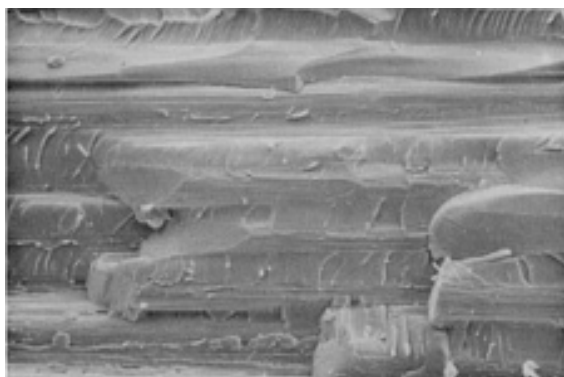
Fig. 1297 Fracture surface of transverse (90°) carbon/epoxy specimen that failed in tension. The "room

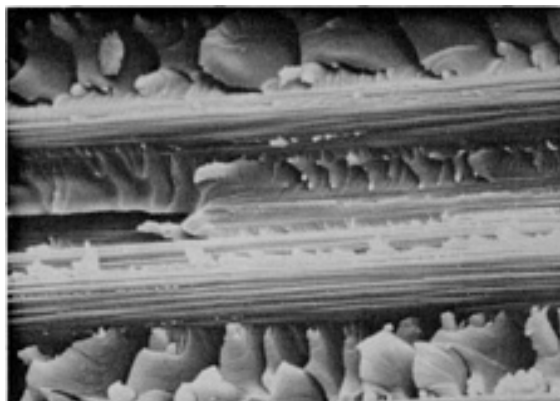
D3039, and the 0° flexural three-point-bend specimens were tested in accordance with ASTM D790. The composites were dried before testing in the same manner as the epoxy specimens described in Fig. 1294 and 1295. "Dry" specimens were tested as-dried and had essentially 0 wt% moisture. "Room" moisture specimens had about 0.6 wt% moisture, having been placed after drying in a chamber at 60 °C (140 °F) and 60% relative humidity for at least 2 months and then placed in a drawer in the laboratory for several months before testing. "Wet" specimens had about 1.5 to 2.0 wt% moisture, having been placed for several months in an environmental chamber at 60 °C (140 °F) and 100% relative humidity. The composites were tested at moisture conditions designed not to alter their conditioning, and at the temperatures noted.) (L. Clements, San Jose State University, and J.C. Liu, Cornell University)

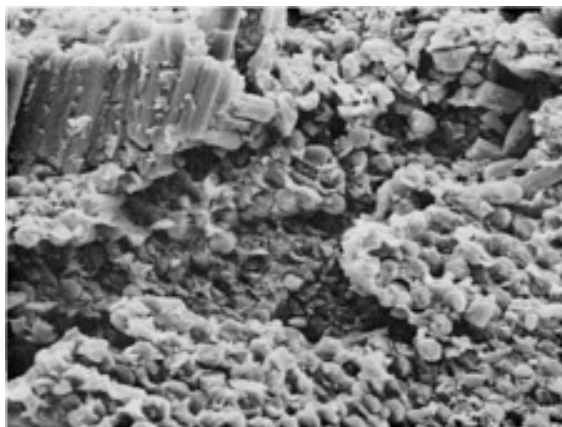
chamber at 60 °C (140 °F) and 60% relative humidity for at least 2 months and then placed in a drawer in the laboratory for several months before testing. "Wet" specimens had about 1.5 to 2.0 wt% moisture, having been placed for several months in an environmental chamber at 60 °C (140 °F) and 100% relative humidity. The composites were tested at moisture conditions designed not to alter their conditioning, and at the temperatures noted.) (L. Clements, San Jose State University, and J.C. Liu, Cornell University)

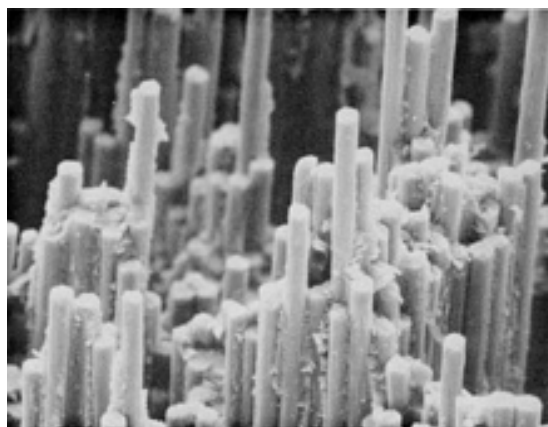
Fig. 1303 A typical area in the tensile failure region of the carbon/epoxy flexural specimen shown in Fig. 1300 and 1301. Note the long, protruding fibers with some attached epoxy remaining. This area resembles typical regions in a specimen failed in pure tension. See also Fig. 1302. SEM (same conditions as in Fig. 1294), 500× (The composite specimens shown in Fig. 1296, 1297, 1298, 1299, 1300, 1301, 1302, 1303, 1304, 1305, 1306, 1307, 1308, 1309, and 1310 all consisted of *circa* 1978 Thornel 300 fibers in Narmco 5208 epoxy resin. The composites were all fabricated by lay-up of prepreg tape and were autoclave cured 175 °C (350 °F) according to the manufacturer's recommendations. Specimens were then end-tapped and cut in accordance with the

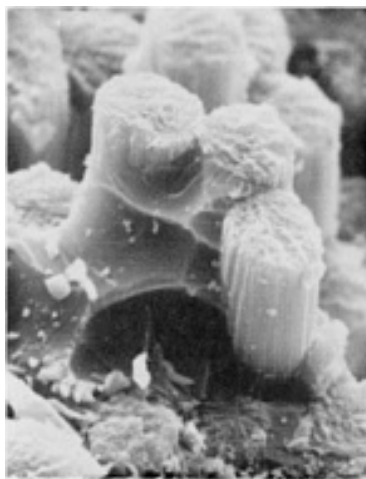
Fig. 1308 Fracture surface of a longitudinal (0°) carbon/epoxy specimen that failed in tension. Specimen was tested at 25 °C (77 °F) in the dry condition. This fractograph shows typical tensile failure of the epoxy resin in a local resin-rich region. This results when fibers break and produce overload tensile failure in the resin. SEM (same conditions as in Fig. 1294), 2000× (The composite specimens shown in Fig. 1296, 1297, 1298, 1299, 1300, 1301, 1302, 1303, 1304, 1305, 1306, 1307, 1308, 1309, and 1310 all consisted of *circa* 1978 Thornel 300 fibers in Narmco 5208 epoxy resin. The composites were all fabricated by lay-up of prepreg tape and were autoclave cured 175 °C (350 °F) according to the manufacturer's recommendations. Specimens were then end-tabbed and cut in accordance with the ASTM D3039. The 0° and 90° tensile specimens were tested in
