به نام خدا

مرکز دانلود رایگان
مهندسی متالورژی و مواد

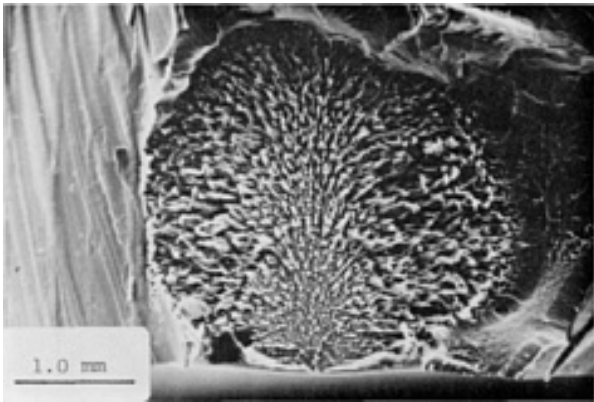
Crack-growth mechanisms in three-point bending of notched 0.4-mm (16-mil) thick specimens of linear polyethylene (density = 0.964 g/cm³). The notch, made by a razor blade, was held open during observation in the scanning electron microscope. Fig. 1318: Notched three-point-bend specimen after 215 min at 42 °C (110 °F) and constant load. Stress intensity = 0.30 MPa \sqrt{m} (0.27 ksi \sqrt{in}). Note the craze-like damage zone emanating from the notch (far left). Damage zone propagated at 0.16 $\mu\text{m}/\text{min}$ prior to crack growth. SEM, 540×. Fig. 1319: Specimen in Fig. 1318 after 367 min at 42 °C (110 °F) and constant load. Stress intensity = 0.36 MPa \sqrt{m} (0.33 ksi \sqrt{in}). Damage mechanism is microcrazing in advance of the propagating crack. SEM, 315× (N. Brown and X. Lu, University of Pennsylvania)

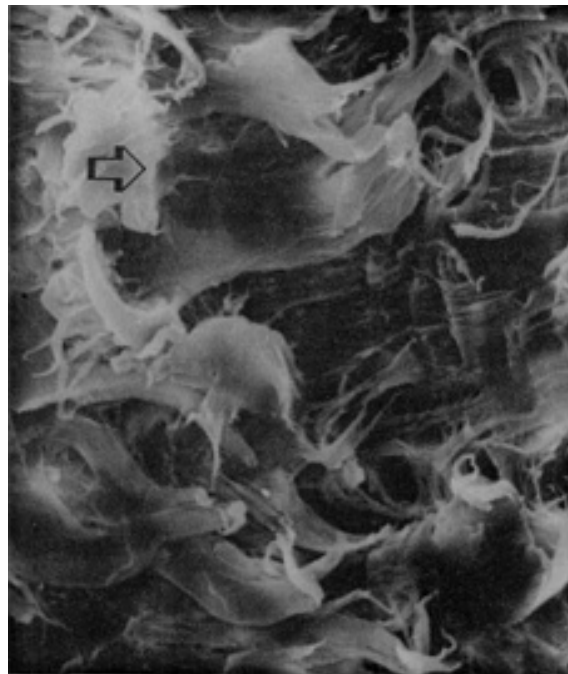
Fig. 1322 Tearing and fibrillation in medium-density polyethylene tested in creep at room temperature. Arrow indicates direction of crack propagation. Fracture stress (σ_f) = 15.5 MPa (2.25 ksi). Applied stress = $0.37 \sigma_f$. SEM, $200\times$ (A.S. Moet, Case Western Reserve University)

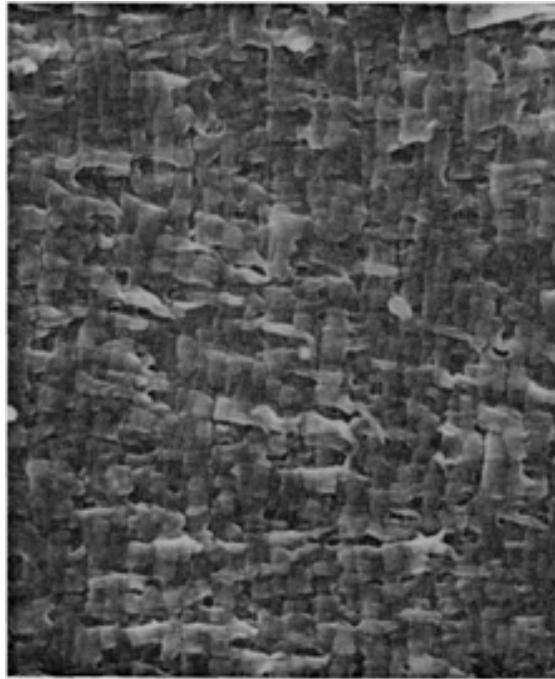
Fig. 1323 Fatigue striations in medium-density polyethylene. Crack growth direction is left to right. Loading conditions: $\sigma_{\min}/\sigma_{\max} = R = 0.5$, where $\sigma_{\max} = 0.3 \sigma_{\text{yield}}$ and $\sigma_{\text{yield}} = 22.6 \text{ MPa}$ (3.278 ksi); frequency = 0.5 Hz. SEM, 200 \times (A.S. Moet, Case Western Reserve University)

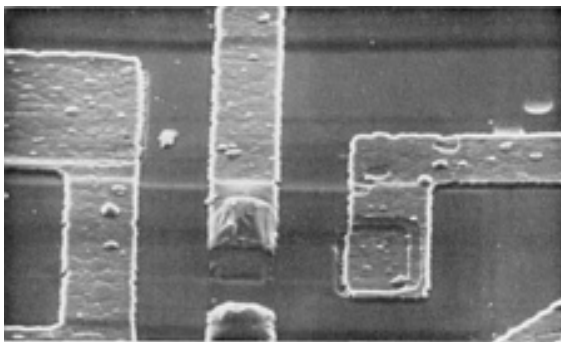
Effect of exposure to the atomic oxygen environment found in low earth orbit (LEO) on a silver solar cell interconnect. The pure silver foil, 40 μm (1.5 mil) thick, was exposed to the LEO environment for 40 h at 100 °C (210 °F) in the spacecraft velocity direction. The sample was flown on Space Shuttle flight 8. The original surface of the interconnect (Fig. 1326) was converted to an oxide of silver (Fig. 1327). Both reflectivity and electrical conductivity decreased as a result. SEM, 3800 \times (R.J. Schwinghamer, NASA Marshall Space Flight Center)

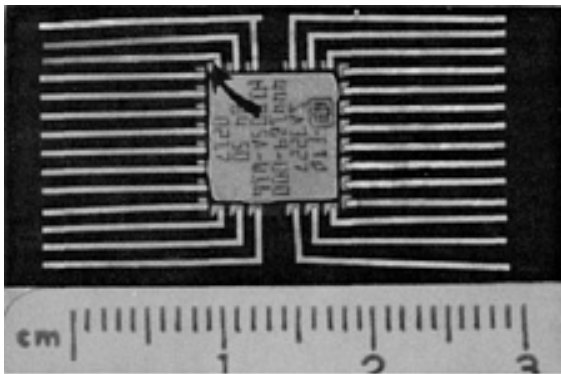
Integrated circuit (IC) defects. Material: pure aluminum vacuum deposited on Si/SiO₂. Fig. 1328: Oxide flaws under the metallized layer on this IC produced a thin oxide layer that promoted voltage "punchthrough" and failure (center). SEM, 800 \times . Fig. 1329: Shown here is a base emitter for input transistors. The cracklike defect at center was caused by electrical discharge across the junction. SEM, 3360 \times (R.J. Schwinghamer, NASA Marshall Space Flight Center)

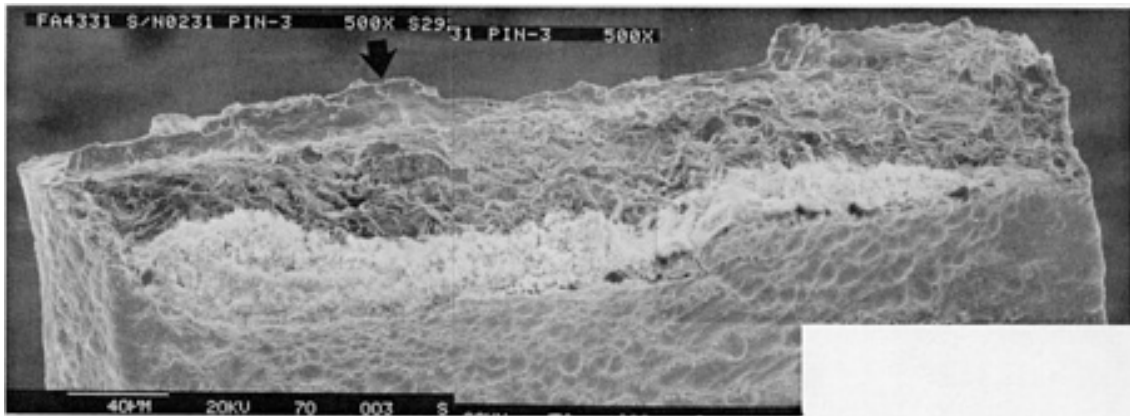
Fatigue failure of L-shaped electronic flat pack leads due to cyclic, eccentric loading during ultrasonic cleaning. The 0.13-mm (5-mil) thick Alloy 42 (42Ni-58Fe) leads were nickel electroplated, soldered (Cu-Ag alloy) to tungsten, and then gold plated. Fig. 1330: A 28-lead electronic flat pack. Cracking was predominantly observed in the smallest L-shaped leads (arrow). 2.5 \times . Fig. 1331: Cracks in L-shaped leads were found in the solder and near the edge of the solder in both top and bottom fillets (arrows). See also Fig. 1332, 1333, and 1334. SEM, 300 \times (T. O'Donnell, P. Tung, A. Shumka, R. Ruiz, and J. Okuno, California Institute of Technology)

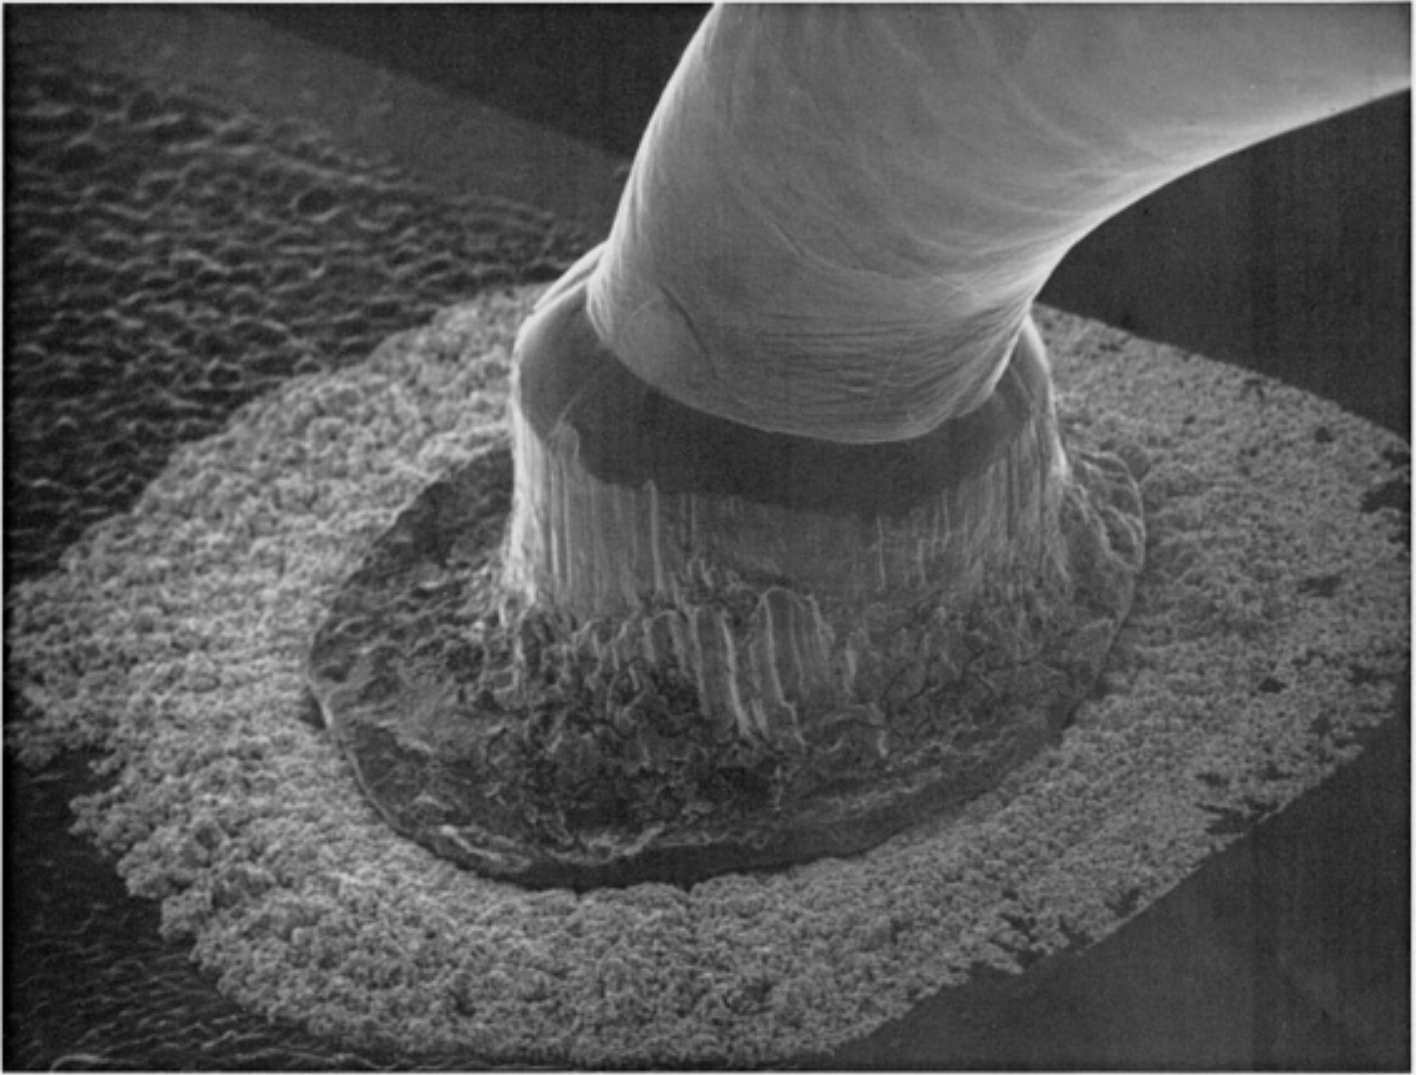
Fig. 1336 Thermocompression ball bond defect between a gold wire, 25 μm (1 mil) in diameter, and vacuum-deposited aluminum. Note the relatively thick intermetallic layer that formed during power cycling. SEM, 2750 \times (R.J. Schwingamer, NASA Marshall Space Flight Center)

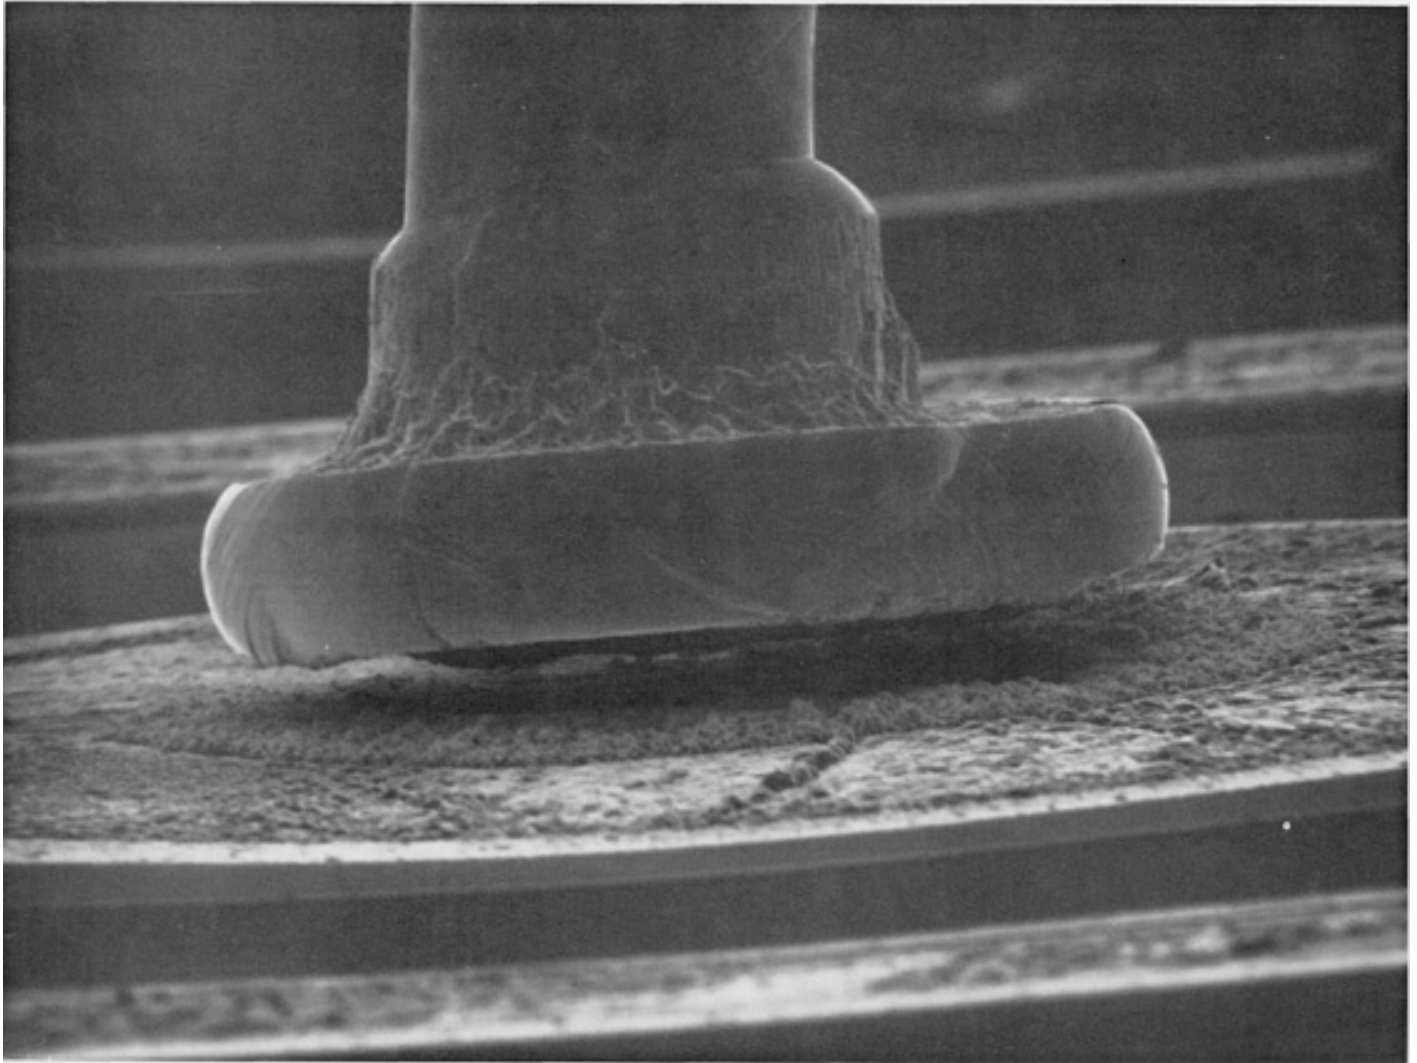
Fig. 1337 Same type of ball bond as in Fig. 1336. In this case, intermetallic formation weakened the bond, causing it to lift. SEM, 2700 \times (R.J. Schwinghamer, NASA Marshall Space Flight Center)
