# ASM Handbook®

## Volume 13C Corrosion: Environments and Industries

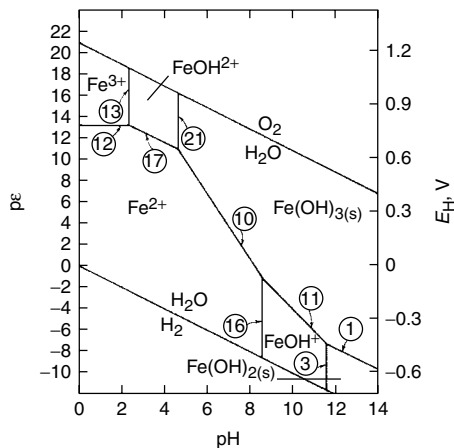
**Fig. 1**  $E$ -pH diagram for iron-water system at 25 °C (77 °F). It is a graphic representation of thermodynamic stability. The potential  $E_H$  is expressed in reference to the standard hydrogen potential.  $pe$  is defined as  $-\log a_{e^-}$  where  $a_{e^-}$  is the activity of the free aqueous electrons and is related to  $E_H$ .

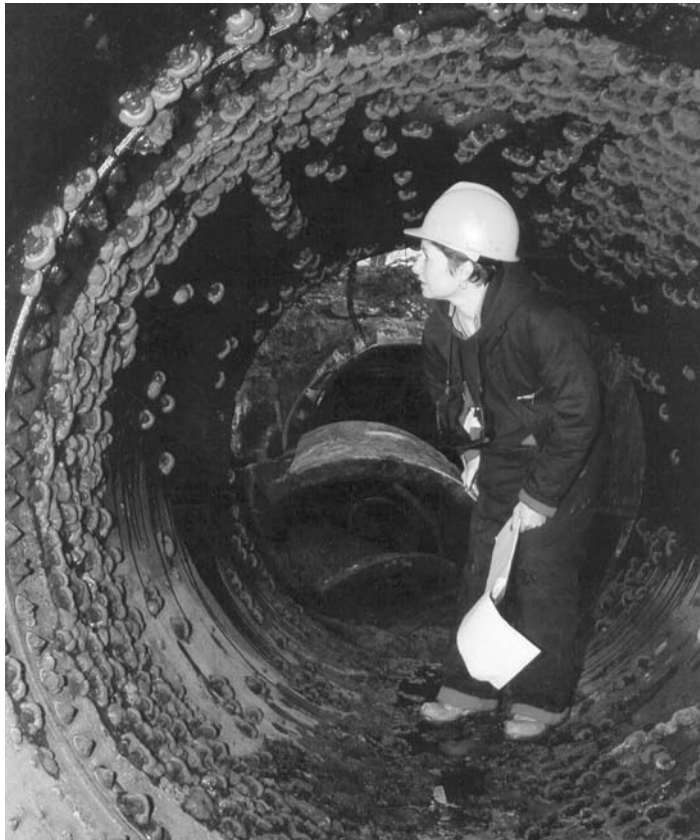
**Fig. 2** A 1.5 m (60 in.) cast iron pipe with tuberculation. Courtesy of Terry Bickford

Figure 2 shows a 1.5 m (60 in.) cast iron water main that has been in contact with water. Mushroomlike ferric tubercles have formed on its interior surface. Detailed analyses of similar deposits have shown the presence of ferrous solids such as ferrous carbonate (siderite), mixed ferrous-ferric solids (green rust, magnetite), various ferric oxyhydroxides (goethite, lepidocrocite), and amorphous ferric hydroxide. In principle, each distinct solid would have different energies of formation and occupy different regions in the  $E$ -pH diagram. Increasing levels of chloride and sulfate enhance corrosion by increasing conductance of the electrolyte. Their presence appears to be important for the formation of green rust. Micro-organisms also play an important role in enhancing corrosion of iron water mains.

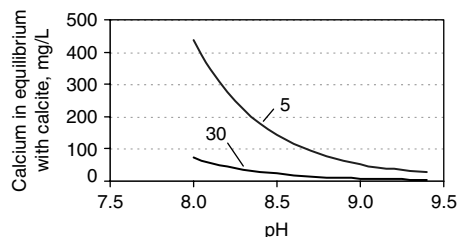
**Fig. 3** Amount of calcium in equilibrium with calcite at alkalinity values of 5 and 30 as a function of pH. This is a graphic interpretation of the Langelier saturation index.

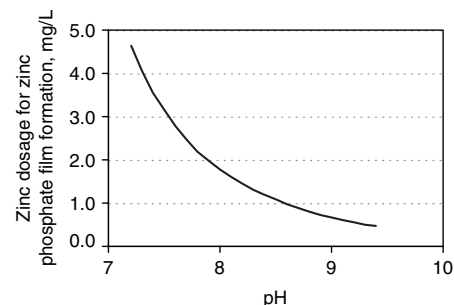
**Fig. 4** Calculated zinc dosage for the formation of zinc phosphate scale as a function of pH. The zinc levels shown exceed those recommended by some potable water standards.

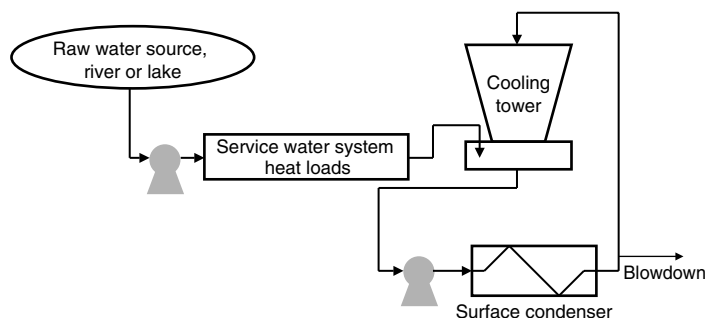
**Fig. 1** Typical arrangement where raw water is used in service water system and as makeup to the cooling tower. Because the condenser loop is an open-recirculating system, make-up water is needed to replace evaporation and blowdown.

In Fig. 1, the raw water from a lake or river passes through the service water system and is then used as makeup to the cooling tower. The cooling tower recirculating water removes heat from the main surface condenser.

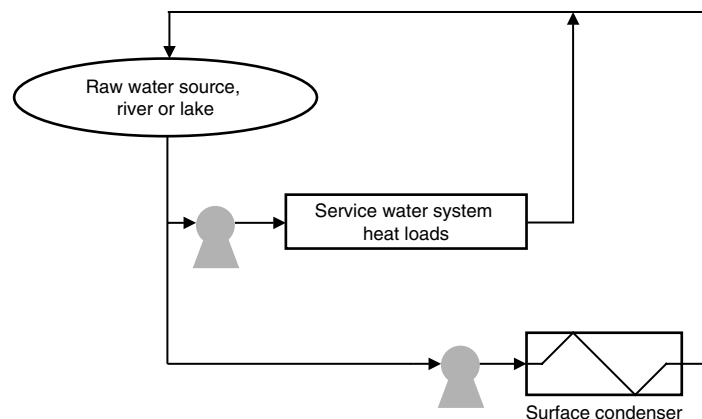
**Fig. 2** In a once-through service water and circulating water system without a cooling tower large quantities of water are circulated through the systems and back to the source.

In Fig. 2, there is no cooling tower. Both the service water system and circulating water system (surface condenser cooling water) are

“once-through” from the lake or river and back again.

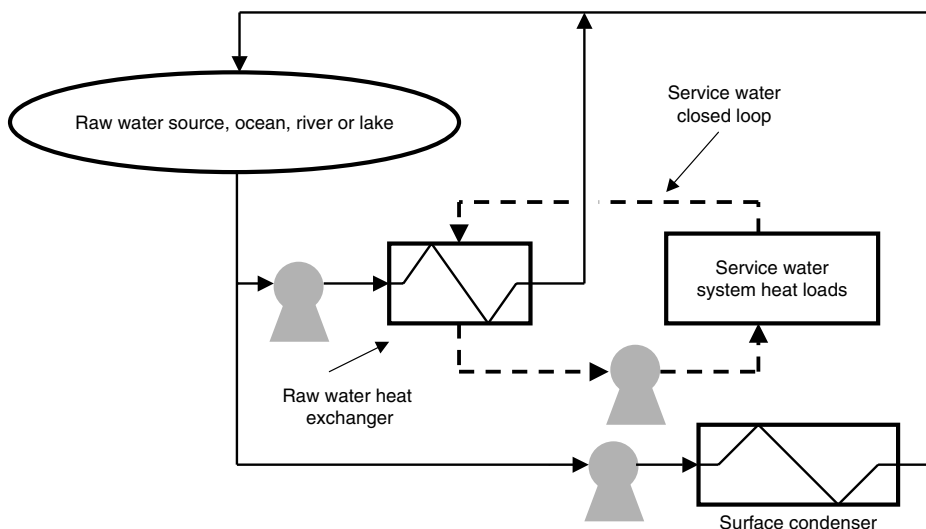
Fig. 3 A closed loop service water system typical for plants using sea water as the prime coolant. As the service loop is a closed-recirculating system, little make-up water is needed.

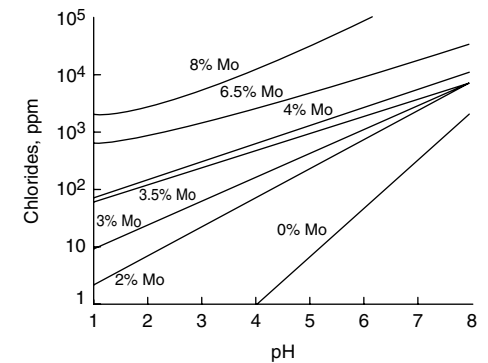
**Fig. 2** Pitting corrosion as a function of chloride content, pH, and molybdenum content of austenitic iron-chromium-nickel alloys. Temperature range 65 to 80 °C (150 to 180 °F). Pitting is not a problem below the line but may be severe above the line. Source: Ref 5

illustrates the pitting relationship between chlorides, pH, and molybdenum content. If the pH and chloride content are above the molybdenum content curves, the alloy will pit. If they are below the molybdenum content curves, the alloy is safe to use. Figure 3 is the crevice corrosion relationship between the alloy, expressed as the pitting resistance equivalent number (PREN), and the critical crevice temperature. The PREN includes nitrogen content and is related to the composition of the alloy. The PREN is equal to  $\%Cr + 3.3\%Mo + 16\%N$ . Table 4 lists the PREN for a number of common alloys based on the minimum allowed alloy content. This relationship (Fig. 3) gives an indication of the temperature for onset of crevice

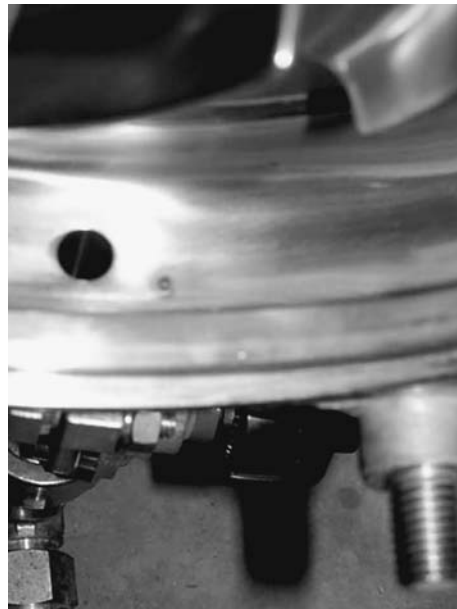
**Fig. 1** Chloride pit on the casing of a centrifugal pump used for hot water for injection. The pit was caused by chloramines.

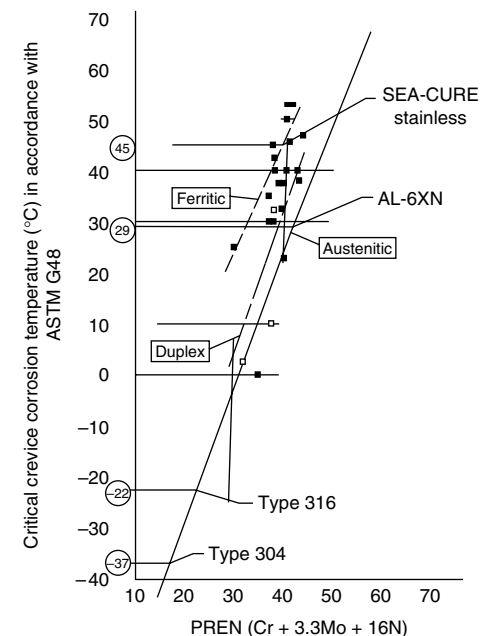
**Fig. 3** Critical crevice corrosion temperature as a function of the pitting resistance equivalent number (PREN) and alloy type. Crevice corrosion will not occur below the temperature indicated but will above. Tests made in 6% ferric chloride. Source: Ref 5

corrosion, known as the critical crevice temperature. If the temperature and PREN are above the alloy type line (austenitic, duplex, or ferritic), the alloy will crevice-corrode. If it is below, the alloy is safe to use. The greater the interval between the critical crevice temperature, and the operating temperature, the greater the potential for crevice corrosion to occur. Figure 4 illustrates the probability of stress-corrosion cracking of a nickel alloy in a chloride environment. Three conditions must be met for this to take place: nickel content in the range of 6 to 25%; a residual tensile stress that exceeds the yield strength; and the proper environmental conditions of pH, chloride content, and threshold temperature. Each alloy has a threshold temperature above which it will crack but below which it will not. Table 5 lists the approximate threshold temperatures for some of the more common alloys.

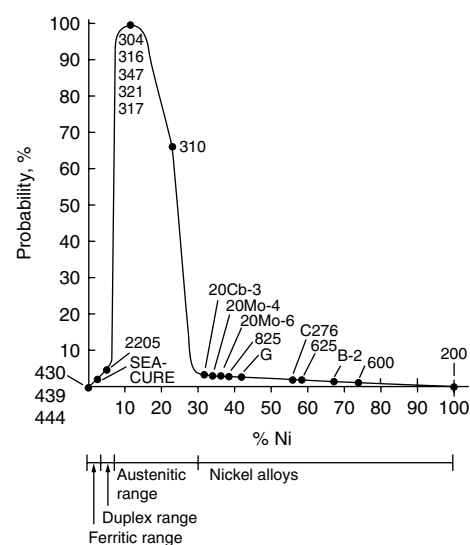
**Fig. 4** Probability of chloride stress-corrosion cracking occurring as a function of the nickel content of the alloy. Cracking will not occur below the stress-corrosion cracking threshold temperature but will above (Table 5). Source: Ref 5

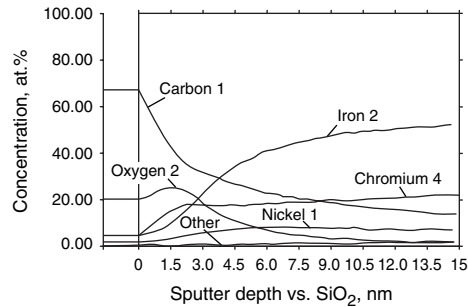
**Fig. 5** Auger electron spectroscopy depth profile of a type 316L stainless steel surface. The exposed metal surface is on the left, and the composition with depth from the surface changes as one moves to the right. The base metal composition is reached at approximately 12.5 nm, or 35 atoms, from the surface. In this example, the chromium/iron ratio is 1.5.

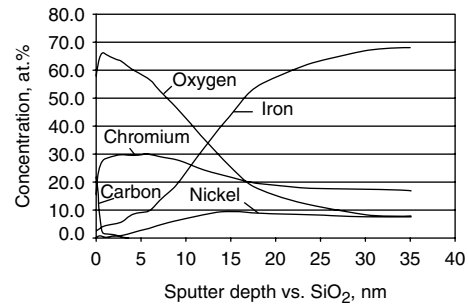
**Fig. 6** X-ray photoelectron spectroscopy depth profile of a type 316L stainless steel surface. The base metal composition is reached at approximately 35 nm, or 100 atoms, from the surface. In this example, the chromium/iron ratio is 7.7, an outstanding value.

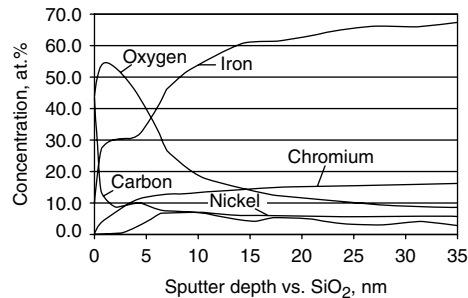
**Fig. 7** X-ray photoelectron spectroscopy depth profile chart of a type 316L stainless steel surface with an extremely poor chromium/iron ratio of only 0.13. This material will show rust in only a few hours in a humid environment.

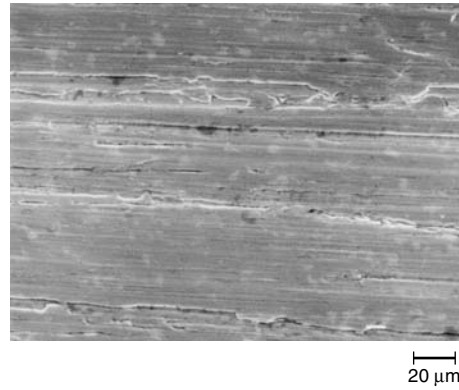
**Fig. 8** Mechanically polished surface with a 0.508  $\mu\text{m}$  (20  $\mu\text{in.}$ )  $R_a$  finish. The dark deposits in the grit lines are residual polishing debris. This debris typically leads to class 1 rouging of the stainless steel surfaces. SEM; original magnification 500 $\times$

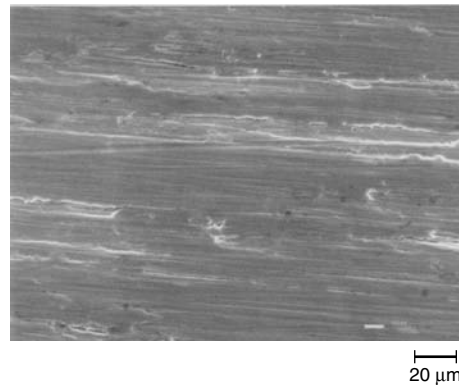
**Fig. 9** Same surface as in Fig. 8 after a hot nitric acid passivation treatment. Many of the laps on the grit lines have been dissolved and much of the polishing debris removed.

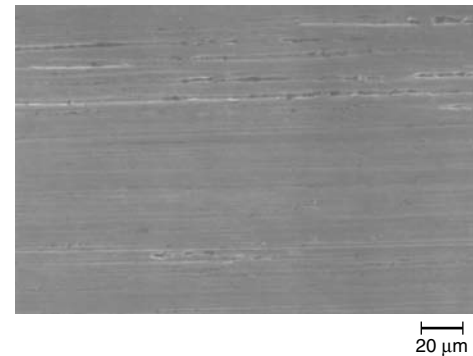
**Fig. 10** Mechanically polished surface with a profilometer reading of 0.203  $\mu\text{m}$  (8  $\mu\text{in.}$ )  $R_a$ . Note the polishing debris in the grit lines. SEM; original magnification 500 $\times$

Pharmaceutical equipment is normally specified with either mechanically polished or electropolished surfaces. Mechanically polished surfaces are either 0.635 or 0.508  $\mu\text{m}$  (25 or 20  $\mu\text{in.}$ )  $R_a$  (average roughness), and electropolished surfaces are either 0.381 or 0.254  $\mu\text{m}$  (15 or 10  $\mu\text{in.}$ )  $R_a$ . Figure 8 illustrates a mechanically polished surface with a 0.508  $\mu\text{m}$  (20  $\mu\text{in.}$ )  $R_a$  finish. Polishing debris is seen in the grit lines, and metal laps fold over some of the grit lines. This debris leads to rouging of the system. Figure 9 is the same surface after a hot nitric acid passivation treatment. Much of the debris is gone, and many of the laps have been dissolved. Figure 10 is a much finer polish, 0.203  $\mu\text{m}$  (8  $\mu\text{in.}$ )  $R_a$ , that shows finer grit lines with occluded polishing debris. An electro-

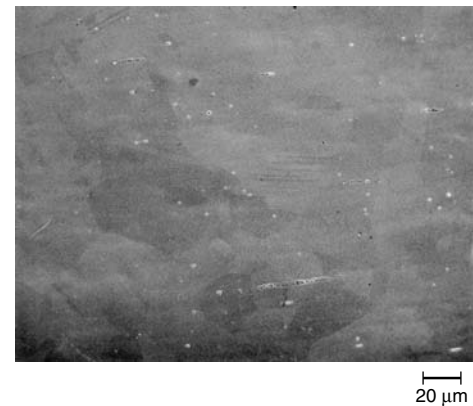
**Fig. 11** Electropolished surface with a profilometer reading of 0.102  $\mu\text{m}$  (4  $\mu\text{in.}$ )  $R_a$ . The white spots are pits from which manganese sulfide inclusions were leached out. The grains are clearly visible. SEM; original magnification 450 $\times$

polished surface is depicted in Fig. 11. This surface is very smooth; in fact, it is possible to see the grains. The white specks in this micrograph are pits where manganese sulfide inclusions were dissolved during electropolishing. Because this material was purchased to the American Society of Mechanical Engineers biopharmaceutical equipment requirements, the sulfur content was approximately 0.012%.

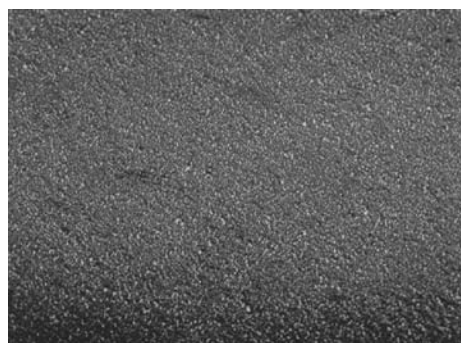
**Fig. 12** Class 1 rouge that is transported from other locations and deposited on the stainless steel surface. It is amorphous in structure, and the color varies from orange to red. The primary mineral form is hematite,  $\text{Fe}_2\text{O}_3$ . SEM; original magnification 450 $\times$

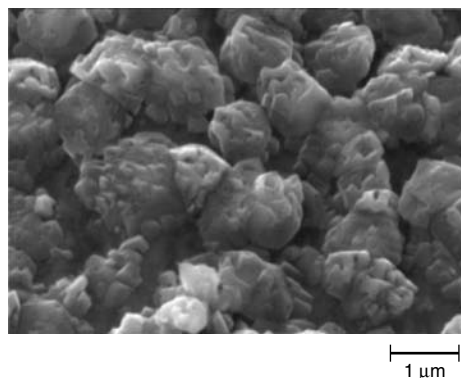
**Fig. 13** Highly magnified view of the amorphous class 1 rouge crystals. They appear to be rhombohedral in form. SEM; original magnification 20,000 $\times$

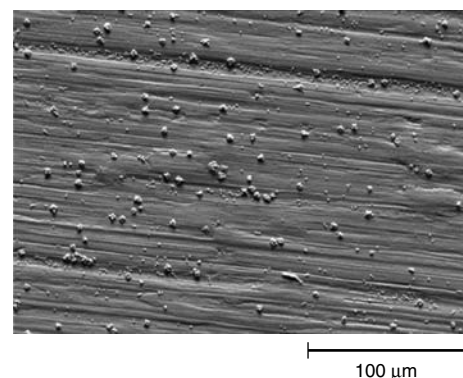
**Fig. 14** Rhombohedral crystals forming on the surface of a mechanically polished tube with a high chromium/iron ratio. This appears to be class 1 originating from polishing debris. Note the high density of small crystals in the polishing striations. SEM; original magnification 450 $\times$

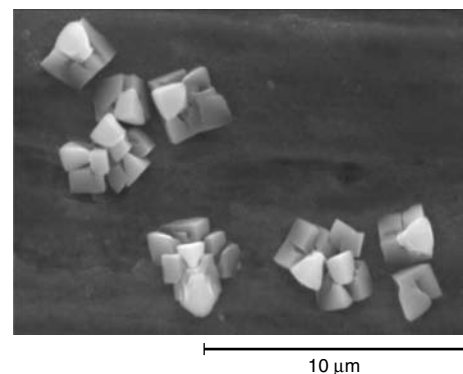
**Fig. 15** These twinned rhombohedral crystals do not appear to be growing on the surface. They are associated with residual polishing debris. Class 1 rouge. SEM; original magnification 7500 $\times$

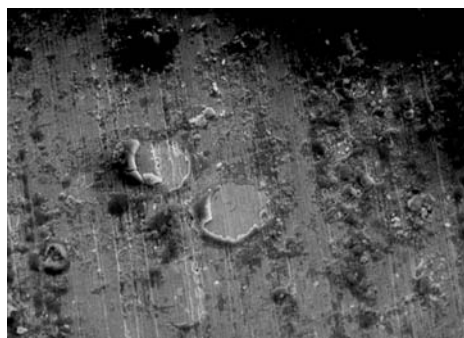
**Fig. 16** Class 2A rouge that forms in the presence of chlorides. When the tubercles are broken off, a bright silver spot is under them, indicating an active chloride corrosion cell. SEM; original magnification 450×

**Class 2A.** This forms in the presence of chlorides. This type of rouge can be removed only by chemical or mechanical means. The chromium/iron ratio under the rouge approaches that of the base metal composition, and tubercles or crystal growths are observed on the surface. The metal surface under the tubercle, when removed, is bright silver, representing an active corrosion site. Figure 16 illustrates rouge that grows in the presence of chloride. The corrosion mechanism was described earlier. Figure 17 illustrates acicular crystals growing from the surface, possibly from chloride micropits. Rhombohedral crystals can then grow from these seeds, using the iron from the metal or from that in the water. Figure 18 illustrates the fibrous structure that develops from the acicular crystals.

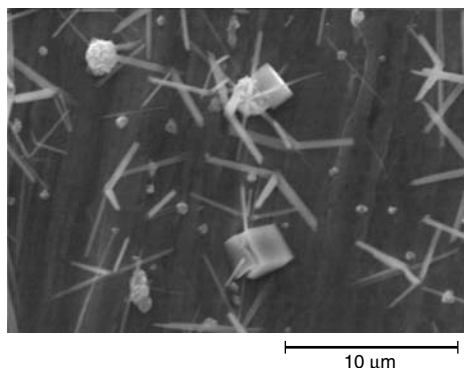
**Fig. 17** Acicular crystals growing from the surface of stainless steel exposed to chloramines at steam temperatures. The acicular crystals appear to be growing from the surface of the stainless steel, perhaps from a chloride micropit. They appear to be the start of class 2A rouge. The large rhombohedrons may be from polishing debris or may have grown from dissolved iron in the water. SEM; original magnification 5000×

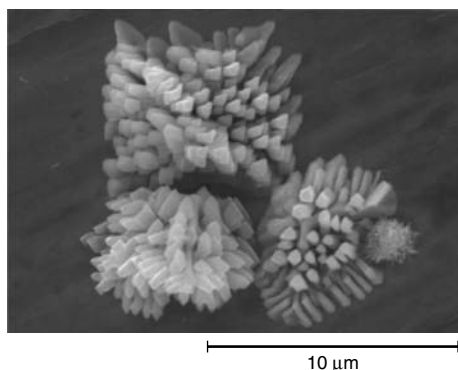
**Fig. 18** Fibrous rhombohedral crystals growing on the surface. Probably class 2A rouge that originated from chloride micropits on the stainless steel surface. SEM; original magnification 7250×

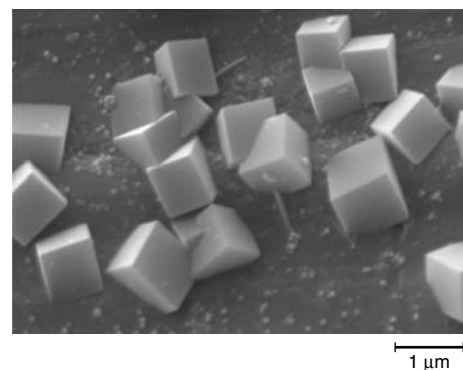
**Fig. 19** These rhombohedrons appear to be growing from the surface. The stainless steel had a lower chromium/iron ratio. This appears to be class 2B rouge. SEM; original magnification 20,000×

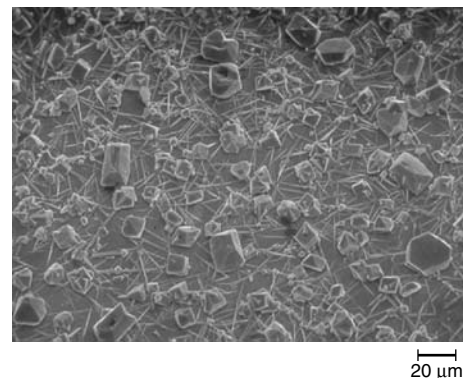
**Fig. 20** Class 3A rouge. This is a black, glossy rouge that forms on the surface of electropolished stainless steel in high-temperature steam. The crystals completely cover the surface. The crystal form is octahedral, and the mineral is magnetite. SEM; original magnification 450×

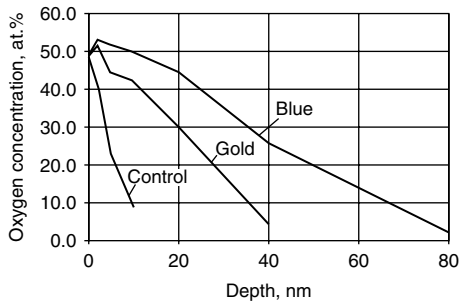
**Fig. 21** Oxygen content as a function of depth for various iridescent color rouge films. The control is the standard silver electropolished surface finish. The darker the color, the thicker the oxide film.

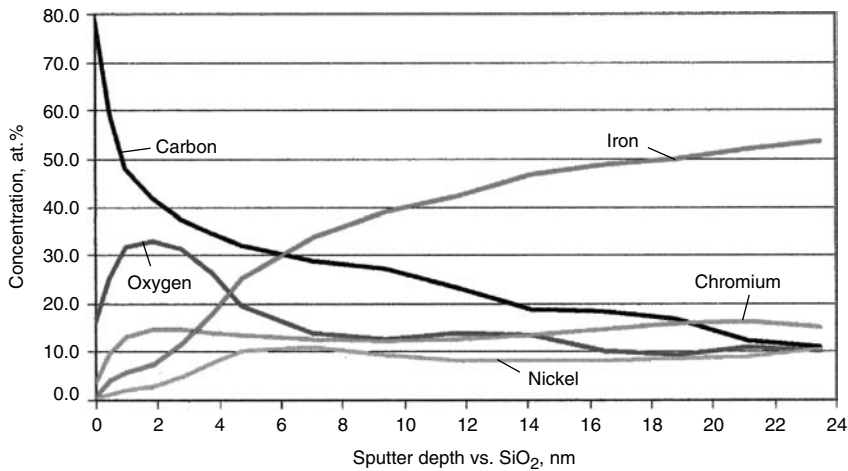
**Fig. 22** Depth profile for a CF-3M (type 316L) casting that has been machined, electropolished, and nitric acid passivated. The chromium/iron ratio on the surface is 4.1.

the ferrite can be dissolved by a long-term solution anneal. If the heat treatment is inadequate or if the ferrite content is greater than 8%, ferrite remains in the structure. Ferrite will corrode preferentially, resulting in pits on the surface. If machining or grinding, as in the case of valve components, removes the high-ferrite skin, the substrate surface composition becomes the nominal composition of the alloy. A high chromium/iron ratio results (Fig. 22) if this surface is electropolished and passivated.

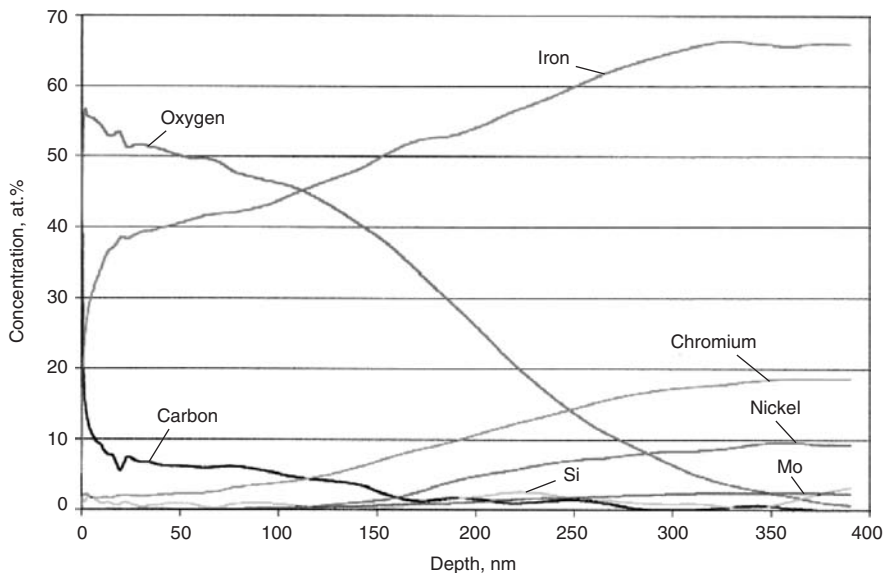
**Fig. 23** Depth profile for an investment cast pump impeller that had essentially no metal removed from the surface. The chromium/iron ratio is low (0.06), and the metal does not meet nominal composition until a depth of 350 nm is reached. This surface will be subject to corrosion and cavitation/erosion. It can be a source of class 1 rouge in the system.

Investment casting is used to produce complex shapes such as pump impellers. Because the surface is so smooth, little or no grinding is performed; the surfaces are simply buffed. The ferrite-rich skin is not removed, and the resulting chromium/iron ratio is very low, 0.06 (Fig. 23). Such a surface will be subject to corrosion and cavitation/erosion and will be a source of class 1 rouge. Figure 24 illustrates the surface of an impeller vane that has been subjected to cavitation and/or erosion. The delta-ferrite ridges (the white phase) stand in relief because they represent the harder material, and the interdendritic austenite (the dark phase) has eroded away.

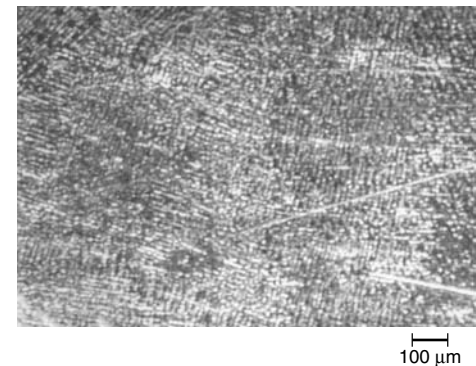
**Fig. 24** Investment cast impeller surface roughened by cavitation/erosion in water for injection service. The white ridges are harder delta ferrite, and the dark areas are the softer interdendritic austenite. Original magnification 100x

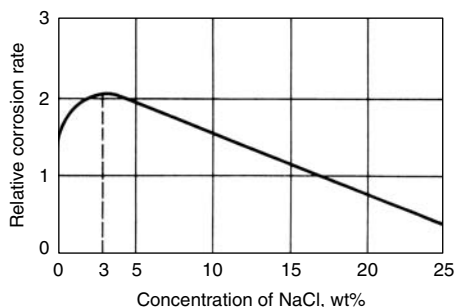
**Fig. 1** Effect of NaCl concentration on the corrosion rate of iron in aerated room-temperature solutions. Data are compiled from several investigations. Source: Ref 1

ALTHOUGH SEAWATER is generally considered to be a corrosive environment, it is not widely understood just how corrosive it is in comparison to natural freshwaters. Figure 1 shows the corrosion rate of iron in aqueous sodium chloride (NaCl) solutions of various concentrations. The maximum corrosion rate occurs near 3.5% NaCl—the approximate salt content of average full-strength seawater (Ref 1).

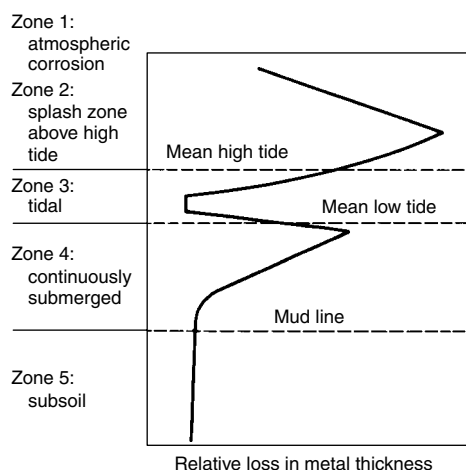
**Fig. 2** Zones of corrosion for steel piling in seawater, and relative loss of metal thickness in each zone. Source: Ref 2

The general marine environment includes a great diversity of subenvironments, such as full-strength open ocean water, coastal seawater, brackish and estuarine waters, bottom sediments, and marine atmospheres. Exposure of structural materials to these environments can be continuous or intermittent, depending on the application. Structures in shallow coastal or estuarine waters are often exposed simultaneously to five zones of corrosion. Beginning with the marine atmosphere, the structure then passes down through the splash, tidal, continuously submerged, and subsoil (or mud) zones. The relative corrosion rates often experienced on a steel structure passing through all of these zones are illustrated in Fig. 2.

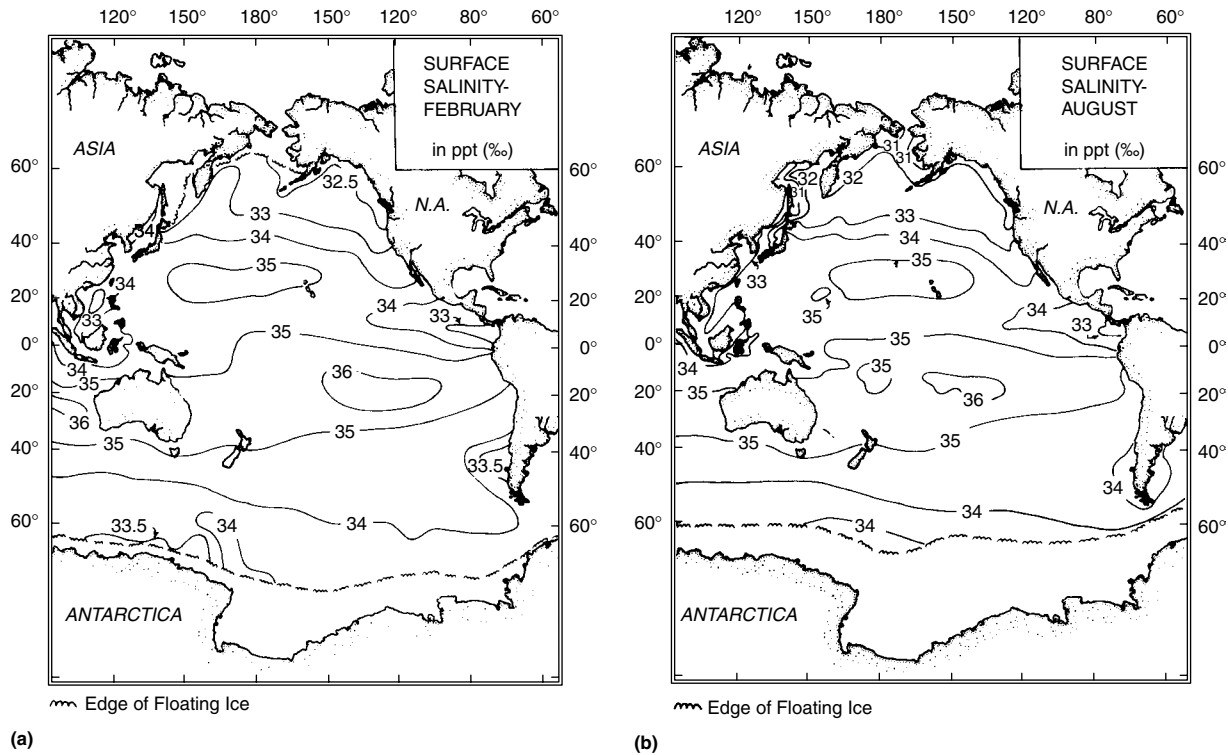
Fig. 3 Pacific Ocean surface salinity (‰) for (a) February and (b) August. Source: Ref 5

The open ocean salinity changes shown in Fig. 3 and 4 have very little effect on the processes of galvanic, pitting, and crevice corrosion. The much larger salinity changes found in coastal and brackish waters can have a substantial effect on both the susceptibility to and the intensity of localized corrosion. These coastal salinity changes have undoubtedly contributed to the variability in reported pitting and crevice corrosion rates with season and location or with time at a given location. For alloys that corrode uniformly, variations in corrosion rate due to salinity changes are small compared to those caused by changes in oxygen concentration and temperature.

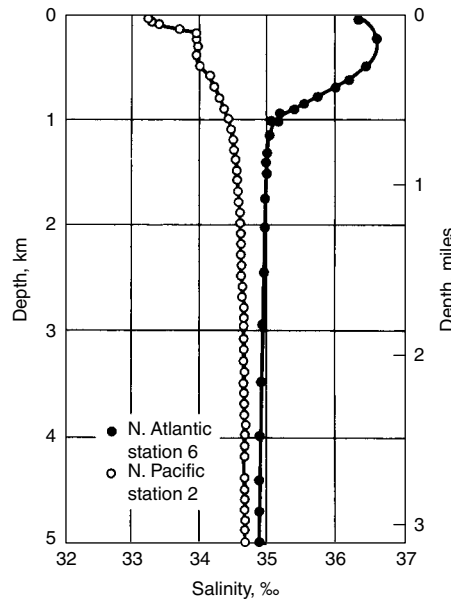
Fig. 4 Comparison of salinity-depth profiles for open ocean sites 2 and 6 (see Fig. 5 for site locations). Source: Ref 5

Salinity variations with depth at given locations in the Atlantic and Pacific Oceans are shown in Fig. 4. The locations from which these and other data on variations with depth were taken are illustrated in Fig. 5. It should be noted that the open ocean salinity variations with horizontal location and depth are quite small.

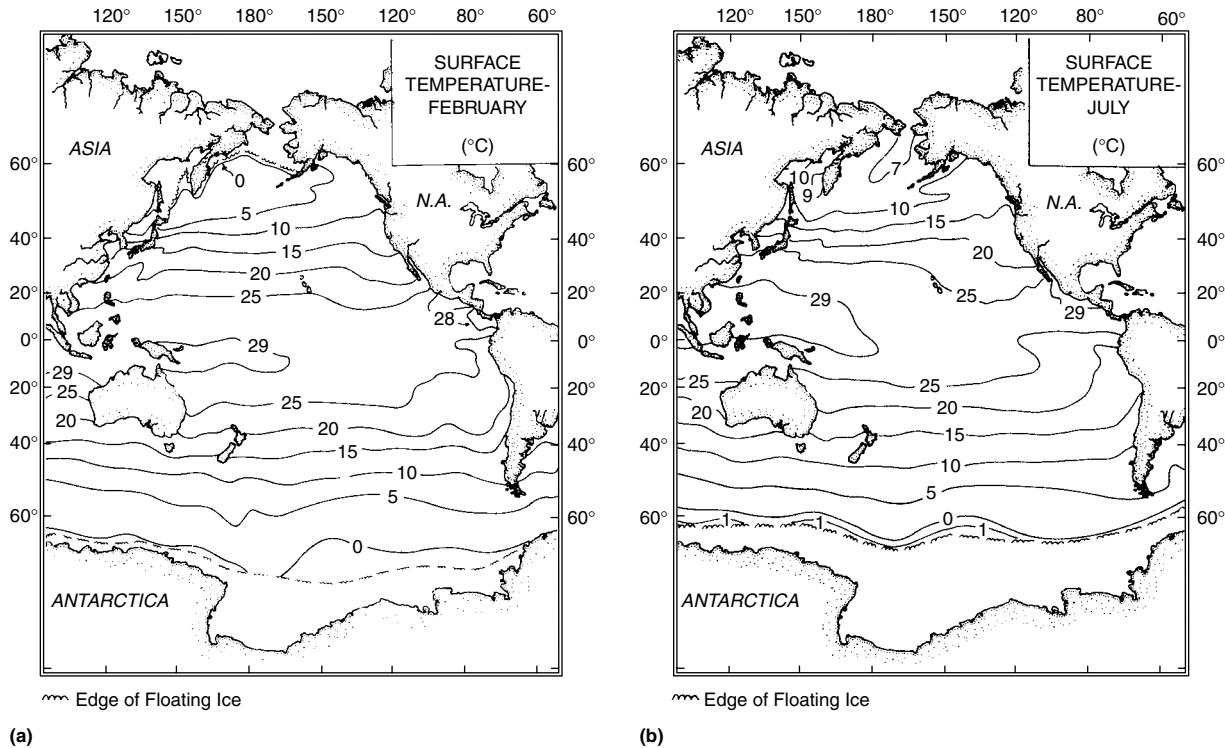
**Fig. 6** Pacific Ocean surface temperature ( $^{\circ}\text{C}$ ) for (a) February and (b) July. Source: Ref 5

Open ocean temperature variations are shown for surface waters in Fig. 6 and, as a function of depth, in Fig. 7. From these data alone, one would expect corrosion rates in tropical surface waters to be approximately twice those in the polar regions or in deep water. Corrosion rates are usually higher in warm surface waters than in cold deep waters, as illustrated in Fig. 8 and 9 (Ref 9, 10), but the picture is not nearly as simple as temperature alone would indicate. For surface waters, the saturation level of dissolved oxygen increases as the temperature decreases, and the effects of dissolved oxygen on the corrosion rate are often stronger than those of temperature. Short-term local temperature fluctuations and the effects of biofouling and scaling films must also be considered.

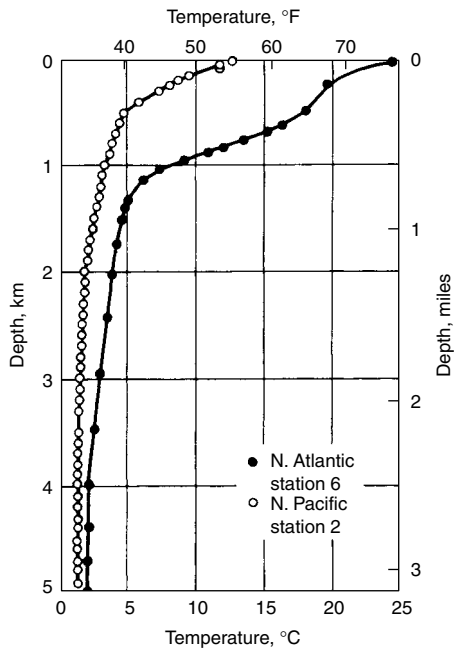
Fig. 7 Comparison of temperature-depth profiles for open ocean sites 2 and 6 (see Fig. 5 for site locations). Source: Ref 5

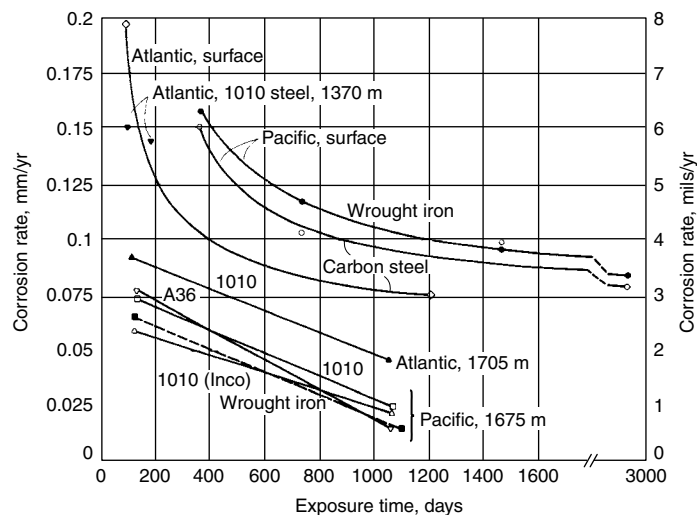
Fig. 8 Corrosion rates of carbon steels and wrought iron in the Atlantic and Pacific Oceans at various depths. Source: Ref 9, 10

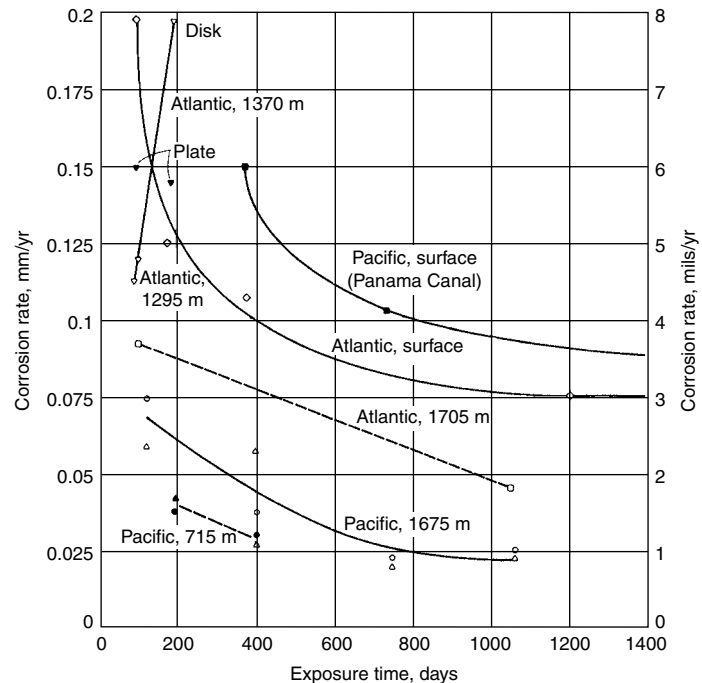
Fig. 9 Corrosion rates of low-carbon steels in the Atlantic and Pacific Oceans at various depths. Source: Ref 9, 10

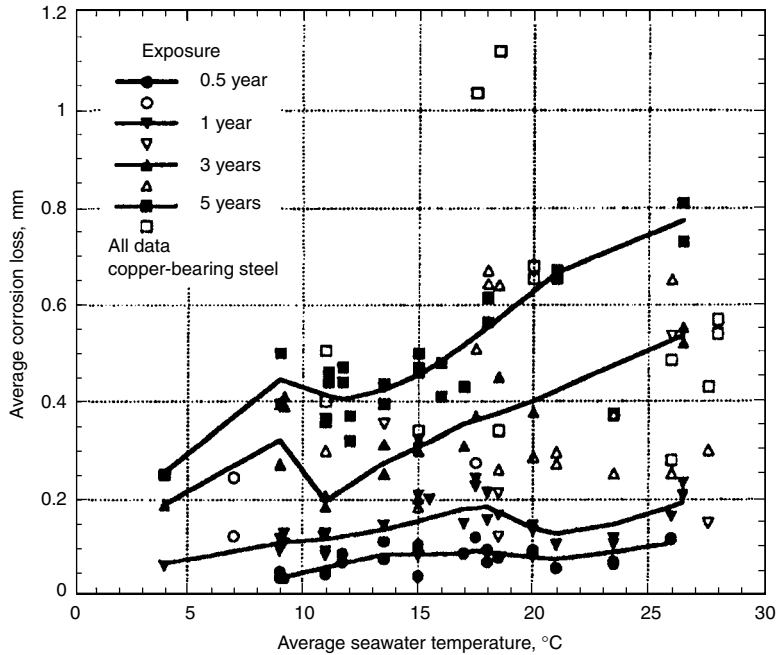
**Fig. 10** Average corrosion loss versus average seawater temperature for copper-bearing steels, showing data points and trend lines. Solid points are considered by author of Ref 11 to have a strong correlation to aerated open sea conditions. Open points have a weaker correlation. Source: Ref 11. (Copyright NACE International 2002, used with permission)

The historical database for seawater immersion corrosion of carbon steels and low-alloy steels taken at a variety of sites has recently been analyzed, and a model for general corrosion has been proposed (Ref 11). Results from the modeling effort have revealed (Ref 11, 12) that for fully aerated seawater, the general trend is for increasing corrosion rates with average water temperature, as shown in Fig. 10. There is some indication that the temperature at the time of initial immersion may be more important than subsequent seasonal temperature fluctuations (Ref 11, 12).

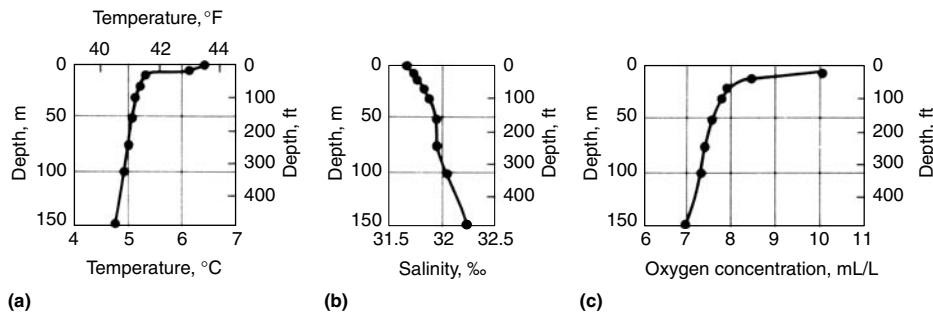
**Fig. 11** Variation of (a) temperature, (b) salinity, and (c) dissolved oxygen concentration with depth at Cook Inlet (station 1, Fig. 5) for May 1968. Source: Ref 5

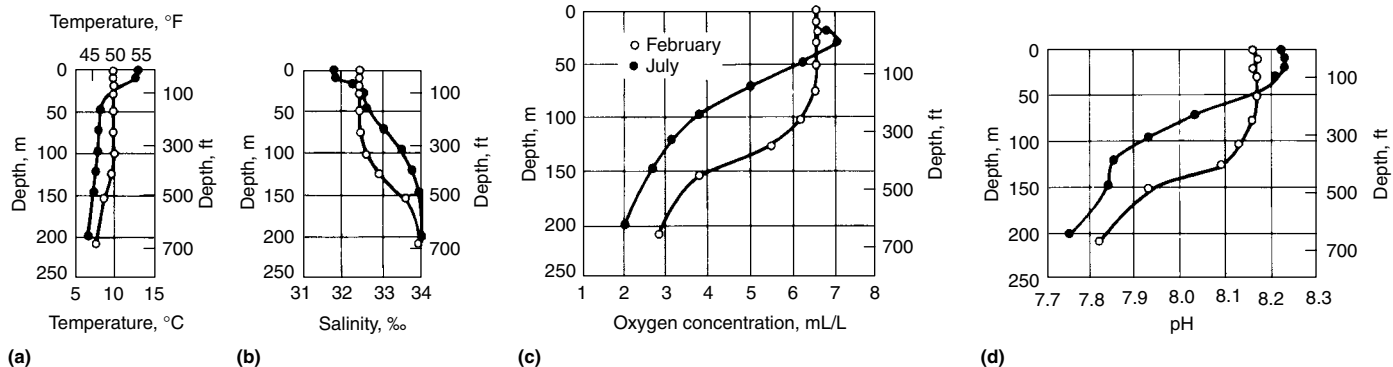
**Fig. 12** Variation of (a) temperature, (b) salinity, (c) dissolved oxygen, and (d) pH with depth and season off the Oregon coast (station 3, Fig. 5). Source: Ref 5

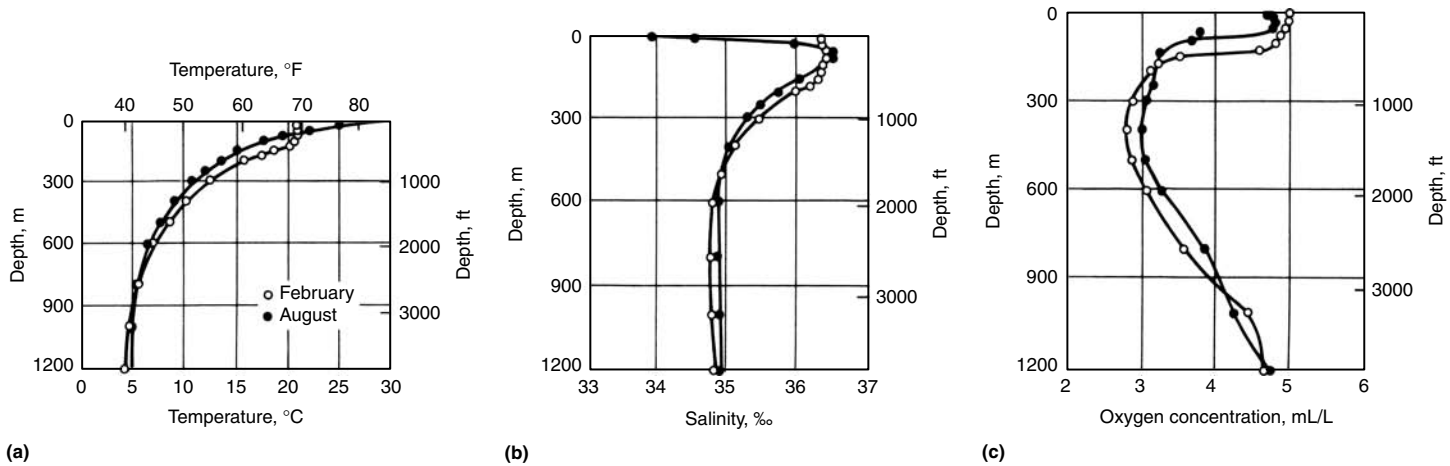
Fig. 13 Variation of (a) temperature, (b) salinity, and (c) oxygen concentration with depth and season in the Gulf of Mexico (station 4, Fig. 5). Source: Ref 5

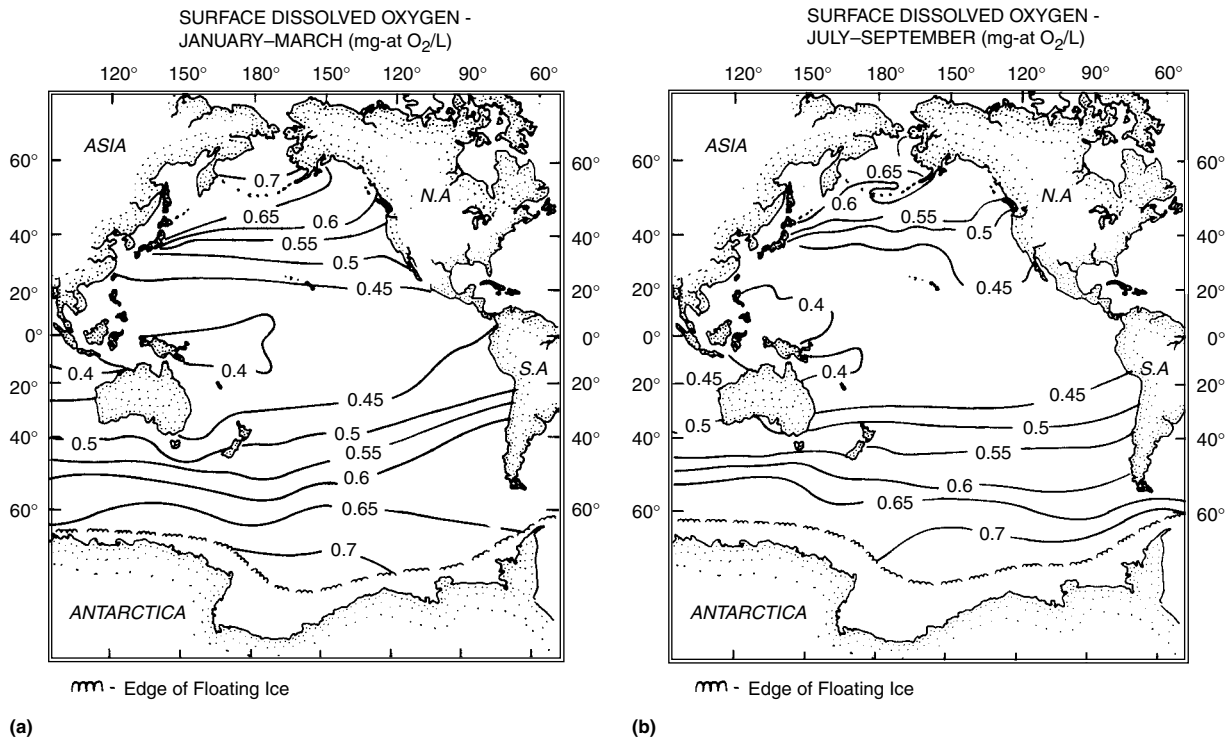
**Fig. 15** Pacific Ocean surface dissolved oxygen (mg · atm/L) for (a) January through March and (b) July through September. (1 mg · atm/L = 12.2 mL/L). Source: Ref 5

of 500 and 1000 m (1640 and 3280 ft) are shown in Fig. 27 and 28, respectively. In comparing these to the dissolved oxygen distributions at the same depths (Fig. 15 and 16), it should be noted that the trends for the two variables are similar. For example, at a depth of 500 m (1640 ft), the region of maximum dissolved oxygen, centered on 180° longitude between 20 and 40° north latitude in Fig. 16(a), is reproduced closely for pH in Fig. 27.

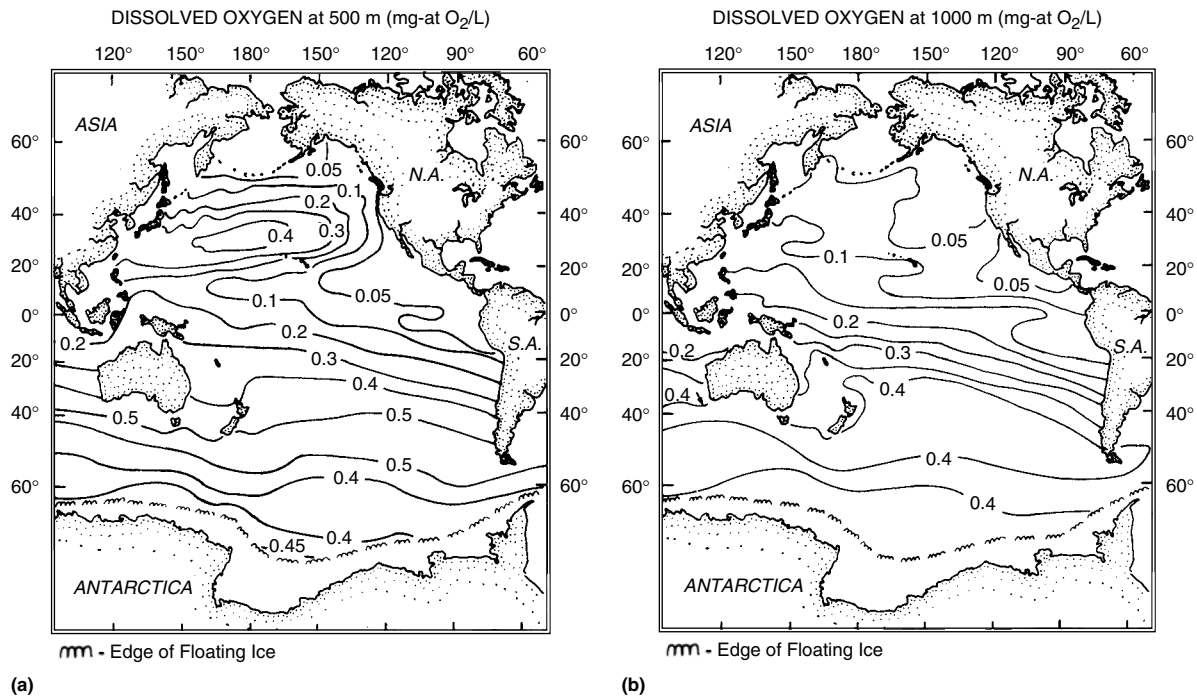
**Fig. 16** Pacific Ocean dissolved oxygen (mg · atm/L) at depths of (a) 500 m (1640 ft) and (b) 1000 m (3280 ft). (1 mg · atm/L = 12.2 mL/L). Source: Ref 5

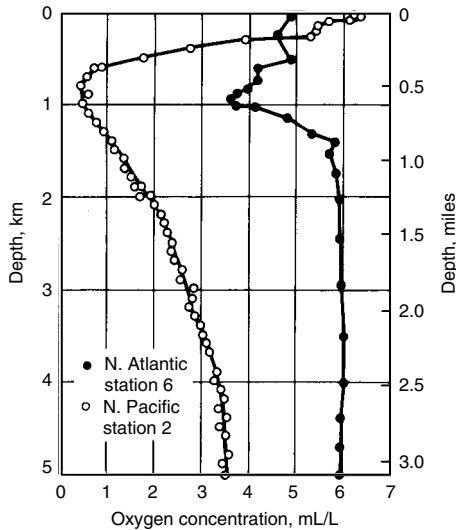
**Fig. 17** Comparison of dissolved oxygen-depth profiles for open ocean stations 2 and 6 (see Fig. 5). Source: Ref 5

Profiles of pH with depth for the two open ocean locations are shown in Fig. 29. A comparison of the corresponding pH and oxygen profiles from Fig. 17 and 29 reveals the closely coupled nature of their relationship through the carbon dioxide system. The oxygen and pH minima are reached at the same depth for a given location, as was predicted. The deep North Pacific water is from 0.15 to 0.40 pH units more acidic than that in the North Atlantic, primarily because of the increased oxidation of organic matter in the North Pacific.

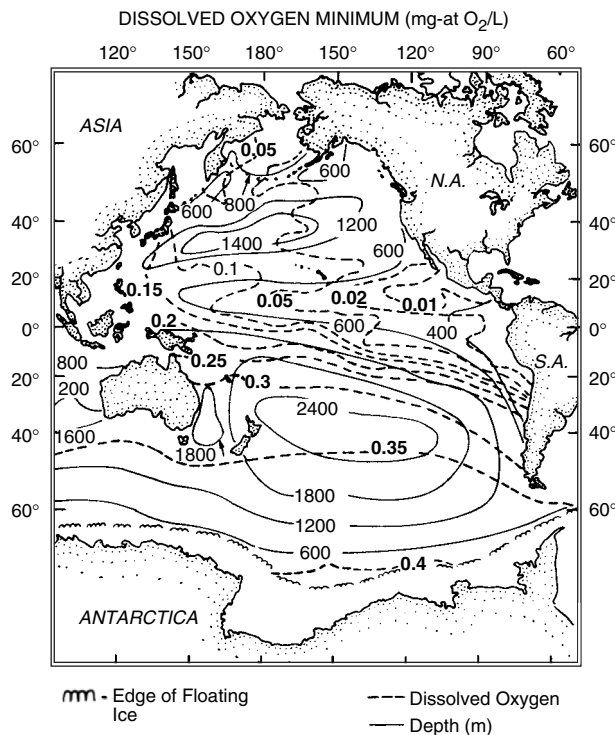
**Fig. 18** Depth (meters) of the dissolved oxygen minimum in the Pacific (solid contours) and the value of the minimum in mg · atm/L (dashed contours). (1 mg · atm/L = 12.2 mL/L). Source: Ref 5

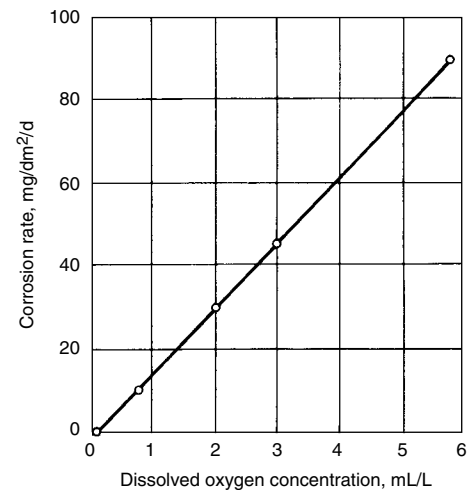
**Fig. 19** Effect of oxygen concentration on the corrosion of low-carbon steel in slowly moving water containing 165 ppm CaCl<sub>2</sub>. The 48 h test was conducted at 25 °C (75 °F). Source: Ref 1

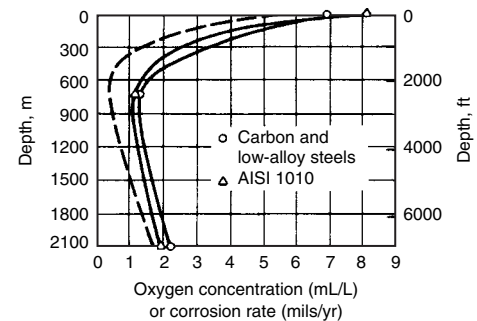
**Fig. 20** Corrosion of steels versus depth after 1 year of exposure compared to the shape of the dissolved oxygen profile (dashed line). Source: Ref 2

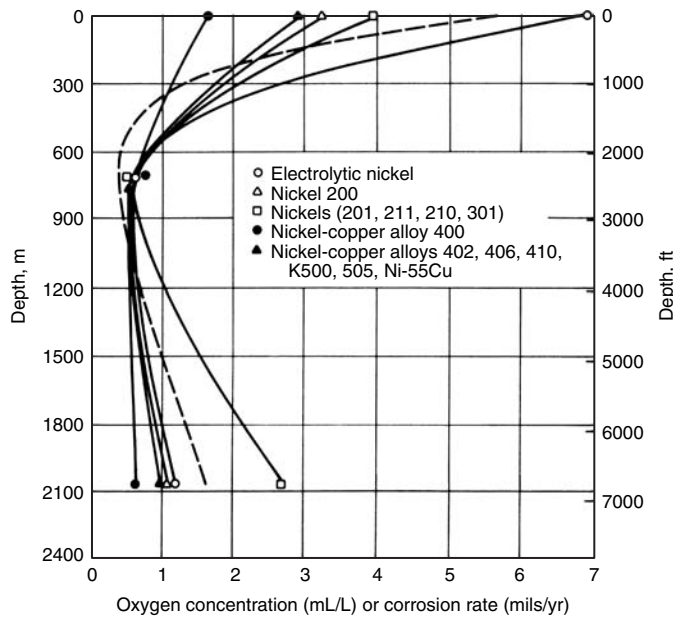
**Fig. 21** Corrosion of nicks and nickel-copper alloys versus depth after 1 year of exposure compared to the shape of the dissolved oxygen profile (dashed line). Source: Ref 2

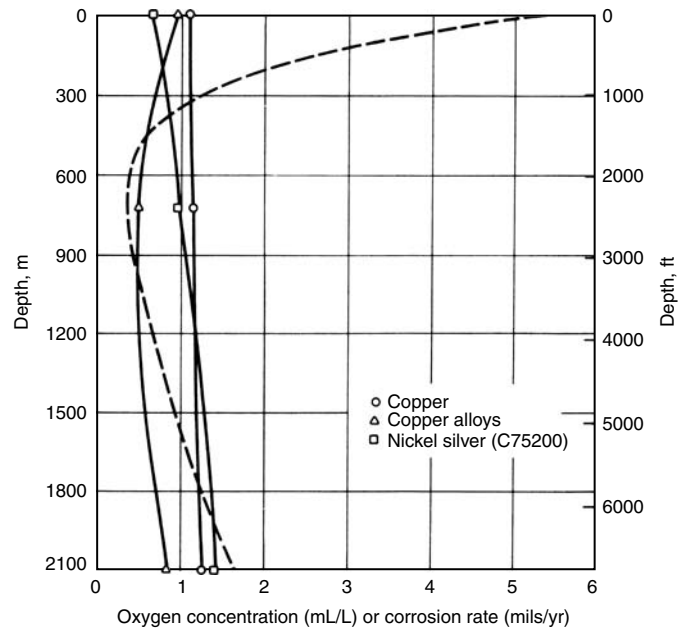
**Fig. 22** Corrosion of copper alloys versus depth after 1 year of exposure compared to the shape of the dissolved oxygen profile (dashed line). Source: Ref 2

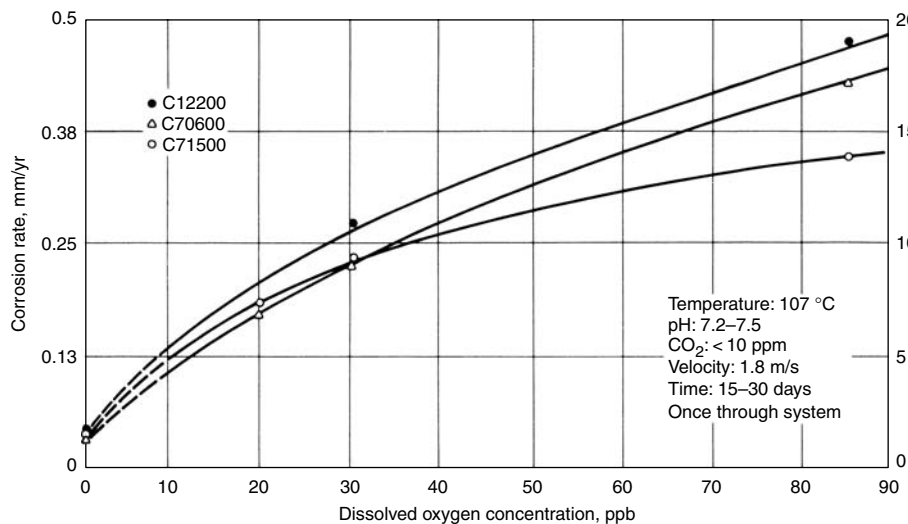
**Fig. 23** Effect of dissolved oxygen in seawater on the corrosion rate of three Copper Development Association copper alloys. Source: Ref 9
