# ASM Handbook®

## Volume 13C Corrosion: Environments and Industries

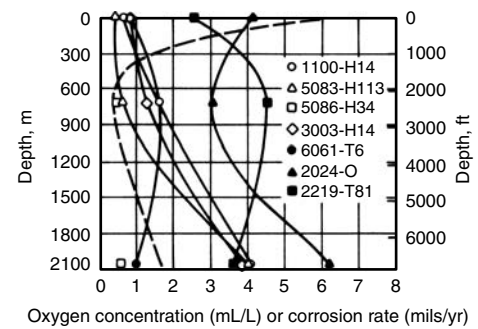
**Fig. 24** Corrosion rates of aluminum alloys versus depth after 1 year of exposure compared to the shape of the dissolved oxygen profile (dashed line). Source: Ref 2

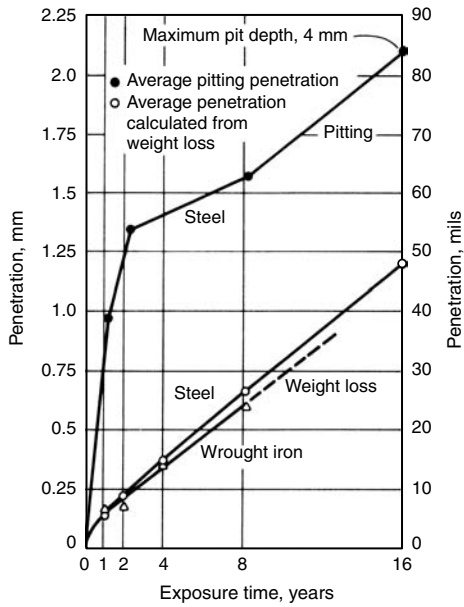
**Fig. 25** Corrosion of carbon steel and wrought iron continuously immersed in seawater. Average penetration rate was 0.068 mm/yr (2.7 mils/yr) for steel; that of wrought iron was 0.061 mm/yr (2.4 mils/yr). Source: Ref 9

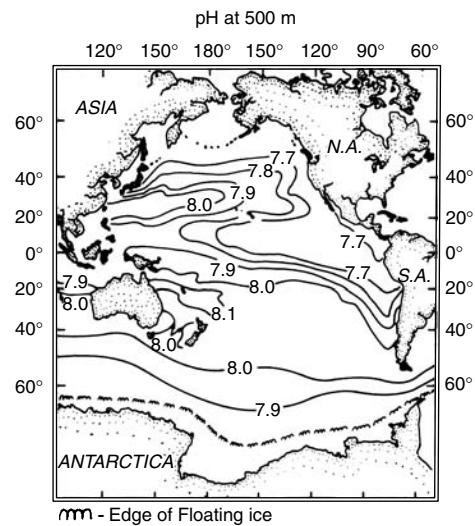
**Fig. 27** Pacific Ocean pH at a depth of 500 m (1640 ft). Source: Ref 5

of 500 and 1000 m (1640 and 3280 ft) are shown in Fig. 27 and 28, respectively. In comparing these to the dissolved oxygen distributions at the same depths (Fig. 15 and 16), it should be noted that the trends for the two variables are similar. For example, at a depth of 500 m (1640 ft), the region of maximum dissolved oxygen, centered on 180° longitude between 20 and 40° north latitude in Fig. 16(a), is reproduced closely for pH in Fig. 27.

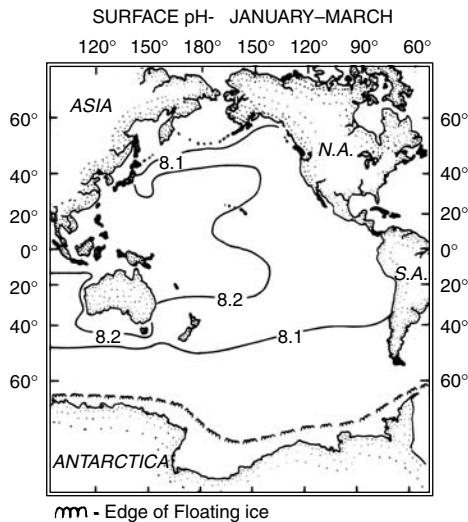
**Fig. 26** Pacific Ocean surface pH for the period January to March. Source: Ref 5

*Variability of pH.* The pH of the Pacific surface waters ranges from 8.1 to 8.3, and its general distribution for the months of January to March is shown in Fig. 26. Distributions of pH at depths

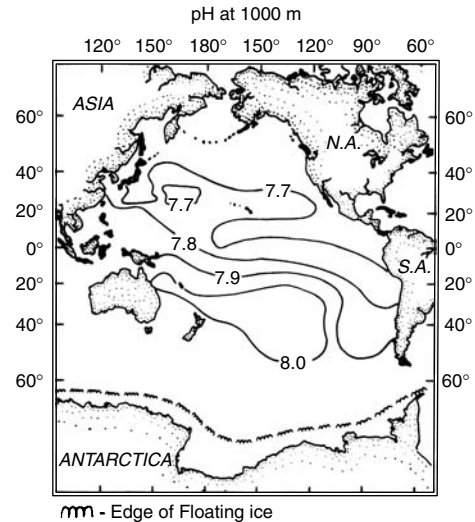
**Fig. 28** Pacific Ocean pH at a depth of 1000 m (3280 ft). Source: Ref 5

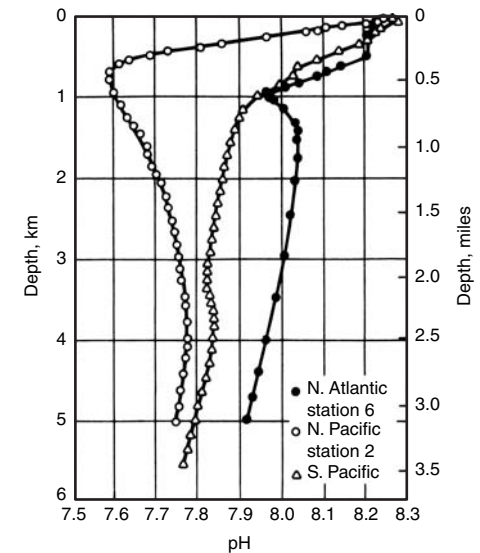
**Fig. 29** Comparison of pH-depth profiles for open ocean sites 2 and 6 (see Fig. 5). Note that the data for the South Pacific are highest at the surface but are intermediate at depths greater than 500 m (1640 ft). Source: Ref 5

Profiles of pH with depth for the two open ocean locations are shown in Fig. 29. A comparison of the corresponding pH and oxygen profiles from Fig. 17 and 29 reveals the closely coupled nature of their relationship through the carbon dioxide system. The oxygen and pH minima are reached at the same depth for a given location, as was predicted. The deep North Pacific water is from 0.15 to 0.40 pH units more acidic than that in the North Atlantic, primarily because of the increased oxidation of organic matter in the North Pacific.

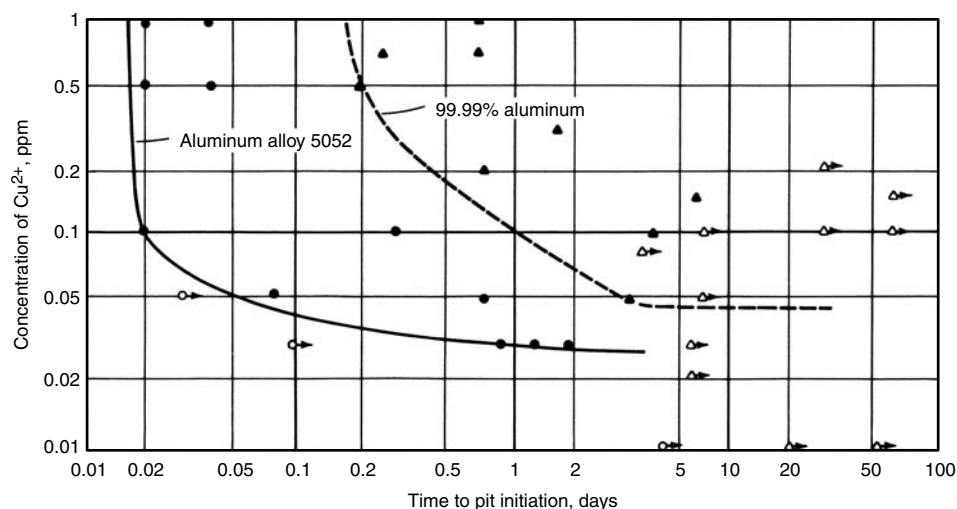
**Fig. 30** Effect of adding  $Cu^{2+}$  ion to seawater on the time to pit initiation for aluminum alloy 5052 and 99.99% Al. Solid points represent conditions under which pitting started; open points indicate conditions under which no pitting occurred. Source: Ref 24

Acceleration of aluminum corrosion by copper corrosion products has often been observed in seawater piping systems having copper alloy pumps, even when the aluminum piping is not in direct electrical contact with the copper alloy (Ref 23). In freshwater, copper concentrations as low as 0.05 ppm have been found to accelerate aluminum corrosion. In seawater, the threshold concentration below which copper contamination has no effect seems to be approximately 0.03 ppm, as shown in Fig. 30 (Ref 24). Copper accumulates on the aluminum surface by

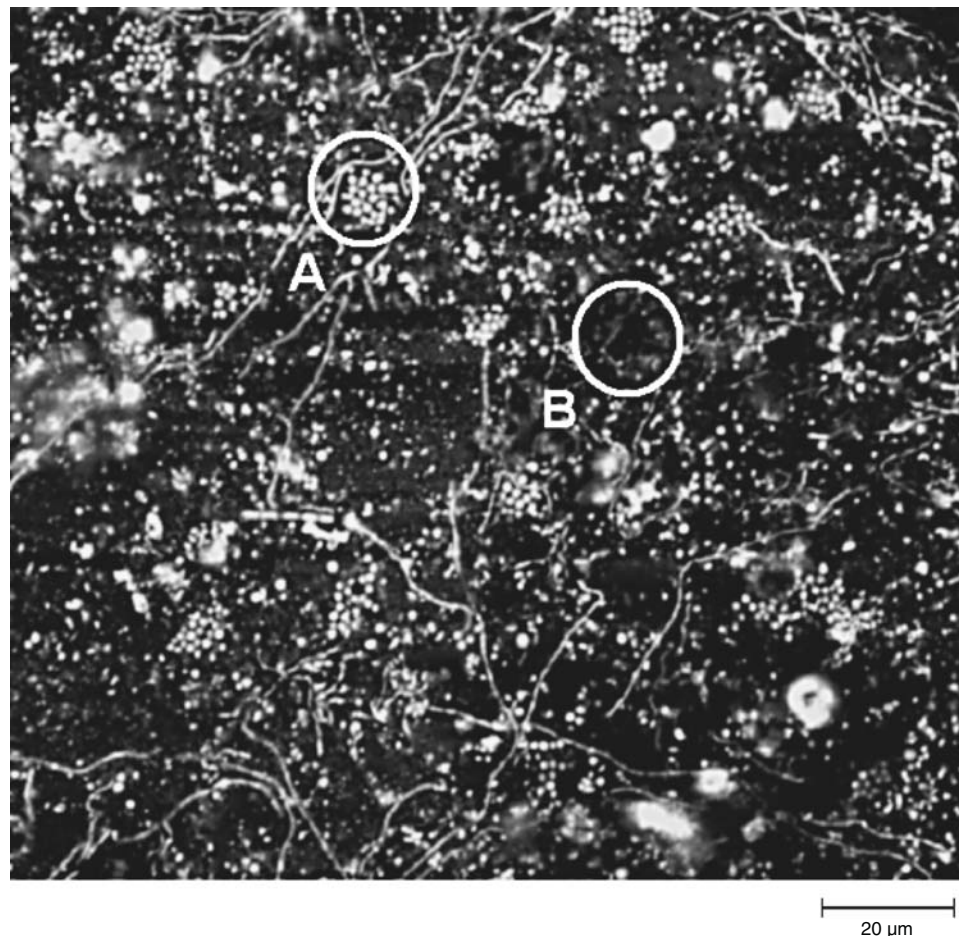
**Fig. 31** Laser confocal microscope image of the variability in distribution and types of microorganisms in a 2 week old biofilm grown on a stainless steel substratum in Lower Delaware Bay coastal seawater. The chemistry at the metal surface within a microcolony, as shown at location "A," will be quite different from that in either the bulk seawater or at location "B." Source: Ref 39

Moreover, the development of a microbial biofilm, an example of which is shown in Fig. 31, results in a heterogeneous distribution of microorganisms both parallel and perpendicular to the metal surface (Ref 39). This creates a heterogeneous distribution of the chemistry from point to point along the metal surface. The result is not only a different chemistry at the metal surface from that of the bulk water but also a highly variable chemistry along the surface on a scale of tens to hundreds of micrometers (Ref 40, 41). Such chemical concentration cells increase the likelihood that the corrosive attack will be localized rather than uniformly distributed.

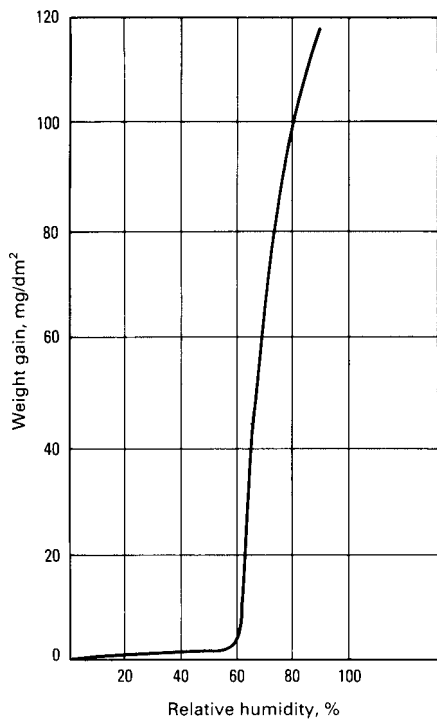
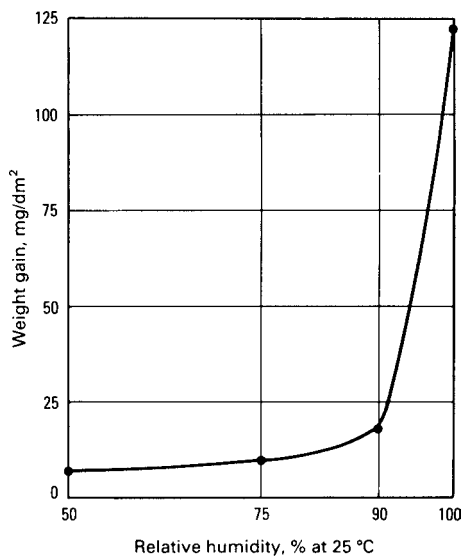
**Fig. 1** Corrosion rates of iron and magnesium as a function of relative humidity. (a) For iron, the critical relative humidity is 60%. (b) For magnesium, corrosion rate increases significantly at a critical relative humidity of approximately 90%. Source: Ref 5

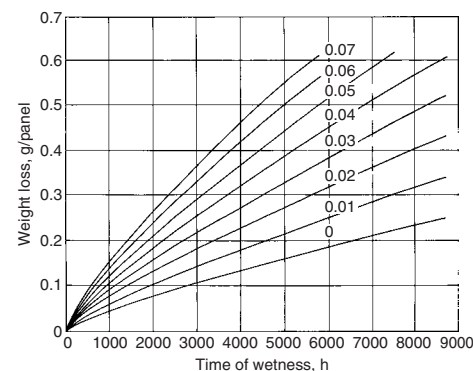
**Fig. 2** The increase in corrosion rate of zinc as a function of time of wetness and  $\text{SO}_2$  concentration. Numbers on lines are ppm  $\text{SO}_2$ . Source: Ref 6

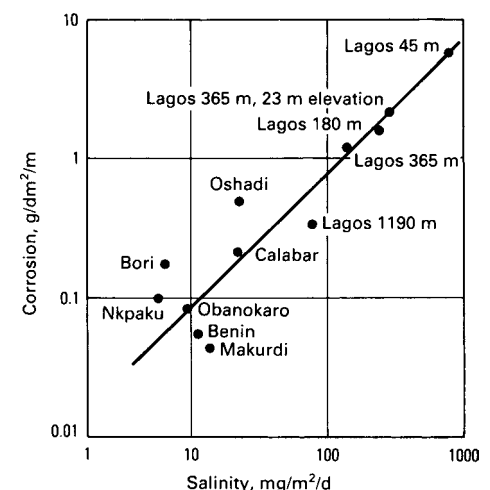
**Fig. 3** Atmospheric corrosion of mild steel as a function of salinity at various sites in Nigeria. Source: Ref 8

**Chlorides.** There is a direct relationship between atmospheric salt content and measured corrosion rates. The amount of sea salts measured off the coast of Nigeria illustrates this relationship between salinity and corrosion rate (Ref 8). This is shown in Fig. 3, in which salinity of  $10 \text{ gm/m}^2/\text{d}$  results in a corrosion rate of less than  $0.1 \text{ g/dm}^2/\text{mo}$ , while a salinity of  $1000 \text{ gm/m}^2/\text{d}$  results in a corrosion rate of almost  $10 \text{ g/dm}^2/\text{mo}$ . At the LaQue Center for Corrosion Technology (Wrightsville Beach, NC) test site at Kure Beach, NC, a similar effect has been observed for carbon steel. The corrosion rate at the site 25 m (80 ft) from the mean tide line (this site is now called the oceanfront lot) was  $1.19 \text{ mm/yr}$  ( $47 \text{ mils/yr}$ ), while at the 250 m (800 ft) location (this site is now called the near-ocean lot), the corrosion rate for the same material was  $0.04 \text{ mm/yr}$  ( $1.6 \text{ mils/yr}$ ).

**Distance from the Sea.** Figure 3 shows the effect of moving inland along the coast of Nigeria from the 45, 365, and 1190 m (50, 400, and 1300 yd) sites at Lagos. From studies done on Barbados, the effect of distance is confirmed by the map of the island shown in Fig. 6 (Ref 11). This represents one of the worst conditions: tropical beach, on-shore winds, and facing a large, uninterrupted stretch of ocean. Similarly, at a site in Aracaju, Brazil, low-carbon steel samples were tested at five sites from approxi-

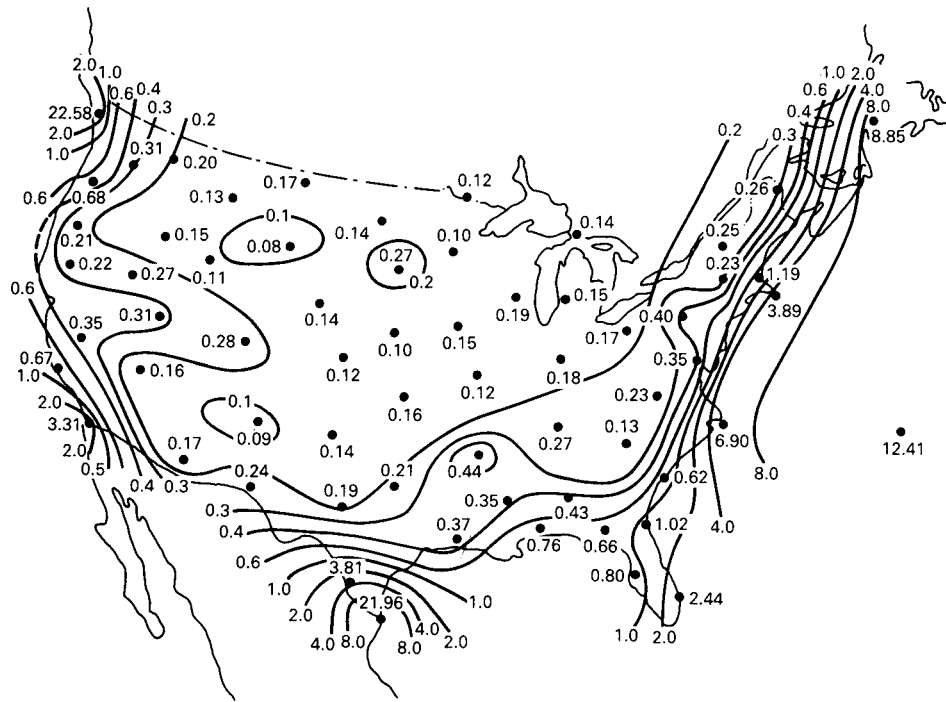
Fig. 4 Average chloride concentration (mg/L) in rainwater in the United States. Source: Ref 6

The average atmospheric chloride levels collected in rainwater for the United States are shown in Fig. 4 (Ref 6). The highest levels occur along the coast of the Atlantic Ocean, Pacific Ocean, and the Gulf of Mexico. The maximum corrosion rate is related to the maximum chloride in the atmosphere. This will be related to the distance inland, the height above sea level, and the prevailing winds. The chlorides of calcium and magnesium are hygroscopic and have a tendency to form liquid films on metal surfaces, which increases TOW.

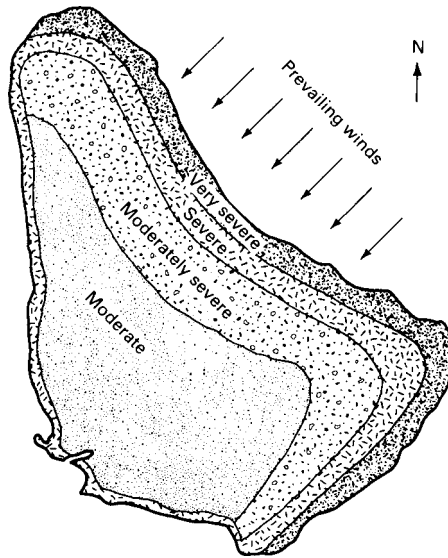
Fig. 6 Estimates of marine-atmosphere corrosivity at various locations on the island of Barbados in the West Indies. Based on CLIMAT data. Source: Ref 11

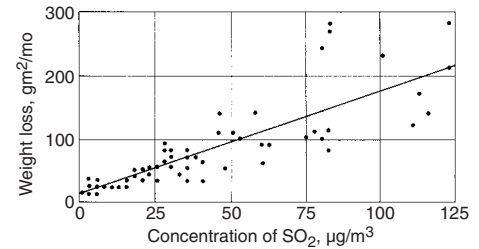
Fig. 5 Effect of SO<sub>2</sub> concentration on the corrosion rate of carbon steel at three Norwegian sites. Source: Ref 9

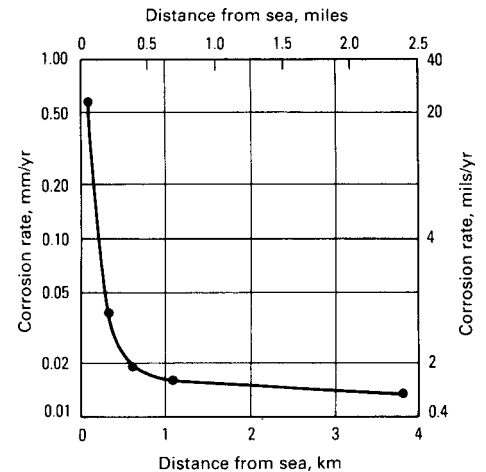
Fig. 7 Corrosion rate of carbon steel as a function of distance from the sea at Aracaju, Brazil. Source: Ref 12

mately 0.1 to almost 4 km (0.06 to 2.5 miles) from the sea. There was a rapid falloff in the corrosion rate as the testing sites were moved inland (Fig. 7). By approximately 1.5 km (0.9 miles) inland, the corrosion rate had reached a value that showed it was basically independent of the marine atmosphere (Ref 12). The formation of aerosol droplets as a function of wind and surf zones for the distance ~400 m to 600 m (440 to 660 yd) inland is characterized by an exponential expression and describes nicely the variation in corrosion rate (Ref 13).

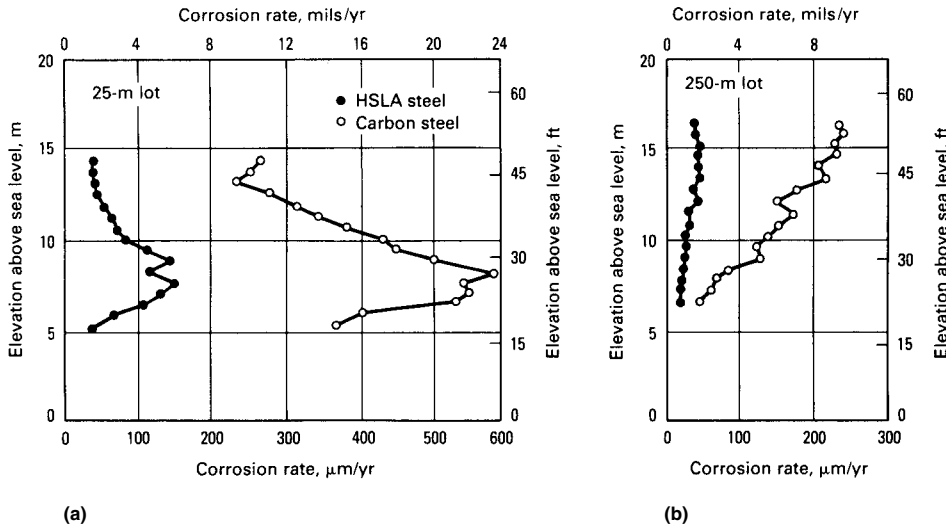
**Fig. 8** Effect of elevation above sea level for carbon and high-strength, low-alloy (HSLA) steels at Kure Beach, NC. (a) 25 m (80 ft) lot. (b) 250 m (800 ft) lot. Source: Ref 14

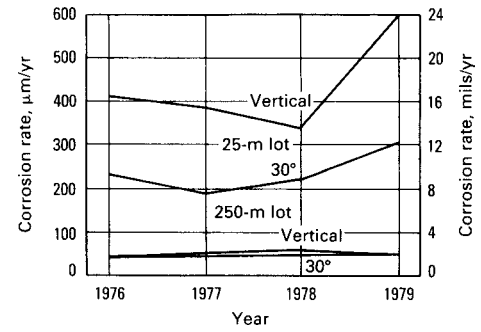
**Fig. 9** Effect of specimen orientation on corrosion rates of iron specimens exposed vertically and at an angle of 30° to the horizontal. Results of one-year test at Kure Beach, NC. Source: Ref 14

an angle of 30° with respect to the ground are shown in Fig. 9 (Ref 14). The spread in the data is much greater for the Kure Beach 25 m (80 ft) test lot than for the 250 m (800 ft) test lot. In both cases, the vertical specimens showed a higher corrosion rate. This was attributed to the formation of a nonuniform, less protective oxide in the vertical position than in the 30° position. It is also possible that the 30° samples have the chloride deposits cleaned from their surfaces more easily than the vertical specimens. Ratios of the corrosion rate in the vertical position to that in the 30° position are given in Table 2 for five sites (Ref 14). In the vertical position, the corrosion rate is greater on the side facing the sea than on the side facing land. At the 25 m (80 ft) lot at Kure Beach, steel pipe specimens corroded at the rate of 850 μm/yr (33.5 mils/yr) facing the ocean, as compared to 50 μm/yr (2 mils/yr) facing away from the ocean over a 4.5 year period.

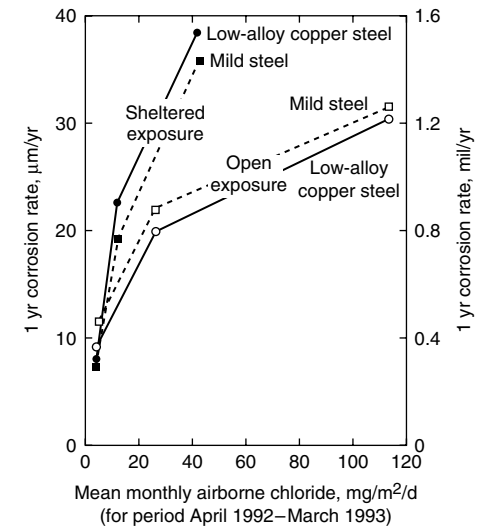
**Fig. 10** Corrosion rates of mild steel and low-alloy copper steel versus site mean level of airborne chloride. Source: Ref 15

For corrosion tests performed on mild steel and low-alloy copper steel in Australia, the 1 year corrosion rates for sheltered and open exposures are shown in Fig. 10. The chloride content has a significant effect. For example, at 40 mg/m<sup>2</sup>/d, the corrosion rate for the sheltered locations was approximately 38 μm/yr (1.5 mil/yr), while for the open exposure it was approximately 20 μm/yr (0.8 mil/yr). It is interesting to note that the alloys swapped positions when comparing open and sheltered sites (Ref 15).

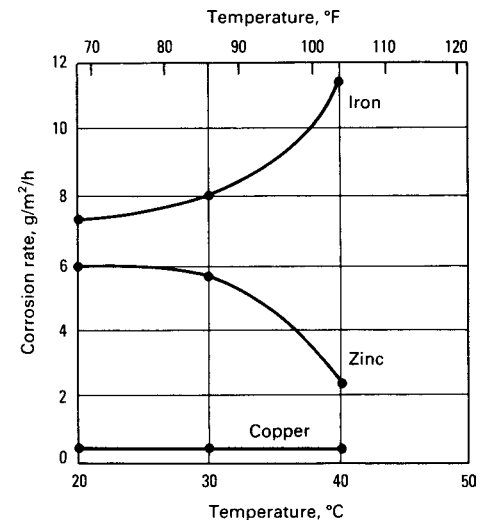
**Fig. 11** The effect of temperature on the corrosion rates of iron, zinc, and copper. Source: Ref 5

**Temperature** affects the RH, TOW, and the kinetics of the corrosion process. For atmospheric corrosion, the presence of moisture as determined by TOW is probably the most important role of temperature. Figure 11 shows the effect of temperature on iron, zinc, and copper (Ref 5). Increasing temperature over the range of 20 to 40 °C (70 to 100 °F) while holding the chloride content (16 mg/m<sup>3</sup>) and RH (80%) constant results in three distinct patterns: corrosion rate increases for iron, decreases for zinc, and remains constant for copper.

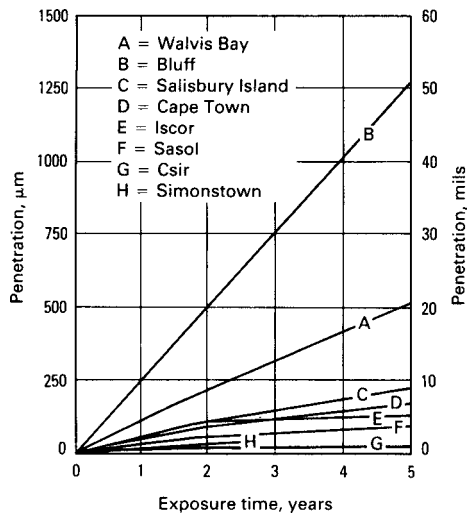
Fig. 12 Change in corrosion rate as a function of time for eight South African sites. Source: Ref 16

**Time.** For many materials, there is a decrease in the corrosion rate as time increases. This decrease is associated with the formation of protective corrosion layers. Figure 12 provides an example of this for low-carbon steel at eight sites in South Africa (Ref 16). An initial increase in the atmospheric corrosion rates occurs, followed by a slowing down of the corrosion rates as corrosion products form on the alloy surface. This is true only for sites C through G. For site A and B, the corrosion rate is sufficiently high to prevent the formation of a protective layer; therefore, a constant very high corrosion rate was maintained. The effect of marine-atmospheric corrosion on tensile strength is shown in Fig. 13 for low-carbon steel and three aluminum alloys. The initial rate of loss in ultimate tensile strength is highest, but as time continues, the rate of loss decreases except for the low-carbon steel at Kure Beach and Point Judith (Ref 17).

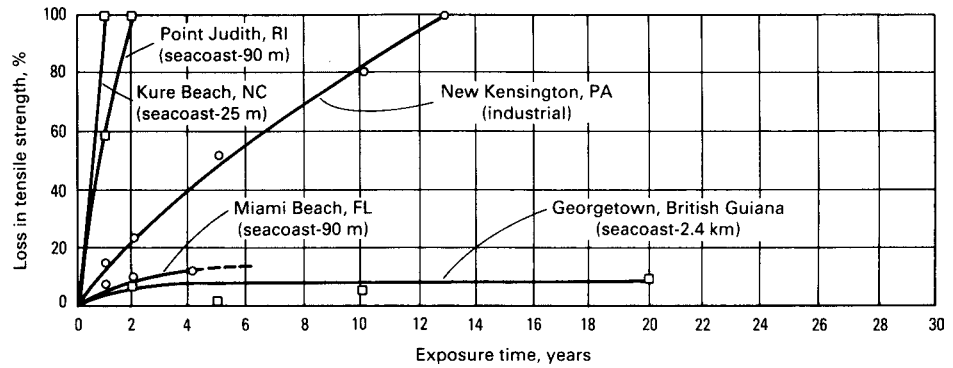
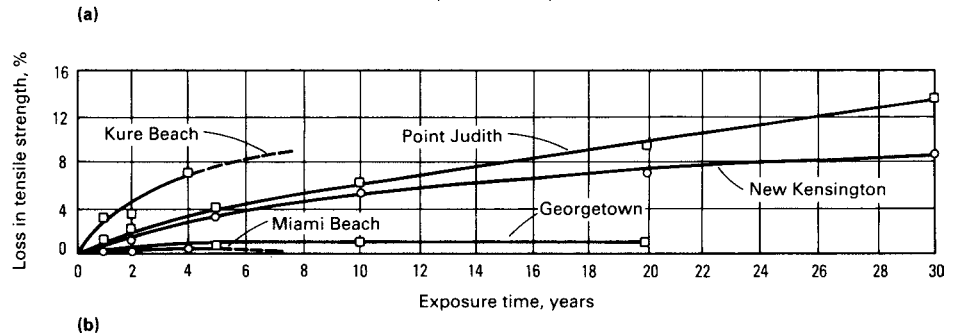
Fig. 13 Loss in tensile strength as a function of time for (a) 1.6 mm (1/16 in.) low-carbon steel and (b) aluminum alloys of the same thickness at five test sites. Data in (b) are averages for aluminum alloys 1100, 3003, and 3004. Source: Ref 17

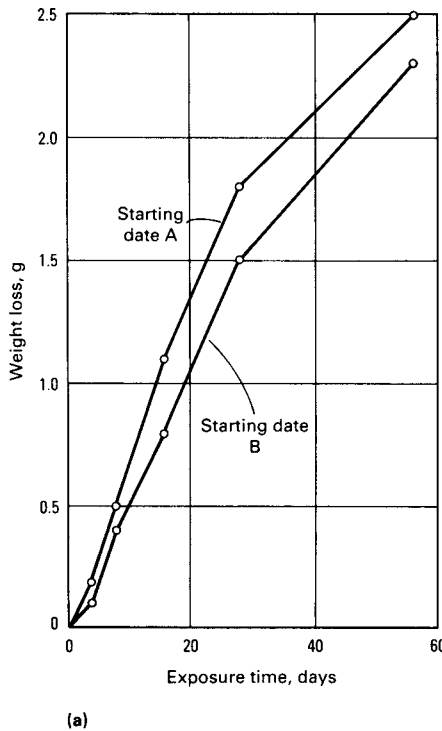
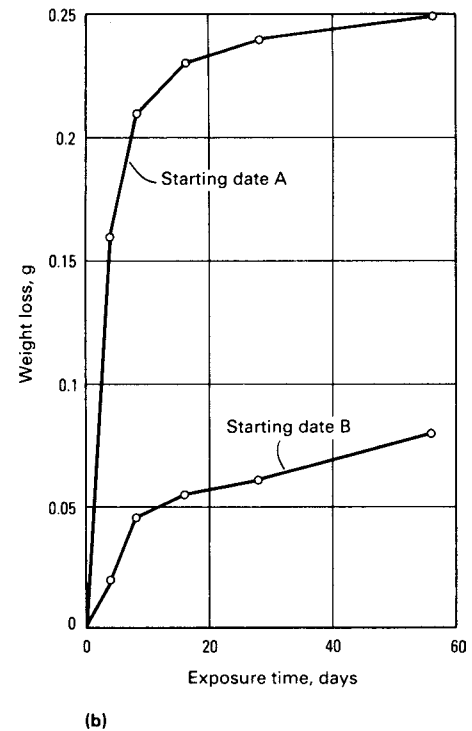
Fig. 14 Effect of different starting dates on the corrosion rate of (a) iron and (b) zinc. Source: Ref 6

**Starting Date.** The initial variation in the corrosion rate may depend on when the tests were started. Figure 14 compares the measured weight losses for iron and zinc in tests started at two different dates (Ref 6). Over a 60 day test, the variation in corrosion rate for zinc is much larger than that for iron. Similarly, for iron specimens at the Kure Beach oceanfront lot (25 m, or 80 ft), there are variations of hundreds

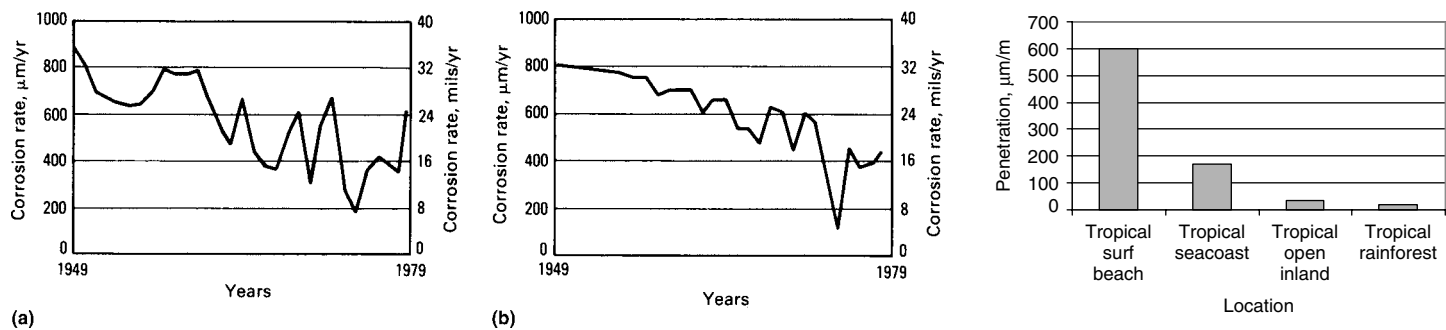
**Fig. 15** Corrosion of iron calibration specimens tested for (a) 1 year and (b) 2 years at the 25 m (80 ft) lot at Kure Beach, NC. Source: Ref 14

of micrometers per year in corrosion rates as measured on samples exposed vertically for 1 and 2 years each. This is shown in Fig. 15 for iron calibration specimens tested from 1949 through 1979 (Ref 14).

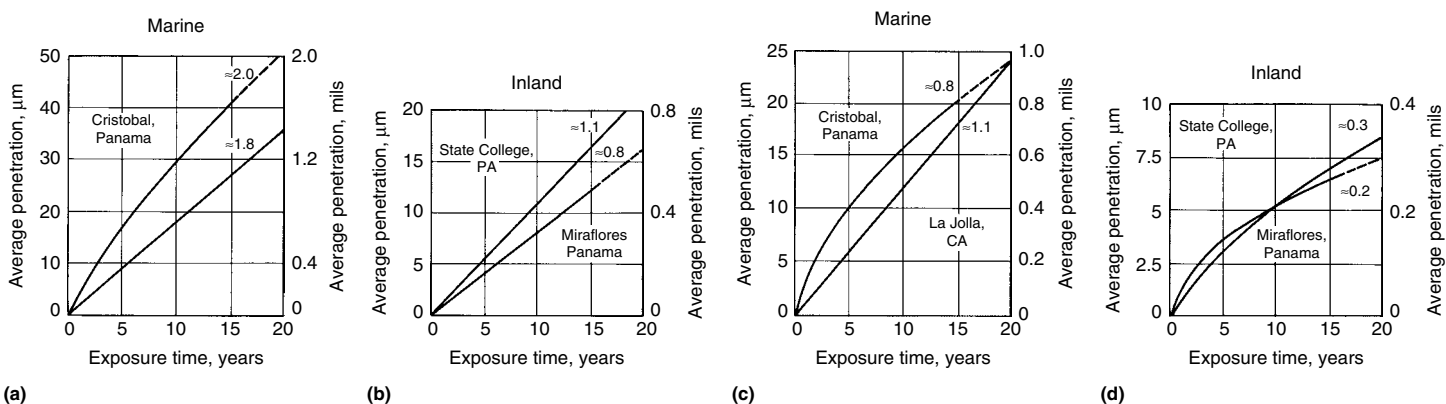
**Fig. 17** Comparison of corrosion rates for zinc (a and b) and copper (c and d) at tropical and temperate exposure sites. Numbers on curves are stabilized corrosion rates in micrometers per year. Source: Ref 18

Temperature, tropical-marine sites, and inland sites are compared in Fig. 17 for zinc and copper. The zinc corrodes more rapidly at the tropical-marine site; however, the reverse is true at the inland site, where the corrosion rate at State College, PA, is higher than at Miraflores, Panama. Overall, the long-term (15 to 20 years) rates for copper are similar at both marine and inland sites (Ref 18).

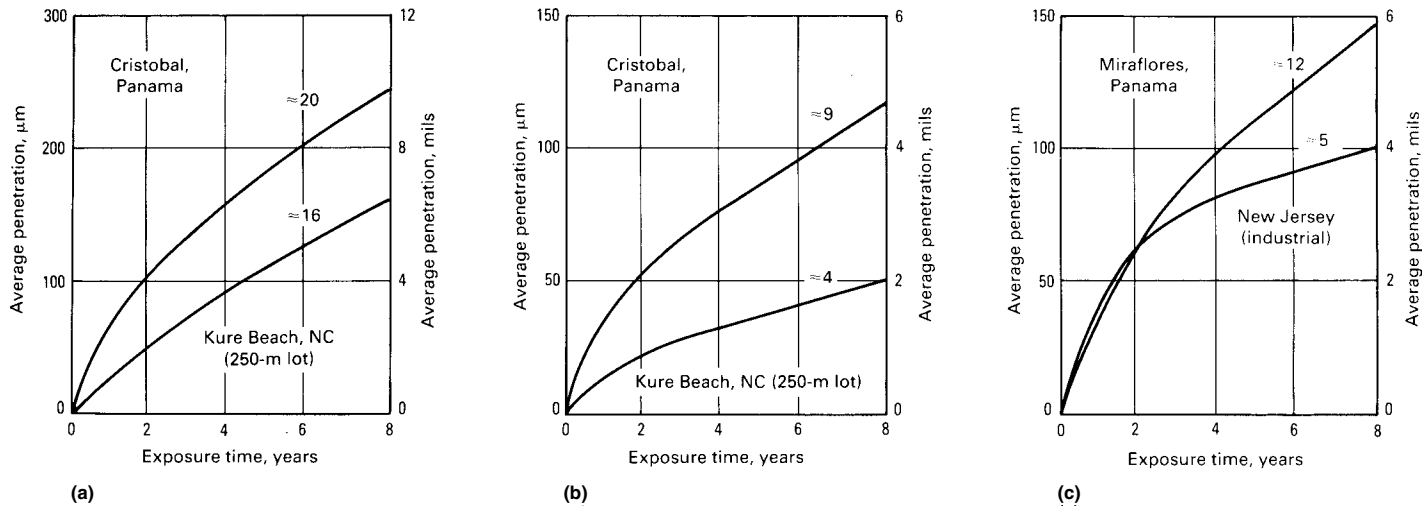
Fig. 18 Comparison of corrosion rates of steels at temperate and tropical exposure sites. Numbers on curves are stabilized corrosion rates in micrometers per year. (a) Carbon steel, marine exposure. (b) Low-alloy steel, marine exposure. (c) Carbon steel, inland exposure. Source: Ref 18

A similar comparison for carbon and low-alloy steels (Fig. 18) illustrates that the tropical environment has a higher overall corrosion rate. Figure 18(a) compares the stabilized corrosion rate for carbon steel of 20  $\mu\text{m}/\text{yr}$  (0.8 mil/yr) at Cristobal, Panama, to 16  $\mu\text{m}/\text{yr}$  (0.63 mil/yr) at Kure Beach, NC, near-ocean lot (250 m, or 800 ft). Low-alloy steel exhibited a similar increased rate of corrosion, as shown in Fig. 18(b). The stabilized corrosion rate is the slope of the average penetration corrosion loss-time curve. The values are given next to the curves in Fig. 18 and 19. The same pattern is exhibited for carbon steel at inland sites (Fig. 18c) (Ref 18).

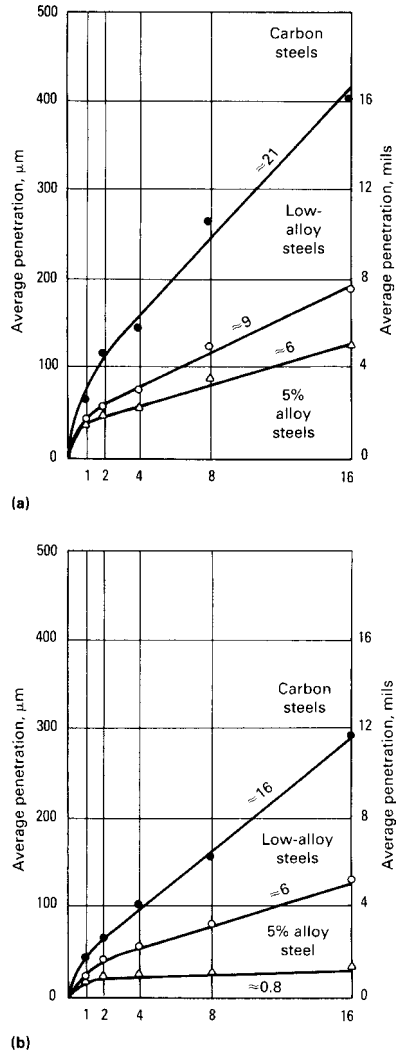
Fig. 19 Comparison of (a) marine and (b) inland corrosion rates for carbon steel, low-alloy steels, and 5% alloy steels at the Naval Research Laboratory test site in Panama. Numbers on curves are stabilized corrosion rates in micrometers per year. Source: Ref 18

**Alloy Content.** The particular alloy composition can make a significant difference in the marine-atmospheric corrosion rate of a material. For steels, a comparison of carbon steels, low-alloy steels, and steels with 5% alloying elements is shown in Fig. 19 for marine and inland exposure (Ref 18). In each case, the long-term corrosion rate is greater for the marine environment. Additionally, Fig. 19 shows the accelerated corrosion that occurs in the first 1 to 3 years and the constant rate associated with long-term atmospheric corrosion. Very similar results (Fig. 12) have been reported for a study done in South Africa at eight sites that are classified as rural to severe marine.

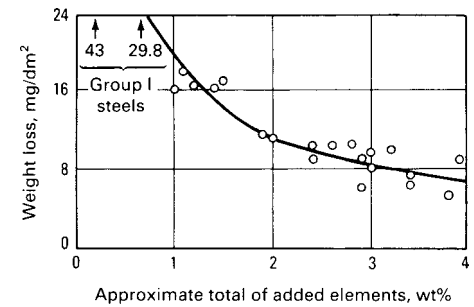
**Fig. 20** Corrosion data for 25 low-alloy steels tested over a 15.5 year period at the Kure Beach, NC, 250 m (800 ft) lot. Source: Ref 8

The results of 15.5 year studies of low-alloy steels conducted at the Kure Beach, NC, near-ocean lot (250 m, or 800 ft) are shown in Fig. 20, in which the mass loss per unit area is plotted as a function of the total alloy content. If alloy additions of approximately 2 wt% are considered, then the mass loss per area is reduced from greater than 40  $\text{mg}/\text{dm}^2$  to less than 8  $\text{mg}/\text{dm}^2$  (Ref 8).

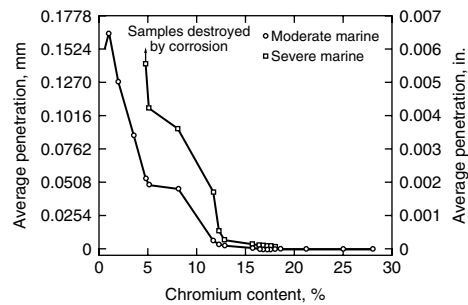
**Fig. 21** Effect of chromium addition on the atmospheric corrosion of steels. Source: Ref 20

The significance of chromium as an alloying element is shown in Fig. 21 for atmospheric

corrosion conditions classified as moderate and severe marine (Ref 20). Above 12 or 12.5 wt% Cr, the atmospheric corrosion becomes negligible; lower chromium levels result in a rapid increase in the corrosion rate. Table 5 provides compositions for 11 type 300- and 400-series stainless steels tested at the near-ocean lot

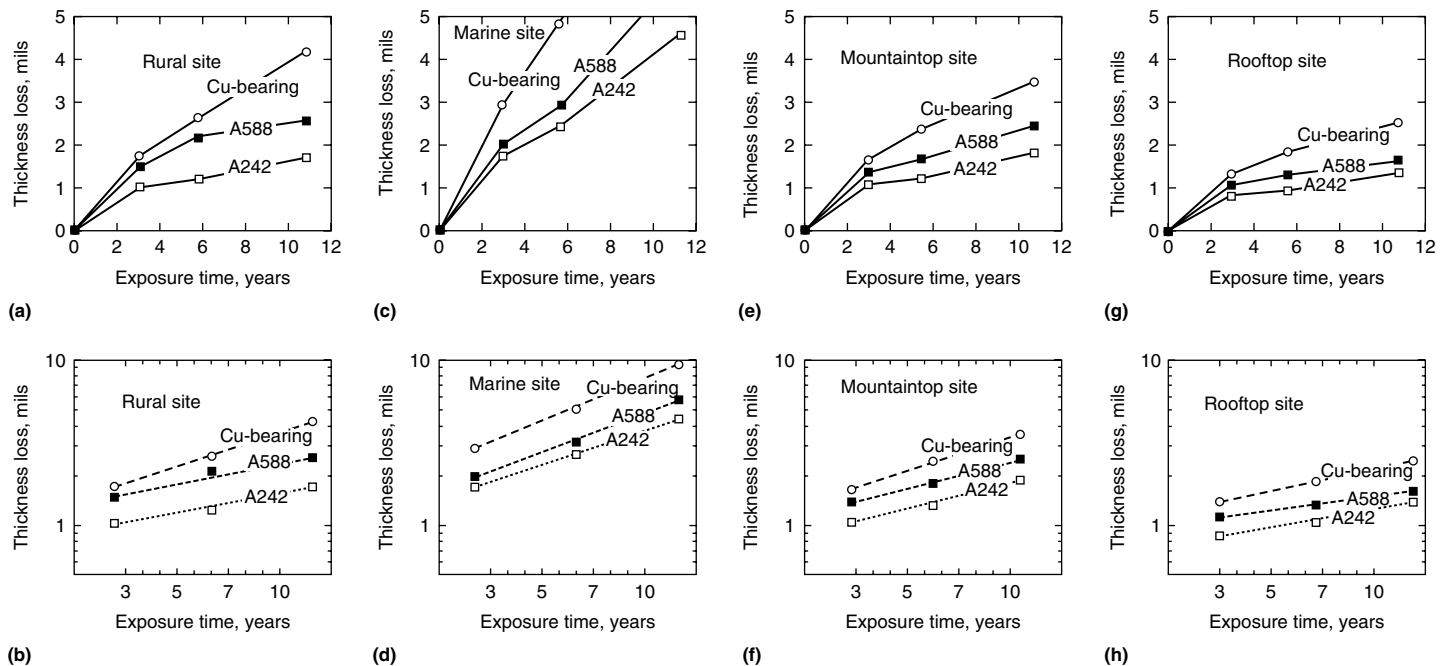
**Fig. 22** Corrosion performance of copper-bearing, A588B, and A242 weathering steels. Locations: (a) and (b), rural; (c) and (d), marine; (e) and (f), mountaintop; and (g) and (h), rooftop. Linear plots: (a), (c), (e), and (g). Logarithmic plots: (b), (d), (f), and (h). Source: Ref 23

Another category of steels that is of interest for marine-atmospheric corrosion applications are weathering steels. Four weathering steels and their compositions are listed in Table 7 (Ref 22). The predicted 50 year corrosion penetration results are given in Table 8 for three environments. Each material has four orientations. The highest average predicted penetrations (2523 µm, or 99.3 mils) are for the carbon steel, which has the lowest copper alloy content, in the moderate-marine environment. In contrast, the predicted average value for ASTM A242, under the same conditions, is approximately one-tenth of the carbon steel value (268 µm, or 10.5 mils) (Ref 22). Using the ISO corrosivity recommendations, the moderate-marine site would be a C<sub>4</sub> or C<sub>5</sub> site (Ref 3). Figure 22 shows a comparison of the aforementioned weathering steels at marine, rural, mountaintop, and rooftop sites. Of those four sites, the marine environment exhibits the highest corrosion (Ref 23). Additional sources of information are available in the ASTM standards listed in Table 9.

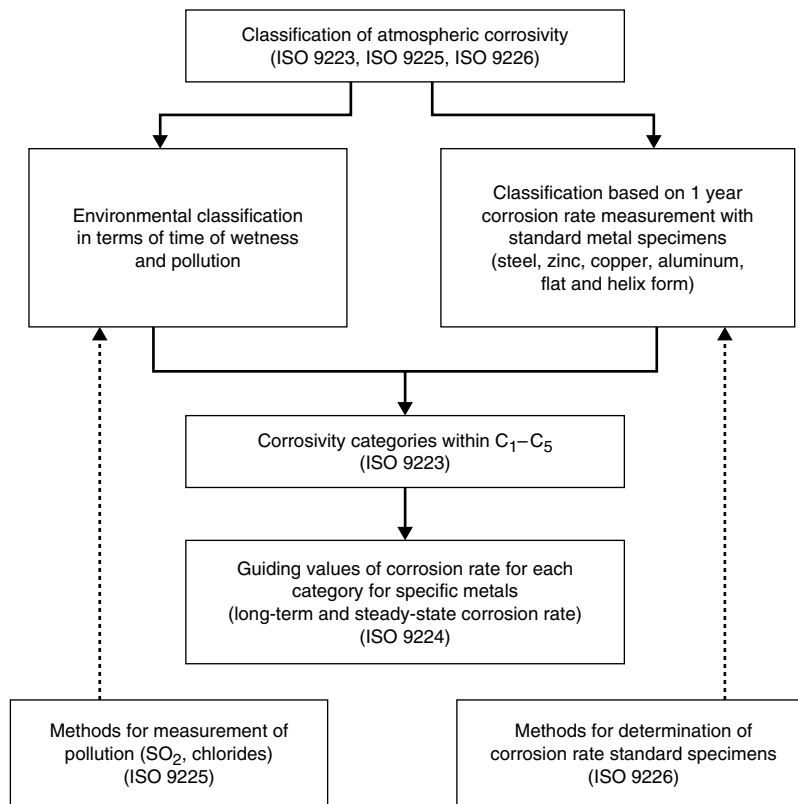
Fig. 23 Scheme for classification of atmospheric-corrosivity approach in ISO 9223 to 9226. Source: Ref 29

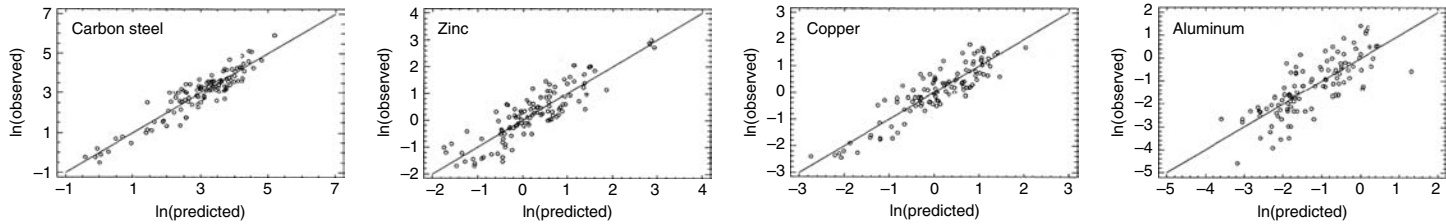
Fig. 24 Observed versus predicted values (logarithmic) for carbon steel (Eq 6), zinc (Eq 7), copper (Eq 8), and aluminum (Eq 9). Source: Ref 30

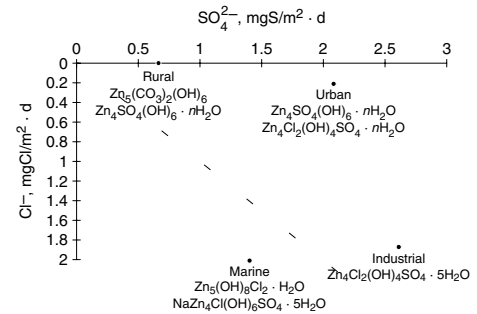
Fig. 25 Compositions of corrosion products on zinc as a function of sulfate on chloride. Source: Ref 33

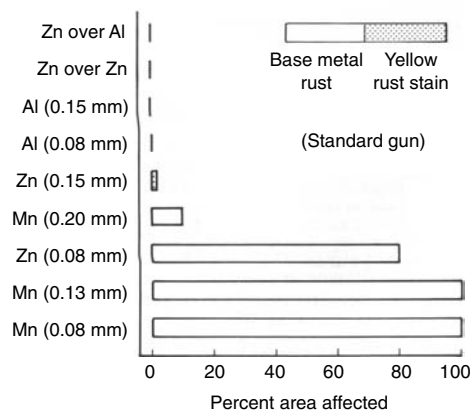
**Fig. 1** Percent of area corroded on single-element powder thermal spray coatings after 34 years of marine atmospheric exposure in the 250 m (800 ft) lot at Kure Beach, NC. Source: Ref 1

A report was issued after 34 years of marine exposure in the 250 m (800 ft) lot in Kure Beach, NC, revealing that the aluminum powder thermal coatings and the layered zinc/aluminum and aluminum/zinc powder thermal spray coatings showed no base metal corrosion or rust staining of the thermal spray coatings after 34 years. A comparison of the performance of the pure metal coatings evaluated in this study after 34 years of exposure is presented in Fig. 1. When observed in August 2001, almost 50 years after initial exposure at the 250 m (800 ft) marine atmospheric site, the 0.08 mm (3 mils) and 0.15 mm (6 mils) thermal spray aluminum coatings were fully intact with only a small amount of rust staining noted on the 0.08 mm (3 mils) panel at a cut edge and no rust or rust staining noted on the thicker coating as shown in Fig. 2.

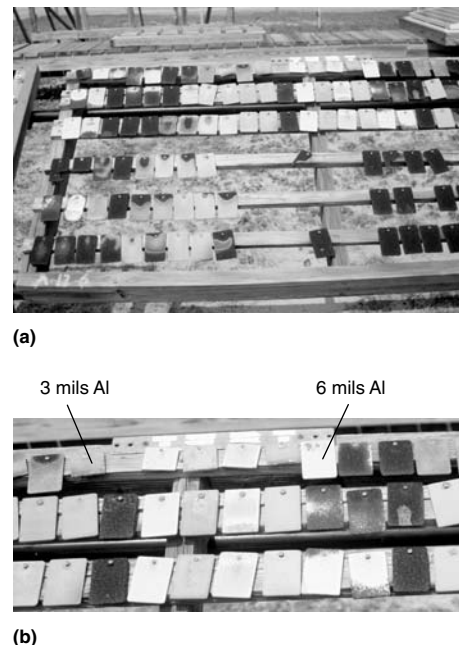
**Fig. 2** Original T.P. Hoar study panels after over 48 years of exposure at the 250 m (800 ft) marine atmospheric exposure site in Kure Beach, NC. (a) View of test rack. (b) Closer view of thermal spray coatings and other panels.

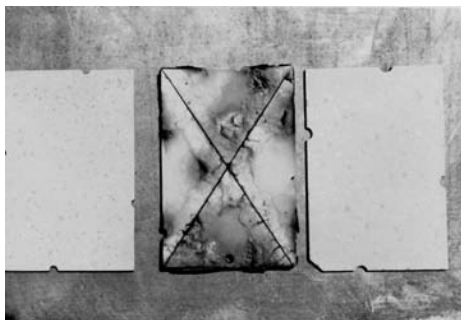
**Fig. 3** Comparison of scribed, sealed, and painted thermal spray coatings on steel substrates to a scribed painted steel panel after 42 months of severe marine atmospheric exposure. (a) Flame-sprayed aluminum on steel, sealed/painted. (b) Painted steel panel (one coat MIL P24441 F150 primer followed by one coat of formula 150 and one coat formula 151). (c) Arc-sprayed aluminum on steel, sealed/painted

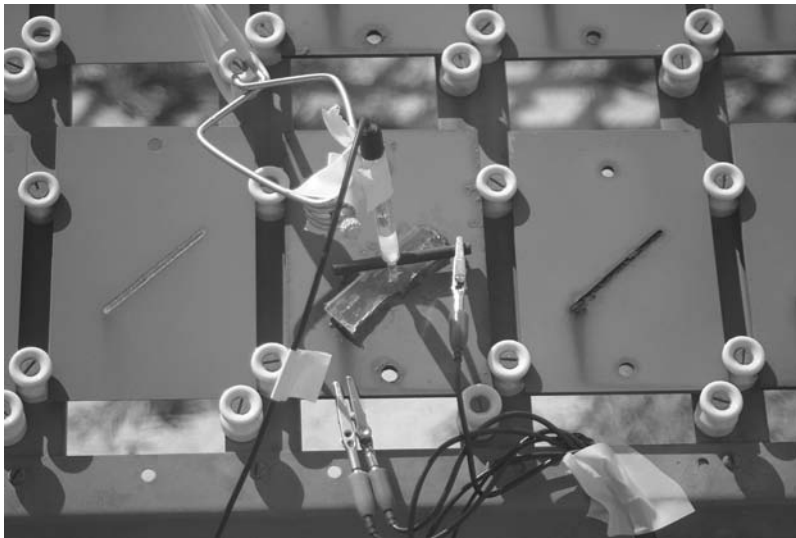
Fig. 4 In-situ electrochemical measurement on scribed area of a panel exposed to the marine atmosphere

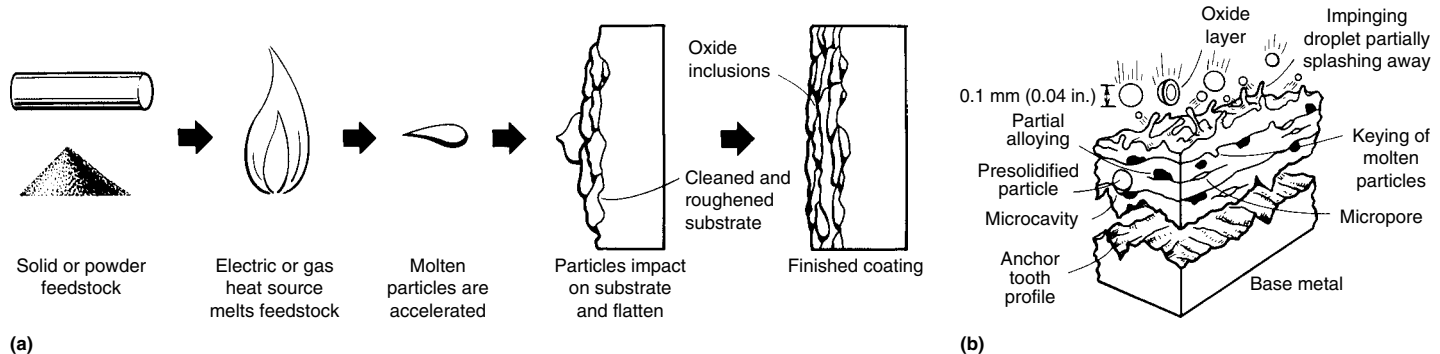
Fig. 5 Schematics showing (a) coating deposition in thermal spray processes and (b) the morphology of thermal spray coatings

from powder, wire, or rod in a gas stream and project the molten metal onto a suitably prepared substrate. Upon impact with the substrate, the molten droplets rapidly solidify to form a thin “splat” (Ref 16) as shown in Fig. 5. Thin overlapping and interlocking particles forming the coating characterize this splat. The coating is built up by successive impingement and interbonding among splats as illustrated in Fig. 5 and 7. Imperfections originate from “unmelted” particles that are not totally molten, large particles that are bigger than the median size, low velocities, oxidation of particles, and fragmented splats (Ref 16). Note that voids and oxides form an interconnected network within the coating, allowing the environment to eventually work its way through the coating, if the coating is not sealed and/or painted. In addition to the thickness and composition of these coatings, the microstructure can be extremely varied. Materials deposited may be in thermodynamically metastable states, and the grains within the splats may be sub-micron-size or even amorphous (Ref 17). This ultrafine-grained microstructure leads to an anisotropy of the coating in the direction perpendicular to the spray direction (Ref 16). Despite their being fine grained, the thermal sprayed microstructures have an abundance of imperfections comprising a variety of particle sizes, volume densities, morphologies, and sometimes orientations (Ref 16). Micrographs of a few common imperfections in thermal spray coatings are presented in Fig. 9.

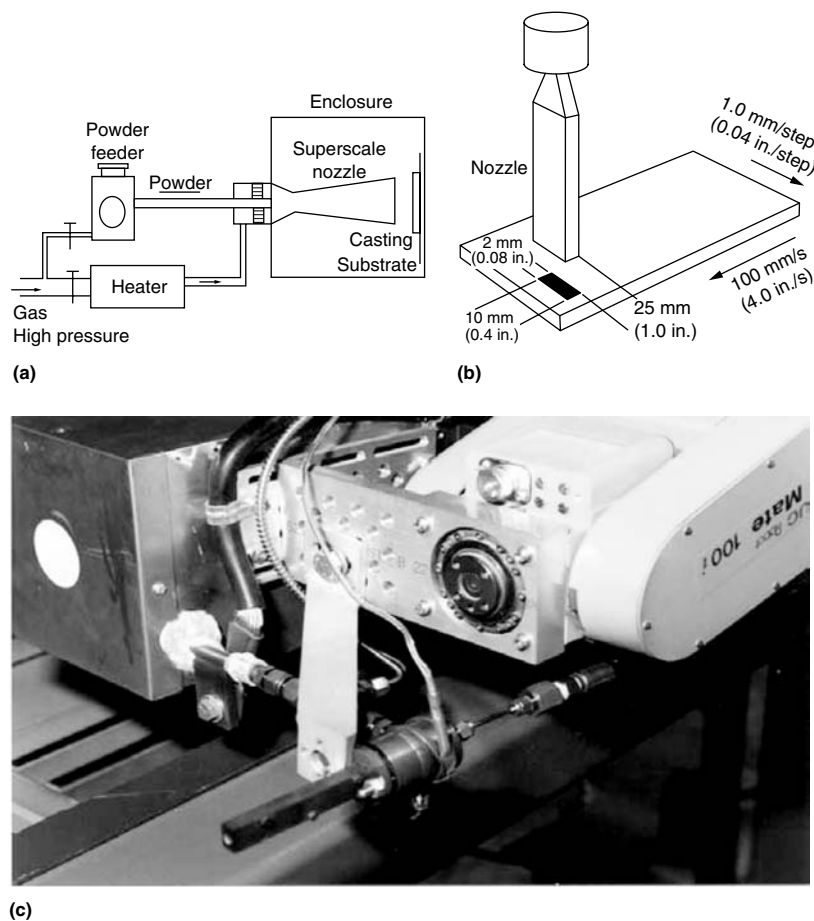
**Fig. 6** Schematic illustration of (a) the high-velocity particle consolidation (HVPC) coating deposition process and (b) the nozzle placement with regard to substrate surface in HVPC. The nozzle and gas heat can be mounted on a robot for optimal deposition. (c) Close-up photograph of HVPC nozzle and gas heater mounted on a 6-axis robot. Source: Ref 10

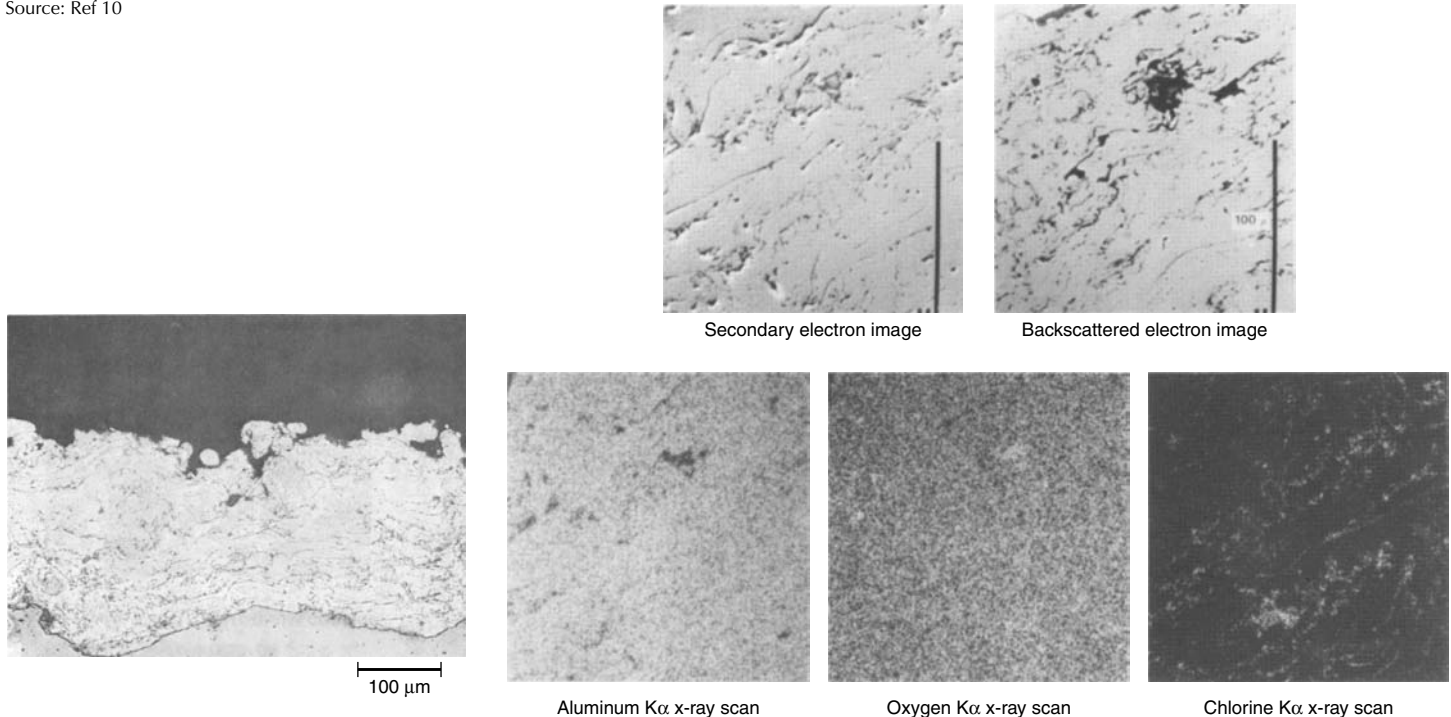
**Fig. 7** Micrograph through a flame-sprayed aluminum coating showing oxide layers within the coating (thin dark lines)

**Fig. 8** Electron microprobe x-ray scans of flame-sprayed aluminum coating cross sections after full immersion in filtered seawater for 15 months
