# ASM Handbook®

## Volume 13C Corrosion: Environments and Industries

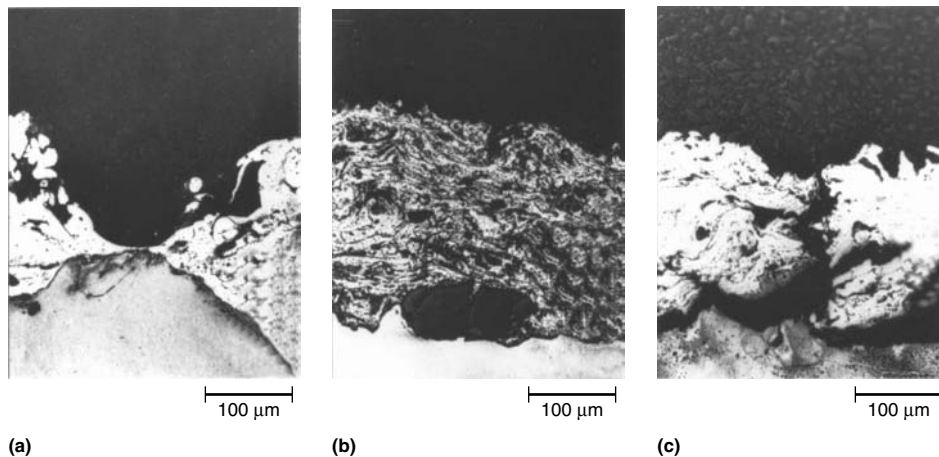
**Fig. 9** Typical imperfections in flame/arc spray coatings. (a) Thin area in coating. (b) Imbedded blasting grit. (c) Void extending to substrate

from powder, wire, or rod in a gas stream and project the molten metal onto a suitably prepared substrate. Upon impact with the substrate, the molten droplets rapidly solidify to form a thin “splat” (Ref 16) as shown in Fig. 5. Thin overlapping and interlocking particles forming the coating characterize this splat. The coating is built up by successive impingement and interbonding among splats as illustrated in Fig. 5 and 7. Imperfections originate from “unmelted” particles that are not totally molten, large particles that are bigger than the median size, low velocities, oxidation of particles, and fragmented splats (Ref 16). Note that voids and oxides form an interconnected network within the coating, allowing the environment to eventually work its way through the coating, if the coating is not sealed and/or painted. In addition to the thickness and composition of these coatings, the microstructure can be extremely varied. Materials deposited may be in thermodynamically metastable states, and the grains within the splats may be sub-micron-size or even amorphous (Ref 17). This ultrafine-grained microstructure leads to an anisotropy of the coating in the direction perpendicular to the spray direction (Ref 16). Despite their being fine grained, the thermal sprayed microstructures have an abundance of imperfections comprising a variety of particle sizes, volume densities, morphologies, and sometimes orientations (Ref 16). Micrographs of a few common imperfections in thermal spray coatings are presented in Fig. 9.

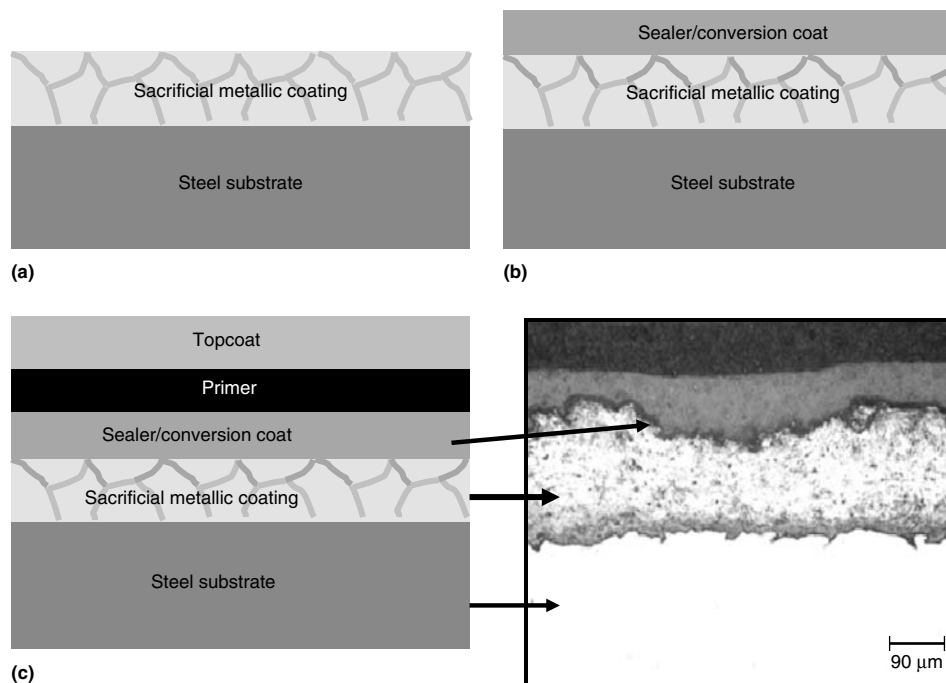
**Fig. 10** Schematics of typical coating systems. These include (a) the “as-deposited” pure aluminum or zinc sacrificial metallic coating, without the addition of any organics, applied to SAE 1018 steel; (b) the pure sacrificial coating applied to SAE 1018 steel plus a sealer or conversion coat; and (c) the pure aluminum or zinc sacrificial coating applied to SAE 1018 steel plus a water or solvent-based sealer, primer, and a topcoat. 200 $\times$

takes 7 days (Ref 19). Finally, finish coating layers (water or solvent reducible primer/topcoat combinations) are applied. The primer is applied on top of the sealer to aid in adhesion of the paint to the remaining coating system. Available primers include water or solvent reducible, air-drying, and corrosion-inhibiting primers. A typical coating system, illustrating the various layers in the system, is presented in Fig. 10.

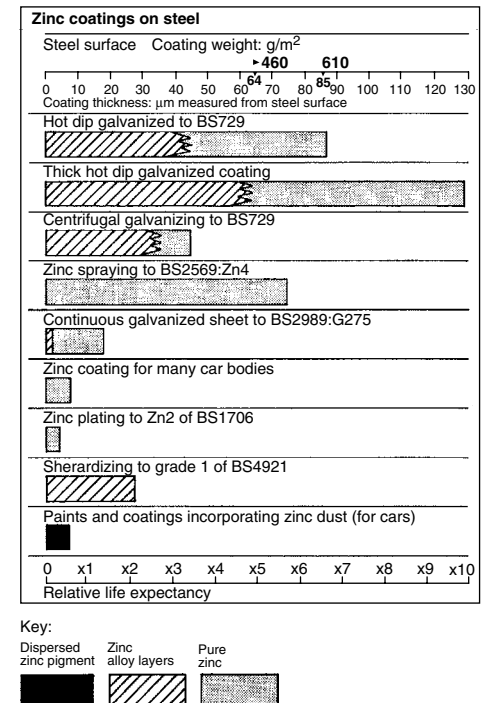
**Fig. 11** Range of thickness for typical zinc coatings and their respective relative life expectancies.

Galvanizing has been used extensively for protection against marine environments and approximately 40 million tons of steel are hot-dip galvanized each year (Ref 20). The advantages associated with applying zinc by thermal spray versus galvanizing makes the former method attractive for certain applications and the latter attractive for others (Ref 21). Hot dip galvanizing produces a fully dense coating that is metallurgically bonded to the substrate. In galvanizing, the size of the part, heat distortion, ease of application, and the thickness and uniformity of the coating are factors that must be considered. The thickness of galvanized coatings can vary from less than 25 to 200  $\mu\text{m}$  (<1 to 8 mils) and should be selected depending on the environment to be experienced and the desired lifetime. A range of zinc coating processes, including hotdipping, and their respective coating lifetimes are presented in Fig. 11 (Ref 20). Thick galvanizing and thermal spray were the

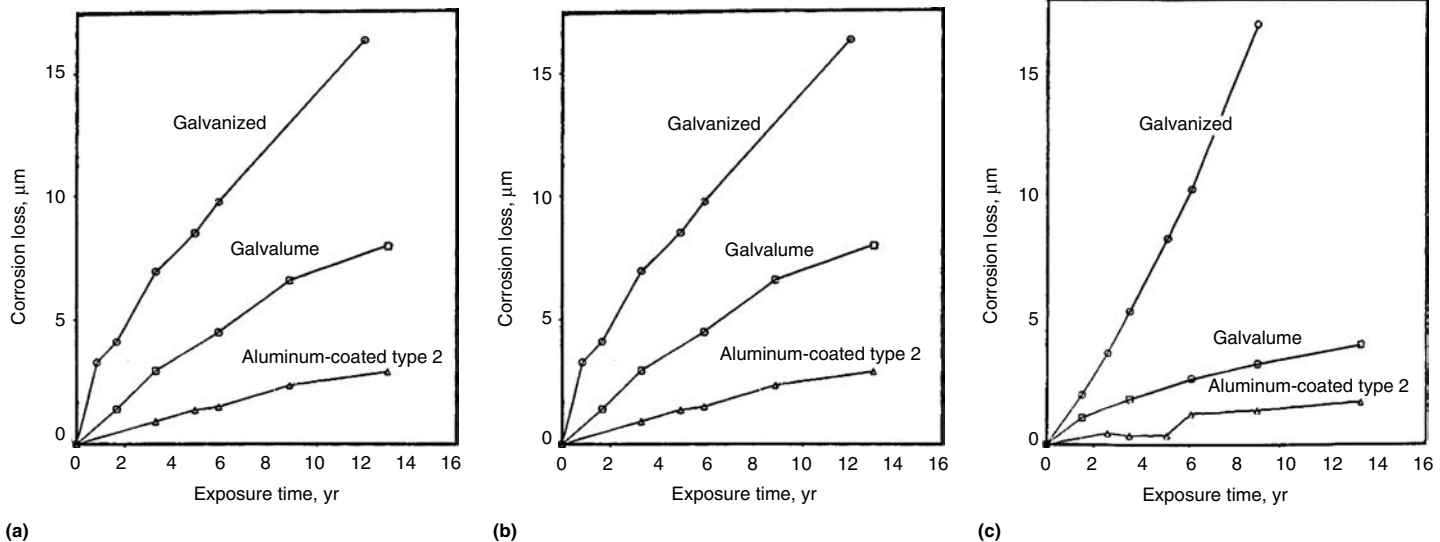
**Fig. 12** Corrosion-time plots for hot dip zinc, zinc-aluminum (55Al-1.5Si-43.5Zn), and aluminum-coated steel in (a) marine atmosphere (Kure Beach, NC: 250 m, or 800 ft, lot), (b) severe marine atmosphere (Kure Beach, NC: 25 m, or 80 ft, lot), and (c) industrial atmosphere (Bethlehem, PA)

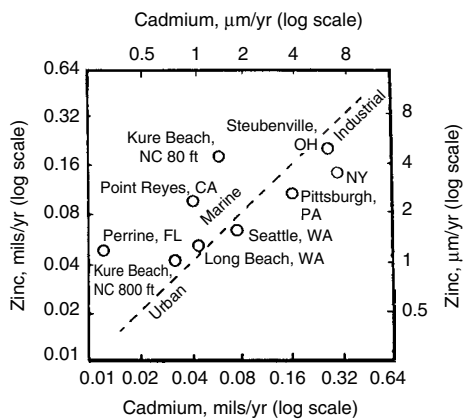
**Fig. 13** A comparison of corrosion rates of zinc and cadmium in marine, urban, and industrial atmospheres. Source: Ref 20

the plating process. Zinc plating also has a short service life. A comparison of zinc and cadmium coatings in industrial and marine sites (Fig. 13) illustrates the importance of zinc in marine environments. Alternatives for zinc plating include ion vapor deposited aluminum and paints containing zinc or aluminum pigment in a ceramic binder. These coatings, including zinc with a potassium silicate binder and aluminum with a phosphate-chromate binder, exhibit excellent corrosion protection for fasteners (minimum 1 year marine protection) (Ref 29). They are normally applied by conventional hand spraying.

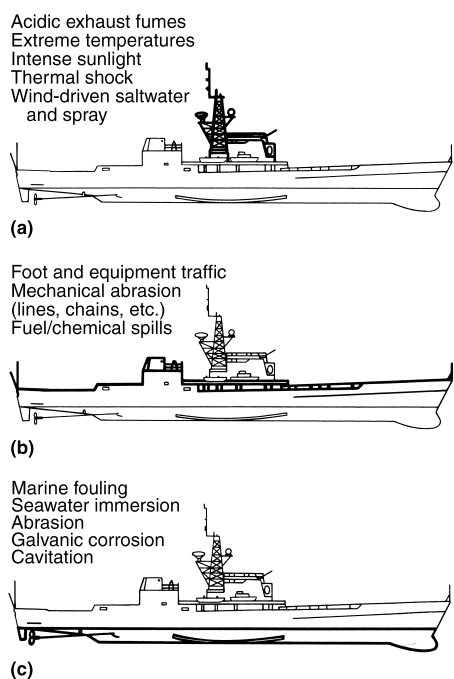
**Fig. 1** Environments that are destructive to shipboard coatings. (a) Antennas and superstructures. (b) Deck areas. (c) Underwater hull

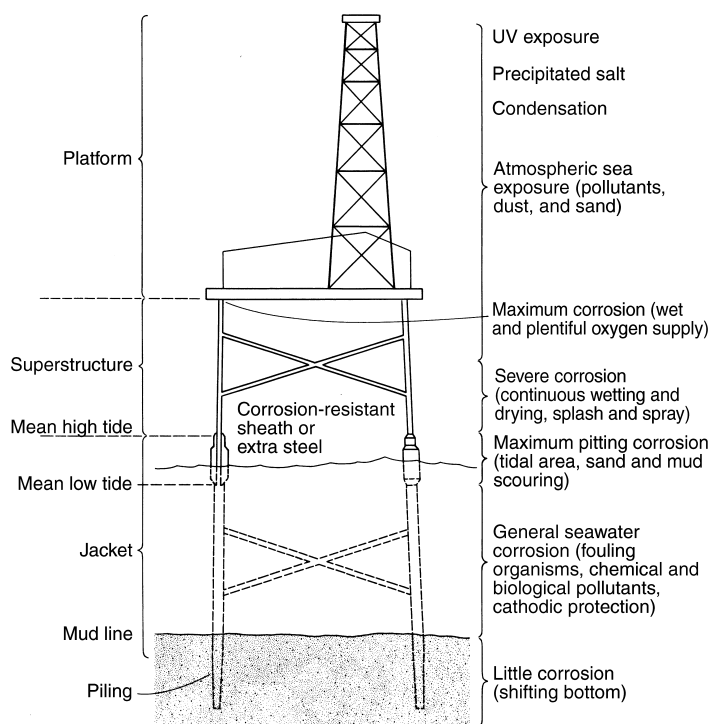
**Fig. 2** Zones of severity of environment for a typical offshore drilling structure. UV, ultraviolet

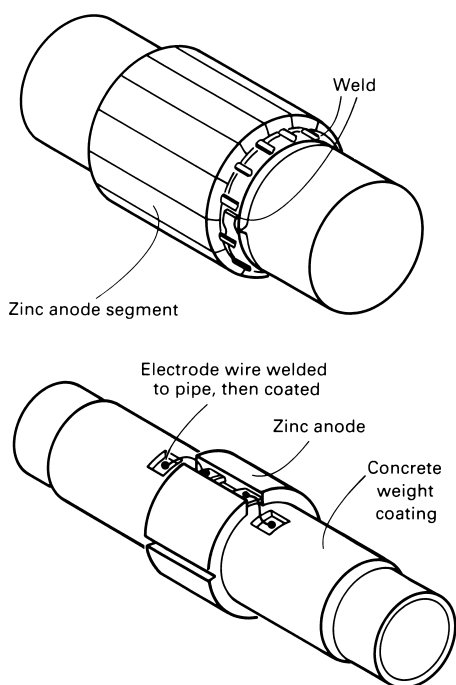
Fig. 1 Typical pipeline bracelet anodes

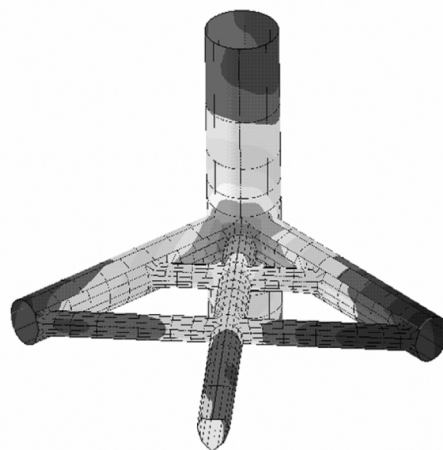
Fig. 2 Computer-generated plot of potential gradient distribution at the node of an offshore platform support structure

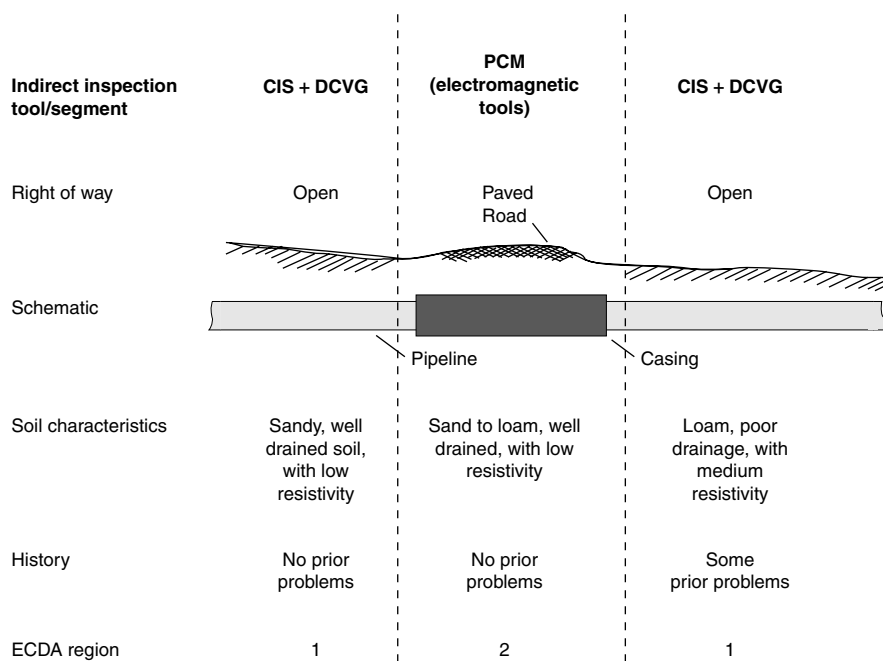
**Fig. 1** Characteristics of external corrosion direct assessment (ECDA) regions. Inspect tool/segments: close interval survey, CIS; direct current voltage gradient, DCVG; pipeline current mapper, PCM

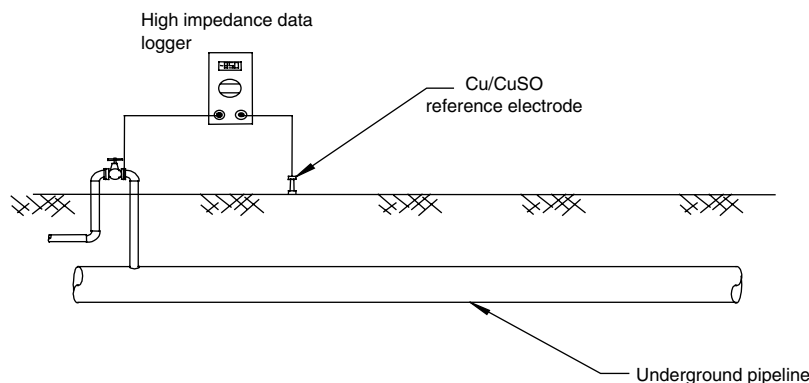
Fig. 1 Arrangement of close-interval survey components

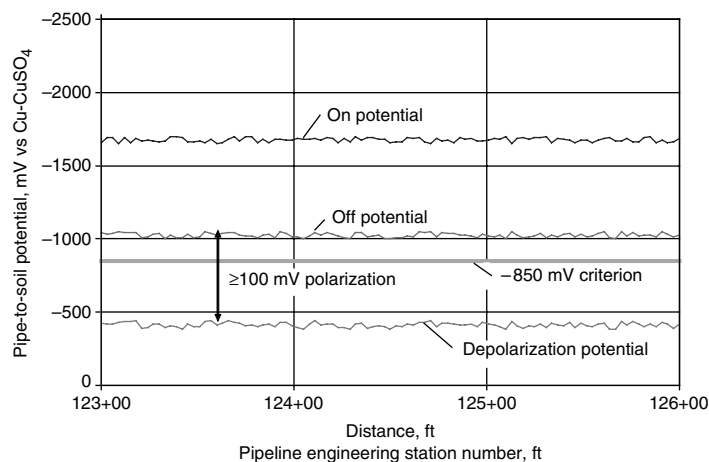
Fig. 2 Typical graph of fast-cycle interrupted survey combined with depolarized survey. Distances are measured from a specified starting point, 123+00 is 12,300 ft.

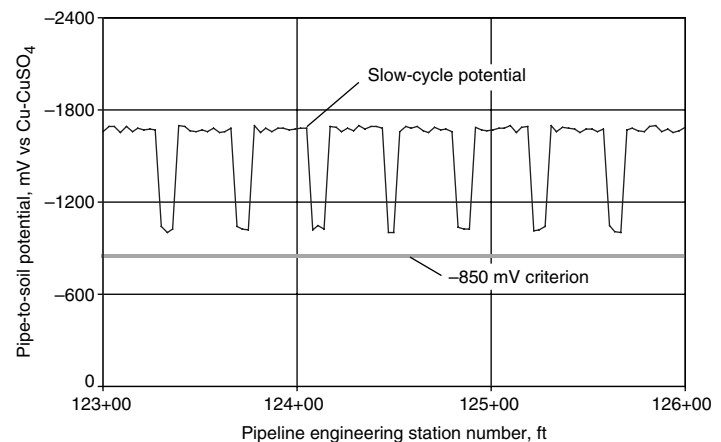
Fig. 3 Typical graph of slow-cycle interrupted close-interval survey. Distances are measured from a specified starting point, 123+00 is 12,300 ft.

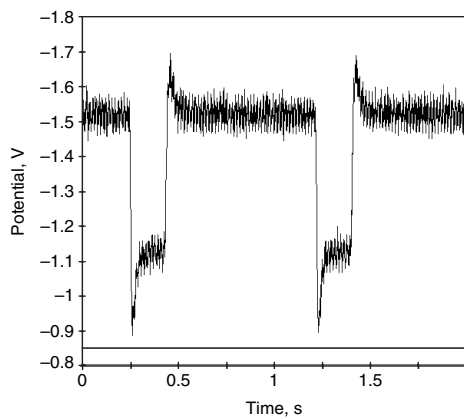
Fig. 4 Typical oscilloscopic wave form of fast-cycle interruption

There are various methods to confirm the operation of the current interrupters. Oscilloscopic waveforms may be used to show that the interrupters that influence a location are synchronized (Fig. 4). Waveforms do not indicate influencing current that is not interrupted. Lateral potentials and measurement of metallic *IR* drop may be used to obtain an indication of influencing CP current that is not being interrupted or foreign currents that are causing *IR* drops in the off cycle.

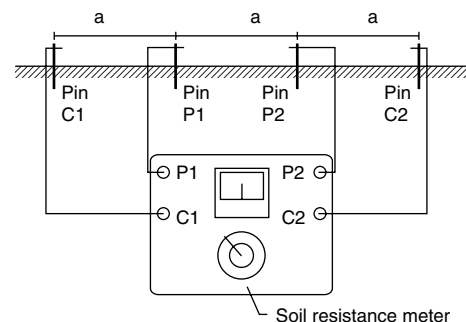
**Fig. 1** Soil-resistivity testing by the four-electrode test method. Current is applied to the outside electrodes (pins C1 and C2), while potential is measured on the inside pins P1 and P2. The pins are placed in a line and equally spaced ( $a$ ) to simplify resistivity calculation (in text). This resistivity is the average resistivity of a hemisphere of radius ( $a$ ). Source: Ref 15

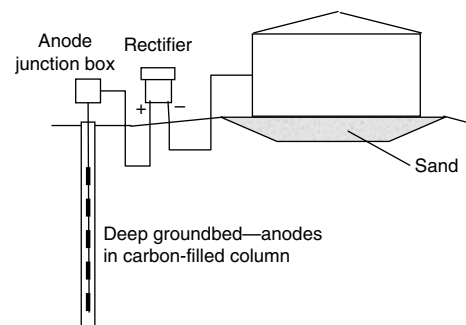
**Fig. 2** Typical deep anode groundbed CP system. Groundbed can be 20 m (65 ft) to several hundred meters deep. Source: Ref 2

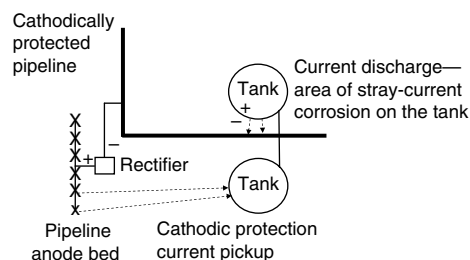
**Fig. 3** Stray-current corrosion caused by electrically common tanks picking up current from pipeline protection anode bed. Corrosion is most severe where current density leaving tank is highest (arrows). Source: Ref 2

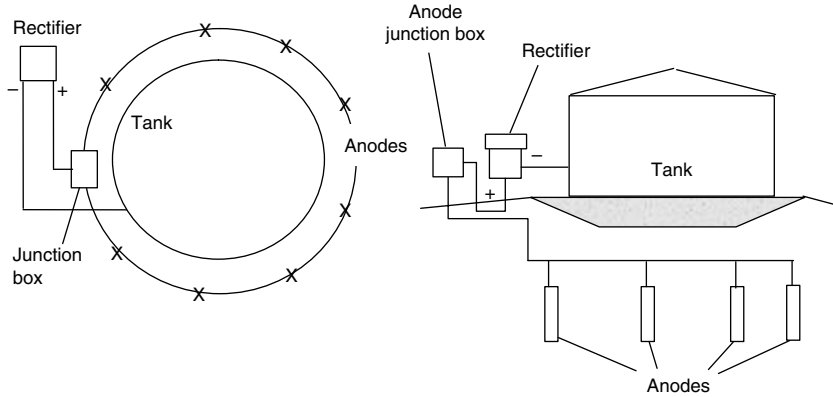
Fig. 4 Vertically drilled anode CP system, plan and elevation views. Source: Ref 2

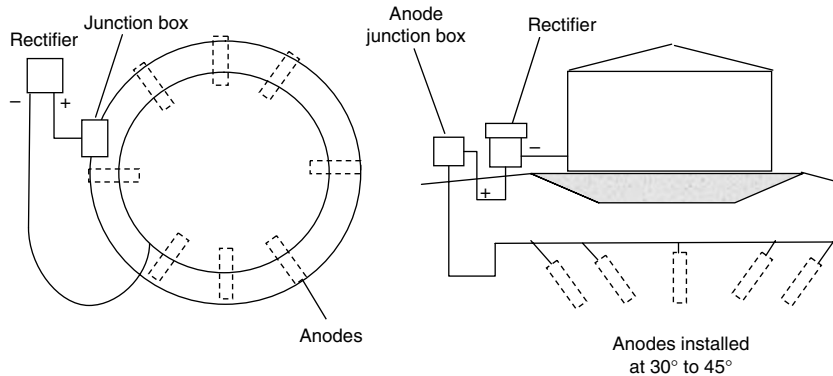
Fig. 5 Plan and elevation view of angle drilled anode CP system. Source: Ref 2

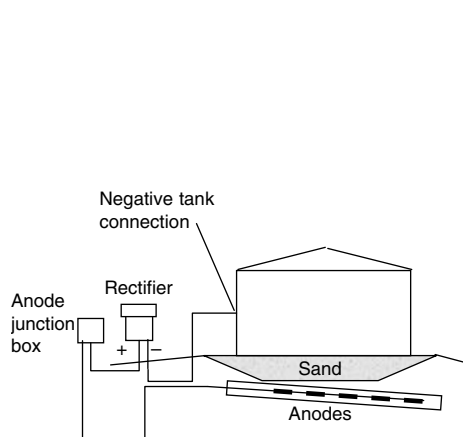
Fig. 6 Horizontally drilled anode system. Source: Ref 2

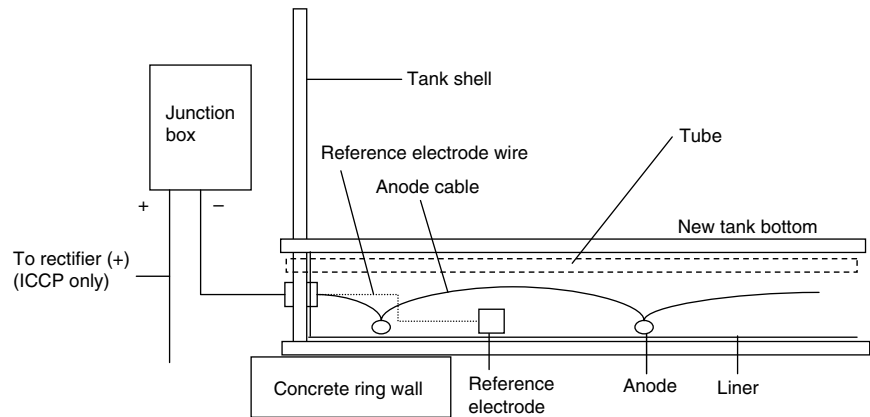
Fig. 7 Typical double bottom tank impressed current (ICCP) anodes layout. Sacrificial anodes can be placed in a similar fashion. Tube is a perforated nonmetallic tube for monitoring CP system.

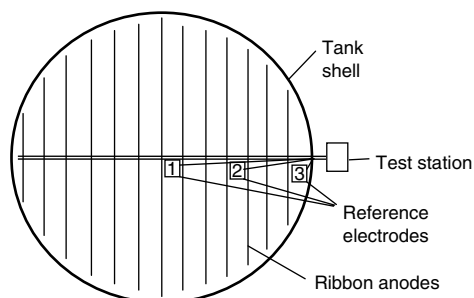
**Fig. 8** Plan view of sacrificial anode grid pattern. Source: Ref 2

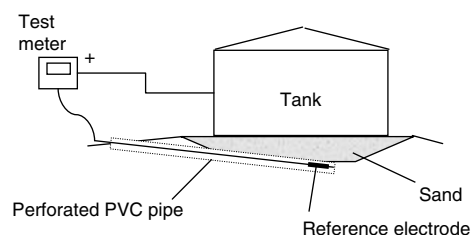
**Fig. 10** Perforated nonmetallic pipe for monitoring the CP potentials under the tank bottom. Source: Ref 2

A perforated nonconductive tube can be directionally drilled and placed under the tank (Fig. 10). A permanent reference electrode can be installed in the tube, or a portable reference electrode can be used to measure the potential profile under the tank.

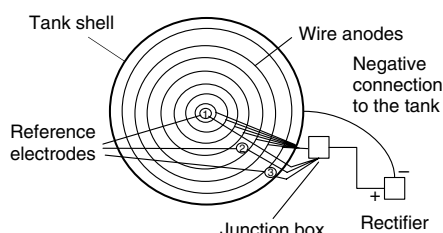
**Fig. 9** Impressed current grid using wire anodes. Plan view. Source: Ref 2

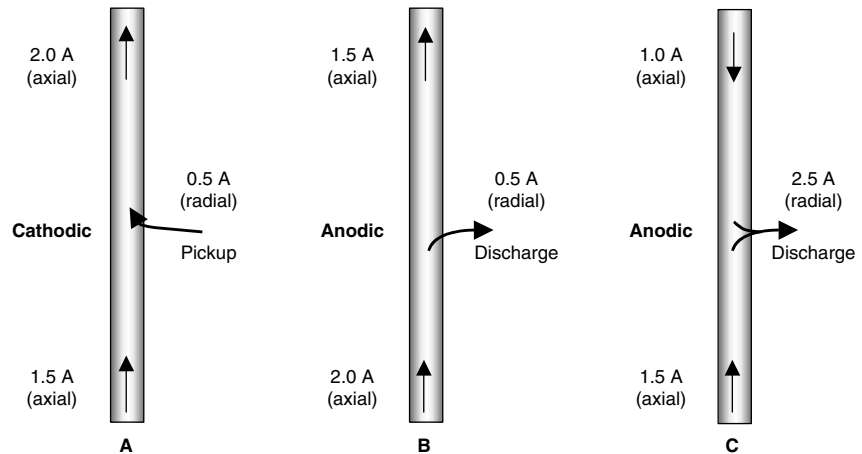
**Fig. 1** Example of radial current pickup or discharge from axial current. Refer to the text for a discussion of scenarios A, B, and C.

The anodic or corroding sections of a casing are at the sections of current discharge, while the current pickup areas are cathodic and are not corroding. Scenario A of Fig. 1 shows the axial current increasing from 1.5 to 2.0 A; therefore, there must have been a 0.5 A pickup in between, indicating that this section is cathodic. The current of 2.0 A coming up the casing in scenario B is greater than the 1.5 A that continues up the casing; thus, 0.5 A must have discharged from the section in between the two points, causing this to be anodic or corroding. The current of 1.0 A that is coming downhole at the top of scenario C is in the reverse direction from the 1.5 A coming uphole; therefore, the current coming into the casing section from both ends must discharge from the pipe section somewhere in between. This section is therefore anodic and would be corroding.

at about 90% of depth as shown in Fig. 3. This is the same as scenario C in Fig. 1. In a similar fashion, the current at a depth between 0 and 25% and also 40 and 55% of depth is less than the current below, although in the same direction, which is the same as scenario B in Fig. 1. This also indicates a current discharge (anodic) area. The remainder of the casing in this example is picking up current and is cathodic, which fits the condition illustrated by scenario A in Fig. 1.

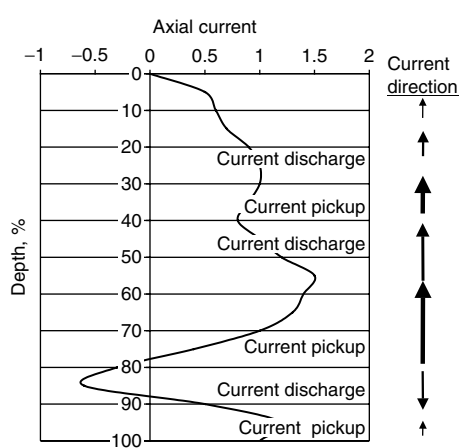
**Fig. 2** Example of axial current profile in casing without cathodic protection

By measuring the axial current at regular intervals along the casing, a complete current map along the casing can be obtained as shown in Fig. 2. Such a test is called a casing potential profile (CPP), and the plot in Fig. 2 is called an axial current profile. Both the amount and the direction of current have to be determined to predict a current pickup or discharge. An increasing slope coming uphole (equal to a negative change in depth per change in current going downhole) in Fig. 2 indicates a current pickup (cathodic section), while the reverse slope indicates a current discharge (anodic section). The amount of metal loss can be predicted for a given period of time on the assumption that the relative current will remain the same.

Determination of the amount of current pickup and discharge along the casing in Fig. 2 results in the radial current profile shown in Fig. 3. Referring to Fig. 2, the direction of net current flow at about “85% of depth” is in the downhole direction as it crosses the zero (0) current axis, while the current below that depth is coming uphole. This causes a current discharge centering

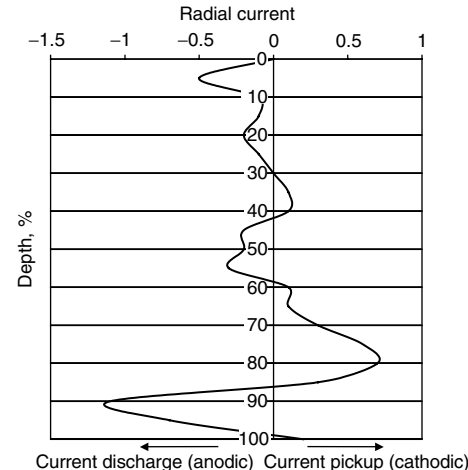
**Fig. 3** Calculation of radial current profile from Fig. 2

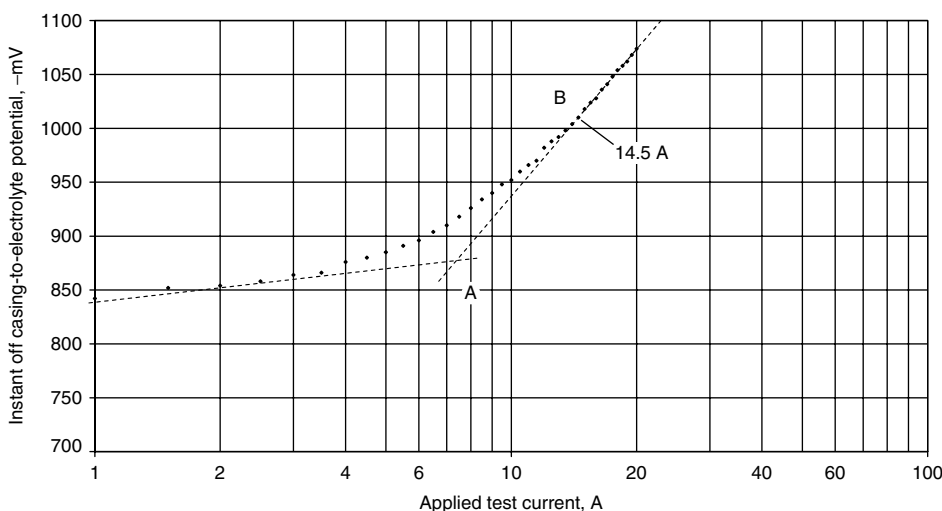
Fig. 4 An example of an  $E \log I$  plot. Refer to text for a discussion of points A and B.

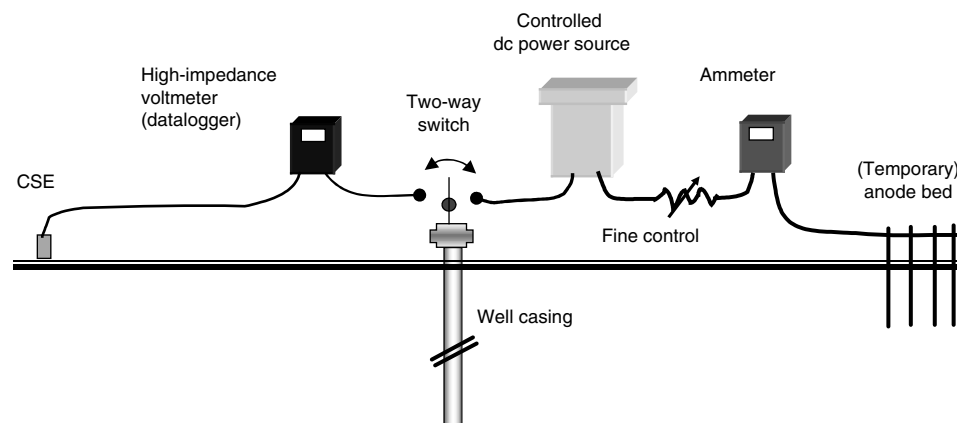
Fig. 5 Basic  $E \log I$  test. CSE, copper/copper-sulfate reference electrode; dc, direct current.

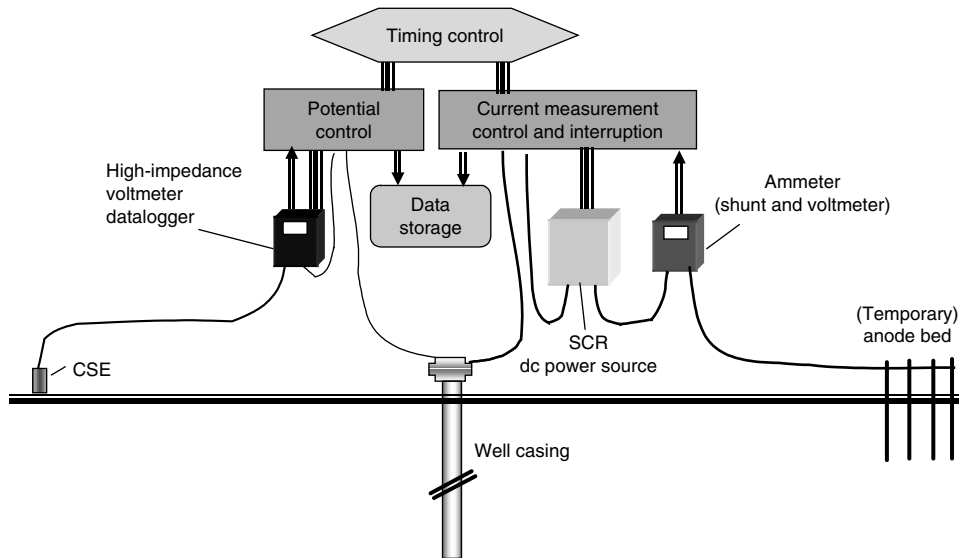
Fig. 6 Automatically controlled  $E \log I$  test. CSE, copper/copper-sulfate reference electrode; dc, direct current; SCR, silicon-controlled rectifier

Equipment (Fig. 6) can be set to automatically interrupt the current and record casing-to-electrolyte potentials continuously during the current interruption. In this way, the existence of a "spike" can be seen and the appropriate instant off casing-to-soil potential selected for each current interval. Furthermore, the current output

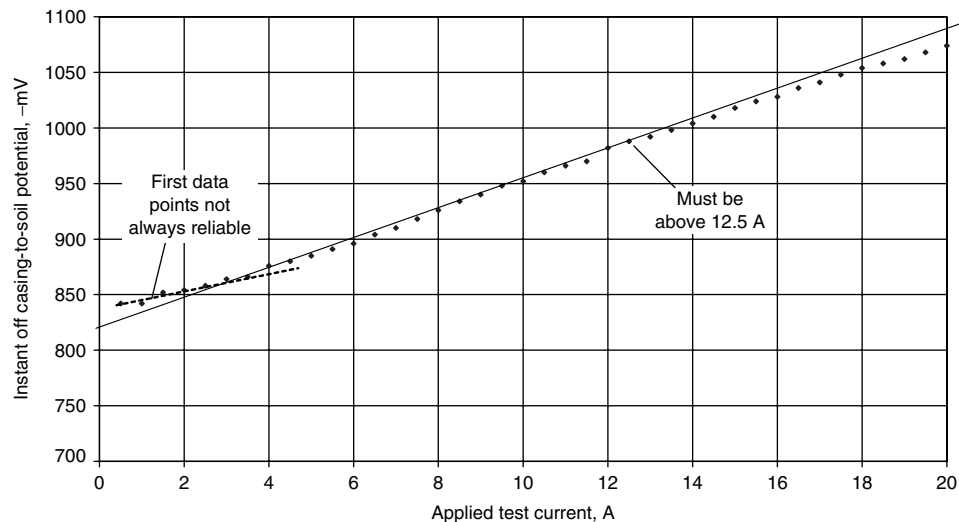
Fig. 7 Linear plot showing where the curve leaves a linear relationship. Tafel point on  $E \log I$  must be at a higher current than the point that deviated from a linear straight line in this figure. Data generated from Fig. 4

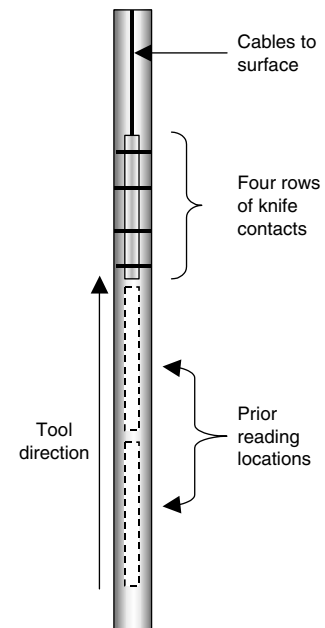
Fig. 8 CPET casing potential profile tool. CPET, corrosion protection evaluation tool

The original CPP tool had two contacts that were 3 m (10 ft) to 7.6 m (25 ft) apart. The tool was stopped at regular intervals for microvolt ( $\mu V$ ) measurements. Davies and Sasaki (Ref 13) describe a newer CPP tool (the CPET corrosion-protection evaluation tool) that has four rows of knife contacts that are 0.6 m (2 ft) apart between rows (Fig. 8). Measurements taken between the different rows of contacts include the pipe resistance, a voltage drop ( $\mu V_2$ ) between the inner 0.6 m (2 ft) contacts, and another voltage drop ( $\mu V_6$ ) across the outer contacts 1.8 m (6 ft) apart.

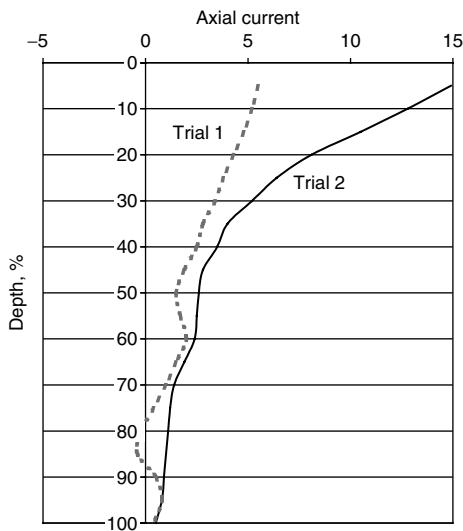
Fig. 9 Sample casing potential profile axial current profile

Figure 9 illustrates two cathodic protection trials with current applied. From the plots it can be seen that trial 1 did not eliminate all of the anodic areas. Thus, the applied current was increased until the anodic areas were eliminated as indicated by the axial current increasing continuously from the casing bottom to top, trial 2.

Trial 1 in Fig. 9 shows an axial current pickup at all but two sections. One current discharge is at approximately 55% of depth and the other at approximately 85% of depth; both of which are identified by "downward" slopes on the profile. The axial current at 85% of depth is in the

downhole direction as it crosses the zero (0) current axis, while the current below is coming uphole. While the axial current at 55% of depth is in the same downward direction, the current above is less than that below, which also indicates a current discharge or an anodic section.

Since this was unsatisfactory, the current was increased for trial 2 (it must be noted that during an actual test, time must be given to ensure a steady state has been achieved after ampere adjustments before another log is run to obtain reliable results). Here, continuous axial current pickup occurred from bottom to top as shown by the positive slope in the accumulated current profile. The total current value established by this test now becomes the criterion for cathodic protection. It should be noted that errors can occur in this measurement due to poor contacts. However, this is the best technology available at the present time to determine the amount of cathodic protection current required to protect a well casing, or a portion of a well casing.

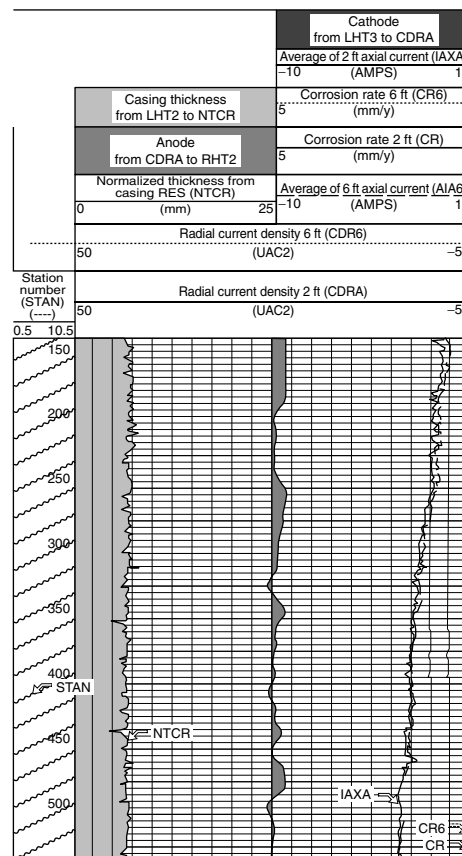
Fig. 10 CPET axial and radial current plot with a conventional rectifier and casing thickness. Total current is 15.3 A.

A partial CPET plot is shown in Fig. 10 that illustrates the axial current, radial current, and the casing thickness. The casing thickness is an estimate based on Faraday's law (Eq 1) and the assumption that the radial current discharge has remained the same over time. As a result, the casing thickness estimate may not be a true

measure of the wall thickness remaining. Experience has shown that there is often quite a discrepancy between corrosion-prediction losses by this method when compared to actual metal-loss measurements.

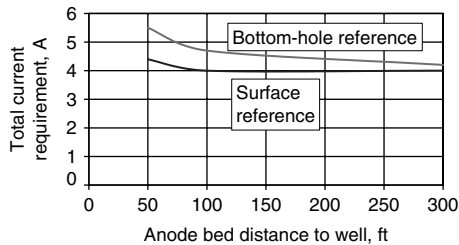
**Fig. 11** An example of the change in current requirements with anode to well spacing. Source: Ref 11

The spacing of the anode to the casing can also change the current required for a particular casing as illustrated by data from Blount and Bolmer (Ref 11) plotted in Fig. 11. The current requirement to protect the casing increases if the anode is brought too close to the casing. There is an optimum distance beyond which a further increase in distance is of no benefit. Hamberg et al. (Ref 7) also demonstrated a similar result in offshore well casings.

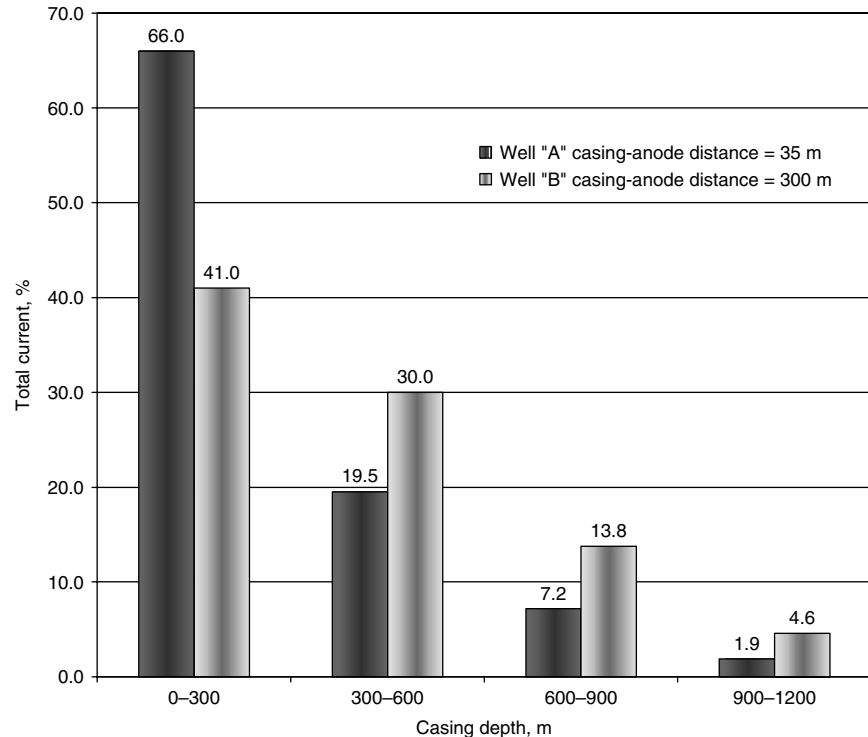
**Fig. 12** An actual example of current distribution in similar casings but with different casing-to-anode distances. Source: Ref 18

A comparison of the distribution of current in two similar casings that were 2600 m (8530 ft) (well casing “A”) and 2475 m (8120 ft) (well casing “B”) deep in the same area but with different casing-to-anode separations is shown in Fig. 12. The excess current being impressed onto the casing near the surface helps provide an

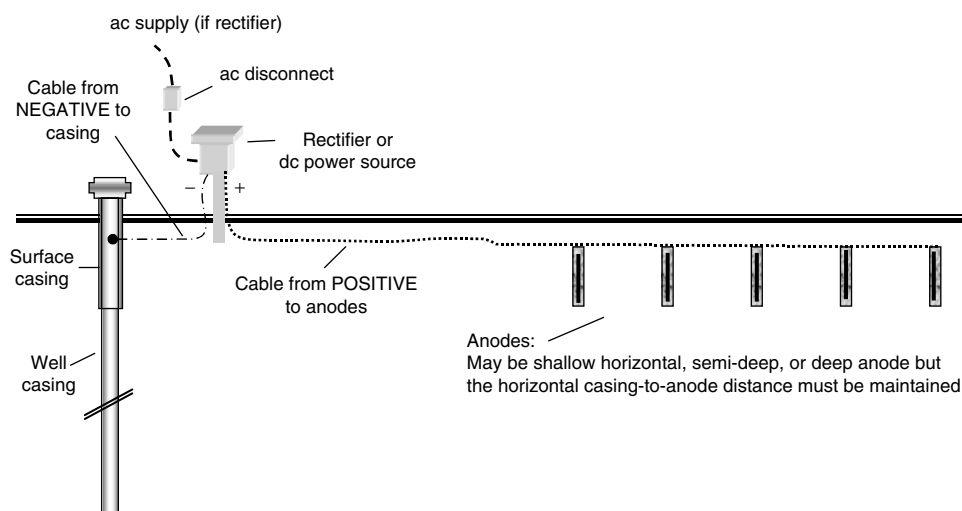
Fig. 13 Typical cathodic protection installation

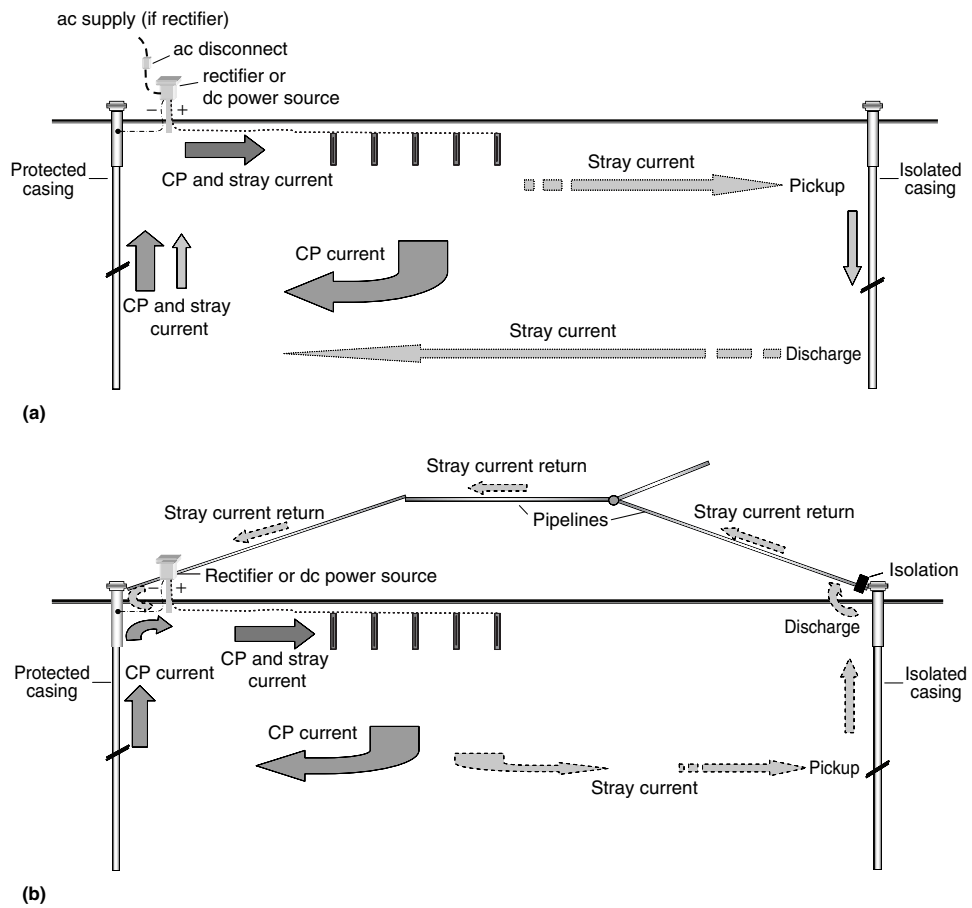
**Fig. 14** Direct-current stray-current interference. (a) Stray-current pickup near top with discharge downhole. (b) Stray-current pickup downhole with discharge near top. CP, cathodic protection

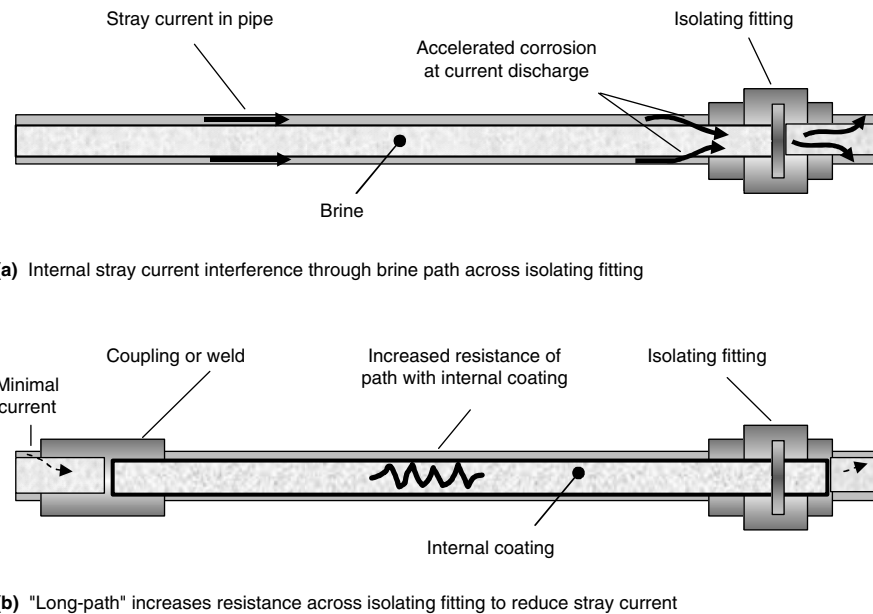
**Fig. 15** (a) Internal interference across an isolating feature and (b) reduced by a long-path isolating feature

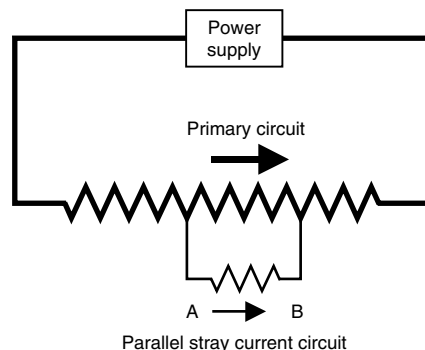
Fig. 1 Schematic of a parallel interference path

Stray current applies to a parallel electrical circuit where the structure is a parallel path within another electrical circuit as depicted in Fig. 1. The point of current pickup in Fig. 1 is indicated by "A," while the point of discharge is at "B" and may be either a metallic or electrolytic path to a structure.

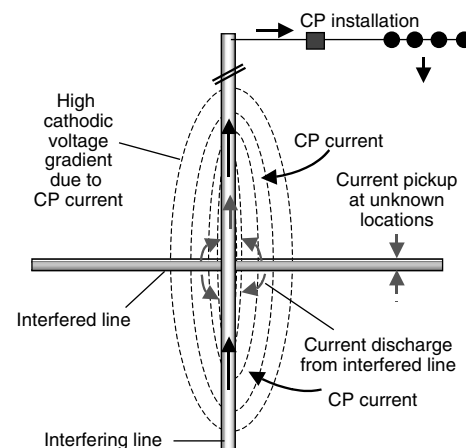
Fig. 2 Illustration of cathodic stray-current interference. CP, cathodic protection

When a structure passes through a cathodic gradient, a current discharge, often called cathodic interference, can occur (Fig. 2). This current discharge must return to its source, but in this case, the controlling factor is the cathodic gradient.

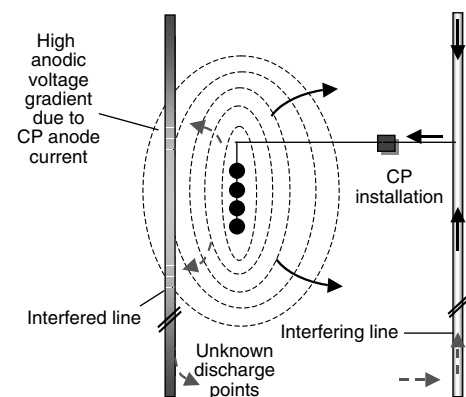
Fig. 3 Illustration of anodic stray-current interference. CP, cathodic protection

When a structure passes through an anodic gradient, a current pickup is encouraged and is often called anodic interference (Fig. 3). Again, this current must return to its source, and the manner by which this occurs is of the most concern. Both cathodic and anodic interference can occur at the same time.

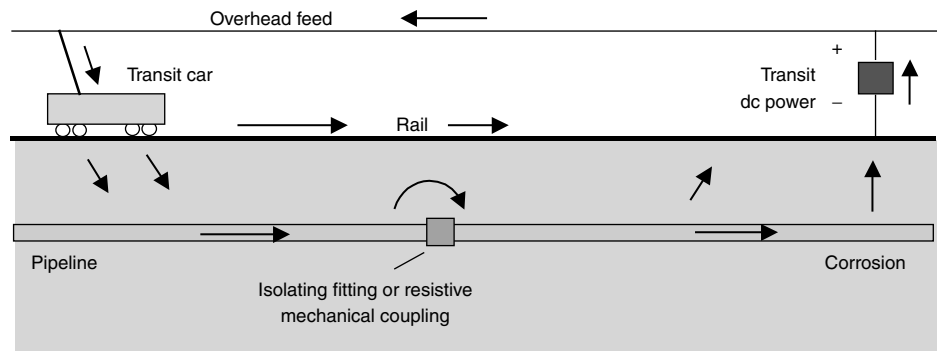
Fig. 4 Example of dynamic interference from a transit system

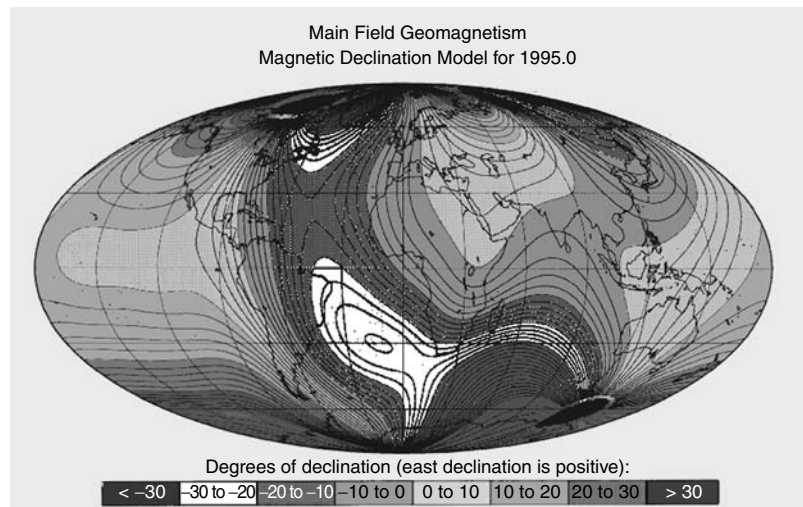
Fig. 5 World isomagnetic chart. Source: Ref 5

which passes through this changing magnetic field. These voltages will be essentially permanent on the pipeline but will vary somewhat with the actual load on the power line.

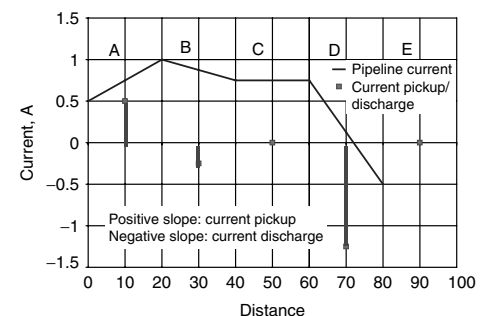
Fig. 7 Plot of pipeline current from Fig. 6

These current values measured in the pipeline can be plotted on a graph as shown in Fig. 7, where the current going in the opposite direction is given a negative value. The bars are the actual current pickup and discharge in this figure. The current discharge and pickup sections can readily be noted by the pipeline current profile. A positive slope indicates a current pickup and a negative slope indicates a current discharge.

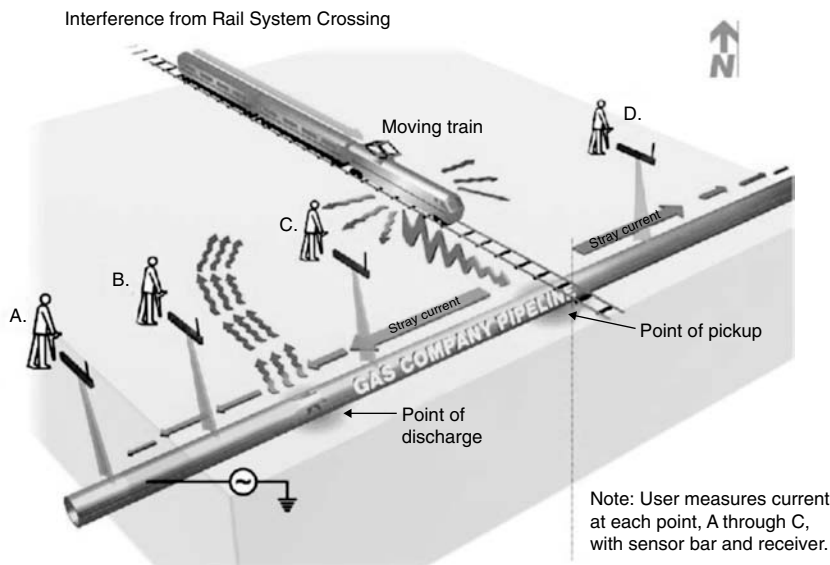
Fig. 8 Current mapping of stray current at a buried pipeline. Source: Ref 7

A second type of current mapping can be used where the current in the soil is determined by measuring the voltage gradient caused by the current in the soil (Ref 17). This is illustrated in Fig. 8. The data are then processed by a computer program to show the variations in stray current at any given location compared with another.

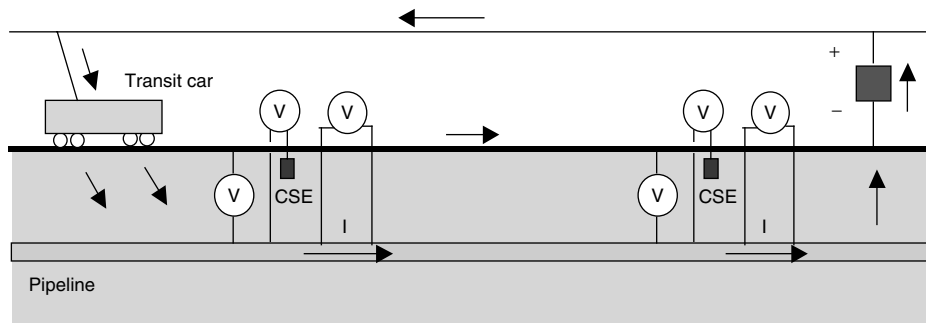
Fig. 9 Potential and current tests on a dc transit system

**Combination of Current and Potentials.** Where possible, a combination of both line current and potentials can be compared at different locations. Such procedures are often used for a dynamic stray-current situation, as in the transit system shown in Fig. 9, and are often called beta curves (Ref 18). In the past, the use of x-y plotters was popular, but data loggers are now more commonly used to gather data under these conditions.

The current in the pipeline at different locations can be determined by a current span as shown in Fig. 9, or by a clamp-on ammeter. The current at a given point in time can be plotted as shown in Fig. 10. Knowing the direction of current, the sections of current pickup and discharge can be determined. The current over a period of time at one location, however, will vary, in which case the current at one location can be plotted against the current at the next location over a given time period. Knowing the current direction, the slope of the line will indicate a current pickup ( $<45^\circ$ ), no

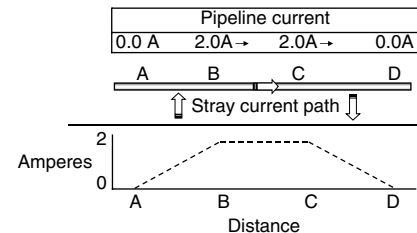
Current and direction shown above at a given time

Fig. 10 Relationship of line current and direction

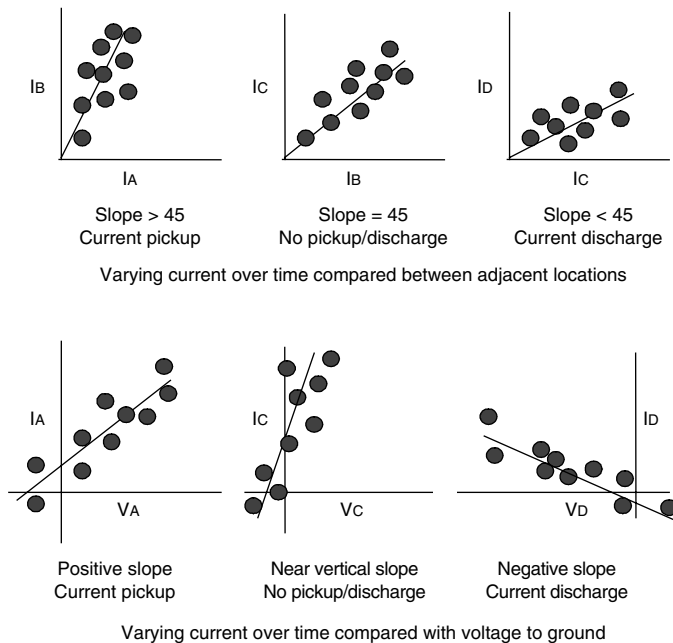
**Fig. 11** Relationship of varying line current and pipe-to-electrolyte potentials over time

pickup/discharge ( $45^\circ$ ), or current discharge ( $>45^\circ$ ), as shown in the top of Fig. 11.

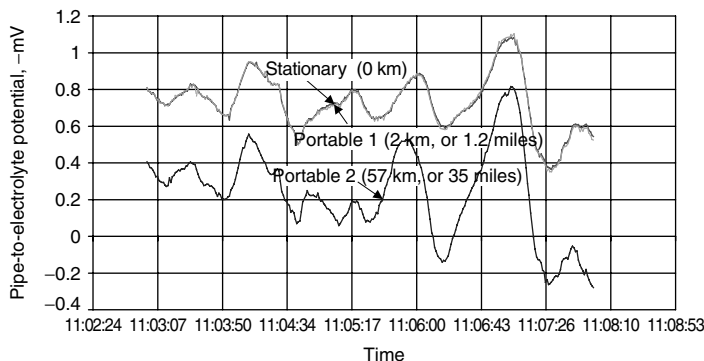
**Fig. 12** Potentials measured with two stationary and one portable data logger at different locations along a fusion bonded epoxy-coated pipeline. Note that the Portable 1 profile is virtually identical to the Stationary profile 2 km (1.24 miles) away and similar in shape to Portable 2 profile 57 km (35 miles) away. Source: Ref 4

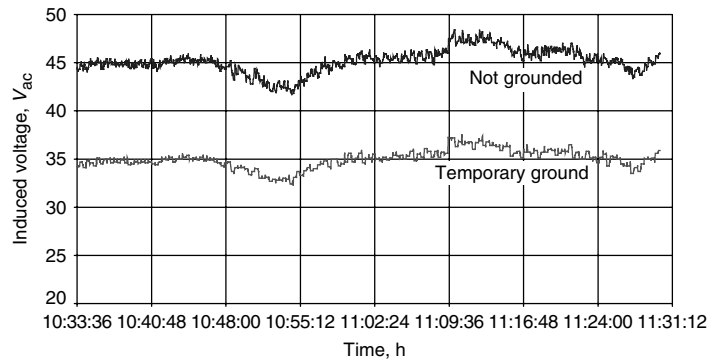
**Fig. 13** Sample induced ac voltage on a pipe (top profile) and the effect of a temporary ground (lower profile)

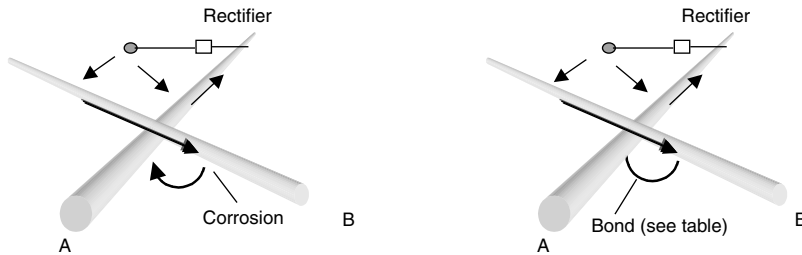
Fig. 14 Mitigation bond showing when and when not practical
