# ASM Handbook®

## Volume 13C Corrosion: Environments and Industries

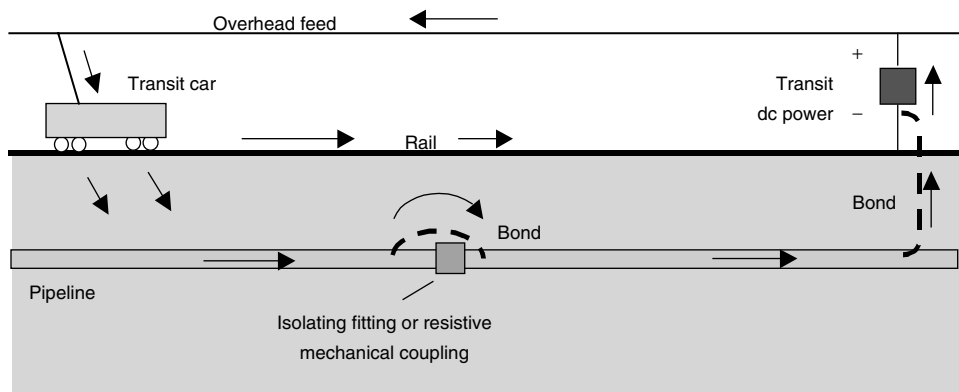
Fig. 15 Mitigation bonds for a transit system (reverse current switches often put in bond back to power supply)

Figure 15 shows the use of mitigation bonds on a transit system.

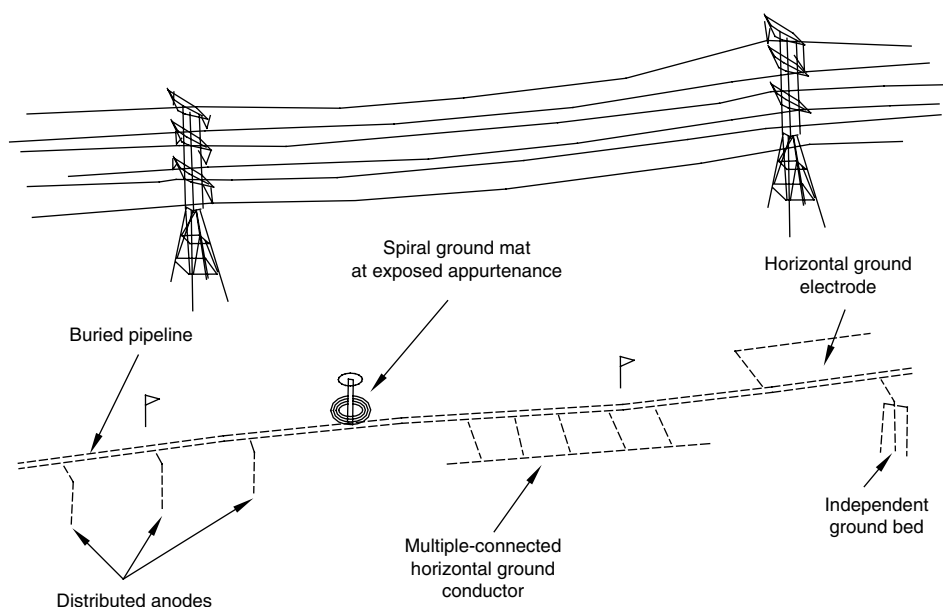
Fig. 16 Alternating current voltage protection during operations. Source: Ref 16, 22

Pipeline personnel working in these areas need to be trained properly in the hazards of ac voltage on pipelines and the necessary safety procedures to include in maintenance, excavations, and repairs (Fig. 16). This is particularly important on the well-coated pipelines that are

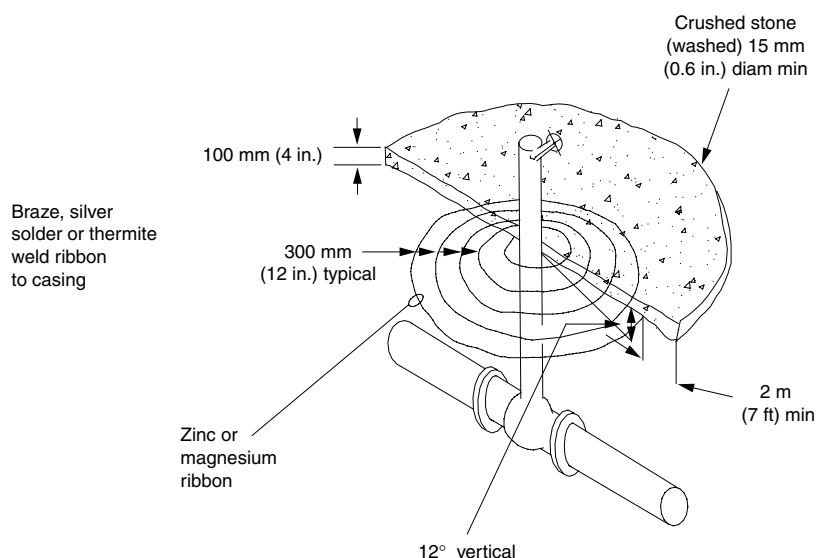
Fig. 17 Ground mat (gradient grid) at underground valve

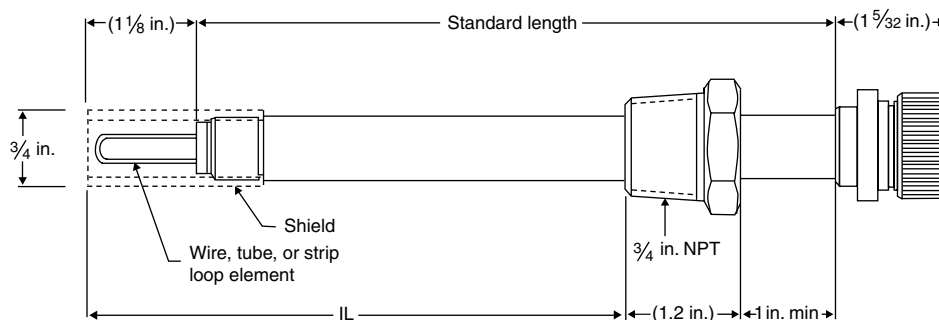
Fig. 1 Fixed-length electrical response probe schematic. Dimensions given in inches. IL, insertion length. NPT, American National Standard Taper Pipe Thread. Source: Metal Samples, Munford, AL

Figure 1 shows a common configuration for a multiuse ER probe. The fixed-length ER probe has a wire, tube, or strip loop element of fixed length. While not configured for deep soil use, this probe can be adapted or reconfigured for those uses. Figure 2 shows a surface strip element ER probe that is more appropriate for

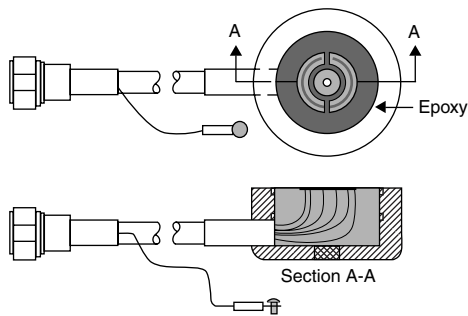
**Fig. 2** Surface strip electrical resistance probe schematic. Source: Metal Samples, Munford, AL

monitoring of underground pipelines and other structures. As shown, it includes a grounding wire for connection to a structure that is under cathodic protection (CP).

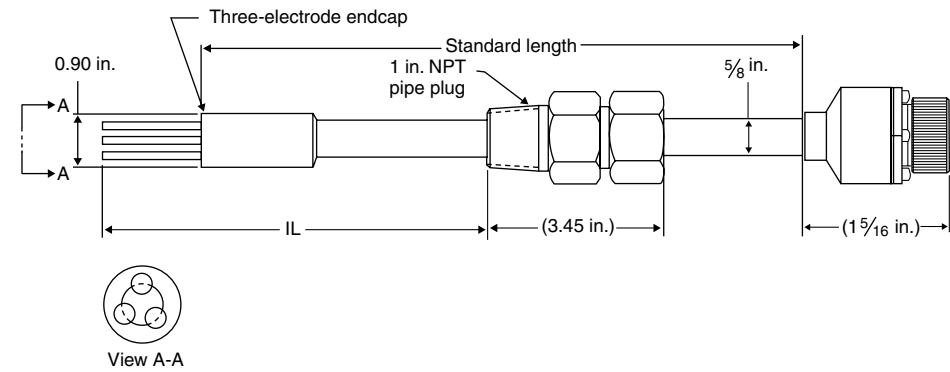
**Fig. 3** Three-electrode linear polarization resistance probe schematic. Dimensions given in inches. IL, insertion length. NPT, American National Standard Taper Pipe Thread. Source: Metal Samples, Munford, AL

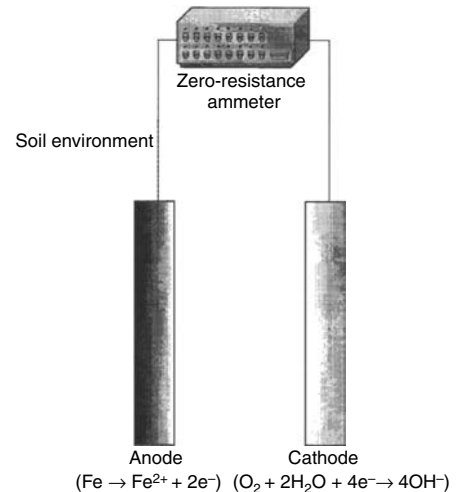
**Fig. 4** Galvanic probe. Source: Ref 6

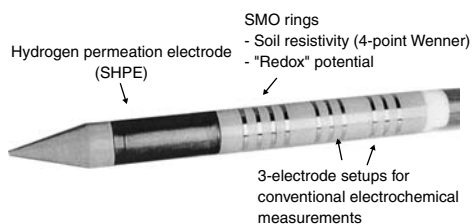
Fig. 6 A modified Novaprobe showing the soil hydrogen permeation electrode (SHPE), four stainless steel (SMO) rings for measuring soil resistivity and redox potential, and two sets of three electrodes for conventional electrochemical measurements. Source: Ref 9

A modified Novaprobe was coupled with EIS to measure soil corrosion rates (Ref 18). Investigators preferred the EIS technique over other electrochemical techniques because of the following reasons: (a) the EIS technique is non-destructive because the 10 mV signal is not large enough to drive either the anodic or the cathodic reactions; (b) the EIS equipment can change the polarization state of the working electrode from freely corroding to anodic or cathodic while measuring the corrosion rate; and (c) the measurements are instantaneous (<20 min/measurement). The EIS-determined corrosion rates gave a good correlation to OCP with corrosion rates the highest at more negative potentials (Fig. 7). Corrosion rates more than 0.025 mm/yr (1 mil/yr) occurred only where soil resistivity was less than 10,000  $\Omega \cdot \text{cm}$ .

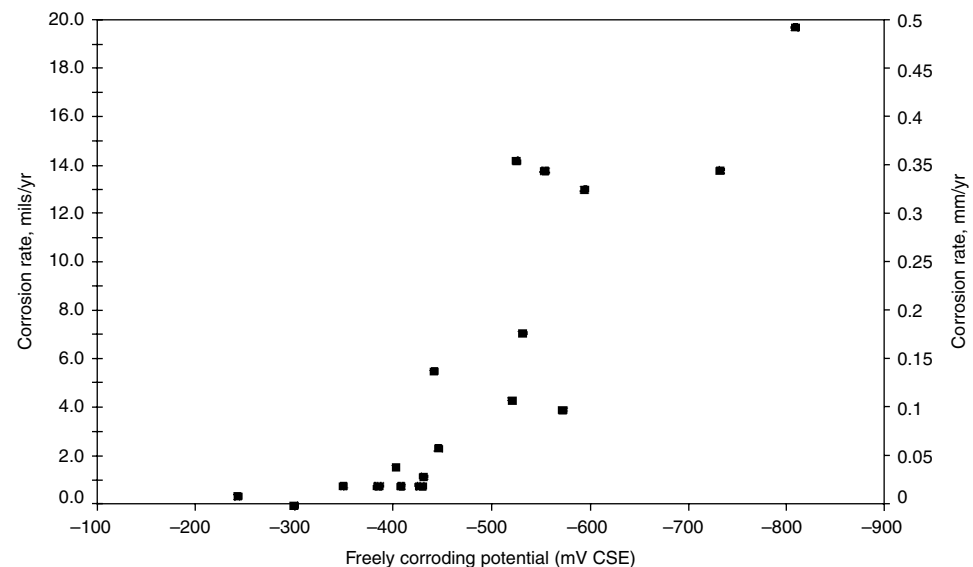
Fig. 7 Corrosion rates of unpolarized coupons (measured using electrochemical impedance spectroscopy) vs. freely corroding potential throughout the test section. Source: Ref 18

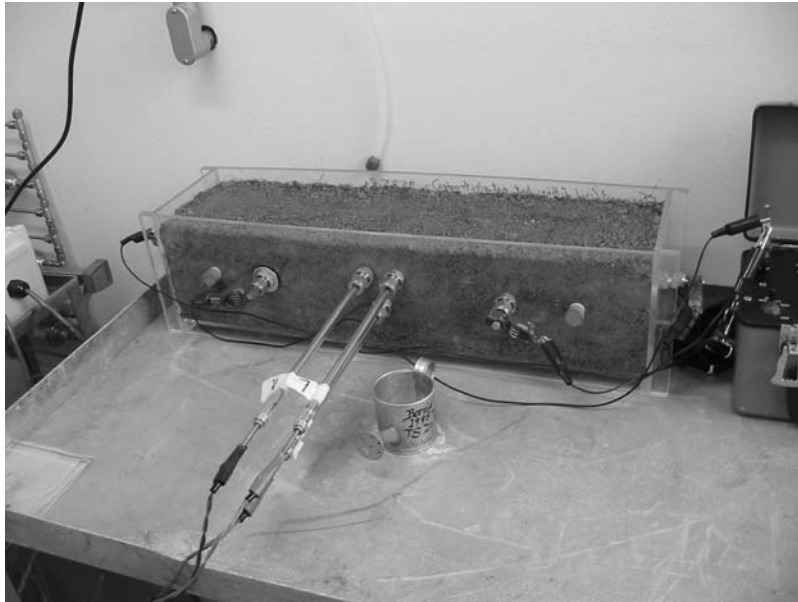
Fig. 8 Soil test cell with three corrosion electrodes and four resistivity electrodes

Laboratory studies of soil corrosion were conducted using the LPR/EN/HDA techniques to measure the simulated external corrosion of gas transmission pipelines (Ref 20). The test cell (Fig. 8) was a typical soil box as specified in ASTM G 57, "Field Measurement of Soil Resistivity Using the Wenner Four-Electrode Method." Three cylindrical electrodes of X42 gas transmission pipeline steel, Fig. 9, were inserted into the soil box as the corrosion rate monitoring electrodes. Four stainless steel electrodes were inserted at and near the ends of the test cell in order to measure soil resistivity, which could then be correlated with corrosion rate. Figure 10 shows the effect of added water and soil resistivity on the corrosion of X42 gas transmission pipe cylindrical electrodes as a

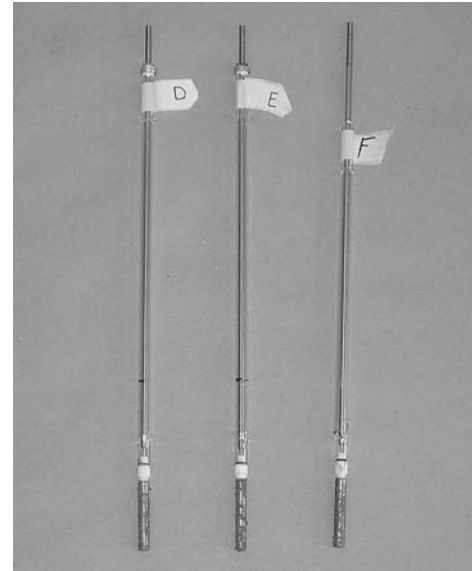
Fig. 9 Soil corrosion electrodes used in the soil test cell in Fig. 8.

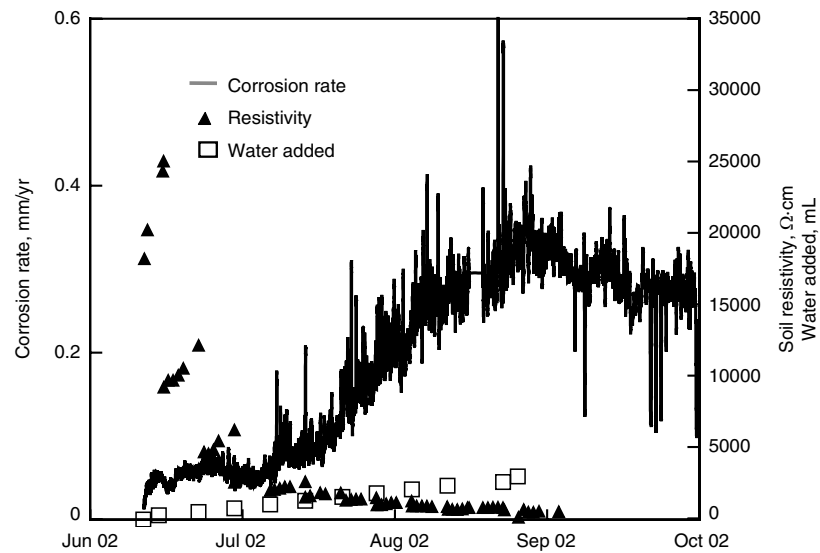
Fig. 10 Effect of added water on the soil resistivity and corrosion rate of X42 steel transmission pipeline electrodes in soil + 1 wt% NaCl

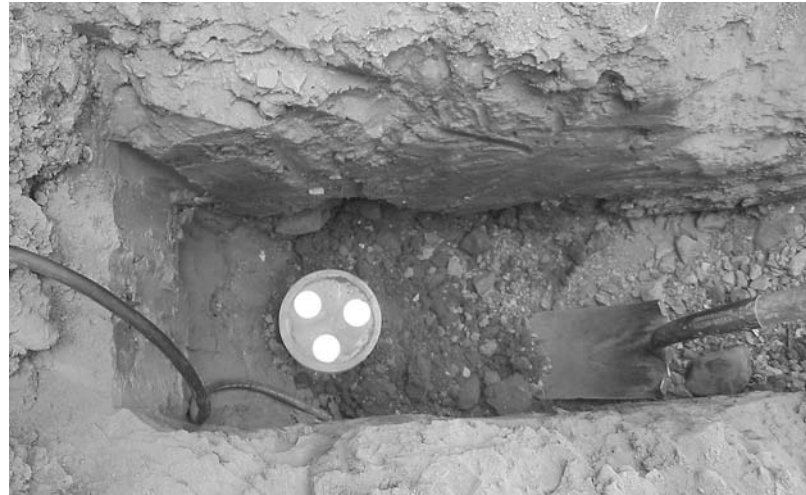
Fig. 11 Three-electrode soil corrosivity probe

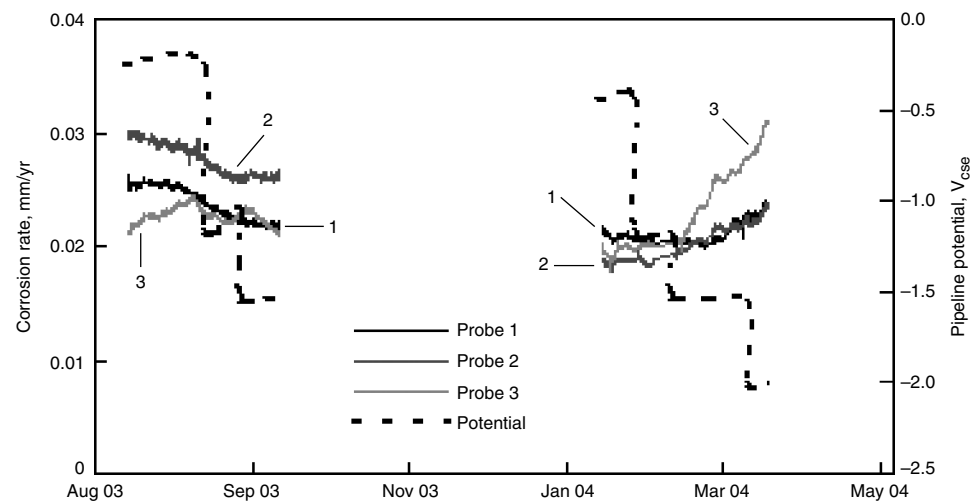
Fig. 12 Linear polarization resistance corrosion rates of the three soil probes (not connected to pipeline) and the pipeline potentials of the two experiments as a function of time

the corrosion rate-time data that could be correlated to the application of CP current, the increase in CP current, or any other cause. The same is true of the PF data in Fig. 13. The conclusion is electrochemical corrosion rate probes will have no interference problems when monitoring the corrosivity of the soil near a cathodically protected pipeline when using the LPR, EN, or HDA techniques. Note that if the probes were electrically connected to the CP system, the LPR, EN, and HDA measurements would have been affected.

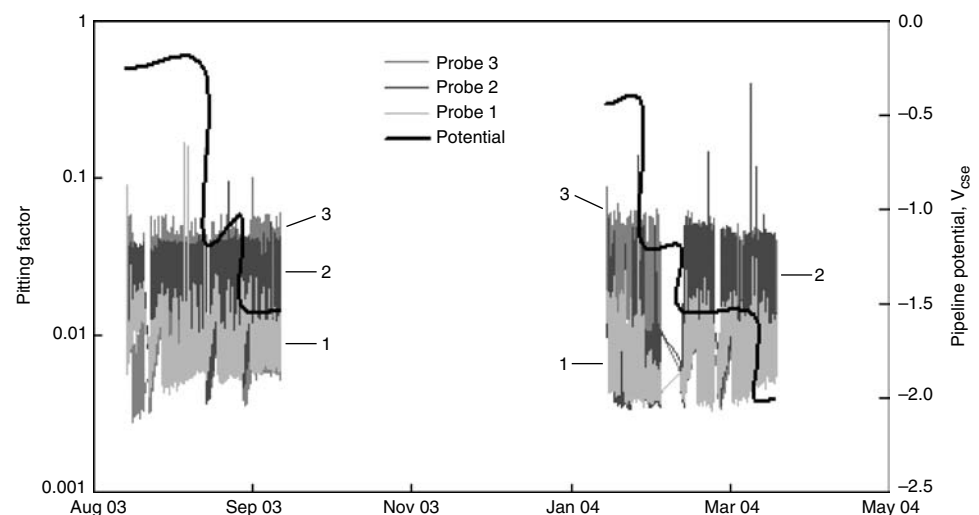
Fig. 13 Pitting factors of the three soil probes and the pipeline potentials of the two experiments as a function of time

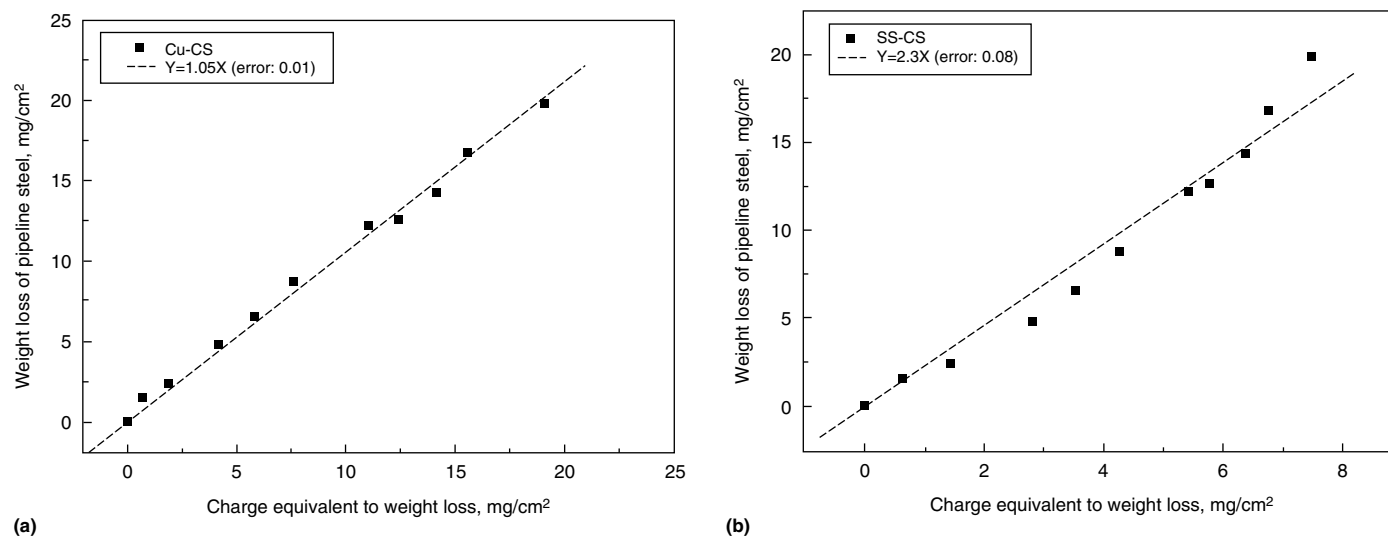
**Fig. 14** Relationship between the weight loss as detected from the corrosion probe and measured weight loss for the specimens. (a) Carbon steel (CS)-Cu probe. (b) Carbon steel (CS)-stainless steel (SS) probe. Source: Ref 6

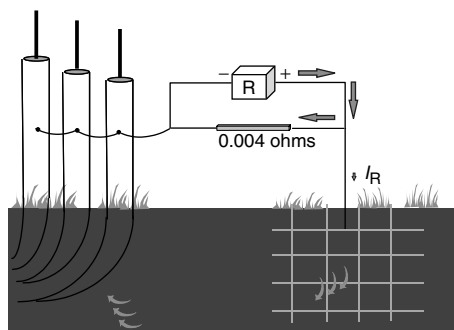
**Fig. 1** Resistor rectifier. The rectifier (R) circulates dc current through two parallel paths, the 0.004  $\Omega$  resistor bar and the ground path.  $I_R$  is the current required to cathodically protect the pipes. The three individual pipes above ground entering the substation combine underground into a single pipe containing the three conductors.

In the previous discussion on resistor rectifiers, it was shown that if the pipe-type cable were grounded through a 0.004  $\Omega$  resistor bar, a large rectifier (most of whose output would circulate through the resistor) would be needed

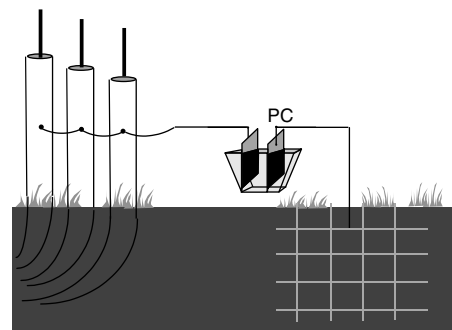
**Fig. 2** Polarization cell. The polarization cell (PC) is an electrochemical device that blocks dc and passes ac current. It replaces the resistor bar and makes it possible to reduce the number and size of rectifiers. The three individual pipes above ground entering the substation combine underground into a single pipe containing the three conductors.

for adequate cathodic protection. If, however, polarization cells or ISPs were substituted for the resistor, this circulating current would be eliminated and the rectifier(s) would be sized only to supply the small amount of current required for cathodic protection. These rectifiers and their associated anode-groundbeds would be located in the “field” along the route of the pipe-type cable, allowing for better current distribution on the pipe surface.

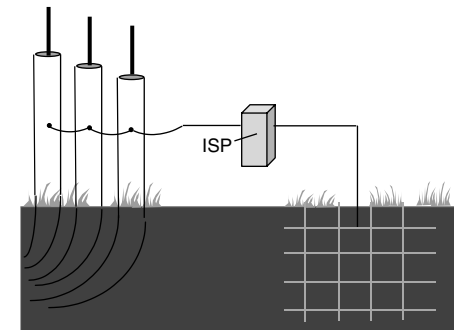
**Fig. 3** Isolator surge protector (ISP). The ISP is a solid-state device that blocks dc and passes ac current. It also replaces the resistor bar and requires little maintenance. The three individual pipes above ground entering the substation combine underground into a single pipe containing the three conductors.

The high maintenance considerations led the industry to develop other devices to serve the same function as the PC; one of these is the isolator-surge protector (ISP) (Fig. 3). The ISP is

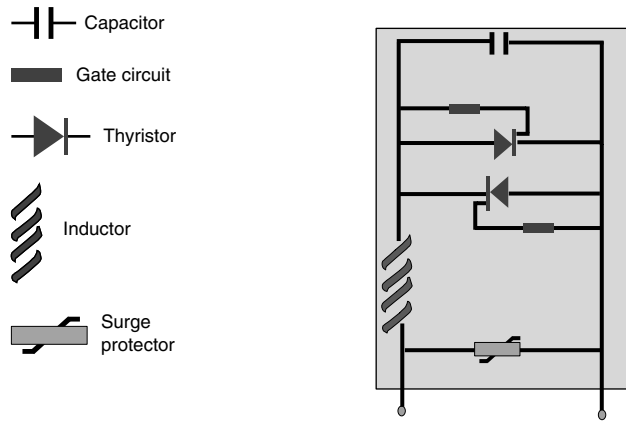
Fig. 4 Isolator surge protector components. The various components work together to keep the pipe-type cable effectively grounded during ac faults.

a solid-state device, and the basic circuitry is shown in Fig. 4.

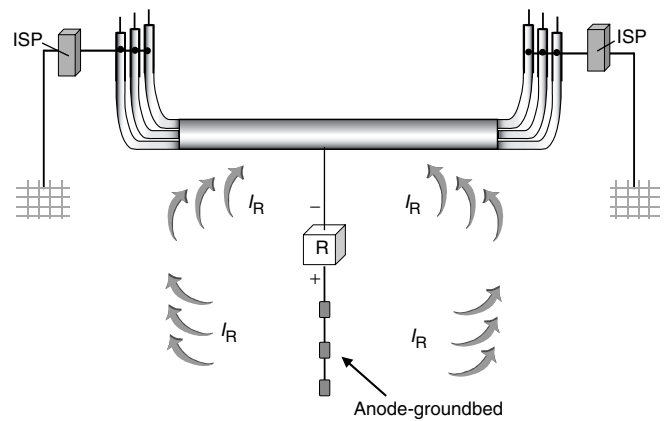
Fig. 5 Field rectifier and grounded. Rectifiers are removed from their substation locations and are replaced by fewer, smaller rectifiers in the “field.” The current required by the pipe ( $I_R$ ) is impressed by the rectifier via anode-groundbeds. One rectifier as shown could theoretically protect the pipe, but in order to lower the current impressed by each rectifier, smaller rectifiers at multiple locations are preferred. The single underground pipe-type transmission cable with a mild steel outer wall branches into three separate pipes at the substation termination. These are generally stainless steel.

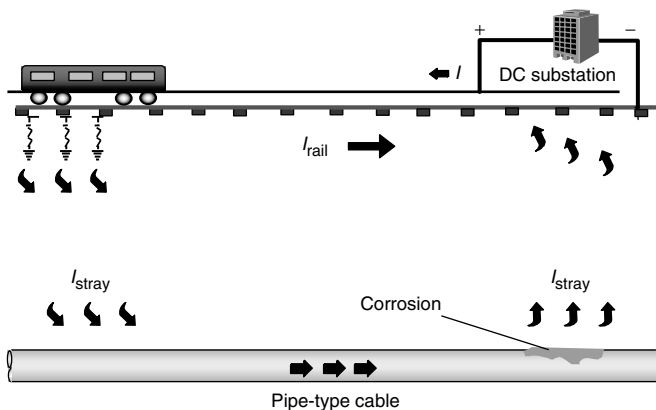
Fig. 6 Stray current interference. Most of the current that powers dc trains returns to the substation via the rails. A small portion of this current “strays” from the rails and is discharged into the ground. The pipe-type cable provides a low resistance return path. Localized corrosion can occur where the stray current is discharged by the pipe-type cable as it flows back to the train’s dc substation.

ground resistance of approximately  $5 \Omega$  per mile. Since the stray current pickup areas can extend for several miles and since old dc rail systems often impress large voltage gradients in the soil, it is possible to pick up considerable amounts of stray current through the coating. In this example, pipes are 25.4 and 12.7 cm (10 and 5 in.), coating resistance is  $186,000 \Omega \cdot \text{m}^2$ , and the resulting pipe to ground resistance is  $3.1 \Omega/\text{km}$ .

The strays that are picked up travel along the pipe until, due to the change in the polarity of the earth gradients, they are discharged back into the earth resulting in corrosion failures. Stray current discharge areas are generally more localized than pickup areas and occur in the vicinity of dc power stations or other grounded structures. These include bridges, tunnels, overpasses, and support structures for elevated lines. In each case, testing must be done over the route of the feeder to determine the extent of the exposure areas and appropriate action taken.

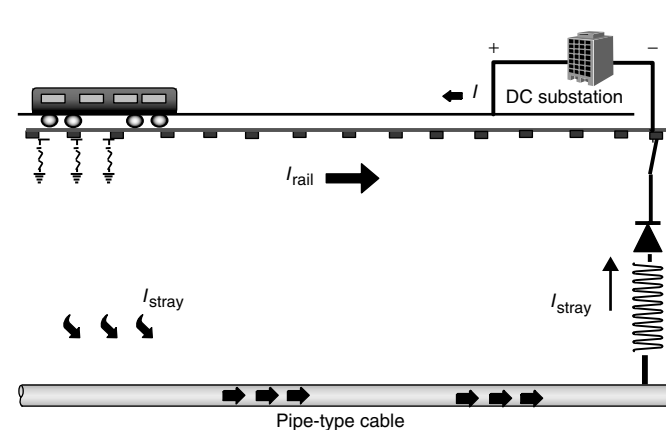
Fig. 7 Stray current drain bonds. Drain bonds prevent stray current picked up by the pipe-type cables from being discharged back into the ground. The drain bonds provide a metallic return path to the substation. The diode in the circuit prevents reverse currents.

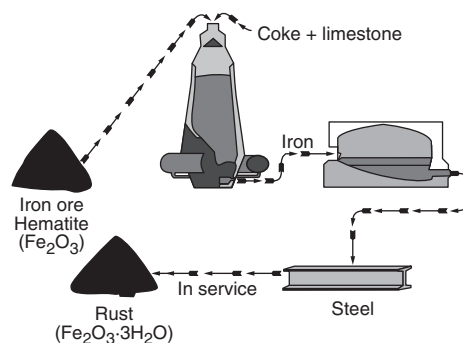
**Fig. 1** The corrosion cycle illustrating the need for energy to convert oxides/ores to metallic form. If not protected in-service, the metal reverts back to oxides due to corrosion.

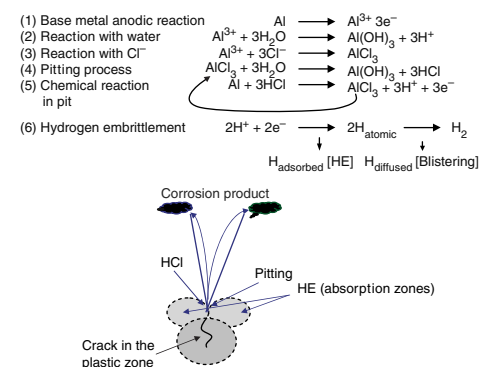
**Fig. 2** A cracking model illustrating the mechanism of pit initiation and growth and hydrogen embrittlement (HE)

**Pit-Initiated Cracking.** The cracking model, as shown in Fig. 2, illustrates the mechanism of pit formation and growth through corrosion action of chloride and acid by an autocatalytic process. Figure 3 shows the schematic of crack initiation and growth from the pit under cyclic mechanical loading. Under tensile loading (fatigue half cycle) the pit, as shown in Fig. 3(a), leads to the generation of a new surface in its bottom by slip deformation and produces a step D, shown in Fig. 3(b). This step D is very reactive and dissolves very fast, as shown in Fig. 3(c), and flattens out or creates a trough which under compression (second half cycle) pushes back the step to create a crack as illustrated in Fig. 3(d). This process repeats with every cycle and the conjoint actions of corrosion and fatigue lead to a much greater increase in crack growth rates than one would expect under pure fatigue mode. The illustration of such a pit-initiated service failure is shown Fig. 4. The collapse of the main landing gear of an F/A-18 aircraft strut (a load-bearing cylindrical support) of high-strength 300M alloy steel (UNS K44220) under its own weight was due to severe pitting and crevice corrosion found all around the barrel, and high-pulse load fatigue was a serious warning of the shortcomings in the inspection protocol and techniques (Ref 10).

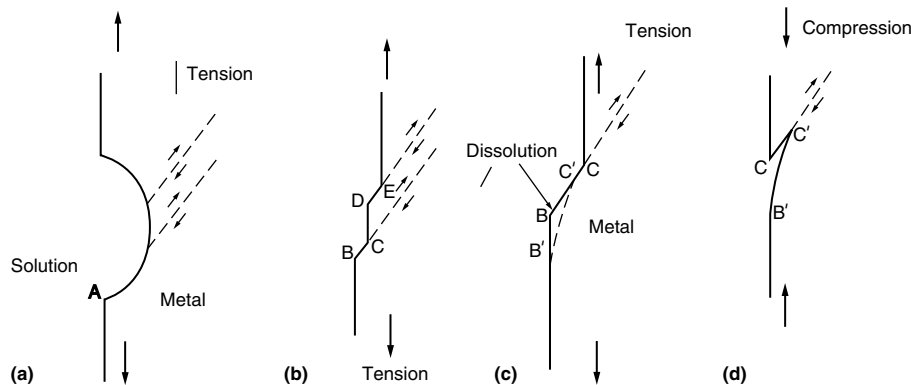
**Fig. 3** Corrosion (active path dissolution) action and crack initiation under cyclic mechanical loading. Refer to text for a discussion of stages (a) through (d).

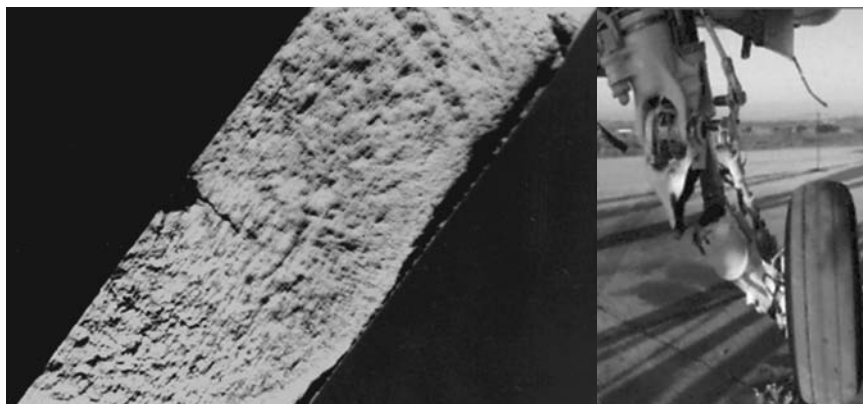
**Fig. 4** Pit-initiated in-service failure of a landing gear due to dynamic stresses. The collapse of the high-strength 300M steel main landing gear load barrel was due to severe all-around pitting.

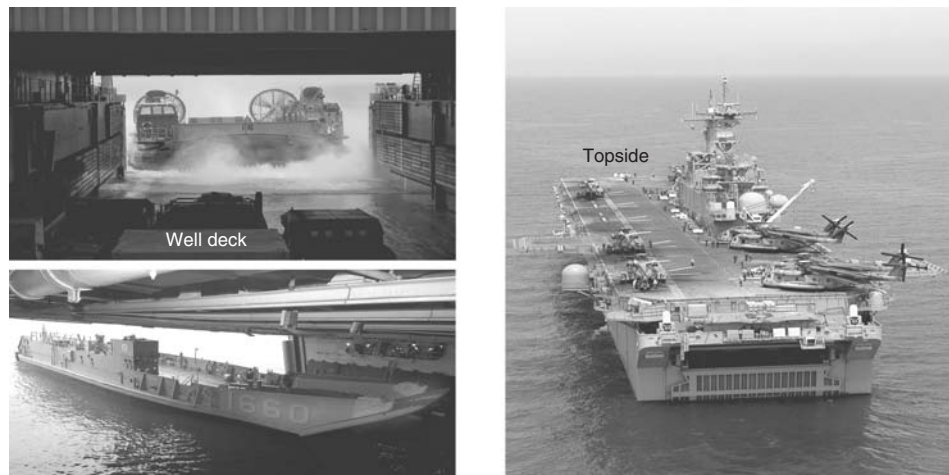
Fig. 6 Examples of coatings on surface ships. Topside (right side), freeboard (lower left), and well-deck (upper left) areas require very frequent stripping and repainting.

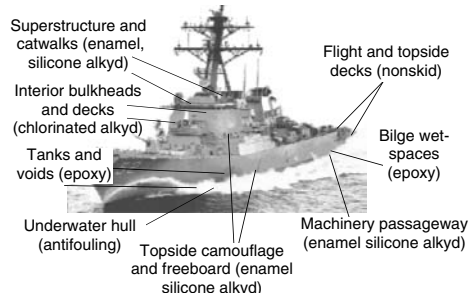
Fig. 5 Shipboard coatings are a major maintenance driver for corrosion control. Navy ships use a variety of organic coatings for interior and exterior applications.

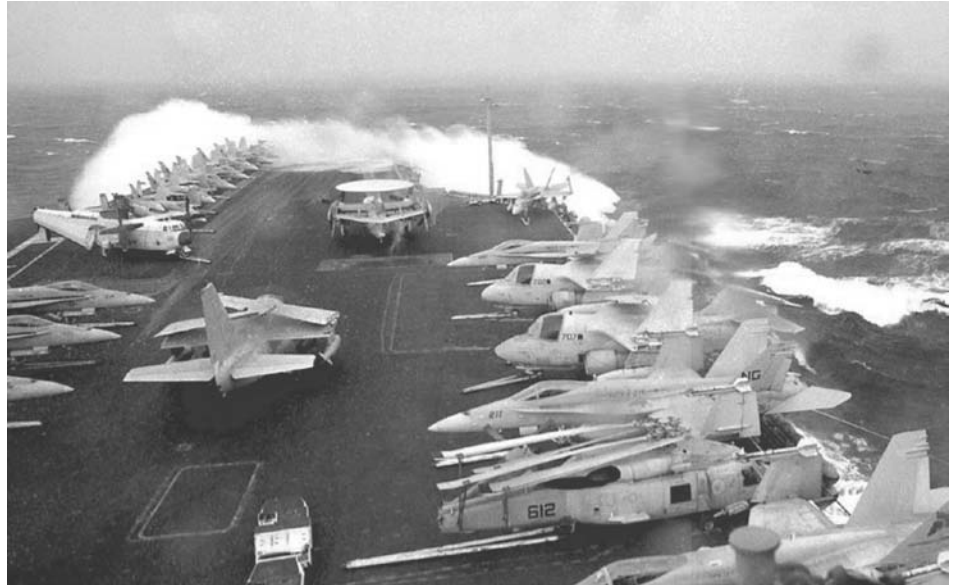
Fig. 8 Naval aircraft carrier flight deck environment containing salt fog, hydrocarbons, and engine exhaust gases such as  $\text{SO}_2$ ,  $\text{NO}_x$ , and so forth

- Facing the challenging environments that contain chloride, sulfate, SO<sub>2</sub>, and other marine seawater species (Fig. 8)
- Being subjected to high electromagnetic fields or electromagnetic interference (EMI) environment
- Being exposed to solar radiation effects
- Being serviced in a very limited space to perform adequate maintenance for corrosion protection

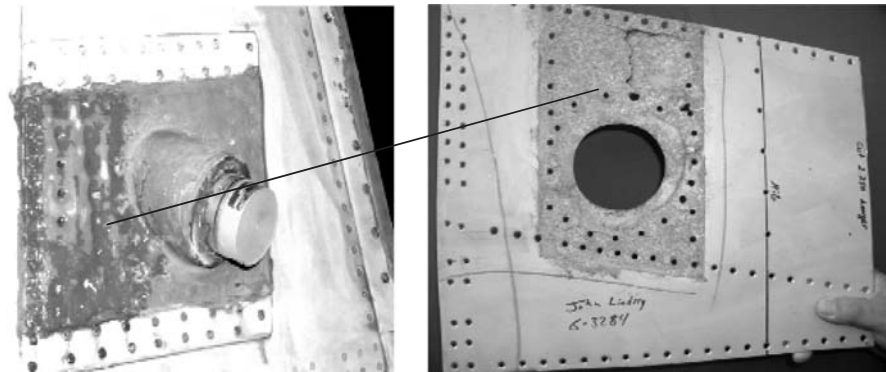
Fig. 9 Severe crevice corrosion of aluminum plate under the antenna mounts resulting from the absence of sealant in the joints

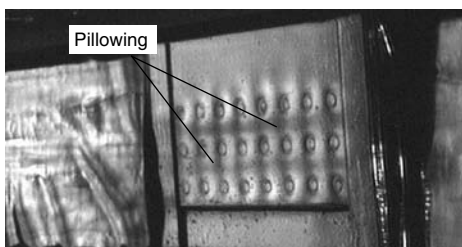
**Fig. 10** Corrosion of the aircraft structure from the inside. A hidden corrosion phenomenon called "pillowing" occurs where corrosion products grow under the aluminum skin and puffs up the top surface of the thin metal sheet in the area around fasteners.

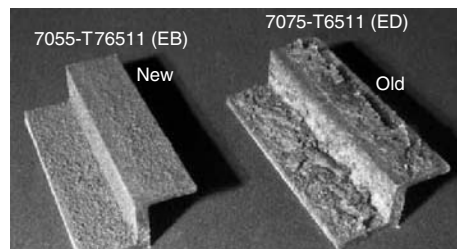
**Fig. 11** Exfoliation corrosion resistance of alloy 7055-T765 (ASTM rating EB) is much superior to that for 7075-T65 (ASTM rating ED)

To address the problems of SCC and CF in primary structures, airframes, and skins, alloy substitution to replace corrosion-prone materials such as aluminum alloy 7075-T6 has been established by the Air Force. A user-friendly software was developed to make use of MIL-HDBK-5 data (now MMPDS) for drop-in replacements of certain alloys. For example, alloys 7055-T76 and 7055-T74 are excellent replacement candidates with much better exfoliation resistance (ASTM Standard G 34, rating EB), and almost double the threshold for SCC (Fig. 11) (Ref 12, 24).

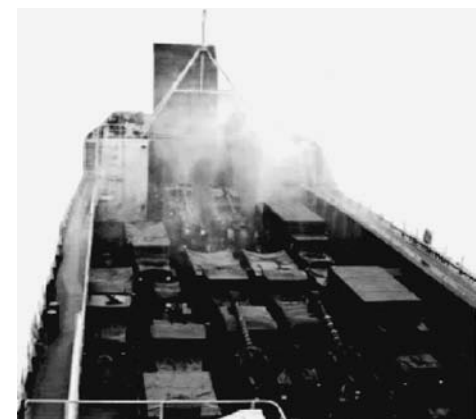
**Fig. 12** Army shipment (equipment) via sea is exposed to the elements of marine environment during transportation

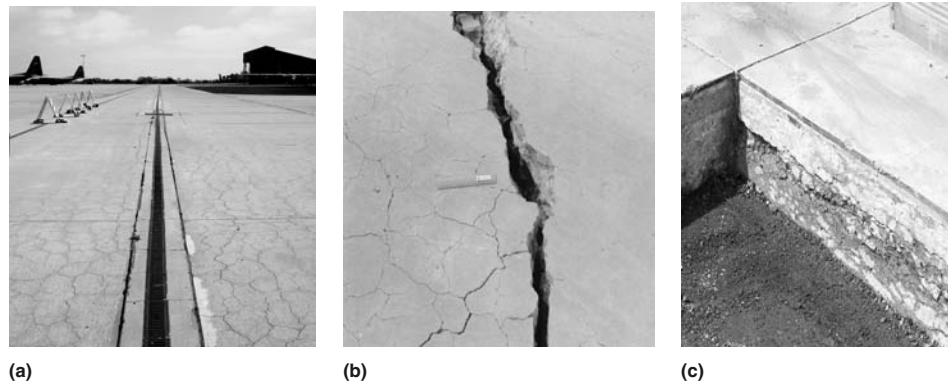
**Fig. 13** Concrete decomposition at Channel Islands Air National Guard airfield from alkali-silica reactivity. (a) The airfield, which was built in 1978. (b) Surface (apron) damage and cracking. (c) Concrete decomposition through pavement thickness. The cost of repair was \$14 million.

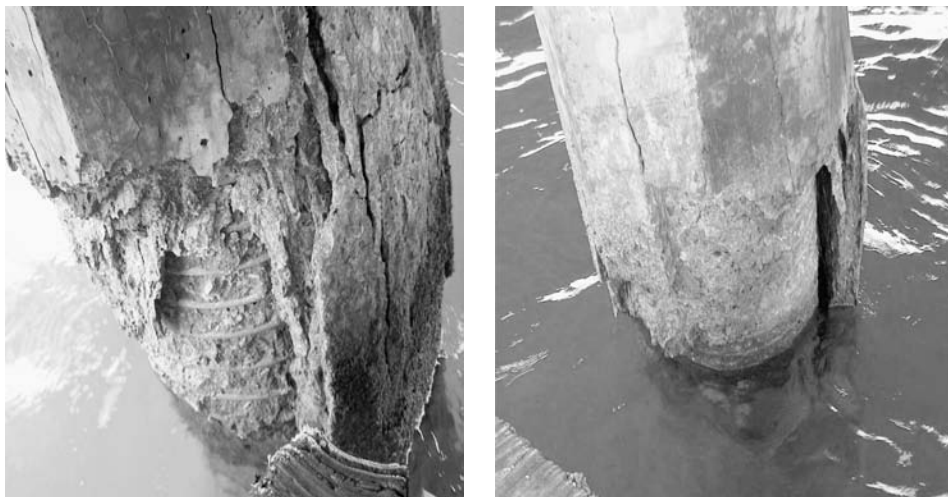
**Fig. 14** Severe concrete degradation caused by rebar corrosion of piers of a NAVSTA bridge in Pearl Harbor, HI

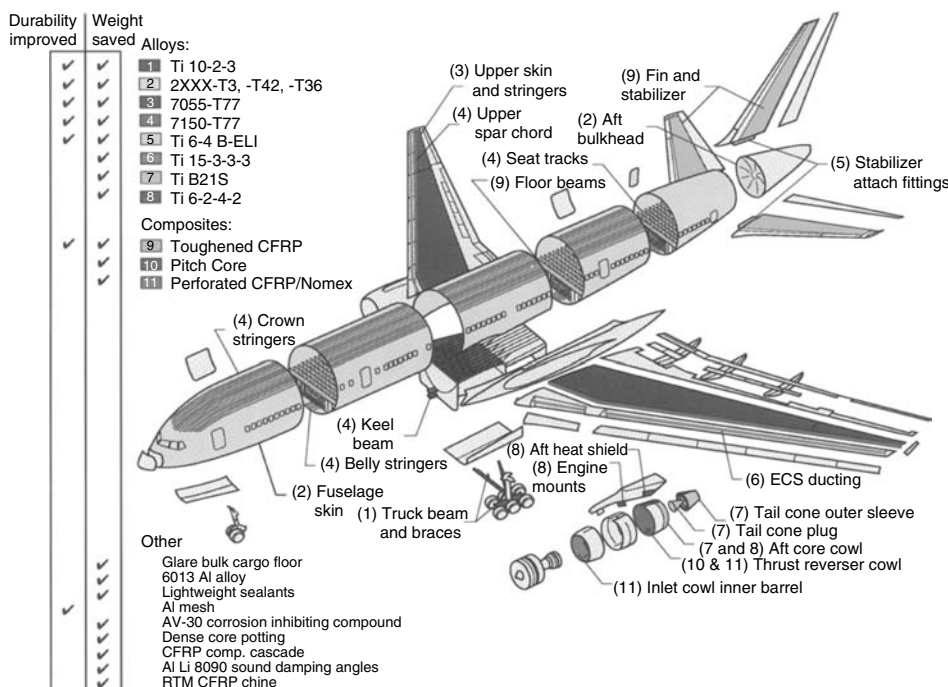
**Fig. 15** Material substitution on Boeing 777 aircraft. Aluminum alloys 7075-T6 and 2024-T3 have been replaced by 7055-T7 and 2324-T3 and other more corrosion- and SCC-resistant aluminum alloys.

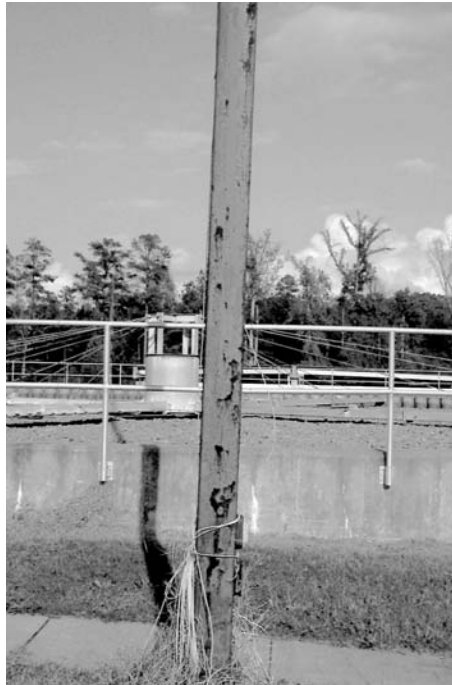
**Fig. 1** Corroded low-carbon steel light pole due to corrosive atmosphere at a wastewater treatment plant on a military installation

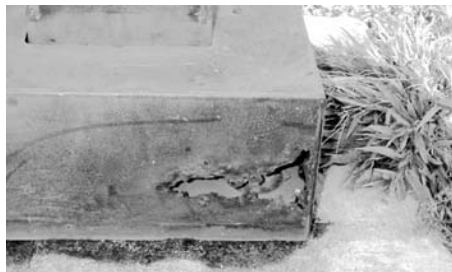
**Fig. 2** Close-up of corrosion at the base of the pole shown in Fig. 1

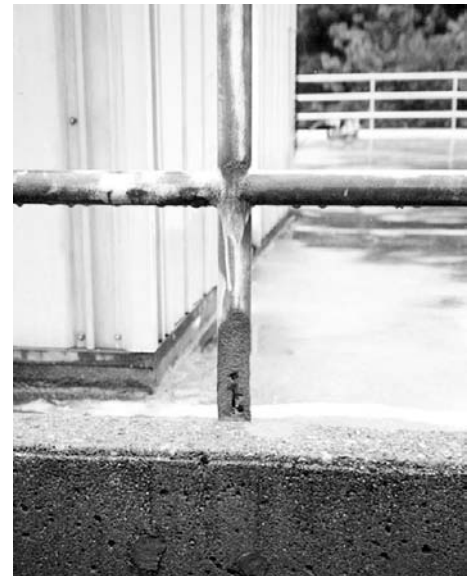
**Fig. 3** Corrosion pattern on a mild steel pedestrian guardrail at a military installation exposed to a coastal atmosphere

hazardous waste disposal problem. Current guidelines for dealing with lead in construction such as that shown in Fig. 3 allow the material to remain in place. Having identified the lead alloy prior to guardrail removal, the replacement was redesigned, so that the attachment was left in place and the new guardrail was bolted to the concrete curb. In early 2004, a positive chemical analysis to identify lead use in the attachment cost only a small fraction (<0.04%) of the cost for lead hazardous waste disposal of the lead. Current specifications require that guardrails and handrails be fabricated from a suitable anodized alloy such as 6061-T6 (Ref 3, p 37).

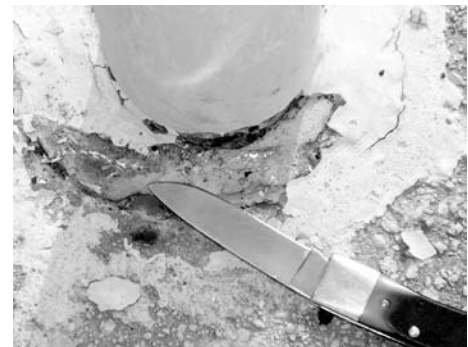
**Fig. 4** Close-up of the base of the vertical pole shown in Fig. 3. Note that the pole was soldered in place using a lead-base low-melting-point alloy.

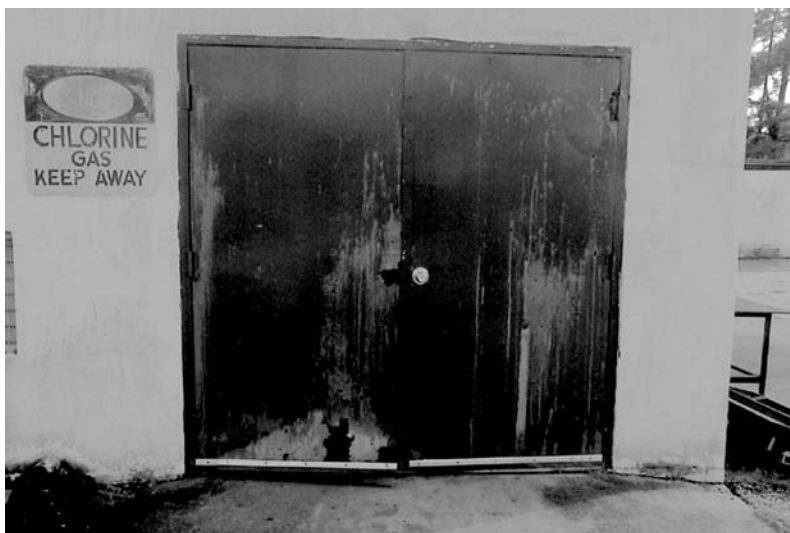
Fig. 5 Corroded metallic doorway at a military installation water treatment plant due to chlorine atmosphere

**Doors and windows** are locations where corrosion is frequently more severe than walls, roofs, and other components of a building. Figures 5 and 6 show corroded doorways near a wastewater treatment plant on a military installation. The replacement of a few doors is a fairly inexpensive project. However, since there are large numbers of doors on military installations any cost savings due to the use of more corrosion-resistant materials can result in major savings on maintenance costs. Fiberglass-reinforced plastic doors with type 304 stainless steel handles and kickplates are viable corrosion-

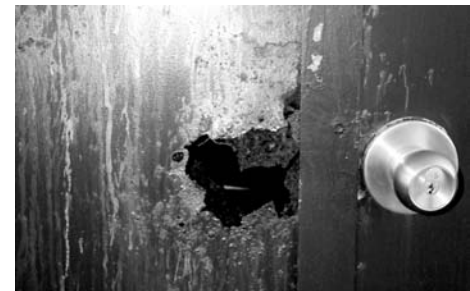
Fig. 6 Close-up of corrosion on doors shown in Fig. 5

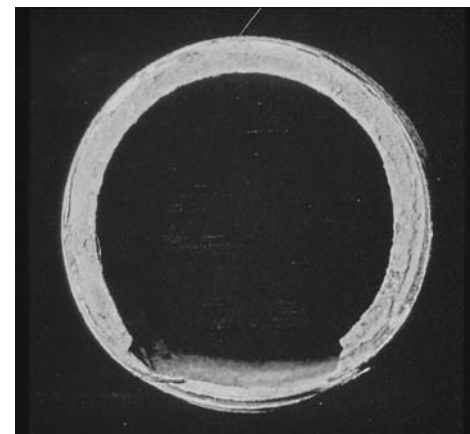
Fig. 7 Channeling ("grooving") of condensate return line due to carbon dioxide leaking into steam/condensate system

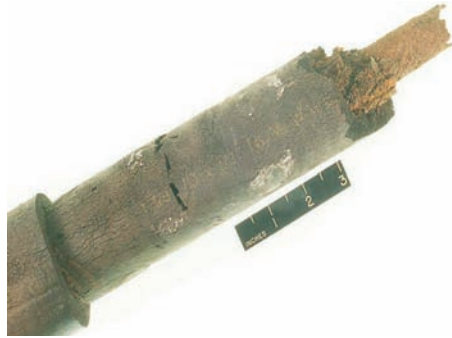
**Fig. 8** Corrosion of hot water line after insulation was degraded by water intrusion

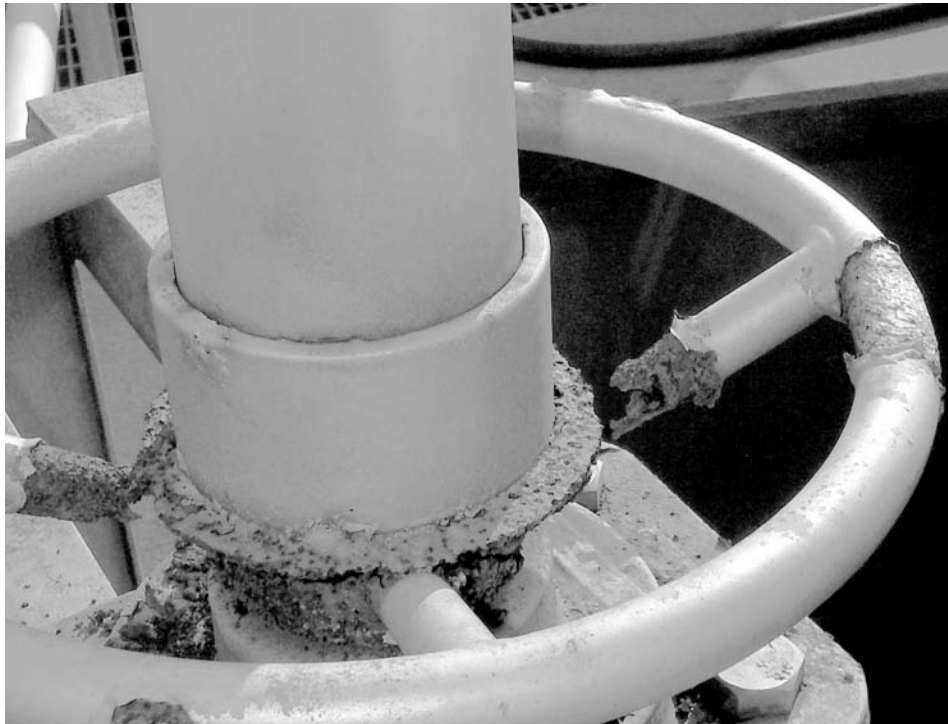
**Fig. 9** Corroded control handle exposed to corrosive atmosphere at a wastewater treatment plant on a military installation

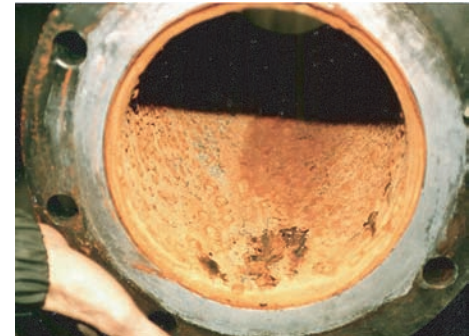
**Fig. 10** Corroded water pipe contaminates water that services an Air Force Base hospital

**Protective Coatings and Linings.** Many new coatings are under development in the civilian sector and are being applied on military installations. Figure 10 shows a potable water pipe contaminated by rusty water that services an Air Force Base hospital. It was repaired in situ by draining, drying, and abrasively blasting the interior followed by pumping an epoxy slug through the pipe, as shown in Fig. 11. The coating application to a thickness of 350 to 500  $\mu\text{m}$  (14 to 20 mils) was successful in rehabilitating the piping system in question with a cost savings of more than 30% over the cost of replacement piping. The in situ pipe coating technology accommodates a variety of pipe lengths, diameters ( $> 12.5$  mm, or 0.5 in., diameter), bends, and materials. It eliminates corrosion and scaling, and lead and copper dissolution in potable water and energy piping systems, and restores full water pressure.

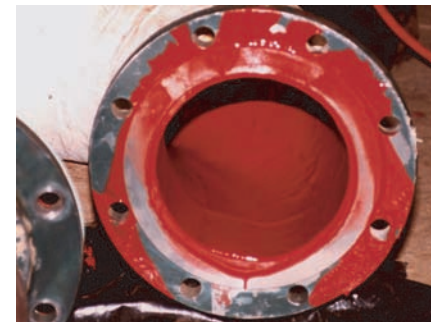
**Fig. 11** In situ epoxy coating applied to the inside of the pipe shown in Fig. 10 after abrasive blast cleaning

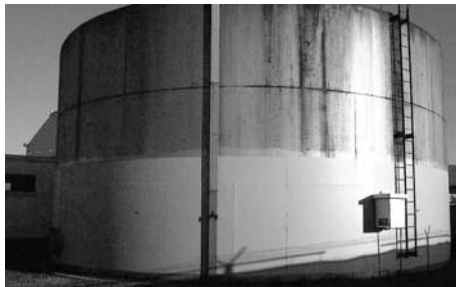
**Fig. 12** Deluge tank (for fire-suppression system) with test patches overcoat applied to lower half of exterior surface. Later, the entire tank was overcoated with a moisture-cure polyurethane system

Figure 12 shows a deteriorated protective coating for a water deluge tank (part of a fire-suppression system at an Army airfield), where

the original lead-base paint was overcoated to dry film thicknesses of about 190  $\mu\text{m}$  (7.5 mils) with test coatings of two moisture-cured polyurethanes. Both overcoating systems performed well over a winter test period with no evidence of blistering, spalling, or peeling. This entire tank was then repainted with one of the moisture-cured polyurethane systems. The coating exhibited no evidence of cracking or peeling, no evidence of rust, and no evidence of corrosion for the past 4 years (Ref 10).

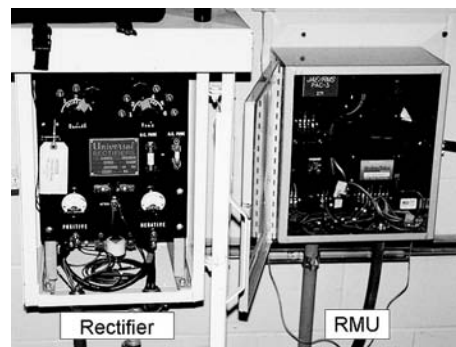
**Fig. 13** Rectifier with remote monitoring system (RMU) for use as part of an elevated water tower cathodic protection system for water side corrosion protection.

Impressed-current CP is used to prevent internal corrosion of the water side of potable water storage tanks by applying a negative potential to the structure from an external source. Remote monitoring units (RMUs) are being used to demonstrate the reliability of CP in controlling corrosion of elevated water towers. Cathodic protection systems for water storage tanks must be periodically tested in order to ensure proper performance (Ref 12). Remote monitoring units provide the ability to continuously monitor CP system performance data from remote locations using modem-equipped personal computers. Figure 13 shows a CP rectifier coupled to a RMU. Elevated water towers are frequently the largest structures at military installations that use impressed-current CP.

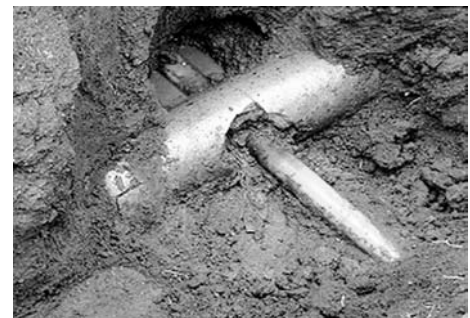
**Fig. 14** Clay sewer line breached as a new gas distribution line was laid, due to lack of knowledge of where the sewer lines were located. A remote camera inserted into the sewer lines was later utilized to ascertain that no additional breaches had occurred.

**Inspection and Monitoring.** Nondestructive analysis of equipment condition is a priority with many DoD installations. Figure 14 shows where a clay sewer line on a military installation was breached during the horizontal insertion of a plastic gas distribution line. Discovery of five breaches of the sewer lines led the installation to question whether damage to other buried utilities had gone undetected. A remote camera was utilized to inspect more than 6000 m (20,000 ft) of buried sewer lines in only four weeks.

The inspections revealed no additional breaches of the sewer line due to gas pipeline penetration. However, the inspection did result in the identification of a blockage in one of the sewer lines and allowed maintenance personnel

to excavate and repair only the affected section of that pipeline. This saved an estimated 8 man-years in labor cost and completed the inspection in one-third of the time it would have taken if maintenance personnel had to excavate the entire area affecting the 400 housing units.

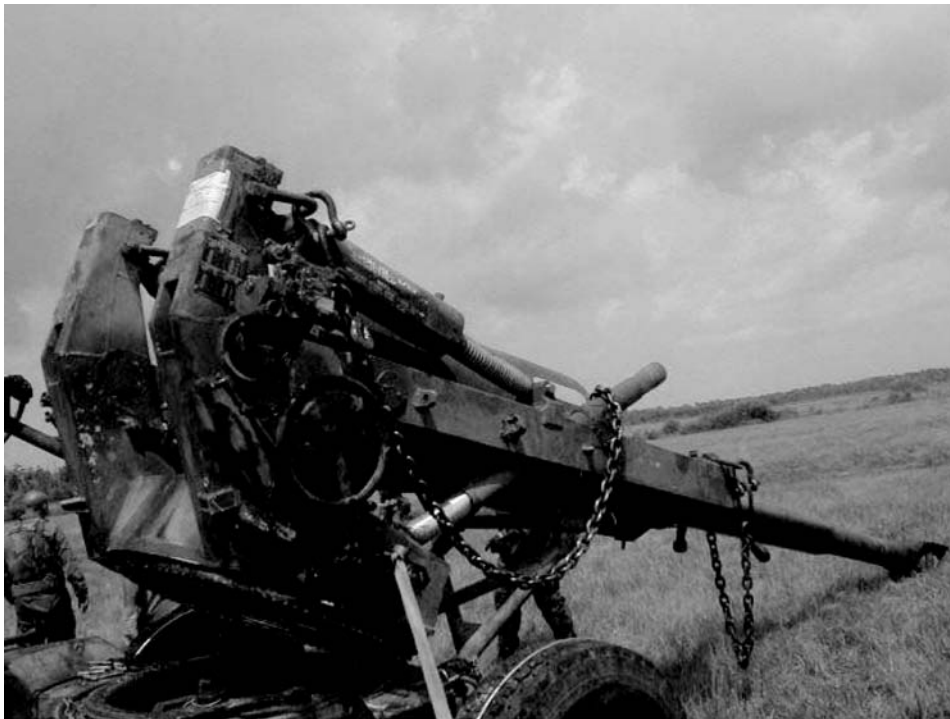
Fig. 1 Results of ring gear failure in the M198 howitzer. Source: Ref 1

**Examples of Design-Related Problems.** An example of design affecting the corrosion resistance of an engineered system is the M198 howitzer. There is an anodized 7079-T6 aluminum alloy ring gear that connects the upper carriage and the gun tube to the lower carriage and the trails. The ring gear allows the gun tube to rotate and is fastened to the upper and lower carriage with mounting bolts. Figure 1 shows the results of a poor design on the system. The upper carriage of the ring gear has become completely disconnected from the lower carriage and the gun tube has fallen to the ground. There are multiple problems with the design of this system. First, the material selected, 7079-T6 aluminum, is susceptible to stress-corrosion cracking (SCC) in the transverse direction. For SCC to occur, a susceptible material, a specific corrodent, and a sustained tensile load are needed. 7079-T6 aluminum has a transverse SCC threshold of 55 MPa (8 ksi). The 13 mm ( $1/2$  in.) and 16 mm ( $5/8$  in.) mounting bolts used to secure the ring gear to the upper and lower carriage, when proper torque is applied, produce 110 and 172 MPa (16 and 25 ksi) sustained tensile loads, respectively, at the countersink. This load is sufficient to produce SCC if a corrodent is present, and for aluminum alloys, 50% relative humidity is sufficient. In this case, all three cri-
