# ASM Handbook®

## Volume 13C Corrosion: Environments and Industries

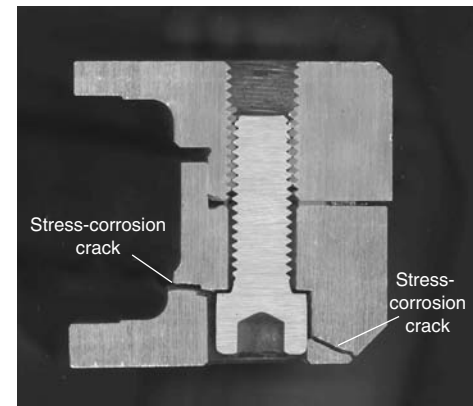
Fig. 2 Cut-away view of the ring gear and bolt showing stress-corrosion cracking. Source: Ref 1

teria for SCC are present and the material experienced a large amount of SCC. Figure 2 shows SCC at the countersink of the ring gear.

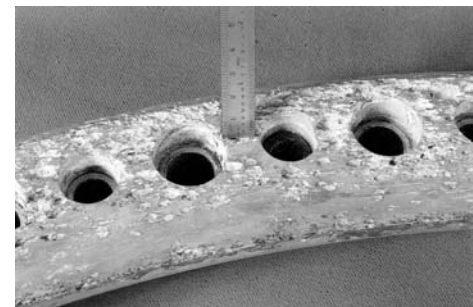
Fig. 3 Severe pitting on the surface of the aluminum alloy ring gear. Source: Ref 2

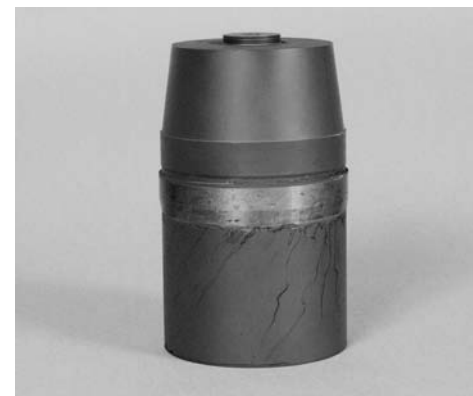
Fig. 4 Galvanic corrosion at the interface of the copper rotating band and the steel base metal in a 105 mm cartridge. Source: Ref 3

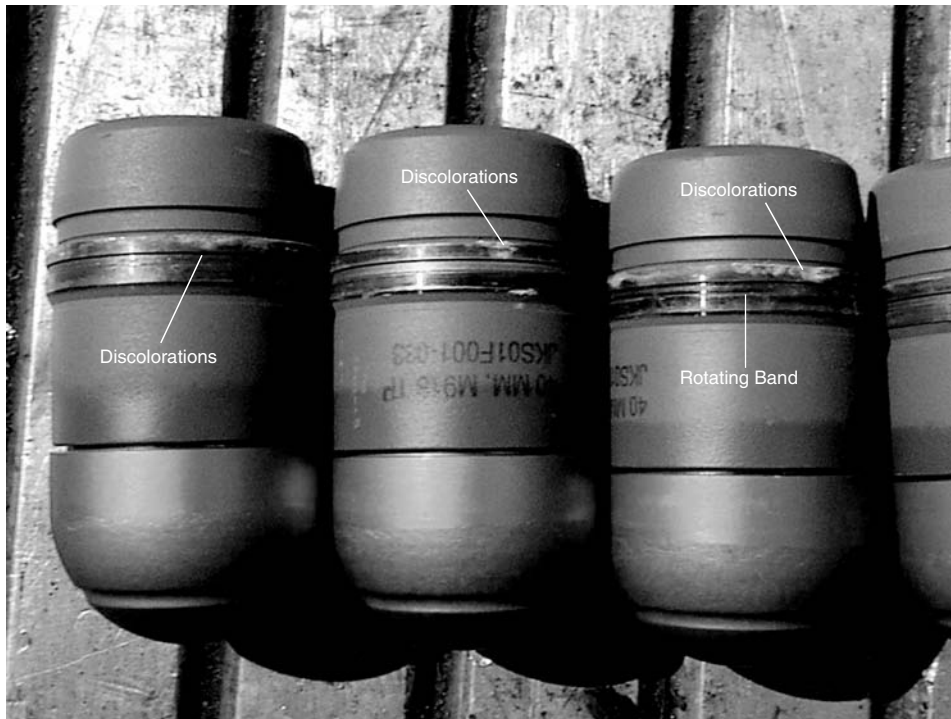
**Fig. 5** Grenade body showing discoloration of copper rotating bands resulting from exposure to trapped machining lubricant. Source: Ref 4

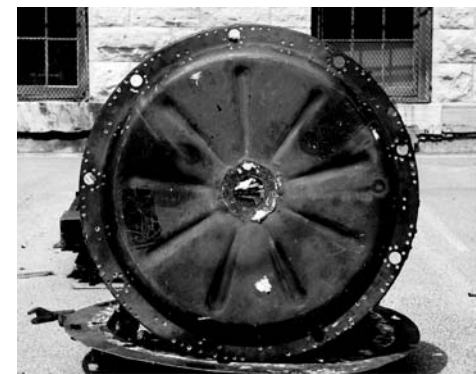
**Fig. 6** Failed M119 firing platform. Source: Ref 5

aluminum with chromate conversion pretreatment and painted using the CARC primer and topcoat system. After five years of service in Hawaii, the firing platforms failed due to exfoliation corrosion. It was determined that new platforms were required and again the T73 heat treatment was specified. The new platforms with this heat treatment failed after 2 years of service. Figure 6 shows the failed firing platform. Figure 7 is a close-up of the exfoliation corrosion on the firing platform. The T73 temper was designated because it is highly resistant to exfoliation. Then why did the parts exfoliate in only two years of service? They were not tested or documented during production to verify that the parts had in fact been treated to the T73 condition. To obtain a T73 temper, a part must first be placed in a T6 temper. If the parts are not adequately heated, they will not achieve the T73 state and will not be resistant to exfoliation corrosion. In this case, the parts and the temper recipe were never tested under ASTM B 209, "Standard Specification for Aluminum and Aluminum Alloy Sheet and Plate." Based on the premature failure of the supposed 7075-T73 parts, it is apparent the treatment was not sufficient. To verify the heat treatment of the platforms, tensile bars were cut from a failed platform and tested. The results indicated that the parts were in fact not in the T73 condition. If the parts had been properly monitored with the heat

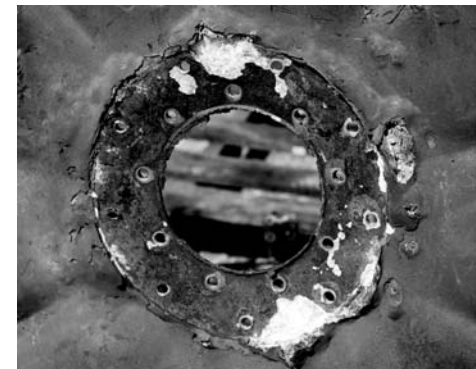
**Fig. 7** Firing platform exfoliation corrosion. Source: Ref 5

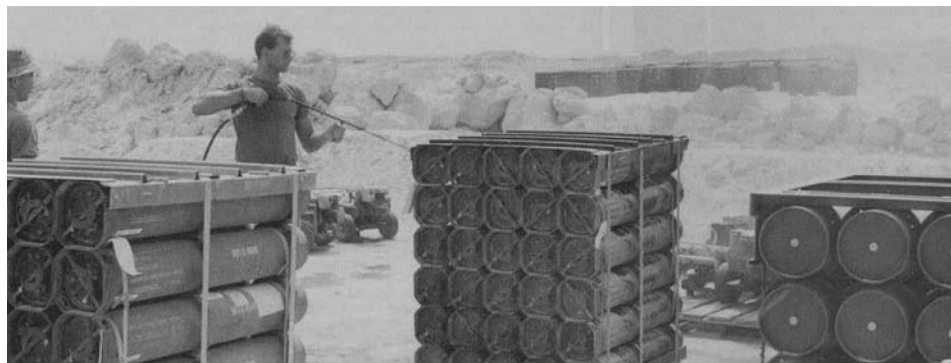
Fig. 9 Pressure washing of ammunition containers. Source: Ref 6

repairing parts. The other case is that the crews will be told to clean this system. The crew will then determine the best way to clean it. They could clean it by hand using solvents, then let it dry, and finally re-oil the equipment, or they could simply power-wash the equipment and then re-oil. The process of solvent cleaning and drying can take upwards of 4 h, while power-washing the parts and oiling with a water-displacing oil will take 5 min. It is easy to see which is done more often, and without guidance or properly reading the manuals the soldiers do not see the benefit associated with the other process. Figure 9 shows a soldier using a pressure washer to clean ammunition containers. The problem with this process is that the rubber seals on the storage containers are only watertight to 21 kPa (3 psi), and the soldier is washing the containers at a pressure of 690 kPa (100 psi).

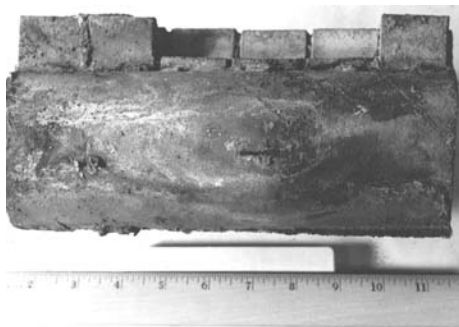
**Fig. 1** Roof tube "as received." Narrow 25 mm (1 in.) long failure is along the hot side crown. See also Fig. 2 through 6.

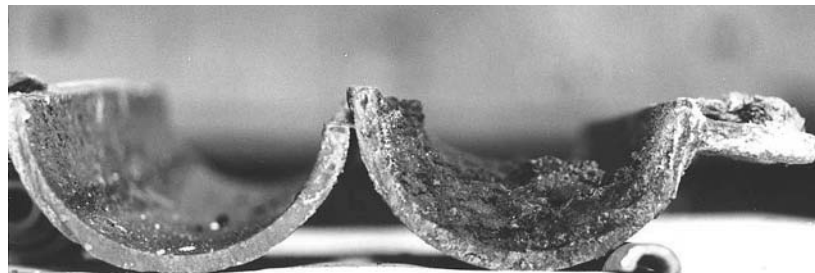
**Fig. 2** Side view of tube sample reveals that hot side deposits are as much as 25 mm (1.0 in.) thick. Relatively little deposition was present on the cold side

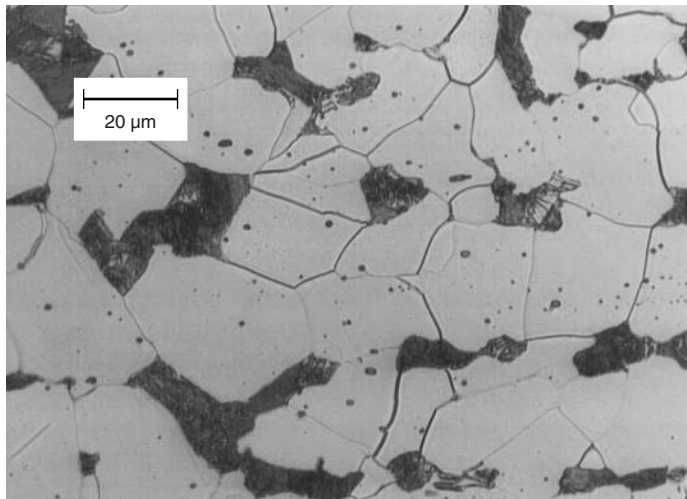
**Fig. 3** Magnified view of cold side microstructure shows the lamellar carbides in the pearlite colonies. Spherical phases are small alloy constituents such as oxide and sulfide inclusions. Original magnification  $1050\times$

A view of the cold side microstructure (180° and opposite from the failure) by SEM as shown in Fig. 3 attests to the lamellar nature of the pearlite colonies in the ferrite matrix. The waterside deposit in the vicinity of the failure exhibited several distinct layers of oxide (Fig. 4). There was also heavy oxidation and corrosion of the waterside surface. The deposit shown in this micrograph is 0.61 to 0.71 mm (0.024 to 0.028 in.) thick. Some of the layers are quite dense while others are very porous. One layer exhibits a dispersion of copper metal particles while still another layer revealed needlelike, fibrous oxides.

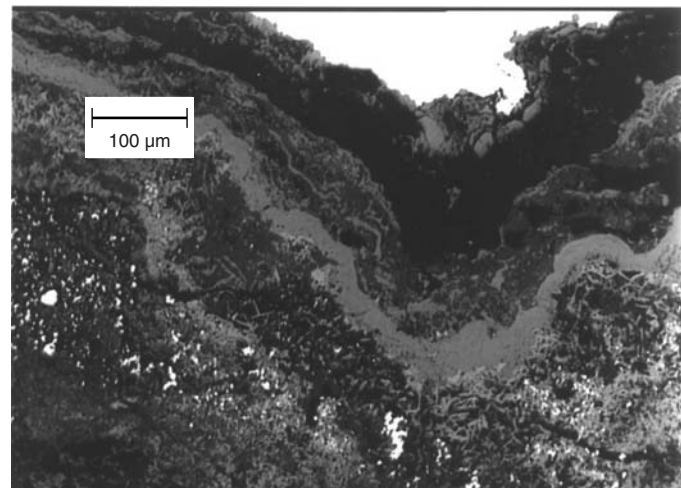
**Fig. 4** Hot side deposit in the vicinity of the failure displays several layers and waterside oxidation/corrosion. Some layers are dense, while others are very porous. One layer displayed needlelike, fibrous oxides. Another layer contains a number of particles of copper metal. Original magnification  $210\times$

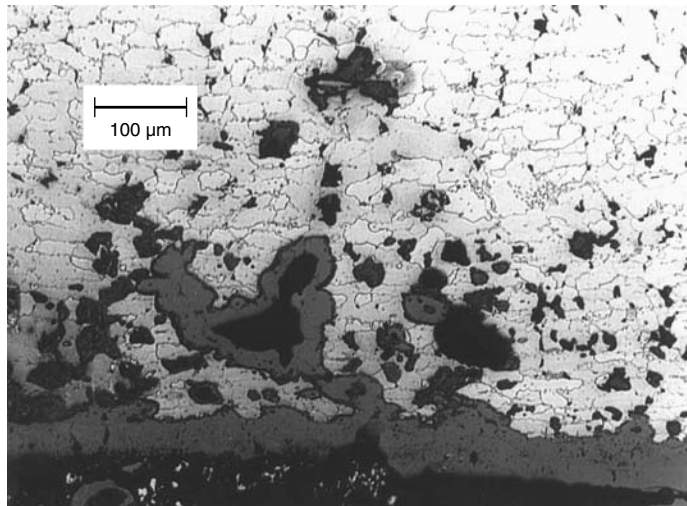
**Fig. 5** Waterside surface, hot side, near the failure. Carbides in prior pearlite colonies have completely spheroidized from overheating. Creep voids have developed at grain boundaries; some of these voids have grown and coalesced. Original magnification 210×

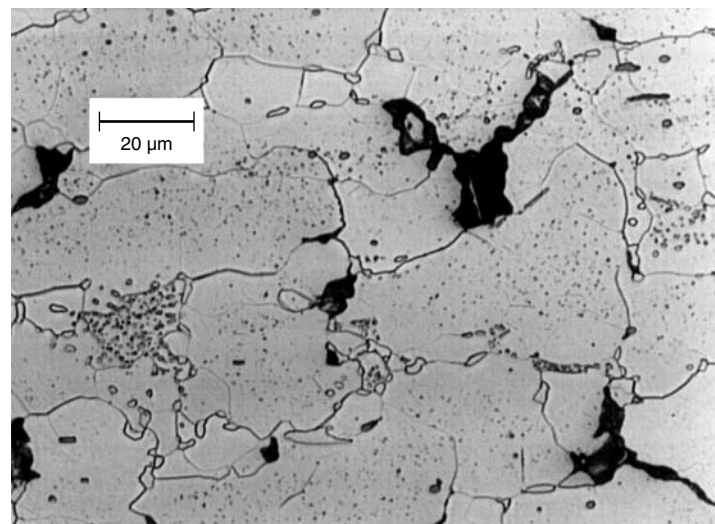
**Fig. 6** Carbides are fully spheroidized from thermal degradation near failure. Voids (dark sites) have formed along the grain boundaries that are perpendicular to the direction of applied stress. Original magnification 1050×

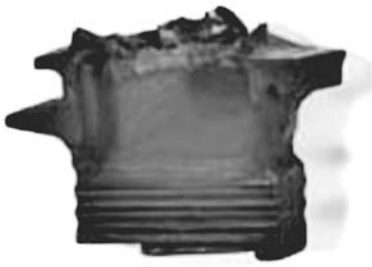
Fig. 7 Failed shipboard turbine at the transition between blade and stem. See also Fig. 8 through 11.

**Case Study: Turbine Blade Failure.** A case study of a marine gas turbine failure centered on the extent of corrosion that occurred under the platform of a turbine blade. Figure 7 shows a failed turbine blade. Figure 8 show unfailed blades that displayed heavy deposition under the platform of the double-stemmed blade. The blade alloy was within material specifications and the corrosion-resistant coating was applied by thermal spray. Metallographic examination showed that the coating thickness under the platform and in the curved area of transition between the platform and the blade stem was either very thin (up to 40 μm thick) or non-existent. The coating, if present, usually was porous or had entrained contamination under the platform due to lack of adequate spray deposition in these non-line-of-sight areas as shown in Fig. 9. MCrAlY coating thickness at other sites along the blade stem was 35 to 105 μm.

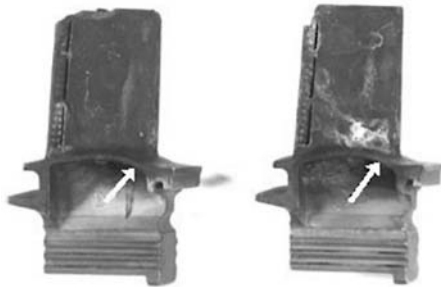
Fig. 8 Two shipboard turbine blades. Pressure side shown facing out of the page. Arrows denote areas where heavy corrosion products are observed.

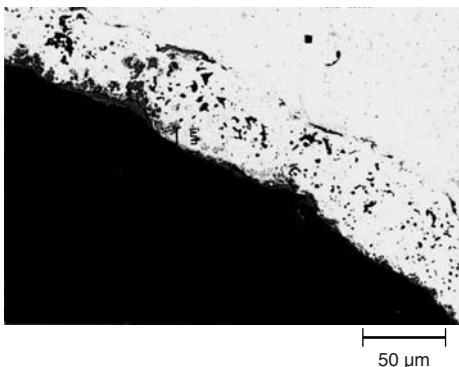
Fig. 9 Blade location along curvature at platform/stem transition. Poor coating quality at this site provides easy pathways for corrosion penetration. Original magnification 200x

The corrosion that was observed under the platform, in all cases, was caused by type II, LTHC, which occurs in the temperature range of

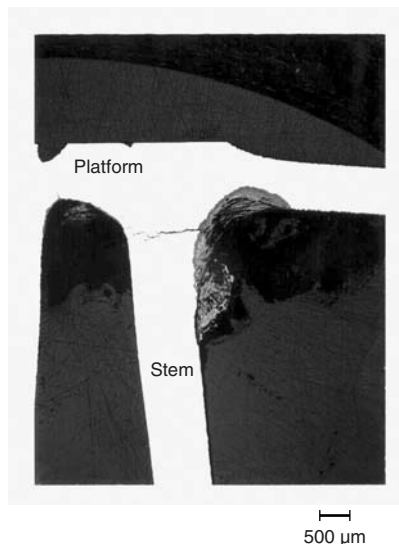
Fig. 10 Close-up of failed turbine blade. Cracking has initiated at platform/stem transition where corrosion has occurred. Original magnification 20x

650 to 730 °C (1200 to 1350 °F). In addition to the presence of hot corrosion, cracking was observed to initiate at several hot corrosion sites (Fig. 10). This was found to be advancing to various degrees through the stem of several blades. The pitting caused by the type II hot corrosion provided initiation sites for cracking to begin and reduced the overall undamaged cross section at the stem, thus increasing the applied stress to the corroded area. The cracking initially advanced via corrosion fatigue, but later, in some blade cases, by high-cycle fatigue (Fig. 11). Some cracking proceeded through both blade stem walls, causing some blades to break off during service. Many of the “unfailed” blades exhibited evidence of hot corrosion and varying degrees of corrosion fatigue/fatigue cracking.

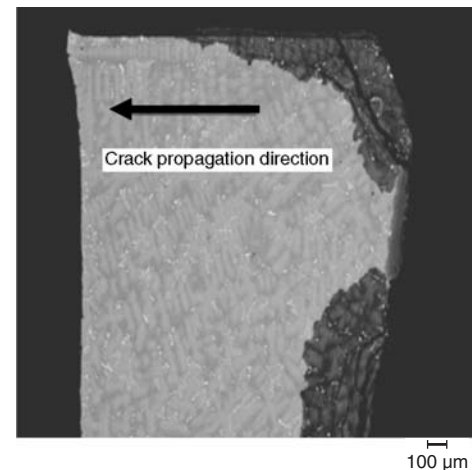
Fig. 11 Crack propagation direction of failed turbine blade. Corrosion propagates over 60% of the stem wall, thus increasing the applied stresses in the remaining stem wall. Fracture shows a sharp transgranular characteristic suggesting cleavage or high cycle fatigue. Original magnification 55x

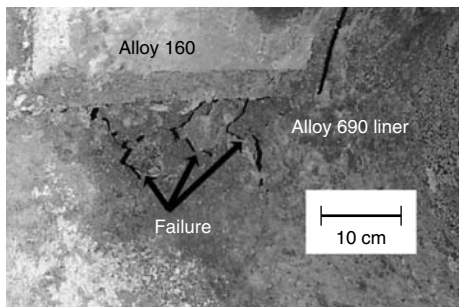
**Fig. 12** Failed incinerator liner. Hole near alloy 160 patch shows that the original 6.4 mm (0.250 in.) wall thickness had been reduced to 1.3 mm (0.050 in.) or less in the general area. See also Fig. 13 through 15.

The uncoated liner developed a very large perforation on the liner directly under the burner head where the incinerator flame could impact the liner surface, but inspection of this liner also revealed other, smaller perforations at numerous locations and elevations. The plate had not experienced any appreciable, visible corrosion after its 265 h of shipboard incinerator service. The alloy 690 liner adjacent to the alloy 160 patch showed severe deterioration and thinning of the liner wall, which had reduced the liner thickness from 6.4 mm (0.25 in.) to less than 0.51 mm (0.020 in.). Figure 13 displays generalized, uniform corrosive penetration about 0.125 to 0.20 mm (0.005 to 0.008 in.) deep into the alloy 690 liner that was caused by sulfidation. The major, outer, unexposed portion of liner alloy at this site was undisturbed. The surface corrosion had initiated at the inner, exposed liner surface; corrosives penetrated and advanced along the grain boundaries and combined with intragranular species to form oxide/sulfide precipitates.

Sulfidation led to corrosion and thinning of the incinerator wall and the diffusion of sulfur into the liner weakened the overall alloy mechanical strength and led to loss of ductility of the local microstructure. This induced an increased susceptibility to fatigue or corrosion fatigue cracking from cyclic thermal stresses from incinerator operation as shown in Fig. 14. Sulfidation and hot corrosion caused a large perforation of the liner under the burner head. Remaining perforated and pitted sections of the uncoated liner displayed varying degrees of attack from sulfidation and

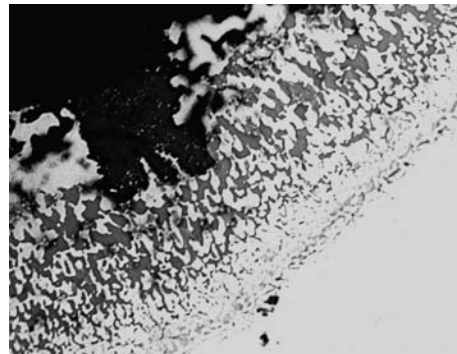
**Fig. 13** Uncoated incinerator liner. Diffusion of sulfur species along the grain boundaries has led to sulfidation of the liner alloy. Sulfur species concentration decreases as it moves deeper into the alloy. Original magnification 250×

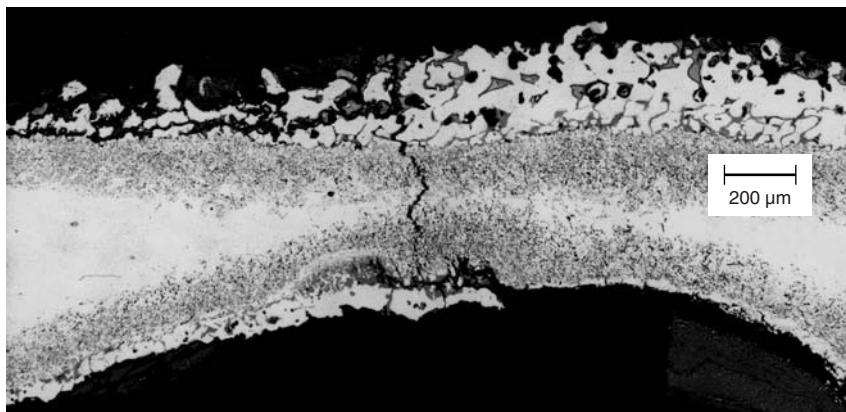
**Fig. 14** Uncoated incinerator liner near failure. Corrosion penetration from both inner and outer surfaces accompanied by cracking of liner. Total wall thickness has been reduced to 350  $\mu\text{m}$  (0.014 in.). Some grain reorientation and corrosion products are present. Original magnification 50×

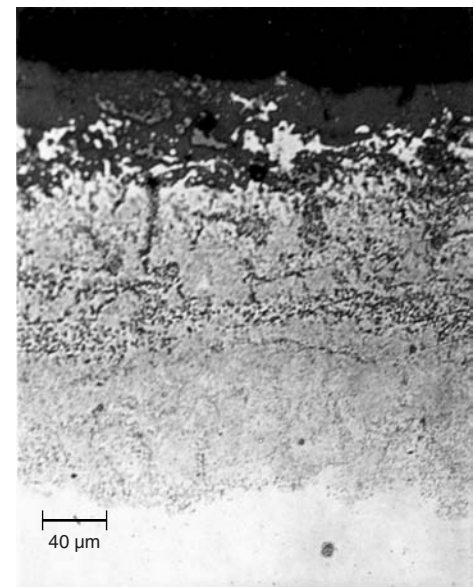
**Fig. 15** Uncoated incinerator liner. Diffusion of sulfur species extends about 250 to 300  $\mu\text{m}$  (0.01 to 0.012 in.) into the liner alloy. Severe sulfidation and type II hot corrosion had penetrated about 175  $\mu\text{m}$  (0.007 in.) into the liner alloy. Original magnification 250×

hot corrosion. Figure 15 shows that diffusion of sulfur penetrated about 0.25 to 0.30 mm (0.01 to 0.012 in.) into the liner alloy. Severe sulfidation and type II hot corrosion had penetrated about 0.175 mm (0.007 in.) into the liner alloy. Debris blocking the air cooling channel between the inner and outer liners raised the overall alloy liner temperature and acerbated the high-temperature corrosion. Sulfur species reacted with alloy 690 constituents at breaks in the surface oxide. Those sites affected by sulfidation were susceptible to cracking and accelerated wall loss and thinning. Alloy 160 appeared to offer some improvement in hot corrosion resistance over alloy 690.

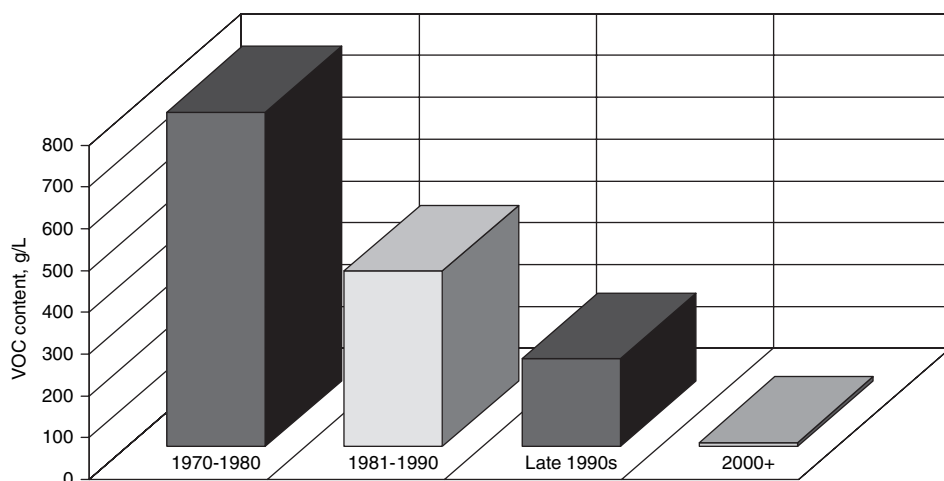
Fig. 3 Summary of volatile organic content (VOC) levels in standard military coatings over time

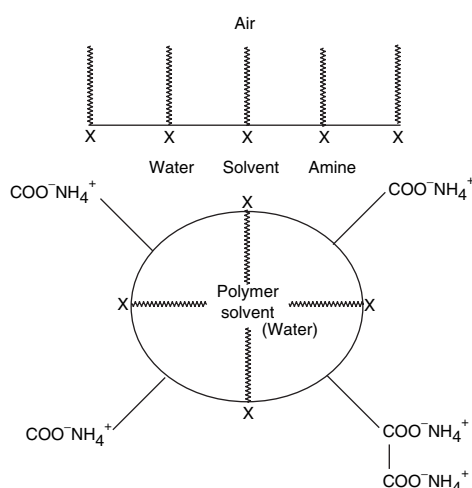
**Fig. 5** Schematic diagram of a resin micelle (approximately 120 nm in diameter) in a waterborne coating

Waterborne or water-reducible high-performance coatings are unique in the way that they employ resins that are usually not soluble in water. The resin exists in its own micellar phase (Fig. 5). Neutralized carboxylic groups and surfactants stabilize the particle. Excess amine and solvent distribute between the phases. Because the polymer exists in its own organic phase surrounded by water, the solvent distributes

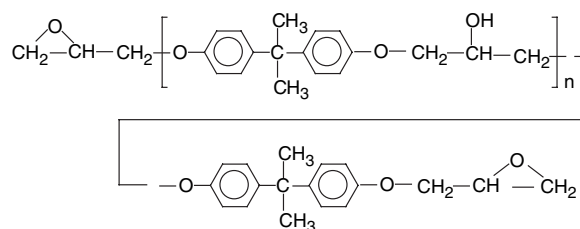
**Fig. 6** Chemical structure of an epoxy resin based on the glycidyl ether of bisphenol-A.

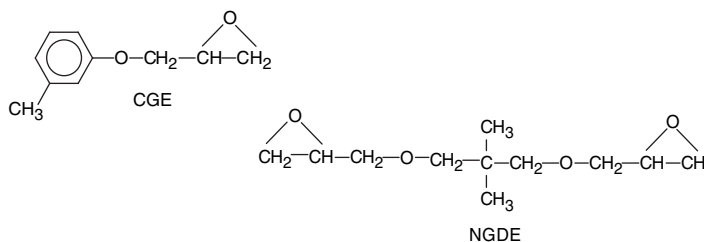
**Fig. 7** Chemical structures of the reactive diluents cresyl glycidyl ether (CGE) and neopentyl glycol diglycidyl ether (NGDE)

Reactive diluents were used in the development of a low-VOC epoxy topcoat. For more than 30 years, epoxy/polyamide systems have been used as the standard binder for coatings requiring superior chemical and corrosion resistance. These coatings use an epoxy resin cured with a standard high-viscosity polyamide curing agent. The epoxy resin is based on the glycidyl ether of bisphenol-A given in Fig. 6. Here, the value of “n” is between 2 and 3, and the epoxide equivalent weight (molecular weight divided by functionality) is approximately 500. In formulations containing such systems, 40 to 50 vol% solvent is necessary to attain a sprayable viscosity, significantly contributing to VOCs. Two reactive diluents were explored: one was monofunctional and the other was difunctional. The number of epoxide groups contained in the molecule defines the functionality. The monofunctional cresyl glycidyl ether (CGE) and the difunctional neopentyl glycol diglycidyl ether (NGDE) are pictured in Fig. 7.

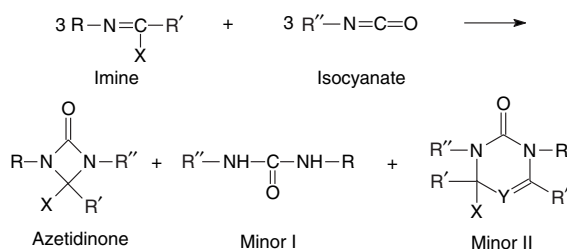
**Fig. 8** Imine-isocyanate chemical reaction scheme. R, R', and R'' are repeating polymer chains. If the imine is aldimine, X is H; if it is ketimine, X is methyl or greater. In minor II, Y = X - 2H; for example, if X is CH<sub>3</sub>, then Y is CH.

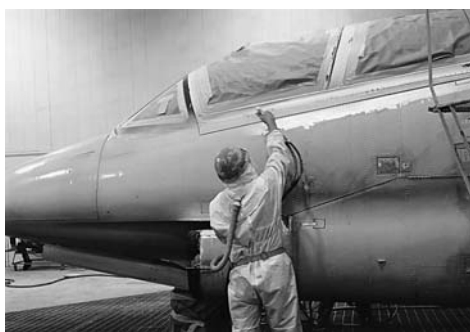
**Fig. 9** Application of nonchromated waterborne epoxy primer to a T-2 aircraft at a naval air depot

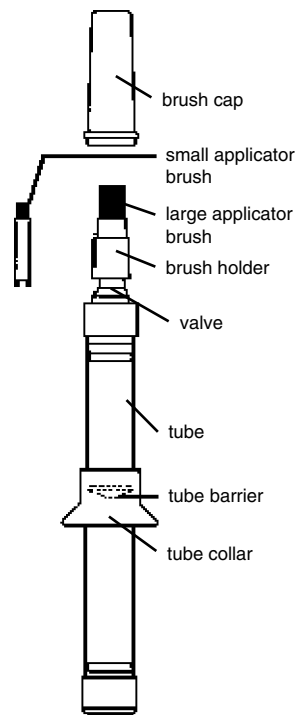
**Fig. 10** Schematic diagram of the Sempen, a self-contained paint applicator pen

A unique kit designed to store, mix, and apply small quantities of two-component paints has been developed. Approximately 10 cm<sup>3</sup> (0.6 in.<sup>3</sup>) of the base and curing agent are contained in a clear plastic tube, separated by an impermeable barrier. When the barrier is displaced, the two components are easily mixed by shaking. A narrow brush on one end is used to dispense and apply the mixed material. A wider brush is also included. This kit, known as a Sempen, can be used to touch up areas of 0.1 to 0.2 m<sup>2</sup> (1 to 2 ft<sup>2</sup>) and is shown schematically in Fig. 10.

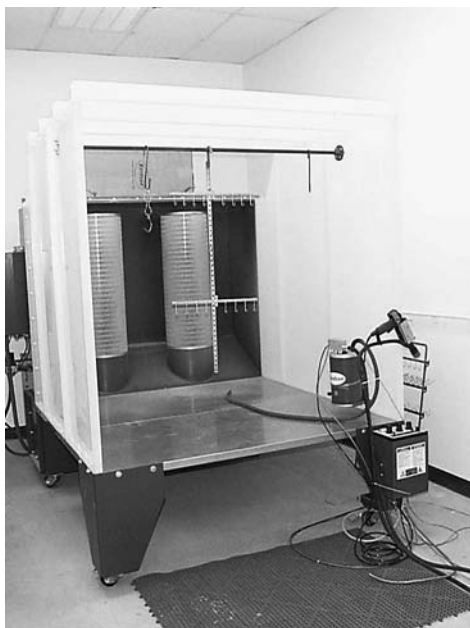
**Fig. 11** Powder coating spray booth at a naval air depot

Powder coatings can be applied by a variety of methods, including fluidized bed, dip coating, and electrostatic spray. With electrostatic spray, as the powder passes the high-voltage electrode at the tip of the spray gun, it picks up the electrostatic charge and is attracted to grounded work. There, the powder adheres and will remain until fused and cured in an oven. More

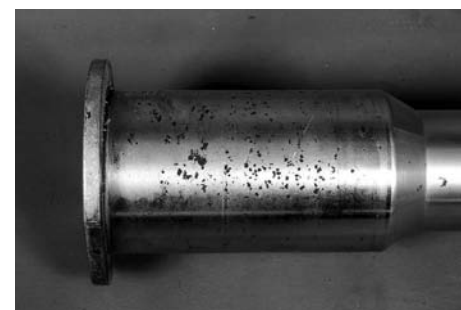
**Fig. 1** Pitting of 25 µm (1.0 mil) chromium plating on a steel pin used to join the lower carriage to the trails on a towed howitzer. The chromium plating should be twice this thickness to serve as an effective barrier coating for this application

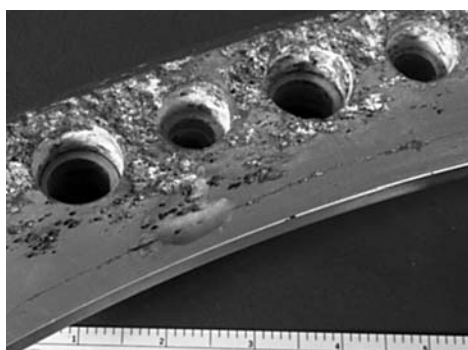
**Fig. 2** A section of a ring gear bearing from a howitzer in Hawaii. The gear is hardcoated aluminum and shows severe pitting at defects in the coating and at a defect from a scratch (bottom center). The coating is cathodic with respect to the scratch that is anodic.

Anodize and hardcoat finishes on aluminum convert the aluminum metal to a thicker aluminum oxide film (relative to the “natural” or air-formed film). As shown in Fig. 2, aluminum oxide is a cathode with respect to aluminum, so pitting corrosion occurs at defects in the coating. Not sealing the hardcoat improves the wear resistance, but significantly compromises the corrosion resistance.

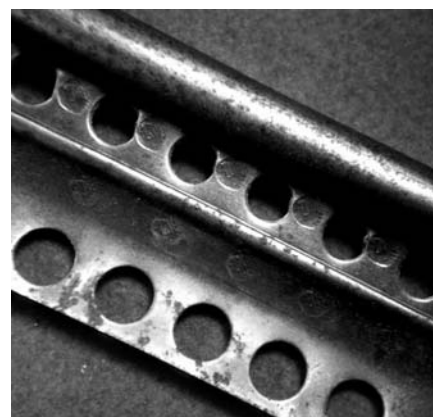
**Fig. 3** Rusting on a phosphated part after service in a desert environment. The phosphate coating had been blasted off by blowing sand leaving a bare metal surface. Phosphate coatings are specified on 75 to 90% of the parts for small arms.

almost no phosphate coating due to the abrasive action of blowing sand in the area. The phosphate coating is relatively soft, and the sand blasted the coating off the parts. Weapon parts became susceptible to rusting without the phosphate coating to hold the oil.

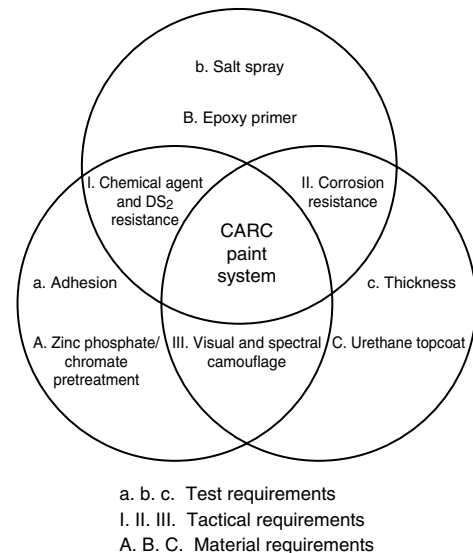
**Fig. 4** A logical schematic of the relationship of materials (pretreatment, primer, and topcoat) used for chemical agent resistant coating (CARC) paint systems with the tactical and test requirements.  $\text{DS}_2$  is decontamination solution.

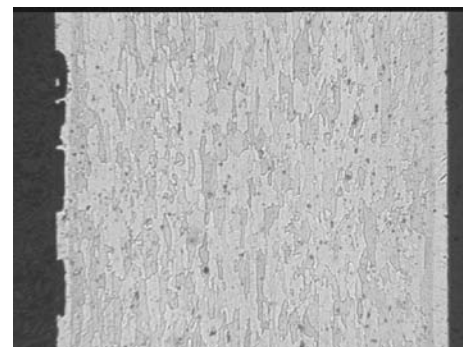
**Fig. 3** Aluminum laminate. Al 7072 aluminum cladding providing corrosion protection of Al 7075-T6 core. Note lateral spread of corrosion at clad layer to prevent through wall failure of a P-3 fuel tank divider web. Courtesy of K. Himmelheber, Naval Aviation Depot—Jacksonville

Aluminum cladding is used on sheet products, such as fuselage skins, fuel tank divider webs, and other components. Cladding alloys are selected to be anodic to the core alloy and provide cathodic protection to the core. Cladding materials are metallurgically bonded via rolling processes to the core material. Corrosion progressing through the cladding will progress to the core interface and spread laterally and prevent perforation of the core material. Figure 3 illustrates the protective nature of aluminum cladding and the associated resistance to pitting corrosion of the core material.

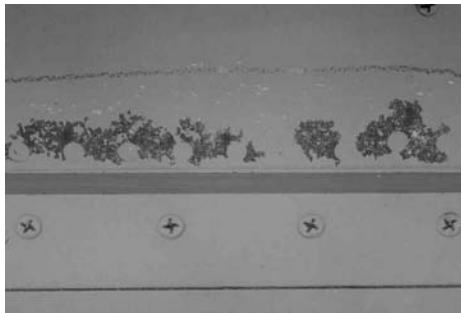
Fig. 4 Filiform corrosion of an aluminum external surface adjacent to steel fasteners. Courtesy of J. Benfer, Naval Air Depot—Jacksonville

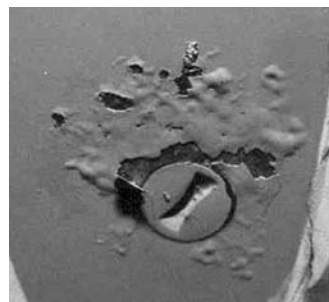
Fig. 5 Macrograph illustrating filiform corrosion of an aluminum aircraft surface adjacent to steel fastener. Courtesy of J. Benfer, Naval Air Depot—Jacksonville

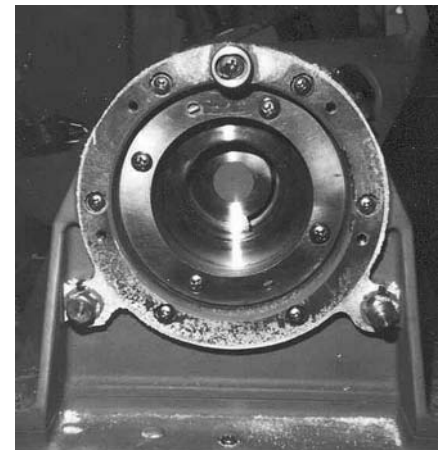
Fig. 6 Surface corrosion of AZ-91C magnesium radar assembly resulting from atmospheric exposure. Courtesy of J. Benfer, Naval Air Depot—Jacksonville

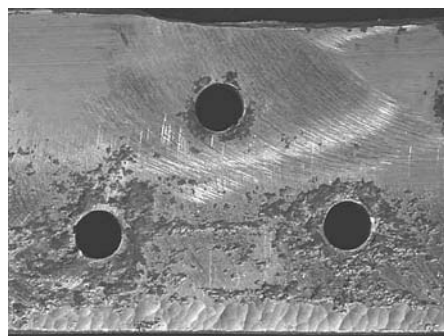
Fig. 7 Extensive pitting corrosion damage of an aluminum lower longeron from a EA-6B aircraft requiring removal and replacement with newly manufactured item. Courtesy of J. Benfer, Naval Air Depot—Jacksonville

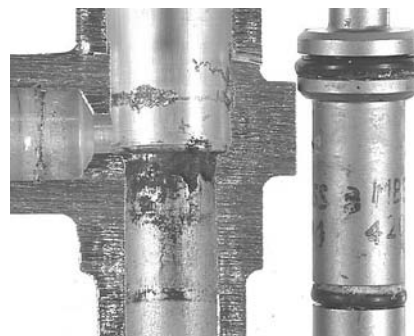
Fig. 8 Internal exfoliation corrosion of a barostatic release unit associated with an F-14 ejection seat. Courtesy of J. Benfer, Naval Air Depot—Jacksonville

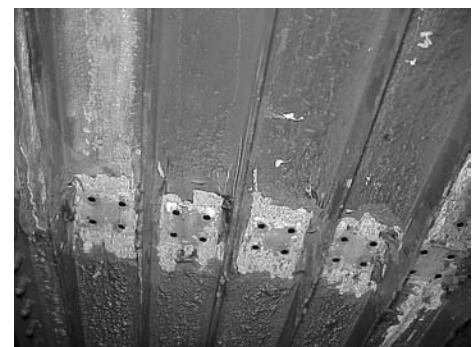
Fig. 9 Exfoliation corrosion of a integral fuel tank on a P-3 aircraft resulting from long-term exposure to moisture, salts, and fuel-system icing inhibitors. Courtesy of J. Benfer, Naval Air Depot—Jacksonville

**Example 5: Exfoliation corrosion** damage occurred on an aluminum P-3 integral fuel tank resulting from long-term exposure to moisture, salts, and fuel-system icing inhibitors (Fig. 9). Corrective action involved the mechanical removal of corrosion with powered abrasive sanders followed by surface treatment and application of AMS-C-27725 fuel tank coating.

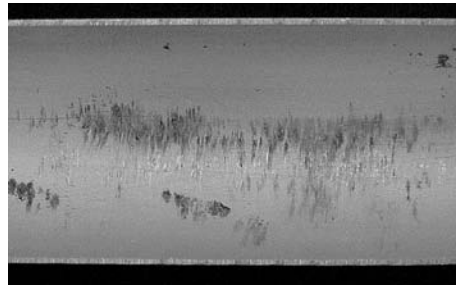
**Fig. 10** Fretting corrosion damage on the internal walls of aluminum electrical wire conduit installed within the wing of an EA-6B aircraft. Courtesy of J. Benfer, Naval Air Depot—Jacksonville

**Example 6: Fretting corrosion** damage occurred on the interior of an aluminum electrical wiring conduit located within the integral fuel tank of an EA-6B aircraft (Fig. 10). Through-wall corrosion damage resulted in significant fuel leaks, requiring the rerouting of electrical wires. Corrective action included the removal of wire bundle ties and application of additional protective coatings to newly installed conduits.

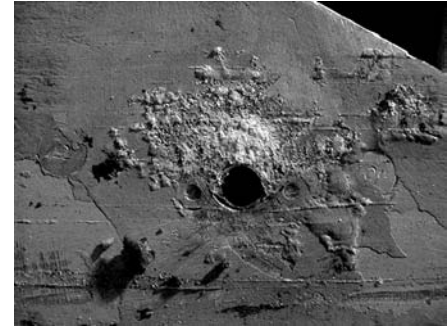
**Fig. 11** Corrosion around an aluminum floorboard mounting hole due to saltwater intrusion. Courtesy of J. Whitfield, Naval Air Depot—Cherry Point

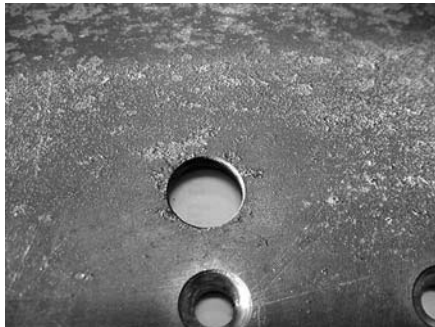
**Fig. 12** Corrosion of a nickel-plated aluminum mounting bracket for AV-8 aircraft due to atmospheric exposure. Courtesy of J. Whitfield, Naval Air Depot—Cherry Point

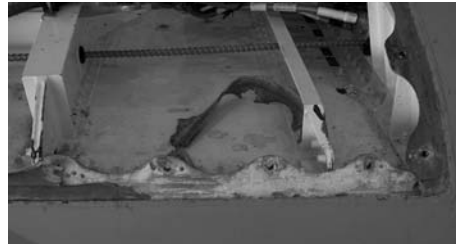
**Fig. 13** Galvanic corrosion of F/A-18 aircraft dorsal scallops resulting from composite doors attached to aluminum substructure with titanium and steel fasteners in the presence of moisture. Courtesy of S. Long, Naval Air Depot—North Island

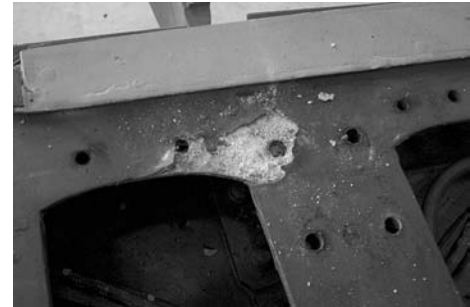
**Fig. 14** Galvanic corrosion of an F/A-18 aircraft wing substructure resulting from composite doors attached to aluminum substructure with titanium and steel fasteners in the presence of moisture. Courtesy of S. Long, Naval Air Depot—North Island

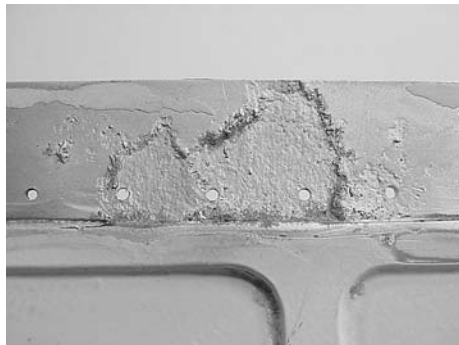
**Fig. 15** Corrosion damage of a T-45 aircraft access panel. Corrosion initiates at and beneath electromagnetic interference (EMI) fingers (removed) needed to control the EMI. Courtesy of J. Benfer, Naval Air Depot—Jacksonville

substructure for control of EMI through the use of conductive EMI fingers prevents the usage of many protective coating systems. Corrective action is the frequent application of avionics-grade corrosion-preventive compounds and a recommended design change to incorporate the replacement of EMI fingers with a conductive sealant.

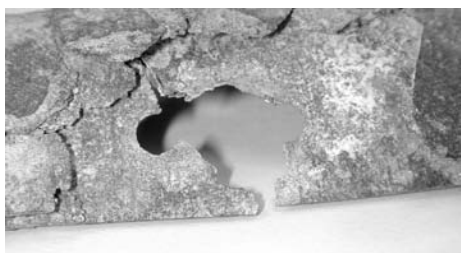
**Fig. 18** Exfoliation corrosion of an aluminum T-45 cockpit kick plate angle resulting from water intrusion within cockpit areas. Courtesy of J. Benfer, Naval Air Depot—Jacksonville

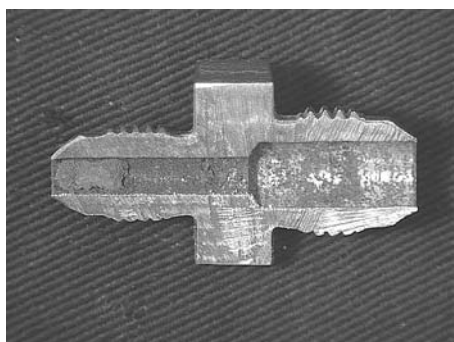
**Fig. 19** High-temperature corrosion of a 300 series stainless steel union fitting within an EA-6B canopy ejection system. Courtesy of J. Benfer, Naval Air Depot—Jacksonville

**Example 13: High-temperature corrosion** of a 300 series stainless steel union fitting located within the canopy ejection system of an EA-6B aircraft is shown in Fig. 19. High-temperature exposure during previous actuation of the canopy ejection system resulted in the oxidation of interior surface.

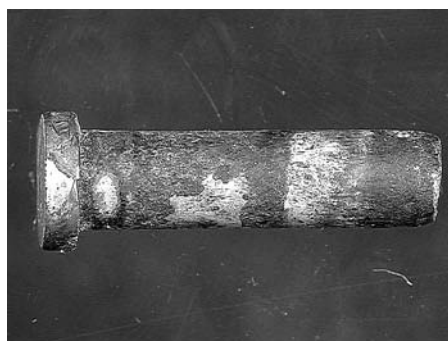
**Fig. 20** General corrosion of a cadmium electroplated carbon steel pin associated with the locking pawl of a F-14 ejection seat. Courtesy of J. Benfer, Naval Air Depot—Jacksonville

**Example 14: General corrosion** of a cadmium electroplated carbon steel pin associated with the locking pawl system of a F-14 ejection seat is shown in Fig. 20. Water intrusion and atmospheric exposure resulted in consumption of the protective cadmium electroplate. Cor-

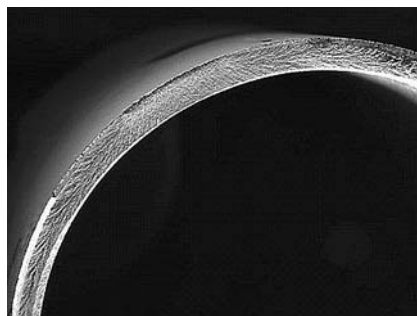
**Fig. 23** Macrograph of the fracture initiation area of a catastrophically failed F-14 arresting gear tail hook. Courtesy of J. Yadon and K. Himmelheber, Naval Air Depot—Jacksonville

**Example 16: Hydrogen Embrittlement.** F-14 arresting gear tail hook stinger catastrophically failed during an attempted arrested landing aboard a carrier. Failure occurred at the forward weld area and was the result of hydrogen embrittlement of the 300M high-strength steel. Figure 22 shows the component as received in the laboratory, and Fig. 23 is a macrograph of the fracture initiation area that was an area of high residual tensile strength.

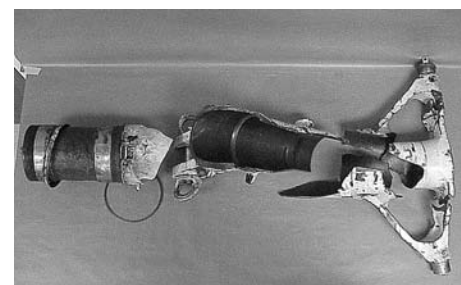
**Fig. 21** Catastrophic failure of F-14 nose landing gear cylinder, caused by corrosion-induced fatigue cracking of high-strength steel. Courtesy of S. Binard, Naval Air Depot—Jacksonville

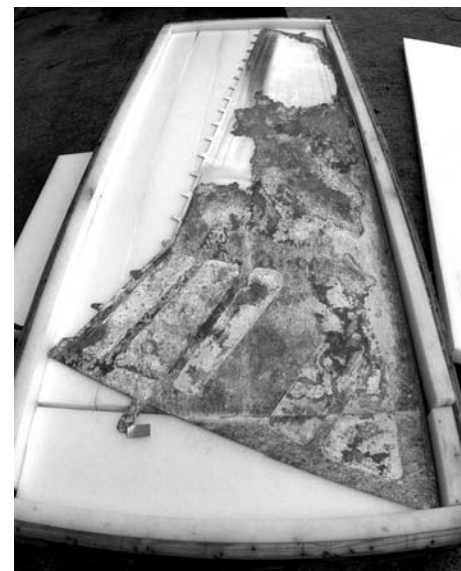
**Fig. 24** EA-6B aluminum horizontal skin exhibiting extensive water-induced corrosion due to improper packaging and preservation during shipment from manufacturer. Courtesy of S. Bevan, Naval Air Depot—Jacksonville

**Example 17: Damage Due to Improper Packaging.** Newly manufactured EA-6B aluminum horizontal skin in Fig. 24 exhibited extensive corrosion as the result of water ingress from improper packaging and preservation during shipment from the manufacturer.

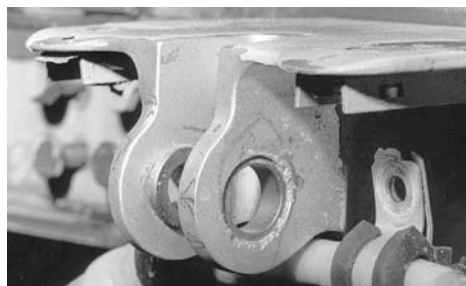
**Fig. 2** Corrosion of an aluminum alloy hinge (7050-T74) around a copper alloy bushing (UNS C17200, beryllium copper)

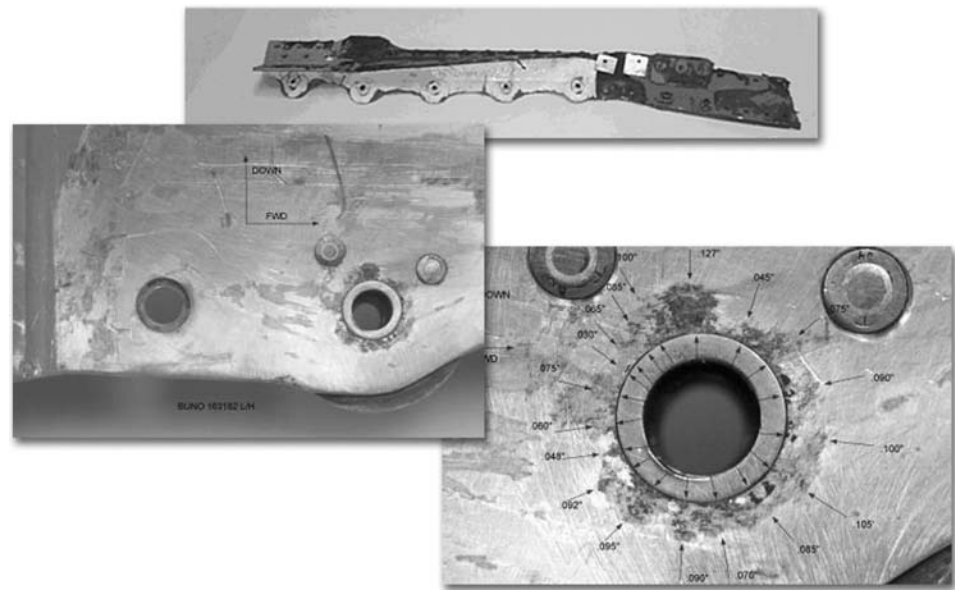
**Fig. 3** Exfoliation corrosion around a fastener hole in a 7049-T73 aluminum alloy longeron. Radial arrows indicate measurements taken to assess damage.

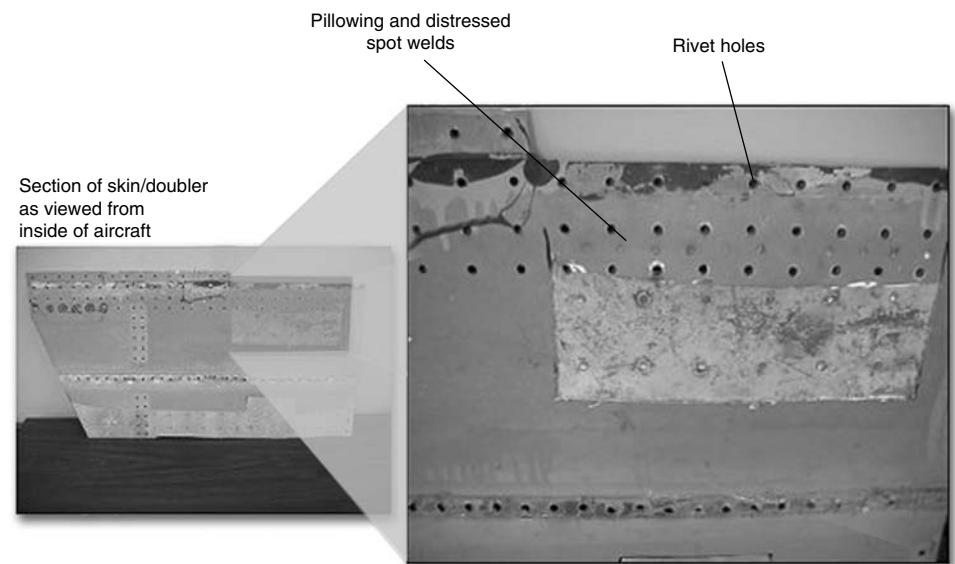
**Fig. 4** Corrosion pilling on aircraft skin at joint. Aluminum alloy 2024-T4 skin is joined to doubler by spot welding and with fasteners (2017-T3). Rivet holes for the lap joint are seen in the lower (inside) portion of the joint.

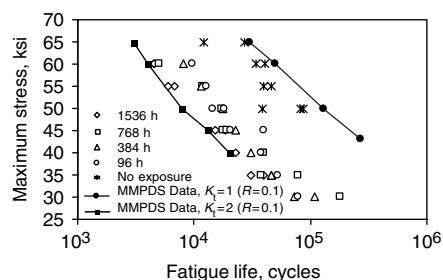
**Fig. 5** Fatigue properties of unexposed and corroded, 0.080 in. thick 7075-T6 sheet. Data of various exposure times of prohesion corrosion spray test are compared to MMPDS Handbook data. Stress-concentration factor  $K_t = 1$  is smooth specimen,  $K_t = 2$  has a discontinuity that doubles stress.  $R$  is the ratio of minimum stress to maximum stress applied each cycle.

Since corrosion causes stress concentrations, prior corrosion will reduce the fatigue lives of materials. This is illustrated by the measured fatigue lives of 7075-T6 aluminum alloy specimens with and without prior corrosion damage (Fig. 5) (Ref 20). The corroded 7075-T6 specimens contained varying amounts of damage caused by exposing them to various durations in the prohesion salt-spray test (ASTM G 85, Annex 5). Prohesion used to describe this test was derived from “protection is adhesion.” The measured lives are also compared with the values

contained in the *Metallic Materials Properties Development and Standardization Handbook* (MMPDS, formerly MIL-Handbook-5) for the fatigue lives of bare 7075-T6 alloy without any prior corrosion damage (Ref 21). The MMPDS values are plotted for lives of specimens at values of stress-concentration factor,  $K_t$ , of 1 (smooth specimen with no surface stress concentration) and  $K_t = 2$  (specimen containing a geometrical discontinuity that raises the local stress at the discontinuity to two times the nominal stress applied to the specimen). The  $R$  value of 0.1 is

the ratio of the minimum stress to the maximum stress applied in each load cycle during the fatigue test.

A continuous decrease in fatigue life with increasing prior corrosion damage is observed. It is interesting to note that the measured fatigue lives for 7075-T6 containing various levels of prior corrosion damage are bounded by the design handbook values for noncorroded 7075-T6 at  $K_t$  values of 1 and 2. The observation that the magnitude of the reduction of the fatigue lives by prior corrosion is similar to that due to a geometric flaw or discontinuity suggests that equivalent stress-concentration factors attributable to corrosion damage could be used as a measure or metric to quantitatively describe the effects of corrosion.

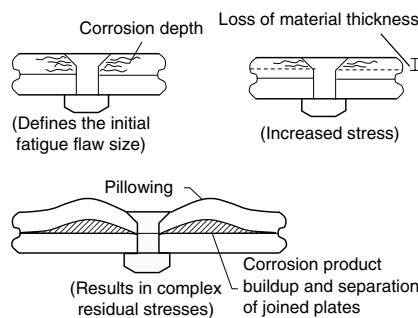
**Fig. 6** Corroded lap joint showing pillowing mechanism

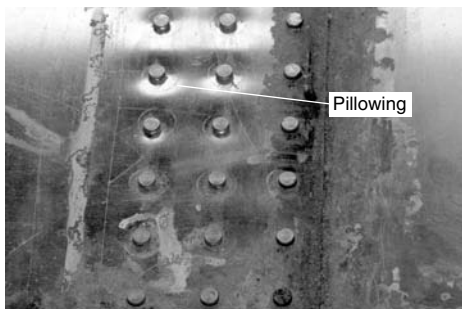
**Fig. 7** Overall surface appearance of panels representing a fuselage skin joint. 7075-T6 alloy skin with 2017 fasteners was exposed 110 days in an ASTM copper-assisted salt solution spray test.

In investigating the effects of corrosion of lap joints, varying amounts of pillowing must be obtained without the pillowing stresses causing failure of the fasteners. An example of pillowing resulting from the exposure of specimens representing a fuselage lap-splice joint is shown in Fig. 7. The specimens were fabricated from clad aluminum alloy 7075-T6 sheet (1.6 mm, or 0.063 in., nominal thickness) and 2017 aluminum alloy fasteners. Aluminum alloy products, particularly sheet and tube, are clad with a layer of a different aluminum alloy that is 80 to 100 mV more anodic than the core to provide cathodic protection to the core alloy. Alloys 7008, 7011, and 7002 are commonly used for cladding 7075. In clad alloys, corrosion progresses to the core/cladding interface and then laterally, thus eliminating perforation of thin products (Ref 43).

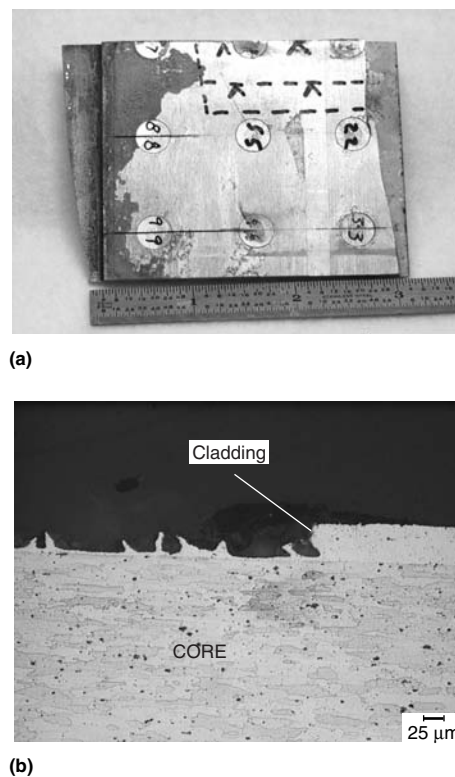
**Fig. 8** Corroded lap joint of 7075-T6 skin with 2017 fasteners. (a) Specimen from panel exposed in the ASTM CASS spray test show pillowing and attack of cladding. (b) Micrograph cross section show loss of cladding, but no loss to the 7075-T6 core. Original magnification: 200 $\times$

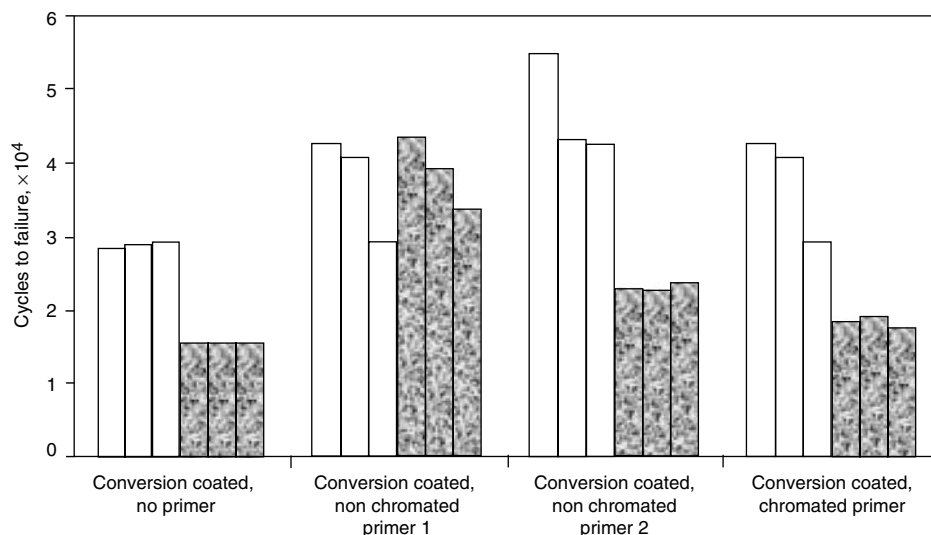
**Fig. 9** Effect of various corrosion protection schemes on the fatigue behavior of 7075-T6 alloy. Six samples were fatigue tested from each protection scheme. Fatigue test maximum stress 380 MPa (55 ksi),  $R = 0.1$ . The white bars had no prior corrosion exposure. The three shaded bars in each set were exposed to 1536 h prohesion corrosion environment.

Figure 9 presents the results of constant amplitude fatigue testing of chromate conversion coated 7075-T6 specimens further treated with primers and tested in four different conditions, treated with: a chromated primer, two different nonchromated primers, and no primer (tested as conversion coated) (Ref 46). For each of these

four conditions, six specimens—three without any prior corrosion exposure and three with 1536 h exposure to the prohesion corrosion environment (ASTM G 85, Annex 5)—were fatigue tested at a maximum stress level of 55 ksi and  $R$  ratio of 0.1. The fatigue cycles to failure for specimens with and without the corrosion exposure are shown by the shaded and unshaded bars, respectively. Corrosion exposure resulted in a decrease in the fatigue lives of all specimens except those with one of the nonchromated primers. Development of new environmentally compliant systems is presently aimed primarily at achieving corrosion-protection performance approaching that of chromated systems. Their corrosion fatigue behavior under service conditions needs to be characterized to assess effects on structural integrity.

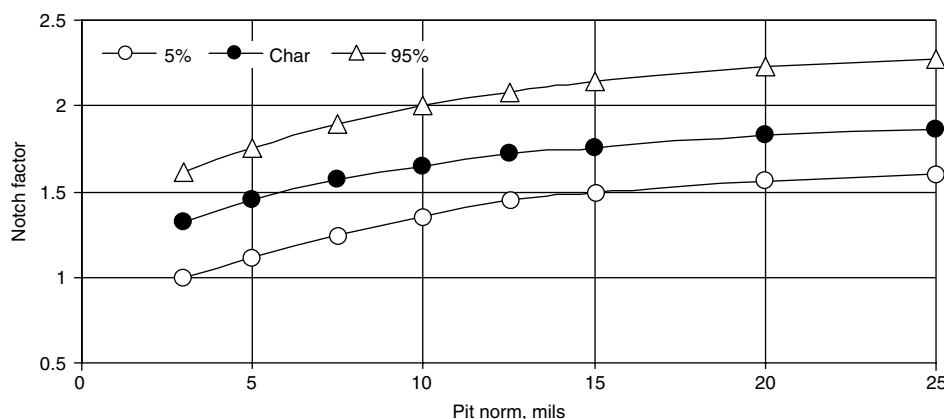
**Fig. 11** Corrosion notch factor (corrosion severity) as a function of characteristic pit norm corrosion metric. Notch factors were computed for data of Fig. 10.

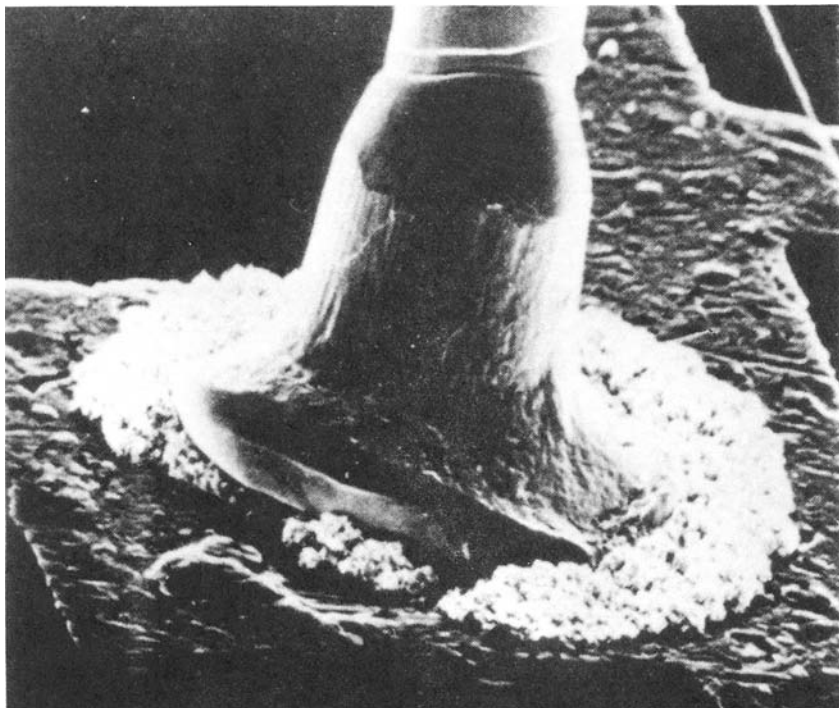
**Fig. 1** Example of purple plague. The failure characteristics often associated with purple plague are increased electrical resistance and lower mechanical (bond) strength.
