# ASM Handbook®

## Volume 13C Corrosion: Environments and Industries

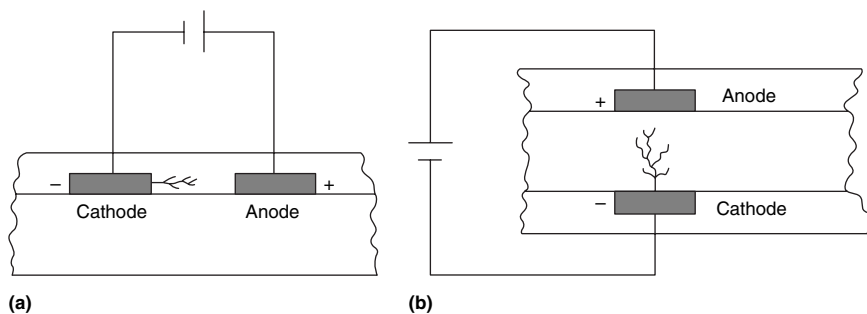
**Fig. 2** Schematic showing an electrolyte bridging two circuits on an electronic board. (a) Transverse view of the board. (b) Top-down view of the circuits on the board. Source: Ref 22

plate out across circuits, similar to the shorting shown in Fig. 2, when the circuits are at different potentials. However, silver can also plate out across nonconductive surfaces by a dissolution/plating mechanism that also creates an electrical short between two conductors. In addition, most

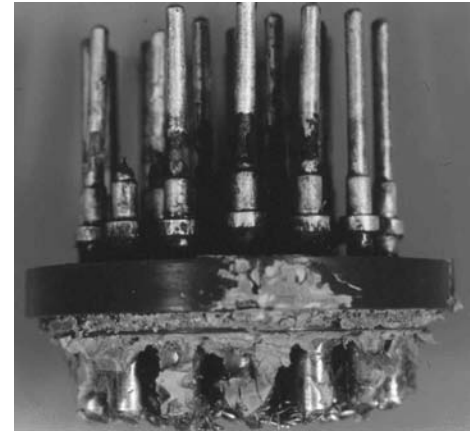
**Fig. 3** Effects of water being trapped inside a connector. The high-voltage pin (anode) is completely corroded off (right side), while the ground pins (cathodes) exhibit no corrosion. The pins in between are at lower voltages and show a lesser degree of corrosion.

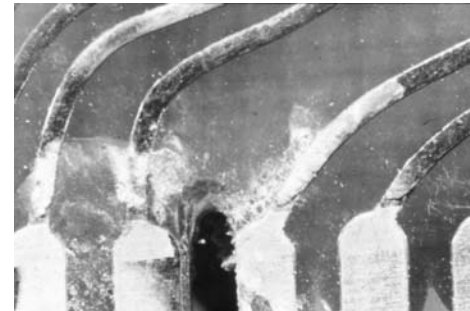
**Fig. 4** White corrosion products on tin-coated circuits and galvanic corrosion between the gold-tin contact/circuit interface resulting from a coffee spill

Coffee spillage was encountered on PCBs mounted in the flight control unit of a C-5 aircraft. Figure 4 shows the result of the coffee spill in the contact area. Naval electronic maintenance personnel have suggested that black boxes have a pointed top (shaped like a doghouse) to prevent liquid containers from being set on the devices.

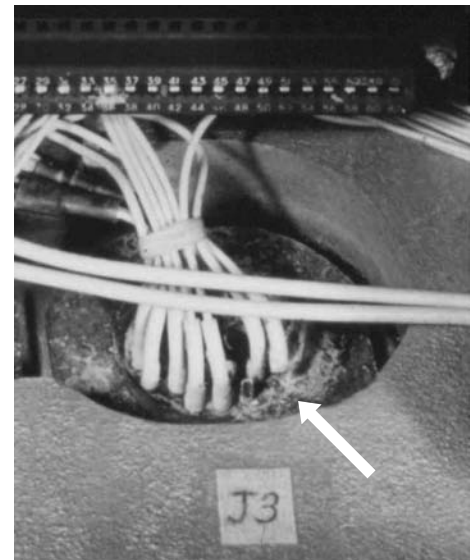
**Fig. 5** Effects of water accumulation in the sump area of a black box. The arrow points to the high-voltage lead wire that has completely corroded, rendering the unit nonfunctional. Note that the connector is wrongly positioned horizontally inside the box.

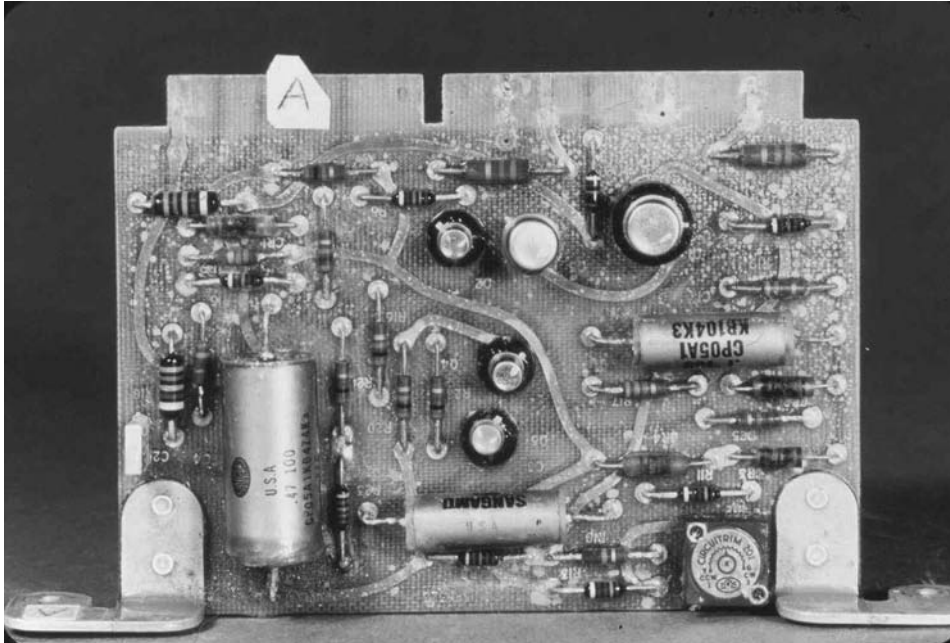
**Fig. 6** Tin-plated contacts (a + A) that have been completely corroded as a result of being inserted into a gold-plated beryllium-copper connector. Electrolyte was retained as a result of the board being in the horizontal position.

maximum reliability. In other instances, tin plating, lead-tin plating (solder plating), or silver plating may be used on various components. It is essential to use similar metals on the connectors, PCB contacts, and circuits to prevent galvanic corrosion. Gold in contact with tin or solder plating will result in severe galvanic corrosion of the tin or solder plating. Figure 6 shows tin-plated contacts that were inserted into a gold-plated beryllium-copper connector in the horizontal position.

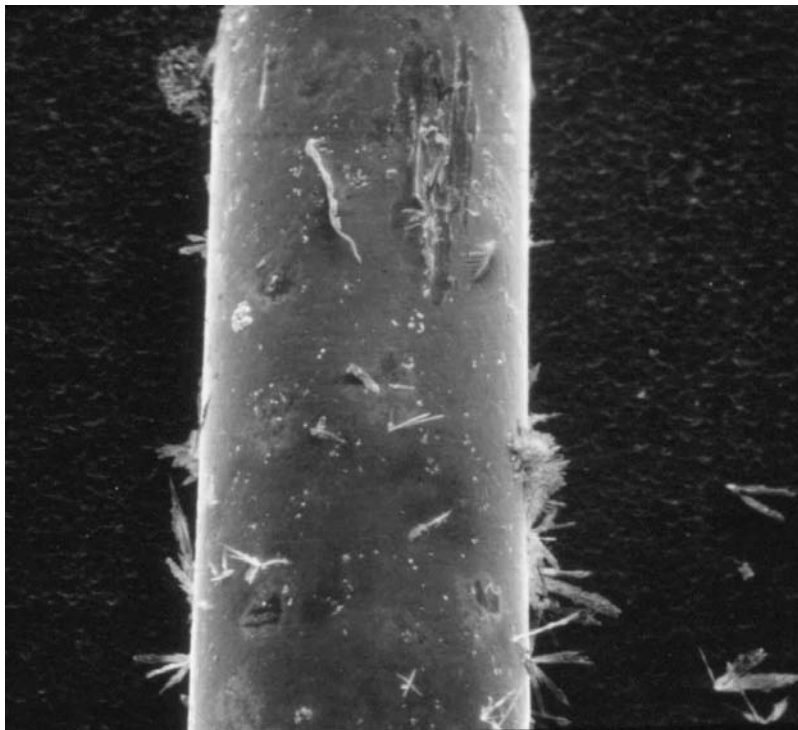
**Fig. 7** Silver sulfide whiskers growing on a copper pin that was coated with silver plating followed by gold plating

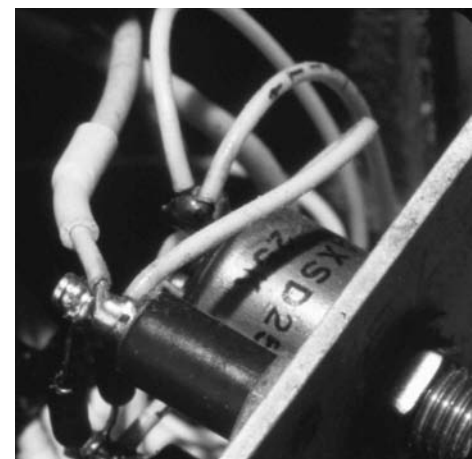
**Fig. 8** Two solder connections that were made without a heat sink. The solder area was hot enough to initiate the thermal decomposition of the polyvinyl chloride insulation. The continuing decomposition of the insulating material resulted in the release of hydrogen chloride gas to the inside of the electronic unit.

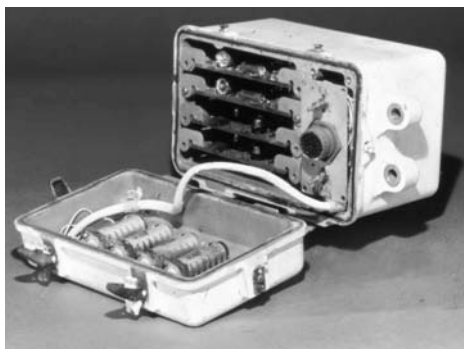
**Fig. 9** Electronic black box that ceased to function in the tank in which it was mounted. The design of the box (see related text) violated the rules for building a reliable piece of equipment.

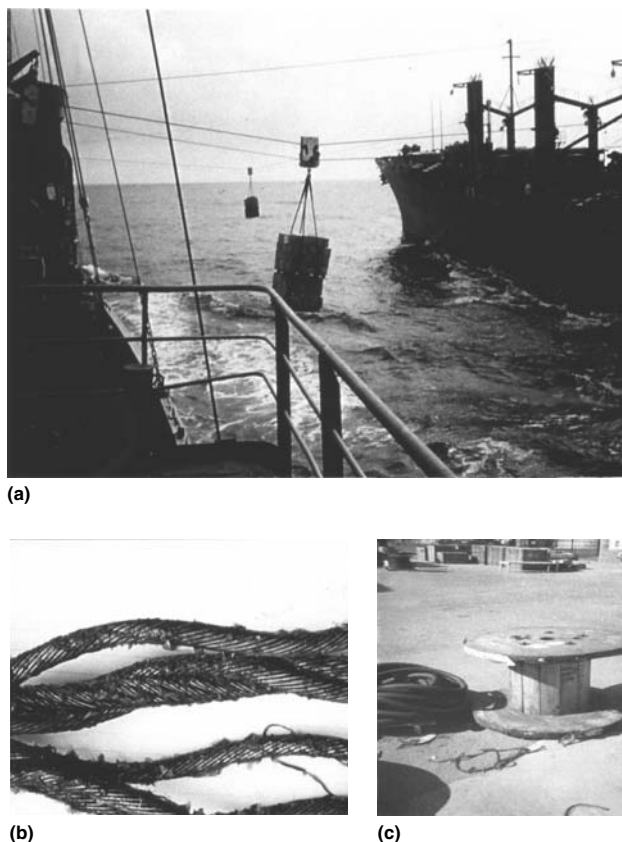
Fig. 3 Carbon steel wire rope. (a) Carbon steel highline being used to transfer equipment between ships at sea. (b) Seven-strand carbon steel wire rope with maintenance grease. (c) Typical wooden spool used to store wire rope

Indirect dissolution of protective greases by fungi was investigated (Ref 14). Protective greases are used to provide corrosion protection for seven-strand carbon steel cable used as wire rope and as highlines. Each cable is made of six strands wrapped around a central core. When cable is used as rope or highline, the cable is coated with thick maintenance grease, threaded onto wooden spools (Fig. 3a–c), and wrapped in brown paper and black plastic. The maintenance grease is applied to the cable to provide corrosion protection. Wire rope is stored on wooden spools for weeks to months before being used. In an investigation of localized corrosion on wire rope stored on wooden spools, fungal growth was observed on interiors of some wooden spools stored outdoors. Corrosion was most severe on wraps of wire in direct contact with the wooden

spool flanges. *Aspergillus niger* and *Penicillium* sp. were isolated from wooden spool flanges (Fig. 4). Fungal isolates could not grow on the protective grease as the sole nutrient source. The isolates grew on wood and produced copious amounts of acids and CO<sub>2</sub>. In all cases, localized corrosion was observed in areas where acidic condensate dissolved the maintenance grease and exposed bare areas of carbon steel.

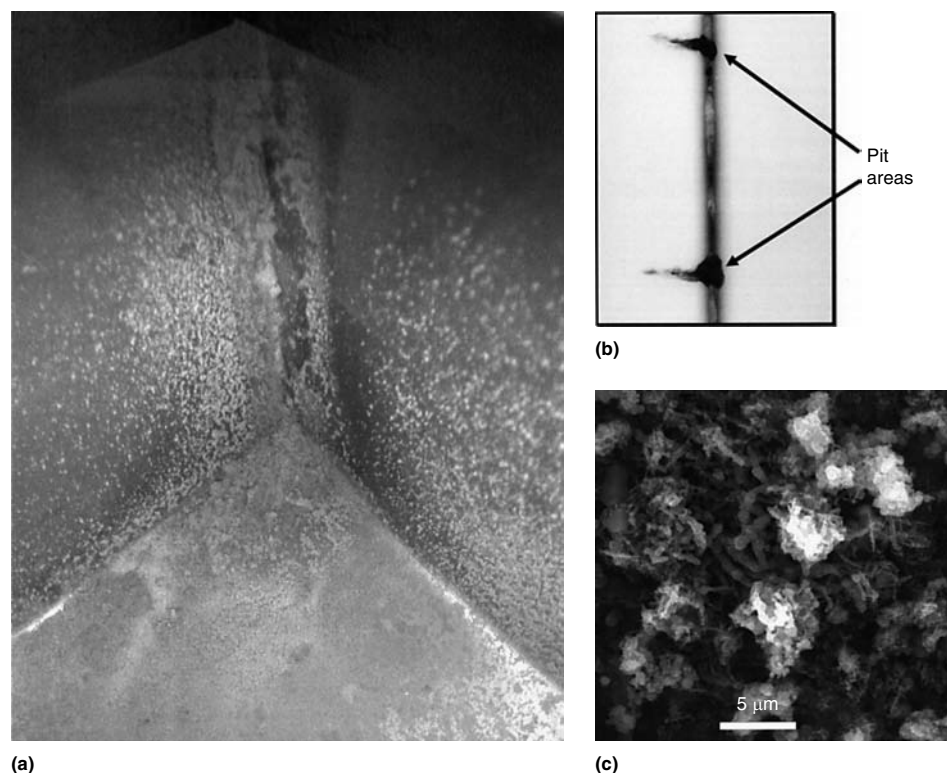
**Fig. 5** Vertical weld in 316 stainless steel after exposure to stagnant natural seawater for 8 weeks. (a) Weldment. (b) X-ray of failed vertical weld. (c) Bacteria associated with corrosion products.

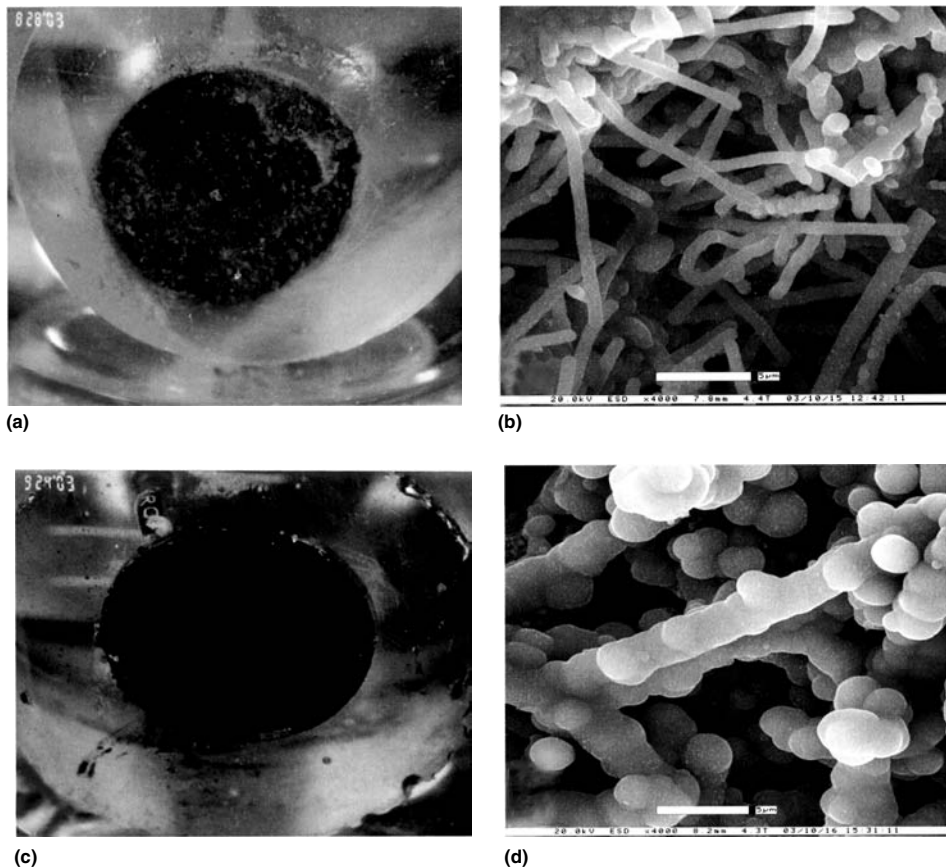
**Fig. 7** Carbon steel electrodes exposed to aerobic and anaerobic natural seawater for 290 days. (a) Aerobic. (b) Aerobic. Scanning electron micrograph of iron-oxide encrusted bacteria enmeshed in corrosion products. (c) Anaerobic. (d) Anaerobic. Scanning electron micrograph of sulfide-encrusted organisms enmeshed in corrosion products.

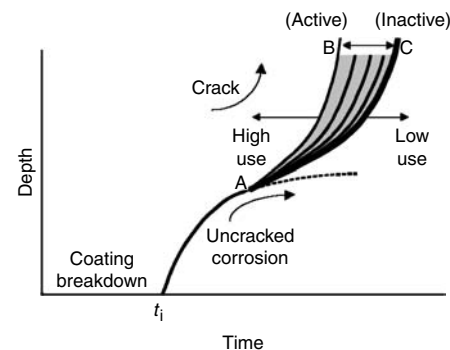
Fig. 1 Growth of corrosion and fatigue cracking with time

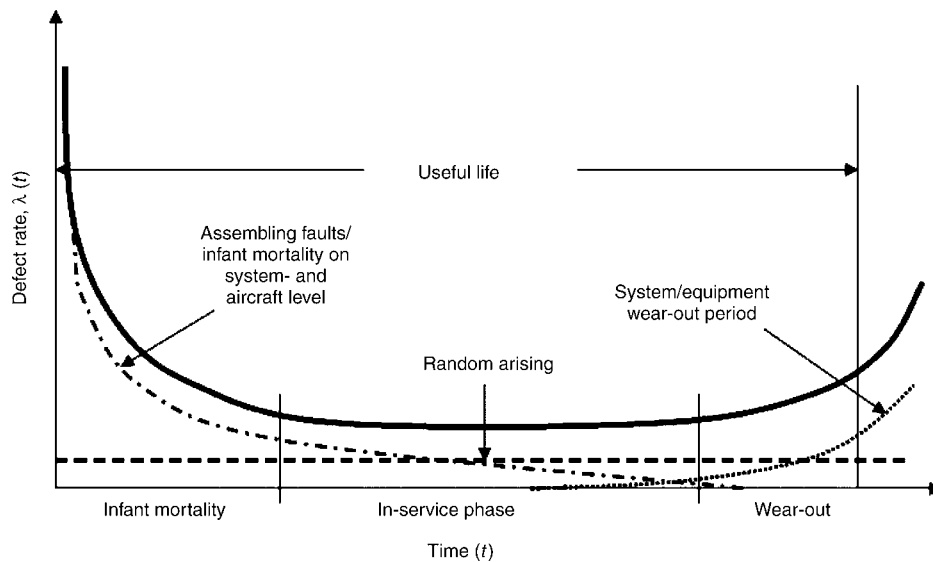
**Fig. 2** Reliability of equipment as defined by the bathtub curve. The infant mortality phase can typically be 20% of useful life.

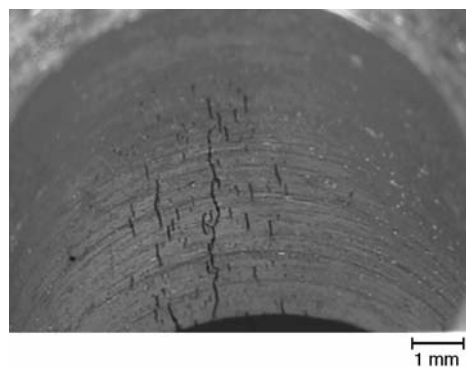
**Fig. 3** Optical micrograph of a high stressed region in a B707 wing panel showing extensive corrosion fatigue cracking

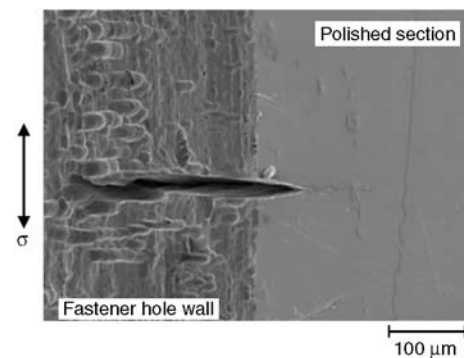
**Fig. 4** Scanning electron micrograph of a section through an elongated damage in a B707 wing panel showing corrosion fatigue cracking

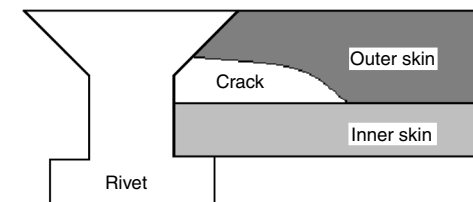
**Fig. 5** Suggested shape of cracks under influence of pillowing

In effect, pillowing produces a compressive stress in the rivet area on the outer surface or skin while a high tensile stress is present on the faying surface or inner skin, causing the growth of nonsurface breaking cracks with the suggested shape shown in Fig. 5. This circumstance strongly reduces the probability of detection before first linkup in a MSD situation occurs and therefore significantly increases the risk of an in-service failure. Attempts have been made to quantify this effect by means of mechanistic models (Ref 14), but the many parameters needed render the models unreliable so far, and a more empirical approach continues to be relied upon.

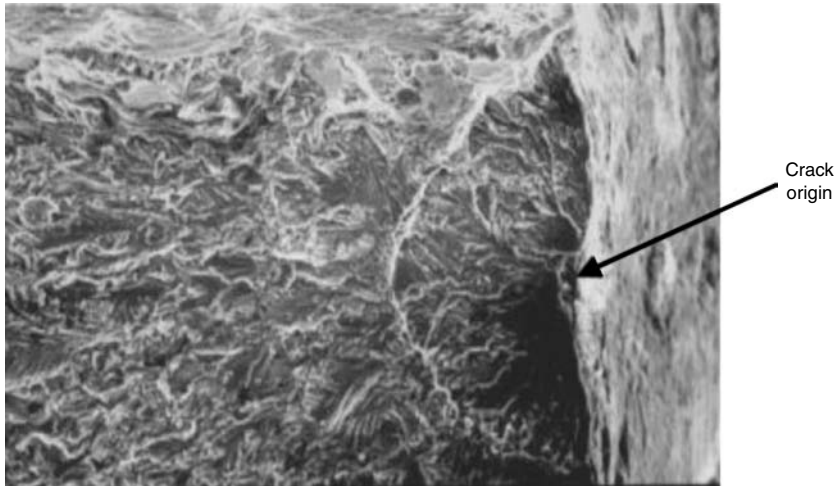
Fig. 6 Crack origin inside a rivet hole developed from an existing corrosion pit

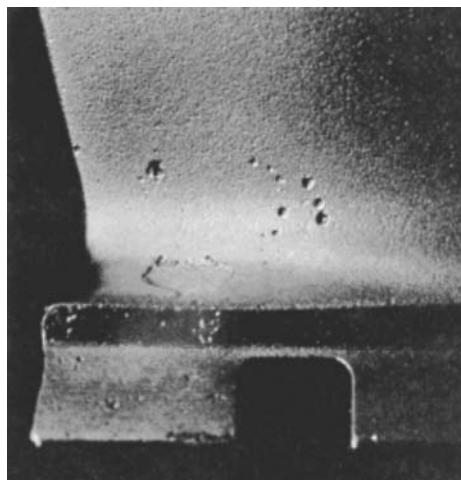
Fig. 7 Corrosion pits exceeding allowable limits in the root section of a compressor blade

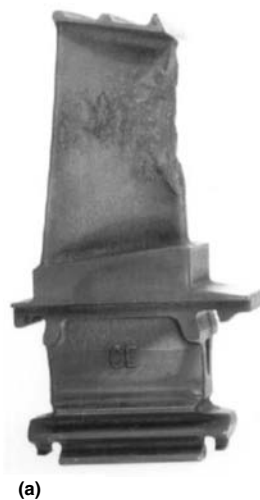
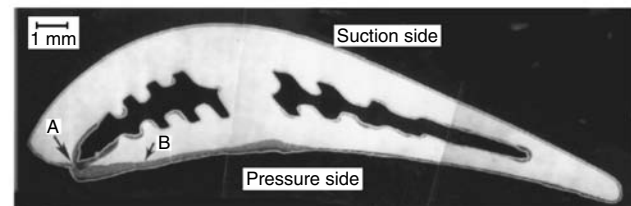
Fig. 8 Examples of engine component surface damage. (a) Evidence of hot corrosion damage on the pressure side of a MAR-M-246 turbine blade. (b) Metallographic section across the airfoil of the MAR-M-246 blade, showing evidence of hot corrosion damage penetrating the leading edge (B) right through to the internal cooling passage (A)

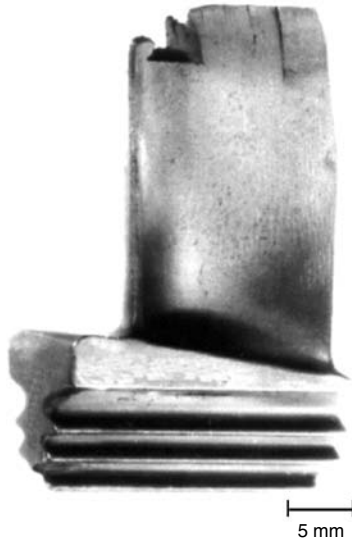
**Fig. 9** Tip cracking of a directionally solidified MAR-M-246 turbine blade

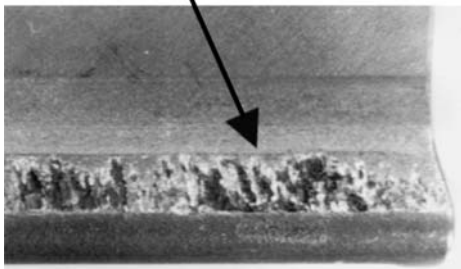
Enlarged view of dovetail

**Fig. 10** Fretting fatigue damage along a titanium fan stage-2 blade dovetail experienced on F-400 engines

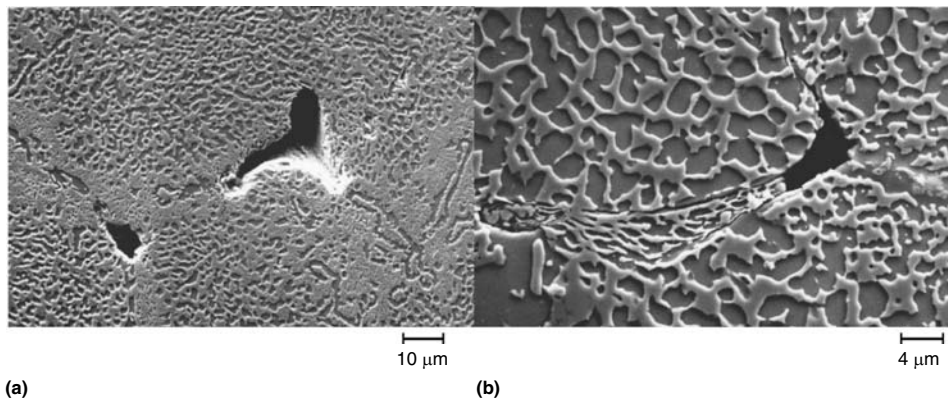
**Fig. 11** Microstructures of nickel-base Alloy 713C turbine blades. (a) Original structure prior to service. (b) Coarsening of  $\gamma'$  precipitates and elimination of secondary  $\gamma'$  caused by 5000 h of service

Time-dependant aging reactions occur primarily in hot parts, such as turbine blades and vanes; they are varied but invariably detrimental to mechanical properties. Coarsening of  $\gamma'$  precipitates, for instance, causes loss of creep strength in nickel-base superalloys (Fig. 11).

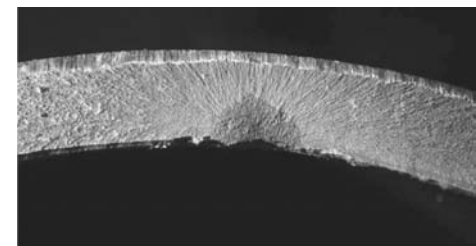
**Fig. 12** Cross section of a stress-corrosion cracking failure occurred on high-strength steel AISI 4340 B707 truck beam, caused by a preexisting uniform corrosion phenomenon

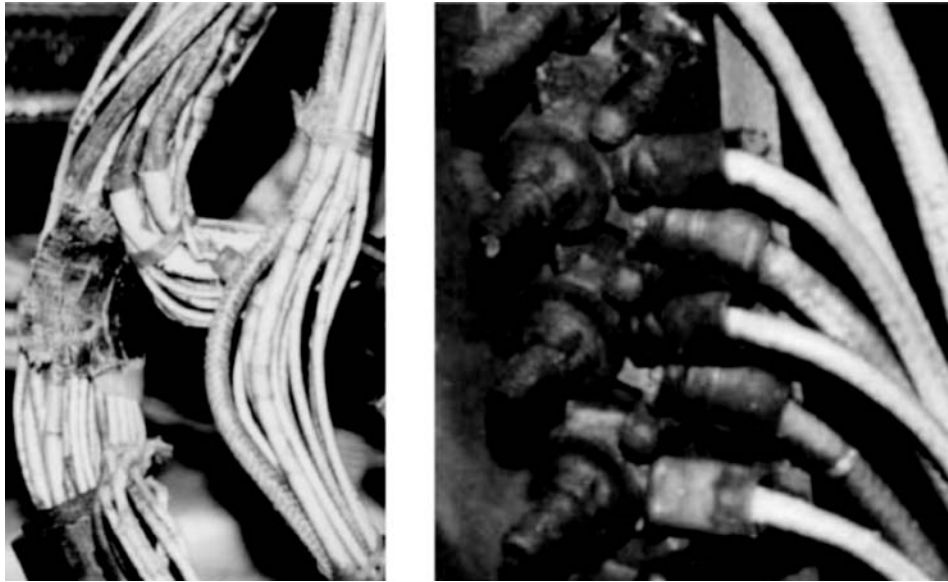
Fig. 13 Wiring insulation cracks (left) and corroded terminals on a C130 (right)

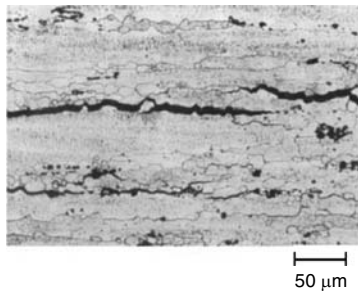
Fig. 14 Stress-corrosion cracking on the Macchi MB-326 7075-T6 stabilizer spar of RAAF aircraft used by the acrobatic team

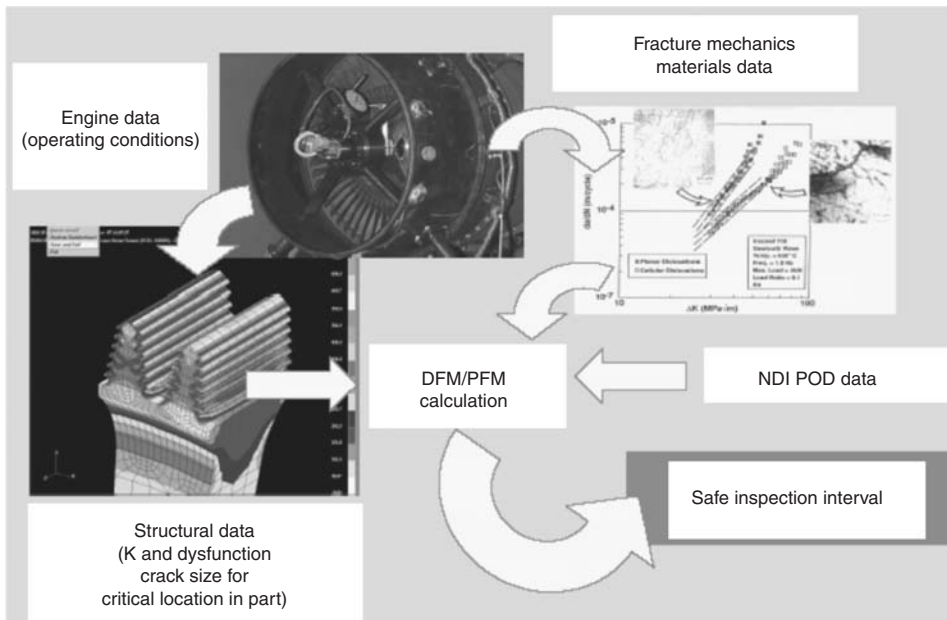
**Fig. 15** Steps associated with safe inspection intervals (SII) calculation for damage tolerance based life management of critical engine parts

- Reuse of components under a damage tolerance-based life cycle management scheme, achieved using five steps: (1) determination of stress and temperature data, (2) identification of the fracture critical location in the component of interest, (3) determination of the stress-intensity factor, (4) generation of fracture mechanics data for safe inspection interval calculations, and (5) generation of probability of detection (POD) curves from nondestructive inspection (NDI) data

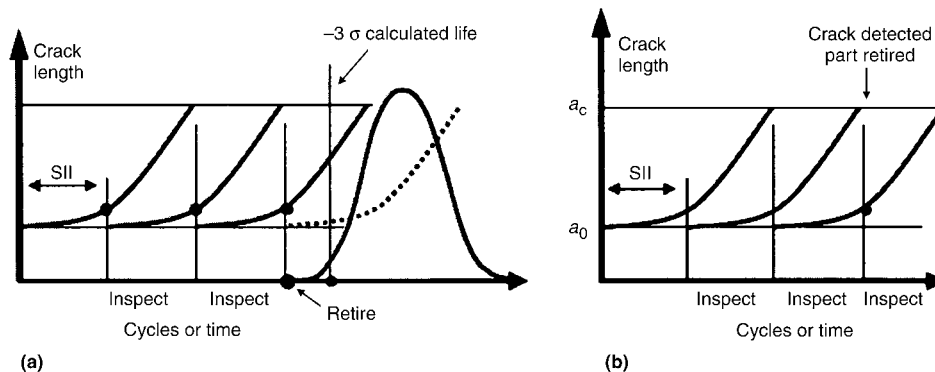
**Fig. 16** Application of damage tolerance by ENSIP (a) and RCF (b) and relation to safe inspection interval (SII)

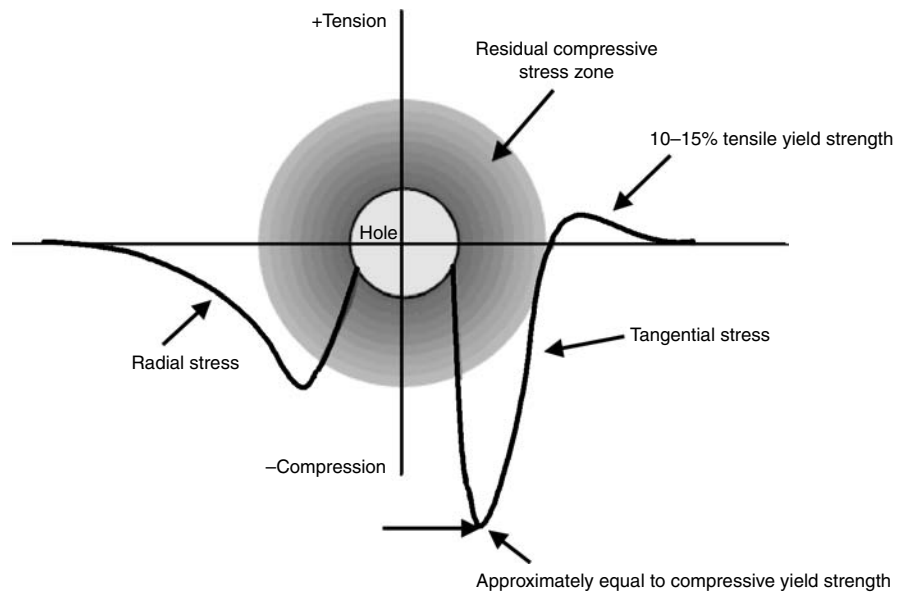
Fig. 17 Typical residual and circumferential stress distributions around a cold expanded hole

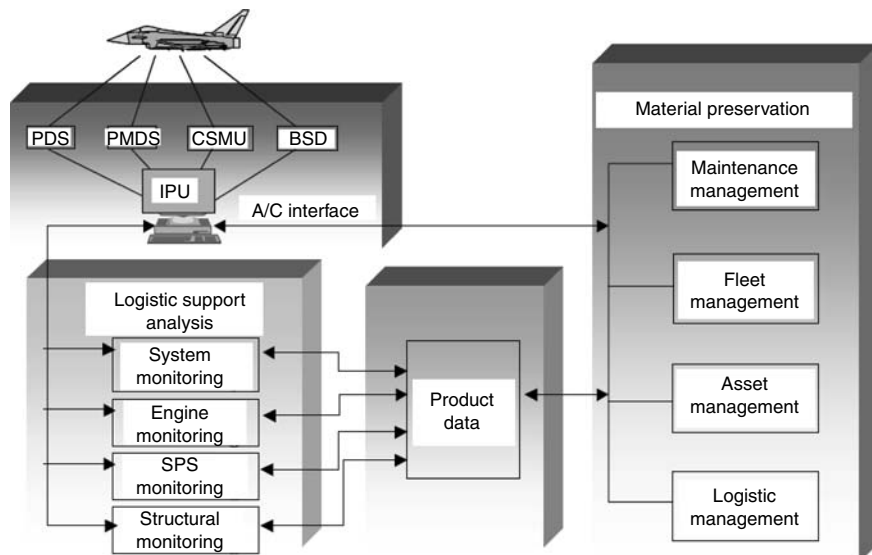
Fig. 18 Usage monitoring system data processing for the Eurofighter

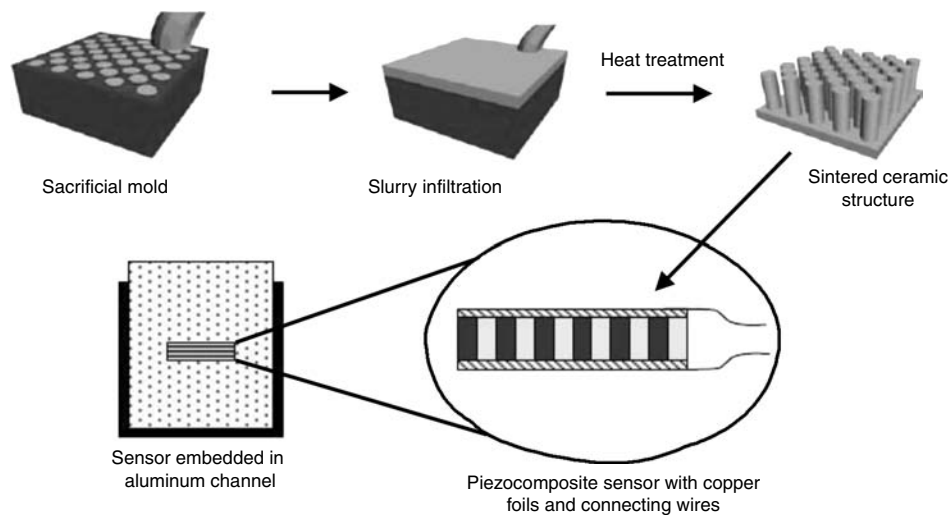
Fig. 19 Process for making the embedded piezoelectric ceramic-polymer composite sensors

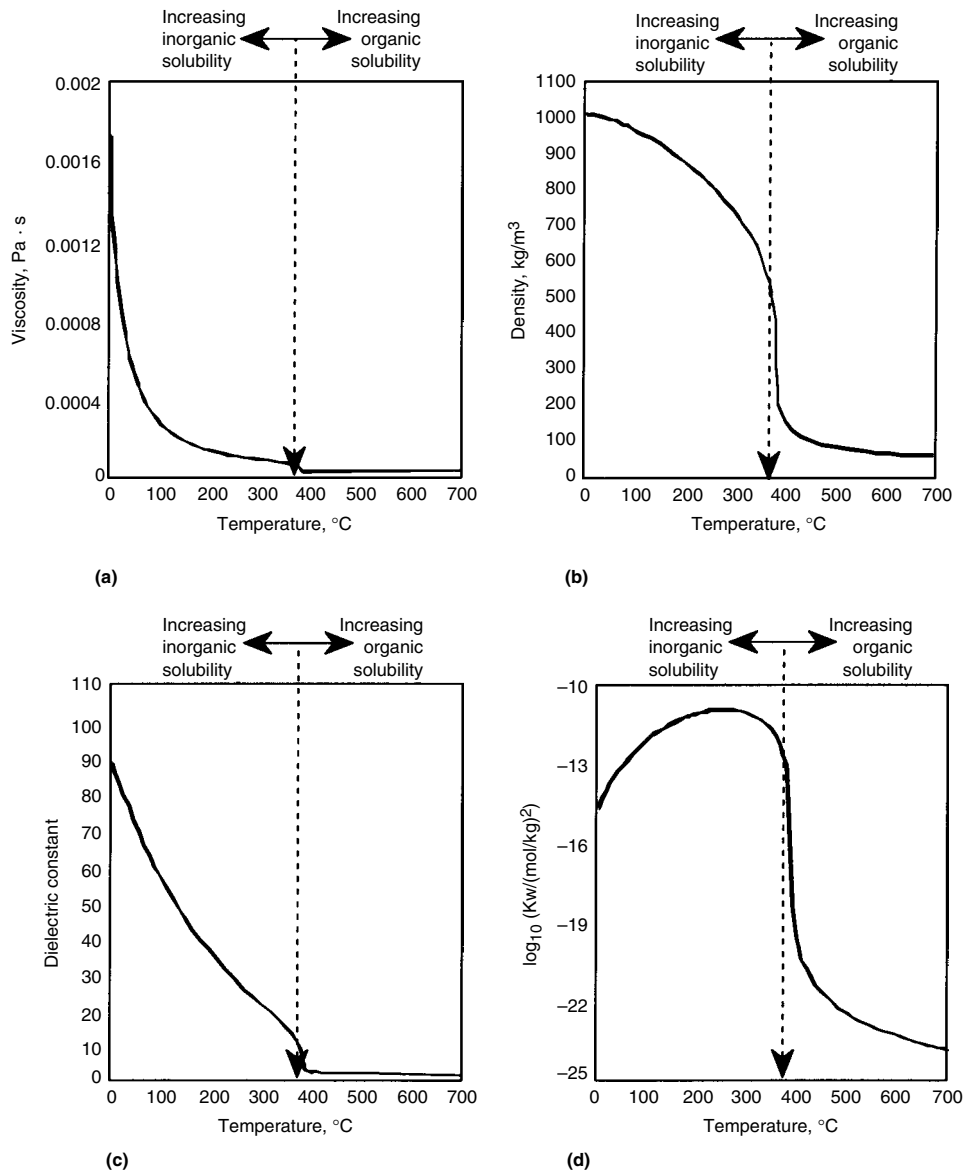
Fig. 1 The properties of water at 25 MPa (250 bar) in the vicinity of the critical point. Source: Adapted from Ref 6

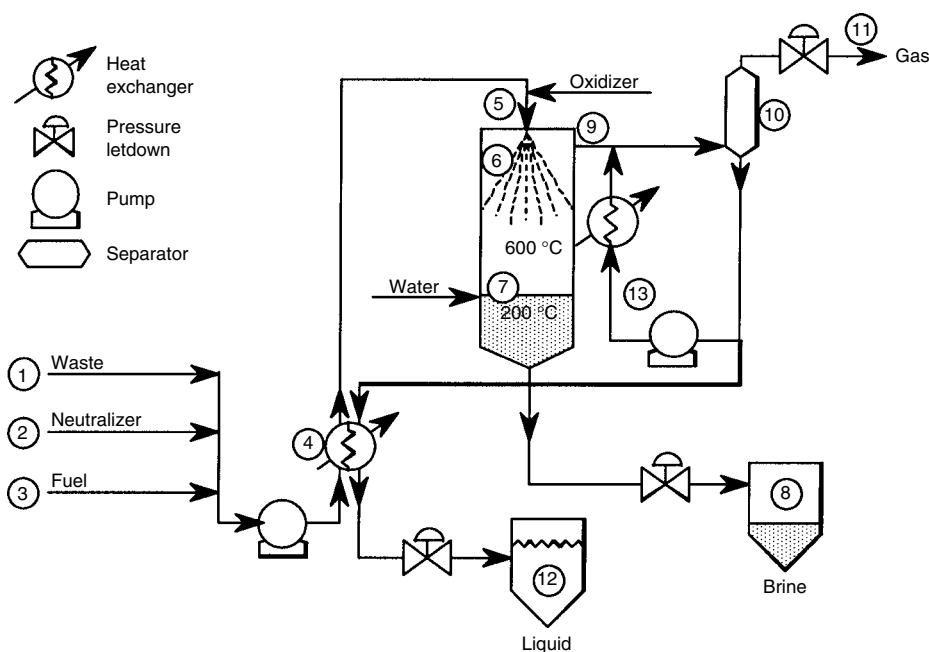
Fig. 2 A downflow vertical vessel waste treatment system based on supercritical water oxidation technology. Circled numbers are explained in text. Source: Adapted from Ref 13

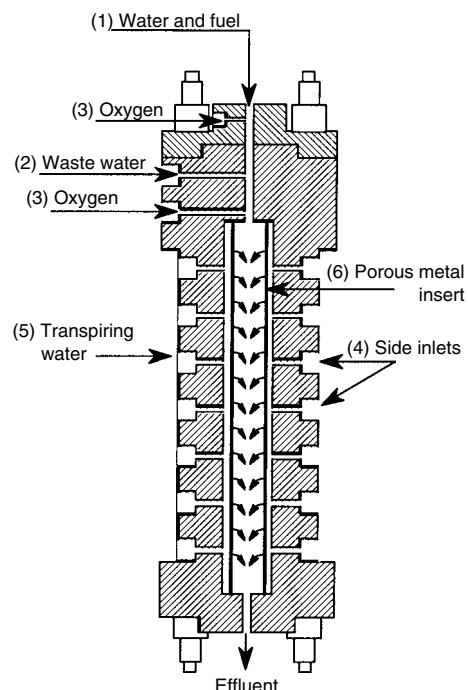
Fig. 3 The main components of a transpiring wall reactor. The numbers are used in text. Source: Adapted from Ref 16

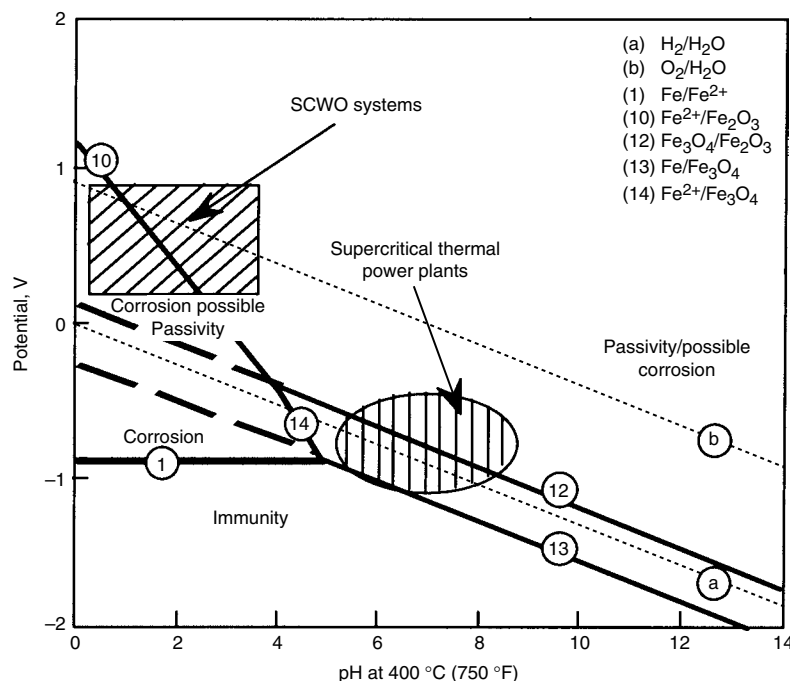
**Fig. 4** Potential-pH diagram for iron in supercritical aqueous solution at 400 °C (750 °F) and 50 MPa (500 bar), showing the approximate regions in potential-pH space for the operation of supercritical water oxidation (SCWO) reactors and supercritical thermal power plants. Source: Adapted from Ref 24

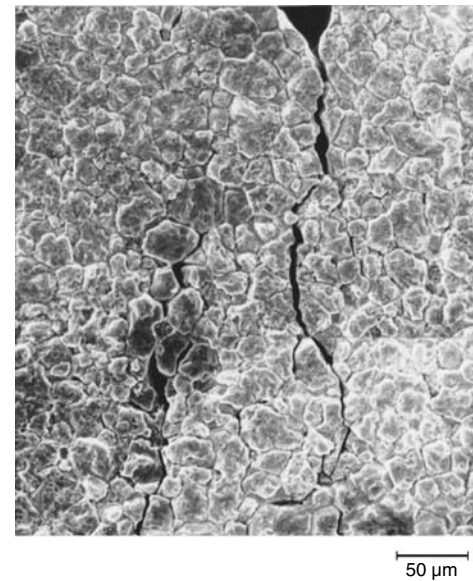
**Fig. 5** A micrograph of a cracked section at the top of a 316L alloy U-bend sample exposed to a highly chlorinated oxidizing environment for approximately 66 h at 600 °C (1110 °F). Source: Ref 27

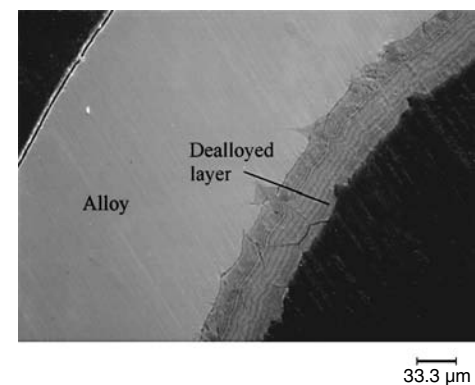
**Fig. 6** Dealloying of a C276 alloy tube after exposure to an aggressive chlorinated environment at a high subcritical temperature. Original magnification 300 $\times$

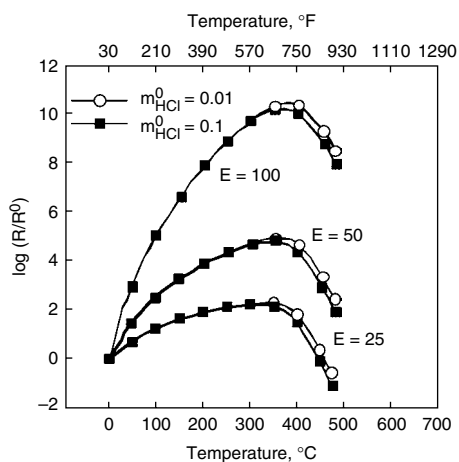
**Fig. 7** The relative corrosion rate ( $R/R^0$ ) at two different molal concentrations of HCl ( $m_{HCl}^0$ ) for the temperature range associated with supercritical water oxidation systems at a pressure of 50 MPa (500 bar) and activation energies ( $E$ ) of 25, 50, and 100 kJ/mol. Source: Adapted from Ref 43

of the subject considers  $H^+$  and  $O_2$  as the only aggressive species, and  $Cl^-$ -induced localized attack is not considered. By calculating the relative corrosion rate ( $R/R^0$ ), based on changes in the hydrogen ion concentration and the density of water as a function of temperature over the temperature range associated with SCWO systems, an increase with increasing temperature is observed until a maximum is reached as the critical point is approached (Fig. 7). With a further increase in temperature, the relative corrosion rate decreases. This decrease is associated with a rapid reduction in the concentration of aggressive species as a function of an increasing supercritical temperature. The reduction in aggressive species reflects the combined effect of a decrease in the dissociation constant (resulting in a decrease in acid dissociation) and a decrease in the solution density.

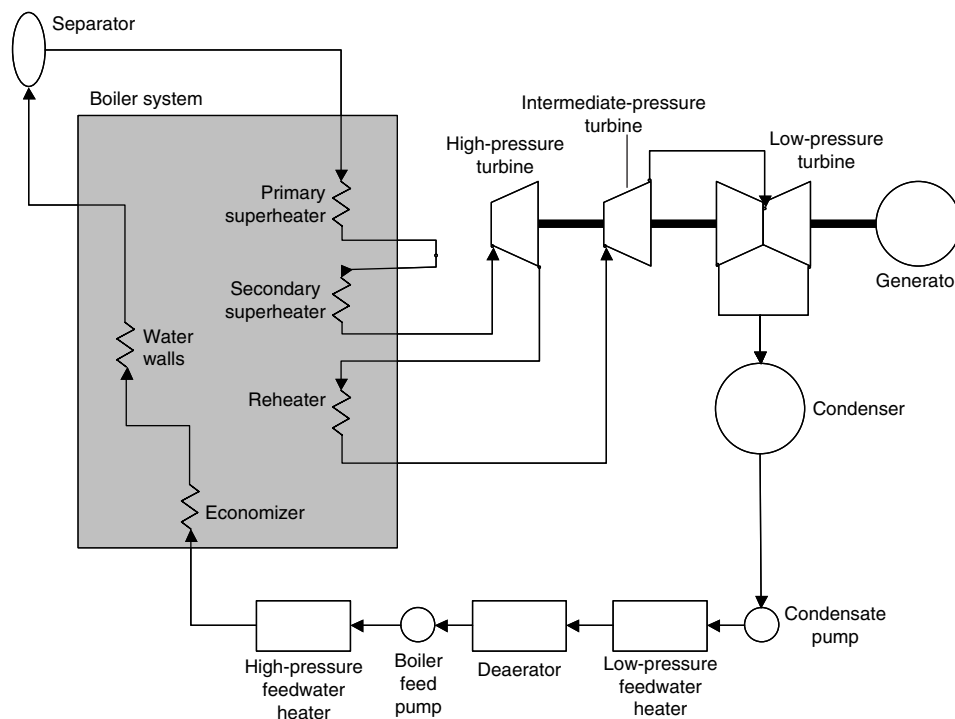
Fig. 1 Simplified water path in a large supercritical utility boiler, with a single reheat step

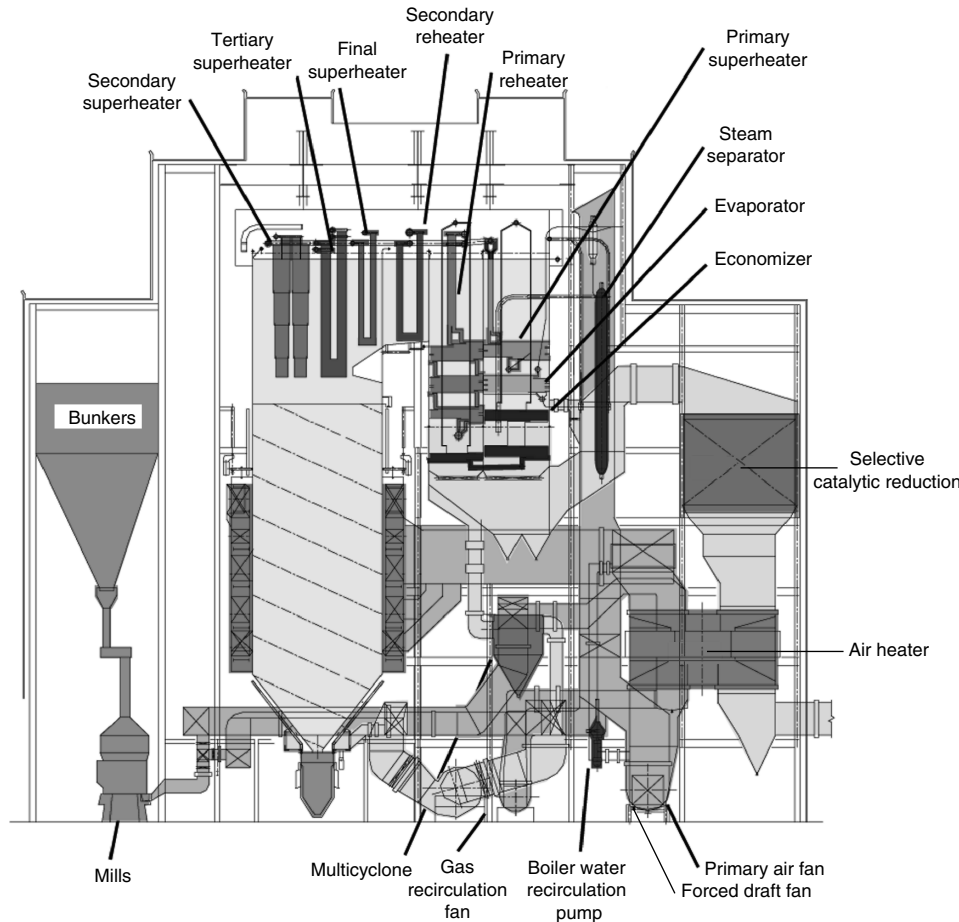
**Fig. 2** Schematic of a supercritical sliding pressure Benson boiler, Tachibana-Wan No. 2, 25.0 MPa/600 °C/610 °C/610 °C. Source: Ref 5

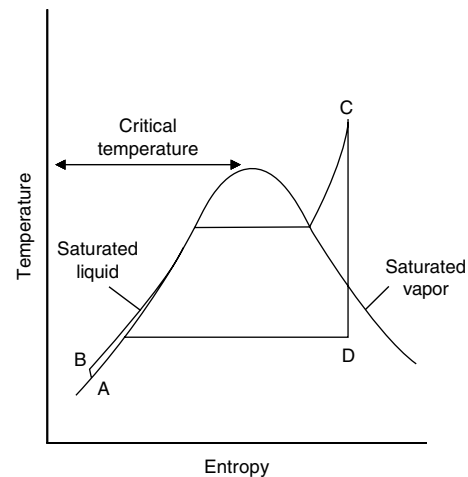
**Fig. 3** Rankine cycle for a subcritical boiler. Source: Ref 3

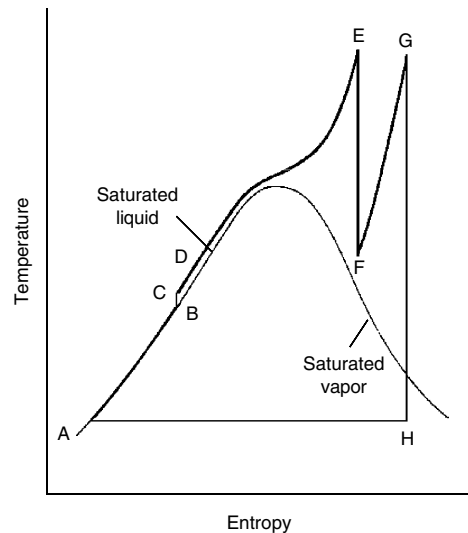
**Fig. 4** Rankine cycle for a supercritical boiler. Source: Ref 3

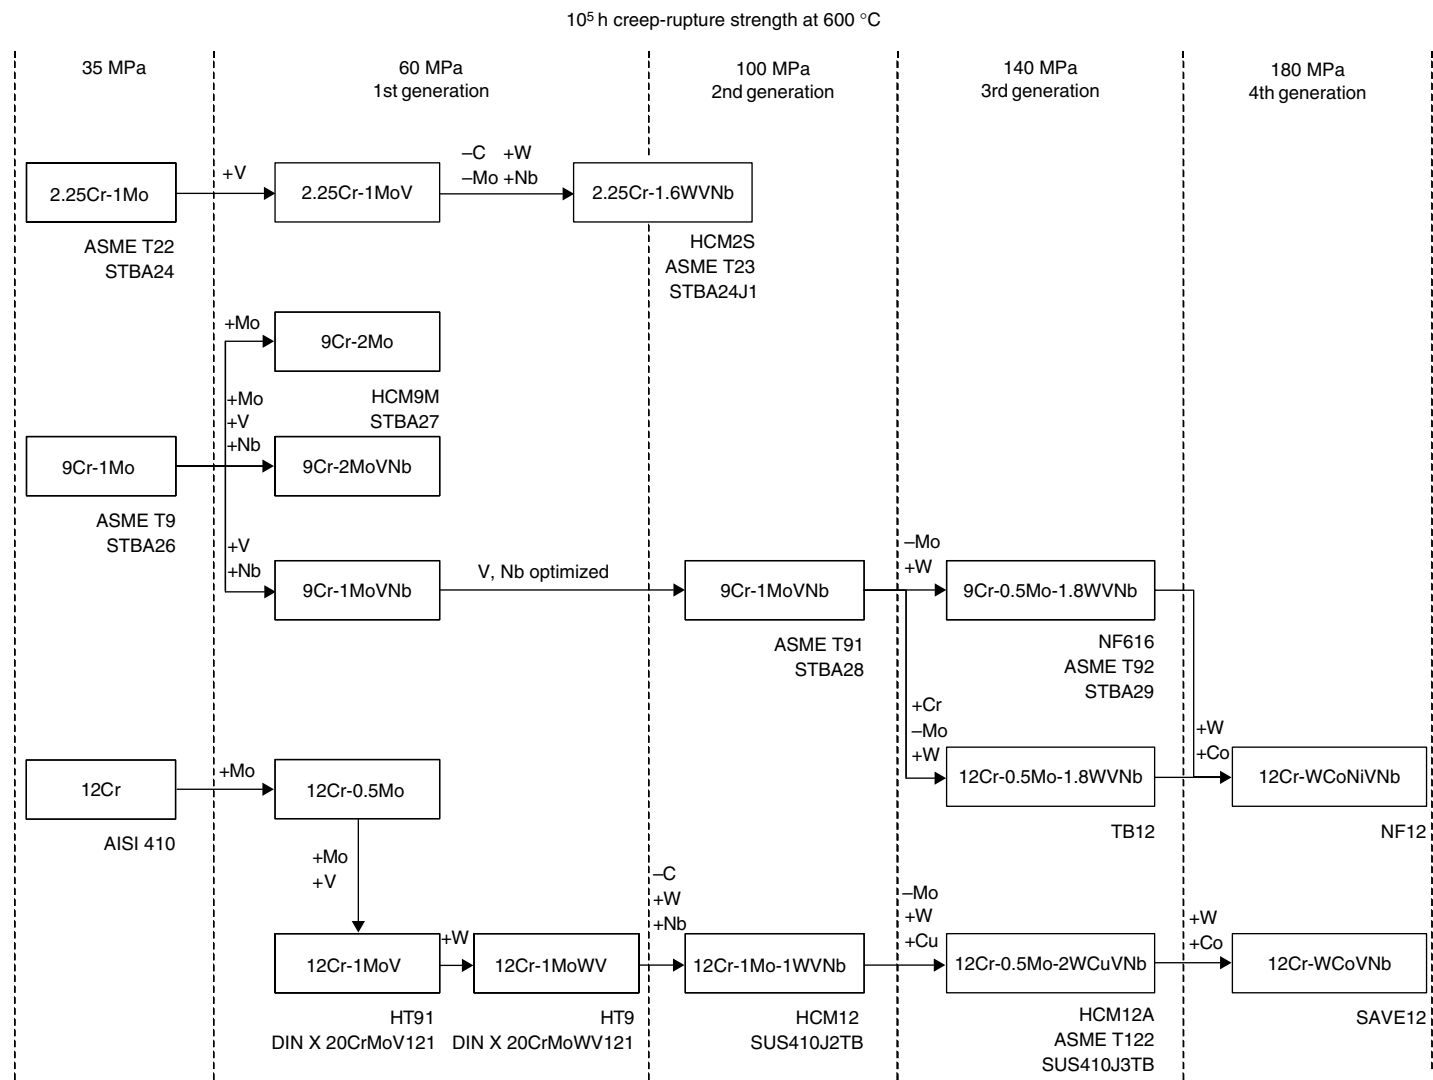
Fig. 5 The evolution of ferritic steels for boilers. Generations are categorized by the 10<sup>5</sup> h creep-rupture strength at 600 °C. Source: Ref 7, 10

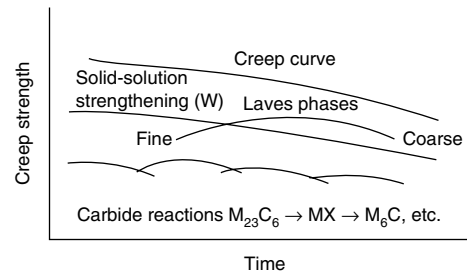
Fig. 6 Strengthening mechanisms and their effect on creep strength with time. Source: Ref 11

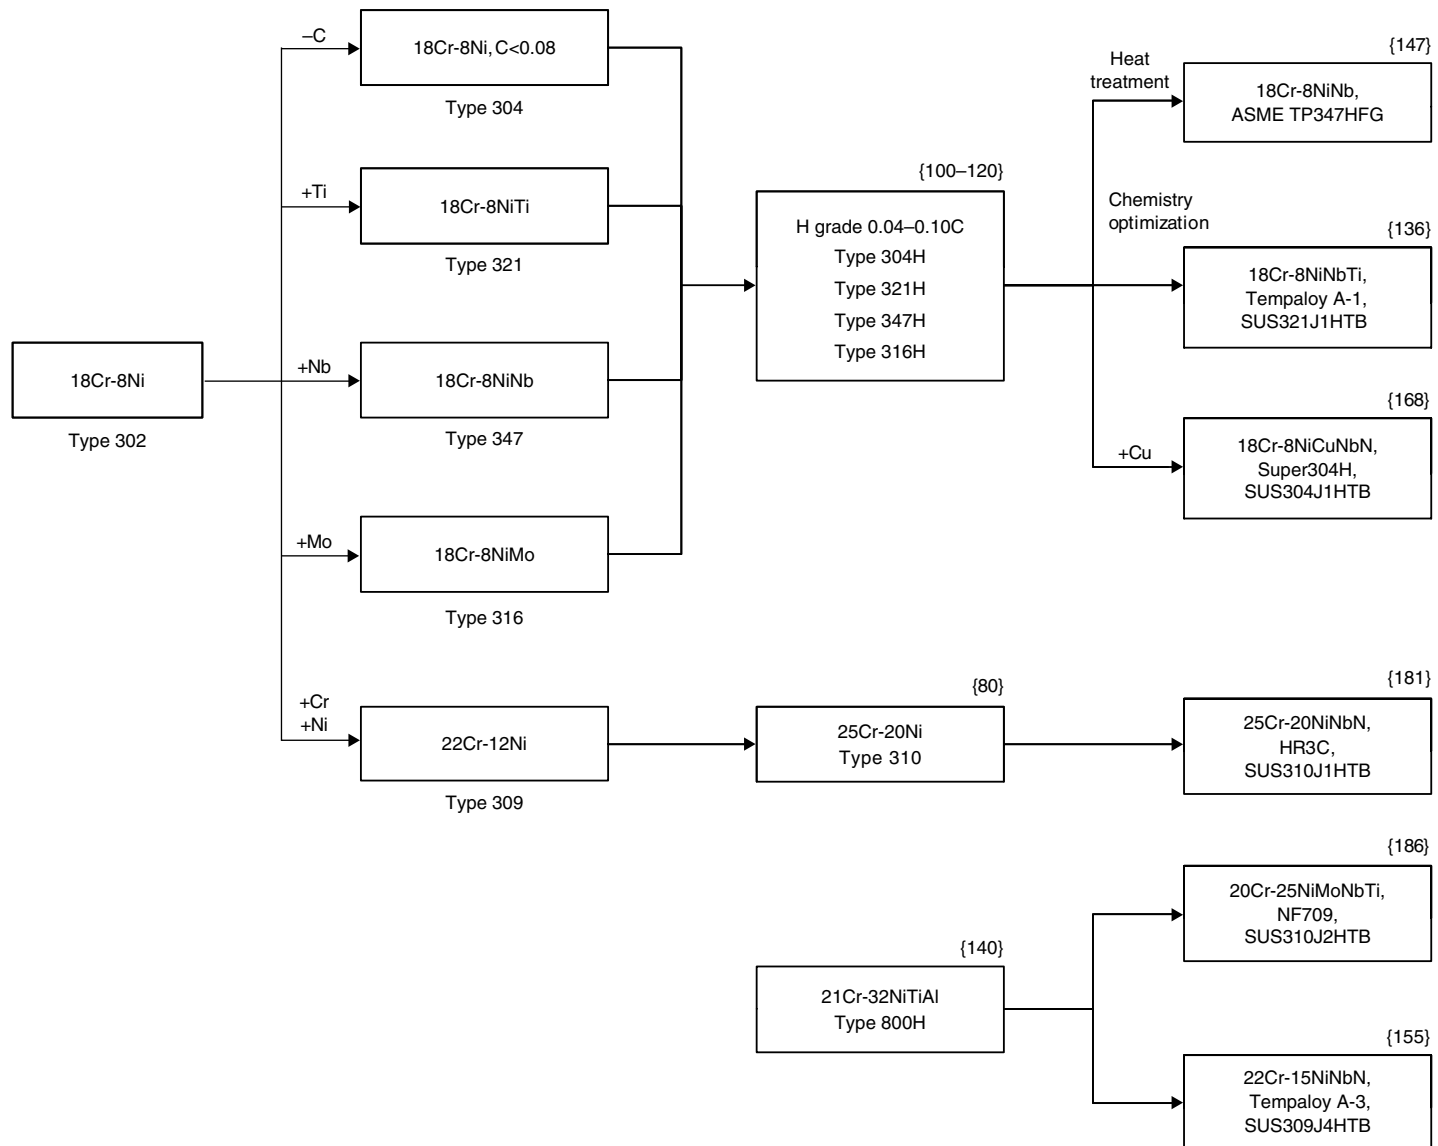
Fig. 7 The evolution of austenitic steels for boilers. {#} indicates  $10^5$  h creep-rupture strength at 600 °C, 2 Mpa. Source: Ref 7,10

**Austenitic steels** evolved as shown in Fig. 7, beginning from alloys 302 and 800H (Ref 7, 10). Austenitic steels have better oxidation and fireside corrosion resistance than ferritic steels and thus are primarily candidates for the finishing stages in superheater and reheater tubing (Ref 7).
