# ASM Handbook®

## Volume 13C Corrosion: Environments and Industries

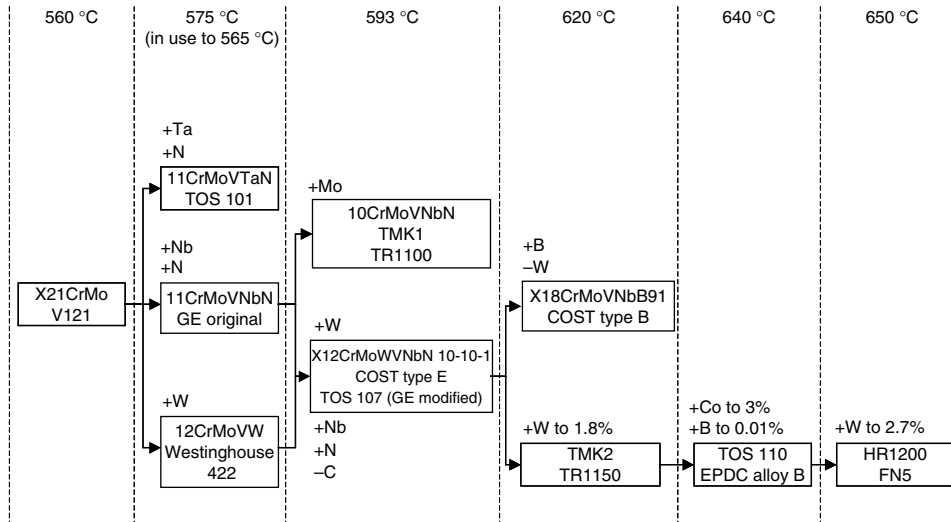
Fig. 8 The evolution of ferritic steels for rotors for use at higher temperatures. Source: Ref 7

used for rotors was X21CrMoV121. The evolution of ferritic rotor steels from X21CrMoV121 for high- and intermediate-pressure steam turbines has loosely followed that of ferritic boiler steels. Alloy additions have been added and their amounts optimized, as shown in Fig. 8 (Ref 7). Nominal compositions of ferritic rotor steels are given in Table 5.

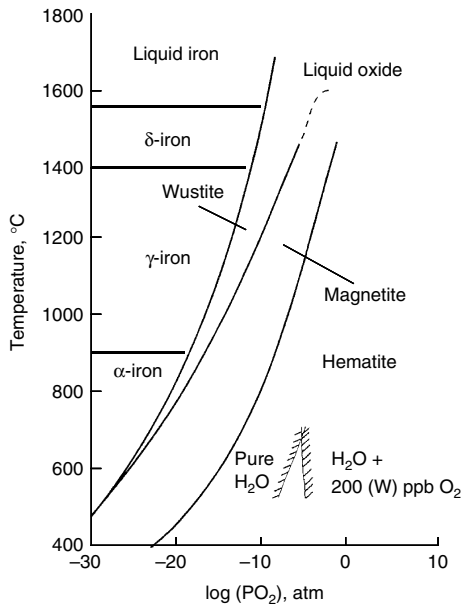
**Fig. 9** The phase stability of iron as a function of temperature and oxygen partial pressure. Included are calculations of boiler conditions predicted from feedwaters of pure H<sub>2</sub>O and H<sub>2</sub>O with 200 ppb oxygen. Source: Ref 19, 24

The phase stability diagram for iron in water, as functions of temperature and oxygen partial pressure, is shown in Fig. 9, based on calculations by Gaskell (Ref 24) and including the predicted conditions by Paterson et al. (Ref 19). This diagram helps to explain the scale morphologies found on low-alloy boiler steels. Typically, the scales consist of several layers that correspond to the decreasing oxygen activity found within the scale closer to the metal. Hematite ( $Fe_2O_3$ ) may form as a thin outer layer. A duplex magnetite layer forms under the hematite. The outer magnetite layer is  $Fe_3O_4$  and grows out from the original metal surface. The inner magnetite layer is  $(Fe,Cr)_3O_4$  and grows inward from the original metal surface. The interface between the two magnetite layers

Hematite formation is also associated with increased spallation during shutdowns, due to its large thermal mismatch with magnetite. In addition to the excess oxygen conditions of Fig. 9, hematite can also be formed due to a lowering of the amount of iron arriving at the outer scale, which has been attributed to the voids that form at the base of the scale after many tens of thousands of hours of exposure (Ref 27).

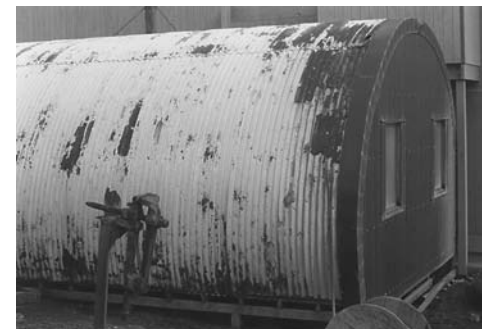
**Fig. 3** Corrosion on a metal building in Antarctica. Corrosion is also evident on the steel vise. Source: Ref 12

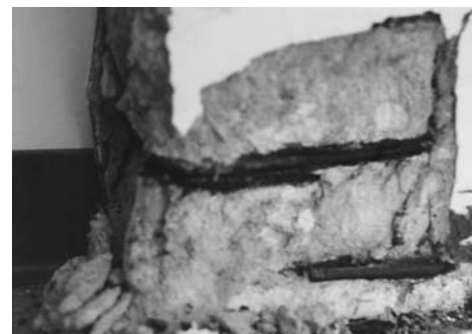
**Fig. 4** Spalling on precast concrete panels occurred in three years after exposure to seawater during shipment. Reinforcing bars are exposed.

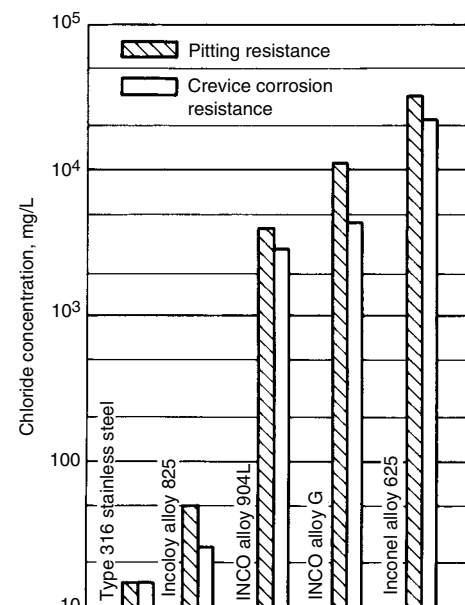
**Fig. 1** Minimum levels of chloride that cause pitting and crevice corrosion in 30 days in  $\text{SO}_2$ -saturated chloride solutions at  $80^\circ\text{C}$  ( $175^\circ\text{F}$ ). Source: Ref 1

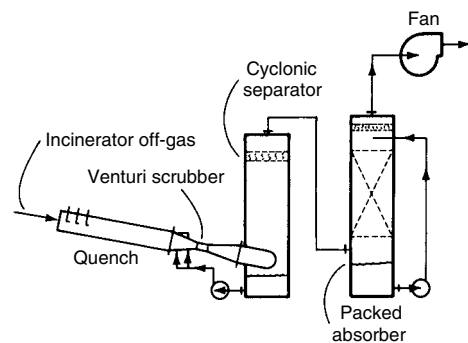
**Fig. 2** Schematic of a general scrubber system arrangement

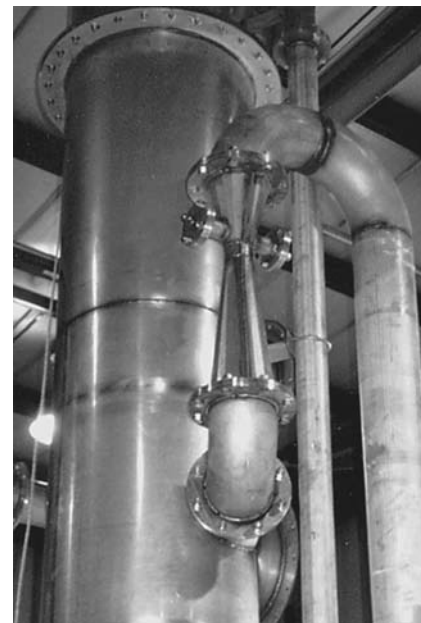
**Fig. 3** A stainless steel venturi tube scrubber separator. Courtesy of Branch Environmental Corporation

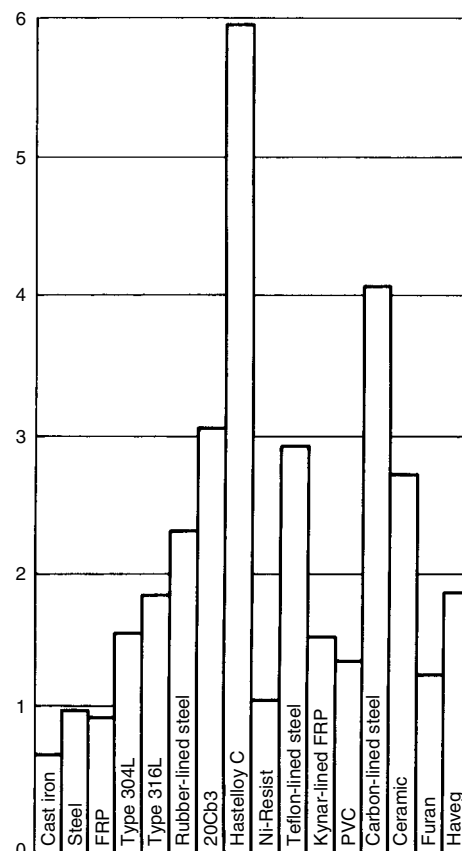
Fig. 4 Relative costs of scrubber materials. FRP, fiberglass-reinforced plastic; PVC, polyvinyl chloride

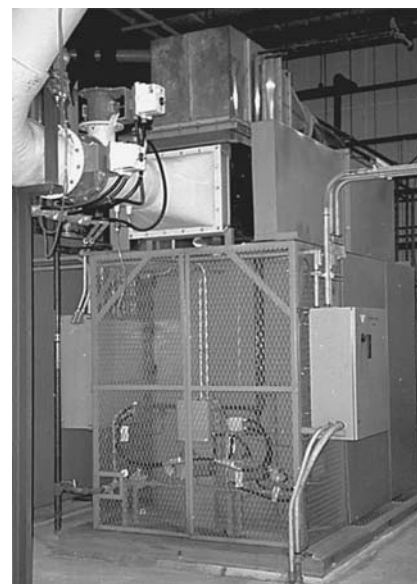
**Fig. 5** A catalytic oxidizer of stainless steel construction. Courtesy of Branch Environmental Corporation

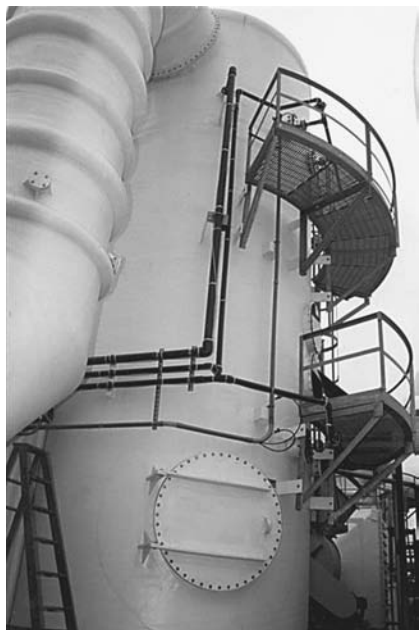
Fig. 6 A scrubber tower constructed with fiberglass. Courtesy of Branch Environmental Corporation

While the air containing sulfide compounds will be somewhat corrosive, the scrubber solution containing sodium hypochlorite (bleach) is extremely aggressive and will attack most metal compounds. Fiberglass or other thermoplastics have found extensive use in wastewater plants for this reason (Fig. 6). The scrubber housing, recycle pump, and related components are typically made of fiberglass using vinyl-ester resins with synthetic veils. Where critical components

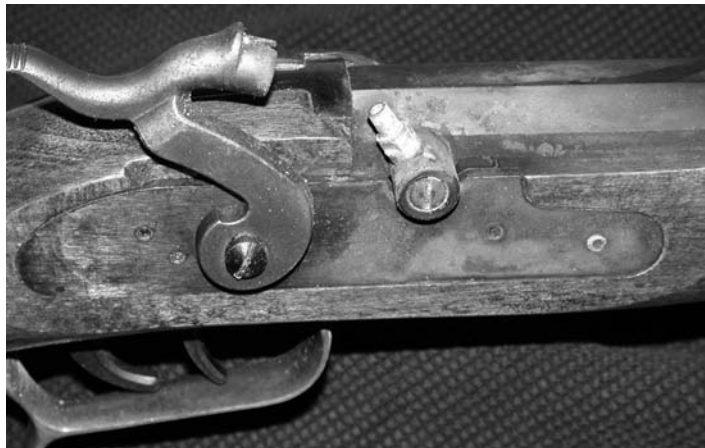
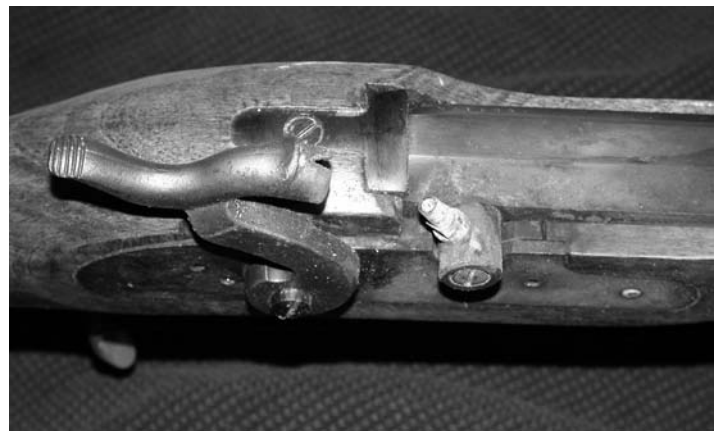
**Fig. 1** The red dust shown from two views on the dark barrel exterior of this black powder replica rifle was the result of residue in the exhaust and implies that far worse corrosion is probably present on the interior surface. Courtesy of Daniel Sullivan

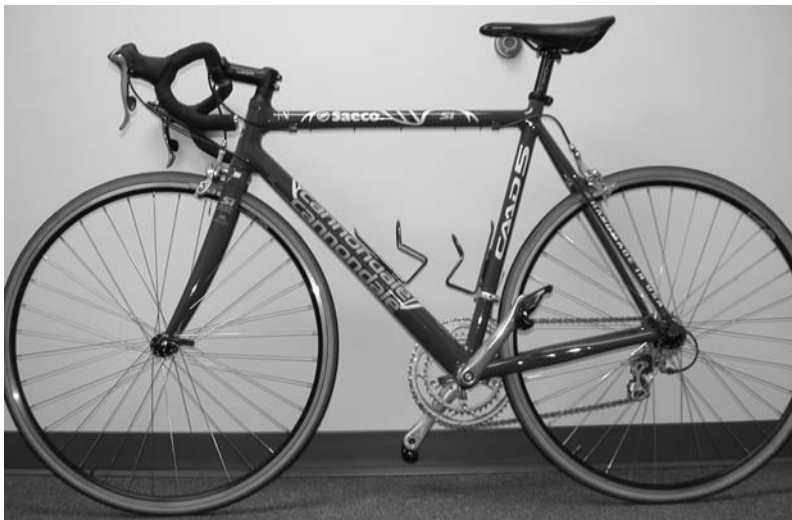
**Fig. 2** This Cannondale composite bicycle has an aluminum frame and a carbon fiber fork, resulting in a more corrosion-resistant bicycle than the more common (worldwide) steel frames. However, important components such as chains, axles, and bearings are still commonly made of steel for strength requirements and must be maintained to prevent corrosion from forming and interfering with performance. Courtesy of Greg Welsh

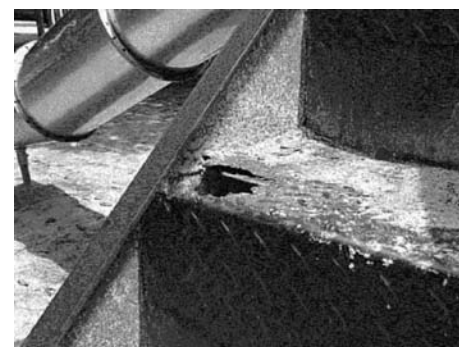
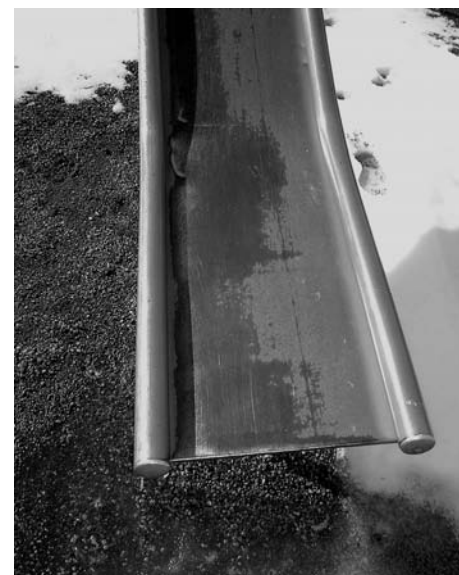
**Fig. 3** Examples of playground and equipment corrosion. (a) When debris and moisture become trapped on surfaces for long periods of time due to lack of maintenance, improper design, or improper installation, corrosion can affect the function and safety of the play component. (b) All materials will corrode over a long period of time, as demonstrated by this stainless steel slide bedway. Courtesy of the NRPA NPSI

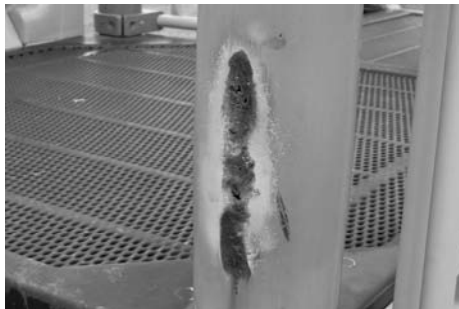
**Fig. 4** Once protective coatings have been removed from playground equipment, corrosion occurs rather rapidly, accelerated by dirt, moisture, and other environmental factors including human contact. Courtesy of the NRPA NPSI

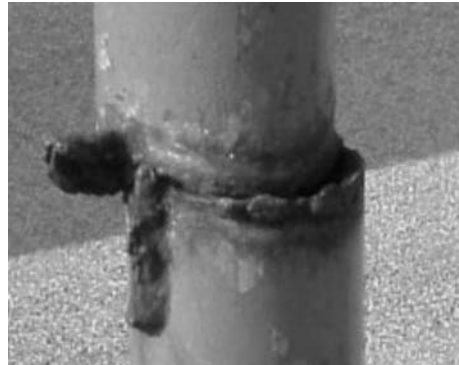
**Fig. 5** If a weld joint separates as a result of corrosion, it is difficult to repair to its original structural integrity. Courtesy of the NRPA NPSI

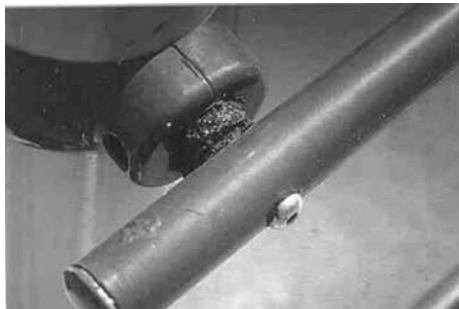
**Fig. 6** A noncompatible metal bushing in contact with a stainless steel bolt and other adjacent metal surfaces if left uncorrected may corrode away and weaken the connection. Courtesy of the NRPA NPSI

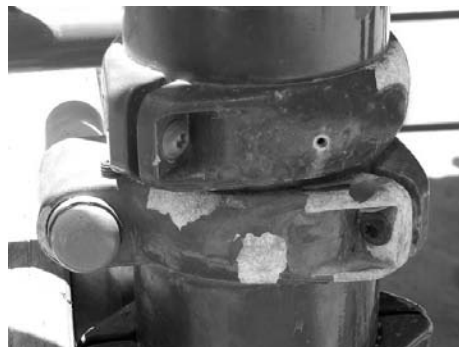
**Fig. 7** White rust on galvanized parts will cause paint to blister off and provides little protection against subsequent rusting of the metal underneath. Courtesy of the PDRMA

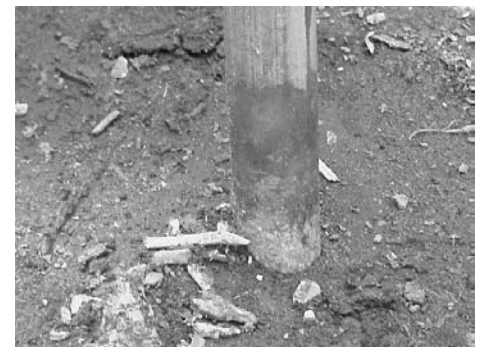
**Fig. 8** Galvanized post at a concrete footer corrodes from a moist subgrade environment. Chlorides from the fresh concrete can accelerate the corrosion process. Courtesy of the PDRMA

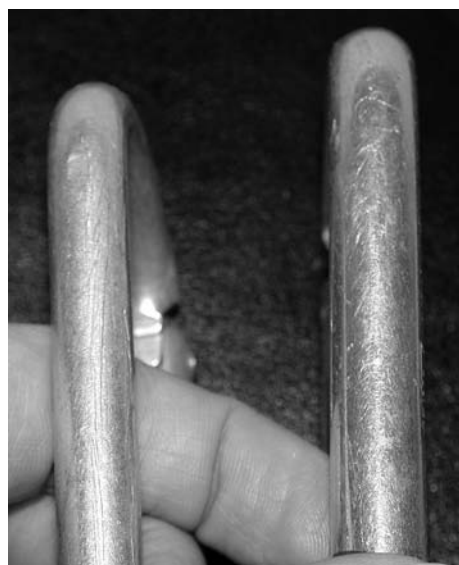
**Fig. 9** One way to reduce weight when climbing is to use carabiners with smaller cross sections. The trade-off is in the load-bearing capacity rating. Courtesy of Lorrie Krebs, Anderson Materials Evaluation, Inc.

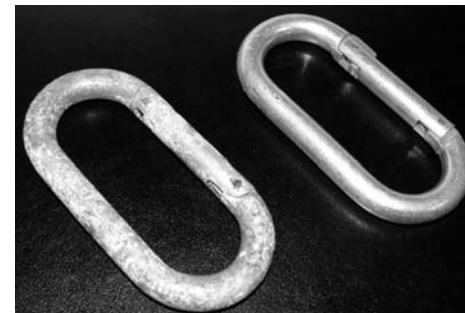
**Fig. 10** The carabiner in the foreground was found in a damp cave in upstate New York. A similar aluminum alloy carabiner is shown for comparison. In addition to white corrosion product generally present over all surfaces, there is red rust at the hinge and catch pins and the carabiner is frozen in the closed position. Courtesy of Lorrie Krebs, Anderson Materials Evaluation, Inc.

Equipment that is left behind intentionally or unintentionally should always be approached with caution. "Found" equipment, such as the carabiner shown in Fig. 10, should never be relied upon, even without the dramatically poor appearance of this particular piece. Even if the piece had been cleaned, the poor condition of the hinge and catch pins suggests that it may fail during a fall.

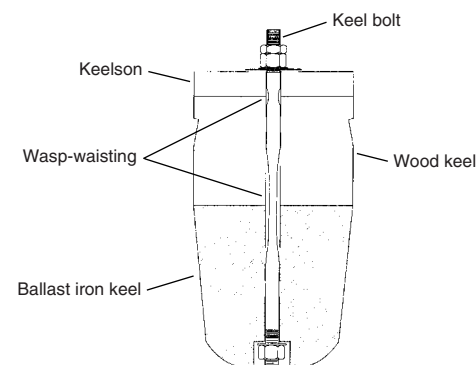
**Fig. 1** Fasteners that appear solid at the ends may have hidden corrosion damage, such as the wasp-waisting of bilge fastenings.

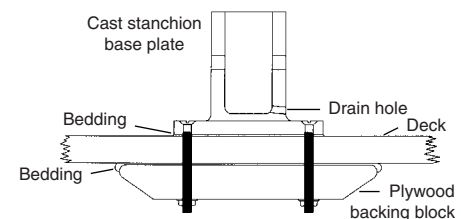
**Fig. 2** A backing plate installation distributes stanchion forces. The drain hole in the stanchion base reduces a possible corrosive environment.

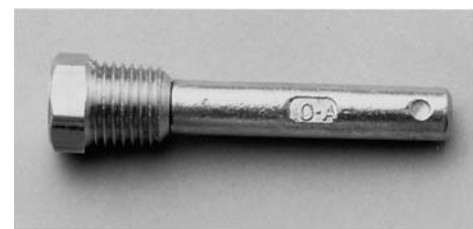
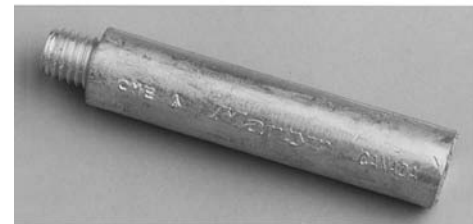
**Fig. 3** Zinc sacrificial anodes for an engine cooling system. (a) Engine anode. (b) Replacement pencil anode

To reduce galvanic corrosion, engine manufacturers make provision for the insertion of sacrificial zinc anodes in the cooling system. Figure 3(a) shows a complete engine zinc anode

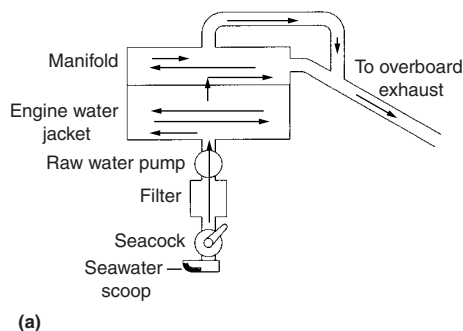
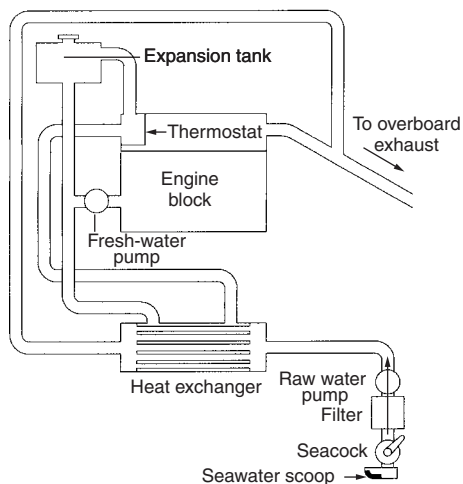
**Fig. 4** Engine cooling water systems. (a) Raw water system. (b) Freshwater system

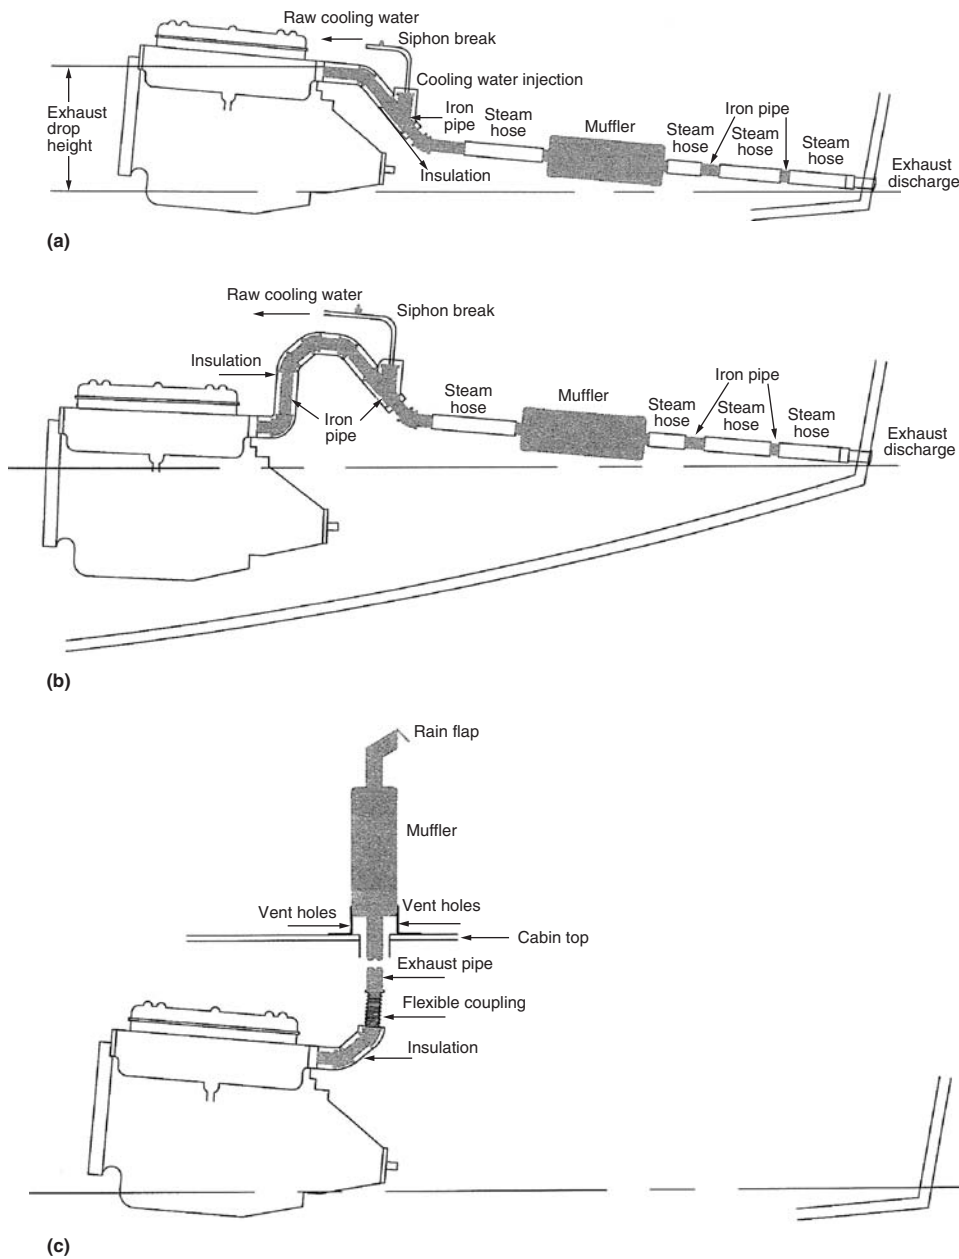
Fig. 6 Exhaust systems. (a) Traditional wet system. (b) Sailboat wet system. (c) Dry system

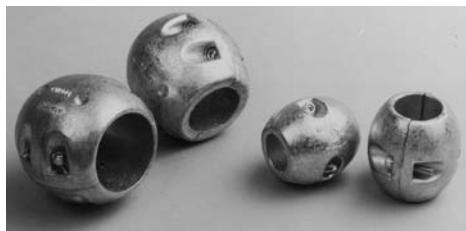
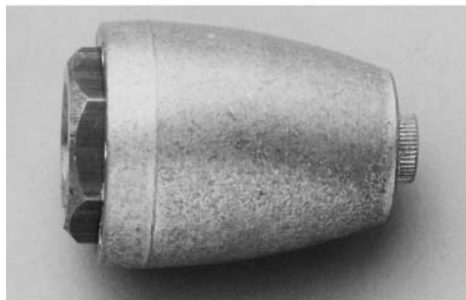
**Fig. 7** Zinc sacrificial anodes. (a) Shaft collar zincs are used on immersed exposed propeller and rudder shafts. (b) A propeller nut zinc is threaded onto the end of the propeller shaft

Tobin bronze, which is roughly 60% Cu and 39% Zn, is, like manganese bronze, subject to dezincification. Bronze propellers on stainless steel shafts require cathodic protection. The propeller, propeller shaft, and rudder assembly can be protected by the use of zinc anodes. The collar zinc, such as that shown in Fig. 7(a), is installed on the propeller shaft. Zinc anodes may also be attached to the struts. The propeller nut zinc, such as that shown in Fig. 7(b), is also sometimes used on the end of the propeller shaft behind the propeller nut.

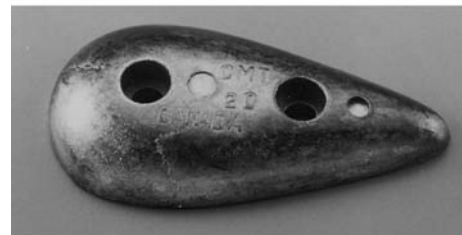
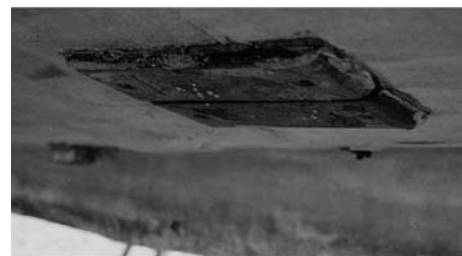
**Fig. 8** Zinc sacrificial anodes for the boat underbody. (a) Remote zinc plate. (b) Teardrop zinc. (c) Remote plate installation

The zinc and its through-bolts should be insulated from the wood hull to reduce the possibility of alkali damage to the wood. A teardrop-shaped zinc (Fig. 8b) mounted on, but insulated from, a fairing block reasonably close to the metals it is protecting would be ideal. It should be located so that it will not disturb the smooth flow of water to the propeller, and it should be immersed at all times.

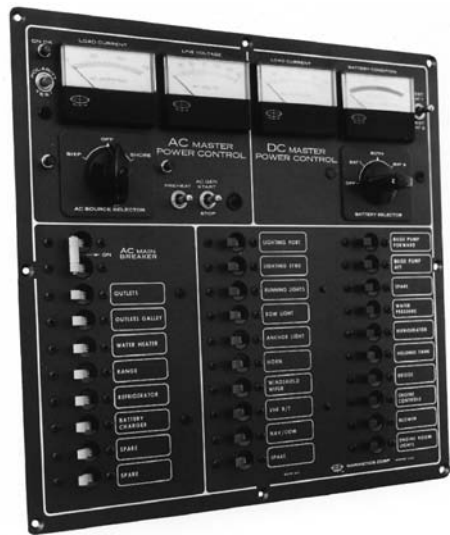
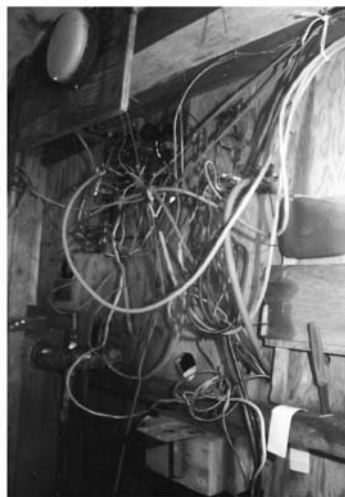
**Fig. 9** Electrical power distribution. (a) 28 branch alternating current and direct current circuit breaker panel. (b) Wiring for an 11 m (36 ft) workboat without distribution panel

skipped by a hardworking fisherman who did not have time for the electrical niceties. Moisture penetrates into all cracks and crevices—wire splices, butt connectors, screw contacts, fuse blocks, and even nonmarine-grade circuit breakers. Contacts and mating surfaces oxidize, resistance increases, voltage is lost, and heat is generated. At best, performance deteriorates or equipment fails; at worst, the possibility of fire exists. This boat also had a severe stray current corrosion problem.

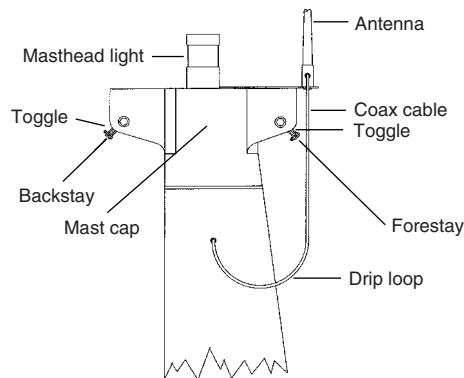
**Fig. 10** Typical cable drip loop to prevent water entry into a hollow mast

loops (Fig. 10). After all contacts, connections, and metal surfaces are clean and properly made up, a moisture-displacing corrosion-preventive spray should be used.

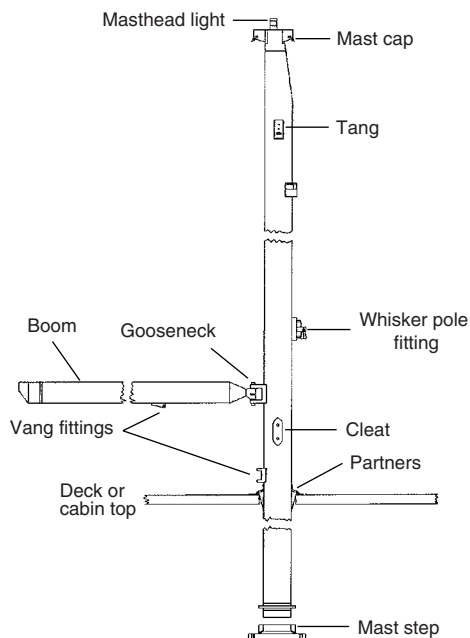
Fig. 11 Typical aluminum mast system

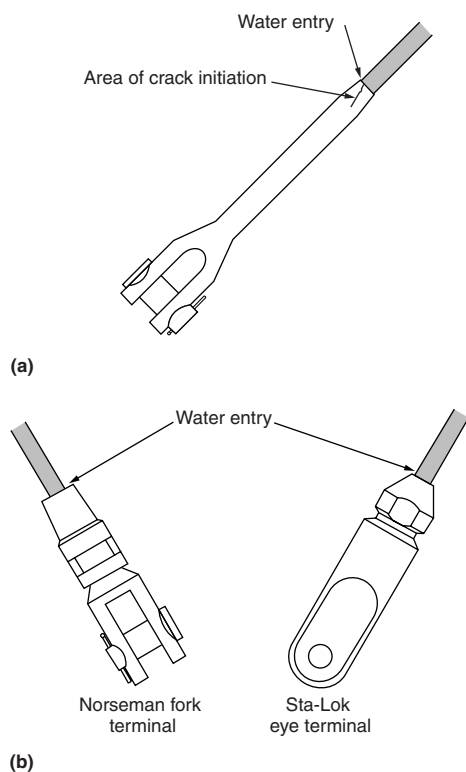
**Fig. 12** Terminals for wire rope rigging. (a) Swage terminal fitting. (b) Norseman and Sta-Lok terminal fitting

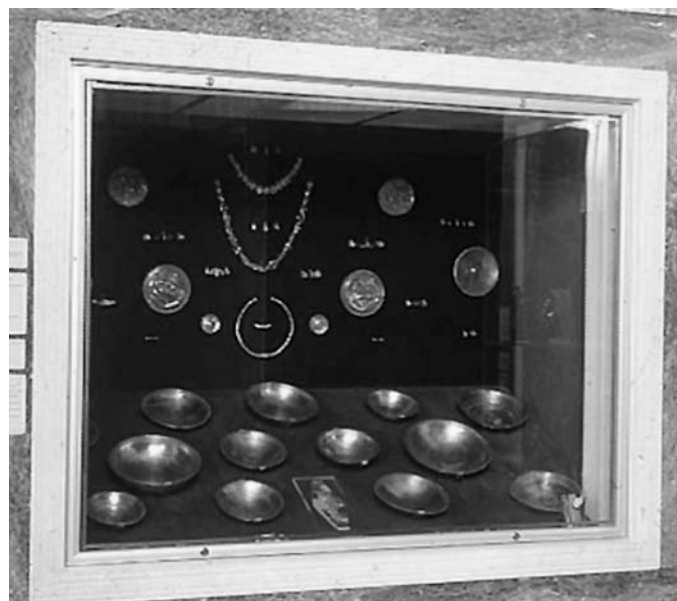
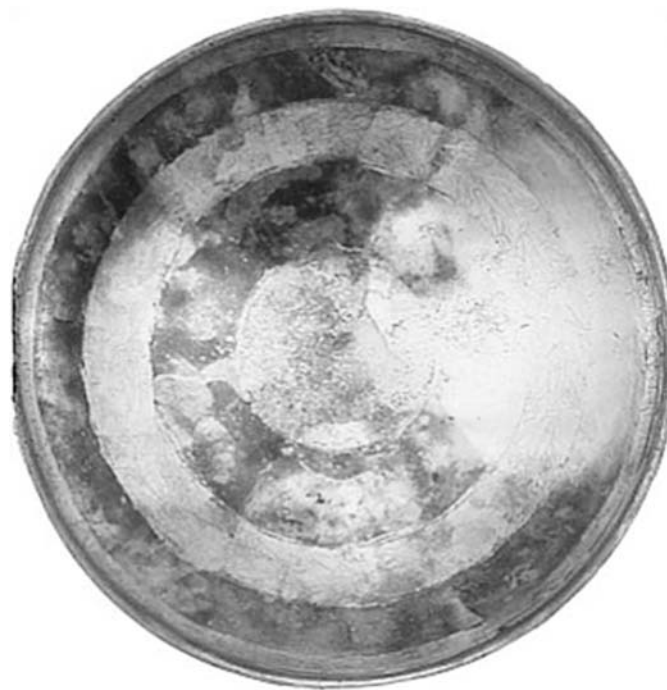
**Fig. 1** An exhibition case of Hellenistic silver vessels at the Getty Museum in the late 1970s. (a) Red velvet lines the case walls. (b) One of the ancient Hellenistic silver bowls showing significant tarnishing due to sulfur from the red velvet. Tarnish began to appear on the surface of the silver within one month of the objects being placed in the exhibition case. Courtesy of J. Podany, 1979.

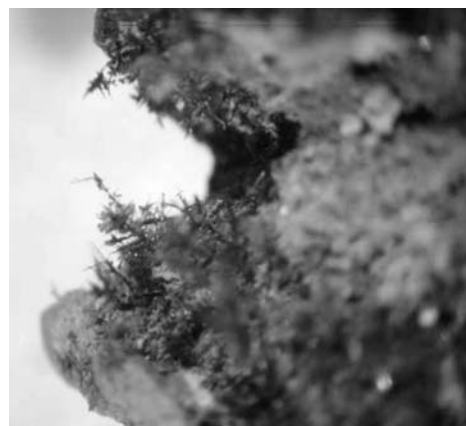
**Fig. 2** Dendritic silver sulfide crystals growing on a Greco-Roman silver bowl. Walters Art Museum, Baltimore. Original magnification 10 $\times$ . Courtesy of Terry Drayman-Weisser.

**Example 2: Silver Sulfide Dendrites Growing on a Greco-Roman Silver Bowl.** Rubber floor mats installed in the 1930s at the Walters Art Museum in Baltimore were meant to protect the objects from breaking should they fall. Sulfurous gases emitted from the mats eventually affected some of the metal artifacts in the storeroom. The objects were undisturbed for a long period of time (many years), and this may have allowed for the dendritic formation of the silver sulfide crystals (Fig. 2). The Walters Art

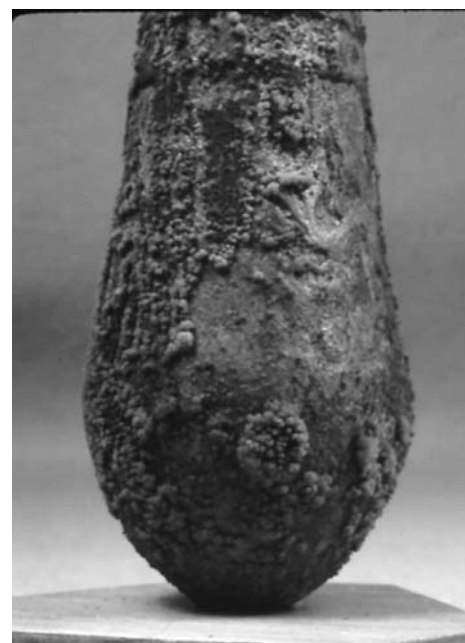
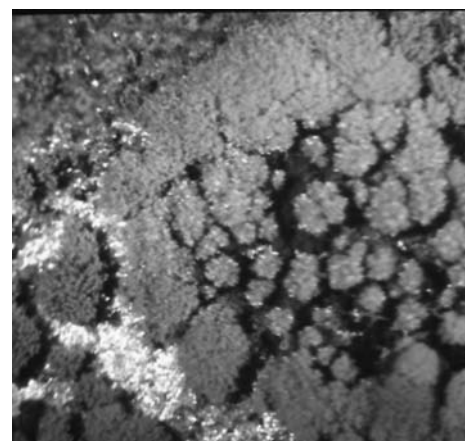
**Fig. 3** Velvetlike corrosion growths on the surface of an ancient copper alloy vessel. (a) The subtle form of the object is all but obscured by corrosion growths. (b) At higher magnification, the velvetlike corrosion begins to reveal its dendritic structure. Original magnification 15 $\times$ . The corrosion was identified as djurleite, a copper sulfide. The Chicago Oriental Institute.

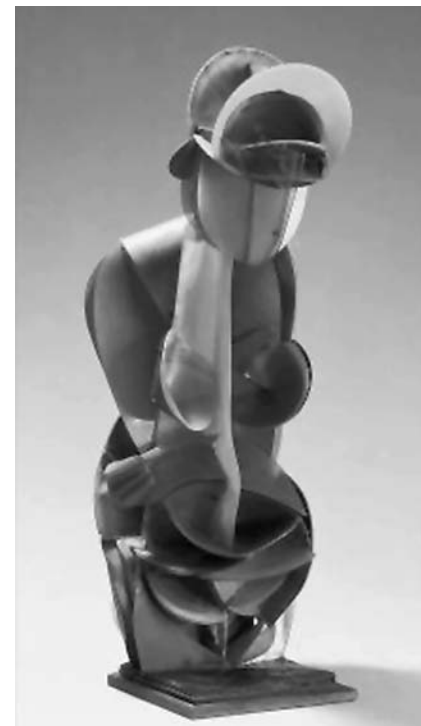
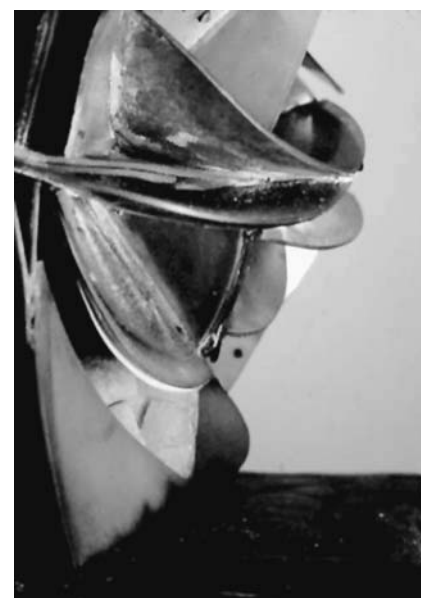
**Fig. 4** *Torso* (1924 to 1926) by Antoine Pevsner constructed in plastic and copper. (a) Full image showing corrosion of the copper segments of the sculpture due to gas emission from and contact with cellulose nitrate segments. (b) A close-up detail of the sculpture. The Museum of Modern Art, New York. Katherine S. Dreier Bequest. ©The Museum of Modern Art, New York, © 2004 Artists Rights Society (ARS), New York/ADAGP, Paris.

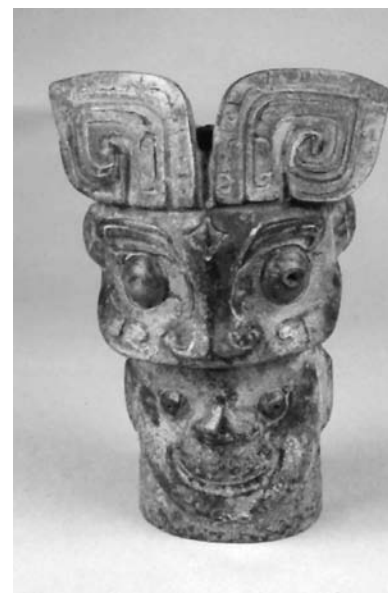
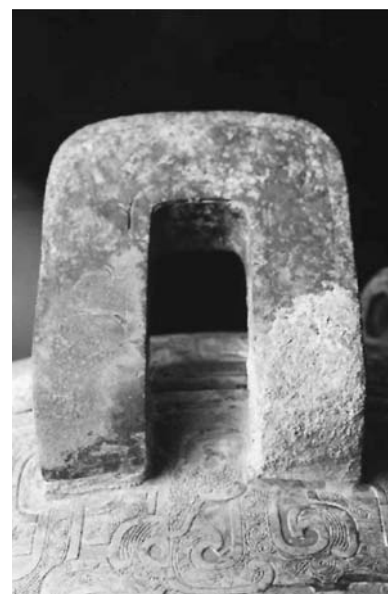
**Fig. 5** Two bronze pieces exhibiting corrosion. (a) A finial, approximately 1300 to 1050 B.C.E. from the Shang dynasty (approximately 1600 to 1050 B.C.E.), China. (b) A closeup of the handle of a ritual food vessel (ding) with cover, approximately 500 to 400 B.C.E. Eastern Zhou dynasty (771 to 221 B.C.E.), China. Asian Art Museum of San Francisco, The Avery Brundage Collection. Both images used by permission. Courtesy of Donna Strahan.

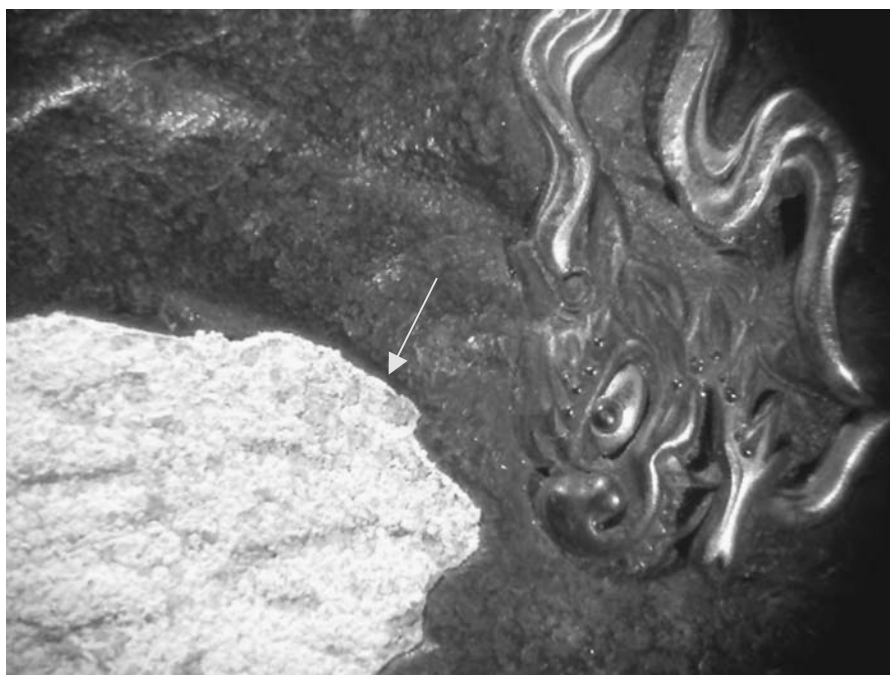
**Fig. 6** Japanese tsuba from the Edo/Meiji period with corrosion (arrow) caused by proximity of wood. Original magnification 6×. Courtesy of Terry Drayman-Weisser.

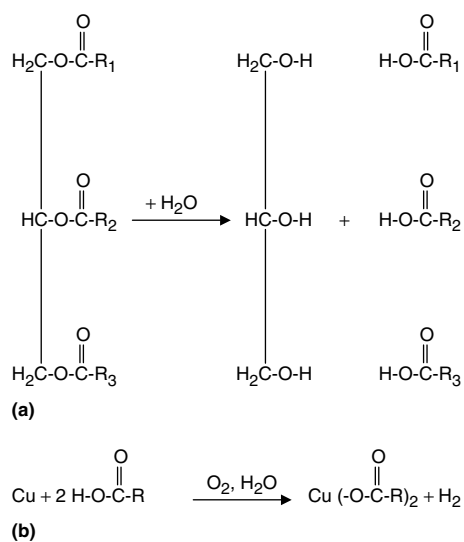
**Fig. 7** The attack on bronzes by oils and fats. (a) Fats with three ester linkages are hydrolyzed, producing free fatty acids.  $\text{R}_1$ ,  $\text{R}_2$ , and  $\text{R}_3$  are long hydrocarbon chains, typically containing 12, 14, 16, 18, or 20 carbon atoms. (b) The free fatty acids attack copper in the presence of water and oxygen, and a fatty-acid salt is formed.

It has been pointed out (Ref 38) that oils and fats that cause this type of corrosion on bronzes (as well as on zinc and lead) have three ester linkages that can be hydrolyzed (the addition of water across the bond) to produce free fatty acids that can attack metals, as shown in Fig. 7.

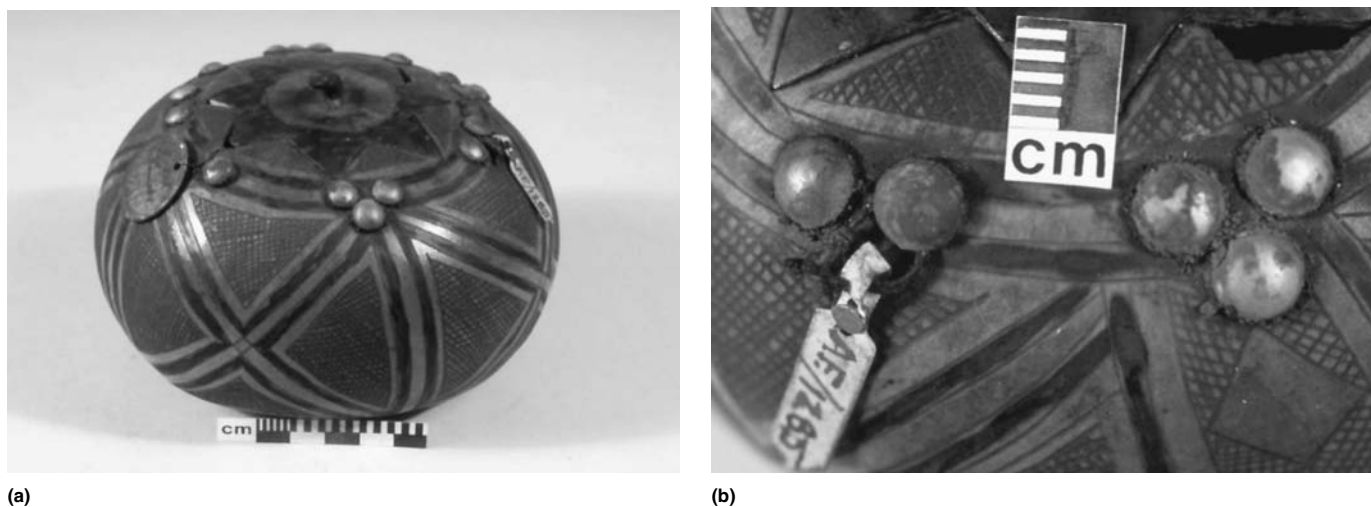
**Fig. 8** The interaction of components of an artifact. (a) Gourd box, late 19th or early 20th century, Kasai District, Zaire. (b) Detail shows the corrosion of the copper alloy tacks due to the oil applied to the surface of the gourd during manufacture or use. Original magnification 5 $\times$ . Conservation Laboratory, University of Pennsylvania Museum of Archaeology and Anthropology

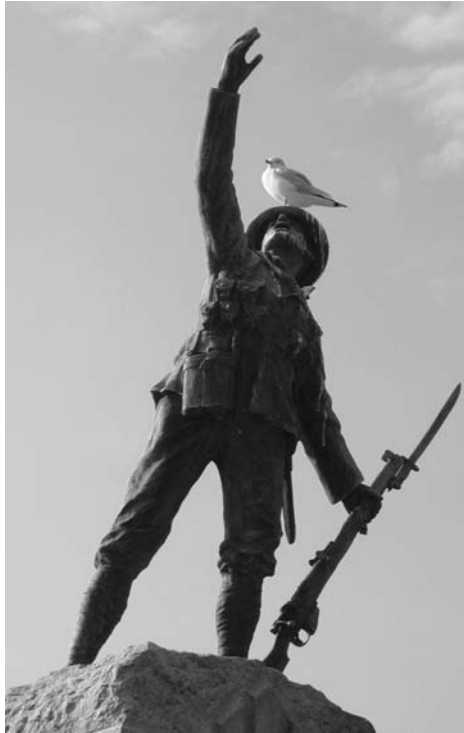
**Fig. 1** Bird damage to a 1931 bronze statue located in Kingston, Ontario, that commemorates the 21st Battalion battles in World War I. Courtesy of Pierre Roberge, Royal Military College of Canada. Photograph 2002

corrode. Nesting material traps moisture next to the metal surface, and degrading organic material introduces additional salts and acidic by-products (such as acetic acid) to the water layer.

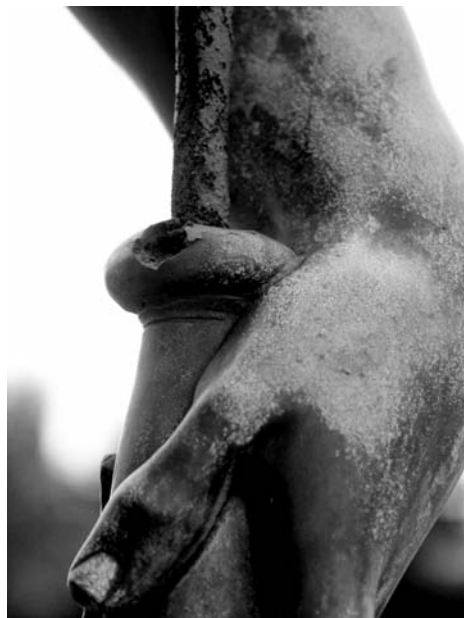
**Fig. 2** Detail of damage by galvanic corrosion of an iron staff in contact with a cast bronze hand on a statue of *Mercury* (date 1962) located in Kingston, Ontario. Courtesy of Pierre Roberge, Royal Military College of Canada. Photograph 2003

**Fig. 19** Detail of damage by galvanic corrosion of an iron staff in contact with a cast bronze hand on a statue of Mercury (date 1962) located in Kingston, Ontario. Courtesy of Pierre Roberge. Photograph 2003. See the article "Corrosion of Metal Artifacts Displayed in Outdoor Environments" in this Volume.

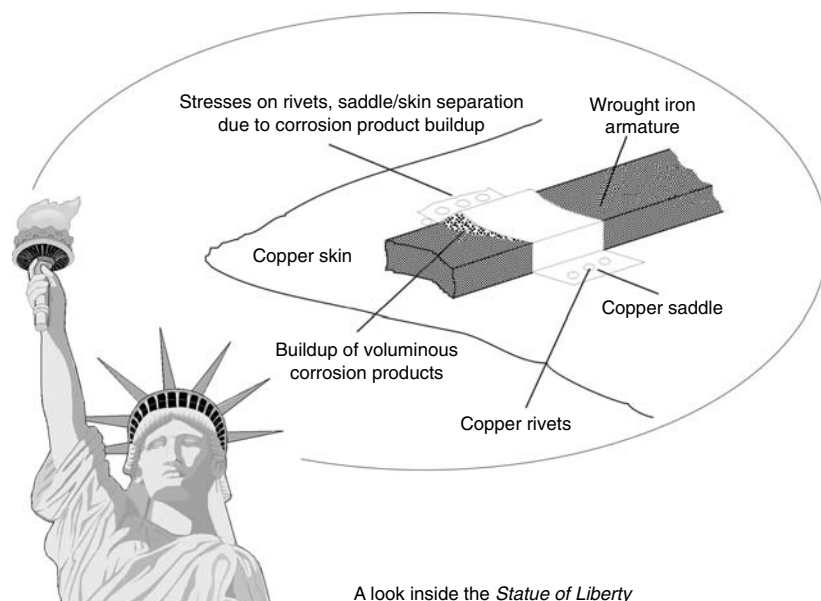
**Fig. 3** Galvanic corrosion between copper and wrought iron on the *Statue of Liberty*, causing accelerated corrosion of the iron

Large metal sculptures are usually supported with an internal structure (an armature) made of another metal, often iron. Moisture enters into the interior of these sculptures (through openings or by condensation), and usually, the iron suffers from galvanic corrosion. The corrosion rate of the iron is accelerated when it is in direct contact with more noble metals, such as copper and bronze. The formation of rust exerts huge destructive forces on surrounding metal and can cause it to crack; rust staining of adjacent material is also a problem. Figure 2 shows damage to a cast bronze hand holding a rusting iron staff. Figure 3 illustrates galvanic corrosion

on the *Statue of Liberty* (officially titled *Liberty Enlightening the World*) where the wrought iron armature was originally in direct contact with copper (Ref 25). Furthermore, severe rusting of iron bolts can dangerously weaken the attachment points (Ref 68).

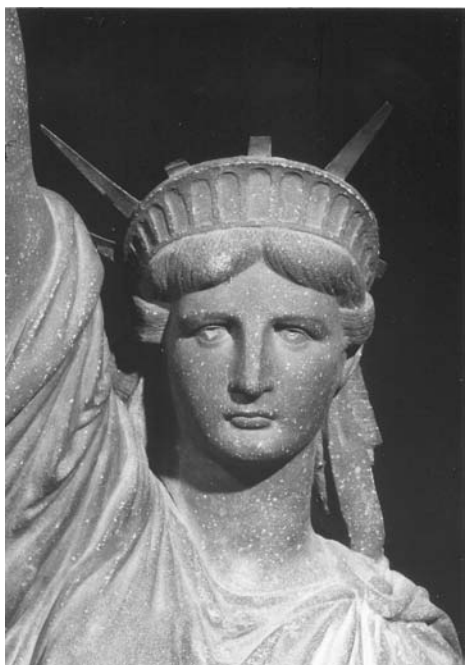
**Fig. 4** Pinhole corrosion on a copper-plated cast zinc statue of *Liberty Enlightening the World* after outdoor exposure. The statue (127 cm, or 50 in., tall) was modeled after Auguste Bartholdi's original model for the *Statue of Liberty*, and many copies were sold to raise money. It was cast in zinc, plated with copper, and given an imitation bronze patina by the foundry Avoiron in Paris sometime between 1878 and 1886. Courtesy of Carol Grissom, Smithsonian Center for Materials Research and Education. Photograph 1981

Zinc sculptures that were electroplated with copper (a process that allowed zinc sculptures to be patinated to resemble more expensive bronze sculptures) and then left outdoors suffer from galvanic corrosion. The surface suffers from severe pitting at breaks in the copper where local galvanic cells are created (Fig. 4). The more-active zinc suffers from accelerated corrosion, pits develop and become covered with white

zinc corrosion products, and the surface of the sculpture becomes covered with unsightly pimples (Ref 56).

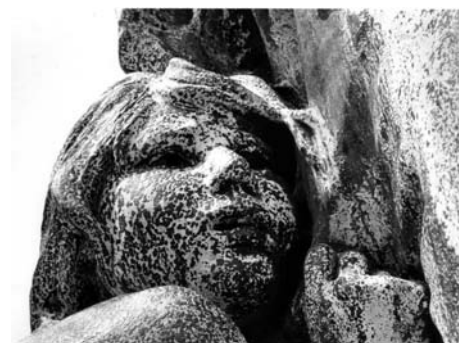
**Fig. 5** Detail of severe pitting on a child's face in the 1887 bronze statue *Stone Age in America* by John J. Boyle located in Philadelphia. Courtesy of the Fairmount Park Art Association. Photograph by Franko Khoury © 1983

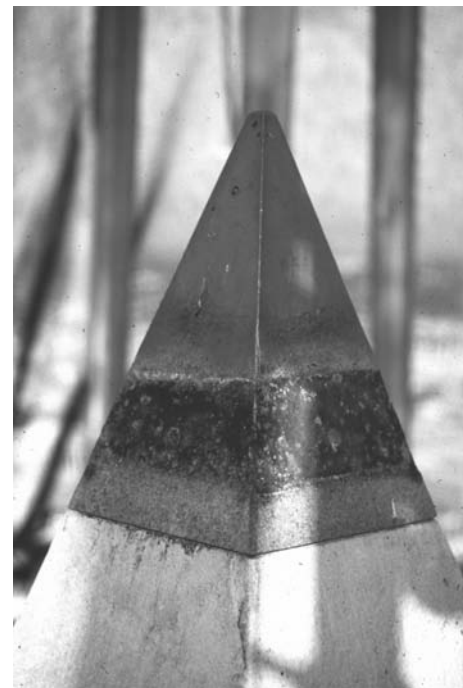
**Fig. 6** The pyramidal cast aluminum cap (14.2 cm, or 5.6 in., square at base; 22.6 cm, or 8.9 in., high) at the apex of the Washington Monument in Washington, D.C., set in place in 1884 and exposed outdoors for 115 years. The darker area shows a region where a gold-plated collar (temporarily removed) serves as a lightning protection system. Courtesy of Judith M. Jacob, National Park Service. Photograph 1999

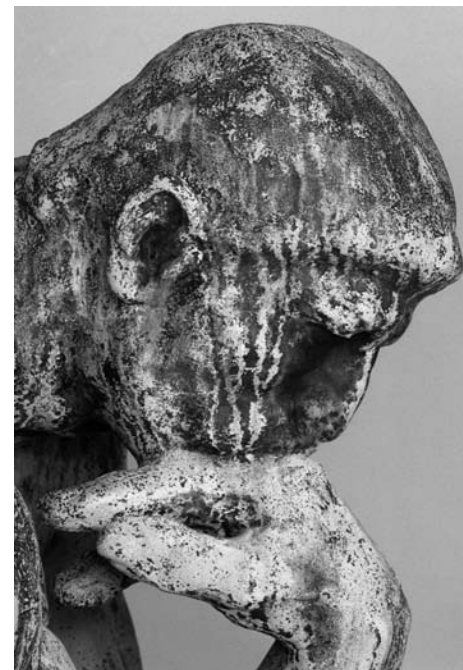
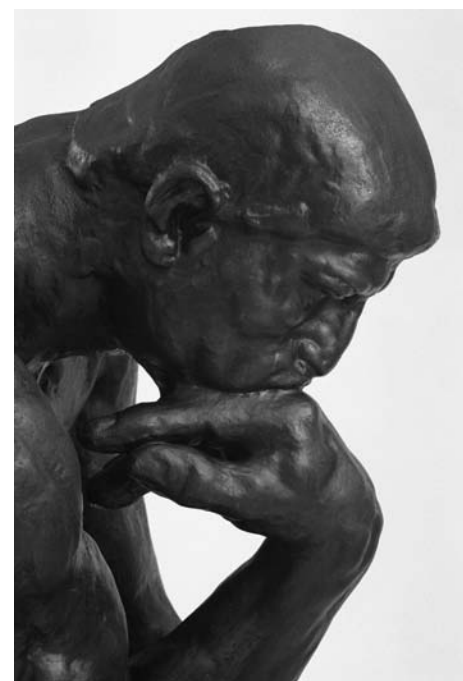
**Fig. 7** Detail of the bronze sculpture of *The Thinker* by Auguste Rodin (installed outside the Rodin Museum in Philadelphia in 1929) (a) before treatment and (b) after treatment. Courtesy of the Philadelphia Museum of Art, Conservation Department. Photographs 1992

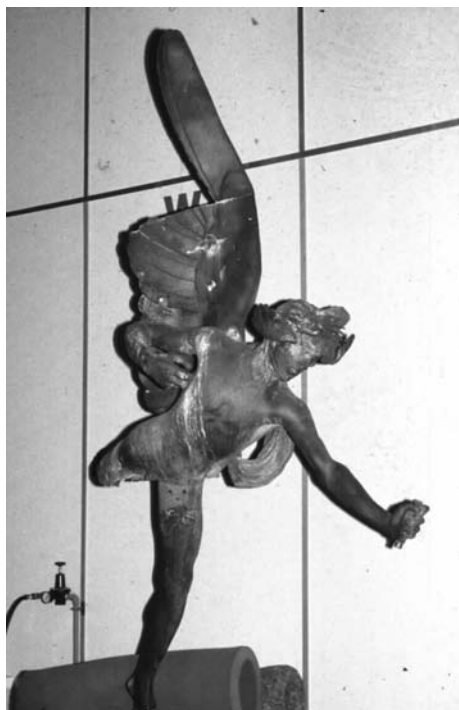
**Fig. 8** Cast aluminum statue of *Eros* by Alfred Gilbert (cast 1929) in Liverpool, England, before treatment. The damage to wings was caused by corrosion of internal iron armatures. Courtesy of Martin Cooper, National Museums Liverpool. Photograph circa 1994

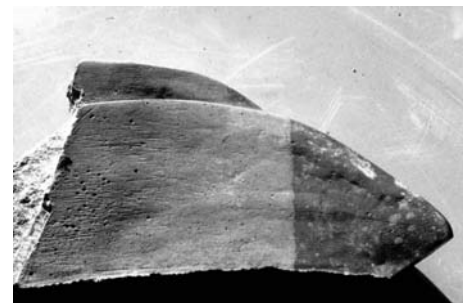
**Fig. 9** Partially cleaned section of a wing (20 cm, or 7.9 in., long) from *Eros* (see Fig. 8). Laser cleaning has been used to remove the dark-gray corrosion layer from the left half. Courtesy of Martin Cooper, National Museums Liverpool. Photograph 1995–1996

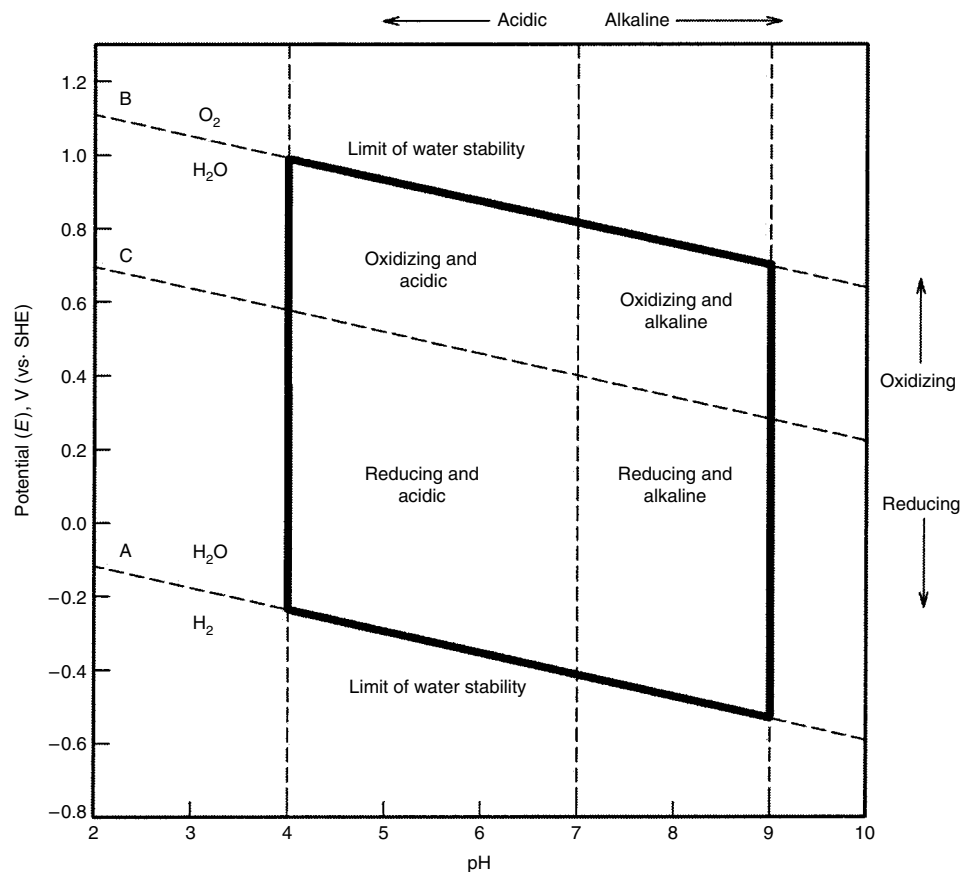
**Fig. 1** Schematic diagram of potential versus pH showing the various regions found in nature at a total pressure of 1 atm. The limits of stability for water are given by the lower line A,  $E = 0.000 - 0.059 \text{ pH}$  (standard hydrogen electrode, or SHE), and the upper line B,  $E = 1.228 - 0.059 \text{ pH}$  (SHE). Line C,  $E = 0.813 - 0.059 \text{ pH}$  (SHE), separates oxidizing regions from reducing ones. The dashed vertical line at pH 7 separates acidic and alkaline regions. Adapted from Ref 23
