# ASM Handbook®

## Volume 13C Corrosion: Environments and Industries

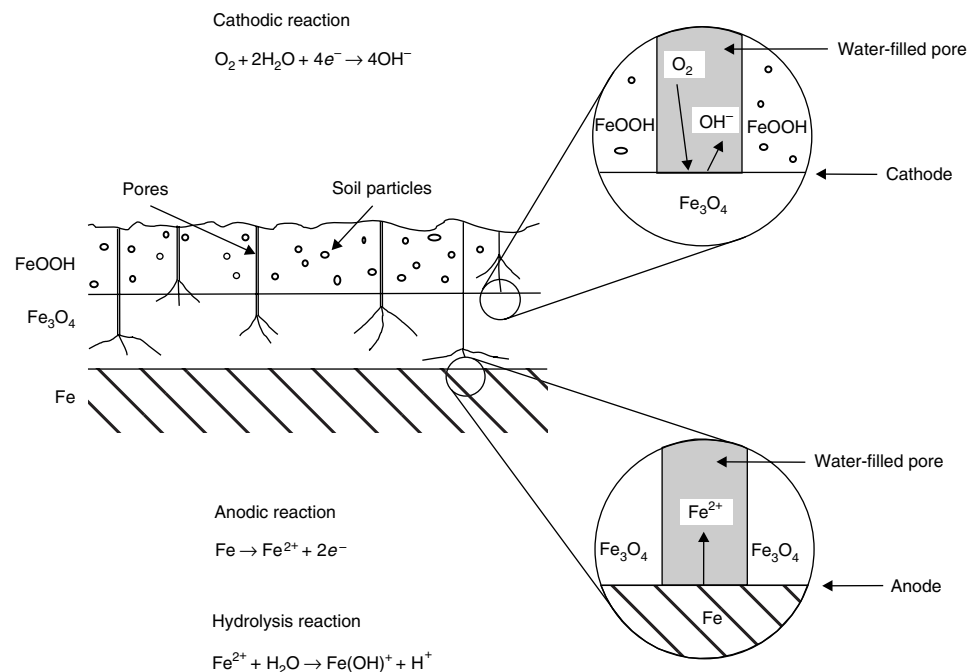
**Fig. 2** Schematic diagram showing the corrosion layers on buried iron as well as the separation of anodic and cathodic regions. Adapted from Ref 75

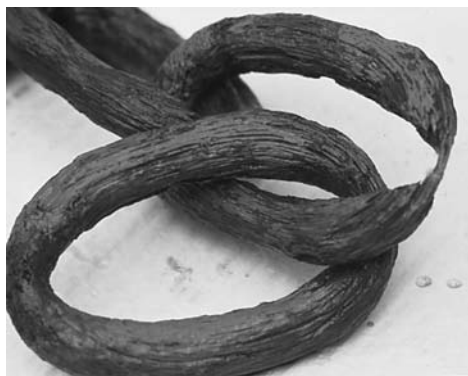
**Fig. 3** A corroded iron chain with the fibrous characteristic of wrought iron. Courtesy of H. Unglik, Parks Canada

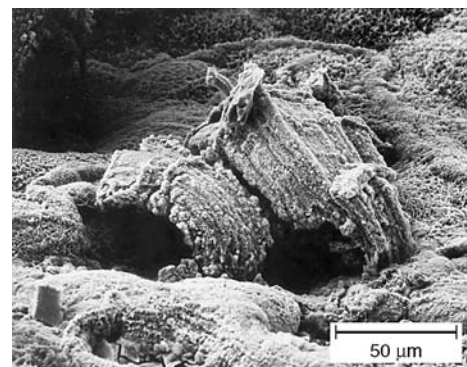
**Fig. 4** Scanning electron micrograph of akaganéite on an archaeological iron fragment (gold coated). 600×; picture width, 190 μm. Adapted from Ref 74

**Akaganéite Formation.** The formation of characteristic bright red-brown elongated particles of akaganéite at exposed metal surfaces on excavated archaeological iron is a symptom of active corrosion (Ref 21, 74, 106, 107). Akaganéite particles form at the metal surface underneath the corrosion products and push them off. Figure 4 contains an image of akaganéite (Ref 74).

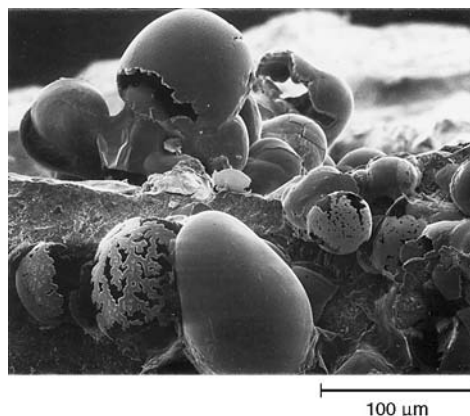
**Fig. 5** Scanning electron micrograph of the hollow shells of weeping on archaeological wrought iron. 100 $\times$ ; picture width, 300  $\mu\text{m}$ . Adapted from Ref 74

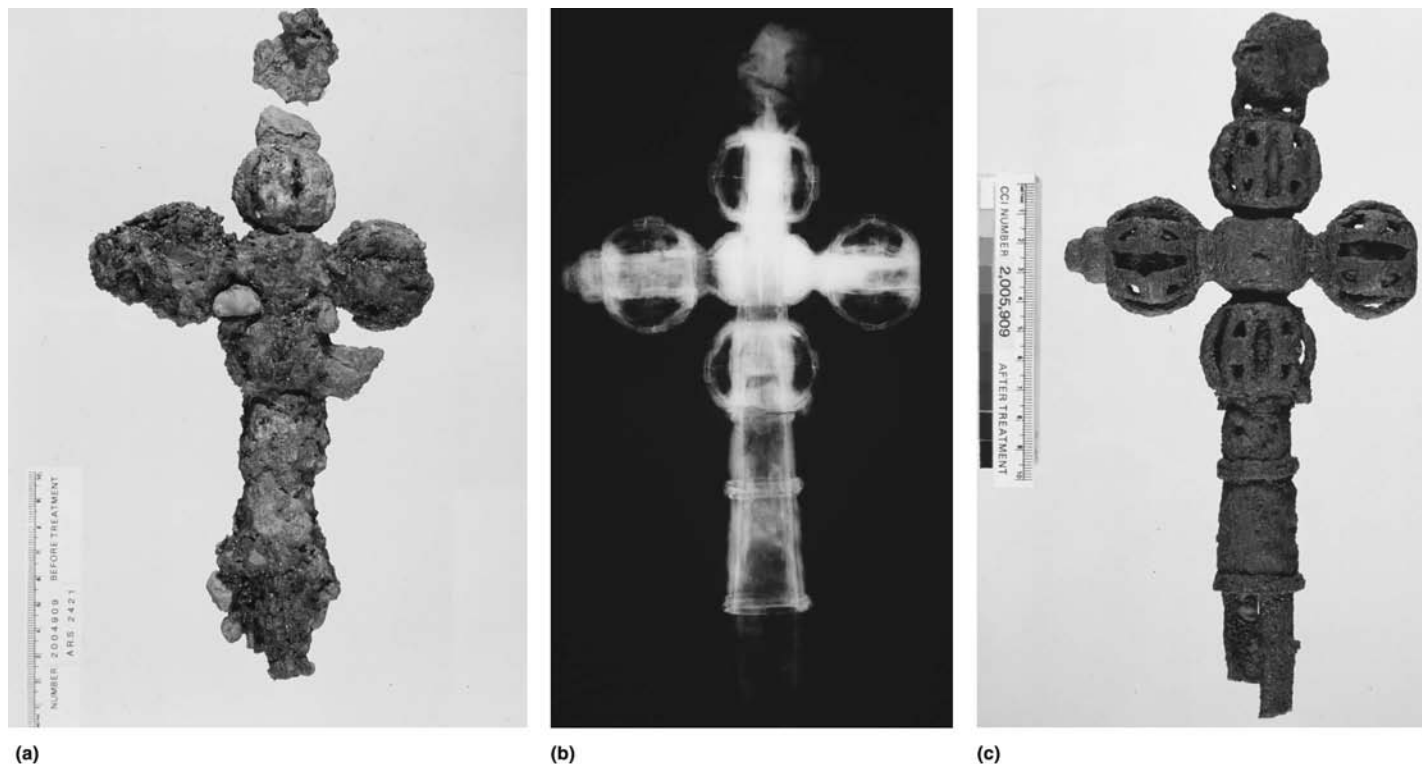
**Fig. 7** A 17th century gilded wrought iron cross with brass inlay from an archaeological site in Ferryland, Newfoundland. (a) Before cleaning. (b) X-radiograph. (c) After mechanical cleaning. Courtesy of Lil Hawkins and the Canadian Conservation Institute

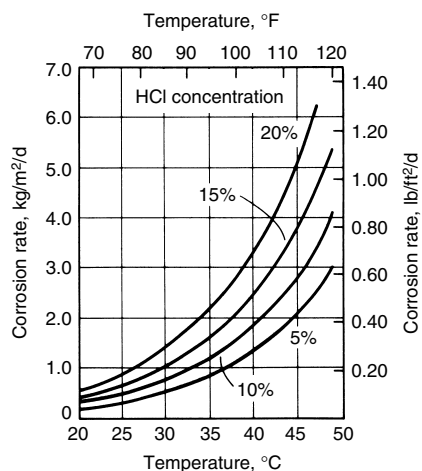
Fig. 1 Effect of temperature on corrosion of mild steel in uninhibited HCl

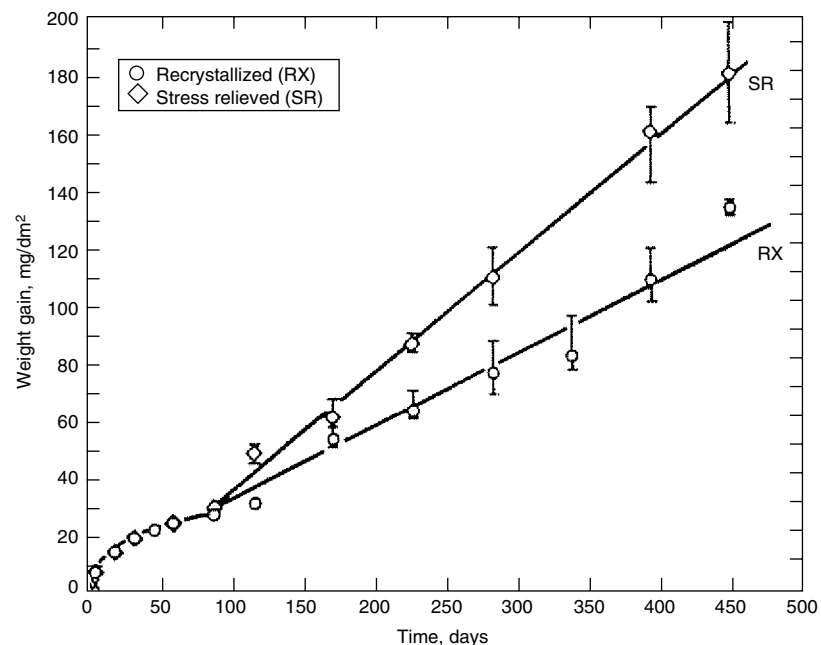
**Fig. 1** General oxidation kinetics of Zircaloy in high-temperature water ( $1 \mu\text{m ZrO}_2 \sim 15 \text{ mg/dm}^2$ ). Source Ref 4

Various corrosion kinetics laws have been developed to predict the oxide thickness with time. Detailed modeling procedures separate the pretransition and posttransition phases; the pretransition regime is of the type  $\varepsilon_1 = \varepsilon_{1,0} \cdot t^{1/3} \cdot \exp(\Delta H_1/RT)$ , and the posttransition regime following the equation  $\varepsilon_2 = \varepsilon_{2,0} \cdot t \cdot \exp(\Delta H_2/RT)$ . In these equations,  $\varepsilon_i$  is the oxide thickness for the  $i$ th regime,  $\varepsilon_{i,0}$  is an experimental kinetics constant,  $t$  is the time,  $\Delta H_i$  the activation energies of the oxidation process,  $R$  is gas constant, and  $T$  is absolute temperature. From a practical viewpoint, the pretransition kinetics and thickness can be neglected for oxide thickness typical of claddings after a few years in reactor (larger than 10  $\mu\text{m}$ ) (Ref 6).

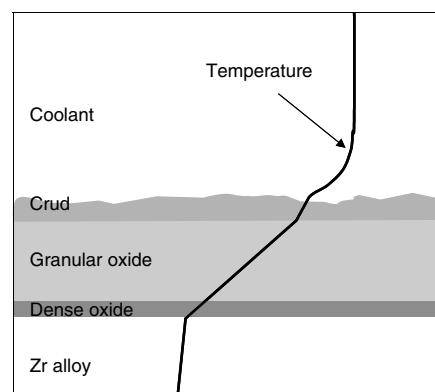
Fig. 2 Temperature profile through the oxide layer in heat flow condition. Temperature decreasing from zirconium alloy to coolant

Detailed computations of the metal/oxide interface temperature require accurate thermal-hydraulics and heat transfer modeling codes. Such approaches should consider the bulk coolant temperature, single- and two-phase flow behavior (pressurized and boiling reactors), limited temperature drop in the loose crud layer (frequent in boiling conditions), and the heat transfer in the zirconia. Several thermal-hydraulic codes have been developed for such computations, and their detailed descriptions are beyond the range of this review on corrosion. Typical profiles are illustrated in Fig. 2.

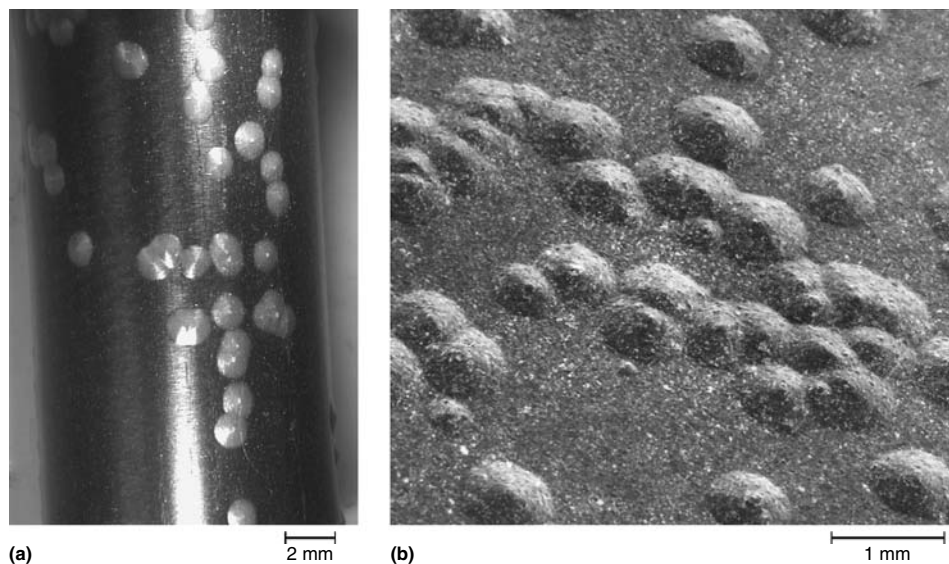
Fig. 3 Nodular corrosion in Zircaloy 2 fuel cladding. (a) Unaided view. (b) Scanning electron micrograph enlargement.

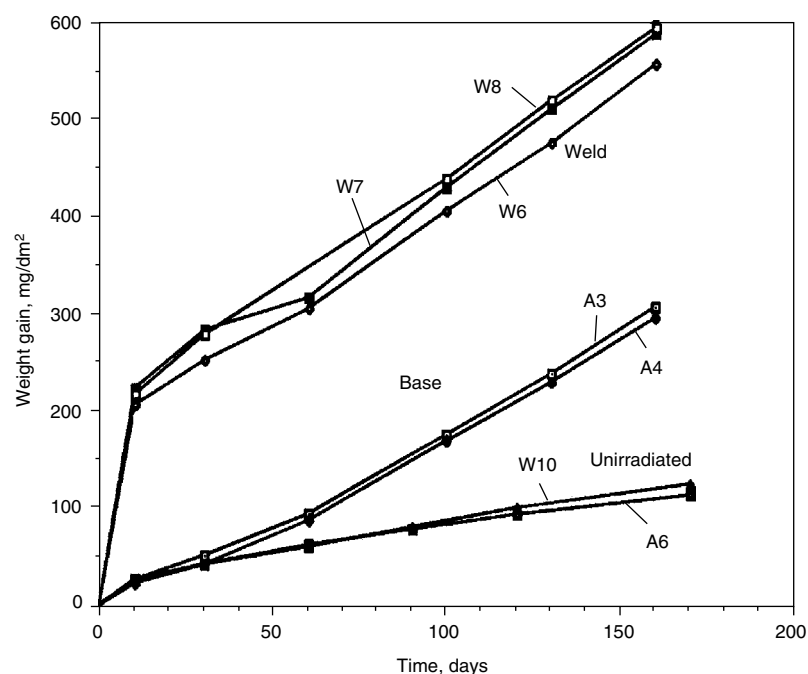
Fig. 4 Corrosion behavior of several Zircaloy specimens in autoclave with and without irradiation. Source Ref 22

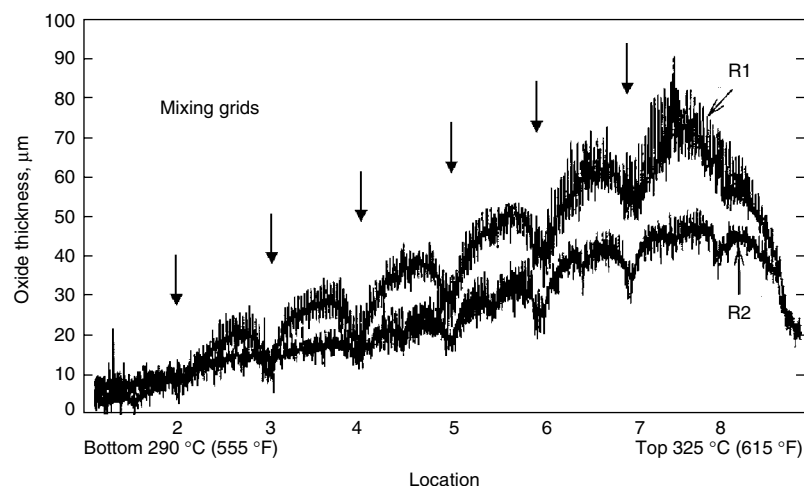
Fig. 5 Oxide thickness along two PWR fuel rods, R1 and R2, of the same assembly. Source Ref 24

temperature (see Table 1), while the upper parts of the rods exhibit higher oxide thickness. At a finer scale, large oscillation in oxide thickness can be observed. They correspond to the enhanced heat exchanges induced by the mixing effects of the grids. Downstream of the grids (above them as the coolant flows upward), a more turbulent flow enhances heat exchanges and reduces the temperature of the oxide in contact with the water. Typical distance between grids for PWR and BWR are approximately 0.5 m (1.6 ft). Specific research and development is focused on improving the turbulent efficiency of the grids without increase of the corresponding pressure drops. Finer observation reveals higher-order oscillation related to the fuel pellet/pellet interfaces, where hydride precipitation had occurred, locally increasing the corrosion thickness.

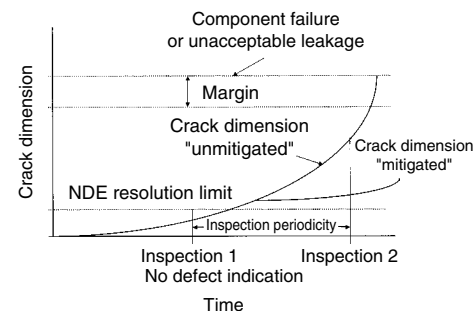
Fig. 1 Evolution of a crack, and the roles of crack dimension resolution and inspection periodicity in managing the structural degradation

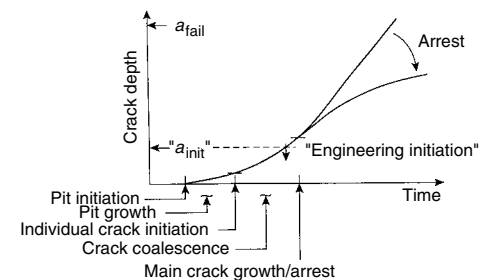
Fig. 2 Sequence of crack initiation, coalescence, and growth during subcritical cracking in aqueous environments. Note that "engineering initiation" corresponds to crack dimensions equal to crack detection capabilities, i.e., function of crack resolution and probability of detection. Source: Ref 36

depths correspond to a definition of "initiation" based on a defined amount of load relaxation (say 25%) in a strain-controlled test (upon which current fatigue design codes are based). Thus, for the current objective of lifetime prediction, it is assumed (Fig. 2) that crack initiation (Ref 36) is associated with *microscopic* crack formation, that is, well below a depth of 2 mm (80 mils), at localized corrosion or mechanical defect sites; such sites are related to, for instance, pitting or intergranular attack that may have dimensions of the order of 10 to 100  $\mu\text{m}$  (0.4 to 4 mils), or scratches, weld defects, or design notches. The latter mechanical/design defects will exist at the time of construction, and it is assumed that the former undetectable microscopic initiation sites will exist relatively early in the life of larger-section components. Therefore, the problem of life prediction for larger-section components narrows down to understanding the growth of small cracks from each of these geometrically separated crack-initiation sites, and the coalescence of these small cracks to form a major crack that may then accelerate or arrest depending on the specific material, environment, and stress conditions. For the cracking systems relevant to BWRs this crack coalescence and subsequent growth of a single crack occurs, as shown in Fig. 3 (Ref 37), at crack depths of 50  $\mu\text{m}$  (2 mils), which is well below normal

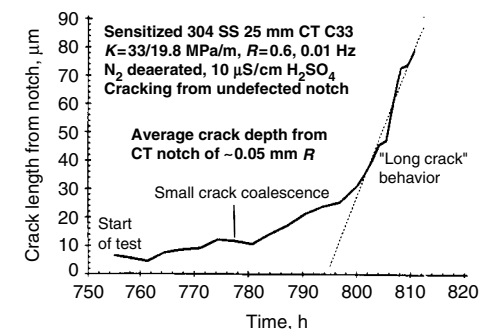
Fig. 3 Observed evolution of intergranular stress-corrosion crack in sensitized stainless steel (SS) compact tension (CT) specimen with single dominant crack being created at  $\sim 50 \mu\text{m}$  depth. Source: Ref 37

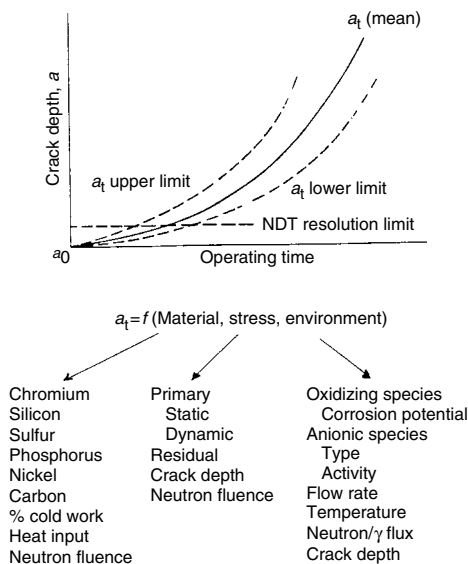
**Fig. 4** Materials, stress, and environmental parameters relevant to environmentally assisted cracking in BWRs. NDT, non destructive testing. Source: Ref 38

There are numerous parameters (Ref 38) that have an effect on EAC propagation in BWR systems (Fig. 4). These initially were characterized (Ref 18) in a macroscopic sense as those that defined the degree of material susceptibility, the “aggressiveness” of the environment, and the magnitude of the tensile stress. This early concept is illustrated in Fig. 5, in which the small region consisting of the overlapping areas of three circles symbolizing the material, environment, and stress factors represents the conditions under which EAC may occur. The presence of these specific factors is a conjoint criterion; that is, all three factors must be present. This explains why the real percentage of, for instance, welded piping exhibiting cracking in a given plant is relatively low. It also indicates that if one factor is missing or reduced sufficiently, then the EAC susceptibility may be significantly reduced. Thus it is evident that there are three obvious methods for mitigating EAC:

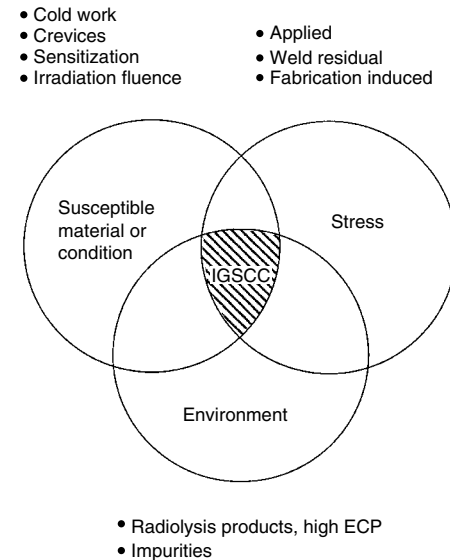
**Fig. 5** The three conjoint factors necessary for producing intergranular stress-corrosion cracking (IGSCC). Appropriate changes in the stress, environment, or material conditions make such a Venn diagram applicable to other modes of EAC. ECP, electrochemical corrosion potential. Source: Ref 18

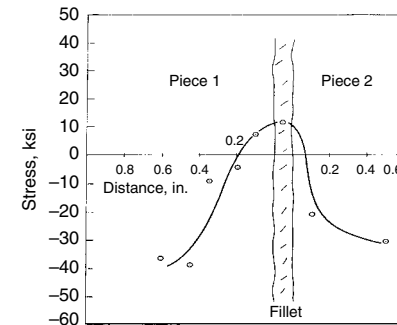
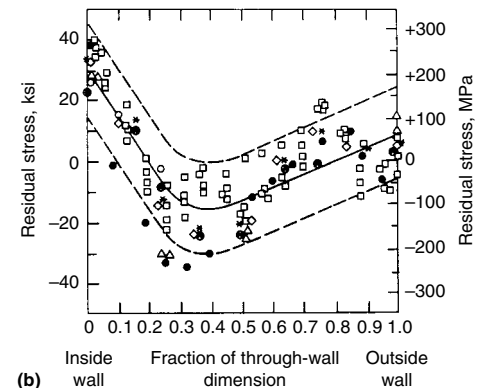
**Fig. 6** (a) Variation in longitudinal residual stress adjacent to a weld on the internal pipe surface of a 100 mm (4 in.) pipe. Source: Ref 18. (b) Variation in through-wall residual stress in 700 mm (28 in.) diam schedule 80 piping close to the fusion line. Source: Ref 41

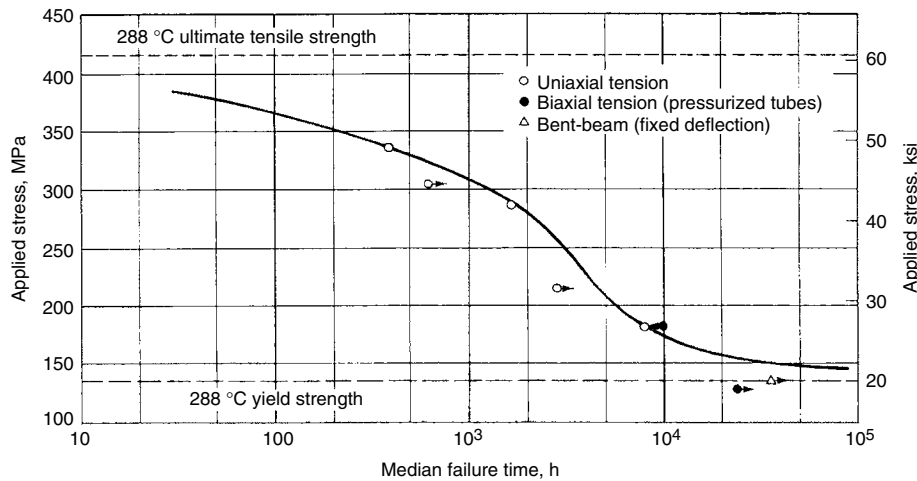
**Fig. 7** Stress dependence of intergranular stress-corrosion cracking of a furnace-sensitized type 304 stainless steel in 288 °C (550 °F) water with 0.2 ppm oxygen. Source: Ref 19

The effect of stress level on the time to failure of sensitized austenitic stainless steels in BWR environments has been studied in detail, and a well-defined dependence of stress on time to cracking has been observed (Ref 19). This relationship is shown in Fig. 7 for furnace-sensitized (24 h at 650 °C, or 1200 °F) type 304 stainless steel subjected to various applied tensile stress modes in 0.2 ppm dissolved oxygenated BWR-type water. As expected, the lower the tensile stress the longer the time to component “failure.” It is also apparent that the stress-dependency curve is asymptotic to the at-temperature yield strength of the sensitized material. This laboratory observation led to the development at General Electric (Ref 42) of a “stress rule index” (SRI) for evaluating plant

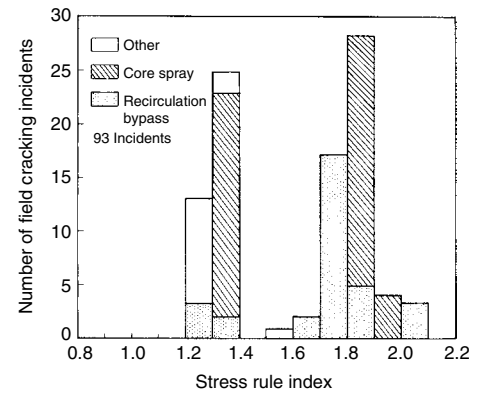
**Fig. 8** General Electric stress rule index evaluation of 93 pipe-cracking incidents. Source: Ref 42

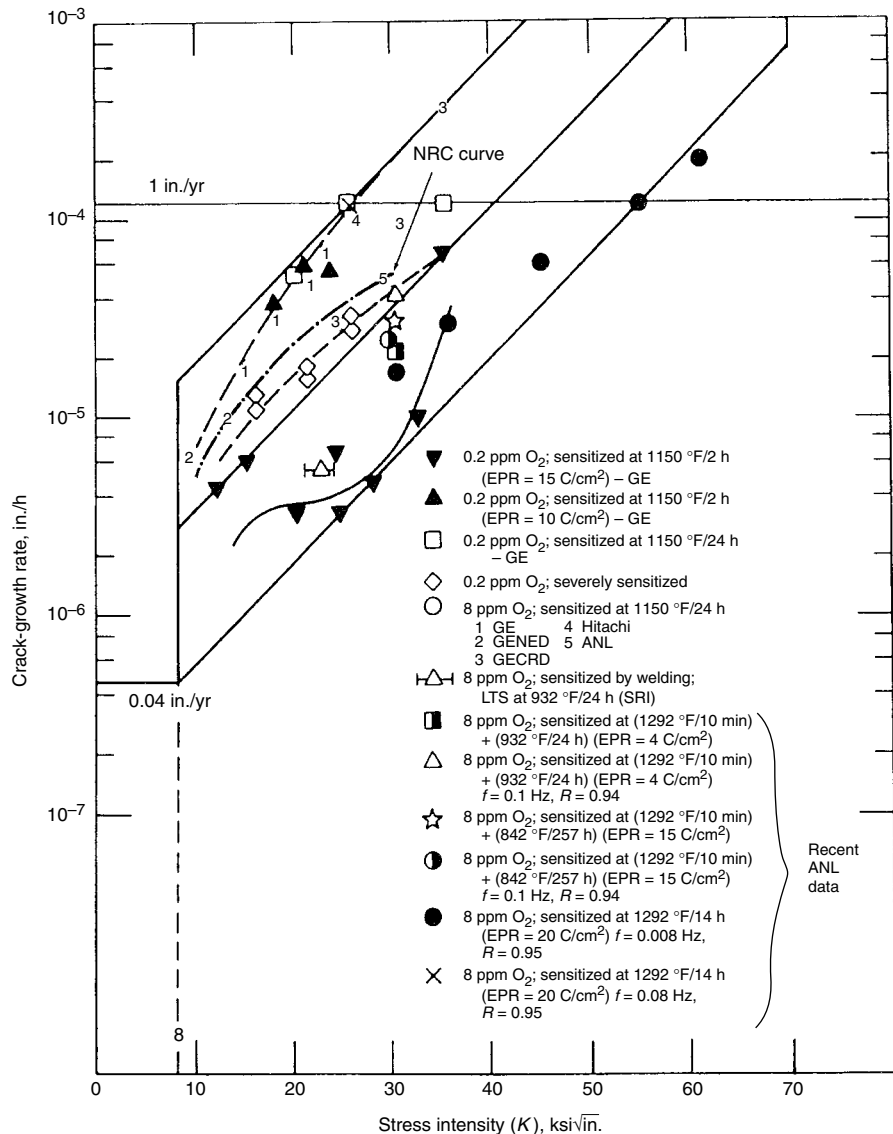
**Fig. 9** Crack-propagation-rate data for sensitized stainless steel as a function of stress intensity in oxygenated 288 °C (550 °F) water. Source: Ref 43

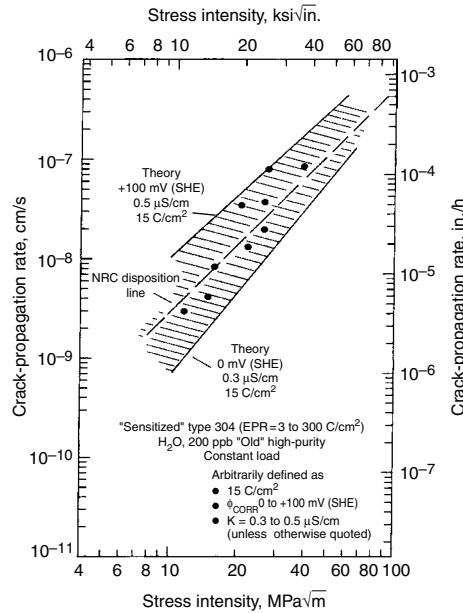
**Fig. 10** Crack-propagation-rate/stress-intensity dependence for sensitized stainless steel in 288 °C (550 °F) water with 0.2 ppm oxygen and conductivity of 0.3–0.5 μS/cm. Note the insertion of theoretical relationships (discussed later) and the NRC regulatory relationship used for structural integrity evaluations. NRC, Nuclear Regulatory Commission. Source: Ref 38, 42, 43

content in the water. The corresponding data set for a more controlled oxygen content in the range 0.1 to 0.3 ppm, which is more representative of that in BWR water in the recirculation piping, is shown in Fig. 10 (Ref 38, 45);

the variance is reduced and the USNRC disposition line (Eq 2) approximates the mean of this data set. It is important to point out that the crack-propagation rates are relatively low compared to those in other classical stress-corrosion systems (e.g., copper alloys in ammoniacal solutions and mild steel in carbonate/bicarbonate solutions) and, given the logarithmic scale in Fig. 10, it would take a considerable experimental time to make an unambiguous case for the existence of a “threshold  $K_{ISCC}$ ” below which the crack-propagation rate is “zero.” However, a stress-intensity value can be quoted that corresponds to a very low propagation rate that is “acceptable” over many years of operation. As is discussed later, this “pseudo- $K_{ISCC}$ ” value is not a constant since its value will depend on the specific values of other system parameters.

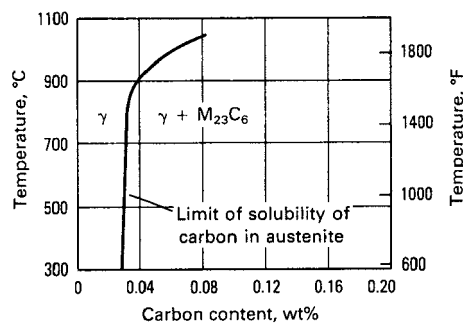
Fig. 11 Solid solubility of carbon in an Fe-18Cr-8Ni alloy. Source: Ref 46

solution over the temperature range shown provided the carbon is less than approximately 0.03 wt%. Austenite-containing carbon in excess of 0.03 wt% should precipitate  $M_{23}C_6$  upon cooling below the solubility line. However, at relatively rapid rates of cooling, this precipitation reaction is partially suppressed, and the room-temperature microstructure is characterized by austenite supersaturated with carbon. If this supersaturated austenite is reheated to elevated temperatures within the ( $\gamma + M_{23}C_6$ ) field, further precipitation of the chromium-rich  $M_{23}C_6$  will take place preferentially at the austenite grain boundaries. Certain time-temperature combinations will be sufficient to precipitate this chromium-rich carbide, but will be insufficient to rediffuse the larger chromium atoms back from the grain matrix into the austenite near the carbide in the grain boundaries. The net result is the formation of envelopes of chromium-depleted austenite around the carbide (Fig. 12), which in certain environments will not resist intergranular attack and IGSCC. The sensitized regions adjacent to a weld are known as the heat-affected zone (HAZ) (Fig. 13), and it is within this zone where the grain boundaries are in such a chromium-depleted condition that the IGSCC is concentrated (Fig. 14).

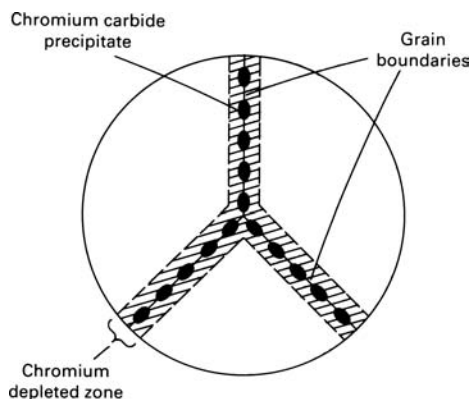
Fig. 12 Grain boundary in sensitized type 304 stainless steel. Source: Ref 19

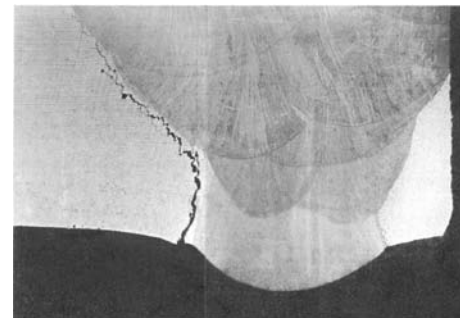
Fig. 14 Pipe test results showing intergranular stress-corrosion cracking in a 400 mm (16 in.) type 304 pipe heat-affected zone. Source: Ref 19

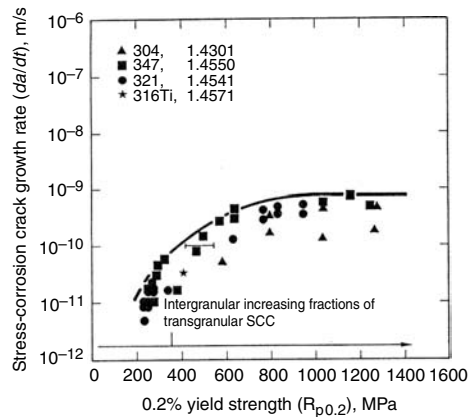
**Fig. 15** Crack-propagation rate for nonsensitized stainless steels in simulated boiling water reactor water at 288 °C (550 °F) as a function of yield stress. Source: Ref 56

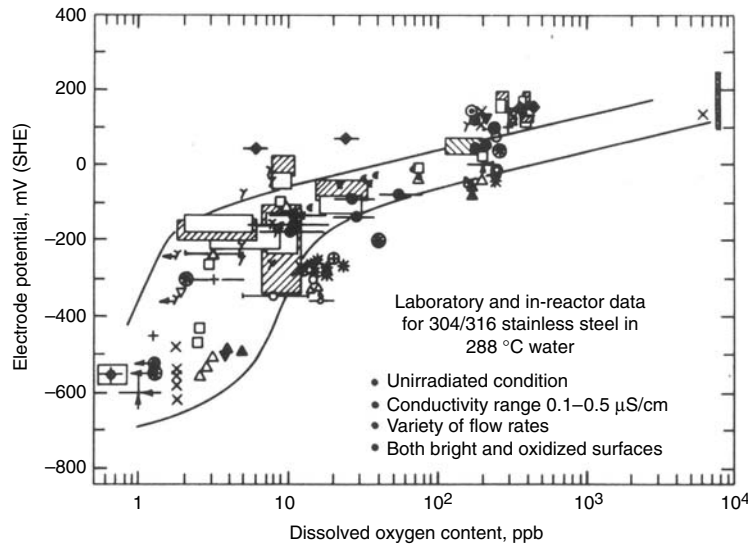
**Fig. 16** Relationship between electrochemical corrosion potential (ECP) and dissolved oxygen content. Data from operating reactors, with the different symbols being associated with specific plants. Source: Ref 38

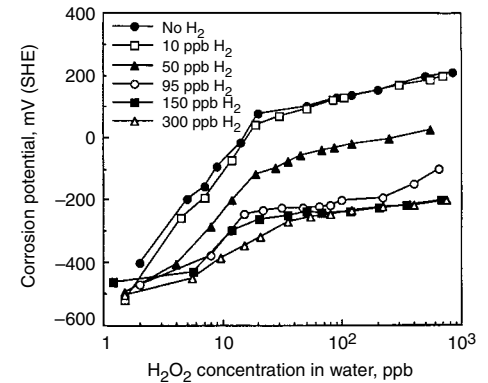
**Fig. 17** Laboratory data indicating variation of corrosion potential type 316 of stainless steel with dissolved hydrogen peroxide and hydrogen in 288 °C (500 °F) water. Source: Ref 57

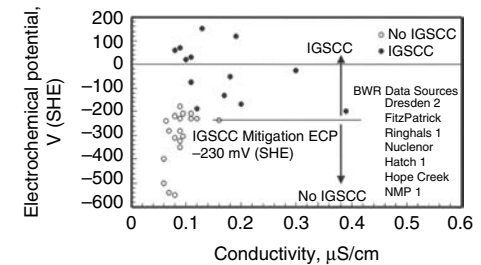
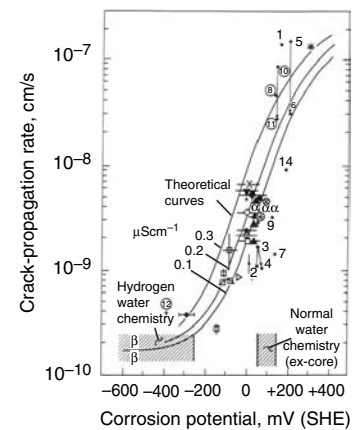
**Fig. 18** (a) Corrosion potential and coolant conductivity combinations in which IGSCC is observed in sensitized type 304 stainless during an accelerated slow-strain-rate test conducted at various operating BWRs. Source: Ref 58. (b) Observed and predicted relationships between the crack-propagation rate and corrosion potential for sensitized (15 C/cm<sup>2</sup>) type 304 stainless steel in 288 °C (550 °F) water under constant load (27.5 MPa√m, or 25 ksi√in.). Water conductivity in range 0.1 to 0.3 μS/cm. The data point (\*) and those that are numbered refer to tests conducted under irradiation conditions in either an operating reactor or a variable energy cyclotron. Source: Ref 38, 59

tenitic and ferritic alloys in BWR environments; this is illustrated in Fig. 18 and 19 for SCC of sensitized stainless steel and SA333 grade 6 carbon steel, respectively. It is apparent from

Fig. 18(b) and 19 that there is a very high sensitivity of the crack-propagation rate on the corrosion potential, thereby suggesting a prime mitigating parameter for EAC. Caution should be given, as with the concept of  $K_{ISCC}$  discussed earlier, in defining an absolute value of corrosion potential below which EAC “will not occur”; for instance, early investigations (Fig. 18a) ascribed a value of  $-230$  mV standard hydrogen electrode (SHE) as a “threshold potential” for EAC of stainless steels based on data from accelerated slow-strain-rate tests in operating reactors. There are two concerns in this absolute definition. The first is that in many cases (see, for instance, Fig. 18b) cracking can occur, albeit at very slow propagation rates, at corrosion potentials below the “threshold” corrosion potential value; such rates would not be resolvable in an accelerated test such as that used for the data collection shown in Fig. 18(a). The second is that, although under most operating conditions  $-230$  mV (SHE) is a conservative limiting value for constant load/deflection conditions, the absolute “threshold” value will depend on the interactions of other system variables (e.g., stress/strain rate, water purity, alternate alloys, irradiation flux/fluence, etc.) and, in fact, more positive threshold values of corrosion potential than  $-230$  mV (SHE) may be appropriate for many current operating conditions.

The relationships between the crack-propagation rate and the corrosion potential and conductivity shown in Fig. 18(b) and 19 to 21 indicate that it is not the conductivity of the bulk water that is of fundamental importance, but rather the crack-tip (non- $\text{OH}^-$ ) anionic activity. This crack-tip activity will be increased over the bulk value by a factor of 10 to 50 (Ref 38) due to potential-driven diffusion down the crack since the crack mouth corrosion potential under “normal” oxidizing water chemistry conditions may be of the order of  $+50$  mV (SHE), while the crack-tip potential will be of the order of  $-500$  mV (SHE). Such a potential-driven increase in (non- $\text{OH}^-$ ) anionic activity at the crack tip will be accompanied by a decrease in pH to maintain local electroneutrality. These combined effects of increased anionic activity and increased acidity at the crack tip will affect the oxidation kinetics occurring in this region and thereby the crack-propagation rate.

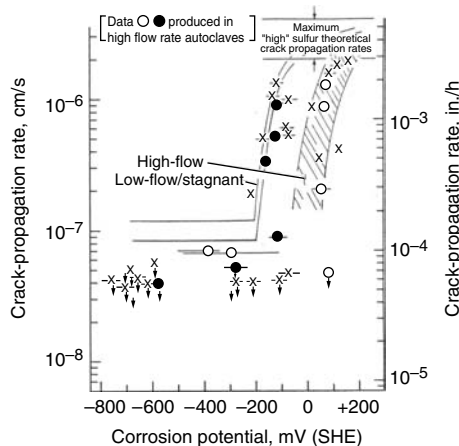
**Fig. 19** Predicted (Ref 60) and observed (Ref 61, 62) dependency of the stress-corrosion crack-propagation rate on corrosion potential for A508 steel containing 0.01% S strained at  $1$  to  $1.5 \times 10^{-6}$   $\text{s}^{-1}$  in  $288$   $^{\circ}\text{C}$  ( $550$   $^{\circ}\text{F}$ ) water with conductivity of  $0.2$   $\mu\text{S}/\text{cm}$

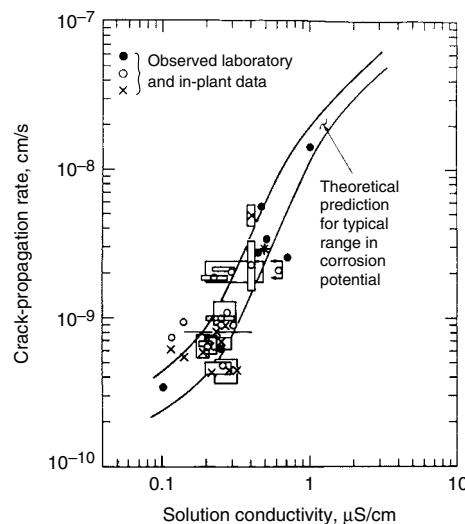
**Fig. 20** Observed and predicted relationships between the crack-propagation rate and water conductivity for 316L stainless steel under constant load ( $27.5$   $\text{MPa}/\sqrt{\text{m}}$ , or  $25$   $\text{ksi}/\sqrt{\text{in.}}$ ) in  $288$   $^{\circ}\text{C}$  ( $550$   $^{\circ}\text{F}$ ) water containing 200 ppb oxygen. Source: Ref 38, 59

maintained below 5 ppb. Early observations (Ref 25, 26) indicated that the incidence of plant component cracking correlated well with the plant reactor water conductivity or coolant impurity level. Subsequent laboratory measurements on the austenitic and ferritic alloys confirmed correlations between the crack-propagation rate and conductivity under both steady-state and transient water purity conditions as shown in Fig. 20 and 21, respectively (Ref 38, 59).

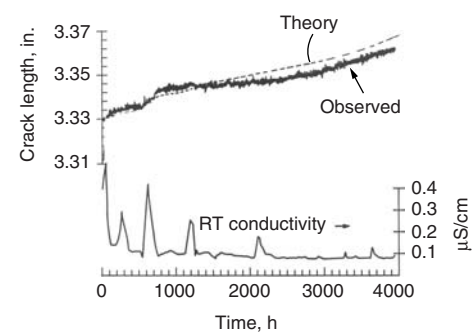
**Fig. 21** Observed and predicted (theory) crack depth versus time relationship for sensitized type 304 stainless steel under constant load ( $27.5$   $\text{MPa}/\sqrt{\text{m}}$ , or  $25$   $\text{ksi}/\sqrt{\text{in.}}$ ) during conductivity transients during reactor operation. RT, room temperature. Source: Ref 38, 59

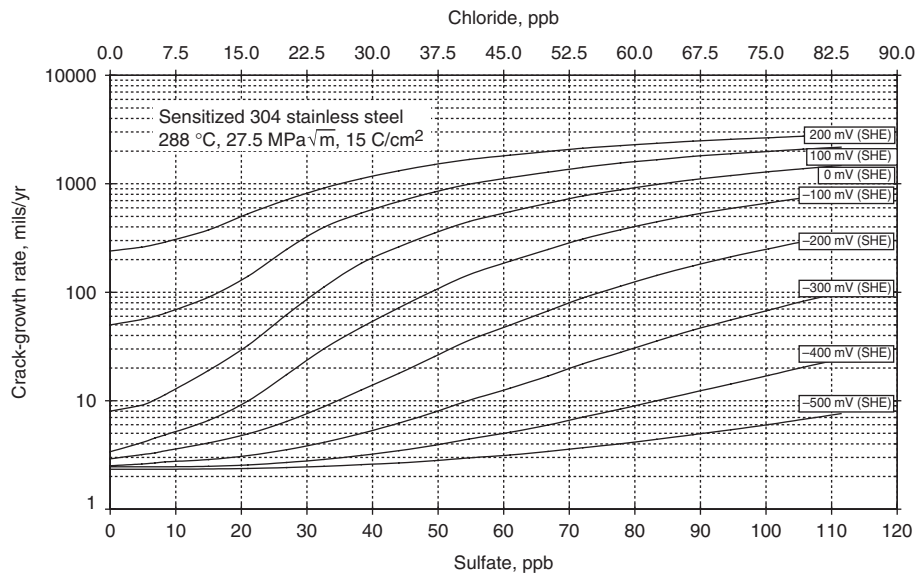
Fig. 22 Crack-growth prediction as a function of sulfate and chloride concentration

predictions of the effect of corrosion potential and anionic activity on the IGSCC propagation rate of sensitized type 304 stainless steel stressed at  $27.5$   $\text{MPa}/\sqrt{\text{m}}$  ( $25$   $\text{ksi}/\sqrt{\text{in.}}$ ) is indicated in Fig. 22 for sulfate and chloride anions. It is seen that under “normal” water chemistry conditions corresponding to a corrosion potential of approximately  $+50$  mV (SHE) for a recirculation line, increasing the anionic activity from a preferred operating value of  $<5$  to 20 ppb or, in a worst case scenario of 100 ppb, the crack-propagation rate would be predicted to increase by up to two orders of magnitude under oxidizing conditions. Under lower corrosion potential conditions associated with hydrogen water chemistry (HWC) with or without noble metal technology, it is predicted and confirmed (Ref 72) that the increases in propagation rate for stainless steels due to such anionic transients are markedly lower. Preliminary data for nickel-base alloys (Ref 73) indicate that the beneficial effect of lowering the propagation rate in sulfate-containing environments by decreasing the corrosion potential may not be quite as effective as observed in stainless steels, indicating possibly a change in cracking mechanism at low potentials to that pertinent to nickel-base alloys in PWR primary side environments.

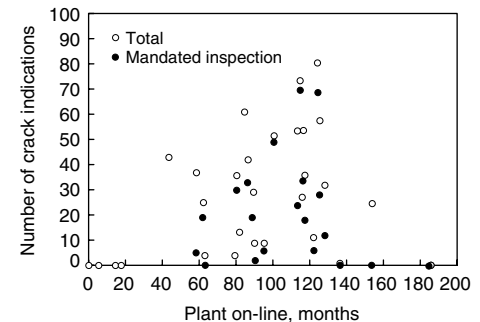
Fig. 23 Relationship between incidences of cracking in BWR piping and operational time. Source: Ref 18

pipings as a function of plant operational time (Fig. 23) can exhibit extensive scatter because of an imprecise definition of the system upon which the data was derived. Thus, although analyses of trends in plant behavior as a function of alloy type or water chemistry are useful for predicting the likelihood of a particular failure mode in a given component and for developing risk-informed component inspection procedures (Ref 91), they are insufficient for development of deterministic relationships such as described in Eq 3 or Fig. 4.

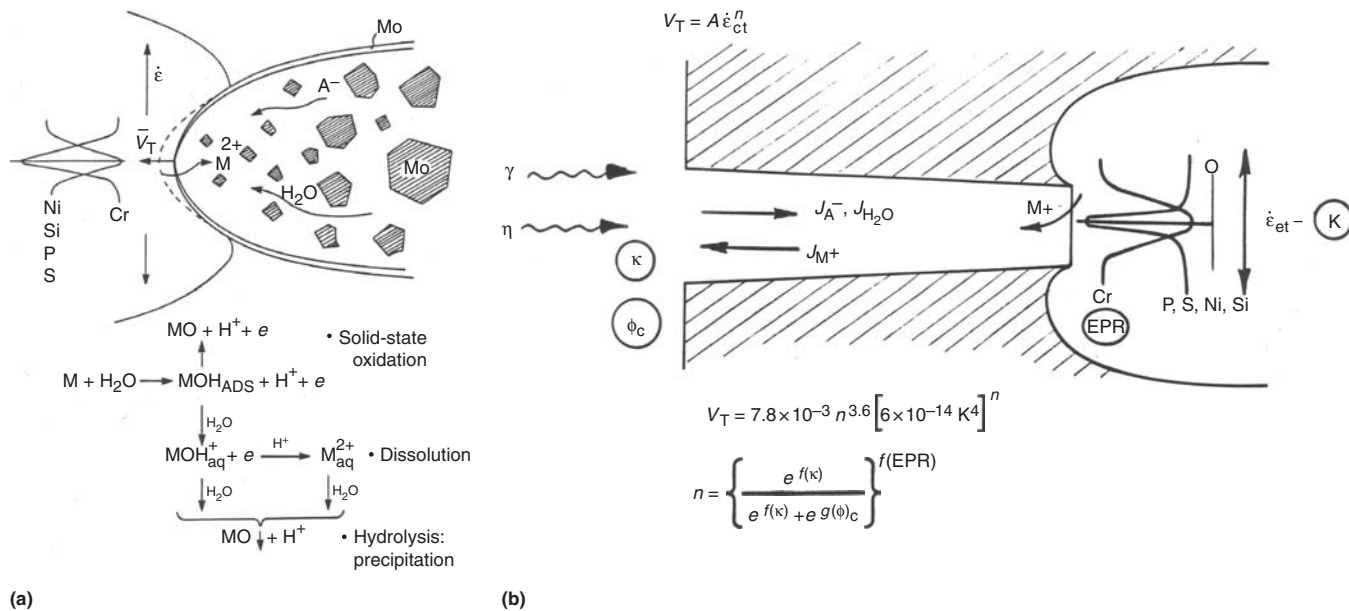
**Fig. 24** Relevant phenomena in the crack enclave. (a) Physical processes at the crack tip, illustrating the large amount of precipitated oxide that is expected and noted in the crack enclave. (b) Crack enclave and the relevant phenomena associated with the slip-oxidation mechanism of crack advance. See Eq 5 to 8 for details. Source: Ref 59

The slip-oxidation model equates, via Faraday's relationship, crack propagation to the oxidation charge density at the crack tip that is associated with the transformation of the metal to the oxidized state (e.g., MO or  $M_{aq}^{2+}$ ). As shown in Fig. 24, the relevant phenomena in the crack enclave are (Ref 59):

To advance this concept to application to BWR cracking systems, it is necessary to redefine the fundamental Eq 5 in terms of measurable engineering or operational parameters (Fig. 24b). This involves:

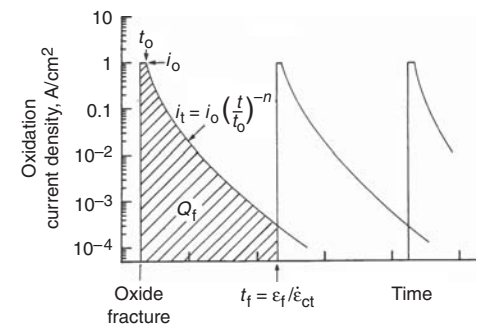
**Fig. 25** Oxidation current density versus time relationship for a strained crack tip. Source: Ref 59

The change in oxidation current density with time (and hence oxidation charge density) following the rupture of a protective film at the crack tip is shown in Fig. 25. Initially, the oxidation rate and, hence, crack-propagation rate will be rapid, controlled by activation or diffusion kinetics as the exposed metal dissolves (Ref 59). However, in most of the cracking systems of interest in the BWR, a protective oxide or salt is thermodynamically stable and will reform via solid-state oxidation and/or precipitation from solution on the bare surface. As a result, the oxidation (dissolution) rate,  $i_t$ , will fall from the bare surface value,  $i_o$ , following a time period,  $t_o$ , according to:

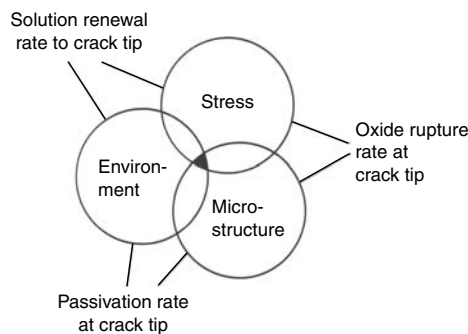
**Fig. 26** Relationship between the empirical conjoint factors necessary for EAC: stress, environment, and material conditions, and the crack-tip mechanistic factors, oxide rupture frequency, passivation rate, and solution renewal rate. Source: Ref 38, 59, 96

Recognition of the interacting effects of mass transport within the crack enclave, oxidation or reduction rates at the crack tip and crack mouth, and the crack-tip strain rate has proven of great value in identifying the generic system changes that are likely to reduce the extent of a particular EAC problem (Ref 95). For instance, increasing cracking resistance is to be expected by increasing the passivation rate at the crack tip (by control of the corrosion potential/anionic activity combinations or by material composition changes) and by reduction in crack-tip strain rate (by attention to dislocation morphology, the imposed stress history, etc.) (Ref 84, 95). Thus, there is a mechanisms-informed basis for understanding and developing quantitative predictions of the empirical observations of the effects on EAC susceptibility of, for instance, zinc (effect on oxide fracture strain and passivation rate), chloride and sulfate (effect on passivation rate), and so forth. It is also important to point out that these mechanisms-informed arguments meld into the empirical observations of the factors that influence EAC in BWR systems (Fig. 26).

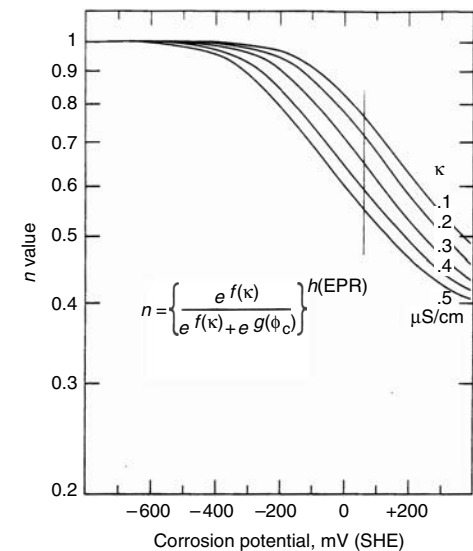
**Fig. 27** Relationships between  $n$  in Eq 6 and 7 and the corrosion potential and bulk solution conductivity for a sensitized ( $EPR = 15 C/cm^2$ ) type 304 stainless steel in water at 288 °C (550 °F). EPR, electrochemical potentiokinetic repassivation. Source: Ref 38

which is related to the chromium depletion in the grain boundary. Thus, as shown in Fig. 27:

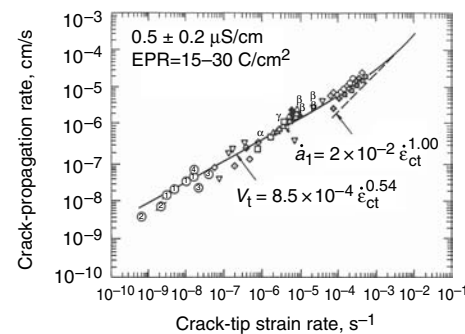
**Fig. 28** Observed and theoretical crack-propagation rate versus crack-tip strain-rate relationships for sensitized type 304 stainless steel in oxygenated water at 288 °C (550 °F). EPR, electrochemical potentiokinetic repassivation. Source: Ref 38, 59

The general validity of the prediction methodology is indicated in Fig. 28, which covers data obtained on sensitized type 304 stainless steel in

8 ppm oxygenated water at 288 °C (550 °F) stressed over a wide range of constant load, monotonically increasing load, and cyclic load conditions. The solid line shows the theoretical relationship from Eq 6 and 7 and the appropriate strain-rate formula for the stressing mode. The agreement between prediction and observation illustrates the applicability of the methodology to the whole stress-corrosion/corrosion-fatigue spectrum. The effect of, for instance, coolant (water) deaeration on the relationship between crack-propagation rate and crack-tip strain-rate is shown in Fig. 29. The degree of the predicted and observed beneficial effect of deaeration is very dependent on the strain rate (i.e., stress level and/or degree of dynamic loading), and this has an impact on evaluating the benefit of deaeration and the choice of the test technique that will be used to quantify the benefit. For instance, the factor of improvement (defined as the ratio of the crack-propagation rates in the two environments at a given crack-tip strain rate) decreases with increasing strain rate: thus factors of improvement determined by an accelerated “slow-strain-rate test” (with crack-tip strain rates in the range  $10^{-4}$  to  $10^{-6}$  s $^{-1}$ ) will significantly underestimate the improvement expected in a plant component subject to weld residual stresses (with crack-tip strain rates less than  $10^{-8}$  s $^{-1}$ ).

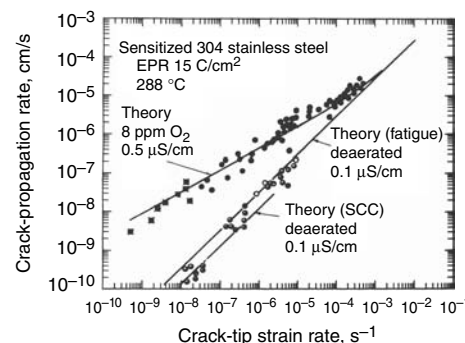
**Fig. 29** Observed and theoretical crack-propagation rate versus crack-tip strain-rate relationships for stainless steel in aerated and deaerated water. Source: Ref 38, 59

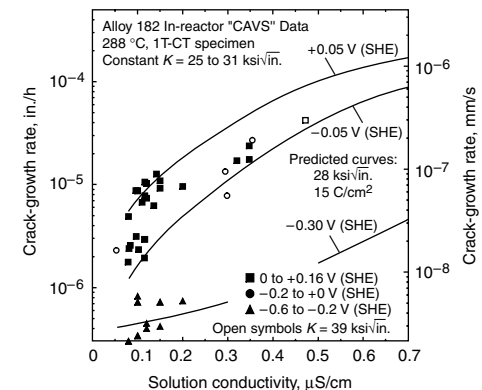
**Fig. 30** Comparison between the predicted and observed crack-growth rates versus coolant conductivity for alloy 182 compact tension (CT) specimens exposed to BWR water of varying chemistries

the crack-propagation rate versus water conductivity relationships observed in operating plant at various corrosion potentials for alloy 182 are in reasonable agreement with the theoretical predictions (Fig. 30). In addition, the variation in cracking of alloy 600 access hole covers and shroud head bolts as a function of the average plant conductivity are also reasonably predicted. The data and predictions for these cases are shown in Fig. 31(a) and (b). In Fig. 31(a), the importance of the detrimental effect of excessive

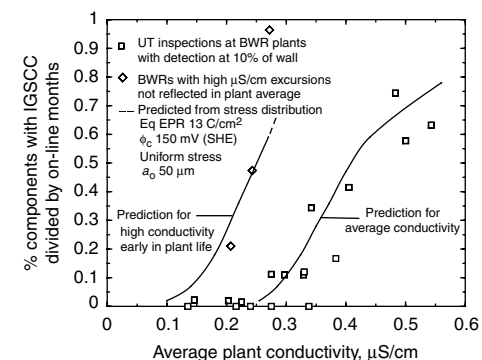
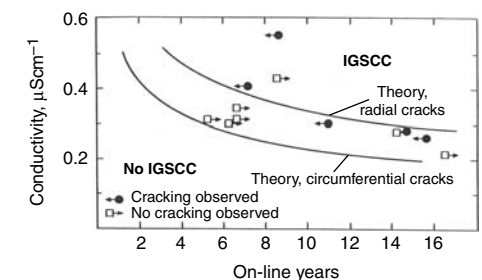
**Fig. 31** (a) The predicted and observed effects of average plant water purity on crack incidence in creviced alloy 600 shroud head bolts. (b) Predicted and observed IGSCC on 15 mm (0.600 in.) welded access hole covers

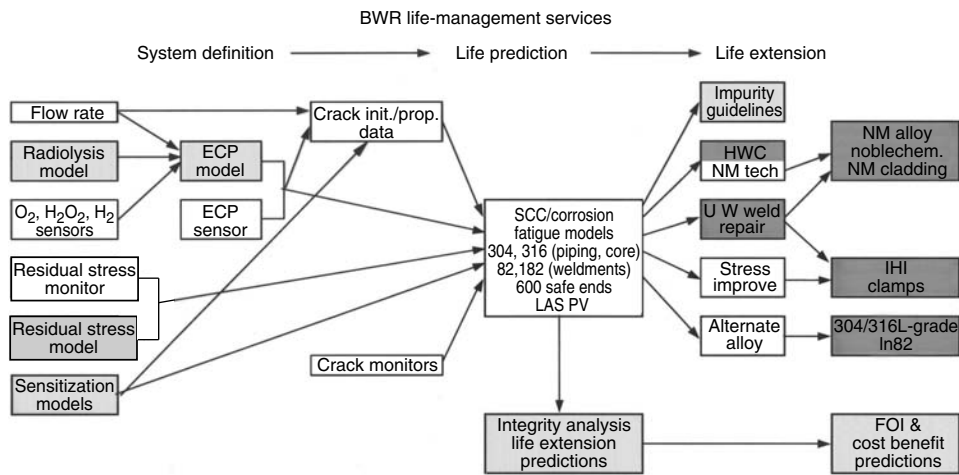
Fig. 32 Proactive management scheme for addressing environmentally assisted cracking (EAC) problems and assessing the cost-effective mitigation action

In conclusion, there is now the methodology to predict the extent of EAC damage for many of the BWR structures, provided the relevant materials, environment, or stressing variables are known, or can be calculated, with sufficient accuracy. This capability offers the opportunity to *proactively* manage the material degradation problems (Fig. 32) by defining cost-effective mitigation actions that may be implemented before costly (Table 2) repairs are necessary.

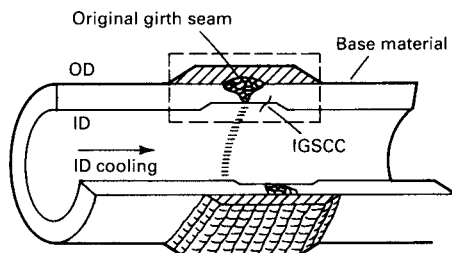
**Fig. 33** Weld overlay intergranular stress-corrosion cracking (IGSCC) mitigation technique. ID, inside diameter; OD, outside diameter

**Weld overlay repair** is similar to corrosion-resistant cladding in that it uses layers of IGSCC resistant duplex weld metal (Ref 104). For cases where alloy 182 is to be overlaid, alloy 82 or 52 weld metal is used. The most significant difference is that the layer of weld metal is placed on the outside surface of the pipe while the pipe is being cooled internally with water and is used to prevent an existing crack from penetrating through the wall. The weld overlay is also applied as a structural reinforcement to restore the original piping safety margins (Fig. 33). An equally important effect of the weld overlay is that it produces a favorable (compressive) residual stress pattern that can retard or arrest crack growth.

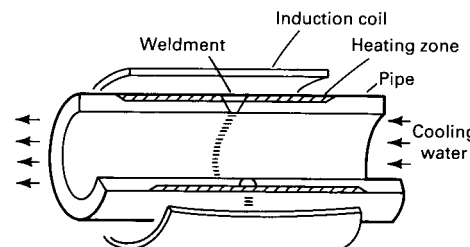
**Fig. 34** Heating and cooling process for induction heating stress improvement

heating of the outer pipe surface of completed girth welds to approximately 400 °C (750 °F) while simultaneously cooling the inside surface, preferably with flowing water (Fig. 34). Thermal expansion caused by the induction heating plastically yields the outside surface in compression, while the cool inside surface plastically yields in tension. After cool down, contraction of the pipe outside surface causes the stress state to reverse, leaving the inner surface in compression and the outside surface in tension (Fig. 35).

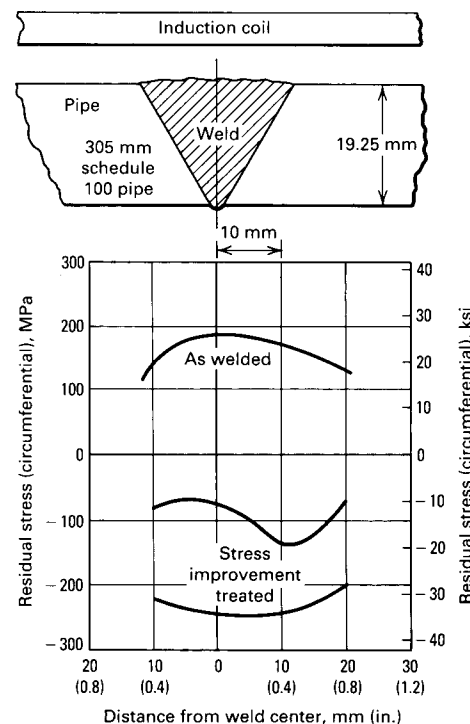
**Fig. 35** Residual stress comparison for induction heating stress improvement

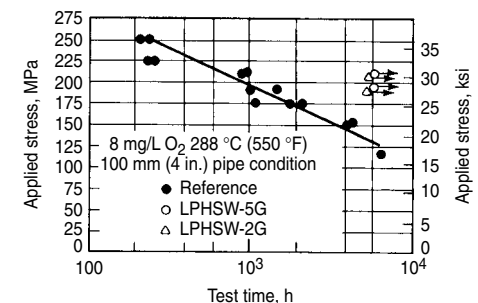
**Fig. 36** Comparison of last-pass heat sink welding pipe tests with reference pipe tests

Finally, intergranular SCC improvement was evaluated by using pipe tests performed at applied stresses above yield in a high-oxygen (8 ppm) high-temperature (288 °C, or 550 °F) water environment. As shown in Fig. 36, at the end of the program period, the pipes had been on test for more than 5500 h, demonstrating a factor of more than 5.5 and more than 6.5 improvement, respectively, at the two test stresses of 193.7 and 211 MPa (28.1 and 30.6 ksi), respectively. This factor of improvement approaches that determined for induction heating stress improvement.
