# ASM Handbook®

## Volume 13C Corrosion: Environments and Industries

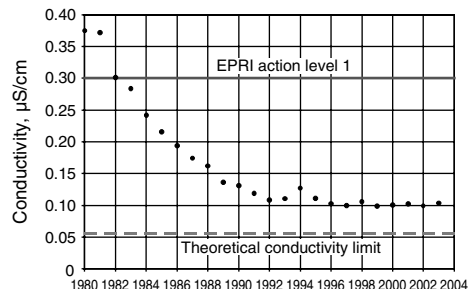
Fig. 37 BWR mean reactor water conductivity history

**Water Purity Control.** As indicated previously in Fig. 20 to 22, 30, and 31, the BWR coolant conductivity or purity has a profound impact on the degree of EAC susceptibility for all the major materials of construction in the BWR system. As a result, water chemistry guidelines recommend maximum limits to the BWR feedwater and recirculation water coolant conductivity and cationic and anionic activities. Action levels (e.g., ultimately reactor shutdown) are prescribed should these limits be exceeded by specific amounts for given time periods. As a result, the purity levels that are maintained in the BWR coolant have markedly improved, with the mean conductivity level of approximately 0.37  $\mu\text{S}/\text{cm}$  observed in 1980 decreasing to approximately 0.10  $\mu\text{S}/\text{cm}$  in 2003 (Fig. 37).

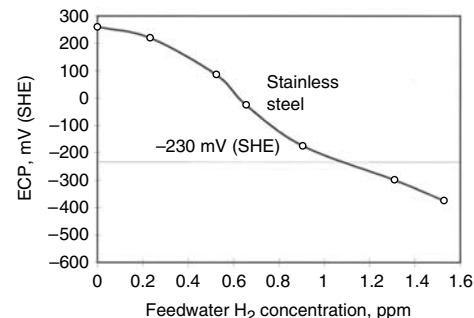
Fig. 38 Variation of electrochemical corrosion potential (ECP) of stainless steel as function of feedwater hydrogen concentration

As shown in Fig. 38, the amount of hydrogen required to achieve this “protection potential” is nominally of the order of 1.0 to 1.5 ppm injected into the feedwater line. However, the kinetics of the  $\text{H}_2/\text{O}_2$  recombination on the reactor structural surface is catalyzed by gamma radiation primarily in the downcomer region between the RPV wall and the core shroud. Consequently, the actual amount of hydrogen required for protection is plant-geometry specific and, in some cases, considerably more hydrogen is required, especially for protection of core internal structures such as the core shroud and top guides. The consequence of injecting an excessive amount of hydrogen is that volatile nitrogen species (e.g.,  $\text{N}_2$ ,  $\text{NH}_3$ ,  $\text{NO}$ ,  $\text{NO}_2$ ) are formed due to homogeneous reduction reactions, and the radiation levels in the main steam line and turbine may increase by a factor of 4 to 5 due to the formation of  $^{16}\text{N}$  via a neutron-proton (np) reaction on  $^{16}\text{O}$ . As a consequence, hydrogen water chemistry is not effective in protecting reactor core internals without an unacceptable increase in radiation levels outside the reactor containment.

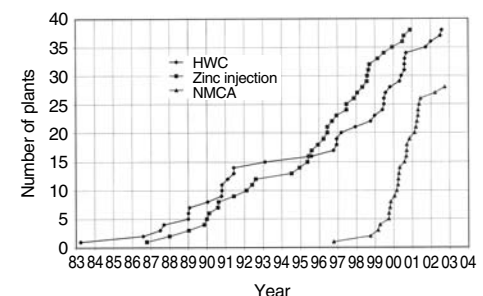
Fig. 39 Chronology of implementation of hydrogen water chemistry (HWC), and zinc injection, and noble metal chemical application (NMCA)

in the form of  $\text{Na}_2\text{Pt}(\text{OH})_6$  and  $\text{Na}_3\text{Rh}(\text{NO}_2)_6$ . This latter process, known as noble metal chemical application (NMCA), has found wide application (Fig. 39) in that it effectively lowers the corrosion potential to below  $-230$  mV (SHE) in core structures with less than 0.3 to 0.4 ppm  $\text{H}_2$  addition to the feedwater line, that is, injection levels that do not lead to increases in the main steam line radiation level.

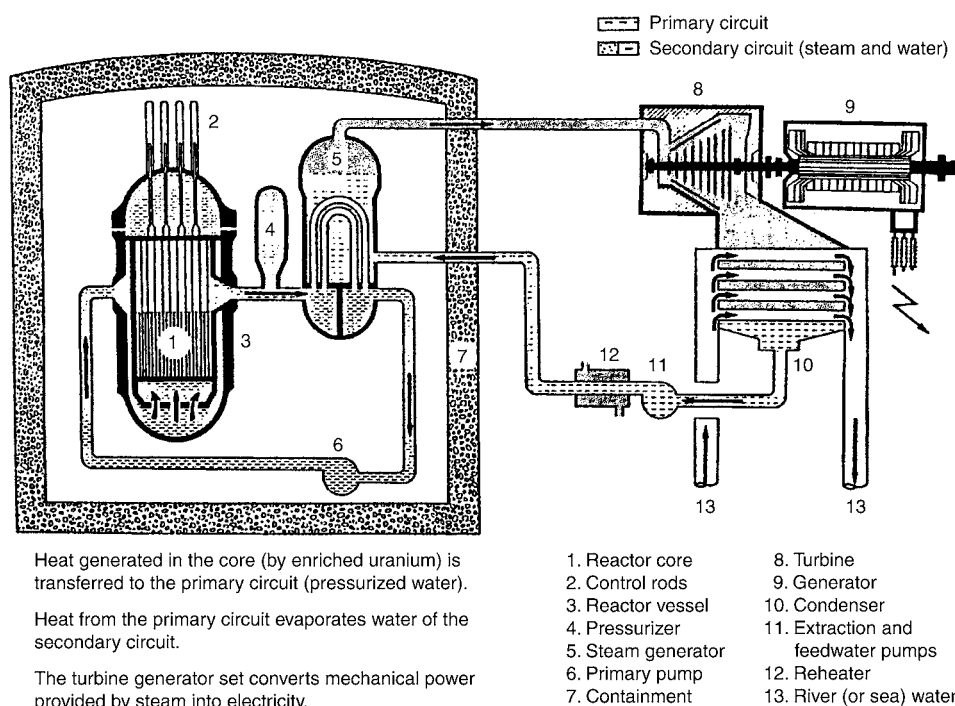
Fig. 1 Basic flow diagram of a pressurized water reactor (PWR) nuclear power station

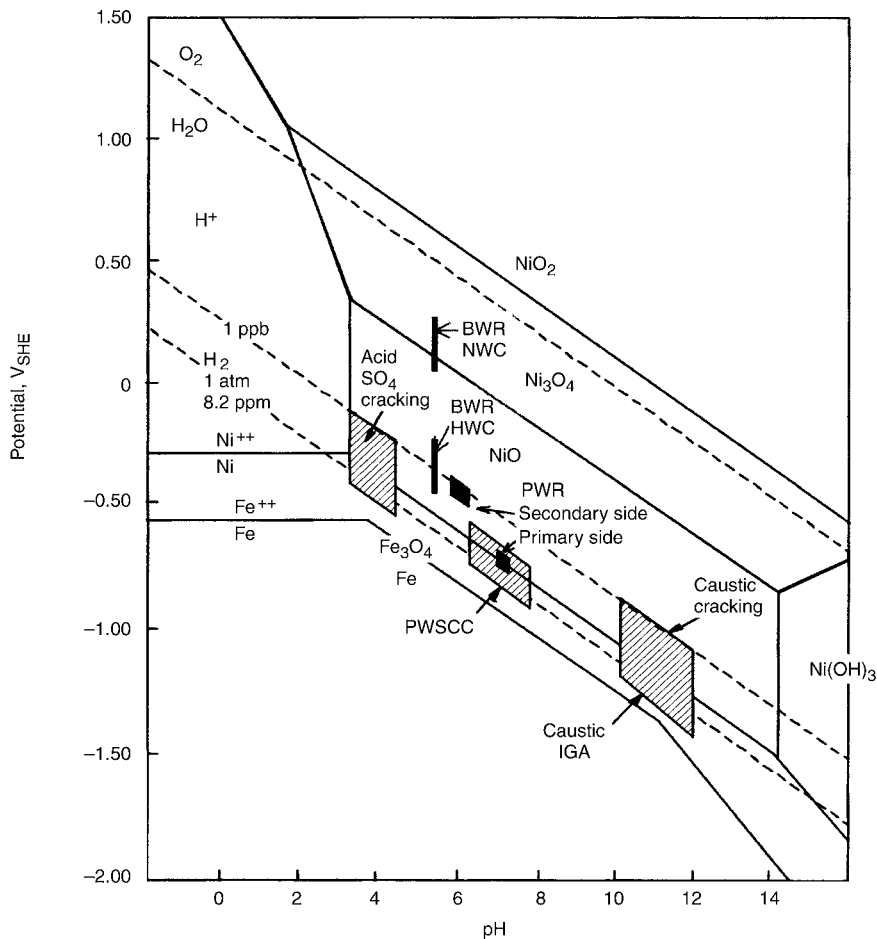
**Fig. 2** Pourbaix diagram for nickel and iron at 300 °C (570 °F) showing the principal pH-potential combinations for PWR primary and secondary water, boiling water reactor (BWR), normal water chemistry (NWC), and BWR hydrogen water chemistry (HWC), and the modes of stress-corrosion cracking (SCC) of Alloy 600. IGA, intergranular attack. Source: Ref 1

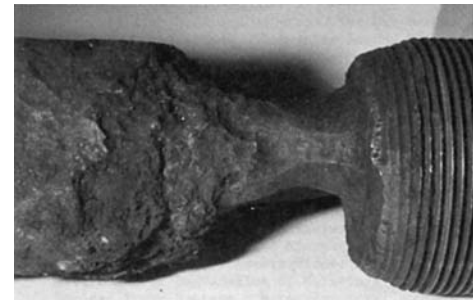
Fig. 3 Reactor coolant pump closure stud degraded by exposure to borated water. Source: Ref 20

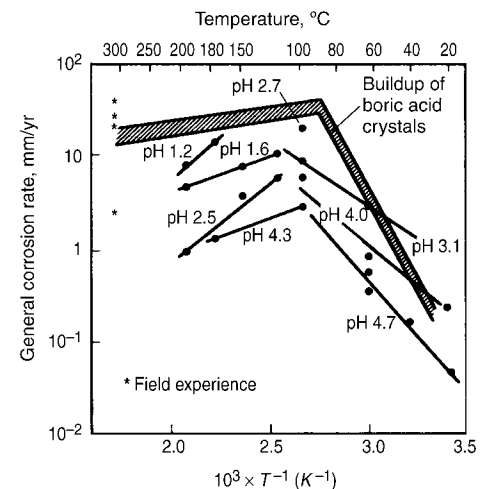
Fig. 4 Variations of iso-pH general corrosion rates of low-alloy steels. Source: Ref 23

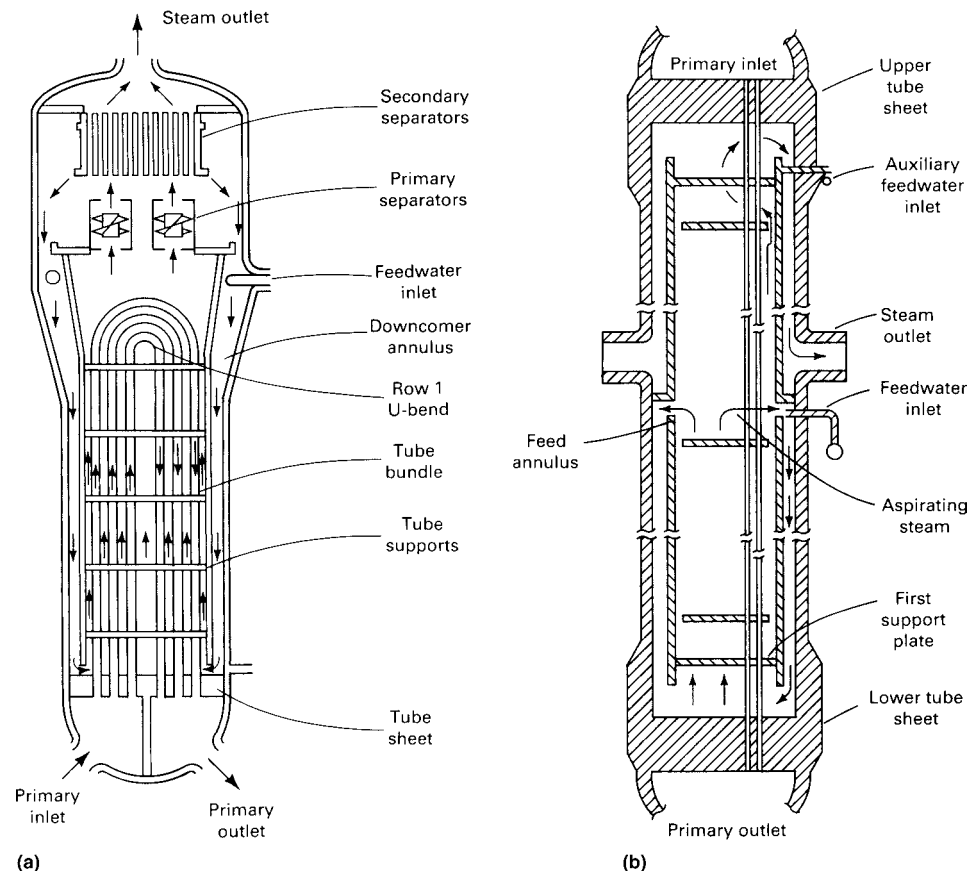
**Fig. 5** Sketches of (a) recirculating and (b) once-through type PWR steam generators.

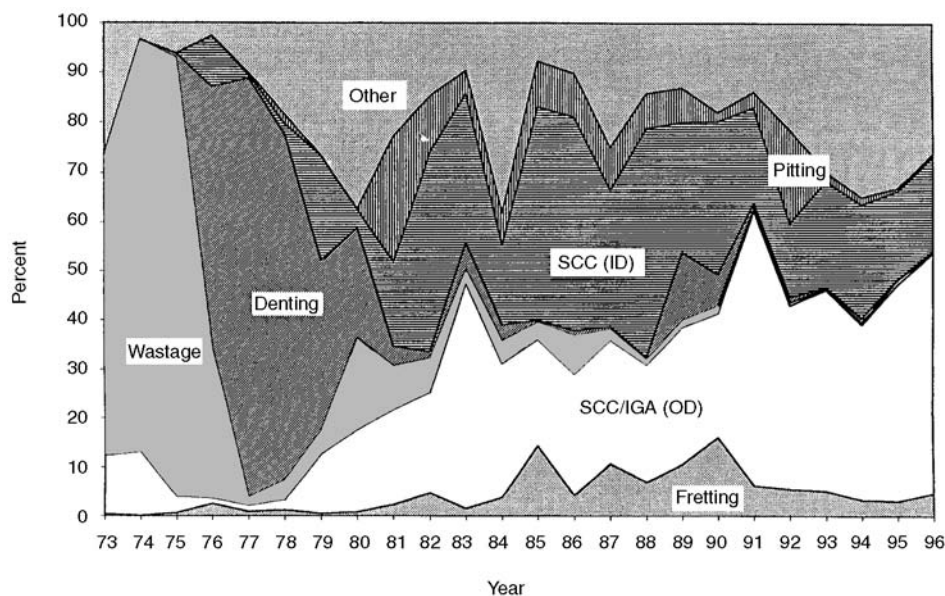
Fig. 6 Worldwide causes of steam generator tube plugging. SCC (ID), primary side SCC; SCC/IGA, outside surface SCC/IGA. Source: Ref 28

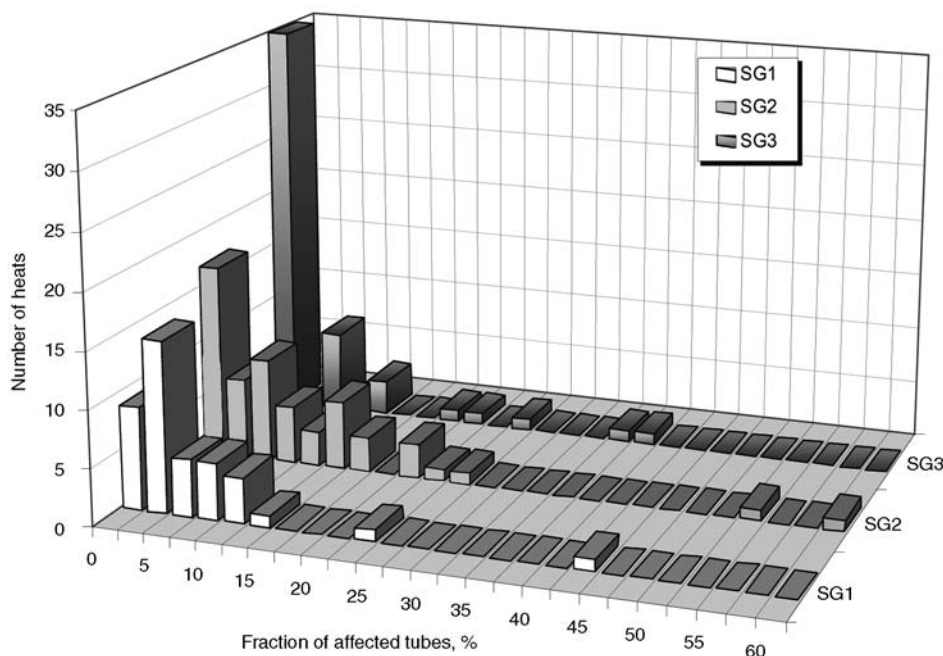
**Fig. 7** Distribution of heats of Alloy 600 by susceptibility to intergranular stress-corrosion cracking (IGSCC) on the primary side of steam generator tube roll transitions in three steam generators (SG1, SG2, SG3) of the same plant. Source: Ref 1

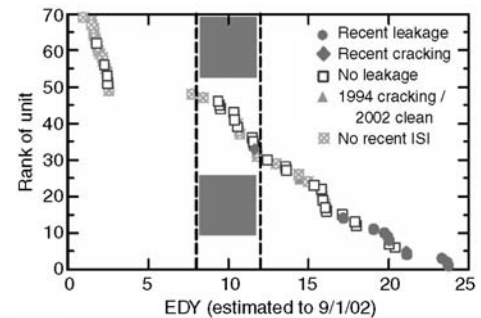
**Fig. 8** Equivalent damage years (EDY) for the upper head control rod drive mechanism (CRDM) nozzles of U.S. PWRs in Sept 2002. ISI, in-service inspection. Source: Ref 38

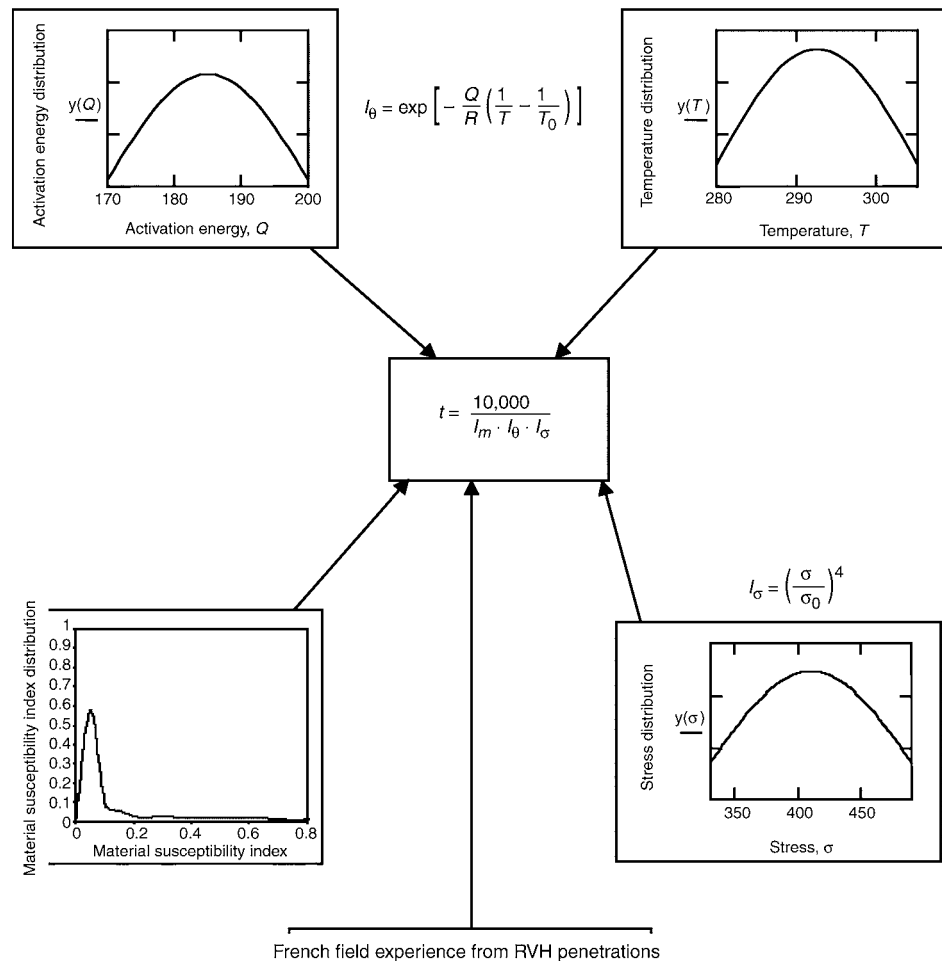
Fig. 9 Illustration of Monte Carlo simulation of upper head penetration cracking. RVH, reactor vessel head. See text for an explanation of other symbols. Source: Ref 42

of upper head penetration cracking encountered in French PWRs, the inherent dispersion in the input parameters of stress, temperature, activation energy, and material susceptibility index was taken into account. It was clearly not physically realistic to treat heat-to-heat variability as a quantized phenomenon as implied by Table 7, and a log-normal distribution of material susceptibility indices was chosen in accordance with the populations of heats assessed in each class A, B, C, and so forth. The Monte Carlo simulation technique of randomly sampling distributions of the input parameters in Eq 1 to determine a distribution of failure times was adopted, as illustrated in Fig. 9 (Ref 42).

An example of the results using the Monte Carlo approach outlined in Fig. 9 is shown in Fig. 10 in the form of a Weibull distribution comparing the results of these simulations with the inspection results for upper head penetrations in each susceptibility class of Alloy 600 (Ref 42). When the Monte Carlo simulations are repeated many times, the dispersion in the resulting Weibull distribution of failure times is relatively small because the number of penetrations considered for each PWR plant series is over 1000.

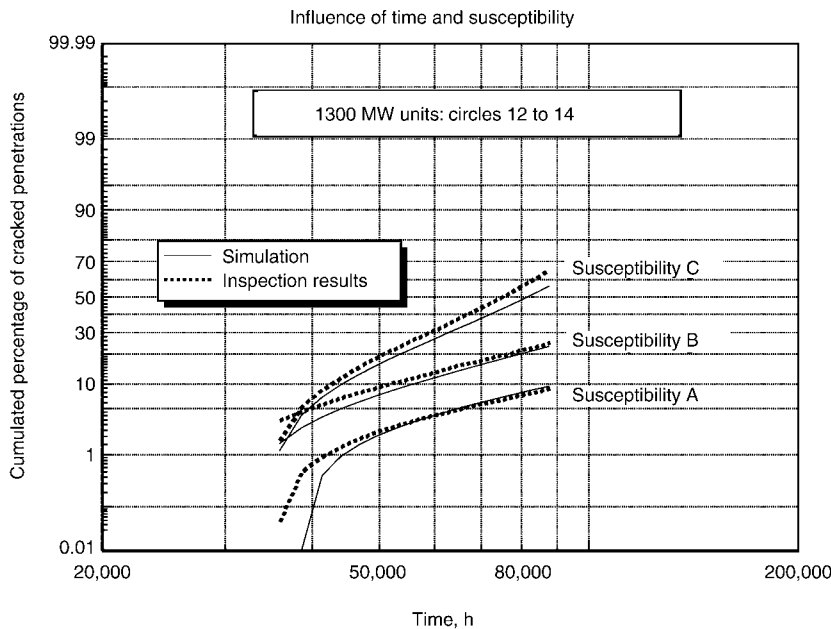
Fig. 10 Results of Monte Carlo simulations of intergranular stress-corrosion cracking (IGSCC) in upper head penetrations of 1300 MW French PWRs and comparison with inspection results for each class of Alloy 600. Source: Ref 42

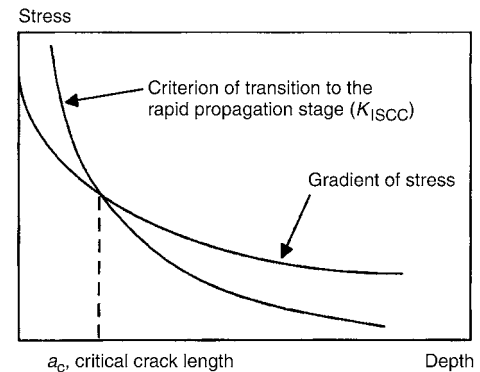
Fig. 11 Illustration of the conditions necessary for transition from slow to rapid intergranular stress-corrosion cracking (IGSCC) propagation. Source: Ref 43

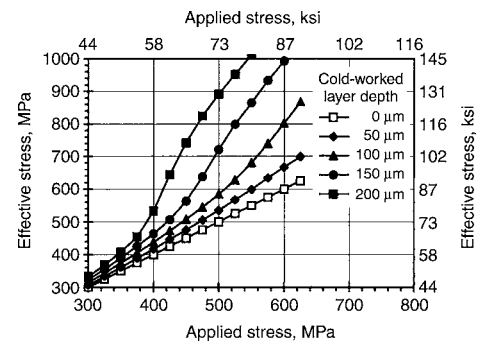
Fig. 12 Equivalent stress for intergranular stress-corrosion cracking (IGSCC) on an electro-polished surface as a function of applied stress and thickness of a cold-worked layer on a cold-worked surface. Source: Ref 43

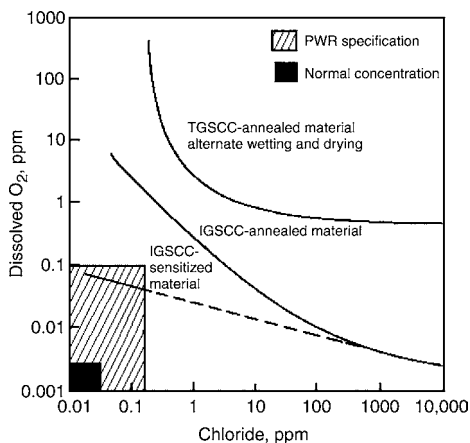
**Fig. 13** Stress-corrosion cracking of austenitic stainless steels as a function of chloride and oxygen concentrations in high-temperature water. IGSCC, intergranular stress-corrosion cracking; TGSCC, transgranular stress-corrosion cracking. Source: Ref 56

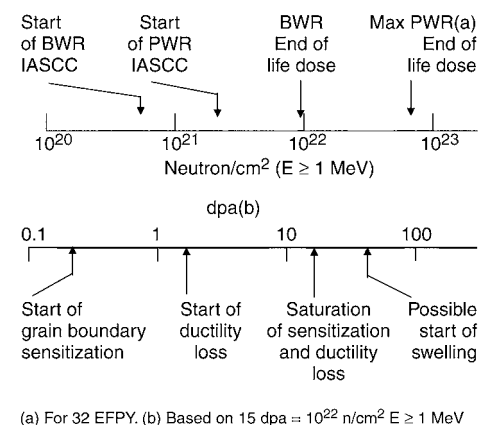
**Fig. 14** Summary of irradiation-assisted stress-corrosion cracking (IASCC) in light water reactors and associated metallurgical changes in austenitic stainless steels as a function of neutron irradiation in n/cm<sup>2</sup> ( $E \geq 1$  MeV) or displacements per atom (dpa). EFPPY, effective full power year. Source: Ref 70–72

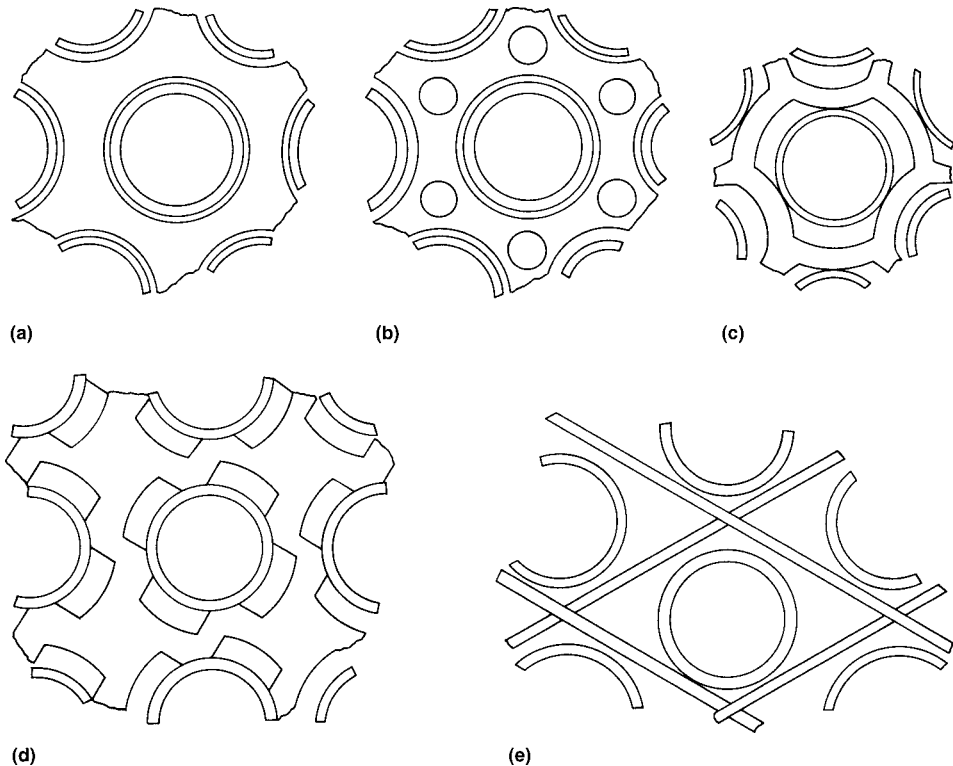
Fig. 15 Steam generator tube support designs. (a) Drilled without flow holes. (b) Drilled with flow holes. (c) Broached trefoil. (d) Broached quatrefoil (concave contact lands). (e) Egg crate (lattice bars)

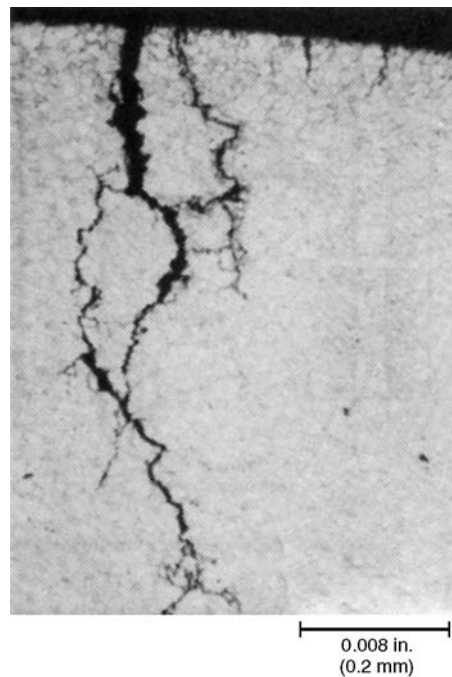
**Fig. 16** Secondary side intergranular stress-corrosion cracking (IGSCC) in Alloy 600. Source: Ref 15

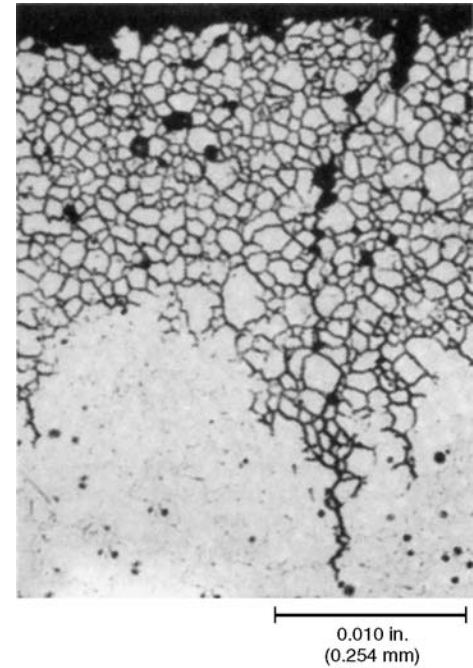
**Fig. 17** Intergranular attack of an Alloy 600 steam generator tube (etched sample). Source: Ref 15

distinguishes it from IGSCC. Nevertheless, the two are closely related, as is apparent in Fig. 17, where stress-assisted fingers of IGA penetrate deeper than the layer of uniform IGA. The microscopic morphology of secondary side cracking observed in service is often that of IGA near the OD surface developing into finger-shaped IGA penetrations and finally into IGSCC toward the primary side. There is a strong presumption that as IGA gradually deepens, its morphology changes to that of IGSCC, although there is no proof that the two forms of attack occur in that order. Figure 18 shows a particularly severe case of IGA/IGSCC from a steam generator that has since been retired and replaced (Ref 80). The detailed morphology of the IGA may vary somewhat from case to case with islands of more resistant grain boundaries sometimes giving a cellular appearance to the IGA.

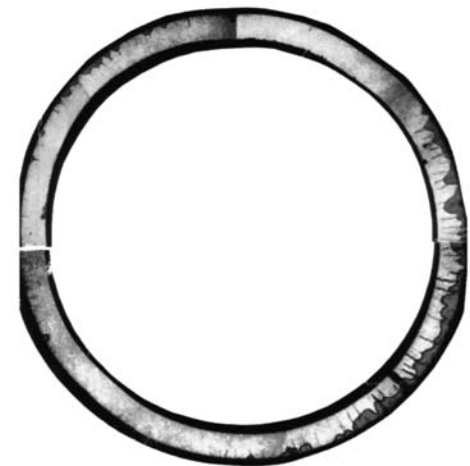
**Fig. 18** An example of severe intergranular attack/intergranular stress-corrosion cracking (IGA/IGSCC) at a tube support location. Source: Ref 80

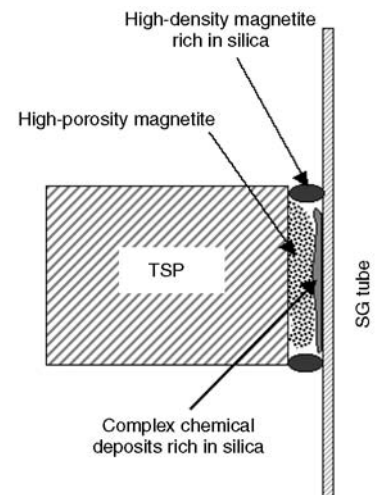
Fig. 19 Sketch of fouled steam generator (SG) tube/tube support plate (TSP) crevices after many years of operation. Source: Ref 84

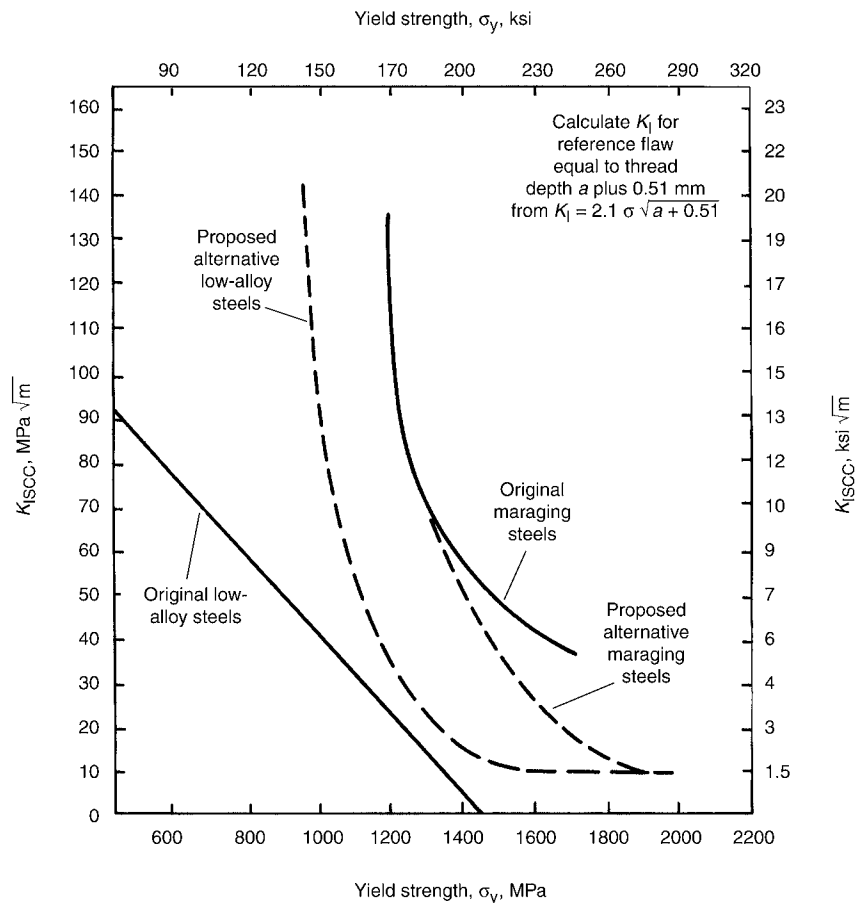
Fig. 20  $K_{I,SCC}$  limits for support bolting as a function of yield stress. Source: Ref 103

based on this information were published in the United States (Ref 103). Acceptability of high-strength bolting was based on a lower-bound approach to  $K_{ISCC}$  as a function of yield strength as shown in Fig. 20. This fracture mechanics-based approach has some attractions for defining a quality assurance procedure and for defect assessment. However, hydrogen cracks can start from free surfaces, usually in crevices; consequently, it is advisable also to have an upper-bound strength limit (normally defined by a hardness level acceptance criterion such as <350 HV) to guard against this eventuality.

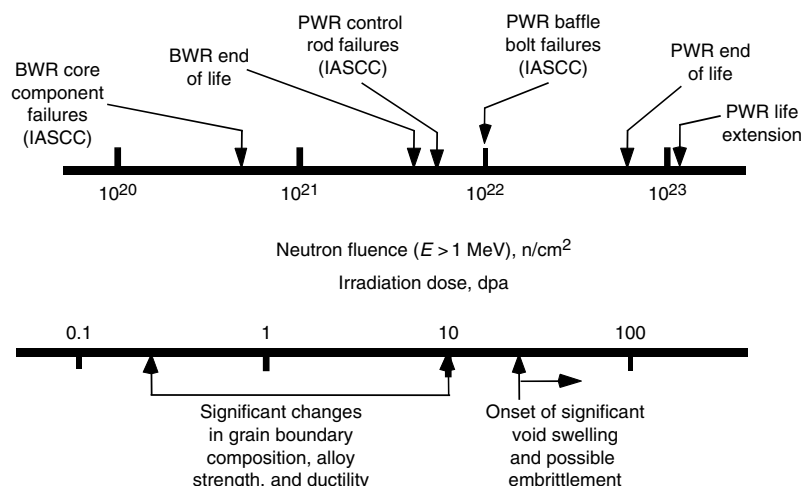
**Fig. 1** Neutron fluence effects on irradiation-assisted stress-corrosion cracking susceptibility of type 304 stainless steel in boiling water reactor (BWR) environments. PWR, pressurized water reactor; IASCC, irradiation-assisted stress-corrosion cracking; dpa, displacements per atom. Source: Ref 4

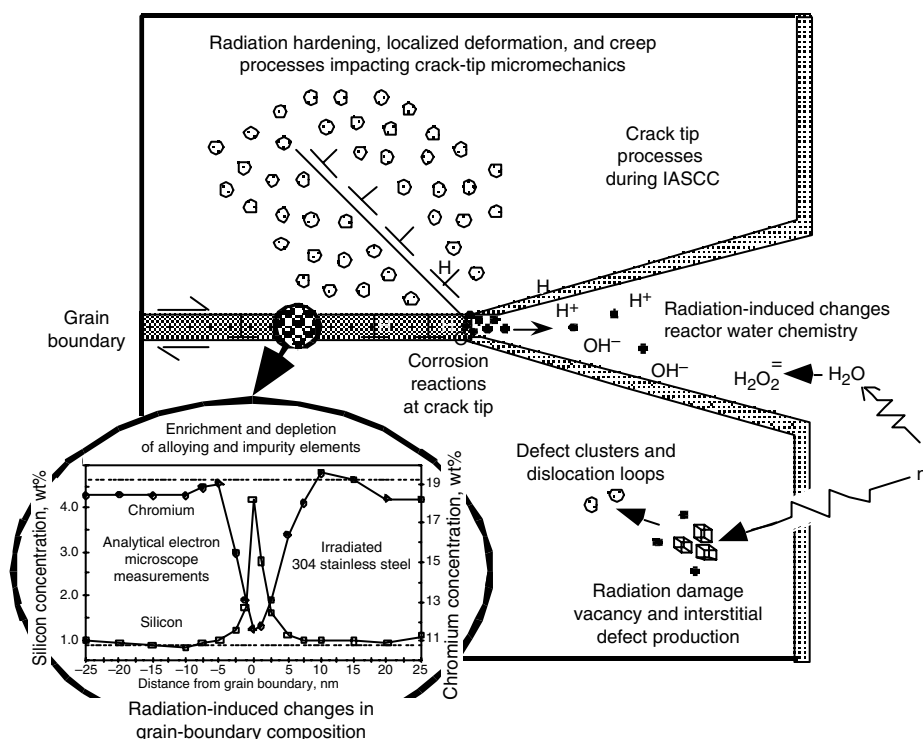
Fig. 2 Mechanistic issues believed to influence crack advance during irradiation-assisted stress-corrosion cracking (IASCC) of austenitic stainless steels.

irradiated and properly characterized materials are sorely lacking due to the inherent experimental difficulties and financial limitations. Many of the important metallurgical, mechanical, and environmental aspects that are believed to play a role in the cracking process are illustrated in Fig. 2. Only persistent material changes are required for IASCC to occur, but in-core processes such as radiation creep and radiolysis also have an important effect on IASCC. The following section examines the current understanding of persistent material changes that are produced in stainless alloys during light water reactor (LWR) irradiation based on the fundamentals of radiation damage and existing experimental measurements.

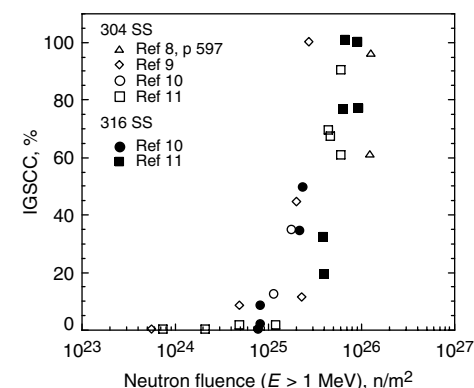
Fig. 3 Dependence of cracking in neutron-irradiated high-purity type 304 stainless steel (SS) on accumulated high-energy neutron fluence. IGSCC, intergranular stress-corrosion cracking

(although not invariant) “threshold” fluence at which IASCC is observed under LWR conditions (Ref 8, p 583). Because this “threshold” occurs at a fraction to several dpa (depending on the alloy, stress, water chemistry, etc.) as shown in Fig. 3, in situ effects (corrosion potential, conductivity, and temperature) may be important, but only “persistent” radiation effects (microstructural and microchemical changes) can be responsible for the “thresholdlike” behavior versus fluence in postirradiation tests.

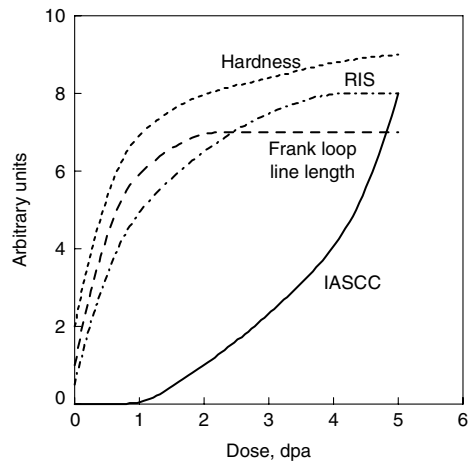
Fig. 4 Composite diagram showing the increase in all parameters (RIS, dislocation loops, hardness) with dose. The IASCC response is shifted by test technique and water chemistry conditions. RIS, radiation-induced segregation; dpa, displacements per atom

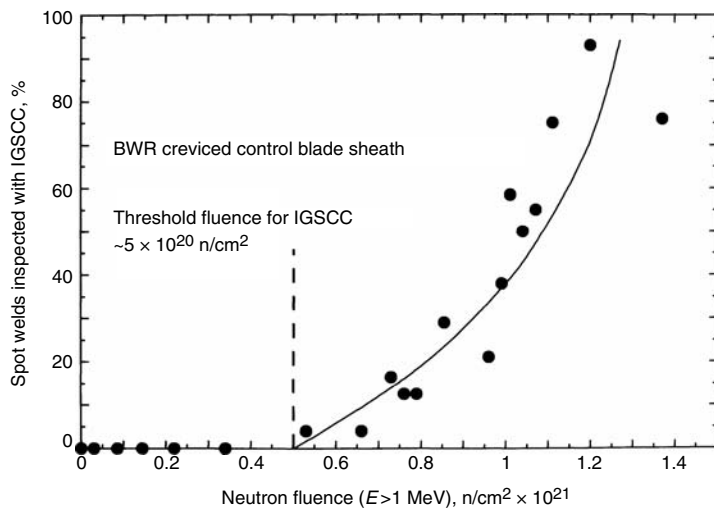
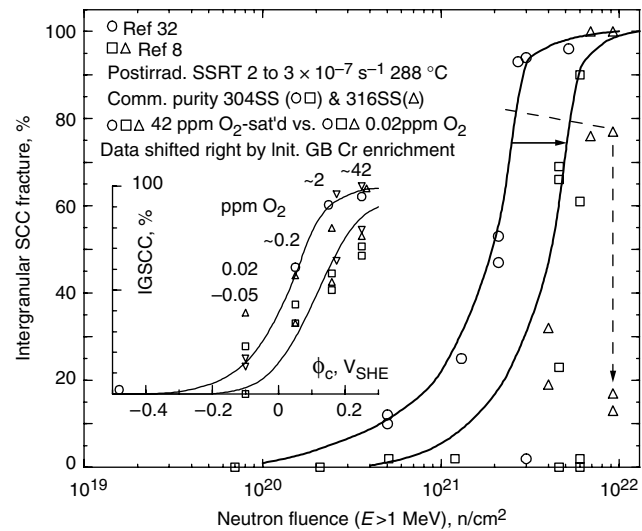
Fig. 5 Dependence of irradiation-assisted stress-corrosion cracking on fast neutron fluence for (a) creviced control blade sheath in high conductivity boiling water reactors (BWRs) (Ref 30) and (b) as measured in slow strain rate tests at 3.7 × 10<sup>7</sup> s<sup>-1</sup> on preirradiated type 304 stainless steel (SS) in 288 °C (550 °F) water (Ref 33). The effect of corrosion potential via changes in dissolved oxygen is shown at a fluence of ~2 × 10<sup>21</sup> n/cm<sup>2</sup>. IGSCC, intergranular stress-corrosion cracking; GB, grain boundary

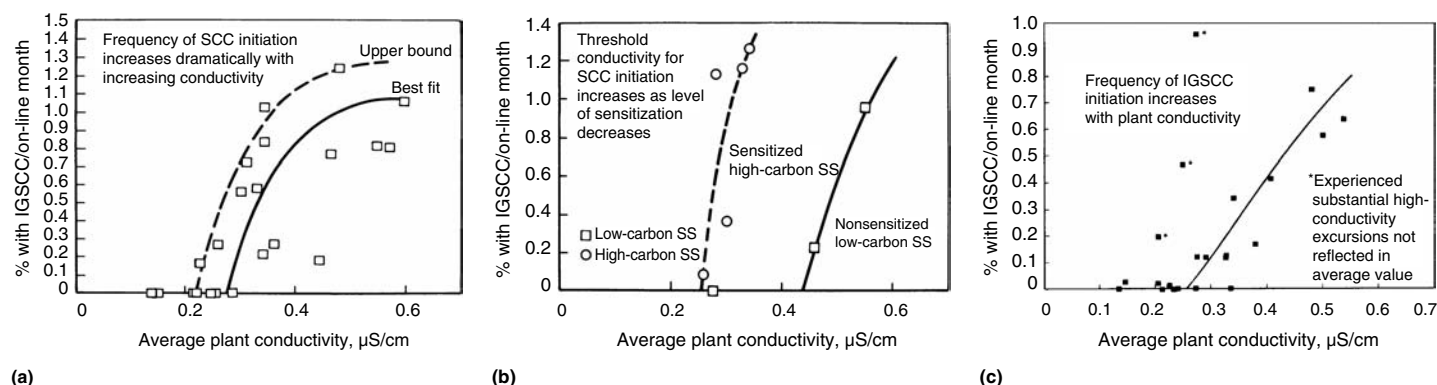
**Fig. 6** The effects of average plant water purity (measured by coolant conductivity) are shown in field correlations of the core component cracking behavior for (a) stainless steel (SS) intermediate range monitor/source range monitor (IRM/SRM) instrumentation dry tubes, (b) creviced stainless steel safe ends, and (c) creviced Inconel 600 shroud head bolts, which also shows the predicted response versus conductivity. SCC, stress-corrosion cracking; IGSCC, intergranular stress-corrosion cracking

prediction of the shroud head bolt cracking also provides reasonable agreement with observation (Fig. 6c).

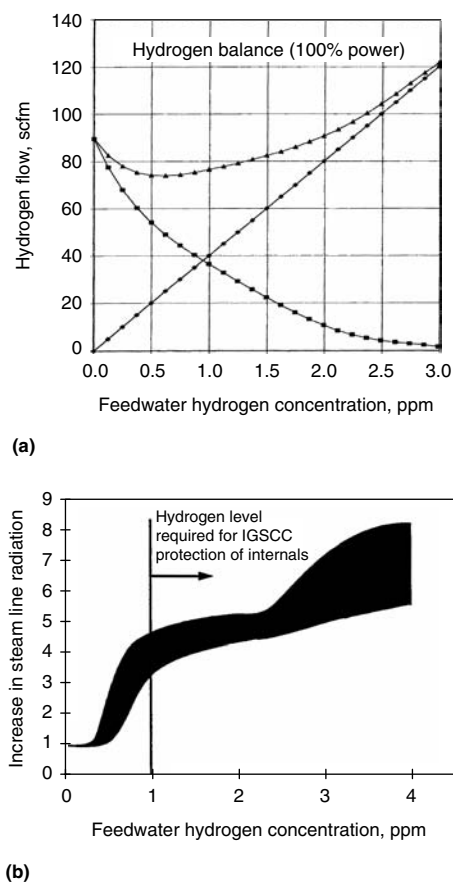
**Fig. 7** (a) The relationship between the  $H_2$  concentration in the feedwater and the  $H_2$  injection flow (straight line, round data points). The descending curve (square data points) is  $H_2$  generated by radiolysis, which decreases as  $H_2$  is injected due to suppression of radiolysis. The curve that decreases and then increases (upper curve, triangle data points) is  $H_2$  in steam. (b) The effect of  $H_2$  injection on the radiation level in the steam lines and turbine from  $^{16}N$  (transmuted from  $^{16}O$ ), which results in changes from soluble  $NO_3^-$  to volatile  $NO_x$  and  $NH_3$ . IGSCC, intergranular stress-corrosion cracking

In-core, in situ measurements in BWRs show that the corrosion potential, which is approximately +0.2 to +0.25 V<sub>SHE</sub> in normal water chemistry, can be decreased by >0.5 V by sufficient additions of dissolved hydrogen in a BWR (Ref 60). This is corroborated by other measurements (Ref 56 and Fig. 8b), which show very little radiation-induced elevation in corrosion potential when the fully deaerated inlet water contains moderate dissolved hydrogen (>200 ppb H<sub>2</sub>, 0 ppb O<sub>2</sub>). However, at high H<sub>2</sub> levels, the core becomes reducing, and the small concentration of <sup>16</sup>N (transmuted from <sup>16</sup>O) changes from soluble NO<sub>3</sub><sup>-</sup> to volatile NO<sub>x</sub> and NH<sub>3</sub>, causing a large increase in radiation level in the steam lines and turbine (Fig. 7b).

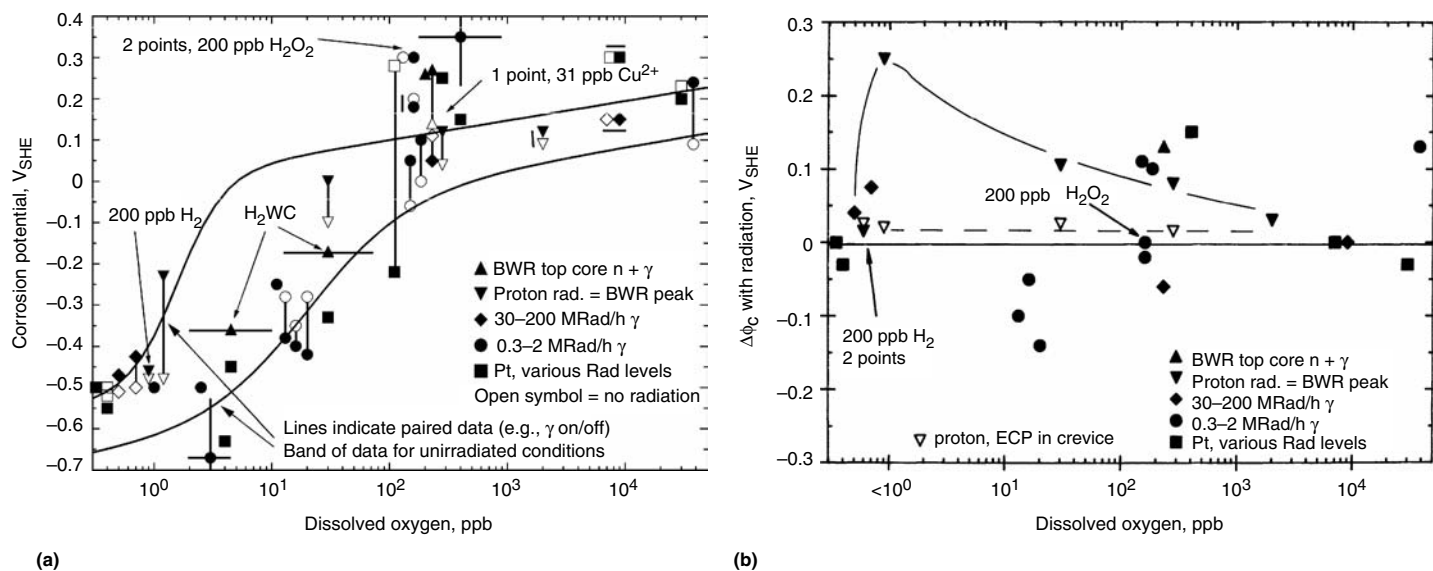
**Fig. 8** (a) Effect of radiation on the corrosion potential of type 304 stainless steel in 288 °C (550 °F) water. The curves denote the range of typical values in the unirradiated corrosion potential data (Ref 1). (b) Effect of radiation on the shift in corrosion potential from the value under unirradiated conditions for type 304 stainless steel in 288 °C (550 °F) water. With the exception of the boiling water reactor (BWR) measurements, all data were obtained in controlled radiation on/off experiments (Ref 1). Curves in (b) show the trends in the proton-irradiated data, where the effects of radiation (on/off and over a range of fluxes) were evaluated for a variety of dissolved O<sub>2</sub> and H<sub>2</sub> concentrations under otherwise identical conditions.

The relationship between dissolved oxygen and corrosion potential in hot water as a function of radiation type and flux is shown in Fig. 8(a), in which the connected points represent data obtained in controlled, radiation on/off experiments. The data from these latter experiments are shown in Fig. 8(b) in terms of a radiation-induced shift in potential. The curves in Fig. 8(a) represent the scatter band for the data obtained under unirradiated conditions. Similar scatter also exists in the irradiated corrosion potential data in Fig. 8(a) and comprises contributions from both real effects and experimental error. These radiation measurements are quite complex and should involve careful qualification of the radiation resistance and thermodynamic response of reference electrodes. High radiation flux experiments were performed by Taylor (Ref 56) and Miller and Andresen (Ref 57, 58)

Figures 8(a) and (b) show that little, if any, elevation in corrosion potential results from irradiation sources that do not include neutrons or simulate their contribution (e.g., using high-energy protons as described in Ref 57). Some studies using gamma radiation (Ref 1, 12, 57) showed a significant decrease in corrosion potential, especially in the intermediate (e.g., 10 to 200 ppb) range of dissolved oxygen. This is consistent with enhanced recombination of oxidizing and reducing species, which occurs in the downcomer region of BWRs (Ref 56) and is relied upon to produce SCC mitigation using hydrogen water chemistry (HWC). In instances where neutrons or protons have been used, a consistent, significant elevation in corrosion potential is observed. This is more pronounced in hot water containing low dissolved oxygen concentrations and no dissolved hydrogen (Fig. 8b), where increases of over +0.25 V occur. At higher inlet oxygen concentrations (e.g., approximately 200 ppb), the data still show a significant shift (typically +0.1 to 0.15 V) in corrosion potential for radiation conditions representative of peak LWR core fluxes (Fig. 8b); less increase is observed for inlet oxygen concentrations associated, for example, with air saturation (approximately 8.8 ppm O<sub>2</sub>) or oxygen saturation (approximately 42 ppm O<sub>2</sub> at standard temperature and pressure, STP). A similar elevation in corrosion potential is observed for additions of hydrogen peroxide (200 ppb H<sub>2</sub>O<sub>2</sub>, Fig. 8a), which suggests that H<sub>2</sub>O<sub>2</sub> may be a major factor

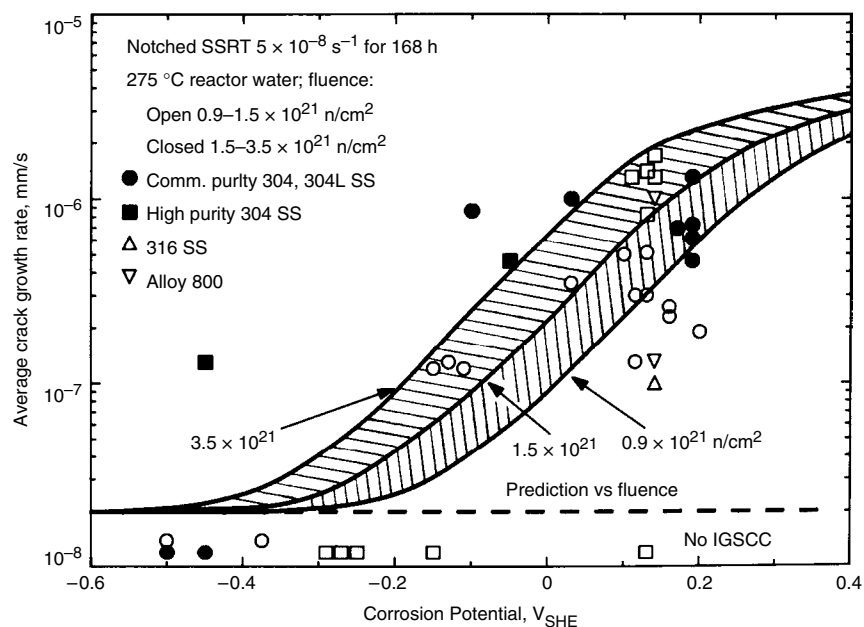
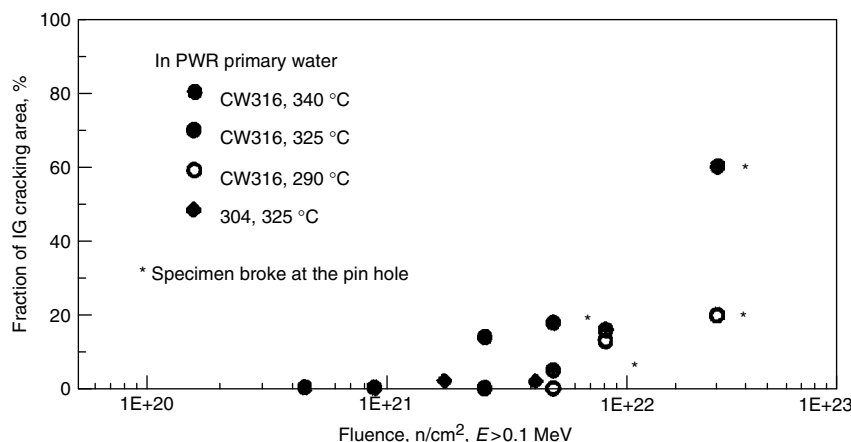
**Fig. 9** (a) Comparison of predicted and observed crack growth rates for stainless steels irradiated in a BWR at 288 °C (550 °F) to various fluences. Notched tensile specimens were tested by Ljungberg (Ref 66) at a slow strain rate in 288 °C (550 °F) pure water (Ref 1) and interrupted after a given strain/time. (b) Percentage IGSC versus fluence for cold-worked type 316 stainless steel (SS) tested at various temperatures. Despite the low potential environment of PWR primary water, at high fluence (especially at higher temperature) there is significant susceptibility to SCC. SSRT, slow strain rate test, IGSC, intergranular stress-corrosion cracking

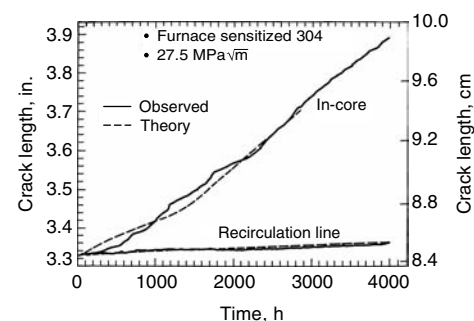
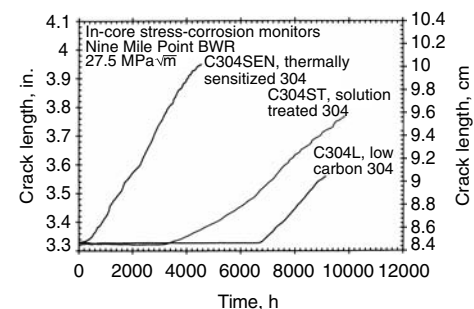
**Fig. 10** Data for fracture mechanics specimens of type 304 stainless steel exposed in the high flux region of the core and in the recirculation line of Nine Mile Point Unit 1 Boiling Water Reactor (BWR). All specimens were precracked and wedge loaded to an initial stress-intensity factor of  $\sim 27.5 \text{ MPa}\sqrt{\text{m}}$  ( $\sim 25 \text{ ksi}\sqrt{\text{in.}}$ ). (a) Comparison of predicted and observed crack length versus time for furnace-sensitized type 304 stainless steel specimens in the core and recirculation line. (b) Crack length versus time for a furnace-sensitized and two annealed specimens of type 304 stainless steel in the core. Source: Ref 1, 6, 12, 13, 59

that the higher corrosion potentials measured in-core versus in the recirculation piping induced significantly higher measured crack growth rates (Fig. 10). Ex situ crack growth rate testing on irradiated (4 dpa) type 304 stainless steel (Fig. 11a), shows one of many examples of well-behaved crack growth rate at high corrosion potential, along with the strong effect of reduced corrosion potential. One evolving concern for high fluence stainless steels is the prospect of a major reduction in the effect of corrosion potential and stress-intensity factor, and Fig. 11(b) shows that this is indeed observed in unirradiated alloys possessing high silicon. The detrimental effect of silicon is likely associated with its ability to oxidize at all LWR-relevant potentials

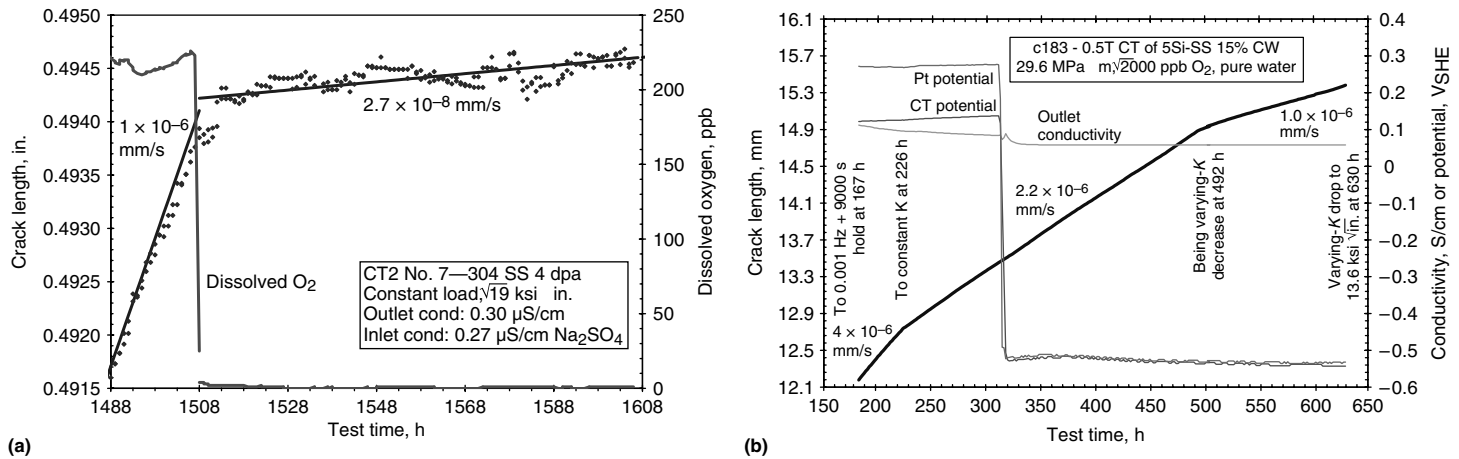
**Fig. 11** (a) Crack length versus time for type 304 stainless steel irradiated to 4 dpa in a boiling water reactor showing the elevated crack growth rates at high corrosion potential, but significant decrease in growth rate as the corrosion potential is decreased. These data are plotted as large triangles on Fig. 12. (b) Crack length versus time for a custom “stainless steel” representative of the composition of an irradiated grain boundary, notably containing high silicon. There is no effect of the change in corrosion potential, nor an effect from decreasing stress intensity (*K*) from 29.6 MPa√m (27 to 13 ksi√in.). While the crack growth rate response of such a bulk alloy cannot be presumed to be representative of an irradiated material, these data and other data on type 304L stainless steel possessing 3 or 1.5% Si show broadly similar behavior.

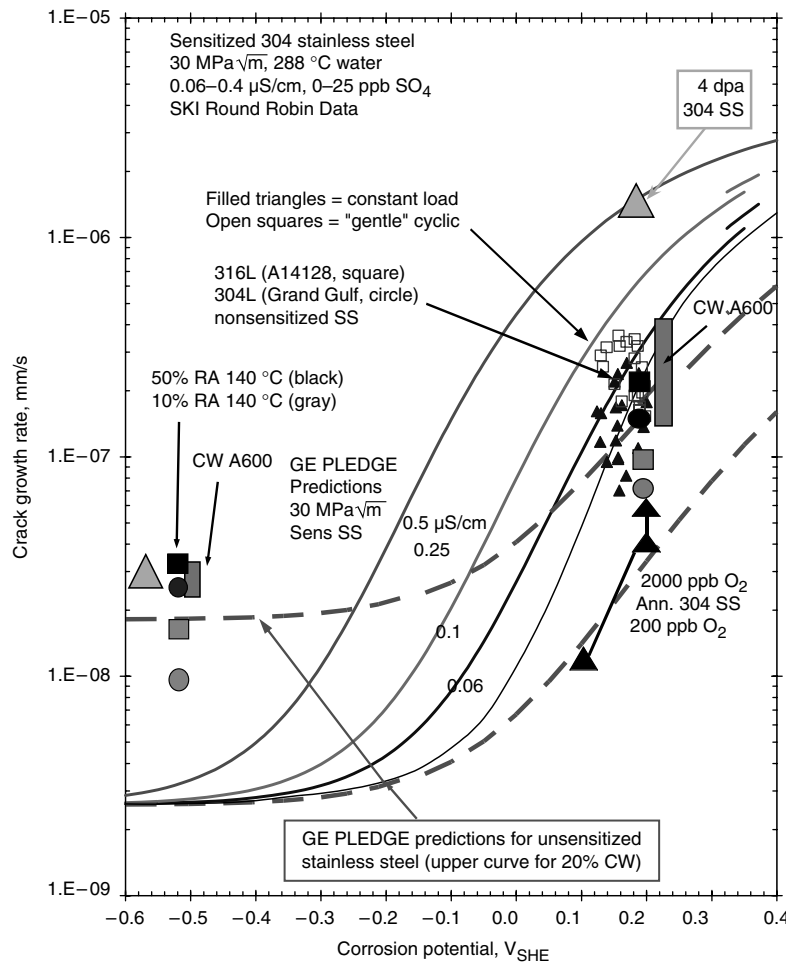
**Fig. 12** Observed and predicted relationships of crack growth rate versus corrosion potential for furnace-sensitized type 304 stainless steel (SS) at a constant stress intensity (*K*) of  $\approx 27.5 \text{ MPa}\sqrt{\text{m}}$  (25 ksi√in.). The observed data were obtained in water of conductivity between 0.1 to 0.3  $\mu\text{S}/\text{cm}$ . The predicted relationships show the sensitivity of the crack growth rate to changes in combinations of corrosion potential and water purity (0.1 to 0.5  $\mu\text{S}/\text{cm}$ ) (Ref 5–7, 46, 47). The large triangles were obtained on type 304 stainless steel irradiated to 4 dpa. The larger circles and rectangles represent cold-worked stainless steel and Alloy 600.

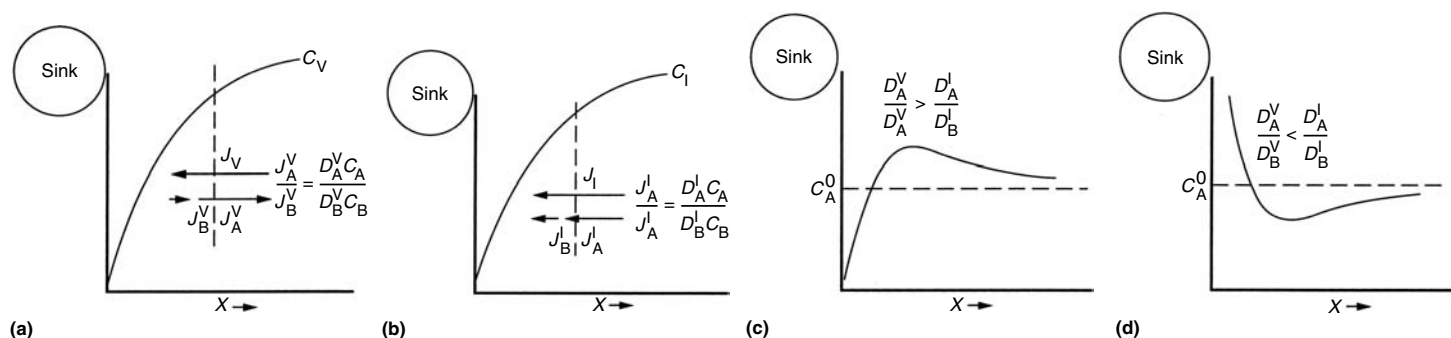
**Fig. 13** Inverse Kirkendall effects induced by (a) vacancy flux, (b) interstitial flux, and (c) and (d) the effect of diffusion coefficients on the depth distribution for A atoms in an AB alloy. J, C, and D refer to the flux, concentration, and diffusion coefficient, respectively, of diffusing species defined by the subscript, by way of the complementary species defined by the superscript (V, vacancies, I, interstitials). Source: Ref 68

Radiation-induced segregation is a common phenomenon in irradiated alloys and describes the redistribution of major alloying elements and the enrichment or depletion of impurity elements at point defect sinks (Ref 67–76). By virtue of their susceptibility to IGSC, the sinks of greatest interest are the grain boundaries. Radiation-induced segregation is driven by the flux of radiation-produced defects to sinks and is therefore fundamentally different from thermal segregation or elemental depletion due to grain-boundary precipitation processes. Vacancies and interstitials are the basic defects produced by irradiation and can reach concentrations that are orders of magnitude greater than the thermal equilibrium concentrations. Diffusion of solutes by vacancy or interstitial mechanisms (inverse Kirkendall) is accelerated by the elevated concentration of these defects. If the relative participation of alloying elements in the defect fluxes is not the same as their relative concentration in the alloy, then a net transport of the constituents to or from the grain boundary will occur (Fig. 13). This unequal participation of solutes in the vacancy and/or interstitial fluxes to sinks
