# ASM Handbook®

## Volume 13C Corrosion: Environments and Industries

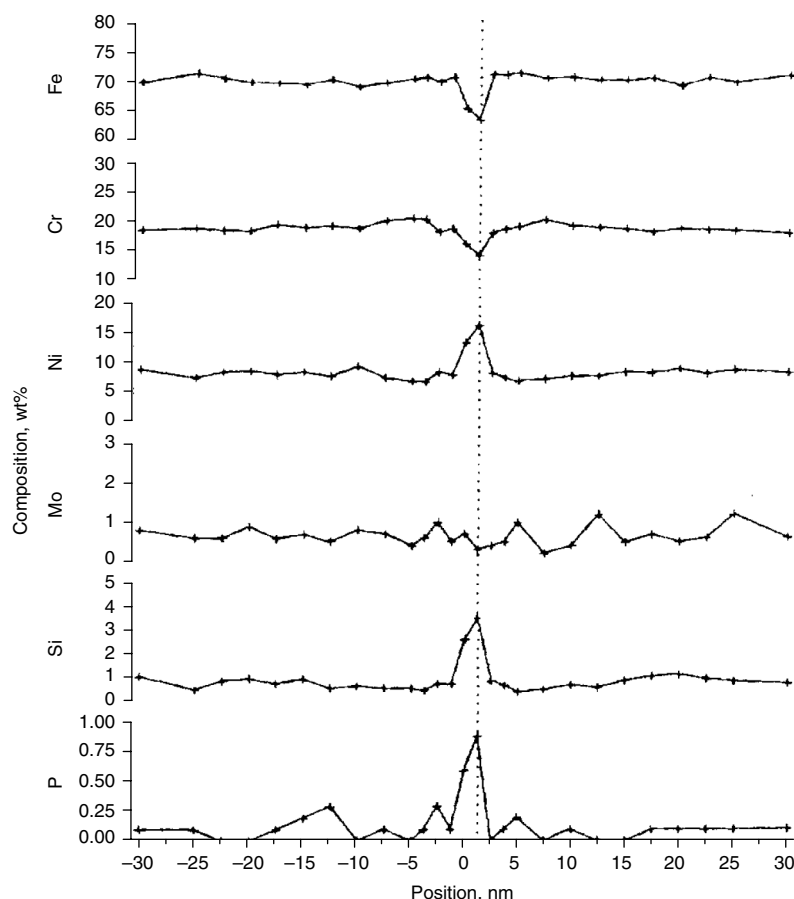
**Fig. 14** Typical segregation profiles in commercial purity type 304 stainless steel irradiated to  $10^{22}$   $n/cm^2$  at 275 °C (525 °F). Composition profiles were measured using a field emission gun scanning transmission electron microscope (FEGSTEM). Source: Ref 72

results in either enrichment or depletion of an alloying element at the grain boundary. The species that diffuse more slowly by the vacancy diffusion mechanism are enriched, and the faster diffusers become depleted. Enrichment and depletion can also occur by association of the solute with the interstitial flux. The undersized species will enrich, and the oversized species will deplete (Ref 69). The magnitude of the buildup/depletion is dependent on several factors such as whether a constituent migrates more rapidly by one defect mechanism or another, the binding energy between solutes and defects, the dose, dose rate, and the temperature. The RIS profiles are also characterized by their narrowness, often confined to within 5 to 10 nm of the grain boundary, as shown in Fig. 14 for an irradiated stainless steel.

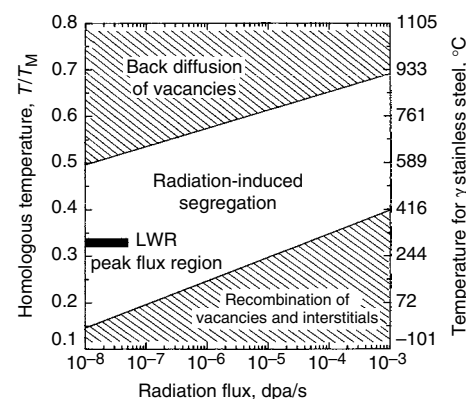
**Fig. 15** Dependence of radiation-induced segregation on homologous temperature and dose rate for austenitic stainless steels. LWR, light water reactor

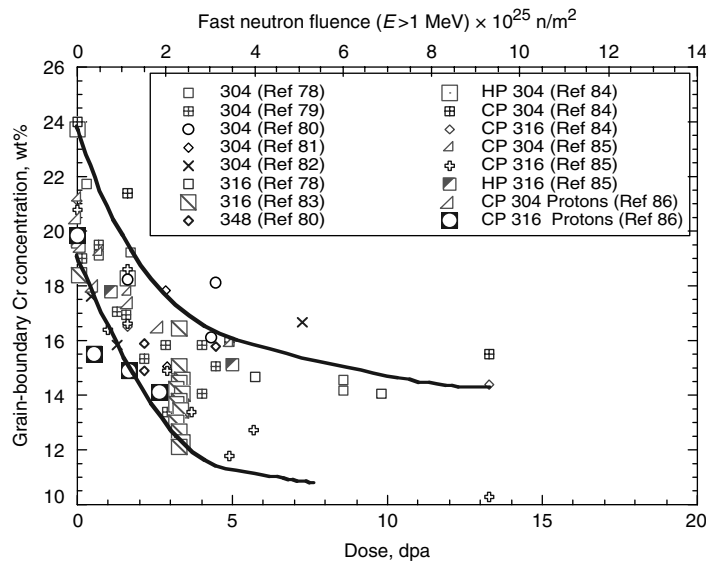
**Fig. 16** Dose dependence of grain-boundary chromium concentration for several 300-series austenitic stainless steels irradiated at a temperature of about 300 °C (570 °F). Source: Ref 78–86

Radiation-induced segregation is often implicated in IASCC of stainless steels, especially in oxidizing environments, due to the wealth of data from laboratory and plant operational experience with sensitized components (Ref 3, 4, 12, 31, 34, 94, 95). As shown in Fig. 16, grain-boundary chromium depletion during irradiation can be severe. Figure 19(a) shows a correlation between grain-boundary chromium level and IGSCC susceptibility in stainless steels where the grain-boundary depletion is due to sensitization (Ref 96). Much data have been accumulated to support the role of chromium depletion as an agent in IGSCC of austenitic alloys in oxidizing conditions. Numerous studies show that as the grain-boundary chromium level decreases, IGSCC increases. Typical chromium-depleted zone widths are of the order of 100 to 300 nm

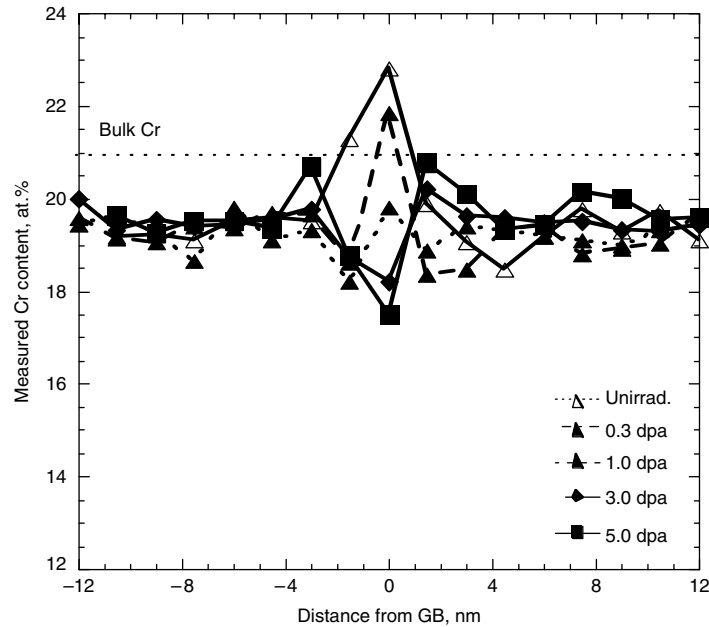
**Fig. 17** Variation of the grain-boundary (GB) chromium concentration profile in commercial-purity type 304 stainless steel with dose for 3.2 MeV proton irradiation at 360 °C (680 °F). Source: Ref 86

at low dose. The W-shape is due in part to the initial chromium enrichment. However, inverse Kirkendall-based calculations of grain-boundary composition under irradiation show that the W-shape should transform to a V-shaped depletion profile for doses beyond 0.1 dpa, when in fact, observations show (Ref 86) that it tends to persist beyond 1.0 dpa (Fig. 17).

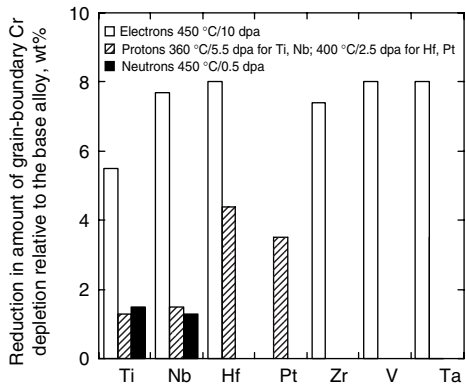
**Fig. 18** Effect of oversizedolute on the grain-boundary chromium concentration following irradiation with electrons (Ref 90), protons (Ref 91), and neutrons (Ref 92)

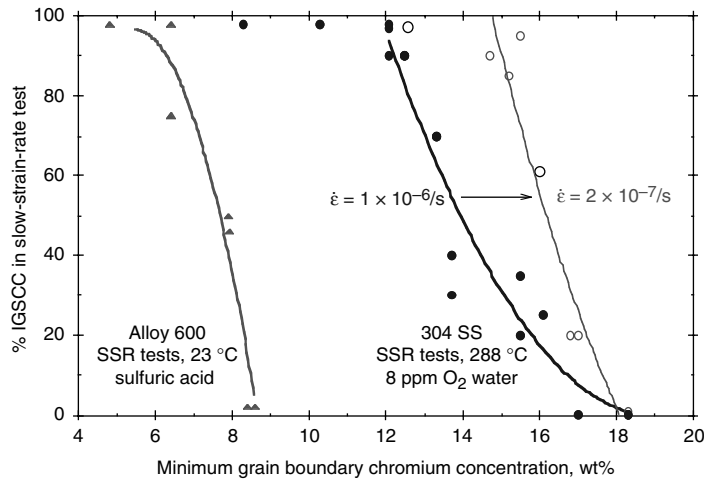
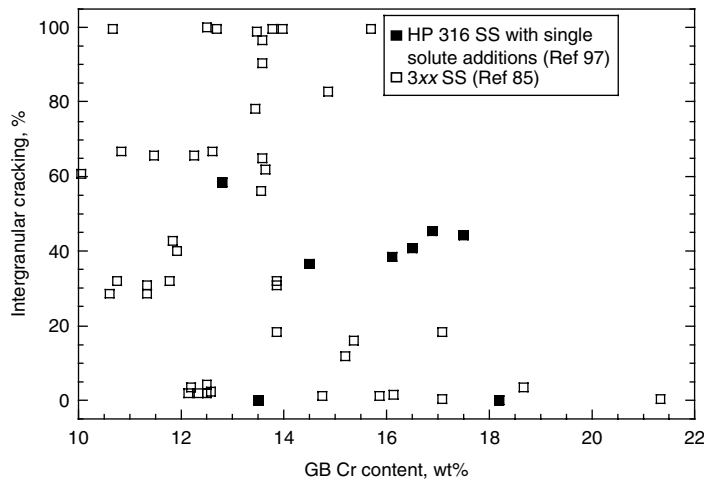
**Fig. 19** Effect of grain-boundary (GB) chromium content on intergranular stress-corrosion cracking (IGSCC) for (a) sensitized stainless steel (SS) and alloy 600 (Source Ref 96) and (b) irradiated stainless steels. SSR, slow strain rate.

Figure 19(b) shows a similar correlation between grain-boundary chromium level and IASCC susceptibility as measured by the percentage of intergranular cracking (%IG) cracking on the fracture surface during SSRT experiments. A major difference between chromium-depletion profiles resulting from RIS and those due to precipitation reactions is that the width of the RIS profiles can be as much as two orders of magnitude smaller, or 5 to 10 nm. There is also a tremendous amount of scatter in the data of Fig. 19(b) that makes a direct correlation difficult to support. In particular, at low grain-boundary chromium levels, the %IG ranges from 0 to 100. However, as the grain-boundary chromium content increases, the data become less “noisy,” suggesting that a higher grain-boundary chromium concentration is a strong indicator of resistance to IASCC. Also, there is a trend in the maximum level of %IG with grain-boundary chromium content. There-

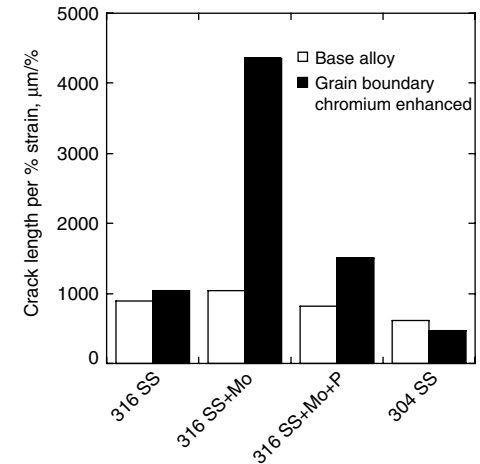
**Fig. 20** Effect of chromium enrichment heat treatment on irradiation-assisted stress-corrosion cracking in constant extension rate test in simulated BWR normal water chemistry at 288 °C (550 °F). Source: Ref 102, 103

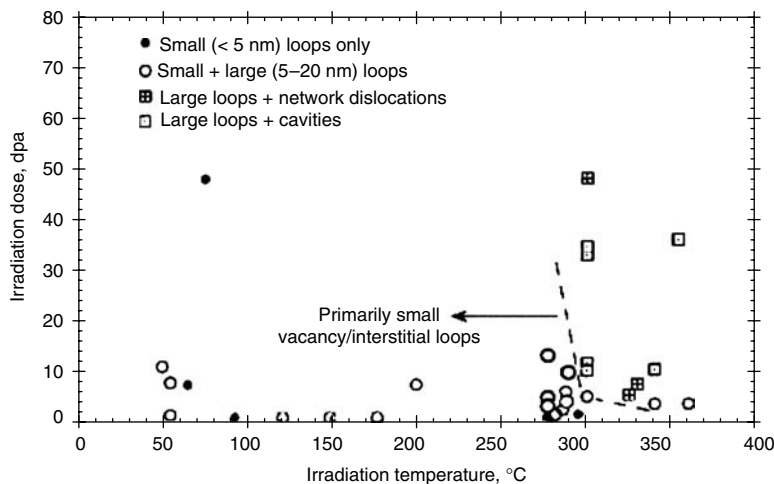
**Fig. 21** Summary of reported defect structures in 300-series stainless steels as a function of irradiation dose and temperature. Source: Ref 85

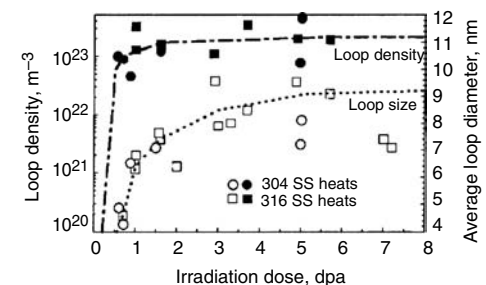
**Fig. 22** Measured change in density and size of interstitial loops as a function of dose during LWR irradiation of 300-series stainless steels (SS) at 275 to 290 °C (525 to 555 °F). Source: Ref 85

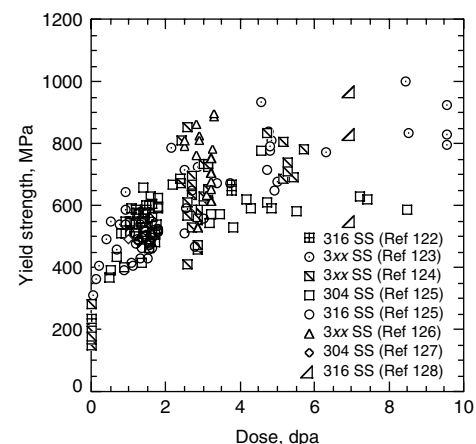
**Fig. 23** Irradiation dose effects on measured tensile yield strength for several 300-series stainless steels, irradiated and tested at a temperature of about 300 °C (570 °F). Source: Ref 122–128

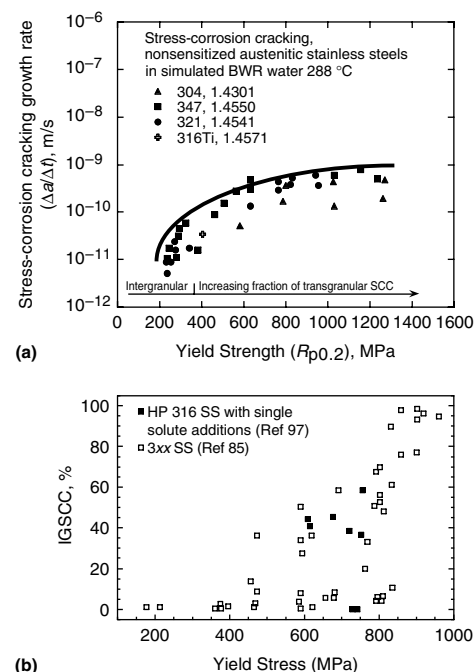
**Fig. 24** Effect of yield strength on intergranular stress-corrosion cracking (IGSCC). (a) Crack growth rate of cold-worked, unirradiated 300-series stainless steels (SS) tested in 288 °C (550 °F) simulated BWR water. Source: Ref 131. (b) IGSCC percentage in slow strain rate tests on 300-series stainless steels where hardening is by irradiation. Source: 85, 97, 120

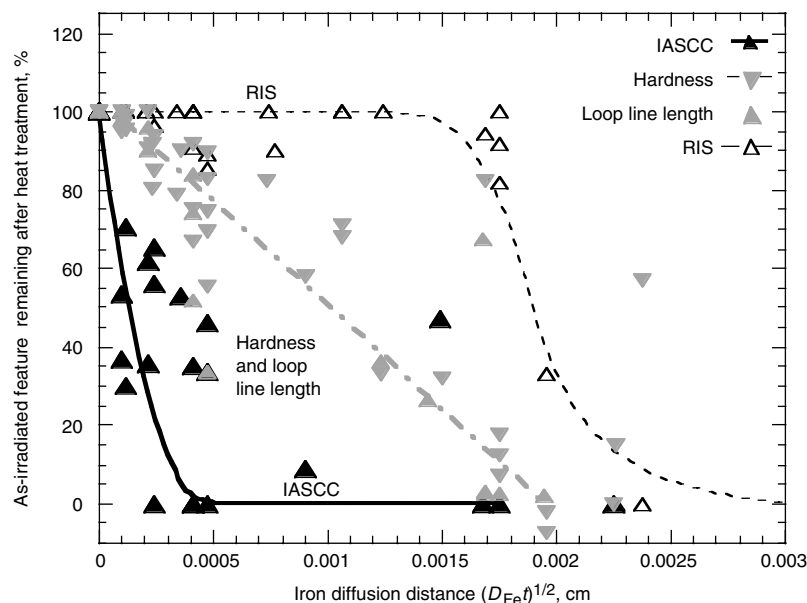
**Fig. 25** Removal of radiation-induced segregation (RIS), dislocation microstructure as measured by loop line length and hardness with extent of annealing as measured by  $(Dt)^{1/2}$  for iron, to account for annealing at different times and temperatures. IASCC, irradiation-assisted stress-corrosion cracking. Source: Ref 98, 101, 116, 135

Several pieces of evidence suggest that hardening alone is not sufficient to explain IASCC. The annealing experiments shown in Fig. 25 also tracked the change in hardness and dislocation loop microstructure versus annealing condition (Ref 134). Figure 25 shows the change in hardness and the change in the dislocation loop line length

( $N_{avg} \times d_{avg}$ ) along with the change in IASCC susceptibility as annealing progresses, as measured by several authors (Ref 101, 116, 135). Note that except for very short annealing times, the loop line length and the hardness track each other extremely well, as would be expected if the loop structure is controlling the hardening. At very small values of  $(Dt)^{1/2}$ , the hardening remains flat before proceeding downward with increased annealing. While both hardening and cracking are reduced with increased annealing, the behavior of the hardness cannot fully explain the rapid and complete reversal in IASCC susceptibility with annealing condition. In particular, the cracking susceptibility changes dramatically before the hardness begins to drop from its as-irradiated value, as indicated by the plateau at low  $(Dt)^{1/2}$ .

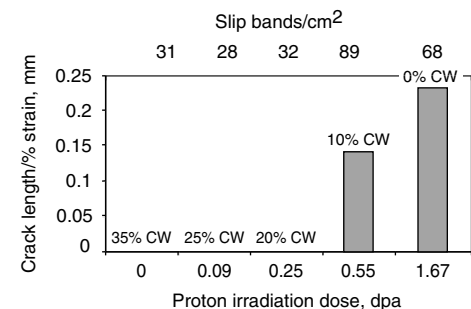
**Fig. 26** Degree of irradiation-assisted stress-corrosion cracking in type 304 stainless steel samples with the same hardness but with different combinations of hardening by cold work (CW) and irradiation using 3.2 MeV protons at 360 °C (680 °F). Source: Ref 136

type 304 stainless steel with nominally the same hardness, but with different contributions from cold work and irradiation. At the extremes were a sample that was cold rolled to a 35% reduction in thickness and no irradiation and one with 1.67 dpa irradiation and no cold work. Three samples had varying amounts of cold work (10%, 20%, and 25%) and corresponding amounts of irradiation dose (0.55, 0.25, and 0.09 dpa) to result in a nominally constant hardness level that varied by no more than 5% over the five samples. Stress-corrosion cracking susceptibility was measured by the amount of IG cracking in a constant extension rate test in 288 °C (550 °F) simulated BWR water with normal water chemistry. Results showed that the IASCC susceptibility was not constant, as would be expected if hardness were the only factor. Rather cracking occurred for only the two highest dose samples (0.55 dpa with 10% cold worked and 1.67 dpa with no cold worked), irrespective of their hardness (Fig. 26). The amount of cracking in the lower dose sample was higher than that in a companion sample at the same dose but without cold work (not shown), indicating that cold work can enhance the IASCC susceptibility. These results also suggest that hardening by irradiation may promote crack initiation. Nevertheless, this result along with the annealing results suggests that the microstructure itself and not just the hardness level play a role in the IASCC process.

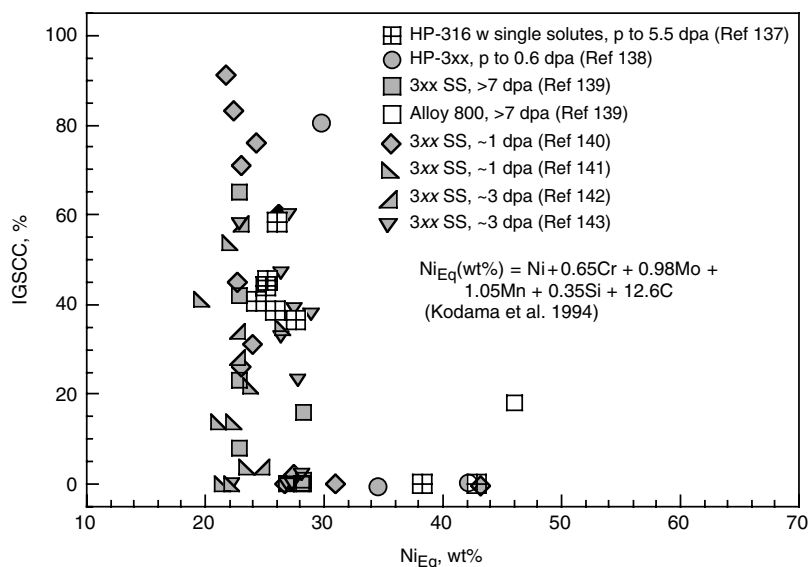
**Fig. 27** Intergranular stress-corrosion cracking susceptibility as measured by percentage of intergranular cracking in slow strain rate tests as a function of nickel equivalent ( $Ni_{Eq}$ ) determined using data from Kodama et al. (Ref 140)

IASCC compared to type 304 stainless steel with 8 wt% Ni. Figure 27 shows existing literature data on IASCC versus nickel equivalent ( $Ni_{Eq}$ ) as determined from correlations by Kodama et al. (Ref 140). It shows that there is a good, but not perfect correlation between  $Ni_{Eq}$  and IASCC. Notable exceptions are alloy 800 (Ref 144) and a Fe-20Cr-25Ni-1Nb alloy used in advanced gas-cooled reactors (AGRs) that experienced IGSCC (Ref 145). While nickel may affect IASCC directly through a change in composition, it may also affect IASCC indirectly through a change in the slip character. Higher nickel content in stainless steel increases the stacking fault energy (SFE) significantly. The increased SFE results in a change in the nature of slip from planar to wavy. Swan et al. (Ref 146) conducted a study on the effect of SFE on slip behavior of a series of Fe-18Cr-xNi alloys where  $8 < x < 23$ . They showed that for the 8% Ni alloy, the slip was entirely planar and as nickel increases, cross slip increases. By 20% Ni, there was no evidence of planar slip and the deformation microstructure consisted of a web of dislocation tangles, evident of wavy slip in a high SFE material. The process is shown in the micrographs and schematics in Fig. 28 in which planar slip is likely to result in greater dislocation interaction with grain boundaries than is wavy slip.

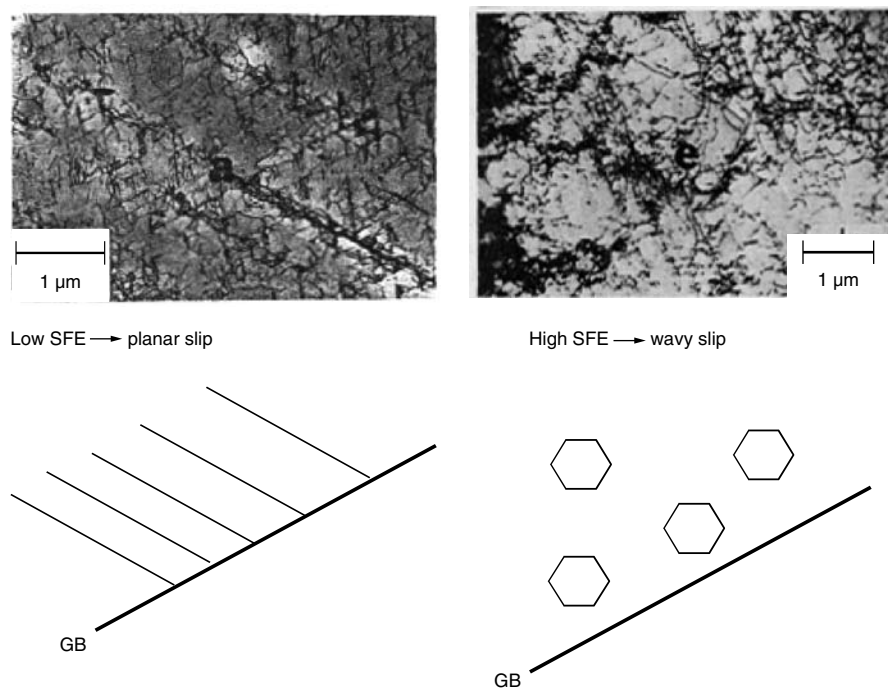
**Fig. 28** Micrographs and corresponding illustrations of planar and wavy slip in the vicinity of a grain boundary (GB). SFE, stacking fault energy. Micrographs from Ref 146

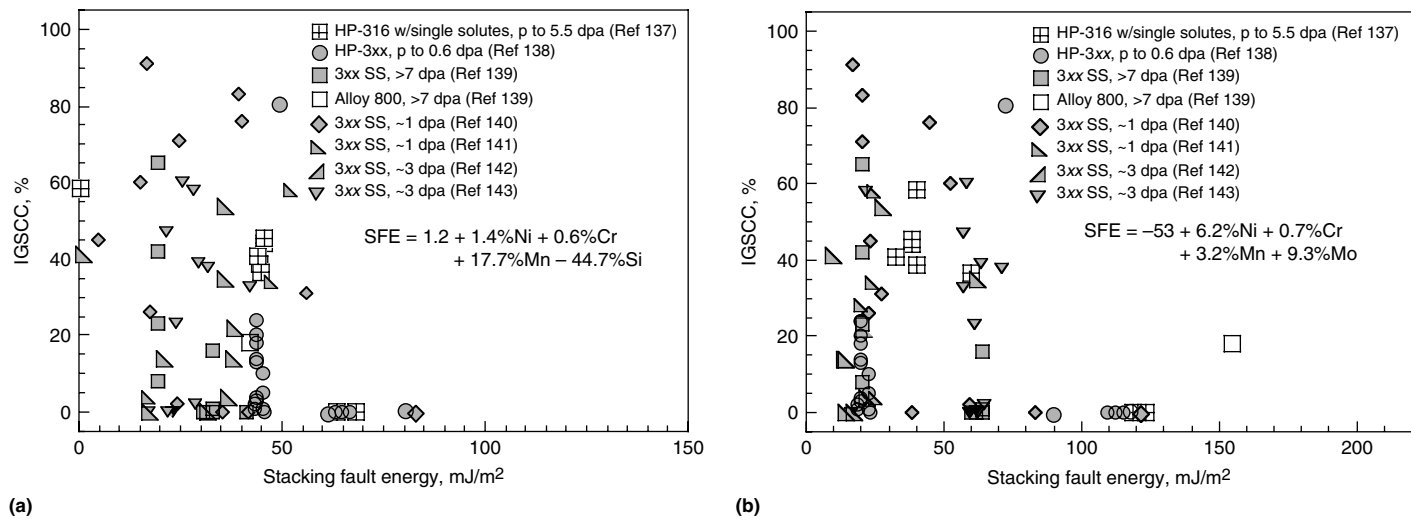
**Fig. 29** Irradiation-assisted stress-corrosion cracking susceptibility as measured by percentage of intergranular stress-corrosion cracking (IGSCC) as a function of stacking fault energy determined using (a) Rhodes' correlation (Ref 148) and (b) Schramm's correlation (Ref 149)

Stacking fault energy has been linked to SCC resistance in stainless steels by Thompson and Bernstein who found that increasing SFE correlates well with increased reduction in area and decreased SCC susceptibility (Ref 147). The IASCC susceptibility of several irradiated stainless steels is plotted as a function of SFE in Fig. 29 and shows that there is a good correlation between SFE and IASCC using Rhodes's (Ref 148) and Schramm's (Ref 149) correlations for SFE. These correlations differ in the elements included and the weights given to each element in terms of  $Ni_{Eq}$ . The correlations are also unable to account for several of the minor elements and therefore may deviate substantially from the true SFE in cases where minor elements carry high weight (such as silicon). Note that there is much scatter in both these plots and the plot for  $Ni_{Eq}$

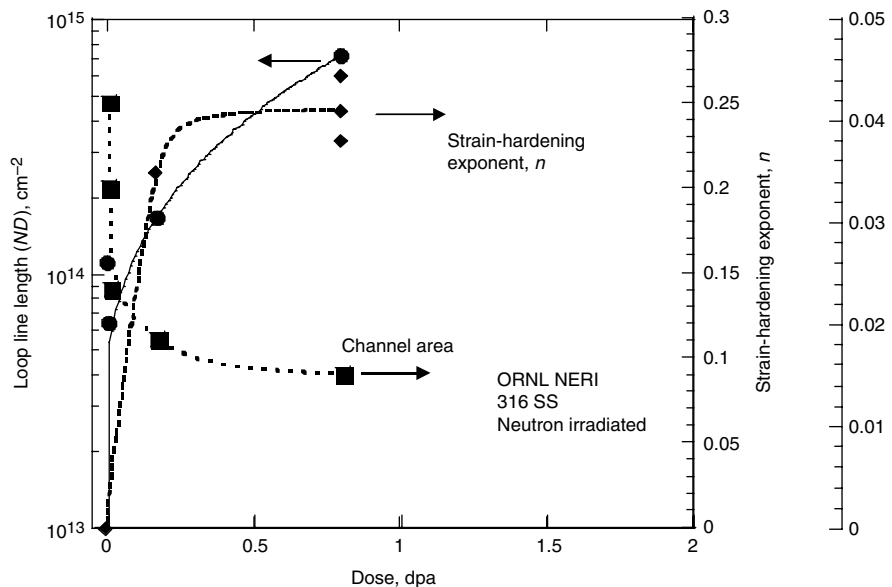
**Fig. 30** Variation in dislocation channel area, dislocation loop line length, and strain-hardening exponent as a function of dose for neutron-irradiated type 316 stainless steel (SS). Source: Ref 150

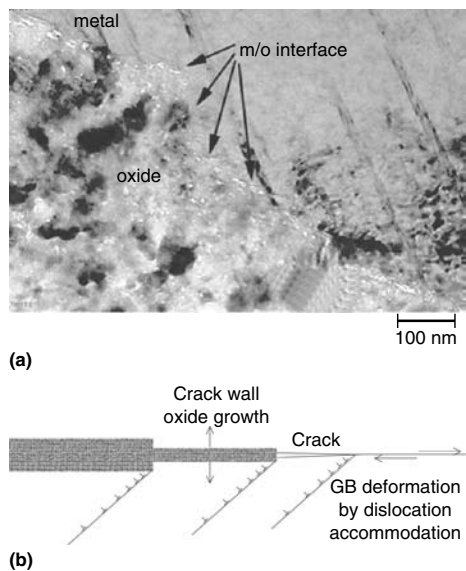
**Fig. 31** Transmission electron micrograph of (a) deformation bands intersecting a crack in a baffle bolt (Ref 154) and (b) a schematic of the role that the deformation bands may be playing in IASCC. m, metal; o, oxide; GB, grain boundary

A final example of the way in which dislocation channels or slip bands may influence cracking is the observation by Bruemmer et al. (Ref 154) of a correlation between slip band intersection with the walls of a growing crack and the accompanying steps on the oxide on the walls. Figure 31(a) shows a transmission electron micrograph (TEM) of an SCC crack in a cold-worked type 316 stainless steel baffle bolt. Note the slip bands intersecting the walls of the narrow crack at 45° to the crack growth direction. The slip band-crack wall intersections are also coincident with steps in the oxide as shown schematically in Fig. 31(b). This image suggests that the flow of dislocations along the slip steps and into the grain boundary may have been responsible for discontinuous growth of the crack along the grain boundary. While the true role of these slip steps and their angle of intersection with the grain boundary are not yet well understood, these observations provide evidence for a dislocation-based mechanism of cracking in irradiated alloys.

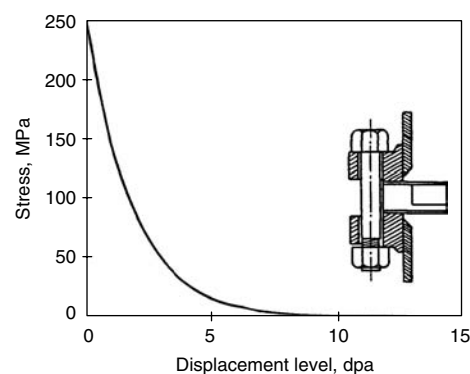
**Fig. 32** The effects of radiation-induced creep on load relaxation of stainless steel at 288 °C (550 °F). Source: Ref 155

Figures 32 to 34 show the load relaxation that occurs under constant displacement conditions. This process is quite reproducible over a wide range of materials and loading modes and generally produces sizeable (> 50%) load relaxation within a few dpa. Thus, for example, in areas of the BWR shroud that receive a moderate neutron flux, if SCC initiation does not occur early in life (e.g., by 1 dpa), the relaxation in residual stress should diminish the likelihood of cracking later in life. Similarly, it is not surprising that the incidence of SCC in BWR shroud beltline welds (exposed to the highest neutron fluence) does not show a strong correlation with fluence.

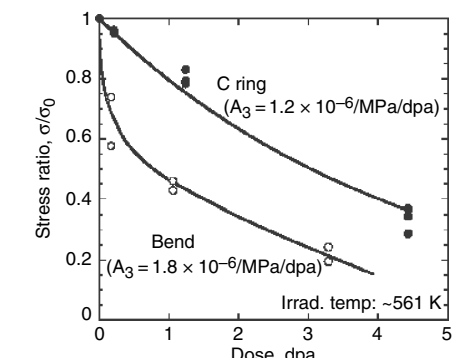
**Fig. 34** Stress relaxation of bent beam and C-ring specimens of type 304 stainless steel in Japan Materials Testing Reactor (JMTR) during irradiation at 288 °C (550 °F). Source: Ref 158

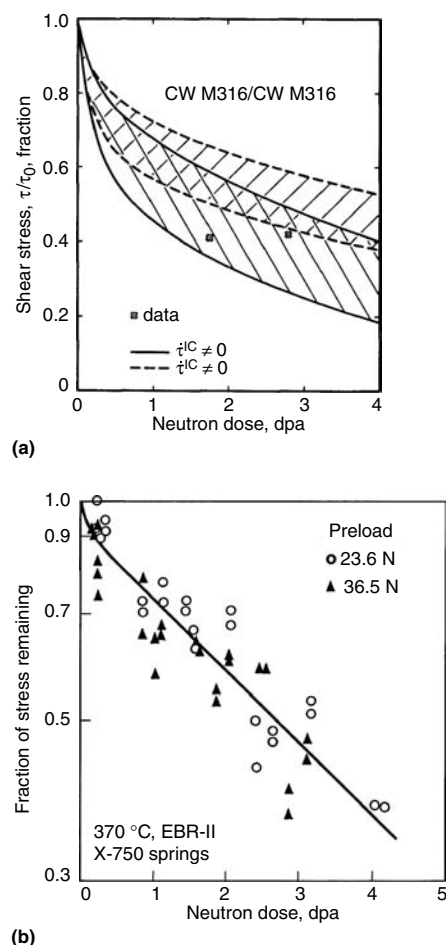
**Fig. 33** (a) Radiation creep relaxation of shear stresses in springs of 20% cold-worked (CW) type 316 stainless steel, along with modeling curves showing the effects of radiation-induced creep on load relaxation of stainless steel. Source: Ref 156. (b) Radiation creep relaxation of alloy X-750 springs at 370 °C (700 °F). Source: Ref 157

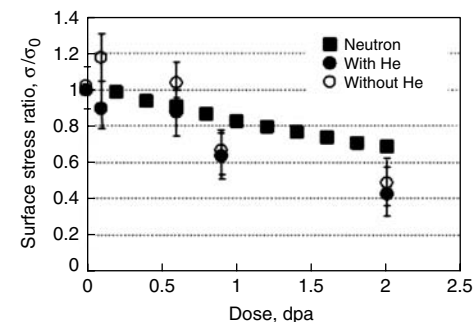
**Fig. 35** Comparison of neutron-based prediction with proton-induced creep after removing the effect of thermally induced relaxation. Source: Ref 159

Creep is also effective in reducing the benefit of compressive residual stress provided, for example, by peening. Figure 35 shows the relax-

ation in surface stress due to neutron or proton irradiation at 288 °C (550 °F) (Ref 159). Between 30 and 60% of the surface residual stress is relaxed by 2 dpa.

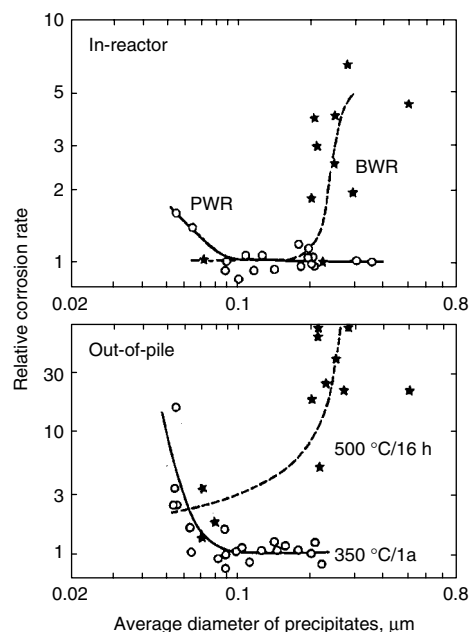
**Fig. 36** Relative corrosion rates for cladding with different precipitate sizes in boiling water reactor (BWR)- and pressurized water reactor (PWR)-type environments, when tested in and out of pile. Source: Ref 173

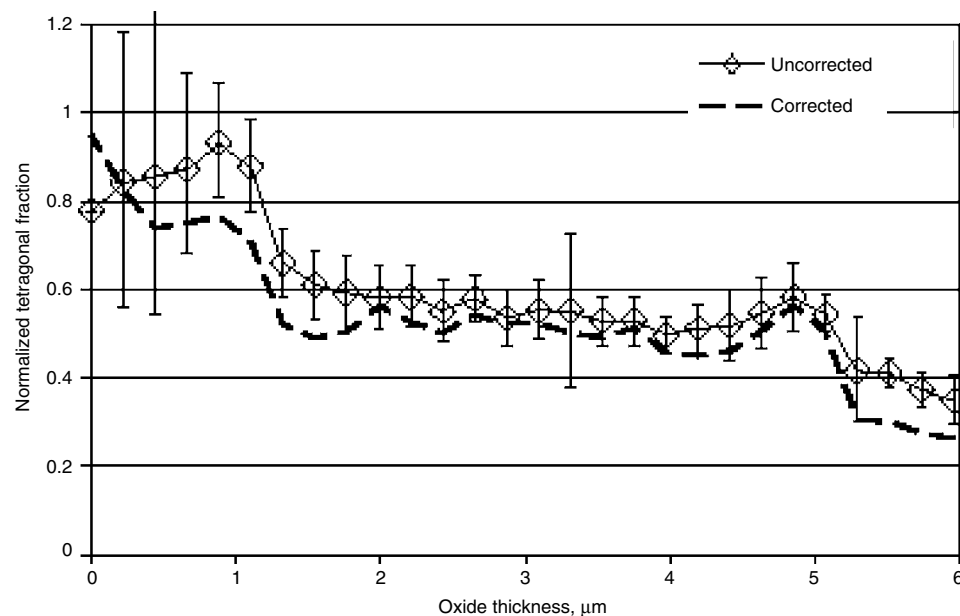
**Fig. 37** Tetragonal fraction in oxide formed in Zircaloy-4 tested in pure water, calculated from synchrotron radiation micro-x-ray diffraction, versus distance from the oxide/metal interface. Source: Ref 176

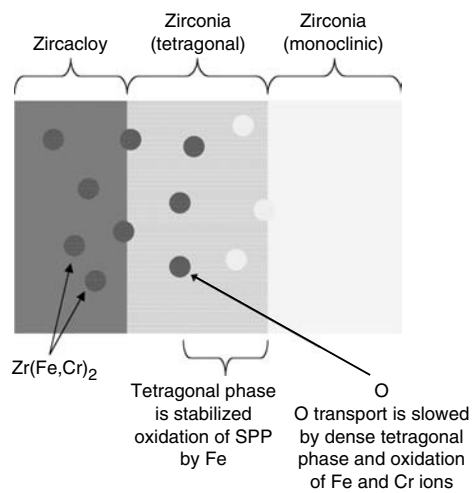
**Fig. 38** The role of precipitates in oxidation of Zircaloy-4

In the initial stages of the oxidation process, the zirconium metal is oxidized preferentially over the precipitates (Ref 177), causing the precipitates to be buried in the oxide layer early in the oxidation process. This is shown schematically in Fig. 38. The precipitates may not begin to oxidize until the surrounding metal phase has been transformed to oxide. During the initial stages of oxidation of a precipitate, the zirconium is oxidized preferentially, releasing chromium and iron to the zirconia matrix (Ref 178). The delayed oxidation of the precipitate is important in the oxidation of Zircaloy as a whole and alters the corrosion process in two ways. First, when the intermetallic undergoes oxidation, the metallic hexagonal close-packed (hcp) phase transforms to the tetragonal oxide, causing an increase in volume. This increase in turn, induces a compressive stress on the oxide layer, which can stabilize the protective tetragonal oxide layer at the metal/oxide interface (Ref 179). The release of chromium and, more significantly, iron, from the second-phase particles, is also important to the uniform corrosion of

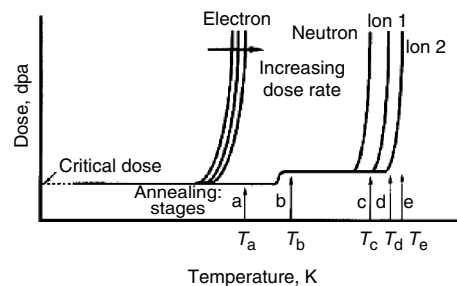
**Fig. 39** Dose-to-amorphization versus temperature for different irradiating particles. Source: Ref 180

Under irradiation, the precipitates are affected primarily through amorphization (Ref 180). This process is highly dependent on irradiating particle type, irradiation temperature, and dose rate. The interplay of these variables is shown in Fig. 39 (taken from Ref 180), where the dose required to amorphize precipitates is plotted as a function of irradiation temperature and particle type. Further, postirradiation examination

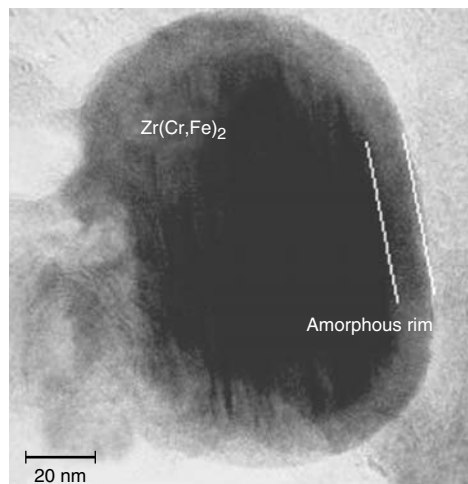
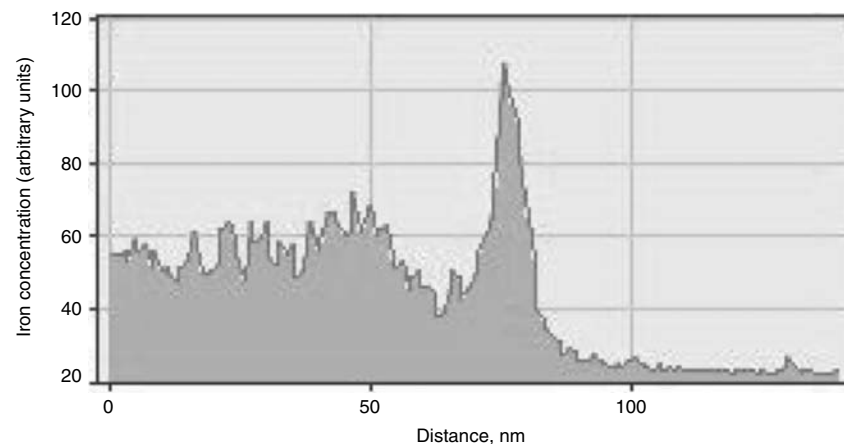
**Fig. 40** (a) A TEM image of a  $\text{Zr}(\text{Cr},\text{Fe})_2$  precipitate after proton irradiation at 2 MeV, 310 °C (590 °F), to 5 dpa and EDS spectra for the region just outside of the precipitate, showing the concentration of iron in the matrix adjacent to the precipitate. Source: Ref 181

reveals that the precipitates are amorphized from the outside to the inside. That is, the outer shell of the particle is amorphous and depleted in iron while the inner core is of the same structure and composition as that prior to irradiation. An example of this phenomenon is shown in Fig. 40 (taken from Ref 181), which shows a TEM image of a  $\text{Zr}(\text{Cr},\text{Fe})_2$  precipitate after irradiation with 2 MeV protons at 310 °C (590 °F) to 5 dpa. The energy dispersive spectroscopy (EDS) plot (Fig. 40b) shows that the iron content drops at the edges of the precipitate and rises sharply in the adjacent matrix. The surrounding matrix contains higher levels of chromium and iron, indicating the particles are amorphizing under irradiation.

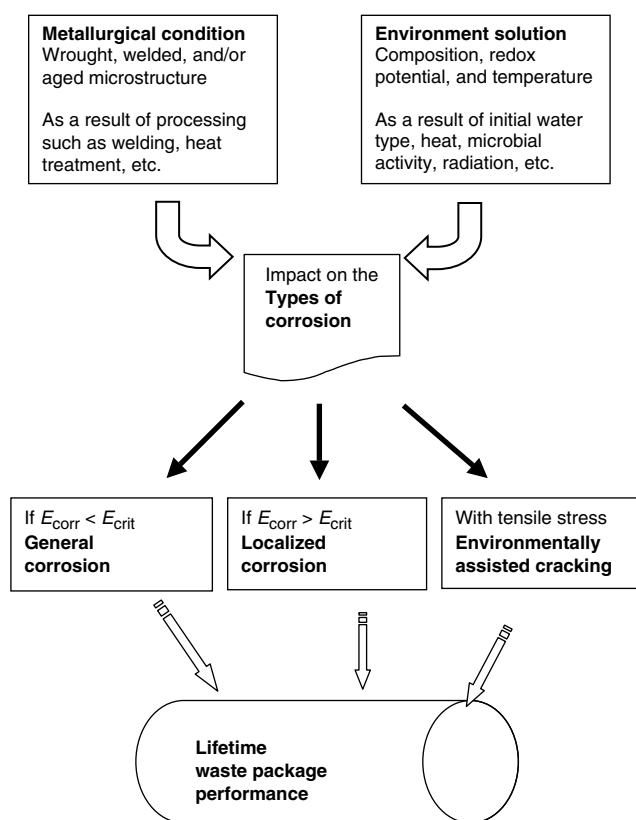
Fig. 1 General model for corrosion degradation of alloy 22

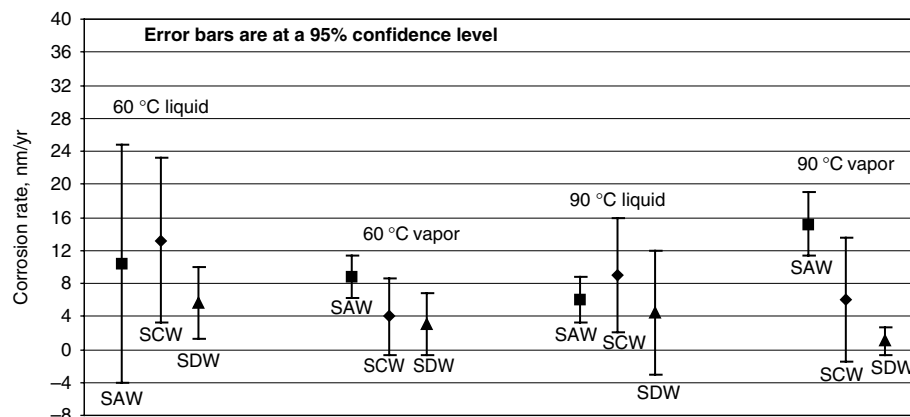
**Fig. 2** Corrosion rates for alloy 22 crevice coupons in simulated acidified water (SAW), simulated concentrated water (SCW), and simulated dilute water (SDW). The tests were carried out for 5+ years at the Long Term Corrosion Test Facility at Lawrence Livermore National Laboratory. Source: Ref 58

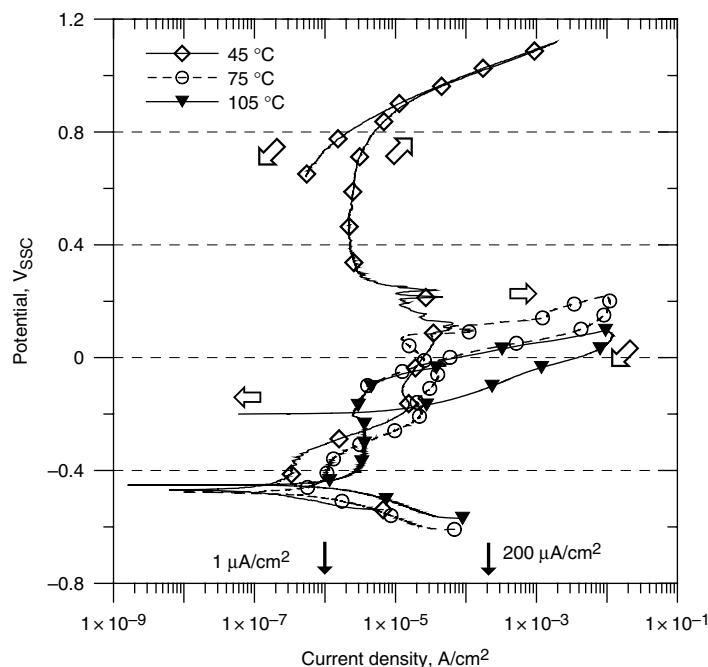
**Fig. 3** Cyclic potentiodynamic polarization for alloy 22 (UNS N06022) in deaerated 5 M CaCl<sub>2</sub> solutions at different temperatures. The higher the temperature, the lower the breakdown potential ( $E_{200}$ ) or repassivation potential (ER1)

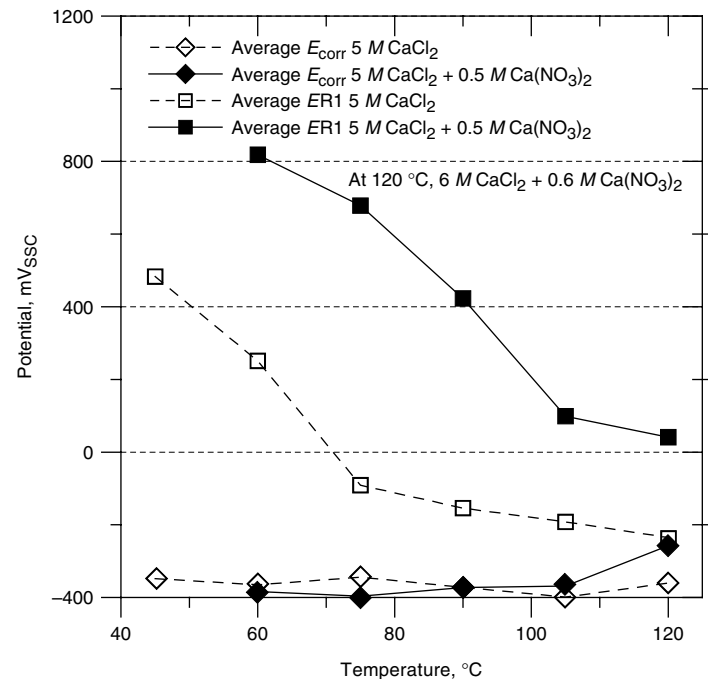
**Fig. 4** Parameters from cyclic potentiodynamic polarization for alloy 22 (UNS N06022) in deaerated 5 M CaCl<sub>2</sub> and in 5 M CaCl<sub>2</sub> + Ca(NO<sub>3</sub>)<sub>2</sub> solutions as a function of temperature. At each temperature (for example at 75 °C, or 165 °F), the repassivation potential (ER1) is raised when nitrate is added to the solution. Source: Ref 70

example, Fig. 4 shows that for 24 h tests,  $E_{\text{crit}}$  (ER1) in each solution was always higher than  $E_{\text{corr}}$ , that is, alloy 22 would remain free of localized attack at its free corroding potential. In a few circumstances, after long exposure times in aerated electrolytes,  $E_{\text{corr}}$  of alloy 22 could raise to a potential value comparable to  $E_{\text{crit}}$ . The fact that  $E_{\text{corr}}$  may reach the value of  $E_{\text{crit}}$  is a necessary but not a sufficient condition for crevice corrosion. The occurrence of crevice corrosion will depend not only on the environmental conditions such as chloride to nitrate ratio and temperature but also on the crevice geometry (tightness) and nature of the crevicing material. Crevice corrosion can be initiated in alloy 22 using potentiostatic tests. Results show that crevice corrosion propagated for the first few hours of testing, but after a couple of days crevice corrosion slowed down and seemed to die since the total measured current density reached the passive current density of the alloy in polarization studies. Mechanisms of crevice corrosion initiation, growth, and arrest (stiffing) still need to be studied in detail.

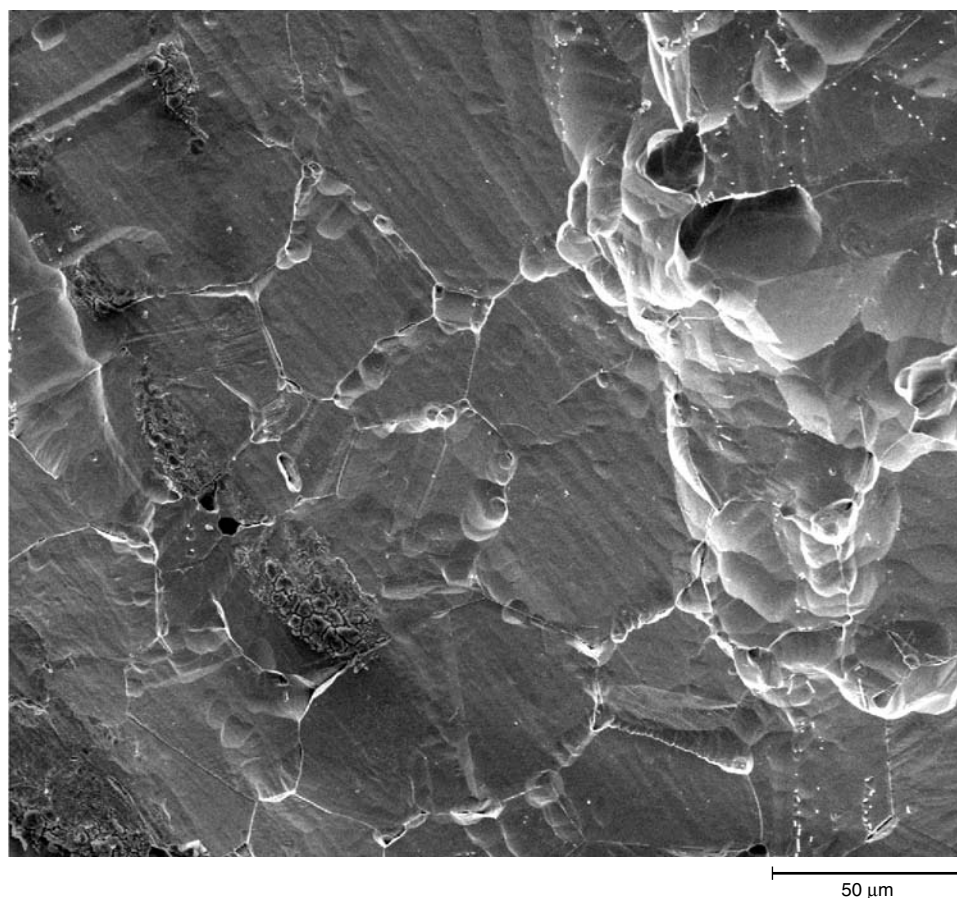
**Fig. 5** Typical appearance of crevice corrosion formed on MA alloy 22 when tested using cyclic potentiodynamic polarization in 1  $M$   $NaCl$  at 90 °C (195 °F). The grain-boundary etching appearance is typical of a hot reducing HCl solution that may be forming inside of the crevice. Specimen DEA3129. Original magnification: 1000 $\times$ . Source: Ref 67

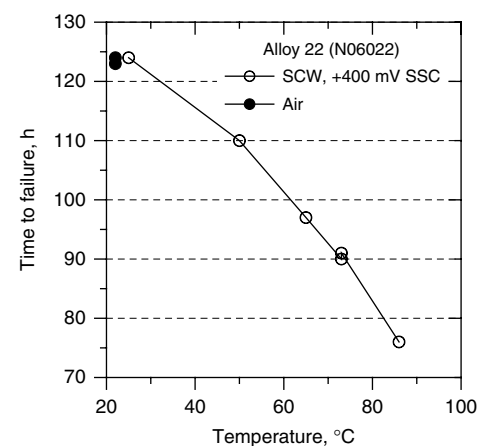
**Fig. 6** Time-to-failure for alloy 22 as a function of the testing temperature when slow strain rate test was performed at  $1.67 \times 10^{-6}$   $s^{-1}$  at the anodic potential of +400 mV. The higher the temperature, the lower the time to failure. SCW, simulated concentrated water

found susceptible to EAC only in hot SCW solution at anodic applied potentials approximately 300 to 400 mV more positive than  $E_{corr}$ . In the anodic region of potentials, the susceptibility to EAC decreased as the temperature decreased. Figure 6 shows the dependence of the time to failure of alloy 22 on temperature when strained at high anodic potentials in SCW solution. Environmentally assisted cracking was not observed for specimens strained in SCW at ambient temperature. Figures 7 and 8 show the influence of temperature for the same applied potential of +400 mV (SSC). While at 86 °C (187 °F), there was secondary cracking and almost no necking (Fig. 7), at 50 °C (120 °F) the secondary cracking disappeared while necking was prominent (Fig. 8). While alloy 22 suffers SCC in hot SCW solution at high anodic potentials using the SSRT technique, cracking did not occur under similar testing conditions using the U-bend or constant deformation technique (Ref 87). Alloy 22 was also slightly susceptible to EAC in SCW at –1000 mV (SSC), especially at ambient temperature. Fluoride seems more detrimental than chloride for the EAC resistance of alloy 22 (Ref 86).

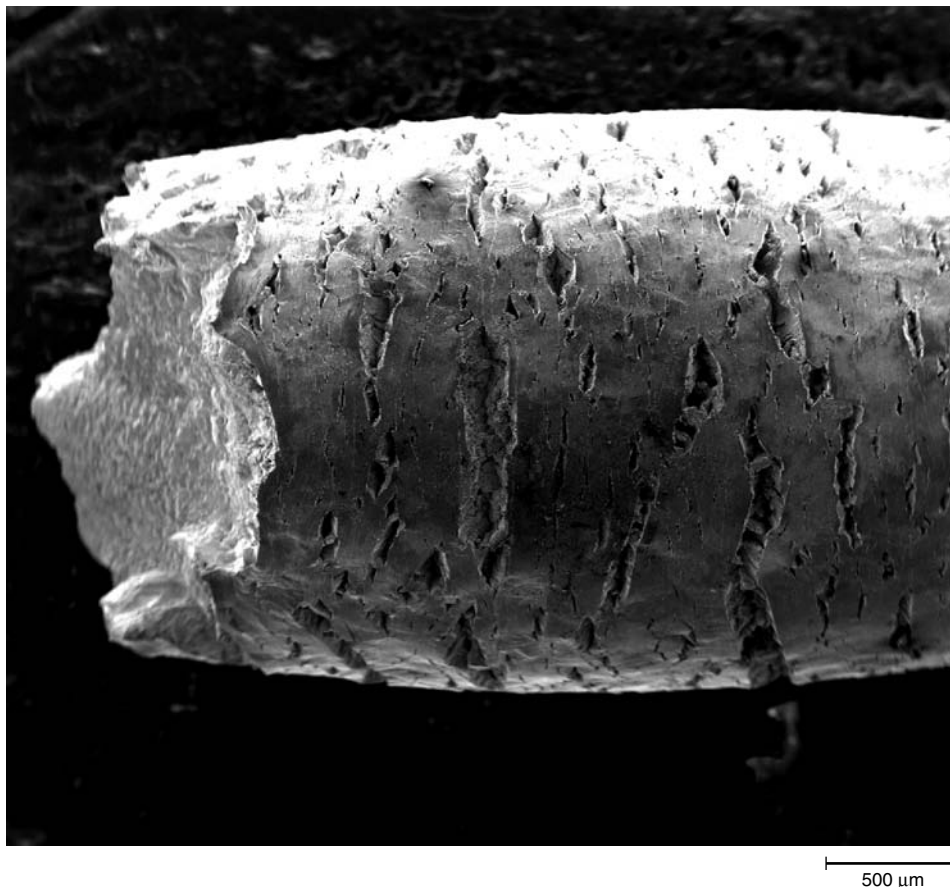
Fig. 7 Mill annealed alloy 22 specimen ARC22-033 strained in simulated concentrated water at 86 °C (187 °F) and +400 mV applied potential. Significant amount of secondary cracking and little necking is observed. Original magnification: 70×

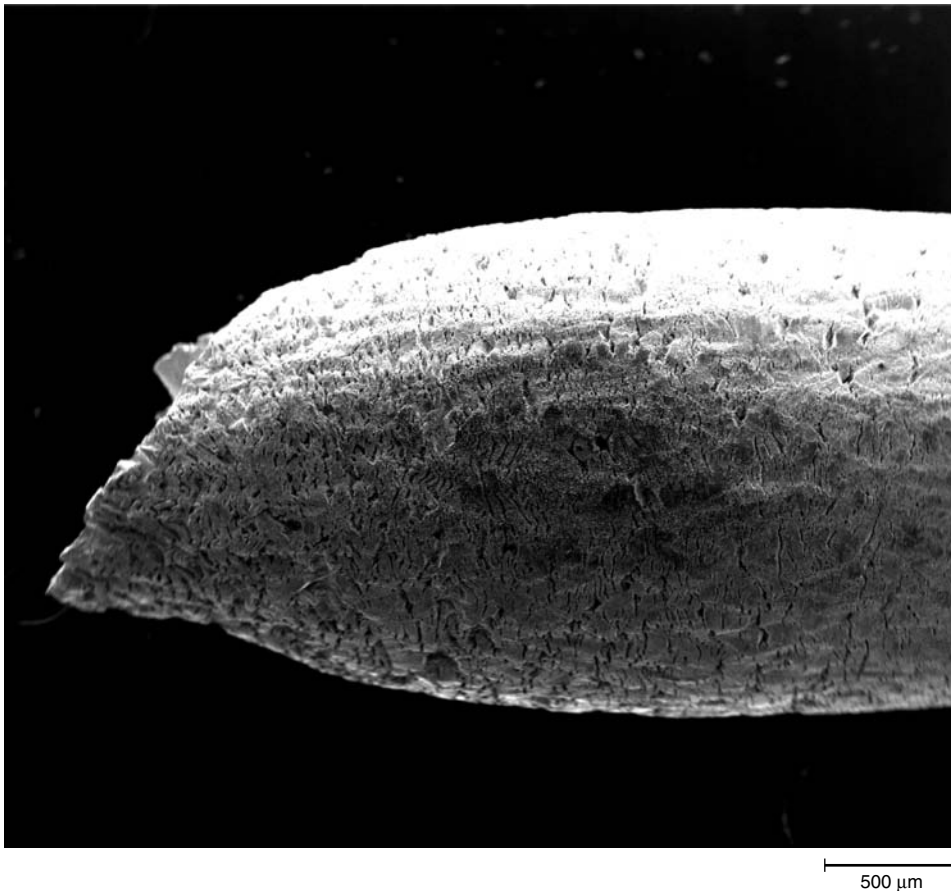
**Fig. 8** Mill annealed alloy 22 specimen ARC22-032 strained in simulated corrosion water at 50 °C (120 °F) and +400 mV applied potential. Negligible amount of secondary cracking and obvious necking is observed. Original magnification: 70×

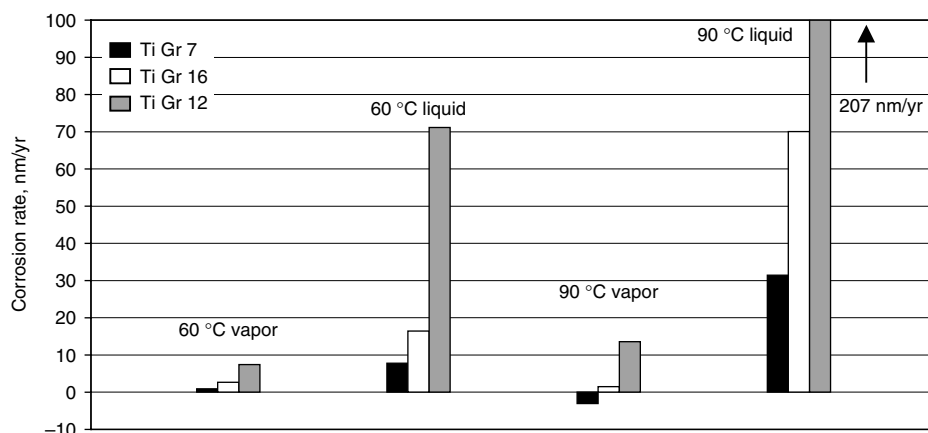
Fig. 9 Corrosion rates for Ti Gr 12, Ti Gr 16, and Ti Gr 7 crevice coupons in simulated concentrated water solution. Ti Gr 12 had the highest corrosion rates Source: Ref 94

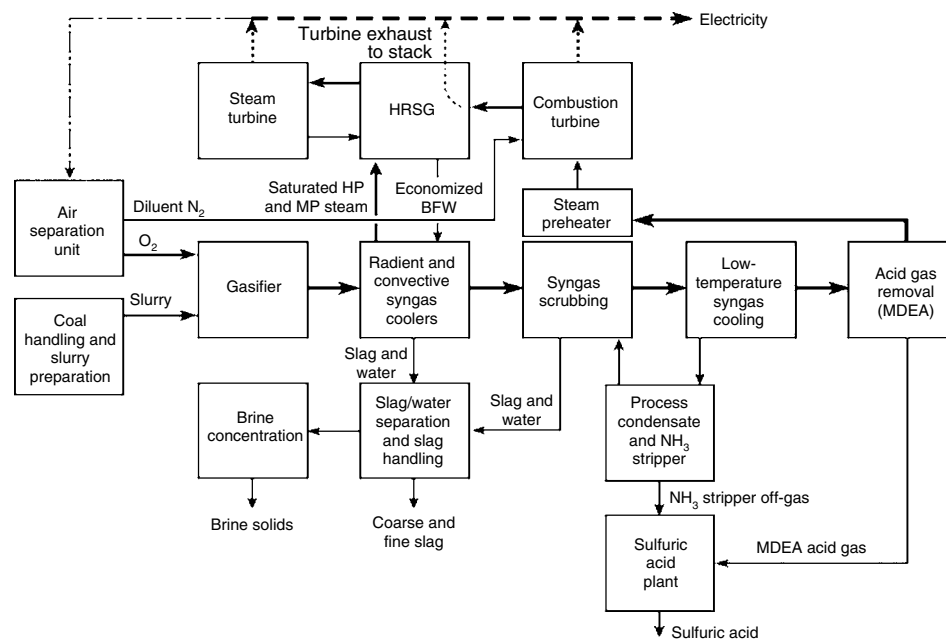
Fig. 1 Coal-gasification combined-cycle CGCC power plant. HRSG, heat recovery steam generator. Acid gas removal uses MDEA, methyldiethanolamine

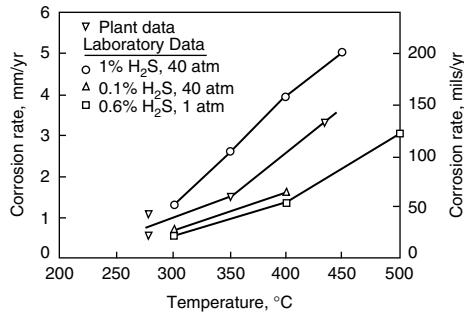
Fig. 2 Corrosion of low-alloy steels in syngas environments. Plant data are compared to laboratory data for various hydrogen sulfide atmospheres.

The major corrosion mechanism in syngas coolers is sulfidation for low-alloy steels and sulfidation/oxidation for more highly alloyed chromium-containing materials. Due to the low  $p_{O_2}$  and relatively high  $p_{S_2}$  of the raw syngas, the sulfidation rate of carbon and low-alloy steels is too high to allow the use of these low-cost materials. This is shown in Fig. 2, which contains information from laboratory as well as plant studies, with good agreement between the two. It is further observed that the corrosion rate of low-alloy steels appears largely independent of the chlorine content of the coal. The plant data in Fig. 2 were obtained from coals or coal-derived fuels with chlorine contents ranging from 0.05 to
