# ASM Handbook®

## Volume 13C Corrosion: Environments and Industries

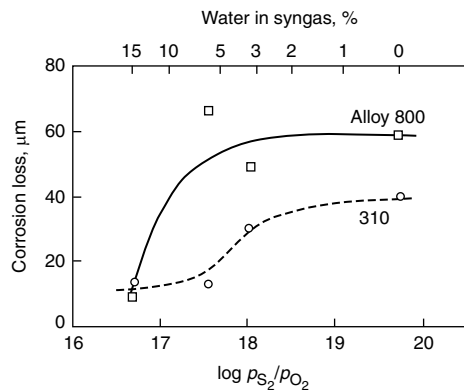
Fig. 3 Corrosion losses of stainless steels as a function of partial pressure ratio  $\log p_{S_2}/p_{O_2}$  without HCl. Laboratory test 540 °C (1000 °F), 600 h. Solid line, nickel alloy 800 (UNS N08800); broken line, type 310 stainless steel (UNS S31000)

In the absence of HCl in the syngas, the corrosion loss indeed increases as a function of the  $p_{S_2}/p_{O_2}$  ratio as shown in Fig. 3 for alloys 800

(UNS N08800, Fe-20Cr-32Ni-0.35Al-0.35Ti) and 310 (UNS S31000, Fe-25Cr-20Ni). Corrosion rates are relatively low and parabolic reaction kinetics are usually observed (Ref 6, 7). Scanning electron microscopy/energy-dispersive x-ray analysis (SEM/EDAX) indicates that at high  $p_{S_2}/p_{O_2}$  ratios, a somewhat protective FeCr<sub>2</sub>S<sub>4</sub> spinel is formed. At lower  $p_{S_2}/p_{O_2}$  ratios, this layer gradually changes to FeCr<sub>2</sub>O<sub>4</sub>. Below the FeCr<sub>2</sub>S<sub>6</sub> layer, an inward-growing scale/precipitation zone is formed consisting of FeCr<sub>2</sub>(S,O)<sub>4</sub> spinel, Cr<sub>2</sub>O<sub>3</sub>, and iron-rich alloy remnants. This corrosion mechanism is labeled

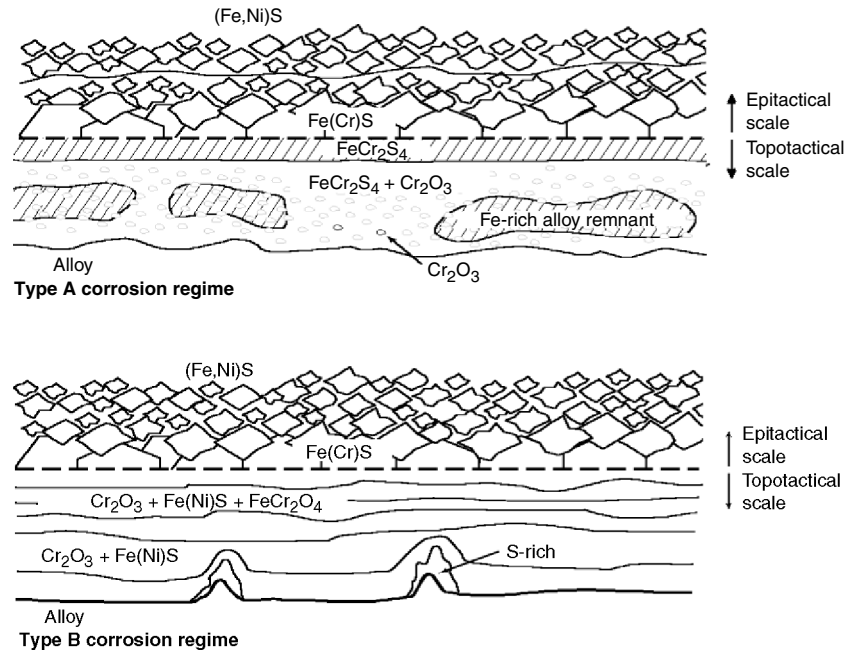
Fig. 4 Scale morphology for type A and B corrosion

type A corrosion and is schematically shown in Fig. 4.

of alloy 800 after exposure to a syngas with a  $p_{\text{S}_2}/p_{\text{O}_2}$  ratio of about 18 and HCl content of 400 ppm indicated the absence of a protective  $\text{FeCr}_2\text{S}_4$  scale. An outward-growing FeS-rich scale is present on top of an inward-growing porous  $\text{Cr}_2\text{O}_3$ -rich scale containing  $\text{Fe}(\text{Ni})\text{S}$ , which appears nonprotective. This corrosion mechanism is labeled type B corrosion and is also schematically shown in Fig. 4.

The main difference between type A and B corrosion is that a protective  $\text{FeCr}_2\text{S}_4$  is formed in type A. The absence of this protection in type B leads to higher corrosion rates. Further studies have shown that the onset of the less desirable type B corrosion depends on the amount of oxide-forming alloying elements in the alloy, the amount of HCl in the syngas, and the presence of chlorides in deposits, which probably increases the  $p_{\text{Cl}_2}$  near the metal surface. For instance, the corrosion loss of stainless steel 310 after 164 h exposure to syngas with a  $p_{\text{S}_2}/p_{\text{O}_2}$  ratio of 18.5 and 1200 ppm is about 15  $\mu\text{m}$ . However, when a deposit containing 5% chloride is present the corrosion loss increases to 86  $\mu\text{m}$  and the corrosion mechanism changes from type A to type B (Fig. 6). Type A attack is shown in Fig. 6(a); here there is a sulfur-rich  $\text{FeCr}_2\text{S}_4$  outer scale and a uniform inner-scale layer. Type B attack is shown in Fig. 6(b); here the outer scale is a mixture of sulfides and oxides and sulfur-rich nodules are observed at the metal/scale interface.

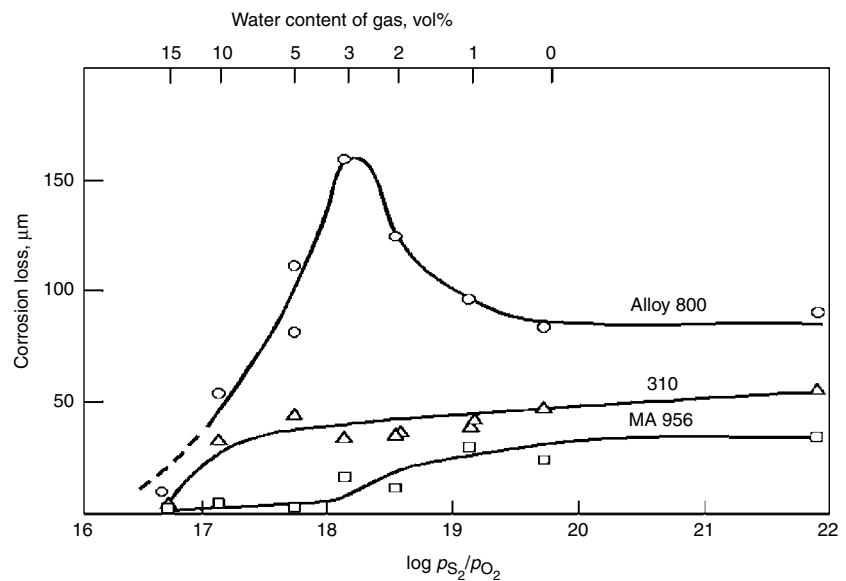
Fig. 5 Corrosion loss of three stainless steels as a function of partial pressure ratio  $\log p_{S_2}/p_{O_2}$  with 400 ppm HCl. Laboratory test 600 h, 540 °C (1000 °F)

When HCl is present in the syngas, the corrosion mechanism changes considerably, as is shown by a comparison of Fig. 5 to Fig. 3 (MA 956 is Fe-20Cr-4.5Al-Ti-Y, UNS S67956). Alloys with a relatively low chromium content such as alloy 800 now show a maximum corrosion rate at a  $p_{S_2}/p_{O_2}$  ratio of about 18, while alloys with a higher chromium content or similar oxide-forming alloying elements such as aluminum or silicon are relatively less affected by the addition of HCl to the gas. SEM/EDAX analysis

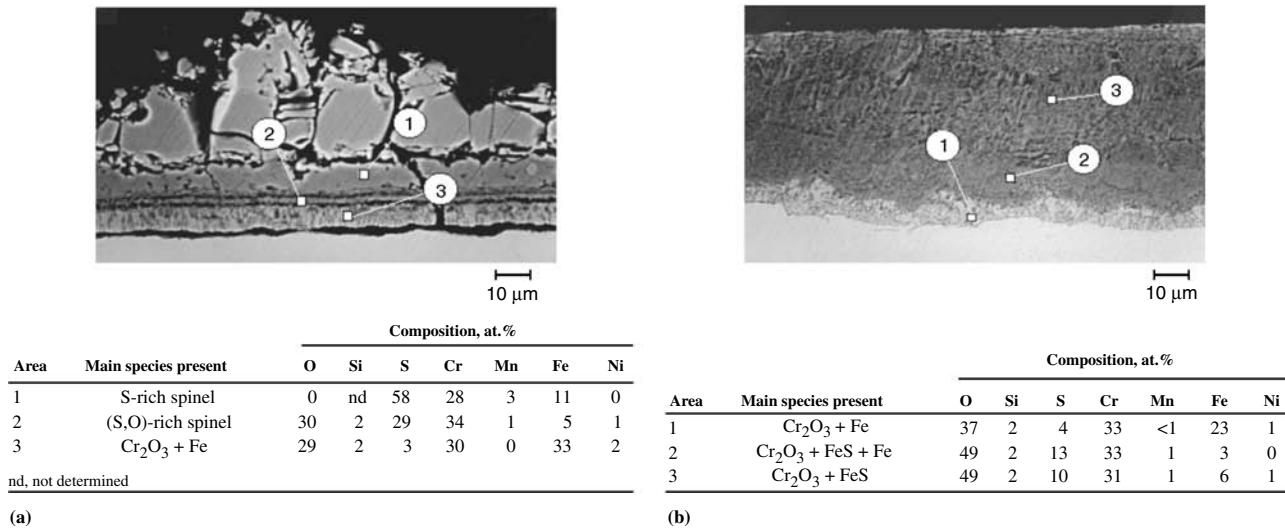
**Fig. 6** Corrosion of type 310 (UNS S31000) stainless steel in syngas with 1200 ppm HCl. The electron dispersive spectroscopy (EDS) analysis is given for indicated areas along with the main species present. (a) Without deposit of 5% chloride, corrosion loss is 15  $\mu\text{m}$  (0.6 mils). (b) With deposit of 5% chloride, corrosion loss is 86  $\mu\text{m}$ . (a) and (b) Original magnification: 750 $\times$

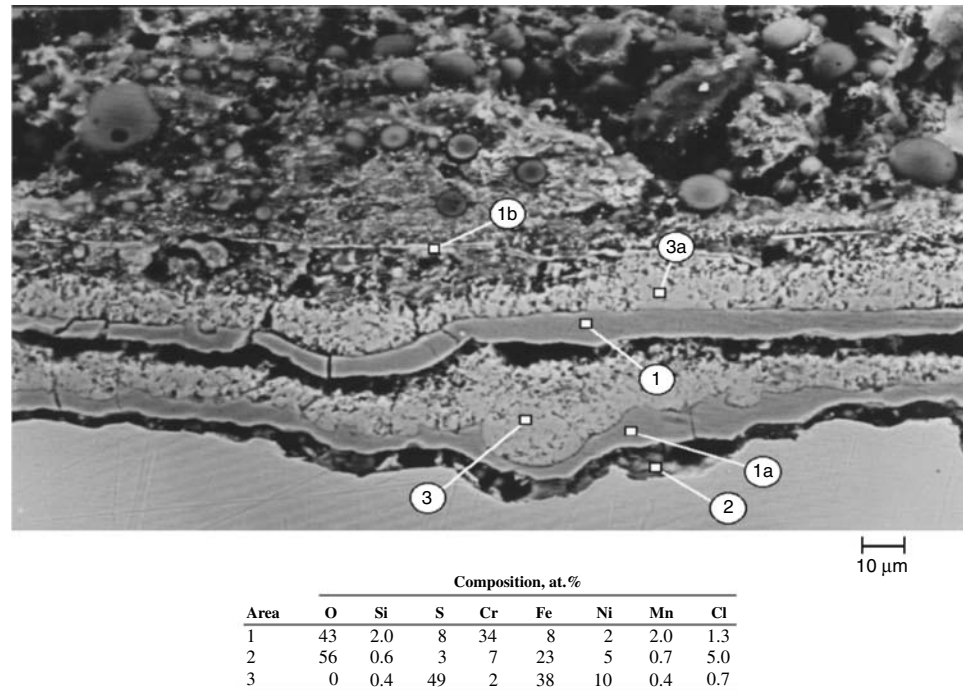
**Fig. 7** Scanning electron microscopy image of type 310 (UNS S31000) stainless steel after 3 high temperature/downtime corrosion cycles. Details of the labeled layers are given in the text. Original magnification: 500 $\times$

sequence repeats itself during each thermal cycle. Figure 7 shows the scale microstructure after three 200 h high-temperature cycles and three 24 h downtime periods in humid air at 400  $^{\circ}\text{C}$  (752  $^{\circ}\text{F}$ ). During the first 200 h, the very thin protective layer 1b is formed, which spalls during downtime. During the next 200 h, a faster-growing, less protective layer (1) forms, which also spalls during downtime. Similarly, layer 1a forms during the third exposure. Layer 2 is the oxide- and chloride-rich layer formed

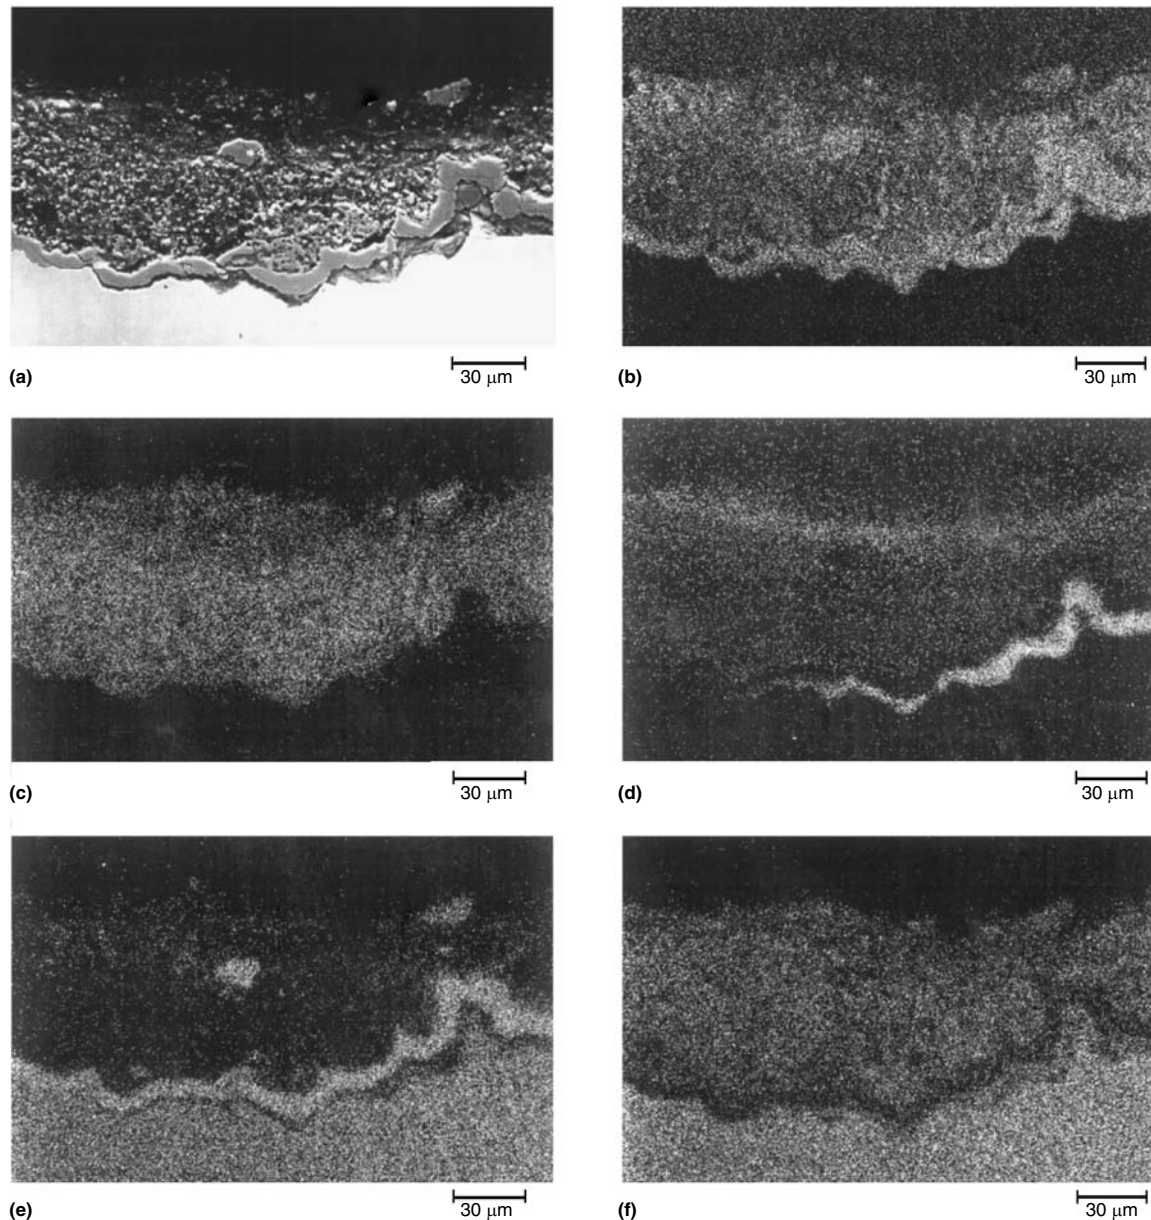
**Fig. 8** Scanning electron microscopy image and elemental maps of scale on 310 (UNS S31000) stainless steel after 17,000 h exposure in a syngas cooler. (a) Backscattered electron image. (b) Oxygen map. (c) Sulfur map. (d) Chlorine map. (e) Chromium map. (f) Iron map distribution

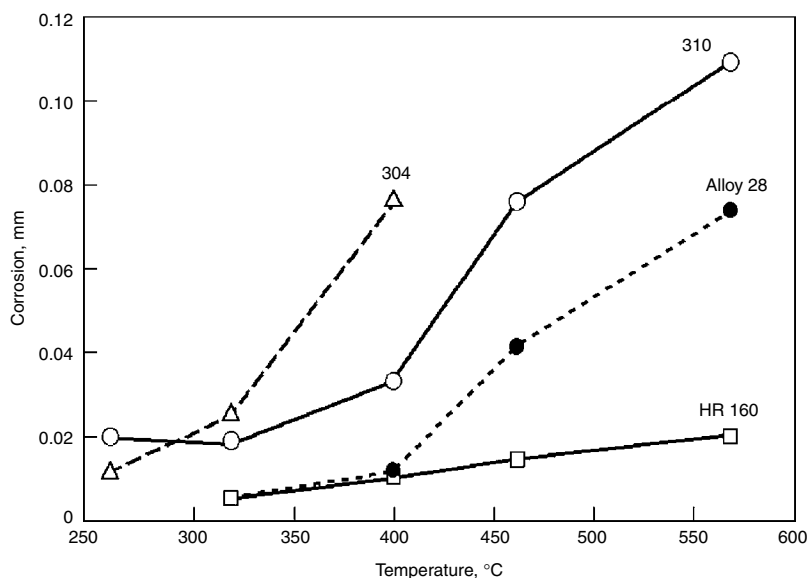
Fig. 9 Corrosion loss of stainless steels after 2000 h exposure in the Prenflo demonstration plant. Alloy 28 (UNS N08028), HR 160 (UNS N12160)

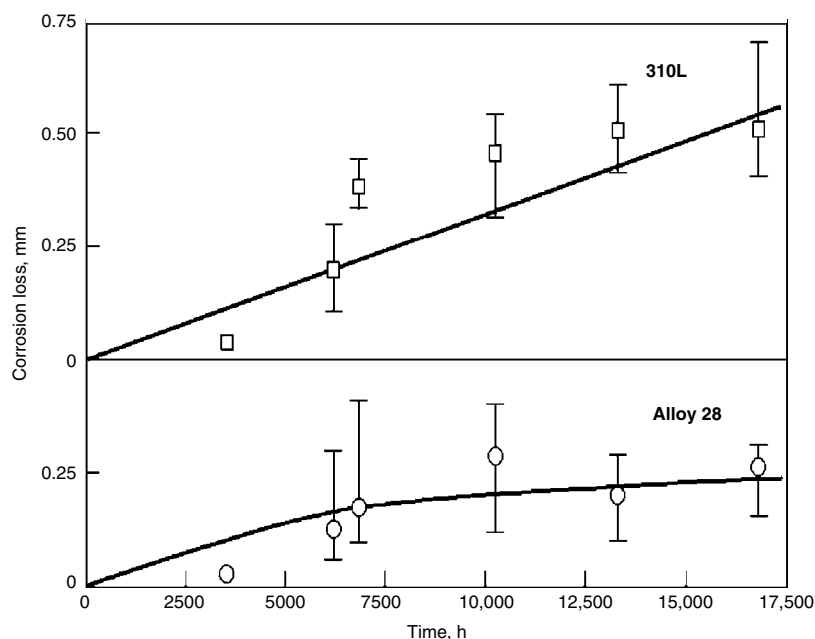
Fig. 10 Corrosion loss as a function of time of type 310 low-carbon stainless steel (UNS S31002) and alloy 28 (UNS N08028), during exposure in a syngas cooled at 390 to 420 °C (734 to 788 °F)

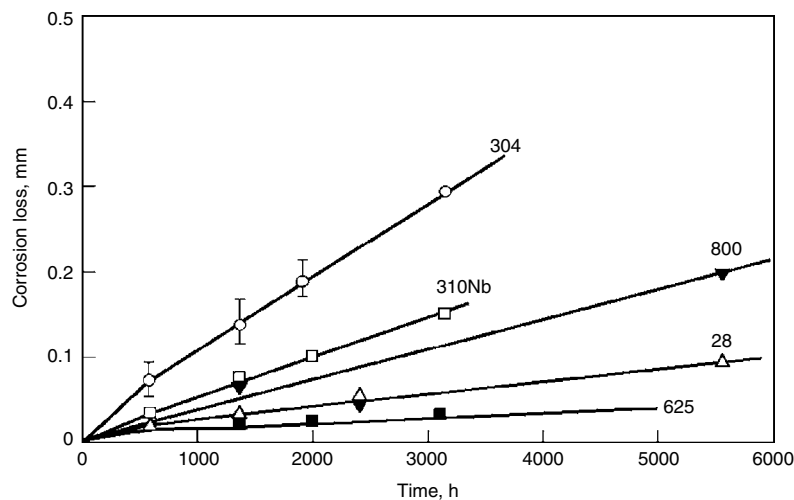
**Fig. 11** Corrosion losses of stainless steels and nickel alloys from a coal-gasification plant, gasifying coal residues with 0.2 to 0.5% Cl. 304 (UNS S30400), 310Nb (UNS S31040), 800 (UNS N08800), 28 (UNS N08028), 625 (UNS N06625)

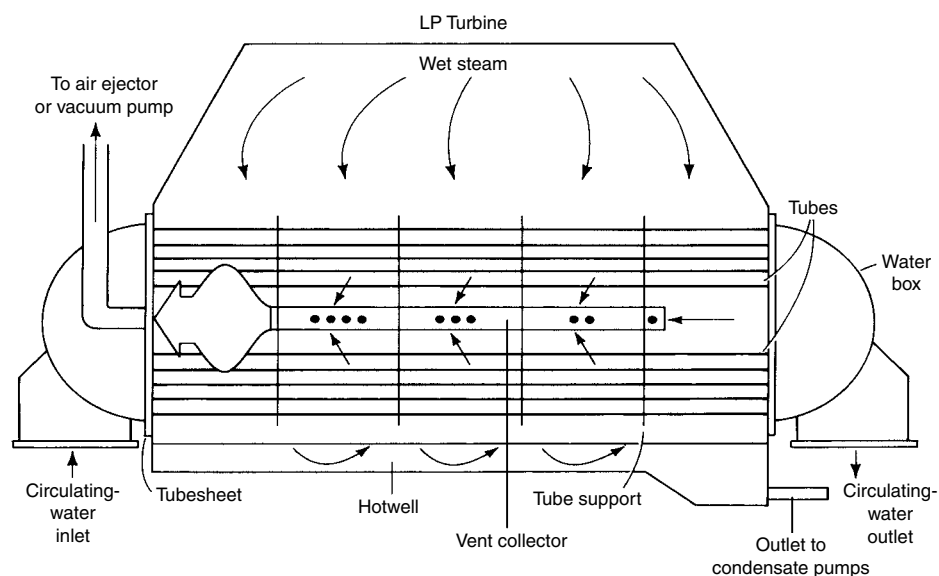
Fig. 1 Schematic of a typical condenser in an electric power plant. LP, low pressure

The lowest-pressure feedwater heaters may be located in the condenser neck. Condenser tubes are arranged to facilitate proper flow of wet steam through the array of tubes toward the air-removal region, from which the noncondensable gases are removed through a vent collector (Fig. 1) by external air ejectors or vacuum pumps (Ref 1–9). Makeup water for the main steam cycle is usually added into the condenser through a sparger (perforated pipe). The condensate, collected in the hotwell at the base of the condenser, is removed by one or more condensate pumps.

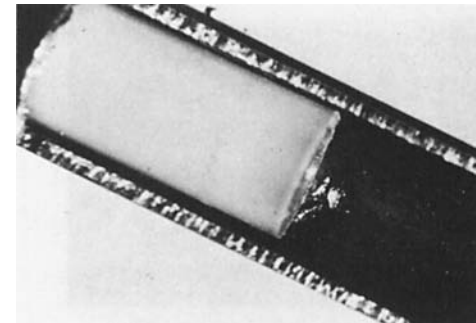
**Fig. 2** Erosion-corrosion occurring immediately downstream of a nylon insert in an aluminum brass condenser tube cooled by seawater

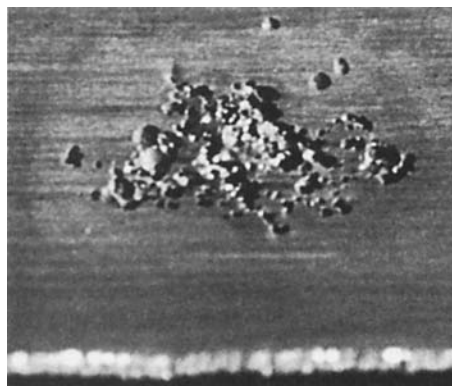
Fig. 3 Example of pitting in type 316 stainless steel in seawater service

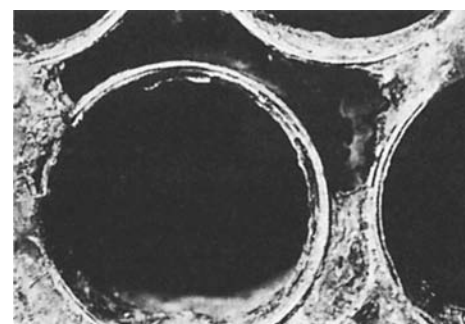
Fig. 4 Galvanic corrosion of a Muntz metal tubesheet, fitted with AL6X stainless steel tubes, after 1 year of seawater service

In seawater, tube materials, such as copper-nickel alloys, stainless steels, and titanium, are more noble than tubesheet materials, such as Muntz metal and aluminum bronze. Consequently, the tubesheet may suffer galvanic attack when fitted with these more noble tubes (Fig. 4) (Ref 2, 3, 19). Laboratory tests have demonstrated that the rate of galvanic corrosion of a Muntz metal tubesheet fitted with titanium or stainless steel tubes can exceed 5 mm/yr (200 mils/yr) in seawater (Table 4) (Ref 19). Similarly, if stainless steel inserts are installed in copper alloy tubes to prevent inlet-end

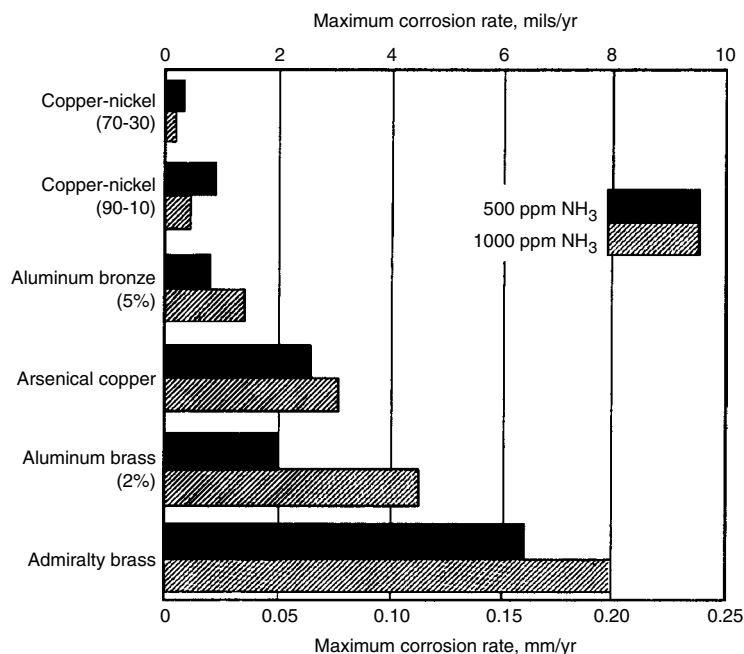
Fig. 5 Corrosion rates of copper alloys in aerated ammonia drip solutions. Source: Ref 26

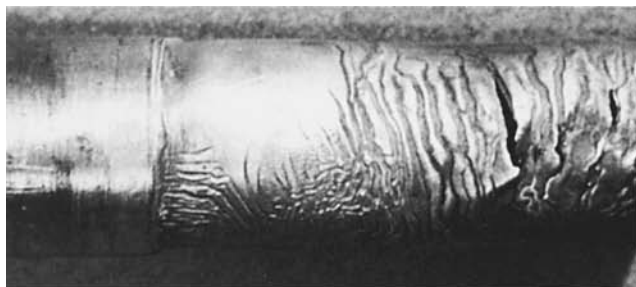
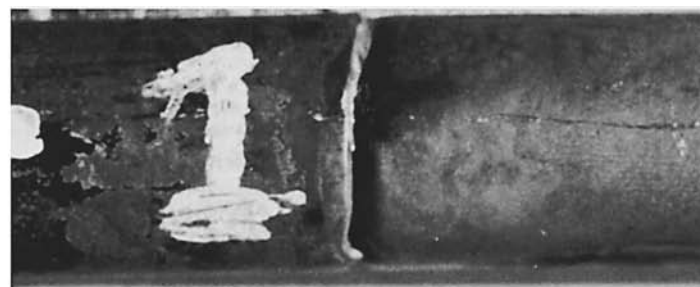
**Fig. 6** Examples of ammonia grooving on admiralty brass. (a) The unattacked tube end (left) was protected by the tubesheet. (b) Attack occurred at one side of a tube support plate

**Ammonia Grooving.** This form of condensate corrosion is localized, because the corrosive environment is localized (Ref 2, 5, 14, 23) (Fig. 6). For example, the slight tilt routinely

given to condenser tubes may promote flow of some of the steam condensate toward one side of a tube support plate. There, the flow from a large number of tubes can collect and run down the plate surface. Such localized flow can create deep circumferential corrosion grooves in the tubes immediately next to the support plate (Fig. 6b) if the condensate contains high levels of ammonia and oxygen. Ammonia grooving can be controlled by reducing the oxygen concentration in the condensate, as discussed previously for steam-side SCC, or by selecting more resistant alloys, such as copper-nickel alloys, or completely resistant alloys, such as stainless steels and titanium.

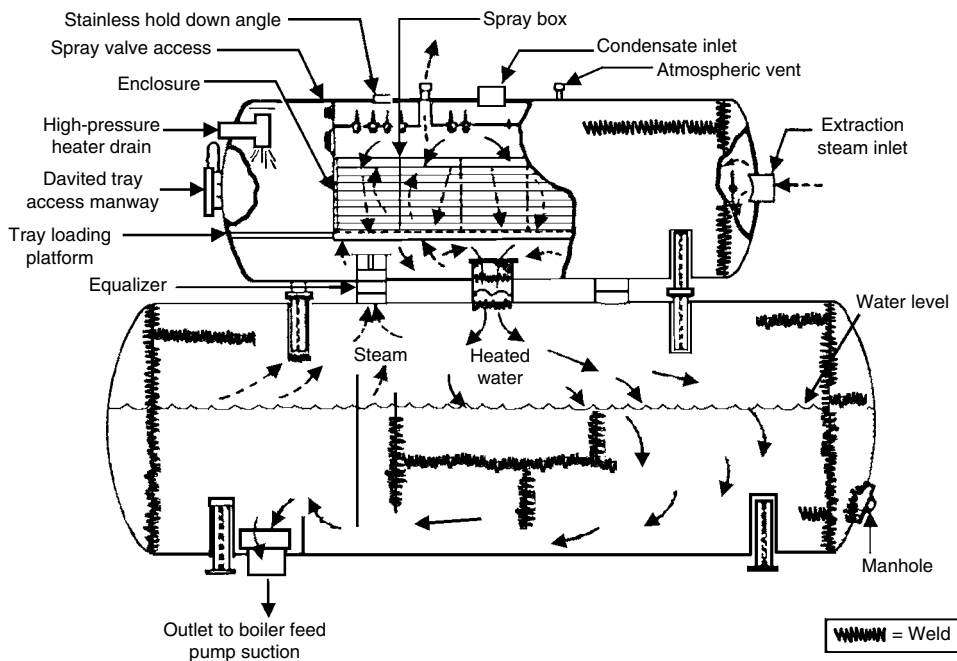
Fig. 7 Utility cycle tray deaerating heater with the deaerating vessel on top of storage tank. Courtesy of Jonas, Inc.

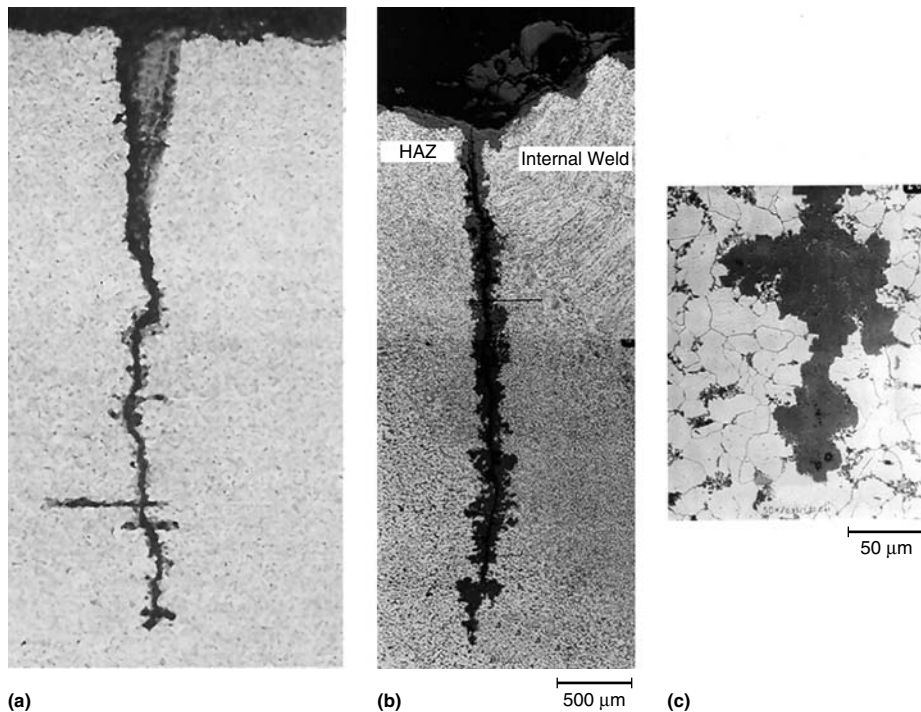
**Fig. 8** Cracks associated with carbon steel deaerator welds, (a) transverse in the weld and (b) longitudinal. (c) Closeup of crack tip in (b). Courtesy of Jonas, Inc.

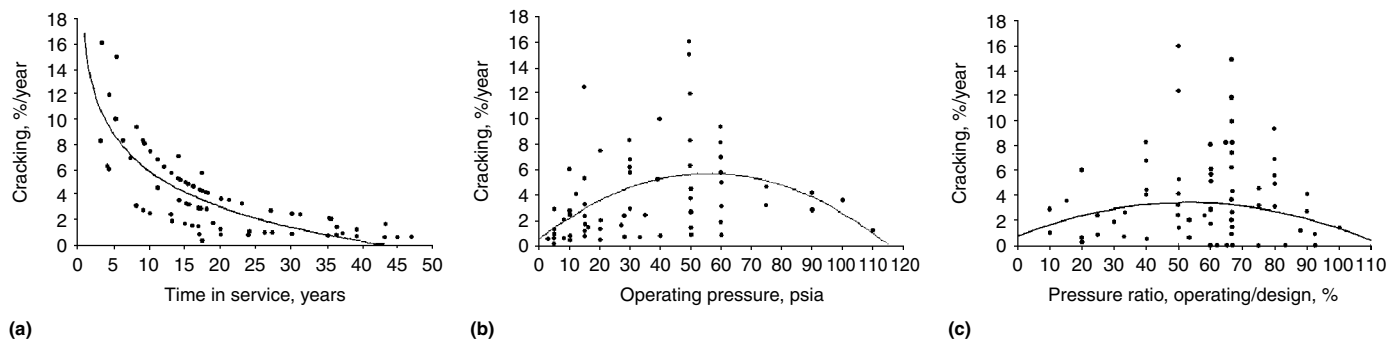
**Fig. 9** Deaerator storage tank weld cracking: crack depth as a percentage of wall thickness per year versus (a) time in service, (b) operating pressure, and (c) operating/design pressure ratio. Source: Ref 50

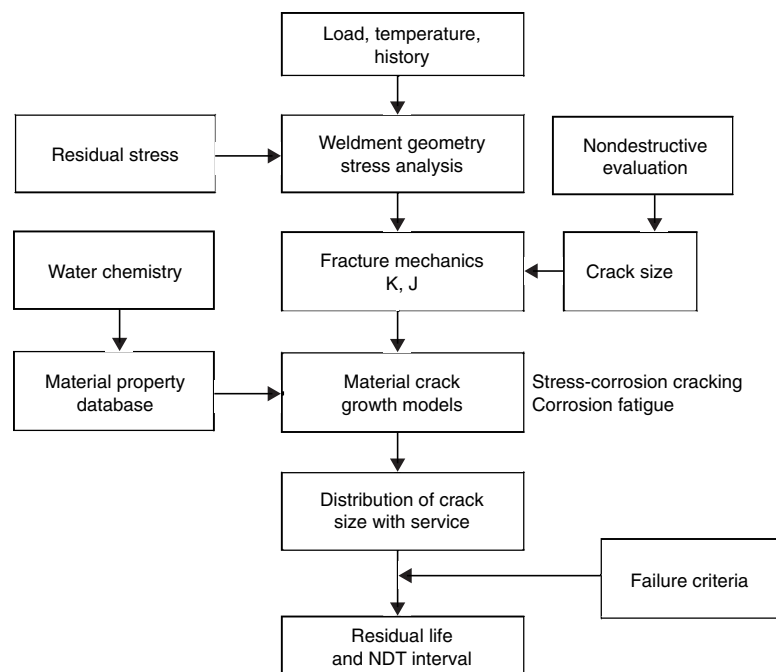
**Fig. 10** Life assessment of deaerators. Source: Ref 50

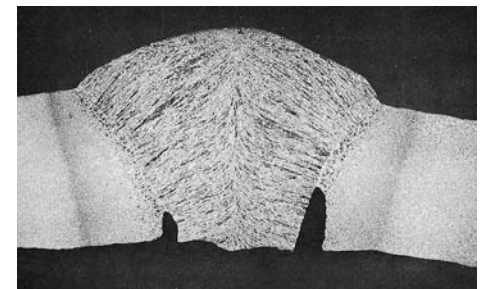
**Fig. 11** Preferential heat-affected zone corrosion in carbon steel from service in aqueous conditions. Original magnification: 5 $\times$ . Source: Ref 63

Although not widely recognized, the HAZ can be subject to preferential corrosion (Fig. 11) (Ref 63). The phenomenon has been observed in a wide range of environments with the common links being an elevated conductivity and pH values normally ranging from below 7 to about 8.

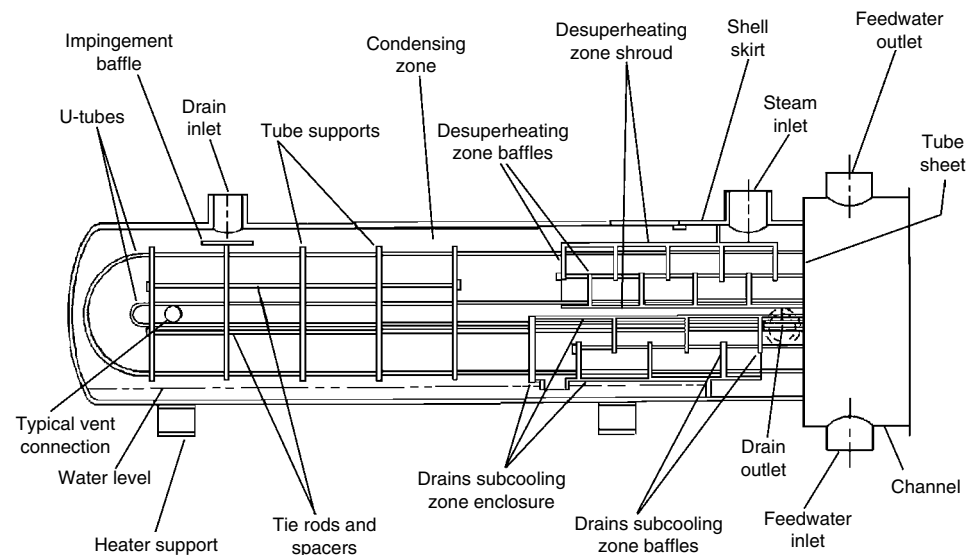
Fig. 12 Three-zone feedwater heater (desuperheating, condensing, and subcooling zones). Courtesy of Heat Exchange Institute

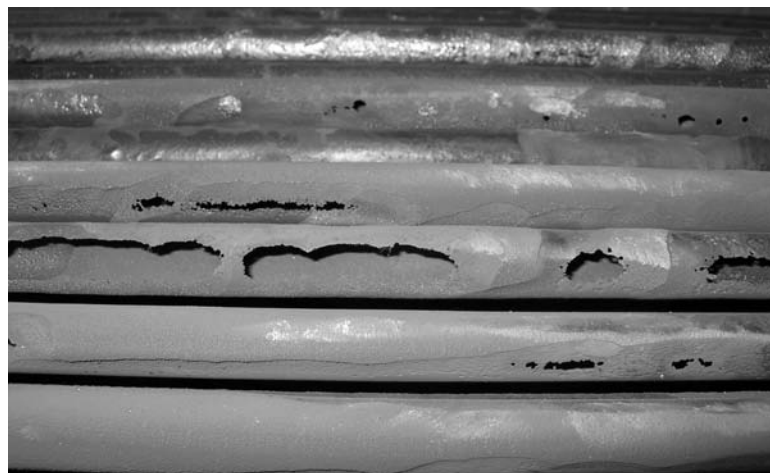
**Fig. 13** Flow-accelerated corrosion of carbon steel feedwater heater tubes. Courtesy of Jonas, Inc.

The inlet-end of the tubes is the most susceptible. Flow-accelerated corrosion can be minimized by the use of flow diffusers in the inlet channel to reduce inlet turbulence and ensure even distribution of the flow to all tubes. Tube inserts may also be used; however, care should be taken to avoid galvanic corrosion. Other measures for preventing flow-accelerated corrosion in feedwater heater tubes include:

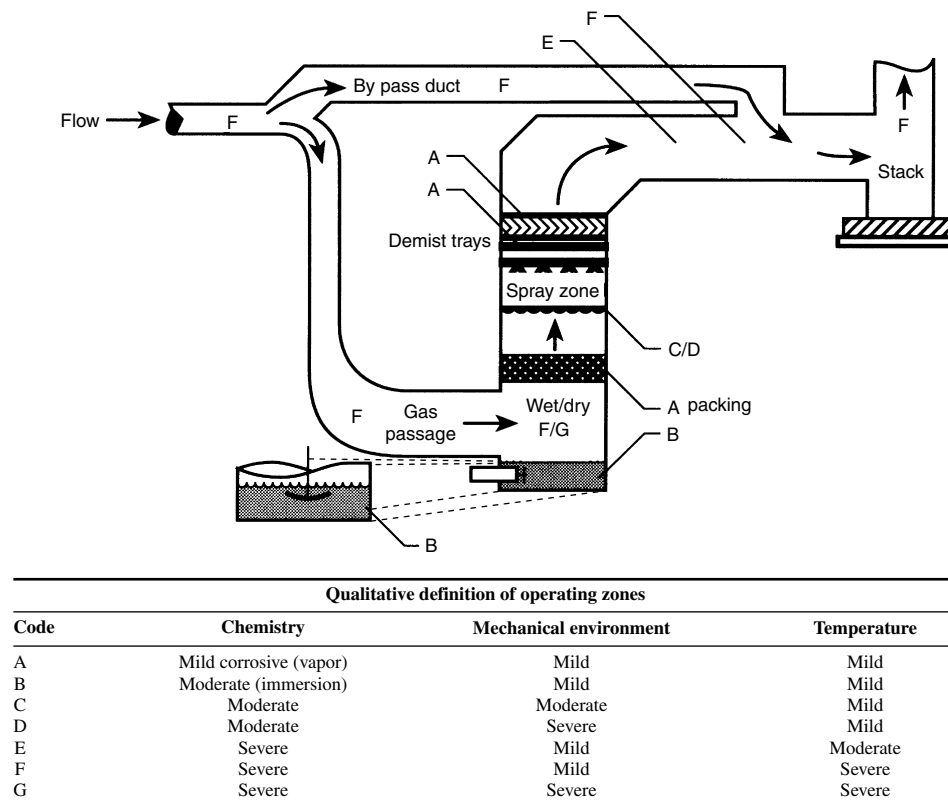
Fig. 1 Operating zones for generic FGD system, ASTM D-33.09 modified. Source: Ref 3

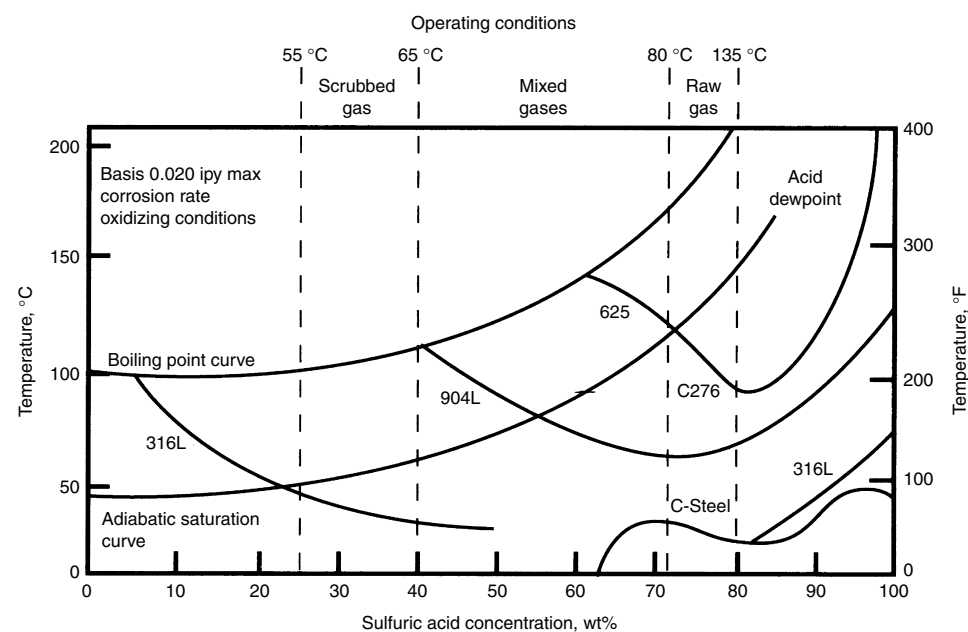
**Fig. 2** Suggested alloys to resist sulfuric acid corrosion in FGD systems. Source: Ref 3

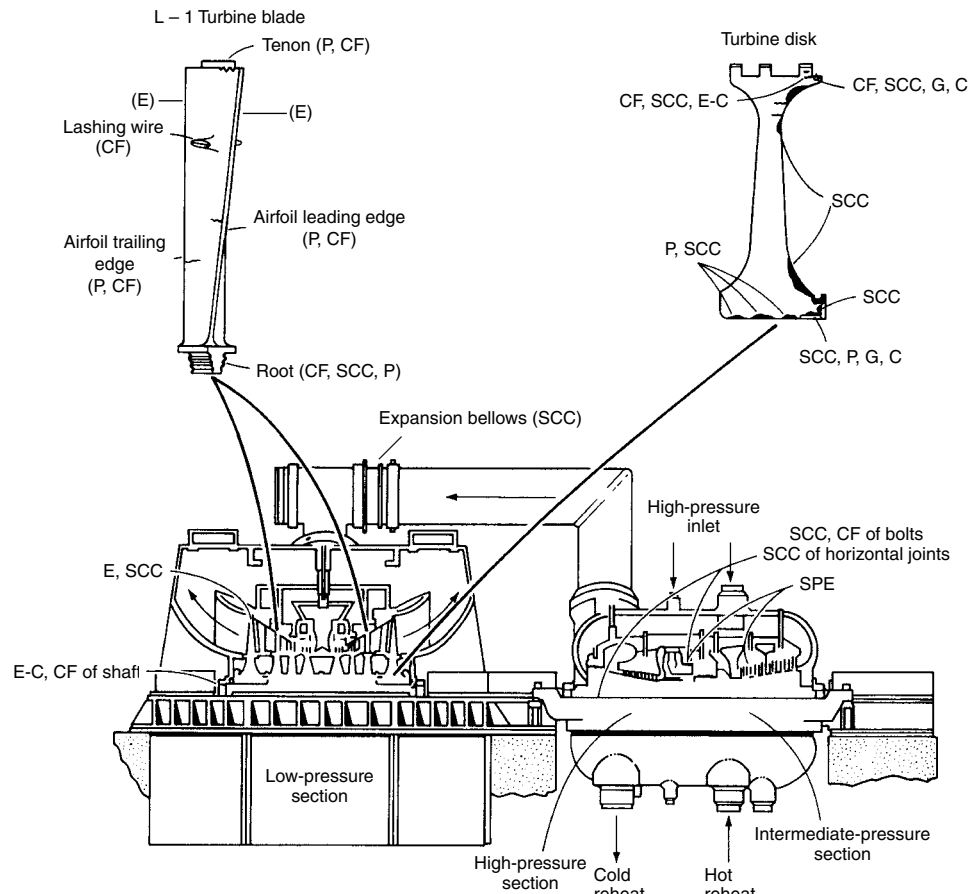
**Fig. 1** Medium-sized utility turbine with locations of corrosion and erosion of steam turbine components. P, pitting; CF, corrosion fatigue; SCC, stress-corrosion cracking; C, crevice corrosion; G, galvanic corrosion; E, erosion; E-C, erosion-corrosion; SPE, solid-particle erosion

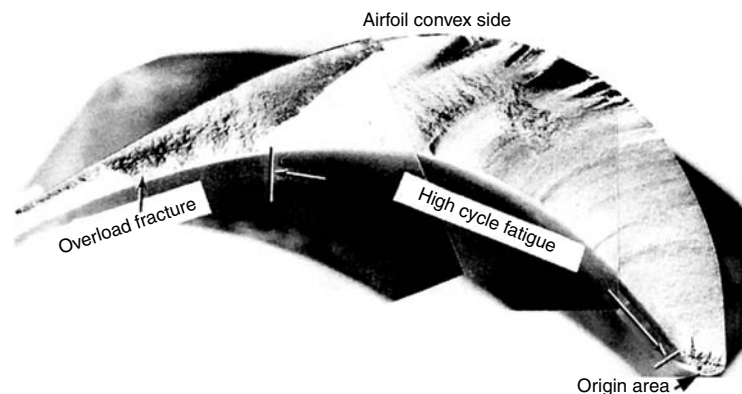
**Fig. 2** Corrosion fatigue of an L-1 blade airfoil. Courtesy of O. Jonas, Jonas, Inc.

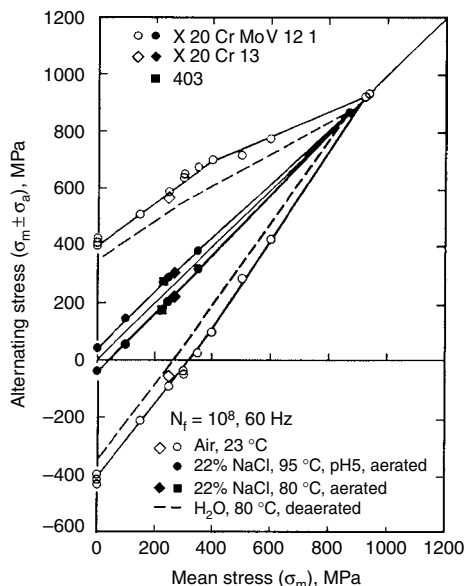
**Fig. 3** Corrosion fatigue (Goodman) diagram for three stainless steel blading alloys in various environments. Based on  $10^8$  cycles to failure at 60 Hz. Source: Ref 23

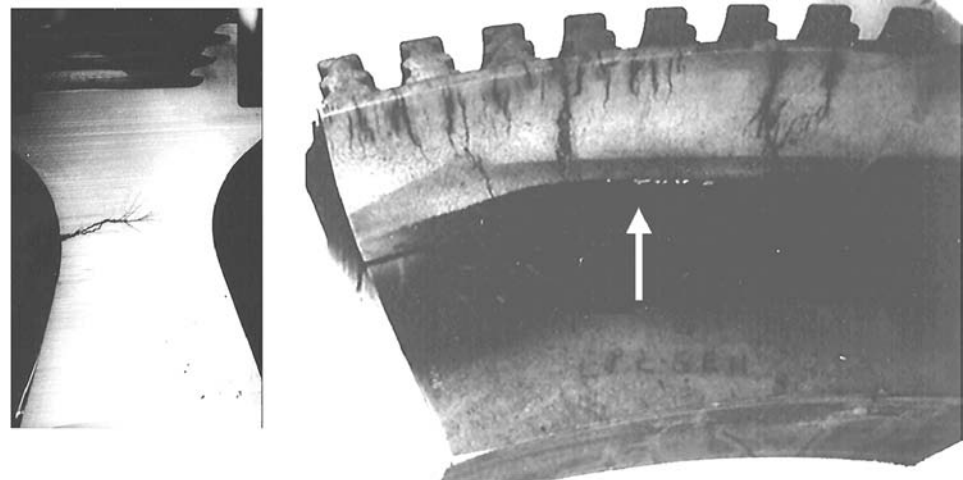
**Fig. 4** Massive stress-corrosion cracking of L-1 disc caused by high concentration of NaOH in steam. Courtesy of O. Jonas, Jonas, Inc.

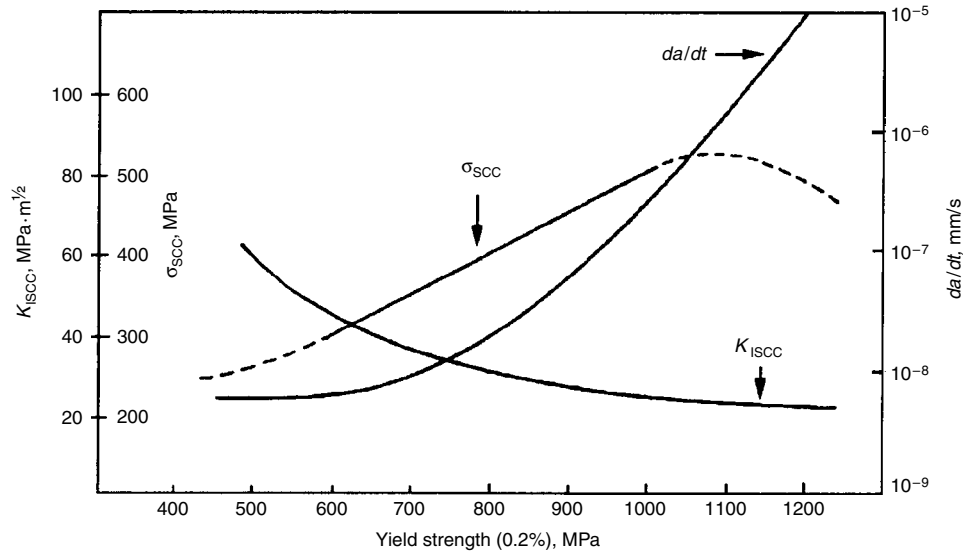
Fig. 5 Stress-corrosion behavior of NiCrMoV disc steel vs. yield strength for “good” water and steam.  $K_{ISCC}$ , threshold stress intensity;  $\sigma_{SCC}$ , threshold stress;  $da/dt$ , stage 2 crack growth rate. Courtesy of O. Jonas, Jonas, Inc.

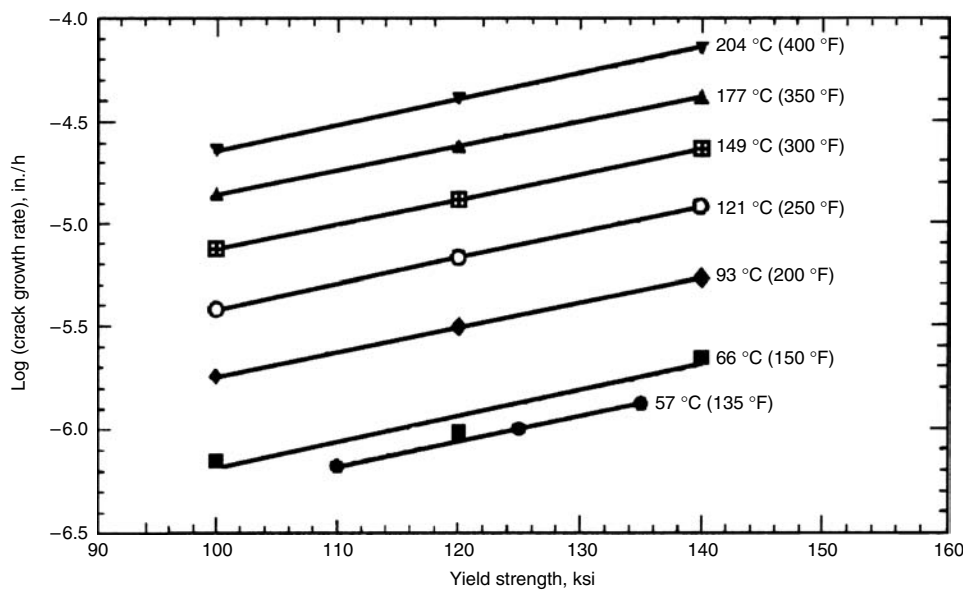
Fig. 6 Average crack growth rates vs. yield strength for several operating temperatures for NiCrMoV disc steel.  $\log (da/dt) = -2.093 - 3218.9 (1/T) + 0.01207 (YS)$ .  $da/dt$ , crack growth rate (in./h); YS, yield strength; T, temperature. Source: Ref 34

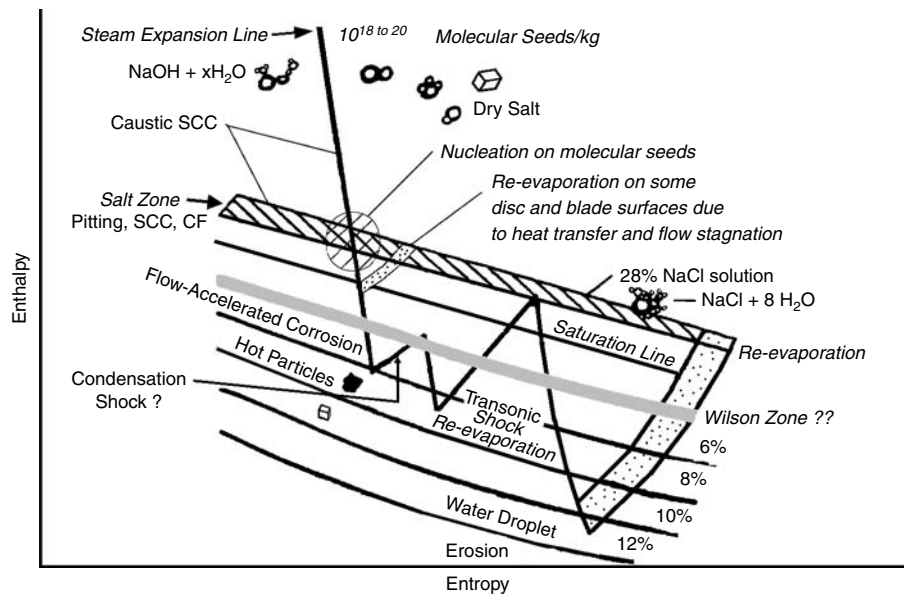
**Fig. 7** Mollier diagram showing the low-pressure turbine steam expansion line, thermodynamic regions of impurity concentration, and corrosion mechanisms. Percent moisture lines are given. SCC, stress-corrosion cracking; CF, corrosion fatigue. Courtesy of O. Jonas, Jonas, Inc.

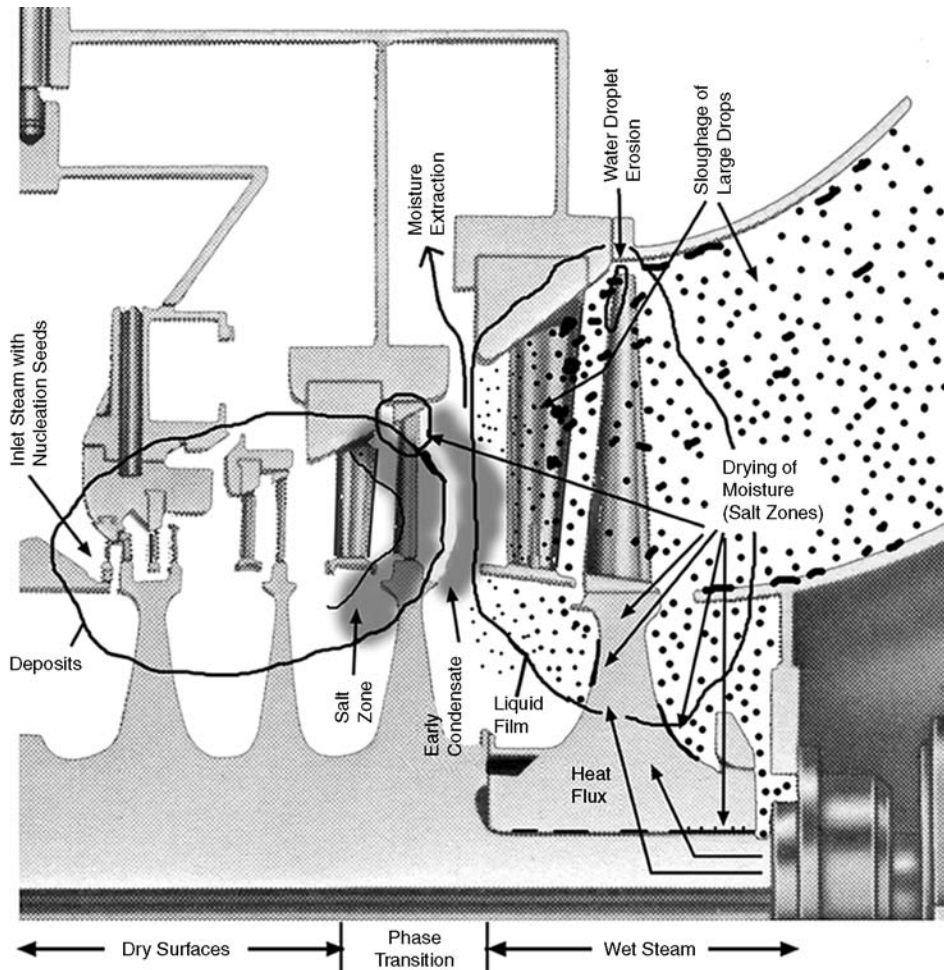
**Fig. 8** Cross section of a low-pressure turbine illustrating the locations where impurities can concentrate by precipitation, deposition, and by evaporation of moisture to percent concentrations, thus becoming very corrosive. Courtesy of O. Jonas, Jonas, Inc.

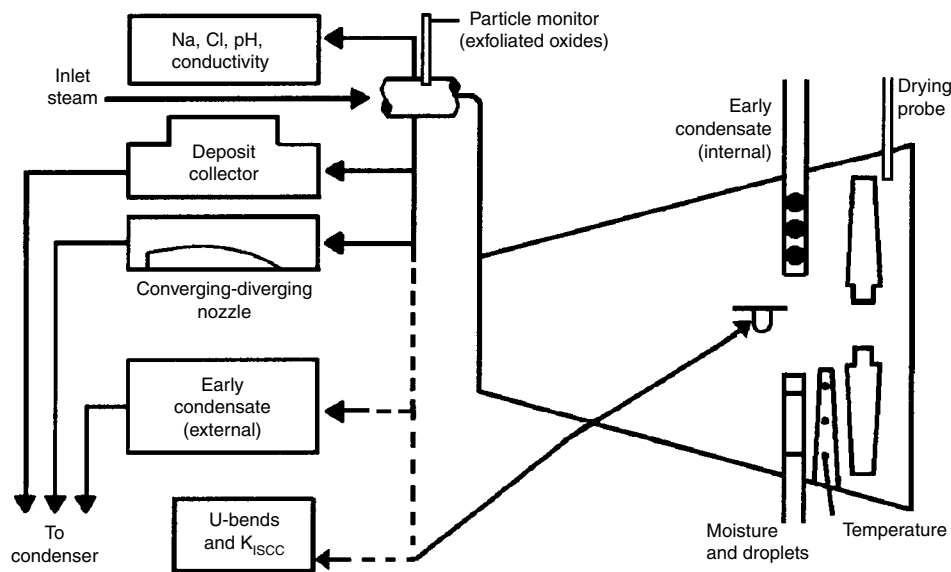
Fig. 9 Low-pressure turbine troubleshooting instrumentation can identify specific corrosive conditions.  $K_{1SCC}$  threshold stress intensity. Courtesy of O. Jonas, Jonas, Inc.

The field monitoring equipment shown in Fig. 9 can be used to diagnose and prevent many common LP turbine corrosion and deposition problems (Ref 68). In addition, there are monitors available to detect vibration and provide vibration signatures of the whole machine, blade and rotor cracking, steam leaks, air leakage, rotor position, and wear of bearings.

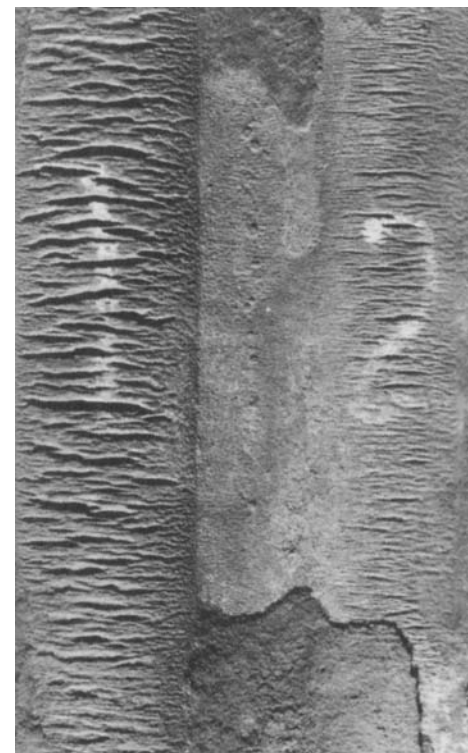
Fig. 1 Surface of a waterwall showing circumferential grooving resembling alligator hide

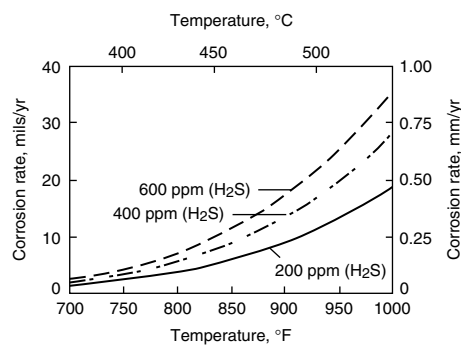
**Fig. 2** Predicted corrosion rates of SA213-T2 (UNS K11547) alloy steel under different  $\text{H}_2\text{S}$  concentrations as a function of metal temperature

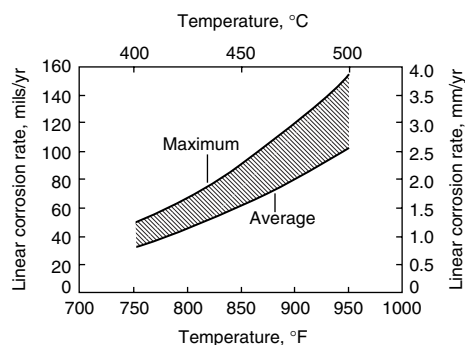
**Fig. 3** Maximum and average corrosion rates predicted for SA213-T2 (UNS K11547) alloy steel covered with FeS-rich ash in combustion gas containing 1%  $\text{O}_2$  as a function of metal temperature

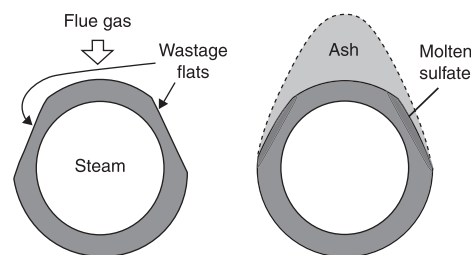
Fig. 4 Fuel ash corrosion on superheater and reheater tubes showing the maximum metal loss at the 2 and 10 o'clock positions

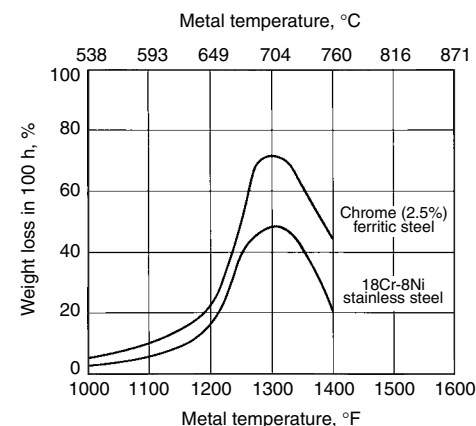
Fig. 5 Corrosion rates of chrome (2.5%) ferritic steel, SA213-T22 (UNS K21590), and 18Cr-8Ni stainless steel, type 304 (UNS S30400), exhibiting a bell-shape curve as a function of temperature

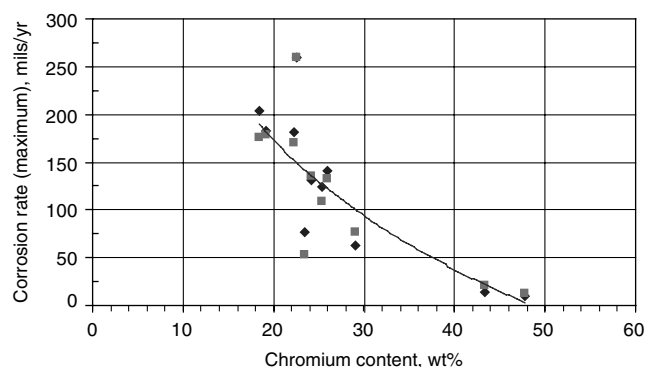
Fig. 6 Maximum coal ash corrosion rates of alloys in ultrasupercritical boilers as a function of chromium concentration. Squares and diamonds are data from different test loops.

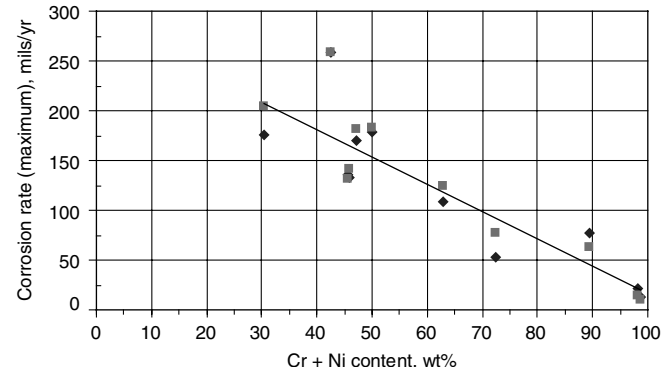
Fig. 7 Maximum coal ash corrosion rates of alloys in ultrasupercritical boilers as a function of Cr + Ni concentration. Squares and diamonds are data from different test loops.

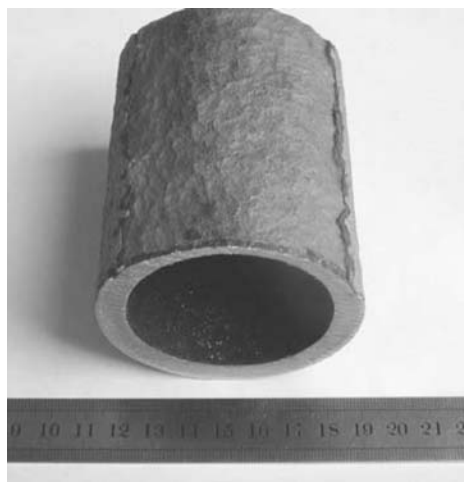
**Fig. 1** The overlay cladding, approximately 2 mm (80 mils) thick of alloy 625 (UNS N06625) overlay superheater tube, was corroded away in 15 months in a waste-to-energy boiler.
