# ASM Handbook®

## Volume 13C Corrosion: Environments and Industries

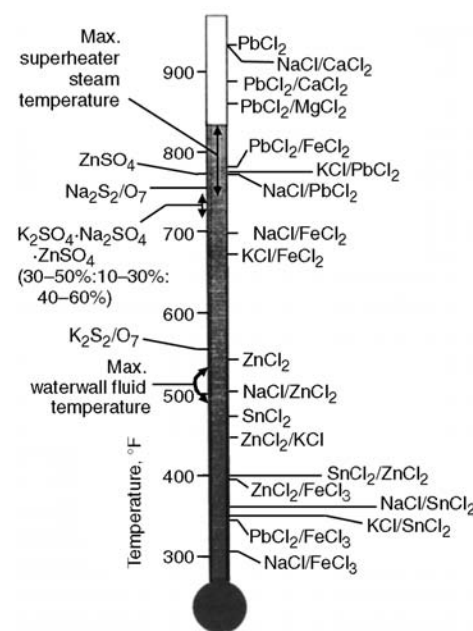
**Fig. 2** Melting points of various metal chlorides including eutectics and sulfur-containing compounds that might be present in waste-to-energy combustion environments (Ref 10)

For example,  $ZnCl_2$  exhibits 10 Pa ( $10^{-4}$  atm) of vapor pressure when the temperature reaches 349 °C (660 °F). This vapor pressure is generally considered to be high enough to cause high-temperature corrosion. Studies of the corrosion of alloys by  $ZnCl_2$  vapor at 540 °C (1000 °F) found alloy 625 suffering an extrapolated corrosion rate of 3.07 mm/yr (121 mils/yr) (Ref 8). Some of the salt vapor might have deposited on the test specimen as well in the test. Thus, the corrosion attack could be due to both  $ZnCl_2$  vapor and liquid deposit. Nevertheless, the extrapolated corrosion rate was in the same order of magnitude as the wastage rates observed for alloy 625 cladding in coextruded composite or weld overlay superheater tubes in some aggressive WTE boilers (Ref 6, 9). Many chlorides exhibit low melting points. Figure 2 shows the

melting points of those metal chlorides including eutectics and sulfur-containing products that might be present in WTE combustion environments (Ref 10).

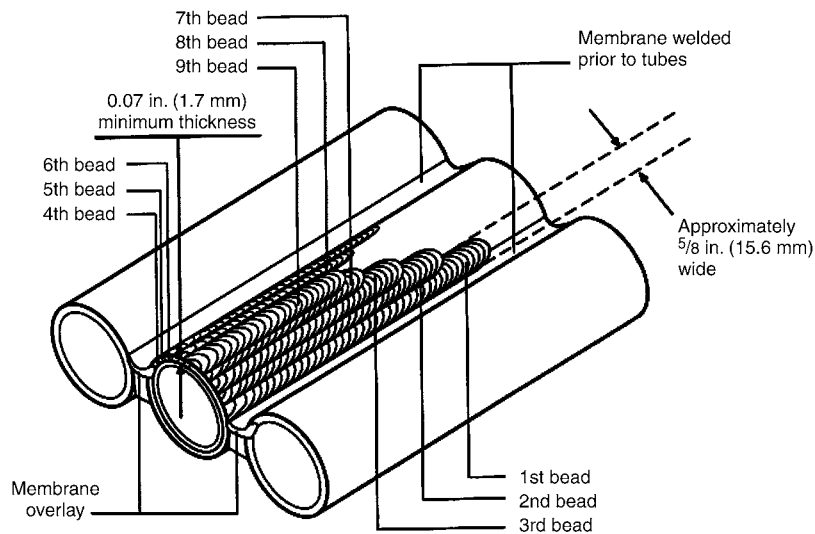
**Fig. 4** Weld overlay cladding of the furnace waterwall for corrosion protection of carbon steel boiler tubes and membranes in WTE boilers. Source: Welding Services Inc.

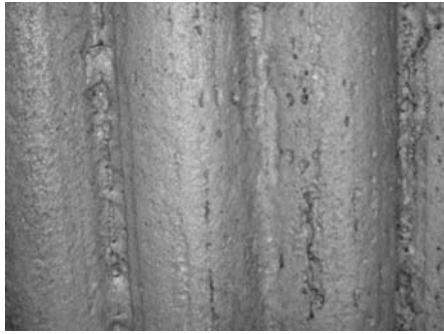
**Fig. 5** Alloy 625 overlay on the waterwall revealing typical pitting type corrosion attack

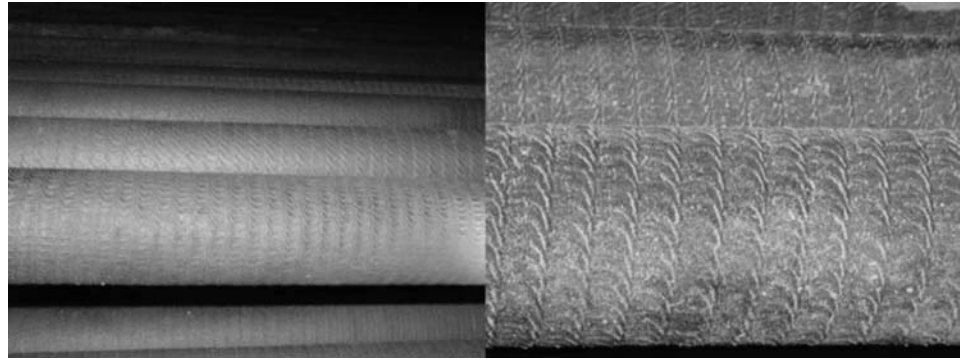
**Fig. 6** Overview (left) and close-up view (right) of alloy 625 overlay tubes after 4½ years of service in a superheater in a WTE boiler. Weld bead ripples are still clearly visible.

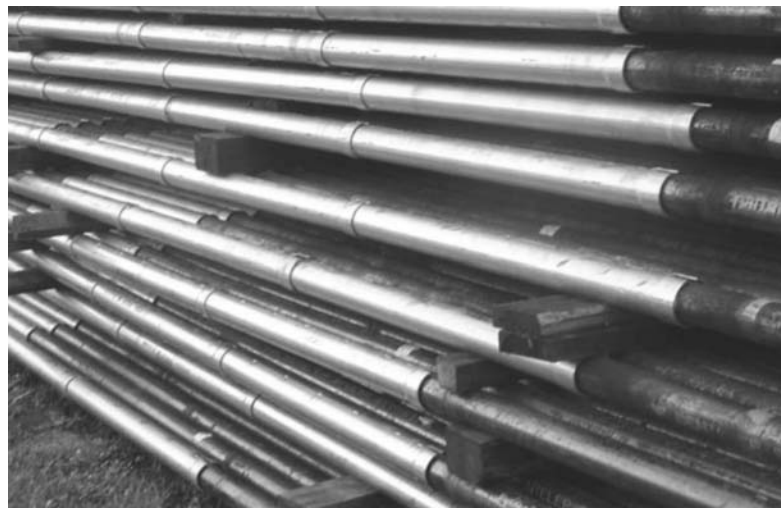
**Fig. 7** Carbon steel superheater tubes protected by metallic tube shields awaiting installation at one waste-to-energy plant

Another common protection method is the use of tube shields, which are typically made of type 309 (UNS S30900), 310 (UNS S31000), 253MA (UNS S30815) stainless steel, or other austenitic alloys. Figure 7 shows carbon steel superheater tubes protected by metallic tube shields awaiting installation at a WTE plant. The tube shields are generally exposed to the temperatures as high as those of flue gas stream entering into the superheater tube bundle, which can vary from 650 to 900 °C (1200 to 1650 °F). As a result, the tube shields typically suffer chloride attack and sulfidation attack. Furthermore, the shields are typically attached to the tube by mechanical clamps and fillet welds. In addition to

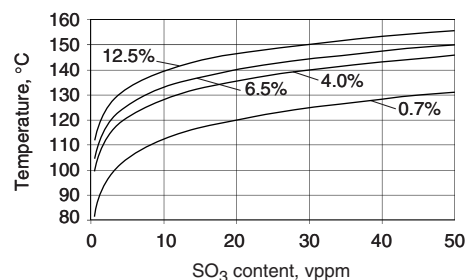
Fig. 1 Dew-point behavior of SO<sub>3</sub> at various water contents in the gas. Source: Ref 1

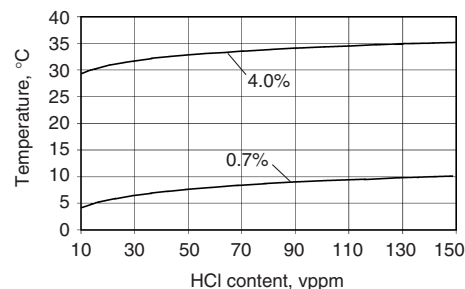
Fig. 2 Dew-point behavior of HCl at 0.4 and 7% water contents in the gas. Source: Ref 2

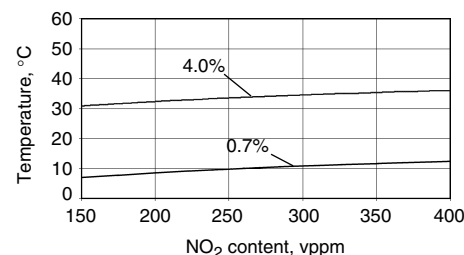
Fig. 3 Dew-point behavior of NO<sub>2</sub> at 0.7 and 4% water content in the gas. Source: Ref 3

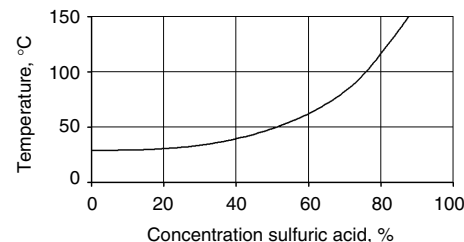
Fig. 4 Concentration of condensed sulfuric acid from an SO<sub>3</sub> gas containing 4% water

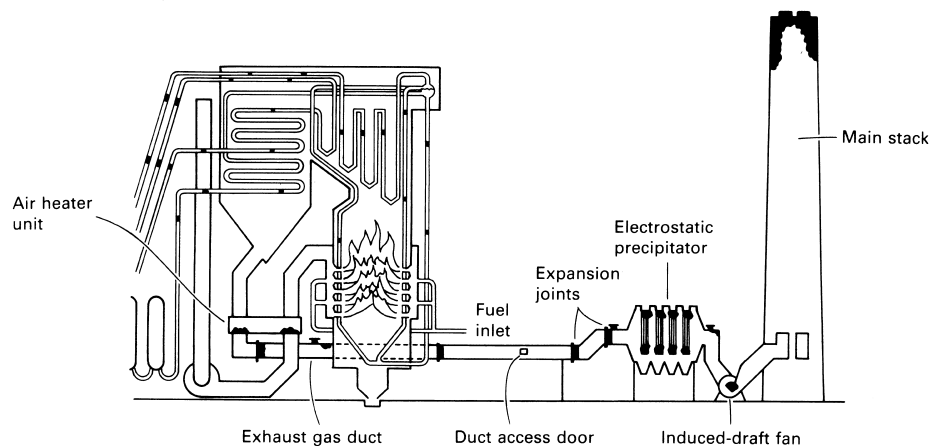
**Fig. 5** Fossil-fired power generation boiler showing areas susceptible to dew-point corrosion (black areas)

A conventional coal-fired power generation boiler is illustrated in Fig. 5; the locations of items prone to dew-point corrosion are indicated. The most susceptible areas are discussed in this section.

**Ductwork, Expansion Joints, Inspection or Sampling Ports, and Access Doors.** Damage at the locations shown in Fig. 5 is often caused by constant low operating temperatures, which normally are related to air entry at fabrication faults, leaking expansion joints and door seals, or careless replacement of sampling port covers. Such leaks can cause an appreciable reduction in duct metal temperature due to stratification effects within the gas stream. Attack rates of 5 mm/yr (200 mils/yr) have been reported in precipitator outlet manifold ductwork. Such

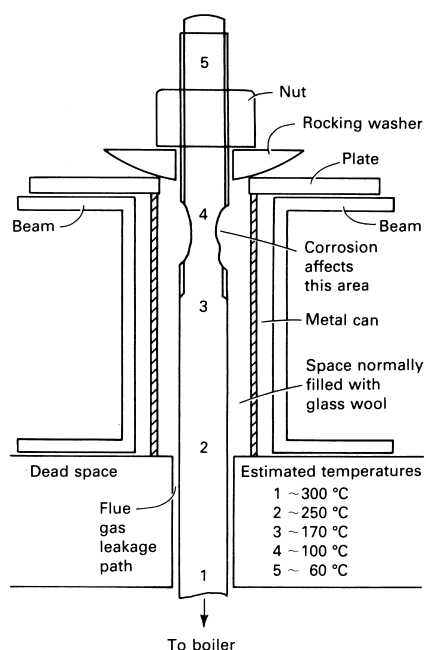
Fig. 6 Hangar bar packing box showing areas prone to corrosion. Source: Ref 4

**Penthouse Casing and Hanger Bars.** The penthouse casing encloses the tube header pipework above the boiler furnace roof. Flue gas leakage from the furnace can cause corrosion of the casing and furnace support steelwork. The hanger bars holding the furnace tube bundles are particularly susceptible to attack near the seals retaining the bars passing from the casing to the external environment (Fig. 6). Bars can corrode such that insufficient cross section remains to support the load, and failure allows collapse of the furnace roof and superheater tube bundles.

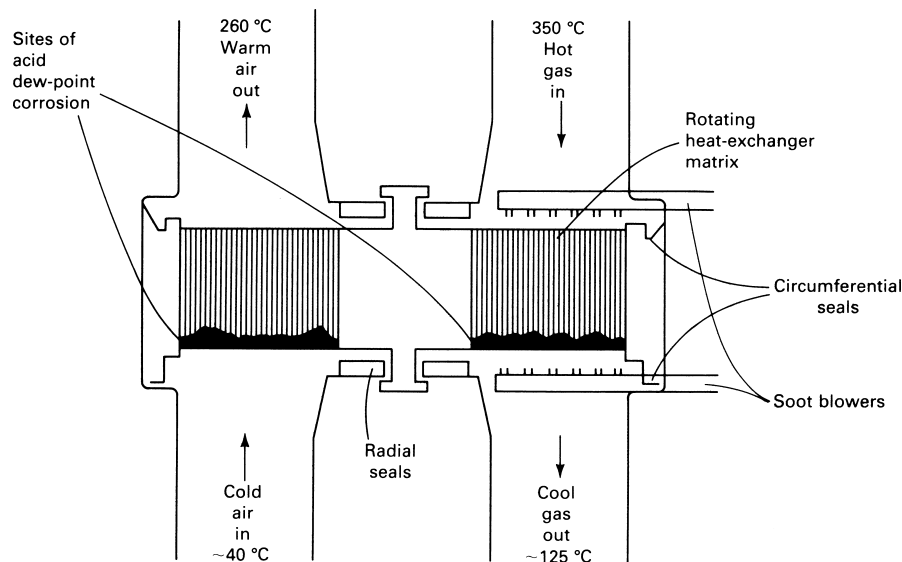
Fig. 7 Ljungström air heater showing the locations of the air seal and cold end basket corrosion sites

contact with the cold intake air, the heat energy is released. For both heat-exchanger types, damage is usually most severe at the cold end. A Ljungström rotating-matrix air heater is shown schematically in Fig. 7. Rothemühle air heaters are similar except that the matrix is stationary and the flue gas/inlet air is supplied by an arrangement of rotating hoods. In the Ljungström type, the ductwork is stationary, and the heat-exchanger matrix rotates in either a horizontal or a vertical plane.

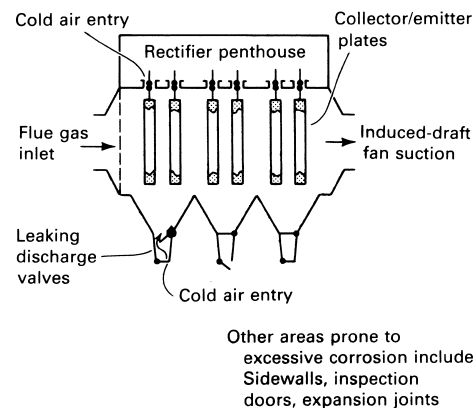
Fig. 8 Electrostatic precipitator showing areas prone to excessive corrosion

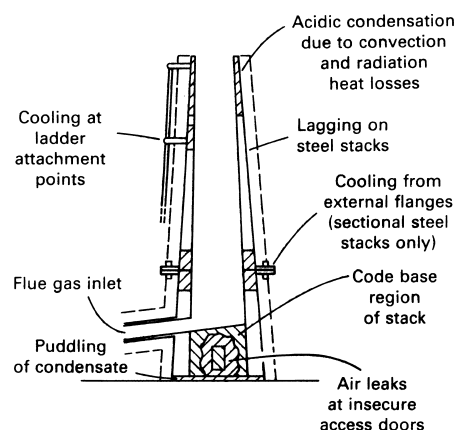
Fig. 9 Chimney stack showing sites prone to corrosion

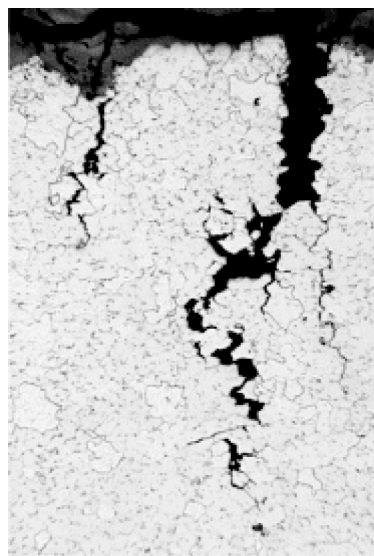
Fig. 10 Intergranular nitrate SCC in a low-temperature heat exchanger

**Low-Temperature Heat Exchangers.** In general, the heat exchangers are fabricated from a standard low-carbon steel used for construction purposes. In some cases soon after going into service (i.e., within one year) nitrate-induced SCC can occur in the HRSGs. Most observed cracking occurs in bends and finned tubes where mechanical stresses were relatively high. Microscopic analyses of samples revealed that intergranular corrosion had occurred, and it was frequently reported that complete grains of material had become detached. A cross section of a cracked tube is depicted in Fig. 10.

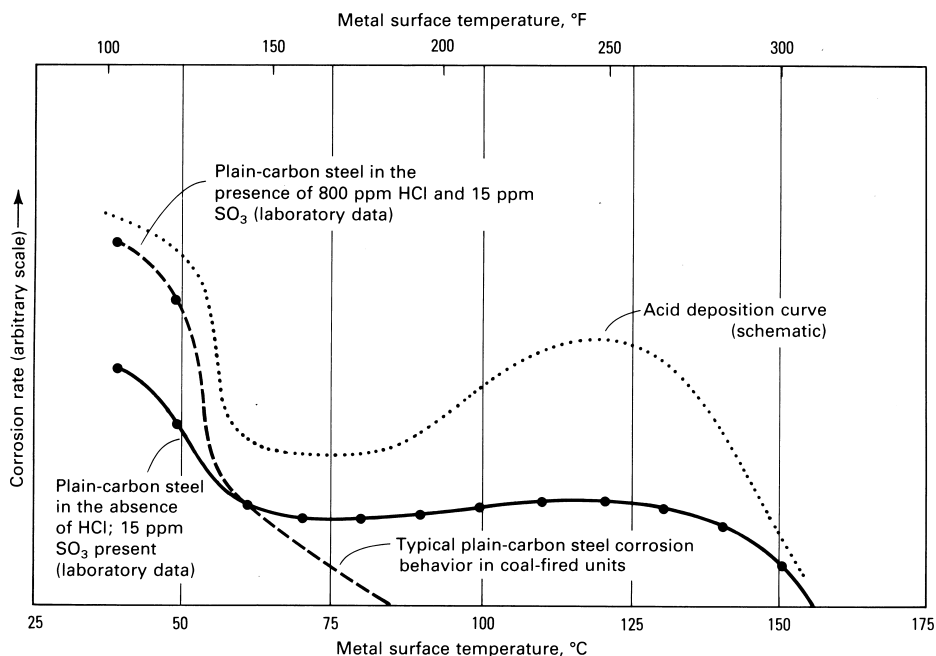
**Fig. 11** Modified acid dew-point curve showing the corrosion rate of freshly prepared plain-carbon steel surface exposed to dust-free flue gas in a laboratory test rig. The increase in corrosion rate at lower temperatures in the presence of HCl is shown. The modification of classic dew-point corrosion behavior in coal-fired power plants also is indicated.

least three times the high-temperature maximum if HCl is present (Fig. 11).

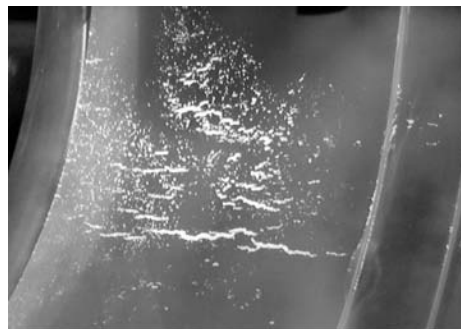
**Fig. 1** Fluorescent dye penetrant examination showing linear indications of stress-corrosion cracking in an 18Mn-5Cr retaining ring

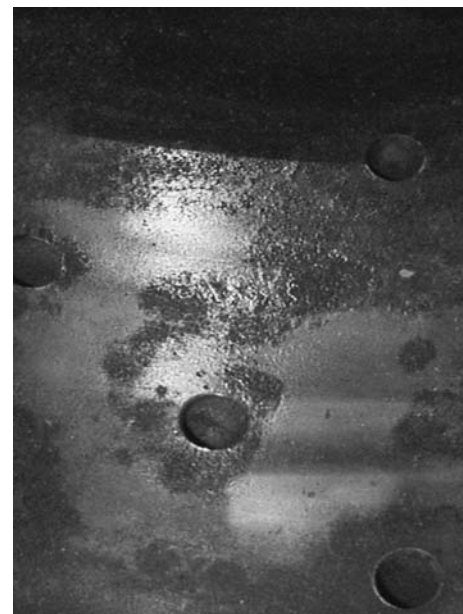
**Fig. 2** Corrosion-related pitting on surface of magnetic retaining ring

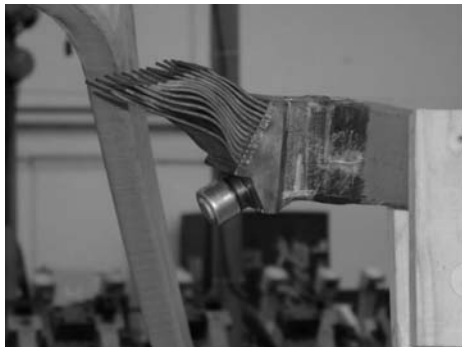
**Fig. 3** End of a water-cooled coil. This "bottle clip," made of copper, allows the coil to be electrically connected to the next coil by means of the laminated flexible connector and also provides a means of cooling water to pass through this coil and out the machine.

Figures 3 and 4 show the location of this crevice-corrosion cracking in generator water-cooled stator coils.

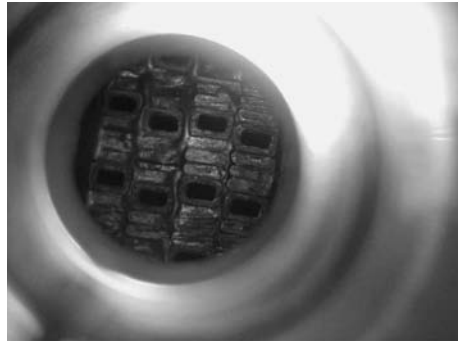
**Fig. 4** Borescopic view through the bottle clip opening into the strand package, which consists of hollow strands that carry cooling water and solid strands that carry the majority of the current. This bundle of copper strands (both the hollow and solid) are brazed together into a single, consolidated "strand package." Braze material, which is porous, covers the surface of the strands, and extends axially back into the coil between strands. It is this material that is susceptible to crevice-corrosion cracking as cooling water is trapped in the porous openings and initiates the corrosion process.

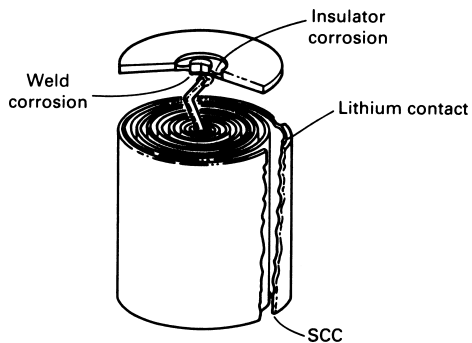
Fig. 1 Sites of corrosion in  $\text{LiSO}_2$  batteries. SCC, stress-corrosion cracking

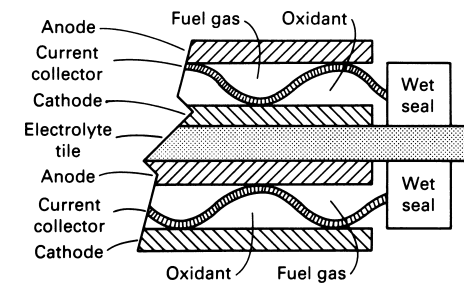
Fig. 3 Schematic of the repeating components of the molten carbonate fuel cell power generation section

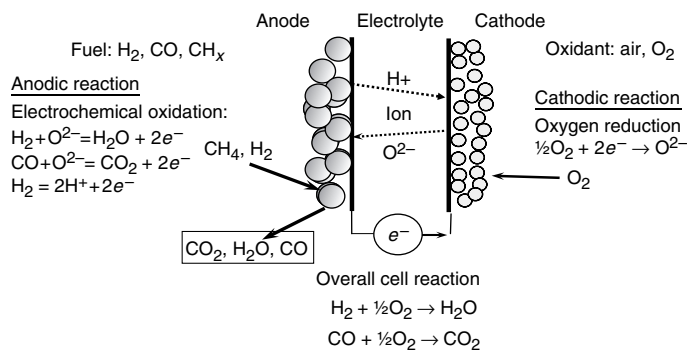
**Fig. 1** Fuel cell. Fuel introduced at the anode is oxidized, and liberated electrons produce useful power in the external circuit.

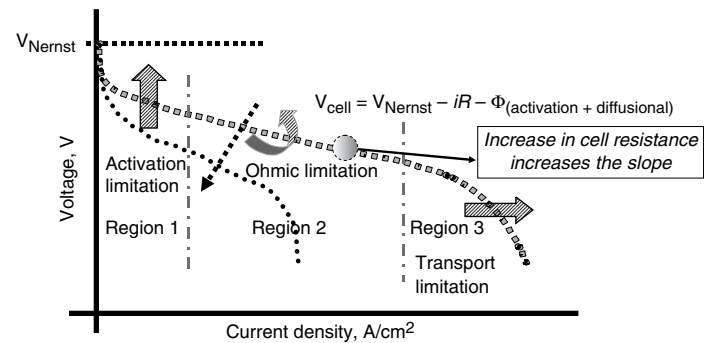
**Fig. 2** Current-voltage characteristic of a fuel cell. Operating cell voltage is less than theoretical (Nernst voltage) due to activation (region 1), resistance (region 2), and mass transport (region 3). To improve output: in region 1, reducing activation polarization will move  $V-I$  curve upward; in region 2, reducing ohmic polarization reduces slope of  $V-I$  curve; in region 3, reducing diffusional polarization moves bend in  $V-I$  curve to the right. Degradation in electrical performance with time is attributed to electrode deactivation, electrode poisoning, and increase in cell resistance.

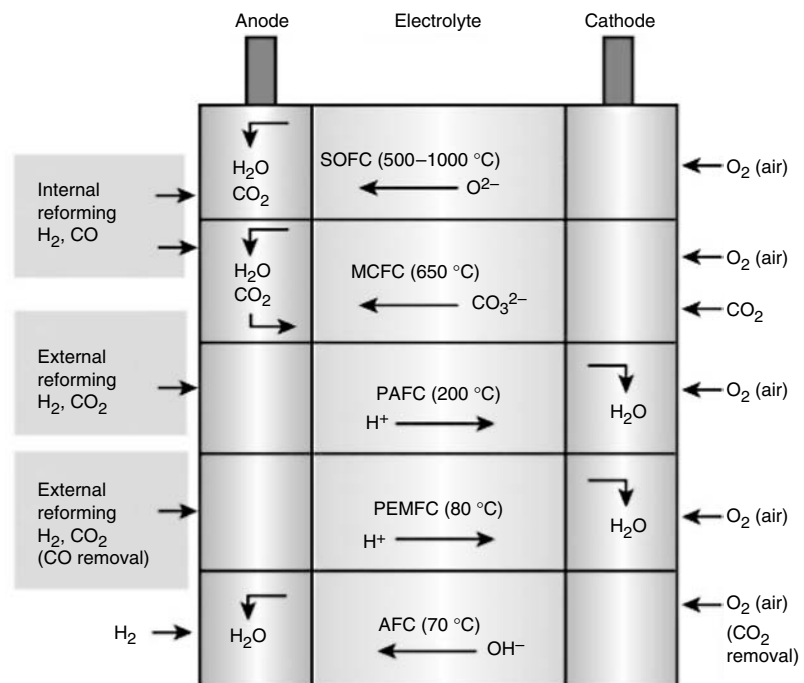
**Fig. 3** Major fuel cell types currently under development for stationary, mobile, and portable applications. See text for fuel cell types. Source: Adapted from Ref 3

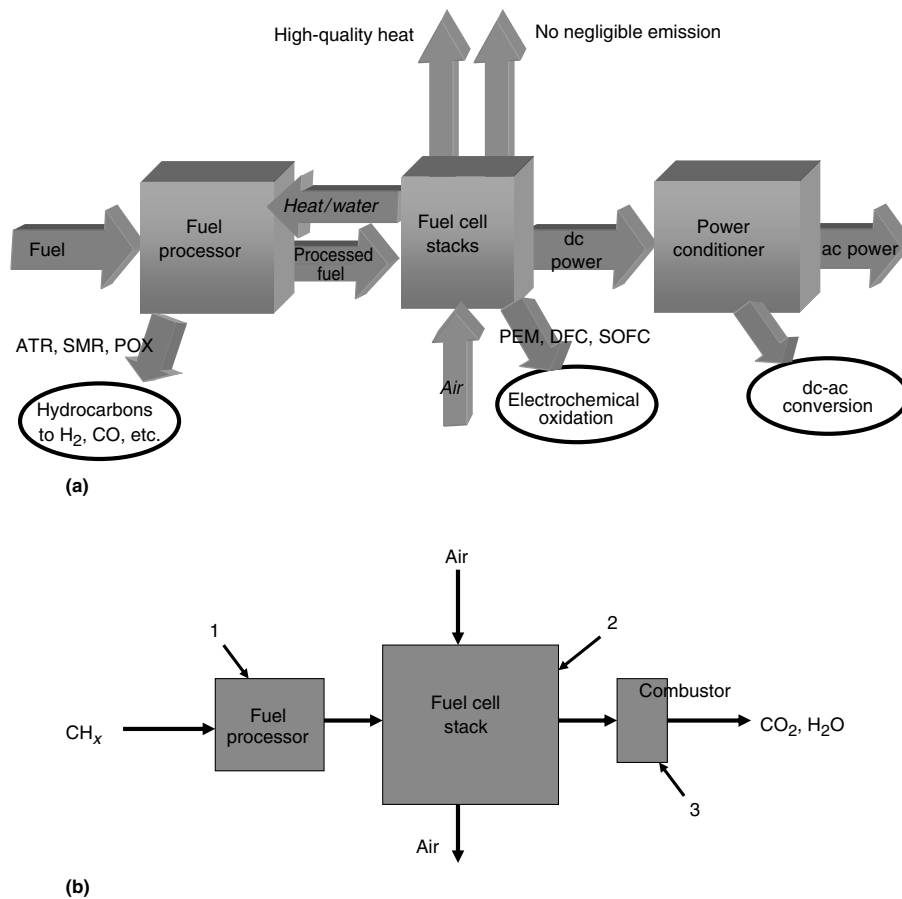
**Fig. 4** Fuel cell system including auxiliary equipment. (a) Fuel cell power generation system incorporating fuel processor, fuel cell stack, and power conditioner. ATR, autothermal reforming; SMR, steam methane reforming; POX, partial oxidation; PEM, polymer electrolyte membrane; DFC, direct fuel cell; and SDFC, solid oxide fuel cell. dc, direct current; ac, alternating current. (b) Respective operating temperatures and exposure environments. Area 1: High carbon activity; partial pressure,  $P_{H_2O\ in} > P_{H_2O\ out}$ ; temperature ( $T$ ),  $>600\ ^\circ C$  (1100 °F); there can be contaminate inclusions. Area 2:  $P_{H_2O\ out} > P_{H_2O\ in}$ ;  $P_{H_2\ in} > P_{H_2\ out}$ ;  $T$ , room temperature to 1000 °C (1830 °F). Area 3:  $P_{H_2\ out} = 0$   $P_{H_2O\ out} + P_{N_2\ out} + P_{CO_2\ out} = 1$ ;  $T > 800\ ^\circ C$  (1470 °F)

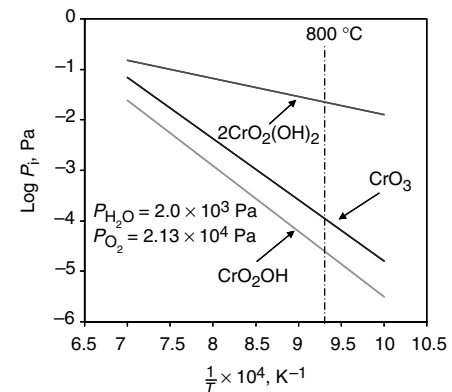
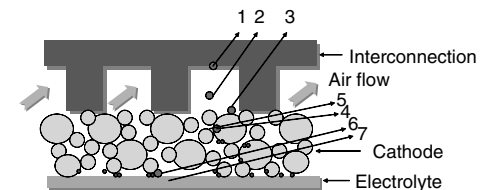
**Fig. 5** Chromia scale evaporation in an oxidizing environment. (a) Partial pressure of various gaseous species formed in humidified air. Chromia evaporation is dominated by  $\text{CrO}_2(\text{OH})_2$  formation, especially at low temperatures (note inverse temperature scale). At 800 °C (1470 °F), for example, partial pressure of  $\text{CrO}_2(\text{OH})_2$  is 220 times greater than  $\text{CrO}_3$ . The level of  $\text{CrO}_2(\text{OH})_2$  gas is still significant at 800 °C (1470 °F) and 0.022 Pa ( $3.2 \times 10^{-6}$  psi), which is 52% of the pressure at 900 °C (1650 °F). (b) Schematic presentation of possible formation, transport, and interactions of chromium species during solid oxide fuel cell operation near the cathode. 1, chromium evaporation from interconnection surface; 2, gas-phase transport of chromia vapor; 3, contact with cathode surface; 4, reaction with cathode; 5, diffusion into cathode; 6, reduction and deposition at cathode/electrolyte interface; 7, diffusion into electrolyte/barrier layer

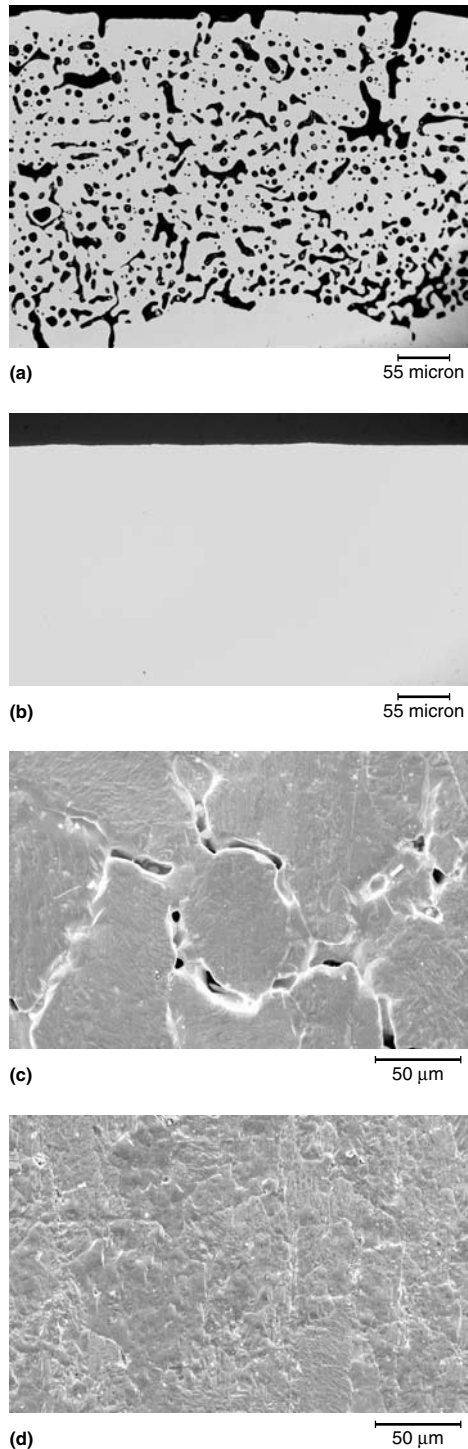
**Fig. 6** (a) and (b) Microstructural cross sections of silver tubular sections, and (c) and (d) surfaces. (a) and (c) were exposed to a bipolar condition ( $\text{H}_2 + 3\% \text{H}_2\text{O}/\text{silver}/\text{air}$ ) at  $700^\circ\text{C}$  ( $1290^\circ\text{F}$ ) for 700 h. (b) and (d) were exposed to air at the same temperature and duration. (c) Grain-boundary porosity is present. (d) No grain-boundary porosity

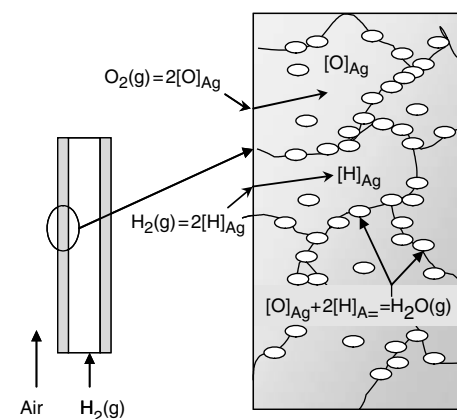
**Fig. 7** Schematic presentation of porosity formation and structural degradation in silver exposed to hydrogen/air dual environment. Partial pressure of steam formed within the bulk metal remains very high at all exposure temperatures.

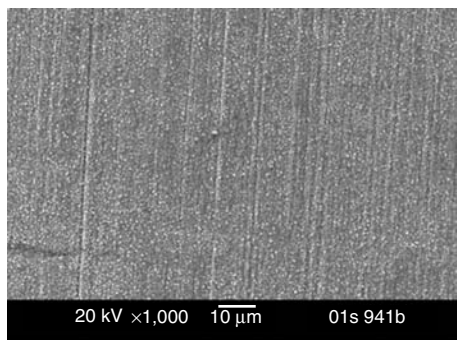
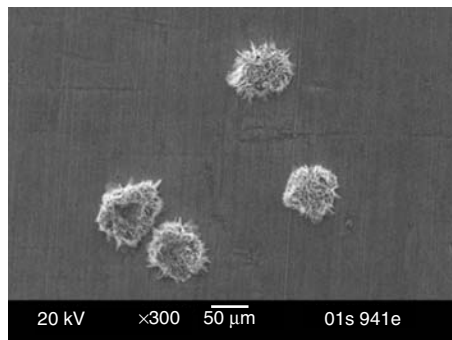
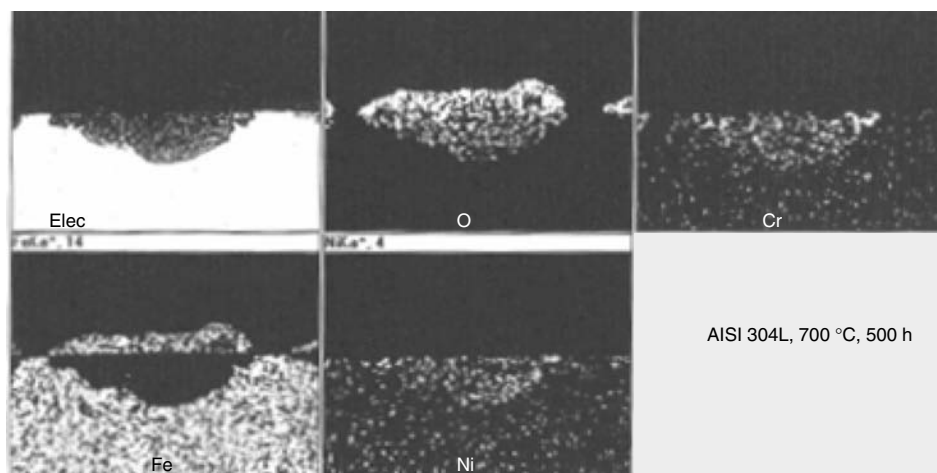
**Fig. 8** Surface morphology and elemental distribution in scales formed on type 304 stainless steel during exposure to single and bipolar exposure conditions. (a) Formation of uniform surface oxide layer in air. (b) Development of local iron-oxide-rich nodules during exposure to bipolar condition. (c) Elemental distribution in the scale formed during bipolar exposure. Note iron enrichment in the outer oxide; chromium and nickel within the inner scale

Similar experiments conducted on types 304 and 430 stainless steels showed localized scale growth and underlying metal loss (Fig. 8, 9) (Ref 26–28). Similar scale morphology has been reported to develop during the oxidation.

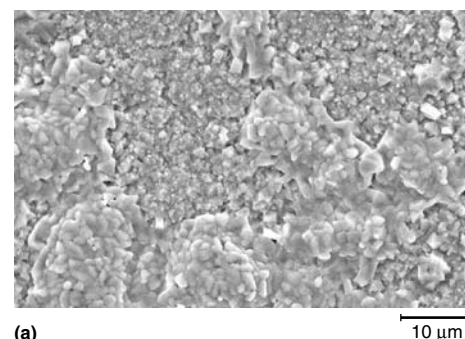
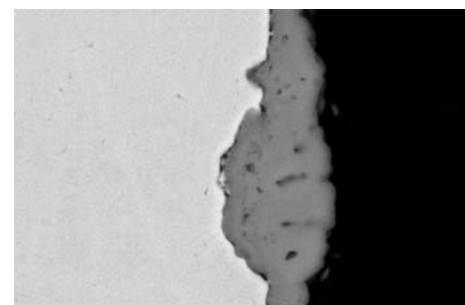
**Fig. 9** SEM observation of the scale on type 430 stainless steel after isothermal oxidation at 800 °C (1470 °F) for 300 h. (a) Surface and (b) cross-sectional microstructures of the airside scale on the coupon that was simultaneously exposed to air on one side and moist hydrogen on the other. Results of the energy-dispersive spectroscopy linear analysis on cross sections are also included. Source: Ref 26

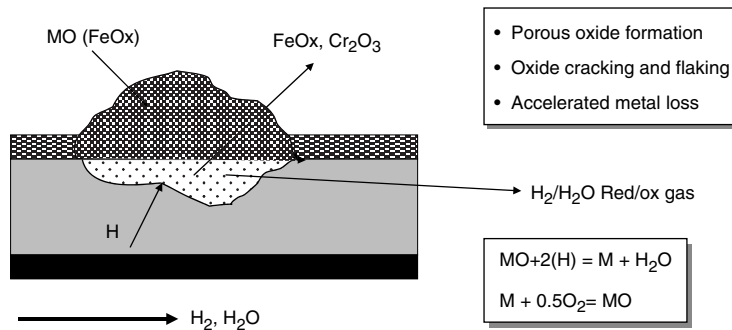
**Fig. 10** Mechanism for the development of scale under the bipolar condition

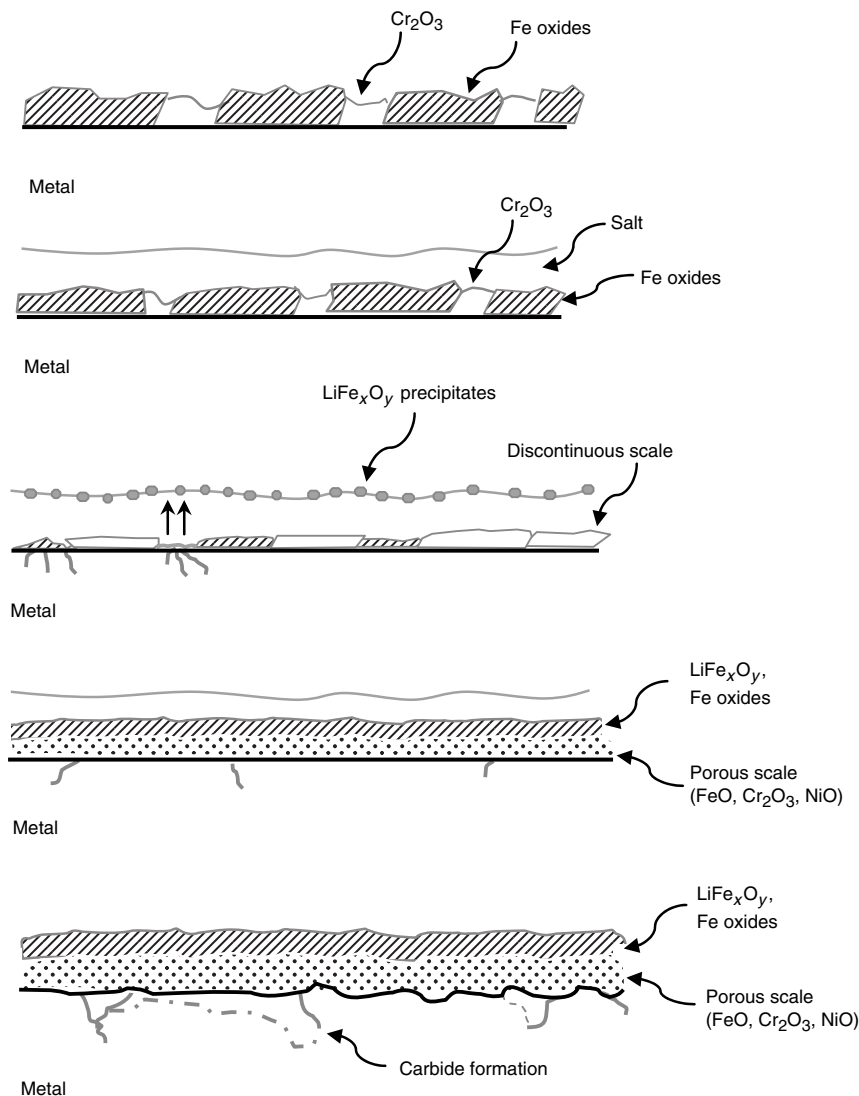
**Fig. 11** Representation of scale growth in the anode atmosphere of the molten carbonate fuel cell. Time progresses from top to bottom. Oxide fluxing is observed during the oxidation of stainless steels.

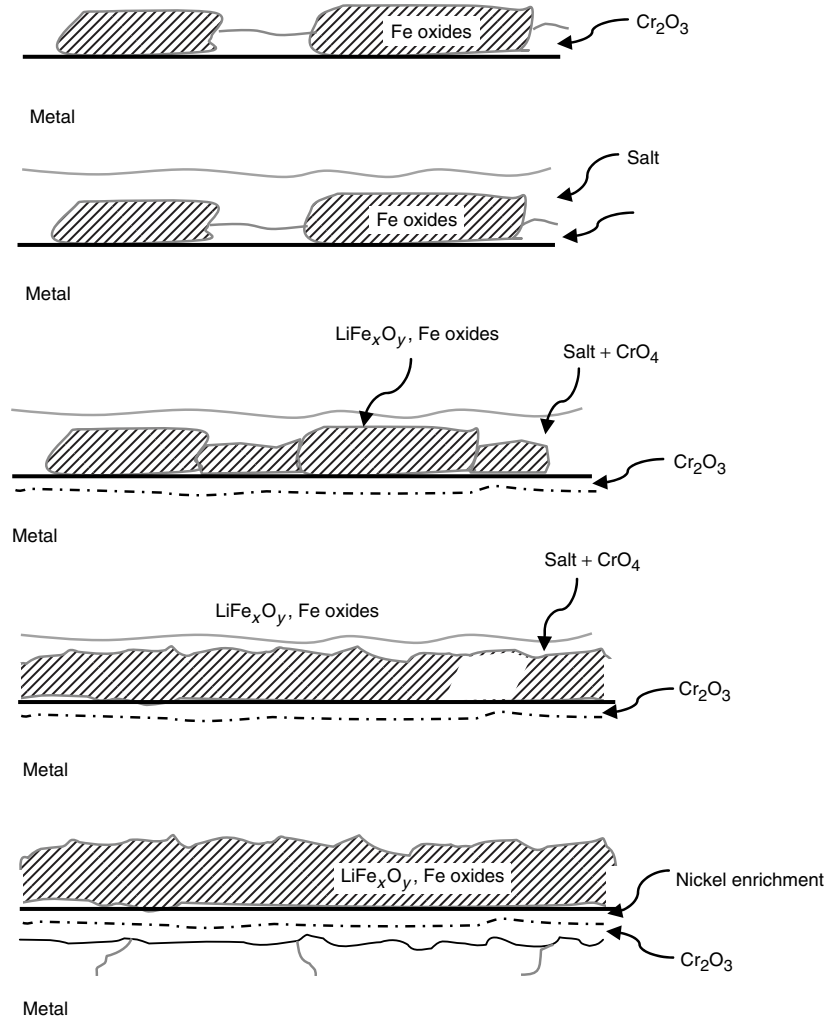
Fig. 12 Representation of scale growth in the cathode atmosphere of the molten carbonate fuel cell. Time progresses from top to bottom. Oxide dissolution is observed during the oxidation of stainless steels.

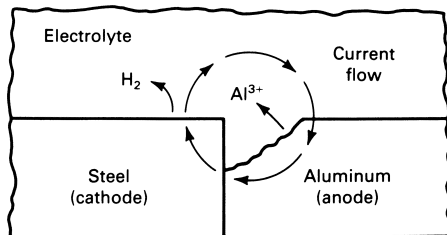
**Fig. 1** Mechanism of galvanic corrosion, which occurs when dissimilar metals are placed in contact with one another and are exposed to a common electrolyte. The more electrochemically active metal will act as the anode and will corrode preferentially (often at an accelerated rate), and the less active metal acts as a cathodic surface for the reduction of an oxidizing species.

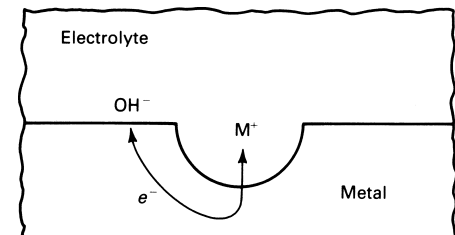
**Fig. 4** Mechanism of pitting corrosion. As with crevice corrosion, pitting occurs in localized areas that are depleted of oxygen, low in pH, and high in chlorides.

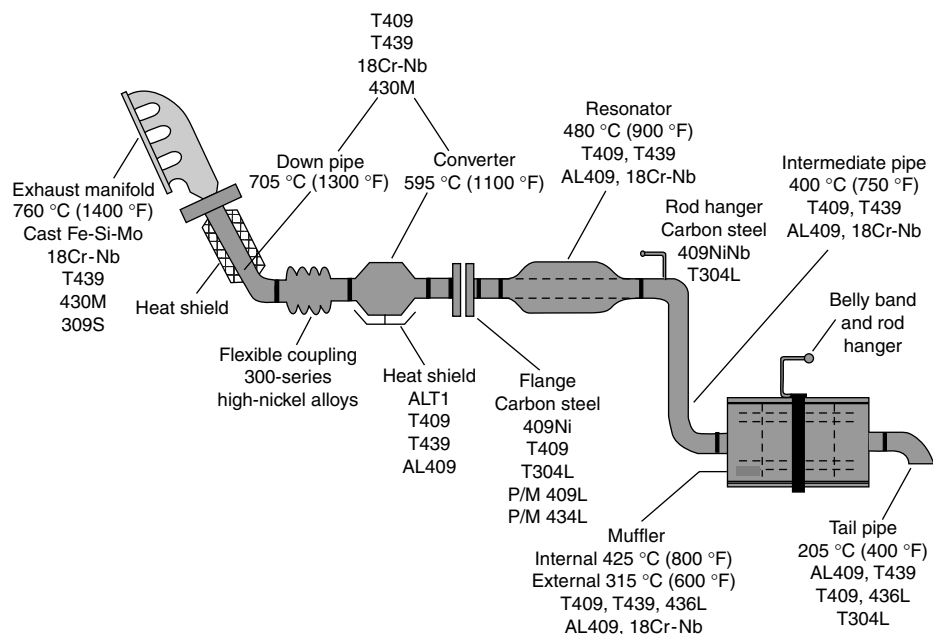
Fig. 1 Exhaust system components with typical upper metal skin temperatures and alloys of construction. P/M 409L and P/M 434L produced by powder metallurgy (P/M) processing

Figure 1 is a schematic of the standard OEM exhaust system and lists the stainless alloys most often used to construct these components. For

each component in Fig. 1, an attempt was made to add a typical in-service maximum metal skin temperature. Obviously, that temperature varies with engine, driving cycle, component design, and degree of insulation and heat shielding. Table 1 shows the compositions of the most common alloys used in exhaust system construction. The heavy use of ferritic 400-series stainless alloys is immediately obvious. The 300-series stainless steels in North America have limited use, most often as tail pipes or fabricated manifolds. Carbon steels, normally as aluminized (type 1) steel, find their way into some heat shield applications, as occasionally do aluminum alloys. Bare carbon steels still are used as 9.53 to 12.7 mm (0.375 to 0.500 in.) thick flat flanges or as 12.7 mm (0.5 in.) diameter rod hangers to attach systems to the car frames. In normal exhaust construction, stainless components will range in thickness from 0.5 mm (0.020 in.) muffler wraps up to 2 mm (0.080 in.) wall thickness downpipes. Some fabricated stainless steel flanges will measure 3.1 to 4.7 mm (0.125

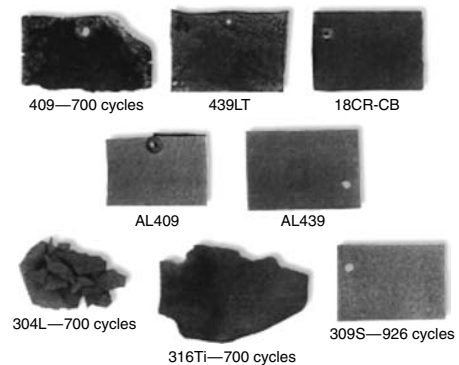
**Fig. 2** Cyclic oxidation exposure coupons after 1050 cycles (unless otherwise noted) at 900 °C (1650 °F). Each cycle: 25 min heat exposure and 5 min cooling

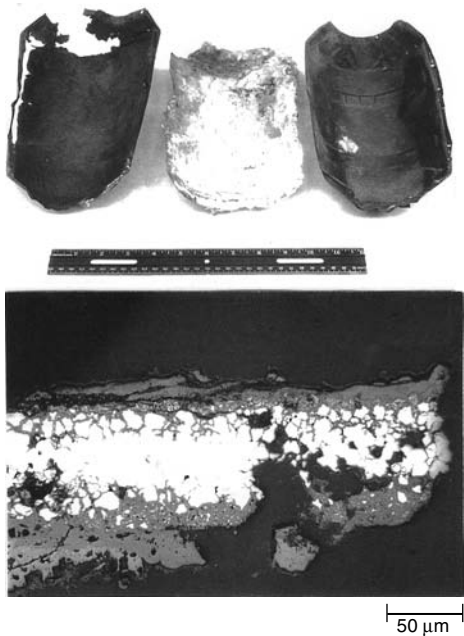
**Fig. 3** Laminated T304 heat shield where insulation became soaked with salt solution, leading to hot salt intergranular attack. At bottom, cross section. 200×

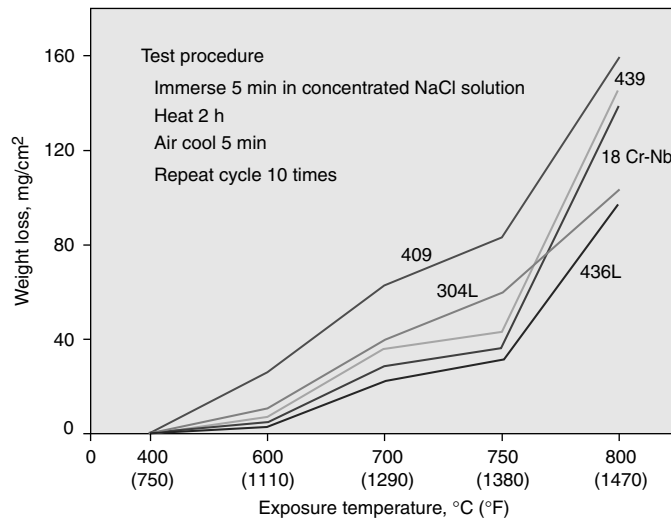
**Fig. 4** Hot salt comparisons of standard exhaust alloy stainless steels with weight losses after 10 cycles versus exposure temperature

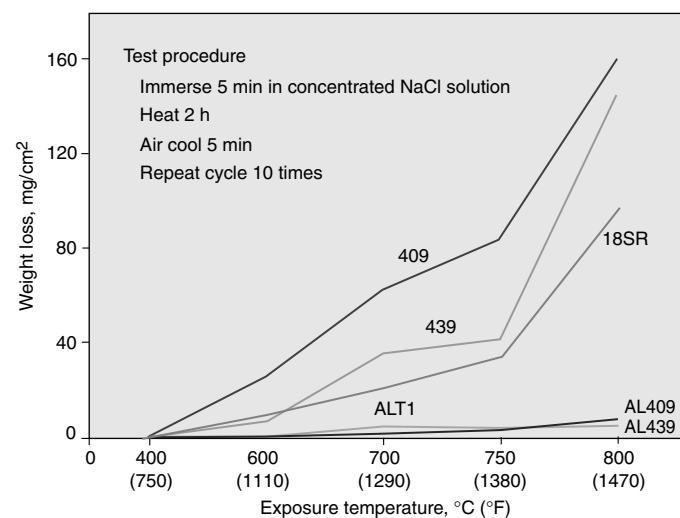
**Fig. 5** Hot salt comparisons of standard and aluminum-coated exhaust stainless steels with weight losses after 10 cycles versus exposure temperature

Figure 5 shows how adding aluminum, either as a coating or alloy addition, affected hot salt resistance. Adding aluminum to the base alloy was beneficial, but there was not as much improvement as when it is added as a coating. Even carbon steel after aluminizing resisted hot salt attack better than the bare stainless alloys. At most of the higher temperatures used in the hot salt evaluations, the aluminum coating alloyed with the substrate, forming an iron-aluminum intermetallic with an outer scale of  $\text{Al}_2\text{O}_3$ .

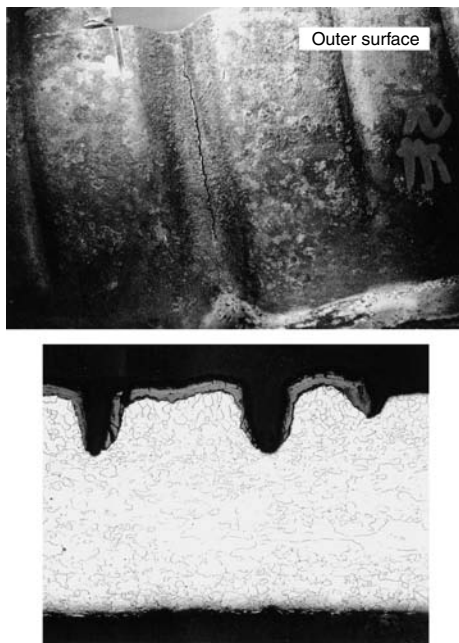
**Fig. 6** Catalytic converter shell with thermal fatigue cracks in formed exterior surface rib. In cross section at bottom, note numerous outer-diameter surface cracks. 50×

**Thermal Fatigue.** A final form of environment-assisted hot end exhaust system failure is thermal fatigue. This type of component failure is oxidation-assisted mechanical fatigue and generally occurs only in hot end applications. Figure 6 shows the exterior of a truck T409 stainless steel catalytic converter shell that failed in service, developing a through-thickness fracture at the deepest midlength rib on the washboardlike converter outer surface. Also in Fig. 6 is a 50× cross section of the rib with a

series of shallow notches in the metal, characteristic of fatigue. Cyclic stresses on the hot shell surface lead to small surface cracks that, due to the elevated service temperature, are oxidized. The oxide within the shallow cracks wedged open the steel surface so that, on subsequent heating cycles, a notch was formed that cracked further and again oxidized. With time, one of these fissures oxidized more rapidly, and eventually, so much of the steel cross section was cracked and weakened that the next heatup led to a ductile rupture failure of the shell. The rib that fractured in this component happened to be the deepest stamping in the converter shell and was situated in a location that was exposed to high heat from internal exhaust gases. Had the rib been shallower or possibly insulated from the internal gases, the temperature and stress concentrations would have been less and fatigue would have been avoided. Without changing shell design, the way to eliminate the problem is to move to a stronger, more oxidation-resistant alloy or thicken the shell wall.

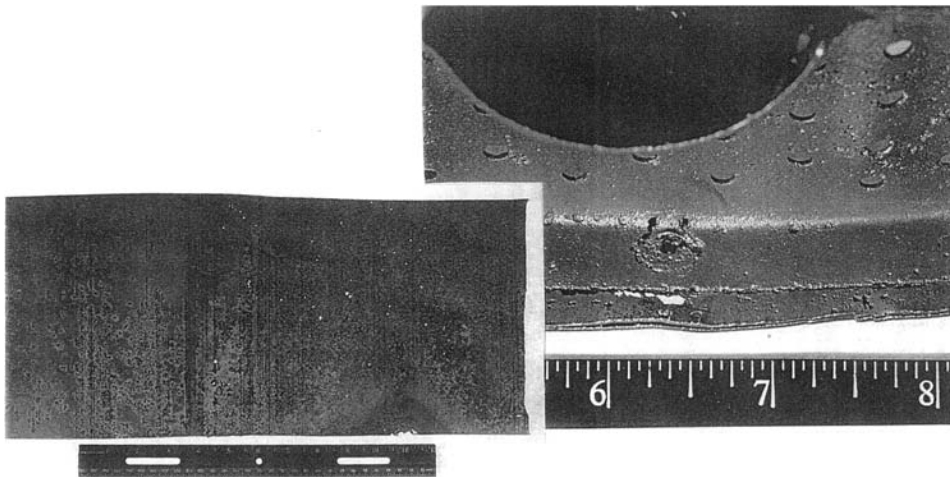
**Fig. 7** South American muffler (409 shell and baffles) designed without drain holes in end caps or baffles (4000 km, or 2500 miles, of driving). Lack of condensate drainage has led to premature pitting perforations.

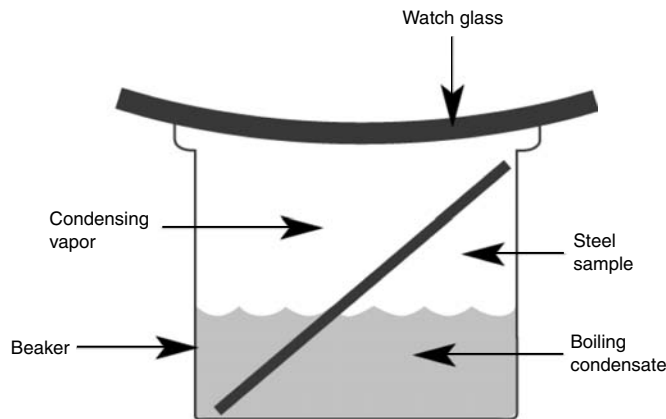
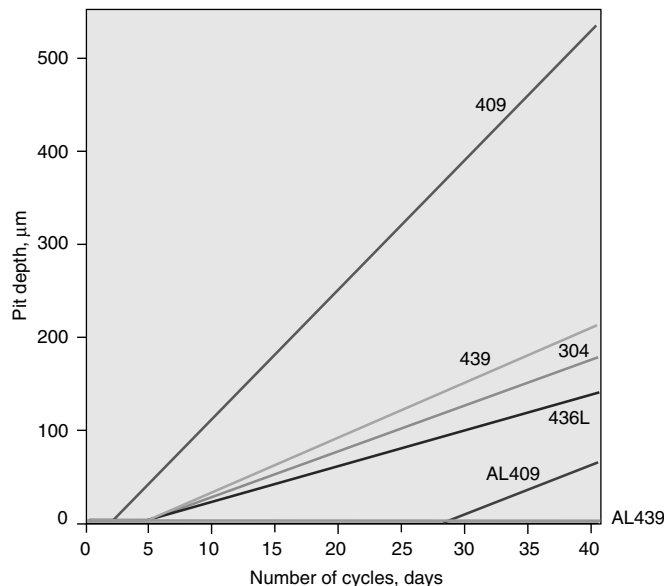
**Fig. 8** Laboratory test to evaluate condensate pitting corrosion. (a) Arrangement of sample. (b) Pitting condensate corrosion results for six exhaust alloys. Pit depths represent the average of the ten deepest pits. Details of the test procedure are given in text.

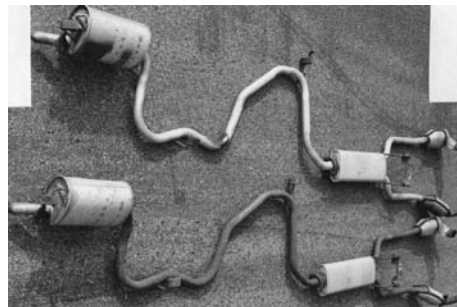
**Fig. 10** Two identical exhaust systems collected from the field. The upper system is AL409 with 201,600 km (125,000 miles) of service. The lower system has bare T409 tubes with 56,500 km (35,000 miles) of service.

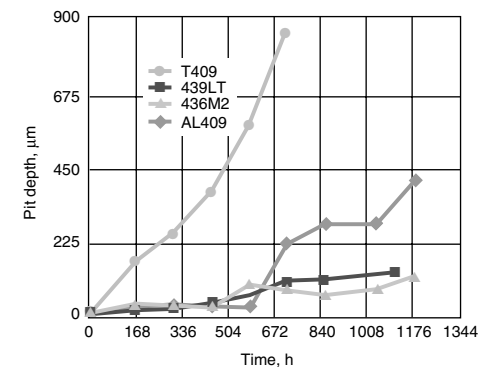
**Fig. 11** Comparison of average pit depths over time for four exhaust stainless steel alloys exposed to cyclic exterior salt humidity cabinet pitting test A. See text for test details.

Figure 11 shows average pit depths after 1176 h of testing with the procedure outlined previously. Results show the benefit of increasing chromium content and, at longer test times, of increasing the molybdenum (1.3% in 436M2) content. The aluminum coating was also beneficial until the galvanic protection of the free-aluminum and alloy layer was eliminated. Then, the underlying 409 base alloy corroded at a rate approaching that of the bare base alloy.

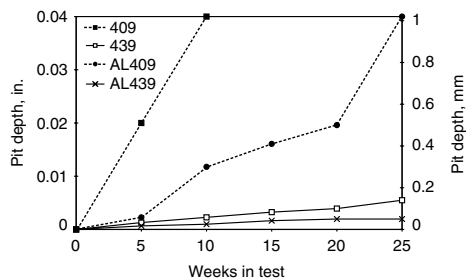
**Fig. 12** Exterior cyclic salt pitting test B after 25 weeks with a weekly 1 h 315 °C (600 °F) heat exposure and daily salt solution dip and humidity exposure

Test A requires a sophisticated programmable humidity cabinet to conduct. A second, simpler test, external salt pitting test B, was developed and has been proven to correlate well with field survey results as well as on-car component durability tests. Test B uses a weekly heat treat cycle of 1 h, but only a once-per-day salt dip and air dry, and spends the balance of each day at 85% RH and 60 °C (140 °F). Figures 12 through 14 show the results of conducting test B at varying

heat treat temperatures, namely 315, 425, and 540 °C (600, 800, and 1000 °F), respectively. The 315 °C (600 °F) test results resemble test A at 260 °C (500 °F). At these hotter muffler temperatures, 17%Cr T439 and aluminum-coated 439 (a premium durability product used on some luxury vehicles) show essentially no attack after 12 weeks of testing. At 425 °C (800 °F) intermediate pipe temperatures, the depth of pitting increased on all the alloys evaluated. Finally, with a converter can 540 °C (1000 °F) heat cycle, bare 409 began rapid pitting, which appears to cease between 2 to 4 weeks, only to reinitiate after 4 weeks. Visual coupon observations indicated the 540 °C (1000 °F) temperatures caused 409 to form a thicker scale jacket than on the higher-chromium alloys. This thicker oxide film filled active pits with debris that shut down the pitting mechanism for a time. The

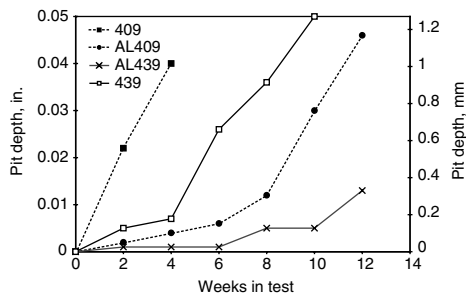
**Fig. 13** Exterior cyclic salt pitting test B after 12 weeks with a weekly 1 h 425 °C (800 °F) heat exposure and daily salt solution dip and humidity exposure

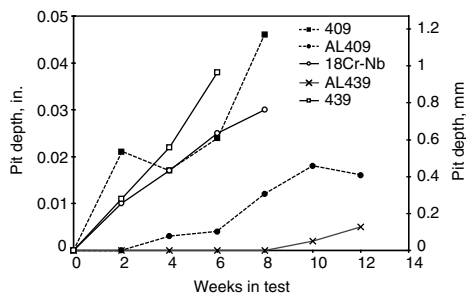
**Fig. 14** Exterior cyclic salt pitting test B after 12 weeks with a weekly 1 h 540 °C (1000 °F) heat exposure and daily salt solution dip and humidity exposure

decrease in pitting corrosion of AL409 at this highest temperature was associated with the total alloying of the free-aluminum layer. While no longer bright cosmetically, the thick alloy layer does provide galvanic and barrier coating resistance to chloride attack. Results shown here with a 540 °C (1000 °F) heat treatment do appear to correlate with converter exhaust systems in the field. One week in this test B cycle appears equivalent to 1 year of service in the severe salt belt of North America.

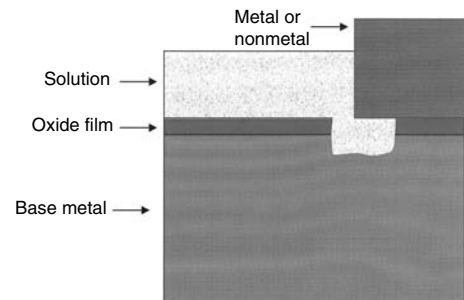
**Fig. 15** Schematic of crevice-corrosion condition where stagnant liquid with a limited supply of oxygen leads to breakdown of the stainless alloy passive film

ides only accelerates the reaction. Figure 15 is a schematic of such a crevice. In cold exhaust applications, there are three areas particularly prone to crevice attack. One is between the wrap and shell of double-walled mufflers, and the other is on external muffler surfaces when belly bands are used for underbody attachment. Welded-on rod or sheet-metal hangers can also cause small crevices where they attach to the muffler end caps or exhaust tubes. A third area of potential crevice attack is the muffler internal surface where baffles are spot welded. Small gaps between the baffle bottom surface and inner muffler shell can create a crevice where stagnant liquid can collect. To combat baffle crevice corrosion, the baffles frequently have a drain hole on their bottom edges to permit liquids to pass through on their way to drain holes in the end plates.
