# ASM Handbook®

## Volume 13C Corrosion: Environments and Industries

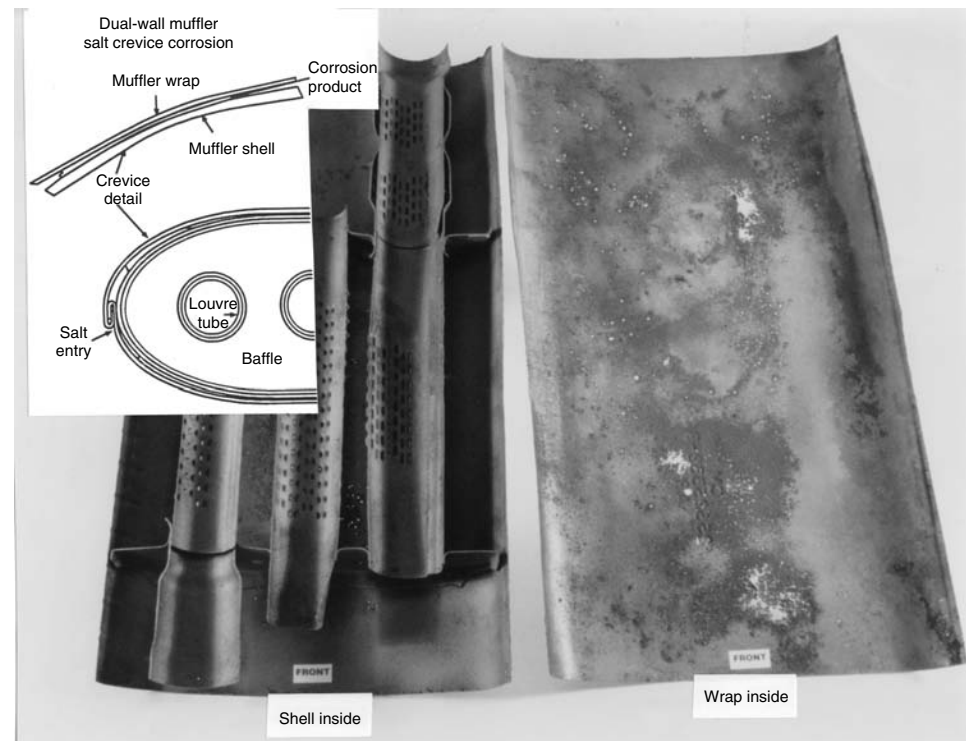
**Fig. 16** Dual-wall 409 muffler after 132,500 km (82,000 miles) with crevice corrosion between the outer wrap and inner shell

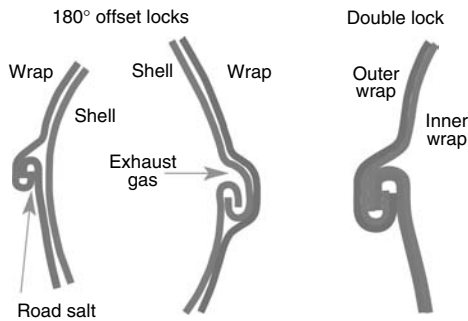
**Fig. 17** Muffler lock seam constructions. The double-lock seam construction (right) helps prevent liquid penetration between the wraps.

To combat double-shell interwrap crevice corrosion, muffler builders have begun adopting a double-lock design where the wrap and shell are simultaneously roll locked together on the same side of the muffler. Figure 17 shows a cross section of this form of muffler seal. While this forming technique requires more power, it does retard liquid intrusion into interwrap areas.

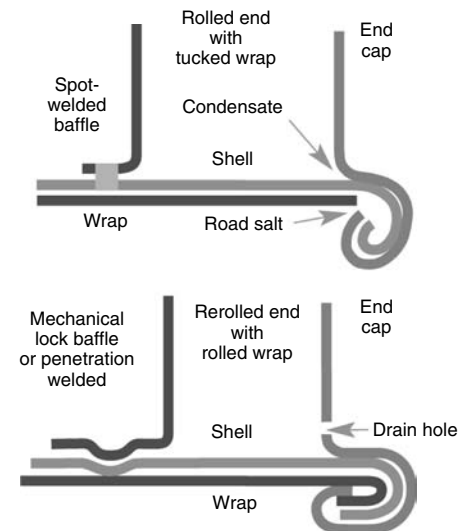
**Fig. 18** Muffler end cap constructions. The more desirable corrosion-resistant muffler design is shown at bottom.

Another source of interwrap leakage in double-wall mufflers is rolled-on end caps. As shown in Fig. 18, if the outer wrap is tucked into the head and not bent 180° with the end cap and inner shell, salt solution intrusion from outside surfaces is possible. The wrap needs to be extended into the shell/end cap seam and the entire thickness rerolled to seal off leaks. Figure 19 shows an AL409 muffler wrap after 27,400 km (17,000 miles) of driving, with internal leakage around the rolled head causing exterior corrosion of the protective aluminum coating. The aluminum-coated stainless alloys, when used in double-wall muffler construction, have been found to improve leak tightness. The softer free-aluminum exterior coating acts similar to a gasket in crimping operations when compared to the smoother, harder mating surfaces presented when bare stainless shells are joined.

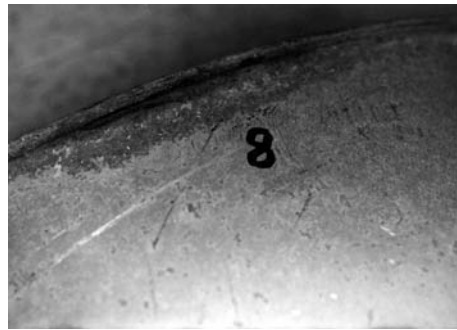
**Fig. 19** Muffler with 27,400 km (17,000 miles) of service and AL409 wrap and end cap. Condensate leakage through the rolled head has attacked the aluminum coating.

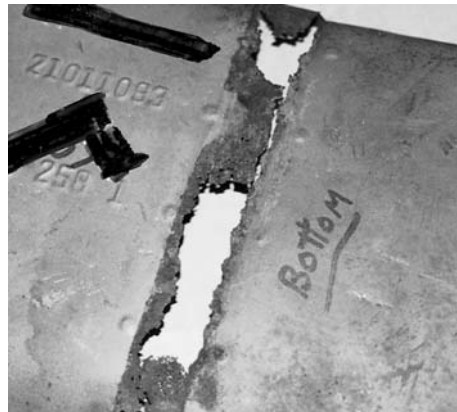
**Fig. 20** Crevice corrosion of a 409 muffler shell under a belly band (removed from photo) on a vehicle driven 114,500 km (71,000 miles) in Montreal, Canada.

Exterior wrapped belly bands for muffler attachment to the car frame also create life-shortening crevices. Figure 20 shows a muffler shell constructed of T409 after 114,500 km (71,000 miles) of driving in Montreal, Canada. The belly band has been removed and the entire surface glass bead blasted to expose corrosion

damage. The crevice under the band has perforated the 409 shell, structurally damaging the shell integrity.

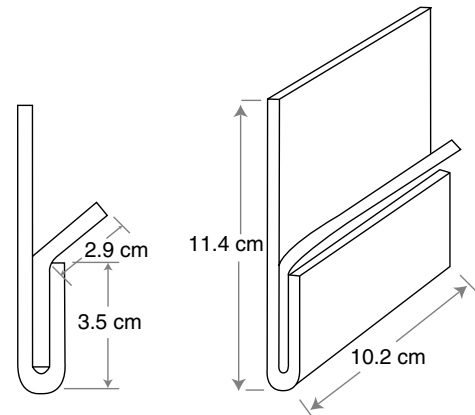
**Fig. 21** Sheet-metal crevice-corrosion hem flange coupon designed for laboratory corrosion tests where both crevice and boldly exposed surface areas are created. With two samples, the test permits the mixing of base metal alloys.

Evaluating crevice-corrosion resistance in the laboratory required the development of a suitable coupon configuration. Figure 21 shows a test coupon made up of two sheet pieces held together with a hem flange 180° bend, similar to the design used to seal the bottom of car door skin panels. The two-piece test panel is exposed to internal condensate solutions or external road salt mixtures and, after the appropriate cycles, can be pulled apart, cleaned as described previously, and pit depths measured by a pointed micrometer or calibrated microscope. The two sheet samples making up the crevice test panel can be of the same alloy or of mixed materials, which adds the possibility of a galvanic corrosion contribution.

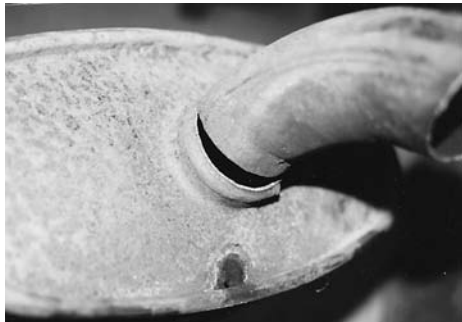
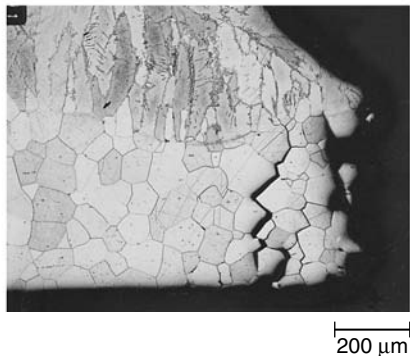
**Fig. 22** Tail pipe and muffler end cap, both of 409, that failed by intergranular corrosion after driving service in Canada. Cross-sectional photo at bottom is 50 $\times$ . Base alloy had Ti/(C+N) ratio of 5.8.

In response to failures like the one in Fig. 22, ASTM International and the stainless steel producers redefined the minimum stabilization in 409 to include both carbon and nitrogen. ASTM International recognizes three T409 stabilization specifications (Ref 5):

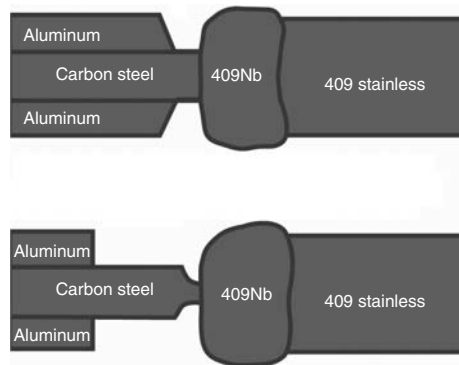
**Fig. 23** Galvanic corrosion when mixing muffler materials. Aluminum sacrifices itself to protect the 409 stainless steel, exposing the carbon steel substrate.

aluminized type 1 carbon steel (ALT1). One scenario involved upgrading the corrosion resistance of mufflers by specifying 409 while continuing to call for ALT1 for the attached intermediate pipe. The two dissimilar metals were joined with a GMA weld using a stainless 409Nb weld filler. Exposure to corrosive road salt solutions on one surface and muffler condensate on the other created a galvanic cell. The aluminum coating on the carbon steel substrate sacrificed itself to protect the 409 muffler shell and weld (Fig. 23). With time, the aluminum was stripped away, revealing the underlying carbon steel base metal. With extended exposure times, the loss of aluminum became great enough that a carbon-steel-to-409 couple was established. The less noble carbon steel now attempted to protect its stainless material mate. A corrosion failure next to the weld soon ensued. A rough rule of thumb would predict that 409 pipes to 409 muffler shells should last a minimum of 5 to 7 years without perforation. The ALT1 tubes and shells, depending on the type of protection used on welds, could survive 3 years or more under the car. The aforementioned dissimilar-metal galvanic couple was predicted to fail in the coated carbon steel in 18 to 24 months of service.

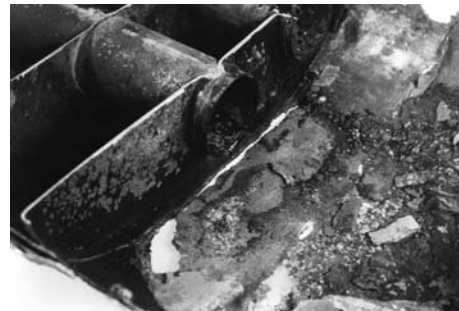
**Fig. 24** Internal view of muffler with 14,500 km (9,000 miles) of service. Condensate galvanic corrosion between the 409 stainless baffles and ALT1 shell has destroyed the wrap.

In a similar problem, Fig. 24 shows an internal view of an exhaust muffler taken off of a vehicle with less than 16,000 km (10,000 miles) of driving. The muffler designer mixed 409 internal

baffles and tubes with an ALT1 exterior shell to take advantage of the coated carbon steel cosmetic resistance to early red rusting. Unfortunately, the galvanic cell created by the stainless baffles contacting the inner surface of the ALT1 shell in the presence of corrosive condensate liquids led to accelerated galvanic attack of the shell and a linear perforation of the shell under the baffle in a very short driving time.

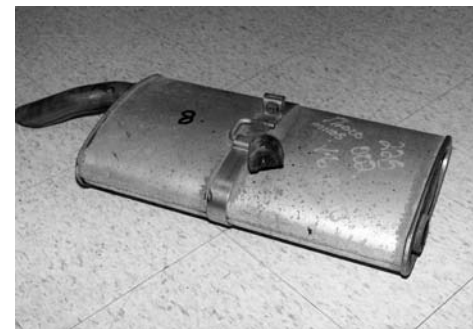
**Fig. 25** Muffler with AL409 wrap and bare stainless belly band and end cap (right side of image). After 27,400 km (17,000 miles) of driving service, the band and muffler end plate have led to galvanic attack on the aluminum coating of the wrap.

Figure 25 shows a muffler with 27,400 km (17,000 miles) of exposure. The muffler shell or

wrap was made of AL409, while the end cap (on the right) and the belly band were bare stainless steel. Note that the band and cap are not heavily rusted or discolored (the benefit of galvanic protection), while the AL409 shell areas adjacent to the cap and belly band show dark-gray stripes where free aluminum has been galvanically removed, exposing the underlying alloy layer. With additional time, those exposed alloy layers will begin showing red rust. In a similar vein, the muffler and tail pipes shown in Fig. 26 were half constructed of bare 409 and half AL409. The muffler/pipes were installed on a vehicle and driven 6 months, with daily spraying with a salt solution. Cosmetically, the aluminum coating made a great difference. The circumferential GMA weld (409Nb) joining the muffler halves further demonstrates the galvanic benefit of the aluminum coating. On the aluminized muffler half, a band of aluminum has been galvanically removed, sacrificing itself to protect the weld bead and bare 409 shell on the other side of the weld. On the bare 409 muffler half, a strip of 409 with far less superficial red rust is apparent, the benefit of the protective nature of aluminum.

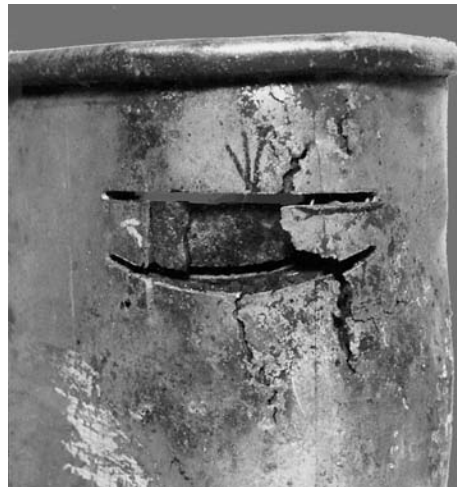
**Fig. 27** Galvanic corrosion between a T439 outer muffler wrap and inner T409 shell caused corrosion debris to build up between the layers and split the outer wrap. Crack visible in wrap despite section removal to show corrosion debris

From a galvanic standpoint, bare stainless alloys can be coupled to each other with but a minimal dissimilar cell being established. One exception to this is the muffler section shown in Fig. 27. Here, a double-wall muffler used a thick inner shell of 409 for support and a thinner

outer layer of 439 for better cosmetic corrosion resistance. Intra-wrap seepage of condensate and road salts caused the 409 to corrode, probably a little faster than normal, because it was the less noble member of the 409/439 couple. With time (103,000 km, or 64,000 miles, of driving), the corrosion product on the 409 surface grew in volume, exerted pressure on the thinner 439 outer wrap, and forced a mechanical fatigue tear. In Fig. 27, a portion of the 439 skin has been cut away to reveal the underlying corrosion debris, but some of the 439 tear is still visible running parallel to the muffler long dimension.

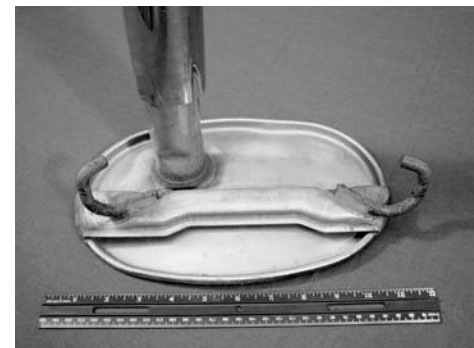
**Fig. 28** Galvanic corrosion of solid carbon steel hanger rods after 1.5 years of driving service in salt belt. Muffler end plate and sheet-metal hanger are 18Cr-Nb.

Even assuming the bare carbon steel flanges or rod hangers have the corrosion durability to meet warranty targets, galvanic corrosion of these components can lead to cosmetic corrosion concerns. Figure 28 shows the muffler end plate and tail pipe of an 18%Cr exhaust section. For attachment purposes, a stainless sheet-metal bracket has been welded to the muffler cap and attached to rubber grommets with bare carbon steel rod hangers. After 1.5 years of service, the attack on the carbon steel rods is obvious. When and if this system fails, the hanger will probably be the most likely point. However, even prior to an actual system failure, concern could be expressed that iron oxide red rust from the hanger may cover the attachment bracket and even bleed down onto the muffler face or tail pipe.

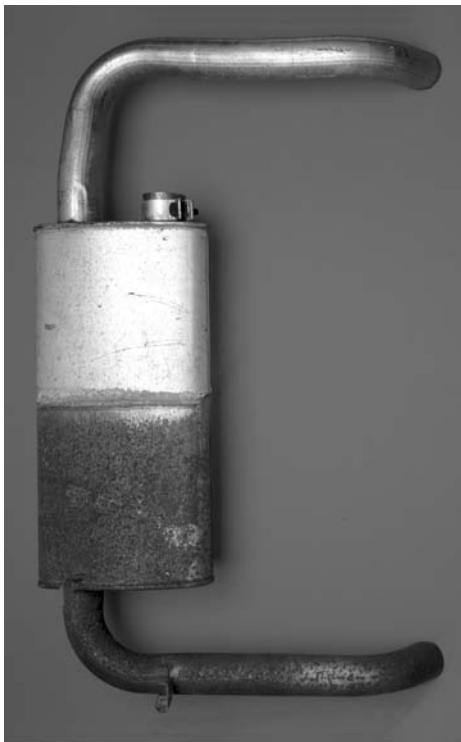
**Fig. 26** Muffler with wrap and heads half made of bare 409 (bottom portion) and half of AL409 (top portion) and test driven 27,400 km (17,000 miles). Bare 409 gas metal arc weld and band of bare 409 adjacent to the weld galvanically protected by aluminum coating

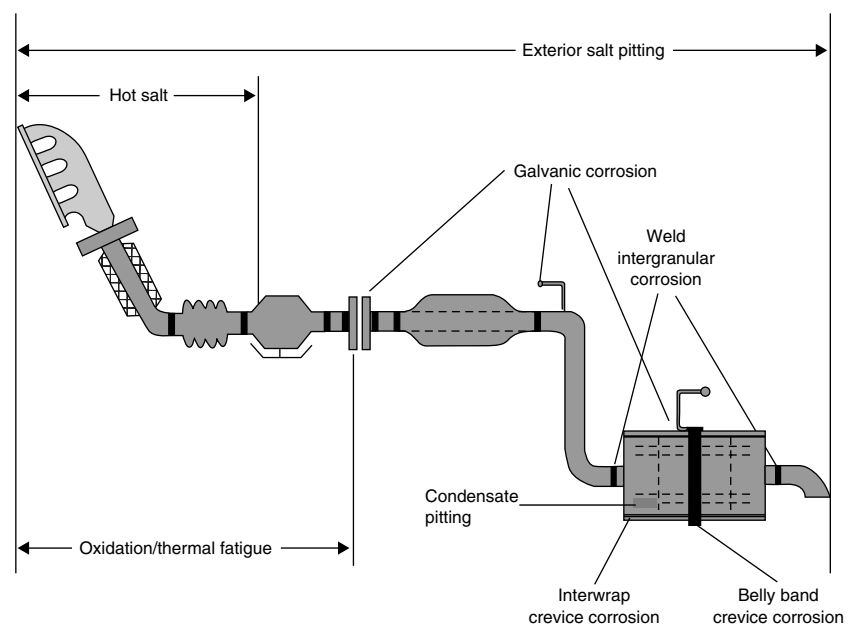
**Fig. 29** Exhaust system schematic with major corrosion concerns by component

In concluding this survey of corrosion in modern automobile exhaust systems, a schematic (Fig. 29) of a typical exhaust system is

once more reproduced, and identifying arrows are added where one would expect to find the various forms of corrosion discussed previously. While today's (2006) typical system is easily capable of 7 to 10 years of durability from a corrosion standpoint, the materials needed for a 15 year exhaust life are probably already available, if engineers can optimize designs to minimize the corrosion mechanisms discussed in this article.

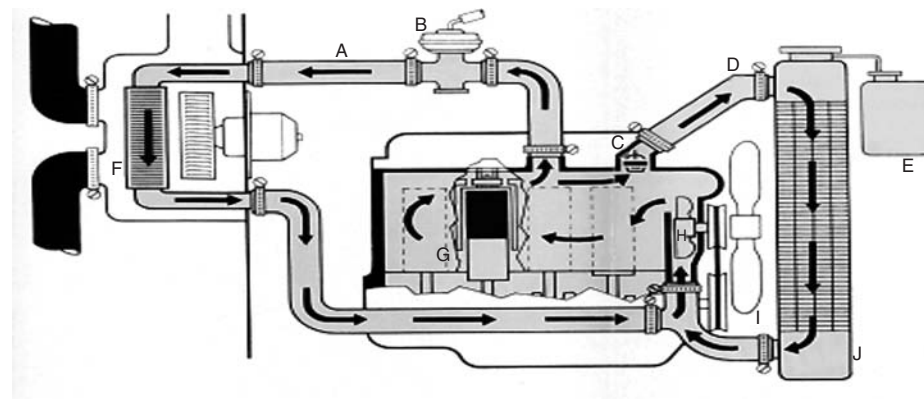
**Fig. 1** Circulation and components of the cooling system. A, heater hose; B, heater control valve; C, thermostat; D, radiator hose; E, overflow reservoir; F, heater core; G, engine; H, coolant pump; I, fan; J, radiator

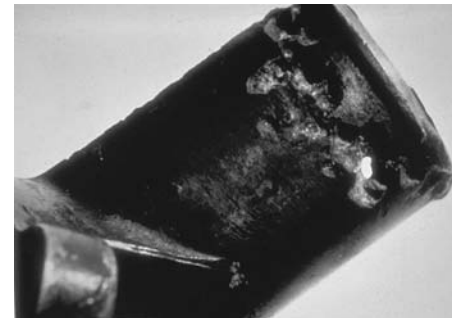
**Fig. 2** Crevice corrosion can occur at hose connections. (a) The right and wrong way to position a hose clamp on a coolant outlet. (b) Severe crevice attack of an aluminum coolant outlet due to incorrect hose positioning

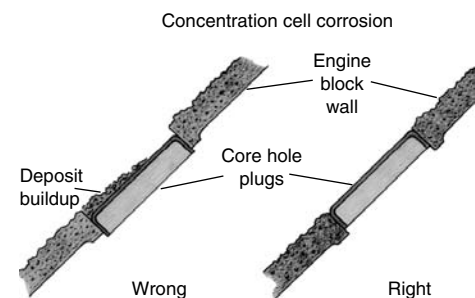
**Fig. 3** An improperly installed steel core hole in an engine block leads to deposit buildup that can form a corrosion cell.

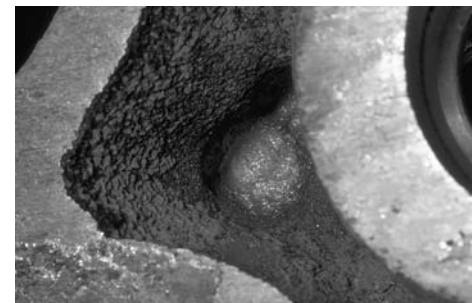
Fig. 5 Pitting corrosion in aluminum cylinder head port

Pitting corrosion by definition is confined to small areas; the highly localized corrosion results in pits that can lead to early failures in the thin metal sections of radiator tubes and heater cores. Similar attack in the engine block would not be as critical considering the greater thickness of metal (Fig. 5).

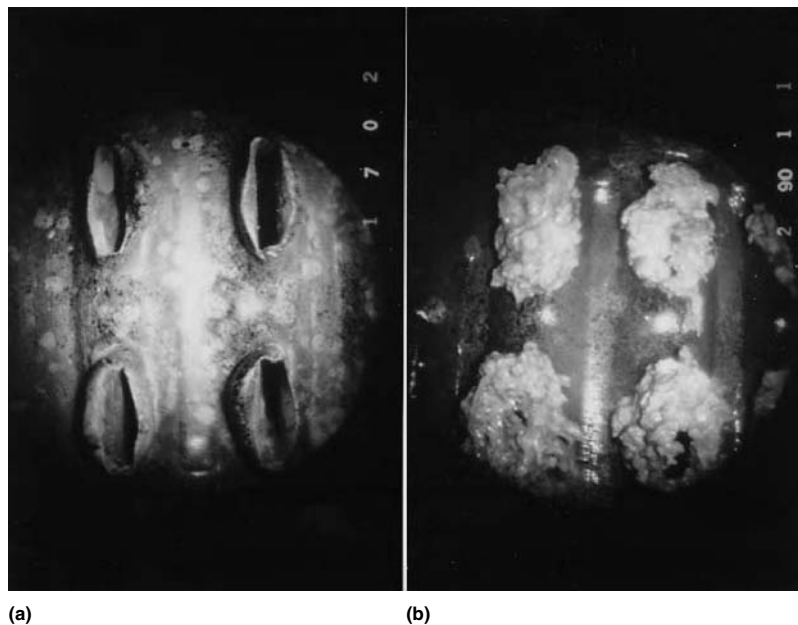
Fig. 4 Solder bloom formation can block and restrict the flow of coolant in the radiator. (a) New radiator core. (b) Solder bloom after just 22,000 miles of normal highway operation

**Solder Bloom.** Brass radiator soldering techniques and materials selection have a direct bearing on solder corrosion and clogging at the tube-to-heater plate joint. Lead solders are used in manufacturing cores and complete radiators because of their high temperature strength and melting point. The lead content makes the alloy difficult to inhibit from forming voluminous corrosion products, i.e., solder bloom. If excessive amounts of solder are deposited around the tube joint, and if the interior of the tube opening is wetted by the solder, there is a better chance that partial clogging of the tube opening will occur after 3 or 4 years of service (Fig. 4). Extended use and/or dilution of the coolant increases the probability of clogging.

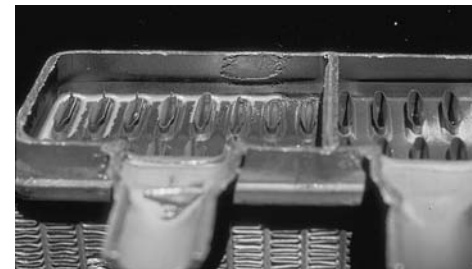
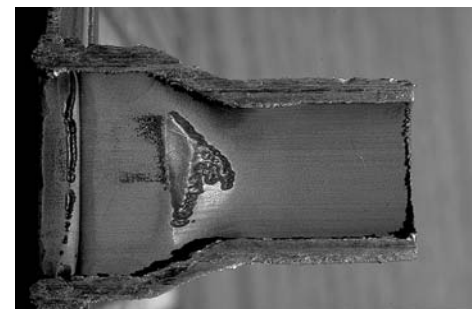
Fig. 6 Erosion-corrosion related to high coolant flow. (a) Radiator tank erosion on wall opposite inlet. (b) Tube narrowing causes increased velocity and turbulent flow.

**Erosion Corrosion.** High velocity fluid flow can result in erosion-corrosion (Fig. 6). Design

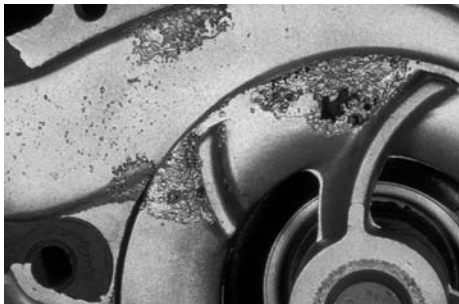
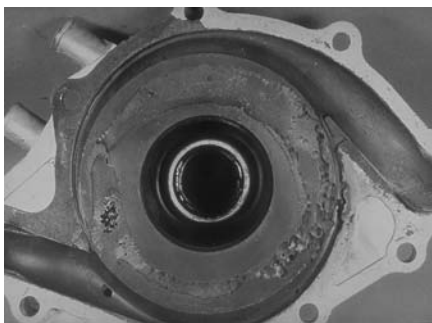
**Fig. 7** Corrosion perforation of (a) aluminum impeller and (b) aluminum cover of a coolant pump resulting from a used and degraded engine coolant

Aluminum water pumps are vulnerable to cavitation-erosion-corrosion in the presence of improperly inhibited, depleted, or diluted engine coolant. The extent of damage and tendency to perforate are also influenced by the cooling system and coolant pump design. Internal configurations that concentrate large pressure gradients (sudden pressure changes) can cause localized pitting and erosion, which can result in decreased pump performance and potential perforation failure of the pump body or cover (Fig. 7).

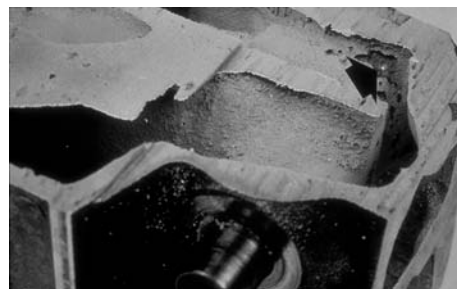
**Fig. 8** Nucleate boiling-induced cavitation corrosion caused perforation at the exhaust valve port of this aluminum cylinder head.

Aluminum cylinder heads are exposed to potential cavitation corrosion conditions in the high-heat flux areas where nucleate boiling is generated (Fig. 8). Here again, coolant inhibitor type, glycol concentration, degree of inhibitor depletion, materials selection, and component design have a major effect on the extent of attack. Design deficiencies in terms of flow rate, flow distribution, and surface-to-volume ratios in the coolant jacket passages can increase the intensity of the corrosion damage (Fig. 9).

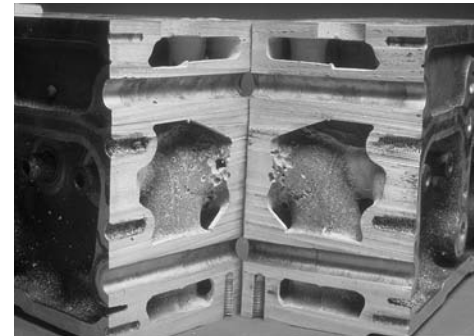
**Fig. 9** Severe cavitation corrosion in an aluminum cylinder head exhaust port manifold

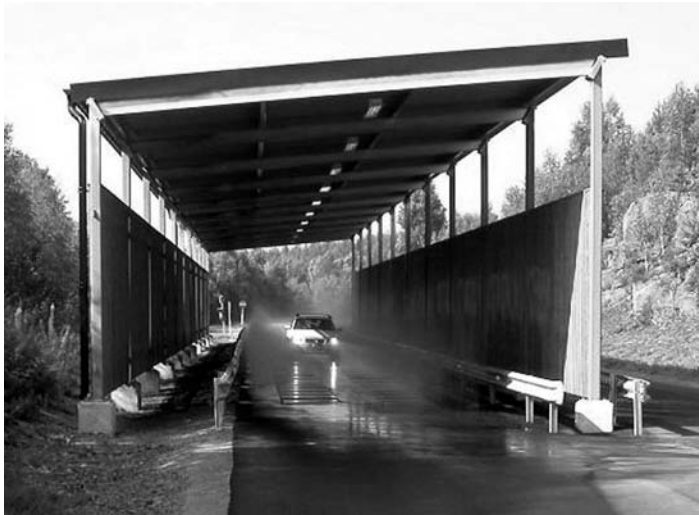
**Fig. 1** Proving ground highway simulating splash/spray during high wintertime conditions with deicing salt use. Note the shallow splash groves in the highway.

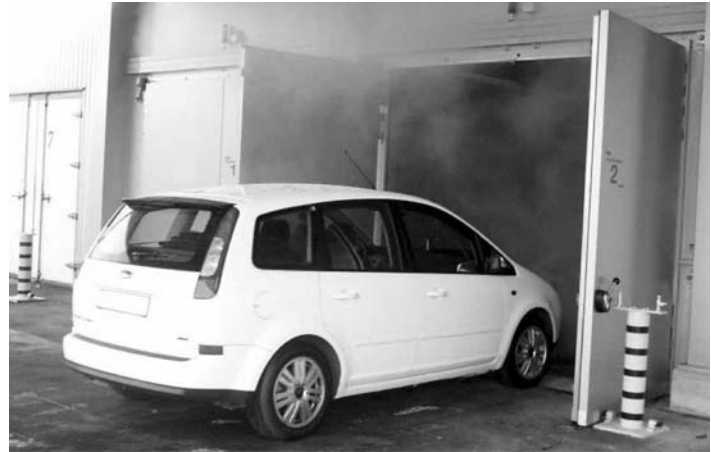
**Fig. 2** Garaging of a test car in a proving ground humidity chamber after a daily test track driving sequence

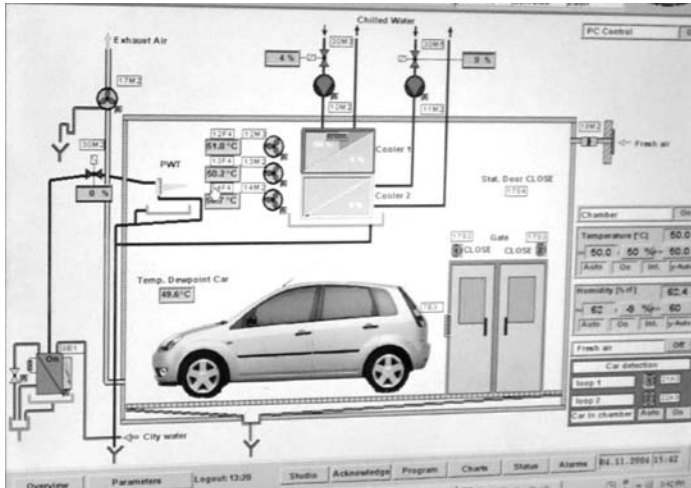
**Fig. 3** Computer-controlled monitoring of corrosive conditions in a modern programmable complete vehicle humidity chamber

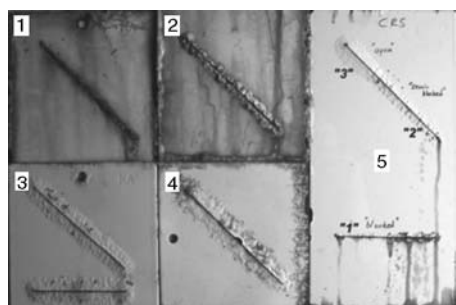
**Fig. 4** Monitoring of underpaint “creepage” from scribe line(s) in the same automotive paint system on cold-rolled steel test panels. Panels 1–3: 12 week results from proving ground tests with decreased nominal corrosion load (panel No. 1 most severe) showing “blocked,” “semiblocked,” and “open” creepage modes, respectively. Panel 4: typical result from 3 year on-vehicle exposure in corrosive panel position/environment. Panel 5: 12 week laboratory test showing all three creepage modes on the same panel due to different salt accumulation caused by scribe orientation and panel inclination

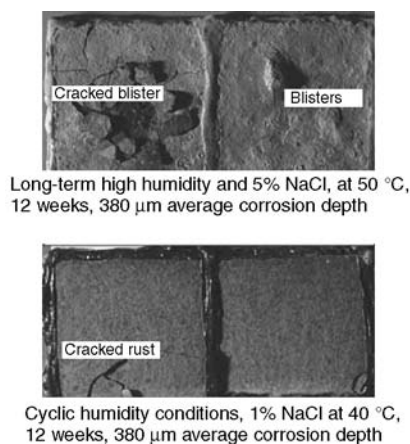
**Fig. 5** Rust morphology under different degrees of corrosivity. Upper panels show gas blisters in the diffusion-tight rust. Lower panels show a more open rust morphology at nominally the same average corrosion depth

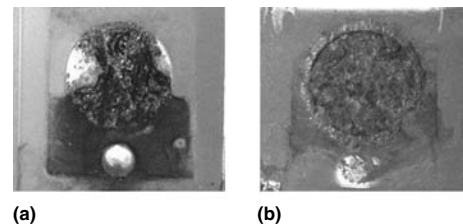
**Fig. 6** Monitoring of crevice corrosion (confined mode) in electrocoated and primed mild steel sheet panels. A 25 mm (1 in.) circular portion of exposed metal (lid removed) is shown. (a) shallow 6 week attack and magnetite slurry after nominally hard exposure conditions resulting in almost constant wetness. (b) 2 year on-vehicle exposure

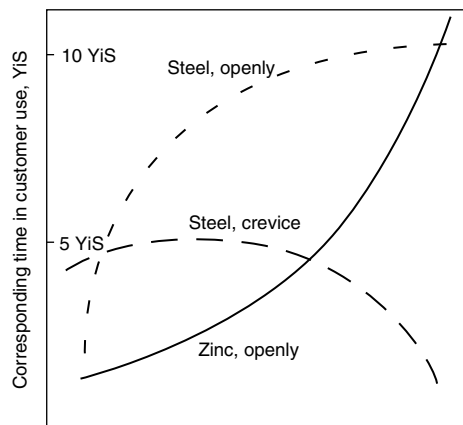
"Nominal corrosivity" of 12 week test (in terms of increased wetness and salt load) →

**Fig. 7** Typical corrosion rate response (YiS, years in service) for steel and zinc during a 12 week test as a function of increased “nominal corrosivity” (a qualitative term for degree of humidity exposure/time of wetness, extent of drying, and salt load)

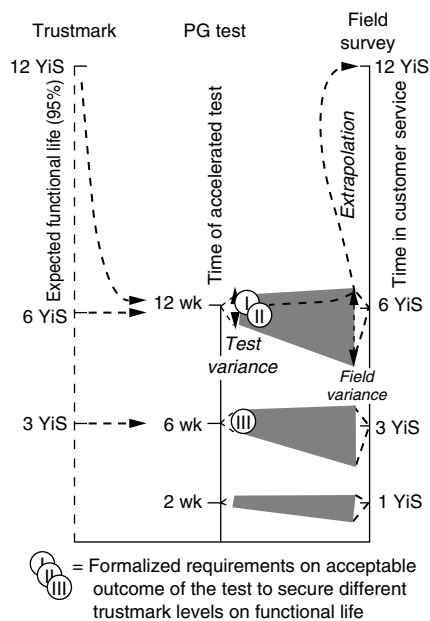
**Fig. 8** Example of how functional requirements on components (involving a specific corrosion mode) are verified by formalized proving ground (PG) test outcome criteria (YiS, years in service). The most benign case for assessing long-term requirements is a “short” test based on previous field survey results.

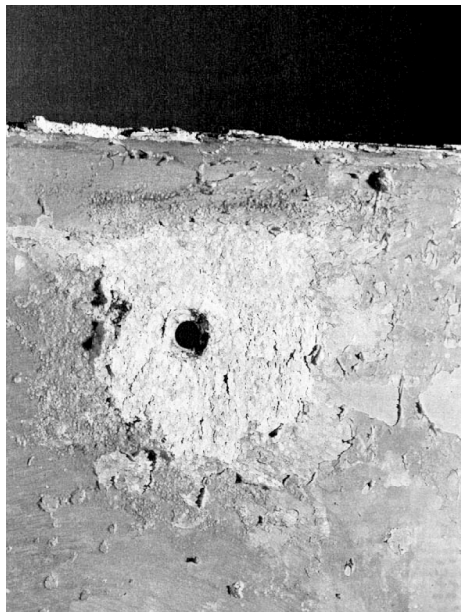
Fig. 1 Crevice corrosion under a floor cover in the proximity of a fastener

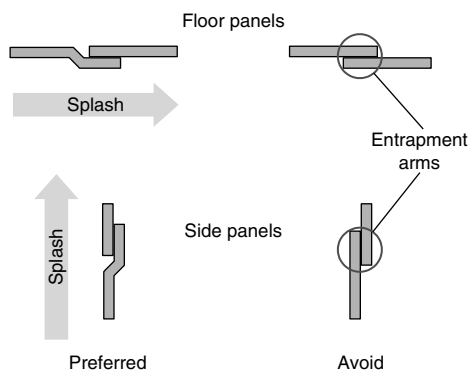
Fig. 2 Design guidelines for corrosion prevention. The component is fabricated so that retention of moisture, salts, and dirt in crevice areas is avoided.

In addition to the use of sealants, design of joints effectively eliminates the potential of crevice corrosion. In essence, components should be constructed in such a manner that entrapment areas for moisture, salts, and dirt are avoided as much as possible (Fig. 2). The joints are made to allow good drainage and prevent the buildup of poultices that can trap salts and moisture. More complete guidelines for the design of components to avoid or reduce corrosion issues can be found in the Aluminum Association literature (Ref 2) and in the article “Designing to Minimize Corrosion” in Volume 13A, *ASM Handbook*.

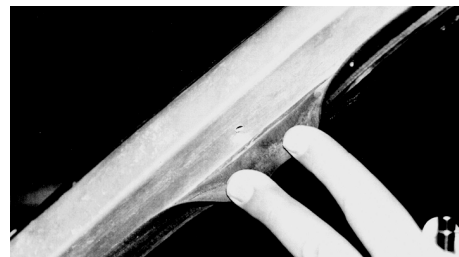
Fig. 3 Crevice corrosion under a windshield gasket

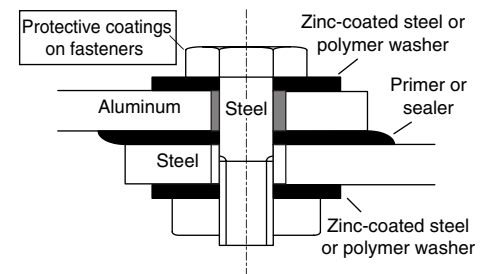
Fig. 4 Methods of sealing crevices between steel and aluminum surfaces

It is important to note, as shown in Fig. 4, that the barrier material should extend beyond the immediate contact area between the dissimilar

metals. A distance of about 10 to 20 mm (0.375 to 0.75 in.) is usually adequate. If the barrier material covers only the adjoining surfaces, electrolyte can form a bridge between the two metals and corrosion can occur.

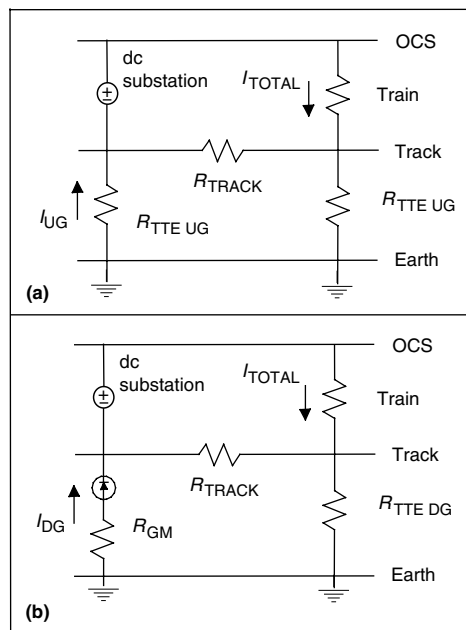
**Fig. 1** Electrical schematic of (a) ungrounded and (b) diode-grounded rail systems. Refer to the corresponding text, and in particular Eq 3(a) and (b), for an explanation of the abbreviations shown in this figure.

Fig. 1(a), in an ungrounded system, half of the track length contributes to current discharge, and half of the track length contributes to current return, so the track resistance is  $2 R_{TTE\ UG}$ . In contrast, diode-grounded systems have a relatively low resistance ground mat ( $R_{GM} \ll R_{TTE\ DG}$ ), and when the diode is conducting, current discharges from the full length of track to the ground mat. Typical resistances of diode system ground mats vary from 0.01 to 0.1  $\Omega$  where the direct current (dc) ground mat is cross bonded with the substation alternating current (ac) ground mat, 0.1 to 1.0  $\Omega$  for a low-resistance dc ground mat, and 1.0 to 10  $\Omega$  or greater for a high-resistance dc ground mat.

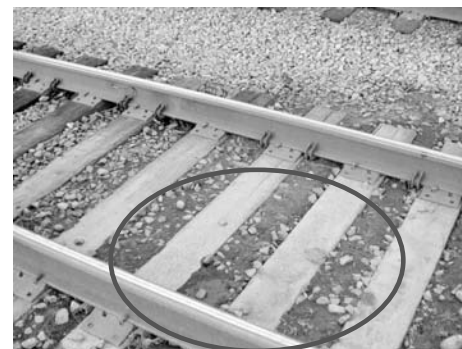
**Fig. 2** Noninsulated tie-and-ballast, with wooden ties, metal spikes, and ballast rock that is fouled with soil fines and moss

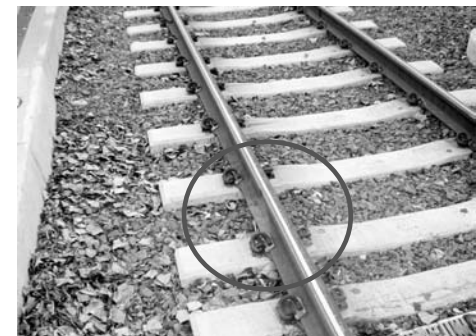
**Fig. 3** Insulated tie-and-ballast track with concrete ties and insulated clips. The ballast rock is clean and well-drained; however, leaves are accumulating.

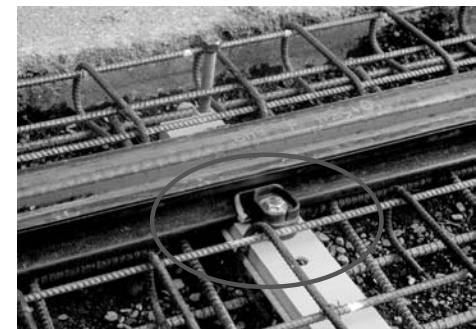
**Fig. 4** Embedded track slab construction, rail with insulating boot held by gauge bar and surrounded by the slab reinforcing steel.

Figure 4 shows the complexity of embedded track construction. The photograph shows a rail with an insulating boot, a gauge bar, and surrounding track slab rebar. The boot must be protected during storage, handling, positioning, and welding of the rail and during rebar installation and placing of concrete.

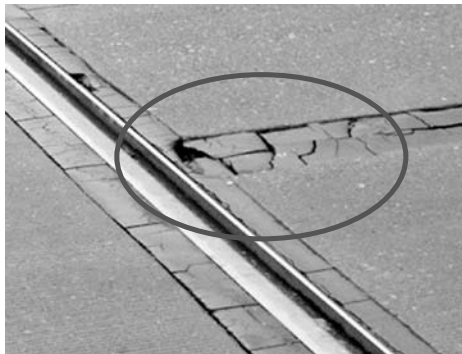
Fig. 5 Embedded track insulated with potting compound, now degraded from mechanical and environmental damage.

Figure 5 shows an insulated embedded rail constructed with a potting compound that is now degraded from environmental and mechanical damage. Figure 6 shows construction of a track slab with an insulating elastomeric boot. Although the elastomeric boot is a promising construction technique, the remaining concern is

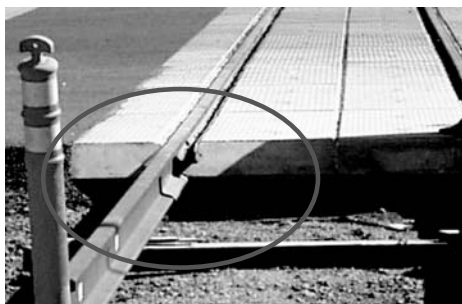
Fig. 6 Embedded track insulated with a surrounding elastomeric boot that is visible at a construction joint in the track slab.

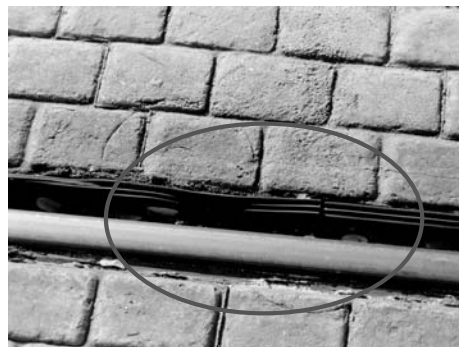
Fig. 7 Embedded track with boot damage. Boot shows surface raveling and an open gap at a splice connection.

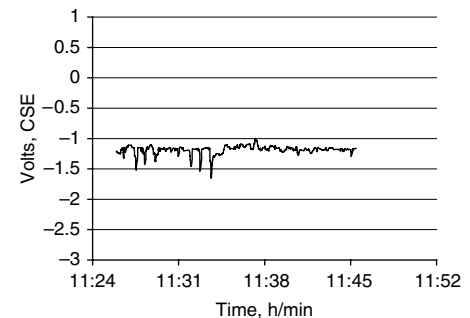
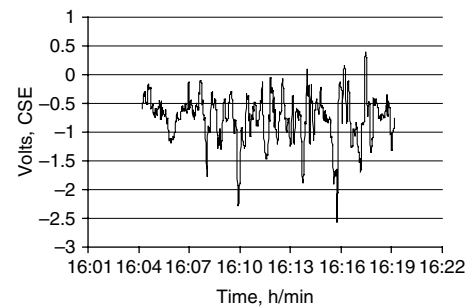
Figure 8 shows pipe-to-soil measurements made during the monitoring of a cathodically protected pipeline at a light rail crossing. During the monitoring shown in Fig. 8(a), the transit system was operated diode grounded, and stray-current flow was always from the track and toward the pipe in the immediate area of the crossing. The pipe-to-soil potential was always more negative than -1.0 V.

During monitoring shown in Fig. 8(b), the transit system was operated ungrounded, and current flow was both to and from the track. The centerline measurement of pipe-to-soil potential is more positive than -1.0 V. Stray-current flow reversed with train movement, and since there is the possibility of current flow from the pipe to the track, there is an increased prospect of corrosion of the pipe at the track crossing. This corrosion mechanism of closely coupled stray current from the pipe to the track can concentrate corrosion at this location. It is of particular concern because there is a multitude of utility crossings along an electric rail system. The location noted in Fig. 8 had been operated for 20 years as a diode-grounded system with an insulated embedded track. The rail had appreciable corrosion where installation of the elastomeric boot was inadequate.

Fig. 8 Substations operated diode-grounded (a) and operated ungrounded (b). CSE, copper/copper sulfate reference electrode

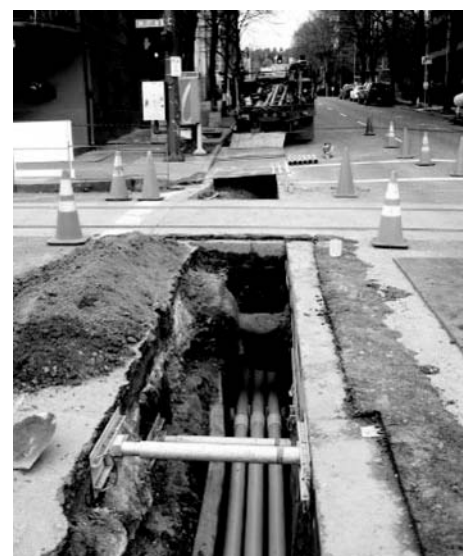
**Fig. 9** Utility work at existing track slab. Tracks remain operational during excavation; however, utility work stops and moves out of the way to allow train to pass unimpeded.

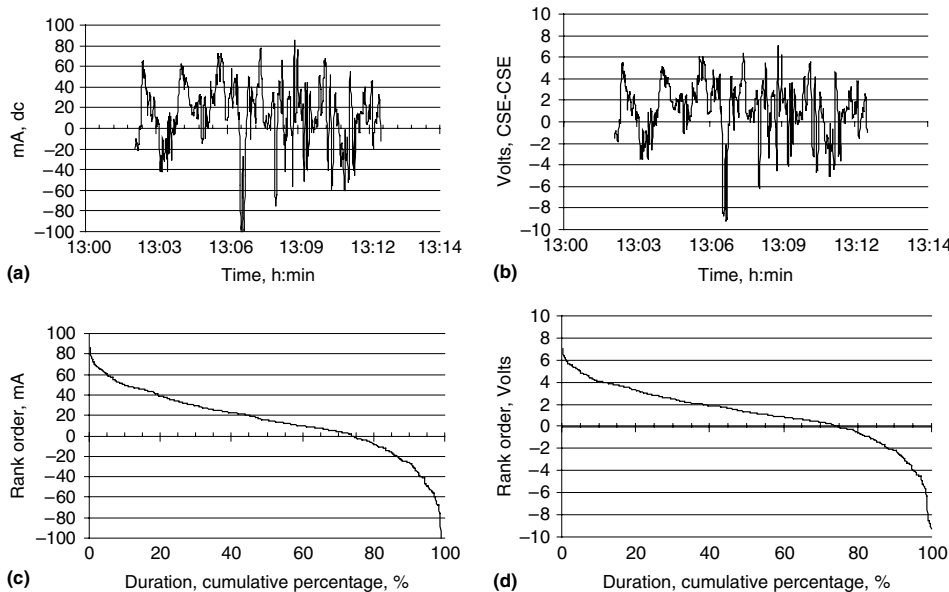
Measurements of current flow through the test short (Fig. 10a), show reversals with both discharge and pickup at the short. The time average current discharge of the short was approximately 20% of peak. Computations of electrolytic corrosion effects are based on time average current.

**Fig. 10** Track-to-earth current (a) and earth gradient (b) for a 100 Ω test short on an ungrounded embedded track system and their respective time durations (c) and (d). The CSE reference cells were located at the short and remote (175 ft, or 53.3 m).

This geometric relationship between current density and distance can be seen in the comparison on the chart recording of Fig. 10(b) with the simultaneous chart recording of Fig. 12. The earth gradient between remote earth and the immediate vicinity of the short, Fig. 10(b), is roughly an order of magnitude greater than the gradient between remote earth and a location

With the cooperation of the transit authority, a calibrated track-to-earth test short can be used to provide a qualitative and semiquantitative measure of site-specific conditions. Subsequent profiles can be readily compared for changes and to verify that the original design assumptions are maintained. Figure 10(b) shows the measured effect of a 100  $\Omega$  short in an embedded track compared to the properly insulated section of embedded track in Fig. 17.

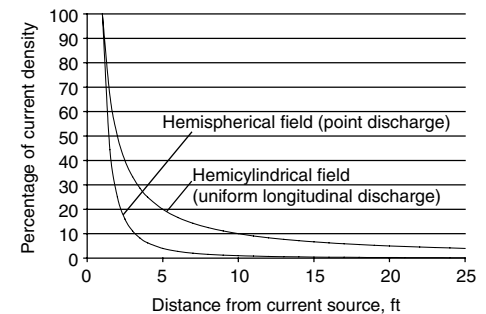
The resulting gradient is paramount in stray-current control and is shown in Fig. 11. Figure 11 shows two curves—the current density in soil resulting from a hemispherical field such as a discrete short, and a hemicylindrical field representing uniform discharge along the track. The figure compares the current density at 1 ft (0.3 m) distance from a current source through a 25 ft (7.6 m) distance. These are common distances for utility clearances in street construction. As a useful field approximation, note that the geometric relationship between current density in the soil and distance from a current source is such that current density is reduced roughly half or more with each doubling of distance from the current source. The change in current density through distance is characteristically a rectangular hyperbola ( $y = c/x$ ) as shown in both the hemispherical and hemicylindrical case.

**Fig. 11** Relative current density in soil as a function of distance from the current source, with the maximum current density of interest 1 ft (0.3 m) from the source.

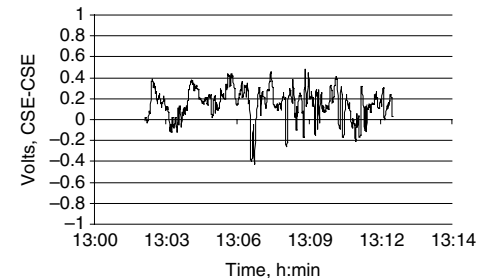
**Fig. 12** Earth gradient for a 100 Ω test short on an ungrounded embedded track system. The CSE reference cells were located 25 ft (7.6 m) from the short and remote (175 ft, or 53.3 m). Refer to Fig. 10(b). See text for details.

25 ft from the short (Fig. 12). Note that Fig. 12 voltage is graphed at 1/10 scale of Fig. 10(b) and that the gradient profiles are analogous.

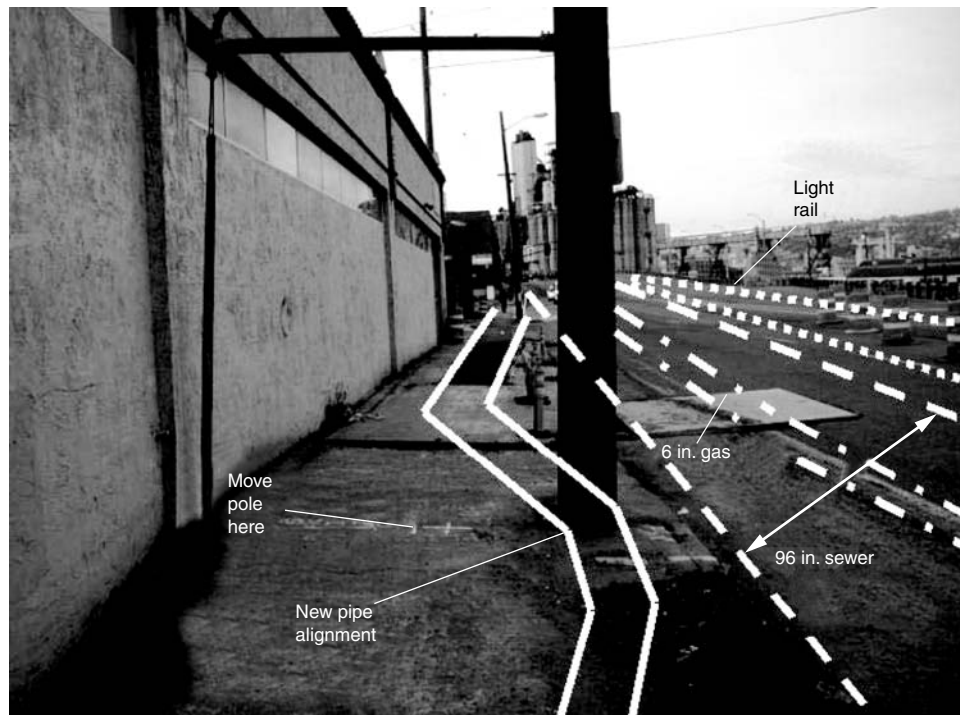
**Fig. 13** Utility relocation encumbered by congestion. Utilities are squeezed together on one side of a proposed light rail. The other side of the road is a bridge viaduct.

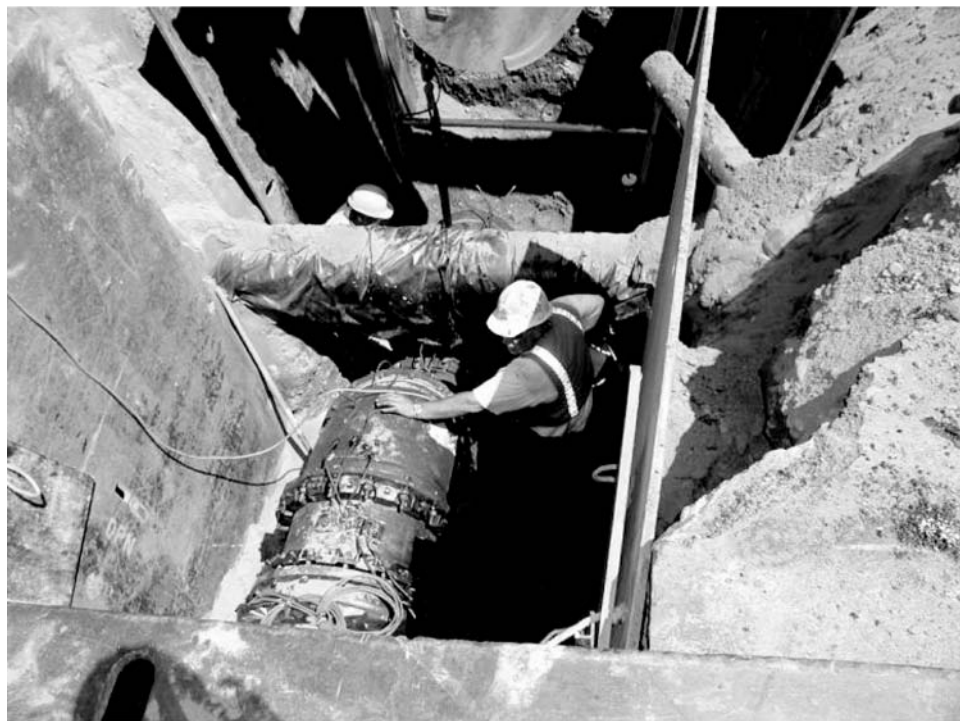
**Fig. 14** Vertical offset of a 24 in. (0.6 m) ductile iron water main to accommodate an existing 12 in. (0.3 m) main.

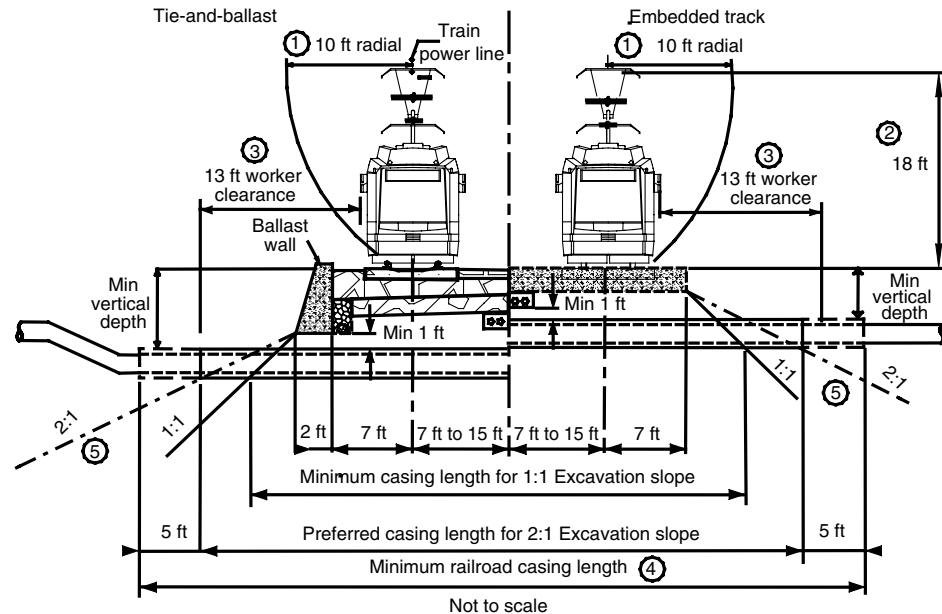
Fig. 15 Work clearances for utilities adjacent to and crossing under electric rail systems. Circled numbers are referred in the text as notes. Units of measure given in feet.

(OSHA) and by various organizations responsible for industry standards. Notes 1 and 2 in Fig. 15 illustrate clearances from the overhead power lines, which are governed by OSHA, National Electrical Safety Code (NESC), and

the U.S. Department of Transportation. Oregon OSHA (Ref 9) and NESC (Ref 10) require a minimum 10 ft working clearance between overhead electrical lines (50 kV or less) and personnel or equipment (Fig. 15, note 1).

The NESC (Ref 11) requires an 18 ft (5.5 m) minimum vertical clearance over roadways for electrical lines 22 kV or less (Fig. 15, note 2). This same regulation requires a minimum of 22 ft (6.7 m) vertical clearance for electrical lines crossing railroads.

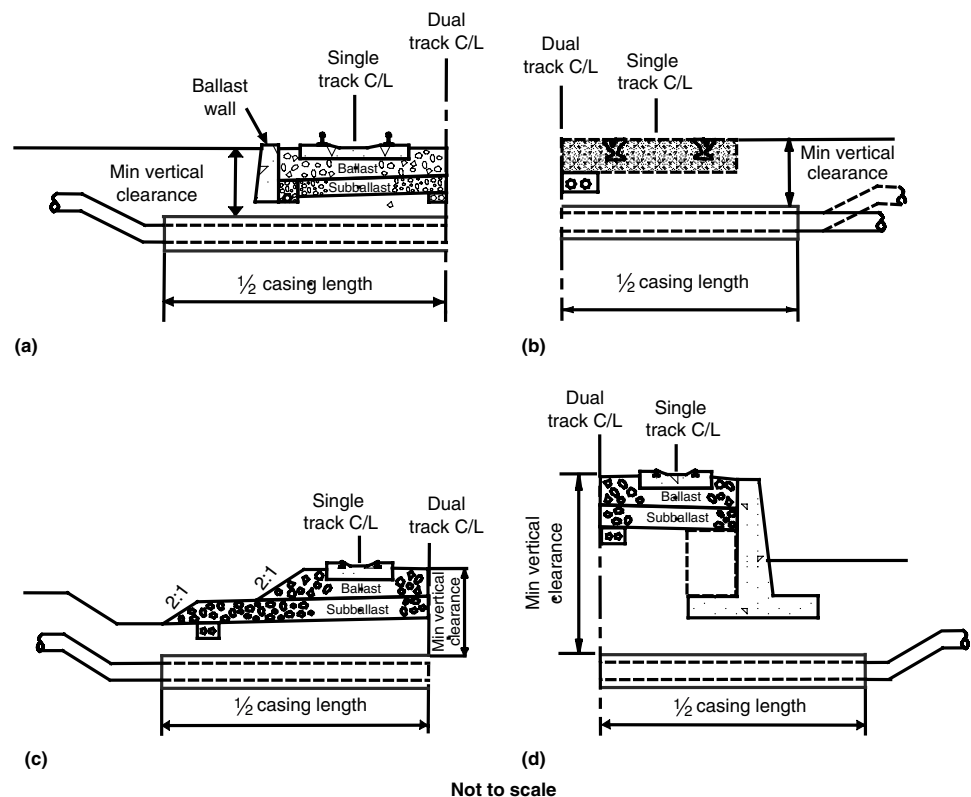
Fig. 16 Track design envelopes and their impacts on utilities crossings. Of particular interest is the depth from the top of the rail to the top of the casing, the length of the casing, and the vertical offset of the carrier pipe outside of the casing. (a) Tie-and-ballast adjacent to roadway. (b) Embedded track. (c) Tie-and-ballast in dedicated right-of-way. (d) Tie-and-ballast retaining wall. C/L, centerline

Tie-and-ballast systems have deep design envelopes of 5 ft (1.5 m) or more, while

embedded track systems can have shallower envelopes, about 2 to 3 ft (0.6 to 0.9 m) in depth. Underground utilities are typically 2 or 3 ft (0.6 or 0.9 m) minimum depth. Most utilities will be physically impacted by tie-and-ballast construction because of the depth of the envelope. With embedded track, fewer utilities will be in direct physical conflict with the envelope construction.

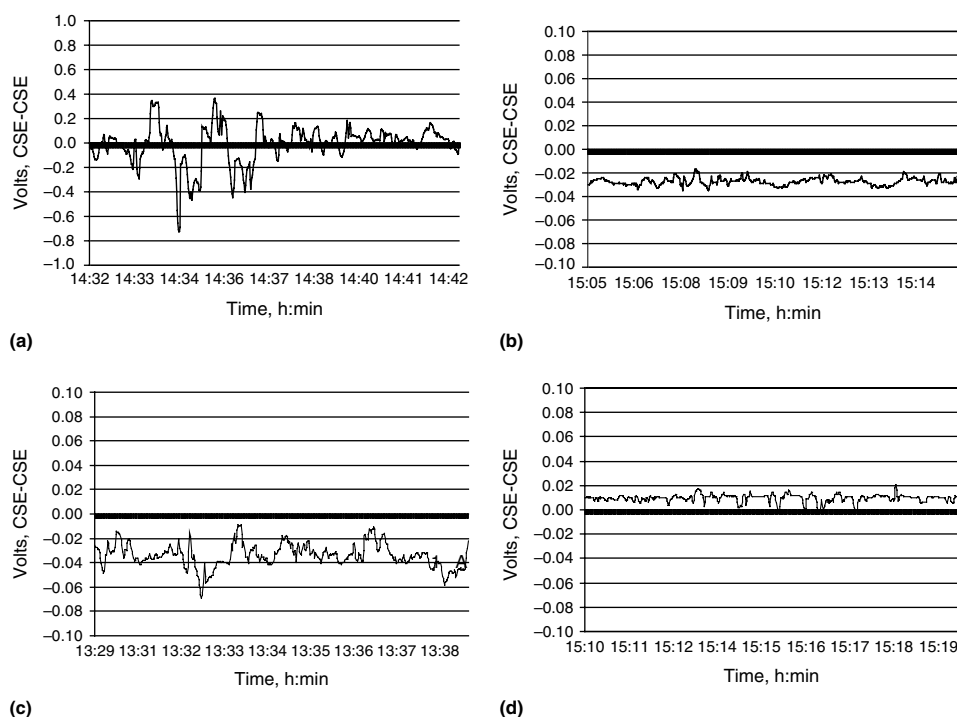
Figure 17 shows typical gradient measurements of tracks at noninsulated tie-and-ballast track (Fig. 17a), insulated tie-and-ballast track (Fig. 17b), embedded track insulated with potting compound (Fig. 17c), and embedded track insulated with an elastomeric boot (Fig. 17d). Note that the scale of Fig. 17(a) is tenfold greater than the others. The gradient for the noninsulated track is an order of magnitude greater than the gradient of the insulated track. This is because the track-to-earth resistance of the noninsulated track is much less than the insulated track systems. The gradient for the track insulated with a potting compound is appreciably greater than the gradient of the other examples of insulated track. The potting compound is failing and the track-to-earth resistance of this track is less than the other insulated track sections. The small bias around the baseline of gradient measurements can be attributed to natural variations in soil; however, an offset of 100 mV or greater might indicate a steady-state source of stray current.

**Fig. 17** Comparative track earth gradients. The tracks are not shorted. The CSE reference cells were located 15 ft from the track and remote (175 ft). See text for details.
