# ASM Handbook®

## Volume 13C Corrosion: Environments and Industries

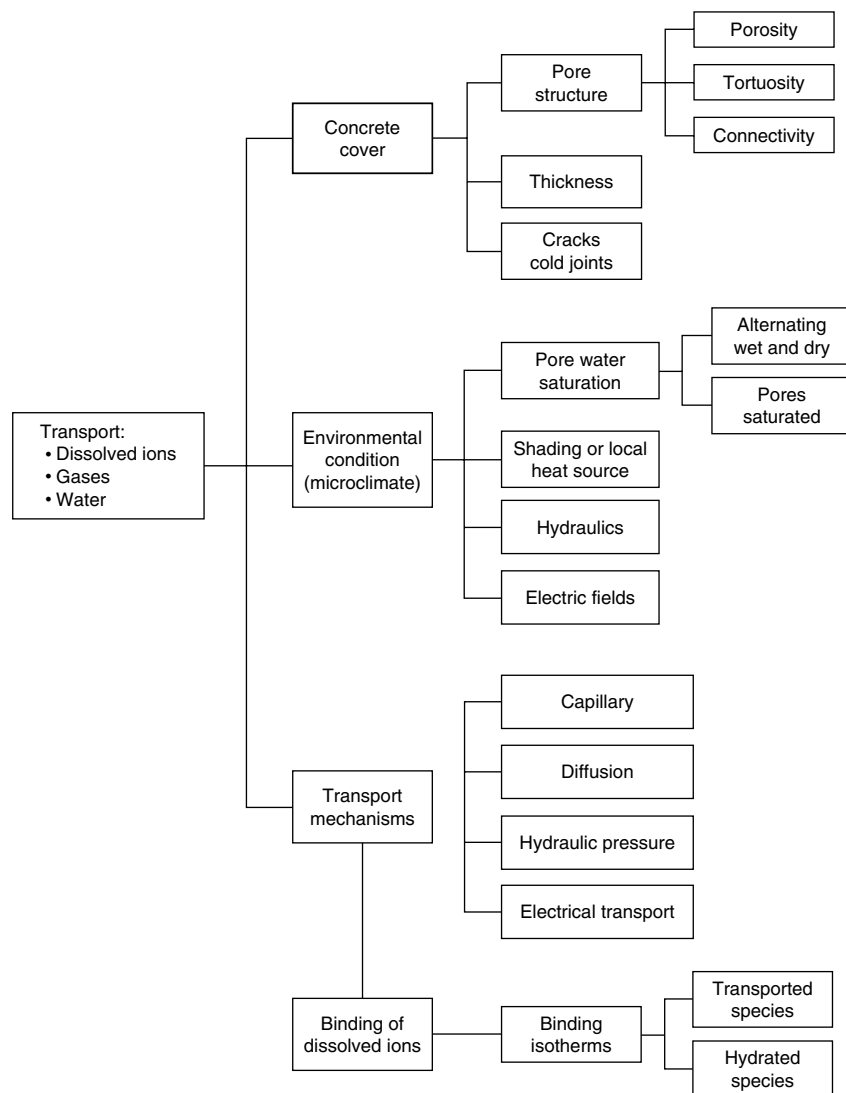
Fig. 1 Factors involved in corrosion of metals embedded in concrete. Adapted from Ref 23

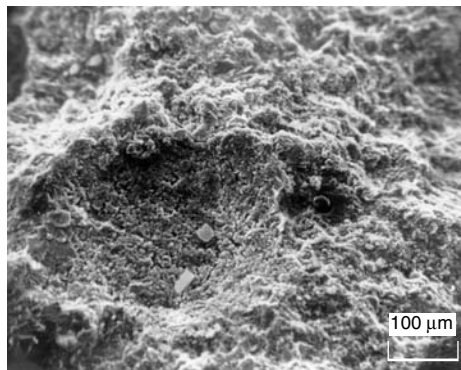
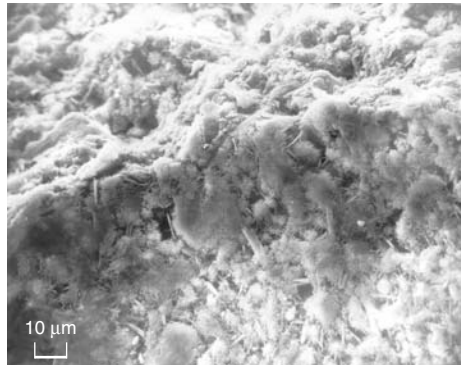
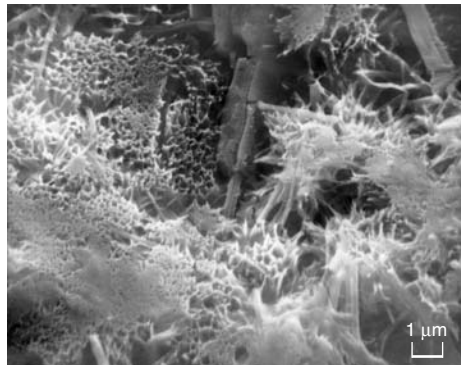
**Fig. 2** (a), (b), (c) Fractured surface of hardened cement paste, with increasing magnification

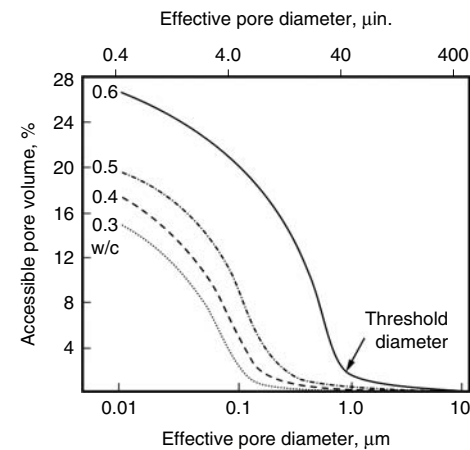
distribution. A common term used to express that volume of water is the water-cement (w/c) ratio. Figure 3 shows the effect of w/c ratio on capillary pore size distribution as measured through mercury intrusion porosimetry (MIP) (Ref 31). Although MIP is not able to provide an absolute measure of pore size, Fig. 3 illustrates that reducing the w/c ratio yields smaller capillaries. A reduction of HCP capillary size will restrict transport of chloride ions and oxygen and thus impede corrosion of embedded steel.

**Fig. 3** Influence of water-cement (w/c) ratio on effective pore diameter

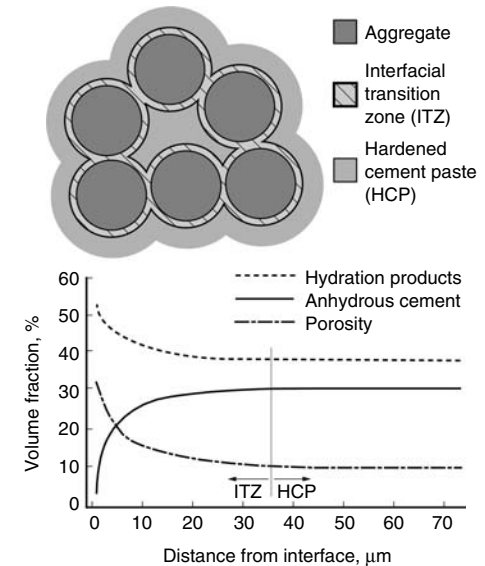
**Interfacial Transition Zone.** The microstructure of HCP is modified near inclusions such as aggregates and reinforcing steel (Ref 32–34). This modification extends 20 to 50 μm (0.8 to 2.0 mils) away from the inclusion surface and is called the interfacial transition zone (ITZ). The origin of the ITZ is the wall effect, which reduces the density of small particles near much larger particles and is further enhanced by the effects of localized bleeding. This creates more space adjacent to the inclusion (aggregate, reinforcing steel) that must be filled by hydration products. The ITZ is characterized by enhanced porosity and a greater amount of cement hydration (Fig. 4). Computer simulations have shown that the ITZ around the aggregates can form a percolating network of porosity (Ref 34). The impact of ITZ and percolation should be considered when formulating concrete mix designs for reinforced structures in aggressive environments or where long life is desired.

**Fig. 4** Schematic view of interfacial transition zone

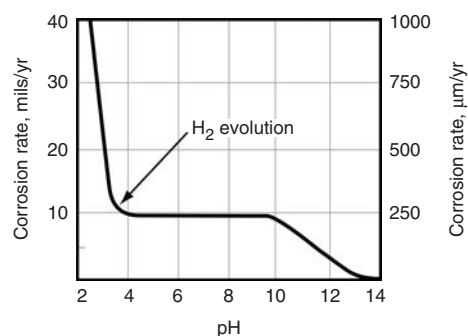
Fig. 5 Influence of pH on corrosion rate

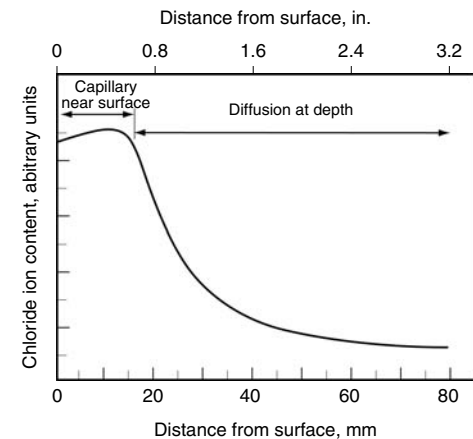
**Fig. 6** Chloride profile showing capillary effects near the surface and diffusion at depth

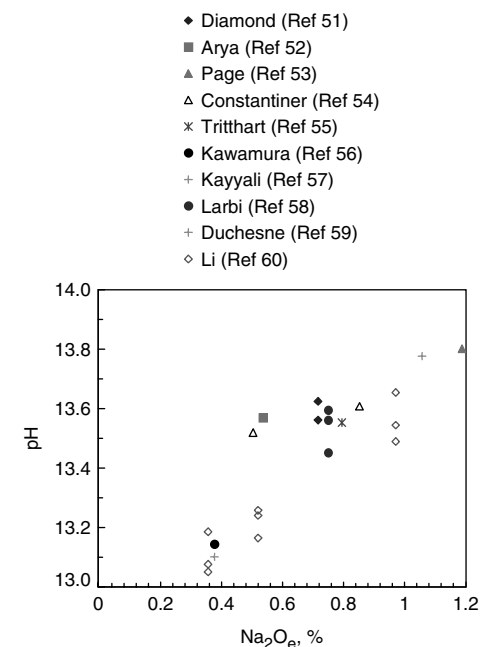
**Fig. 7** Relationship between pore water pH and cement equivalent, Na<sub>2</sub>O<sub>e</sub>, content

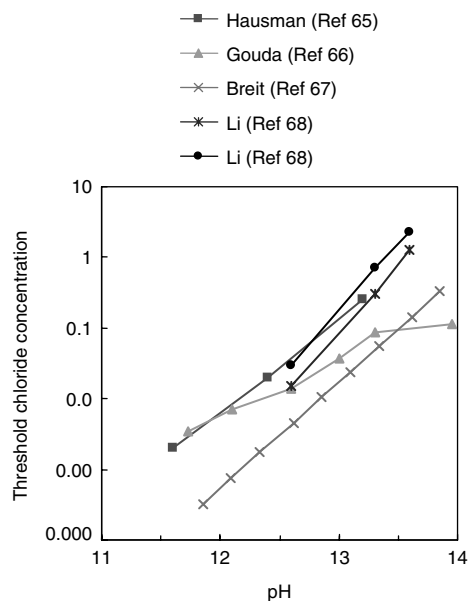
Fig. 8 Relationship between threshold chloride concentration and pH of alkaline solution

**Effect of pH on Chloride Threshold.** The beneficial effect of hydroxide ions in enhancing the resistance to chloride-induced corrosion of carbon steel in alkaline media is widely understood. Based on several published studies, the relationship between the threshold chloride concentration and the pH of alkaline solutions simulating concrete pore water is presented in Fig. 8 (Ref 65–68). It is apparent that the threshold chloride level increased monotonically with the increase of solution pH for all of these cases, irrespective of differences in the solution

and carbon steel chemical composition, specimen size and surface finish, testing procedures, and criteria employed to define the threshold. For that reason, the following equation has been proposed to relate the carbon steel threshold chloride level to the solution pH:

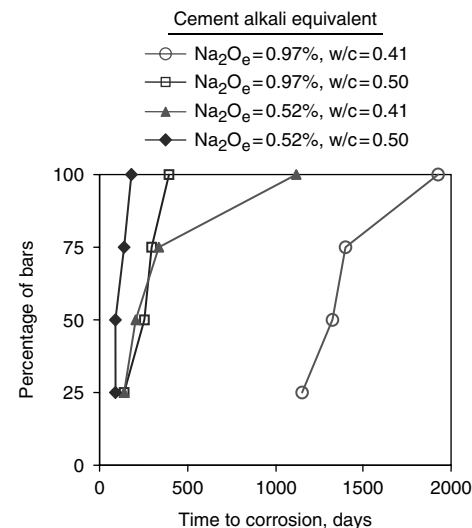
Fig. 9 Number of specimens failed as a function of chloride ponding time.  $w/c$ , water-cement ratio. Adapted from Ref 66

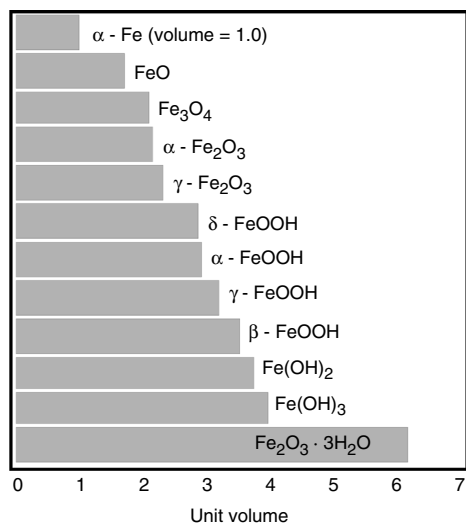
Fig. 10 Comparison of the unit volumes of steel and its corrosion products

In oxygenated concrete, the insoluble corrosion products collect at the reinforcement-concrete surface. Hydration also often occurs. As Fig. 10 shows, these hydrated corrosion products occupy significantly more volume than the parent metal. This increase in volume, which is restrained by the presence of the rebar, leads to the development of tensile hoop stresses in the surrounding concrete (Fig. 11a). Concrete is quite strong in compression but has tensile strength that typically runs only 10 to 15% of its compressive strength. Because of this limited

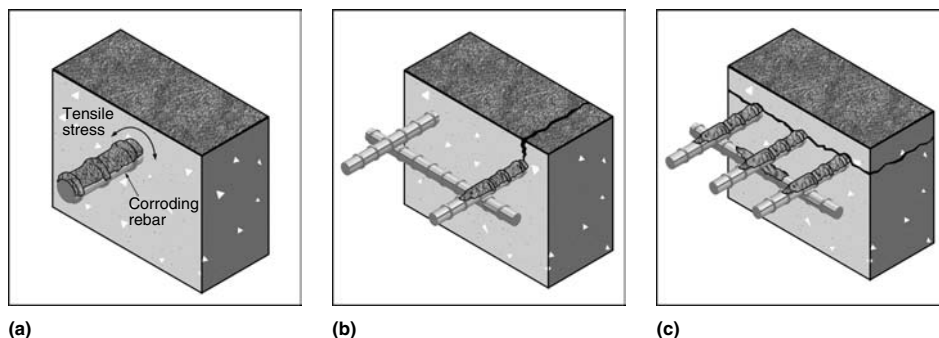
Fig. 11 Expansive corrosion products from rebar generate stress in concrete. (a) Tensile hoop stresses develop adjacent to the corroded steel. (b) Wide bar spacing and/or shallow cover favor formation of vertical cracks to relieve the stress created by the expansive corrosion products. (c) Close bar spacing and/or deep cover favor formation of a delamination plane to relieve the stress created by expansive corrosion products.

tensile strength, the concrete cracks to relieve the tensile hoop stresses generated by the expansive corrosion products. The failure mode depends on the strength of the concrete, the depth of concrete cover over the reinforcement, and the spacing between the bars. If there is shallow concrete cover and/or wide spacing of the reinforcement, then vertical cracks form to relieve the corrosion-initiated stress (Fig. 11b). When the reinforcement is more closely spaced or is overlain with a greater depth of concrete cover, the stress-relieving cracks will run through the concrete from bar to bar, forming what is known as a delamination plane (Fig. 11c). Continued general corrosion of the reinforcement, or mechanical action such as from traffic, can dislodge some or all of the delaminated concrete, creating a spall or pothole.

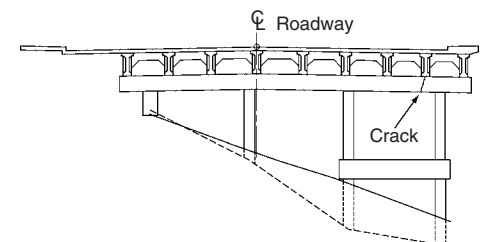
Fig. 12 Elevation view of cracked beam. Localized corrosion cut all the rebars crossing the crack, including those at the beam bottom.

Figure 12 shows an elevation view of a beam supporting a bridge where differential settlement had generated a narrow (<0.5 mm, or 0.02 in., wide) crack. It appears that the concrete had cracked early in the service life of the bridge. The bridge is located in an area with significant tidal variation (>3 m, or 10 ft). At extreme high tides or during storms, the crack would be wetted with saltwater splash. The narrow crack wicked chlorides rapidly to the level of the reinforcement. Although there was a rust stain on the concrete surface, sounding the concrete with a hammer did not indicate a problem, that is, a hollow sound indicating delamination, so initially no repairs were scheduled. The rust staining was attributed to a tie wire or other trivial surface artifact. Measurements of the corrosion potential of embedded steel in the vicinity of the crack showed rapid change of potential (>150 mV) within a short distance (<150 mm, or 6 in.). An abrupt change in the corrosion potential of reinforcement in the vicinity of cracks, cold joints, or even in apparently sound concrete is often indicative of severe corrosion of embedded reinforcing steel. The area was excavated, and all of the lower bars in the pile cap supporting the deck, and shown in Fig. 12, were severely corroded (>50% loss of cross section) or had fully failed. Figure 13 shows a closeup of one of the bars. Figure 14 shows a similar failure of a stirrup at a location where early cracking of the beam occurred. All the stirrups on one side

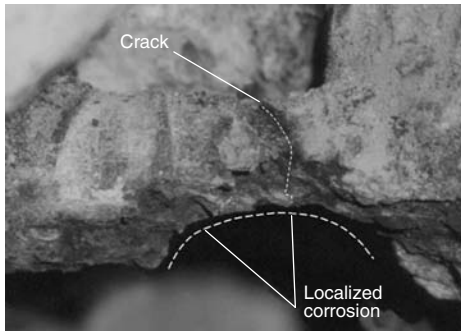
**Fig. 13** Closeup of reinforcing bar that suffered full-section failure. Approximately three-fourths of this bar was fully corroded, with the remaining one-fourth cracked.

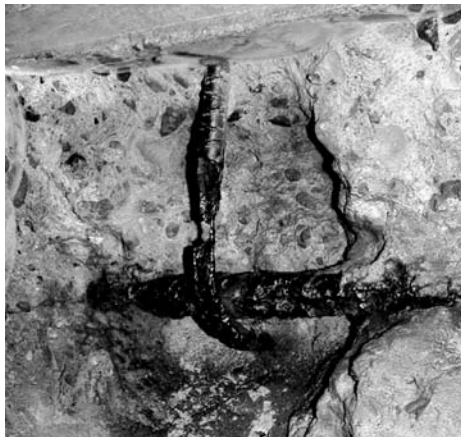
**Fig. 14** Closeup of a fully failed pile cap stirrup. Note that immediately above the severely corroded area, the bar shows no sign of corrosion. The upper area was in a passive condition and served as the cathode for corrosion of the area just below. Close interval mapping of reinforcement corrosion potential can identify these situations.

In both of the cases shown in Fig. 14 and 15, traditional sounding techniques did not indicate a corrosion problem. Close-interval (150 mm, or 6 in.) measurement of the embedded reinforcement corrosion potential clearly indicated abrupt changes in potential and provided a good indicator that localized corrosion was present.

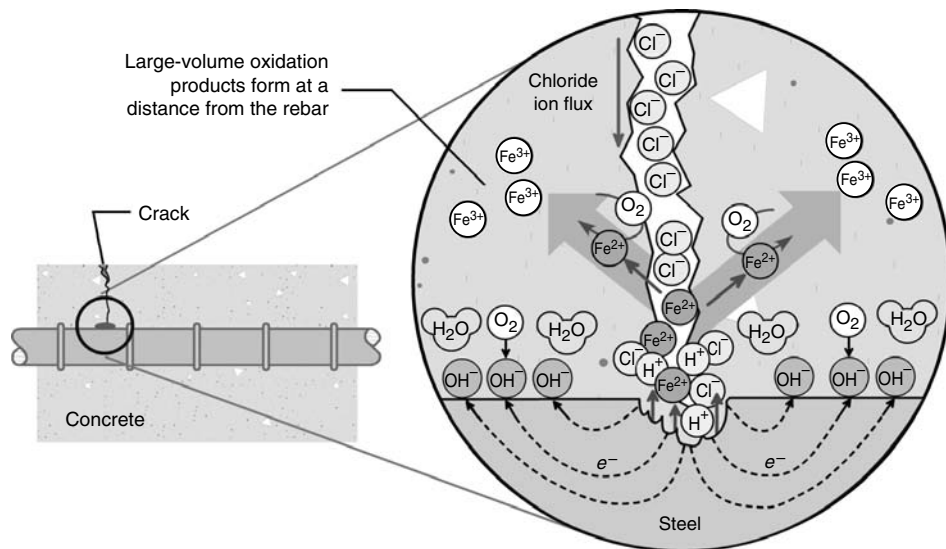
**Fig. 15** Schematic of localized corrosion with adjacent cathode

In both cases, the pile cap and the beam stirrups, the cracks had high average times of wetness. This fact kept the chloride ions available for corrosion activation, iron transport, and hydrolysis. As a consequence, soluble corrosion ferrous ions (Eq 4) were transported from the steel surface. A schematic of the corrosion process is shown in Fig. 15. Here, iron from the steel reinforcement goes into solution as  $Fe^{2+}$ . The ferrous ion is able to move away from the surface of the parent steel as a soluble hydroxide or as a chloride complex. Completion of the oxidation process, and formation of voluminous red rust corrosion products (Eq 5), occurs either at the concrete surface (the crack opening) or in concrete pores ( $Fe^{2+} \rightarrow Fe^{3+}$ ). The differential in chloride concentrations allows steel exposed to the crack to be the anode and metal exposed to the adjacent chloride-free concrete to be the cathode.

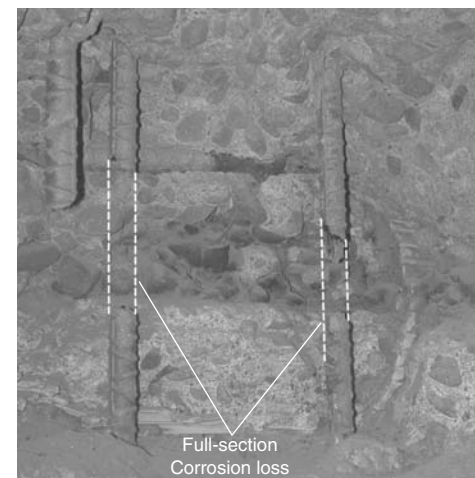
**Fig. 16** Localized full-section corrosion failure with remote cathode

occur on retaining walls and tunnels. Figure 16 shows a localized corrosion failure that occurred at a cold joint in a retaining wall with a double mat of reinforcement. One face of the retaining wall was exposed to chloride-contaminated fill, while the other face was exposed to the atmosphere. Chloride ions migrated along the cold joint to the layer of reinforcement closest to the fill and became the anode in the distinct macrocell. The cathode was the mat of reinforcing steel that was closest to the atmospherically exposed surface and had a higher oxygen concentration.

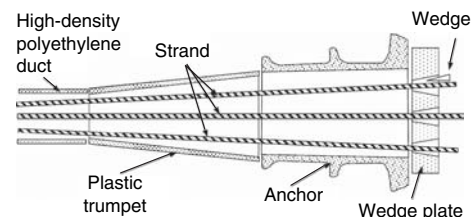
**Fig. 17** Idealized schematic of a typical anchorage system. Only three strands shown for clarity. Anchor, wedge plate, and wedges are ferrous alloys.

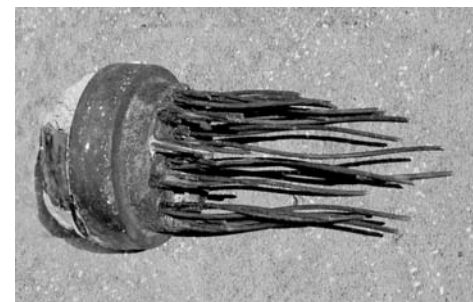
**Fig. 18** Failed strands from corrosion in grout void area of an anchorage. Courtesy of Florida Department of Transportation

Bridge in the Western panhandle (Ref 99), and the 15 year old Sunshine Skyway Bridge over Tampa Bay (Ref 100). In each of these bridges, the observed damage consisted of one completely cut tendon plus one to several partially detensioned tendons. The completely cut tendons had failed in the anchorage region following severe corrosion of many of the strands, as illustrated in Fig. 18.

Mechanical failure appeared to be the result of simple overload of locally reduced cross section, usually in the form of generalized corrosion along several centimeters of strand length, with occasional pitting. In the partially detensioned tendons, severe corrosion and mechanical failure had affected some but not all of the strands. In one instance, the area of severe corrosion was approximately 2 to 3 m (7 to 10 ft) away from the anchorage. All cases of severe corrosion were associated with large void areas that should have been filled with grout. Significant chloride contamination of the remaining grout was observed at some of the corroded regions. In many cases, the affected anchorages were at bridge expansion joints or underneath horizontal surfaces, where salt and moisture availability was significant. Additionally, HDPE duct cracks were commonly encountered in the Mid Bay Bridge. Corrosion was not unique to any particular anchorage manufacturer.

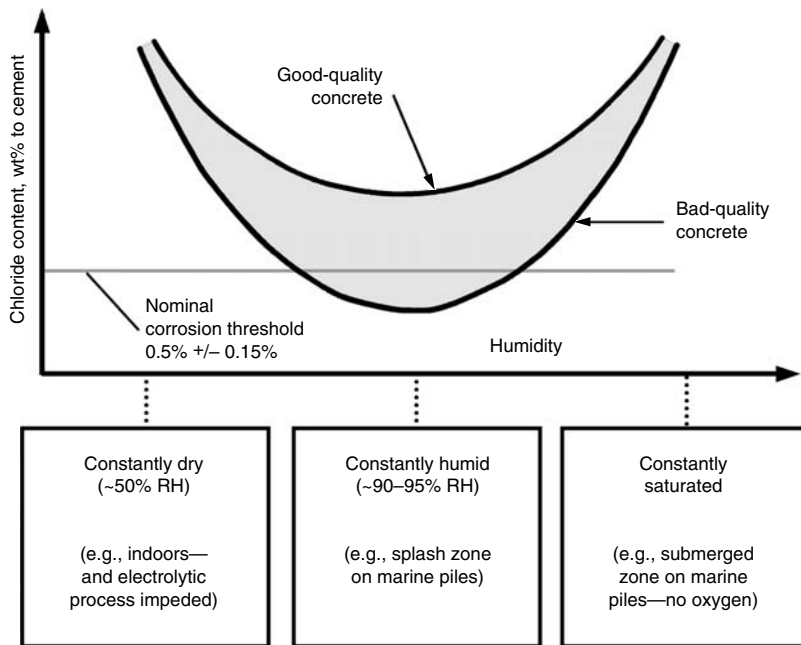
Fig. 19 Impact of concrete quality on chloride content (wt% to cement) corrosion threshold. RH, relative humidity

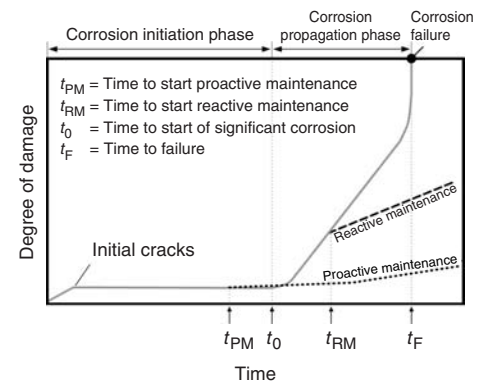
Fig. 20 Plot of cumulative damage versus time, with several maintenance options

The next time interval shown in Fig. 20 is that of the corrosion propagation phase. Note that after a relatively short nonlinear period immediately after  $t_0$ , there is a relatively linear increase in damage with time during most of the remaining propagation phase. Shortly before the point noted as “Corrosion failure,” the rate of corrosion damage typically shows a dramatic increase. “Corrosion failure” is assumed to be the point of maximum allowable corrosion damage and is also noted by the time  $t_F$ . The point of corrosion failure,  $t_F$ , would be the end of the service life with no remediation or repairs.

If maintenance is applied to extend the life of the structure, that maintenance could come either before or after the onset of corrosion,  $t_0$ . The point  $t_{RM}$  and the damage-versus-time plot that follows reflect reactive maintenance, or that

occurring after the onset of significant corrosion. The point  $t_{PM}$  and the following plot reflect proactive maintenance. For example, if chloride ion contamination was the defining corrosion issue for a structure, electrochemical chloride extraction could be applied either before or after the onset of significant corrosion activity and damage. Proactive maintenance typically will minimize incurred damage.

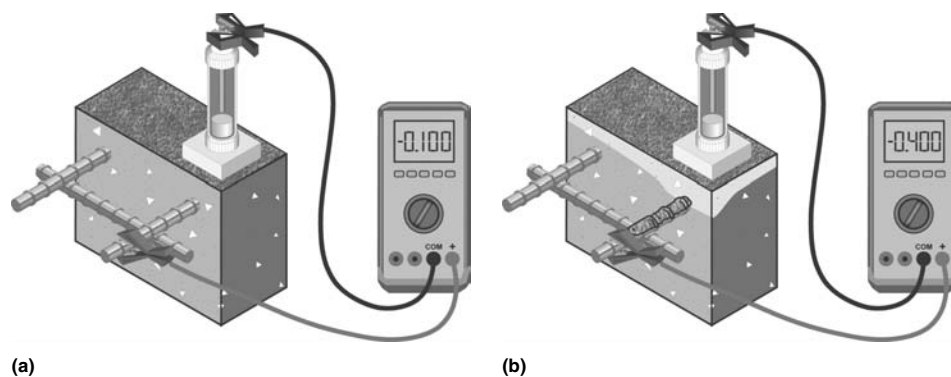
**Fig. 21** Schematic showing the layout for potential testing. (a) The meter reading of  $-0.100$  V to a copper-copper sulfate electrode reflects a noncorroding condition. (b) The  $-0.400$  V to a copper-copper sulfate electrode reading reflects a corroding condition.

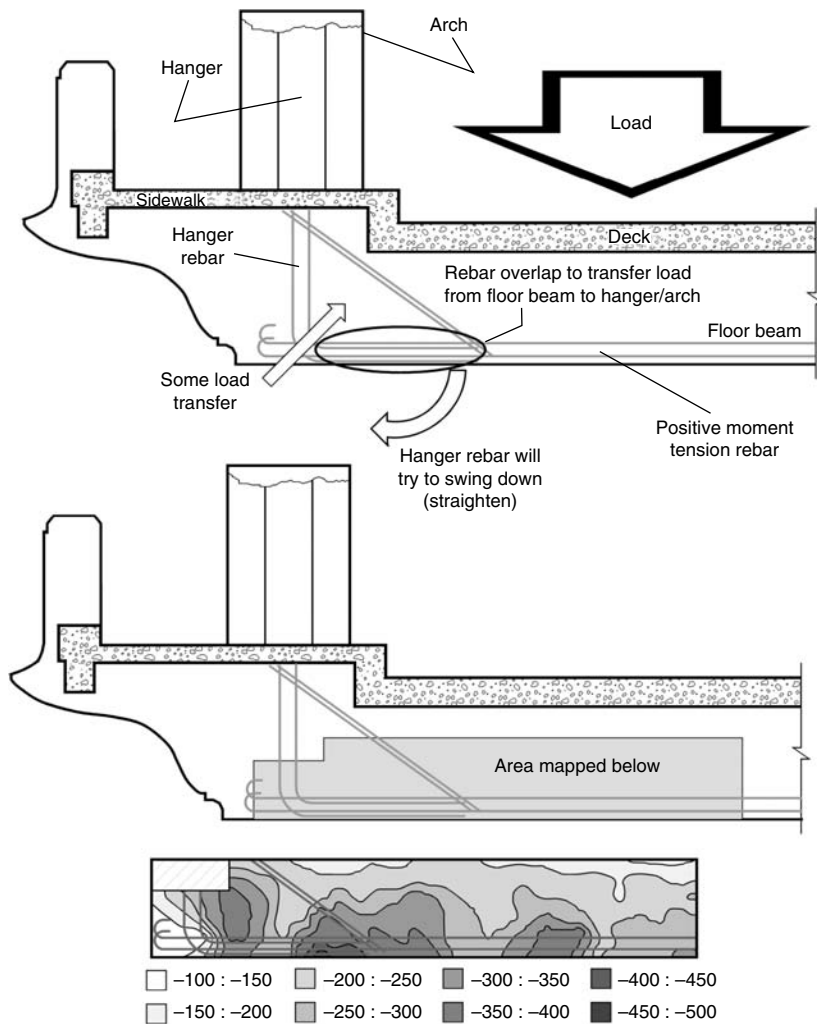
Fig. 22 Close-interval potential map showing the effect of loading and load-transfer fatigue on floor beam reinforcement corrosion

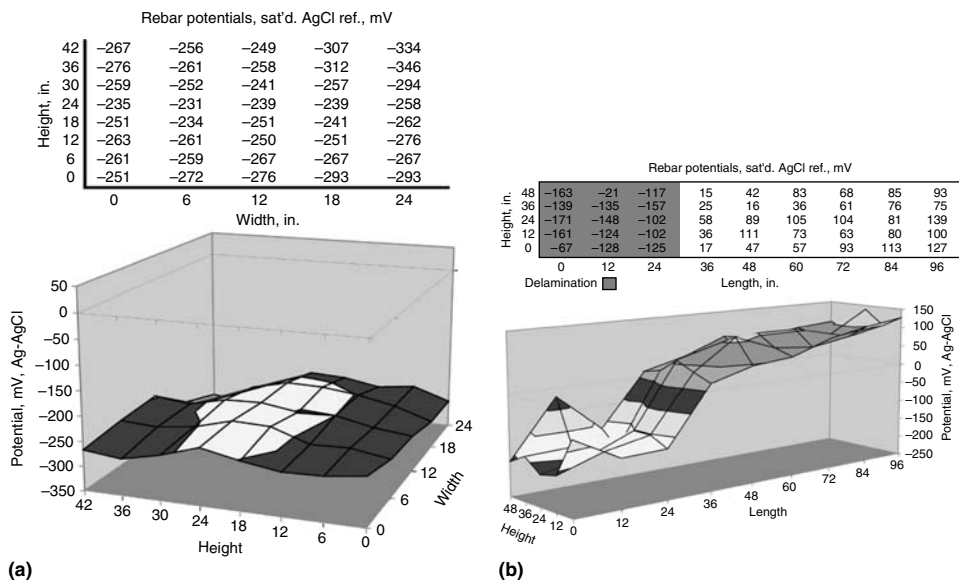
Fig. 23 Map of potential variations. (a) Low potential variation with relatively negative potentials indicates very low oxygen availability and little corrosion. (b) Abrupt variation in potential indicates corrosion activity.

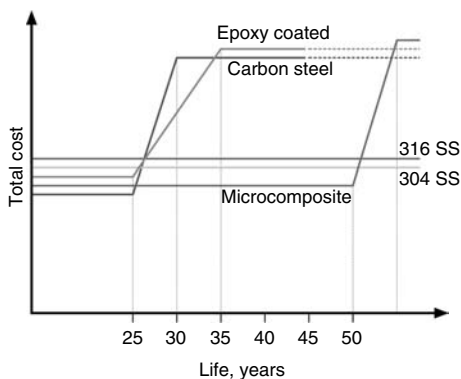
Fig. 24 Relative life costs of corrosion-resistant reinforcement

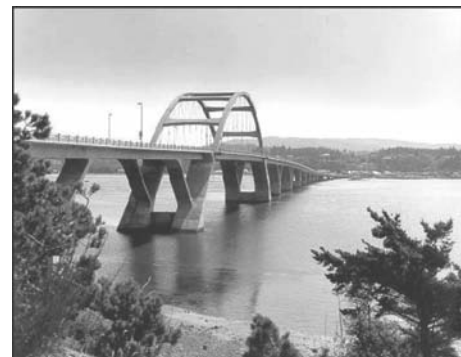
Fig. 25 Alesia Bay Bridge, Waldport, Oregon. Courtesy of Oregon Department of Transportation

the service life of a highway structure. Some are the simple steps of paying attention to detailing. Run-off water from a bridge deck often contains chloride-bearing deicing salts. This can be particularly problematic on curved or skewed bridge decks. If only scuppers are used that are fitted with short drain pipes, the wind may carry salt-water that drains to support piles and causes corrosion in an area where it could easily and very inexpensively be avoided. If a 100 year design life is desired and posttensioning (PT) is to be part of the design, it is reasonable to use the best technology available to avoid premature corrosion of the PT strands. It is also relatively inexpensive insurance to include spare empty PT strand ducts that, although sealed during construction, are readily available for installation of supplementary PT strands, should loss of prestressing occur. Figure 25 is a picture of a bridge where this technique was employed.

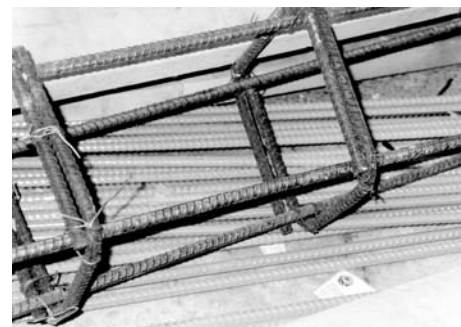
Fig. 26 Bare reinforcement cage resting on a loose pile of epoxy-coated reinforcement

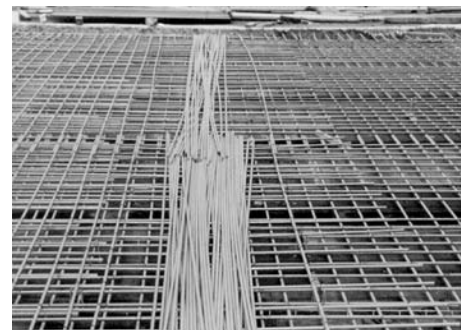
Fig. 27 Epoxy-coated reinforcement (ECR) loosely stacked on in-place ECR

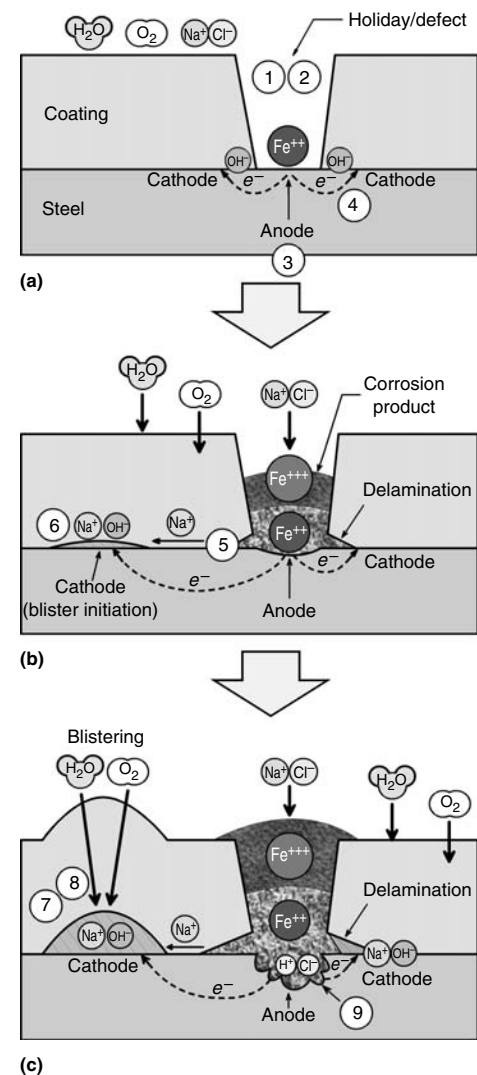
Fig. 28 Failure at a coating defect

**Hydrolysis.** For both initially undamaged and damaged coatings (Fig. 28c and 29d), step 9 shows pits forming in the steel as the result of hydrolysis reactions. These reactions are aggravated by the presence of chloride ions, because iron will form soluble complexes with chlorides. These complexes aid in the removal of reaction products from the active site. Hydrolysis also will reduce the local pH.

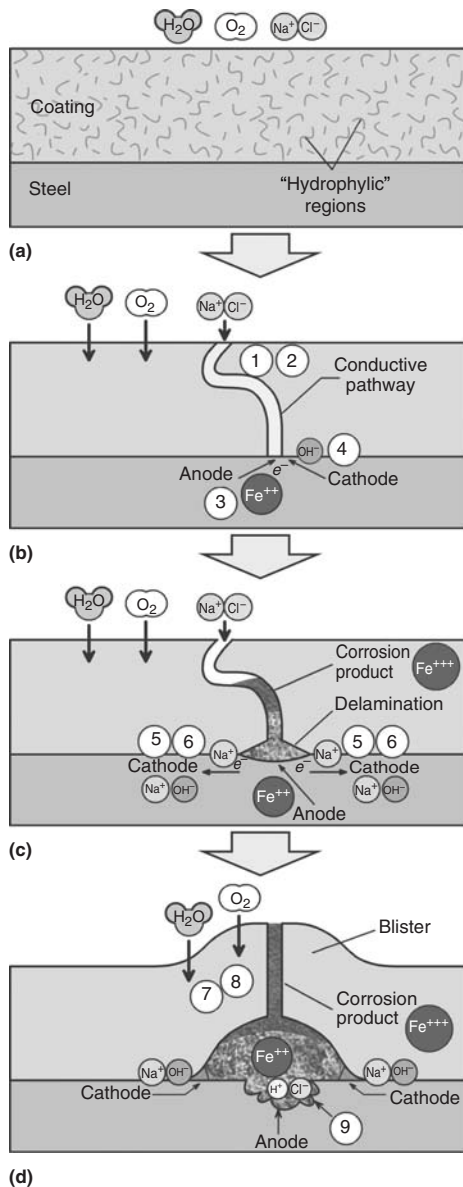
**Coating without Defects.** However, even without field-detectable defects, epoxy coatings have pathways or pores that can be involved in absorption and diffusion of water and sodium and chloride ions. Figure 29 shows a schematic of the NIST model for coating degradation without pre-existing defects (Ref 153). In Fig. 29(a), the gray hydrophilic regions are areas with low-molecular-weight materials that have relatively little cross linking. As such, they can take up water and ions and are subject to hydrolysis.

(step 1 in Fig. 29b). As in the case of ECR with a defect, water and reactants reach the steel (step 2), leading to the formation of anodes and cathodes (steps 3 and 4, respectively).

In Fig. 29(c), the small and mobile sodium ion diffuses along the steel-coating interface in step 5. Through hydrolysis (step 6), alkaline solutions develop. This leads to delamination of the coating adjacent to the conductive pathway.

In Fig. 29(d) (step 7), the alkaline pools generate osmotic pressure gradients that transport water to the reaction site. This inflow of water and expansion due to the formation of corrosion products causes swelling and blister formation in step 8. Generally speaking, the corrosion observed on initially undamaged ECR is much less than that seen with damaged bar (Ref 150).

Fig. 29 Failure without a coating defect

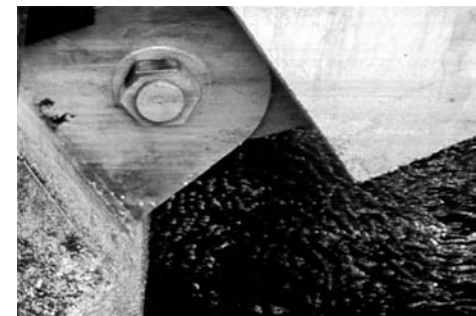
Fig. 30 Stainless steel arch hinge. Note marine growth

In addition to reinforcement, stainless steels may be used for hinged arches (Ref 171). Figure 30 shows an arch hinge used on a coastal bridge. As can be seen, the tide sometimes covers parts of the hinge. The hinge plates were fabricated from duplex stainless steel 2205, while antigalling Nitronic 60 was used for the pins. Figure 31 shows the 316LN studs used to connect the hinges to the concrete arch and abutment.

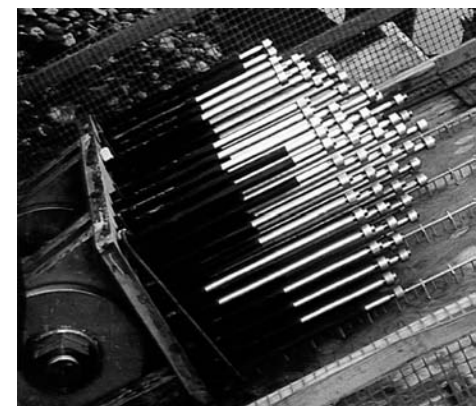
Fig. 31 316LN anchor studs used to connect stainless steel arch hinge to concrete

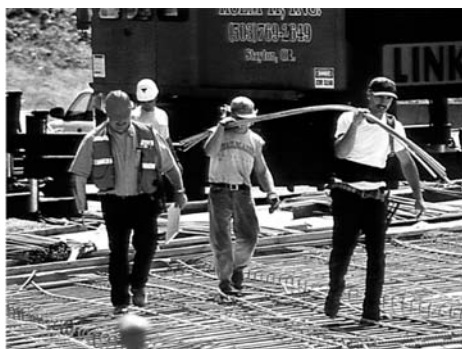
**Fig. 32** Workers can walk on stainless steel bar, where they should not with epoxy-coated reinforcement.

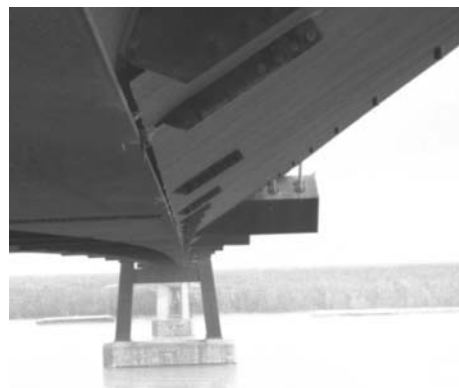
Fig. 33 Protective patina tightly adhering to weathering steel on bridge exterior

Figure 33 shows a protective patina tightly adhering to weathering steel on the exterior of a cable-stay-supported bridge. The relative humidity at the bridge location averages over 80% for four months and over 70% for the remainder of the year. Figure 34 shows a light-colored sheet of weathering steel corrosion product peeling from the interior of the cable stay support pier adjacent to the exterior view shown in Fig. 33. This wallpaper-like corrosion product has a thickness of approximately 2.5 mm (0.1 in.). Although near the coast, corrosion product samples from the interior show no signs that chloride ions aggravated the corrosion. The clear difference in behavior between interior and exterior exposure appears to be the result of the high time of wetness that occurs within the piers. Thus, the interior environment minimizes the alternating wet-dry cycle necessary to produce a protective patina, and instead of protection, the interior conditions produce exfoliation of sheets of corrosion product.

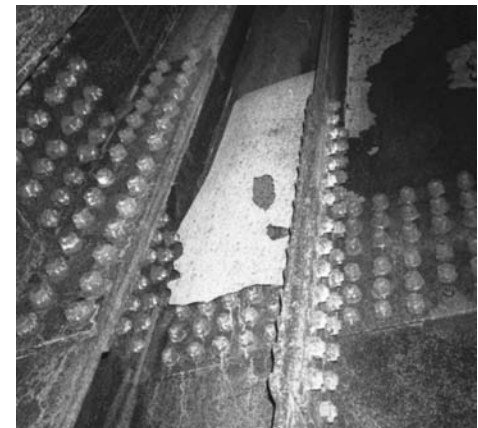
Fig. 34 Wallpaper-like corrosion product peeling from weathering steel on bridge interior

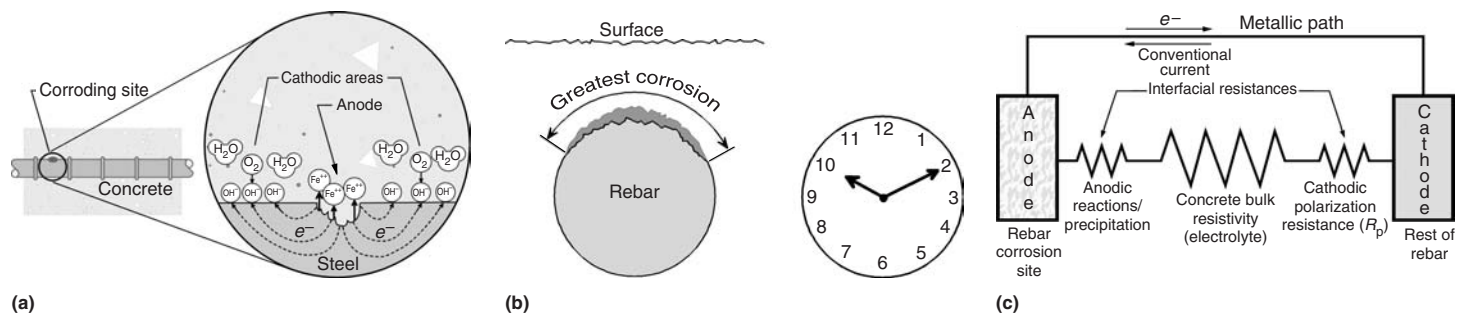
**Fig. 35** Corrosion in rebar. (a) Flow of corrosion current in the reinforcement rod. (b) Cross section of corroding rebar. (c) Electrical circuit analog of corroding rebar

A typical corroding area on a reinforcing bar is shown in Fig. 35(a). Corrosion occurs at the anode. The metal does not corrode at cathodic areas. A cross section of Fig. 35(a) is shown in Fig. 35(b). Note that corrosion is typically observed in the 10 to 2 o'clock position relative to the surface, with the rebar areas at greater depth continuing to manifest passive behavior. An electrical circuit analog of this corroding area is shown in Fig. 35(c).

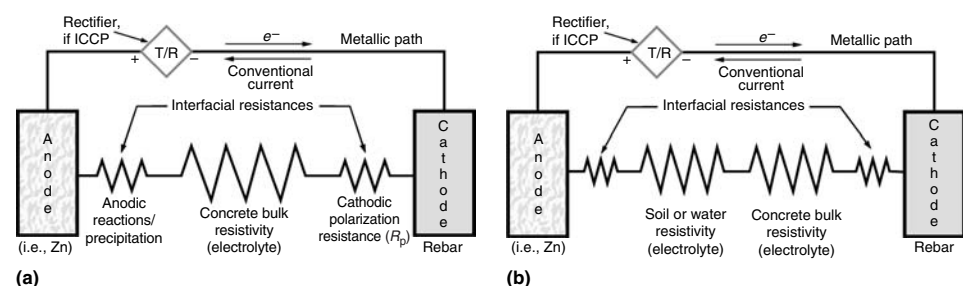
**Fig. 36** Electrical circuit analog of reinforced-concrete cathodic protection system components. (a) Anode is embedded or affixed to structure. (b) Anodes installed remote from the reinforced-concrete structure. ICCP, impressed-current cathodic protection; T/R, transformer/rectifier

**Elements of a CP System.** There are four elements to a CP system. These are the anode, cathode, electrolyte, and metallic path, shown in Fig. 36(a). In a concrete CP system, the cathode is the reinforcement or other embedded metals. The anode is either embedded in the concrete or affixed to the structure surface. The metal path is the reinforcement, reinforcement tie wires, and electrical cables installed as part of the CP system installation. The electrolyte is the concrete.

Note that in Fig. 36(a) and (b), protective current should flow to all of the reinforcement. The goal of CP is to polarize all portions of the reinforcement to a cathodic potential that suppresses corrosion even in crevices or at the base of pits. That is achieved by polarizing the structure to a potential equivalent to, or more negative than, the corrosion potential of the most anodic site. The geometry and variations in electrolyte resistivity of the structure can result in uneven CP current densities collecting on the reinforcement surface at different locations in

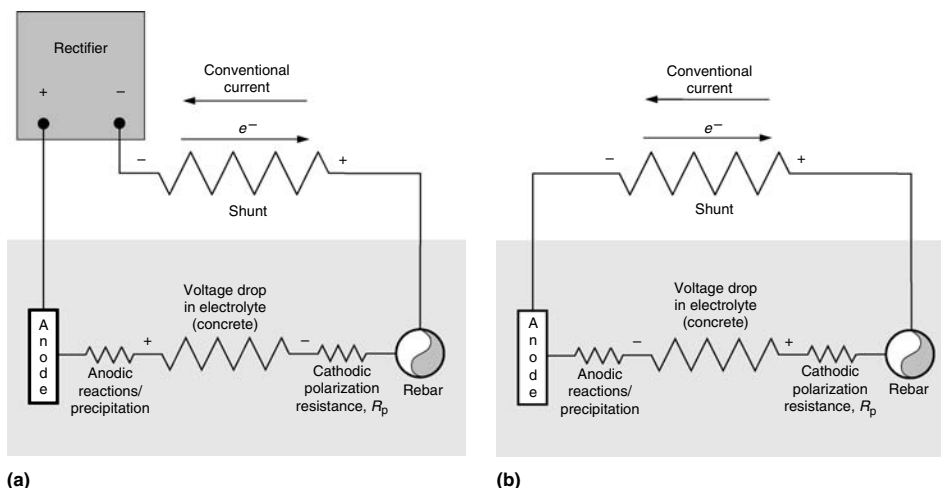
**Fig. 37** System components for cathodic protection. (a) Impressed current. (b) Sacrificial or galvanic system

**Impressed-Current Systems.** The driving voltage necessary to power CP systems can come from external direct current (dc) power supplies. To provide external power, a transformer is coupled with a rectifier to convert available alternating current (ac) to dc of an appropriate voltage range, as shown in Fig. 37(a). This approach is known as impressed-current cathodic protection (ICCP). Anodes employed in ICCP systems include inert metals such as titanium with metal oxide coatings, carbon-loaded coatings and fillers, conductive ceramics, and soluble metallic anodes such as zinc. The rectifier is placed in the metallic path, shown in Fig. 37(a), with its positive terminal connected to the anode and its negative terminal to the reinforcement, the cathode.

**Galvanic Anode Systems.** Galvanic anodes used in sacrificial cathodic protection (SACP) provide a potential that does not require dc or rectified ac power. The SACP employs a metal that is more electrochemically active than the one to be protected. Active metals such as aluminum, magnesium, zinc, and their alloys are typically used as galvanic anodes for mild steel. In SACP, a direct electrical connection is made between the galvanic anode and the metal to be protected, as shown in Fig. 37(b). This is a

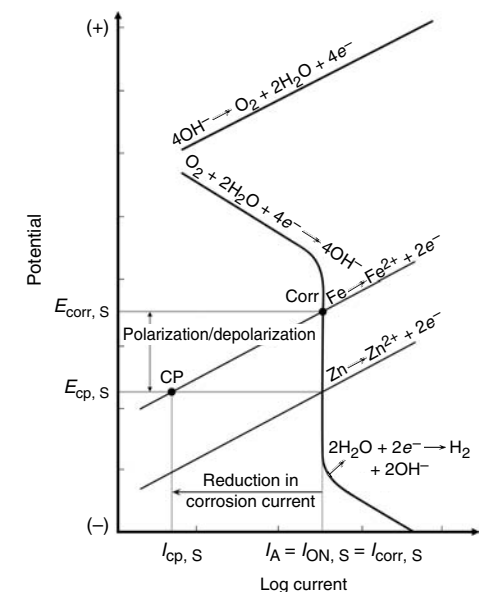
**Fig. 38** Evans diagram for the application of a galvanic cathodic protection (CP) system. Note: Log current is the absolute value of the current density, where both the anodic and cathodic currents are plotted as positive values. See the text for description.

**How CP Controls Corrosion.** Figure 38 is an Evans diagram of SACP applied in a neutral or alkaline environment. Because cement is alkaline, this diagram is appropriate to discuss using CP to control the corrosion of steel in concrete. The ordinate in Fig. 38 reflects the steel (reinforcement) potential measured with respect to a reference electrode, and the abscissa is the log of the corrosion current. The rate of corrosion is directly proportional to the corrosion current.

ment. Zinc is more electronegative than steel. If the zinc is connected to the steel, the steel will be polarized in a negative direction (potential) to the point labeled “CP.” This is the mixed potential for the steel-zinc electrochemical couple. Note the marked reduction in the iron corrosion rate that is attained by polarizing to this potential. The Evans diagram in Fig. 38 provides a brief introduction to the traditional basis for CP. In concrete, however, the opportunity exists to alter the environment surrounding the reinforcement. This is a situation that is not typically possible in applications of CP in natural waters or even soils.

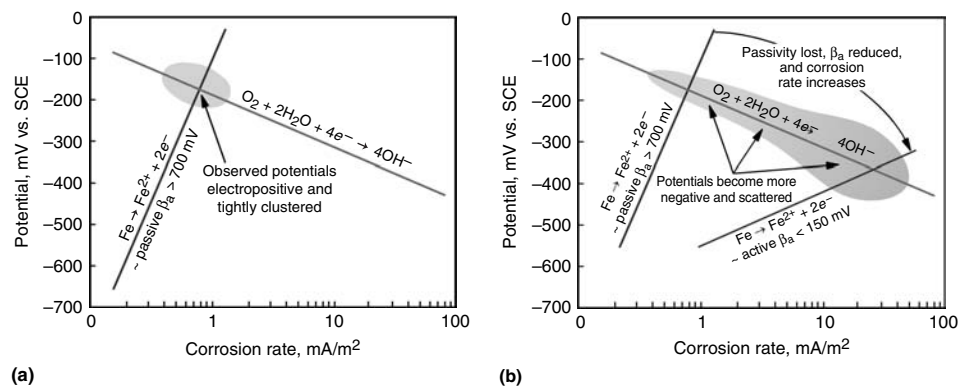
**Fig. 39** Current-potential diagrams. (a) Passive conditions. Tafel slope,  $\beta_a > 700$  mV. (b) Corroding conditions. Tafel slope,  $\beta_a < 150$  mV. Corrosion occurs as passivity is lost and active corrosion proceeds. SCE, saturated calomel electrode

Contamination by chloride ions or loss of pH through carbonation can initiate corrosion. With the onset of corrosion, the observed  $R_p$  becomes less. In Fig. 39(b), a second iron oxidation line is added, showing active corrosion and an anodic Tafel constant  $\beta_a < 150$  mV per decade. The slope flattens for active corrosion iron oxidation reaction, and reinforcement potentials become more electronegative and dispersed. On corroding reinforced structures, a family of  $\text{Fe} \rightarrow \text{Fe}^{2+} + 2e^-$  curves would fill between the two lines shown in Fig. 39(b). The different iron oxidation reaction slopes would reflect the local conditions, such as the ratio of chloride ions to hydroxyl ions ( $[\text{Cl}^-]/[\text{OH}^-]$ ), pH, and oxygen availability.

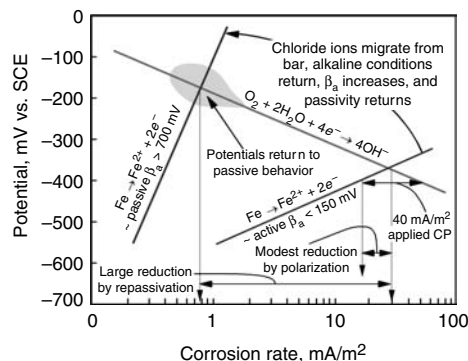
**Fig. 40** Cathodic protection (CP) of reinforcement can lead to repassivation of the rebar when chloride ions migrate from rebar and/or realkalization of the concrete surrounding the rebar occurs. Under these conditions, the CP can be removed. The rebar will depolarize and return to passive conditions, as shown. When chloride ions return to the rebar surface or pH is again lost, corrosion reoccurs.

negative direction. The kurtosis of a data set characterizes vertical asymmetry from normal distribution. Positive kurtosis reflects peaked distribution, while negative kurtosis indicates flattened distribution. The data in Table 7 reflect that this application of CP current was able to return the reinforcement to a passive environment, with the observed corrosion potentials more positive and tightly clustered, following the pattern shown in Fig. 40.

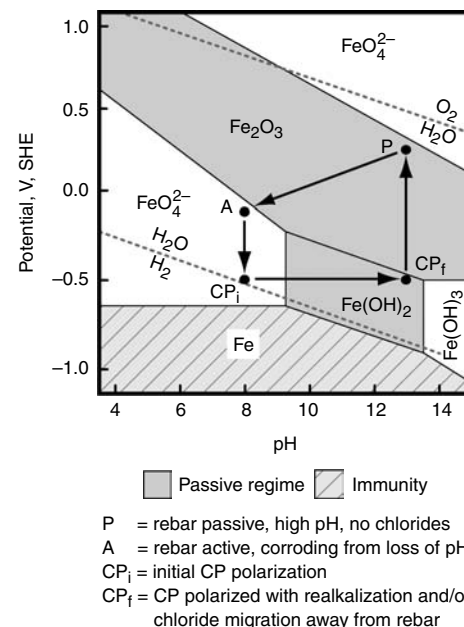
**Fig. 41** Path of cathodically protected steel through an Fe-H<sub>2</sub>O Pourbaix diagram. Using cathodic protection (CP), the corrosion rate is substantially reduced. Under favorable conditions, chloride ions migrate from the rebar surface, alkalinity is reestablished in the concrete surrounding the rebar, and the reinforcement then will reflect passive behavior when the CP current is removed. SHE, standard hydrogen electrode

Figure 41 shows a Pourbaix diagram of the repassivation process. When a reinforced-concrete structure is first constructed, the embedded steel is in the passive regime, as indicated by point "P." In this example, carbonation of the concrete reduces the pH, initiating active corrosion (as show by the arrow from "P" to point "A"). The initial application of CP polarizes the steel to point "CP<sub>i</sub>." With time, realkalization increases the pH, moving the steel to point "CP<sub>f</sub>." If the CP systems were turned off, the steel would then return to point "P."

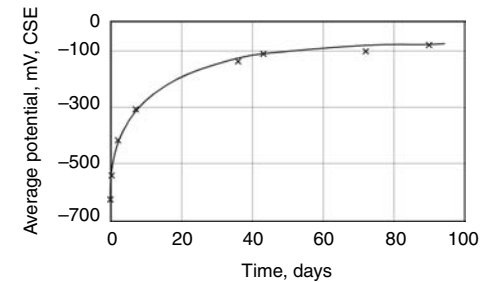
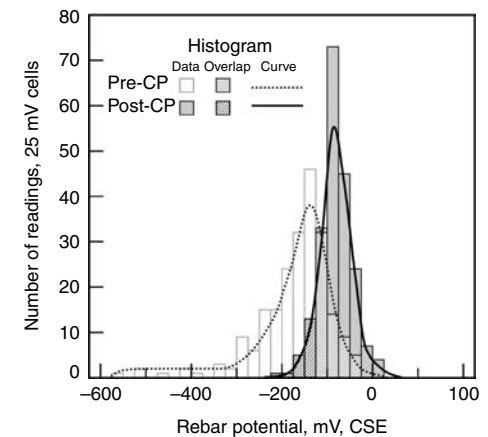
**Fig. 42** (a) Decay of average corrosion potential over a 90 day period. Each data point is the average of 200 individual readings obtained on a square grid of 1.5 m (5 ft) on center over an entire cathodic protection (CP) zone (saw-slot-style anode system). No additional readings were obtained after 90 days. If the CP system were left turned off indefinitely, chloride ions would diffuse back to the steel surface, and corrosion would again commence. (b) Histograms for pre- and post-CP potential surveys of the same CP zone. Post-CP survey potentials were obtained after 90 day depolarization. The abscissa shows the rebar potential observed. Each histogram cell (the rectangular columns) is 25 mV wide. The height of the histogram cell, corresponding to the ordinate value, reflects the number of readings observed within each 25 mV cell. Curves for the two data sets smooth the histogram stair steps. For both data sets, individual readings were obtained on a square grid of 1.5 m (5 ft) on center over an entire CP zone (saw-slot-style anode system). CSE, copper-copper sulfate electrode

Figure 42(a) shows the polarization decay of a CP system zone that had been in operation for over five years (Ref 194). The CP anode system was a saw-slot type installed on a bridge deck. This installation configuration allowed measuring reinforcing-steel corrosion potentials on a square grid of 1.5 m (5 ft). The ordinate of Fig. 42(a) is the average of 200 individual corrosion potential readings relative to a copper-copper sulfate electrode (CSE). The abscissa is the time that the 200 readings were obtained. Note that depolarization continues throughout the 90 day testing period. Also note that after approximately 30 days, the average corrosion potential reflects a return to passive conditions. The depolarization testing was terminated after 90 days.

Table 7 lists statistics for the pre-CP and 90 day depolarized (post-CP) corrosion potentials shown in Fig. 42(a). The post-CP mean corrosion potential for the depolarized rebar is almost 100 mV less active (more electropositive) than the pre-CP value. The most active post-CP reading,  $-219$  mV, is over 300 mV more positive (less active) than the most active pre-CP reading. Pre-CP readings reflect multimodal behavior, with some areas actively corroding and others not. The post-CP data more closely follow standard distribution, as reflected by its lower standard deviation, skewness, and kurtosis. Standard deviation is a metric of the spread or dispersion of a data set. Skewness describes the degree of asymmetry of the sample distribution.

Figure 42(b) shows histograms of the pre-CP and 90 day depolarization post-CP data sets. The abscissa in Fig. 42(b) reflects the measured reinforcement corrosion potential (mV, CSE). For both sets, the histogram cell width was 25 mV. The ordinate for Fig. 42(b) is the reading observed in each 25 mV wide cell. Smoothed curves overlay their respective histogram. The pre-CP readings show a much broader data set that tails to the left (more negative/more corroding corrosion potentials). The tail of the pre-CP readings is reflected in the  $-1.76$  skewness of the pre-CP data set compared to almost no skew with the post-CP data. Both data sets are more peaked than a normal distribution curve, with the post-CP kurtosis much less than that of the pre-CP. The histograms in Fig. 42(b) and the statistics in Table 7 show that post-CP readings are much more tightly clustered and better follow a normal distribution curve than do the pre-CP readings. The pre-CP readings include areas of active corrosion, while the 90 day depolarized post-CP readings reflect a return of passive conditions. This observed statistical behavior of the corroding pre-CP data follows previous observations and discussions that abrupt changes in rebar potential are indicative of corrosion activity. The use of statistics is then a valuable tool to use with absolute corrosion potential values in interpreting bridge data.

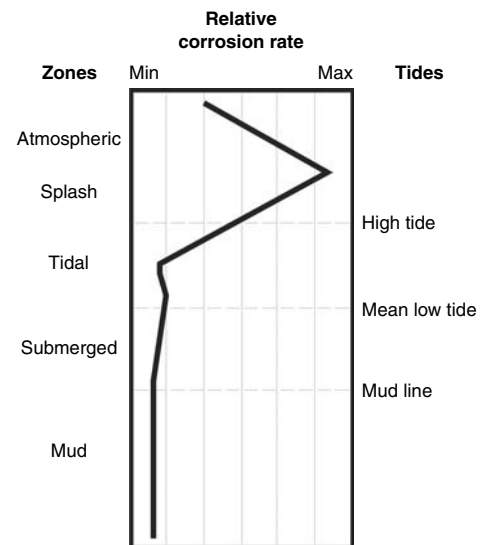
Fig. 43 Marine tidal zones

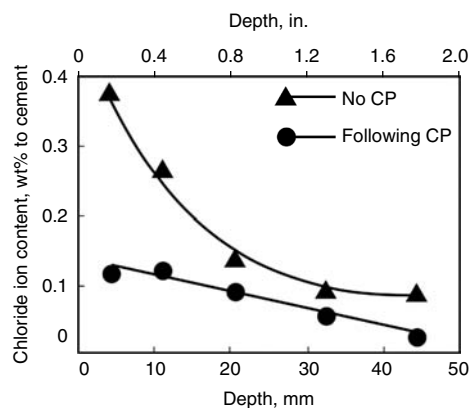
**Fig. 44** Chloride migration resulting from cathodic protection (CP)

**CP Criteria.** Concrete, absent contamination by aggressive ions or the loss of pH through carbonation, provides a much different environment to embedded reinforcement than natural soils or waters do to buried or submerged steel. Typically, natural soils or waters do not provide an environment that passivates steel, as does concrete. Passivating conditions will be restored to the steel reinforcement if the application of CP can cause migration of chloride or other contaminating ions from the steel surface and/or return the high pH to the steel surface. In fact, it has been noted for some years that the operation of CP systems will dramatically reduce the chloride content in previously contaminated structures, as seen in Fig. 44 (Ref 194) and elsewhere (Ref 207, 208).

If structures that previously enjoyed long-term CP were allowed to depolarize over extended periods, it was noted that reinforcement in those previously protected structures exhibited characteristics similar to noncorroding, non-contaminated structures. If sufficient current can be applied to provide initial corrosion control, then with time, the chloride concentration at the level of the reinforcement should diminish (Fig. 44), and reduced current will be required to sustain protection (Fig. 39a, 40).

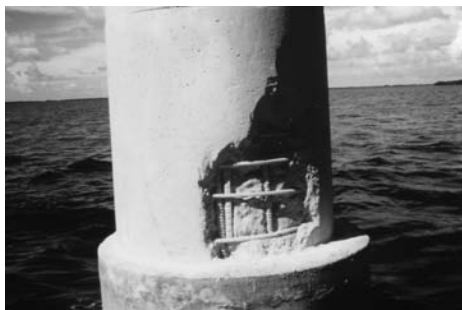
**Fig. 45** Directly applied thermal-sprayed zinc sacrificial cathodic protection system protecting both exposed and embedded reinforcement

between the bar and the anode is possible. For example, Fig. 45 shows a thermal-sprayed zinc coating protecting both exposed and embedded reinforcement on a marine pile. Here, no primary anode was used. Rather, the zinc was directly sprayed on both the exposed reinforcement and over the surface of the adjacent sound concrete, protecting both exposed and buried steel.
