# ASM Handbook®

## Volume 13C Corrosion: Environments and Industries

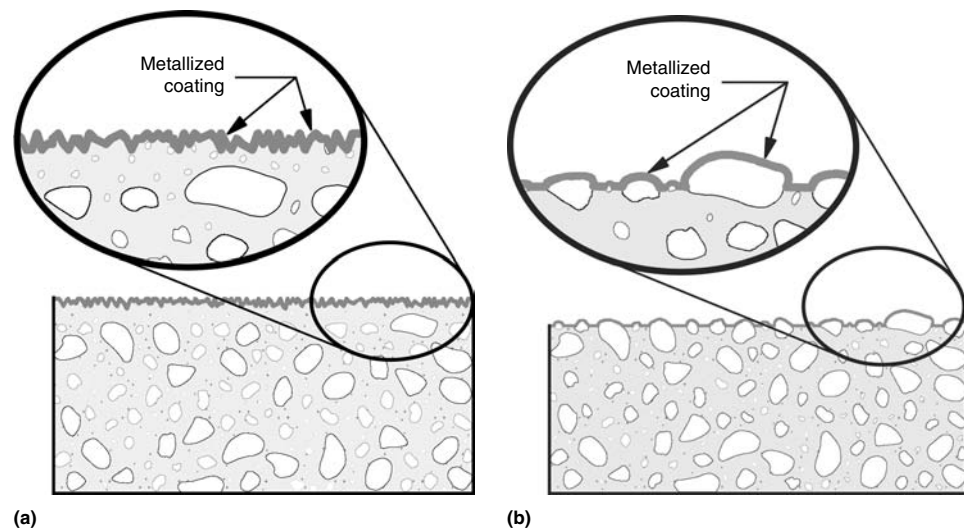
Figure 46(a) shows a proper abrasive blast that cleans the surface and provides a good profile to improve coating adhesion. Figure 46(b) shows a surface where too much cement-rich material has been removed. Note that a significant portion of the metallized coating is applied directly to coarse aggregate. Typically, coarse aggregate has a very much higher resistivity than the cement phase of concrete and also forms a weaker bond with the coating. The effective electrical contact area between the metallized coating and the underlying concrete is much less in Fig. 46(b) than in the situation shown in Fig. 46(a), because the gravel is such a poor electrical conductor. A CP system installed with a proper surface preparation, as shown in Fig. 46(a), will have far better current output than a system installed with a surface prepared as shown in Fig. 46(b).

**Fig. 46** Cross sections of coated concrete. (a) Proper surface preparation where most of the contact between the coating and the concrete is with the cement phase. (b) Improper surface preparation with too much contact between the coating and the nonconductive coarse aggregate

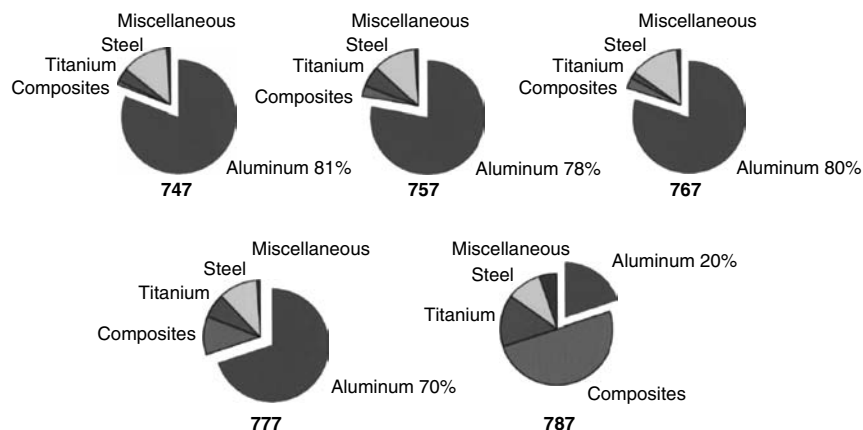
Fig. 1 Material usage in commercial airplane construction

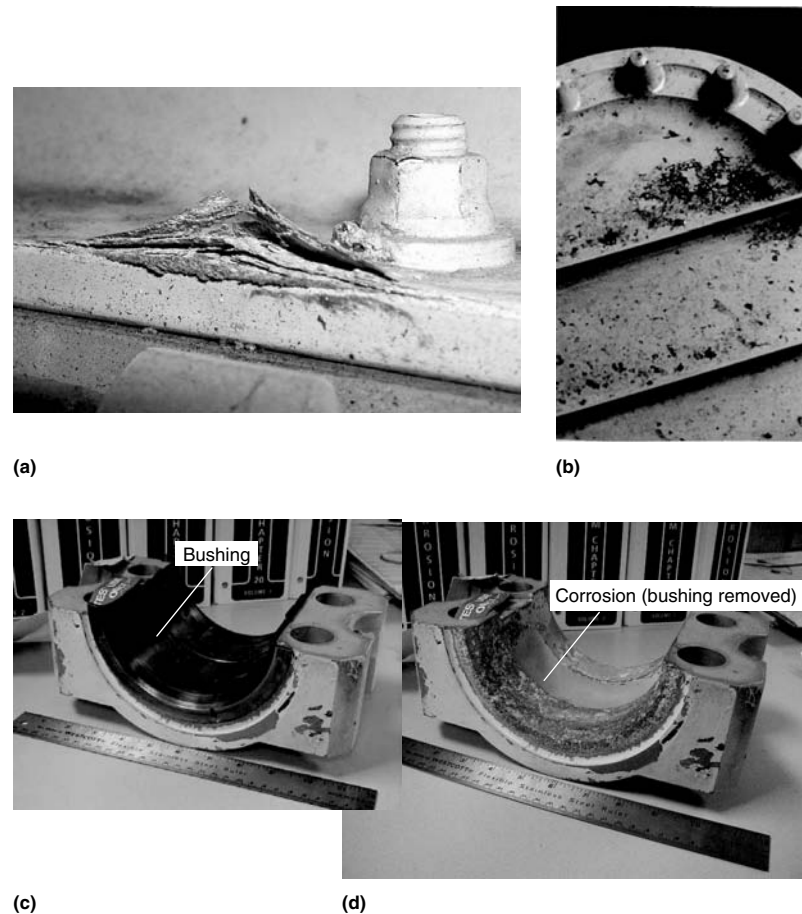
**Fig. 2** Forms of corrosion in aircraft. (a) Exfoliation corrosion. (b) Microbiologically induced corrosion on fuel tank access door. (c) (d) Galvanic corrosion under aluminum-nickel bronze bushing

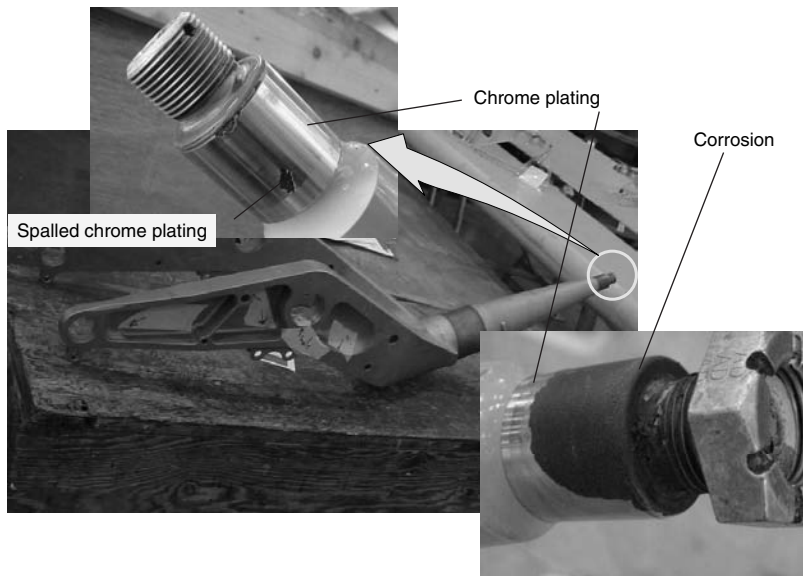
Fig. 4 Chrome plating wear and corrosion of steel on a 747 flap carriage journal. The bottom view shows missing chromium plating and corroded journal.

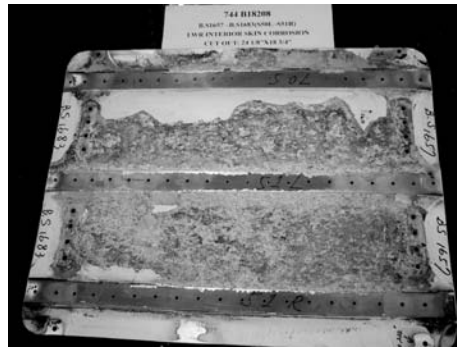
**Fig. 6** Corrosion of 747-400 interior 2024-T351 aluminum belly skin machined interior aluminum cladding

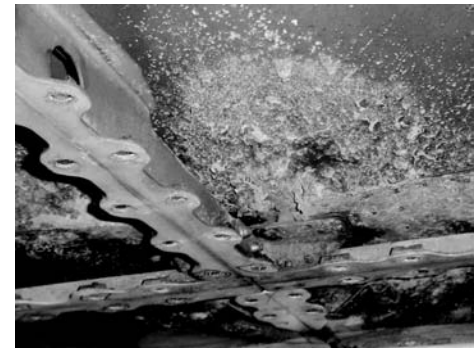
**Fig. 7** Corrosion of 777-300 exterior 2024-T351 aluminum belly skin machined exterior aluminum cladding

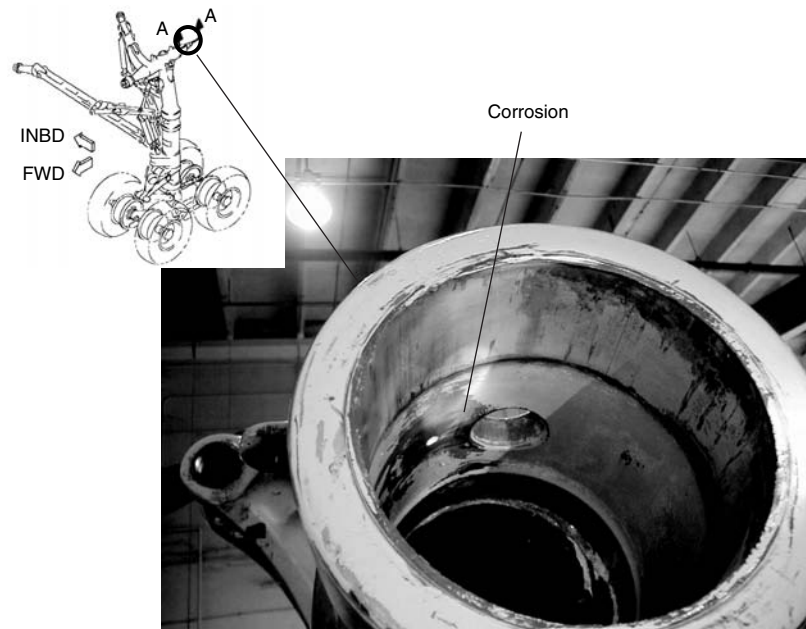
**Fig. 8** Corrosion of the 767 steel main landing gear aft trunnion. Insert shows location. FWD, forward; INBD, inboard

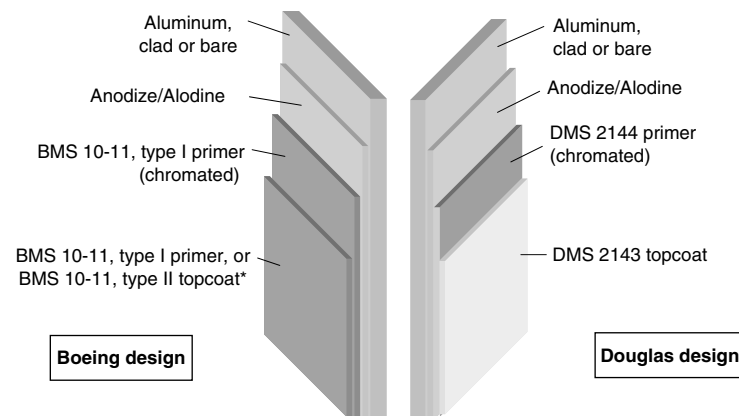
**Fig. 9** Design finishes for all interior aluminum structures

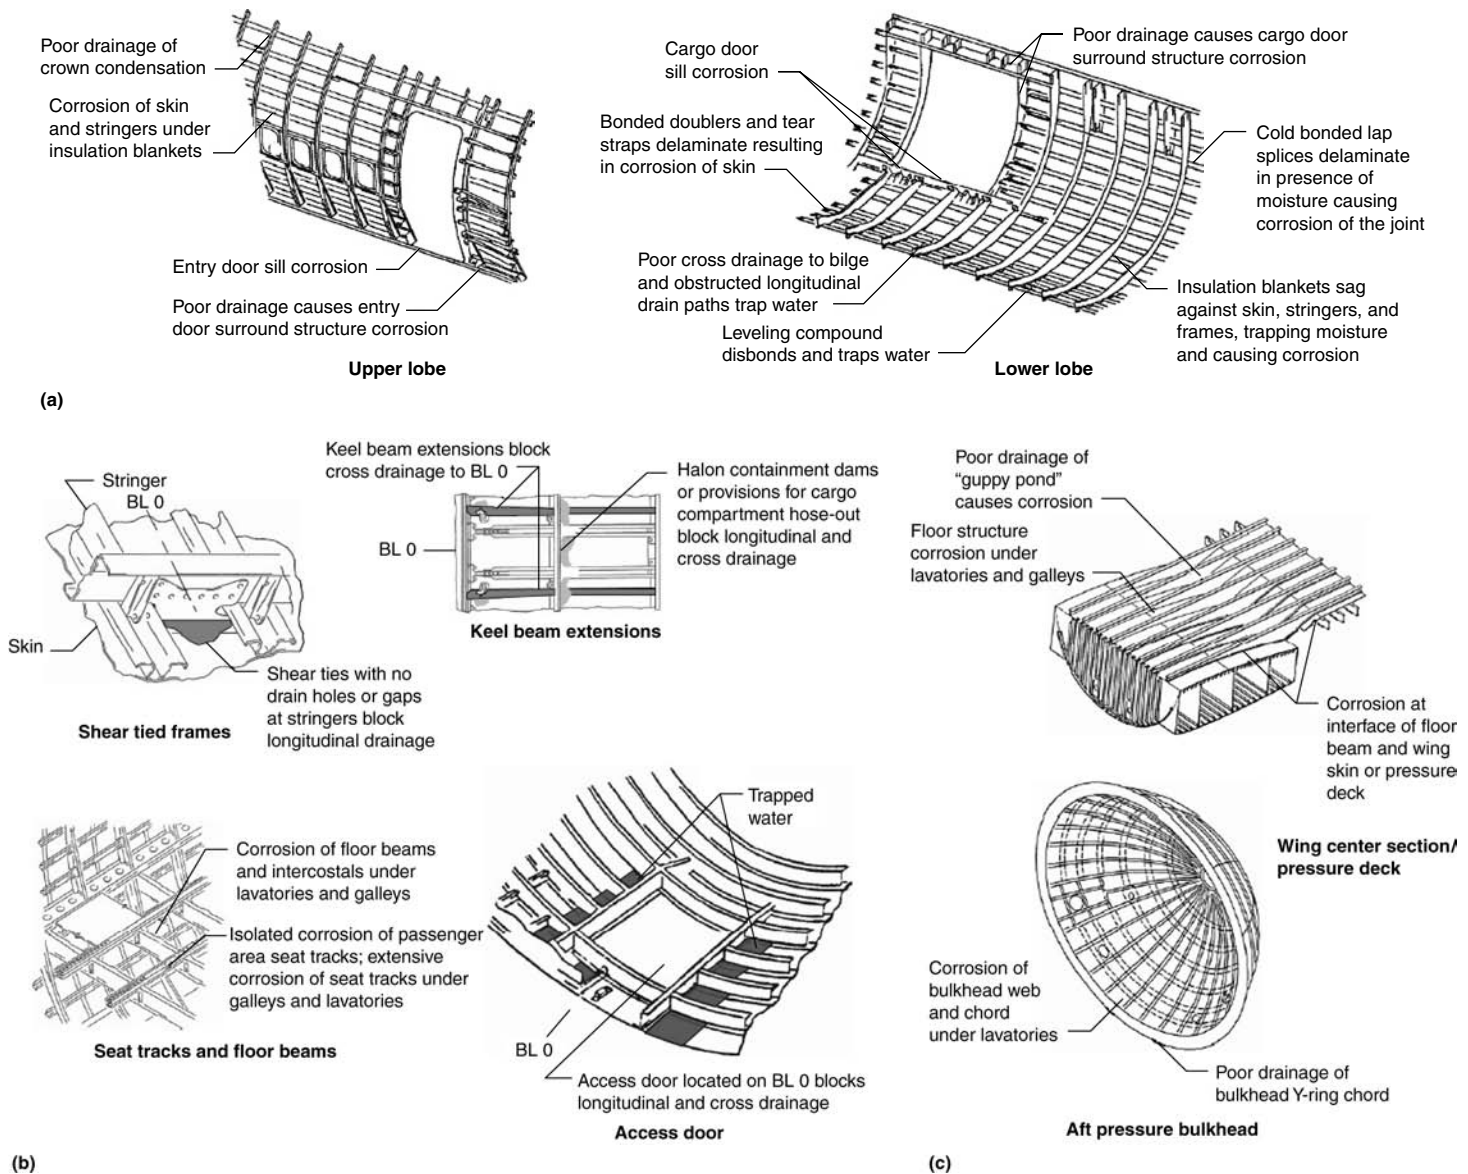
**Fig. 10** Fuselage corrosion locations learned from airplanes in service. (a) Upper and lower lobe. (b) Lower section of fuselage. BL 0 is the lowest longitudinal line of the fuselage (butt line). (c) Aft and wing

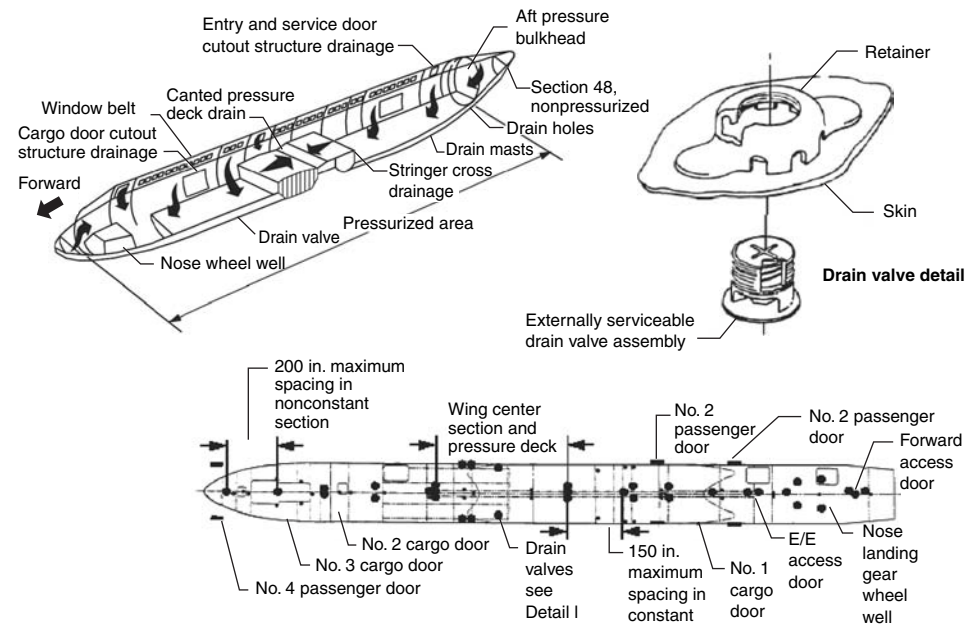
Fig. 12 Fuselage drainage and drain valve design. Drain locations are indicated as closed circles in the lower plan view

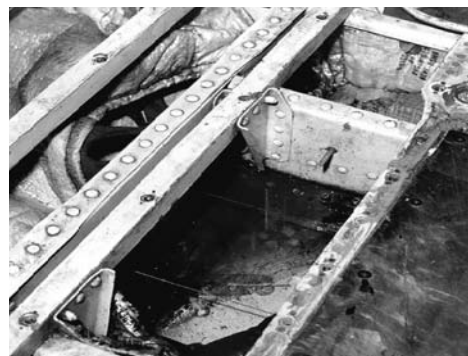
Fig. 11 Moisture accumulation from blocked drain

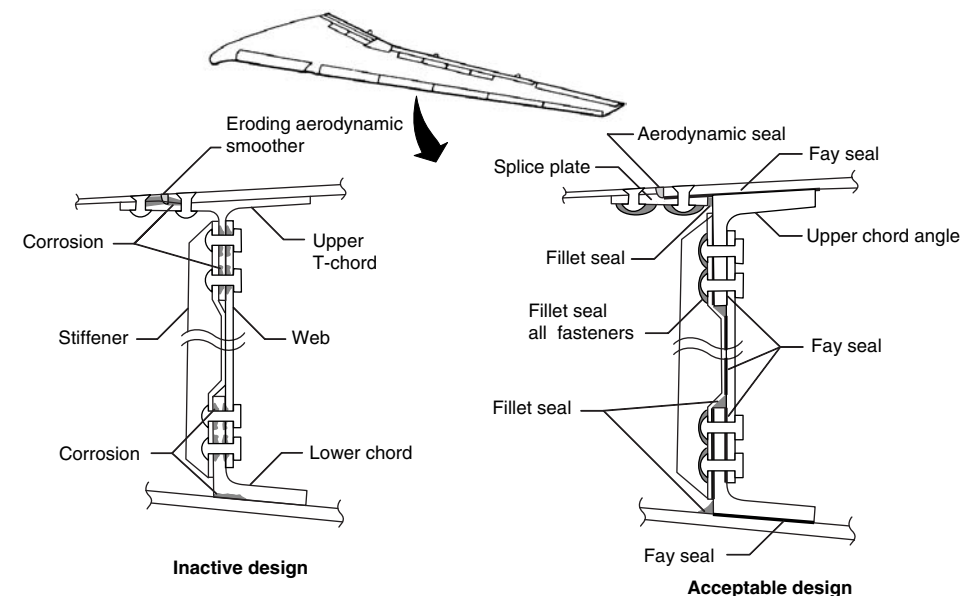
Fig. 13 Wing front spar with corrosion sites. Sealant locations in acceptable design

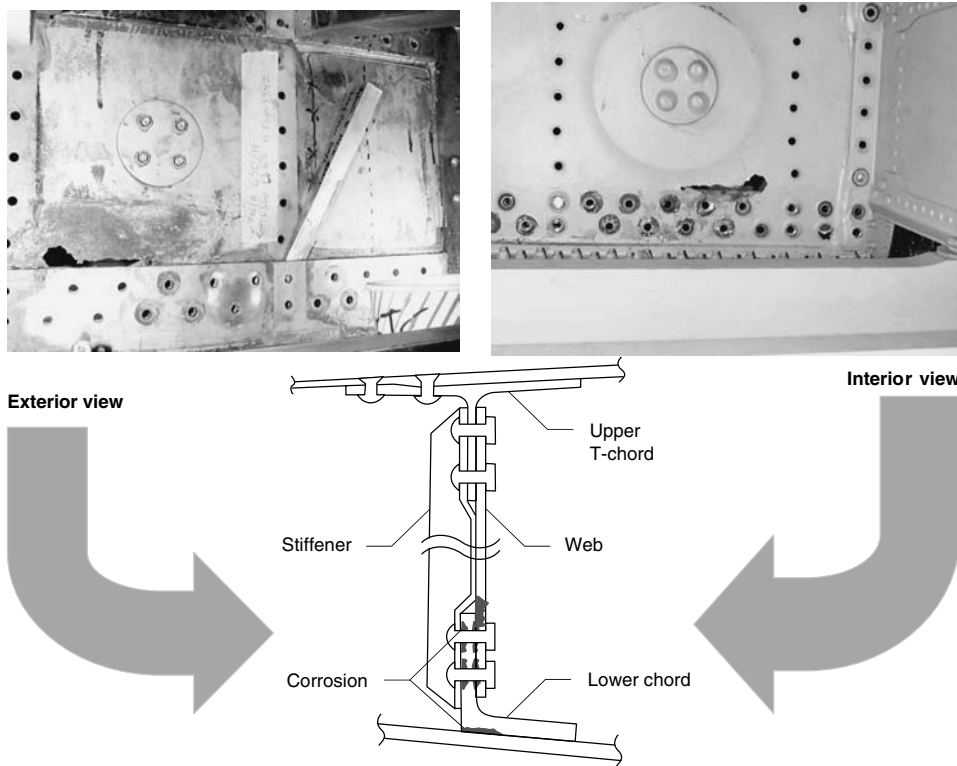
Fig. 14 Corrosion between wing front spar lower chord and web of 747

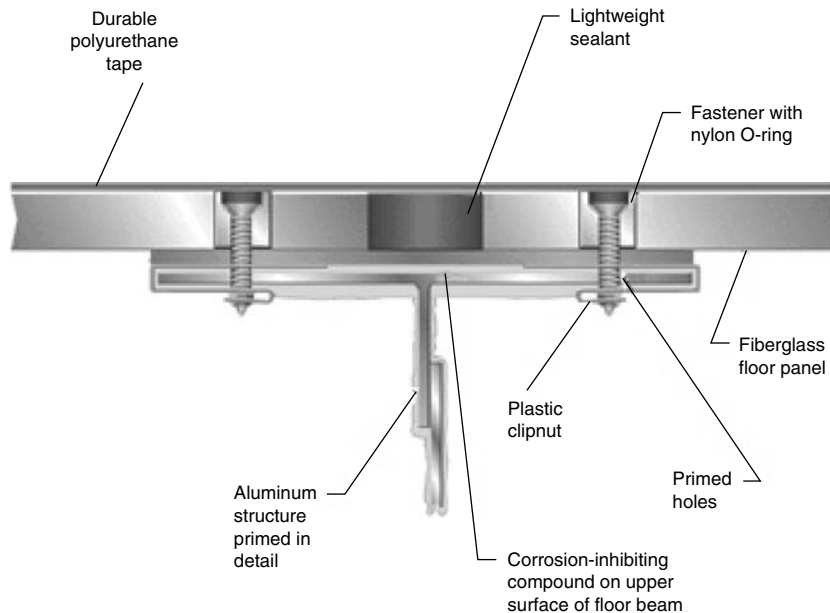
Fig. 16 Typical floor structure design for corrosion protection

have a cocured fiberglass ply, polyvinyl fluoride film, or be primed and topcoated as shown in Fig. 16.

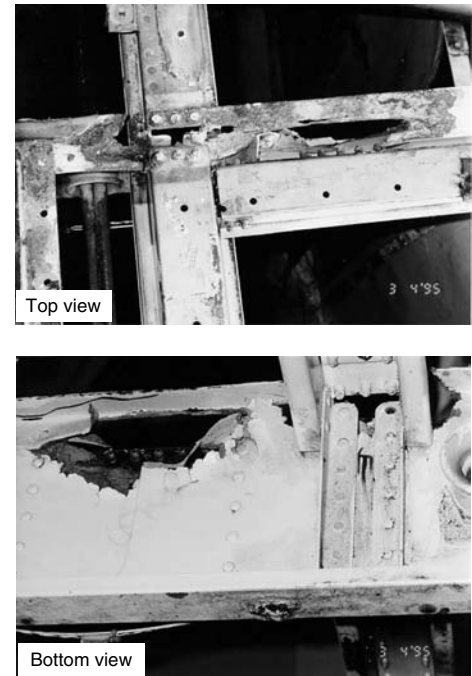
Fig. 15 Aluminum floor structure corrosion in a 767 at forward entry door

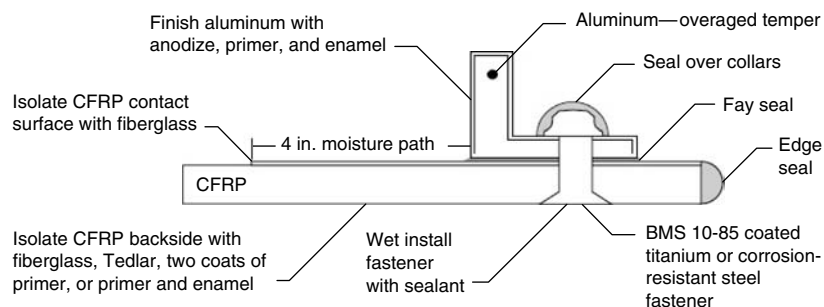
**Fig. 17** Protecting aluminum against galvanic corrosion from contact with carbon fiber reinforced plastic (CFRP)

**Special Assembly Consideration: CFRP-Aluminum Joints.** Nowhere is the risk of corrosion greater than with assemblies involving CFRP and aluminum, materials at opposite poles of the galvanic chart (Fig. 3). Graphite fibers are excellent electrical conductors, do not corrode, and act as cathodes when attached to aluminum. Preventing severe corrosion of any attached aluminum structure involves the use of sealant to block all moisture paths, including fastener holes. It is also as important to ensure that cut edges, where graphite fibers are exposed, are sealed (Fig. 17).

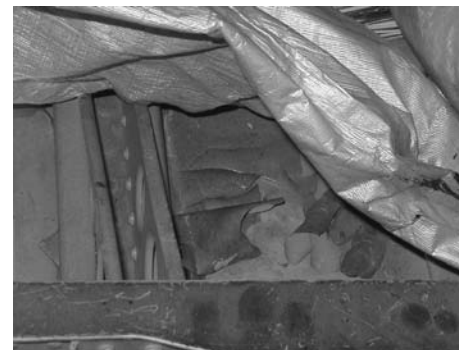
**Fig. 18** Loss of paint adhesion caused by silicone contamination

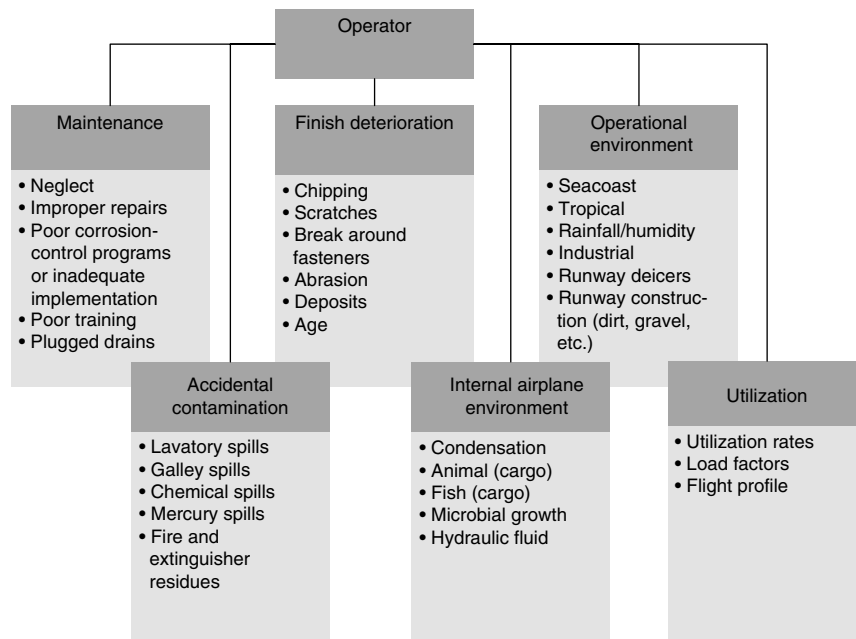
Fig. 19 Operating factors contributing to corrosion

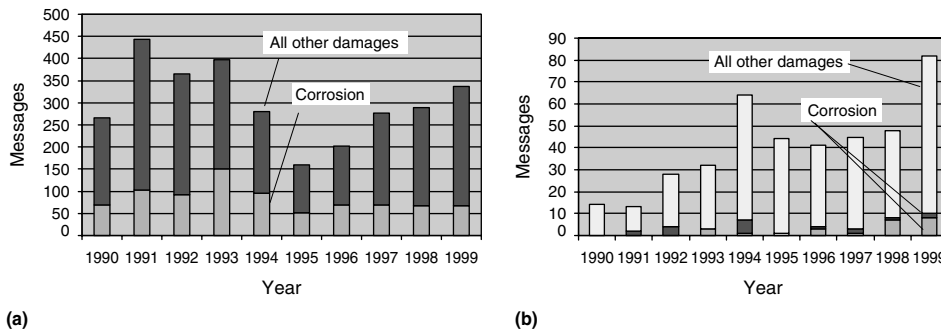
Fig. 21 Pattern of corrosion-related messages. (a) 747 Section 46 monocoque structure. (b) 747-400 Section 46 including monocoque and floor structure corrosion

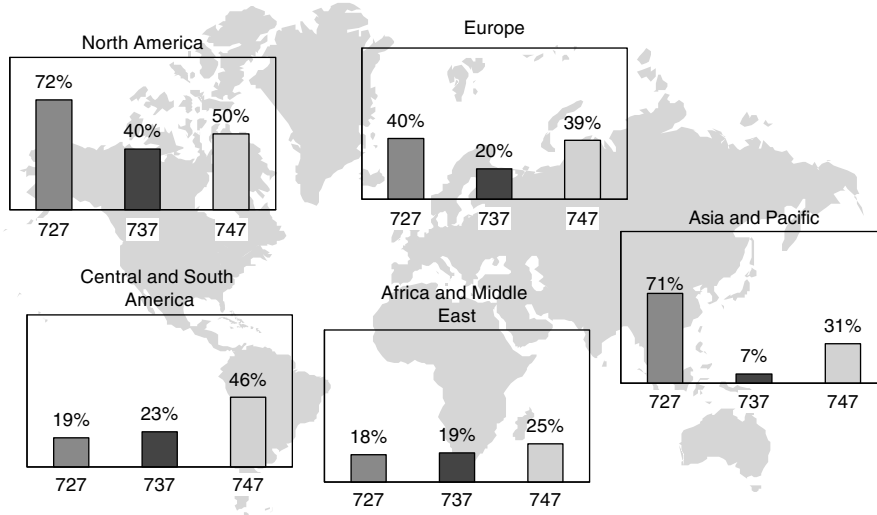
Fig. 22 Percentage of in-service airplanes with CPCP reports of level 2 corrosion. Refer to Fig. 27

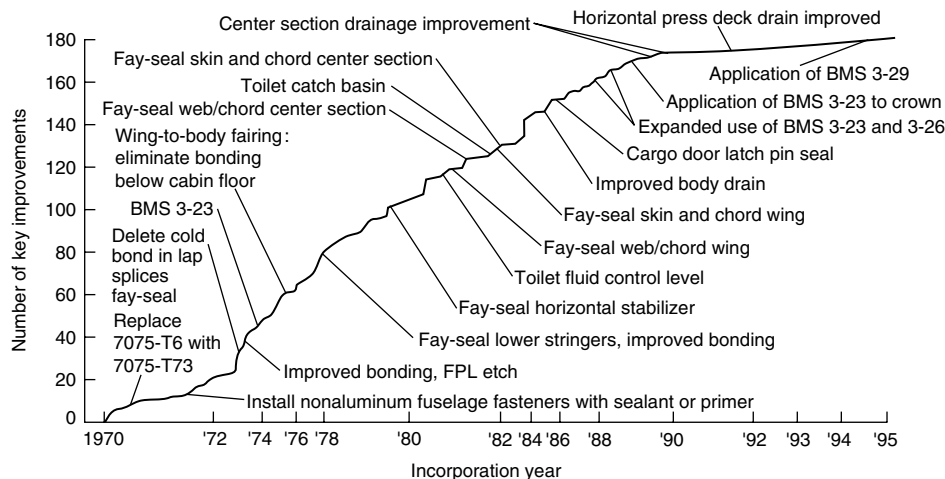
Fig. 23 Cumulative number of corrosion resistance improvements on the 747

Information from the sources listed previously has contributed greatly to increasing Boeing’s understanding of regions with chronic corrosion problems and their severity. This information has driven cumulative design improvements (Fig. 23). These have been incorporated into “Book 4—Design for Corrosion Prevention” used by Boeing-Puget Sound engineers as a guide for the design of new 7xx series airplane models or derivatives. Similarly, lessons learned for Douglas models and derivatives were incorporated into the Type Finish Specifications TF-109 (DC-9, MD80, MD90, Boeing 717) and TF-110 (DC-10/MD-11).

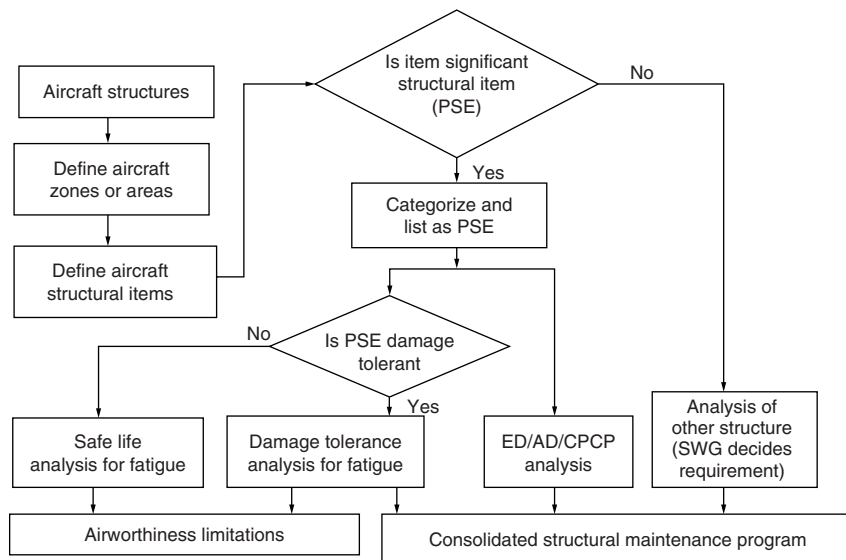
**Fig. 24** Logic diagram for developing consolidated airplanes maintenance programs. MSG, Maintenance Steering Group; SWG refers to Structures Working Group. See text for other acronyms.

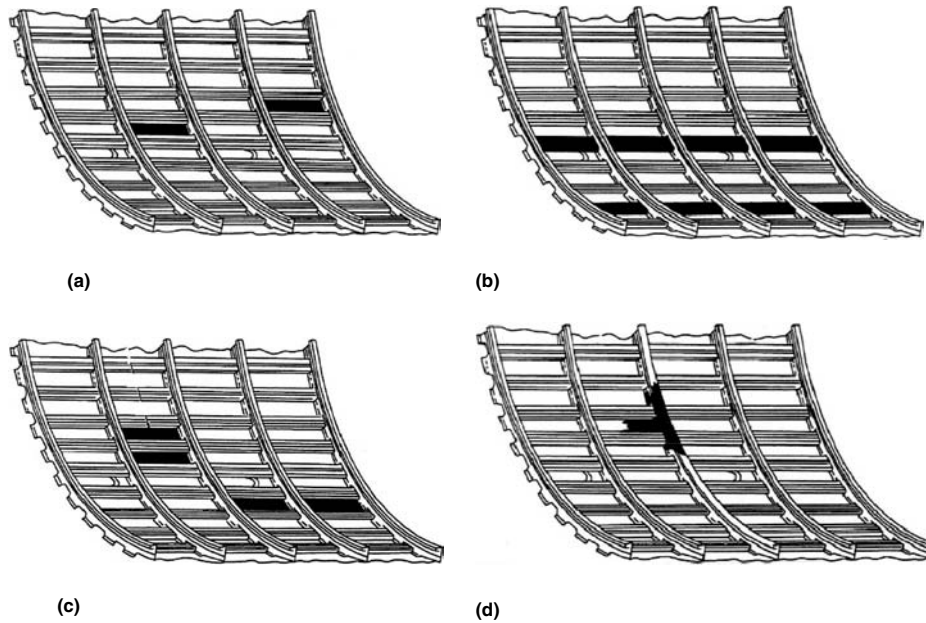
**Fig. 26** Examples of local and widespread corrosion on fuselage structures. (a) Local corrosion involves nonadjacent frame bays. (b) Local corrosion—involves nonadjacent stringers. (c) Widespread corrosion—involves adjacent stringer frame bays. (d) Widespread corrosion—involves adjacent frame and skin

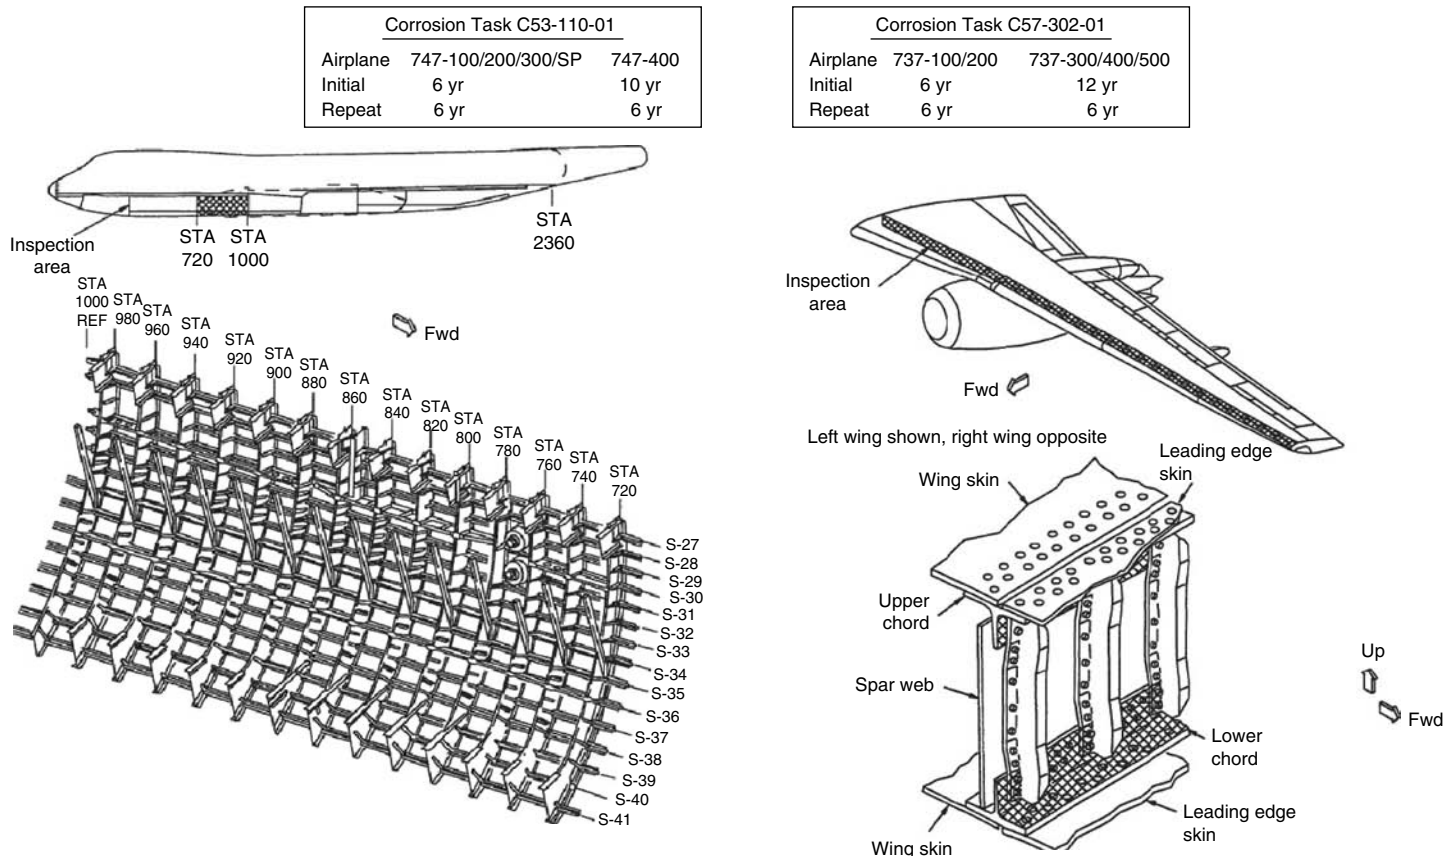
**Fig. 28** Initial Corrosion Prevention and Control Program inspection task. Initial and repeat interval for “Classic” 747, 737 airplanes and their more modern derivatives. Location of the area of inspection is given.

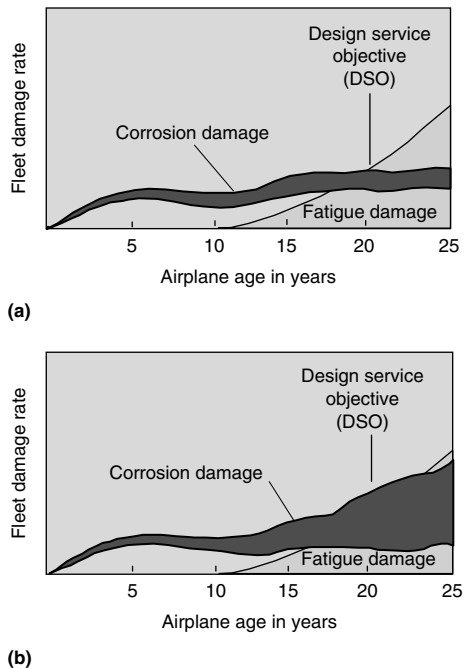
Fig. 29 Fleet damage rate under (a) an effective and (b) an ineffective corrosion-control program

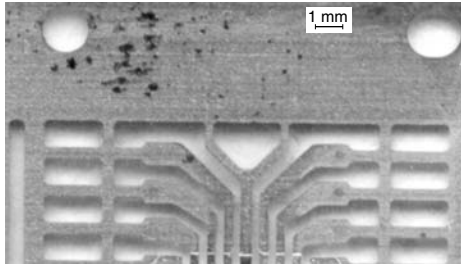
Fig. 1 Pitting of electrodeposit on a copper leadframe

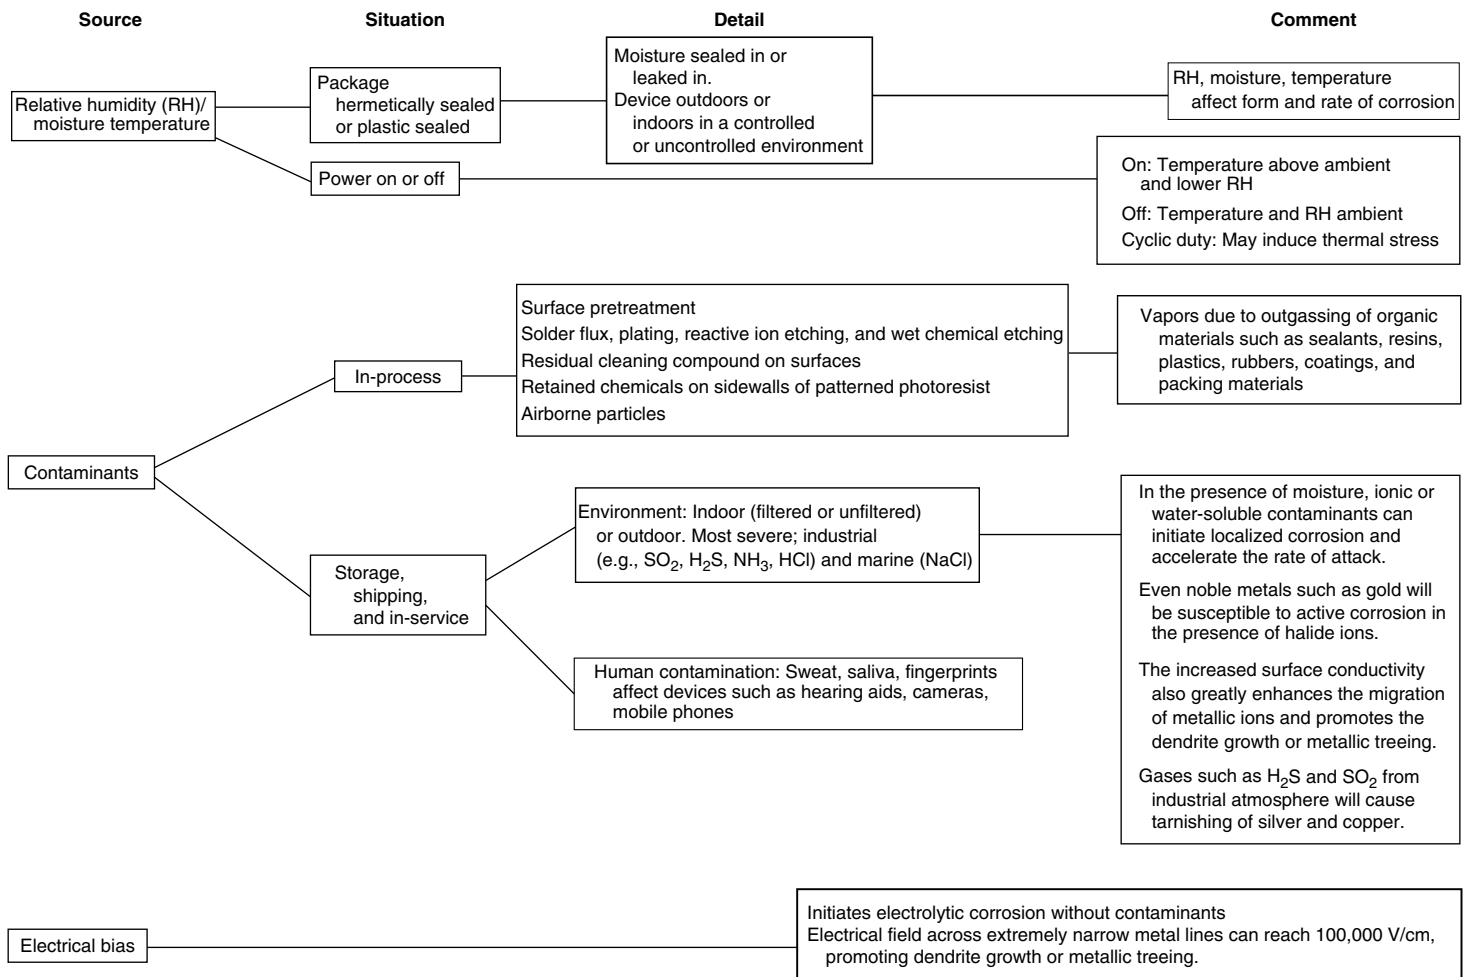
Fig. 2 Common sources of corrosion in microelectronics

to the deterioration of the material and its property” (Ref 20). Under this definition, reliability issues pertaining to humidity, contamination, temperature, and electrical bias are all within the domain of corrosion. Corrosion can originate from many sources during manufacturing, storage, shipping, and service. Moisture, temperature, contaminants, and electrical bias, either alone or in combination, often initiate or accelerate corrosion of many metals. The form and rate of corrosion are dependent on the materials, the fabrication and assembly processes, the design, the package type, and the environmental conditions. Figure 2 shows the common sources of corrosion in microelectronics.

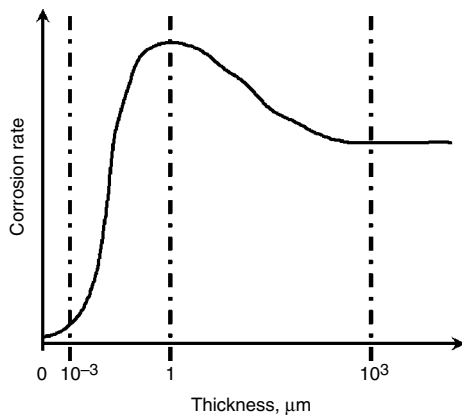
Fig. 3 Dependence of corrosion rate on moisture film thickness. Adapted from Ref 22

air, there is less water in 20 °C (68 °F) air compared to 25 °C (77 °F) when they are both at 60% RH. There exists a critical RH above which significant corrosion takes place. Research (Ref 21) indicates that three monolayers of condensed water molecules are the absolute minimum amount of moisture that can raise the surface conductance to a significant level. As the thickness of the surface moisture film increases, the corrosion rate for most metals rises sharply, and a peak is observed at approximately 1 μm (0.04 mil) (Fig. 3). Further increases in moisture film thickness result in a reduction in the corrosion rate due to diffusion-controlled oxygen reduction. The corrosion rate levels off at a moisture film thickness above 1 mm (0.04 in.), which is equivalent to the total immersion condition.

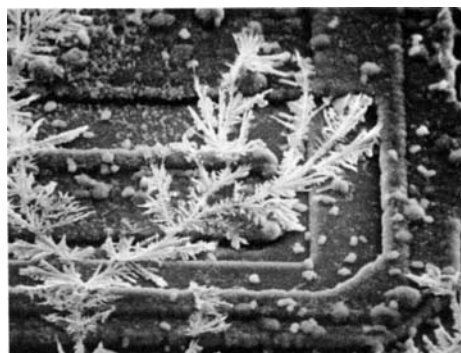
**Fig. 4** Example of dendrite growth on the surface of an integrated circuit, in this case, silver, which is no longer used. Source: Ref 42

magnitude. Under these high-voltage gradients and high-conductivity conditions, most metals, including noble metals, will corrode actively through the electrolytic process, even without the presence of contaminants. The metal ions will diffuse through the surface electrolyte film toward the cathode, where reduction reactions lead to the formation of metal dendrites. The dendrites grow toward the anode and eventually short the circuits (Ref 40). This phenomenon is sometimes referred to as metallic treeing (Ref 41). Figure 4 shows the silver dendrite growth on the surface of an IC (Ref 42). Silver is not used in microelectronics for this reason.

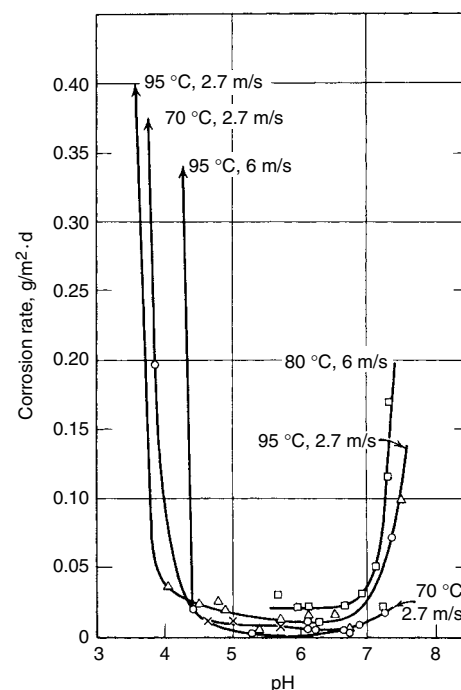
**Fig. 5** Aluminum corrosion rates in acidic and alkaline environments at various temperatures and flow rates. Source: Ref 46

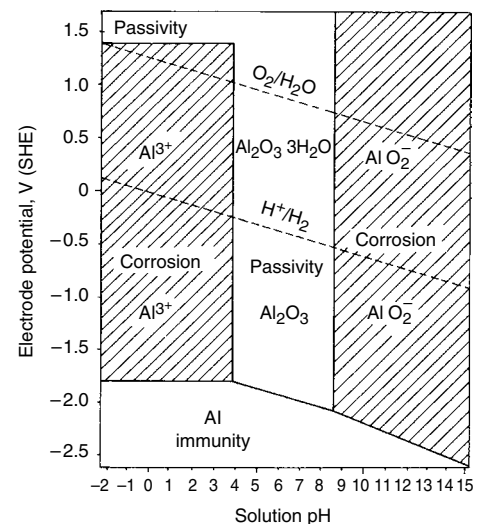
**Fig. 6** Potential-pH diagram for aluminum at 25 °C (77 °F). SHE, standard hydrogen electrode. Source: Ref 47

*Materials*, Volume 13B of *ASM Handbook*, 2005. The more negative the potential, the greater the tendency for the metal to undergo oxidation (corrosion). Aluminum is a reactive metal and is located at the lower end of the emf series. Reactive ion etching of aluminum metallization in plasma containing chlorine-base gases such as Cl<sub>2</sub>, CCl<sub>4</sub>, CHCl<sub>3</sub>, and BCl<sub>3</sub> can result in rapid corrosion in the presence of moisture (Ref 24, 45). Other ionic contaminants may induce either an acidic or alkaline condition to the moisture film, causing accelerated corrosion of aluminum. Figure 5 shows that the corrosion rate of aluminum increases drastically outside the pH range of 4.5 to 7 (Ref 46). The potential-pH diagram at 25 °C (77 °F) for aluminum (Fig. 6) also indicates that active corrosion occurs outside the pH range of 4 to 8

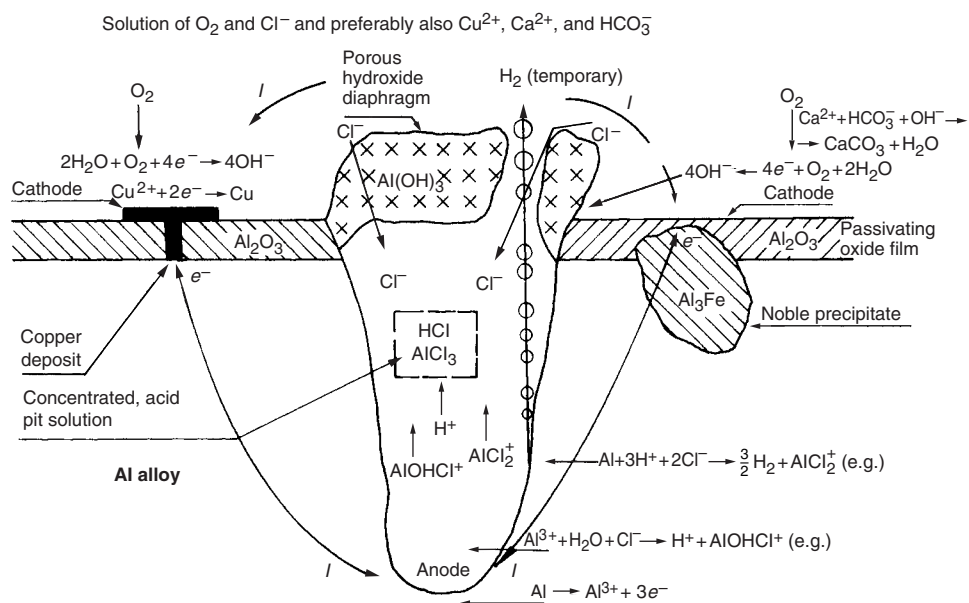
Fig. 7 Electrochemical mechanism of pitting on aluminum. Source: Ref 47

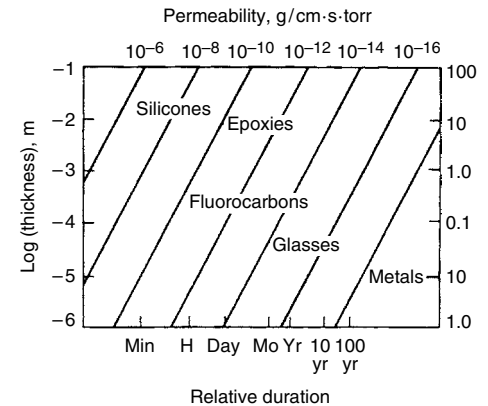
**Fig. 8** Time for moisture to permeate various packaging materials. Adapted from Ref 72

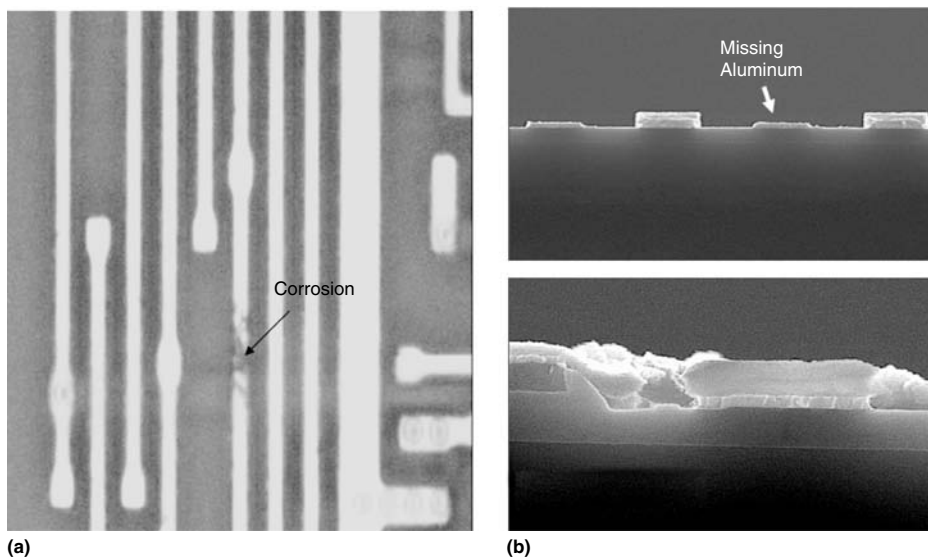
Fig. 1 Corrosion of the aluminum alloy metal lines on a wafer seen (a) in plan view with a light microscope and (b) in profile with a scanning electron microscope (SEM)

The source of the chlorine could be the sidewall polymer where it can be trapped and then can attack the aluminum leads if they are not put in the solvent stripper. Trapped chlorine in thin-etch residue causes severe pitting corrosion. The etch residue can consist of organic, inorganic (from etch species of Cl and F), metal-organic, and metalinorganic species. Combinations of these make them more difficult to remove. Aluminum oxychloride ( $\text{AlClO}$ ) is formed due to time delay between etch and wet strip.  $\text{AlClO}$  is soluble in water and stripper. Chloride corrosion at the plasma step is not seen until the wet strip is complete; hence passivating the sidewall is critical to prevent latent corrosion due to residual halides from etch residues.

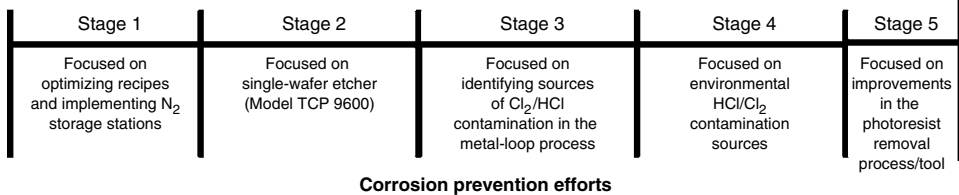
Fig. 2 Timeline of the corrosion-prevention project from one fabrication unit showing stages of work

The corrosion-prevention effort timeline (Fig. 2) summarizes the activities at the fabrication plant to identify corrosion sources and implement the corrective actions. Each

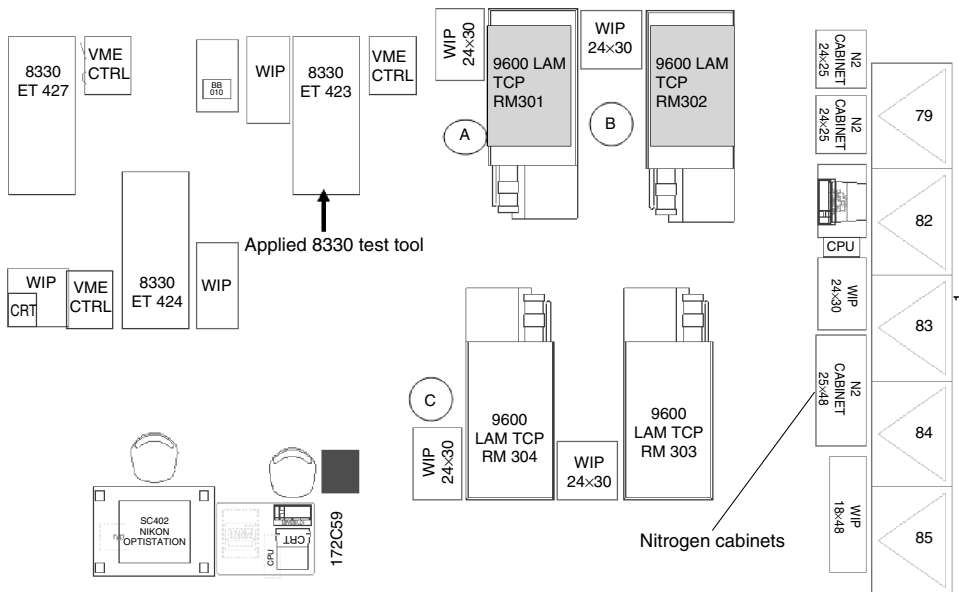
Fig. 3 Floor plan of a fabrication unit with single (9600) and batch (8300) etchers. Applied test tool and sample points (A, B, and C) were used in corrosion study.

The results of the test indicated that good vertical laminar flow existed in most areas. Location points A and B (Fig. 14), however, showed an air-flow drift toward location C (which is location A test point used in the first phase (Fig. 3)). The air-flow dynamics of the room guided the HCl vapor toward this location,

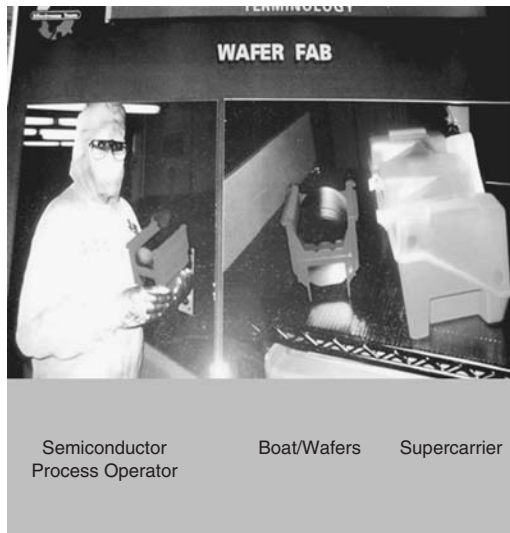
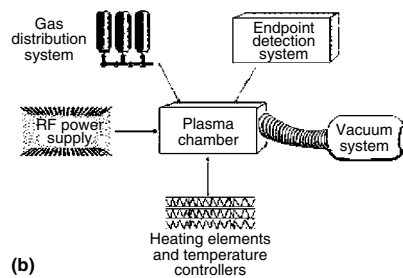
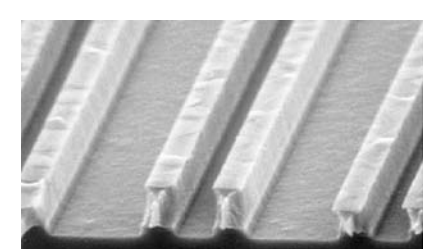
Fig. 4 Aspects of wafer fabrication and metal etching. (a) Operator with supercarrier and boat fixtures. (b) Diagram of etcher-system components. (c) SEM image of a metal-etch feature

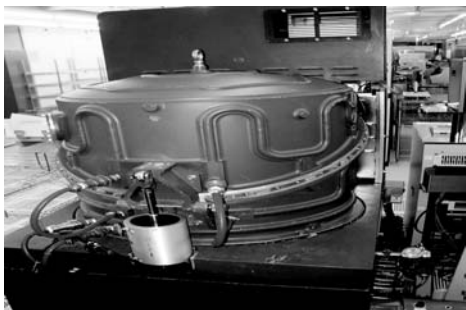
**Fig. 5** A batch metal etcher, model 8330, installed in the fabrication unit

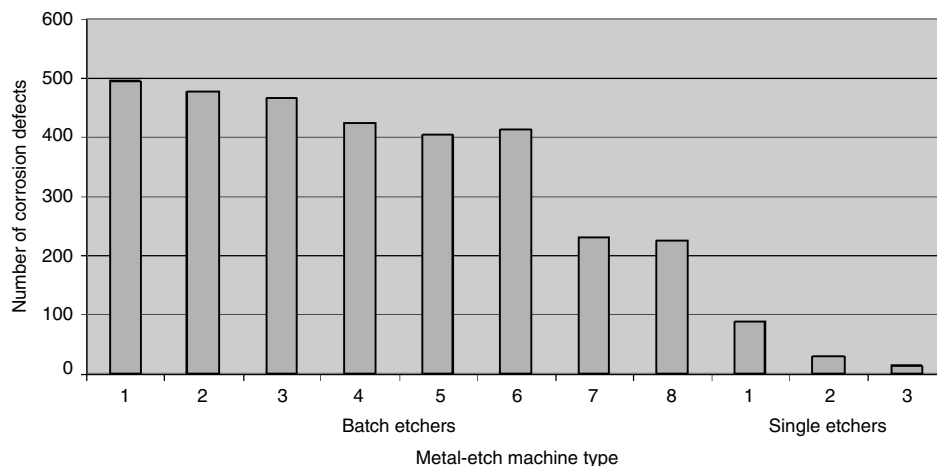
**Fig. 6** Data showing batch etchers are more prone to corrosion than single-wafer etchers

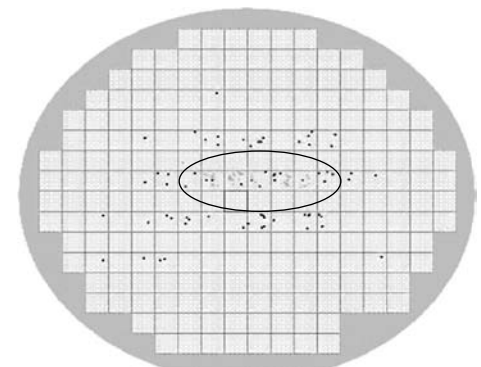
**Fig. 7** Wafer map of typical corrosion defects. Black spots are random corrosion. Gray (or green) spots in circle are clustered corrosion.

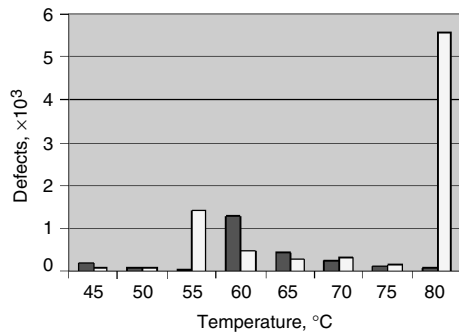
**Fig. 8** Correlation of corrosion defects to atmospheric passivation module water temperature and wafer spin speed. Dark gray bars, 500 rpm; light gray bars, 1000 rpm

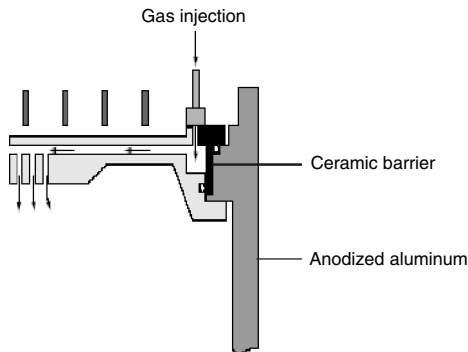
**Fig. 9** Mid-chamber ceramic barrier. Courtesy of LAM Research Corporation

over the anodized aluminum middle chamber, fully enclosing the gas plenum with ceramic (Fig. 9). It prevents exposure of the chamber walls to process gases and extends the mid-chamber life indefinitely, as well as helping to prevent corrosion to the product (Ref 4).

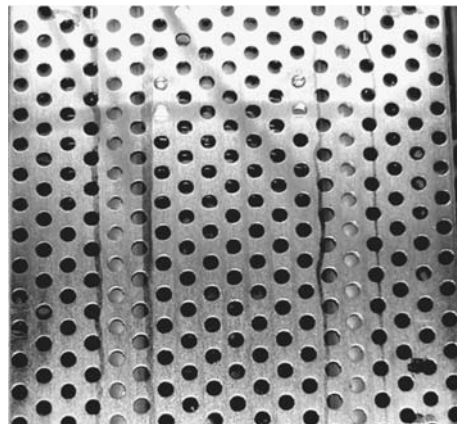
**Fig. 10** Dispersion plates used in solvent tanks to control flow of liquid

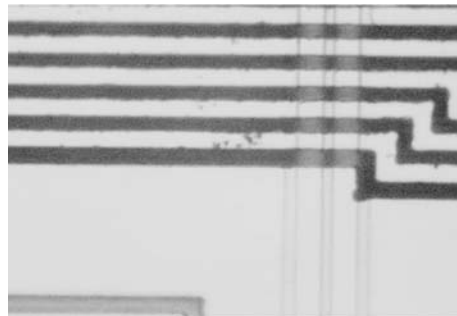
**Fig. 11** Corrosion on wafers from solvent tanks
