# ASM Handbook®

## Volume 13C Corrosion: Environments and Industries

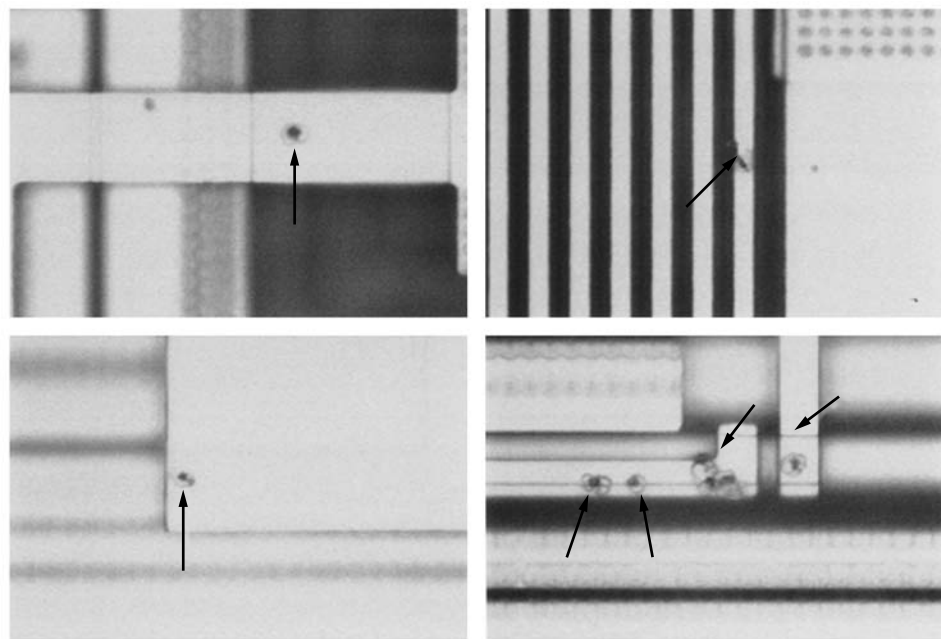
Fig. 12 Fluorine-induced corrosion indicated by arrows on metal leads

*Fluorine corrosion* occurs when an excessive amount of water remains on the wafer surface (Fig. 12). Heater failure, poor nitrogen flow, or a bad door seal of a spin-rinse dryer can cause the wafers not to dry completely after a rinse cycle. Corrosion occurs if wafers are not dried immediately to minimize the wafer contact to moisture.

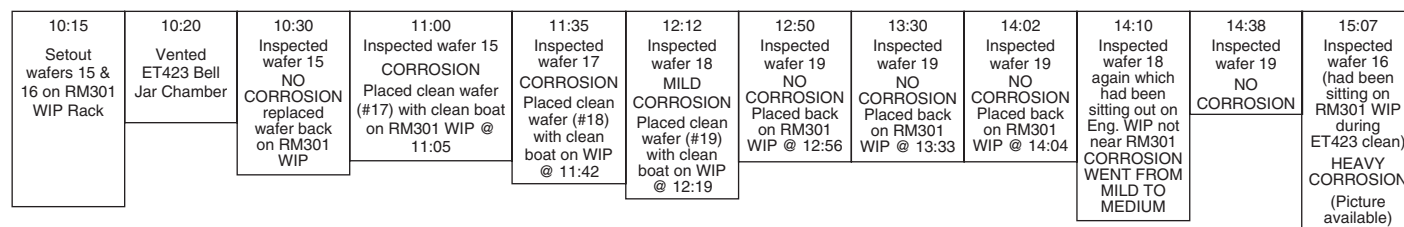
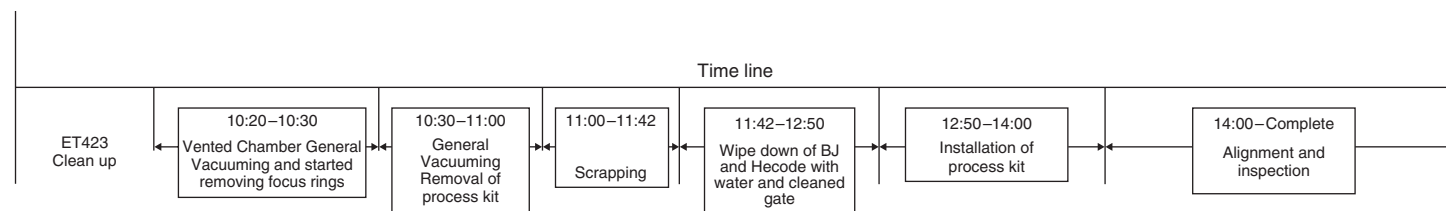
Fig. 13 Residence time study of HCl vapors in a wafer-fabrication unit environment to track the appearance of corrosion on wafers. Parallel maintenance activities are tracked on time line. WIP is work in progress rack.

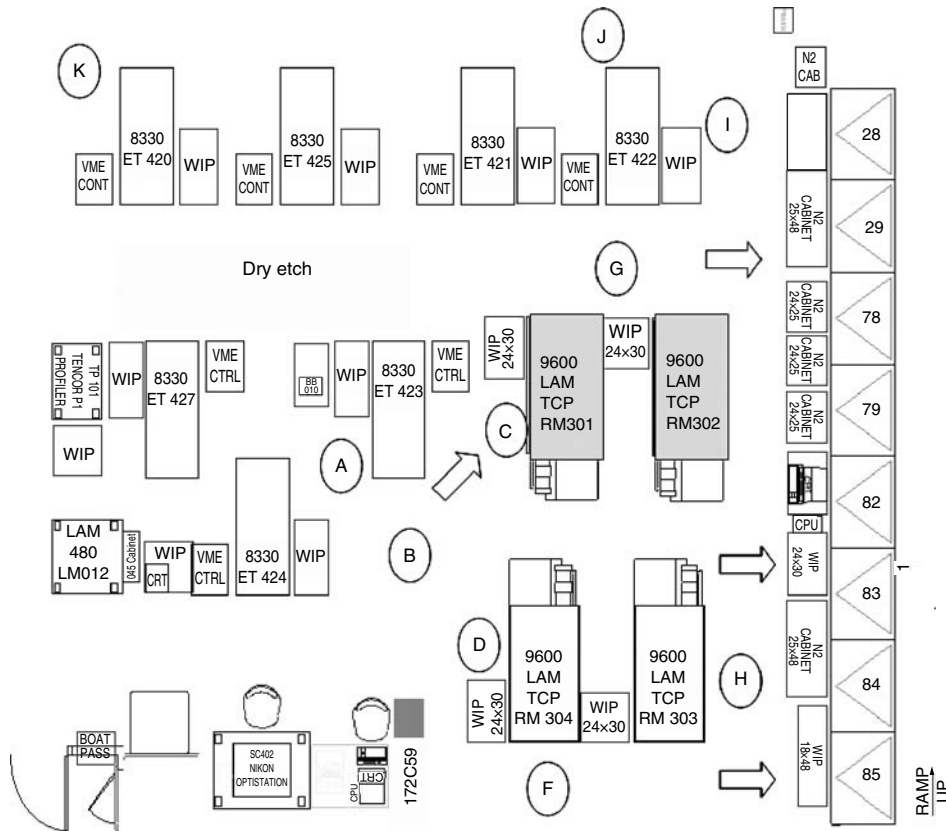
**Fig. 14** Air-flow dynamics in the fabrication unit. Arrows indicate horizontal flow. Circled letters are test locations. Shaded objects are the single-batch etchers.

and only wafers in this vicinity were affected. The area, in general, was observed, and it was noticed that variation in floor tile perforation and the bulkiness of the tools contributed to this air-flow drift.

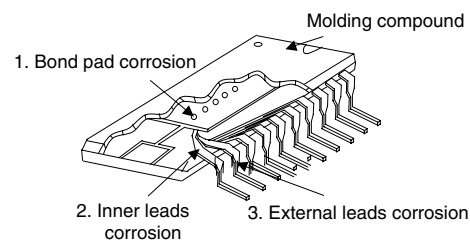
**Fig. 1** Areas where corrosion can be observed in a typical IC component. 1, Bonding pad corrosion; 2, Inner lead corrosion; 3, Leadframe (external leads) corrosion due to environmental impact. The IC package shown here is a partial thin small outline package (TSOP) with molding compound removed showing the silicon die, bonding pad, and the external and inner leads. Source: Ref 1

In a typical IC component, corrosion may be observed at the chip level and at the termination (also known as leads) area, as illustrated in Fig. 1. In this figure, a thin-small-outline package (TSOP) is shown along with the various areas where corrosion can occur. For chip scale package (CSP) type of packages with solder

**Rust Stain Seen at the Interface between Leadframe and Compound.** An example of corroded inner leads (Alloy 42) is illustrated in Fig. 1 (see point 2). This is due to poor adhesion between the compound and the leadframe. The chemicals (acids or alkalis) can diffuse into the package and react with the Alloy 42. The corroded products, oxides of iron and nickel, are illustrated in Fig. 6 where the stain mark is seen.

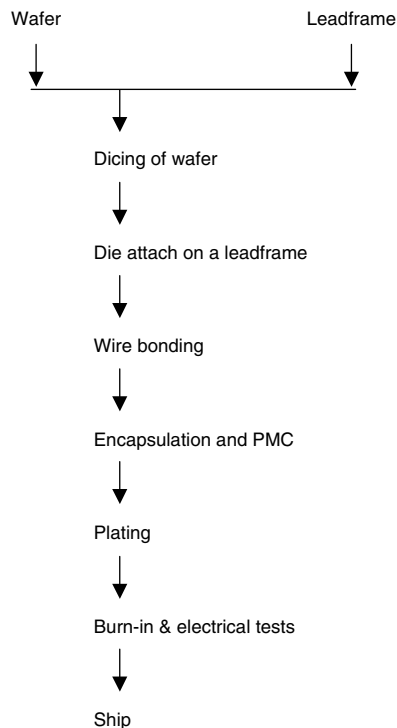
**Fig. 2** Generic process flow of a semiconductor device. Key areas where corrosion could occur are shown. PMC refers to post mold cure, a process whereby the encapsulant (molding compound) is further cured.

**Process Flow of IC Packaging.** The assembly of electronics parts follows a series of processes, as illustrated in Fig. 2, where some corrosive chemicals and elevated temperatures are involved. Corrosion (chip corrosion, tarnished terminations, and rusty discoloration with iron rust or rings of multiple color) has been observed since the beginning of semiconductor

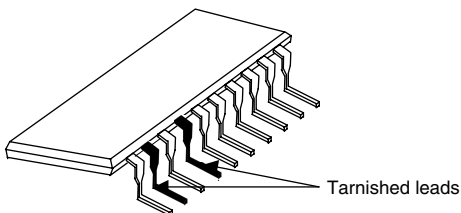
**Fig. 3** Diagram showing a partial thin-small-outline package with tarnished leads caused by galvanic corrosion. Notice that two pins, out of ten, are tarnished. In some cases, only one pin is tarnished. The tarnished leads are seen in a wet process (e.g., oxide wash process).

Galvanic corrosion can also be observed in the assembly. One case is illustrated in Fig. 3, where only a few pins of the entire package are corroded (in this case, two pins of the entire package). In another similar case, an imprint of terminations was seen on a gold lid of a ceramic package as shown in Fig. 4. These two cases are the result of a mishandling arising from a wet process (see also the subsequent discussion on oxide wash and ink symbol rework).

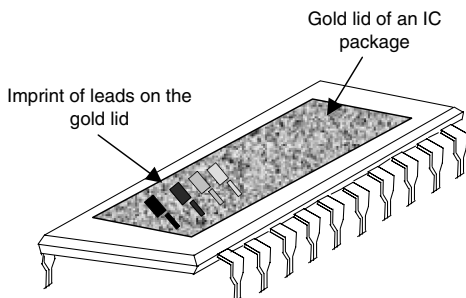
**Fig. 4** Pictorial illustration of an imprint of device terminations on the gold lid of a ceramic package. The imprints are formed when the units are soaked in a sodium-hydroxide solution at an elevated temperature.

The imprint of leads on a gold lid of a ceramic package (a high-reliability product), as illustrated in Fig. 4, shows another example of galvanic corrosion due to dissimilar electrodes in contact. In the presence of an electrolyte and temperature, galvanic corrosion occurs. In the days of the ink symbolization process, mistakes could be made (e.g., wrong symbol or poor symbol). Traditionally, a rework of the cured ink symbol was done by soaking the gold lid package in a sodium hydroxide solution at an elevated temperature. If the cleaning was properly carried out, the cured ink would be removed and the package reused. However, if the ceramic

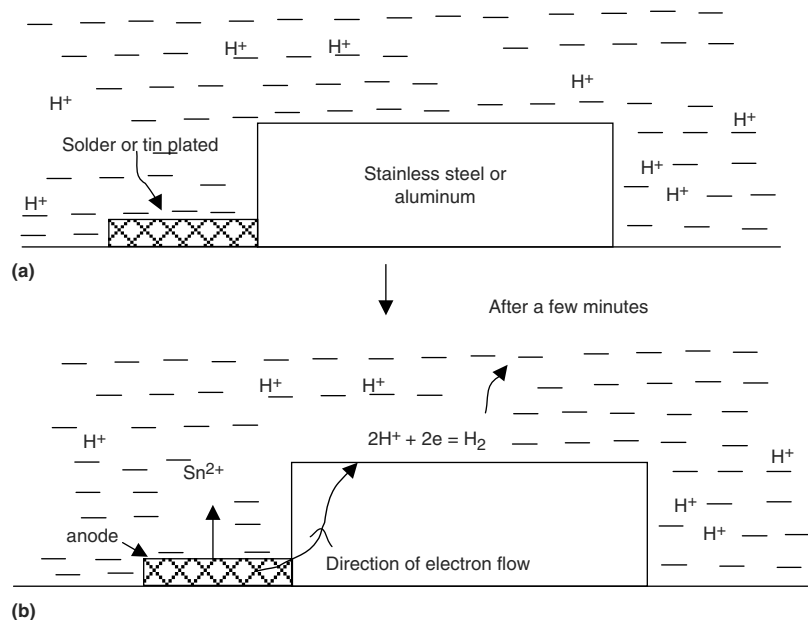
**Fig. 5** Mechanism for a galvanic reaction. The terminal is in contact with a stainless steel or aluminum surface seen in (a). The presence of an acidified electrolyte completes the path that allows the charges to be transported from one dissimilar metal to the other. In this case, the solder (or tin) is the anode, which dissolves anodically with eventual consumption of the solder (seen in b). This results in a tarnished lead.

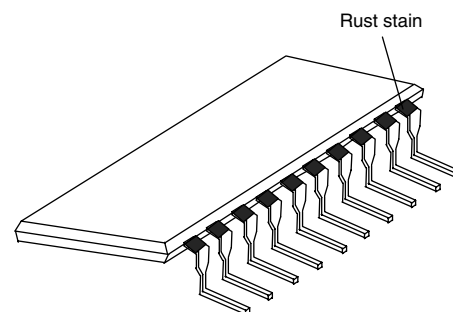
**Fig. 6** Tarnished area of interface between the molding compound and the leadframe of a partially drawn thin-small-outline package. The color of the stain is a typical rust color (for Alloy 42 leadframe) or green color (for copper leadframe).

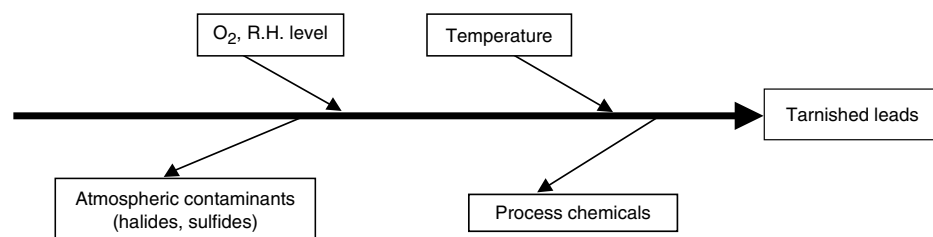
**Fig. 7** A “fish-bone” diagram showing the causes of tarnishing of leads.

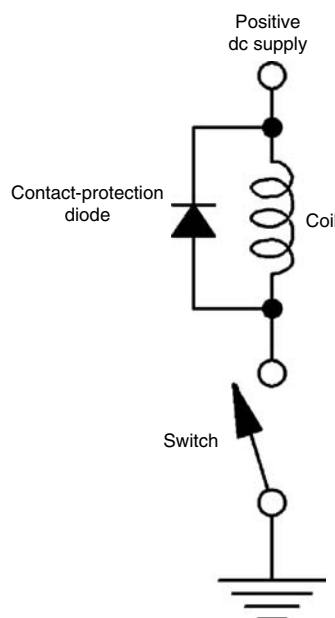
Fig. 1 Coil in low-side-switched circuit

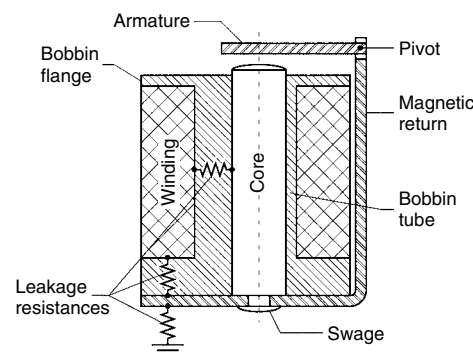
Fig. 2 Electrical-leakage paths in a typical relay structure (not to scale; proportions distorted for clarity)

grounded magnetic-core structure (Fig. 2), and this current causes corrosion of the copper magnet wire and attendant removal of copper ions from the wire; the ultimate result is an open circuit in the coil.

to wick into the coil winding. As suggested in Fig. 2, the most critical locations are near grounded metallic structures, that is, inside surfaces of the coil-bobbin flanges and the bottom layer of the winding. If an insulation pinhole is present at one of these critical locations, then corrosion of the wire is likely to occur. Additionally, if an electrical potential difference exists (e.g., as in a low-side-switched circuit), then the rate of corrosion increases. Figure 3 shows a typical example of corrosion in the bottom layer of a low-side-switched relay coil. The magnet wire had been severed by corrosion at the indicated site, and corrosion products at the site contained chloride ions. The source of chloride ions was the solder flux that had been used in terminating the coil ends.

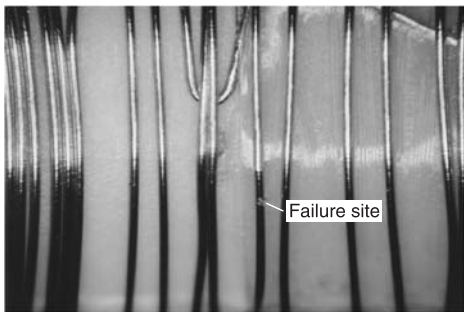
**Fig. 3** Corrosion failure site in bottom layer of relay-coil winding

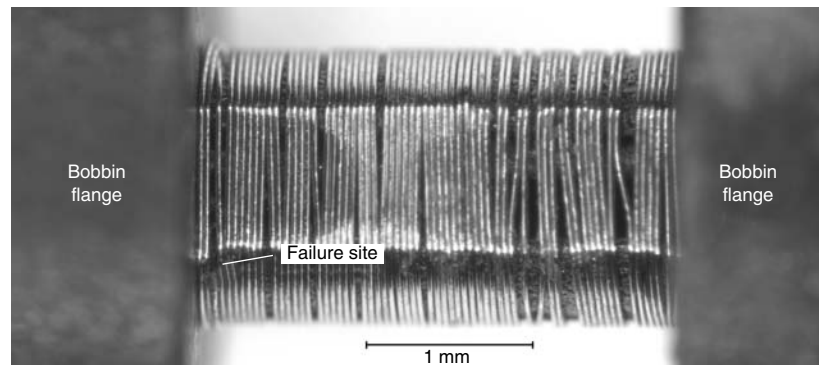
**Fig. 4** Corrosion failure site in bottom layer of coil in magnetic sensor

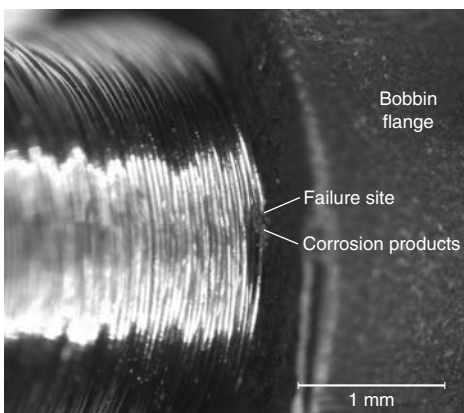
**Fig. 5** Corrosion failure site against bobbin flange in magnetic-sensor coil

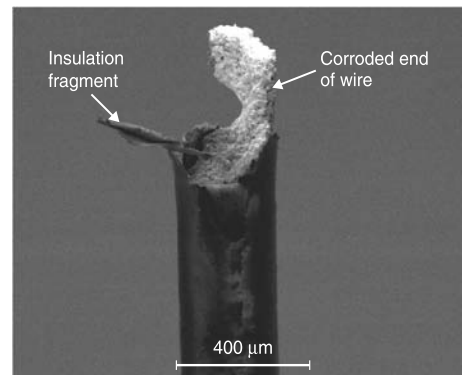
**Fig. 6** Scanning electron micrograph showing end of corroded copper magnet wire

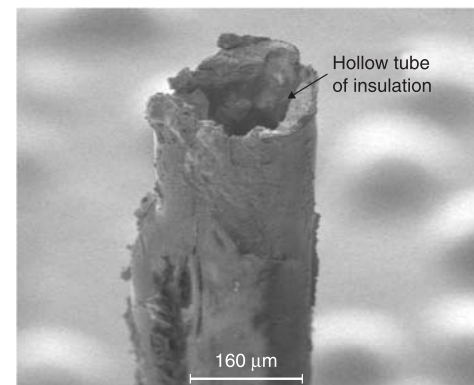
**Fig. 7** Scanning electron micrograph showing hollow insulation sheath at end of corroded copper magnet wire

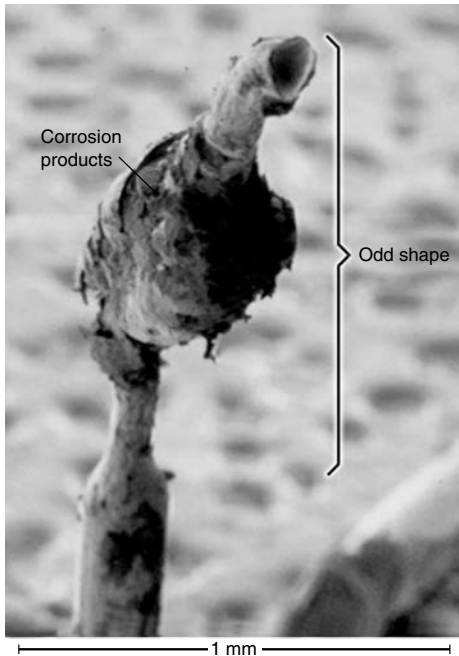
Fig. 8 Scanning electron micrograph showing unusually shaped end of corroded copper magnet wire

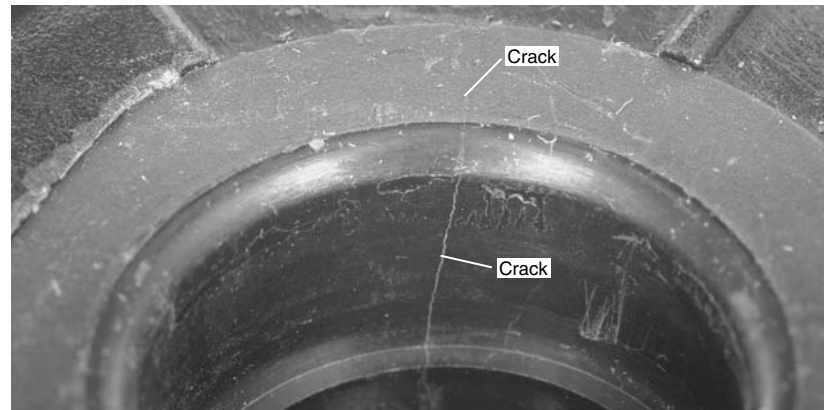
Fig. 9 Inside of failed coil bobbin showing crack (millimeter scale)

Sometimes, corrosion failures in coils are initiated by other failures. Figure 9 is an as-received view of the inside of an encapsulated coil; a package crack caused by elevated-temperature aging of the bobbin material is pointed out. Voltage measurement suggested that the coil had corroded internally, and a subsequent resistance measurement verified that the coil was an open circuit. Because corrosion was suspected, the bobbin material was removed in the vicinity of the crack to facilitate inspection of the magnet wire. A corrosion site was found against the inside of the bobbin flange (Fig. 10, 11). Microprobing of the wire showed that the site pointed out in Fig. 11 was the only break in the coil. Energy-dispersive x-ray spectroscopy (EDS) of the corrosion product detected chlorine. The failed coil had been in service near a seacoast, and it appeared that the detected chloride ions and the moisture required to support corrosion were airborne. Location of the corrosion site suggested that contaminants entered the coil through the crack in the bobbin.

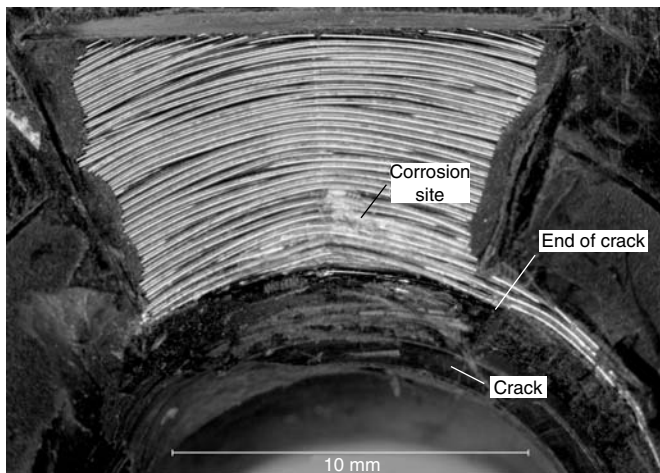
Fig. 10 Overall view of corrosion failure site in failed coil

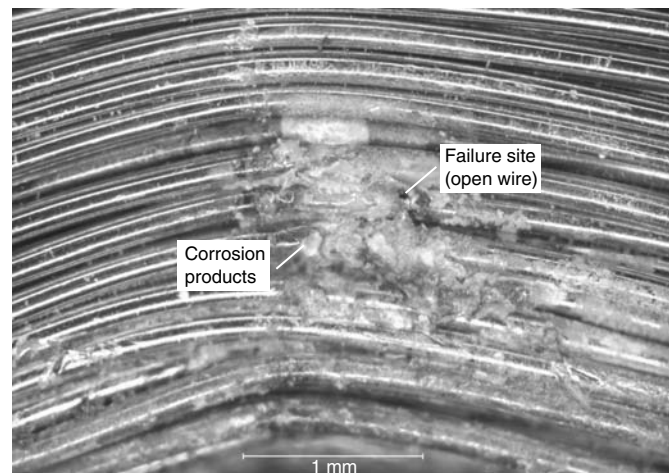
Fig. 11 Detail view of corrosion failure site in failed coil

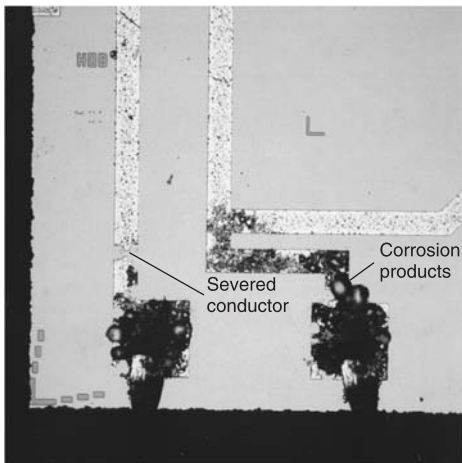
**Fig. 12** Corner of failed strain-gage-bridge die showing corroded metallization

incorporates a silicon strain-gage bridge. There are four diffused resistors on a silicon strain-gage die. Two of these resistors are in a high-stress region of a thin silicon diaphragm, and the other two are in a low-stress region. Resistances of the highly stressed resistors change when pressure is applied to the thin diaphragm, but resistances of resistors in the low-stress region change very little. The function of the latter two resistors is to provide temperature compensation of the bridge. The aluminum bond pads and interconnecting metallization on a silicon strain-gage die removed from a failed pressure transducer were corroded (Fig. 12). Corrosion products, shown in detail in Fig. 13, contained

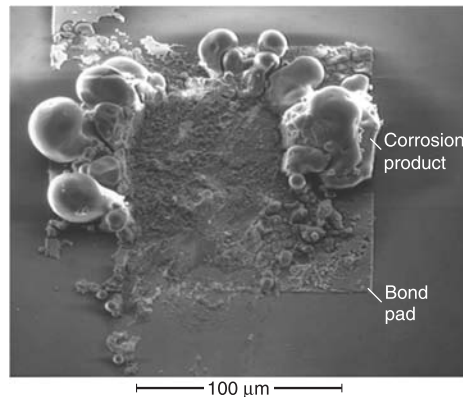
**Fig. 13** Scanning electron micrograph of corrosion products around bond pad on failed strain-gage-bridge die

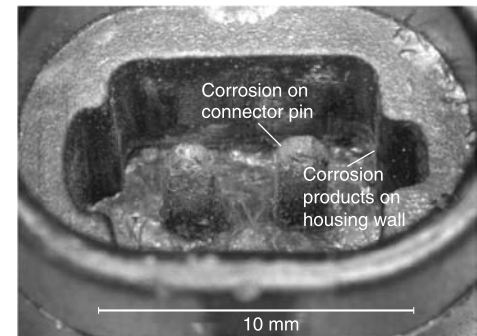
**Fig. 14** Interior of failed electrical connector showing corroded pins

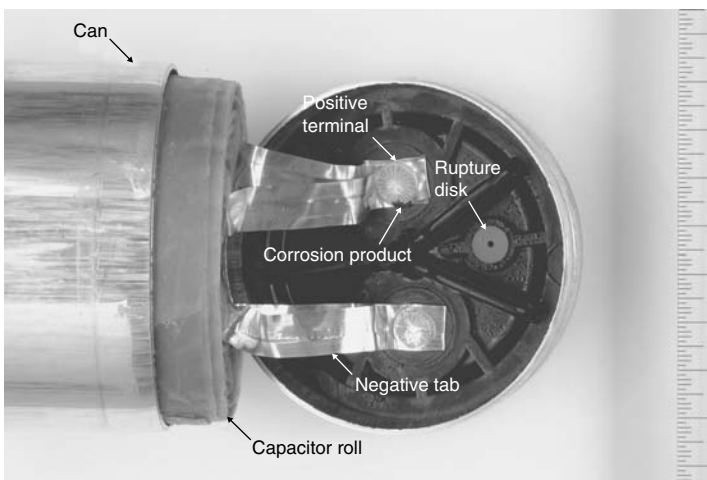
**Fig. 15** Interior of good aluminum electrolytic capacitor (millimeter scale)

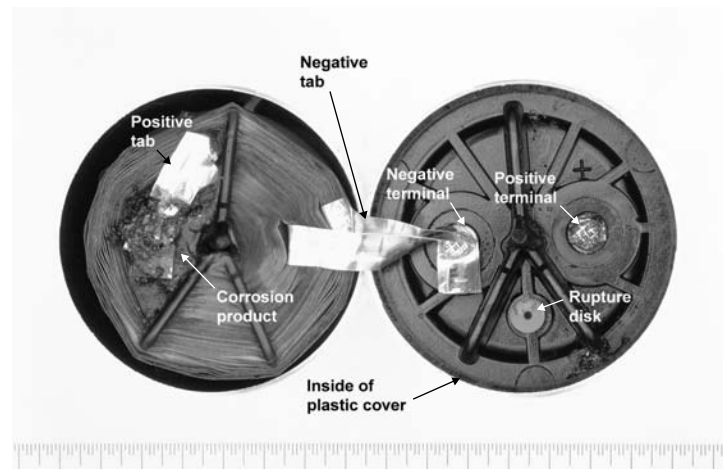
**Fig. 16** Interior of failed aluminum electrolytic capacitor showing effects of corrosion (millimeter scale)

missing did not detect halides, but did detect constituents of organic acids. Moreover, there was evidence that the spot-welded wire-lead attachments to the terminations at the ends of the metallized-film roll had been manually reworked with a soldering iron, an operation that required use of flux. Although an attempt had been made to clean the solder joints, some solder-flux residue remained. Elemental analysis indicated that the flux residue was of the organic-acid type. Leaving potentially corrosive solder-flux residue on the ends of the roll was inadvisable, but cleaning the joints with a solvent and allowing the flux-laden solvent to wick into the roll greatly accelerated the significant metallization damage that subsequently occurred.

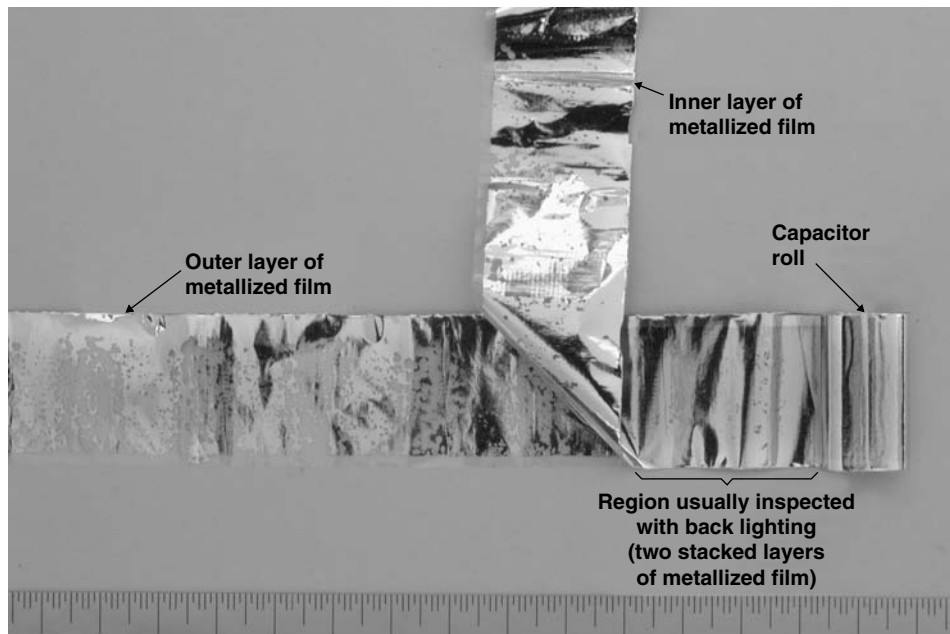
Fig. 17 Partially unrolled metallized-film capacitor showing individual film layers and stacked film layers (millimeter scale)

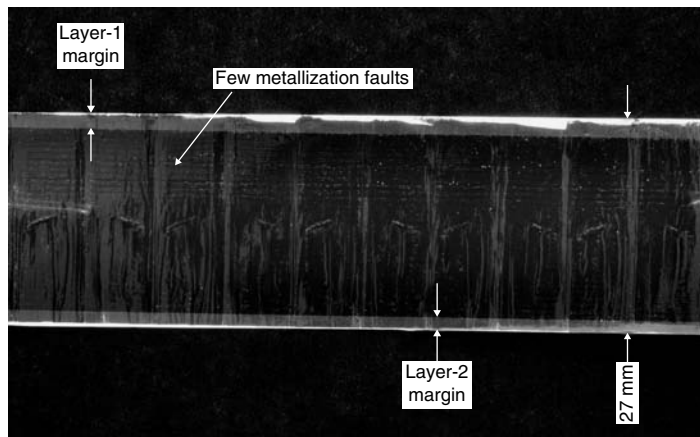
Fig. 18 Backlit view of two stacked film layers removed from a good metallized-polypropylene-film capacitor

capacitor are shown in Fig. 18. Only a few small areas of missing metallization are apparent. In contrast, the backlit film layers shown in Fig. 19 were removed from a failed capacitor that had only two-thirds of its original capacitance. In the darkest areas in Fig. 19, there was metallization on both layers of film; however, in the gray areas, there was metallization on only one of the film layers, and in the brightest areas, the metallization was missing from both layers. Large sizes and irregular shapes of the missing metallization areas and absence of film defects in these areas indicated that clearing was not the failure mechanism; corrosion of the zinc-aluminum metallization had occurred instead. Elemental analysis of areas in which the metallization was

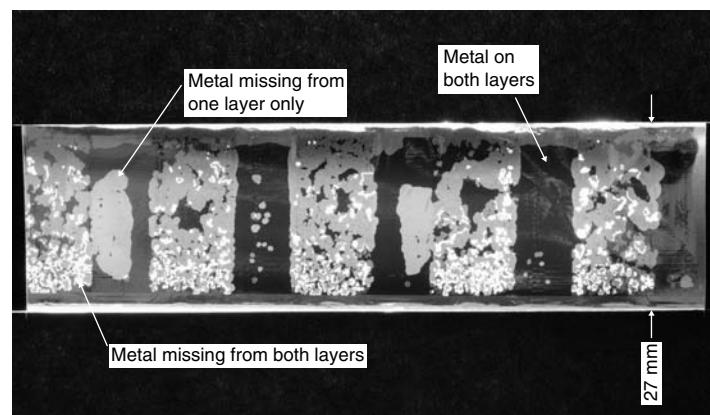
Fig. 19 Backlit view of two stacked film layers removed from a failed metallized-polypropylene-film capacitor

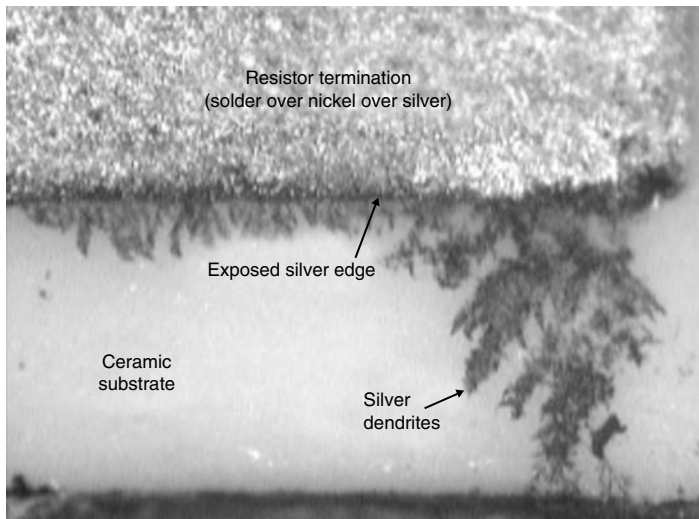
**Fig. 20** Back side of failed surface-mounted chip resistor showing silver dendrites. Courtesy of Pat Kader, ENI

Many surface-mounted electronic components have a layer of silver in their solderable terminations. An electrolytic contaminant, such as solder-flux residue, an electrical potential difference, and moisture combine to support electrochemical migration of silver, a metal highly susceptible to this phenomenon. The resulting dendritic growth usually leads to a short circuit in parallel with the component. Figure 20 shows the back side of a surface-mounted chip resistor that failed in this manner.

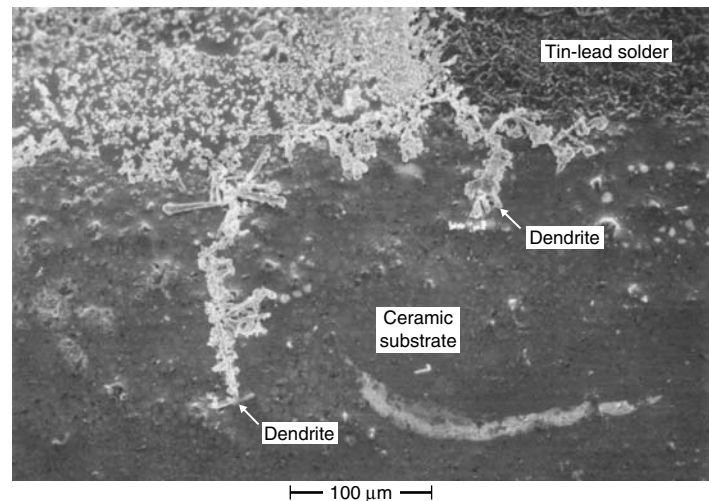
**Fig. 21** Scanning electron micrograph of lead dendrites on substrate of failed thick-film-hybrid resistor network

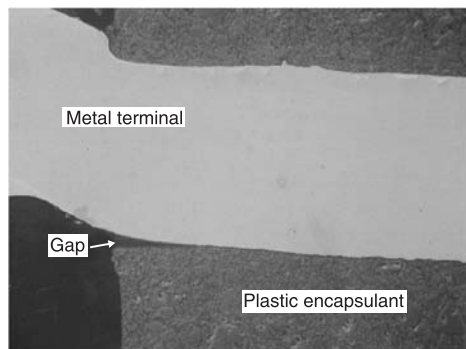
**Fig. 22** Cross section showing gap between metal terminal and encapsulant at terminal entry of thick-film-hybrid resistor network

The failing resistor-network substrate had been encapsulated in a transfer-molded plastic that did not adhere well to the metal terminals of the device. Lack of adhesion caused thin gaps at the terminal entries (Fig. 22). Moreover, the resistor network was mounted on the wave-soldered side of the printed circuit board and, hence, was immersed in chlorine-containing flux just before exposure to the thermal shock of the high-temperature solder wave. Following the soldering operation, the circuit board was cleaned in softened (i.e., sodium-containing) water. The result of this process was that

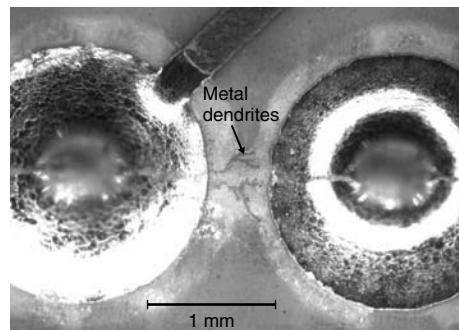
**Fig. 23** Tin dendrites growing between two adjacent solder joints on failed printed circuit board

Figure 23 is a detail view of the area between two adjacent solder joints on a printed circuit board. Tin dendrites growing between the solder joints are clearly visible. The circuit board had been exposed to a chlorine-containing flux during the soldering operation and had not been cleaned properly. Subsequently, the board was conformally coated with a clear polymeric material. Many conformal-coating materials do not adhere well to solder-flux residue, and they eventually delaminate from the circuit-board surface forming thin pockets in which moisture accumulates. The environment in these pockets becomes ideal for metal migration, and dendrites, such as those shown in Fig. 23, grow. The eventual result is a short circuit between the adjacent solder joints.

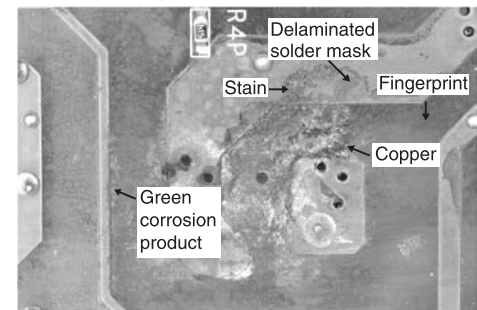
**Fig. 24** Copper migration and corrosion on surface of failed printed circuit board

Less organized metal migration is shown in Fig. 24. In this case, the migrating metal was

copper, and the ionic contamination was from the organic-acid solder flux used in circuit-board assembly. There was plenty of moisture present because failure occurred during a temperature-humidity-bias (THB) test in which the relative humidity was maintained at 85%. Whether the fingerprint pointed out in Fig. 24 was present during the test was unknown. In addition to metal migration, there was a small amount of copper corrosion.

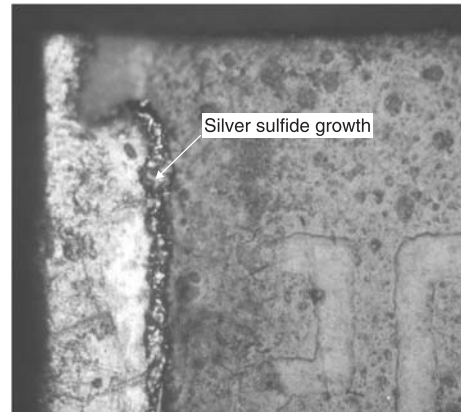
**Fig. 25** Corner of failed surface-mounted thick-film chip resistor showing tarnished silver. Courtesy of Steve Axtell, Vishay

A common source of sulfur-containing gases is vulcanized rubber, which is sometimes used for insulating electrical wires. Other sources of sulfur-containing gases include brown paper bags and cardboard boxes. If rubber objects are enclosed in the same housing with silver-containing electronic components, failure is almost inevitable. A typical example (Ref 5) is illustrated in Fig. 25, which shows a corner of a surface-mounted chip resistor that has a layer of silver in each of its terminations. The silver layer had been consumed by tarnish, and the resistor had become an open circuit. The circuit board on which this resistor and others like it were mounted had been enclosed in a poorly ventilated housing along with a vulcanized-rubber conduit that contained some of the system interconnection wiring. A sulfur-containing gas evolved from the rubber and reacted with the silver terminations of the resistor to yield silver sulfide. A scanning electron micrograph

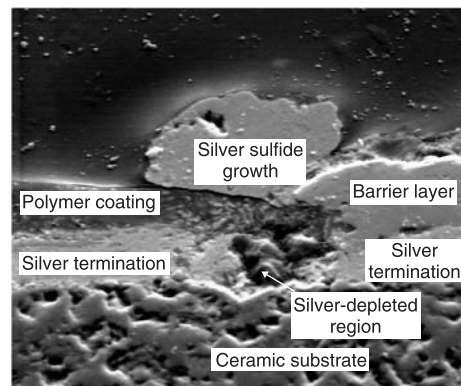
**Fig. 26** Scanning electron micrograph of cross section through termination region of failed surface-mounted thick-film chip resistor. Courtesy of Steve Axtell, Vishay

of a cross section through the failed resistor termination (Fig. 26) shows the silver-depleted region that broke the circuit between the resistive element and the termination.

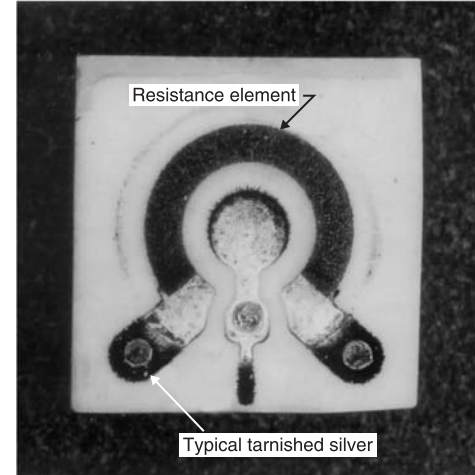
**Fig. 27** Overall view of substrate in failed trimming potentiometer showing tarnished silver terminations

A similar failure occurred in a trimming potentiometer that was installed in a control system located in a tire-manufacturing plant where substantial concentrations of sulfur-containing gases were present. The effect of these gases was to tarnish the silver terminations at the ends of the potentiometer resistance element (Fig. 27). The silver was consumed with the result that the potentiometer became an open circuit. Figure 28 is a scanning electron micrograph showing a detail view of one of the tarnished terminations; the grasslike appearance is typical of tarnished thin films of silver.

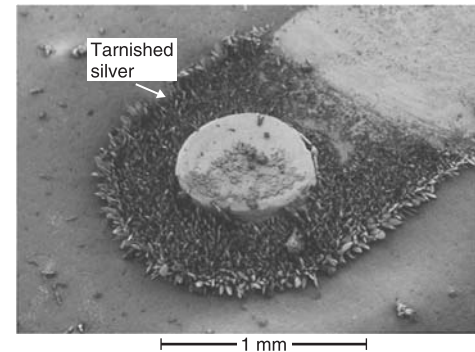
**Fig. 28** Scanning electron micrograph of tarnished silver termination on substrate in failed trimming potentiometer

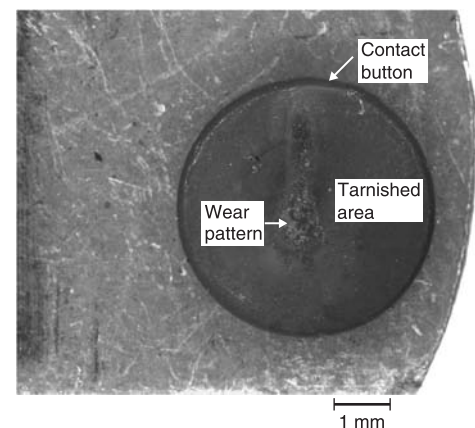
**Fig. 29** Heavily tarnished silver alloy relay contact

to do so. Figure 29 shows a typical heavily tarnished silver alloy relay contact. Even though the mechanism in this relay provided desirable wiping action, as evidenced by the elongated

wear pattern, the wiping action was not sufficiently aggressive to break through the tarnish film that had built up over the long periods of time during which the contact had been held in the open state. Failure of this contact was caused by sulfur-containing gases that evolved from the rubber insulation on wires that were housed in the same enclosure.

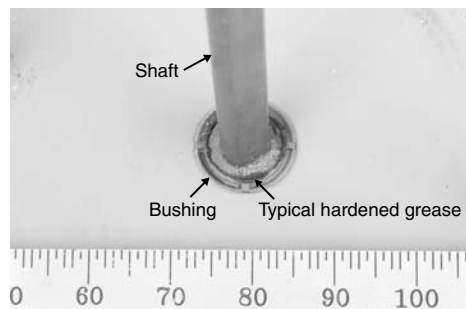
**Fig. 30** Exterior view of shaft and sleeve bearing on failed motor-operated switch (millimeter scale)

The rotor of a motor-operated switch was bound so tightly that the mechanism could no longer rotate. Inspection of the drive mechanism showed that grease in the sleeve bearings had become hard (Fig. 30), and subsequent EDS analysis detected the sleeve-material elements in the hardened grease. Disassembling the mechanism revealed additional hardened grease on the corresponding journal (Fig. 31). Cleaning the sleeve and journal, applying fresh grease, and reassembling the device restored normal operation.

The motor in the switch was operated from a 60 Hz ac source. As a result, low-level 120 Hz vibration was present while the coil was energized continuously for months at a time. The almost continuous vibration caused fretting of the sleeve bearing, and the resulting fine metallic particles led to hardening of the grease and consequent binding of the mechanism. Using dc excitation would have

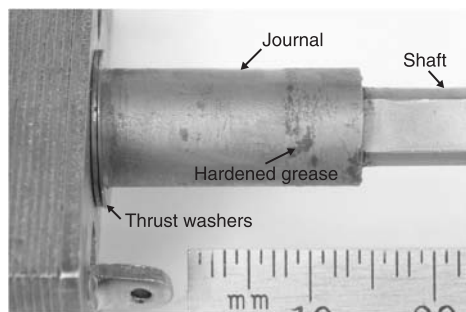
**Fig. 31** Hardened grease on rotor journal of failed motor-operated switch (millimeter scale)

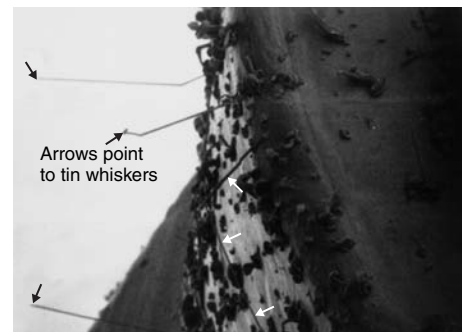
**Fig. 32** Scanning electron micrograph of tin whiskers on base of insulated standoff terminal

Of the metals frequently used in electronic devices, tin is the most likely to form whiskers. Such whiskers may be several millimeters long, and, of course, they are electrically conductive. Examples of tin whiskers projecting from the tin-plated base of an insulated standoff terminal are shown in Fig. 32. One of the whiskers on this terminal contacted an adjacent resistor lead, thereby causing a short circuit to ground. In this situation, there was not enough energy available to evaporate the whisker, so circuit malfunction ensued. However, in many circuit applications, there is enough energy available to evaporate a small-diameter metal whisker, and in such cases, whiskers usually are nuisances rather than causes of hard failures. Tin whiskers are of great concern in outer-space applications in which evaporation of a metal whisker may trigger catastrophic arcing.

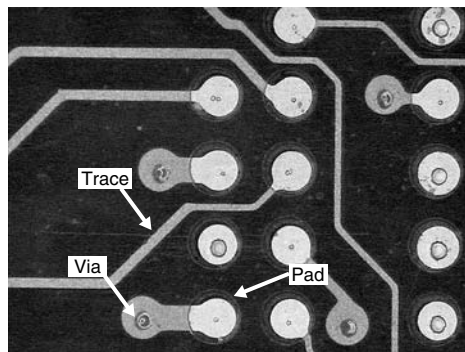
**Fig. 1** Schematic of a printed wiring board explaining the different components that can be affected by electrochemical migration

Dendritic growth can occur between any two conductors on or in a PWB. It could be on the surface or internal to the PWB. The risk or failure locations can be at any of the following locations (see Fig. 1 for an explanation of these terms):

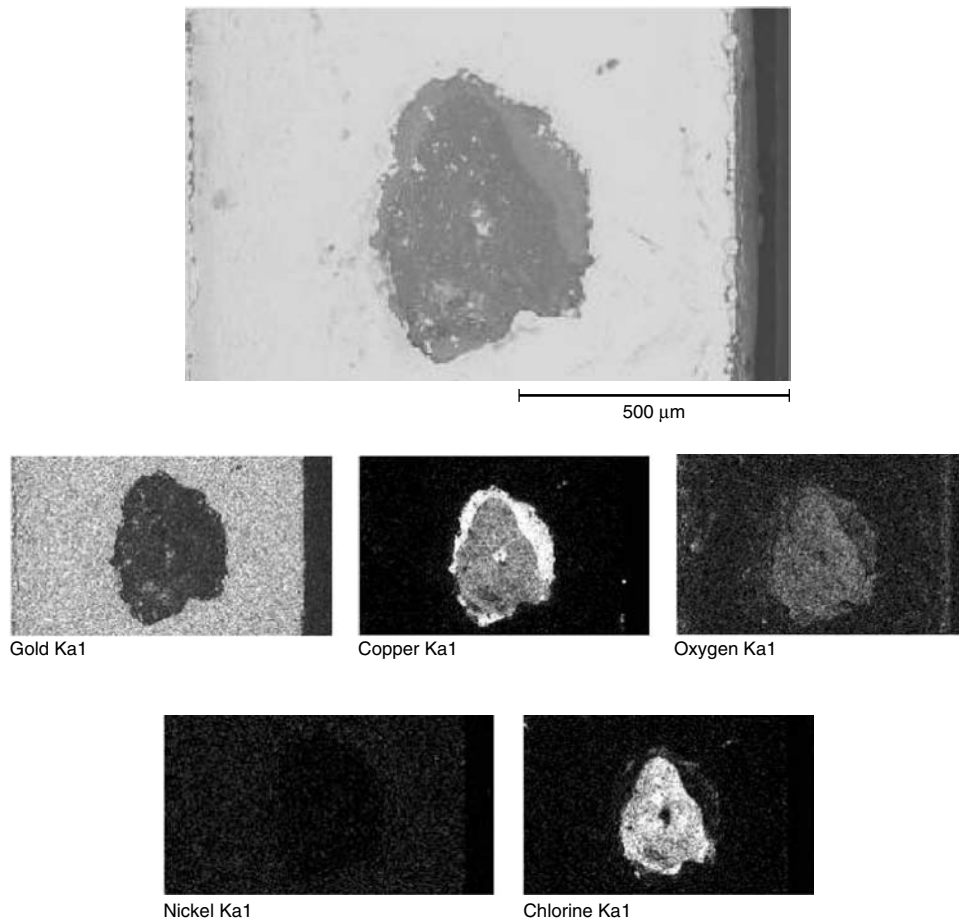
**Fig. 2** Corrosion of gold-plated connector along with energy-dispersive x-ray analysis elemental maps of Au, Cu, O, Ni, and Cl

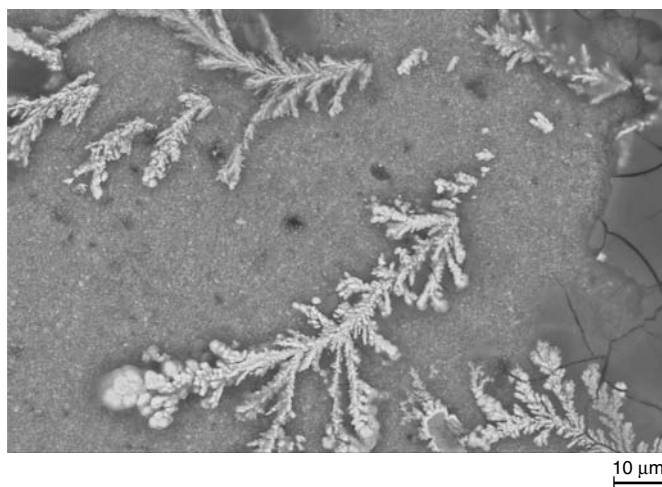
**Fig. 4** Electrochemical migration on a capacitor with tin termination. The right side of the figure shows a higher magnification view of the dendrites at the cathode end of the termination.

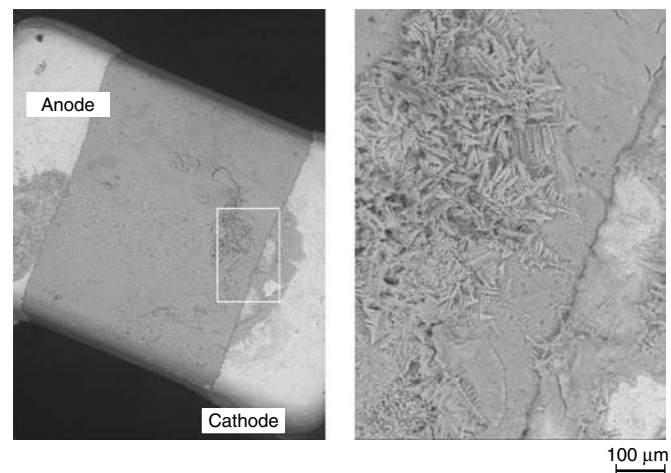
**Fig. 5** Composition of the electrochemical migration product of the capacitor shown in Fig. 4. Energy-dispersive x-ray analysis elemental maps are Ba, Ti, O, Sn, and Ni. These maps show the presence of tin electrochemical migration between the terminations and exposure of the nickel barrier layer under the consumed tin surface at the anode.

Fig. 5. The capacitor dielectric material is composed primarily of barium titanate, and the barium and titanium maps show the extent of the exposed dielectric surface. For the capacitor to function, it is necessary that the cathode and anode terminations are electrically insulated from each other. Therefore, in a functional capacitor, one would not find any tin covering the dielectric material between the terminations (gray area in Fig. 4). However, in this failed capacitor, in addition to the tin at the terminations, which is normal, the tin map also shows the presence of tin between the terminations, where there should be none.

In several passive components (capacitor, resistors, etc.), nickel is used as a barrier layer between the silver adjacent to the dielectric and the tin termination. In this particular case, the nickel barrier layer at the anode is visible in areas where the tin from the surface has been consumed by the ECM process, exposing the nickel barrier layer underneath the tin. Another example of tin ECM is shown in Fig. 6, where a colloidal form of ECM can be observed in addition to dendrite formation.

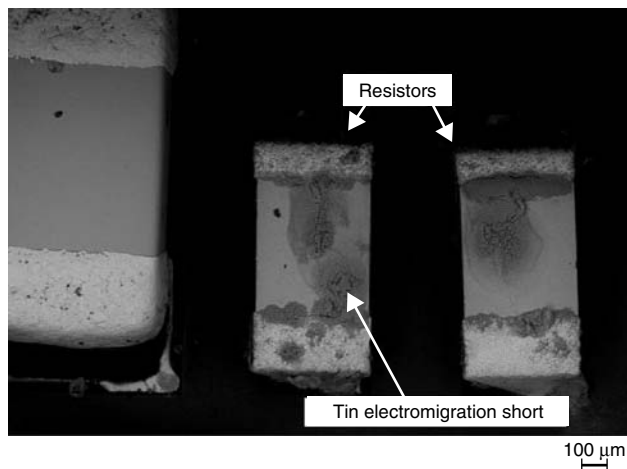
**Fig. 6** Tin electrochemical migration (ECM) involving both formation of dendrites and colloidal form of ECM on a resistor with pure tin termination.

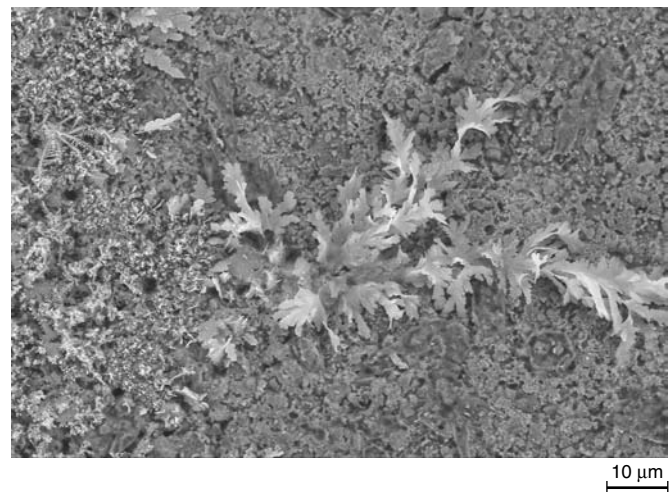
**Fig. 7** Silver electrochemical migration on a resistor with tin termination. Inadequate protection due to poor quality nickel barrier layers enabled the silver to exhibit electrochemical migration.

*Silver ECM* can occur on the PWB if there is exposed metal in the termination or pad finish, or it can occur on the surface of passive devices separate from the surface of the PWB. The occurrence of ECM on the surface of passive devices can potentially be a more serious reliability risk because of the current trend toward smaller-size passives, which provides a ready site for ECM. Furthermore, silver commonly coats the ends of the passive device to ensure that there is a good contact between the electrodes in a capacitor and the termination, which is often made of tin. Therefore, nickel is used as a barrier layer between the silver base and the tin outer layers. If the nickel layer is not continuous or if there are gaps through which silver can be exposed to the environment, silver ECM can occur, as shown in Fig. 7. Here, dendrites of

silver can be seen growing on the surface of the passive component after temperature-humidity tests.

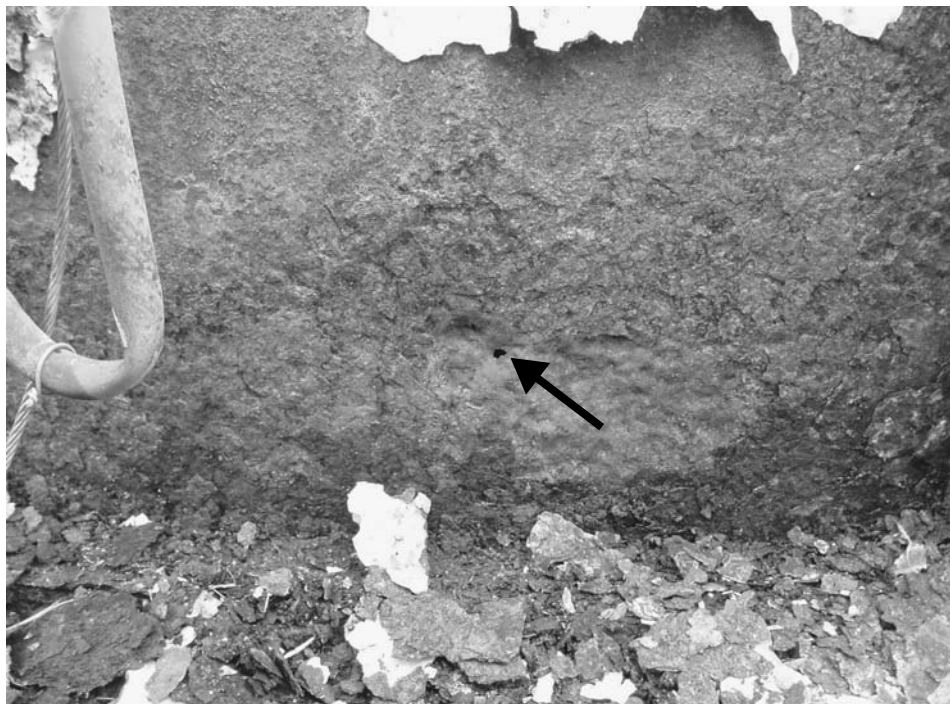
Fig. 1 Through wall corrosion under insulation of a large coated carbon steel storage tank. Through hole at arrow. Courtesy of Paul Powers, GE Inspection

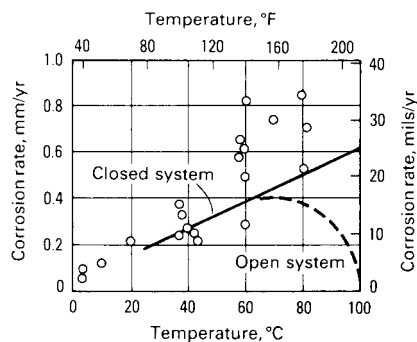
**Fig. 2** Effect of temperature on corrosion of steel in water. Data points are from plant measurements of corrosion under insulation (Ref 3). Closed system, oxygen held in system; open system, oxygen free to escape (Ref 4)

Figure 2 shows the corrosiveness of water versus temperature. The problem of steel corrosion under insulation can be classified as equivalent to corrosion in a closed hot-water system. In an open system, the oxygen content decreases with increasing temperature to the point where corrosion decreases even though the temperature continues to increase (Ref 4). In a closed system, the corrosion rate of carbon steel in water continues to increase as the water temperature increases. Estimated corrosion rate data of carbon steel under insulation plotted in Fig. 2 that were obtained from actual plant case histories confirm that the rate increases with temperature in a manner similar to that of a closed system (Ref 3). It is inferred that the same oxygen cell corrosion mechanism is taking place as in a closed system. The corrosion rates from

field measurements are shown to be greater than laboratory tests, due to the presence of salts in the field. Salts increase the conductivity of the water film and thereby influence the corrosion rate.

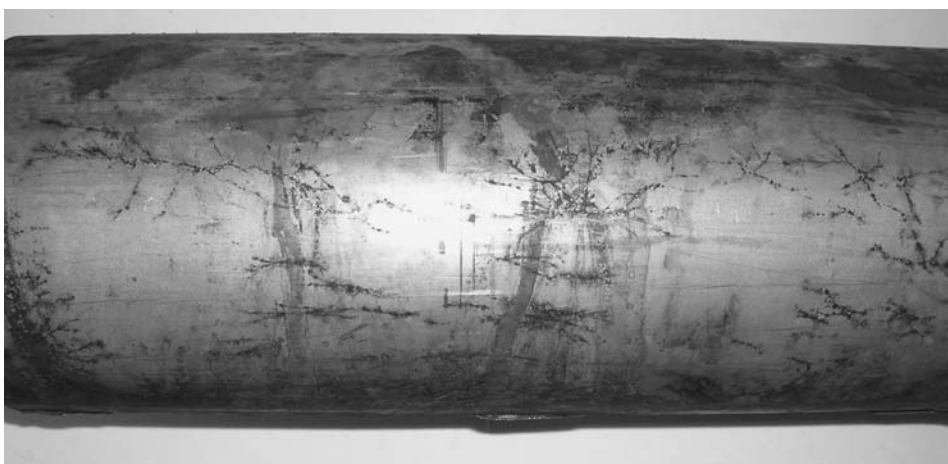
**Fig. 3** External stress-corrosion cracking of a type 304 stainless steel, 100 mm (4 in.) schedule 40 pipe. The piping system was insulated with calcium silicate insulation and operated at temperatures between  $50$  and  $100\text{ }^{\circ}\text{C}$  ( $120$  and  $212\text{ }^{\circ}\text{F}$ ).

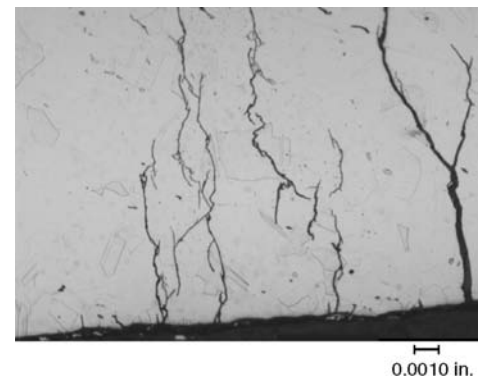
**Fig. 4** Cross section through type 304 stainless steel pipe showing transgranular external stress-corrosion cracking

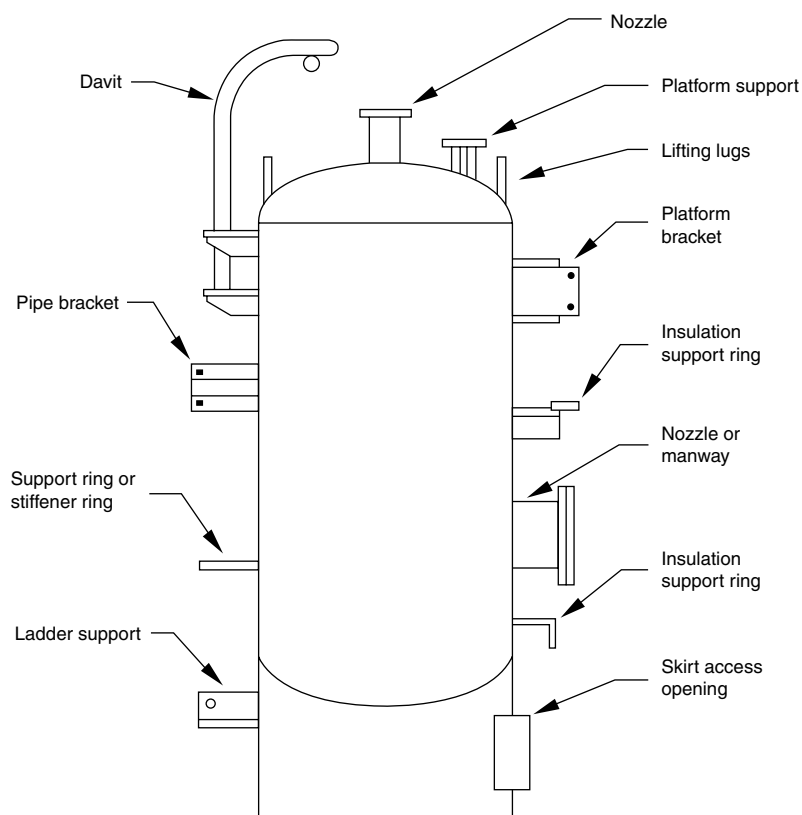
Fig. 5 Typical vessel attachments where water may bypass insulation. Source: Ref 11
