# ASM Handbook®

## Volume 13C Corrosion: Environments and Industries

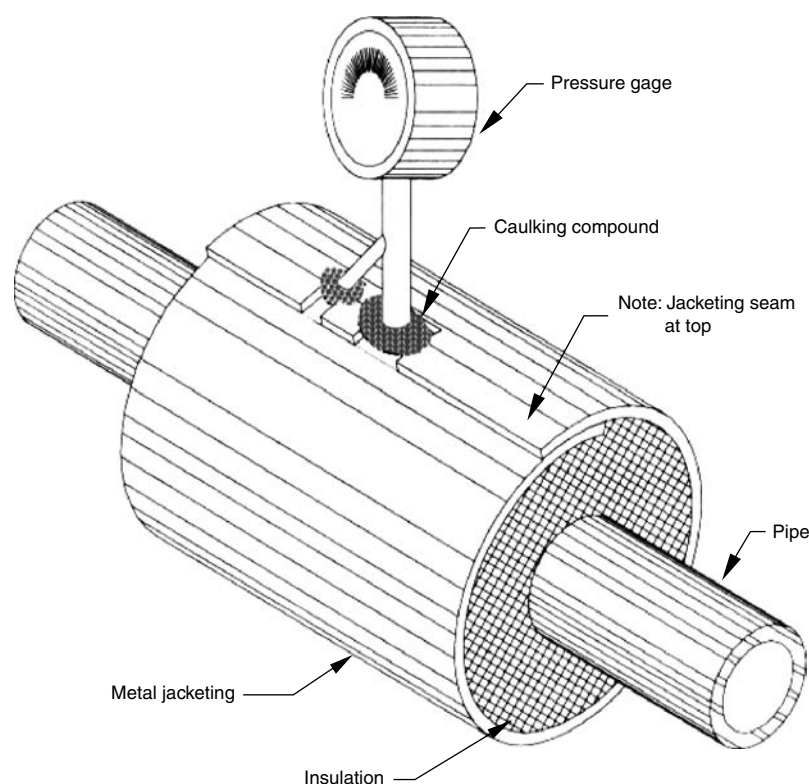
**Fig. 6** Attachment to piping where water may bypass insulation. Attachment relies on caulking compound only. Source: Ref 11

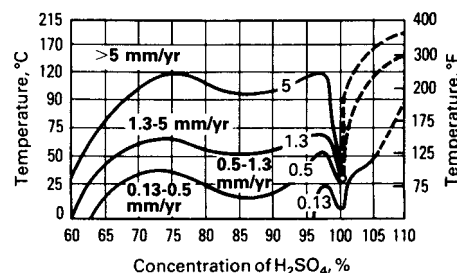
**Fig. 1** Corrosion of steel by  $\text{H}_2\text{SO}_4$  as a function of temperature and acid concentration. Source: Ref 3

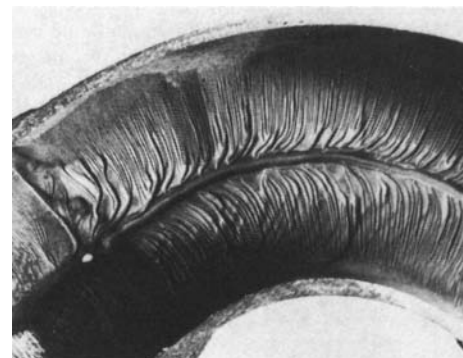
**Fig. 2** Hydrogen grooving of a 75 mm (3 in.) diam steel elbow. The elbow was sectioned; the top half is shown.

**Hydrogen grooving** is another form of localized attack that occurs on vertical or inclined surfaces exposed to the liquid phase. During the corrosion of steel by  $\text{H}_2\text{SO}_4$ , hydrogen is evolved. If produced in sufficient quantities, the hydrogen forms small bubbles that stream along preferred paths on vertical and inclined surfaces, disrupting the soft protective iron sulfate film. Channels and deep grooves may eventually form. Grooving is commonly observed in the tops of horizontal manways on the side of vertical storage tanks and on the top 180° of horizontal pipe runs (Fig. 2). In piping, stagnant conditions promote grooving; therefore, a minimum velocity of 0.3 m/s (1 ft/s) is often recommended.

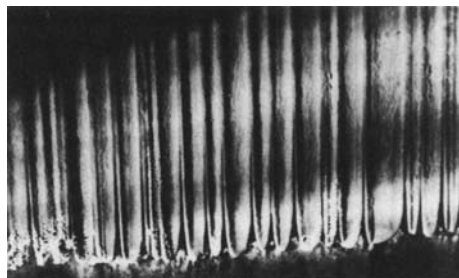
**Fig. 3** Hydrogen grooving on the sidewall of an  $H_2SO_4$  storage tank

Grooving, combined with erosion-corrosion, also occurs on the sidewalls of tanks (Fig. 3). Location of the liquid inlet in the roof near the shell has, in at least two cases, resulted in combined erosion-corrosion and hydrogen grooving, which caused catastrophic rupture of large storage tanks (Ref 5).

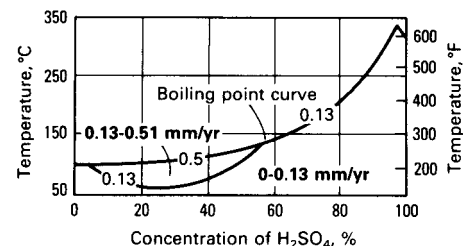
**Fig. 4** Corrosion of high-silicon cast iron in  $H_2SO_4$  as a function of temperature and acid concentration. Source: Ref 14

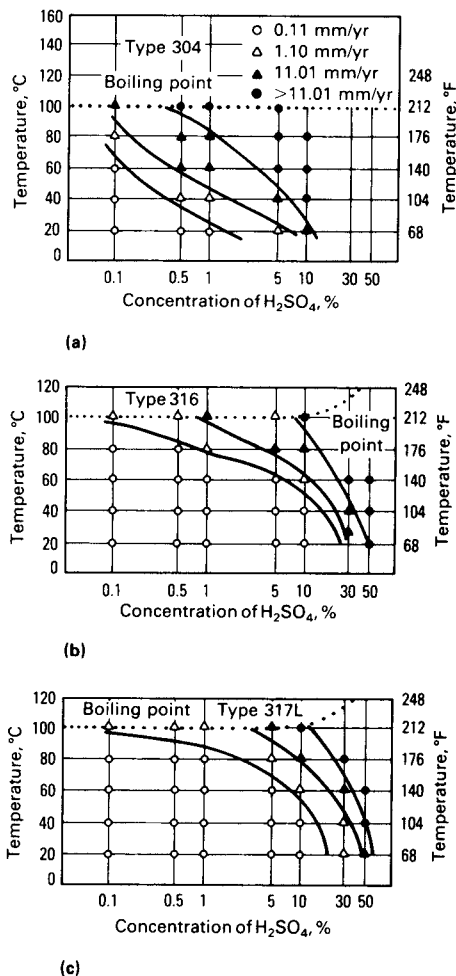
Fig. 5 Isocorrosion diagrams for (a) type 304, (b) type 316, and (c) type 317L stainless steels in aerated  $H_2SO_4$  up to 50% concentration. Source: Ref 17

In dilute acid, the molybdenum grades, such as type 316 and 317, are useful, although type 304 may be used when only a trace of acid is present. Figure 5 shows corrosion data for these alloys in as-mixed and refluxed (aerated)  $H_2SO_4$  solutions (Ref 17). Stainless steels have poor resistance to deaerated dilute solutions. Higher chromium is beneficial for oxidizing conditions. Type 310 stainless steel with 25% Cr and no intentionally added molybdenum is more resistant than the lower-chromium molybdenum-bearing grades when oxidizing agents are present (Ref 15).

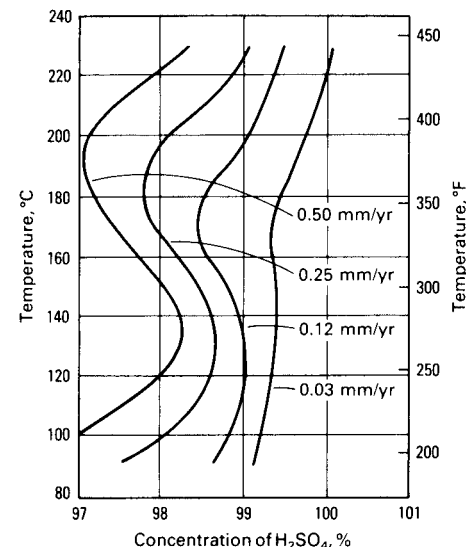
Fig. 6 Isocorrosion diagram of type 304L stainless steel in highly concentrated  $H_2SO_4$ . Source: Ref 24

**Effect of High Concentration and  $SO_3$ .** In strong  $H_2SO_4$  (above 98% concentration) and in oleum, the oxidizing power of the acid increases dramatically and corrosion rates are reduced (Ref 23, 24). Figure 6 shows an isocorrosion

diagram generated for type 304L stainless steel in an absorption tower environment. Most stainless steels and nickel-base alloys have similar reductions in corrosion rates with increasing concentration. However, the higher molybdenum-containing alloys, such as alloys B-2, C-276, 904L, and 20Cb-3, are distinctly inferior (Table 1).

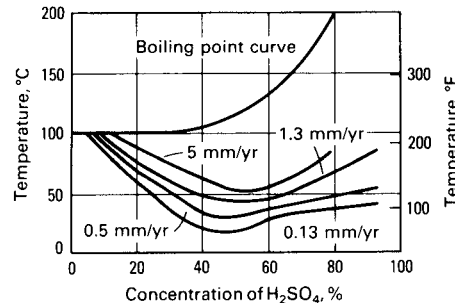
Fig. 7 Isocorrosion diagram for ACI CD-4MCu in H<sub>2</sub>SO<sub>4</sub>. Source: Ref 15

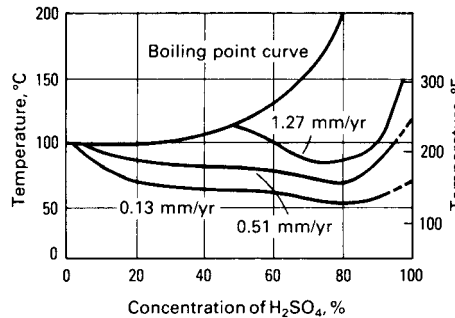
Fig. 8 Isocorrosion diagram for ACI CN-7M in H<sub>2</sub>SO<sub>4</sub>. Source: Ref 15

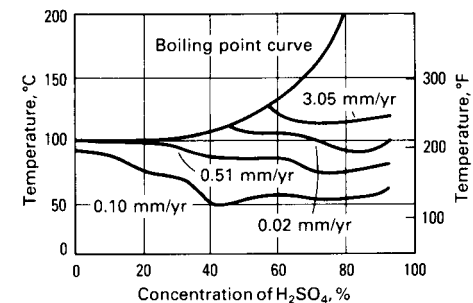
Fig. 9 Isocorrosion diagram for alloy 20Cb-3 in H<sub>2</sub>SO<sub>4</sub>. Source: Ref 15

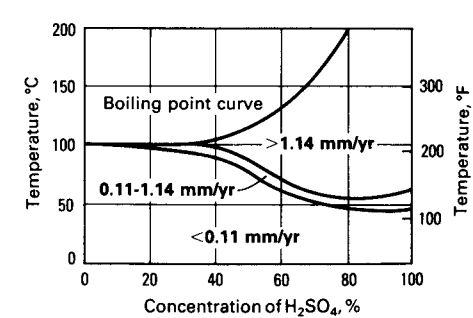
Fig. 10 Isocorrosion diagram for alloy 904L in H<sub>2</sub>SO<sub>4</sub>. Source: Ref 15

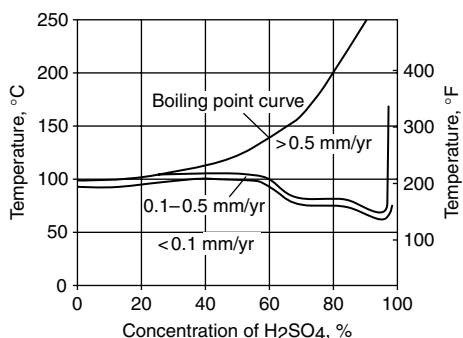
Fig. 11 Isocorrosion diagram for alloy 31 (Nicrofer 3127 hMo) in  $H_2SO_4$ . Source: Ref 27

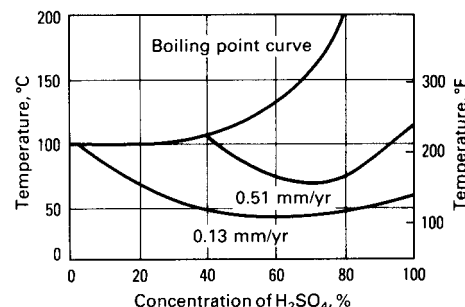
Fig. 12 Isocorrosion diagram for alloy 825 in  $H_2SO_4$ . Source: Ref 15

**Nickel-Base Fe-Cr-Mo-Cu Alloy.** Alloy 825 (N08825) has useful resistance to  $H_2SO_4$  up to 40% concentration and in concentrated acid (Fig. 12). The higher nickel content of this alloy versus the 20-type alloys offers slightly improved corrosion resistance at high temperatures in low and high concentrations of  $H_2SO_4$ .

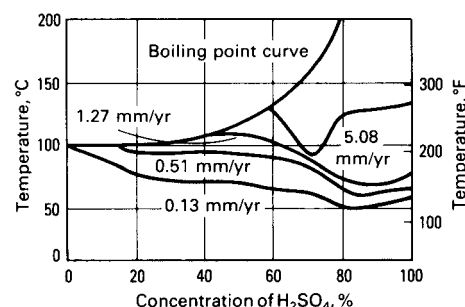
Fig. 13 Isocorrosion diagram for alloy G in  $H_2SO_4$ . Source: Ref 15

with the same general corrosion resistance. It was modified to resist formation of grain-boundary precipitates during prolonged heating, such as stress relief. These alloys are promoted for their resistance to halide-contaminated  $H_2SO_4$  environments. Figures 13 and 14 show isocorrosion diagrams for alloy G.

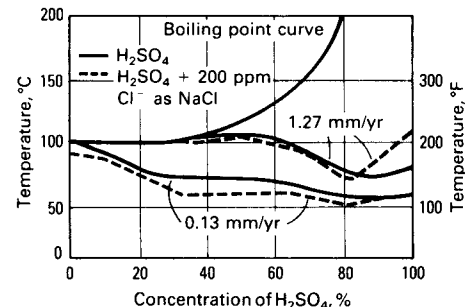
Fig. 14 Isocorrosion diagram for alloy G in  $H_2SO_4$  solutions contaminated with  $Cl^-$  ion. Source: Ref 15

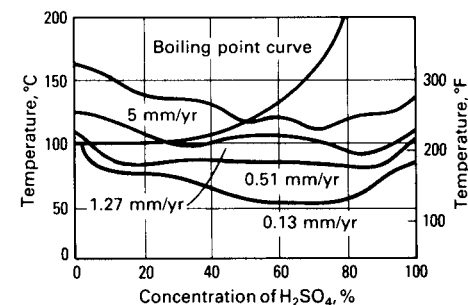
Fig. 15 Isocorrosion diagram for alloy C-276 in  $H_2SO_4$ . Source: Ref 15

**Nickel-Base Molybdenum-Chromium Alloys.** The nickel-base "C" alloys, containing about 16% Mo and 16 to 22% Cr are available in wrought (alloy C-276) (UNS N10276) and cast forms (ASTM A494, grades CW-12MW, CW-6M, CW-2M, CX2MW). In general, the corrosion resistance is excellent (Fig. 15, 16). At room temperature, the corrosion rate for all concentrations is less than 0.1 mm/yr (4.0 mils/yr). Other wrought alloys in the "C" family with similar resistance are N06686, N06059, and N06022. Because of the higher chromium content, these "C" alloys are more resistant to  $H_2SO_4$  containing oxidizing contaminants than alloy 400 or the "B" alloys. Another material in this group, with about 9% Mo, is alloy 625 (Fig. 17) (Ref 30).

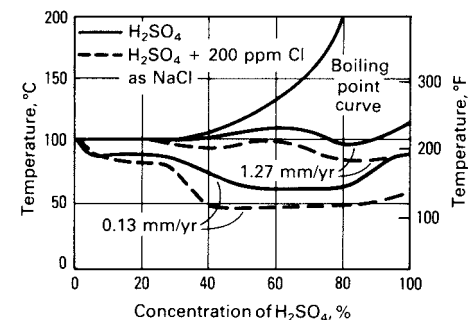
Fig. 16 Isocorrosion diagram for alloy C-276 in  $H_2SO_4$  and in  $H_2SO_4$  contaminated with  $Cl^-$  ion. Source: Ref 15

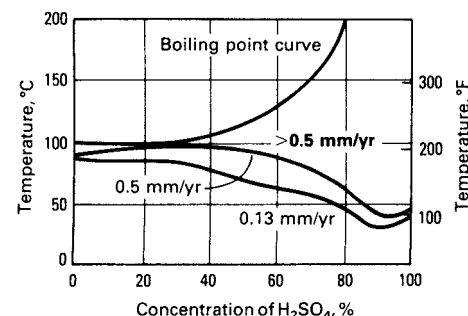
Fig. 17 Isocorrosion diagram for alloy 625 in  $H_2SO_4$ . Source: Ref 30

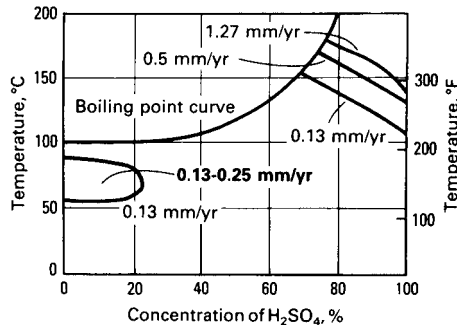
Fig. 18 Isocorrosion diagram for alloy B-2 in H<sub>2</sub>SO<sub>4</sub>. Source: Ref 15

**Nickel-Base Molybdenum Alloys.** The “B” alloys contain about 28% Mo and 1% Cr and are available in the cast and wrought forms. The corrosion resistance of these alloys is excellent in pure H<sub>2</sub>SO<sub>4</sub> over a wide range of temperatures and concentrations. However, oxidizing contaminants, such as Fe<sup>3+</sup> ions, increase corrosion rates considerably and have caused premature failure. Chlorides also increase corrosion rates. Alloys B-2 (N10665) and B-3 (N10675) are the wrought materials in this alloy group (Fig. 18). The cast version with similar corrosion resistance is ASTM A494, grade N-12MV.

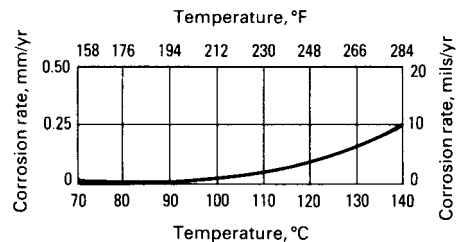
Fig. 20 Corrosion of alloy 55 in 98% H<sub>2</sub>SO<sub>4</sub>. Source: Ref 15

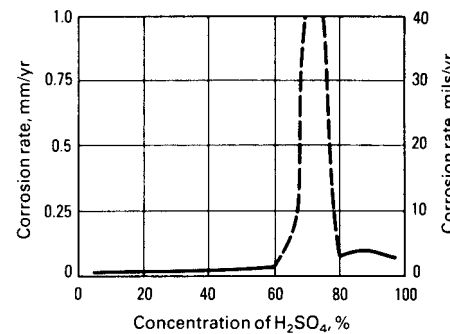
Fig. 21 Corrosion rates of alloy 66 in H<sub>2</sub>SO<sub>4</sub> solutions of 100 °C (212 °F). Source: Ref 15

resistance in the 0 to 60% and 80 to 99% ranges, but performance is erratic in the 60 to 80% range (Fig. 21) for alloy 66.

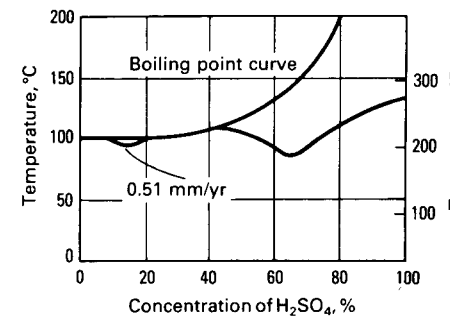
Fig. 22 Isocorrosion diagram for Illium B in H<sub>2</sub>SO<sub>4</sub>. Source: Ref 15

**Nickel-base Cr-Mo-Cu alloys** are proprietary alloys designed to resist H<sub>2</sub>SO<sub>4</sub> concentrations to 98% at temperatures to 100 °C (212 °F). Illium 98 is a weldable, machinable cast alloy. Illium B, also a cast alloy, is a version of 98 that has been modified for enhanced corrosion resistance; however, Illium B is not easily welded (Fig. 22).

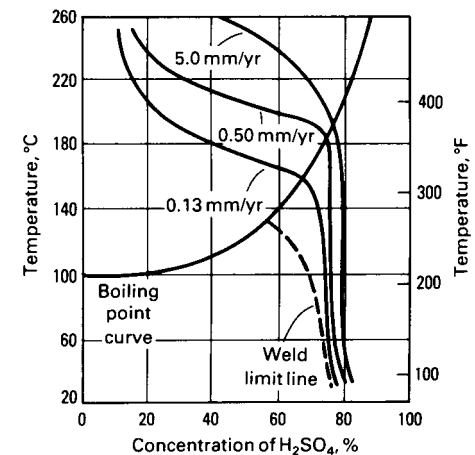
Fig. 23 Corrosion of zirconium by H<sub>2</sub>SO<sub>4</sub> as a function of temperature and acid concentration. Source: Ref 33, 34

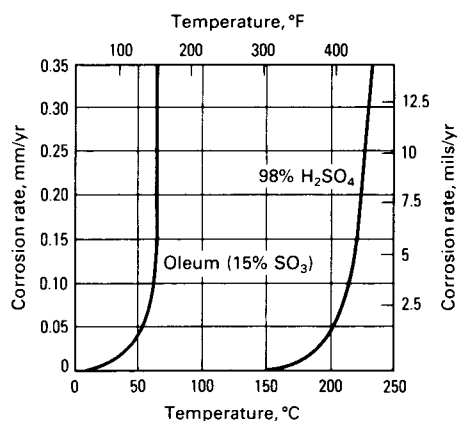
Fig. 24 Corrosion of tantalum in 98% H<sub>2</sub>SO<sub>4</sub> and in oleum

**Tantalum and Ta-2.5W alloys** have resistance to H<sub>2</sub>SO<sub>4</sub> over the entire range of concentration and temperature except for very strong and exceptionally hot conditions. Figure 24 shows the corrosion rates of tantalum in 98% acid and oleum. A common use is for reboilers used for the concentration of H<sub>2</sub>SO<sub>4</sub> in the 70% concentration range. Recent long-term testing has shown that the Ta-2.5W alloy performs at least as well as unalloyed tantalum in hot concentrated sulfuric acid service. In addition, the Ta-2.5W alloy shows clear superiority in hot concentrated acid containing oxidizing impurities such as nitrates (Ref 37, 38).

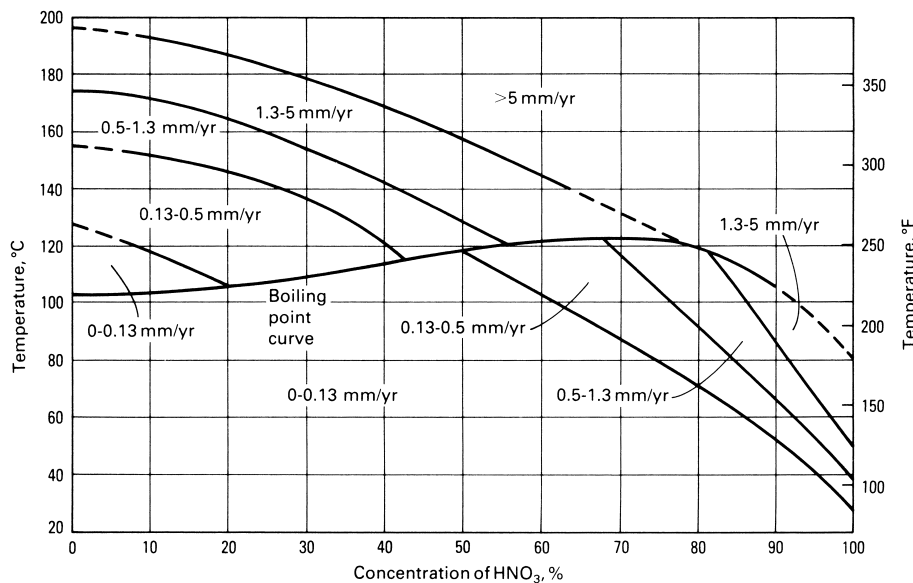
**Fig. 1** Isocorrosion diagram for annealed type 304 stainless steel in HNO<sub>3</sub>. Source: Ref 3

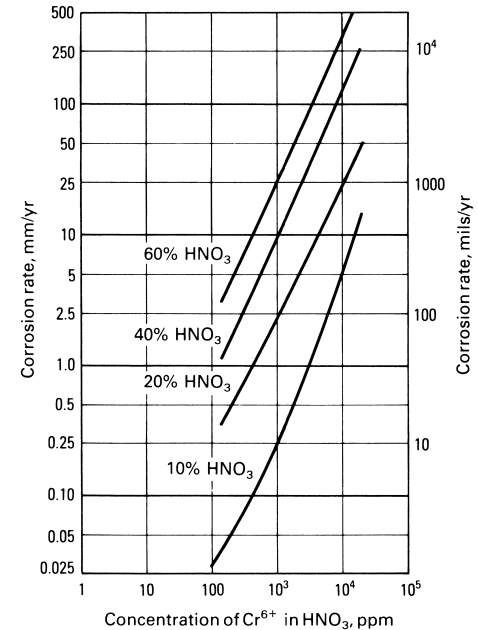
**Fig. 2** Effect of hexavalent Cr<sup>6+</sup> contamination on the corrosion rate of type 304 stainless steel in HNO<sub>3</sub>. Source: Ref 4

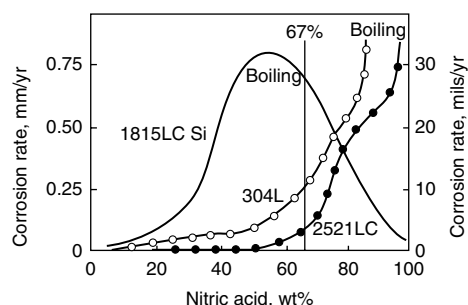
**Fig. 3** Corrosion rates of 304L, 310L (2521LC), and A610 (1815LC Si) in boiling  $\text{HNO}_3$ . Source: Ref 5

The other alloying element that improves the corrosion resistance of stainless steels in  $\text{HNO}_3$  environments is silicon. With levels above 2% Si in the alloy, a thick silica layer forms on top of the normal chromium oxide film present on stainless steels. The two most common austenitic stainless steel alloys containing silicon are A610 (UNS S30600), which contains nominally 18% Cr, 15% Ni, and 4% Si, and A611 (UNS S30601), which contains nominally 18% Cr, 17% Ni, and 5.3% Si. Both these alloys have excellent resistance to highly concentrated  $\text{HNO}_3$ ; however, they are less corrosion resistant than types 304L and 310L at lower concentration. Figure 3 shows the corrosion rate of 304L, 310L (2521LC), and A610 (1815LC Si) in boiling  $\text{HNO}_3$  (Ref 5).

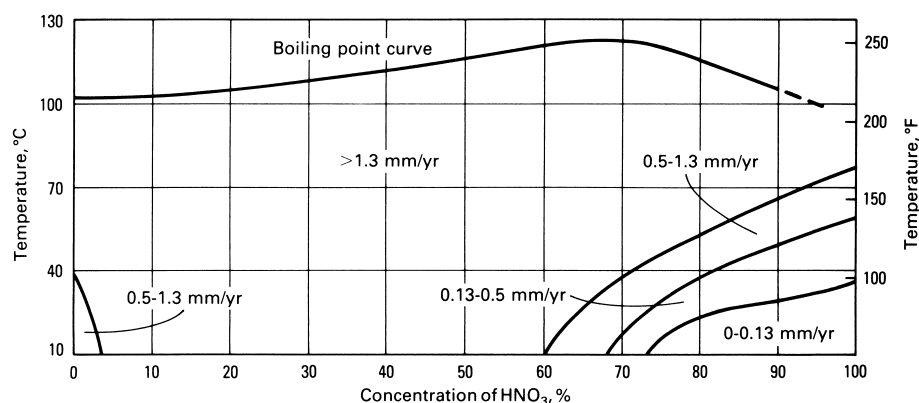
Fig. 4 Isocorrosion diagram for aluminum alloy A91100 in HNO<sub>3</sub>. Source: Ref 3

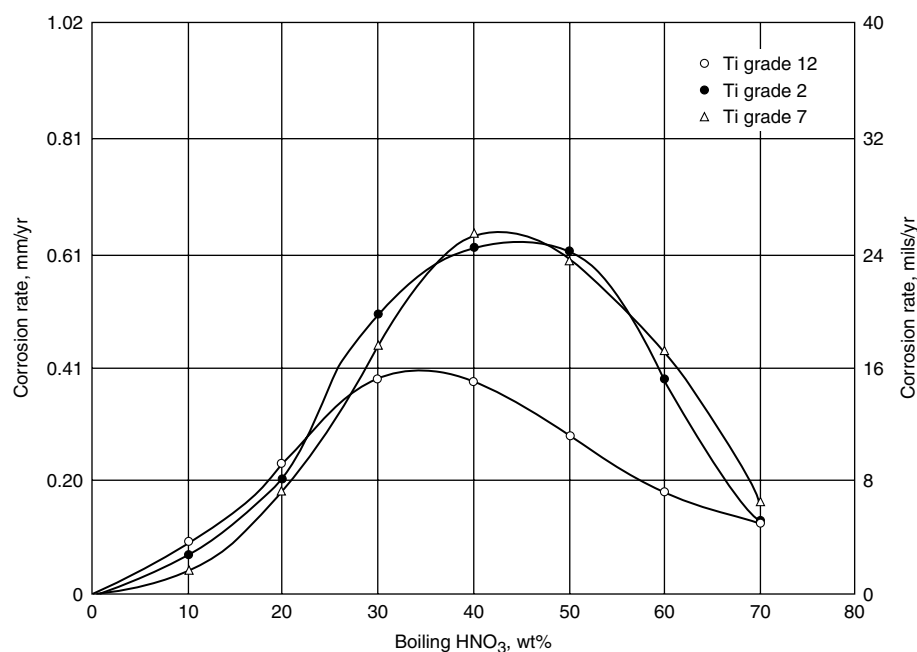
Fig. 5 Corrosion of titanium alloys in boiling HNO<sub>3</sub>. Acid solutions were refreshed every 24 h. Source: Ref 7

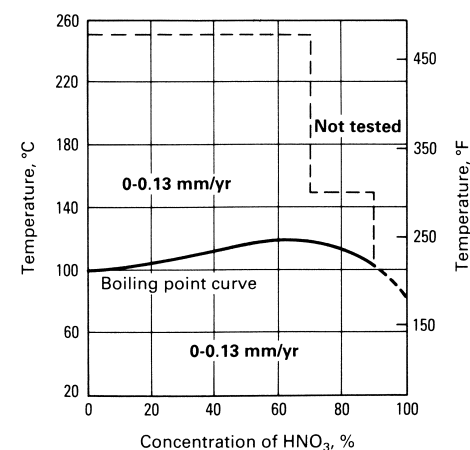
Fig. 6 Isocorrosion curve for zirconium in HNO<sub>3</sub>. Source: Ref 8

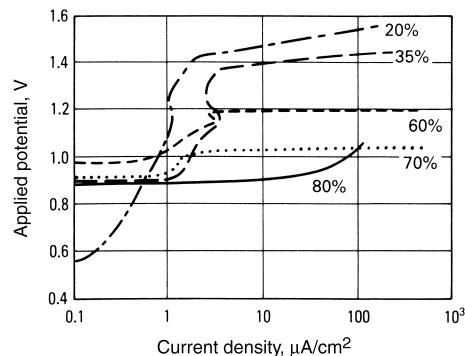
**Fig. 7** Anodic polarization curves for unalloyed zirconium in near-boiling  $\text{HNO}_3$  as a function of concentration (wt%). Applied potential is given in volts versus the saturated calomel electrode (SCE). Source: Ref 8

The polarization curves of zirconium in  $\text{HNO}_3$  are shown in Fig. 7. Zirconium has the passive-to-active transition similar to that which occurs in  $\text{H}_2\text{SO}_4$ . However, corrosion potentials are very noble because of the oxidizing nature of  $\text{HNO}_3$ . Stress-corrosion cracking occurs in zirconium when it is above the transition region between passivity and transpassivity (Ref 12, 13). The relationship between  $\text{HNO}_3$  concentration, potential, and susceptibility to SCC is shown in Fig. 8 (Ref 1, 14). The addition of titanium to zirconium increases the transition potential and thus resistance to SCC. Stress-corrosion cracking of zirconium equipment can be reduced by a stress-relieving treatment.

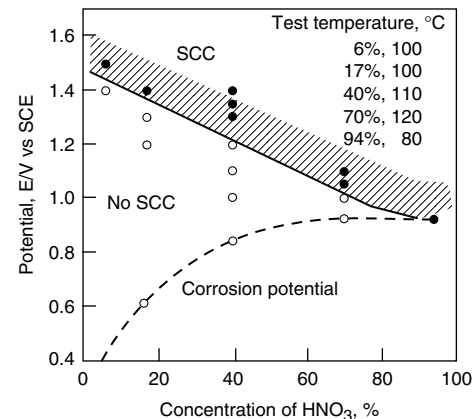
**Fig. 8** Relationship between potential and  $\text{HNO}_3$  concentration on the susceptibility of zirconium to SCC. Source: Ref 14

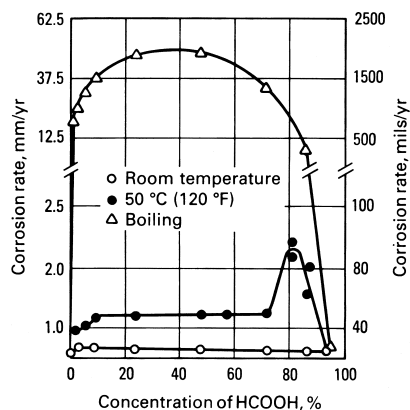
Fig. 2 Rate of corrosion for 1100-H14 (A91100) aluminum in aqueous reagent grade formic acid

(Fig. 2). Although pure aluminum and pure formic acid of all concentrations appears to be compatible from a corrosion viewpoint, the contamination of the acid by various impurities, such as heavy metal salts, limits the use of aluminum to shipment and storage of formic acid with a concentration greater than 95% (Ref 5).

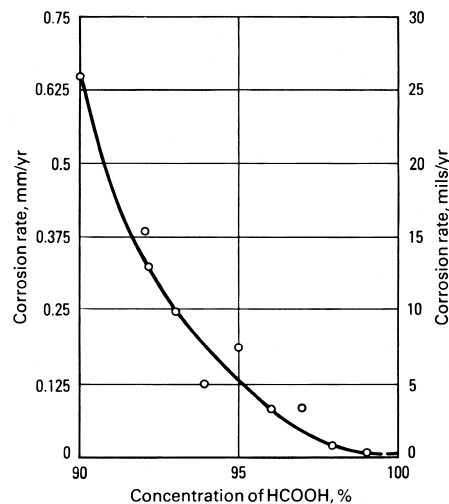
Fig. 3 Corrosion of 5086 (A95086) aluminum in formic acid at 45 °C (115 °F)

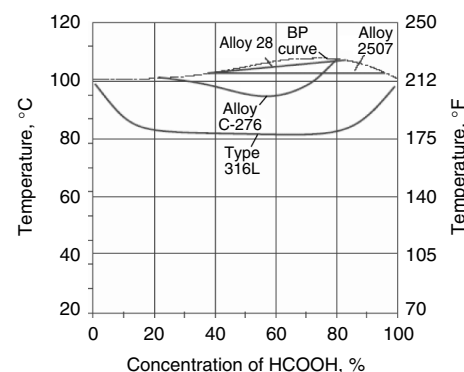
**Fig. 4** Isocorrosion diagram at 0.1 mm/yr (4 mils/yr) in formic acid for S32750 (alloy 2507), N08028 (alloy 28), N10276 (alloy C-276) and S31603 (type 316L) stainless steel. BP curve, boiling point curve

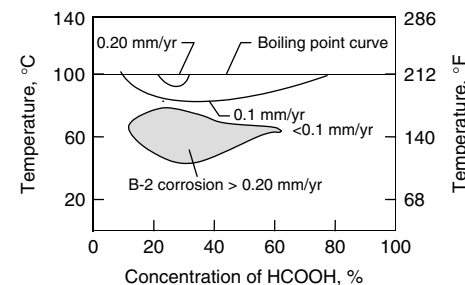
**Fig. 5** Isocorrosion curves for alloys B-2 and C-276 in formic acid. In the gray shaded area, alloy B-2 corrodes at rates that exceed 0.2 mm/yr (8 mils/yr). In all other areas, the rate for alloy B-2 is lower. Alloy C-276 data are shown unshaded.

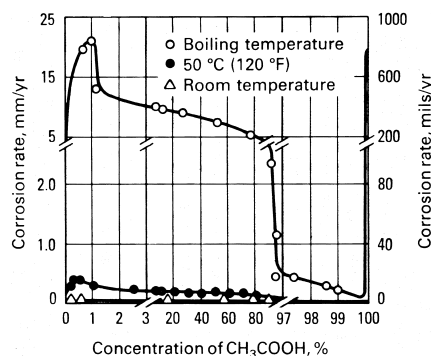
**Fig. 6** Effect of concentration and temperature on corrosion of 1100-H14 (A91100) aluminum alloy in acetic acid

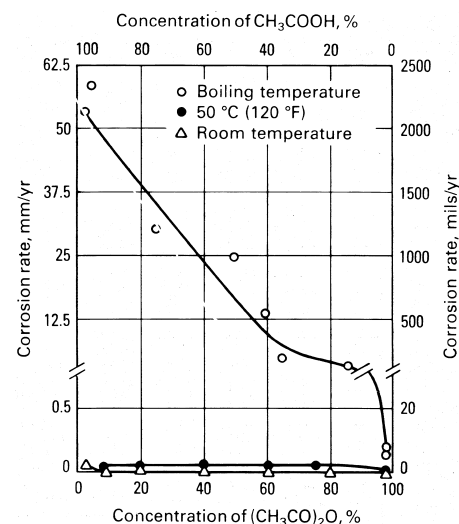
**Fig. 7** Metal loss for 1100-H14 (A91100) aluminum alloy in acetic-acid/acetic-anhydride solutions at atmospheric boiling temperature

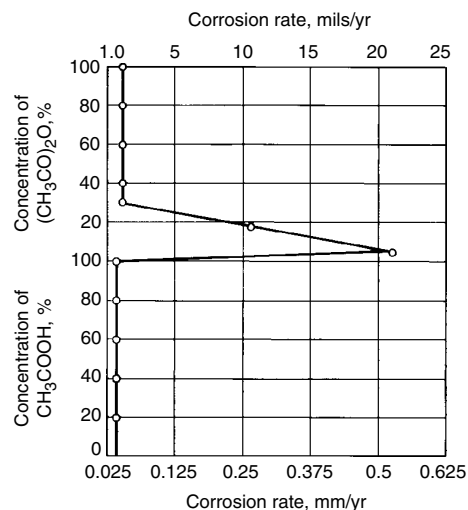
Fig. 8 Laboratory corrosion rates of type 316 stainless steel (S31600) in acetic-acid/acetic-anhydride mixtures

The old acetaldehyde oxidation process for manufacturing acetic acid also produced acetic anhydride as a coproduct, and it is often found in acetic acid streams. If acetic acid contains only small quantities of acetic anhydride or if the acid is truly anhydrous, the rate of attack on type 316L is very high. The introduction of just a few tenths percent of water will reduce the corrosion back to normal rates. Figure 8 illustrates the reduction in corrosion rate as more acetic anhydride is added.

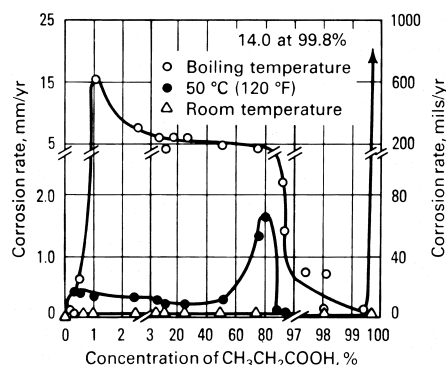
**Fig. 9** Resistance to corrosion of 1100-H14 (A91100) aluminum alloy in propionic acid solutions at various temperatures

**Aluminum** will resist 100% propionic acid at room temperature, but becomes unacceptable at about 80 °C (175 °F). The corrosion diagram displayed in Fig. 9 shows that the attack is very similar to that in acetic acid (Ref 4). Like acetic acid, if the propionic acid is contaminated with anhydride or heavy metal ions, high rates are possible.

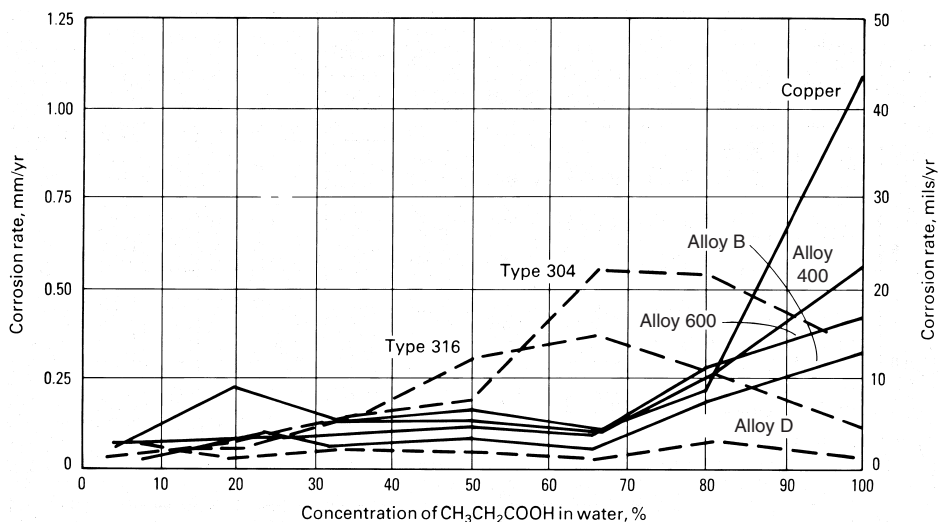
**Fig. 10** Corrosion of metals in boiling propionic acid

**Copper and copper alloys** containing not more than 15% Zn will handle propionic acid in all concentrations. The data shown in Fig. 10 indicate attack on copper in boiling 100% propionic acid, but this is believed to be an anomaly caused by incomplete deaeration of the solution since propionic acid has been routinely handled in copper-lined equipment. As with formic and acetic acid, copper and its alloys are satisfactory only if the solutions are completely deaerated and do not contain other oxidizing agents (Ref 1).

Figure 10 shows the resistance of various materials, including type 316 stainless, to boiling propionic acid solutions. These were short-term tests in which the gaseous atmosphere above the boiling solutions was not controlled. It is likely that this resulted in two erroneous results (Ref 1). The rate of copper corrosion was found to increase rapidly above 65% concentration but copper would have very low corrosion rates at all concentrations if the atmosphere above the solution was oxygen free. Secondly, type 304 stainless steel was shown to have decreasing corrosion rates between 80 and 100% concentration which is not borne out by field experience. Field experience shows that type

Type 316L stainless steel and the molybdenum-containing duplex stainless steels, such as alloy 2205, are the preferred material for handling hot concentrated solutions of propionic acid. The low-carbon grades should be utilized to avoid possible intergranular attack. They are quite suitable for all ranges of concentration, noting that oxidizing conditions are beneficial and that the rate can be somewhat high around 65% concentration as shown in Fig. 10 (Ref 21).

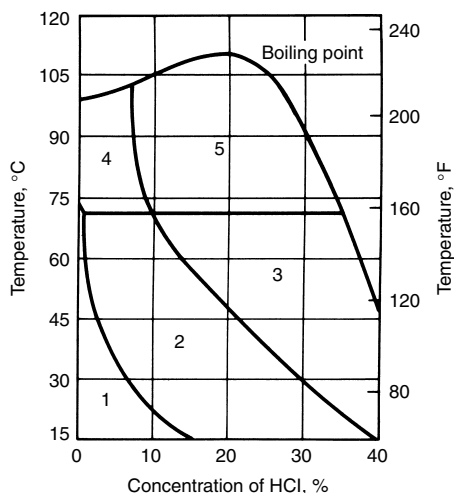
**Fig. 1** Metals with reported corrosion rates <0.5 mm/yr (<20 mils/yr) in HCl. Source: Ref 3

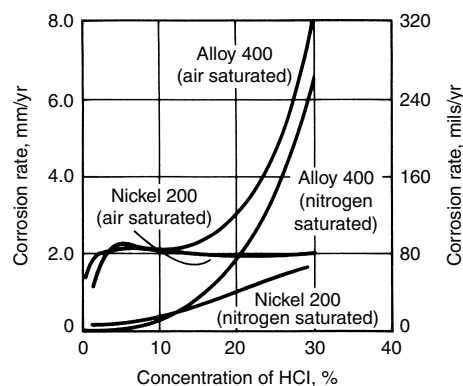
**Fig. 2** Corrosion of Nickel 200 and alloy 400 in HCl solutions at 30 °C (85 °F). Source: Ref 5

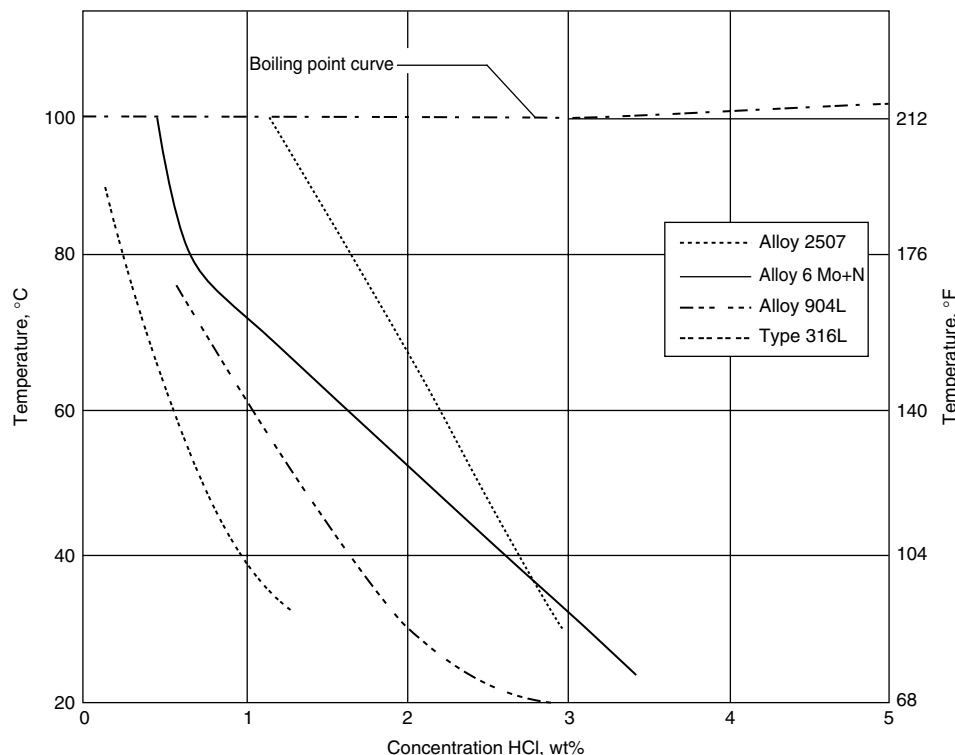
**Fig. 3** Hydrochloric acid isocorrosion diagram of 0.1 mm/yr (4 mils/yr) comparing common stainless steels. Source: Ref 9

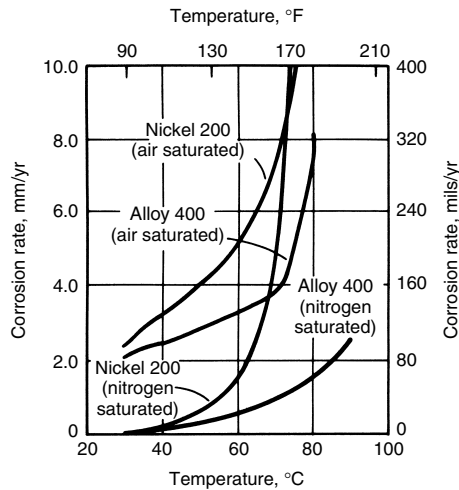
Fig. 4 Effect of temperature on the corrosion of Nickel 200 and alloy 400 in 5% HCl. Source: Ref 5

400 in 5% HCl (Fig. 4). When HCl is formed by hydrolysis of chlorinated hydrocarbons, acid concentrations are often less than 0.5%. Under these conditions, Nickel 200 and alloy 400 have found application at temperatures below 200 °C (390 °F) (Ref 5).

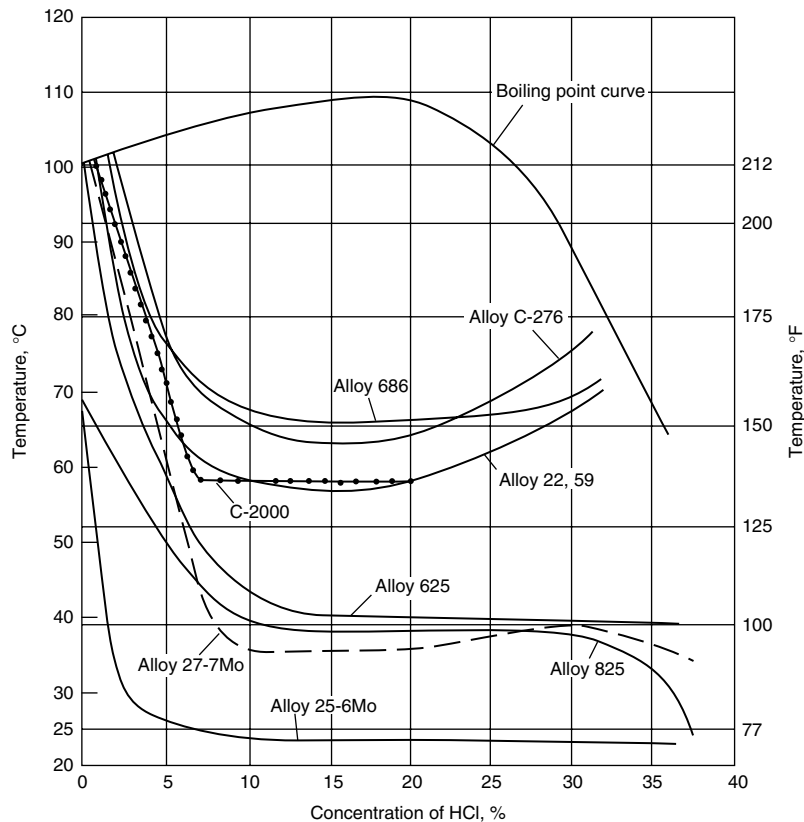
Fig. 5 Comparative behavior of nickel-base alloys in HCl. The isocorrosion lines indicate a corrosion rate of 0.51 mm/yr (20 mils/yr). Source: Ref 11

Many nickel alloys containing chromium and molybdenum have useful resistance to HCl in all concentrations up to approximately, 65 °C (150 °F) and in very dilute acid up to the boiling point (Fig. 5). Corrosion resistance increases with molybdenum content. The most resistant of these alloys, such as alloy C-276 (UNS N10276), also contain tungsten. The materials shown in Fig. 5 are useful for handling hot concentrated HCl, while the other materials discussed previously can only be relied on to resist minor HCl contamination in other chemical processes. These nickel-base, chromium- and molybdenum-containing alloys are also very resistant to chloride SCC. Resistance to pitting and crevice corrosion in acid chloride solutions improves with increasing chromium and molybdenum contents.

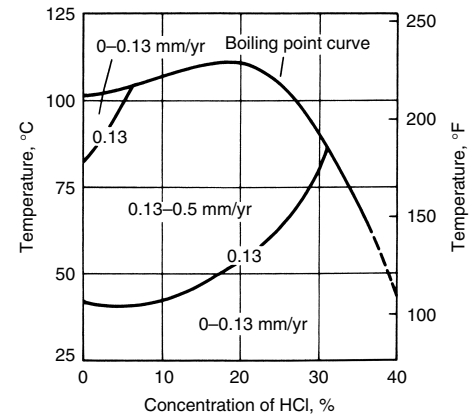
Fig. 6 Isocorrosion diagram for alloy B-2 in HCl

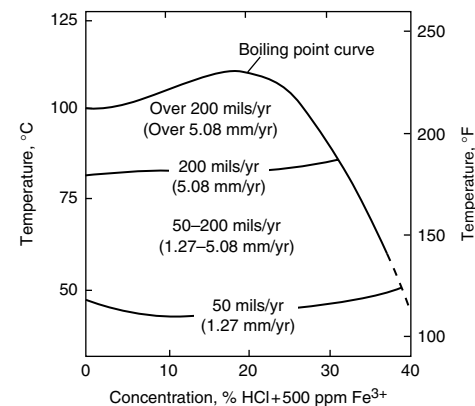
Fig. 7 Isocorrosion diagram for alloy B-2 to HCl with 500 ppm ferric ions. Source: Ref 12

However, small amounts of oxidizers, such as ferric ion, can destroy passivity of alloy B-2 and lead to high corrosion rates (Fig. 7). The presence of approximately 21% Cr in other high-molybdenum alloys, such as alloys C-22 (UNS N06022, 59Ni-21Cr-13Mo-3W-4Fe), 686 (UNS N06686, 59Ni-21Cr-16Mo-3.8W), and 59 (UNS N06059, 59Ni-23Cr-15Mo), promotes passivation in the presence of ferric ion contamination and leads to improved corrosion resistance (Fig. 8).

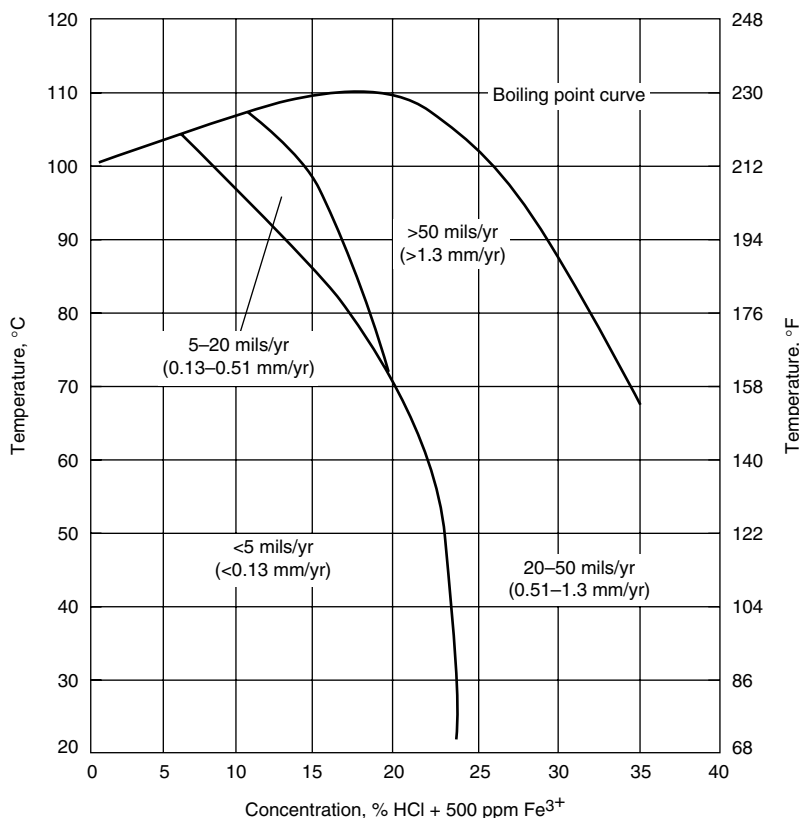
Fig. 8 Isocorrosion diagram for alloy 686 in HCl with 500 ppm ferric ions. Source: Ref 11

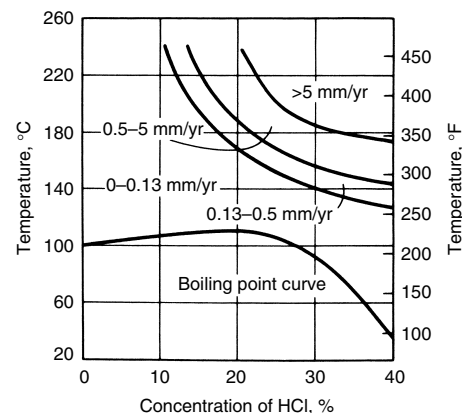
Fig. 9 Isocorrosion diagram for zirconium in HCl solutions. Source: Ref 13

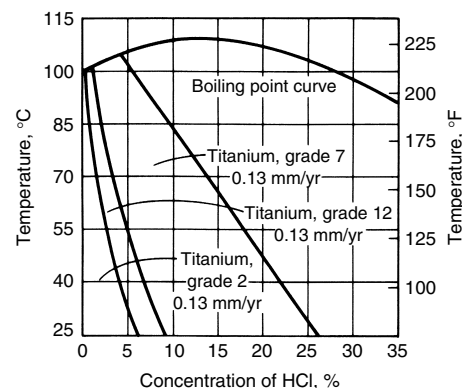
Fig. 10 Isocorrosion diagram for titanium in naturally aerated HCl solutions. Source: Ref 5

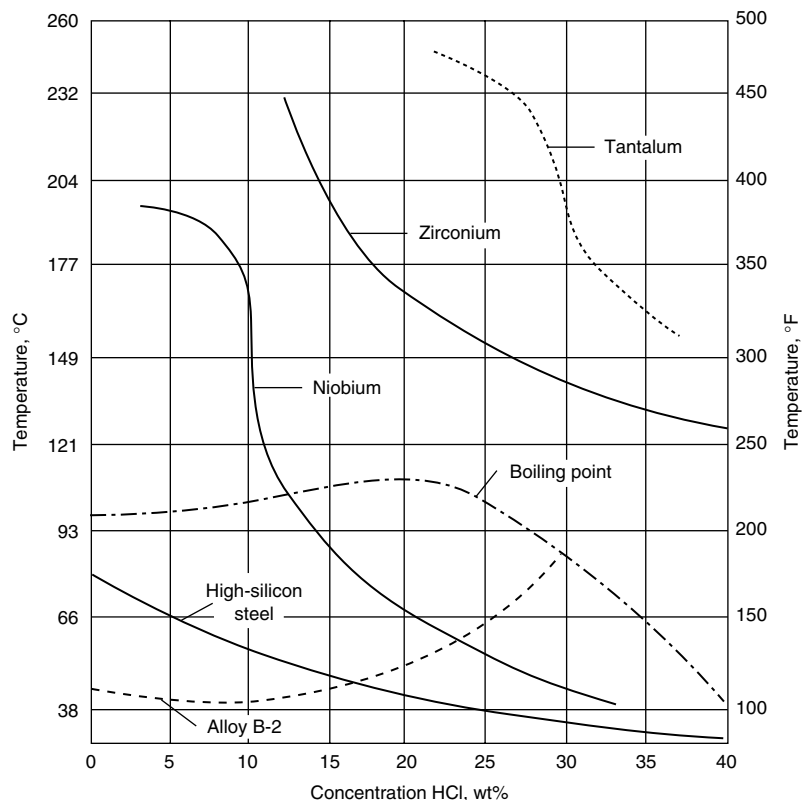
**Fig. 11** Hydrochloric acid isocorrosion diagram of 0.13 mm/yr (5 mils/yr) comparing tantalum, zirconium, niobium, high-silicon steel, and alloy B-2. Source: Ref 15

A comparison of reactive metals is made in Fig. 11. Nickel-molybdenum alloy B-2 and high-silicon steel, at the bottom of the figure, form a baseline for comparison. At temperatures above the HCl boiling point, tantalum and zirconium and their alloys and, in some cases, niobium are among the few metals or alloys that are resistant to attack.

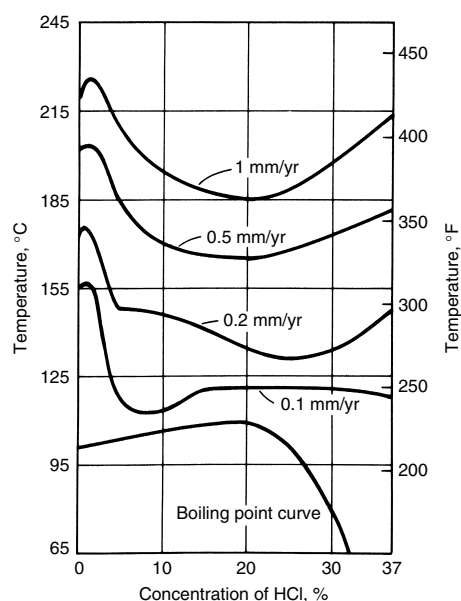
**Fig. 12** Isocorrosion diagram for Glaesteel 5000 in HCl. Source: Ref 28

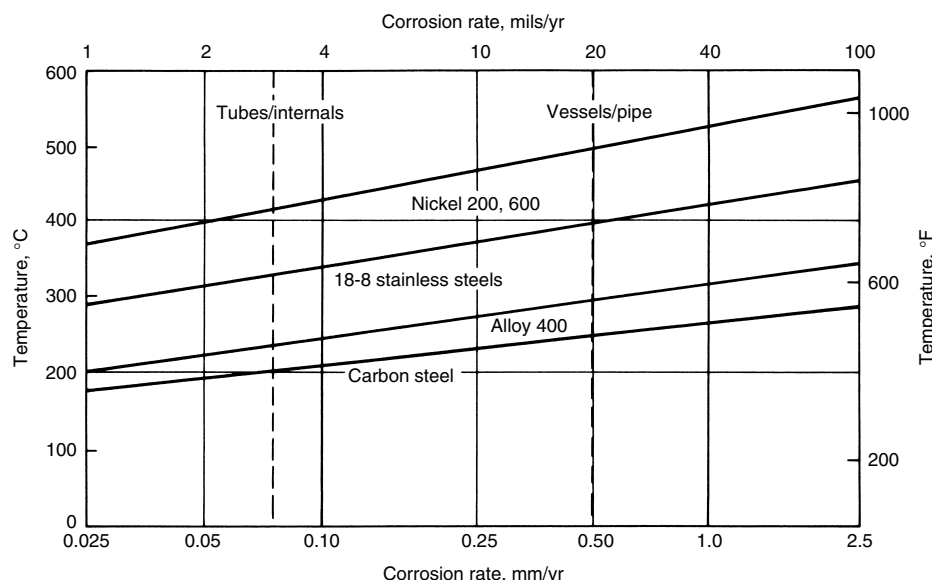
Fig. 13 Maximum temperature limits for various alloys in HCl service. Source: Ref 34

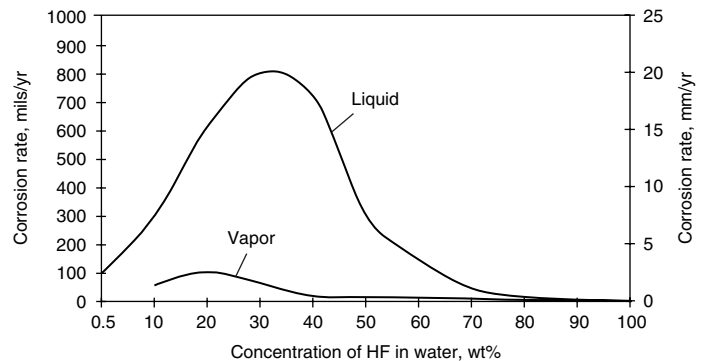
**Fig. 2** Carbon steel corrosion in hydrofluoric acid (HF) liquid and vapor at 38 °C (100 °F). These data represent corrosion rates on carbon steel in HF that is free of contamination and at low- or no-flow conditions. Rates shown for 70 to 100% HF combine laboratory and service experience data. Service experience data reflect ambient temperatures of 21 to 38 °C (70 to 100 °F). Source: Ref 7

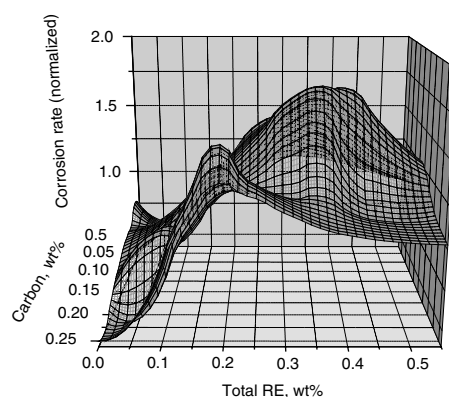
**Fig. 3** Three-dimensional graph showing trends with respect to composition of carbon and residual elements (RE) in steels. The lowest corrosion rates were observed when carbon > 0.18% and Σ<sub>RE</sub> = 0.1%. Source: Ref 12

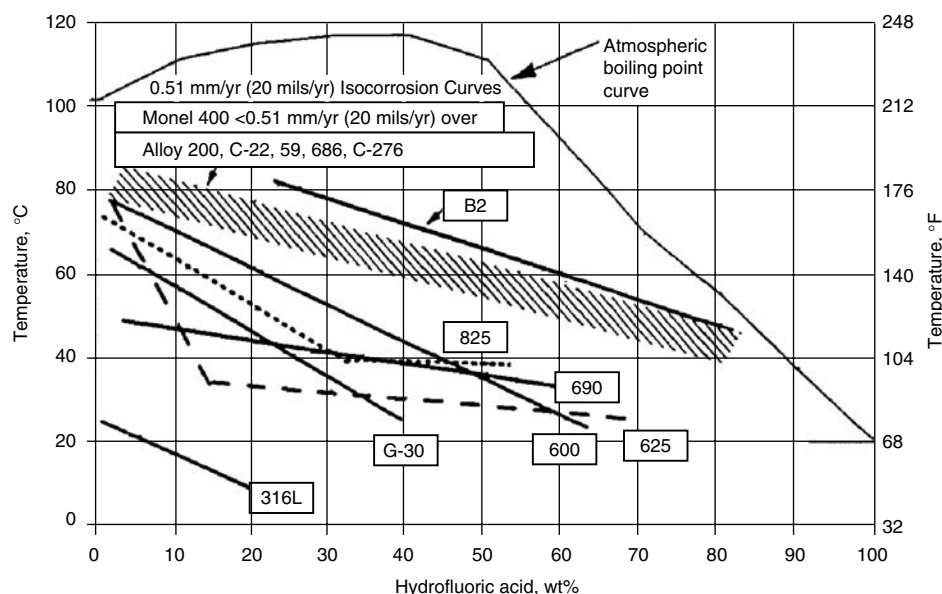
**Fig. 4** Isocorrosion diagrams for various nickel-base alloys and 316L stainless steel in hydrofluoric acid liquid. Source: Ref 22

In HF service, nickel-rich (nickel > 30%) austenitic stainless steels with chromium, molybdenum, and copper, such as alloys G3 (N06985), G30 (N06030), CN-7M (N08007), 20 (N08020), and 825 (N08825), have better resistance than other austenitic stainless steels but only over a slightly greater range of concentration and temperature, as indicated in Fig. 1. These alloys have good resistance to all liquid concentrations of HF at ambient temperatures and up to 10% HF at 70 °C (160 °F) (Ref 8). Corrosion data for alloys 20 and 825 in 1 and 10% HF are presented in Table 4. Also, data for alloy 825 are presented in Tables 5 and 6. The isocorrosion diagram (Fig. 4) includes data on alloys 825 and G30.

**Temperature.** Increasing temperature generally increases corrosion of nickel alloys in HF liquid and vapor (Tables 4, 5, 7, and 9). Figure 4

indicates that in liquid HF, only alloy 400 (UNS N04400) has acceptable corrosion at higher temperatures, while other nickel alloys are limited to lower concentrations with increasing temperature. Figure 6 presents corrosion data on alloys 400 and C2000 (UNS N06200) in 20% HF liquid and vapor over a range of 38 to 93 °C (100 to 200 °F) (Ref 20). One of the conclusions from this study was that nickel alloys containing high chromium and exposed in HF vapors had decreased corrosion rates with time, but when immersed, the corrosion rates were not dependent on time. The corrosion rates for alloys 400 and C2000 increased with HF concentration and temperature. Table 9 presents data from this same study for alloys 400, C276 (UNS N10276),

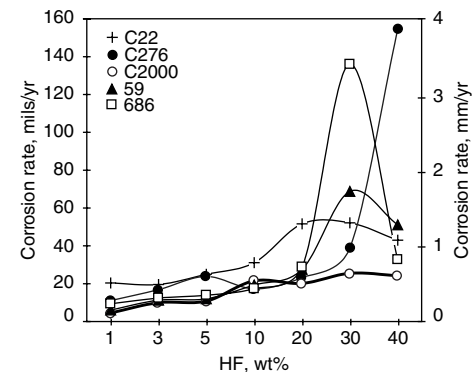
**Fig. 5** Corrosion rates for various nickel alloys in 1 to 40% hydrofluoric acid (HF) at 79 °C (175 °F) for 24 h. Rates increase with HF concentration up to 20% HF, then corrosion behavior diverges. The x-axis is nonlinear. Source: Ref 20

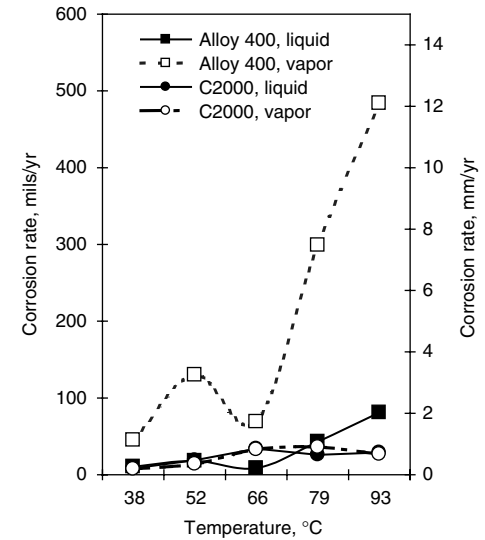
**Fig. 6** Corrosion rates for alloys 400 and C2000 in 20% hydrofluoric acid liquid and vapors, 38 to 93 °C (100 to 200 °F), 240 h, showing comparable liquid rates but diverging vapor rates. Source: Ref 20

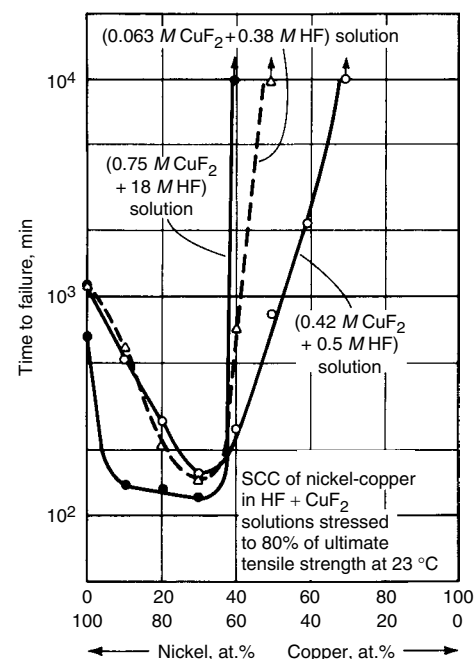
**Fig. 7** Relationship of time for stress-corrosion cracking (SCC) failure for various nickel-copper alloys exposed to hydrofluoric acid (HF) and CuF<sub>2</sub> solutions while stressed at 80% ultimate tensile strength. Source: Ref 32

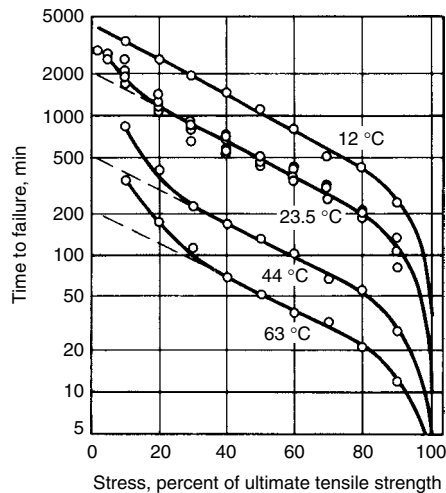
**Fig. 8** Relationship of time for stress-corrosion cracking failure in a hydrofluoric acid and CuF<sub>2</sub> solution versus stress at various temperatures on alloy 400. Source: Ref 32
