# ASM Handbook®

## Volume 13C Corrosion: Environments and Industries

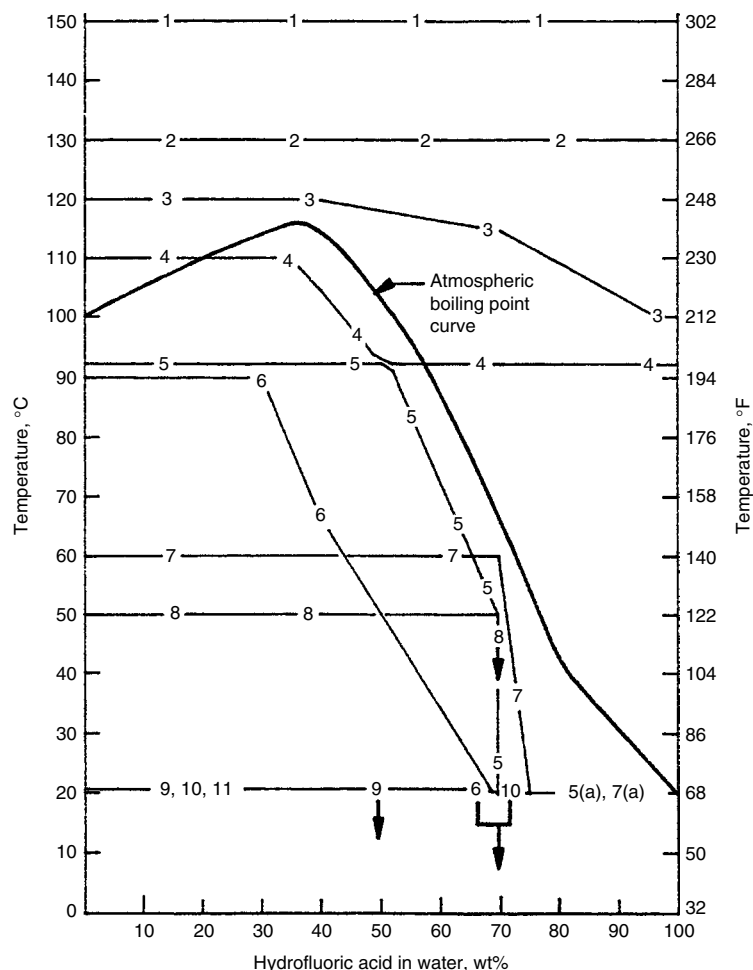
**Fig. 9** Guidance for use of plastics and elastomers in hydrofluoric acid (HF). Regions below and left of lines are suitable in uncontaminated HF. The down arrows (1) are the upper limit of acid concentration for the material. (a) Vapor only. Materials: 1, PTFE, perfluoroalkoxy (PFA); 2, fluorinated ethylene propylene (FEP); 3, ethylene tetrafluoroethylene (ETFE); 4, polyvinylidene fluoride (PVDF); 5, polypropylene; 6, chlorobutyl, bromobutyl, ethylene chlorotrifluoroethylene (ECTFE); 7, cross-linked, high-density, low-density, or copolymer polyethylene; 8, chlorosulfonated polyethylene; 9, soft natural rubber; 10, polychloroprene, butyl rubber, ethylene propylene diene monomer; 11, polyvinyl chloride (PVC), unplasticized. Source: Ref 3

As seen in Fig. 9, several rubber types are useful in HF concentrations below 60% at temperatures below 70 °C (160 °F). Consultation with the rubber supplier is essential to assure that available rubbers will have low silica or magnesia compounding (below 0.3 wt%) for HF service. Some rubber suppliers may be unaware that clays they use as additives contain silica and magnesia compounds. Specially formulated chlorobutyl rubber is used for lining containers for 70% HF. In 70% HF, the useful life of chlorobutyl in warm climates is approximately three years, while in cool climates it is four to six years. Longer chlorobutyl service life is experienced with lower HF concentrations. Bromobutyl rubber is used in HF service in Europe. Table 15 presents 50% HF elastomeric exposure data at 22 °C (72 °F) (Ref 46).

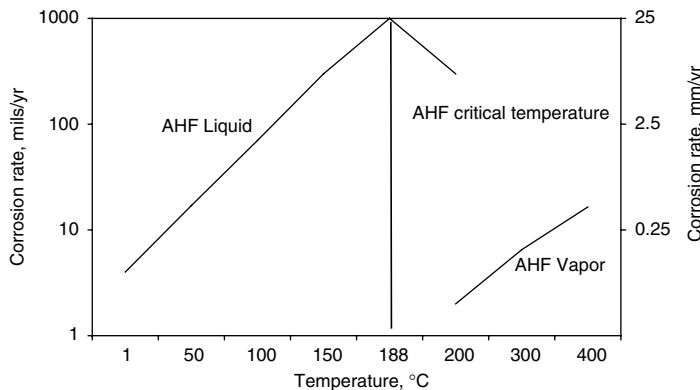
**Fig. 10** Corrosion rates of carbon steels in static anhydrous hydrogen fluoride (AHF) liquid and vapor. These data emphasize that liquid AHF is more corrosive than vapor, and that carbon steels have acceptable corrosion in static AHF at 300 °C (570 °F). The critical point occurs at 188 °C (370 °F) and 64.88 bars (941 psia). Source: Ref 53

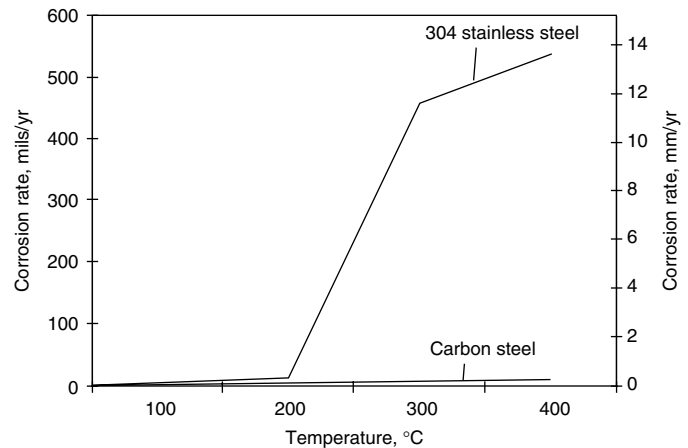
**Fig. 11** Corrosion rates for type 304 stainless steel and carbon steel in static anhydrous hydrogen fluoride vapor. Type 304 corrosion rates are erratic above 100 °C (210 °F).

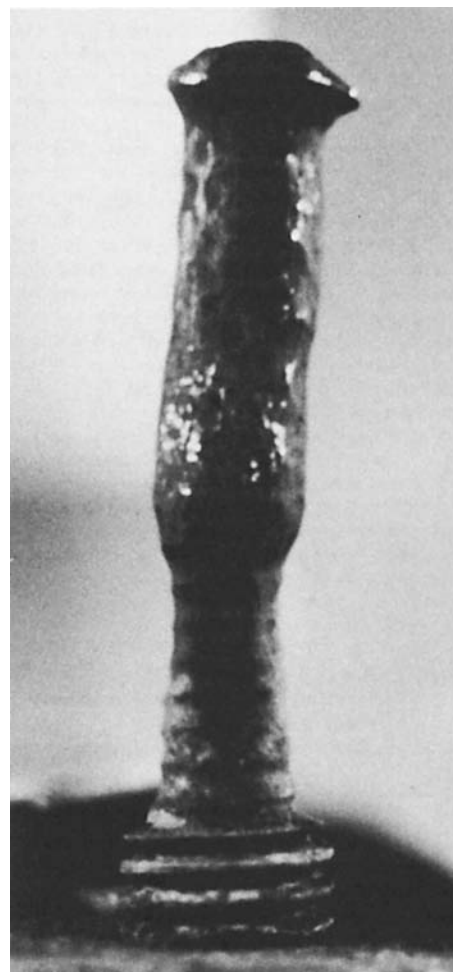
**Fig. 2** Monel 400 bonnet bolt extensively corroded by chlorine gas trapped beneath ice covering a valve in liquid chlorine service

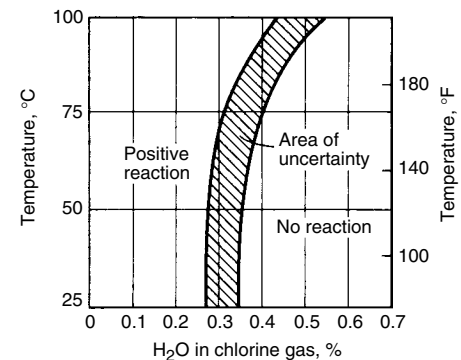
Fig. 3 Estimated water required to passivate unalloyed titanium in chlorine gas

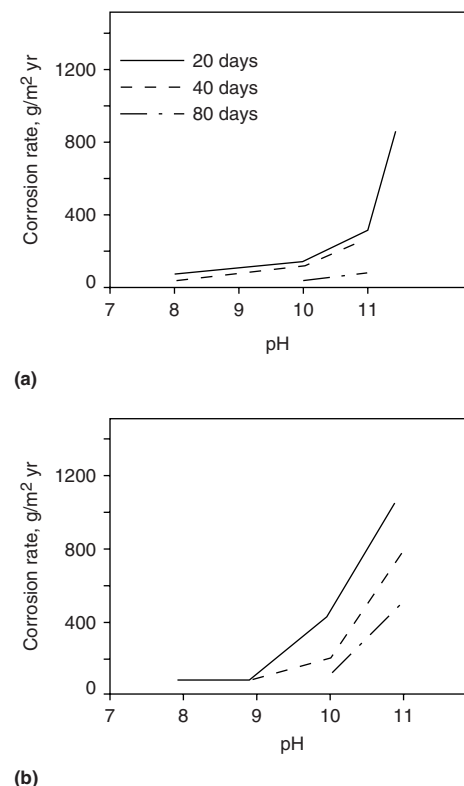
**Fig. 1** Effect of pH on the corrosion rate of aluminum in NaOH at 30 °C (85 °F) (a) and 60 °C (140 °F) (b). Source: Ref 5

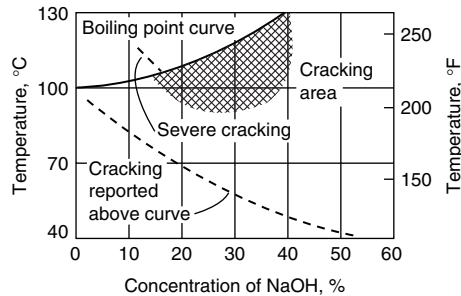
Fig. 2 Temperature and concentration of caustic soda that can cause SCC of carbon steels. Source: Ref 21

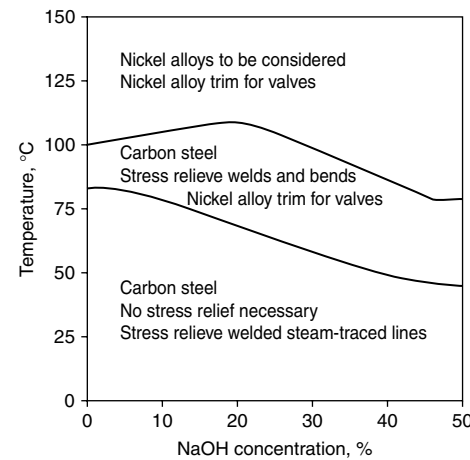
Fig. 3 Temperature and concentrations of caustic soda that require stress relief to prevent SCC of carbon steel. Source: Ref 22

Figure 3 shows the suggested regions, as defined by temperature and concentration, in which postfabrication thermal stress relief (or an alternative alloy) is recommended to avoid SCC in steels (Ref 22).

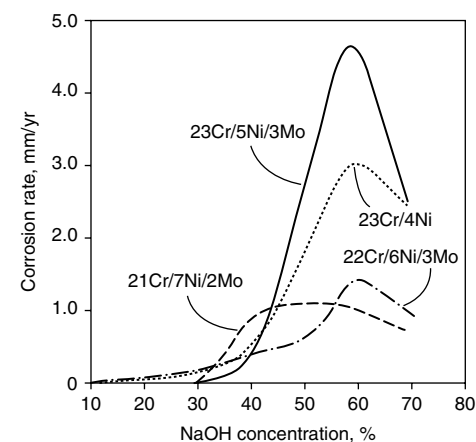
**Fig. 4** Corrosion resistance of duplex stainless steels in boiling NaOH solutions. Source: Ref 34

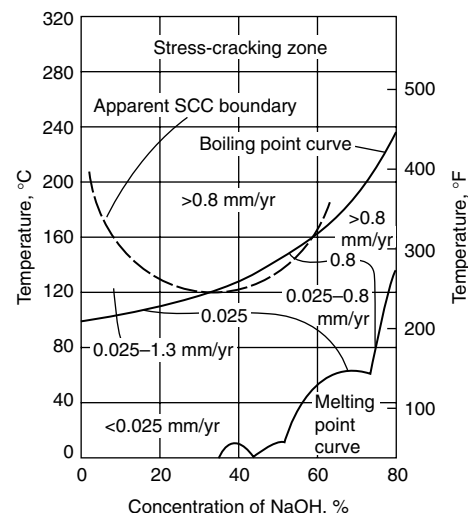
**Fig. 5** Isocorrosion curves for type 304 and 316 stainless steels in caustic soda also showing limits of SCC. Source: Ref 39

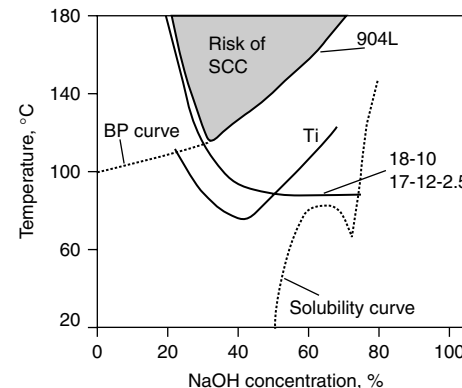
**Fig. 6** Isocorrosion curve for a corrosion rate of 0.1 mm/yr (0.4 mil/yr) for 904L (N80904), other stainless steels, and titanium. BP, boiling point; SCC, stress-corrosion cracking. Source: Ref 42

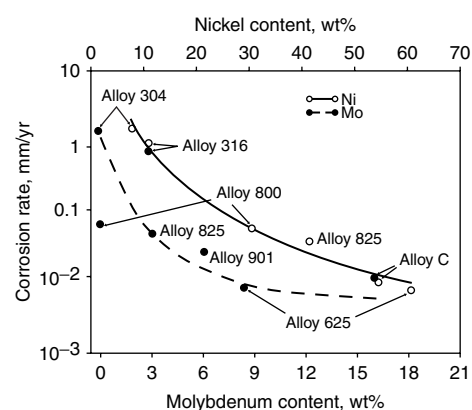
**Fig. 7** Effect of molybdenum and nickel in various alloys on corrosion rate in NaOH solutions. Source: Ref 45

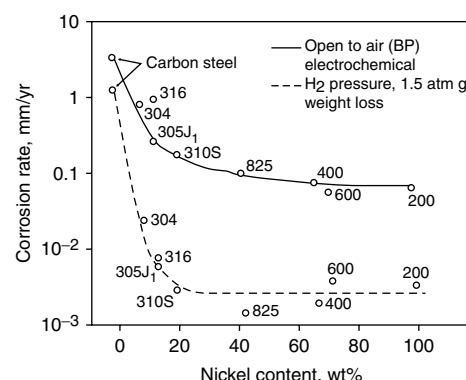
**Fig. 8** Effect of nickel content on corrosion in NaOH of various alloys with and without oxygen in the atmosphere. Source: Ref 48

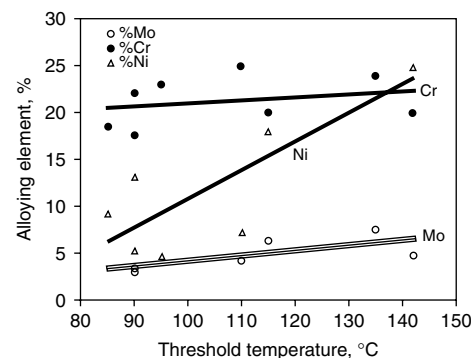
**Fig. 9** Effect of molybdenum, nickel, and chromium on the threshold temperature at which the corrosion rate exceeds 0.127 mm/yr (5 mils/yr) in 50% NaOH. Source: Ref 49

table shows the lowest temperature at which the corrosion rate exceeds 0.127 mm/yr (5 mils/yr). These same data are plotted for the three alloying elements in Fig. 9. Nickel has a strong beneficial effect on corrosion resistance while there is no apparent benefit of additional molybdenum or chromium in this environment, within the range of compositions represented by these steels.

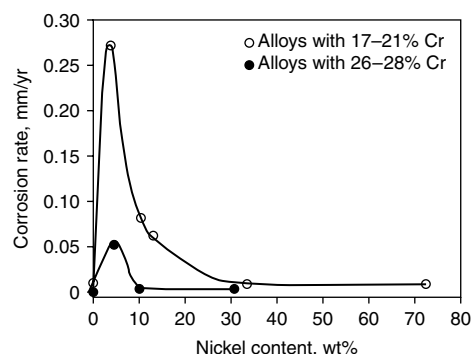
Fig. 10 The effect of nickel on the corrosion of Fe-Ni-Cr alloys in caustic soda. Source: Ref 54

The effect of nickel on the corrosion resistance of Fe-Cr-Ni alloys is shown in Fig. 10 (Ref 54). The results of tests in 28% NaOH with 8% NaCl at 99 °C (210 °F) show that nickel-free and high-nickel alloys are resistant with a maximum corrosion rate at about 5% Ni. The solid data points in this figure relate to alloy 28 (N08028) that has good resistance in this chloride-contaminated environment. This alloy has been used for the evaporation of diaphragm cell NaOH. In this application erosion by sodium chloride crystals can be a problem, and this alloy showed considerably better performance than pure nickel.

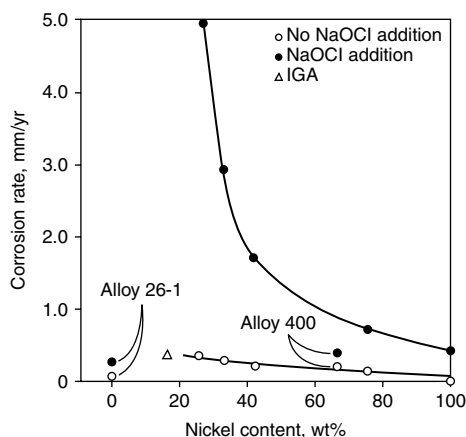
Fig. 12 Effect of nickel content on corrosion of various materials in simulated first effect liquor at 185 °C (365 °F). Source: Ref 91

Some of these data are summarized in Fig. 12, which shows that chlorates increase the corrosion of nickel and nickel alloys, although the effect is not sufficient to cause failures of nickel in evaporators without the presence of additional

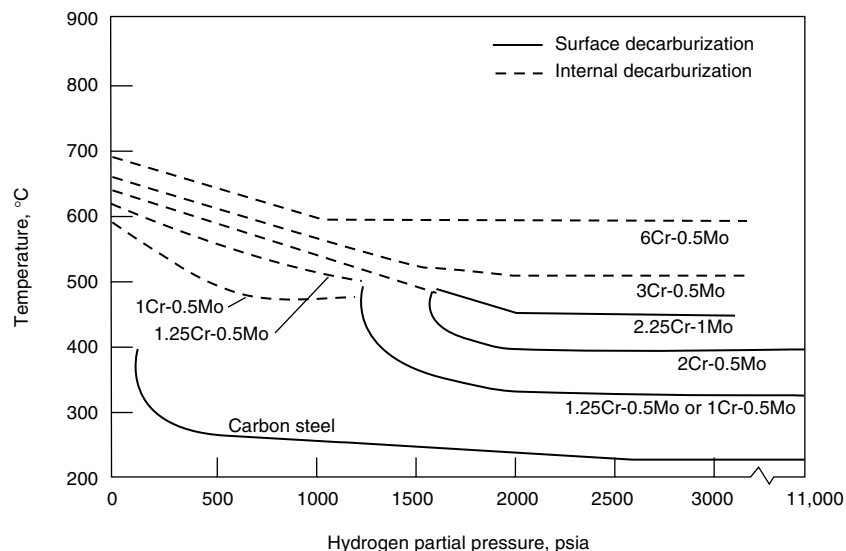
Fig. 1 Modified Nelson curve showing the operating limits for steels in hydrogen service. Source: Ref 14

7Cr-0.5Mo (S50300), and 9Cr-0.5Mo (S50400). Their use in NH<sub>3</sub> service is chiefly in NH<sub>3</sub> synthesis, the alloy selection being based on API Publication 941 (Ref 14). Old editions of this standard have curves showing the resistance of low-alloy steels, with 0.5% Mo without chromium. As mentioned previously in the section "Hydrogen Attack," service experience has shown that this alloy has little more resistance to hydrogen attack than carbon steel so the API publication was updated in 1991 to reflect this experience. Other uses for these chromium-molybdenum steels are in high-strength parts such as fasteners.

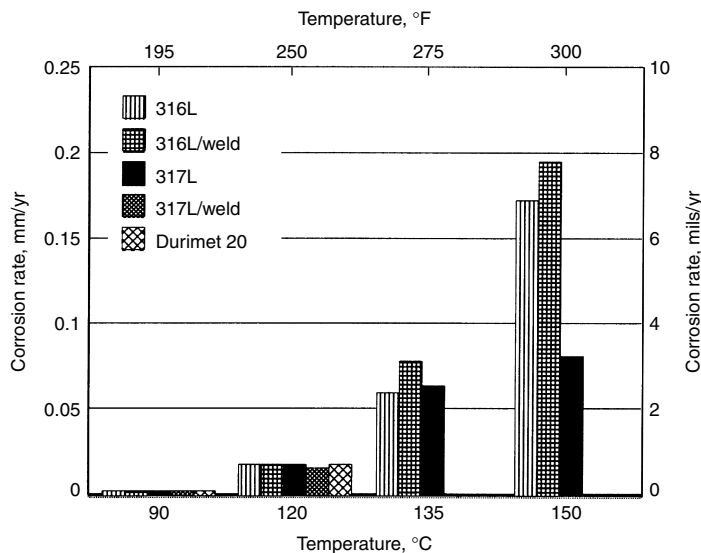
Fig. 3 Corrosion behavior of various stainless steels in 105% superphosphoric acid

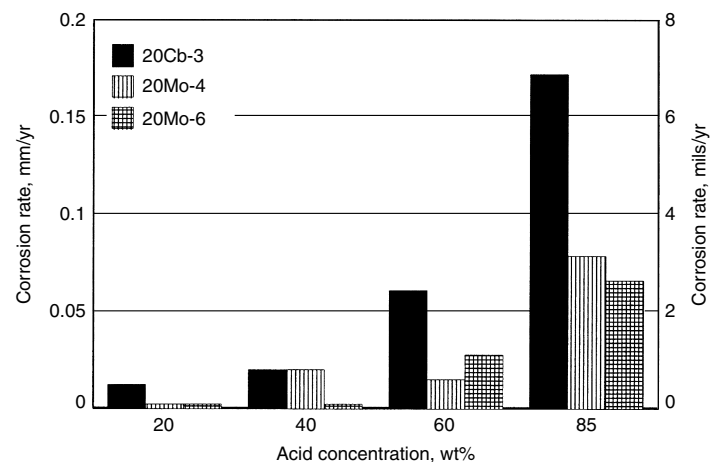
Fig. 4 Corrosion of alloy 20 stainless steels in boiling phosphoric acid

no better corrosion resistance than type 316L up to approximately 60% pure phosphoric acid (44%  $P_2O_5$ ) at boiling temperatures (Fig. 4) (Ref 7). Between 70 and 90% acid, alloy 27-7MO (UNS S31277) shows improved corrosion resistance over 316L, 317L, and alloy 825 (UNS N08825) below the boiling point (Fig. 5) (Ref 8, 9). At higher concentrations and temperatures, these alloys would have very high corrosion rates. The 6 to 7% Mo superaustenitic stainless steels, alloys AL-6X (UNS N08366), AL-6XN (UNS N08367), 254 SMO (UNS S31254), 654 SMO (UNS S32654), 1925hMo (UNS N08926), 20Mo-6 (UNS N08026), and 27-7MO (UNS S31277), may also be useful in contaminated phosphoric acid because of their higher molybdenum content. These alloys are usually referred to as 6% Mo alloys.

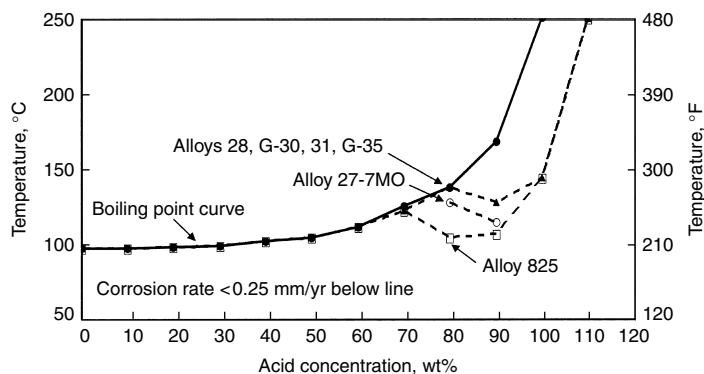
Fig. 5 Isocorrosion diagram for alloy 28 and various nickel alloys in phosphoric acid

Alloys 28 (UNS N08028), also known as 3127LC, UR SB8, and alloy 31 (UNS N08031), are similar in composition and have the highest phosphoric acid corrosion resistance of the superaustenitic stainless steel grades because of their increased chromium and molybdenum content. These alloys can be used in pure phosphoric acid up to 80% acid (58%  $P_2O_5$ ) to the boiling point (Fig. 5) (Ref 4). Their corrosion resistance falls as acid concentration increases

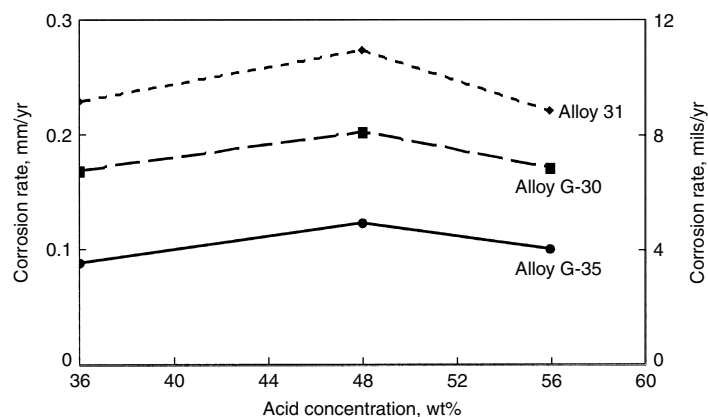
Fig. 6 Corrosion of alloys G-35, G-30, and 31 in wet-process phosphoric acid at 121 °C (250 °F)

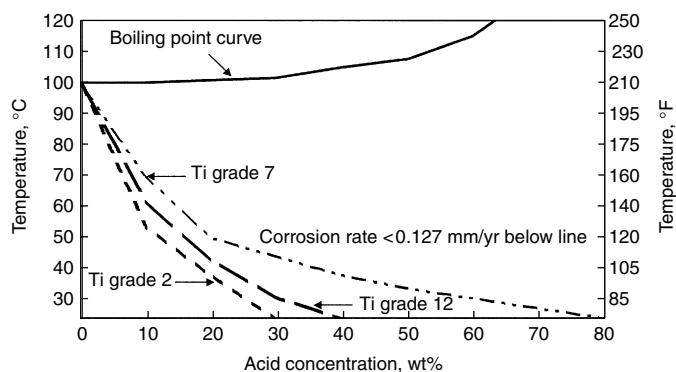
**Fig. 7** Isocorrosion diagram for titanium alloys in phosphoric acid

**Titanium Alloys.** Titanium grade 2 (UNS R50400) shows good corrosion resistance to aerated pure solutions of phosphoric acid up to 30% (22%  $P_2O_5$ ) at room temperature (Fig. 7) (Ref 15). Titanium grade 12 (UNS R53400)

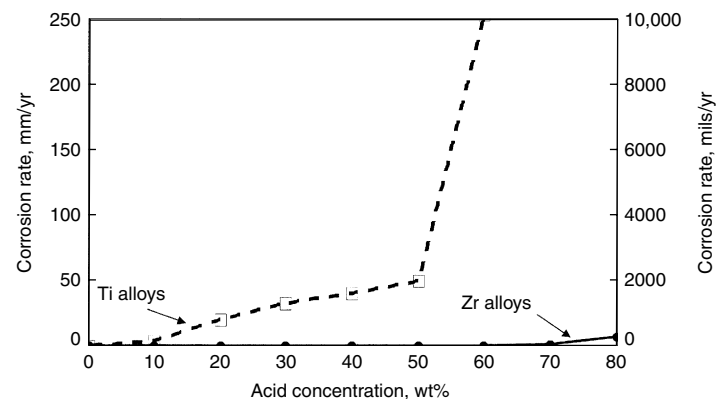
**Fig. 8** Corrosion behavior of titanium and zirconium alloys in boiling phosphoric acid

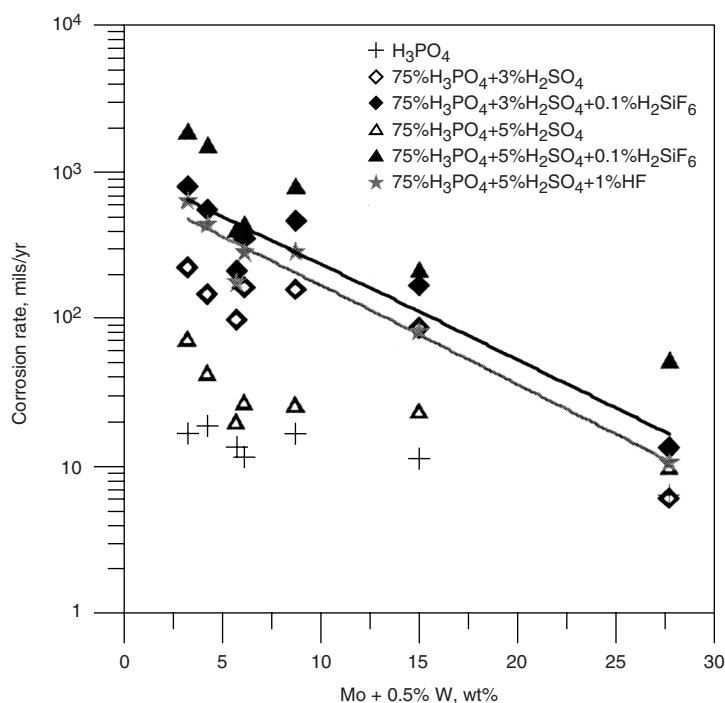
**Fig. 1** Effect of molybdenum on corrosion rates in reagent-grade phosphoric acid mixtures at 149 °C (300 °F)

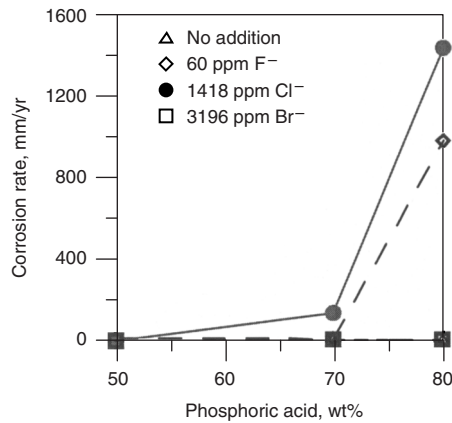
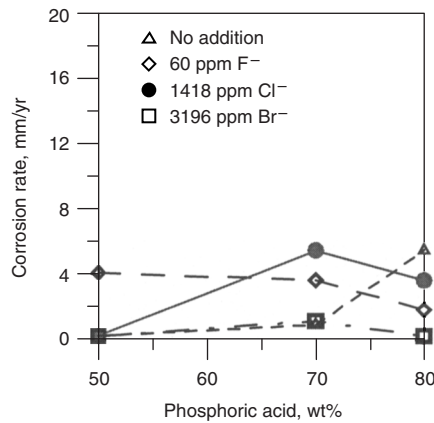
Fig. 2 Effect of  $F^-$ ,  $Cl^-$ , and  $Br^-$  on corrosion rate of stainless steel in reagent-grade phosphoric acid at 80 °C (176 °F). (a) Type 304. (b) Type 316

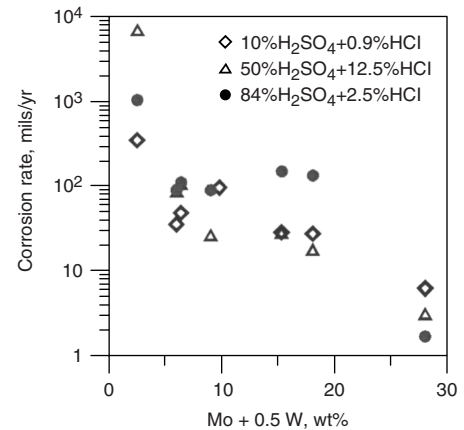
Fig. 3 Effect of alloying elements on corrosion rate of Ni-Fe-Cr-Mo alloys in  $H_2SO_4 + HCl$  mixtures at 79 °C (175 °F)

**$H_2SO_4$  and HCl Mixtures.** The effect of molybdenum plus tungsten on the corrosion rates of alloys in  $H_2SO_4 + HCl$  mixtures (Fig. 3) shows that increasing concentration of molybdenum results in a reduction in corrosion rate. For the chromium-containing alloys, which exhibit passive behavior, the effect of molybdenum may be attributed to its role in increasing the critical potential for localized corrosion for the chromium-containing alloys. For some chromium-containing alloys, only active behavior is seen in these acids. This is the case for type 316L stainless steel. The nickel-molybdenum alloys, such as alloy B-2, also do not exhibit significant passivity in these environments. In these cases, the beneficial effect of molybdenum may be attributed to a decrease in the exchange current density for anodic dissolution (Ref 9). It should be noted that even for the case of passive behavior and localized corrosion, the beneficial effect of molybdenum may be attributed to its effect on the active corrosion in the pit electrolyte (Ref 10). It should be cautioned that the use of alloy B-2 in these mixtures is predicated on the absence of oxidizing agents, such as dissolved iron. Based on the data (Fig. 3), the effect of alloying elements on the corrosion rate can be written in the form of Eq 1, where  $CR$  is corrosion rate in mils/yr, and  $A$  and  $B$  depend on the acid concentration. For 84%  $H_2SO_4 + 2.5\% HCl$  mixture,  $A$  is 0.18 and  $B$  is 6.6.

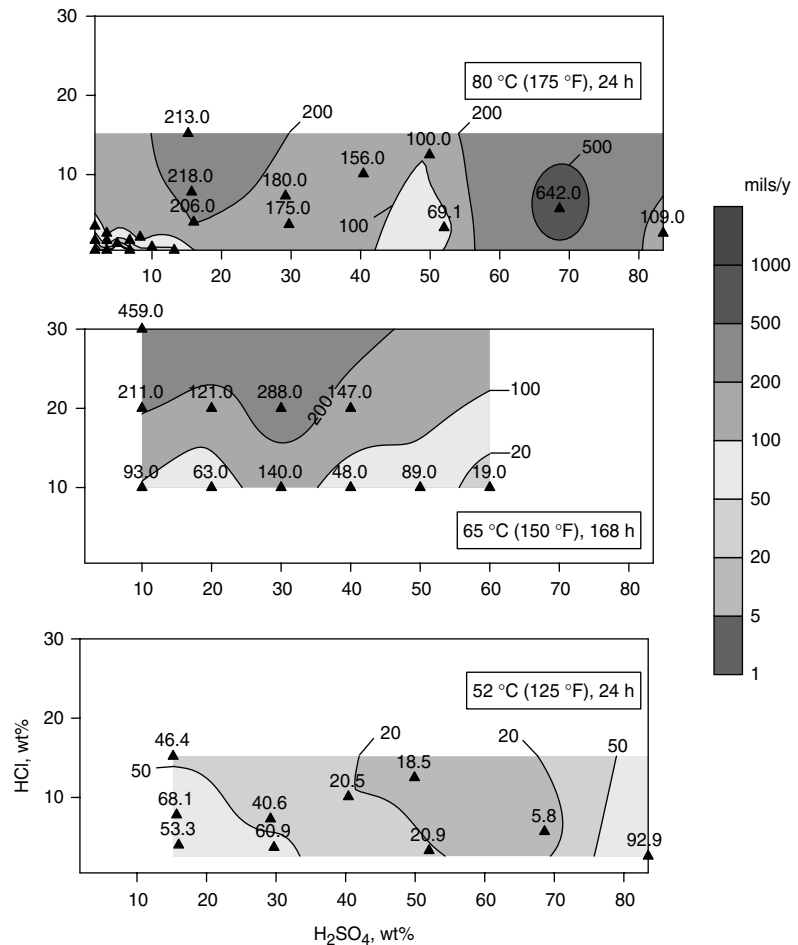
Fig. 4 Isocorrosion contours for alloy G-30 based on data from two sources. The temperatures are indicated within the figures. The numbers next to the symbols are test data. Contour values and test data are both mils/yr. Courtesy of Haynes International and Special Metals

The isocorrosion curves from data from two different sources for alloy G-30 are shown in Fig. 4. While the two sources tested at different temperatures and times, there is general agreement in the data trends. Certain regions of the data field are blocked because of lack of data for developing contours.

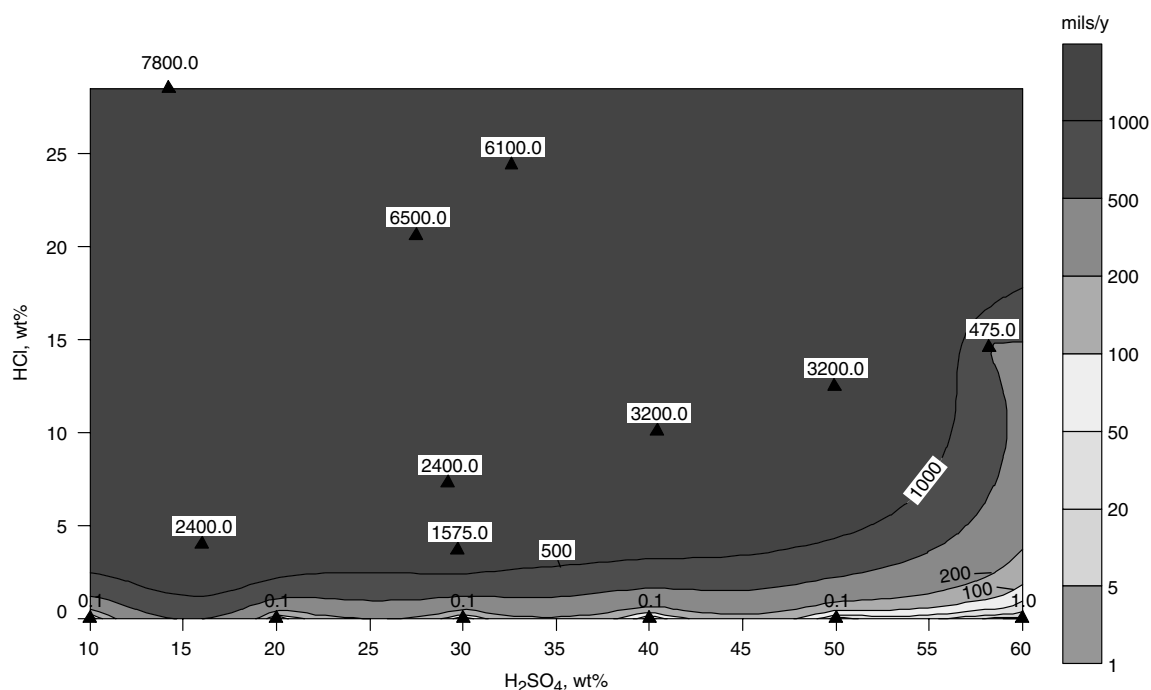
**Fig. 5** Isocorrosion diagram for a duplex stainless steel, Ferralium alloy 255, in  $\text{H}_2\text{SO}_4 + \text{HCl}$  mixtures at  $52^\circ\text{C}$  ( $125^\circ\text{F}$ ). Data point values and contour lines are corrosion rate in mils/yr.

continuous, high corrosion rates may be observed through grain dropping. An isocorrosion curve for a duplex stainless steel is given in Fig. 5.

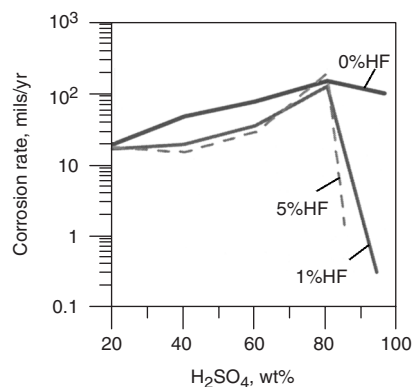
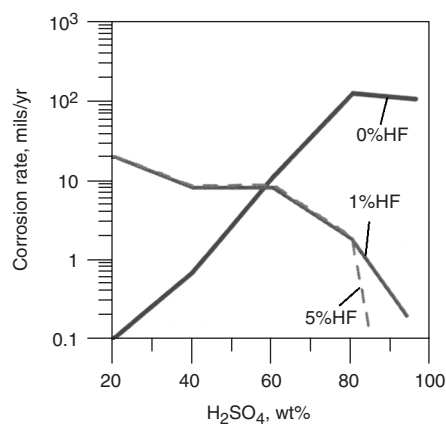
**Fig. 6** Effect of HF addition to mixture at  $79^\circ\text{C}$  ( $175^\circ\text{F}$ ) on corrosion rates of alloys (a) 625 and (b) G-30

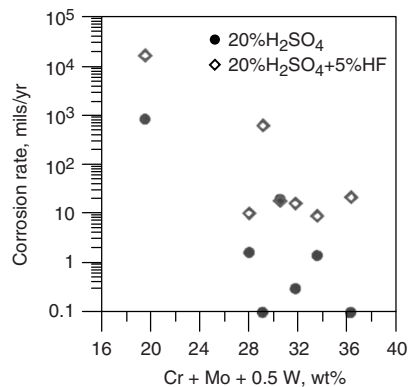
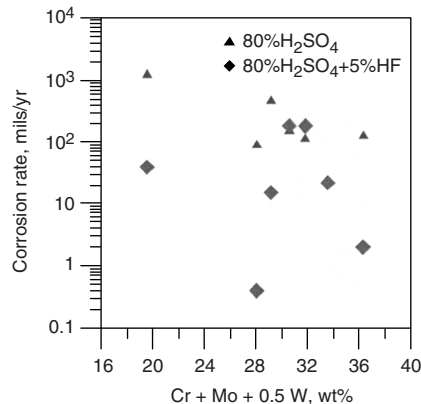
**Fig. 7** Effect of Cr + Mo + 0.5W on corrosion rates in different concentration ranges of sulfuric acid with and without HF at  $80^\circ\text{C}$  ( $175^\circ\text{F}$ ). (a) 20%  $\text{H}_2\text{SO}_4$ . (b) 80%  $\text{H}_2\text{SO}_4$

The effect of alloying elements Cr-Mo-W on corrosion rate in sulfuric acid with and without HF is seen in Fig. 7. In 20% sulfuric acid, the corrosion rate generally decreases with an increase in the level of chromium and molybdenum. It has also been shown previously that copper and nickel contents play a crucial role

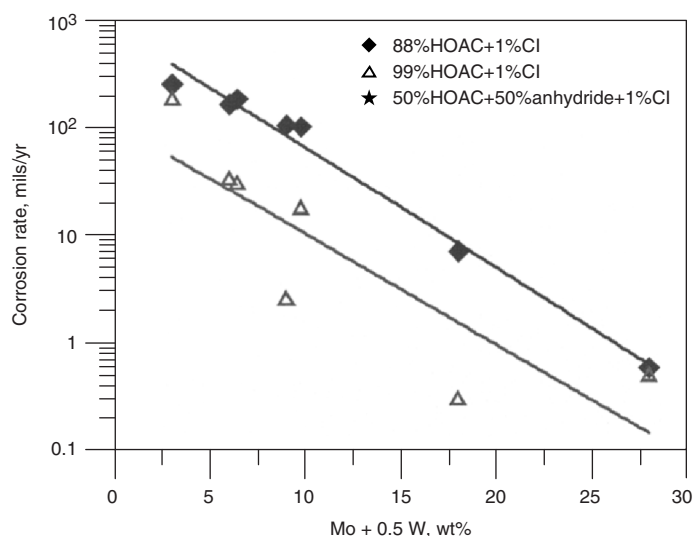
**Fig. 8** Effect of alloying elements on corrosion rates in acetic acid and NaCl mixtures. Boiling point of 100% acetic acid is 117.9 °C (244.2 °F). Boiling point of 100% acetic anhydride is 139.6 °C (283.3 °F).

Figure 8 shows increasing molybdenum results in decreasing corrosion rates, symptomatic of nonoxidizing acids. The effect of alloying elements can be fit to a logarithmic relationship where  $CR$  is in mils/yr.

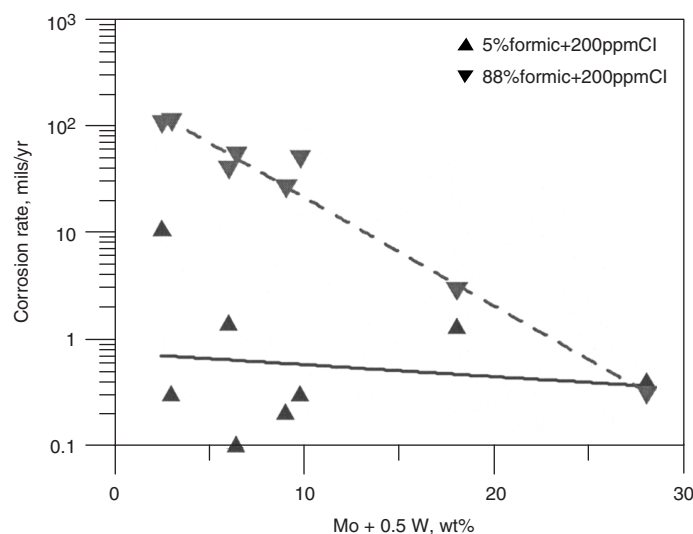
**Fig. 9** Effect of alloying elements on corrosion rates in formic acid and NaCl mixtures, boiling, 24 h

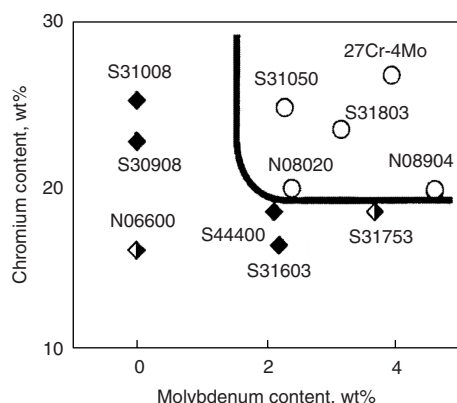
**Fig. 10** Effect of chromium and molybdenum content on corrosion in simulated wet-process phosphoric acid (50 wt%  $P_2O_5$ , 3%  $H_2SO_4$ , 0.5% HF, and 0.5%  $Fe_2(SO_4)_3$ ) at 50 °C (120 °F) for 120 h. Corrosion rates: open circle < 46 mils/yr; half-diamond < 460 mils/yr; solid diamond > 460 mils/yr

dramatically, because the potential shifted from the active to the passive regime (Ref 7). On the other hand, if there is sufficient chloride present, then the presence of  $\text{Fe}^{3+}$  can increase corrosion rates. In wet-process phosphoric acid, this showed that the corrosion rates of stainless steels increased in the order  $904\text{L} > 317\text{L} > 316\text{L}$ , indicating that both chromium and molybdenum played a role. A number of stainless steels in both plant wet-process acid and laboratory mixture simulating the plant acid were examined (Ref 6). The test results are plotted in terms of chromium and molybdenum contents of various alloys in Fig. 10.

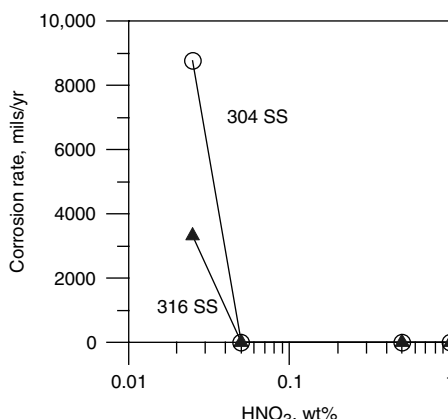
**Fig. 11** Effect of nitric acid on corrosion rate in 50% sulfuric acid at 60 °C (140 °F). Source: Ref 14

decrease the corrosion rates of chromium-containing alloys in sulfuric acid (Fig. 11). The effect of nitrate generally depends on the chromium content of the alloy (Fig. 12). With the exception of the 26-Cr alloy, there is a decrease in corrosion rate with chromium content. The 26-Cr alloy is a duplex stainless steel with low nickel (5Ni), which may be the reason for the difference. Another possibility is the effect of microstructure in inducing interphase corrosion in the duplex stainless steel. No correlation with molybdenum or chromium and molybdenum contents was observed with these data.

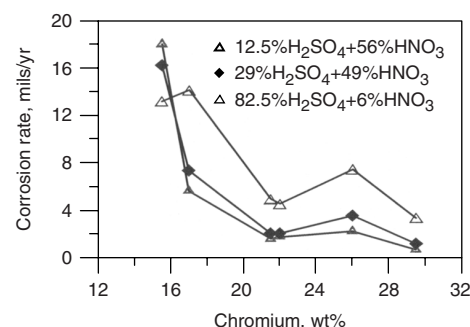
**Fig. 12** Effect of alloying element on corrosion rate in sulfuric and nitric acid mixtures

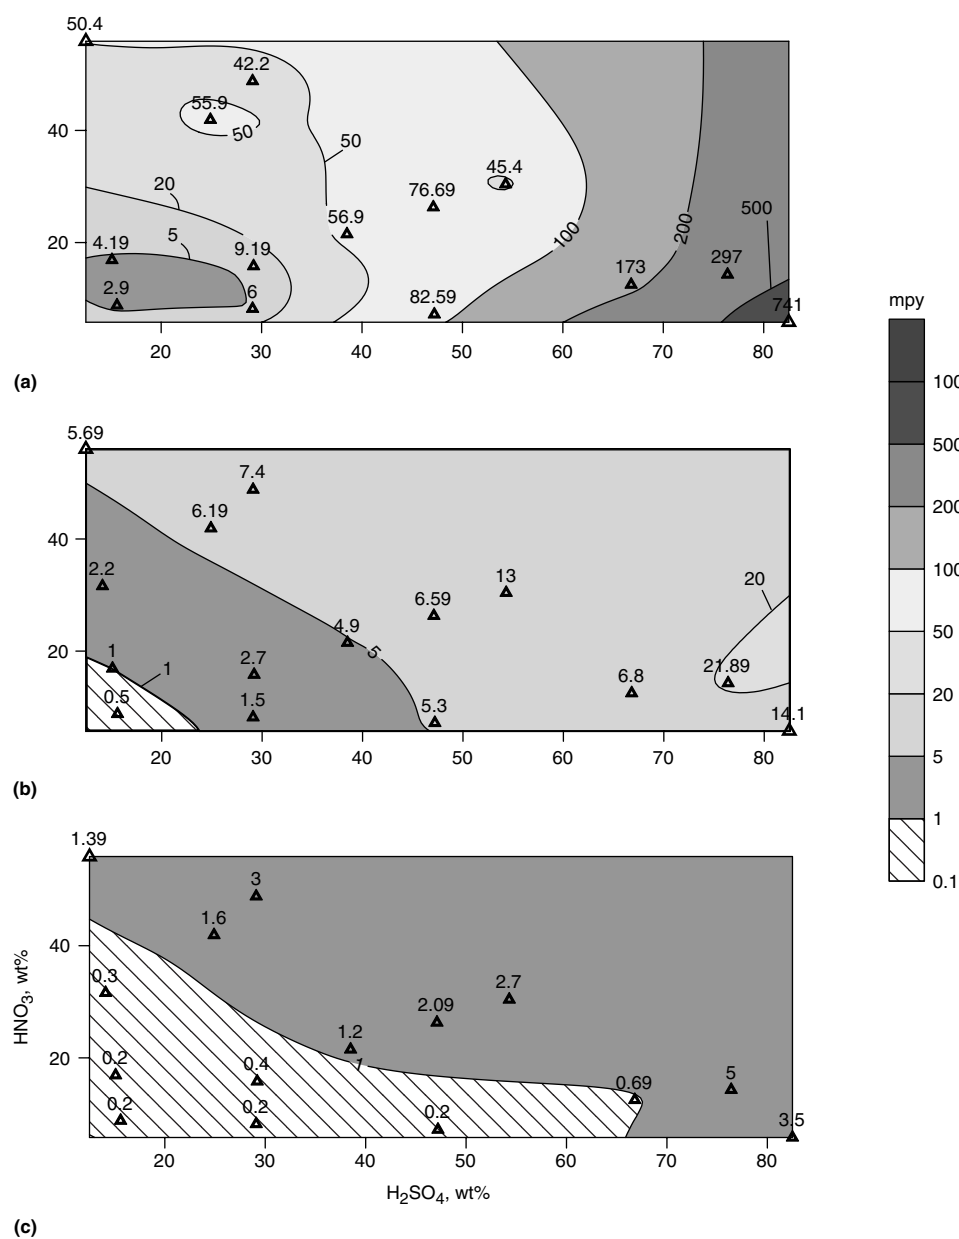
**Fig. 13** Isocorrosion diagrams for type 316L in sulfuric acid and nitric acid mixtures. (a) Boiling. (b) 79 °C (175 °F). (c) 52 °C (125 °F)

The effects of temperature and acid mixture compositions on the corrosion rate of type 316L stainless steel are shown in isocorrosion diagrams (Fig. 13).

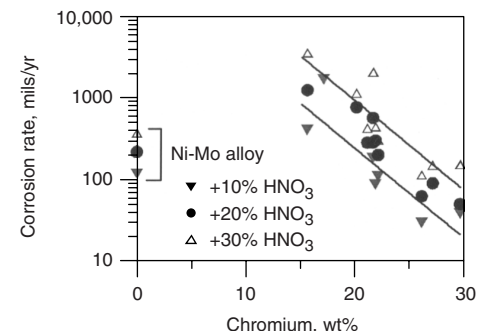
**Fig. 14** Effect of alloying elements on corrosion rate of Ni-Fe-Cr-Mo-W alloys in  $\text{HNO}_3 + 3\% \text{HF}$  at 79 °C (175 °F)

These mixtures are commonly found in descaling baths and fluoropolymer processing. For the chromium-containing alloys, the corrosion rate appears to be a function of chromium, with molybdenum and tungsten playing a relatively minor role (Fig. 14). However, the nickel-molybdenum alloy (alloy B-2) was not as high as expected, although it is still such that its use is prohibited in this environment.

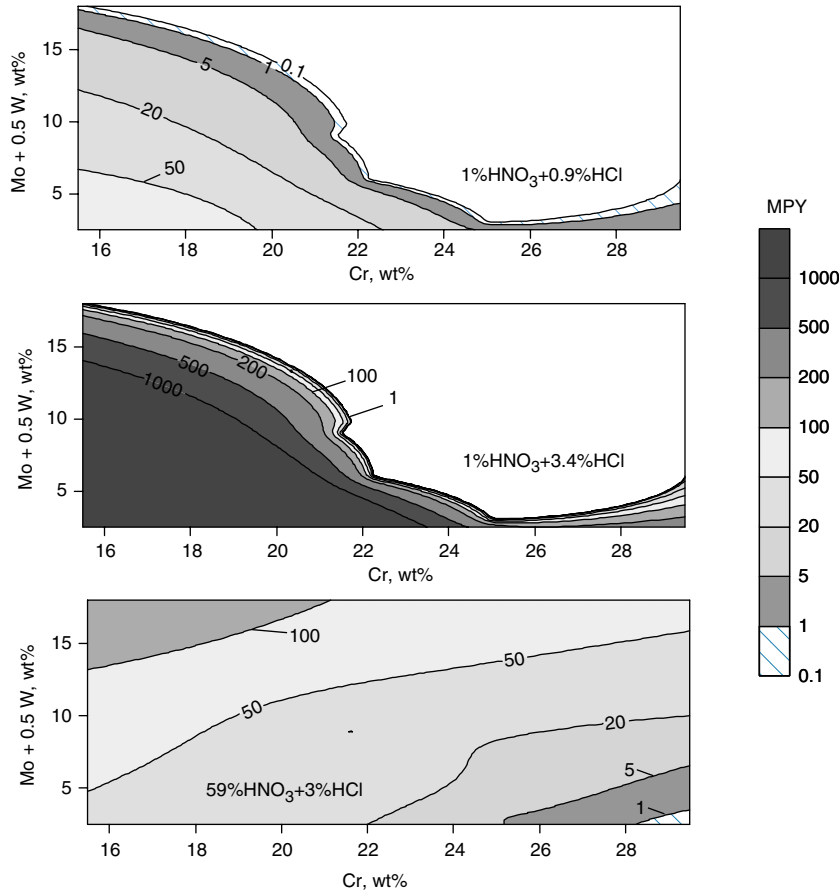
Fig. 15 Isocorrosion diagrams as functions of chromium and molybdenum contents of alloys in three mixtures of nitric and hydrochloric acid

The effect of alloying elements on corrosion depends on the acid composition. This is illustrated in terms of isocorrosion diagrams as functions of chromium and molybdenum contents of the alloy (Fig. 15). Because some of the alloys have tungsten, the effect of tungsten is included in terms of its atomic concentration with respect to molybdenum. For the low nitric acid concentration solutions (<4%  $\text{HNO}_3$ ), the corrosion rate decreases with an increase in molybdenum content. For the high nitric acid concentration, the corrosion rate increases with molybdenum concentration. Thus, high-molybdenum alloys may be detrimental in high nitric acid solutions containing chloride. Nitric acid additions to HCl cause two opposing effects that depend on the concentrations of both constituents as well as the alloy composition. Nitric acid (nitrate) helps in the repassivation of localized

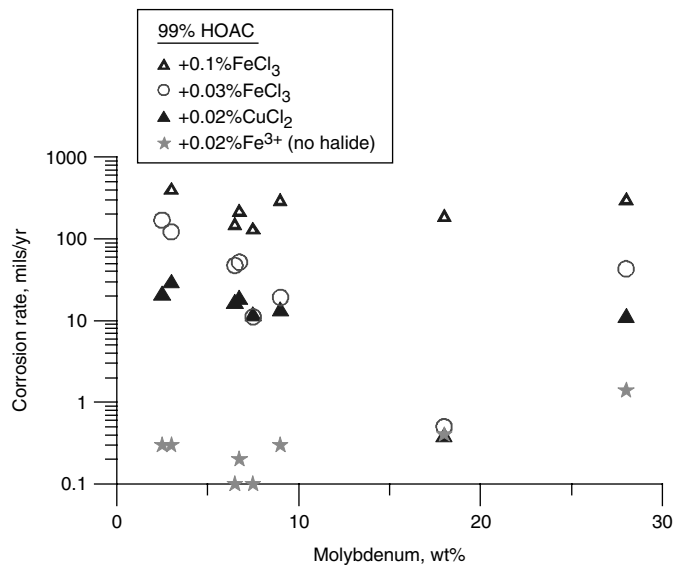
Fig. 16 Effect of redox species concentration and halide concentration on corrosion rate in 99% acetic acid. Boiling point is 117.9 °C (244.2 °F). 24 h

halides have been known to exacerbate corrosion in acetic acid. The effect of  $\text{FeCl}_3$  and  $\text{CuCl}_2$  in glacial acetic acid on corrosion is shown as a function of  $(\text{Mo} + 0.5\text{W})$  (Fig. 16). The corrosion rate in the same acetic acid in the presence of nonhalide ferric salt is quite low. Note that corrosion rate is not a good parameter for evaluating the behavior of chromium-molybdenum alloys because of localized corrosion. Nevertheless, because localized corrosion propagation was considerable, corrosion rate is used as a measure of relative susceptibility rather than actual penetration rate. In the 0.1%  $\text{FeCl}_3$ -containing acid, all alloys exhibited significant corrosion. The B-2 nickel-molybdenum alloy shows uniform corrosion, because it does not form a passive film. In aqueous solutions with similar concentrations of  $\text{Fe}^{3+}$ , the corrosion rate of alloy B-2 would be significantly higher.

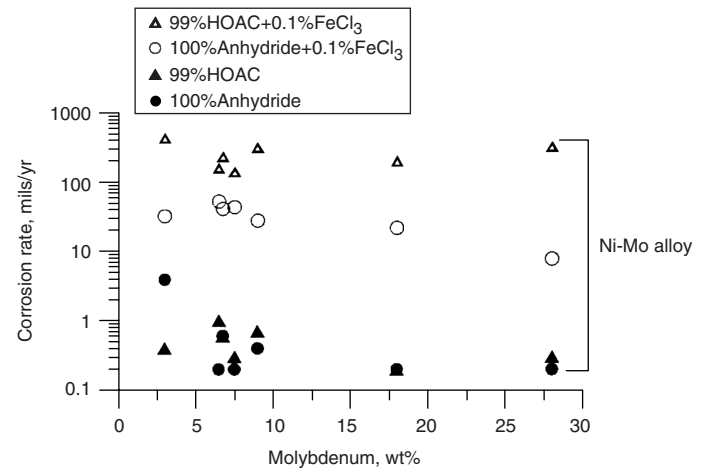
Fig. 17 Effect of anhydride on corrosion rate in the presence of  $\text{FeCl}_3$ . Boiling, 24 h

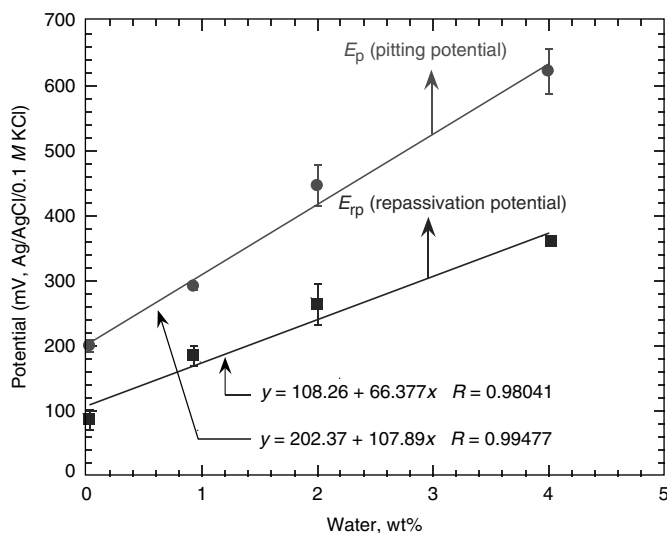
Fig. 1 Pitting and repassivation potential of pure tantalum as a function of water concentration (0–4 wt%) in methanol solutions. 99.5–95.5 wt% MeOH. 0.5 wt% HCl. Room temperature, N<sub>2</sub> purge

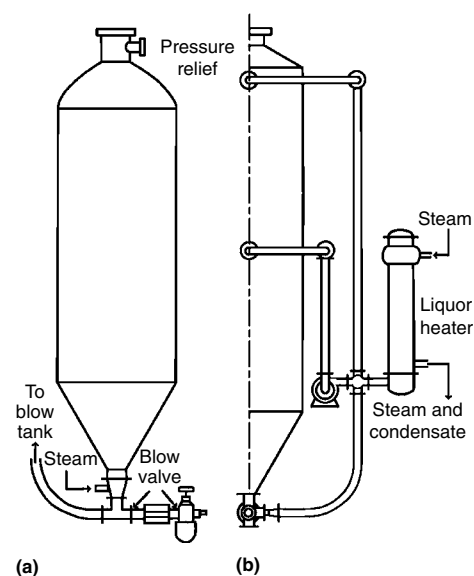
Fig. 1 Two types of batch digesters. (a) Direct-heating digester. (b) Indirect-heating digester

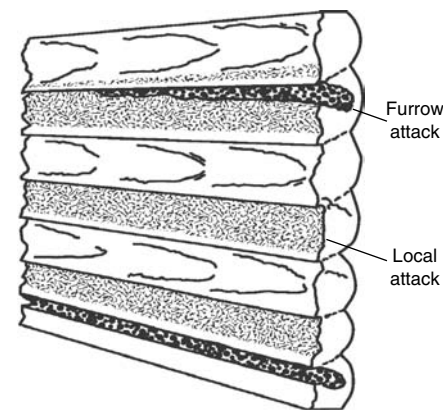
**Fig. 2** Typical problems with digester weld overlays. Accelerated corrosive attack on a stainless steel weld overlay lining in a kraft pulp digester vessel after 18 months of service. Localized furrow attack occurs between weld beads displaying rapid-etching (lean alloy) structure. Deposited by submerged arc process (E-310 electrode).

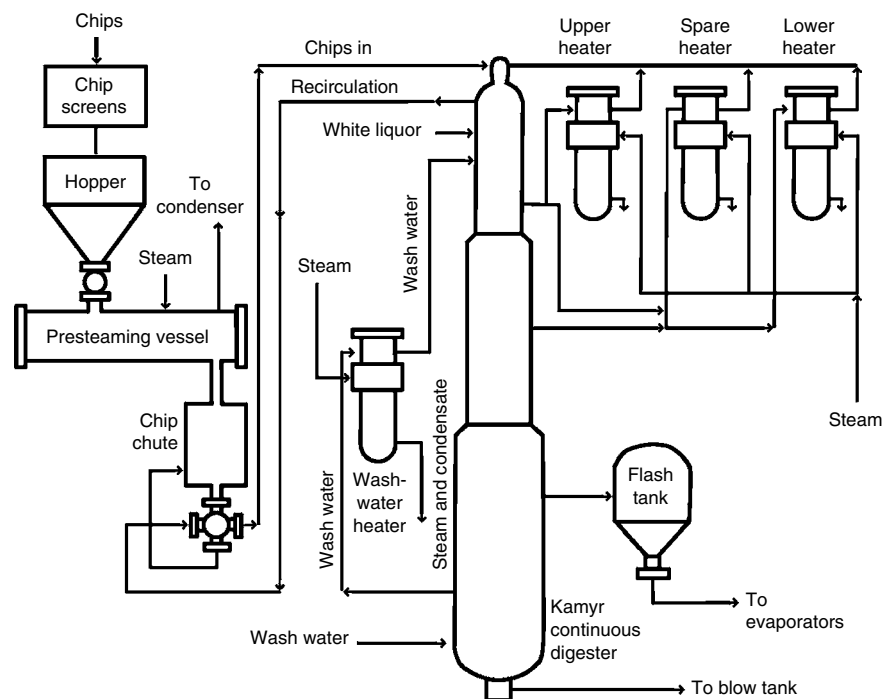
Fig. 3 Kamyr continuous digester

**Liquor Heaters.** External heat exchangers are used for indirect heating of the digester, most of which today (2006) are a two-pass shell and tube construction (Fig. 4). Batch digesters usually have one heat exchanger, while Kamyr units usually have three (see Fig. 3). With the continuous cook, two exchangers are in service while the third is being cleaned or in a standby mode. Tubing is 25 to 37 mm (1 to 1.5 in.) in outer diameter (OD), and from 3 to 4.6 m (10 to 15 ft) in length. Cooking liquor circulates

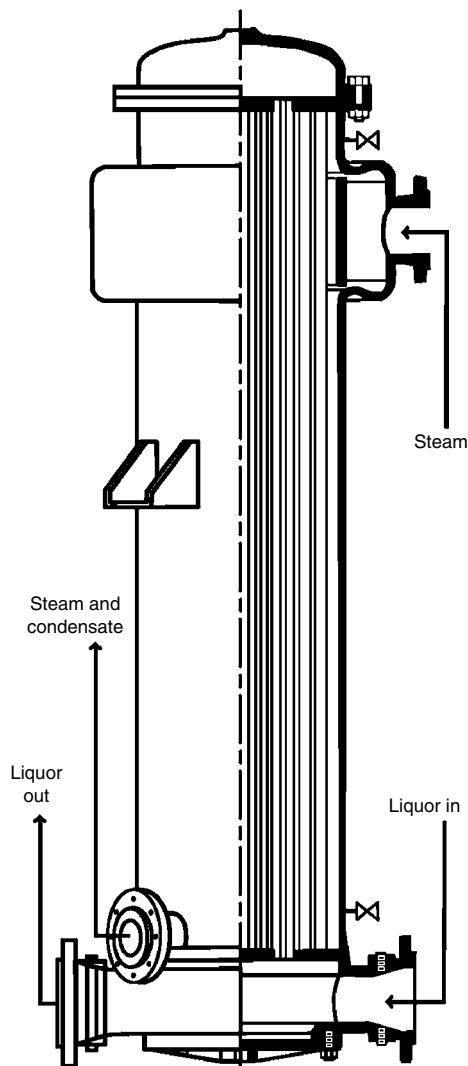
Fig. 4 Digester liquor heater

through the tubes, with saturated steam on the shell side. Shell side temperature is approximately 200 °C (390 °F), while the liquor is 150 to 170 °C (300 to 340 °F).

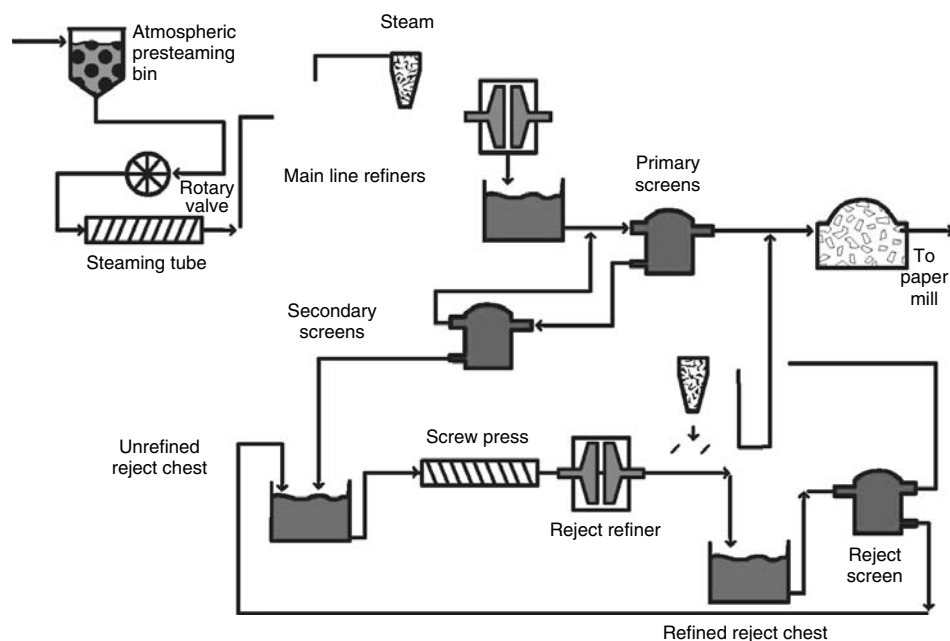
Fig. 5 Flow diagram of a thermomechanical pulping mill

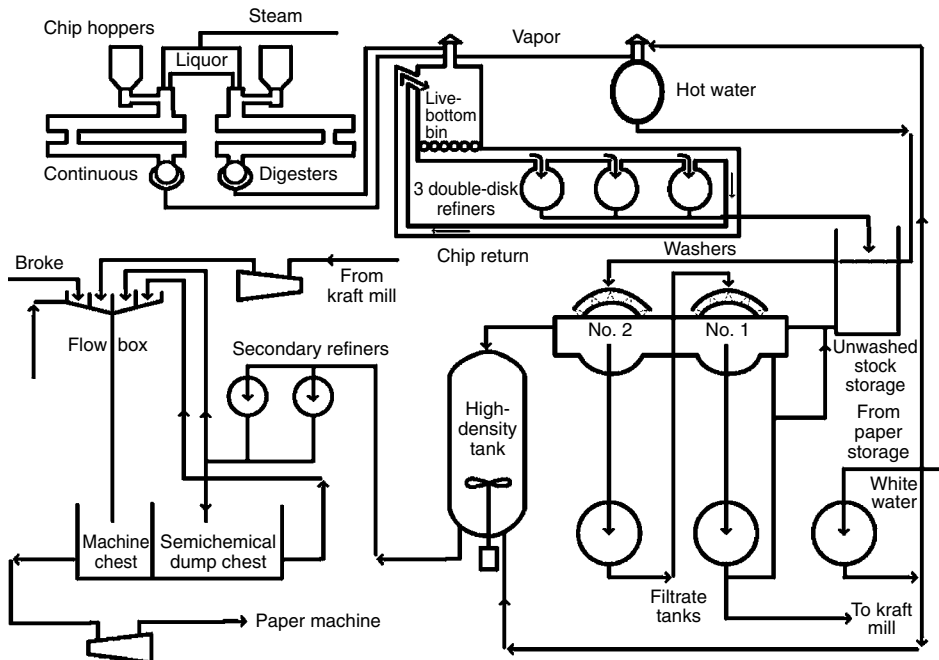
Fig. 8 Flow diagram of a typical neutral sulfite semichemical mill

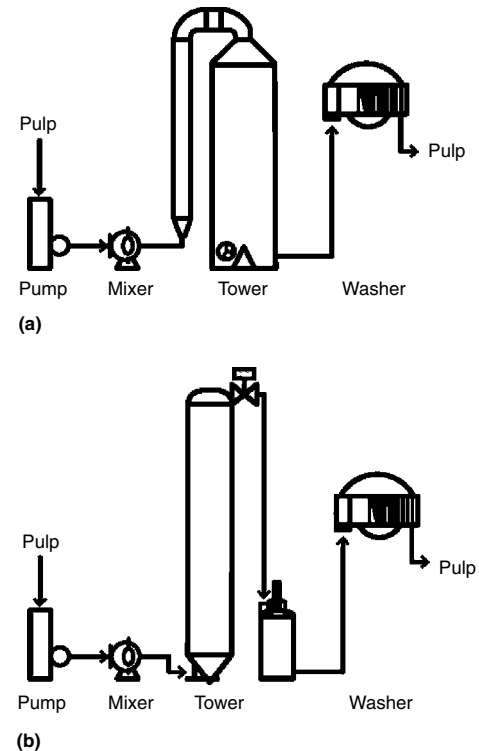
Fig. 9 Bleaching stage components. (a) Atmospheric (upflow/downflow). (b) Pressurized (upflow)

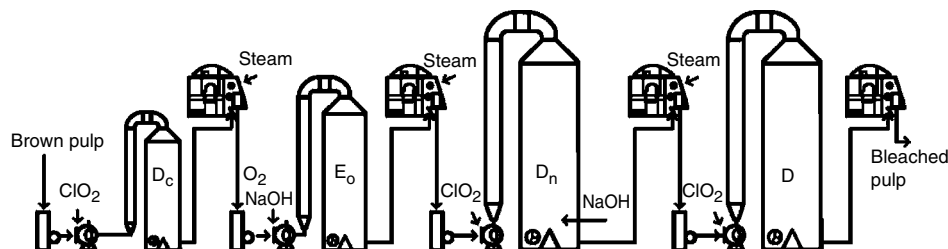
Fig. 10 Flow diagram of a conventional  $D_cE_oD_nD$  bleaching sequence
