# ASM Handbook®

## Volume 13C Corrosion: Environments and Industries

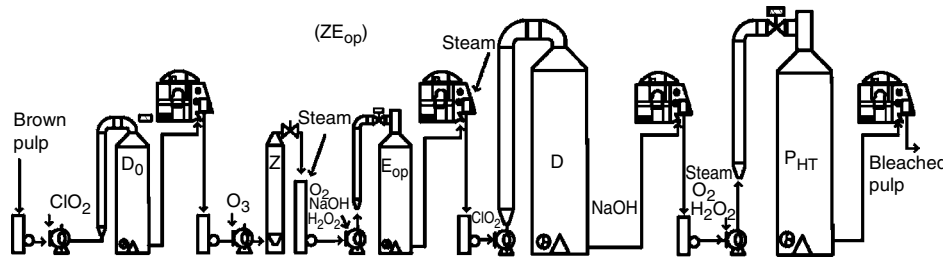
**Fig. 11** Flow diagram of a  $D_0(ZE_{op})DP_{HT}$  elemental chlorine-free bleaching sequence. The  $(ZE_{op})$  stage in parenthesis denotes no wash between stages. In some instances, a chelation or acid-rinse step followed by a wash may be required prior to the  $P_{HT}$  and  $P_o$  stages.

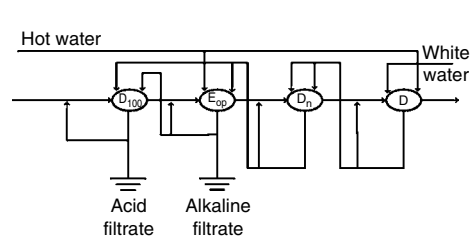
**Fig. 12** Process water reuse for  $D_{100}E_{op}D_nD$  bleaching sequence

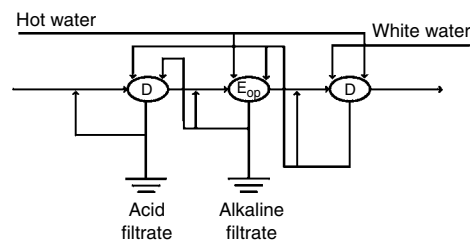
**Fig. 13** Process water reuse for  $D(E_{op})D$  bleaching sequence

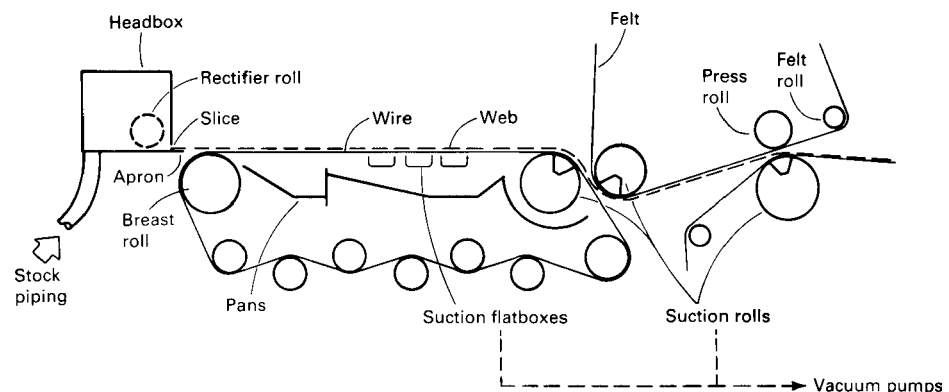
Fig. 14 Wet end of a fourdrinier paper machine

MOST OF THE CORROSION PROBLEMS IN PAPER MACHINES occur in the wet end (Fig. 14) and in ancillary equipment handling white water. Areas susceptible to corrosion are

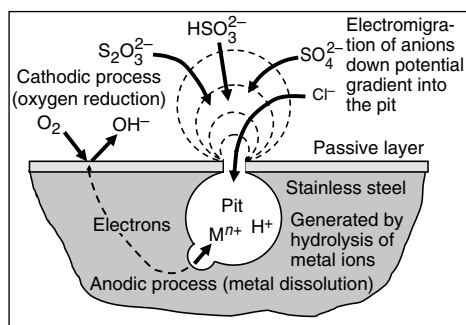
**Fig. 15** Pitting corrosion process in paper machine white water

A newly initiated corrosion pit tends to repassivate unless the conditions for its initiation are maintained (corrosion potential above the breakdown potential). Figure 15 is a schematic diagram of the pitting process.

force for its growth is the development of an oxygen concentration cell. The surrounding metal surface remains passive because it has ready access to dissolved oxygen. Reduction of dissolved oxygen on the surrounding metal is the cathodic half of the net corrosion reaction. Anodic dissolution of metal in a pit can occur at a very high rate since the surface area of the pit is much smaller than that of the surrounding metal surface. Subsequent hydrolysis of dissolved metal complexes inside the pit results in the generation of free hydrogen cations. Anions diffuse into the pit from the outside by the process of electromigration to maintain electron neutrality of the solution in the pit. Of the available anions in the white-water solution, chlorides are the most mobile and can enter the pit more readily than larger anions such as sulfate. Generation of hydrogen cations due to metal ion hydrolysis and the electromigration of chloride anions into the pit can produce an environment inside the pit that resembles hydrochloric acid more than it does white water. Pit growth may then accelerate as acid corrosion.

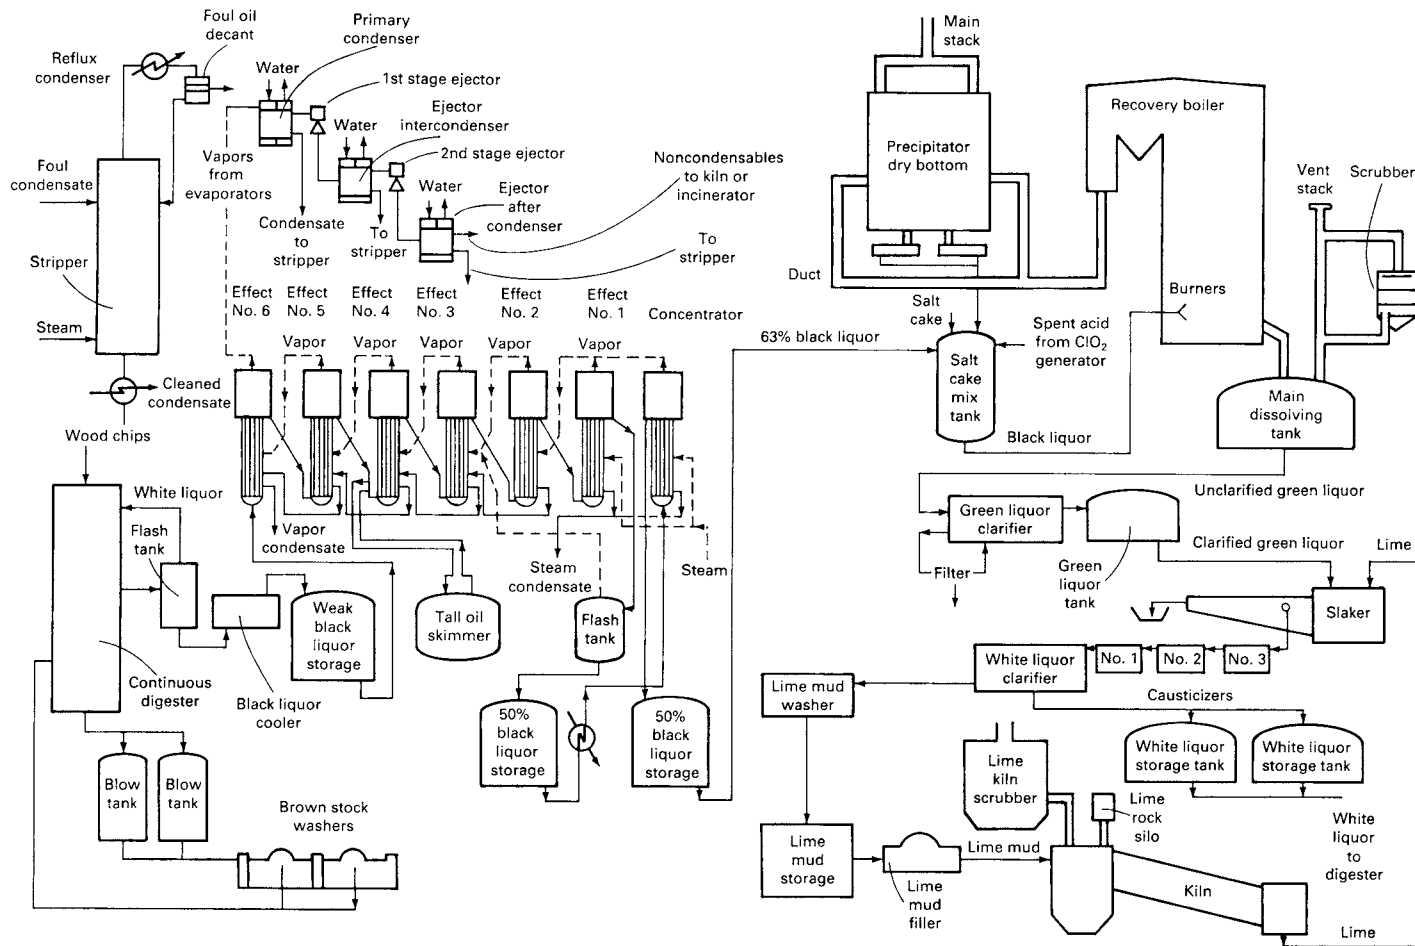
Fig. 16 Flow diagram of kraft pulping and chemical recovery

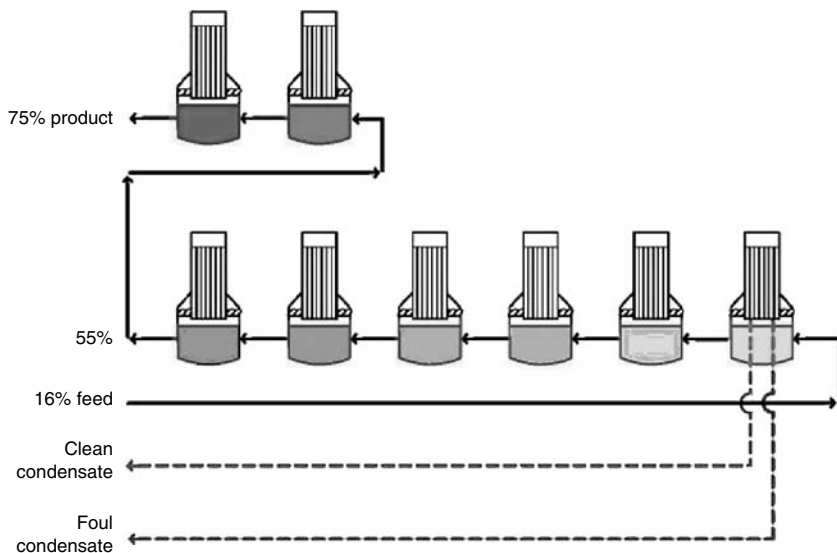
Fig. 17 Multiple-effect evaporator/concentrator design

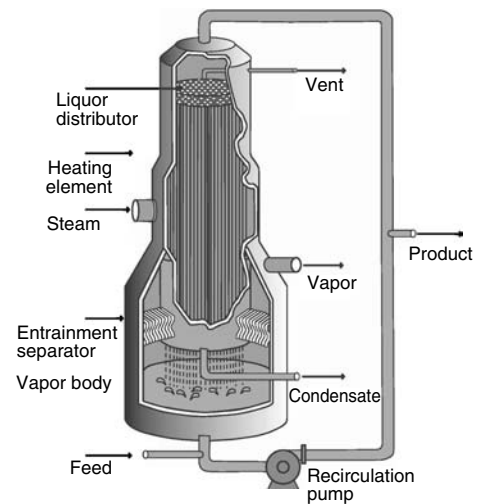
Fig. 18 Cross-sectional view of a falling-film black liquor evaporator and concentrator design

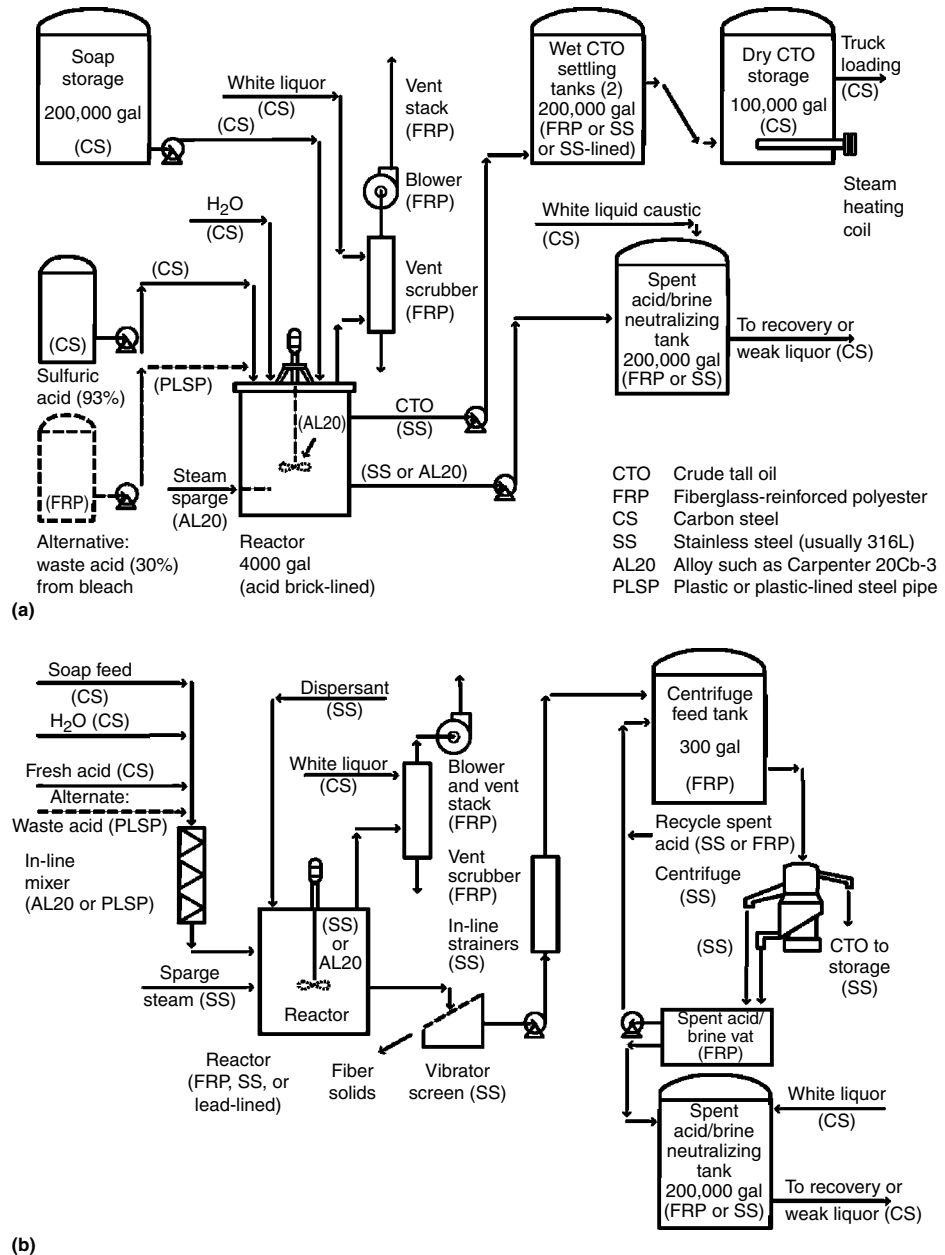
Fig. 19 Flow diagrams and typical materials of construction for the (a) batch and (b) continuous acidulation processes.

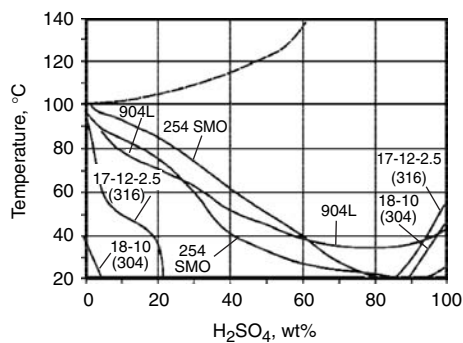
**Fig. 20** Isocorrosion diagram, 0.1 mm/yr (4 mils/yr), of austenitic stainless steels in naturally aerated sulfuric acid of chemical purity. The dashed line represents the boiling point.

the isocorrosion curves for a number of common alloys, including 904L and 6% Mo (254 SMO) in chloride-free sulfuric acid and acid containing a low concentration of chloride (200 ppm).

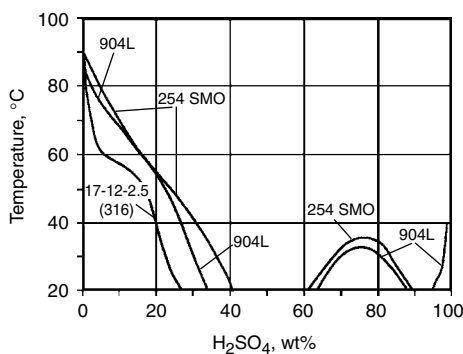
**Fig. 21** Isocorrosion diagram, 0.1 mm/yr (4 mils/yr), of austenitic stainless steels in naturally aerated sulfuric acid with 200 ppm chloride addition

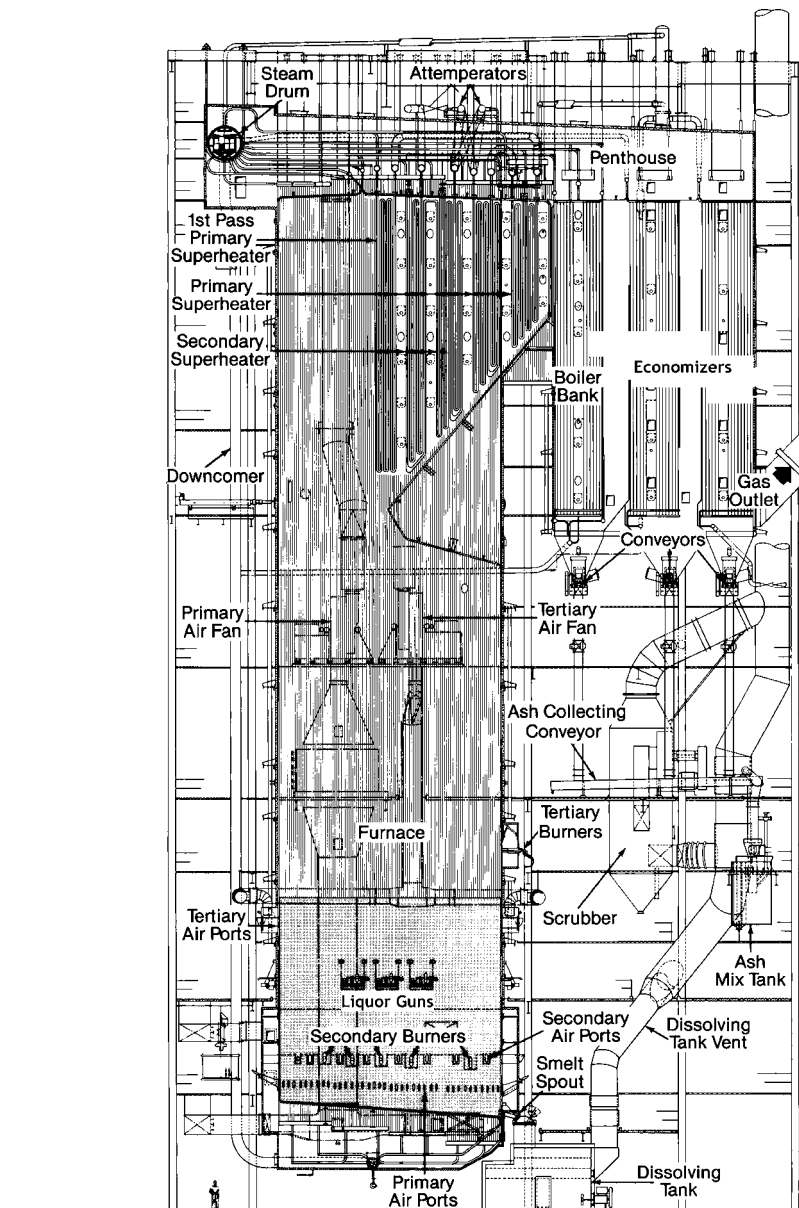
**Fig. 22** Typical kraft recovery boiler used in the wood pulp industry. This is a modern, single-drum design, with the steam drum located outside the gas passage. Most boilers built prior to 1990 incorporated a generating bank, with an upper steam drum and lower mud drum, in place of the boiler bank and external steam drum. Courtesy of the Babcock & Wilcox Company

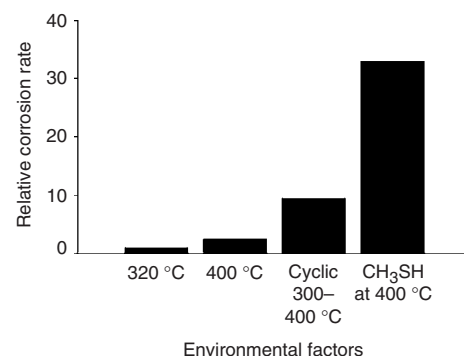
**Fig. 23** Laboratory test results showing relative effect of environmental factors on corrosion of carbon steel in lower furnace. Corrosion rates of alloys are normalized to that of A210-A1 at 320 °C (610 °F).

The mechanisms responsible for corrosion of carbon steel tubes in the lower furnace are well understood. Due to the large temperature difference between the “cold” tube surfaces and the first melting point of the salts in the boiler, fluxing from molten salts is unlikely to contribute significantly to corrosion, except under unusual circumstances. Some corrosion may be the result of exposure to wet liquor, or hydrated sodium sulfide, but it is reactions between the steel and pyrolysis gases that circulate through the porous deposits adhering to the surface of the walls that are likely responsible for most of the observed corrosion. Long-term average corrosion rates can be readily accounted for by isothermal reactions between carbon steel, H<sub>2</sub>O, O<sub>2</sub>, and gaseous H<sub>2</sub>S (along with other sulfur species) in the reducing atmosphere of the lower furnace (Ref 123). Additional factors have been identified as being particularly likely to contribute to accelerated corrosion (Fig. 23) (Ref 125):

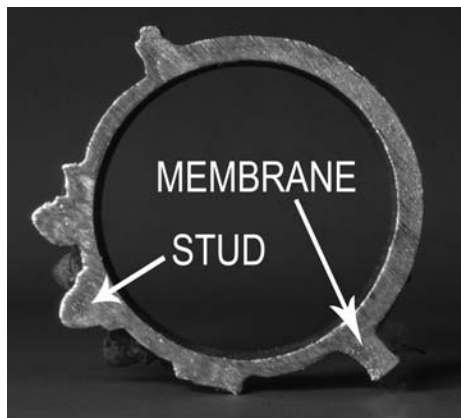
**Fig. 24** Cross section through a studded carbon steel boiler tube, showing reduction in dimensions of the studs that occurs in operation. Note the loss of wall thickness in the tube around the entire fireside circumference, including the crotch of the tube near the membranes.

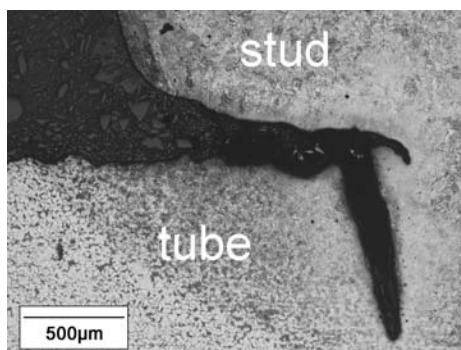
**Fig. 25** Micrograph showing a thermal fatigue crack that originated at a discontinuity in the base of a stud on a carbon steel tube. The crack has turned and begun to propagate into the thickness of the tube.

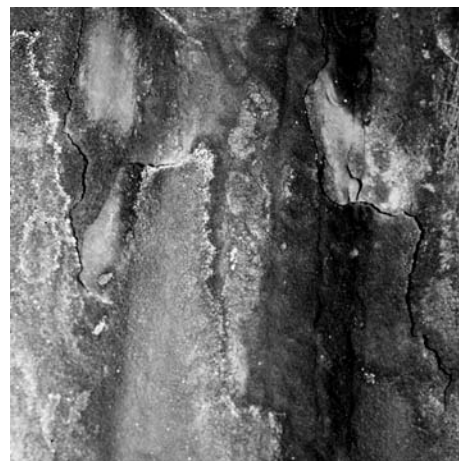
**Fig. 26** Spalling of a plasma sprayed coating as a result of poor surface preparation prior to the application of the coating

frequently encountered (Fig. 26). With stringent quality assurance/quality control in place, and the use of fully automated application, coating lifetimes of 5 to 10 years have occasionally been achieved with only minor annual touch-ups required.

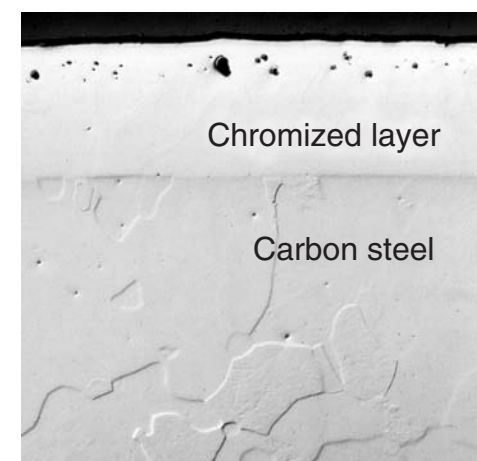
**Fig. 27** Cross-section photograph through a chromized tube. The chromized layer (between 0.2 and 0.4 mm thick) contains about 40 wt% Cr at the surface and about 16 wt% Cr at the diffusion boundary with the carbon steel. The voids near the surface are normal artifacts of the chromizing process, and do not affect the corrosion resistance of the coating unless they provide a migration path to the carbon steel surface.

Pack cementation coatings have also been applied to large boiler wall panels (Ref 127). This process leaves a thin, corrosion-resistant layer of nearly pure chromium on the surface of the tubes (Fig. 27). Several boilers have been built with chromized lower furnace walls with favorable, long-term performance reported by the mills. As with other coatings, quality control and assurance are critical to obtaining a consistently uniform product, particularly when dealing with large panels, or panels that include complex shapes and bends. As one example, the chromizing process by nature leaves porosity in the surface known as Kirkendall voids. Under ideal conditions, these voids are found near the surface and do not affect the integrity of the chromized coating. However, improper processing can cause these voids to form as low as the interface with the carbon steel, leaving a potential migration path for sulfur to the underlying carbon steel. Uneven coating thicknesses and poor adhesion between the chromized layer and the underlying steel are other problems that can arise during the manufacturing process.

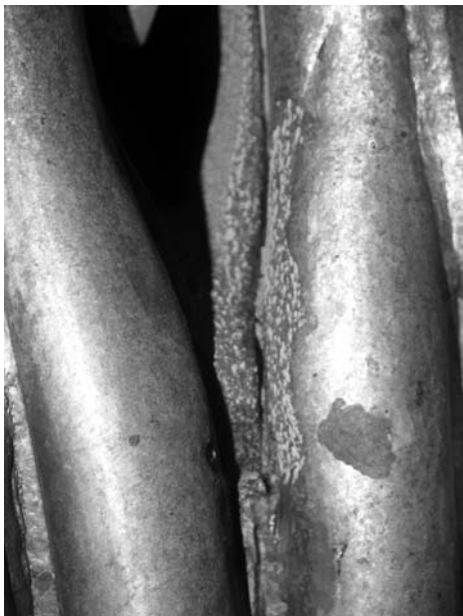
**Fig. 28** Preferential corrosion of the 304L stainless steel layer in a composite tube. Corrosion occurs at the edge of the bolt-on casting in a primary air port and extends out toward the fire-side crown of the tube

place until the exposed area is quite large. "Balding" was first observed at the corners of air-port openings, on the cold side of the tubes in hidden areas behind flat studs and cast inserts (Ref 129). Subsequently, similar preferential corrosion has been observed at primary air-port openings further around the tube circumference toward the fire-side crown (Fig. 28), as well as on the cold side of the tubes behind insert plates in liquor gun, secondary air port, and burner openings, and on the cold side of the tubes underneath the smelt spout openings, where they are shielded by the smelt hoods.

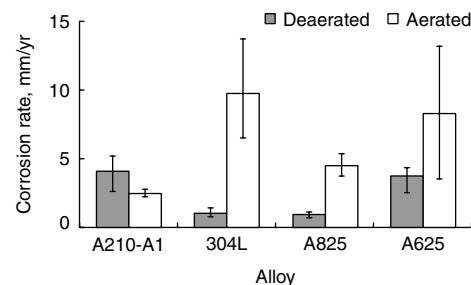
**Fig. 29** Plot comparing average corrosion rate of alloys in 75%Na<sub>2</sub>S-25%NaOH (dry wt%) salt hydrate mixture at 180 °C (355 °F) for a period of 24 h. Error bars show maximum and minimum values obtained in triplicate experiments.

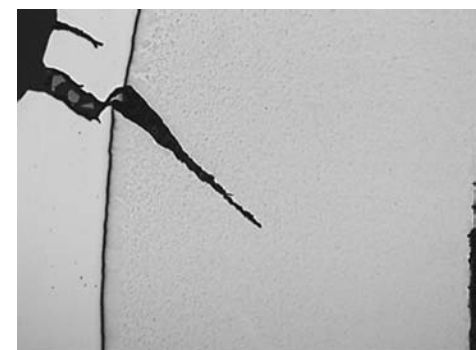
**Fig. 30** Recovery boiler sealed air ports. (a) Crack running along the heat-affected zone of a weld between a composite tube and a crotch plate in a spout opening. (b) Subsequent failure analysis found the crack penetrating into the carbon steel layer of the composite tube.

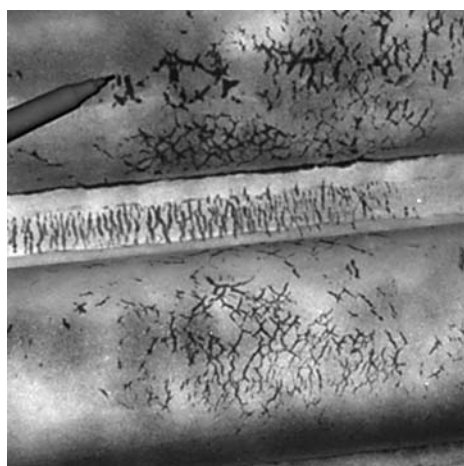
**Fig. 31** Cracks revealed by visible dye penetrant testing in a 304L composite floor tube. Note also the cracking along the tube/membrane interface and in the membrane.

Remedial measures that have been adopted for floor tube cracking include monitoring the cracks over time and then grinding the cracks out and repair welding as necessary, or by replacing 304L/CS composite tubes with either studded carbon steel tubes or composite tubes made with

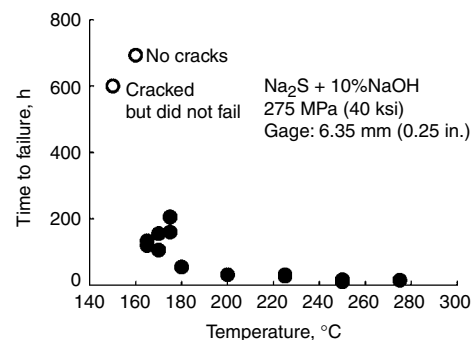
**Fig. 32** Results from constant stress SCC tests of 304L shown as a function of temperature in a hydrated mixture of  $\text{Na}_2\text{S}$  and  $\text{NaOH}$ . Solid circles are data points for specimens that failed during the test. Open circles are for specimens that either cracked, but did not fail from the test, or did not crack at all.

- Measurements of tube surface temperatures during operation revealed that thermal cycling of the tubes does not correlate with the location of cracking, nor was the magnitude and frequency of thermal cycling sufficient to induce fatigue cracks in 304L.
- Modeling and measurement of residual stresses in composite tubes show that the outer stainless layer is in compression during normal operation, but surface stresses become tensile at about 200 °C (390 °F) as the tube is cooled toward ambient.
- It was found that 304L and other alloys are very susceptible to SCC when exposed to hydrated salt mixtures ( $\text{Na}_2\text{S}$ ,  $\text{NaOH}$ , and  $\text{Na}_2\text{CO}_3$ ) that simulate the poultices present on the tubes at temperatures in the range of 160 to 200 °C (320 to 390 °F) (Fig. 32).

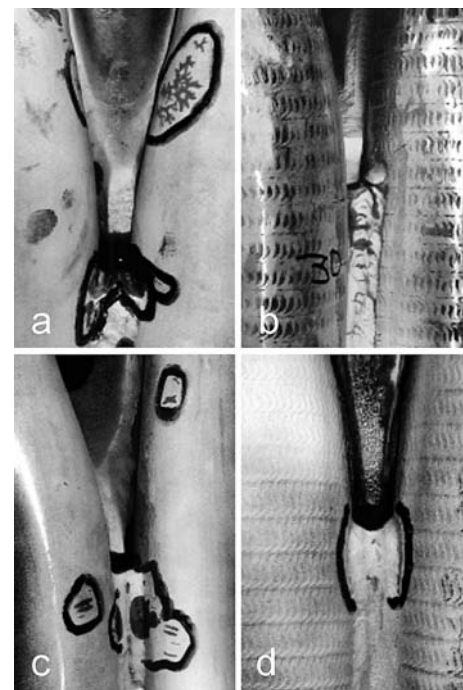
**Fig. 33** Cracks revealed by visible dye penetrant testing on 304L and weld overlay (WO) 625 composite tubes that form primary air-port openings. (a) Craze cracks on 304L. (b) Membrane cracks on WO625. (c) Circumferential cracks on 304L. (d) Tube-membrane weld cracks on WO625.

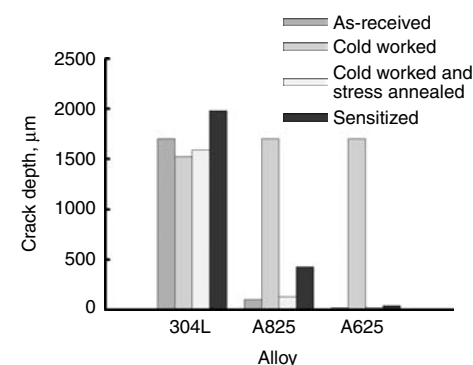
**Fig. 34** Resistance of alloys to stress-corrosion cracking in hydrated 75%  $\text{Na}_2\text{S}$ -25% $\text{NaOH}$  (dry wt%) hydrated salt mixture at 180 °C (355 °F) for a period of 48 h.

much more susceptible to cracking than those that have been annealed (Fig. 34).

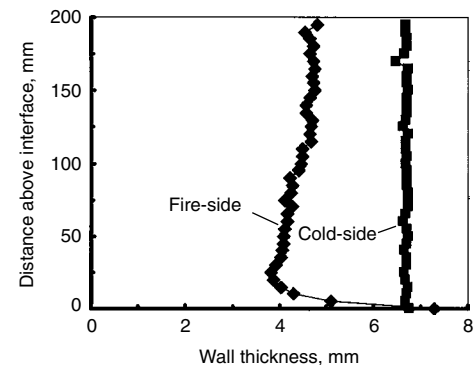
Fig. 35 Thickness profile of a carbon steel tube at the cut-line with the composite tube lower furnace walls

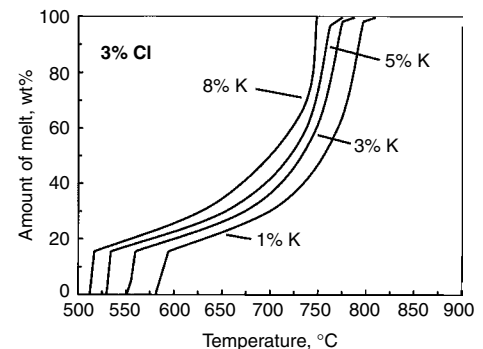
Fig. 36 Influence of chloride (at fixed potassium content) on deposit first melting temperature (Ref 139)

a further increase in concentration does not change the first melting point of the deposit—only the proportion of liquid phase in the deposit at the first melting point (Fig. 36). Conversely, the proportion of liquid phase in the deposit at the first melting point does not change at all with increasing potassium content, but the first melting point will decrease substantially (Fig. 37). To ensure that molten deposits are not in contact with the tube surfaces, current boiler designs typically limit superheater steam temperatures in high-pressure recovery boilers to a maximum of

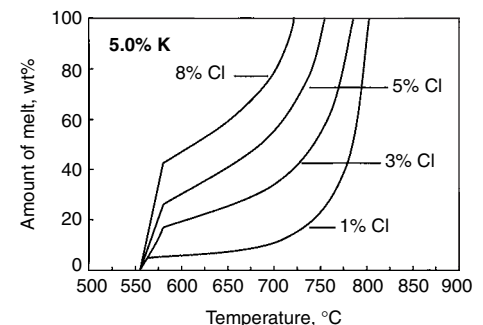
Fig. 37 Influence of potassium (at fixed chloride content) on deposit first melting temperature (Ref 139)

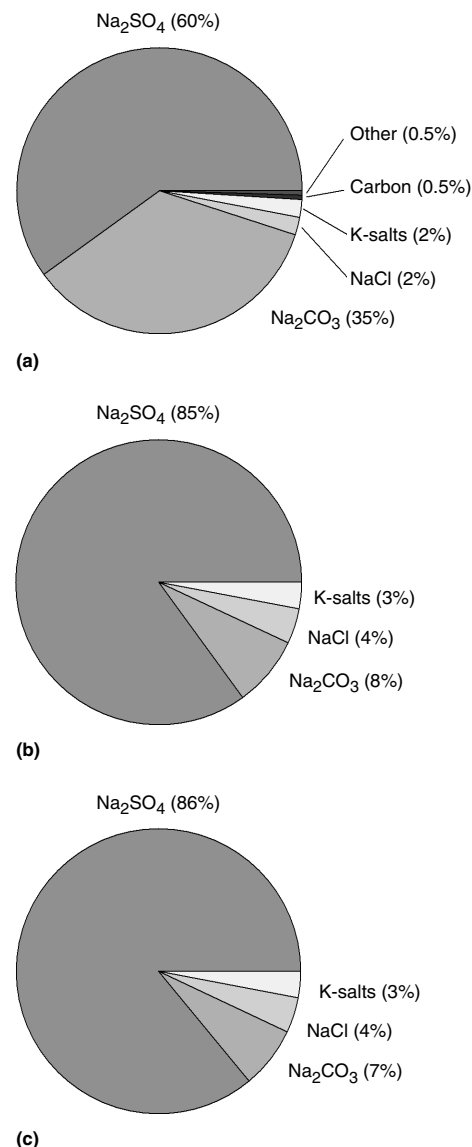
**Fig. 38** Changes that occur in deposit chemistry as the flue gases pass through the (a) superheaters, (b) boiler bank and, (c) economizer

Relative to other boilers, kraft recovery boilers carry a much higher flux of particulate through the superheater, boiler bank, and economizer sections of the boiler (Ref 112). The composition of the deposits changes substantially as the flue gas passes through the boiler (Fig. 38), and also as a function of how the boiler is operated and the overall dimensions of the boiler. Recovery boilers are specifically built with a tall furnace to increase residence time and ensure complete combustion of the fuel, but entrainment of unburned liquor droplets or droplets in various stages of combustion in the superheaters is a common occurrence, especially in older, overloaded boilers. Plugging of the gas passages in the superheaters and boiler banks is a major operational problem for pulp mills and requires constant sootblowing with steam lances, as well as frequent shutdowns to allow the gas passages to be washed clean with hot water. Modern, well-controlled boilers are generally able to run between annual maintenance shutdowns without needing a water wash, but in older boilers, or boilers with high fuel loads, as many as five or six water washes might be required annually. Any of these operational issues can influence the location and severity of corrosion in the superheaters.

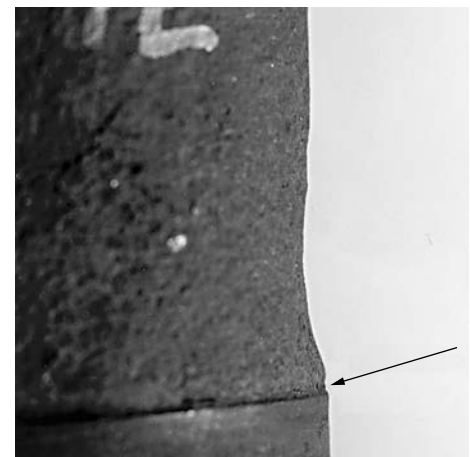
**Fig. 39** Generating bank tube showing near-drum thinning just above the tube seat for the mud drum (arrow points to location where the tube enters the drum)

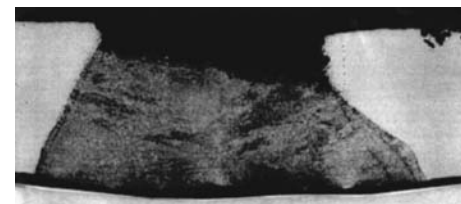
**Fig. 40** Preferential corrosion of type 316L weld metal where aggressive condensate collected in a vapor line

The pH of foul condensates is generally above 8, but in vapor space condensates the pH can be acidic due to dissolved NCGs. Depending on the mill and processes involved, chloride ions may be present. Preferential corrosion of weld metal may occur in the presence of some condensates if they are allowed to collect in "dead" zones. For example, Fig. 40 and 41 show corrosion of ferrite in type 316L weld metal after 20 years of service. Depending on temperature, stress-corrosion cracking of types 304L and 316L has also occurred.

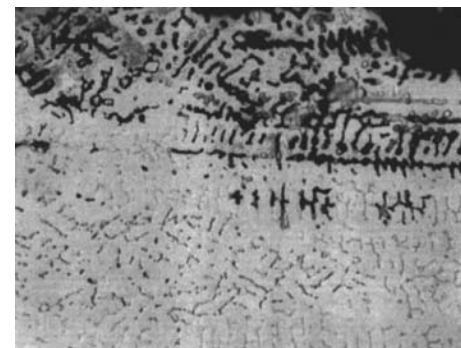
**Fig. 41** Closer view of corrosion of ferrite in weld metal

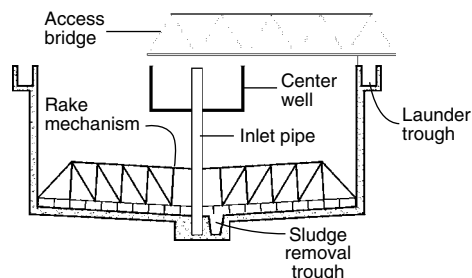
Fig. 42 Primary clarifier

are circular concrete tanks with sloped bottoms. A center-supported, motor-driven rake mechanism as shown in Fig. 42 circulates around the tank to push the settled sludge into troughs in the bottom of the tank for conveyance to a sludge thickener or to sludge dewatering equipment. The center inlet column, feed well, baffles, rake arms, and other metallic components are generally constructed from carbon steel coated with a polymer-based coating system, usually epoxy. Type 316 stainless steel has been used in some rake-mechanism replacement projects. This has generally been very successful.

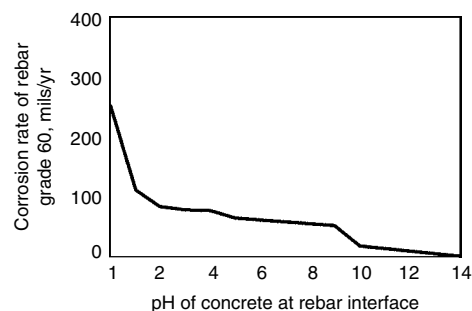
**Fig. 43** Effect of pH on corrosion rate of carbon steel rebar in concrete

Wastewaters with pH values below about 4 are aggressive to concrete structures and promote higher corrosion rates in carbon steel components. Low pH wastewaters will also affect the corrosion rates of austenitic stainless steels (types 304 and 316) provided high chlorides or other aggressive ions are present. pH values of 6 to 12 are generally not aggressive toward concrete. Rebar corrosion can be sustained in concrete where the pH of the surrounding concrete has been reduced from 12.5 (original) to 9.0, chloride is present, and oxygen diffusion is permitted (Fig. 43).

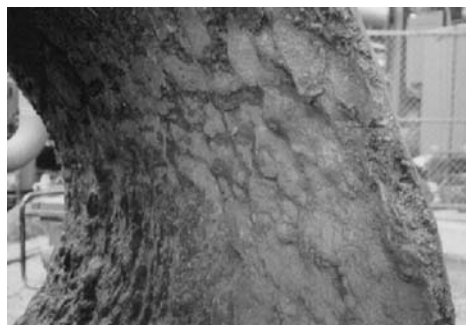
**Fig. 44** Typical carbon steel corrosion morphology due to SRB action

**Microbiologically influenced corrosion (MIC)** occurs commonly in RAS systems causing underdeposit corrosion of carbon steels and stainless steels due to the action of sulfate reducing bacteria (SRB). Uncoated carbon steel and 316L stainless steel have suffered severe corrosion losses due to SRB action in RAS piping systems and in clear effluent piping, respectively (Ref 156). Figures 44 and 45 show carbon steel and 316L stainless steel, respectively, attacked by SRB action.

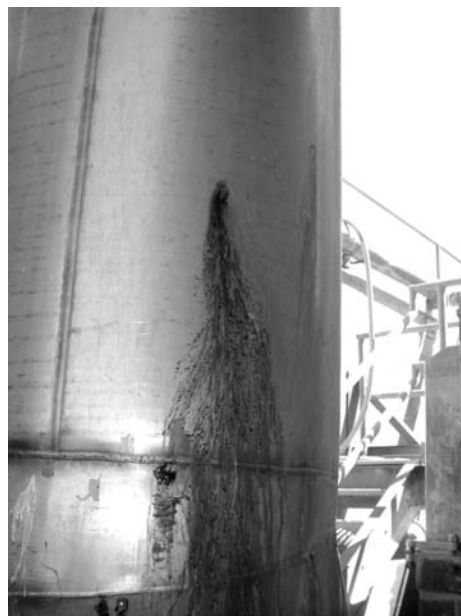
**Fig. 45** Resultant leak of 316L stainless steel due to internal SRB activity

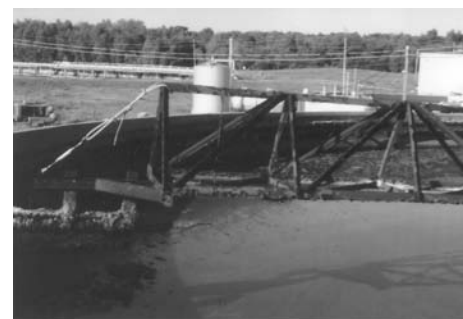
**Fig. 46** Badly corroded rake mechanism in a primary clarifier

Electrolytic couples (galvanic couples) can also occur between the rake mechanism and the reinforcing steel in the concrete walls and floor of clarifiers. With the two metals in a common electrolyte, the steel (rebars) within the alkaline concrete remain cathodic to the submerged steel rake mechanism and center supports, and so forth. Because there is a large surface area of reinforcing steel, corrosion of the immersed-steel clarifier can be significantly accelerated (Ref 156). Figure 46 shows a rake mechanism that suffered severe corrosive attack.

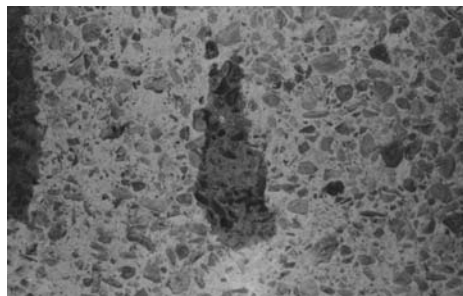
Fig. 47 Typical acidic attack of concrete in a neutralization chamber

The hardened cement paste in concrete is very alkaline, usually starting out with a pH above 12.5. The cement reacts with acidic solutions to produce soluble salts. These are mostly calcium salts because the hydrated cement is about 25% calcium hydroxide. Acid attack dissolves the cement phase of the concrete away, exposing the less soluble aggregate materials (Fig. 47).

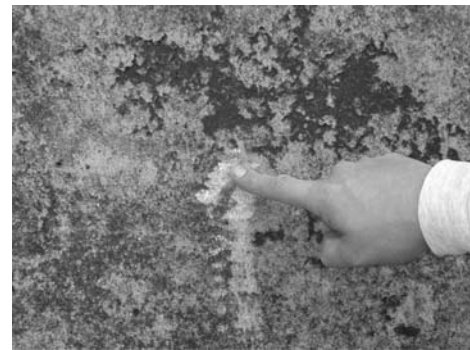
Fig. 48 Cement paste losses due to liquid-phase carbonation in a pure oxygen reactor for a pulp and paper mill

Cement paste depth losses are typically 13 to 19 mm ( $1/2$  to  $3/4$  in.) over 15 or so years of exposure. The rate of cement paste loss is strongly influenced by flow conditions. Under quiescent conditions, the rate of attack is extremely low. The high solubility of calcium carbonate makes carbonation especially influenced by flow conditions. In turbulent flow conditions, the rates are much higher as the reaction products are washed away exposing fresh alkaline surfaces for further attack.

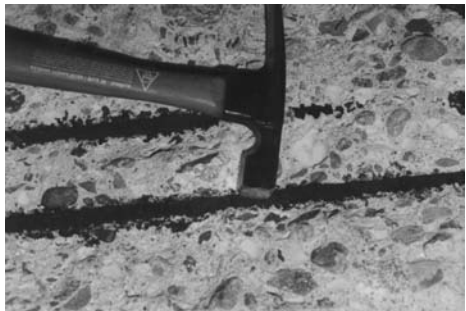
**Fig. 49** Chloride ion induced rebar corrosion in a concrete splitter box that directed flow to two primary clarifiers in a bleached sulfite mill

Passive protection of the steel can be lost when the pH at the rebar/concrete interface decreases because moisture and oxygen penetrate the concrete and reach the steel. Chloride ions are particularly harmful because they disrupt the passive oxide film on the reinforcing steel (Fig. 49). Penetration can occur slowly by permeation of the concrete or rapidly through crack paths. Penetration usually occurs at different times in different locations to form local corrosion sites (anodes) on the reinforcing steel. The uncorroded, still-passive areas serve as the cathodes.

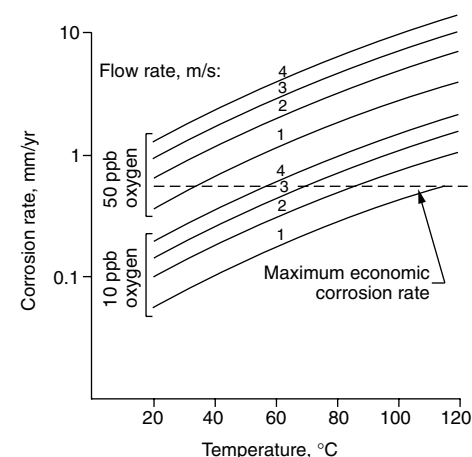
Fig. 1 Effect of flow rate, temperature, and oxygen on corrosion rate of steel in saltwater. Source: Ref 16

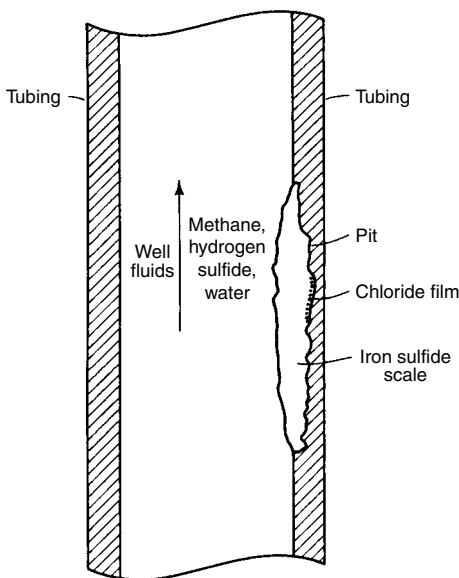
Fig. 2 Barnacle mechanism of sour pitting corrosion. Source: Ref 22

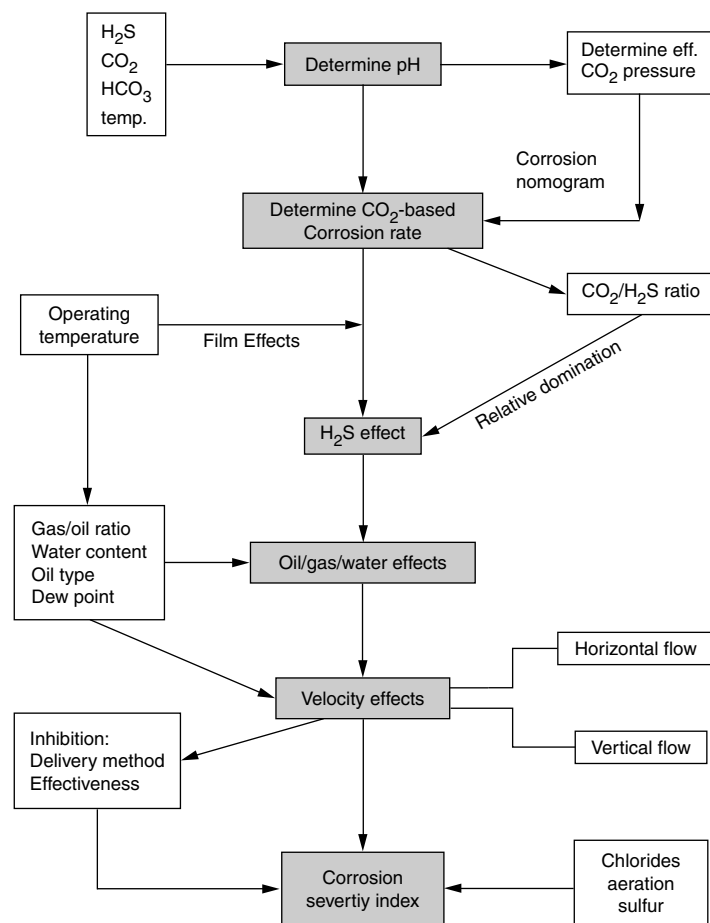
**Fig. 3** Corrosion model software flowchart showing incorporation of multiple effects and variables. Source: Ref 29

Currently, state-of-the-art in corrosion assessment utilizes predictive software tools that can facilitate the use of many simultaneous parametric effects on corrosion through input of production variables (see Fig. 3). Such software tools often incorporate various theoretical and mathematical models combined with heuristics

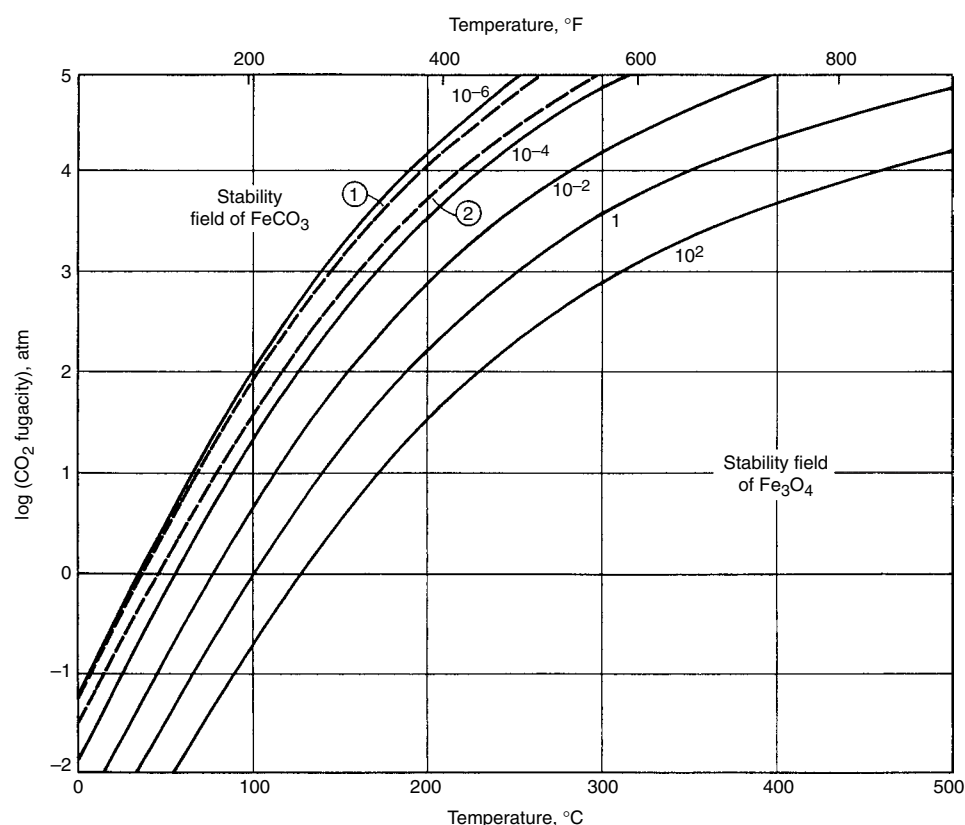
**Fig. 4** Effect of temperature and hydrogen fugacity on the stability of  $\text{FeCO}_3$  and  $\text{Fe}_3\text{O}_4$  in contact with aqueous  $\text{CO}_2$ . Equilibrium calculations determine boundaries (indicated by the isohydrogen fugacity curves, with fugacity given in atmospheres) between  $\text{FeCO}_3$  and  $\text{Fe}_3\text{O}_4$  stability fields in the produced fluid, which contained  $\text{CO}_2$ , water, and traces of hydrogen. Curves 1 and 2 locate boundaries for locations 5180 m (17,000 ft) deep and at the wellhead, respectively, of a 170,000 m<sup>3</sup>/day (6,000,000 ft<sup>3</sup>/day) well corroding at a rate of 0.75 mm/yr (30 mils/yr). Source: Ref 25

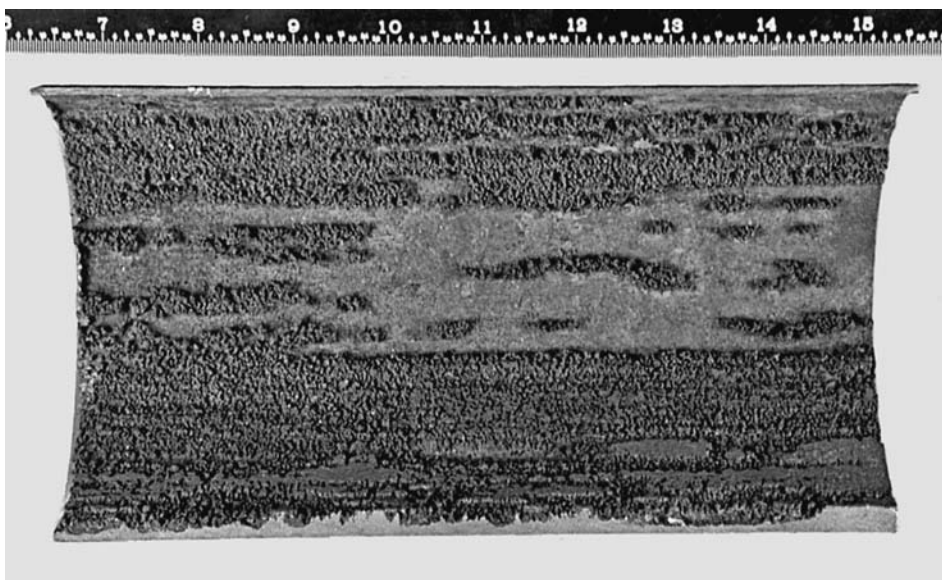
**Fig. 5** Characteristic appearance of mesa corrosion resulting from CO<sub>2</sub>, water, and flow. Source: InterCorr International, Inc.

Iron carbonate lacks conductivity and therefore does not provide an efficient cathode surface. Thus, the types of pitting mechanisms found in oxygenated and in  $\text{H}_2\text{S}$ -containing systems do not occur in a  $\text{CO}_2$ -only system unless contamination occurs. Rather, generalized corrosion occurs at any regions not covered by the protective scale. The result is that on any bare (unfilmed) metal, the anodic and cathodic regions are so microscopically dispersed that salt—to provide conductivity—is not needed to achieve the very high corrosion rates predicted by Eq 1. This often leads to a condition referred to as mesa corrosion in which local, unfilmed areas of steel corrode actively at a high rate, but adjacent filmed regions remain uncorroded. This results in a characteristic corrosion pattern reminiscent of the mesas produced in rock by wind and water erosion (see Fig. 5).

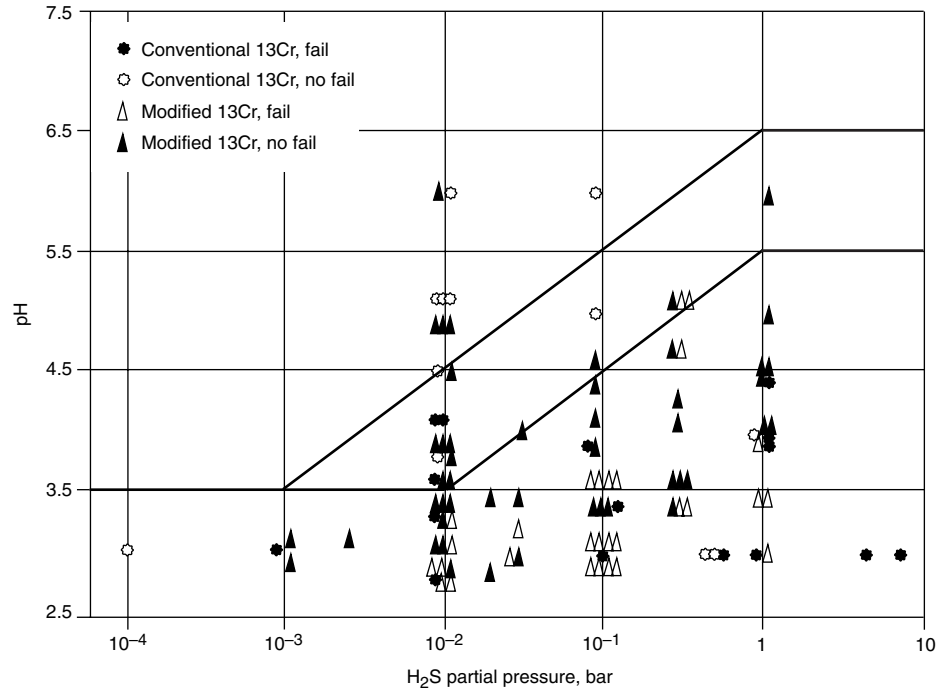
Fig. 6 Effect of H<sub>2</sub>S partial pressure and pH and susceptibility to SSC for 13% Cr martensitic stainless steel tubular grades. Source: Ref 39

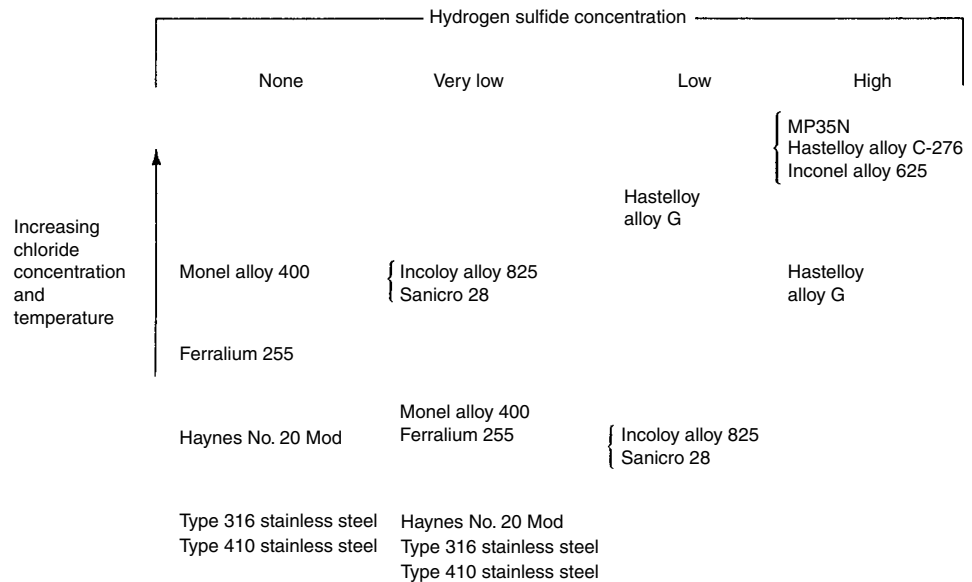
Fig. 7 Corrosion-resistant alloy selection for production environments containing aqueous CO<sub>2</sub> and H<sub>2</sub>S

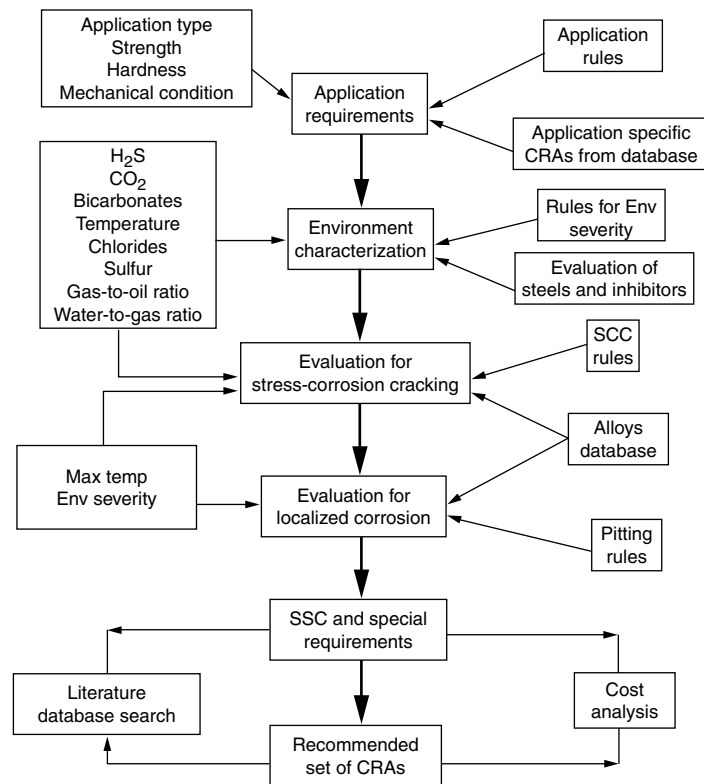
**Fig. 8** Hierarchical decision tree for use in developing software tool for materials selection of oil and gas service applications. CRA, corrosion-resistant alloy; Env, environment; SCC, stress-corrosion cracking; SSC, sulfide stress cracking. Source: Ref 41

More recently, this approach has been broadened to include the full range of conditions in H<sub>2</sub>S and CO<sub>2</sub> production environments through materials selection software. Figure 8 shows a schematic of the hierarchical approach. This approach is called selection

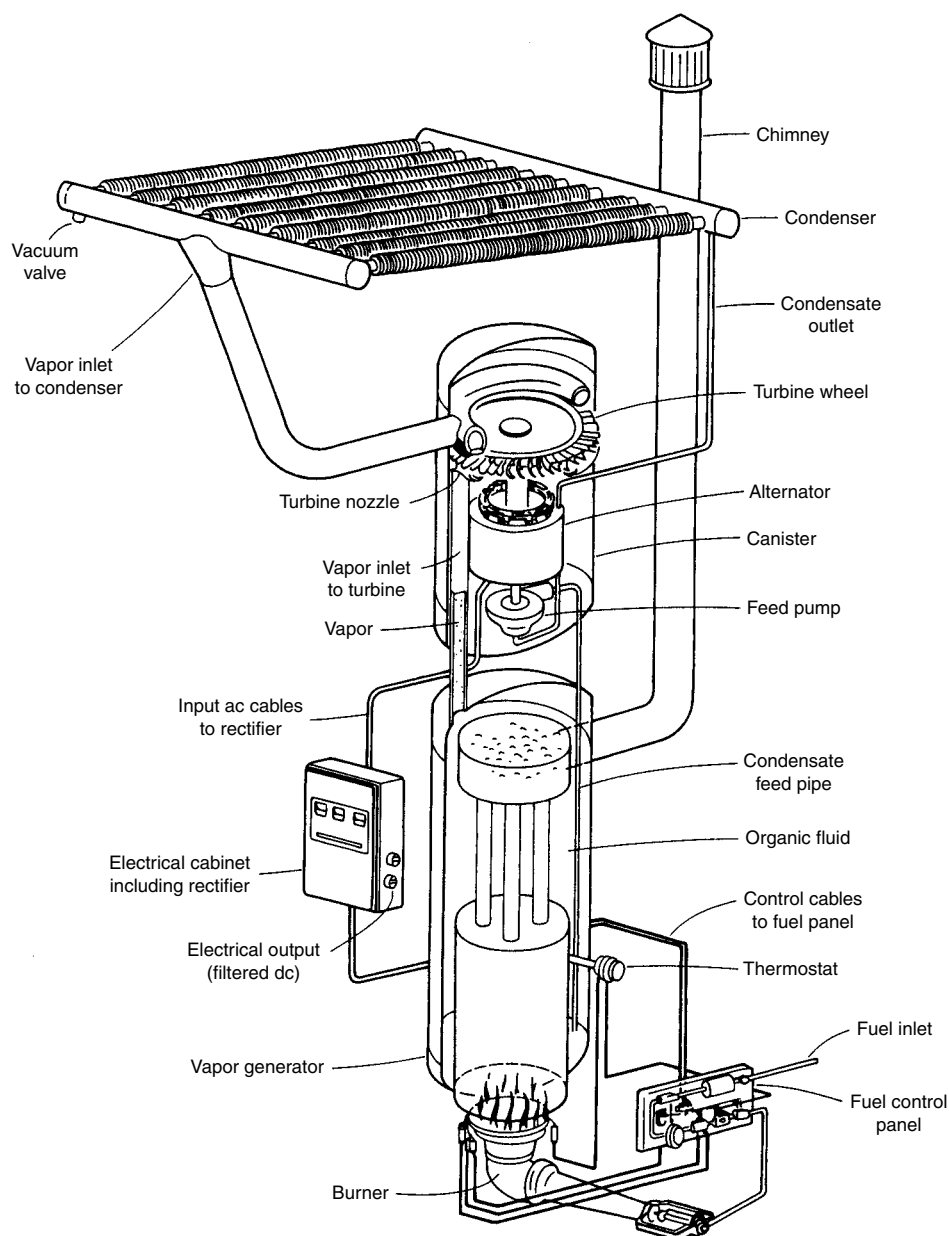
Fig. 9 Thermoelectric generator used to power cathodic protection systems in remote locations. Source: Ref 50

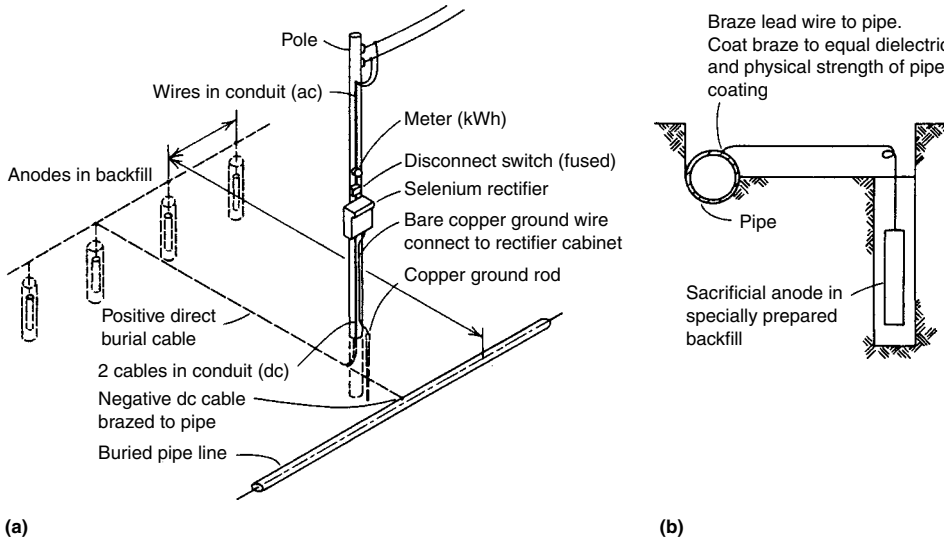
Fig. 10 Typical cathodic protection installations. (a) Impressed current. (b) Sacrificial anode
