# ASM Handbook®

## Volume 13C Corrosion: Environments and Industries

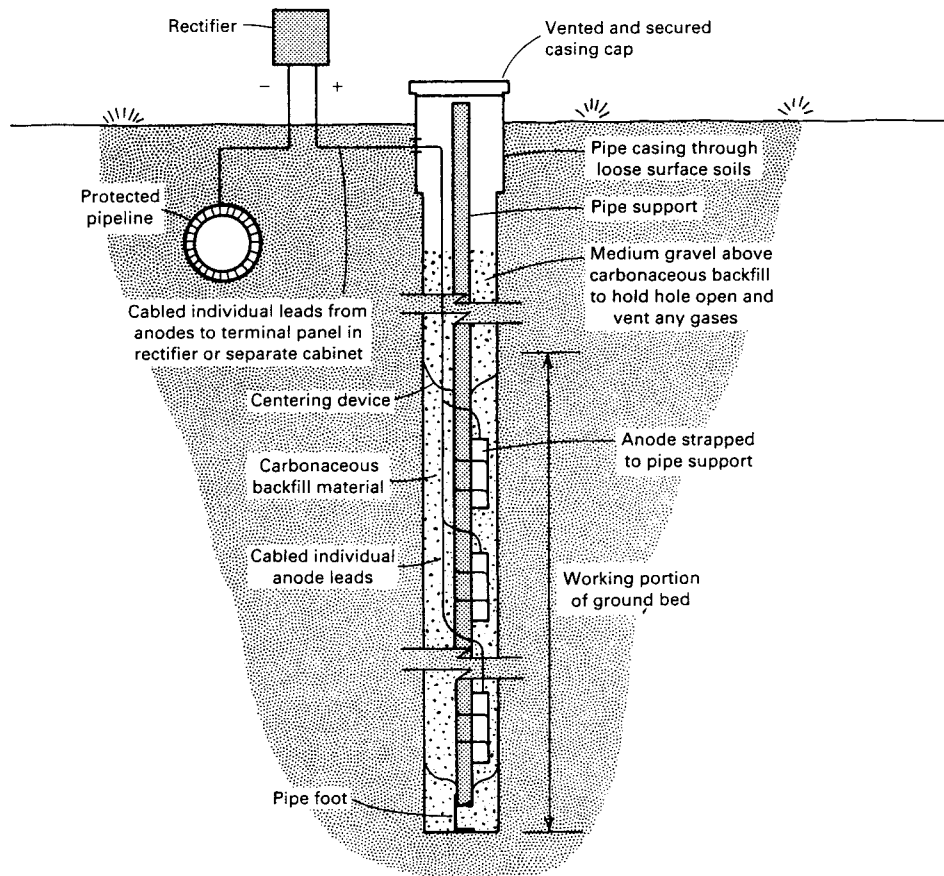
Fig. 11 Typical deep groundbed cathodic protection installation. Source: Ref 53

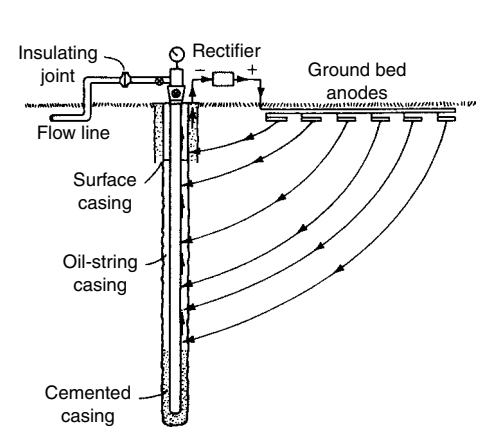
Fig. 12 Cathodic protection installation for a well casing. Source: Ref 54

Another method of reducing the current requirement is to place an insulating joint in the flow line at the wellhead. This joint prevents current from the flow line from flowing into the wellhead and down the casing. This current would leave the casing at low-resistivity zones (Ref 54–56).

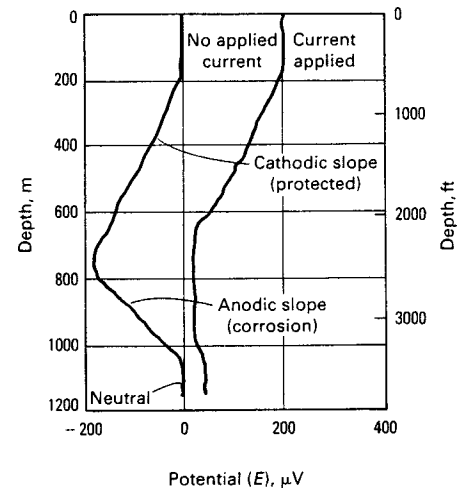
Fig. 13 Casing potential profile curve. Source: Ref 56

potential profile and  $E$ -log  $I$ . The casing potential profile is measured by using a tool that consists of two spring-loaded probes approximately 7.6 m (25 ft) apart. This tool is pulled through the casing, and voltage readings are taken between the probes as they contact the casing every 15 or 30 m (50 or 100 ft). A plot of potential versus depth is made (Fig. 13). A slope upward and to the left indicates an anodic area, while a slope upward and to the right indicates a cathodic area. Current from a temporary grounded is then applied to the casing for protection, and another potential profile is taken. Current is increased until the profile slopes are upward and to the right. Providing a profile slope to the right does not necessarily mean that

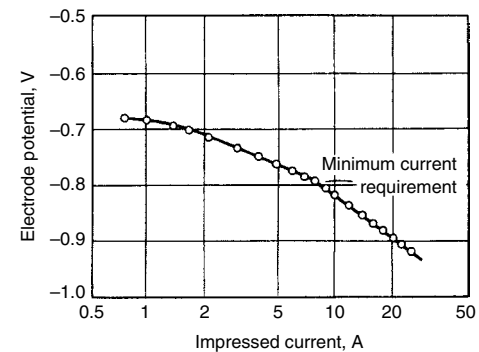
Fig. 14 Typical E-log I curve. The break in the curve indicates the minimum cathodic protection current requirement. Source: Ref 56

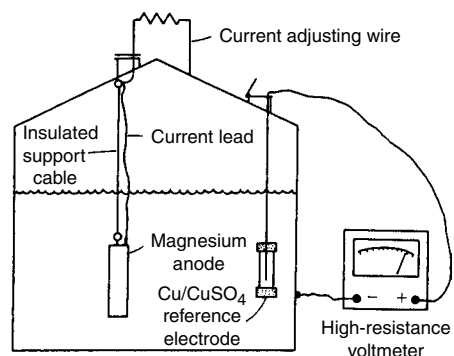
Fig. 15 Cathodic protection system for a water storage tank. Source: Ref 57

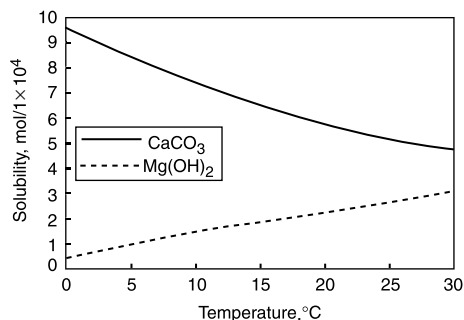
Fig. 16 Influence of temperature on solubility of calcium carbonate and magnesium hydroxide. Source: Ref 61

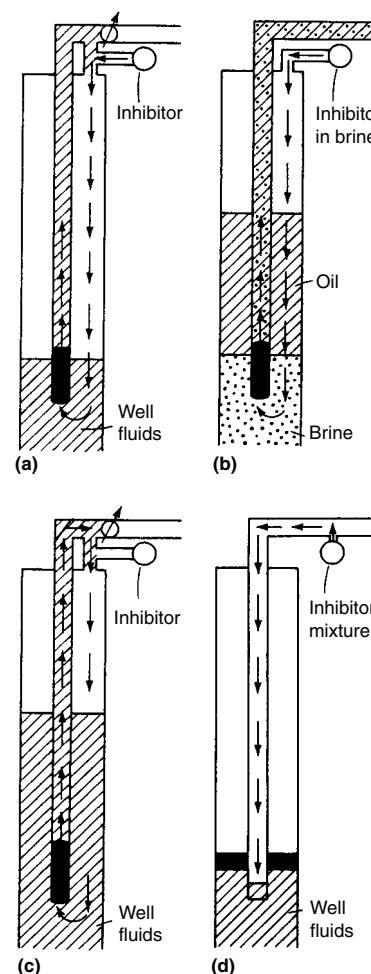
Fig. 17 Four types of batch inhibitor treating techniques. (a) Standard batch. (b) Annular slug. (c) Extended batch. (d) Tubing displacement

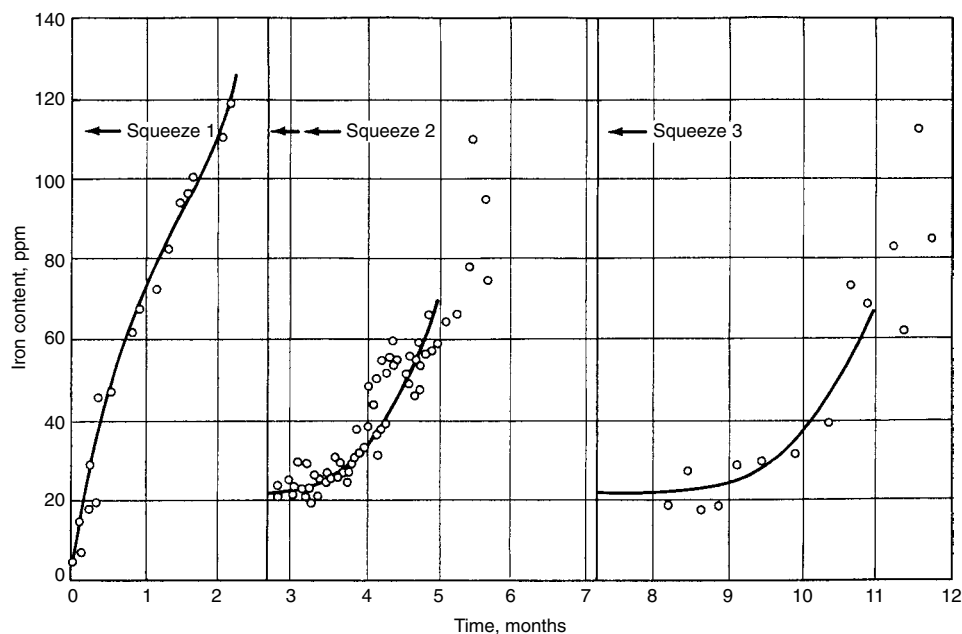
Fig. 18 Iron content of produced water after squeeze treatment. Iron content is one measure of inhibitor effectiveness.

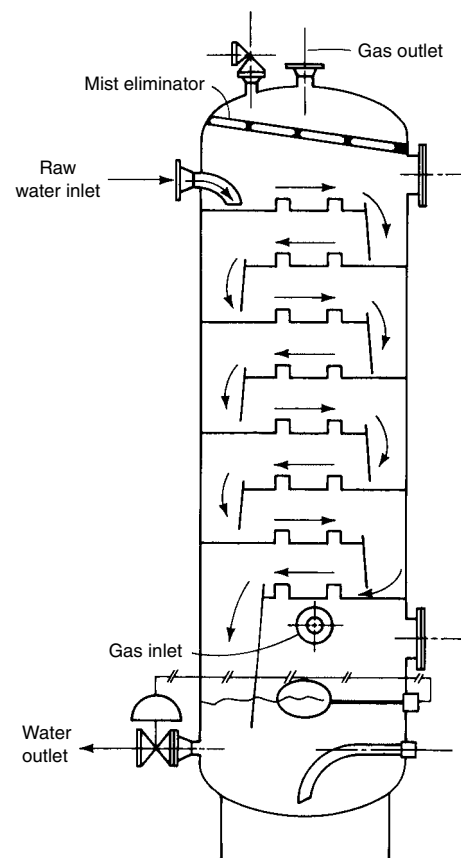
Fig. 19 Tray-type countercurrent gas stripping column. Source: Ref 57

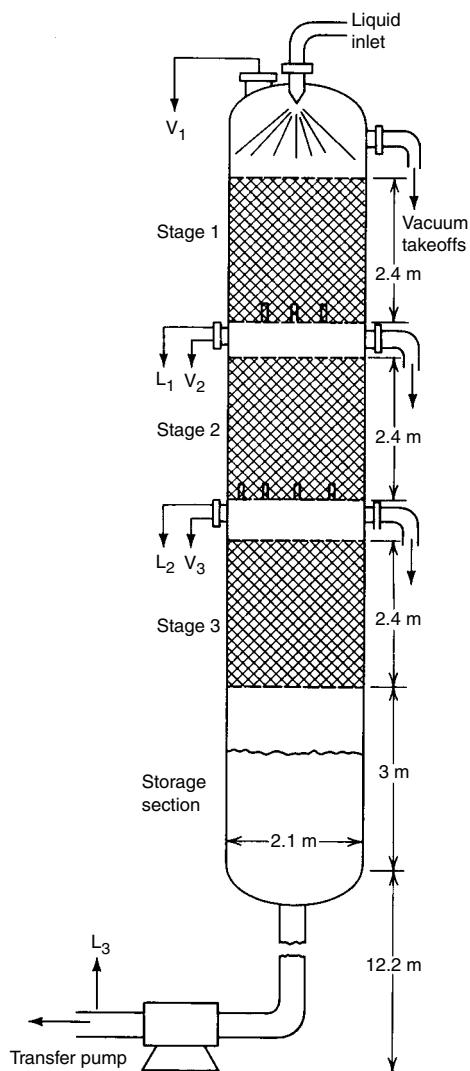
**Fig. 20** Three-stage vacuum deaerator tower.  $L_1$ ,  $L_2$ ,  $L_3$  and  $V_1$ ,  $V_2$ ,  $V_3$  are liquid and vapor sample points, respectively. Pressure decreases as the liquid moves down the tower. Source: Ref 57

**Vacuum Deaeration.** In this process, a vacuum is created in a packed tower, and as the oxygenated water is passed over the packing, the low pressure causes the oxygen to bubble from solution. The vacuum pump pulls the oxygen, water vapor, and other gases from the top of the tower. The tower usually consists of several different pressure stages, as shown in Fig. 20. In a packed column, each stage consists of a height of packing, which is sealed from the stage below by a layer of water in the bottom of the packing (Ref 57). A single-stage tower will economically remove oxygen only to a lower limit of about 0.1 ppm (1000 ppb) because the excessive vacuum pump horsepower required to achieve lower concentrations is not usually feasible. Therefore, multistage columns are needed. Dissolved oxygen concentrations as low as 0.01 ppm (10 ppb) have been achieved in three-stage towers (Ref 57). While this level of

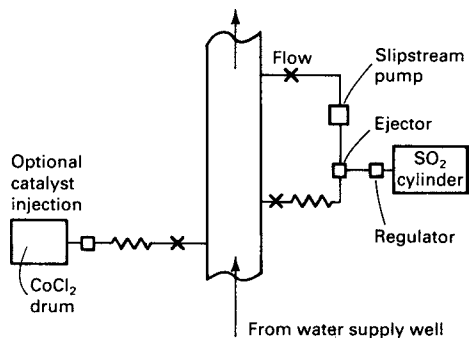
**Fig. 21** Application of  $\text{SO}_2$  through the use of a bypass line.

A quantity of 4 ppm by weight of  $\text{SO}_2$  is required to remove 1 ppm of oxygen. A 10% excess and a catalyst such as cobalt chloride are needed to complete the reaction. Sulfur dioxide from cylinders is applied by using a bypass line that handles approximately 10% of the total fluids, as shown in Fig. 21. The scavenger is added to the bypass fluids. The materials used in this bypass line should be resistant to acid attack because of the low pH formed from the reaction. Use of  $\text{SO}_2$  cylinders is most advantageous in small systems (less than 10,000 barrels per day) or where small concentrations of dissolved oxygen are encountered in larger systems (Ref 83).

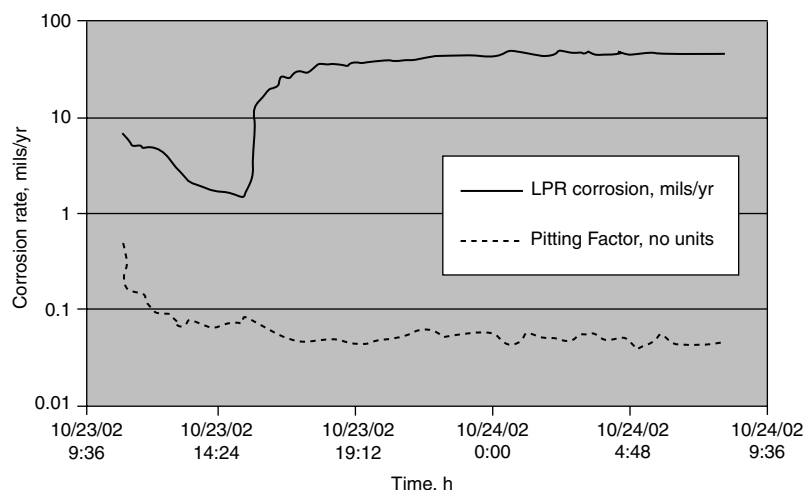
**Fig. 22** Monitoring of corrosion in drilling fluids versus flow conditions. LPR, linear polarization resistance; Pitting Factor values, defined as the standard deviation of the corrosion current divided by the mean corrosion current,  $\geq 0.1$  indicate active pitting conditions.

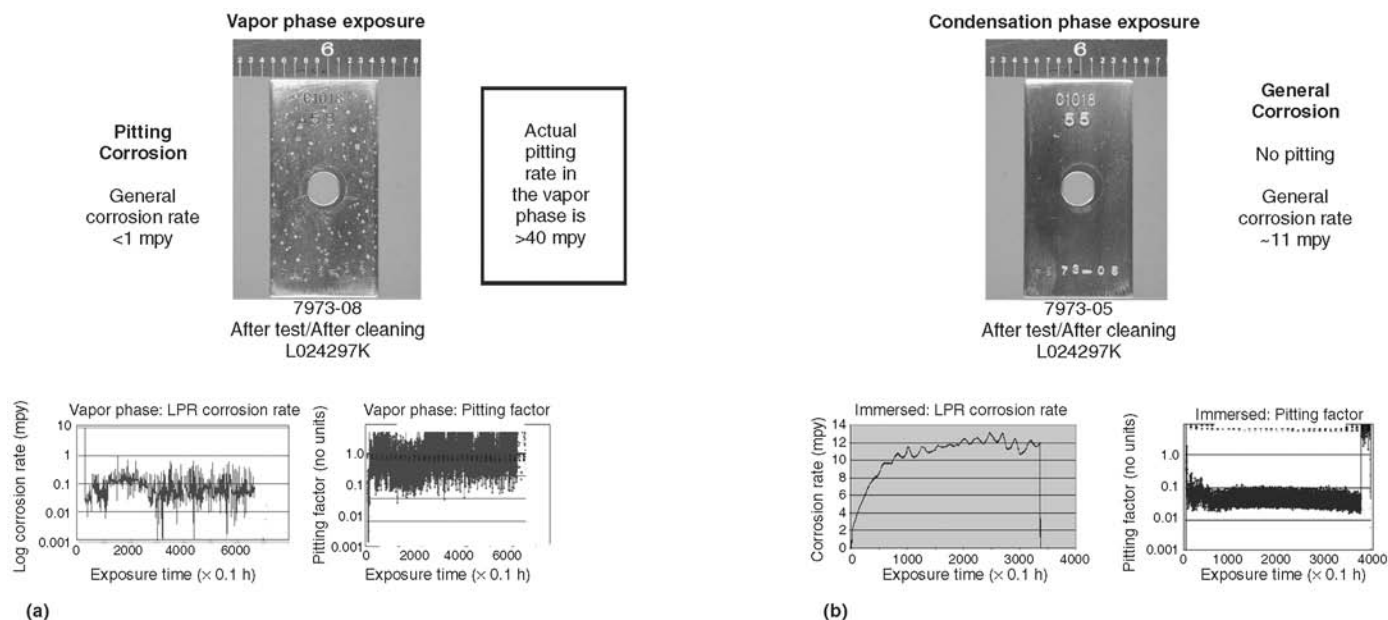
**Fig. 23** Differences in corrosion rate and modality—(a) pitting and (b) general corrosion—as determined by automated, real-time electrochemical corrosion monitoring system using linear polarization resistance, electrochemical noise, and harmonic distortion analysis. Note comparison of electrochemical data from a partially dehydrated CO<sub>2</sub> gas pipeline liquid phase water/glycol and condensing vapor phase in system. Corrosion rates are given in mils per year (mpy). Source: Ref 100

shows a comparison of coupon examination and mass loss determination versus real-time, online monitoring data using an electrochemical device incorporating LPR, HDA, and EN techniques (Ref 100). It can be seen that the corrosion rate and pitting factor obtained by electrochemical monitoring provide accurate assessment of pitting and general corrosion within a time frame of hours. The coupon data required exposure for a period of about 1 month. While corrosion coupons and electrochemical techniques provide similar data, the online, real-time electrochemical data would allow the operator to take corrective measures (e.g., process change, inhibition, etc.) before substantial damage has occurred.

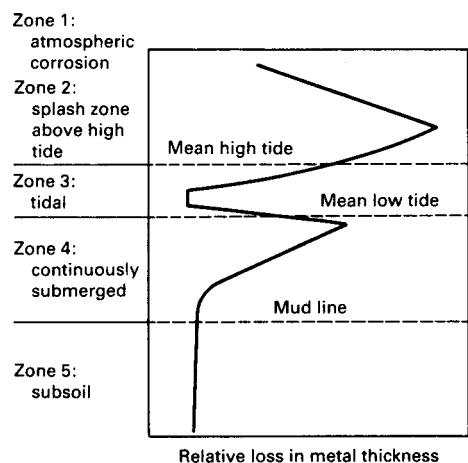
**Fig. 24** Corrosion zones on fixed offshore structures. Source: Ref 106

Marine structures operate in a complex environment that can vary significantly according to site location and water depth. Figure 24 shows the four main platform corrosion zones: soil, seawater, splash zone, and marine atmospheric. Recently, studies have shown that deep seawater conditions also pose their own unique conditions that are different from normal marine service under shallower conditions.

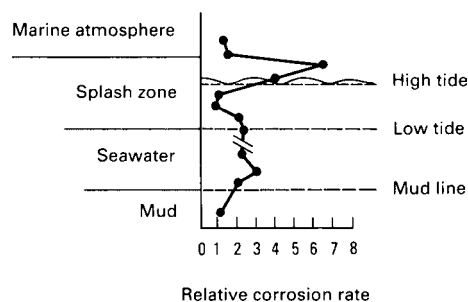
**Fig. 25** Zones of corrosion for steel in seawater and the relative corrosion rate in each zone. Source: Ref 108

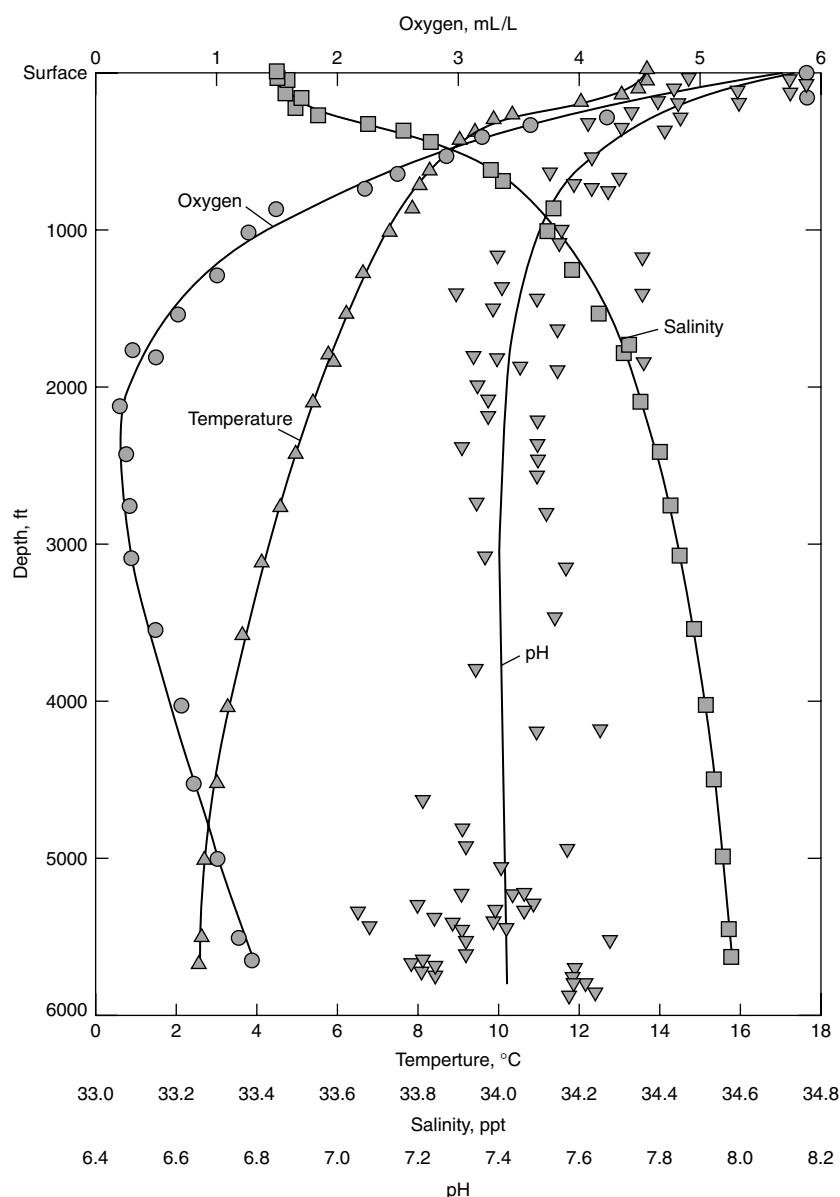
Fig. 26 Variation of oxygen, pH, and other seawater parameters with depth in the Atlantic ocean. Source: Ref 63

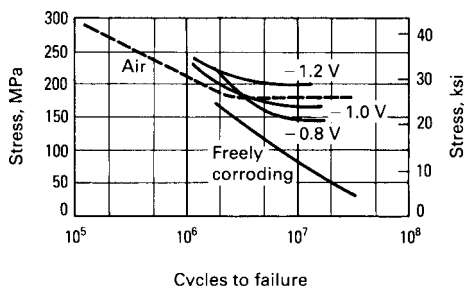
**Fig. 27** Fatigue data for carbon steel in seawater as a function of specimen potential. Source: Ref 114

of corrosion fatigue. As Fig. 27 illustrates, steel immersed in seawater does not exhibit an endurance limit. Because there is no endurance limit, unprotected steel exposed to seawater is susceptible to fatigue failure even at low stress levels after long-term cyclic service. An API study discussed crack initiation in smooth, notched, and welded specimens and summarized a number of earlier investigations (Ref 115). Table 16 ranks according to importance the various seawater environmental variables influencing corrosion fatigue crack initiation of carbon steel. The corrosion fatigue effects are eliminated by the application of cathodic protection (Fig. 28).

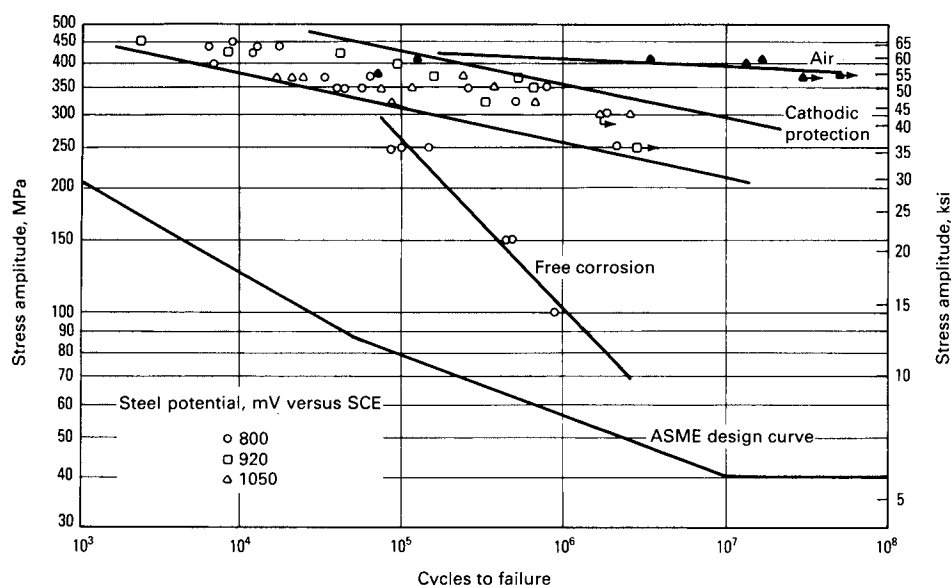
**Fig. 28** Effect of cathodic protection on the fatigue performance of alloy steel in seawater. Tests performed on 6.4 mm (1/4 in.) diam specimens at a mean stress of 425 MPa (69 ksi)

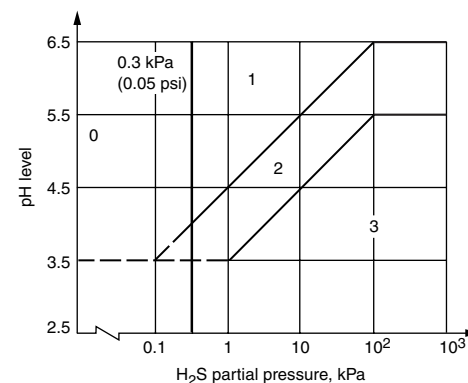
**Fig. 29** Regions of increasing sour-service severity (0, 1, 2, 3) on a plot of pH and H<sub>2</sub>S partial pressure. Source: Ref 14

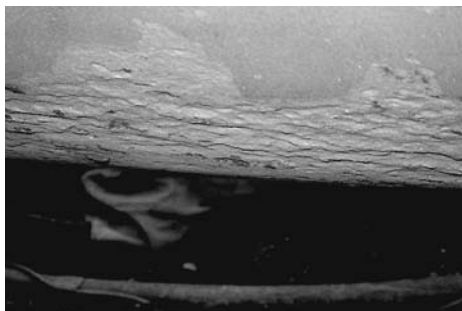
**Fig. 1** Example of external corrosion of an underground pipeline. Lower quadrant of pipeline shown after coating removal and abrasive cleaning

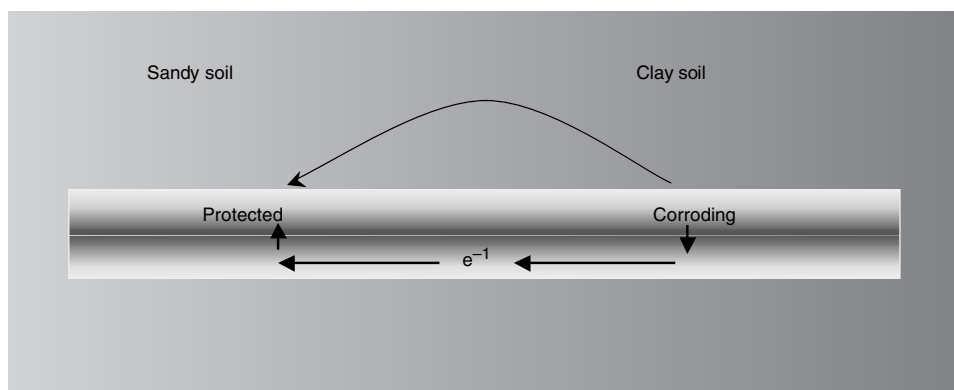
**Fig. 2** Differential corrosion cell created by differences in soils. Arrows indicate the direction of ionic and electronic current flow.

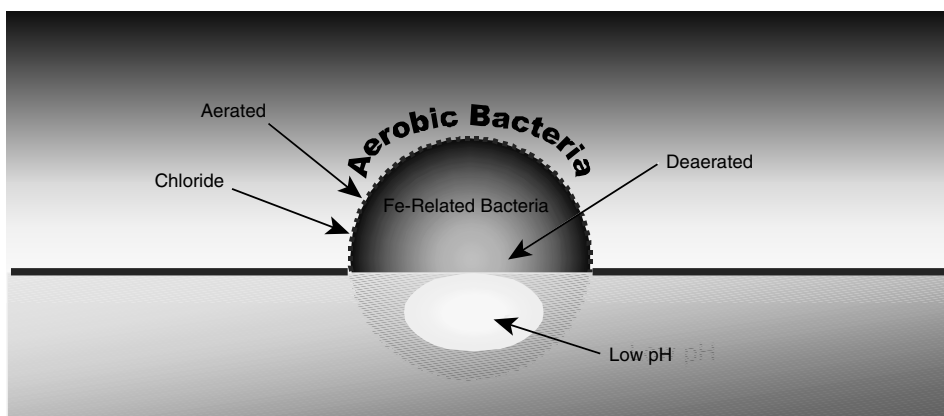
Fig. 3 Iron-related bacteria creating a differential oxygen and pH cell on a metal surface

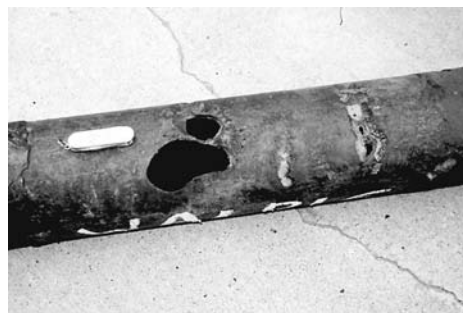
Fig. 5 Pipeline that experienced stray current corrosion caused by inverting the electrical leads to a cathodic protection rectifier

In the case of stray current corrosion from a foreign pipeline, the pipeline acts as a return current path for the cathodic protection system on the foreign pipeline. Stray current corrosion occurs where the dc discharges from the pipeline and collects onto the foreign pipeline, as shown in Fig. 4. While relatively rare, cathodic protection rectifiers are occasionally connected backwards, such that dc current is discharged from the pipeline and the impressed current "anode" actually collects rather than discharges current. This can result in severe stray current corrosion of the pipeline (Fig. 5).

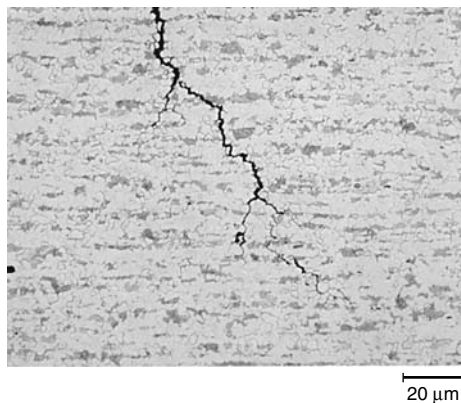
**Fig. 7** Intergranular high-pH stress-corrosion crack in line pipe steel. Nital etchant. Original magnification: 400×

(Fig. 7). The near-neutral-pH form of SCC is transgranular—the cracks propagate through the grains in the metal—and it is associated with corrosion of the crack faces and, in some cases, with corrosion of the external surface of the pipe as well (Fig. 8). This form of cracking was first reported on a polyethylene-tape coated pipeline on the TransCanada Pipelines Ltd. (TCPL) system in the 1980s (Ref 15, 16).

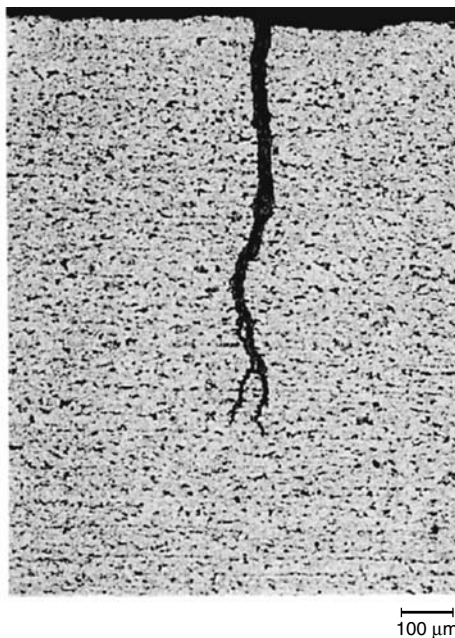
**Fig. 8** Transgranular near-neutral-pH stress-corrosion crack in Nital etchant. Original magnification: 100×

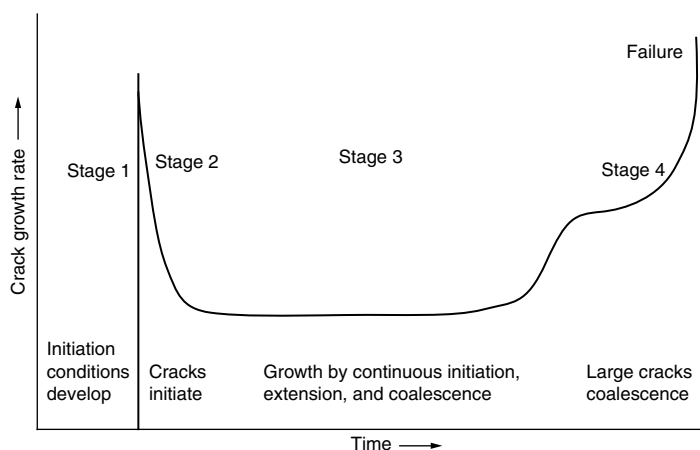
Fig. 9 Life model for a colony of stress-corrosion cracks. Source: Ref 17

Figure 9 shows a “life” model for a pipeline containing stress-corrosion cracks (Ref 17). The model consists of four stages. In stage 1, the conditions for the initiation of SCC develop at the pipe surface. The coating disbonds, a cracking electrolyte develops at the pipe surface, and the pipe surface may become pitted or modified in other ways as a result of the presence of the electrolyte. Cracks begin to initiate in stage 2, and continued initiation, growth, and crack coalescence occur in stage 3. In stage 4, large cracks coalesce and final failure occurs. The coalescence of individual stress-corrosion cracks helps to determine whether a colony of cracks is an integrity concern. If cracks nucleate in close proximity to one another, crack growth may be dominated by the coalescence of collinear cracks. Coalescence can occur throughout the SCC life cycle. Depending on the size of the crack, either environmental or mechanical forces can cause the cracks to grow during stage 3. In stage 4 of growth, coalescence may occur primarily by tearing, when mechanical loading has a stronger effect in producing crack growth.

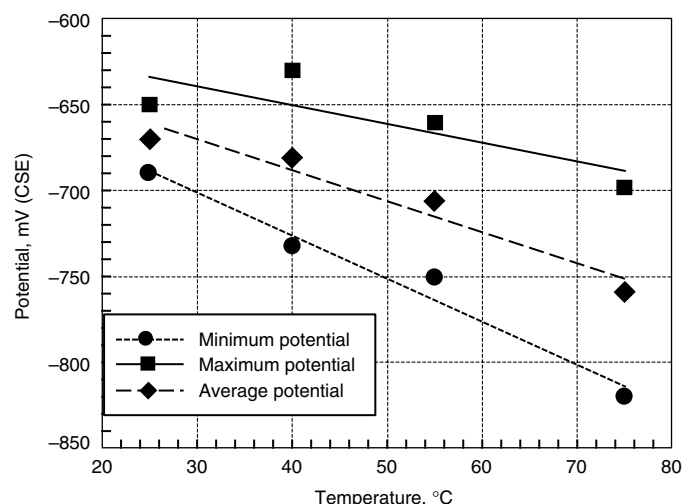
Fig. 10 Effect of temperature on the potential range for cracking in a simulated high-pH cracking environment containing 12 g/L  $\text{Na}_2\text{CO}_3$  and 37 g/L  $\text{NaHCO}_3$ . CSE, copper/copper sulfate electrode. Source: Ref 28

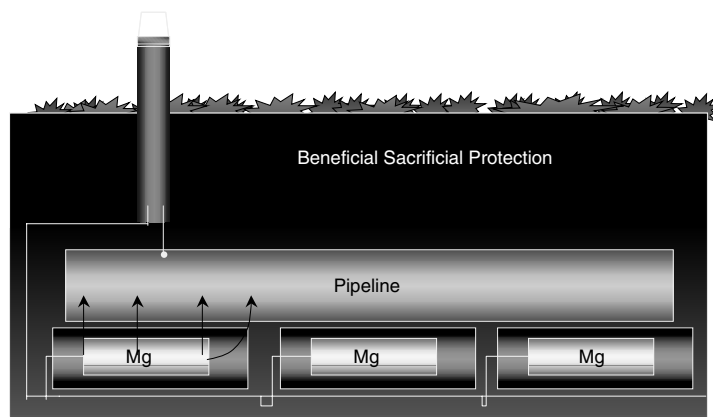
Fig. 11 Sacrificial anode CP system with distributed magnesium anodes and an above-ground test station

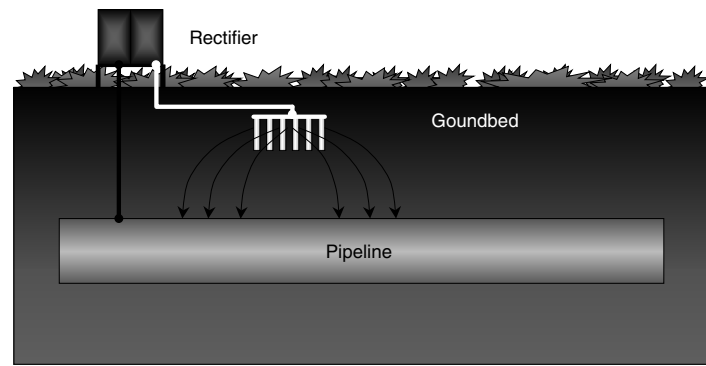
Fig. 12 Impressed current CP system with above-ground rectifier and a single remote anode groundbed

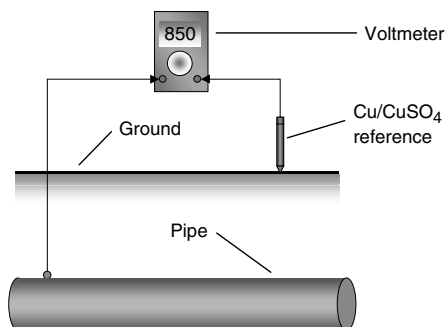
Fig. 13 Pipe-to-soil potential measurement

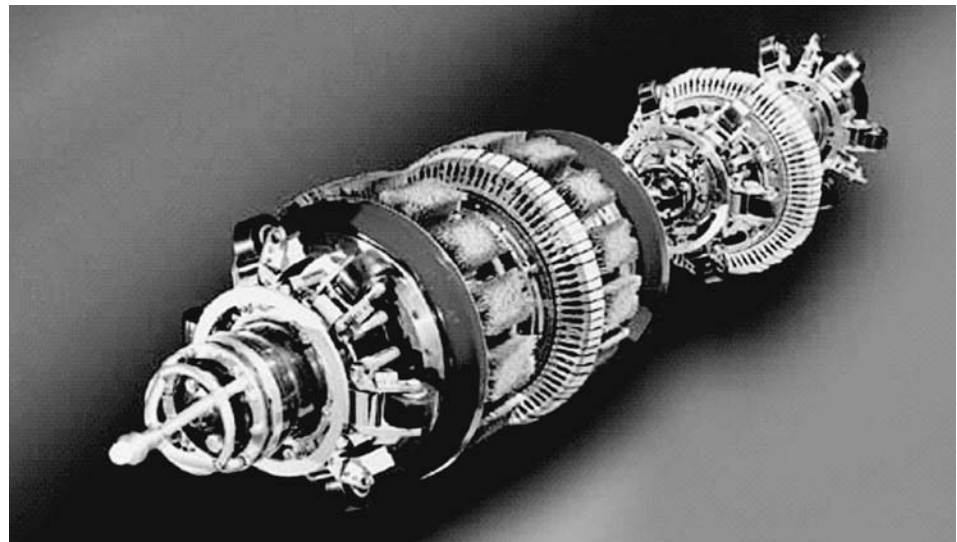
Fig. 14 Magnetic flux leakage tool for detection and sizing of corrosion defects in a pipeline. Courtesy of PII

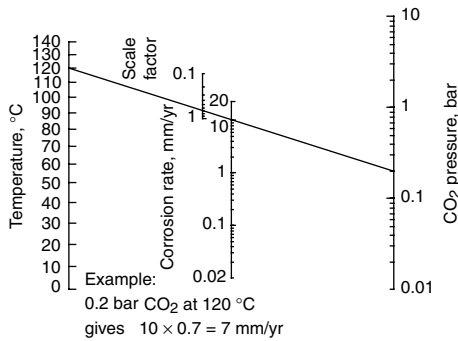
Fig. 1  $\text{CO}_2$  corrosion nomogram. Source: Ref 2

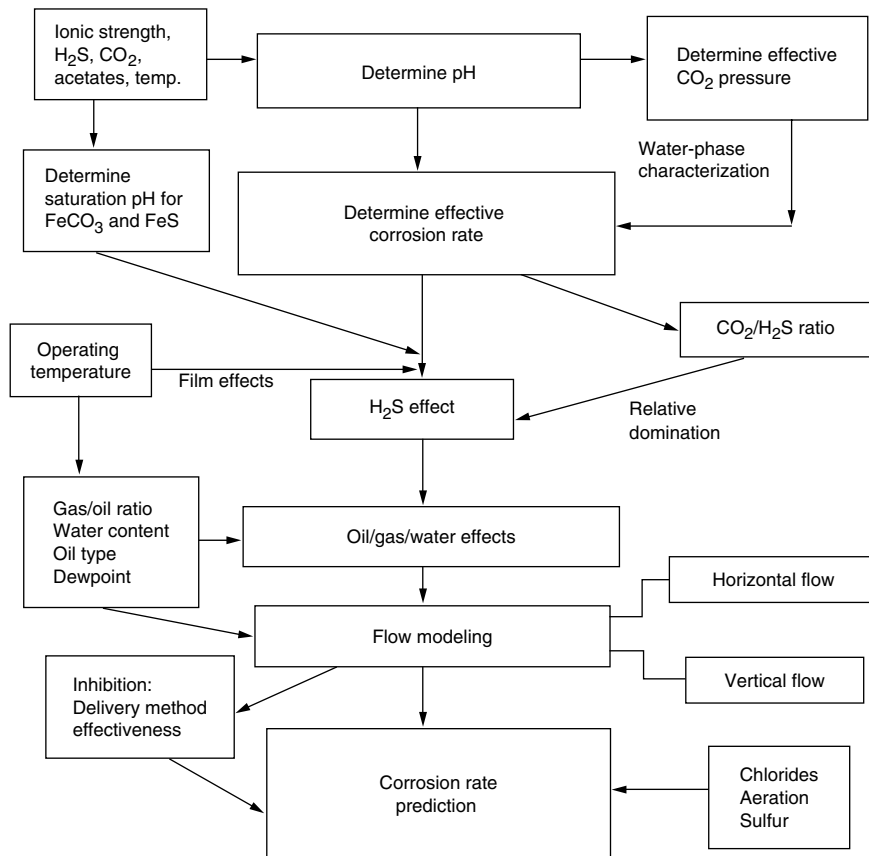
Fig. 2 Corrosion rate prediction flow chart. Source: Ref 9

A typical flow chart delineating the hierarchical reasoning structure of a predictive model described in this article is given in Fig. 2 (Ref 9). The first step in corrosivity determination is computation of the system pH, because it is the hydrogen ion concentration that drives the anodic dissolution. Further, the role of pH in promoting or mitigating  $\text{CO}_2$ -based corrosion has been extensively chronicled (Ref 18–21). For oil/gas production environments, where it is the dissolved  $\text{CO}_2$  or  $\text{H}_2\text{S}$  that contributes significantly to an acidic pH, the pH can be determined as a function of acid gas partial pressures, bicarbonates, and temperature, as shown in Fig. 3 (Ref 22). From a practical standpoint, the contribution of  $\text{H}_2\text{S}$ ,  $\text{HCO}_3^-$ , or temperature to pH determination is another way of representing effective levels of  $\text{CO}_2$  that would have produced a given level of pH.

As indicated earlier, it is necessary to superposition effects of other critical system parameters on base corrosion rate. The flow chart in Fig. 2 provides the lists of sequential effects that are important from the standpoint of corrosivity determination. In addition to the system pH, these include:

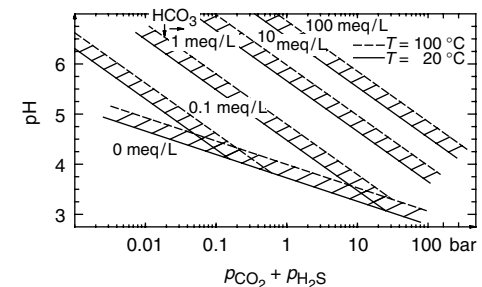
Fig. 3 In situ pH determination for production environments. meq/L, milliequivalents per liter. Source: Ref 22

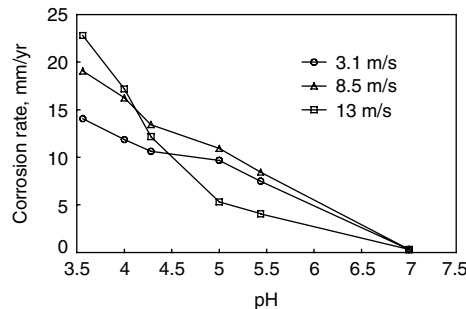
Fig. 4 Corrosion rate of steel as a function of pH and velocity. Source: Ref 13

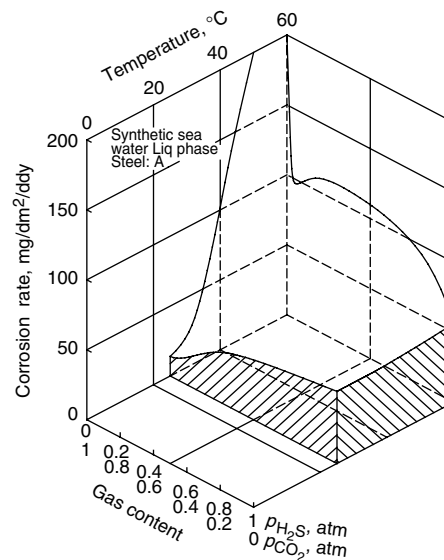
Fig. 5 Effect of gas composition and temperature on corrosion rate of steel. Source: Ref 28

The effect of  $\text{H}_2\text{S}$  adopted in the predictive model reflects work from Ref 28 for  $\text{CO}_2$ -dominated systems. Figure 5 (Ref 28) shows the combined effects of temperature and gas composition on the corrosion rate of carbon steels. Figure 6 (Ref 7) shows the effect of varying degrees of  $\text{H}_2\text{S}$  contamination on  $\text{CO}_2$  corrosion. It is to be noted that the role of  $\text{H}_2\text{S}$  in  $\text{CO}_2$  corrosion is a complex issue governed by film stability of  $\text{FeS}$  and  $\text{FeCO}_3$  at varying temperatures and is an area of further active research by the authors. For additional information on  $\text{CO}_2$  effect on carbon and chromium alloy steels, see Ref 29.

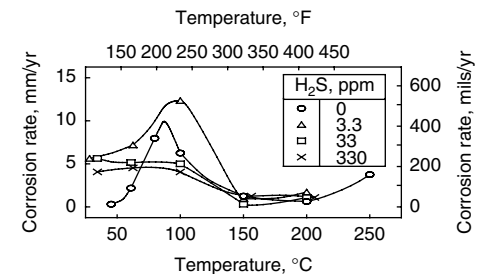
Fig. 6 Effect of  $\text{H}_2\text{S}$  and temperature on corrosion rate in pure iron. Source: Ref 7

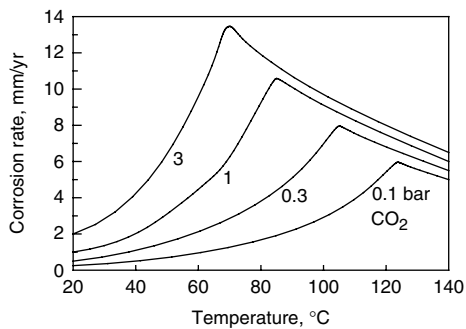
Fig. 7 Corrosion rate as a function of temperature and CO<sub>2</sub> pressure. Source: Ref 2

**Temperature Effects.** Temperature has a significant impact on corrosivity in  $\text{CO}_2/\text{H}_2\text{S}$  systems. Corrosion rate as a function of different levels of  $\text{CO}_2$  and temperature is given in Fig. 7 (Ref 2). It has to be noted that once the corrosion products are formed, there is a significant mitigation in corrosivity. It is also apparent that the

carbonate film is more stable at higher temperatures and affords greater protection at higher temperatures. Figure 7 also shows that at temperatures beyond 120 °C (250 °F), the corrosion rate is almost independent of the CO<sub>2</sub> partial pressure of the system. The carbonate film may, however, be weakened by high chloride concentrations or can be broken by high velocity. In H<sub>2</sub>S-dominated systems, because of the fact that no carbonate scale may be formed and that the FeS film becomes porous and unstable at temperatures beyond 120 °C (250 °F), significant localized corrosion may be observed.

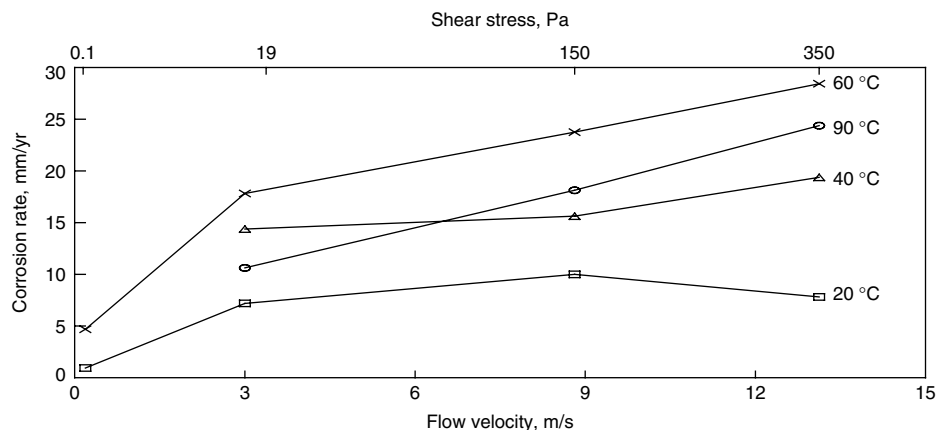
Fig. 8 Corrosion rate as a function of velocity and temperature. Source: Ref 13

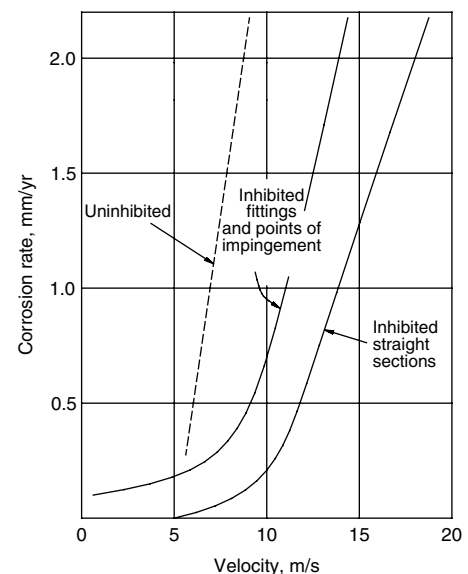
Fig. 9 Effect of gas velocity on corrosion rate

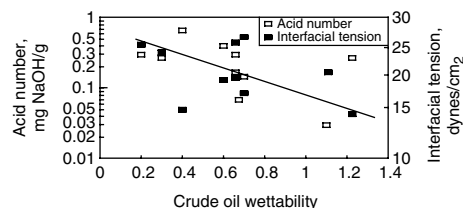
Fig. 10 Effect of acid number on crude oil wettability

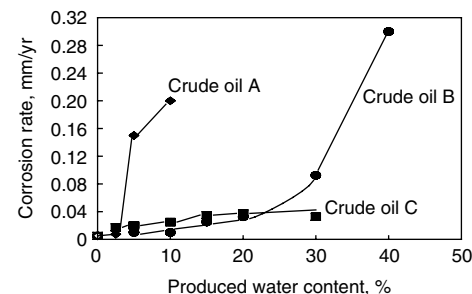
Fig. 11 Effect of changing crude oil type on corrosion rate as a function of water content

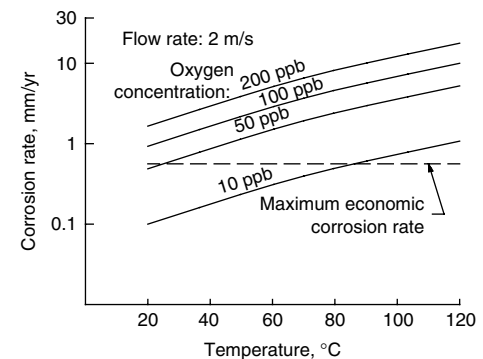
Fig. 12 Effect of oxygen concentration on corrosion as a function of temperature. Source: Ref 37

Data showing increases in corrosion rate as a function of oxygen concentration for differing temperatures are shown in Fig. 12 (Ref 37).

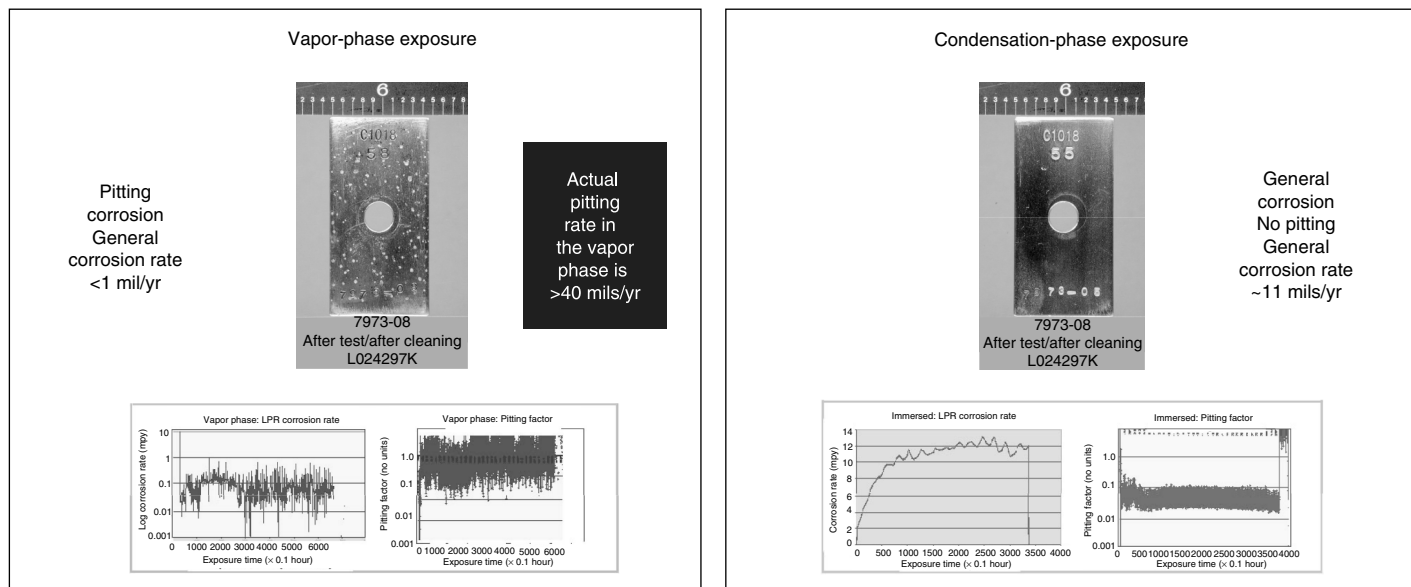
**Fig. 13** Comparison between general corrosion and localized (pitting) corrosion data recorded from a dehydrated gas pipeline environment. Source: Ref 59

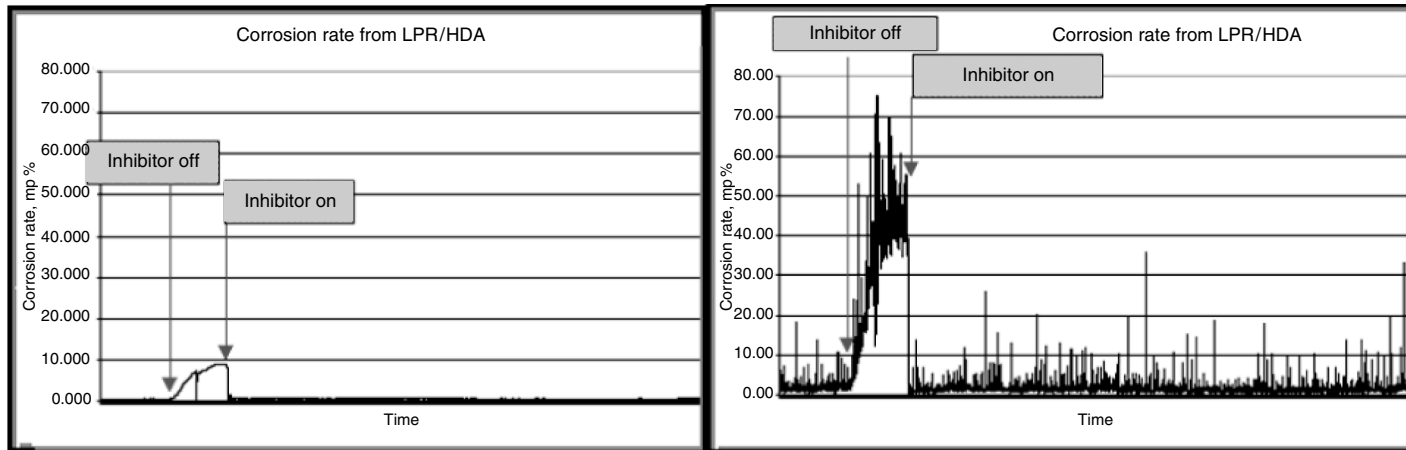
**Fig. 14** Corrosion rate during inhibitor injection on/off cycle in a sour gas pipeline. Note: Measured corrosion rate with default  $B$  value and measured  $B$  value from harmonic distortion analysis. Source: Ref 60

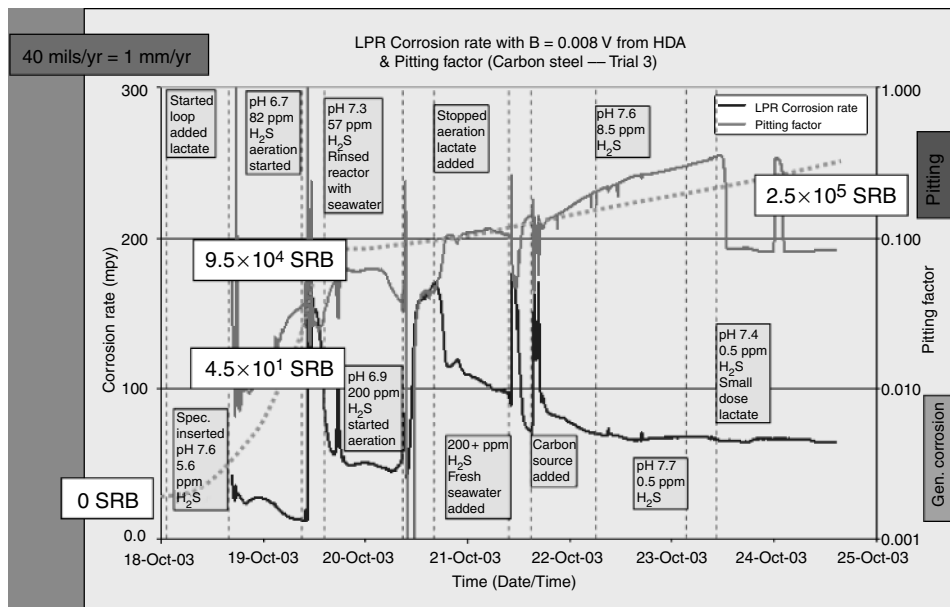
**Fig. 15** On-line, real-time correlation between corrosion rate (left scale), pitting tendencies (right scale), and sulfate-reducing bacteria (SRB) growth (dotted curve). Note: Annotations for short-term process information for  $H_2S$  concentration and imposed aeration. Source: Ref 61

of the presence of biologically produced  $H_2S$  in the system and sulfide films on the steel surfaces. The low  $B$ -value readings demonstrate the inaccuracy at a factor of 3 of noncorrected LPR corrosion rates. Secondly, corrosion and pitting factor varied considerably with operating conditions, with periodic increases in localized corrosion during each aeration cycle. Over the longer term, the system developed a considerable tendency for localized corrosion (high pitting factor) near the end of the monitoring period that matched the rise in sessile SRB count on the metal surface. This is likely the result of formation of a biofilm and the local variations in corrosion tendencies on filmed and nonfilmed areas. Additional measurements of resistance were also made that indicated the buildup of  $FeS$  surface films during the exposure period. None of these

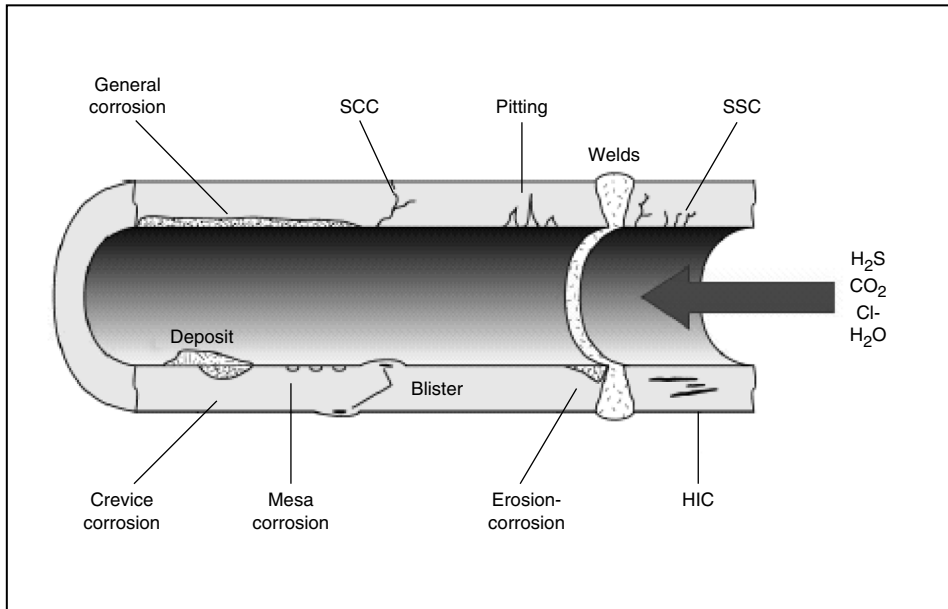
**Fig. 1** Different forms of corrosion and deterioration. SCC, stress-corrosion cracking. SSC, sulfide stress cracking. HIC, hydrogen-induced cracking. Source: Ref 16

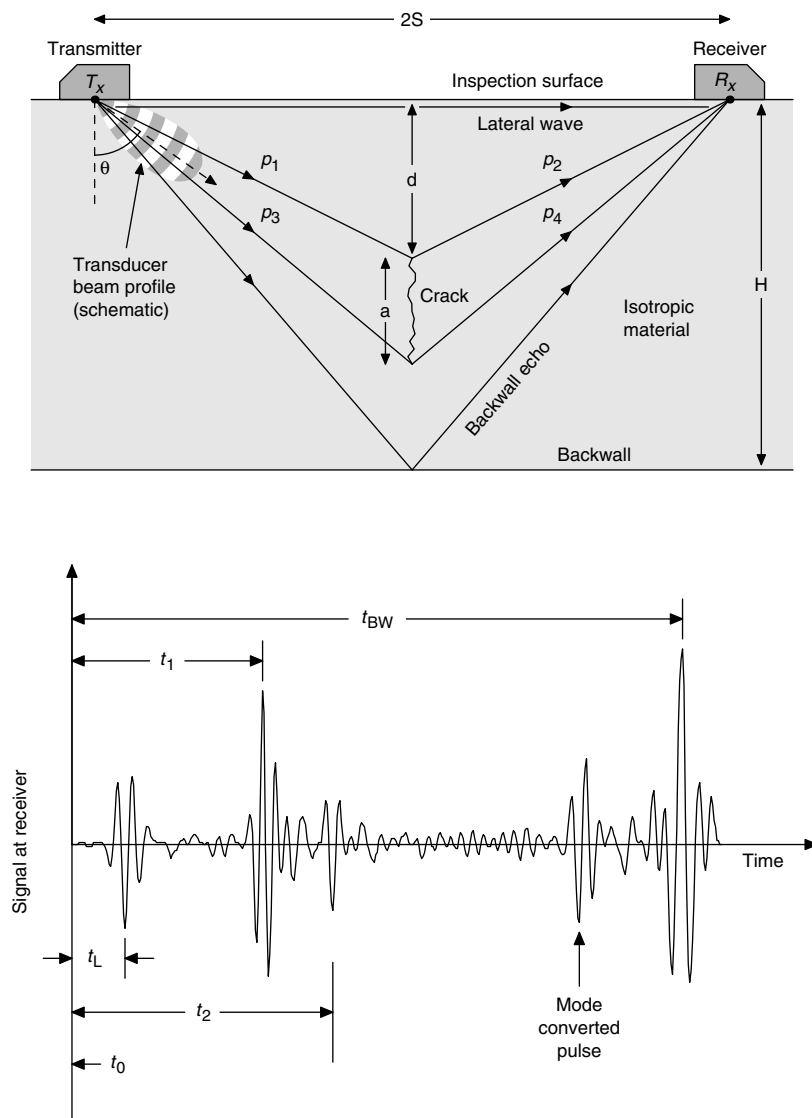
**Fig. 2** The two probe basis for the time-of-flight diffraction technique. The locations of the crack tips are determined from the time differences between the lateral wave and the pulses that follow paths  $p_1 + p_2$  or  $p_3 + p_4$ . These paths correspond to  $t_1$  and  $t_2$ , respectively, in the lower figure. Source: Ref 26

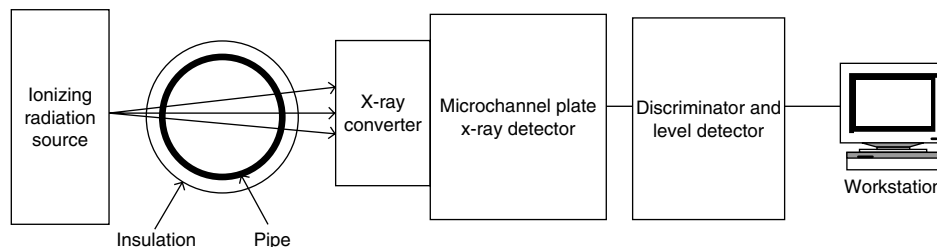
**Fig. 3** Components of a real-time radiographic imaging profiler system for measuring pipe wall thicknesses. The monitor displays the signal pulse readout. Source: Ref 27

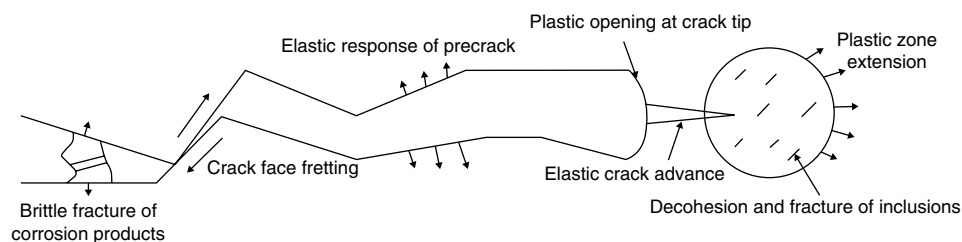
**Fig. 4** Schematic representation of a crack tip showing acoustic emission source mechanisms. Source: Ref 28
