# ASM Handbook®

## Volume 13C Corrosion: Environments and Industries

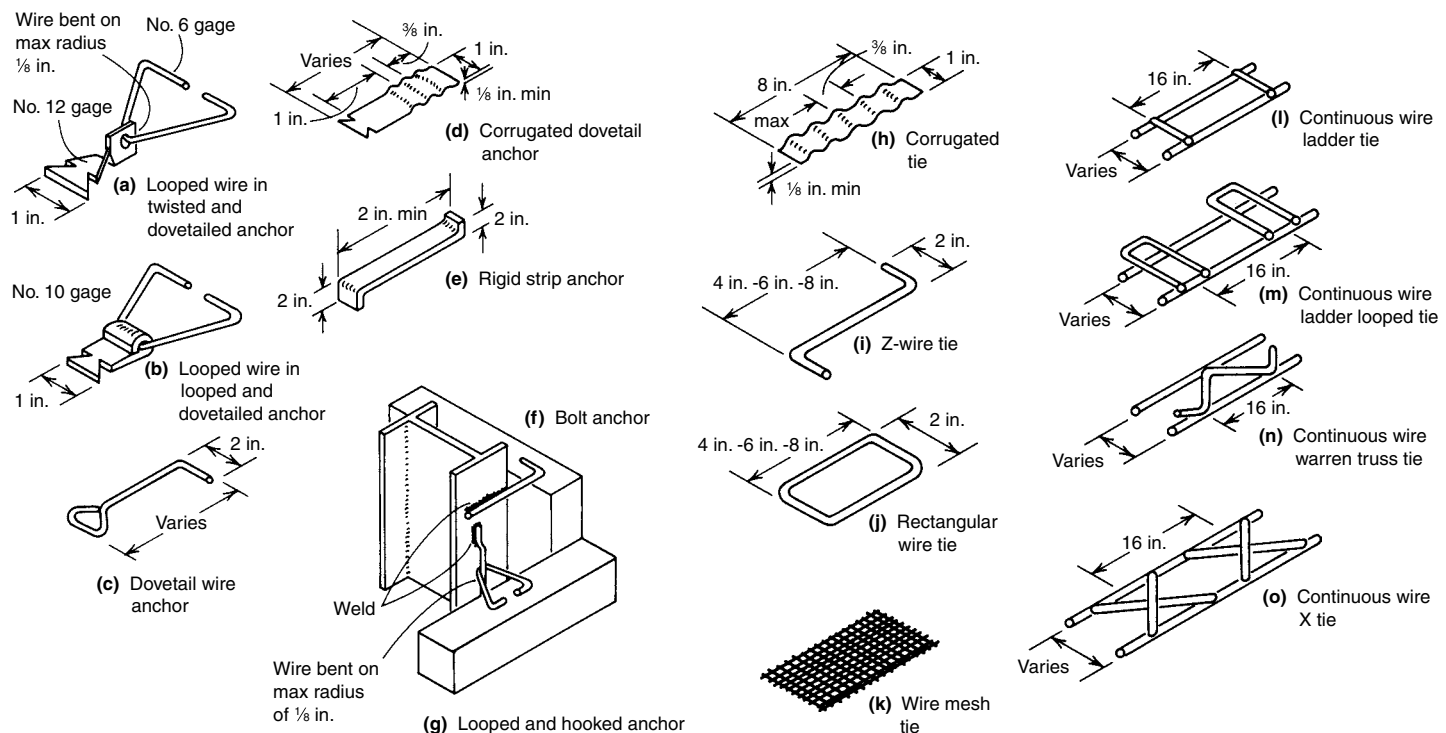
Fig. 3 Typical metallic anchors (a) to (g) and ties (h) to (o) used in masonry walls

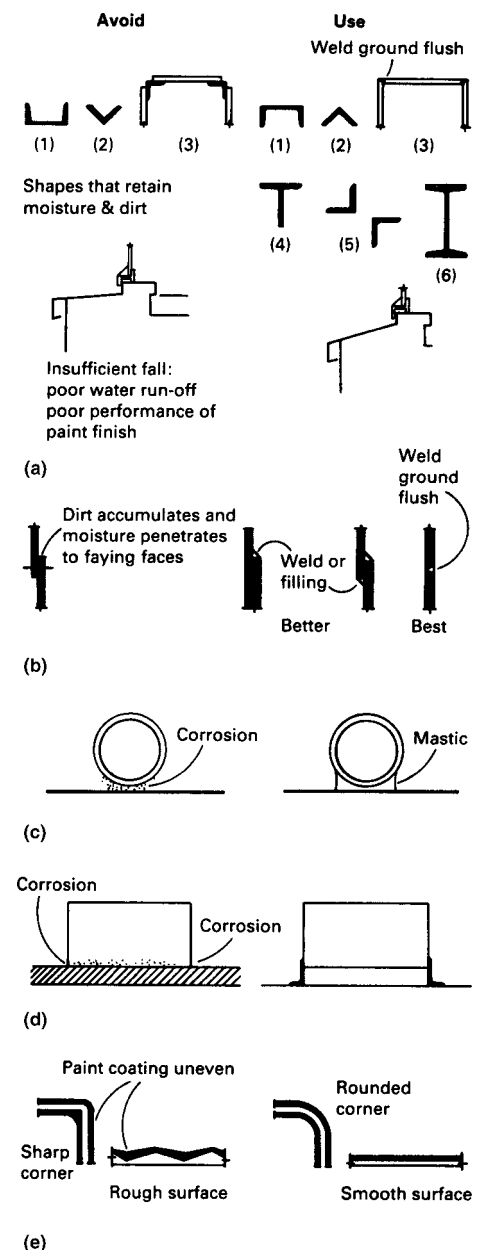
**Fig. 4** Design and fabrication details to be considered in corrosion prevention. (a) Constructional members, sills, etc. (b) Joints. (c) Crevices. (d) Air circulation. (e) Corners, edges, and surfaces

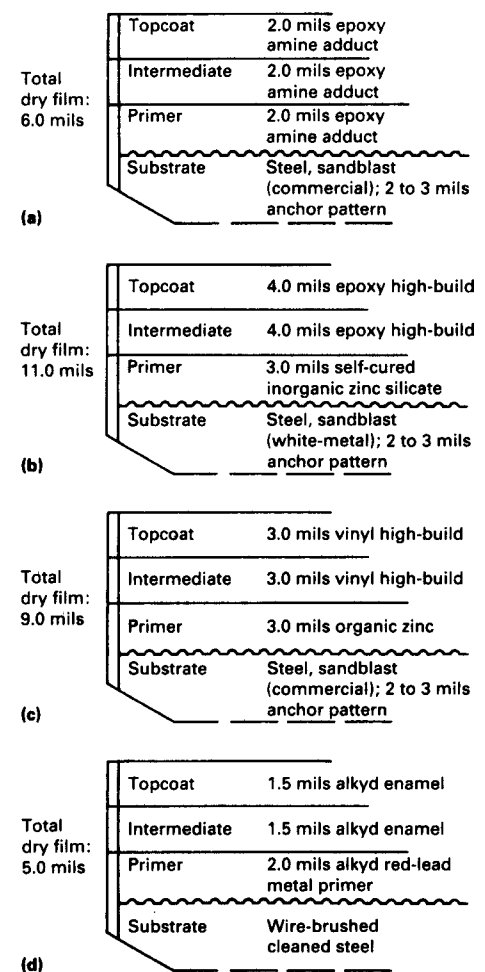
**Fig. 5** Typical coating systems used in various environments. (a) Adduct-cured epoxy for use in exposure to solvent spillage and alkaline dust. (b) Inorganic zinc-epoxy used for severe marine exposures. (c) Inorganic zinc/vinyl coating system for use in mild industrial environments. (d) Alkyd-base coating for mild inland atmospheric exposure. Source: Ref 5

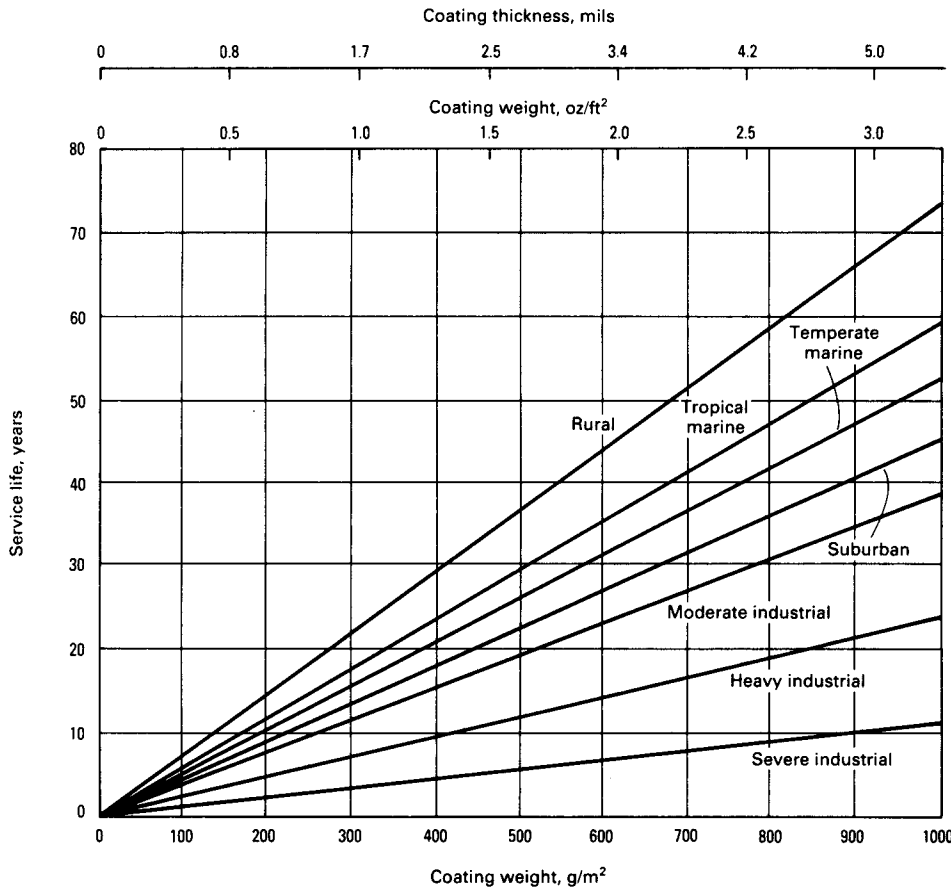
Fig. 6 Effect of zinc coating weight on service life of galvanized steel sheet in various environments. Service life is measured in years to the first appearance of significant rusting.

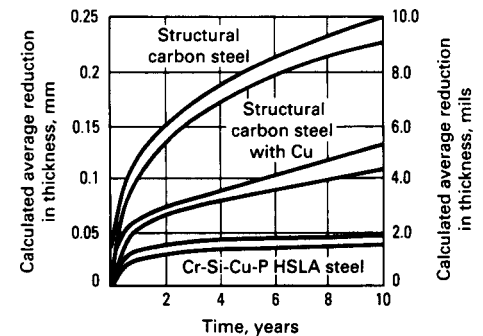
Fig. 7 Corrosion of three types of steels in an industrial atmosphere. Shaded areas indicate range for individual specimens.

7). Under certain fairly specific situations, these alloying elements are incorporated into the oxide layer that forms on the steel, leading to the formation of a dense, more protective oxide. This oxide serves as a barrier to further penetration of moisture and effectively acts almost as a “self-painted” coating, lessening the need for other coating protection. An example of the improvement in corrosion behavior of weathering steels in an industrial environment is shown in Fig. 7 (see also the article “Corrosion of Weathering Steels,” *ASM Handbook*, Volume 13B).

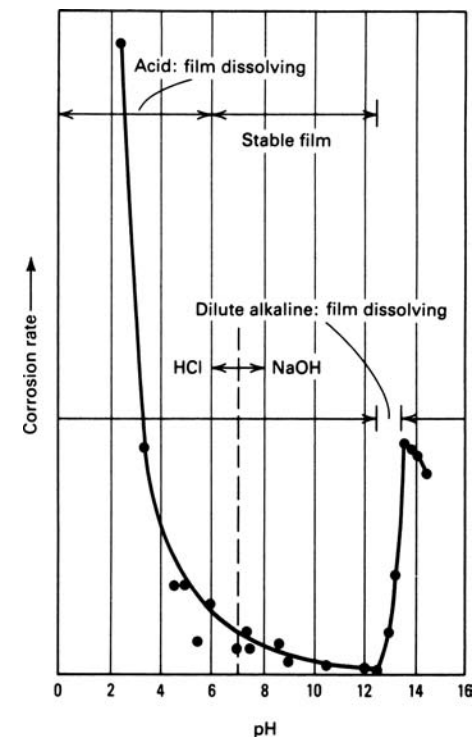
Fig. 8 Corrosion of zinc in aqueous solutions as a function of pH

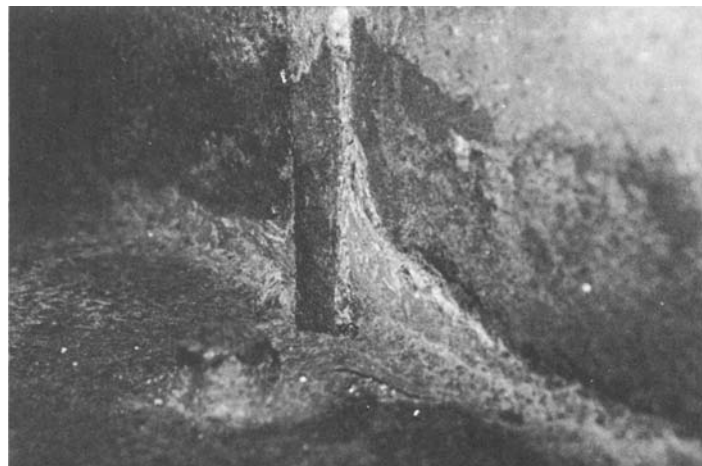
Fig. 9 Heavy buildup of corrosion scale on weathering steel structural members in conditions of poor air circulation, high humidity, and no wetting/drying

- Underneath the stands, where air circulation was poor and wetting/drying cycles could not be anticipated (Fig. 9)
- At sheltered locations on the exterior, again where wetting/drying cycles could not be anticipated (Fig. 10)
- At joint details, where the important concepts of removal of crevices and pockets to retain water had not been practiced in the design of joints for the structure (Fig. 11)

The major problem associated with this structure was the amount of corrosion occurring on the structural steel beneath the stands. Although the loads in these structures were determined to be low, it was apparent that corrosion protection would be necessary. A series of tests was conducted to determine the optimum coating protocol, including surface preparation, type of coating, thickness, and number of coats.

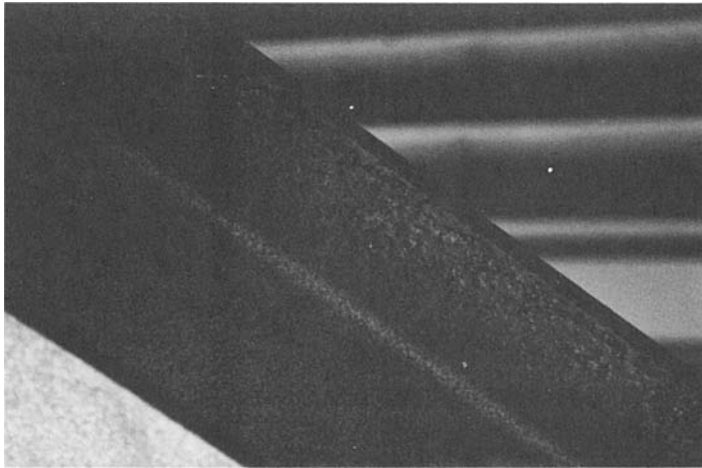
**Fig. 10** Corrosion scale buildup on weathering steel structural members, which were in a sheltered area on a building exterior where wetting and drying did not occur

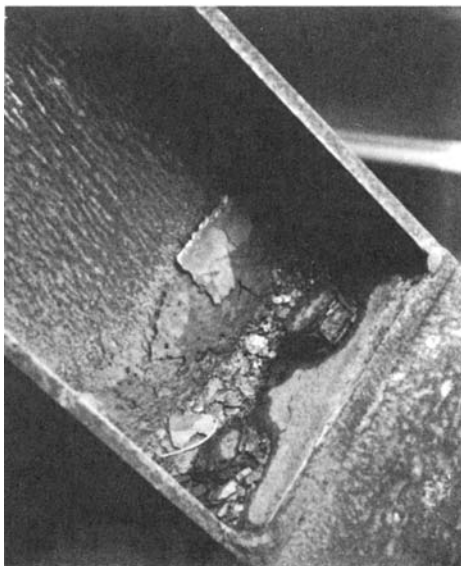
**Fig. 11** Heavy corrosion scale buildup on structural members of weathering steel at a pocket where water could collect and stand

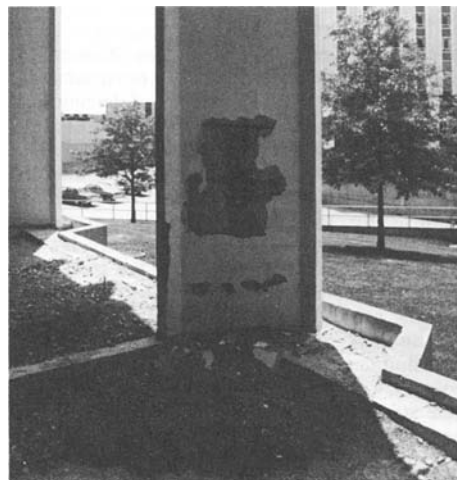
**Fig. 12** Corrosion-induced spalling of overlying concrete on reinforced columns. See also Fig. 13.

**Example 3: Corrosion of Reinforcing Steel in Building Columns.** Figure 12 shows an example of a supporting column in a dormitory building on a midwestern United States campus. The columns are of conventionally reinforced concrete, with a spiral of reinforcement that closely approaches the surface of the concrete column. The concrete showed cracking and spalling within a few years after its installation. Laboratory examination indicated that the concrete cover was low, that the concrete over the steel was carbonated close to the outer surface, and that the concrete contained a significant amount of chloride, apparently added during construction, that was due to either the presence of chloride-bearing aggregate or the deliberate addition of admixtures such as  $\text{CaCl}_2$ . Corrosion of embedded steel was severe in places (Fig. 13).

Because of the likelihood that carbonation might progress into the concrete and, together with the chloride, affect the more deeply embedded steel, the following repair plan was devised. First, loose and spalled concrete was chipped out of the columns. Second, the columns were shotcreted to a depth of approximately 25 mm (1 in.) above the topmost reinforcement. Finally, an impressed-current cathodic protection system was placed on the columns using conductive polymer anodes with integral lead

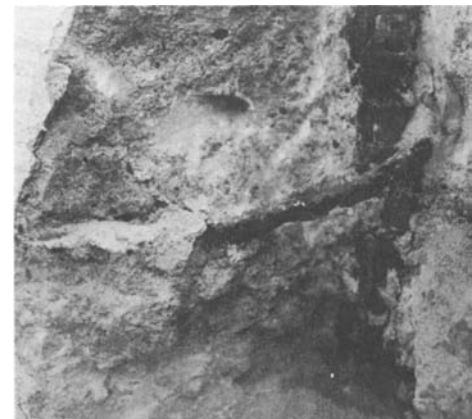
**Fig. 13** Severe corrosion on reinforcing steel from the column shown in Fig. 12

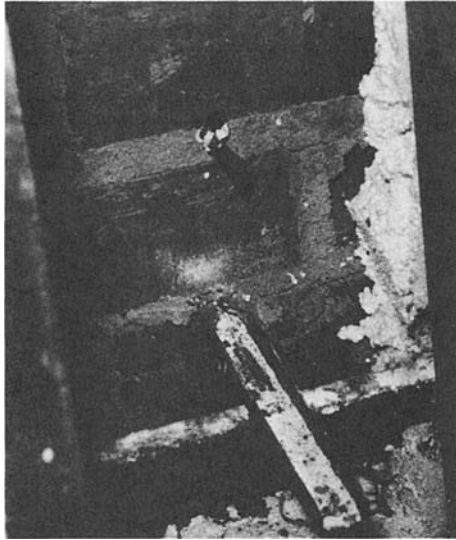
**Fig. 14** Unconventional masonry tie constructed from flattened C-channel and bent to enter the brick core

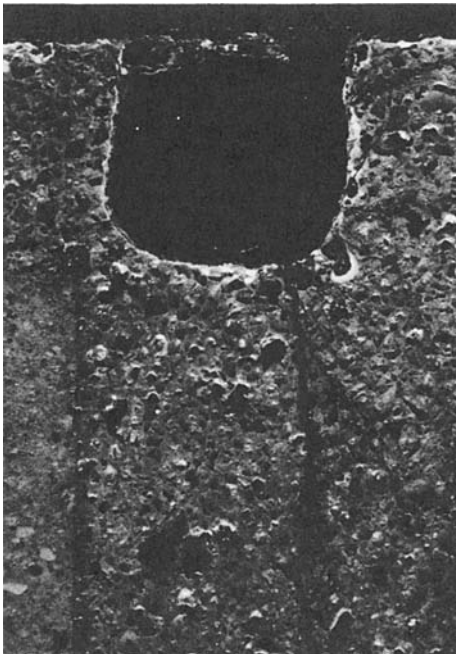
**Fig. 16** Corrosion and resulting masonry cracking on an anchor embedded in high-band mortar. See also Fig. 17

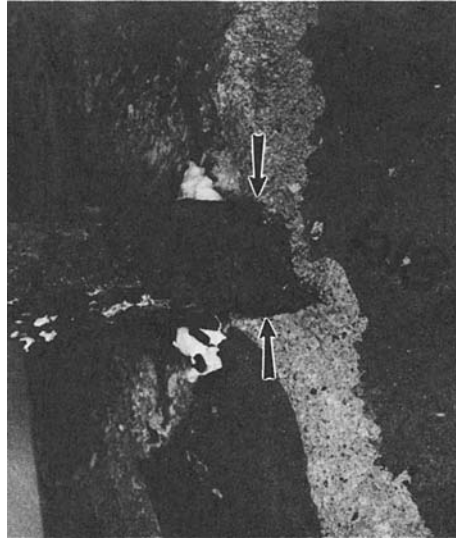
**Fig. 15** Severe corrosion and cracking (arrows) on wall tie

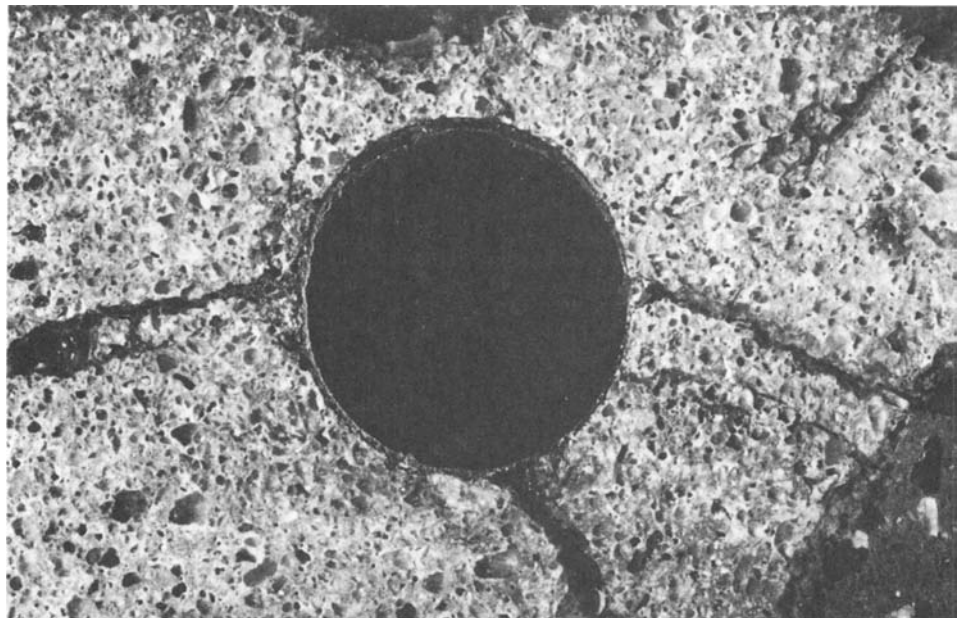
**Fig. 17** Corrosion and resulting masonry cracking on an anchor embedded in high-band mortar. See also Fig. 16

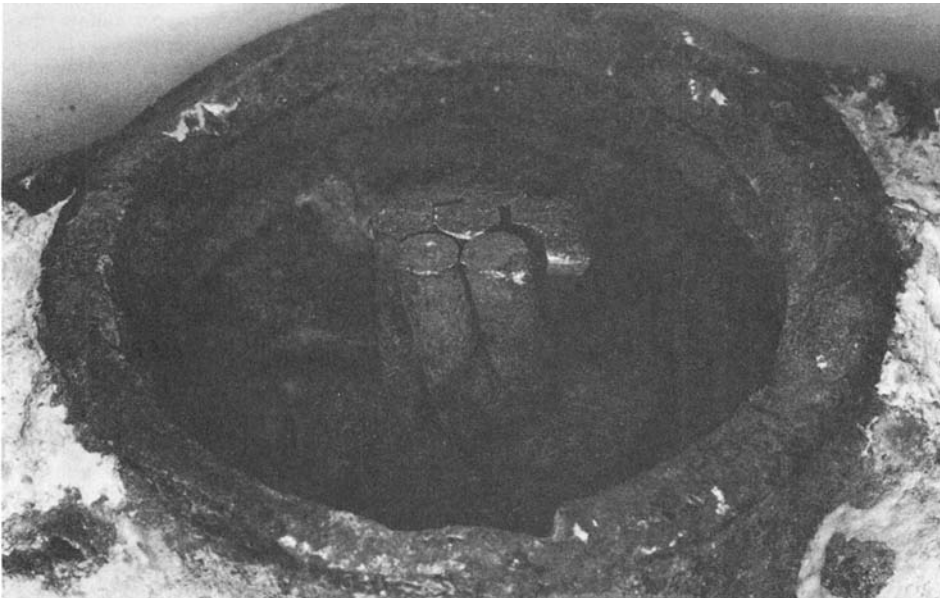
**Fig. 18** Corrosion of posttensioning anchorage. Note severe corrosion at the two wedge halves.

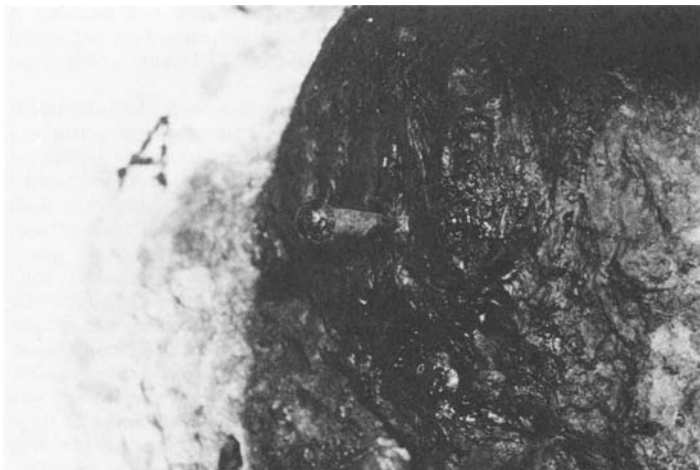
**Fig. 19** Posttensioning anchorage with broken wire extending from anchor plate

**Example 7: Hydrogen Embrittlement of Posttensioning Wires.** Single 6.4 mm (0.25 in.) posttensioning wires failed in a parking garage in the southern portion of the United States. A typical anchorage with a broken buttonhead wire is shown in Fig. 19. Several such wires were removed, and the lengths were examined for signs of corrosion. Localized shallow pitting was common, as illustrated in Fig. 20. Chloride was detected in some of these pits.

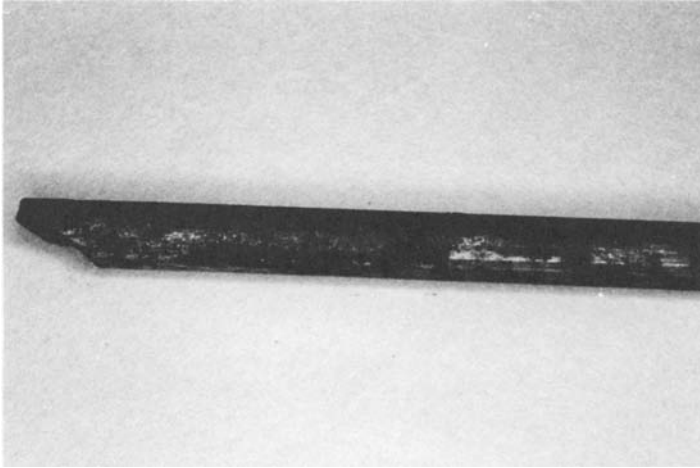
**Fig. 20** Pitting corrosion adjacent to fracture on failed posttensioning wire

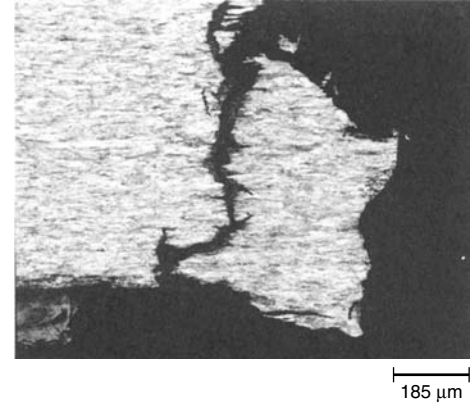
**Fig. 21** Metallographic cross section through the fracture initiation region of posttensioning wire. Note secondary cracks. Etched with 2% nital. Original magnification: 55×

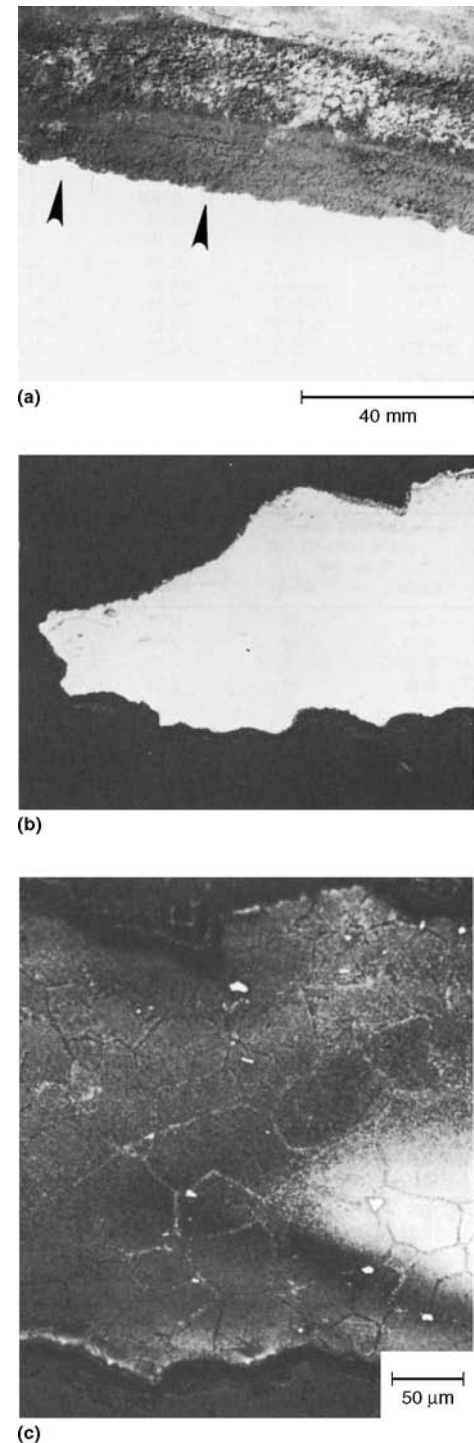
**Fig. 1** Metal dusting of a Multimet alloy component at the refractory interface in a carburizing furnace. (a) Perforation of the component (arrows). (b) Cross section of the sample showing severe pitting. (c) Severe carburization beneath the pitted area

soots, metal, metal carbides, and metal oxides. The attack is normally initiated from the metal surface that is in contact with the furnace refractory. The furnace components that suffer metal dusting include thermowells, probes, and anchors. Figure 1 illustrates the metal dusting

attack on Multimet alloy. The component was perforated as a result of metal dusting. Metal dusting problems have also been reported in petrochemical processing (Ref 12).

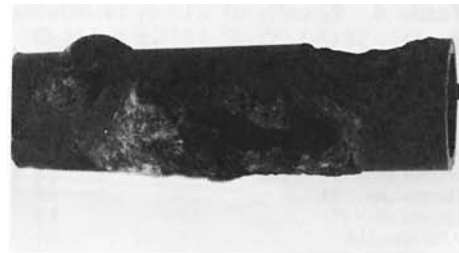
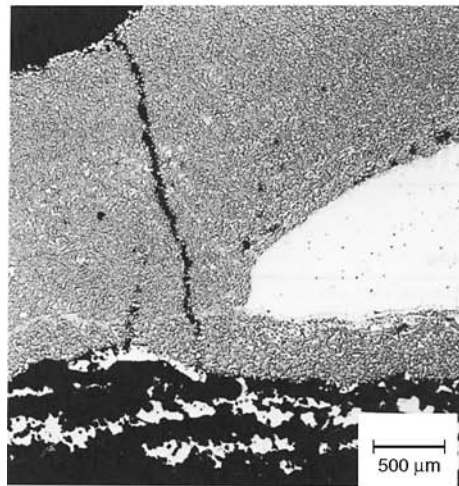
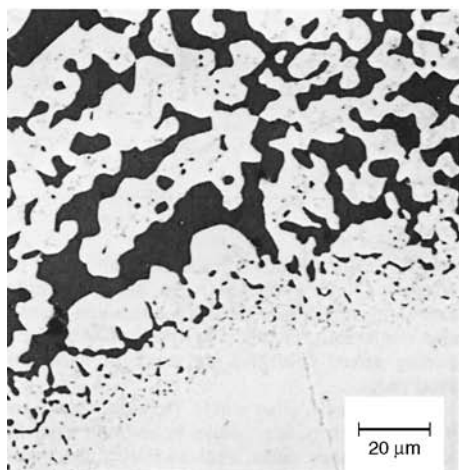
**Fig. 2** Catastrophic sulfidation of an Inconel 601 furnace tube. The furnace atmosphere was contaminated with sulfur; the component failed after less than 1 month at 925 °C (1700 °F). (a) General view. (b) Cross section of the perforated area showing liquid-appearing nickel-rich sulfides. (c) Higher-magnification view of nickel-rich sulfides

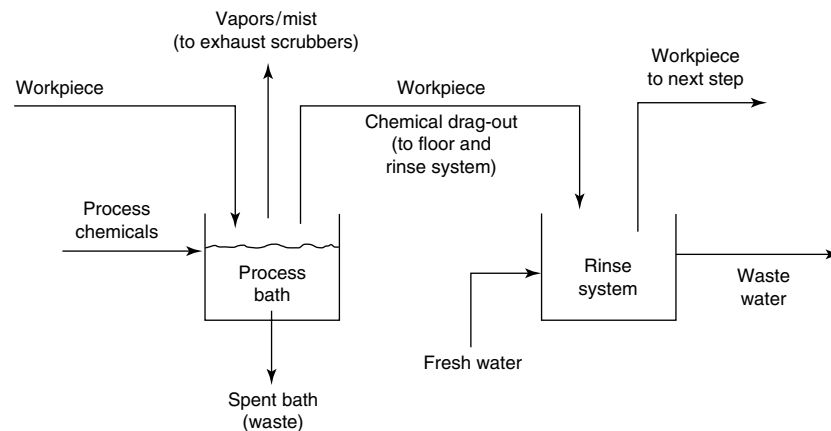
**Fig. 3** Typical process sequence in a metal finishing shop. The process bath could be used for plating, anodizing, or pickling

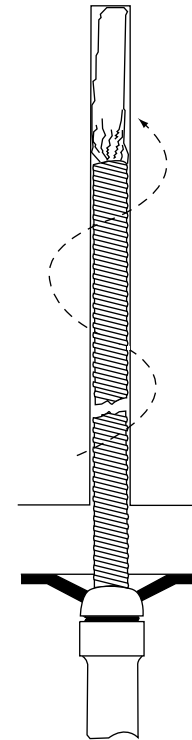
**Fig. 1** Illustration of a rock bolt for mine reinforcement. The rock bolt is rotated, and at the same time pushed through the chemical cartridge, mixing the resin components. Source: Ref 17

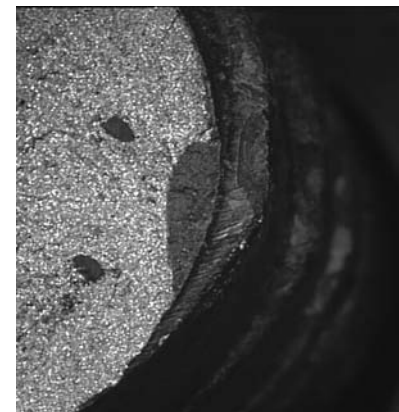
**Fig. 2** Typical fracture surface of a rock bolt that failed due to stress-corrosion cracking. See text for details. Source: Ref 17

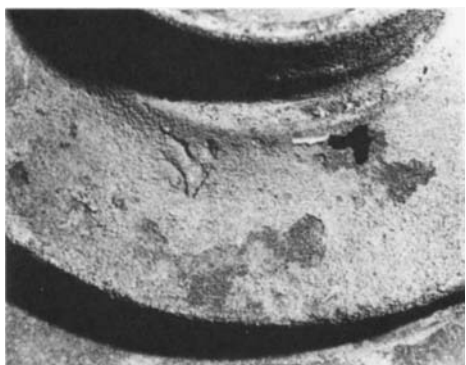
**Fig. 3** Uniform corrosion of ACI CD-4MCu cast stainless steel pump impeller after 1 year in an environment containing 50%  $H_3PO_4$  and 10% gypsum. Courtesy of A.R. Wilfley & Sons, Inc., Pump Division

**Uniform Corrosion.** The most common form of pump corrosion is characterized by uniform attack on the entire exposed surface. Figure 3 shows uniform corrosion on a stainless steel pump impeller that was exposed to 50% phosphoric acid ( $H_3PO_4$ ) and 10% gypsum pumping fluid for approximately 1 year. Uniform corrosion is predictable and, therefore, allows the incorporation of safety factors in pump and piping design.

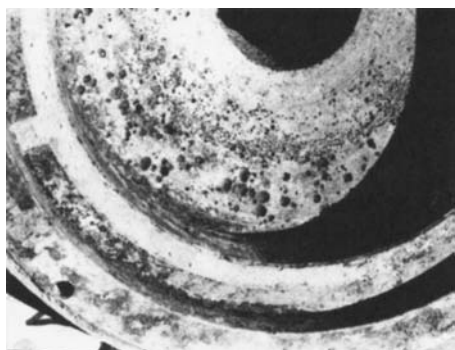
**Fig. 4** Pitting corrosion of an ACI CF-8M stainless steel pump case used to pump a nickel plating solution with a high concentration of  $Cl^-$  and a high operating temperature. This damage occurred during 3 years of service. Courtesy of A.R. Wilfley & Sons, Inc., Pump Division

stainless steel casting pump case is illustrated in Fig. 4. This pump case, which was exposed to low pH and high  $Cl^-$  concentration, failed after approximately 3 years of service. Methods of preventing pitting failures in pump systems would be to prevent any liquid ingress into the contact between dissimilar metals using O-rings or other suitable seals. The use of a more corrosion-resistant material or coatings may also reduce the problem of pitting corrosion (Ref 30).

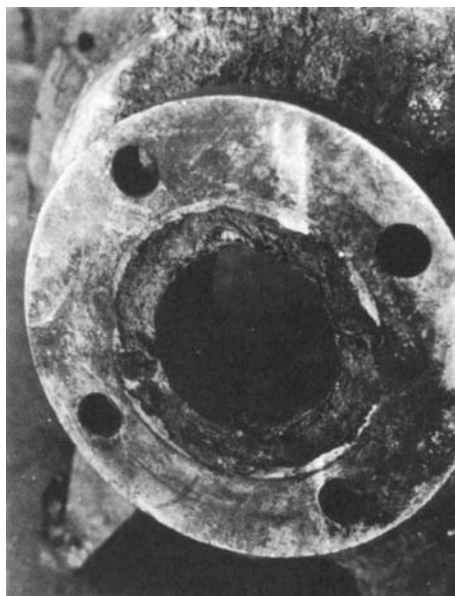
**Fig. 5** Crevice corrosion at the intake flange of an ACI CF-8M stainless steel pump case. Notice that the corrosion damage occurred under the gasket. Courtesy of A.R. Wilfley & Sons, Inc., Pump Division

**Crevice Corrosion.** Figure 5 shows crevice corrosion on an ACI CF-8M cast stainless steel pump case that was gasket sealed on the discharge flange. Attack is evident in the region where the gasket was placed. It is important to design mining and milling equipment for easy drainage and cleaning in order to prevent the buildup of stagnant water that will produce concentration cells and lead to crevice corrosion and pitting. Figure 6 illustrates both poor and improved design for avoidance of localized attack. More information on proper design is available in the article "Designing to Minimize Corrosion" in *Corrosion*, Vol 13A, of the *ASM Handbook* (refer to pages 929 to 939).

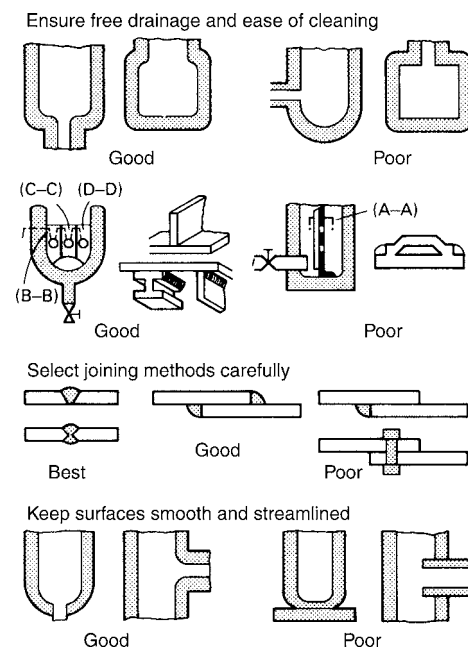
**Fig. 6** Poor and improved engineering design to avoid crevice corrosion. Source: Ref 31

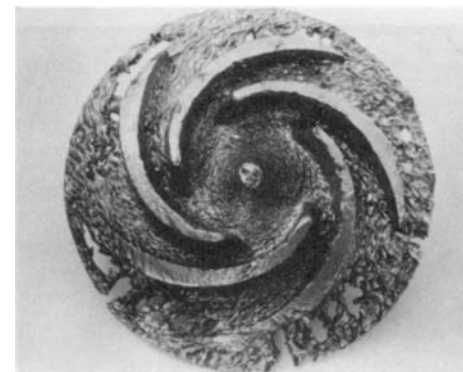
**Fig. 7** Erosion-corrosion of ACI CN-7M stainless steel pump components that pumped hot  $H_2SO_4$  with some solids present. Note the grooves, gullies, waves, and valleys common to erosion-corrosion damage. Courtesy of A.R. Wilfley & Sons, Inc., Pump Division

**Erosion-Corrosion.** Slurry erosion-corrosion can cause significant materials wastage in pump systems. During mill processing, fluids consisting of particulates in a corrosive medium are usually pumped. Pumping this slurry promotes erosion-corrosion in piping, tanks, and pumps. Erosion-corrosion is a function of the fluid velocity and the nature of the particulates and fluid. Erosion-corrosion of a UNS N08007 (ACI CN-7M) stainless steel cast impeller after exposure to hot concentrated  $H_2SO_4$  with solids present is shown in Fig. 7. Erosion-corrosion is also evident in Fig. 8, which shows that the

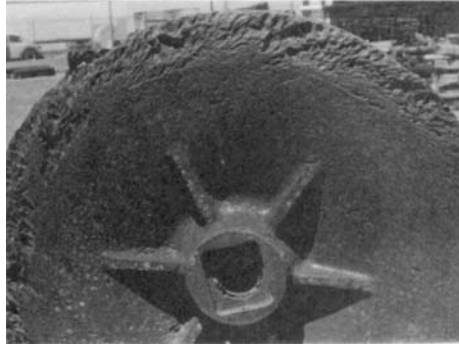
**Fig. 8** Erosion-corrosion of an abrasion-resistant iron pump runner used to pump 30% iron tailings in a fluid with a pH of 11.2. This runner had a service life of approximately 3 months. Note that most of the damage is on the outer peripheral area of the runner where fluid velocity is the highest. Courtesy of A.R. Wilfley & Sons, Inc., Pump Division

erosion-corrosion damage increased on the portion of the impeller that had the greatest fluid velocity. This impeller, cast from an abrasion-resistant white iron, was used to pump fluids containing 30% solids (iron ore tailings) at a pH of 11.2.

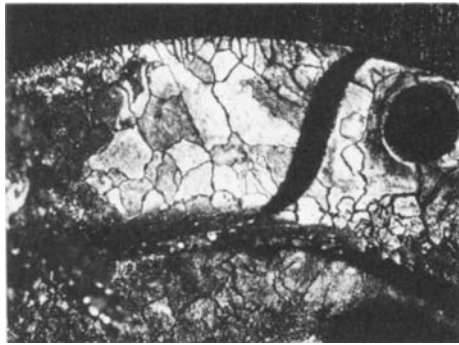
**Fig. 9** Intergranular corrosion of an ACI CN-7M stainless steel pump component that contacted HCl-Cl<sub>2</sub> gas fumes. Note the grain-boundary attack. Courtesy of A.R. Wilfley & Sons, Inc., Pump Division

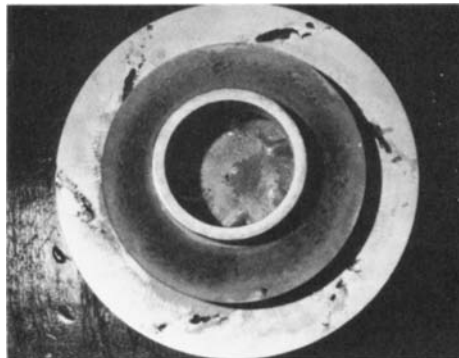
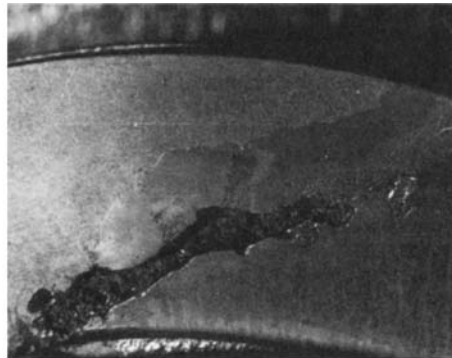
**Fig. 10** Weld decay of an ACI CN-7M stainless steel pump impeller that was field weld repaired with no postweld heat treatment. The pump service was P<sub>2</sub>O<sub>5</sub> solution at 80 °C (175 °F). (a) Overall view of impeller. (b) Closeup view of the weld repair and the associated weld decay, which occurred adjacent to the weld deposit. Courtesy of A.R. Wilfley & Sons, Inc., Pump Division

the pump casting with a small hammer. Loss of acoustical properties is evidence of intergranular grain-boundary attack, especially in sensitized stainless steel castings. A form of intergranular corrosion associated with weld deposits that is commonly called weld decay, is shown in Fig. 10, which illustrates a field-weld repair of an ACI CN-7M stainless steel impeller that was not postweld heat treated (solution annealed and quenched) to restore corrosion resistance. This weld-repaired casting was exposed to a phosphoric anhydride (P<sub>2</sub>O<sub>5</sub>) solution at 80 °C (175 °F). It is evident that the weld decay occurred in the heat affected zone of the weld deposit.

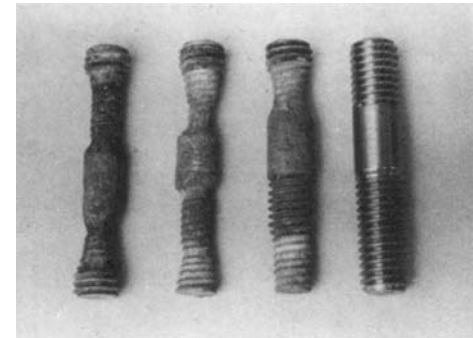
**Fig. 11** Galvanic corrosion of type 304 stainless steel stud bolts that fastened two Alloy 20 (ACI CN-7M) pump components. The pump was pumping 45% H<sub>2</sub>SO<sub>4</sub> at 95 °C (200 °F). The stud bolts were anodic to the Alloy 20 pump housings. Courtesy of A.R. Wilfley & Sons, Inc., Pump Division

**Galvanic corrosion** between two stainless steels is illustrated in Fig. 11. These AISI type 304 stainless steel stud bolts held together an Alloy 20 (ACI CN-7M) pump housing. The bolts became anodic to the housing in 45% H<sub>2</sub>SO<sub>4</sub> and subsequently failed. Table 4 lists various combinations of pump and valve trim materials and indicates the combination that may be susceptible to galvanic attack. The basic rule for materials selection is that two alloy systems that

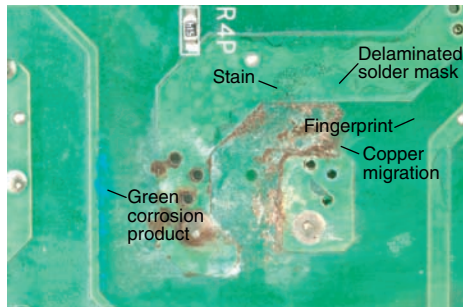
**Fig. 1** Copper migration and copper corrosion by-products on surface of failed printed circuit board. See the article "Corrosion in Passive Electrical Components" in this Volume.

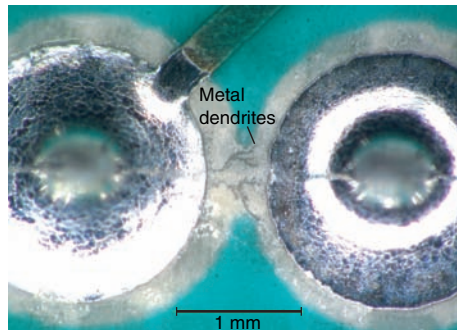
**Fig. 2** Tin dendrites growing between two adjacent solder joints on failed printed circuit board. See the article "Corrosion in Passive Electrical Components" in this Volume.

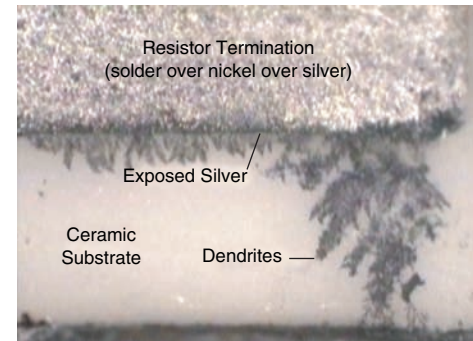
**Fig. 3** Backside of failed surface-mounted chip resistor showing silver dendrites. Courtesy of Pat Kader, ENI. See the article "Corrosion in Passive Electrical Components" in this Volume.

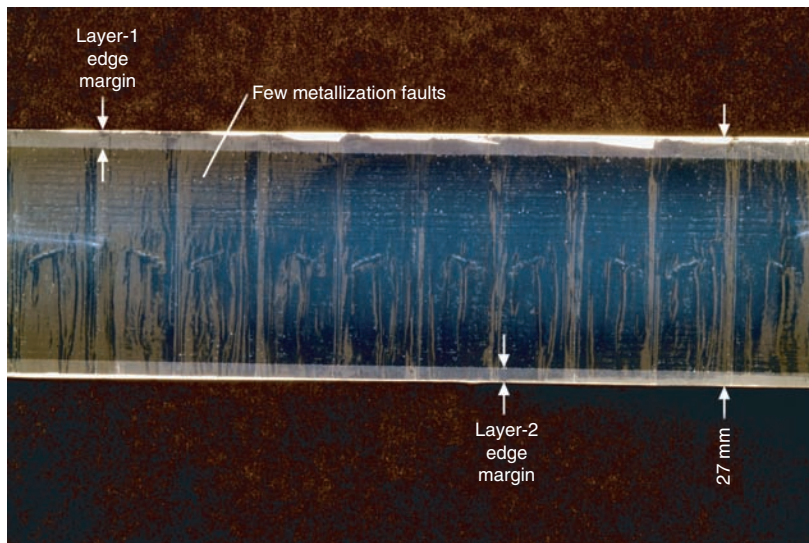
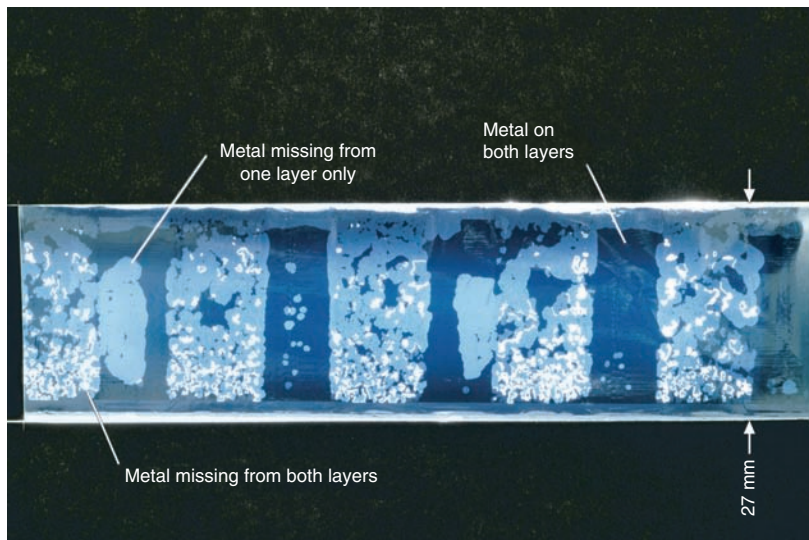
**Fig. 4** Backlighting view of two stacked film layers removed from (a) a good metallized polypropylene film capacitor and (b) a failed metallized polypropylene film capacitor. See the article “Corrosion in Passive Electrical Components” in this Volume.

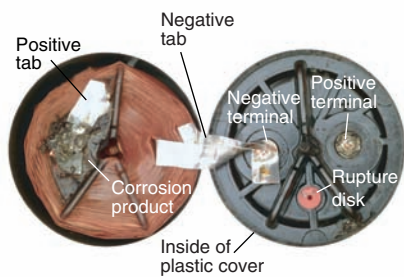
**Fig. 5** Interior of failed aluminum electrolytic capacitor showing effects of corrosion. Note that the positive terminal has significant damage, while the negative terminal is not degraded. Millimeter scale. See the article “Corrosion in Passive Electrical Components” in this Volume.

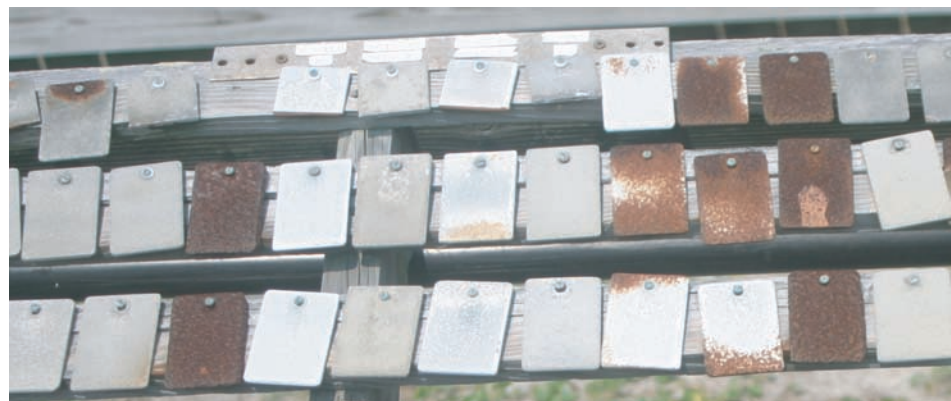
**Fig. 6** Original T.P. Hoar study panels after over 48 years of exposure at the 250 m (820 ft) marine atmospheric exposure site in Kure Beach, NC. See the article “Corrosion of Metallic Coatings” in this Volume.

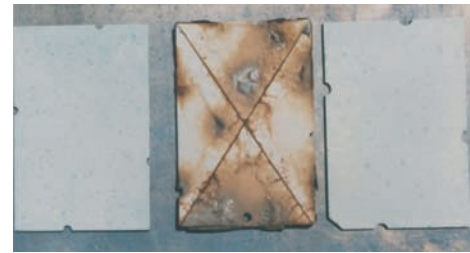
**Fig. 8** Scribed, sealed and painted thermal spray coatings on steel substrates compared to a scribed, painted steel panel after 42 months of severe marine atmospheric exposure. See the article "Corrosion of Metallic Coatings" in this Volume.

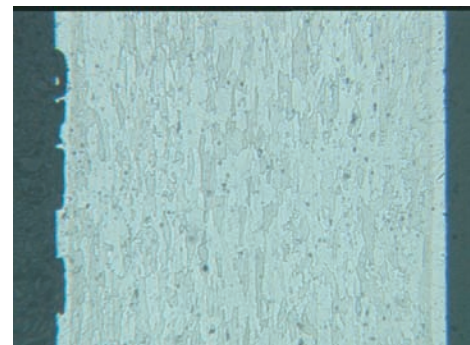
**Fig. 9** Aluminum laminate. A 7072 aluminum cladding providing corrosion protection of 7075-T6 aluminum core. Note lateral spread of corrosion at clad layer to prevent through-wall failure of a P-3 fuel tank divider web. Courtesy of K. Himmelheber, Naval Aviation Depot, Jacksonville. See the article "U.S. Navy Aircraft Corrosion" in this Volume.

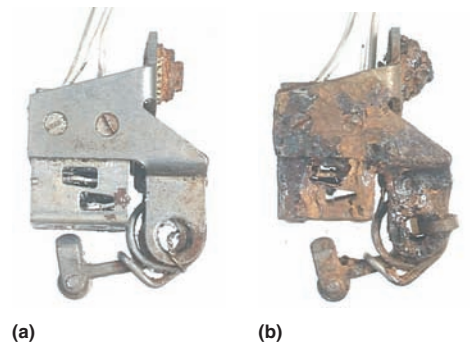
**Fig. 10** EA-6B slat gearbox limit switch following ASTM B117 neutral salt spray corrosion testing (a) with MIL-L-87177 corrosion-inhibiting lubricant and (b) without MIL-L-87177 corrosion-inhibiting lubricant. Courtesy of J. Benfer, Naval Air Depot, Jacksonville. See the article "U.S. Navy Aircraft Corrosion" in this Volume.

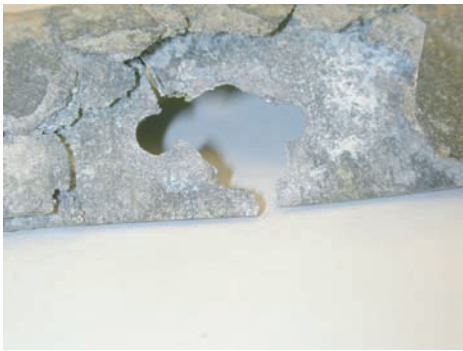
**Fig. 11** Exfoliation corrosion of an aluminum T-45 cockpit kick plate angle resulting from water intrusion within cockpit areas. Courtesy of J. Benfer, Naval Air Depot, Jacksonville. See the article "U.S. Navy Aircraft Corrosion" in this Volume.

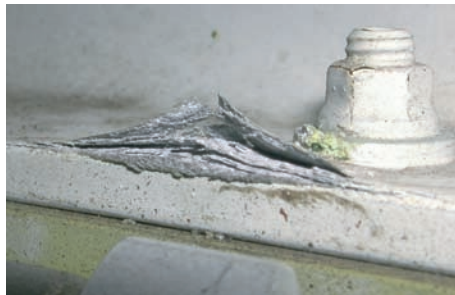
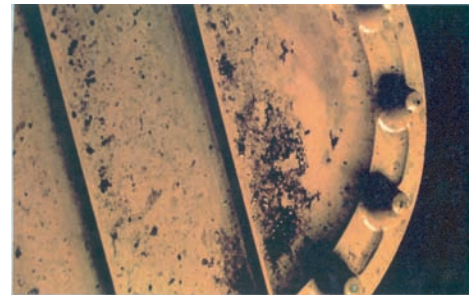
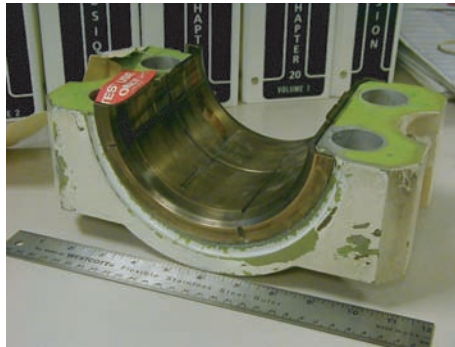
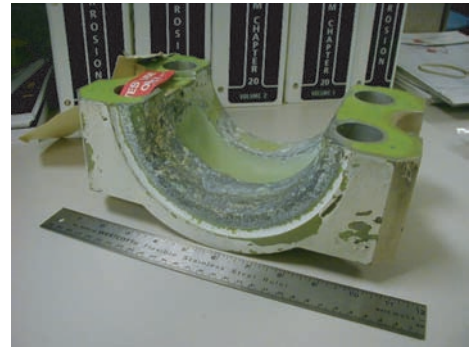
**Fig. 12** Forms of corrosion in aircraft. (a) Exfoliation corrosion. (b) Microbiologically induced corrosion on fuel tank access door. (c) Bushing assembly. (d) Galvanic corrosion under aluminum-nickel bronze bushing, seen with bushing removed. See the article "Corrosion in Commercial Aviation" in this Volume.

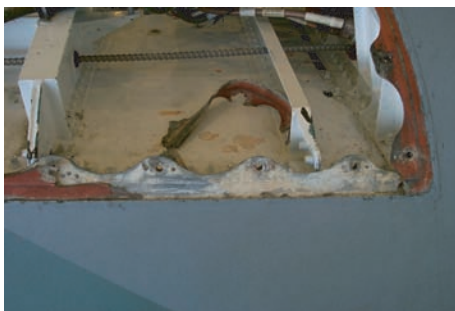
**Fig. 13** Galvanic corrosion of F/A-18 aircraft dorsal scallops resulting from composite doors attached to aluminum substructure with titanium and steel fasteners in the presence of moisture. Courtesy of S. Long, Naval Air Depot, North Island. See the article "U.S. Navy Aircraft Corrosion" in this Volume.

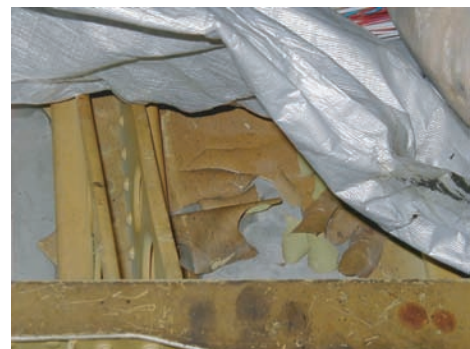
**Fig. 14** Loss of paint adhesion caused by silicone contamination. See the article "U.S. Navy Aircraft Corrosion" in this Volume.

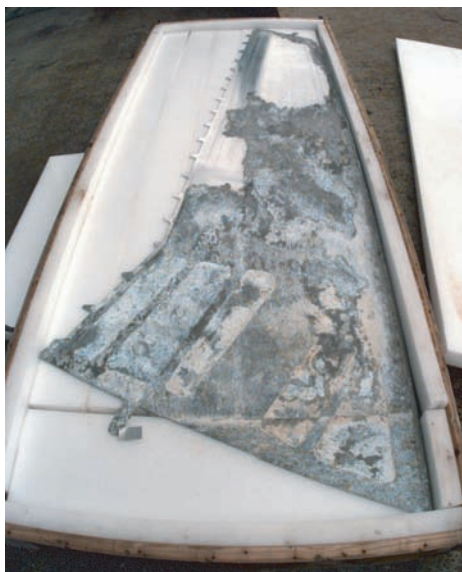
**Fig. 15** Aluminum horizontal skin exhibiting extensive water-induced corrosion due to improper packaging and preservation during shipment from the manufacturer. Courtesy of S. Bevan, Naval Air Depot, Jacksonville. See the article "U.S. Navy Aircraft Corrosion" in this Volume.

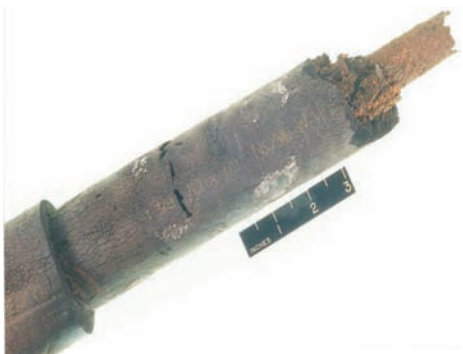
**Fig. 16** Corrosion of hot water line after insulation was degraded by water intrusion. See the article "Corrosion Control for Military Facilities" in this Volume.

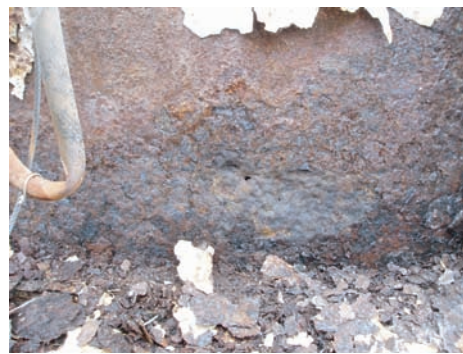
**Fig. 17** Through-wall corrosion under insulation of a large coated carbon steel storage tank. Courtesy of Paul Powers, GE Inspection. See the article "Effects of Process and Environmental Variables" in this Volume.

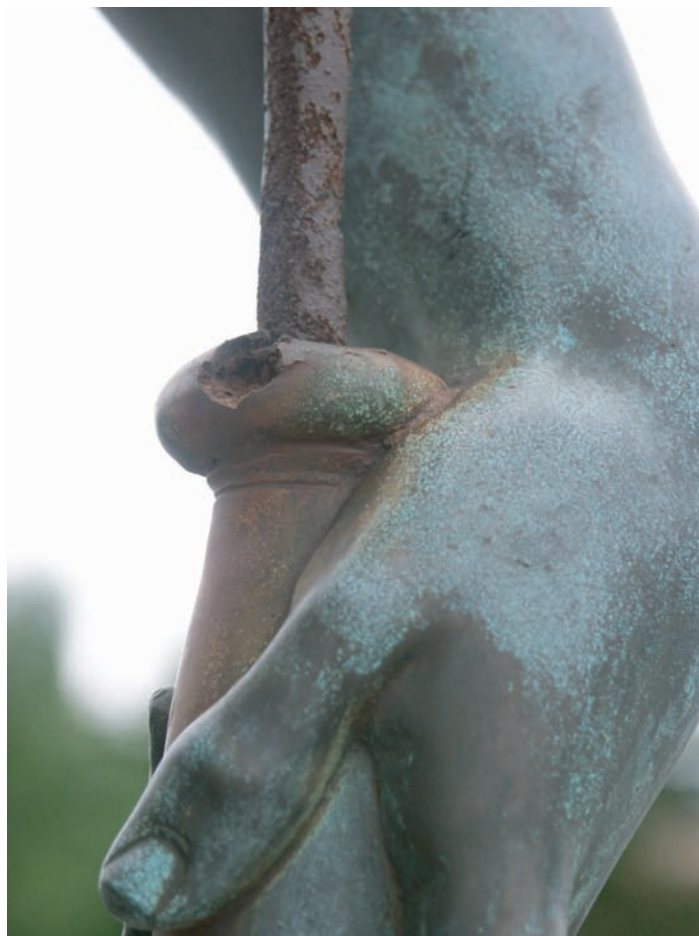
**Fig. 19** Detail of damage by galvanic corrosion of an iron staff in contact with a cast bronze hand on a statue of Mercury (date 1962) located in Kingston, Ontario. Courtesy of Pierre Roberge. Photograph 2003. See the article "Corrosion of Metal Artifacts Displayed in Outdoor Environments" in this Volume.

The bronze hand holding an iron staff forms a galvanic couple in an outdoor statue (Fig. 19). The velvetlike corrosion on an ancient copper alloy vessel (Fig. 20) was found to be a dendritic copper sulfide (Fig. 21). Another collection of dendrites in a museum environment is the silver sulfide crystals on a Greco-Roman silver bowl (Fig. 22).

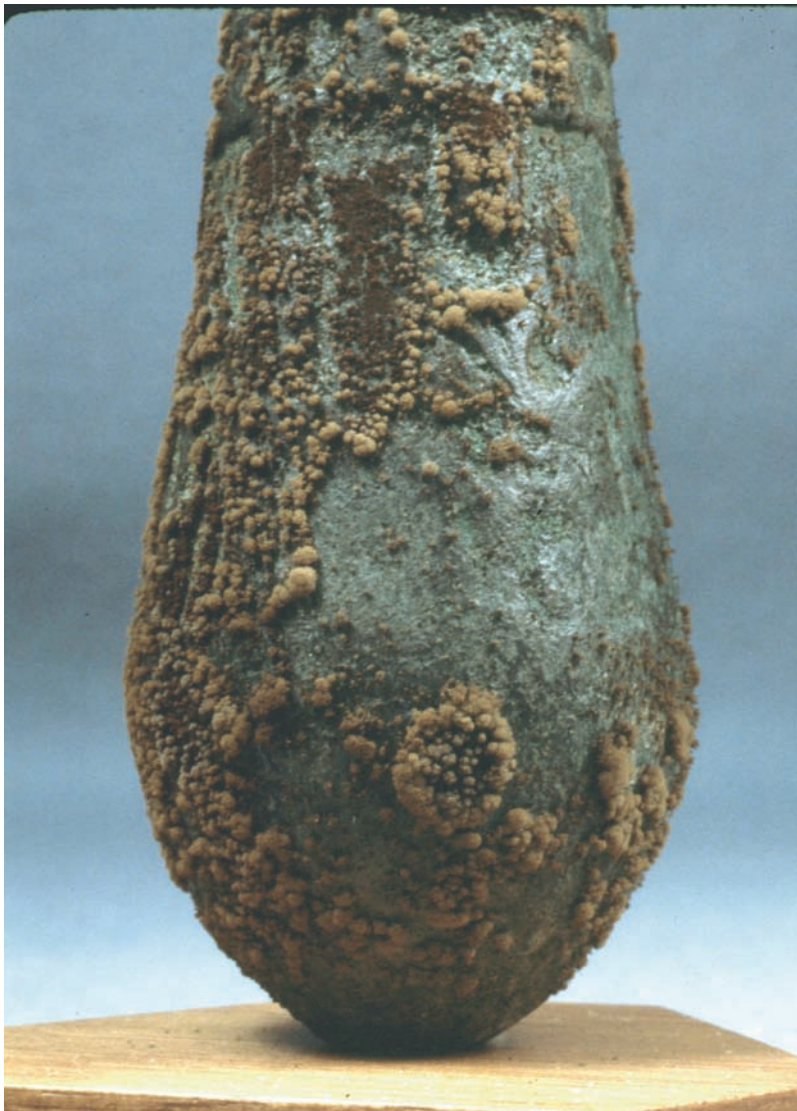
**Fig. 20** Velvetlike corrosion growths on the surface of an ancient copper alloy vessel. The subtle form of the object is all but obscured by corrosion growths. See the article "Corrosion of Metal Artifacts and Works of Art in Museum and Collection Environments" in this Volume.

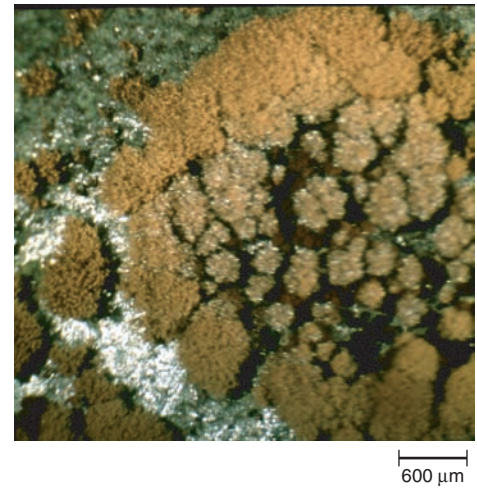
**Fig. 21** At higher magnification, the velvetlike corrosion begins to reveal its dendritic structure. The corrosion was identified as djurleite, a copper sulfide. Original magnification 15×. The Chicago Oriental Institute. See the article "Corrosion of Metal Artifacts and Works of Art in Museum and Collection Environments" in this Volume.

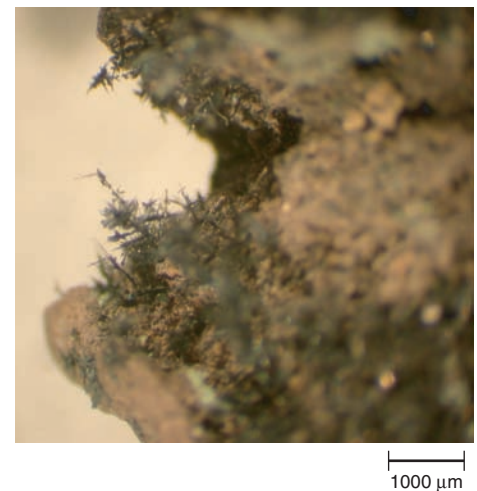
**Fig. 22** In a seemingly benign indoor environment, dendritic silver sulfide crystals are found growing on a Greco-Roman silver bowl. Walters Art Museum, Baltimore. Original magnification 10×. Courtesy of Terry Drayman-Weisser. See the article "Corrosion of Metal Artifacts and Works of Art in Museum and Collection Environments" in this Volume.
