# ASM Handbook®

## Volume 13C Corrosion: Environments and Industries

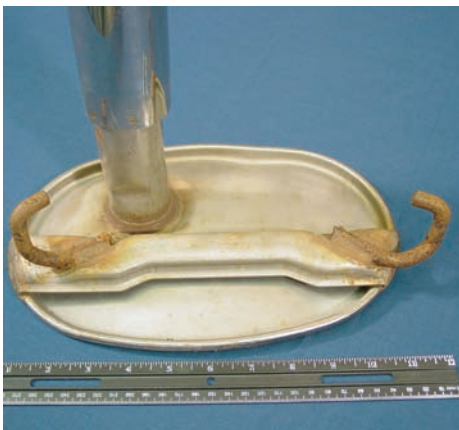
**Fig. 23** Galvanic corrosion of solid carbon steel hanger rods after 1.5 years of driving service in the salt belt. Muffler end plate and sheet metal hanger are 18Cr-Cb. See the article "Automotive Exhaust System Corrosion" in this Volume.

welded to the stainless steel end bracket of the muffler after less than two years of service, although because of its size, the function is not yet jeopardized (Fig. 23). In a radiator, solder bloom has interfered with the ability to remove heat from the engine (Fig. 24). Another form of corrosion evident in a radiator is erosion-corrosion where the fluid removes the passive film, accelerating the rate of corrosion in high-flow areas such as opposite an inlet (Fig. 25a) and at a tube constriction (Fig. 25b). Another form of mechanically assisted corrosion, cavitation corrosion, is possible in an engine block (Fig. 26) where exhaust gases cause the coolant to boil.

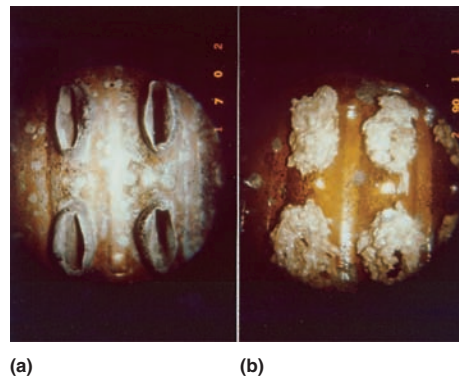
**Fig. 24** Solder bloom formation can block and restrict the flow of coolant in the radiator. (a) New radiator core. (b) Solder bloom after just 22,000 miles of normal highway operation. See the article "Engine Coolants and Coolant System Corrosion" in this Volume.

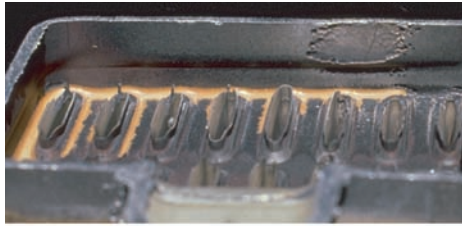
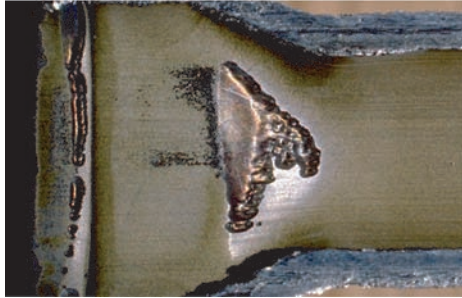
**Fig. 25** Erosion-corrosion related to high coolant flow. (a) Radiator tank erosion on wall opposite inlet. (b) Tube narrowing causes increased velocity and turbulent flow. See the article "Engine Coolants and Coolant System Corrosion" in this Volume.

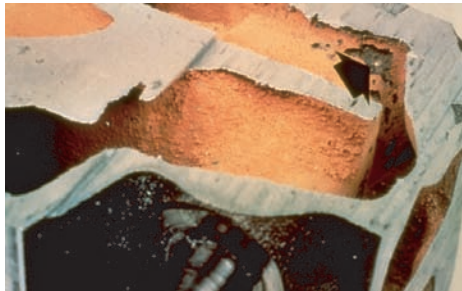
**Fig. 26** Nucleate boiling-induced cavitation corrosion caused perforation at the exhaust valve port of this aluminum cylinder head. See the article "Engine Coolants and Coolant System Corrosion" in this Volume.

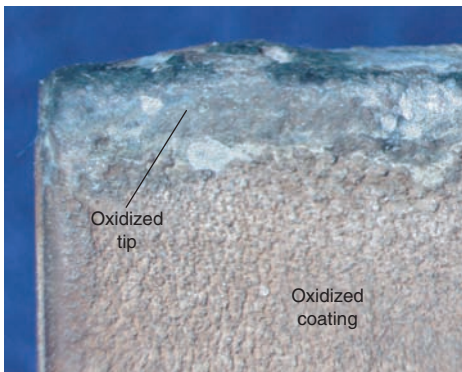
**Fig. 27** High-temperature oxidation of the tip of an industrial gas turbine blade. Below the tip, a coating is protecting the base metal. See the article "Corrosion of Industrial Gas Turbines" in this Volume.

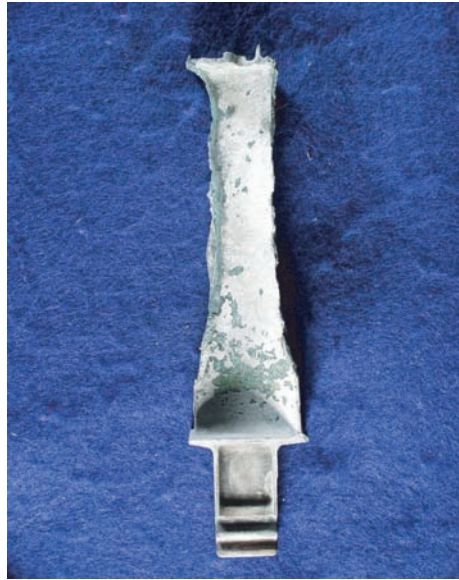
**Fig. 28** Severe attack of an aeroderivative gas turbine blade by hot corrosion. See the article "Corrosion of Industrial Gas Turbines" in this Volume.

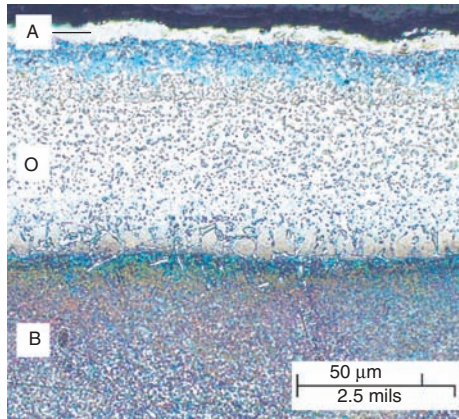
**Fig. 29** Duplex coating consisting of an overlay coating (O) with an aluminide layer (A) on top. There is an interdiffusion zone with the base metal (B) and another interdiffusion zone between A and O. Lactic acid etch. See the article "Corrosion of Industrial Gas Turbines" in this Volume.

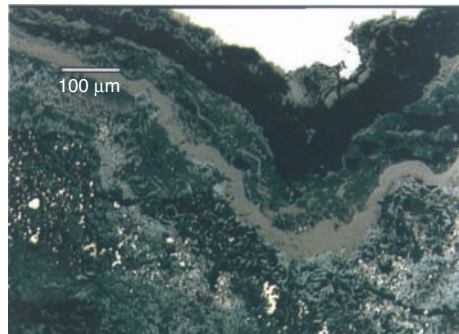
**Fig. 30** Hotside deposit in the vicinity of the failure displays several layers and waterside oxidation/corrosion. Some layers are dense, while others are very porous. One layer displayed needlelike fibrous oxides. Another layer contains a number of particles of copper metal. Original magnification 210 $\times$ . See the article "High-Temperature Corrosion in Military Systems" in this Volume.

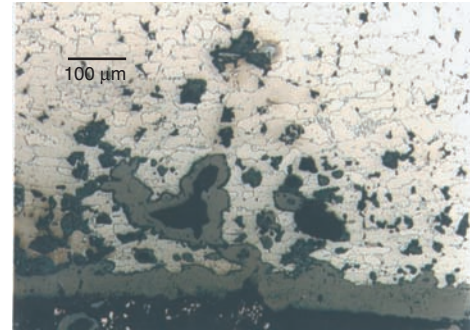
**Fig. 31** Waterside surface, hot side, near failure. Carbides in prior pearlite colonies have completely spheroidized from overheating. Creep voids have developed at grain boundaries; some of these voids have grown and coalesced. Original magnification 210 $\times$ . See the article "High-Temperature Corrosion in Military Systems" in this Volume.

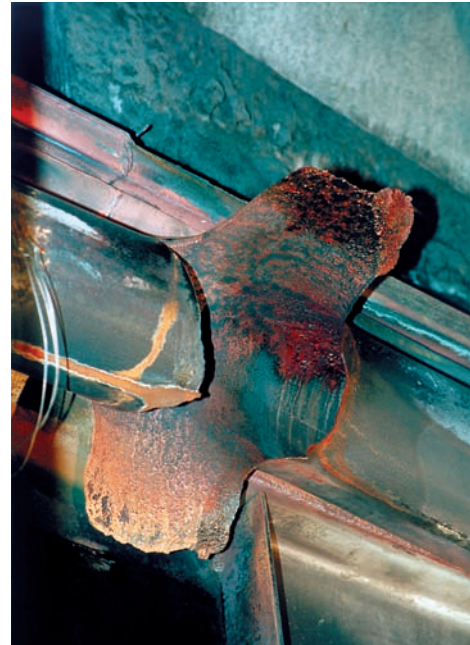
**Fig. 32** Feedwater pipe thinning and rupture. See the article "Corrosion of Steam- and Water-Side of Boilers" in this Volume.

High-temperature feedwater, 120 to 205 °C (250 to 400 °F), caused flow-assisted corrosion that appeared as a general thinning with a scalloped profile and led to a sudden rupture (Fig. 32).

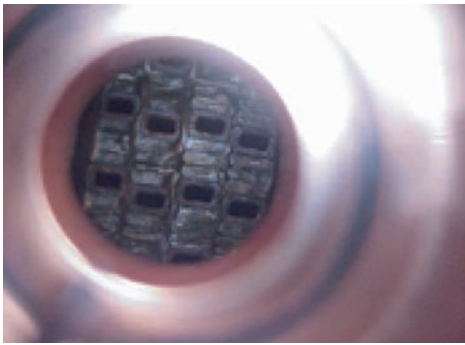
**Fig. 33** Borescopic view through bottle clip opening into strand package made of hollow strands that carry cooling water and solid strands that carry the majority of the current. This bundle of copper strands (both hollow and solid) is brazed together into a single, consolidated strand package. Braze material, which is porous, covers the surface of the strands and extends axially back into the coil between strands. It is this material that is susceptible to crevice corrosion cracking as cooling water is trapped in the porous openings and initiates the corrosion process. See the article "Corrosion of Generators" in this Volume.

On the electrical side of a power plant, a water-cooled generator stator faced crevice corrosion in the braze between the rectangular copper wire, as seen through a borescope (Fig. 33). In a high-speed generator, non-magnetic retaining rings made of an 18Mn-5Cr alloy steel must withstand high residual and dynamic stresses. The stress-corrosion cracking that resulted in this now-obsolete material choice is made more evident through fluorescent dye penetrant examination (Fig. 34).

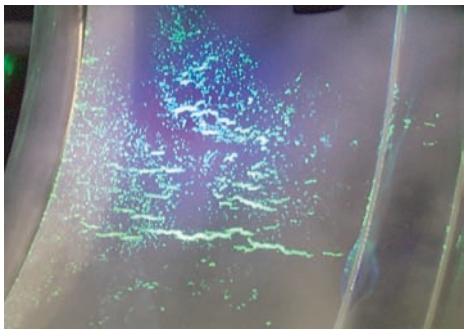
**Fig. 34** Fluorescent dye penetrant examination showing linear indications of stress-corrosion cracking in an 18Mn-5Cr retaining ring. See the article "Corrosion of Generators" in this Volume.

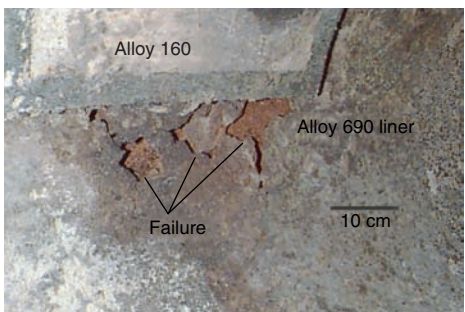
**Fig. 35** Failed incinerator liner. Hole near alloy 160 patch shows that the original 6 mm (0.250 in.) wall thickness had been reduced to 1.2 mm (0.050 in.) or less in the general area. See the article "High-Temperature Corrosion in Military Systems" in this Volume.

**Waste Disposal.** Incinerator gases are especially corrosive, and materials selection is critical because the composition of the combustion gas may vary. Nickel-base liners are often used. In the case of an incinerator used by the military aboard ship, the nickel-chromium alloy 690 (UNS N06690) was repaired with a Ni-Co-Cr-Si alloy 160 (UNS N12160) that is known for sulfidation resistance because it forms a silica-rich scale. Figure 35 demonstrates the performance of this material.

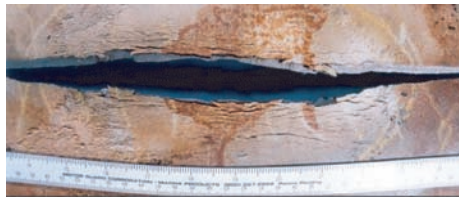
**Fig. 36** Example of colony of stress-corrosion cracks on external surface of high-pressure gas transmission pipeline. See the article "External Corrosion of Oil and Natural Gas Pipelines" in this Volume.

that can be thousands of kilometers long. For the most part, the systems are buried in walls, under streets, under ground, or underwater. Stress-corrosion cracking of a high-pressure gas pipeline led to its rupture (Fig. 36). The corrosion on the inside of a petroleum pipeline is given the descriptive name mesa corrosion, from the appearance of the wasted wall (lower right, Fig. 37). Another appropriately named corrosion morphology is the tuberculation in a cast iron pipe (Fig. 38).

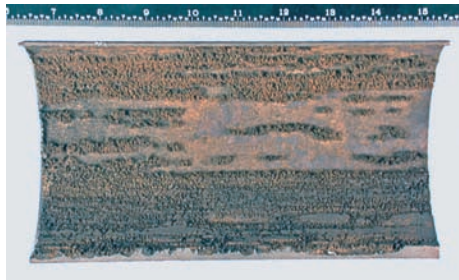
**Fig. 37** Inside of a pipe in the petroleum industry exhibits mesa corrosion. Note profile of pipe wall in lower right corner. Characteristic appearance of mesa corrosion resulting from CO<sub>2</sub>, water, and flow. The scale is in inches. Source: InterCorr International, Inc., Houston, TX. See the article "Corrosion in Petroleum Production Operations" in this Volume.

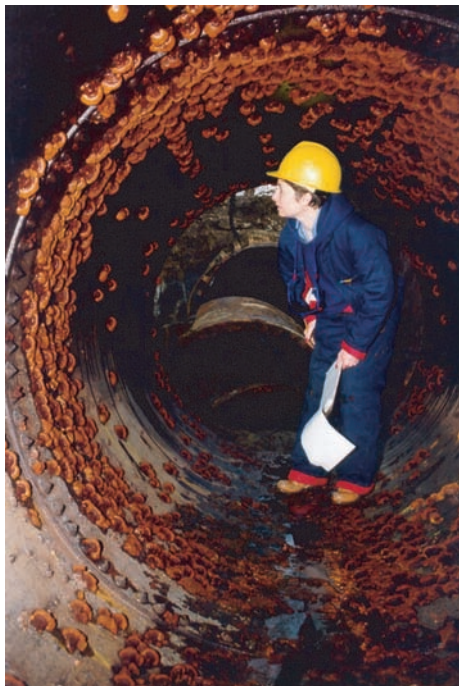
**Fig. 38** A 1.5 m (60 in.) cast iron pipe with tuberculation. Courtesy of Terry Bickford. See the article "Corrosion in Potable Water Distribution and Building Systems" in this Volume.

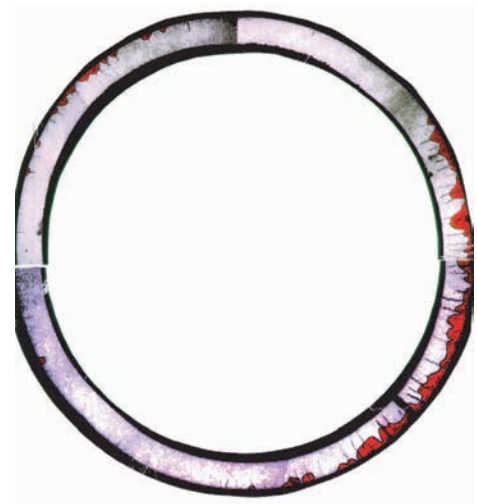
**Fig. 39** An example of severe intergranular attack/intergranular stress-corrosion cracking at a tube support location. See the article "Corrosion in Pressurized Water Reactors" in this Volume.

Piping in a nuclear power plant steam generator unit made of alloy 600 nickel (UNS N06600) was subject to intergranular attack and stress-corrosion cracking at a support location (Fig. 39).

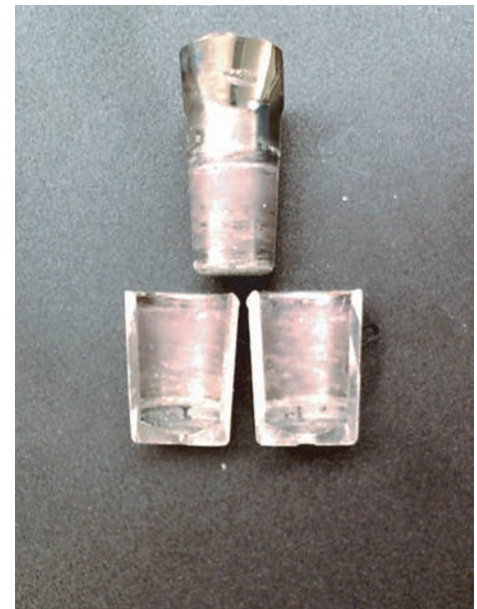
**Fig. 40** Light photographs of modular tapers from prostheses showing evidence of corrosion. Retrieved Ti-6Al-4V neck and Ti-6Al-4V "thimble" (sectioned in half) used to attach a ceramic head to the femoral stem. Two modular interfaces are established in this design, one comprising the titanium-titanium junction and the other the titanium-ceramic junction. Note that the interface regions are highly corroded on both titanium interfaces, and a purple color was present (indicative of Ti<sup>3+</sup> ions). Also found at these interfaces is evidence of titanium-phosphate particles, which indicate that the pH had dropped below 1 inside the taper. See the article "Mechanically Assisted Corrosion of Metallic Biomaterials" in this Volume.

**Biomedical Devices.** The tolerance for any corrosion or corrosion products in implanted medical devices is very small. The body can be an aggressive environment. In Fig. 40, a Ti-6Al-4V neck and (sectioned) thimble used to attach a ceramic head to the femoral stem were retrieved. The purple tint indicates that  $Ti^{3+}$  ions were present, and within the interface it was evident that the pH had dropped below 1. In another case, the head was retrieved from a total hip replacement prosthesis. The Co-Cr-Mo alloy (Fig. 41) shows signs of etching at the dark regions of the inner bowl.

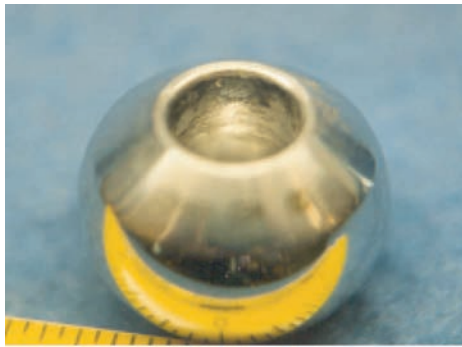
**Fig. 41** Retrieved Co-Cr-Mo modular head that had sat on a Ti-6Al-4V stem. Note the dark and discolored region inside the taper recess and the signs of etching. See the article "Mechanically Assisted Corrosion of Metallic Biomaterials" in this Volume.

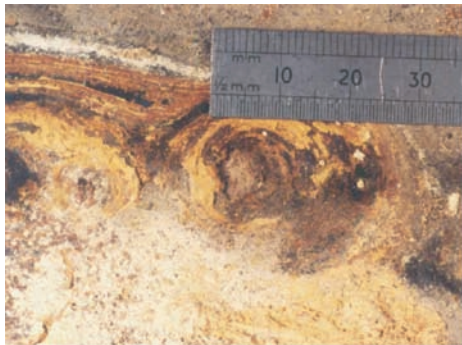
**Fig. 44** Microbiologically influenced corrosion in a water pipe due to sulfate-reducing bacteria. See the article "Evaluating Microbiologically Influenced Corrosion" in *ASM Handbook* Volume 13A.

**Microbiologically Induced Corrosion.** Bacteria and other microorganisms can paint some interesting pictures while inducing corrosion. A microscopic image of stainless steel in seawater reveals a host of microorganisms (Fig. 42). A comparison of aerobic and anaerobic bacteria in seawater is shown in Fig. 43(a to d). The corrosion in a water pipe was induced by sulfate-reducing bacteria (Fig. 44).

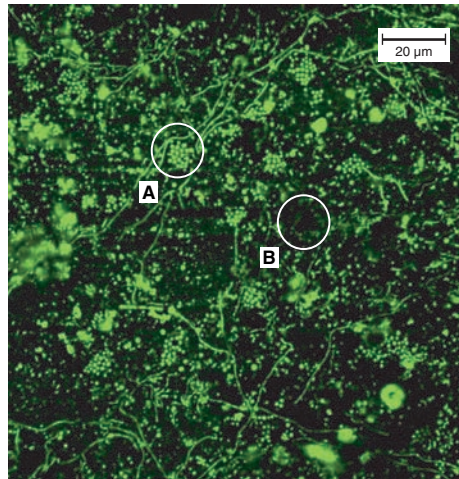
**Fig. 42** Laser confocal microscope image of the variability in distribution and types of microorganisms in a two-week old biofilm grown on a stainless steel substratum in Lower Delaware Bay coastal seawater. The chemistry at the metal surface within a microcolony, as shown at location "A," will be quite different from that in either the bulk seawater or at location "B." Courtesy of K. Xua. See the article "Corrosion in Seawater" in this Volume.

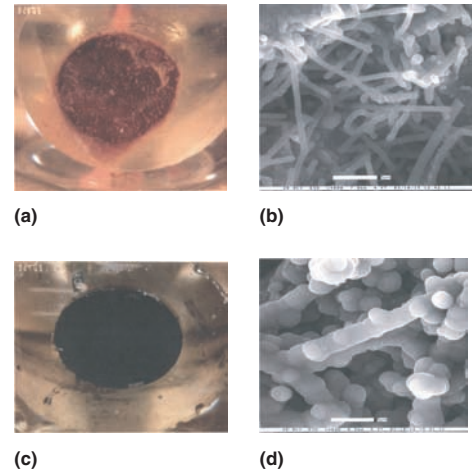
**Fig. 43** (a) Photograph of carbon steel electrode exposed to aerobic natural seawater for 290 days. (b) Scanning electron micrograph of iron-oxide-encrusted bacteria enmeshed in corrosion products. (c) Photograph of carbon steel electrode exposed to anaerobic natural seawater for 290 days. (d) Scanning electron micrograph of sulfide-encrusted organisms enmeshed in corrosion products. See the article "Microbiologically Influenced Corrosion in Military Environments" in this Volume.
