**SOUTHWIRE COMPANY
METALLURGICAL LABORATORY**

***ENCYCLOPEDIA
TEARS OF COPPER WIRE***

**by
dr. E. Henry Chia
and
Gautam R. Patel**

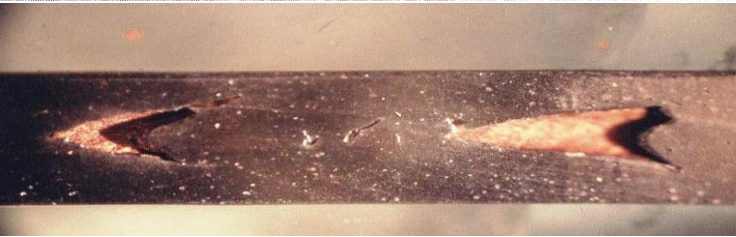
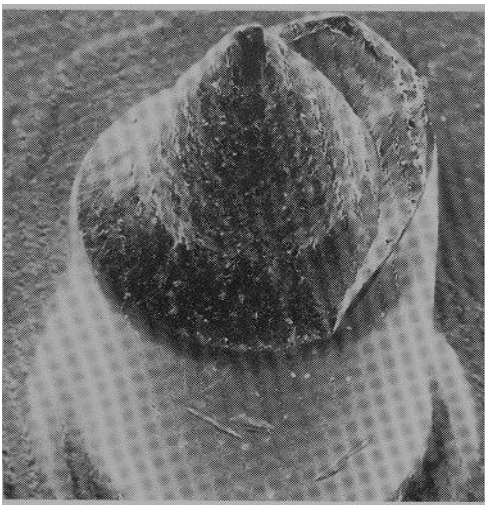
Longitudinal section of a wire showing the formation of defects: central tear (cup-cone)

1- High concentration of particles or copper oxide strings in the central portion of the thread. These particles act as a point of origin where the focus is to initiate a micro-crack which will propagate during the drawing up to occur in the yarn breakage.

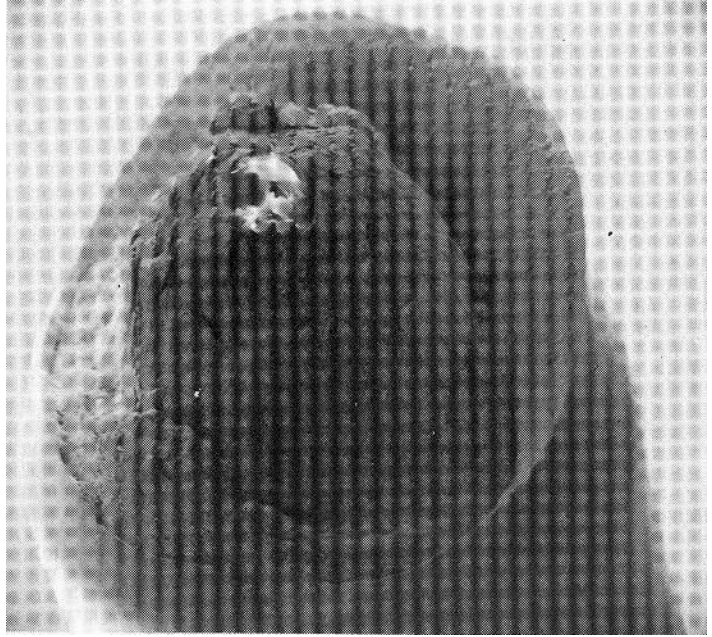
Portion of farm fracture
central
Showing micro particle inclusion
Of non-magnetic material.

Photograph of a fracture caused by particle
containing **Ai-Si-Ti**

1- presence of micro particle of inclusion (composed of aluminum, silicon and titanium, in this case) that caused the crack during the drawing

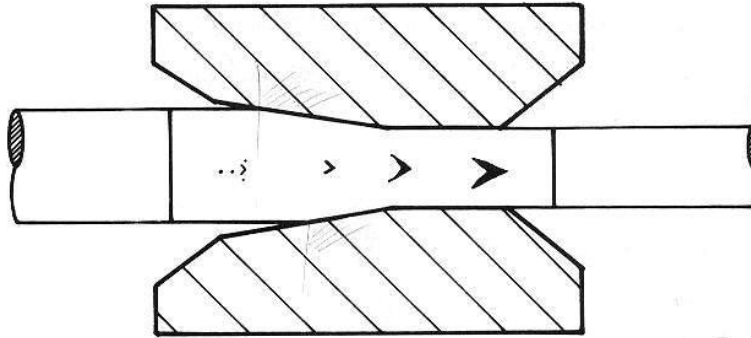
**CLASS III
SUBCLASS C
RIP CENTRAL (CUP-CONE) DUE
THE PARAMETERS OF DRAWING WRONG**

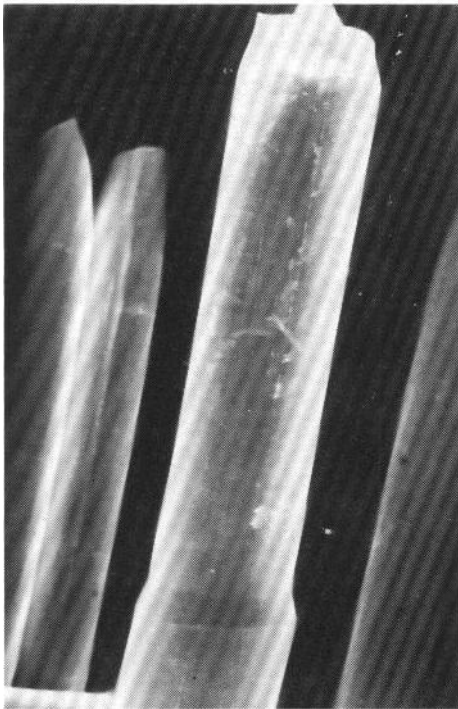
OUTLINE OF THE MECHANISM OF "RIP CENTRAL" BREAKING
"COPPA-CONE"

Macrograph of the longitudinal section of a cup-cone failure, where the "tear - central" lying on the longitudinal axis of the wire, caused by the angle of the incorrect chain reduction cone (20°) are visible

- 1- excessive hydrostatic stress in the central portion of the thread during the drawing.
- 2- Force counterinsurgency increased traction
- 3- Reduction of insufficient section
- 4- Inadequate angle geometry of the chain reduction cone.
- 5- excessive angle of the incoming wire chain
- 6- Friction increased by insufficient lubrication and / or reduction rate or corner is not properly entered.
- 7- excessive length of the cylindrical part of the chain surface
- 8- very worn Capstans

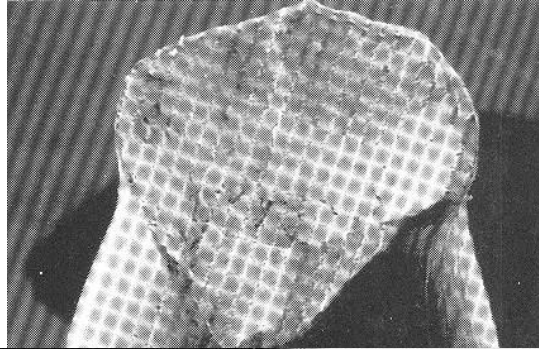
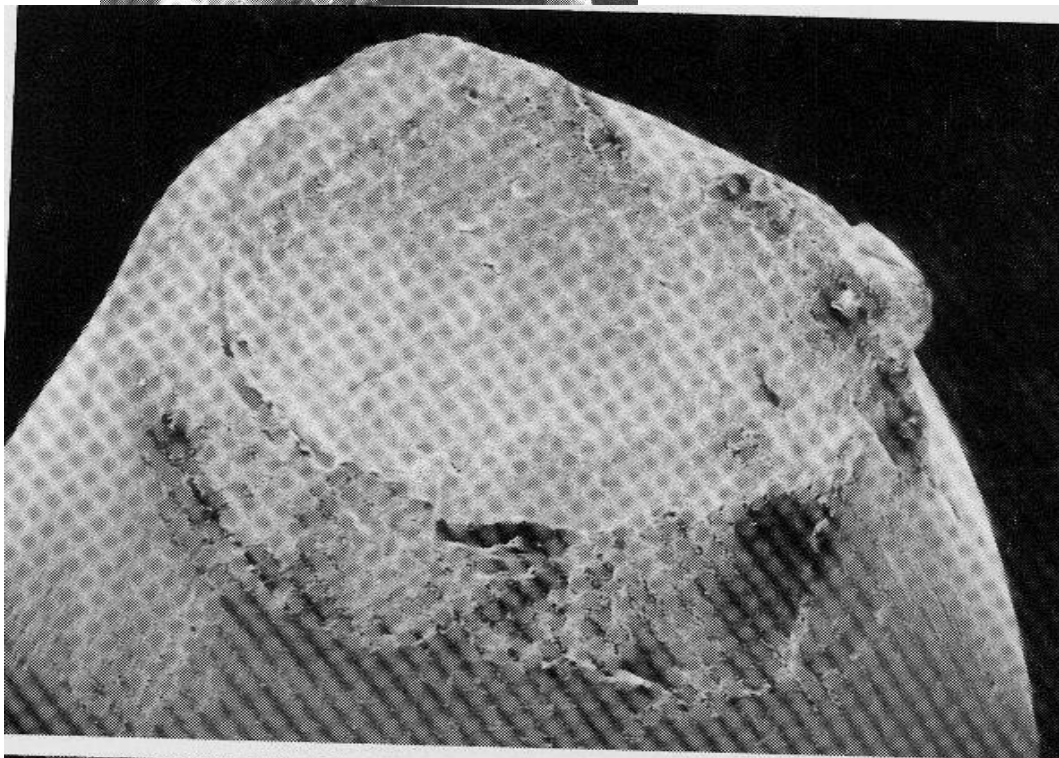
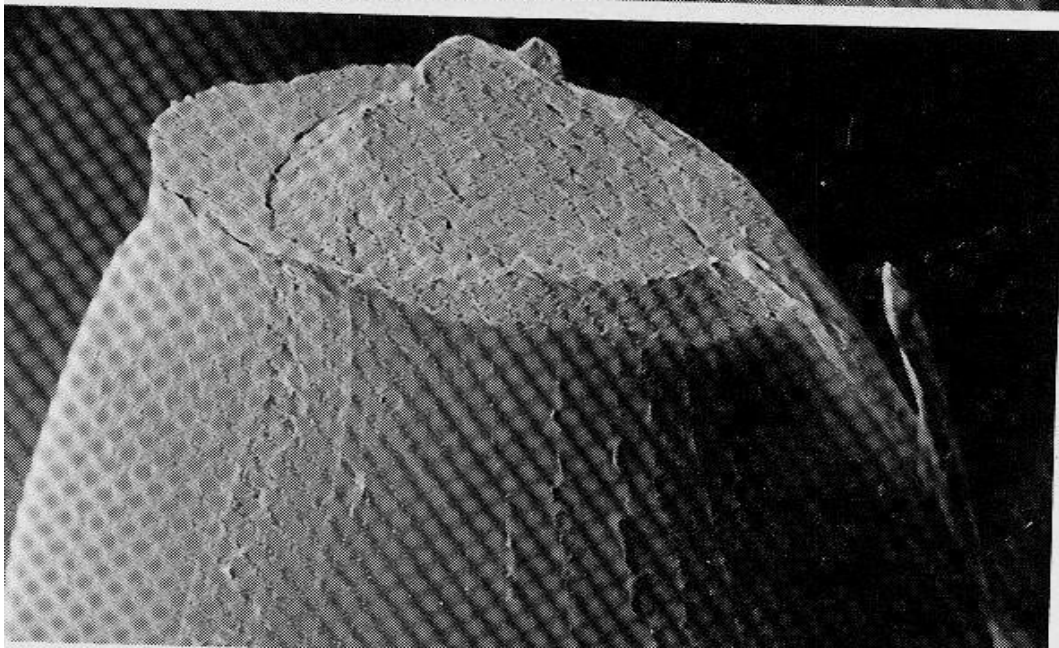
Fractures caused by typically resulting axial tension in the area affected by the reduction of the wire section.

However, the breakdown shows defects (fine burrs) in the vicinity and on the adjacent surface.

The defects are the places of origin of the break.

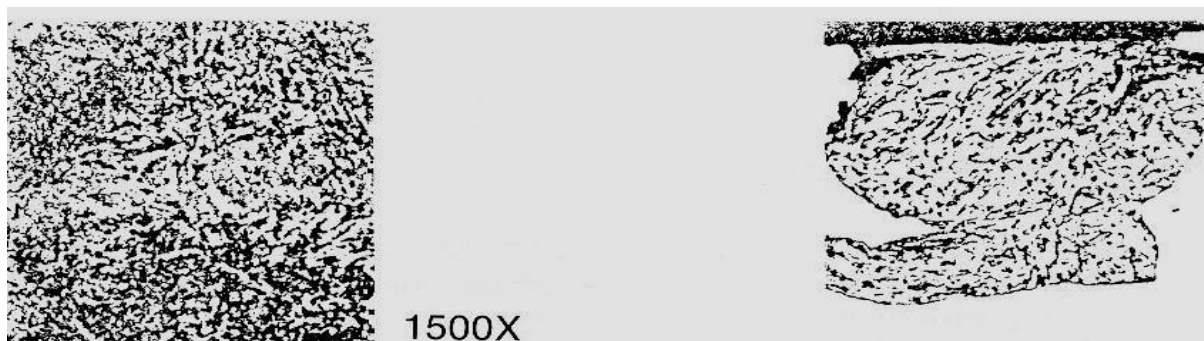
Microstructure of the capstan Macrostructure inclusion of the drawing machine that found in an exhibition tempered martensite break showing tempered martensite.

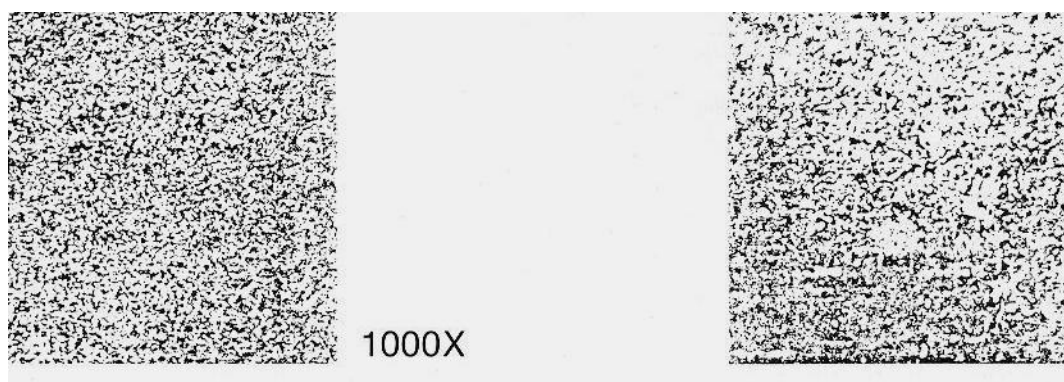
microstructure of the capstan macrostructure inclusion machine made with rott found in steel. wire displays by tool, showing tempered martensite and tempered martensite and carbides. Carbides.

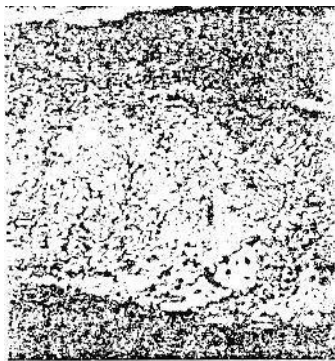
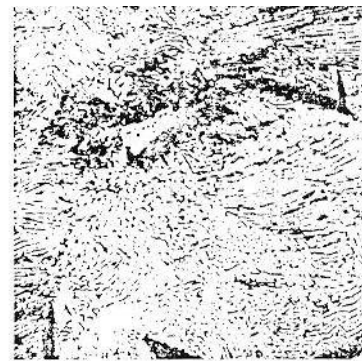
1000X

**Microstructure capstan inclusion microstructure
Grey cast iron, graphite shows found in Rott. Wire, shows
and steatite (eutectic phosphoric) perlite and steatite**

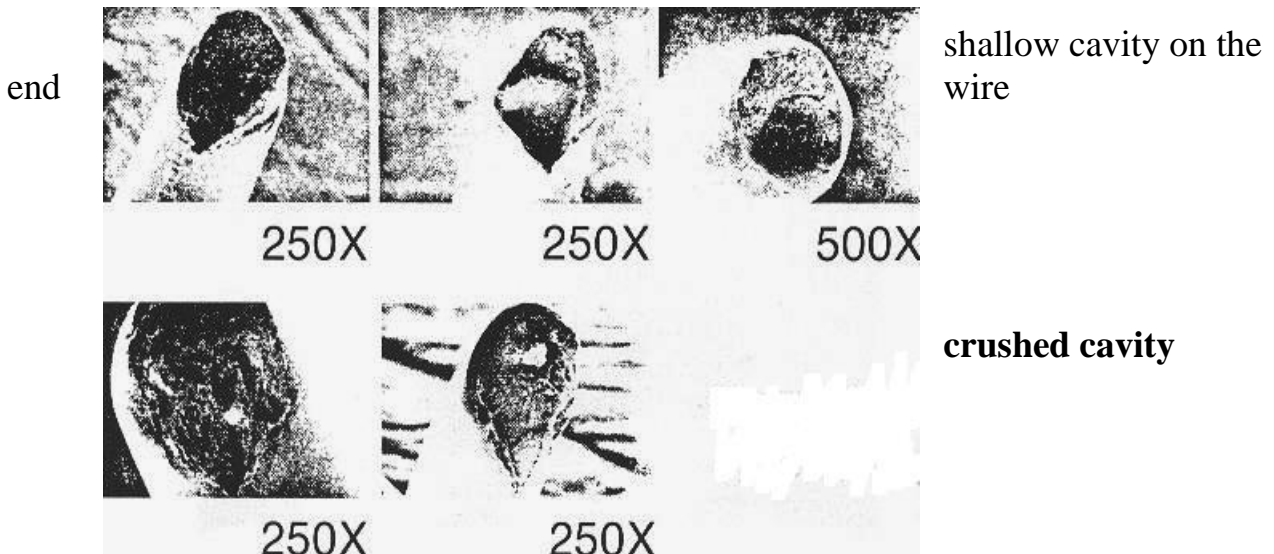
1-magmatic and non-magnetic inclusions that are present in the wire matrix, damage to the beginning of cracking of the wire drawing process to proceed. The inclusion comes to the surface and breaking comes out and falls in the emulsion, leaving on the surface of the wire its cavity.

- 1- magmatic inclusions or non-magnetic colored liquid inside the copper and subsequently rolled inside in the copper wire rod**
- 2- inclusions magmatic or non-magmatic incorporated in the process of wire drawing**

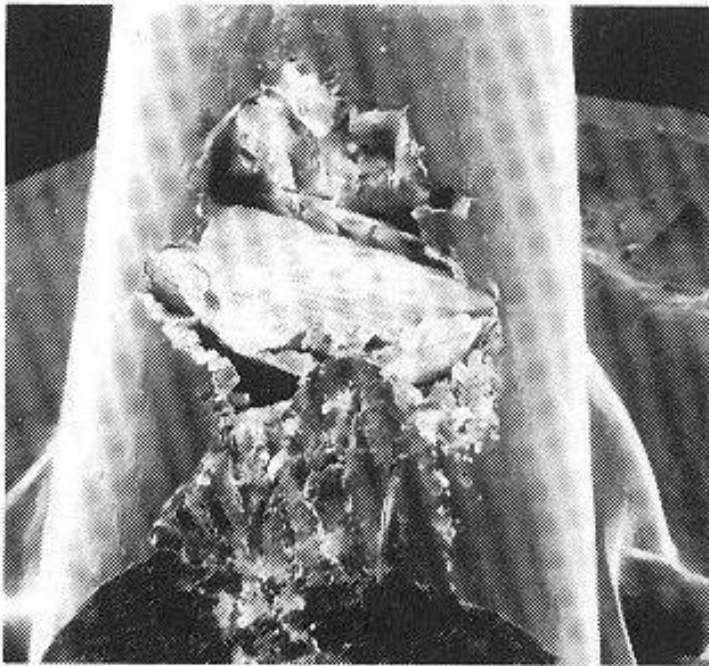
20X

Defects or breakage of the wire characterized by the presence of the inclusion (or from a cavity left by inclusion) on the surface or below the surface of the wire. Foreign particles can be easily introduced below the surface of the

wire during the drawing.
of embedded iron particles under
the surface of the wire.

and hard foreign particles, magnetic or non-magnetic, that are present in the chain or in the lubrication-cooler can be stuck on the wire surface so may cause the final breaking of the wire.

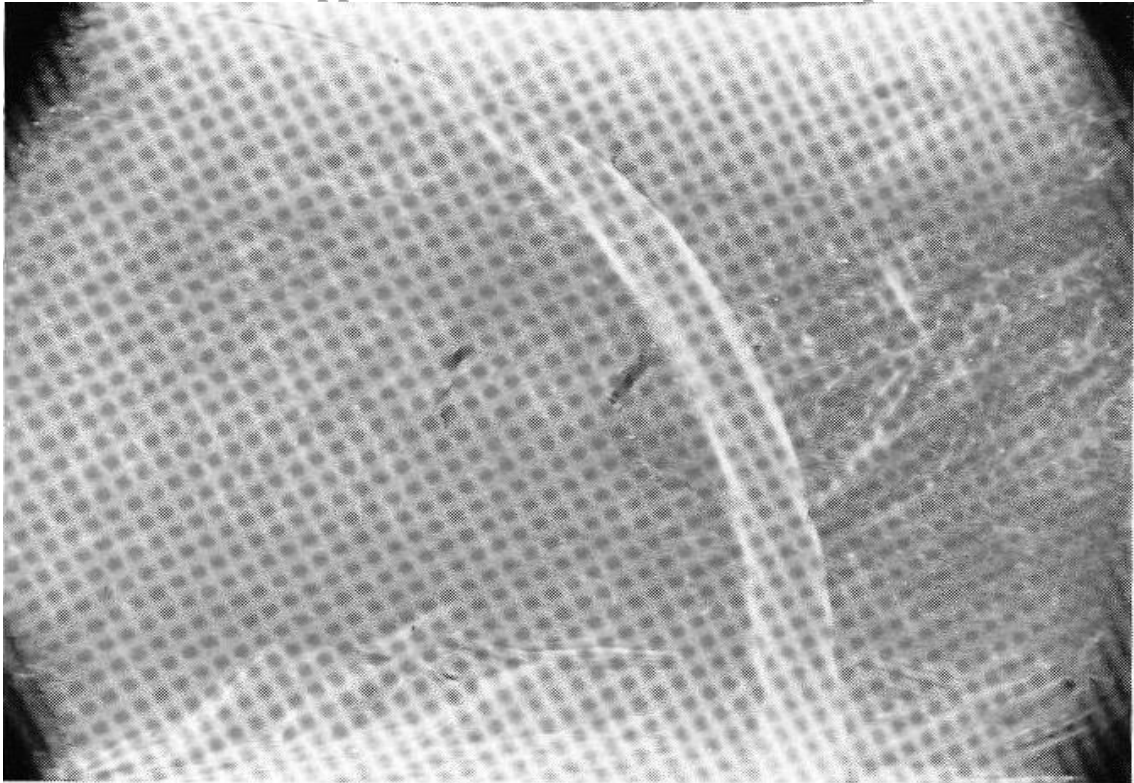
10X

Imprint or engraving left on the surface of the wire from a twisted steel wire, after it has passed from the first chain (7,34mm).

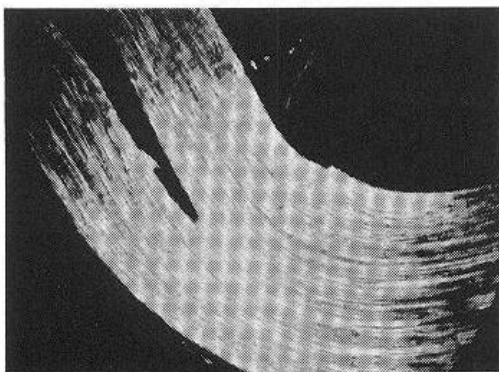
30X

optical micrograph of a longitudinal section showing the central cavity that extends inside the second flow of material.

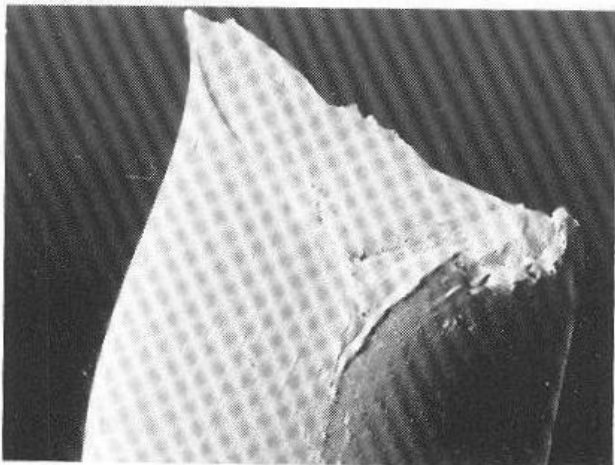
20X

wire breakage associated with a burr on the wire rod.

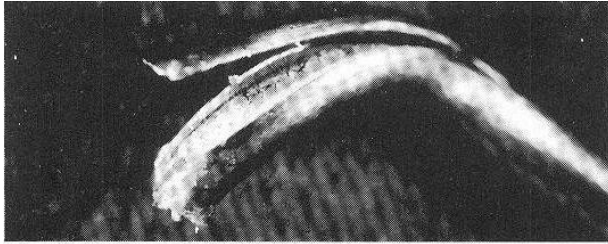
1X

**CLASS XI
UNDER CLASS B
WIRE SPLIT BECAUSE OF SEGREGATION
COPPER OXIDE**

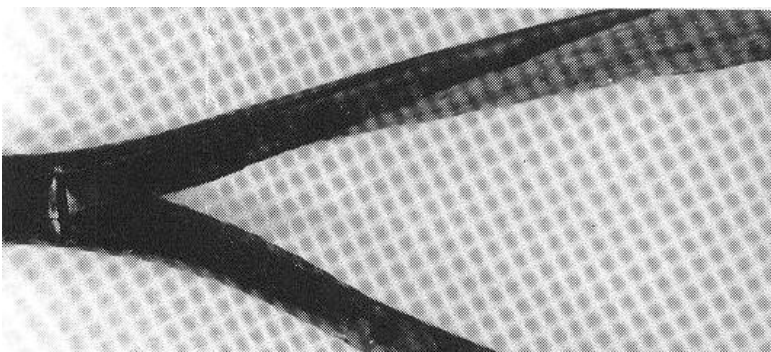
1X

Macro photography of split end which shows the presence, in the fracture zone, of a refractory coating.

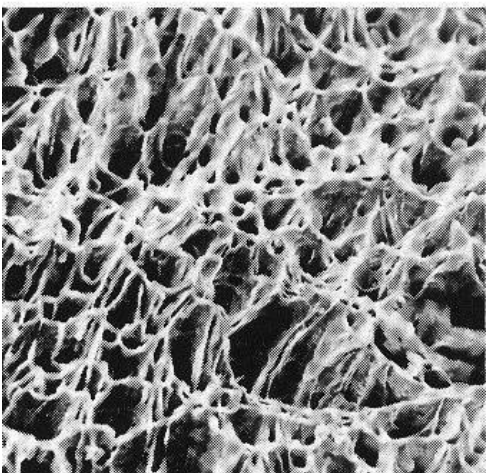
200X

Fractography SEM of a thread break for necking showing the characteristic micro-voids with the peripheral walls lengthened indicating the ductility of copper ETP1.

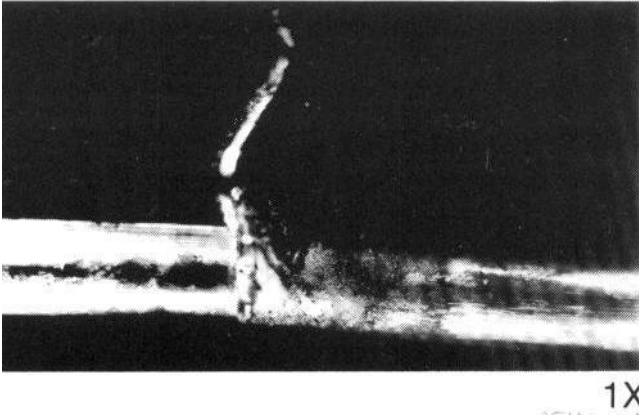
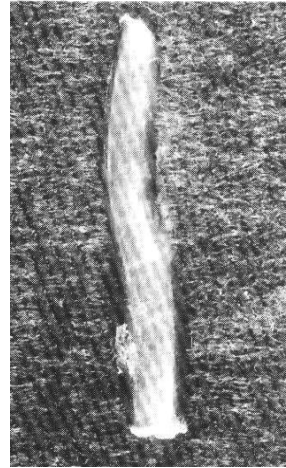
**CLASS III
SUB CLASS A
ANGLE CHAIN**

CAUSE / E: misalignment

chain and the supply chain.

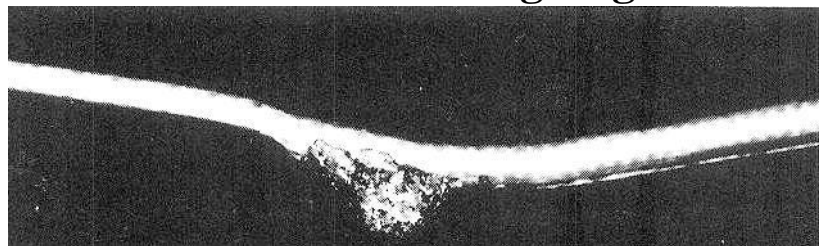
**CLASS III
SUB CLASS B - BROKEN WIRE DUE TO THE CHAIN
STOPPERED.**

- 1- tension caused by metal stuck on the wire rod in the car entry
- 2- Excessive emulsion copper powder
- 3- entry angle and reduction not perfectly coupled.
- 4- no direct emulsion spray good toward entry cone of the supply chain.

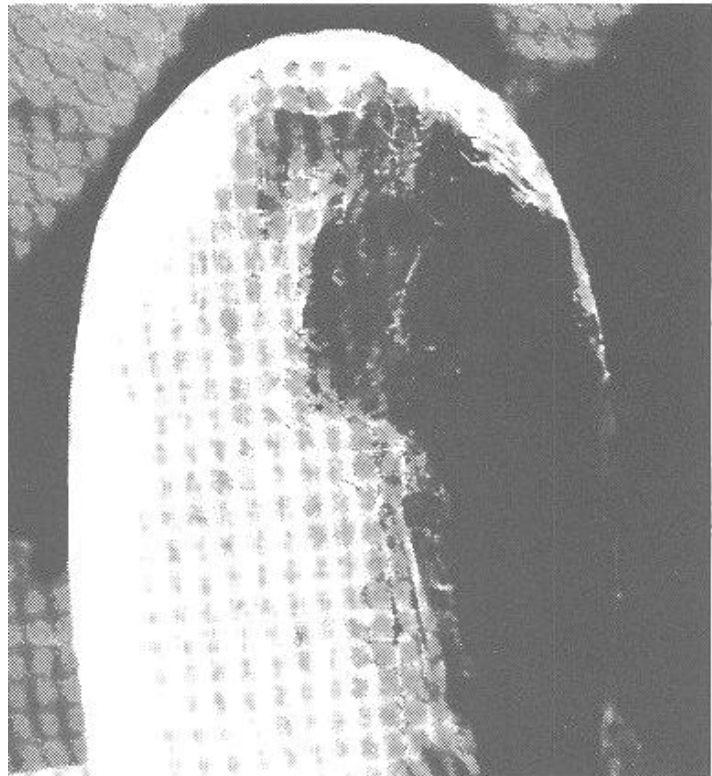
45X

**Tensile failure produced by
poor transfer and / or
handling**

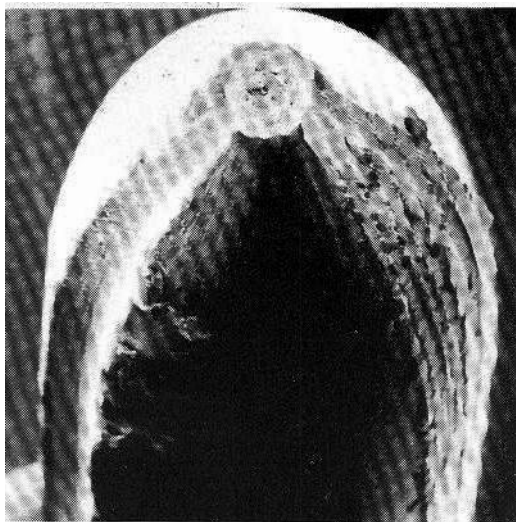
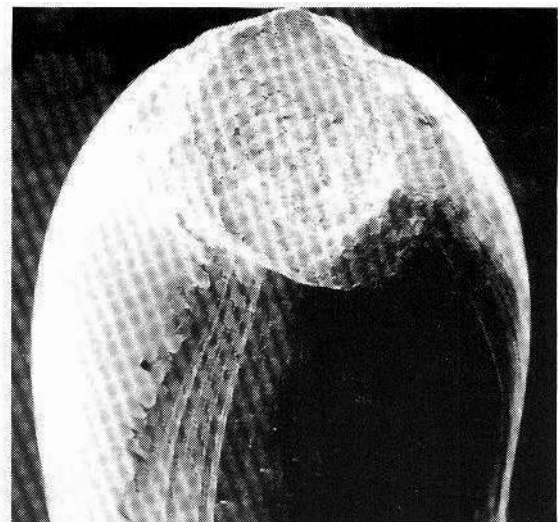
thread breakage due to worn chain, hard particles introduced into the chain, poor lubrication, improper scale reduction chains, supply chains built or adjusted wrong, incorrect chain alignment, emulsion temperature much higher than normal ..

Fractures traction due to a very severe die wear.

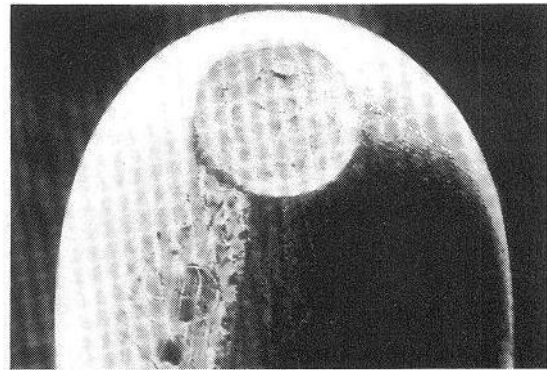
40X

wire breakage caused
from a material node
insulating

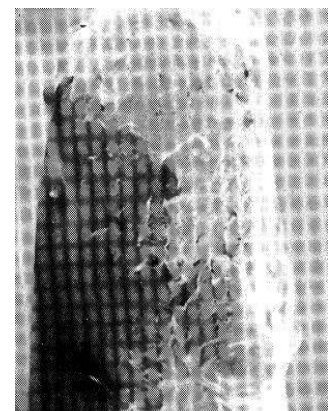
Broken wire produced by an electrical discharge or by too high a temperature set for the lehr. For necking rupture caused by a burn in the oven

- 1-discharge of an electric arc in the oven
- 2-incorrect electrical voltage in the oven
- 3-band of excessively dirty contact
- 4-band excessively grooved wear contact
- 5-incorrect adjustment of the speed between the drawing machine and the oven.
- 6-wrong voltage or high temperature furnace
- 7-speed different between the two pulleys of the oven.

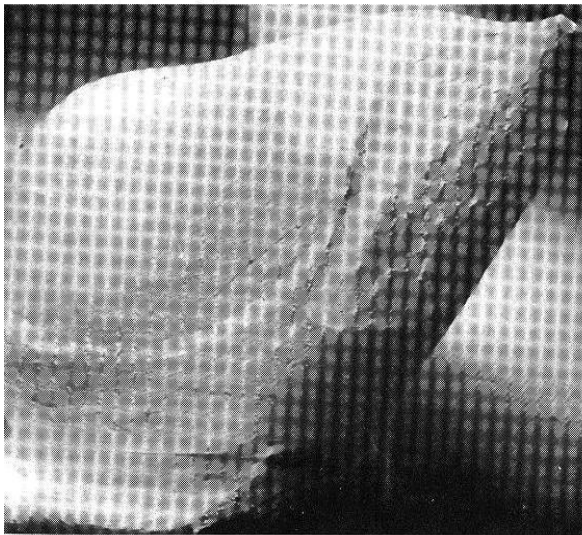
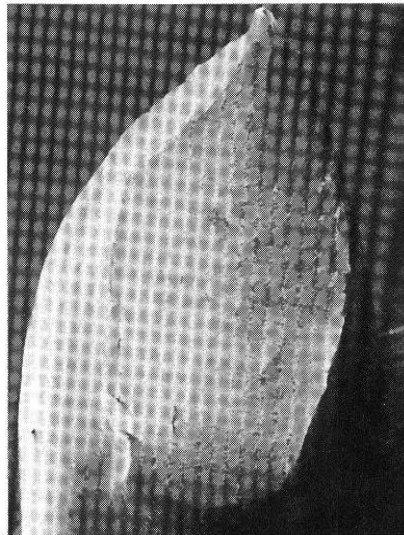
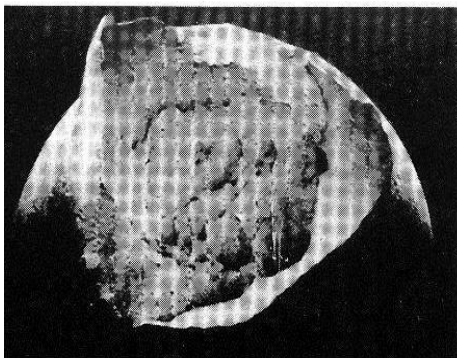
yarn breakage that occurs when two or more coils of wire rod skein tangle together forming a node outside of the drawing machine. This type of breakage resembles a cutting fracture.

**Typical
breakdown
due to tangle
on the
incoming
wire rod.**

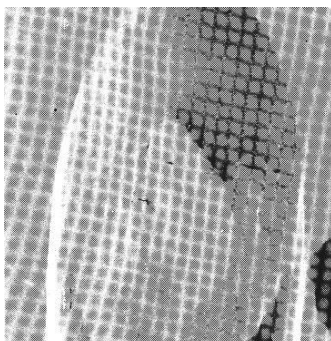
12X

It breaking characterized by an inclined fracture of 45 ° which elapses from one part of the wire. Normally, there are no interruptions in the inclination of the fracture. The cutting forces are the main cause of the spread and affect the area weakened by welding.

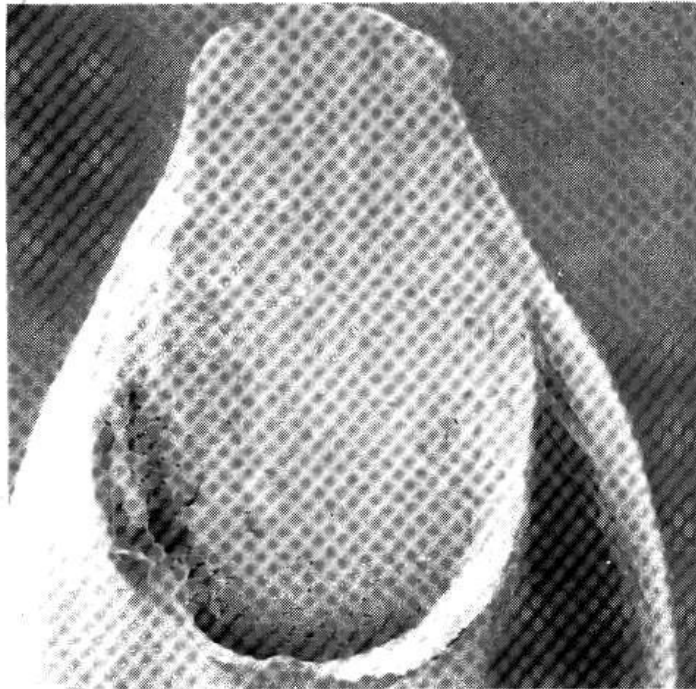
35X

yarn breakage that was manifested in the welding zone and is characterized by a necking at that point. The structure of the material in the area of the weld is normally ductile, but contains micro-voids or internal defects that give beginning to fracture.
