## Construction and Building Materials 101 (2015) 239-245

# **Construction and Building Materials**

Jun Pil Hwang, Min Sun Jung, Moonil Kim, Ki Yong Ann\*

Department of Civil and Environmental Engineering, Hanyang University, Ansan 426-791, South Korea

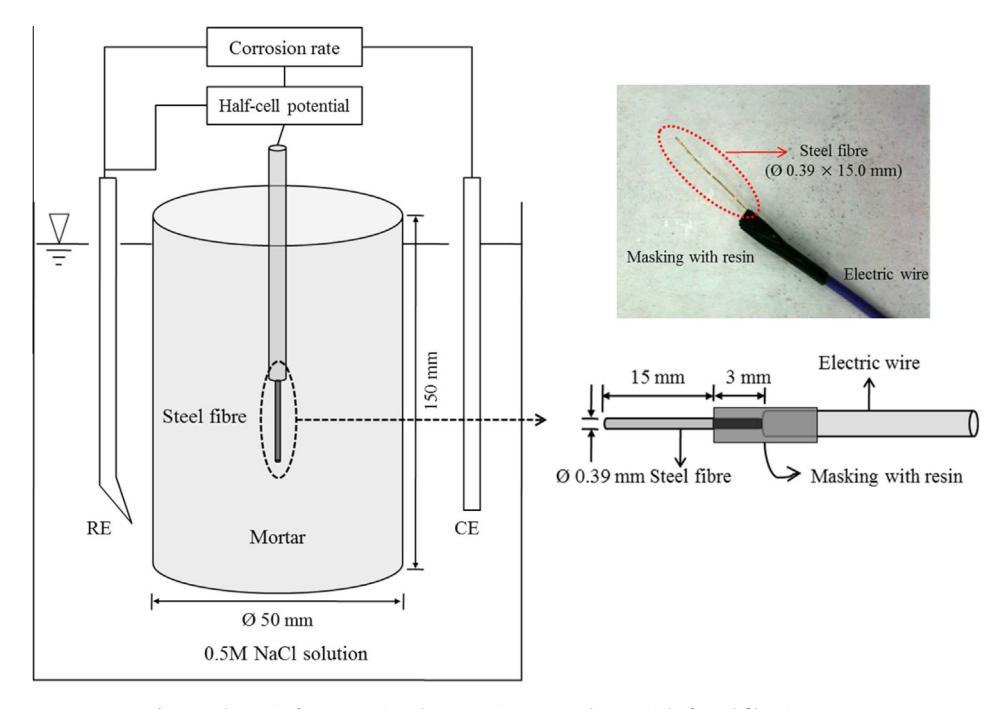
Fig. 1. Schematic for measuring the corrosion rate and potential of steel fibre in mortar.

Mortar was cast in a cylindrical mould ( $050 \times 150$  mm) with a centrally located steel fibre. One end of the steel fibre was electrically connected to an external source for measuring the polarisation resistance to corrosion. To accelerate the corrosion process, chlorides were admixed in mixing water, ranging from 0.0% to 5.0% by weight of cement. After casting and curing the mortar specimen by an equated method for measuring chloride transport, the specimen was immersed in 0.5 M NaCl solution with the top of specimen open to atmosphere for a supply of oxygen for 24 h before measuring the corrosion rate to enhance the electric conductivity in polarising the steel fibre to determine its corrosion rate, as seen in Fig. 1. The potential was swept +25 mV from the corrosion potential at a low scan rate of 0.1 mV/sec. The corrosion rate was calculated by the Ohm's law as given in Eq. (2). The polarisation resistance was determined by the curve of potential vs current density,

whilst the potential for corrosion was set as 26 mV for active corrosion. The electrical resistance of mortar (i.e. IR drop) was automatically compensated by using the interruption technique.

where,  $I_{corr}$  is for the corrosion rate, *B* for corrosion potential and  $R_P$  for the polarisation resistance, respectively. Simultaneously, half-cell potential of the steel fibre in mortar was measured using a copper–copper sulfate electrode to ensure the corrosiveness of steel fibre.

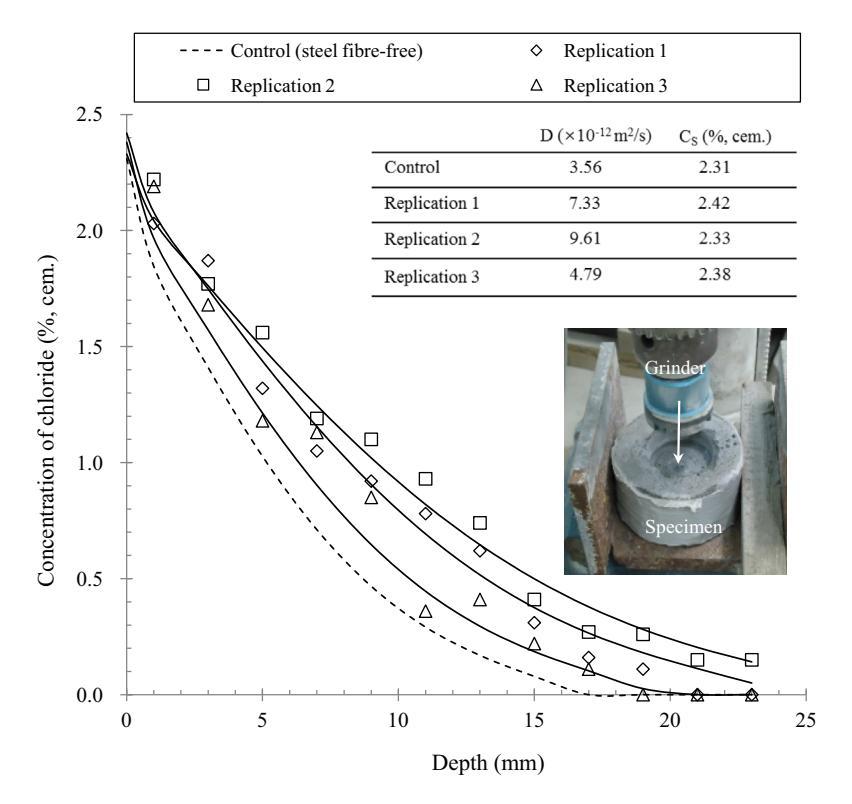
Fig. 2. Chloride ingresses of mortar containing steel fibre exposed to a 4 M NaCl solution for 100 days together with diffusion coefficient and surface chloride concentration.

The chloride profile of mortar is given in Fig. 2, after 100 days of exposure to 4.0 M NaCl solution. It is evident that chloride ingresses for mortars containing steel fibre at each depth were more or less higher than for steel fibre-free specimens. In fact, the apparent diffusion coefficient of chloride ions for steel fibre mortar ranged from  $4.79\times 10^{-12}$  to  $9.61\times 10^{-12}\,m^2/s,$  while steel fibre-free mortar produced  $3.56 \times 10^{-12}$  m<sup>2</sup>/s of the diffusion coefficient. The higher ingresses of chloride in mortar containing steel fibre may arise from increased porosity. As non-hydraulic materials are present in the concrete matrix, the interface between cement paste and those materials, for example, aggregate-paste interface [8] and paste-steel interface [9] may be often occupied by pores, which are usually generated in the process of mixing fresh concrete and subsequently formed underneath them. Thus, these pores may provide further paths for ions to be mobile, thus to accelerate ionic transport. However, there was only a marginal difference arising from the presence of steel fibre in the concentration of surface chloride, of which the range was 2.31-2.42% by weight of cement. This may be attributed to the fact that the surface chloride is influenced by rather concrete mix and exposure duration [10].

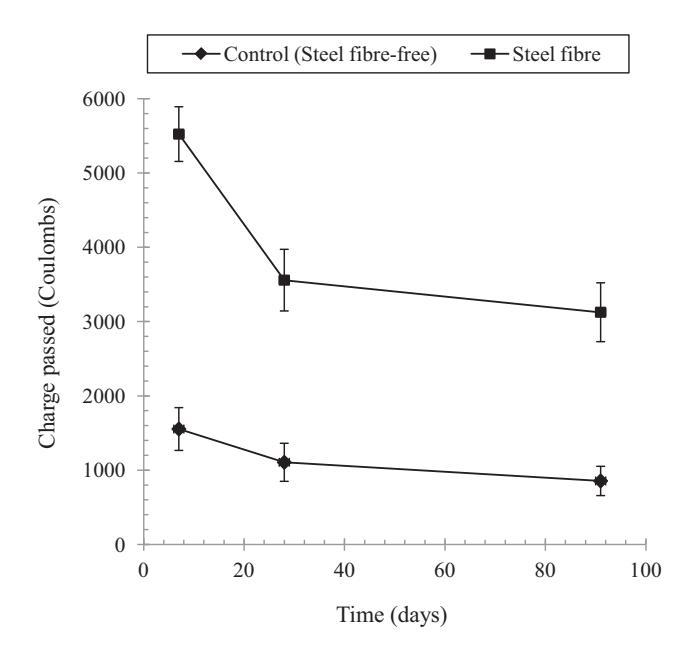
Fig. 3. Charge passed for mortars containing steel fibre with curing age.

As a rapid examination of ionic transport, chloride penetrability under electric charge was measured, as given in Fig. 3. It is clearly seen that the charge passed through the mortar cell was strongly dependent on curing age and whether or not steel fibre was admixed. As expected, an increase in the curing age resulted in a decrease in the passed charge in terms of chloride penetrability, due to densified concrete pore structure with hydration degrees. For steel fibre-free specimens, for example, the passed charge

was reduced from 1553 coulombs at 7 days to 854 coulombs at 91 days. It seems that the presence of steel fibre in concrete was, in fact, very crucial in determining the chloride penetrability. The charge passed for mortar containing steel fibre was in the range of 3125–5523 coulombs at all curing ages, being about 4 times higher than for steel fibre-free specimens. The increased chloride penetrability in steel fibre mortar may be again attributed to pores formed in the vicinity of the steel fibres. Moreover, the electrically

high conductive steel fibre in mortar could further contributed to increased charge even after a long curing age.

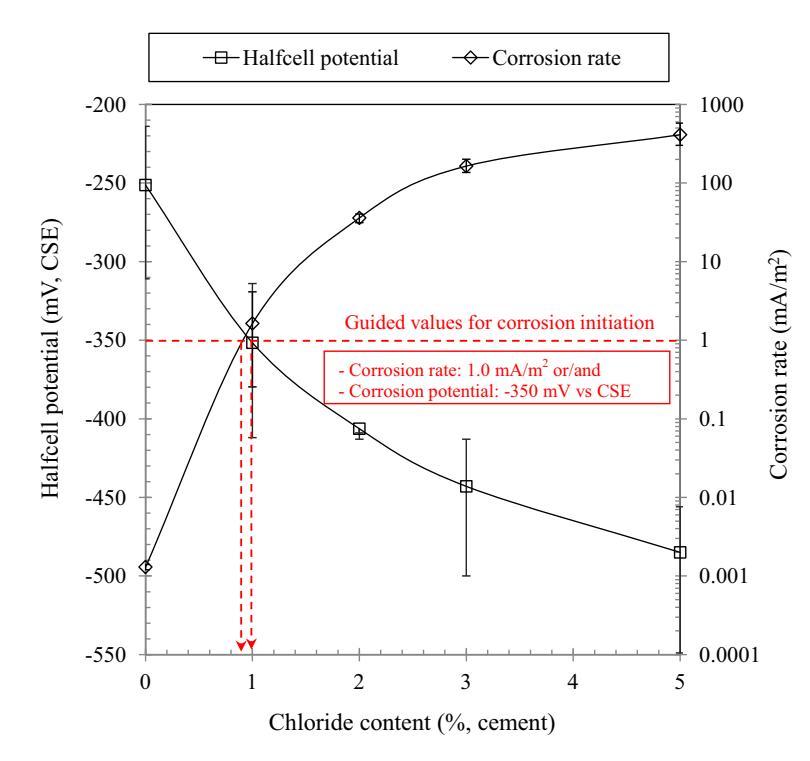
Fig. 4. Corrosion potential and rate of steel fibre in mortar with concentration of chloride in cast.

cement, as seen in Fig. 4. It is evident that an increase in the concentration of chloride in mortar resulted in an increase in the corrosion rate. In chloride-free mortar, the corrosion rate was lower than 0.01 mA/m<sup>2</sup>, indicating the very passive state, while the corrosion rate at 5.0% of chlorides was equated to 410.83 mA/m<sup>2</sup>. In particular, at 1.0% of chlorides in cast, the onset of corrosion was observed, of which the corrosion rate accounted for 1.63 mA/m<sup>2</sup>, in that the corrosion rate often exceeds  $1-2 \text{ mA/m}^2$  at initiation of steel corrosion [11]. In turn, the critical chloride concentration for the onset of corrosion was determined to range 0.8–1.0% by interpolating the curve for chloride vs corrosion rate.

The half-cell potential was simultaneously measured at corresponding concentrations of chloride in cast. As a result, it was seen that an increase in the concentration of chloride in mortar resulted in a decrease in the half-cell potential, being indicative of the corrosive state. For example, at 0.0% of chloride, the half-cell potential was equated to -251.3 mV vs CSE, while -485.0 mV of half-cell potential was measured at 5.0% of chlorides. The critical chloride concentration for corrosion of steel fibre was also determined by interpolating the curve for chloride vs half-cell potential, assuming that the corrosion potential is equated to -350 mV vs CSE at corrosion. In fact, the half-cell potential was -351.6 mV vs CSE at 1.0% of chlorides, as being mostly identical to the value determined by the corrosion rate measurement. Thus, it can be said that the corrosion resistance of steel fibre is higher than for steel reinforcement (i.e. rebar) in concrete, of which the chloride threshold level is often regarded as 0.4–0.6% by weight of cement [12]. The higher resistance of steel fibre to chloride-induced corrosion may be attributed to the presence of protective millscale on the surface, being resistive against oxidation and thus pit nucleation. In the present study, the millscale was not removed to mimic in-situ conditions.

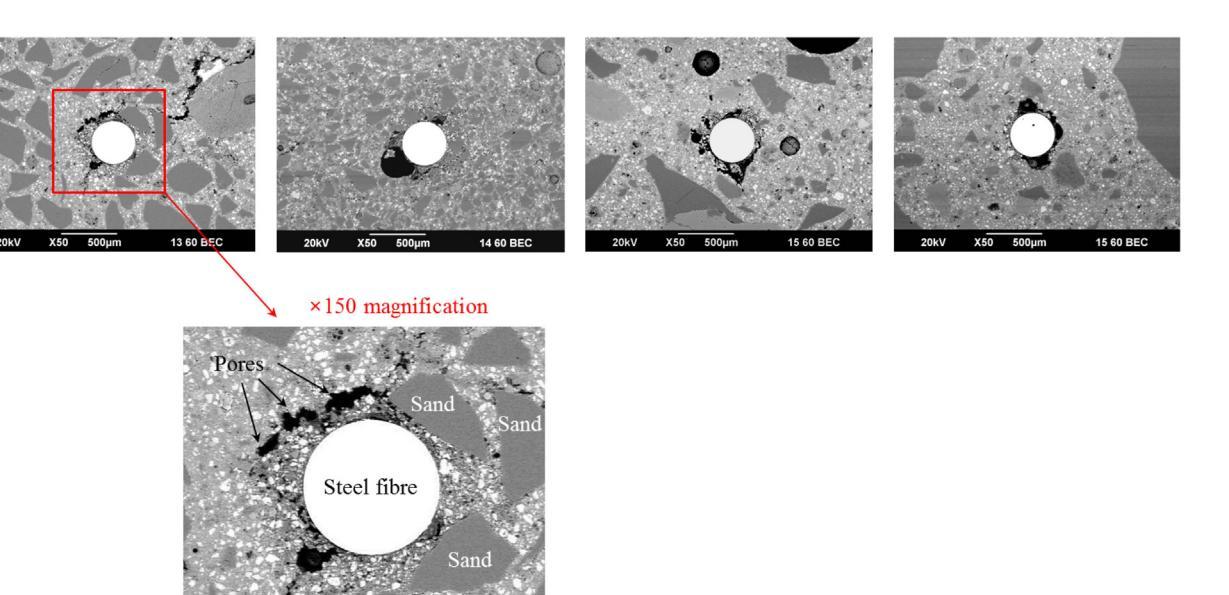
Fig. 5. BSE images for the interfacial zone of steel fibre in mortar at ×50 magnification and explanation of pixels at ×150 magnification.

Microscopic observation at the interface of steel fibre in mortar was performed by SEM imaging at  $\times$ 50 to evaluate the distribution of hydration products and porosity, as shown in Fig. 5. To observe the distribution of pores in-depth, the image containing the steel fibre was further magnified at  $\times$ 150 if necessary. It is evident that a number of pixels indicating pores and air voids were present in the vicinity of steel fibre, of which the size was ranged at 10– 400 µm in different shapes. Air bubbles generated in casting concrete are usually cling to or underneath the steel fibres, which are subsequently formed in hardening. After compaction and vibration, the residual air bubbles may be still deposited along the steel fibre, presumably due to membrane potential between on the surfaces of steel fibre and air bubble. As the pores (i.e. air

bubbles) are mainly formed in the vicinity of the steel fibre, adverse effects to concrete properties may occur, for example, a reduction of bond to cement paste.

Pores generated underneath the steel fibre, seemingly in the process of casting fresh mortar, may impose adverse effects in developing properties of concrete containing steel fibres. The pores in the vicinity of steel fibre are in the range of entrained air void. accounting for up to several hundred  $\mu$ m, as seen in Fig. 5, thereby leading to a reduction of strength of concrete; in fact, an increase in the air voids in concrete result in a decrease in the strength about 5–20%. Steel fibres in concrete is presumed to enhance the capacity to an external loading in terms of compressive and tensile strengths simultaneously, as the steel fibres are well dispersed in the longitudinal and transverse directions. Air voids formed in the vicinity of steel fibre, however, may partially offset increased buffering to external loadings. The air void generated by the steel fibre in concrete has not been clearly quantified, except for a current study showing that air voids at the interface of steel fibre were calculated by a 2-dimensional counting of pores [14]. The increased air void was about 0.5-1.0% depending on the shape of pores, and thus the compressive and tensile strength would be more or less reduced, although its strength might be still higher than for steel fibre-free concrete. Therefore, to maximise the benefit of steel fibre in concrete, a removal of air voids must be accompanied.
